**PHASE II
ENVIRONMENTAL SITE ASSESSMENT**

**FLOOD CONTROL DISTRICT
OF
MARICOPA COUNTY**

**OLD CROSS CUT CANAL
EXCELTECH PROJECT NO. 5-50063-51
FEBRUARY 1991**

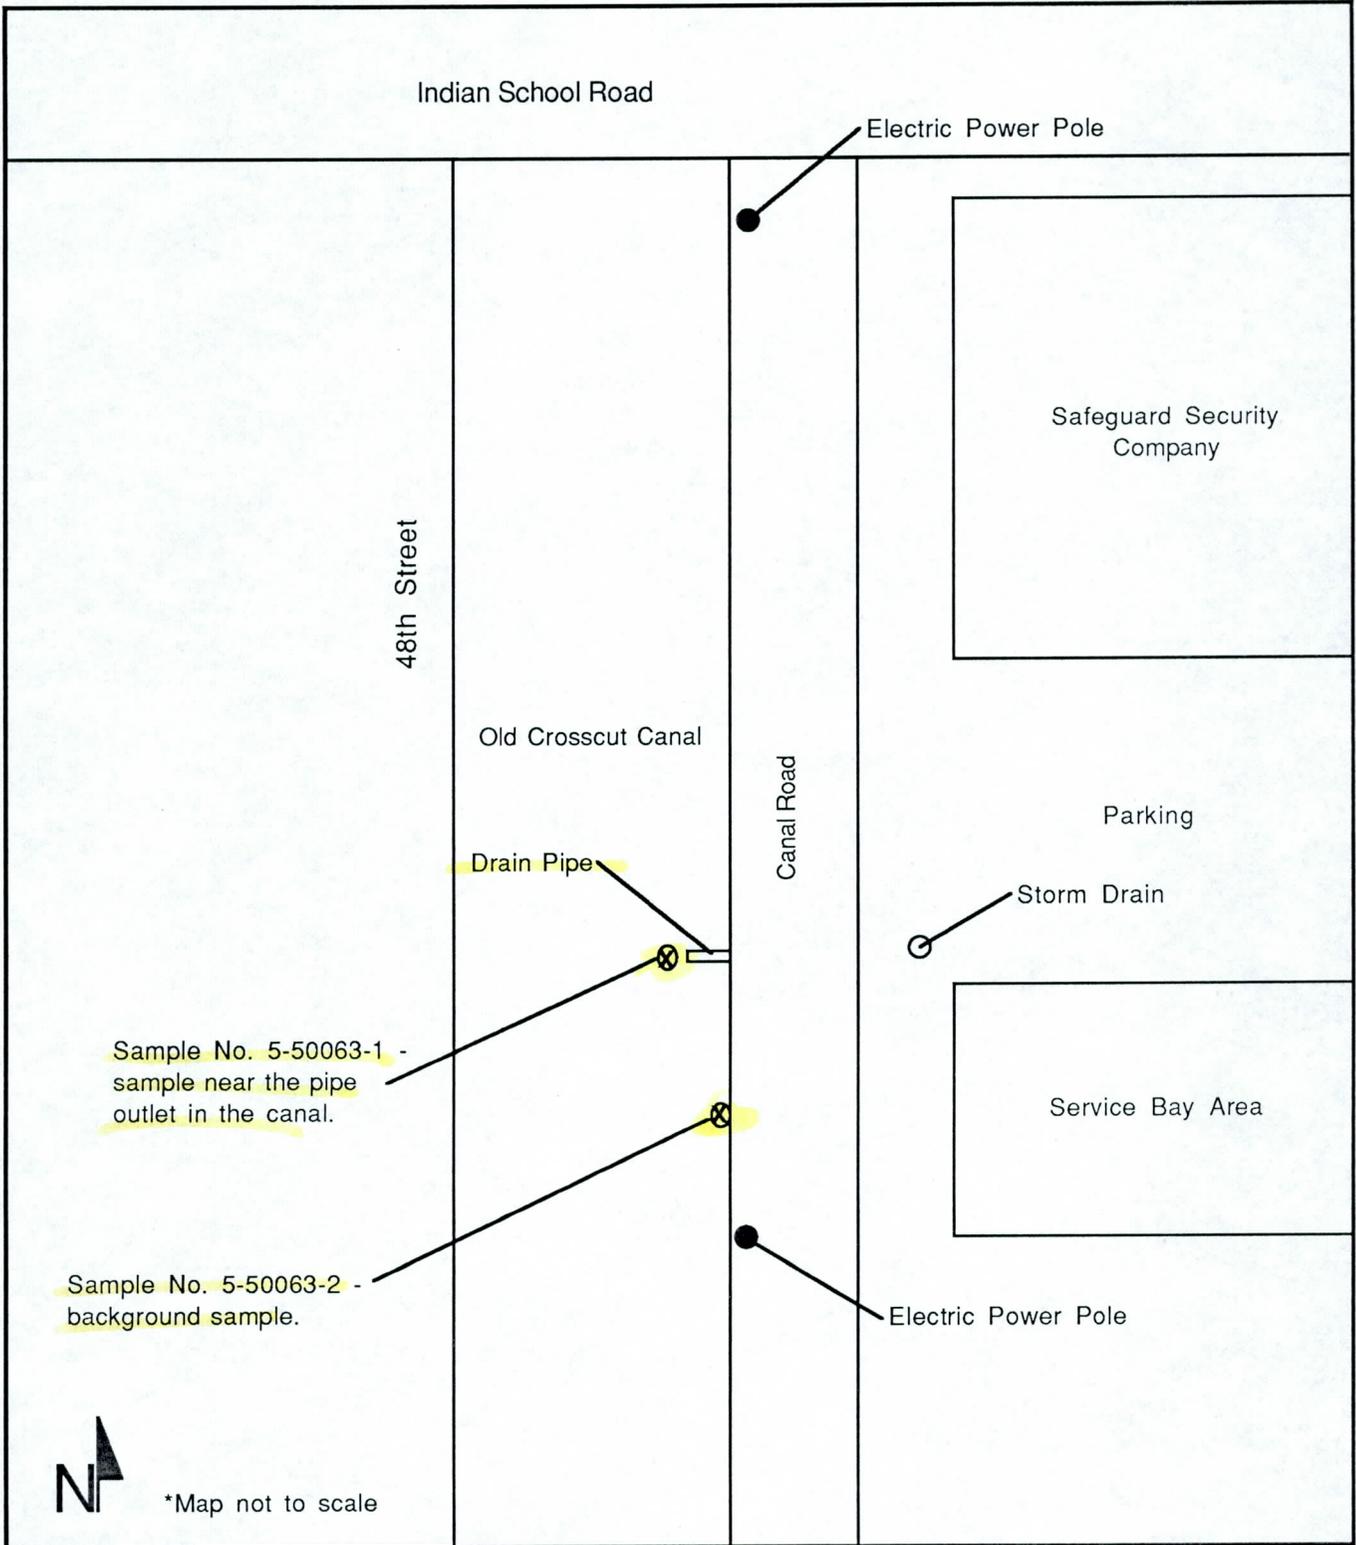
DRAWING #
50063-B1

Two near surface soil samples were collected. The first sample, labeled as Sample No. 5-50063-51-1, was collected directly beneath the pipe outlet in the area of the heaviest staining. The second sample, labeled as Sample No. 5-50063-51-2, was collected from the upper east side of the canal bank above the area of staining. Sample No. 5-50063-51-2 location is 25 feet north of the second power pole that is south of Indian School Road (3 feet west of the wire support for the power pole). This second sample was the background soil sample. Refer to the Site Specific Map in Appendix B for

the sample locations; designated on the map as Sample No. 1, for Sample No. 5-50063-51-1, and as Sample No. 2, for Sample No. 5-50063-51-2.

SITE SPECIFIC MAP

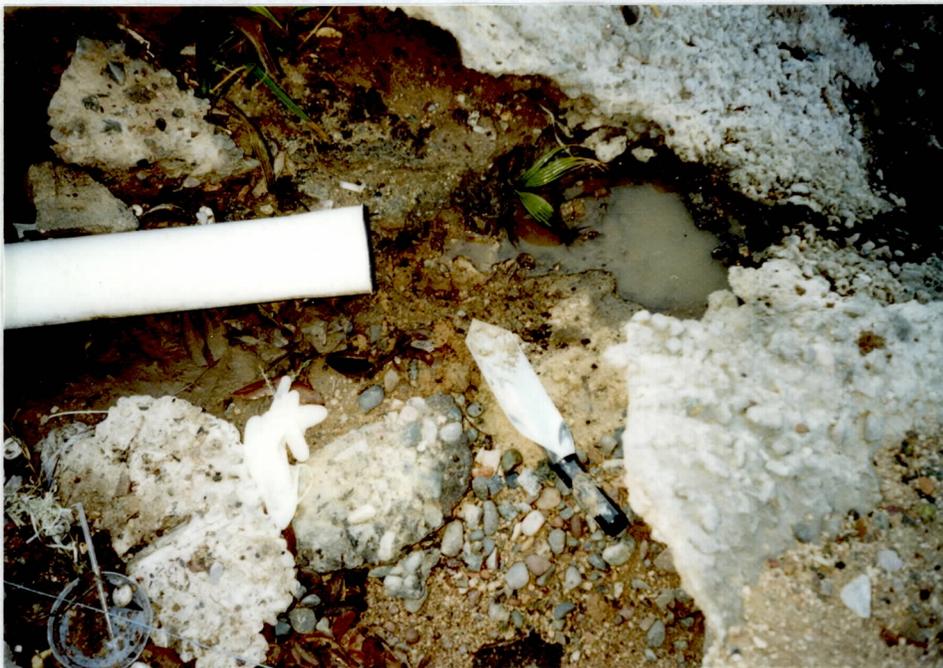
The area of stained soil sampled was located at the north end of the Property, just south of Indian School Road, on the east side of the canal. A 4 inch PVC pipe protrudes from the upper east side of the canal bank. The discharge from the pipe drains down into the bottom of the canal. The pipe originates from the Safeguard Security Company service bay area, located directly east of the Property. The soil directly beneath the pipe outlet shows evidence of staining from a black substance with an oily sheen and that has an odor characteristic of petroleum hydrocarbons, such as motor oil.

Sample No. 5-50063-51-1:
soil sample from area of
staining beneath the PVC
drainage pipe on east canal
bank.

A brief listing of the results are presented below. The results indicated that total petroleum hydrocarbons were identified in Sample No. 5-50063-51-1, at a level below the Arizona Department of Environmental Quality (ADEQ) clean up level of 100 mg/kg (ppm) in the soil. Total xylenes were also identified in Sample No. 5-50063-51-1 at a level well below the ADEQ clean up level of 44 mg/kg (ppm). There were no TCLP Metals detected in either sample.

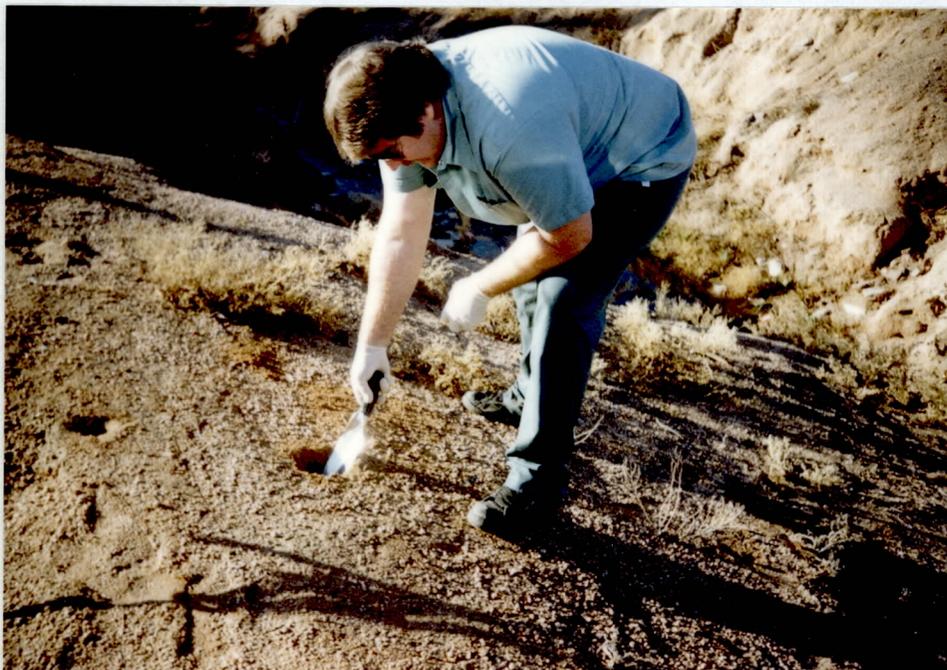
Sample No. 5-50063-51-2:
sample collected from area
of canal bank above the
stained area to be used as a
background sample.
