Attachment 7 ENVIRONMENTAL RESOURCES REPORT

El Rio Watercourse Master Plan and Area Drainage Master Plan

EL RIO ENVIRONMENTAL RESOURCES REPORT

**FLOOD CONTROL DISTRICT
of
Maricopa County**

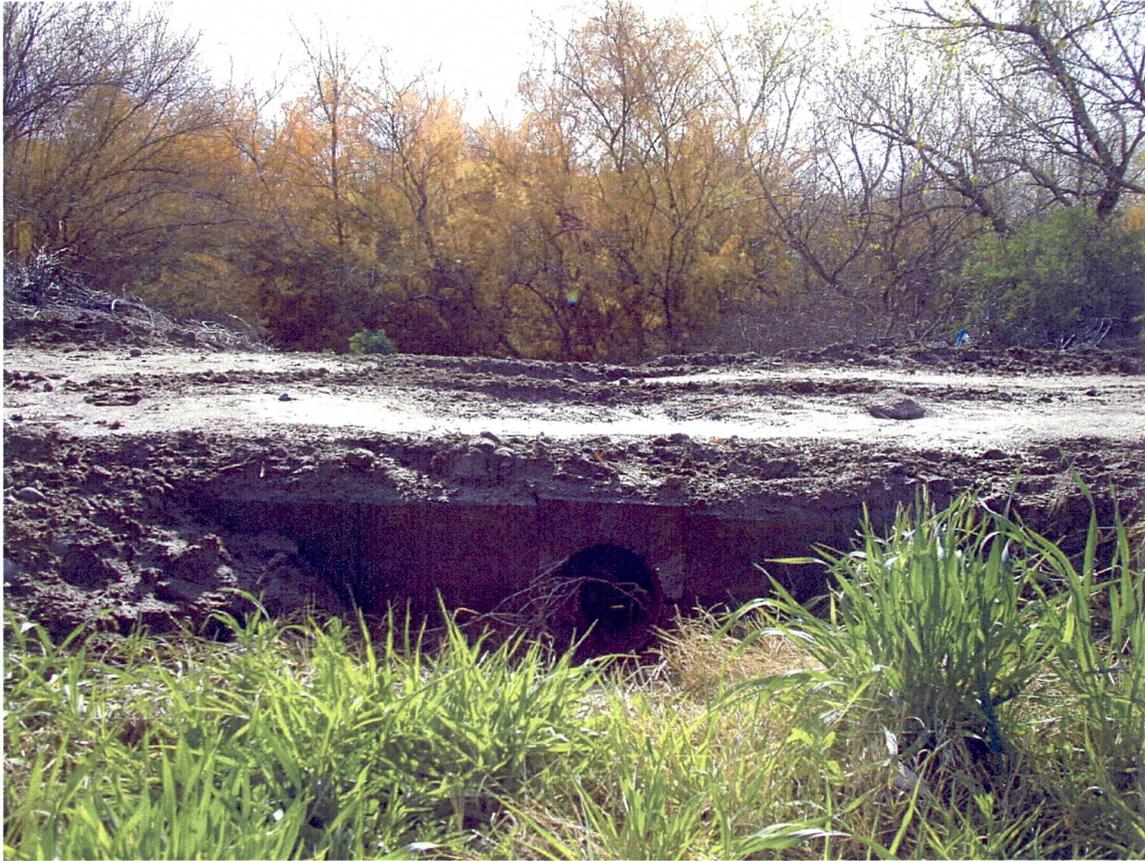
Figure 1: Pipe draining agricultural field directly in to floodway of Gila River.

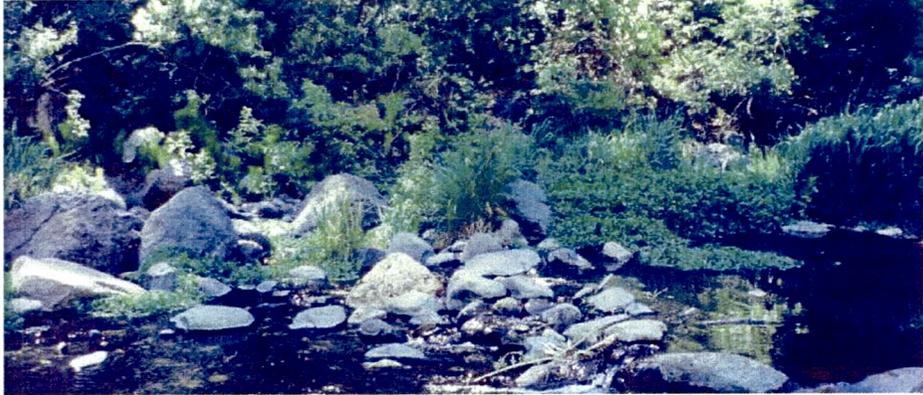
Figure 9: Flowing Water

Flowing waters: Mosquito and midge species found in central Arizona rarely breed in flowing waters. Water movement is not conducive to oviposition or larvae survival. Figure 9 contains an example of a flowing water body in the project area.

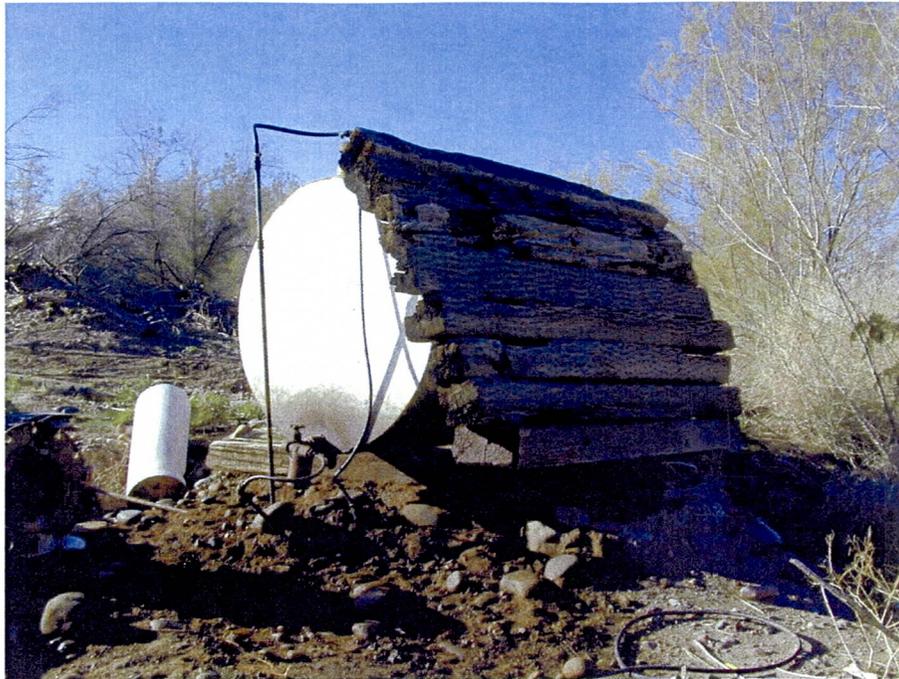
LUST's were not listed within the El Rio project area or within one-half of a mile from the project area. However, the study team did identify a leaking aboveground storage tank (AST) in the Gila River Floodway between Sarival Road and Cotton Lane alignments (Photograph 1; Latitude and Longitude: 33° 23' 14.77" N & 112° 25' 00.85"). The size of the tank was approximately 500 gallons. It is unknown who owns the tank or what the material is, but it appears to be diesel fuel or oil. There was significant surface soil contamination, however, it's not known what the depth of the contamination is and, consequently, if the groundwater is potentially contaminated unless sampling is conducted.

Photograph 1: Leaking AST in the Gila River floodway between Sarival Road and Cotton Lane alignments.

- A leaking aboveground storage tank was identified in the Gila River Floodway between the Sarival Road and Cotton Lane alignments. The tank owner and leaking substance are unknown. The leaking substance appears to be oil or diesel fuel. This site has potential for soil and groundwater contamination.

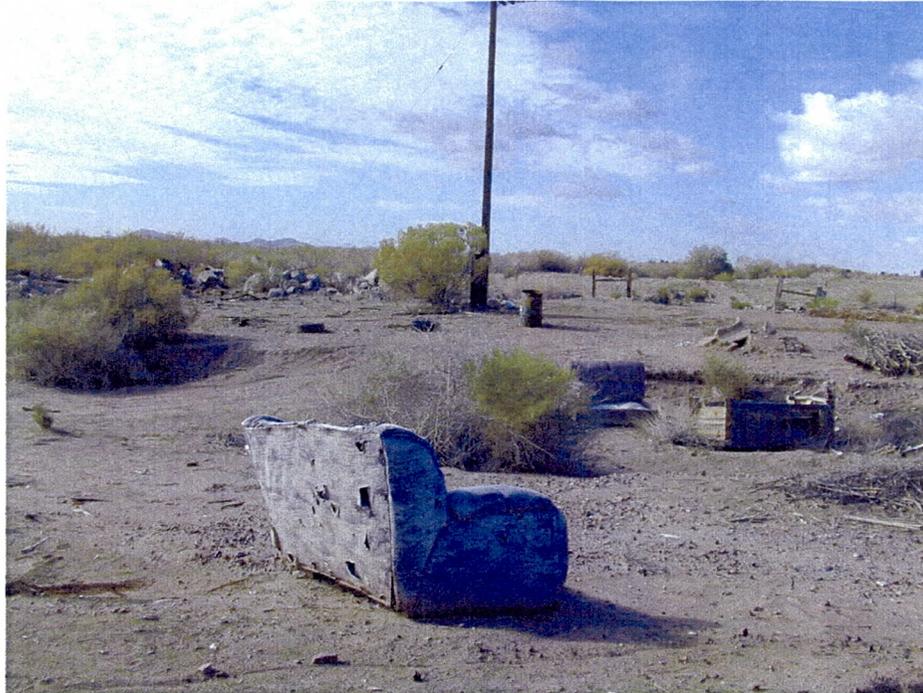
One closed solid waste landfill was listed as being located at Miller Road and the Gila River. The operator was listed as the town of Buckeye. No other closed, active, or inactive solid waste landfills were listed within the project area or within one-half mile search distance from the project area. However, throughout the Gila River and the project area, there are numerous illegal dumping sites (Photograph 2). Most of the solid waste appears to be general household waste, however, some suspect asbestos containing waste was observed.

Photograph 2: Example of the numerous illegal dumping sites throughout the Gila River

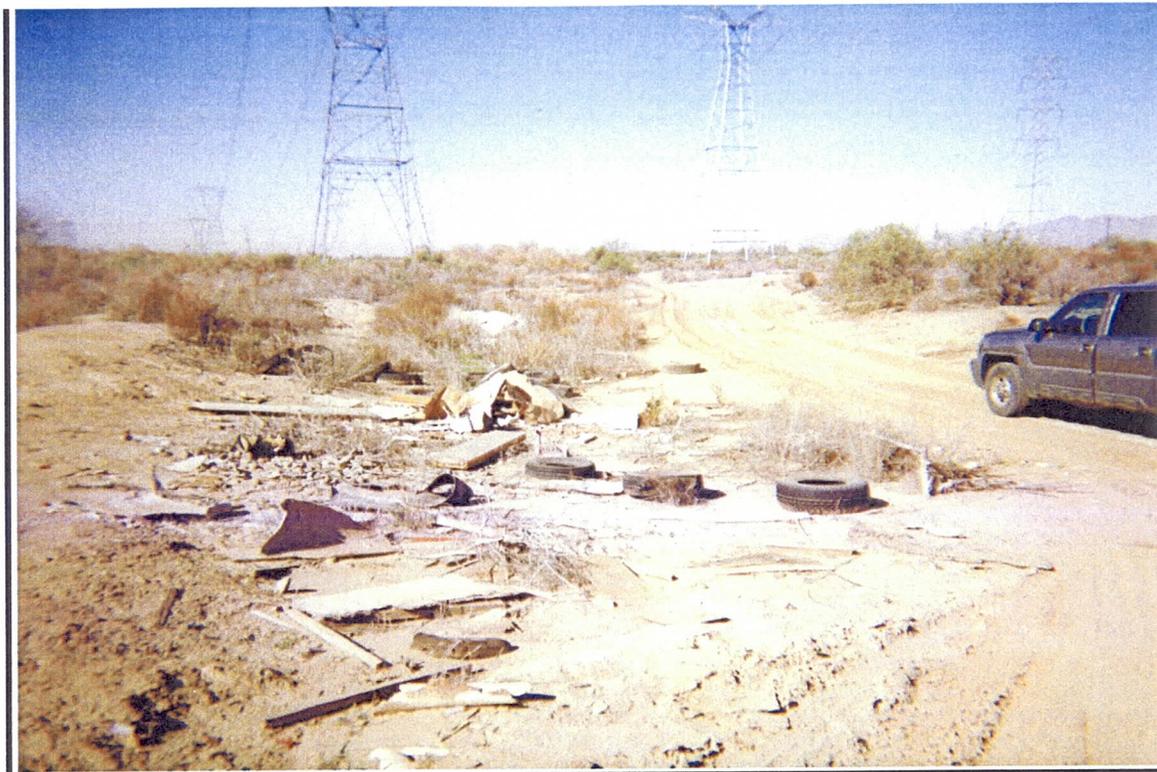
Photo 1: East view of discarded tires and construction debris in powerline ROW west of Estrella Pkwy.

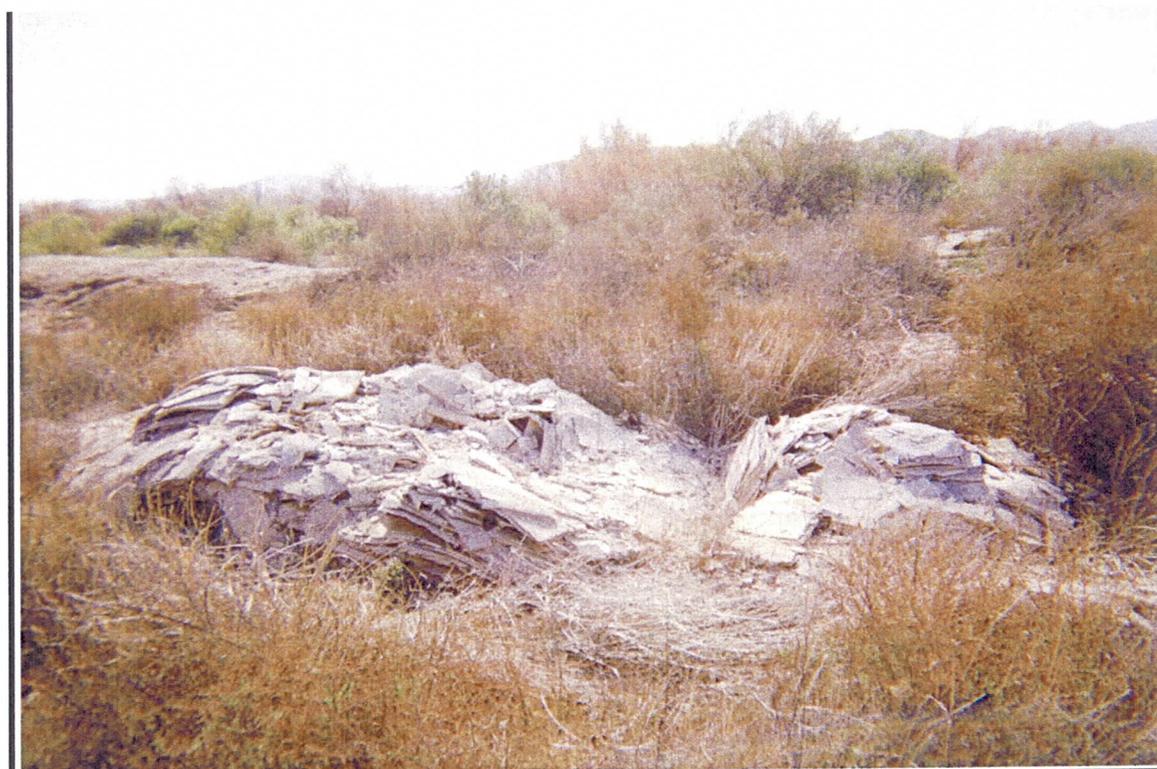
Photo 2: North view of dumped gypsum board (possible ACM) in the powerline ROW west of Estrella Pkwy.

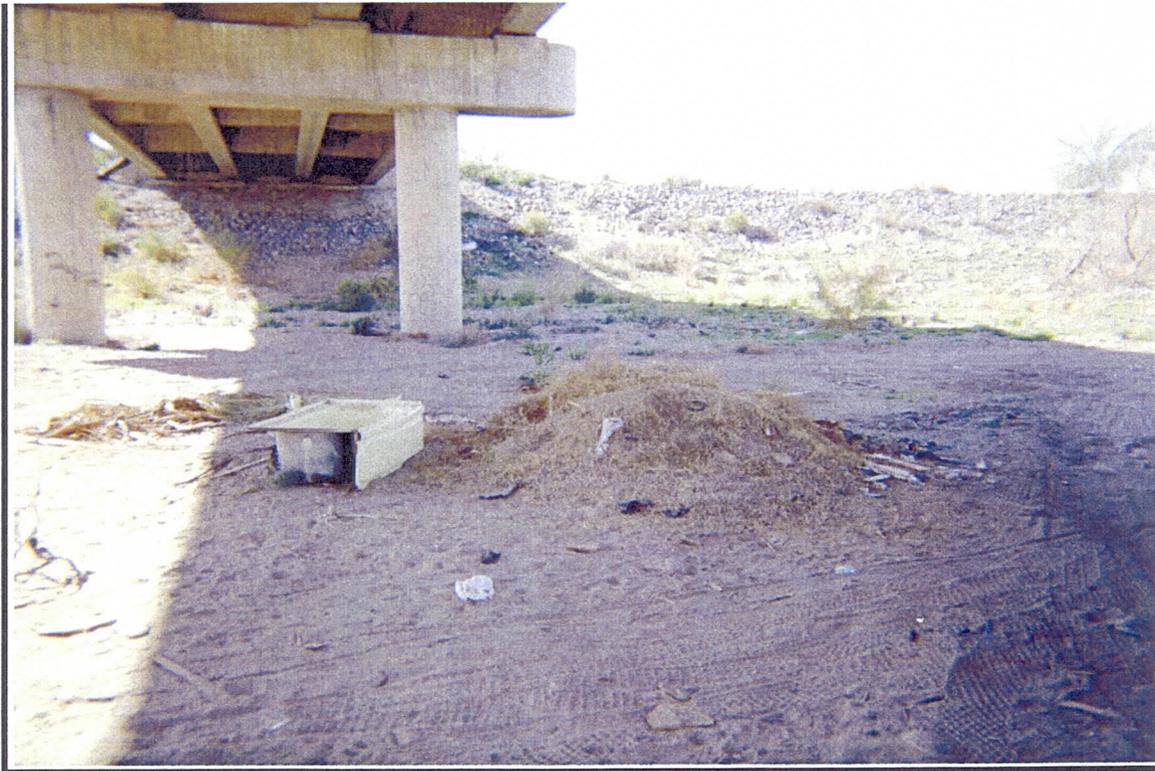
Photo 8: North view of bathtub and dumped landscape material under the Bullard Ave. Bridge.

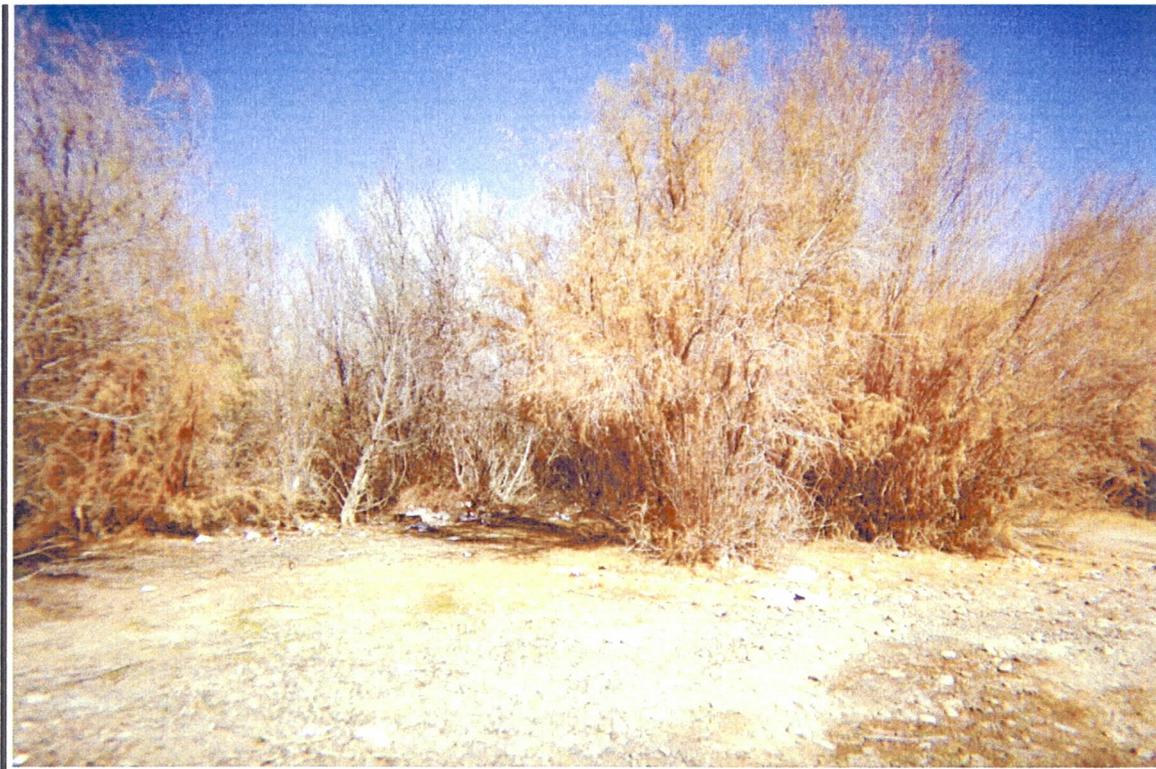
Photo 10: Litter and household trash in the Gila River, 2nd pond west of Waterman Wash.

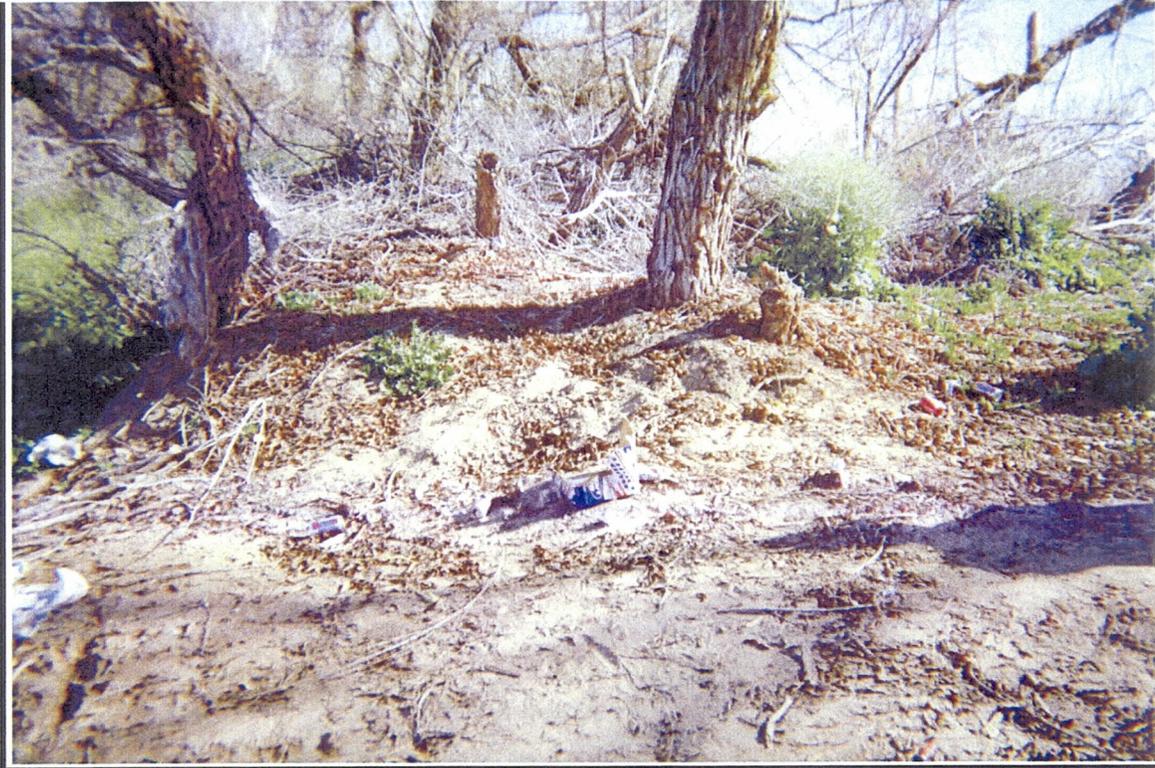
Photo 13: Litter and household trash in Gila River, 1st pond west of Waterman Wash.

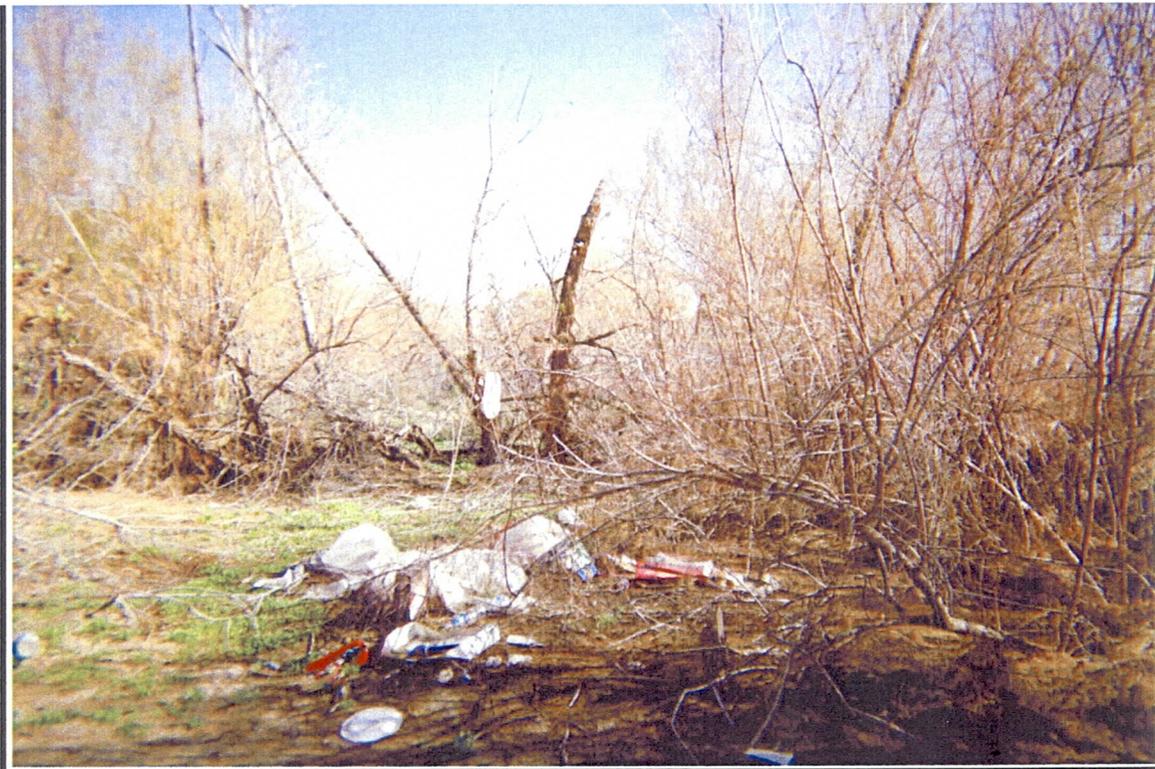
Photo 14: Litter and household trash in Gila River, 1st pond west of Waterman Wash.

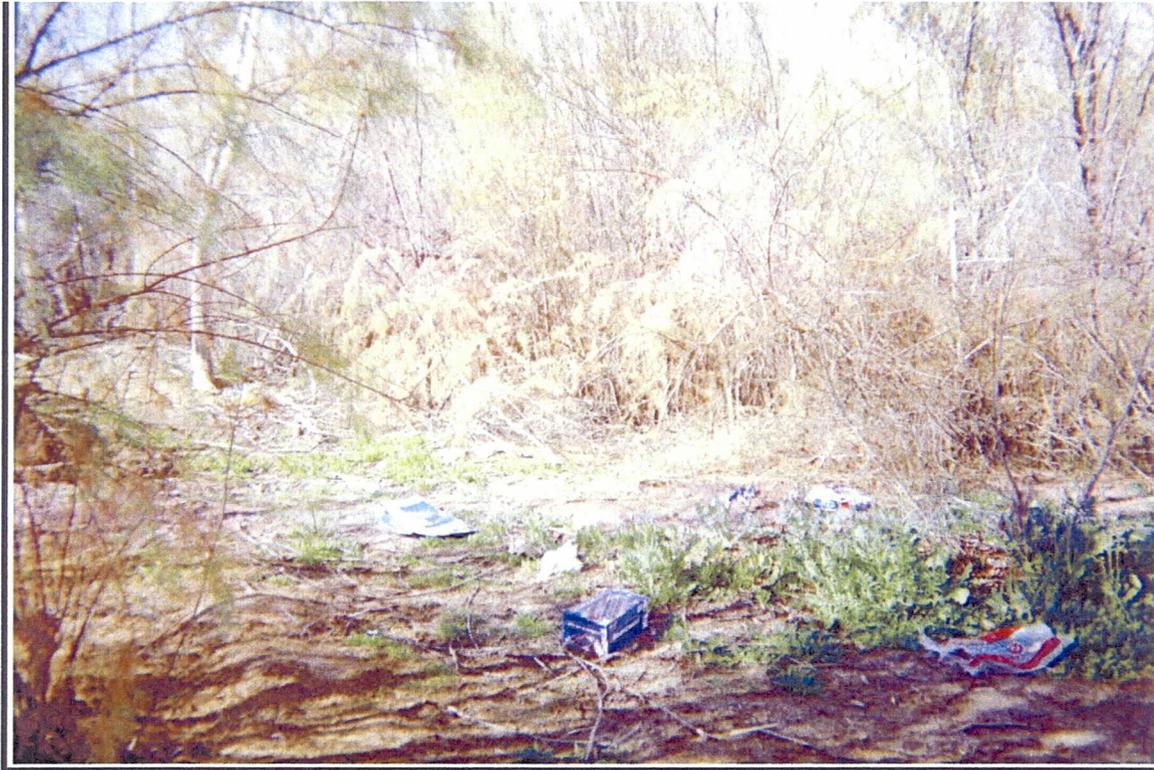
Photo 15: Litter and household trash in Gila River, 1st pond west of Waterman Wash.

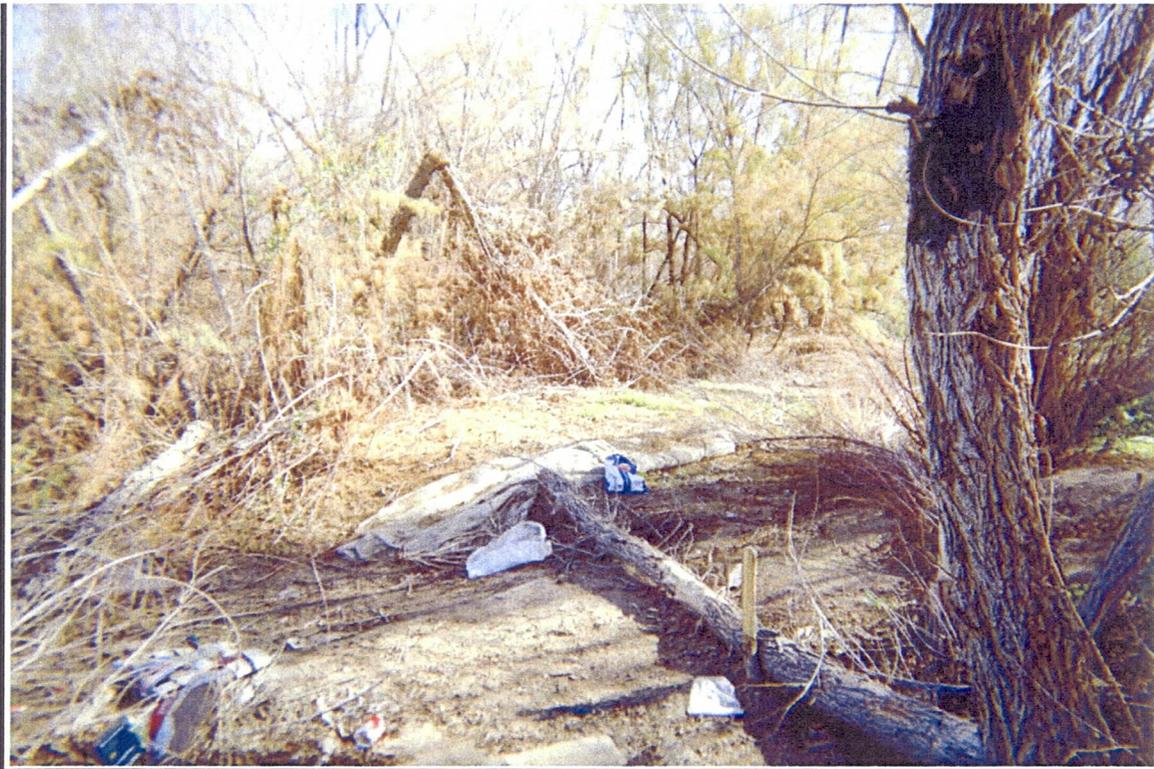
Photo 16: Litter and household trash in Gila River, 1st pond west of Waterman Wash.

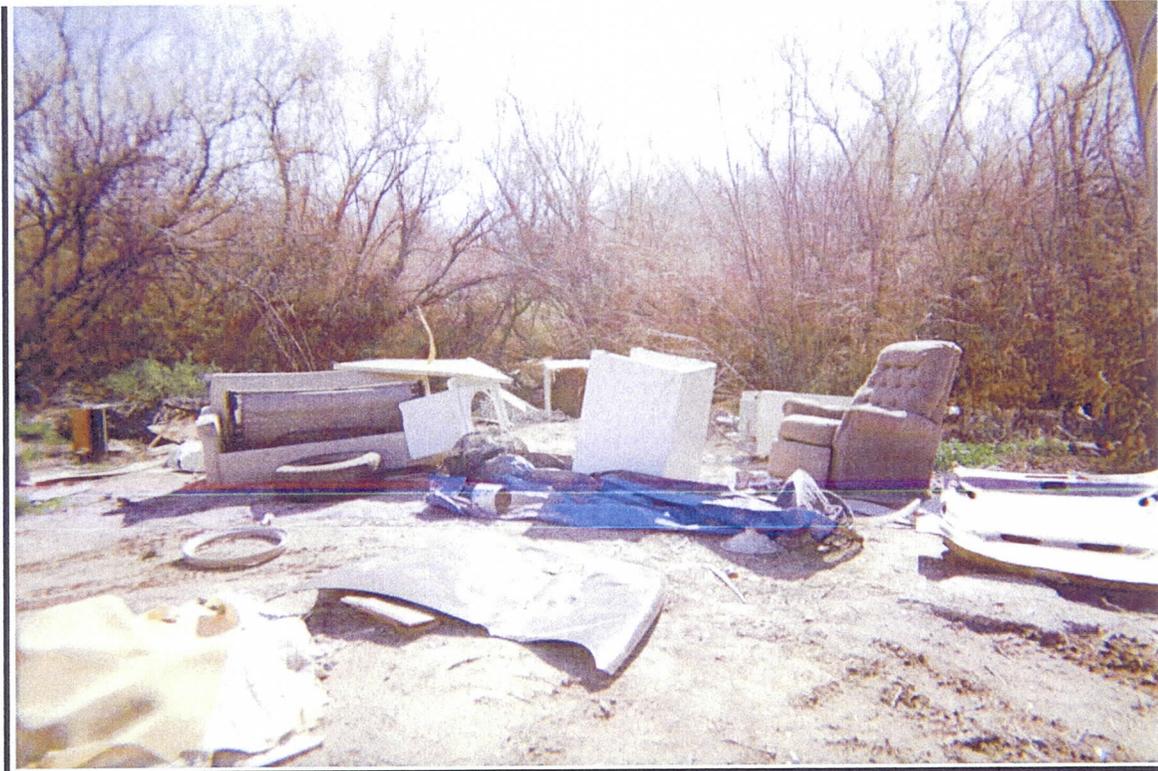
Photo 25: Dumped furniture and appliances along north bank of Gila River between Miller Rd. & SR 85.

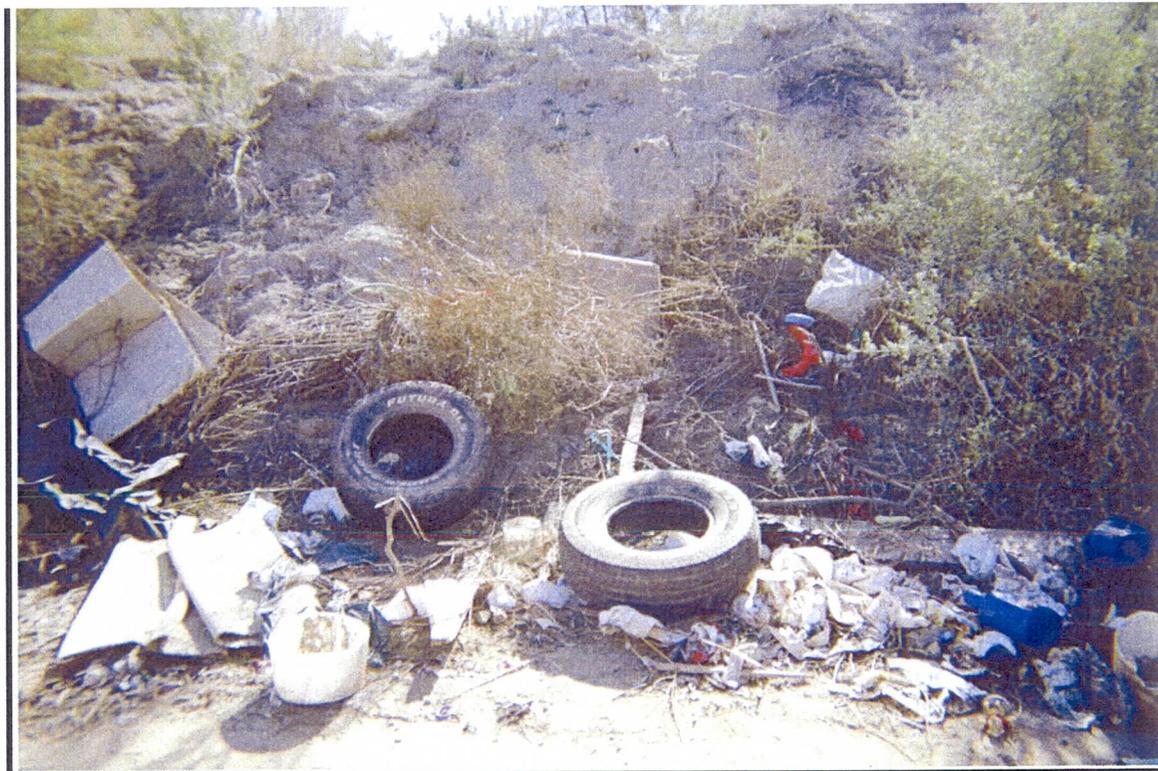
Photo 26: Dumped tires and household trash along north bank of Gila River between Miller Rd. & SR 85.

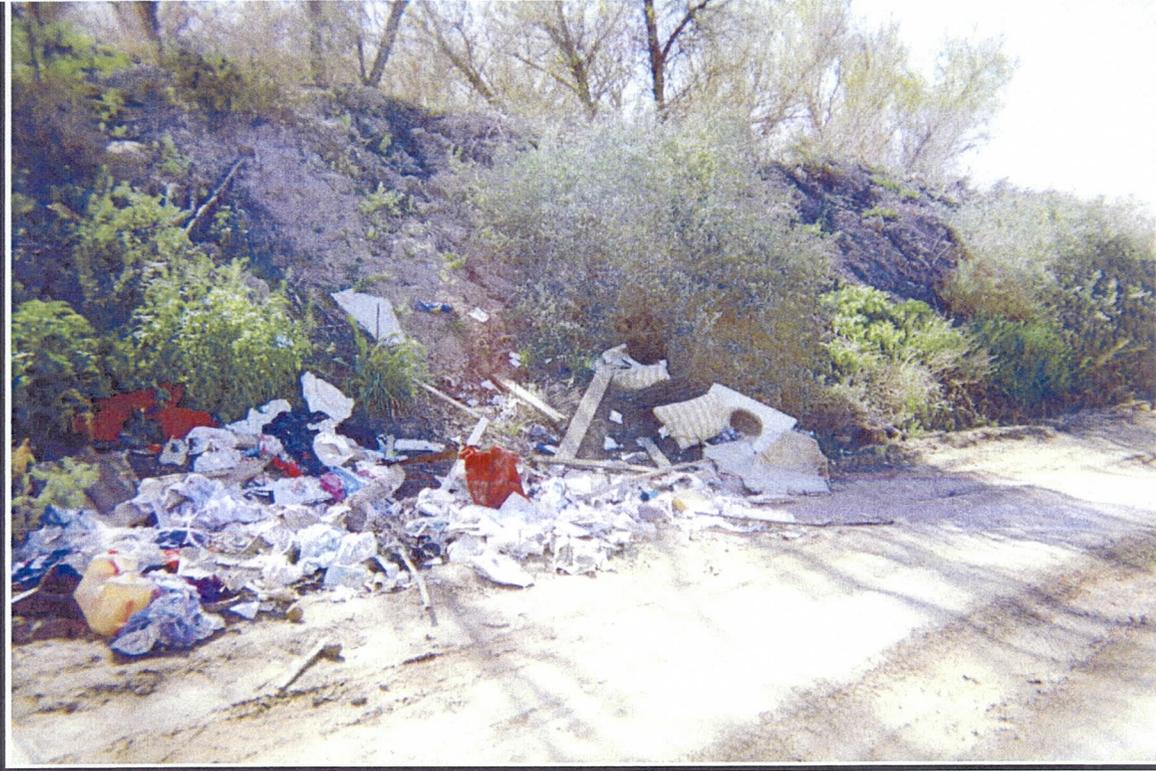
Photo 27: Household trash dumped along north bank of Gila River between Miller Rd. & SR 85.

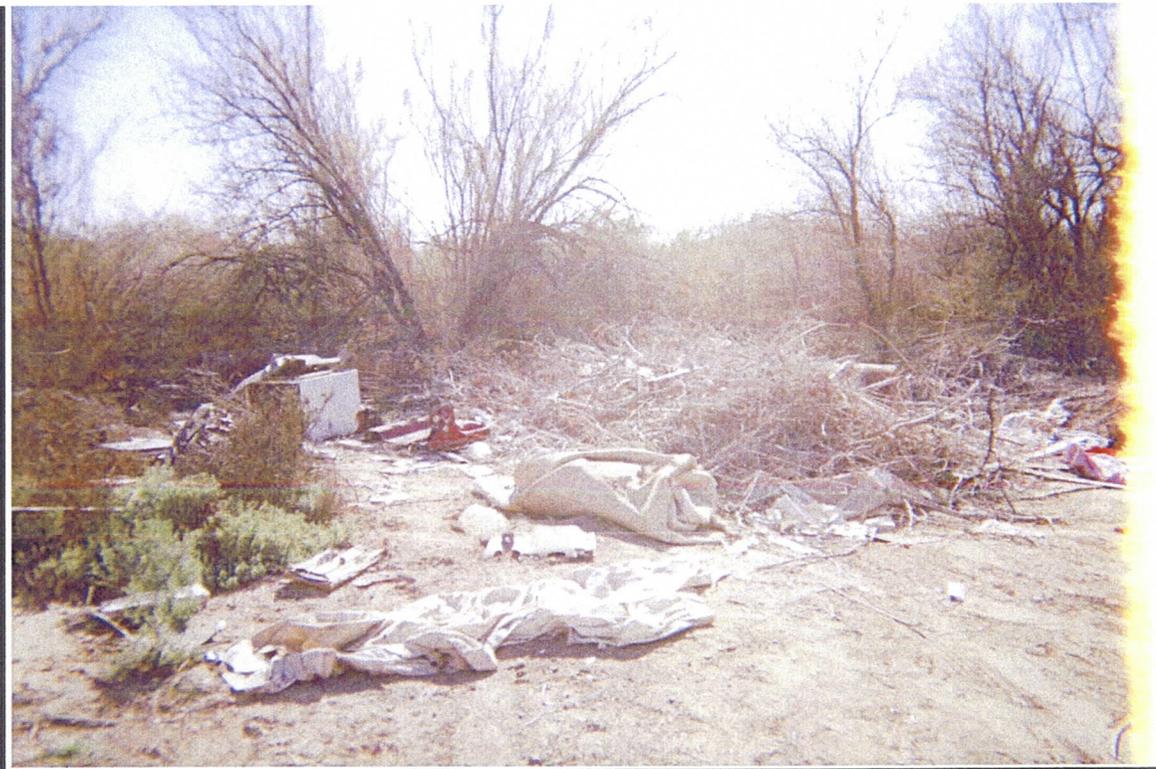
Photo 28: Landscape debris, household trash, and appliances dumped along the north bank of the Gila River between Miller Rd. & SR 85.
