**MATHEMATICAL MODELING OF FLOW  
OVER GILLESPIE DAM**

**HARZA** Engineering Co.

September 15, 1999

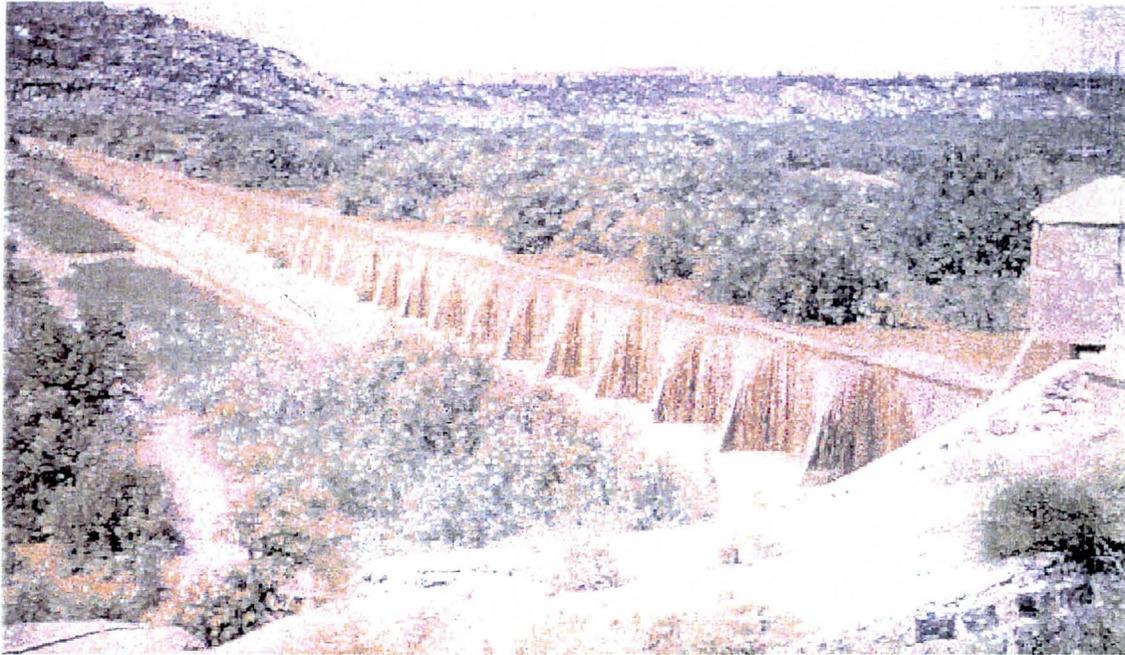
**Figure 1.** US Geological Survey photograph from the east side downstream of the Gillespie Dam taken in 1962. Note that sediment has been deposited to the top of the dam and there is a healthy growth of vegetation on it.

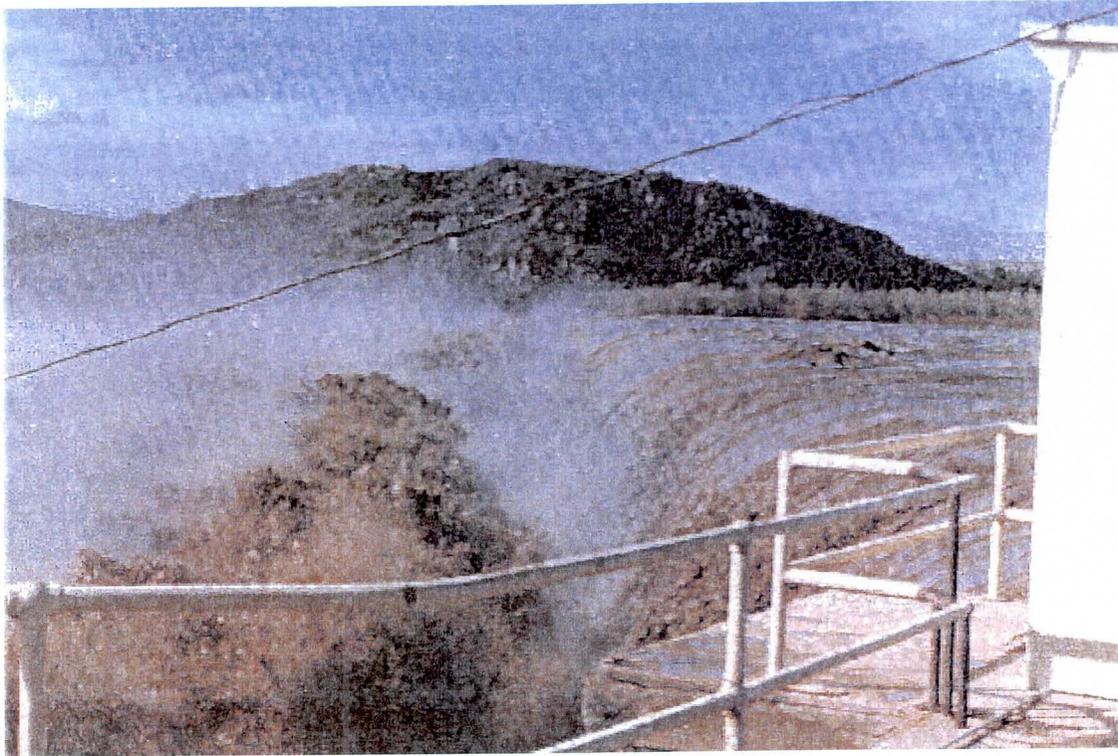
**Figure 2. Flow over the Gillespie Dam before the breach on 9 January 1993 (PILP 09939). The photograph was taken from the east abutment looking to the west.**

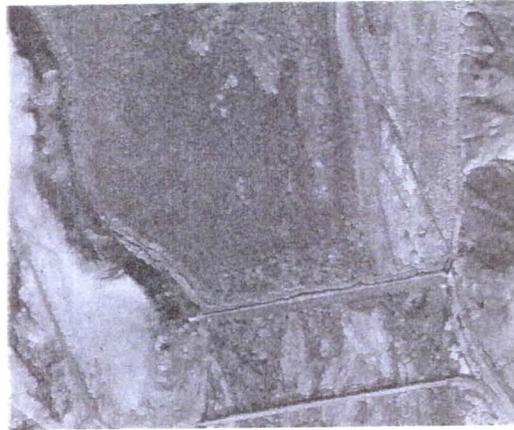
**15 Dec 1975**

Approximately 150 feet wide, the main channel was about 400 feet out from the east abutment. There is a diagonal feature on the photograph indicating a small excavated channel from the main channel to the intake of the Gila Bend Canal at the east abutment of the dam. North is at the top of the photograph.

The channel running along the west edge of the valley to the dam is the Arlington Canal.

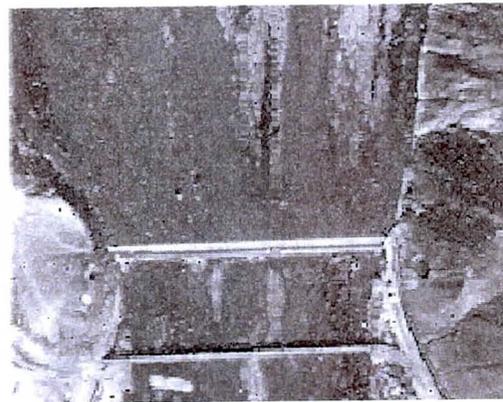
**15 Feb 1979**

After the series of three high flood peaks, the 1975 channel remained, but a bit to the west of the dam center, a new and larger main channel had formed, collecting much of the floodwater from the western side of the floodplain. Flow in the main channel had scoured a hole in the riverbed at the end of the apron. Part of the material from this scour hole was deposited in the wake of the central bridge pier at the highway bridge.

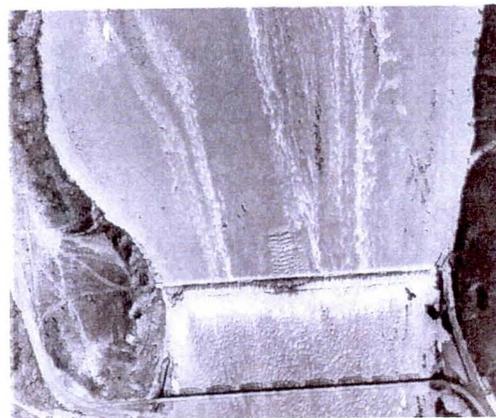
**16 Feb 1980**

At the height of the largest flood ever over Gillespie Dam, this same main channel of the previous year focused the flow at the dam. Evidence of this are the waves on the water surface just upstream from the dam crest and the extent and position of the water boiling up from the wall on the apron floor.

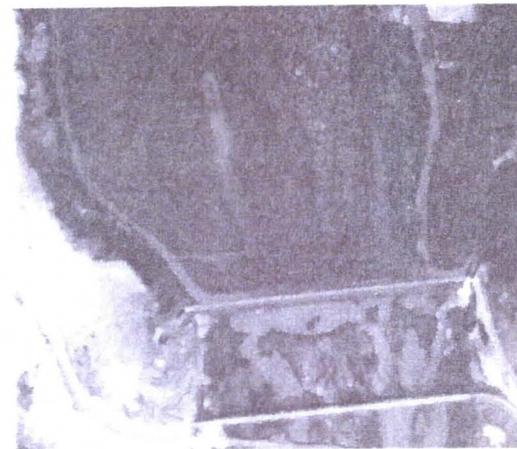
**5 Dec 1982**

A year later, channel conditions remained the same. The 1,000-foot wide corridor had been cleared to within 1,500 feet of the dam. Some new trees were encroaching on the edges of the main channel

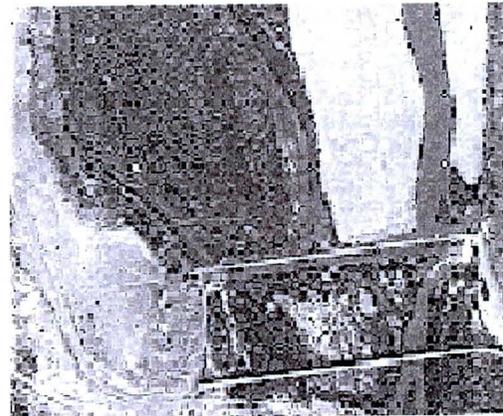
**8 Nov 1986**

The east branch of the two channels had moved to the east at the dam bringing low flows almost directly to the Gila Bend Canal intake. An embankment had been constructed across the west branch. Maintenance of the 1,000-foot wide corridor (light shade) was in progress right down to the dam.

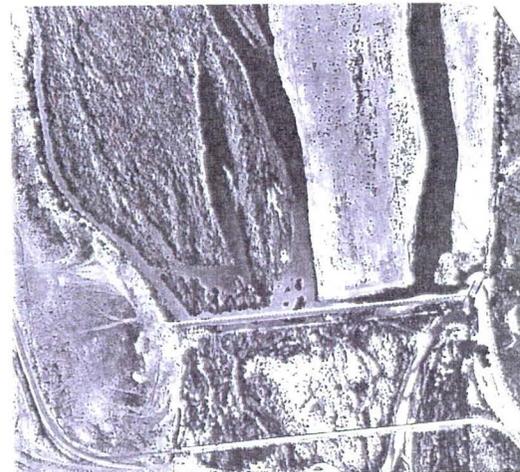
**30 Jun 1989**

The channels remained essentially the same as in 1986 with the west branch of the main channel blocked and the east branch carrying the low flows. In 1989, a growth of vegetation had become established on the apron of the dam, downstream from the wall.

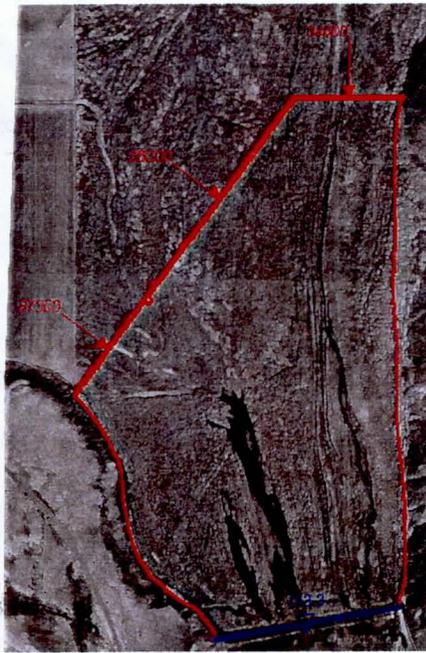
Figure 6-G. 1980 Model.

Unit discharge (cfs/ft)

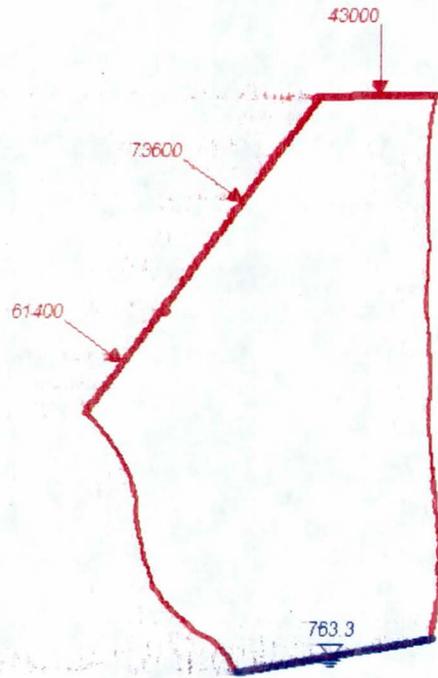
Figure 8-G. Trees Model.

Unit discharge (cfs/ft)
