**Maricopa County
Department of
Transportation**

**Bridge Scour Investigation
and
Design of Corrective Measures**

Final Report

MC 85 Highway Bridge over Agua Fria River

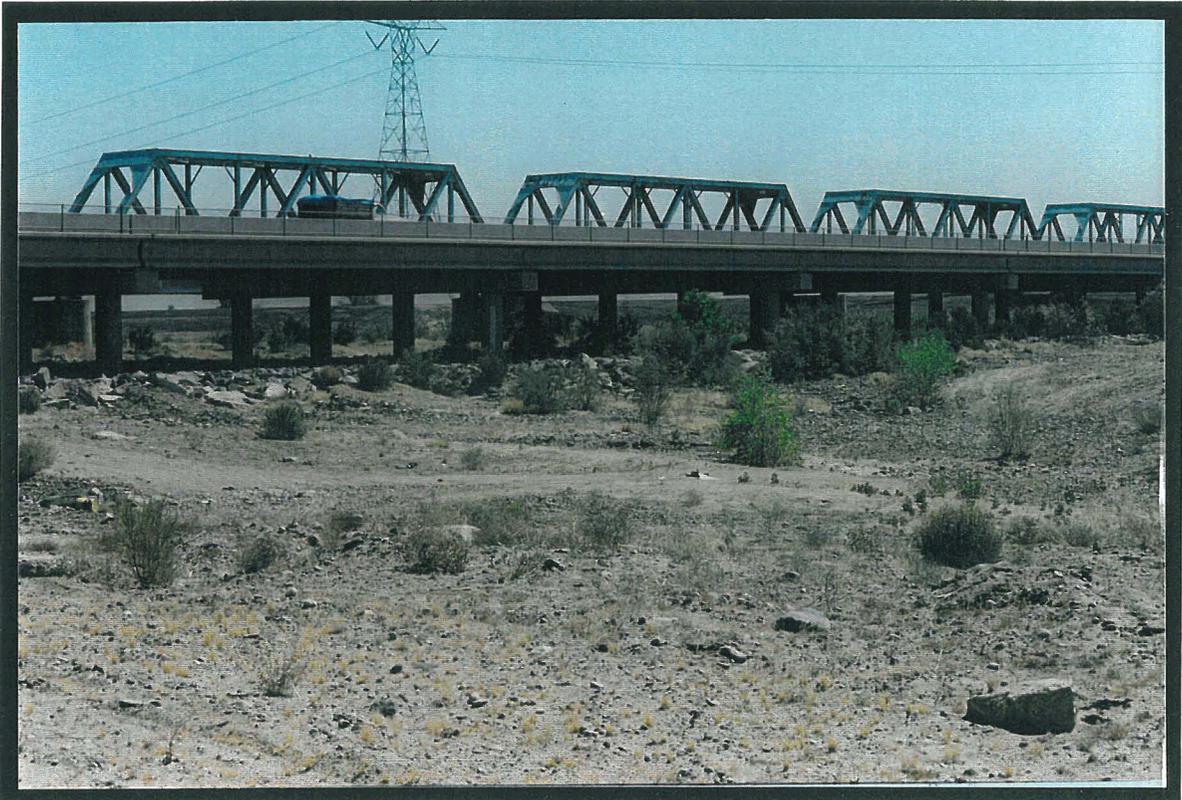
1. Movement of individual stones from the dumped riprap is evident.
2. There is a three to five foot head cut near the downstream face of the dumped riprap and additional degradation noted further downstream. Based on this observation, it is recommended that a long-term scour estimate of five (5) feet be included in the total scour for the bridge site.

Channel Degradation Downstream

If the long-term degradation estimate is added to these values, the recommended toe-down is 12 feet for the 100-year event and 17 feet for the 500-year event.

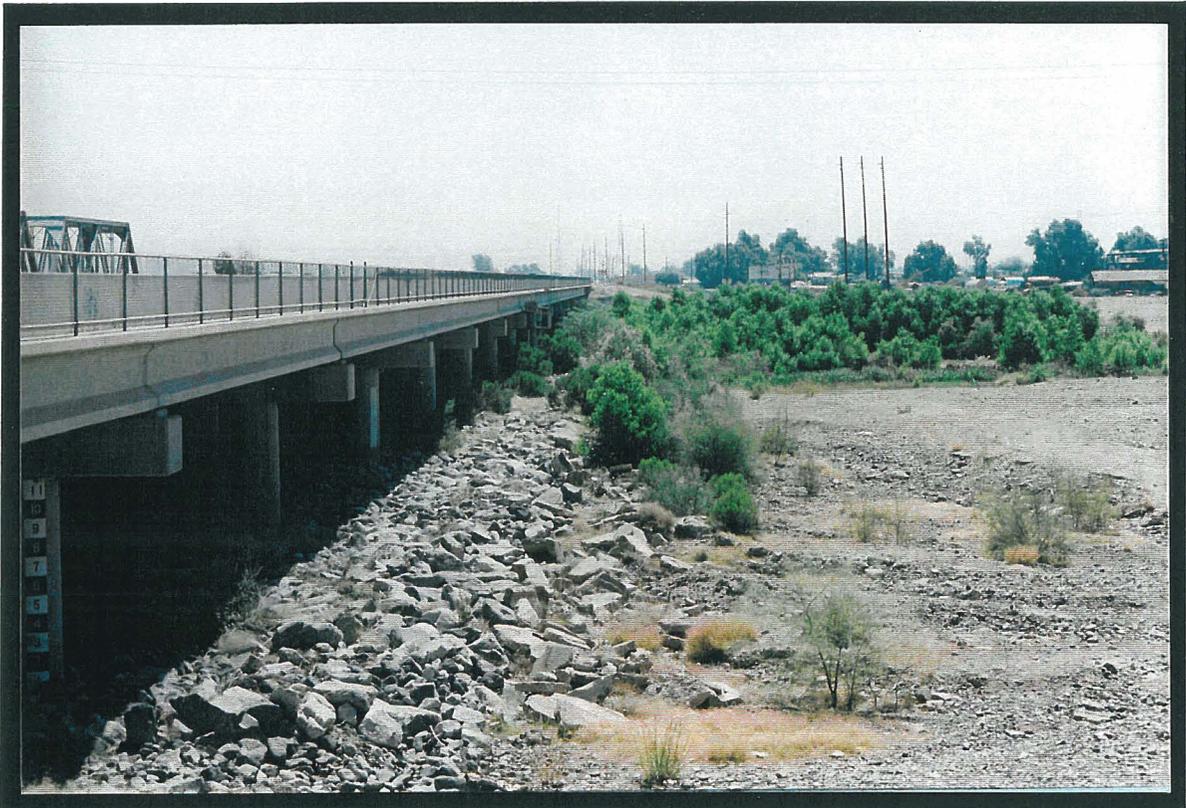
Riprap Moving Downstream and Channel Degradation

A discussion at the site concluded that a soil cement floor would appear to be the most feasible alternative. The in-situ material is well suited for soil cement. The dumped riprap should be placed at the downstream edge of the new floor cut off wall. Any material left over should be salvaged for use at other sites within the County.

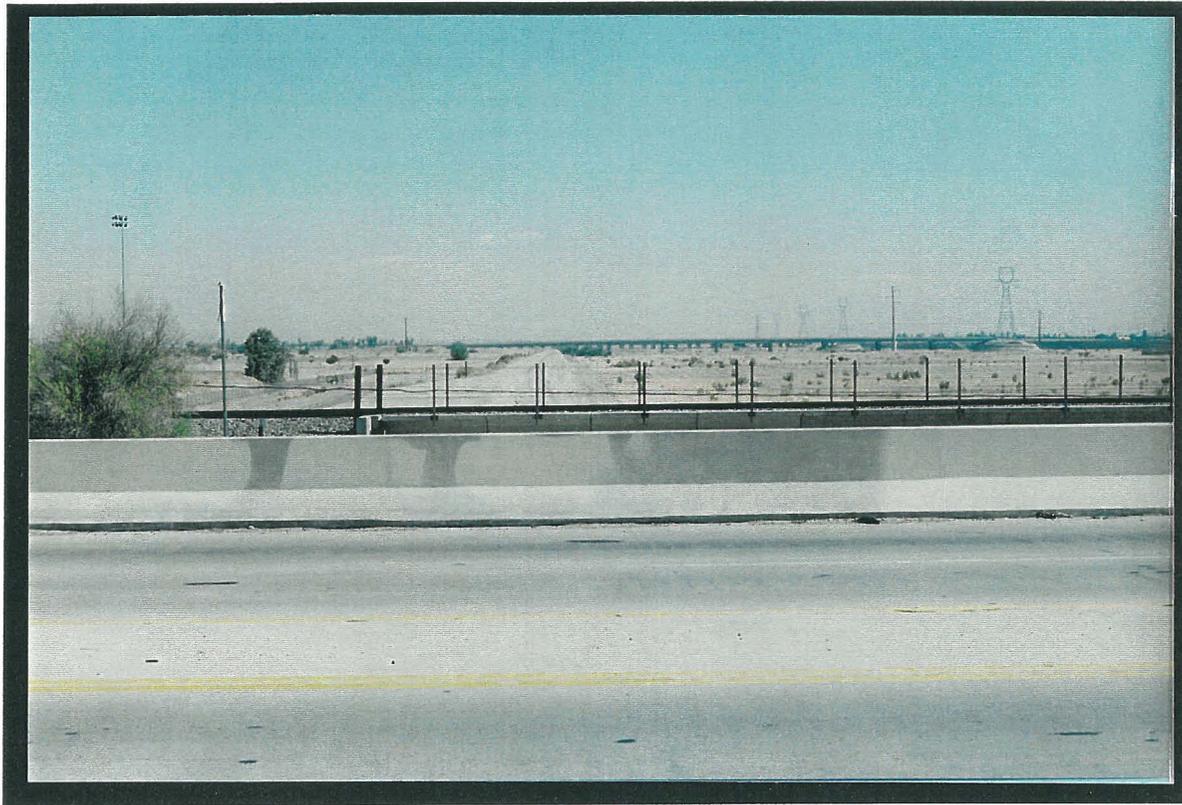
5. Both east and west river banks are protected by soil cement that is in good condition. Both abutments are adequately protected.

West Bank Upstream

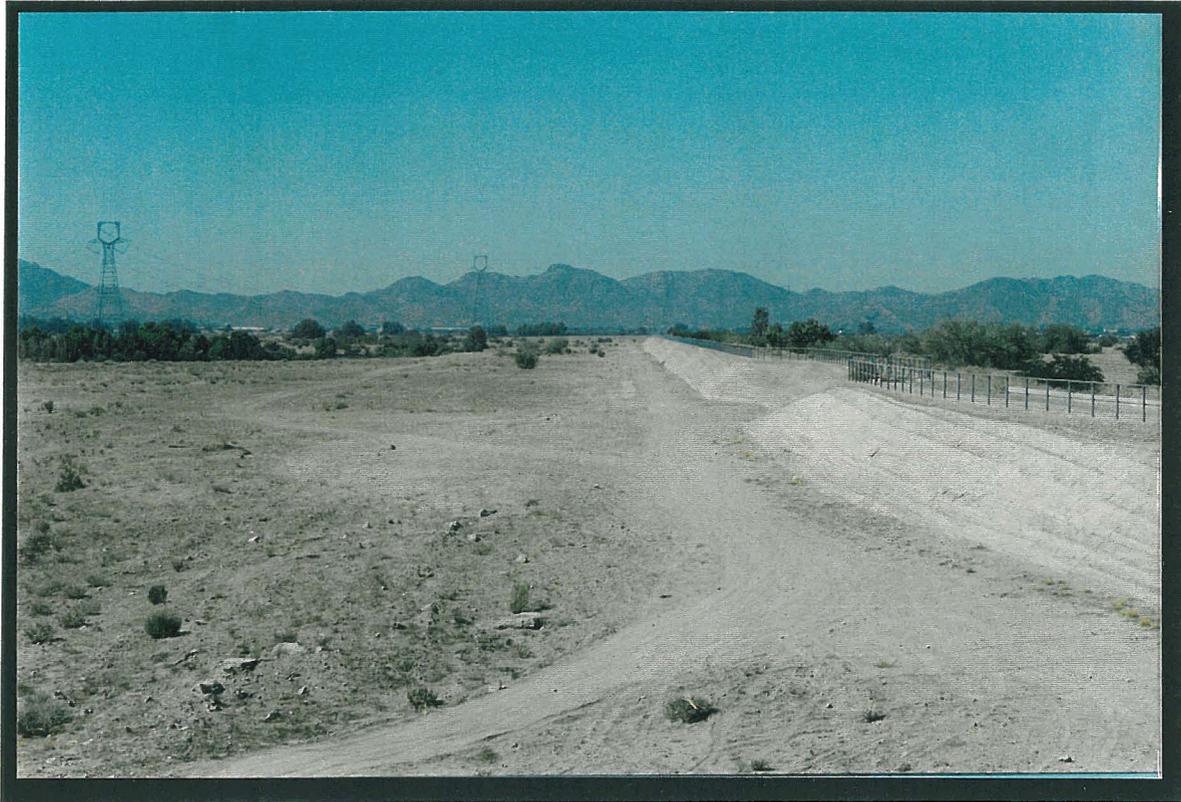
West Bank Downstream

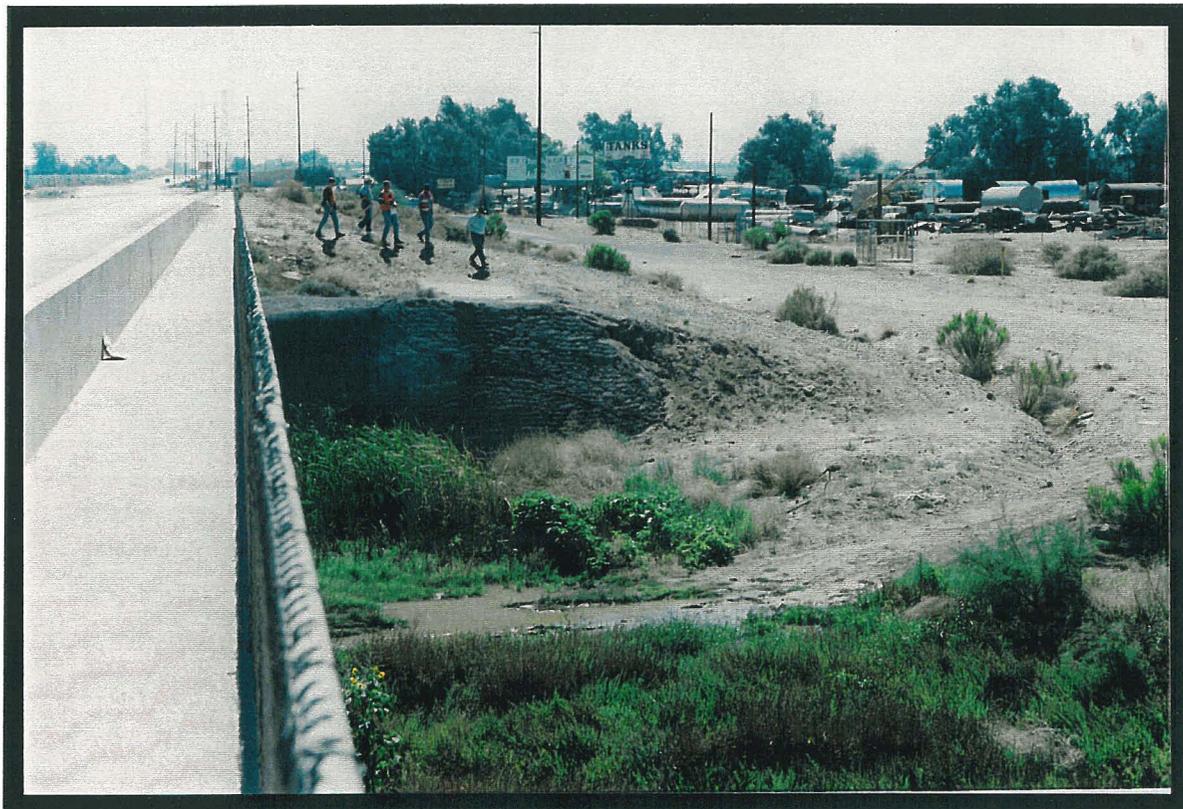
Southeast Corner of Bridge

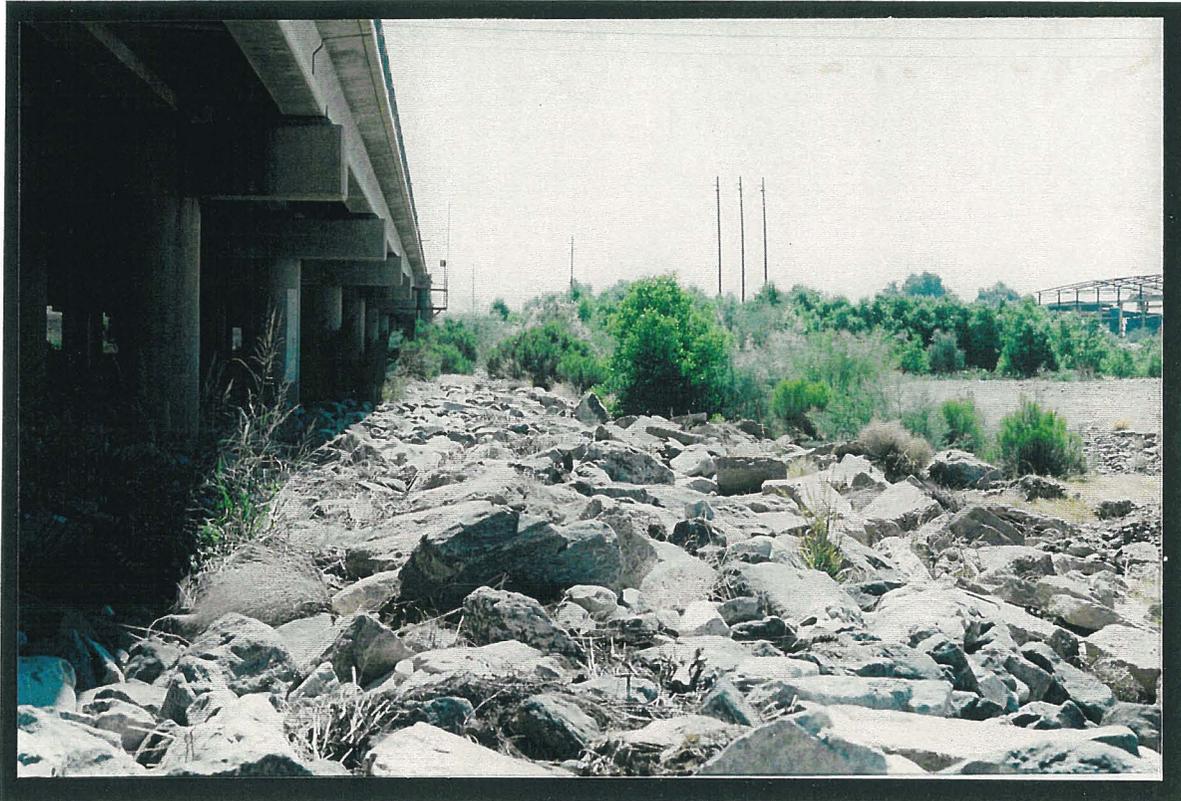
Typical Size of Dumped Riprap

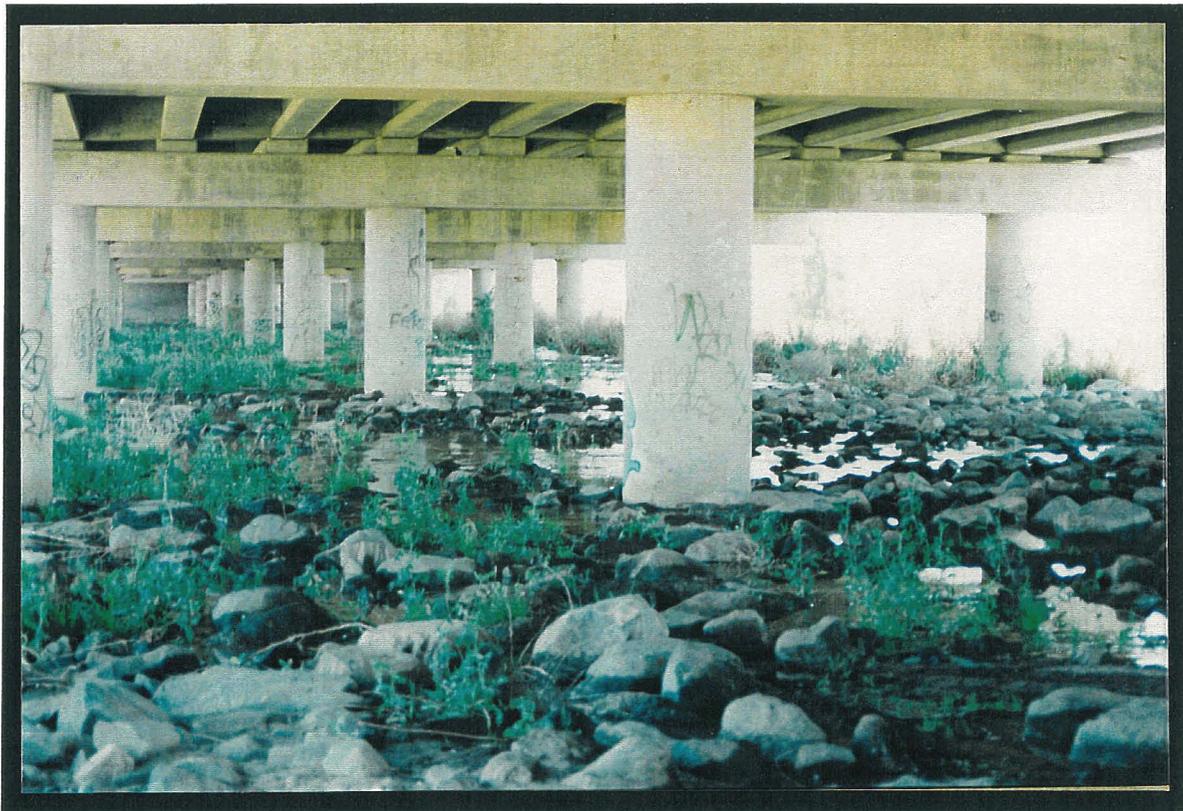
3. Approximately one quarter mile upstream of the bridge irrigation tailwater discharges into the river from three pipes. This runoff follows the east bank at the base of the soil-cement slope until it reaches the east end of the MC 85 bridge, at which point it flows parallel to and beneath the bridge deck, in the existing riprap blanket, for about 800 feet.

Channel Bottom Under Bridge Near East Side

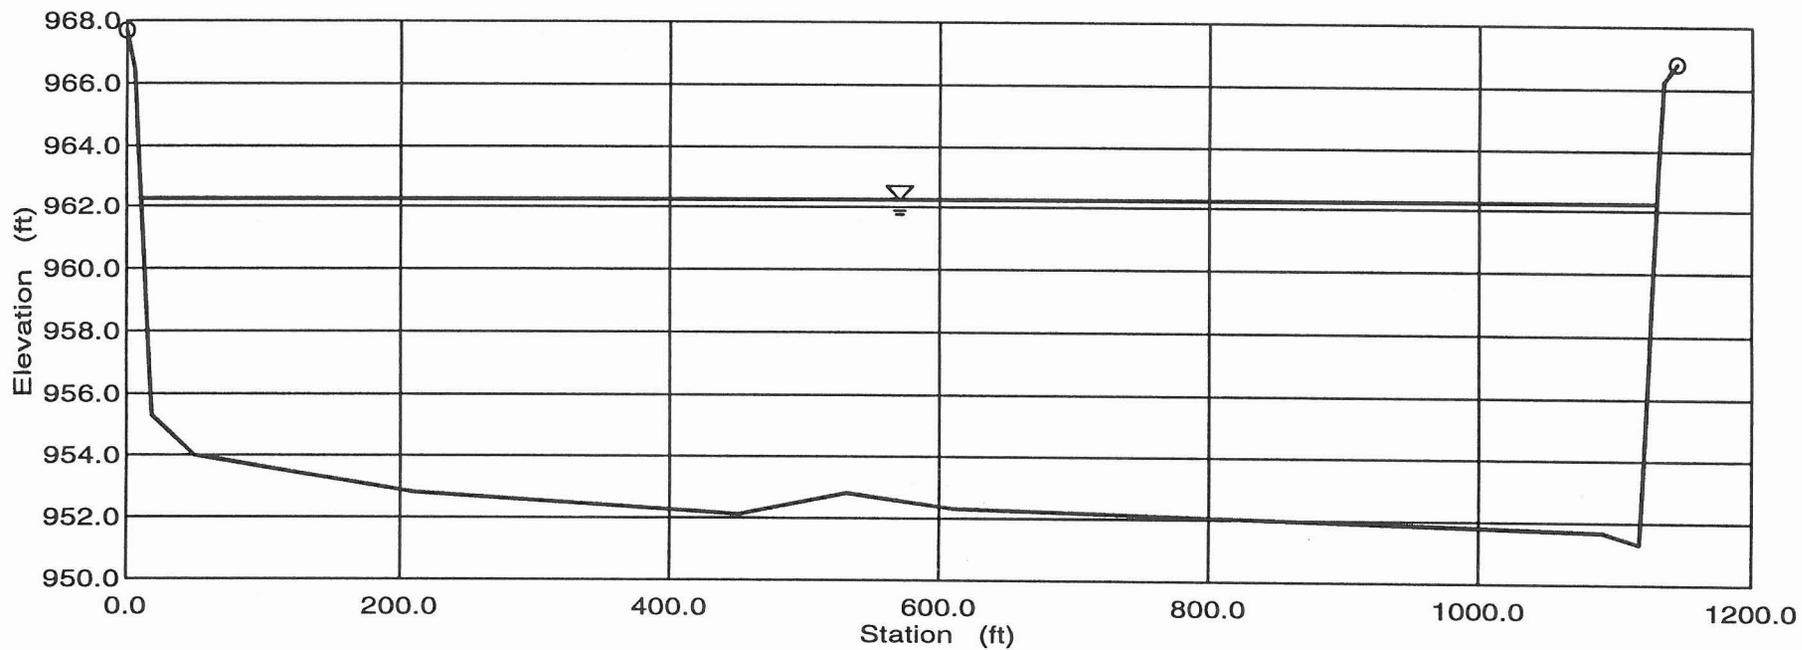
**MC85 Bridge @ Agua Fria - 115,000 cfs
Cross Section for Irregular Channel**

Section Data		
Wtd. Mannings Coefficient	0.028	
Channel Slope	0.001900 ft/ft	
Water Surface Elevation	962.29	ft
Discharge	115000.00	ft ³ /s
