**Buckeye Irrigation Company  
Buckeye, Arizona**

**FLOOD CONDITIONS ALONG SALT RIVER,  
MARICOPA COUNTY, ARIZONA, 1959**

**L. C. Halpenny, K. J. DeCook, and D. K. Greene  
Water Development Corporation  
Consultants in Ground-Water Hydrology  
3938 Santa Barbara Avenue  
Tucson, Arizona**

**THE FLOOD THREAT IN MARICOPA COUNTY  
(Statement of L. C. Halpenny for Buckeye Irrigation Company at Flood Control Hearing, U. S. Army Corps of Engineers and Maricopa County Flood Control District, Phoenix, Arizona, December 9, 1959)**

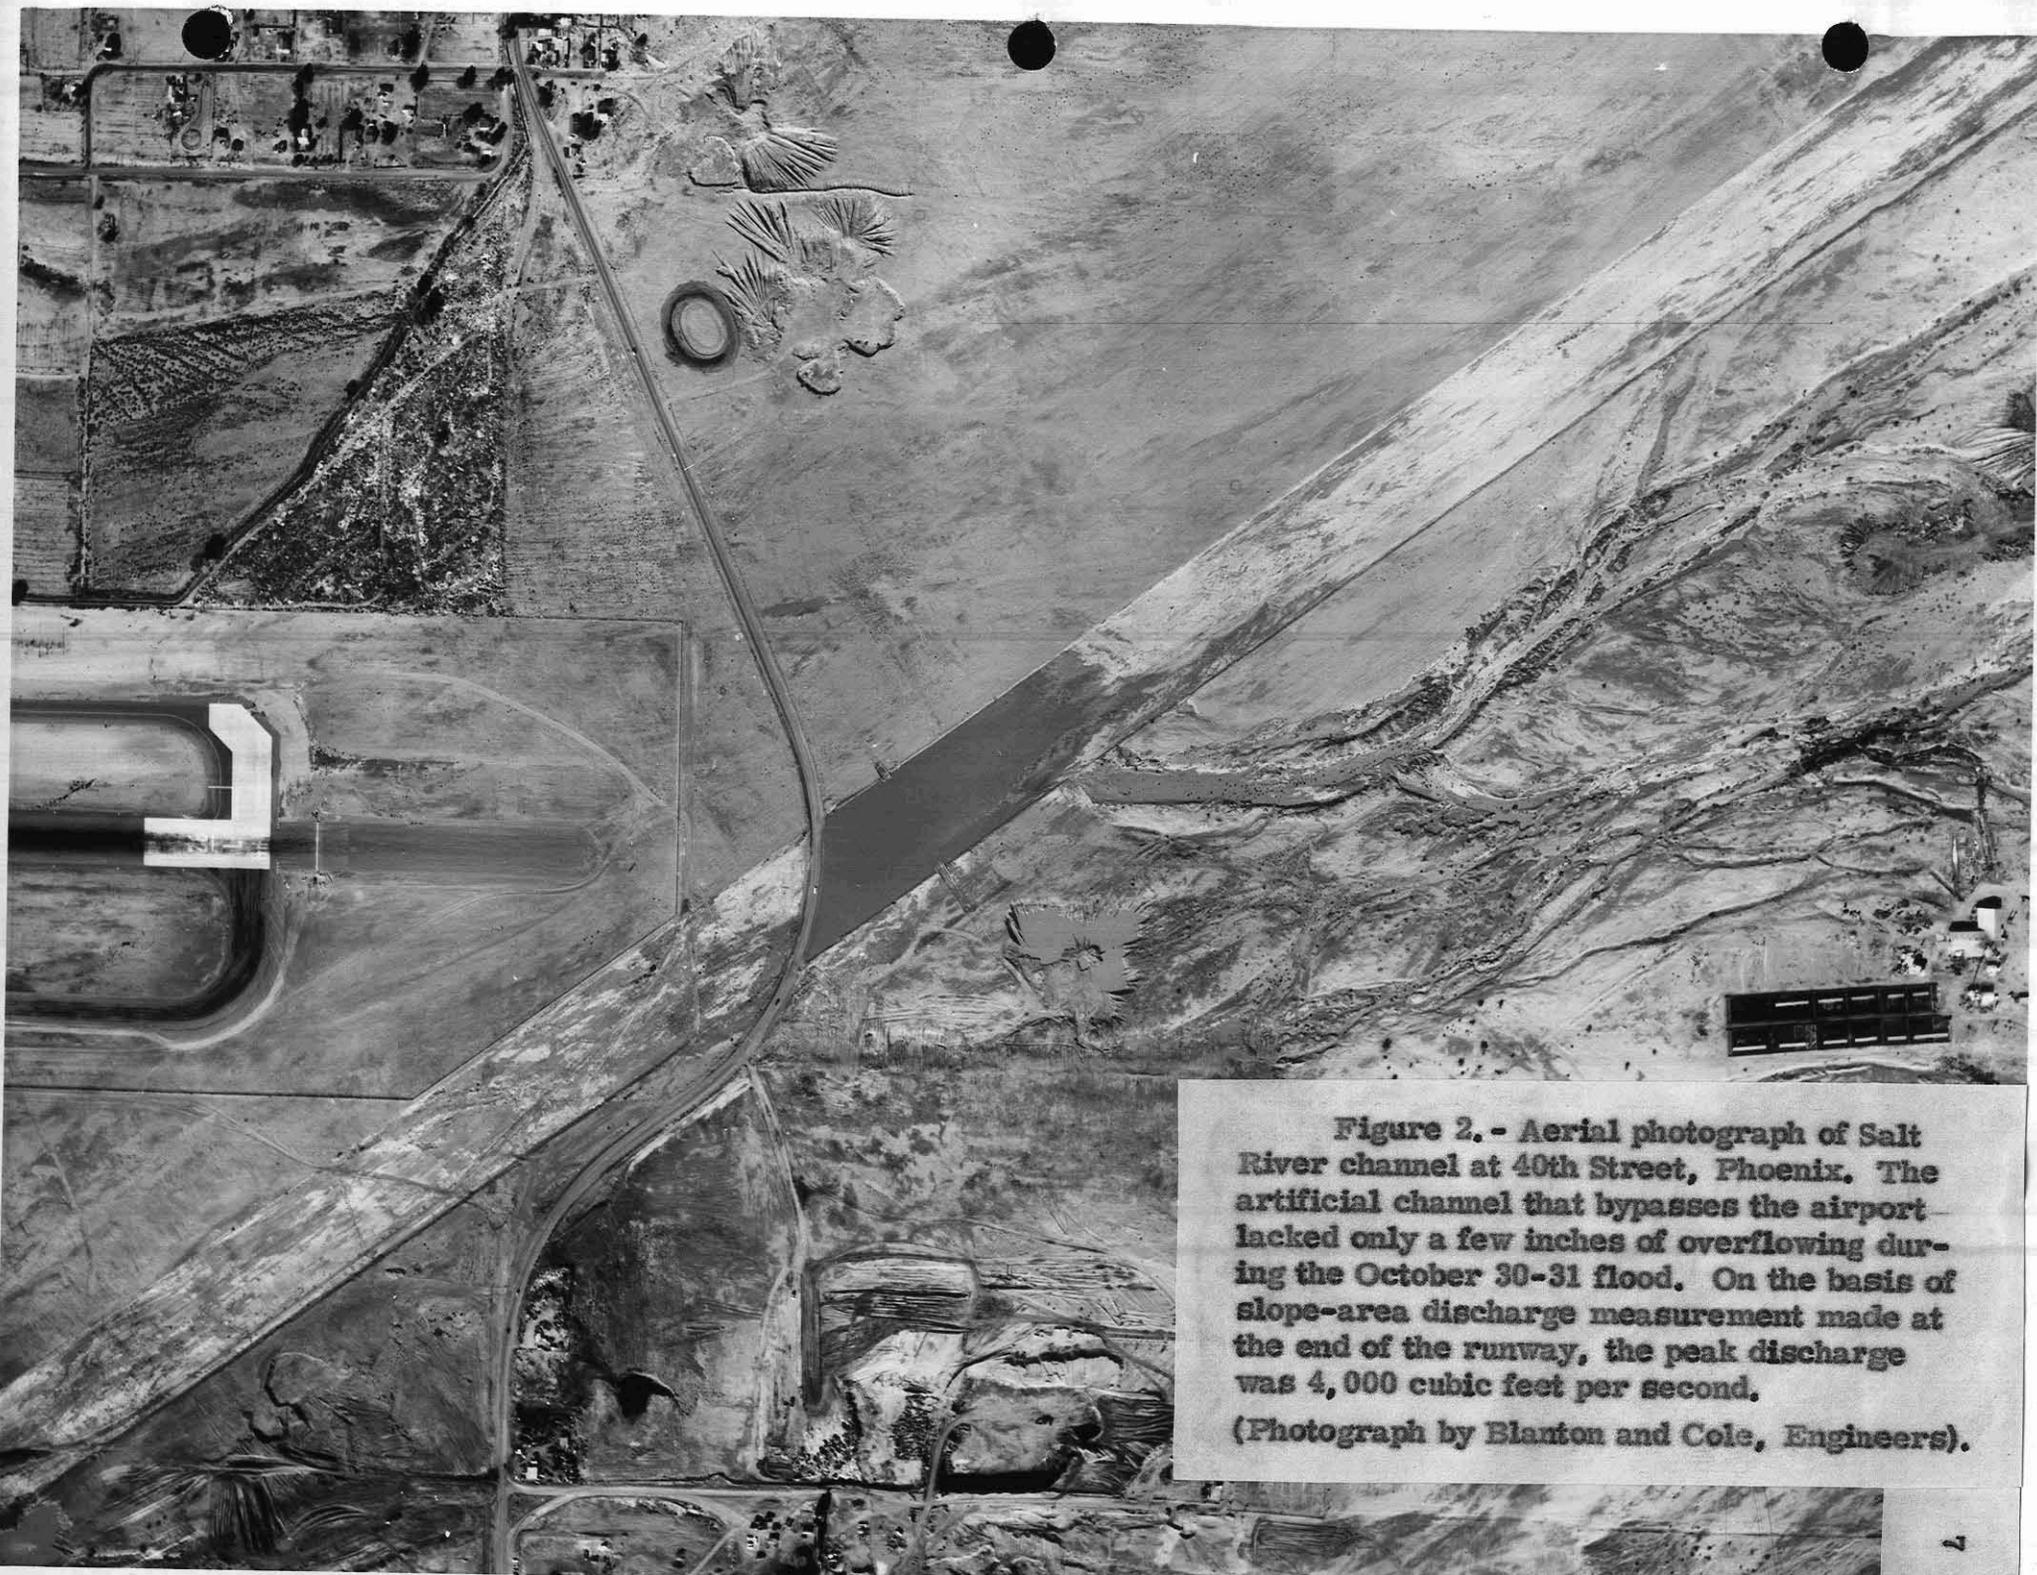
**Figure 2. - Aerial photograph of Salt River channel at 40th Street, Phoenix. The artificial channel that bypasses the airport lacked only a few inches of overflowing during the October 30-31 flood. On the basis of slope-area discharge measurement made at the end of the runway, the peak discharge was 4,000 cubic feet per second. (Photograph by Blanton and Cole, Engineers).**

The potential hazard at 40th Street was amply demonstrated during the October 30-31 flood. The aerial photograph (fig. 2) showed that, at 40th Street, all of the runoff was forced into an artificial channel. The upstream edge of 40th Street at the deepest part of this artificial channel is about 1 foot higher than the eastern end of the airport runway. Thus, water which spills over the lip of the channel on the north side can flow onto the runway. As the artificial channel lacked only a few inches of overflowing during the October 30-31 flood, the peak flow effectively represented the capacity. A slope-area measurement was made on November 11, and the following data were collected:

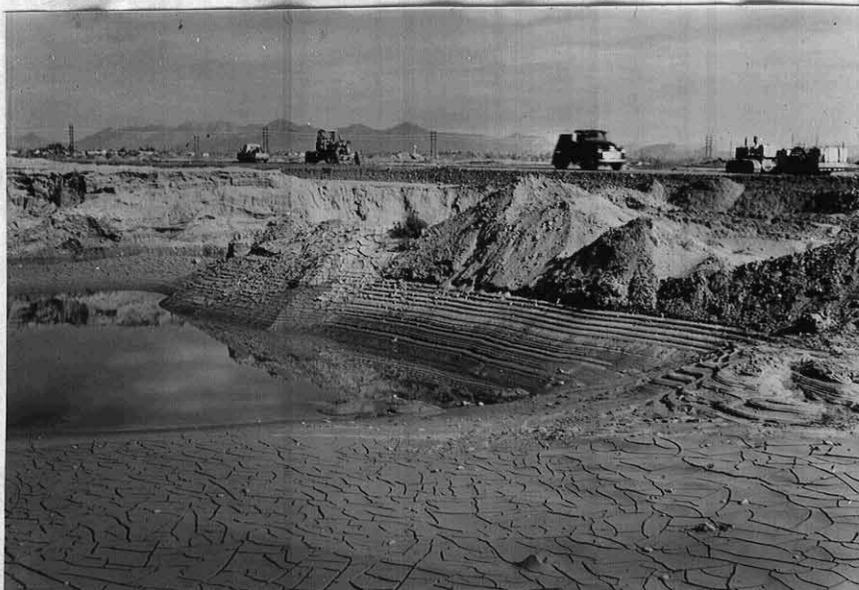
- A. View upstream showing water in small gravel pit below Scottsdale Road, Tempe, November 19, 1959. Maximum stage of water level is shown by the uppermost notch cut in the side of the pit. Note silt deposited on bench.

Figures 3 A, 3 B, and 4 B are photographs showing the sediment deposited from impounded water following the October 30-31 flood.

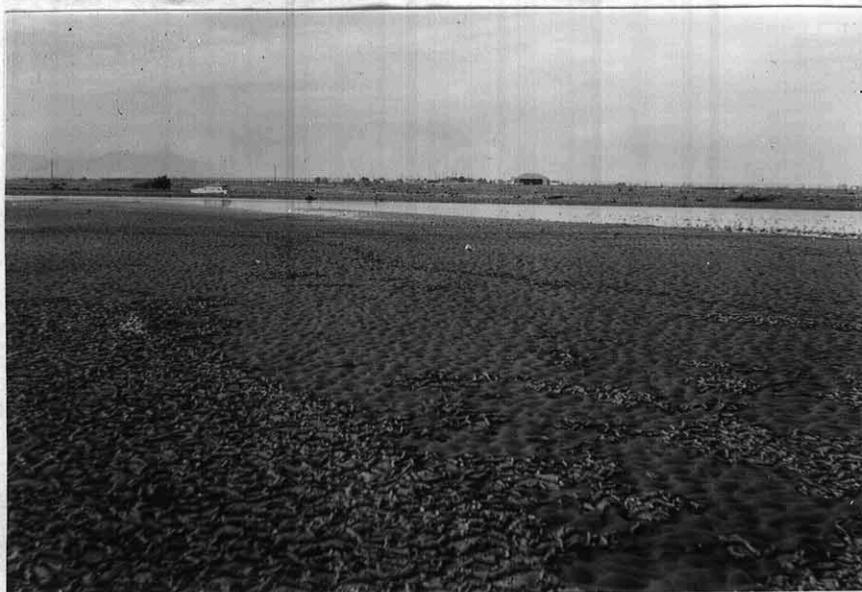
Figure 3

- B. View downstream showing water impounded by 40th Street crossing artificial flood channel near Sky Harbor, November 19, 1959. Note silt on floor of channel. Arizona Air National Guard hangar in background.

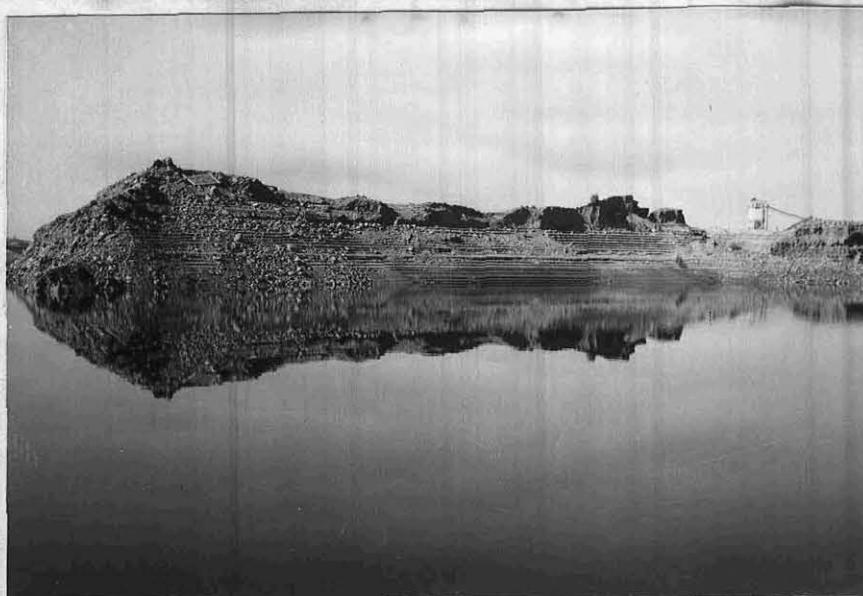
A. Northwest view showing water remaining in gravel pit east of 7th Street, Phoenix, on November 25, 1959. Wave-cut notches indicate stages of water level.

Many of the pits still contained substantial quantities of water on November 25 (fig. 4 A) and the slow rate of subsidence indicated they could continue to hold water for many weeks. Estimates of this remaining quantity of water were made on the basis of the following assumptions: (1) The maximum depth of any pit is no more than 25 feet; and (2) the surface area will decrease at a uniform rate from the area as of November 25 to zero at maximum depth. As most of the pits have fairly flat bottoms, the second assumption is considered to be conservative. Table 5 contains the results of these estimates.

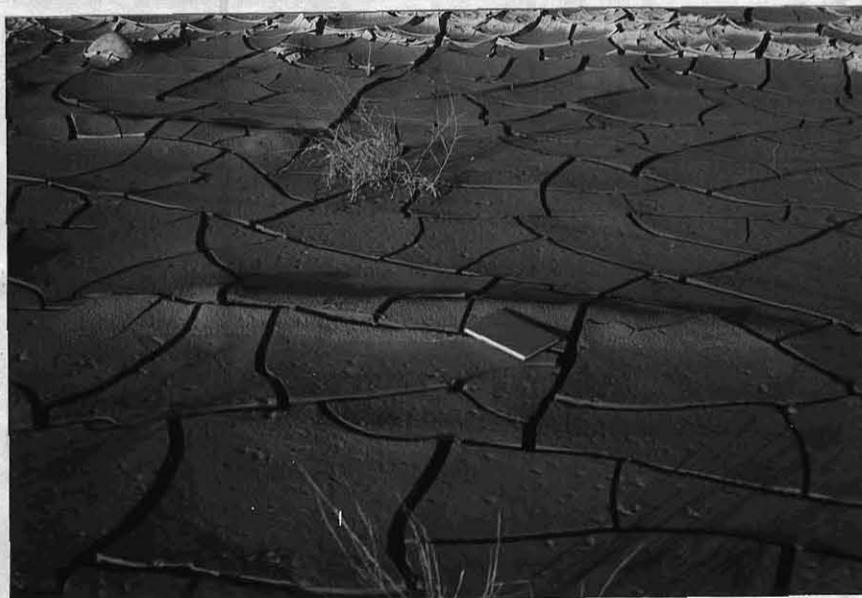
Figure 4

B. View of partially dried and cracked mud or silt deposits in gravel pit west of old highway crossing north of Mesa, November 25, 1959. Notebook indicates size of cracks.

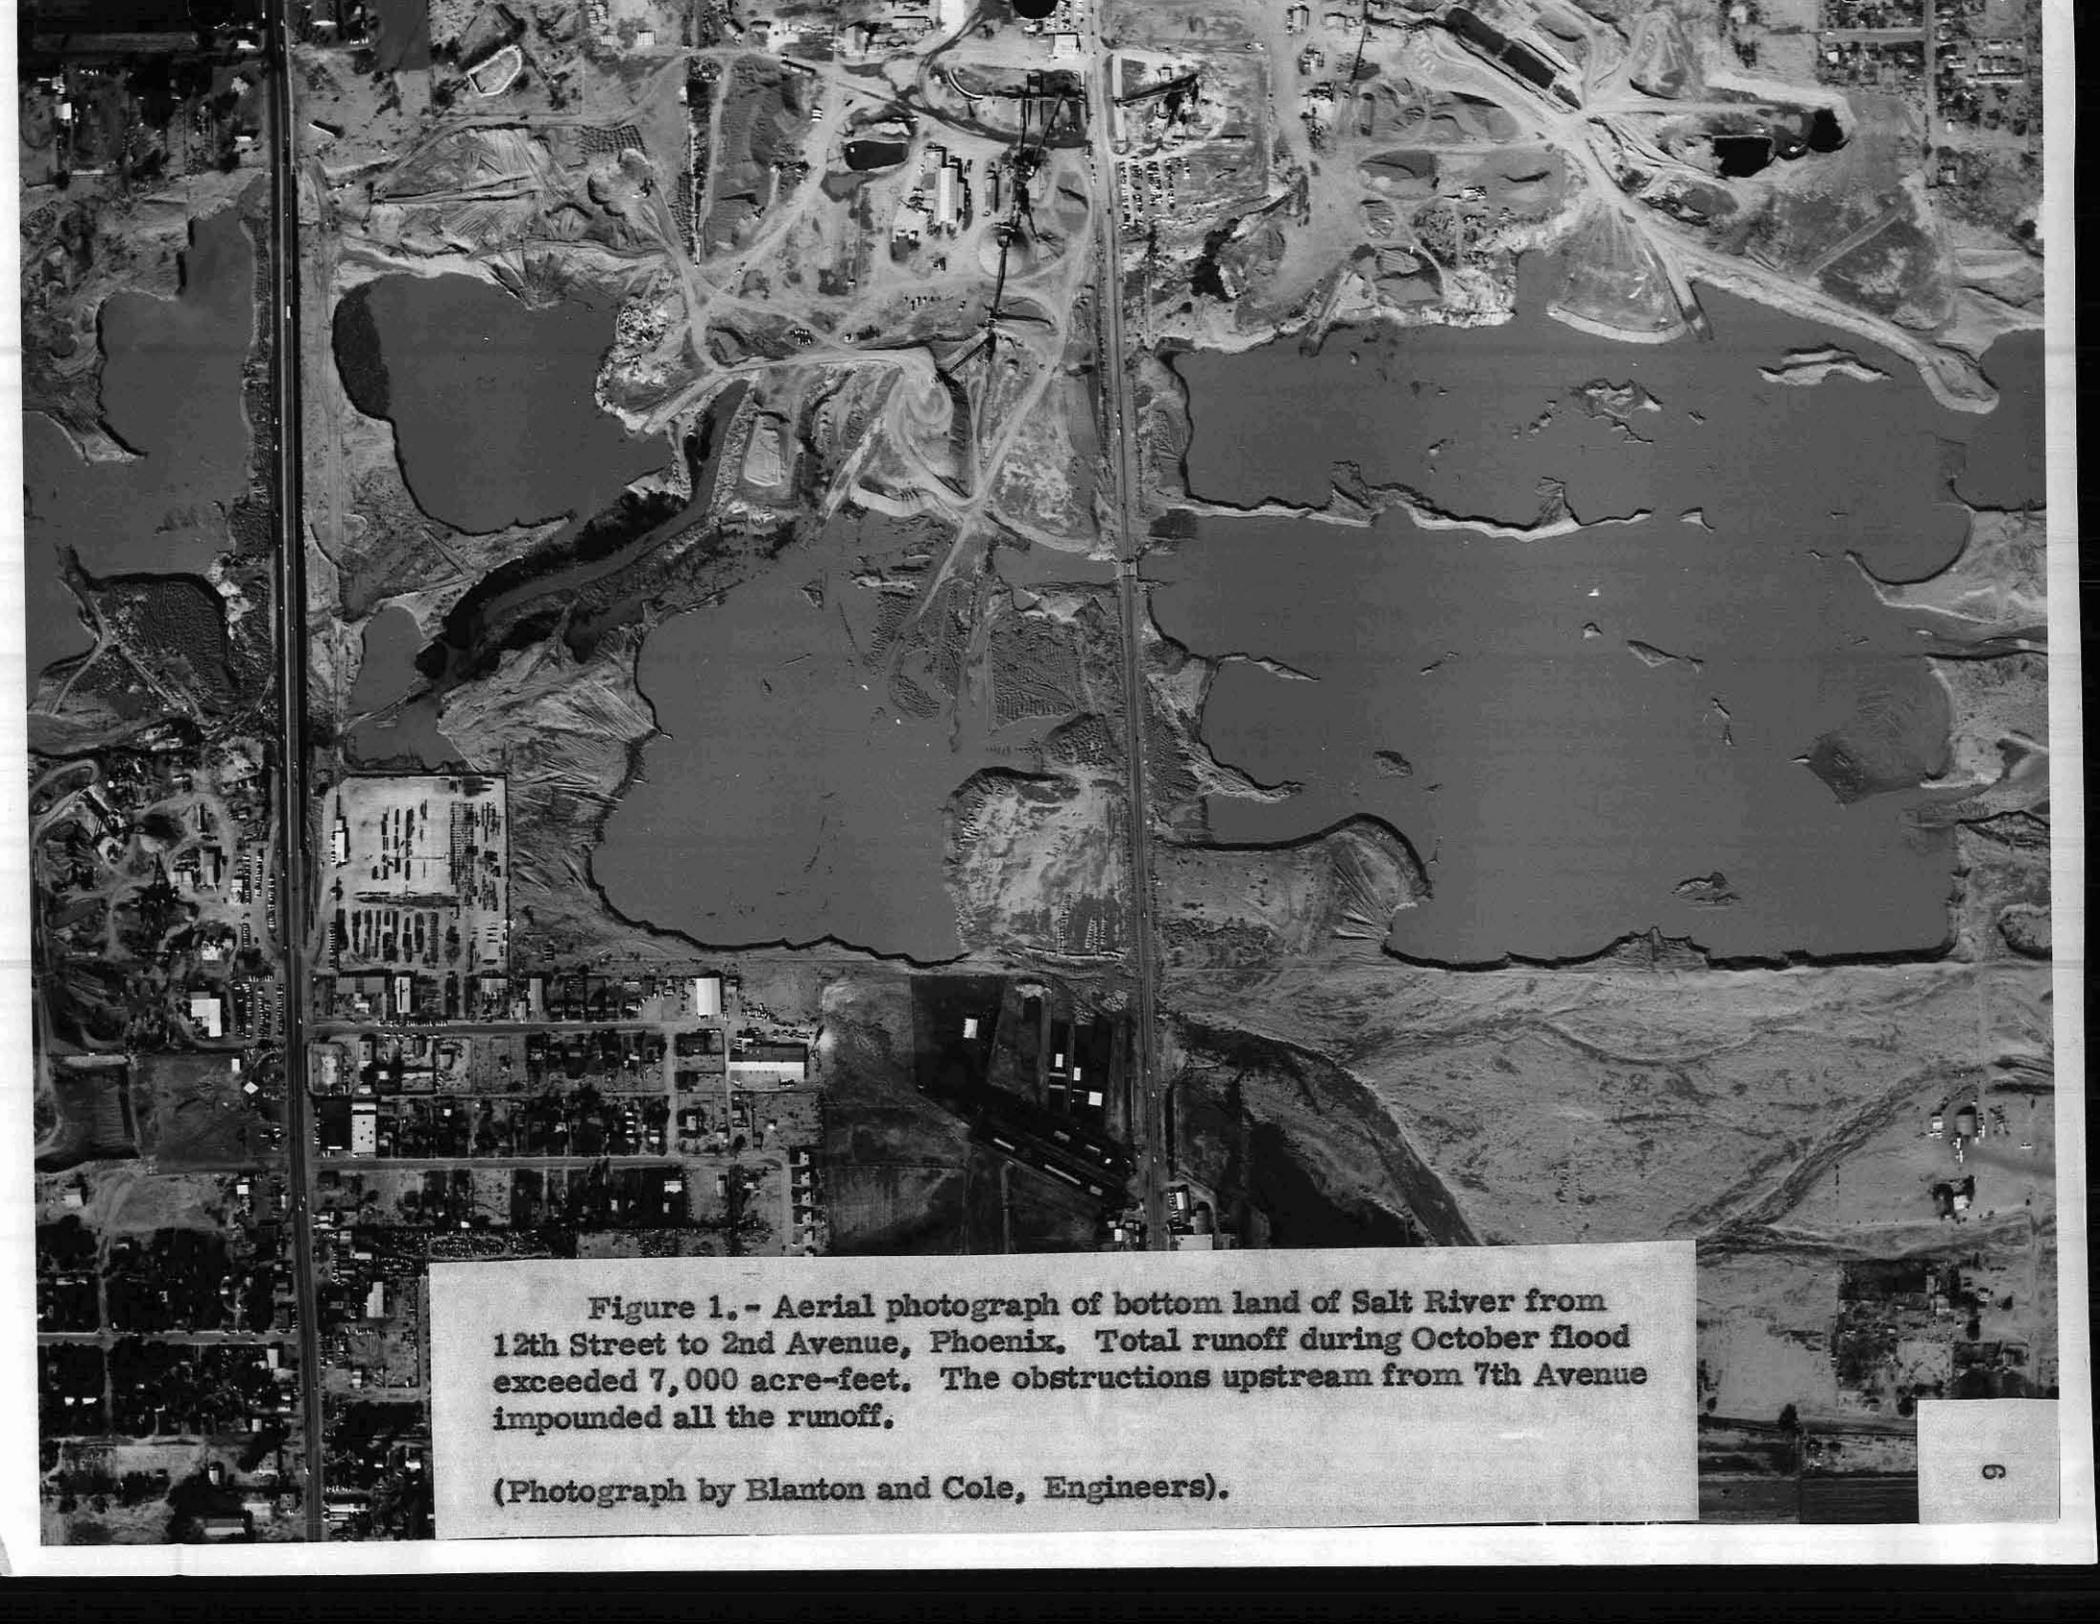
Figure 1. - Aerial photograph of bottom land of Salt River from 12th Street to 2nd Avenue, Phoenix. Total runoff during October flood exceeded 7,000 acre-feet. The obstructions upstream from 7th Avenue impounded all the runoff.

Practically none of this runoff moved farther downstream than 7th Avenue in Phoenix, because of impoundment.
