**TECHNICAL DATA NOTEBOOK  
FOR DAGGS WASH  
SECTION 4.2 FIELD RECONNAISSANCE  
AND HYDRAULIC PARAMETER ESTIMATION**

**DECEMBER, 1992**

**PREPARED FOR:  
FLOOD CONTROL DISTRICT OF MARICOPA COUNTY  
2801 WEST DURANGO STREET  
PHOENIX ARIZONA 85009**

**FCD NO. 92-08  
A-N WEST NO. 7158-02**

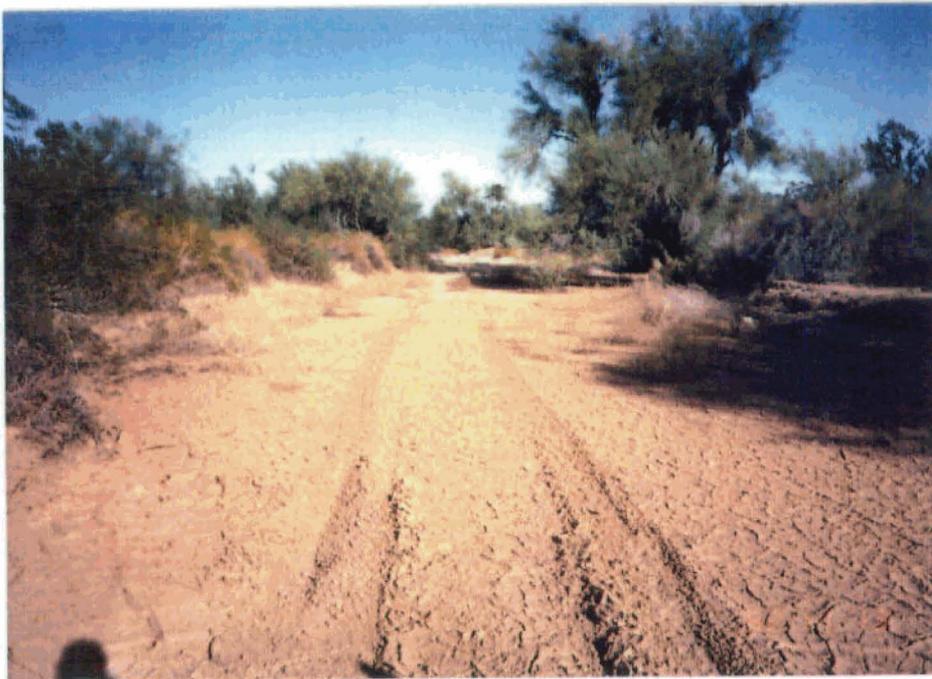
RM 0.0  
Looking Upstream

RM 0.0  
Looking Upstream at Daggs Wash Channel  
Channel Width, 36'±. Depth, 3' to 4' to Adjacent  
Overbank.

Wtd Channel 'n' 0.044

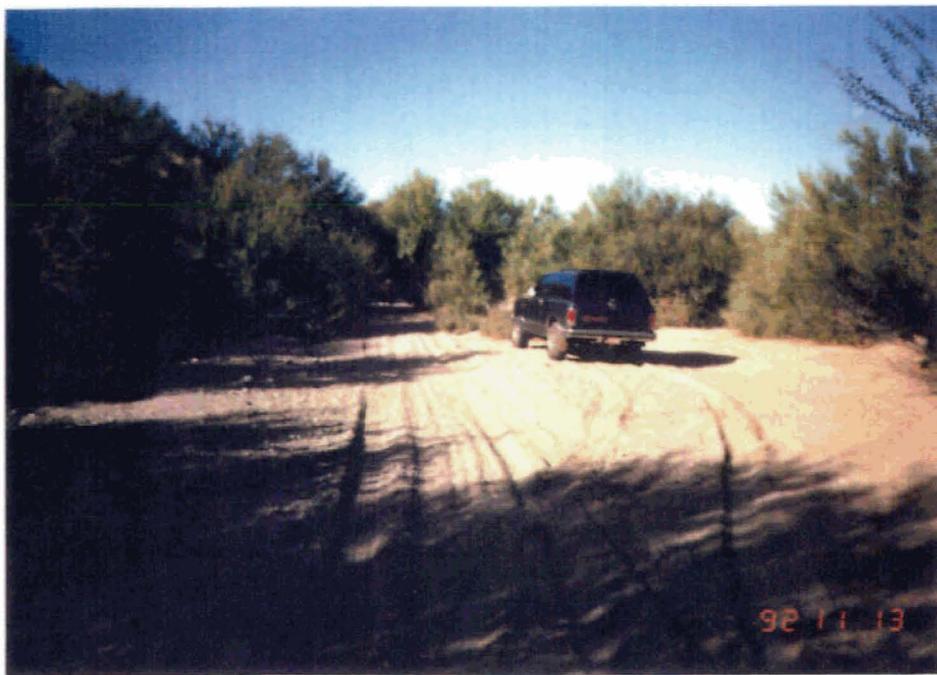
RM 0.6  
Looking Upstream at Daggs Wash  
Main Channel

Channel Width, 30' to 35' Behind  
Truck. Depth 3'± to Overbank to  
Right.

Wtd. Channel 'n' = 0.044

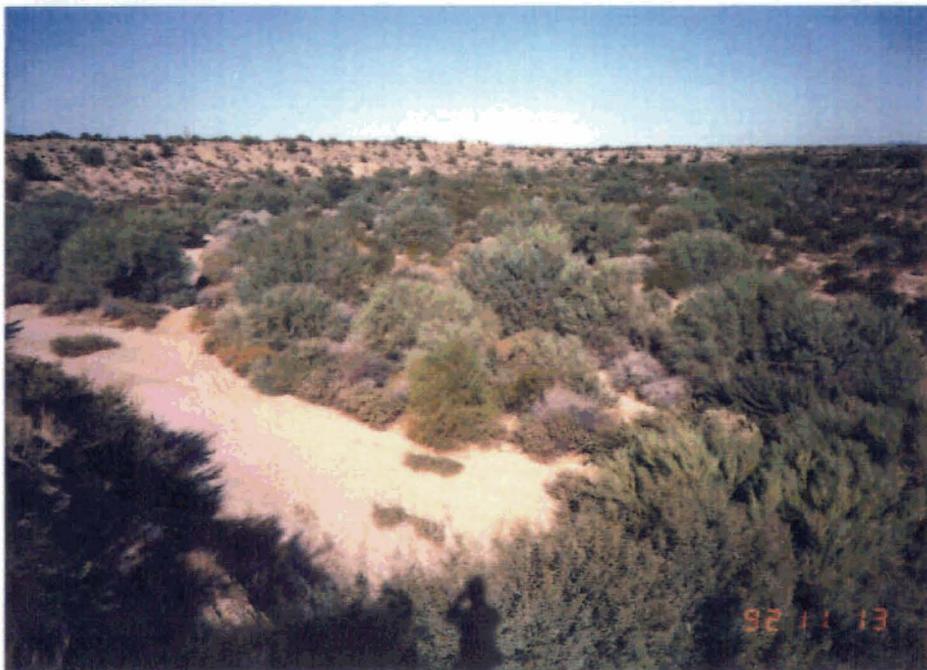
RM 0.6  
Looking Upstream at Daggs Wash  
Channel and Overbank

Wtd. Channel 'n' = 0.044  
Overbank 'n' = 0.055

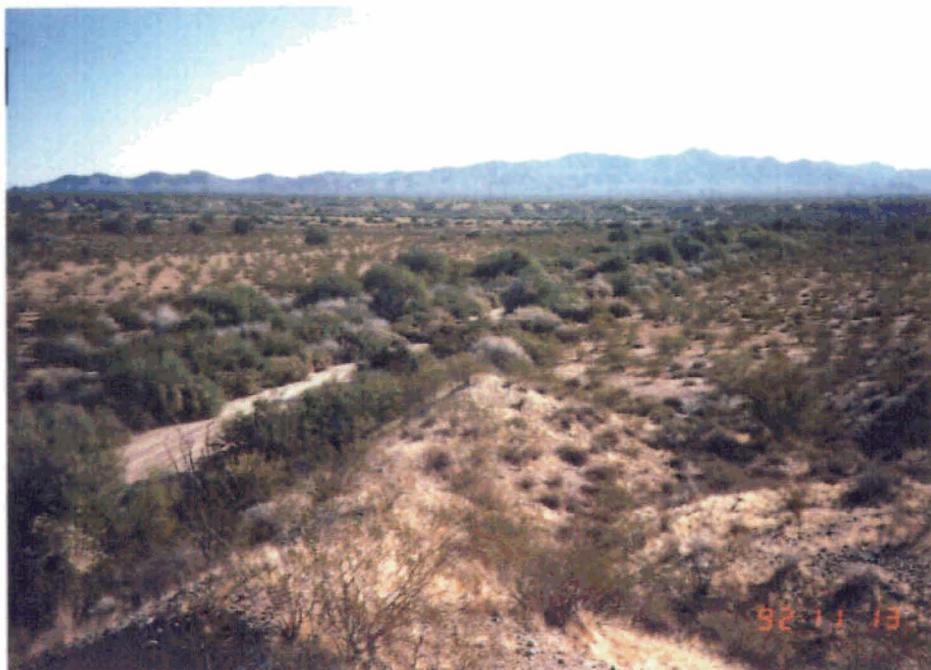
RM 0.6  
Looking Downstream at Channel/  
Overbanks Toward Hassayampa River

Wtd. Channel 'n' = 0.044  
Overbank 'n' = 0.055

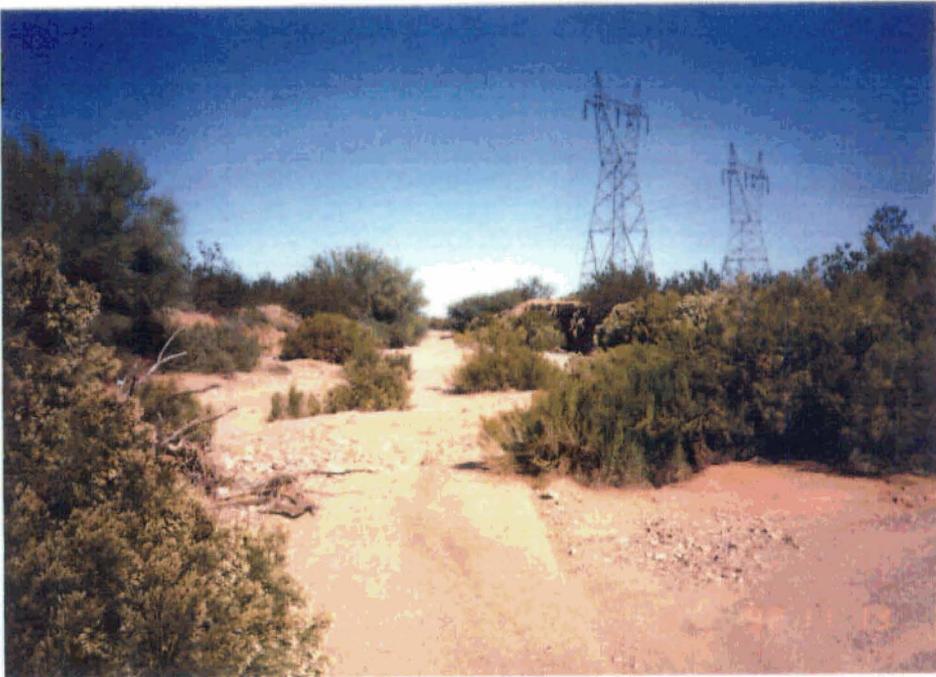
RM 2.1  
Looking Upstream

Wtd. Channel 'n' = 0.040  
Overbank 'n' = 0.054

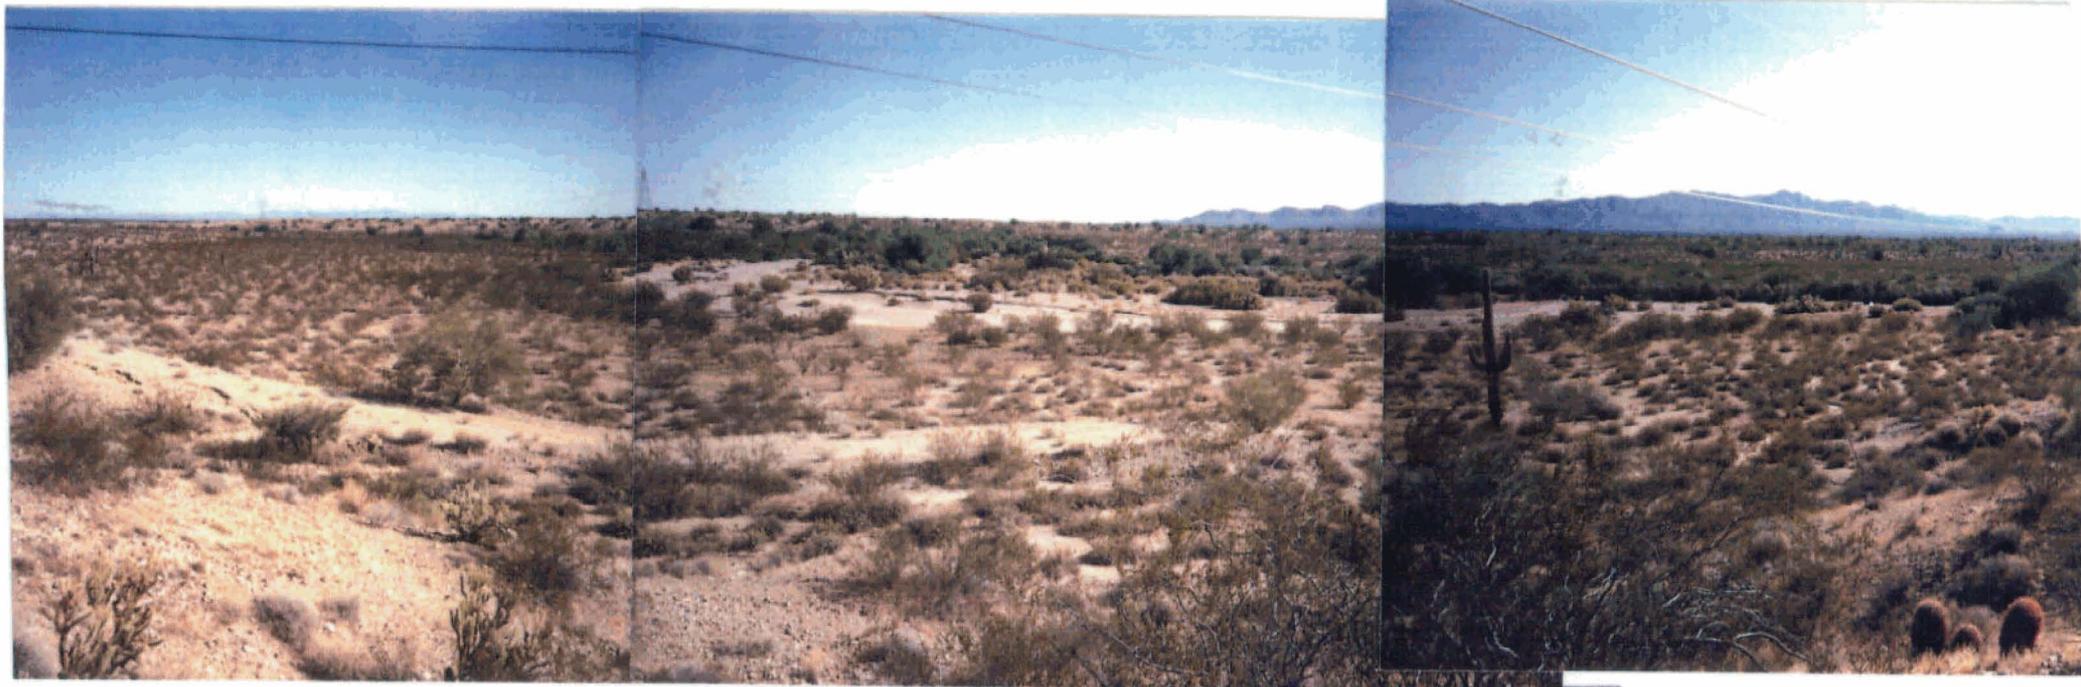
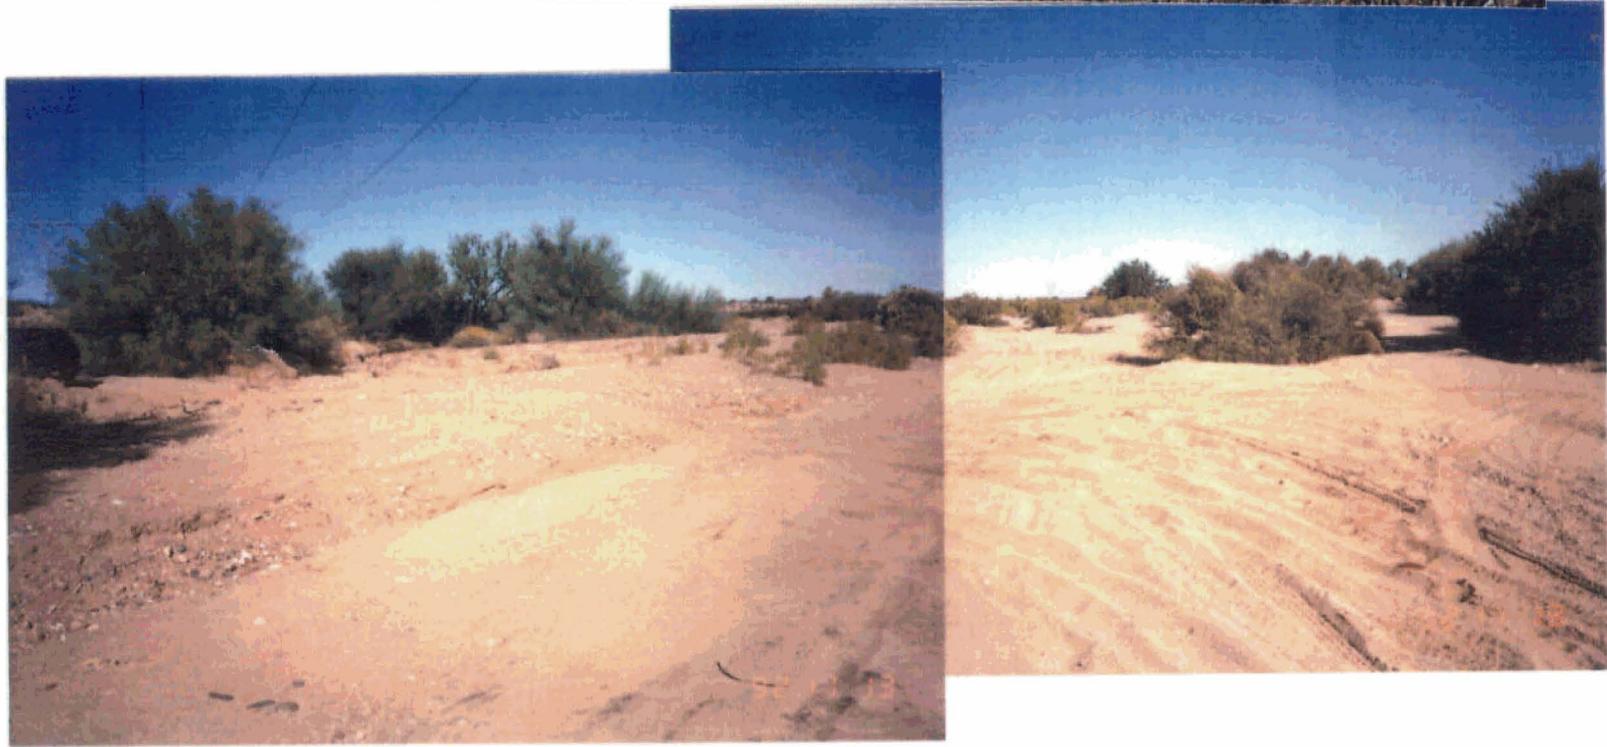
RM 2.2  
Looking Upstream Overlooking  
Channel and Overbanks

RM 2.2  
Looking Upstream

Wtd. Channel 'n' = 0.040  
Overbank 'n' = 0.054

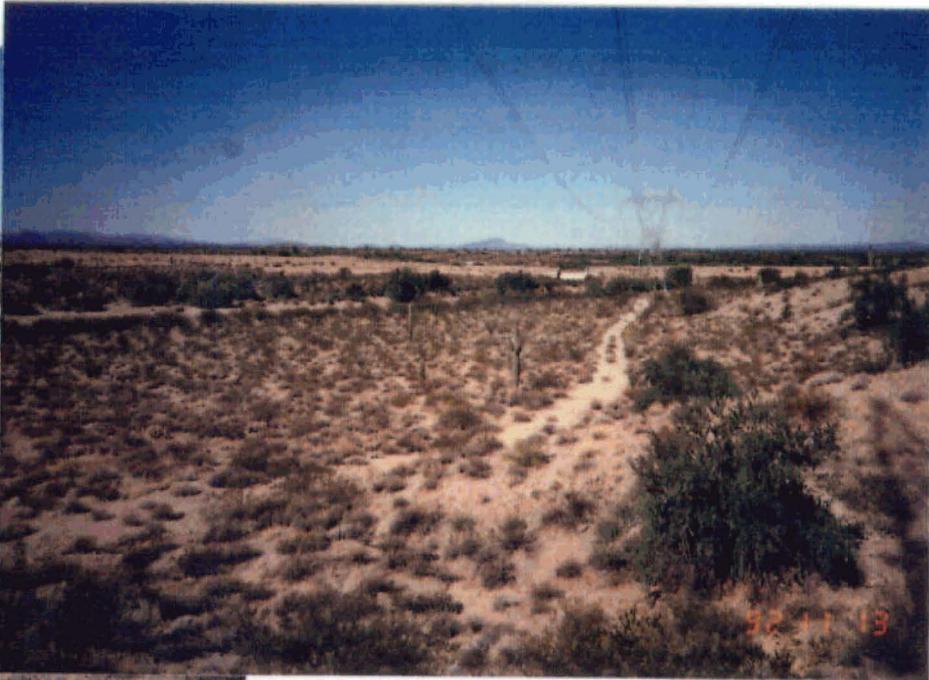
RM 2.8  
Looking West Across  
Channel and Overbanks  
and Upstream

Wtd. Channel 'n' = 0.032  
Overbank 'n' = 0.055

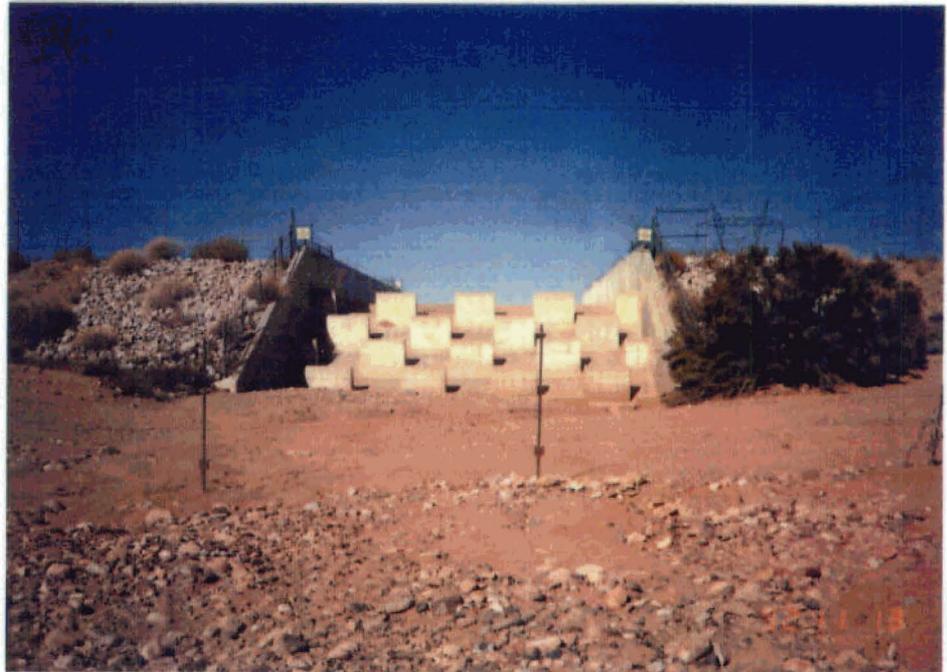
RM 3.1  
Looking Upstream at CAP Overchute

The rectangular concrete flume is 47.33 feet wide and has 7 foot high vertical walls with a 5 foot high chain link fence on top of the walls. Immediately upstream of the rectangular concrete flume is a 25 foot long concrete inlet transition section with transitions in bottom width from 47.33 feet to 72.33 feet and wall height from 7.0 feet to 8.5 feet, respectively, proceeding upstream.

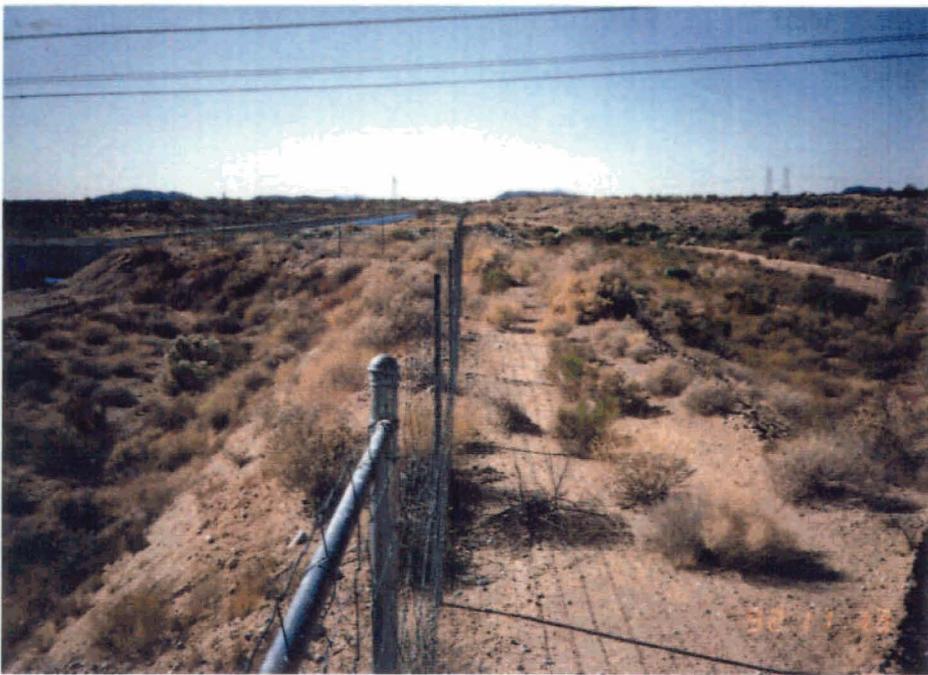
RM 3.1  
Looking West Along CAP on Inlet  
Levee of CAP Overchute

Immediately, upstream of the concrete inlet transition, rock rip-rap protected levees on each side of the overchute, proceed upstream for an additional 100 feet with a radii of 135 feet. The earth channel bottom width transitions from 72.33 feet to approximately 197 feet proceeding upstream over this distance of 100 feet. The channel invert is level at elevation 1373.3 over this entire length of approximately 220 feet of concrete flume, and inlet transition.

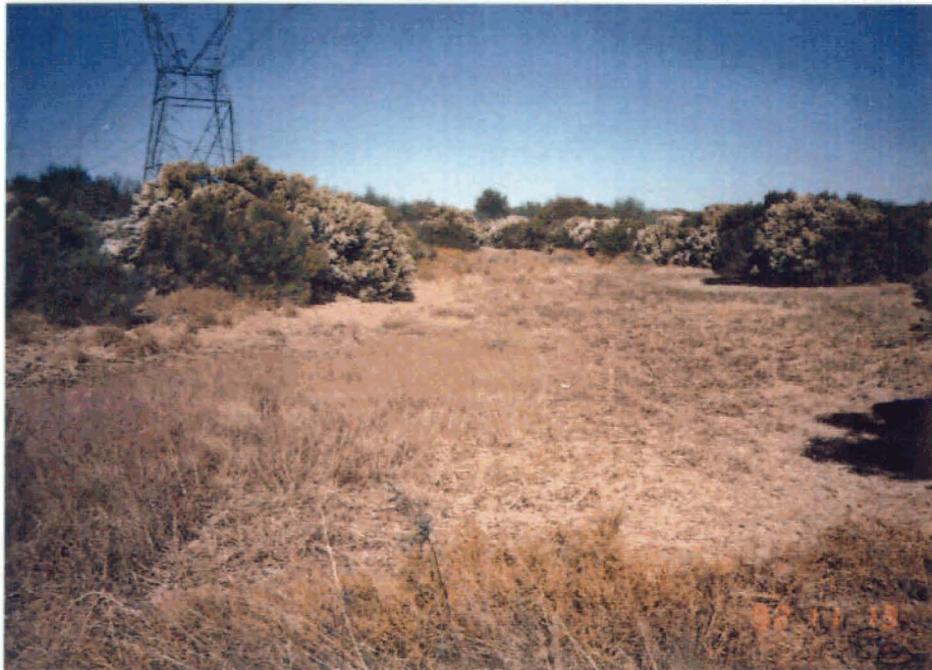
RM 3.1 Looking Upstream from  
CAP Overchute in Channel

Wtd. Channel 'n' = .04  
Overbank 'n' = 0.65

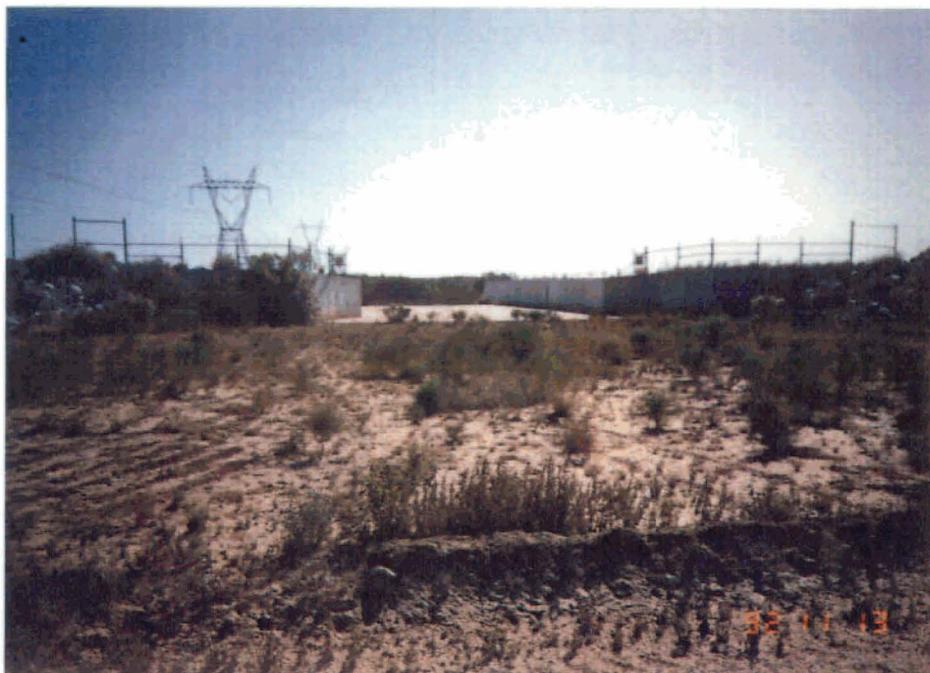
RM 3.1  
Looking Downstream at CAP  
Overchute Width = 47'-4".  
Wall Ht. = 8.5 ', At Upstream  
Edge Wingwall, Transitioning to  
Ht. = 7.0' Through Overchute.

Channel 'n' = 0.030

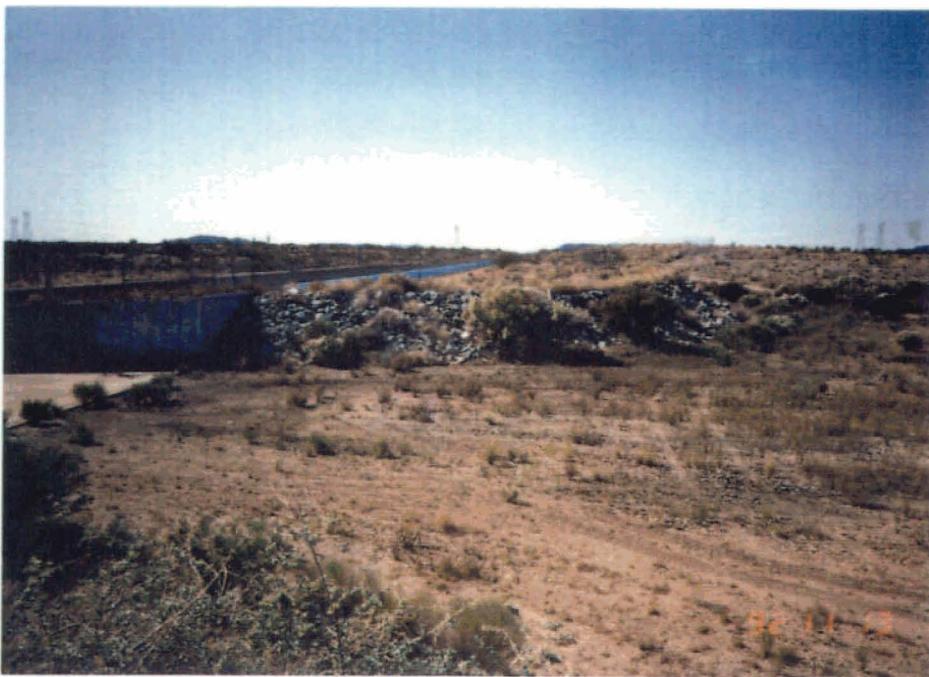
RM 3.1  
Looking West at CAP Overchute  
Inlet and Rip-rap Protected  
Levee

Channel 'n' = .030

The rock rip-rap levees are protected with 2 feet thick rock on a 12-inch sand and gravel bedding material. The upstream and downstream face of the rip-rap protected dikes have slopes of 2(H):1(V) and 1.5(H):1(V), respectively. The dike top width is 14 feet.

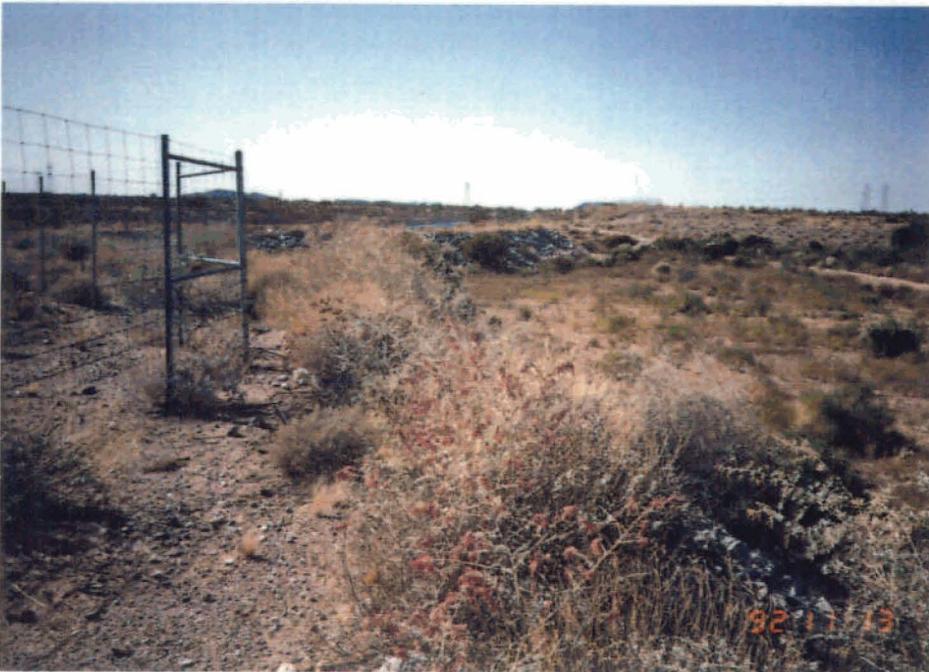
RM 3.1  
Looking West at CAP Overchute's  
West Rip-rap Protected Levee

Channel 'n' .030

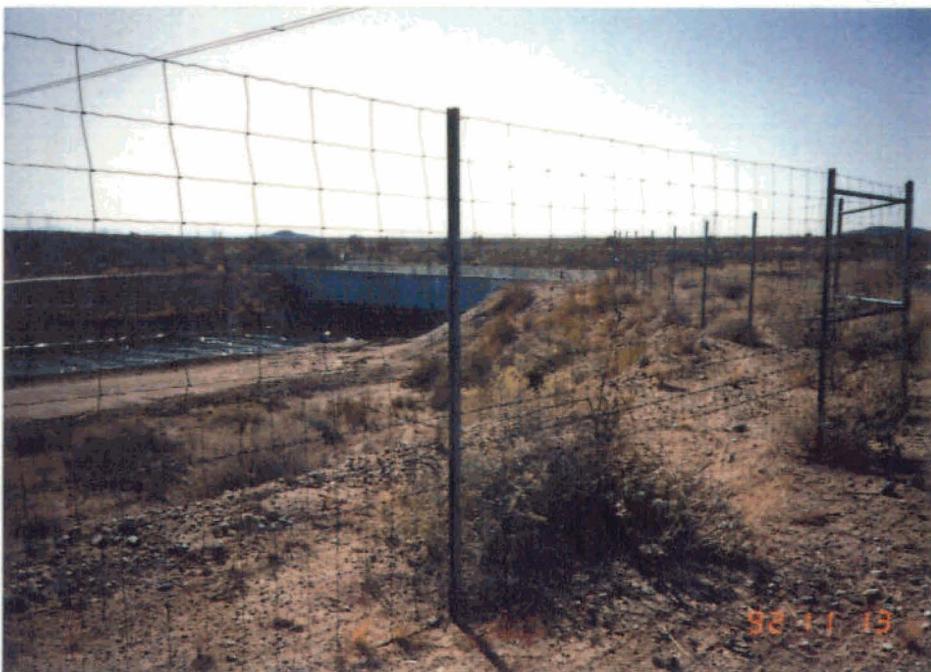
RM 3.1  
Looking West at CAP Overchute  
and Downslope side of Inlet  
Levee

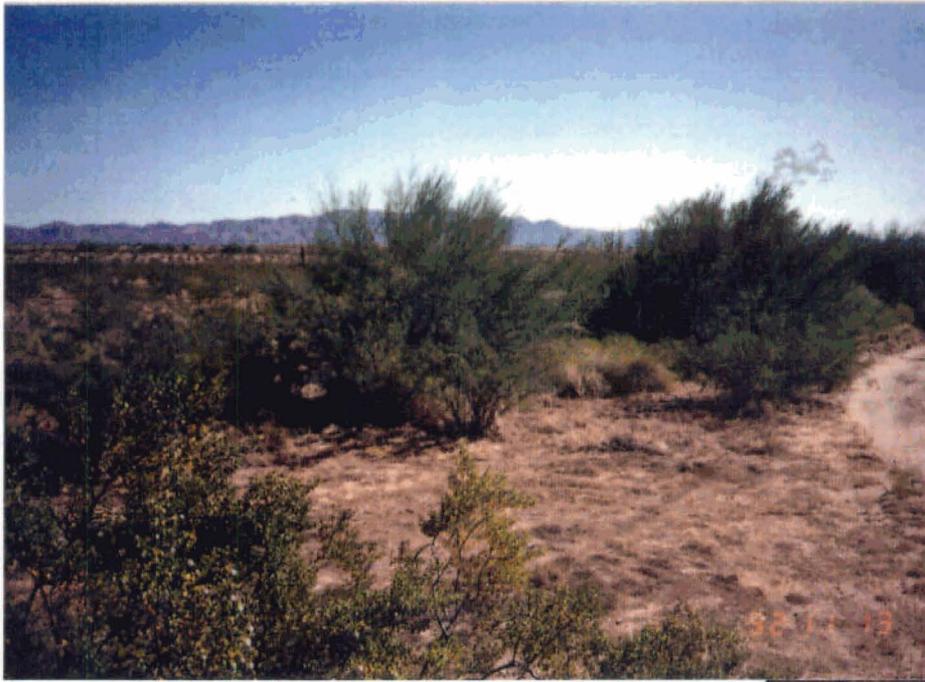
RM 3.6  
Looking Downstream  
at East Overbank  
and Channel

Wtd. Channel 'n' = 0.44  
Overbank 'n' = .055

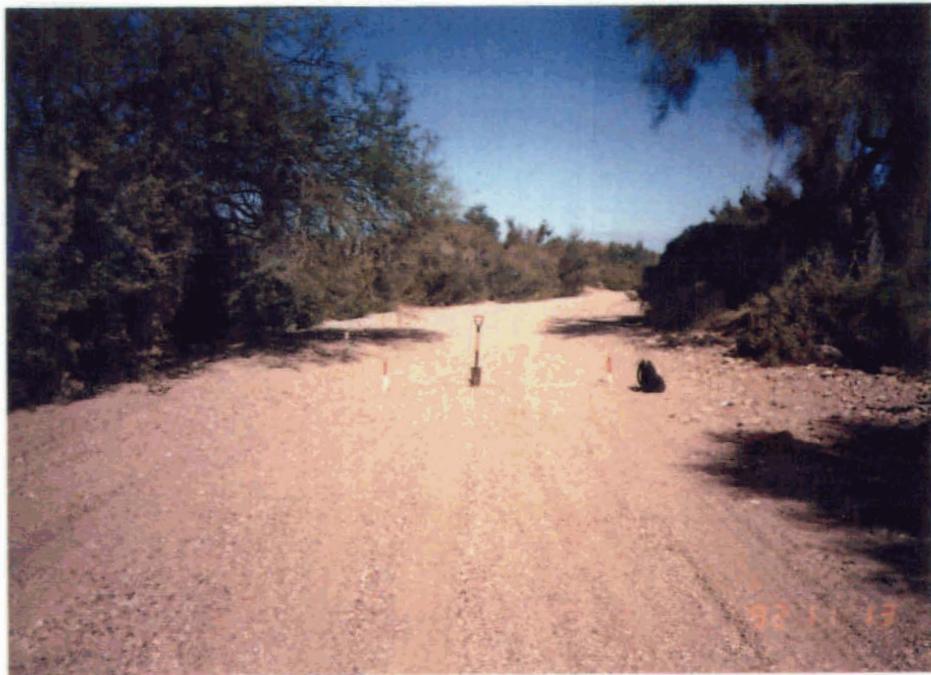
RM 4.0  
Looking Upstream at Channel  
Width = 30', Depth = 3.5'±

Wtd. Channel 'n' = .044

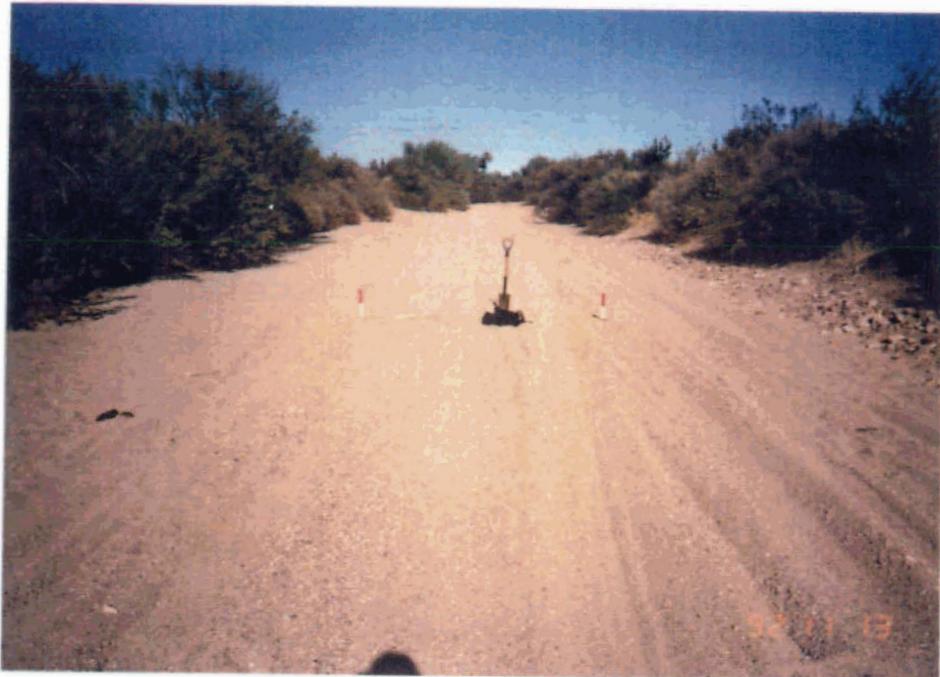
RM 6.0  
Looking Upstream at Channel  
Channel Width = 40'±  
Depth = 4'± to Adjacent Overbank

Wtd. Channel 'n' = .044

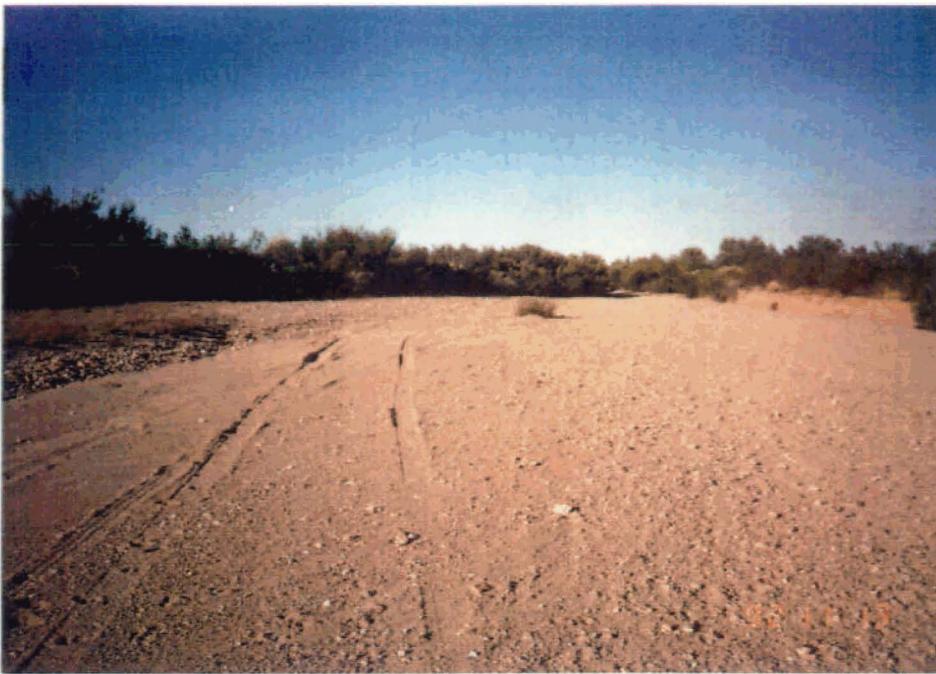
RM 8.9  
Looking Upstream at Channel  
Channel Width = 150'±  
Depth = 3'± to Adjacent  
Overbank

Wtd. Channel 'n' = .038

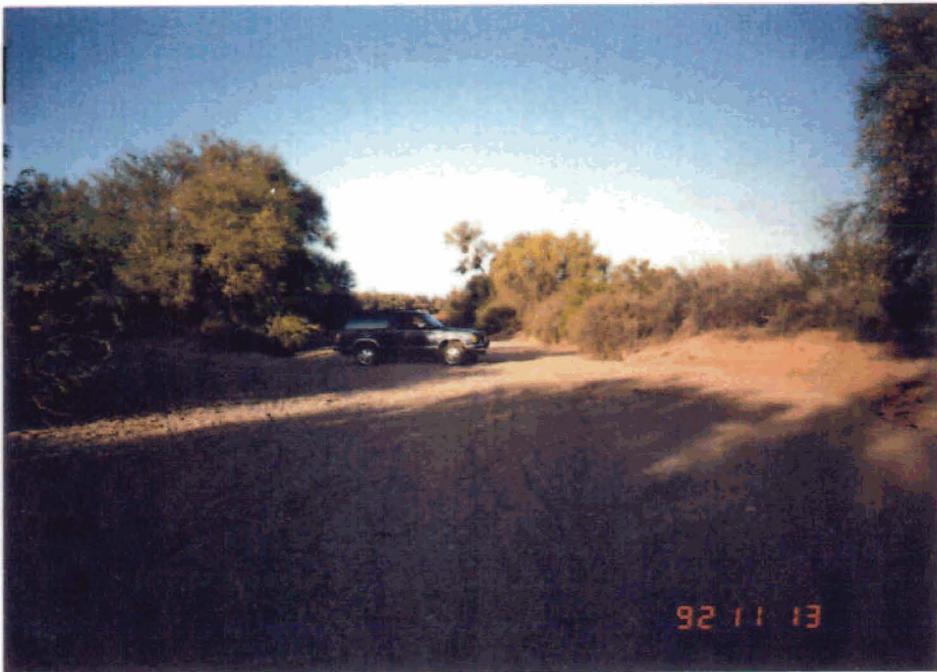
RM 10.4  
Looking Upstream at Private Road  
Crossing of Channel  
Channel Width = 45'±  
Depth = 3'± to Adjacent Overbank

Wtd. Channel 'n' = .044

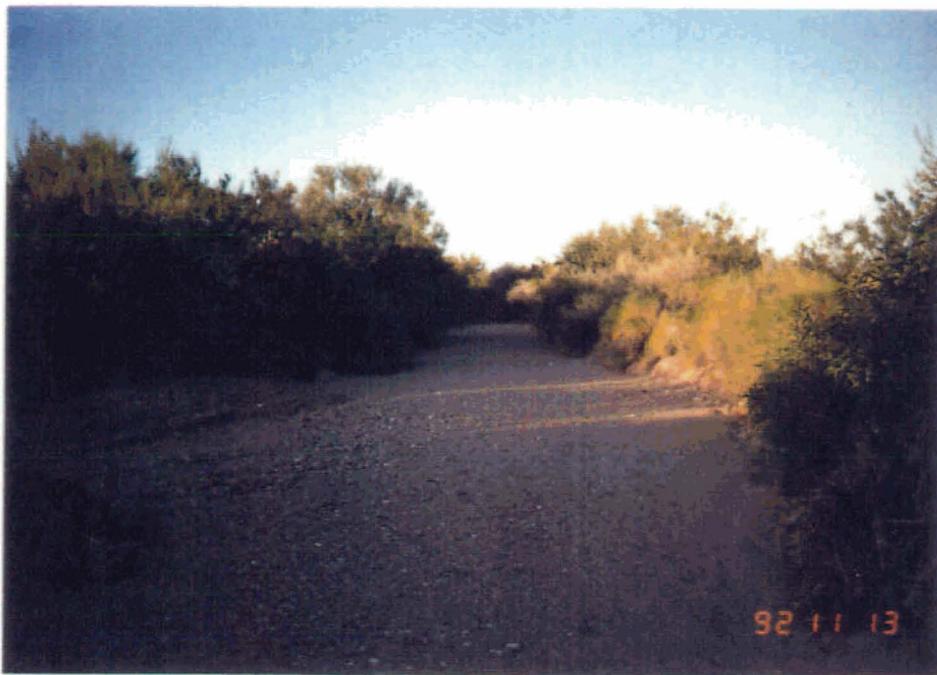
RM 11.3  
Looking Upstream at East Channel of  
Two Channels  
Channel Width = 20'±  
Depth = 3.5'± to Adjacent Overbank  
Wtd. Channel 'n' = .044

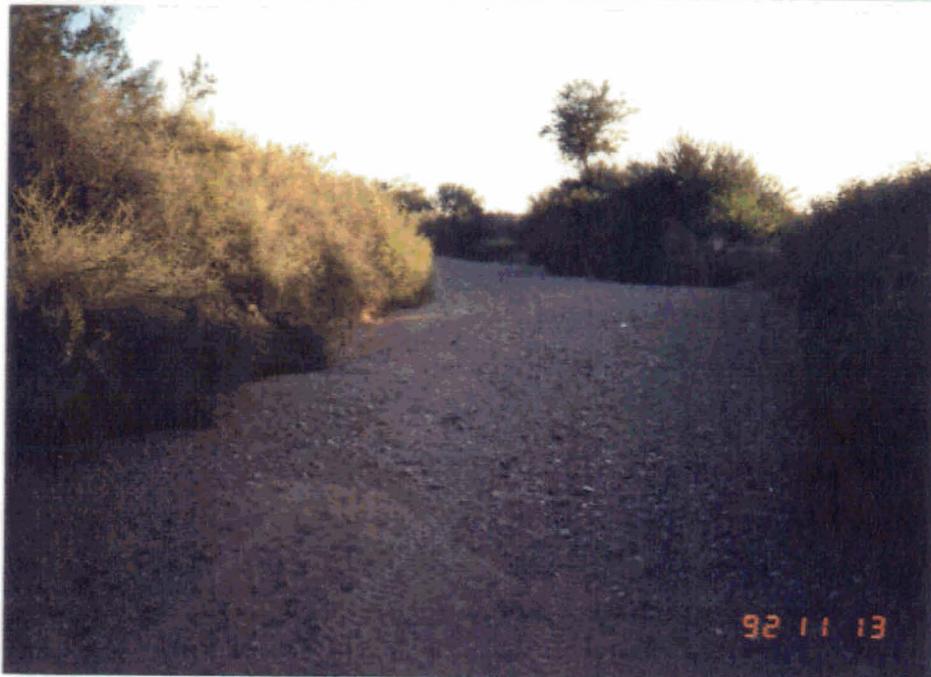
RM 11.3  
Looking Downstream at West Channel  
of Two Channels  
Width = 20'±  
Depth = 4.5' ± to Adjacent Overbank  
Wtd. Channel 'n' = .044

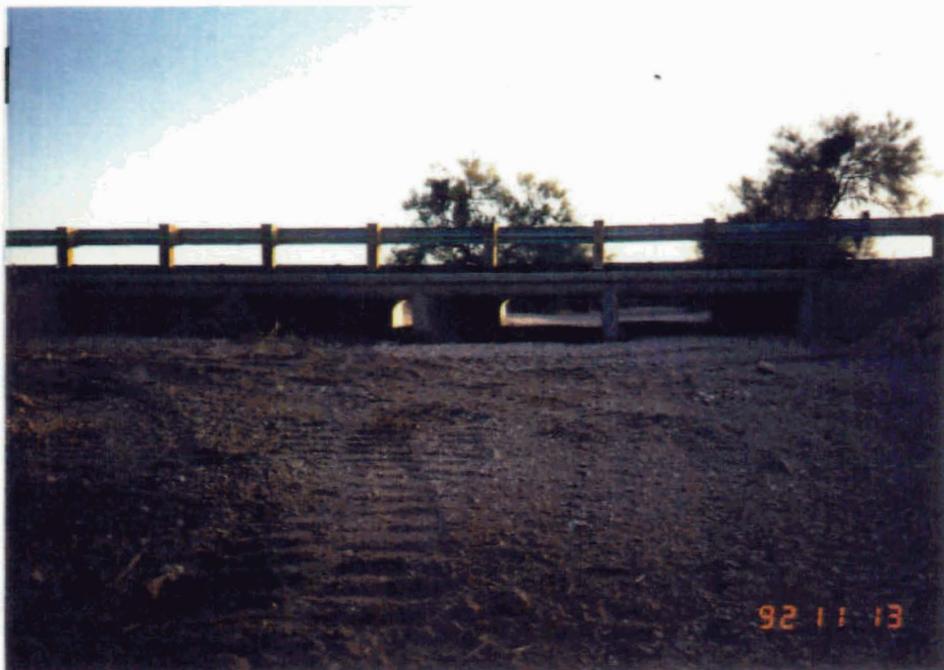
RM 12.2  
Looking Downstream at Inlet to  
4 - 10' Span x 3' Rise Concrete  
Box Culverts Across Paved Access  
Road to Toyota Proving Grounds

The 100-year flood event discharge at the Toyota Proving Grounds Access Road is approximately 3300 cfs. The main wash culvert structures at this road consist of 4-10 foot span x 3 foot rise box culverts. These culverts will convey approximately 840 cfs using an assumed velocity of 7 fps. Thus, overflow of the road is expected for the 100-year event. The change in channel area experienced by the 100-year flows are expected to be gradual and, as such, expansion and contraction coefficients of 0.3 and 0.1, respectively are proposed based on HEC-2 user manual discussions of these parameters.

Of the road crossings listed in Table 1, the Toyota Proving Grounds (TPG) Access Road is the only hard - surfaced road with drainage structures that is expected to require special analysis in the HEC-2 model for culvert and weir flow. The drainage structures will convey less than one-third of the 100-year flow of 3300 cfs. Based on the roadway profile, the majority of the remaining flow will cross over the road to the west of these box culverts.

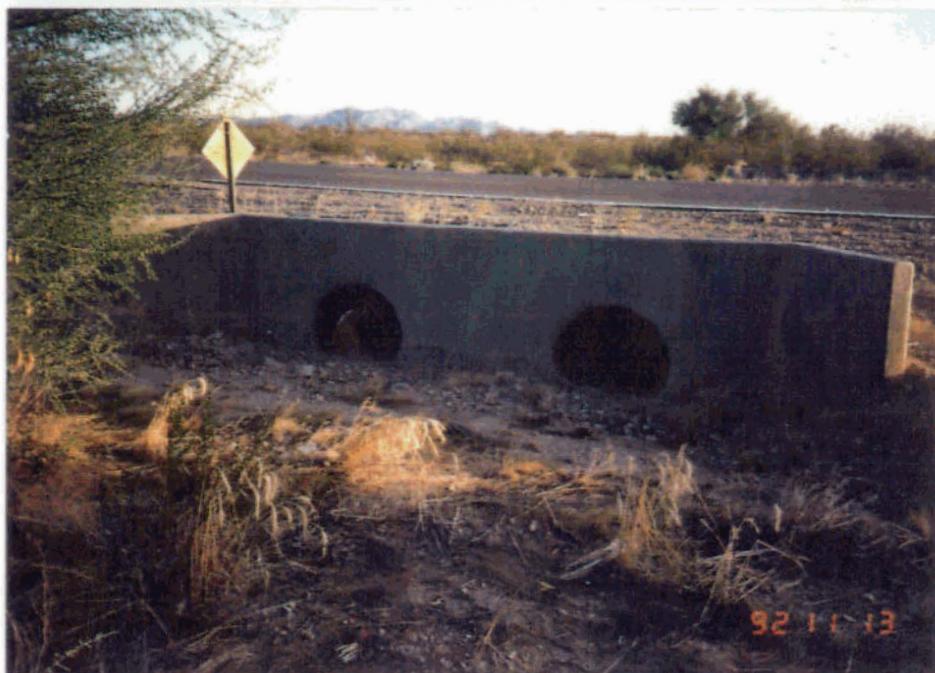
RM 12.2  
Looking Downstream at 2 - 36"  
Span x 22" Rise CMPAs Across  
Paved TPG Access Road  
Located 350'± East of Box Culvert  
at Main Channel

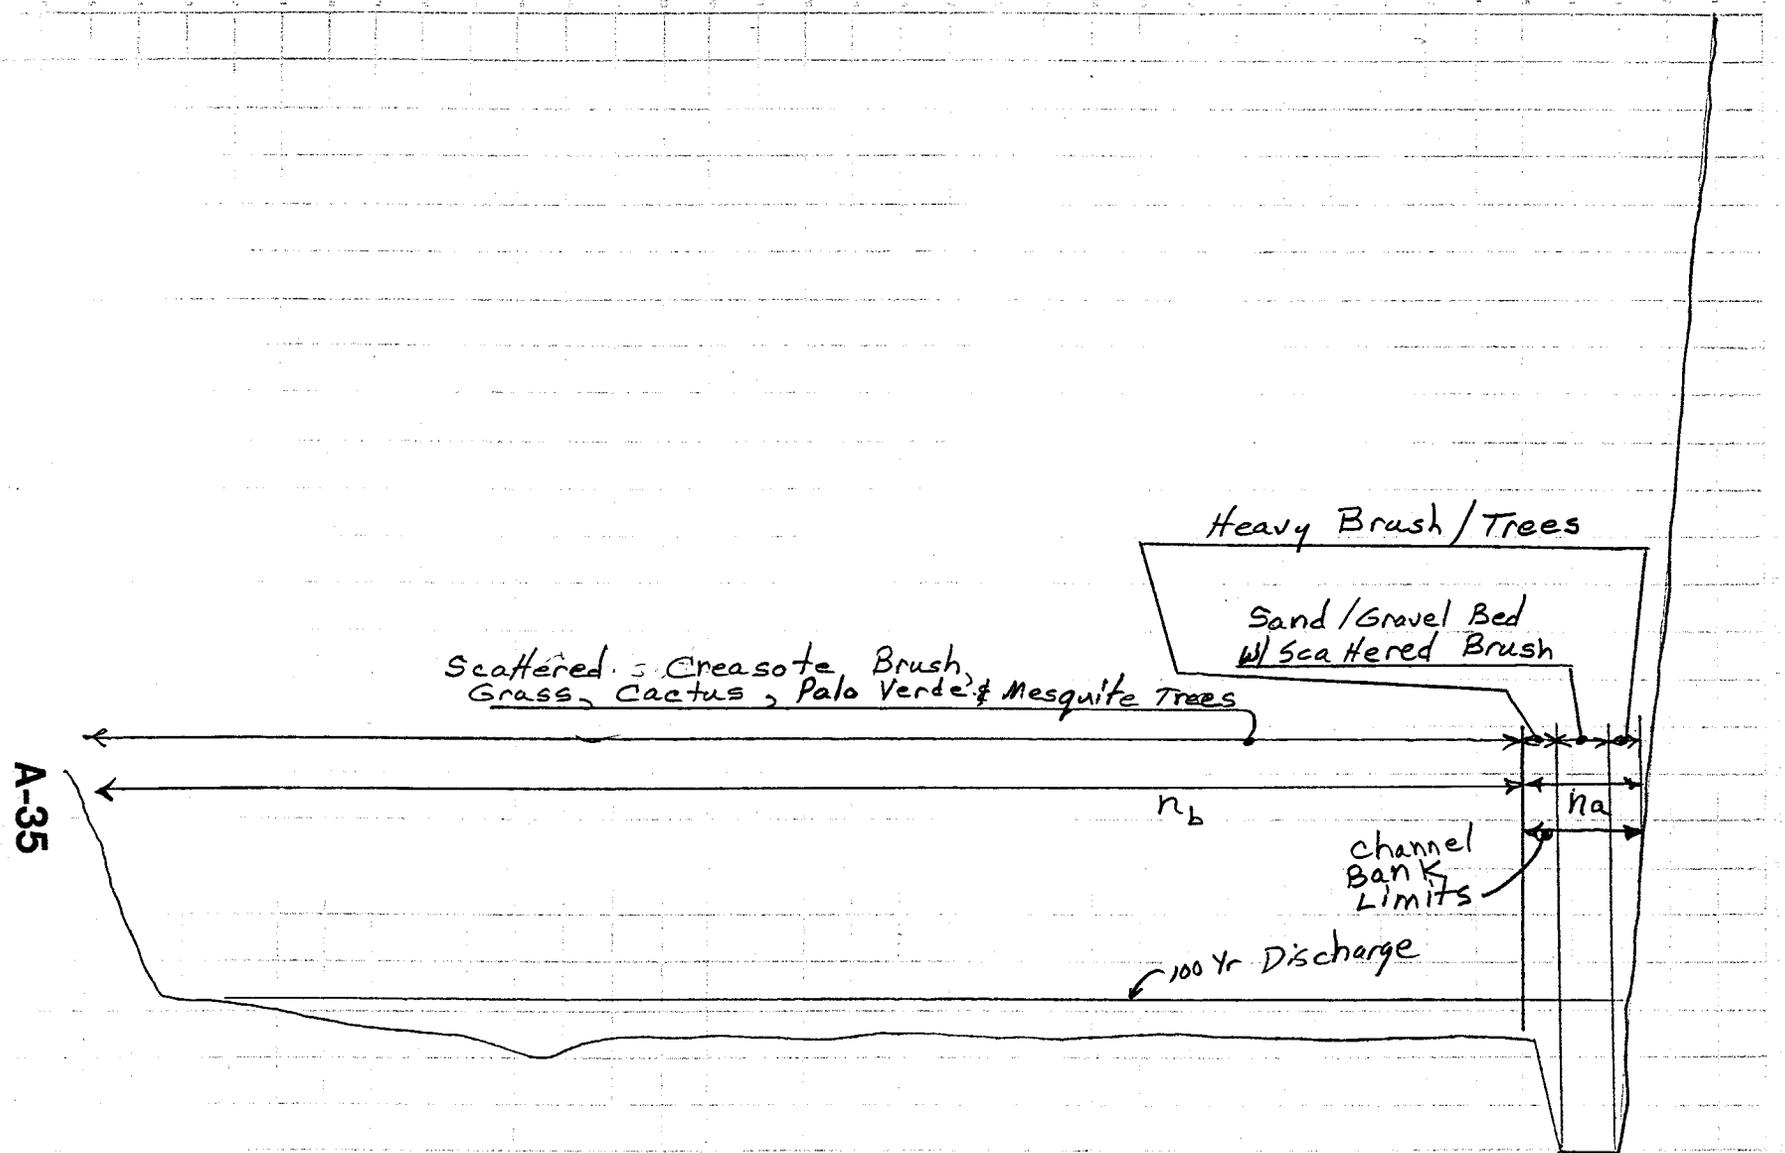
Location of Cross-Section: 0.6 River Miles above confluence with Hassayampa River.

Description of Channel: Main channel has sand/gravel bed with scattered brush. Main channel banks have a heavy growth of brush and trees which are not expected to be overtopped.

The overbanks contain small eroded rivlets interspersed among scattered creosote brush, desert grass, cactus and occasional palo verde and mesquite trees. Flow is expected to be shallow (i.e. 1-2 feet deep) in overbanks.

Sub-division of Cross-Section and Evaluation of 'n': Cross-section was sub-divided by area for main channel, where bank stations are anticipated just outside of the heavy vegetation growth. The overbanks were estimated based on perimeter although, 'n' value was estimated to be uniform over this area.

RM 0.6 Looking Downstream

Scale H : 1" = 100'  
V : 1" = 5'

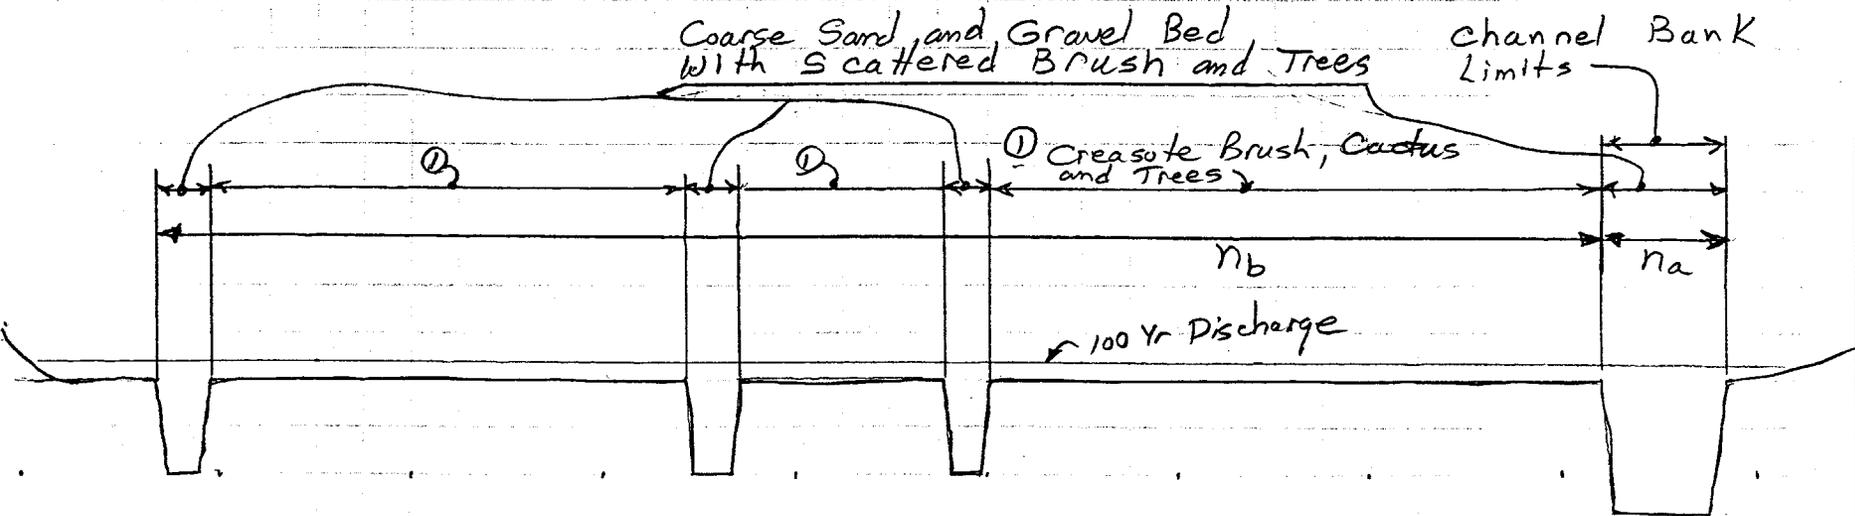
RM 2.05  
Looking Downstream

Scale H: 1" = 100'  
V: 1" = 5'

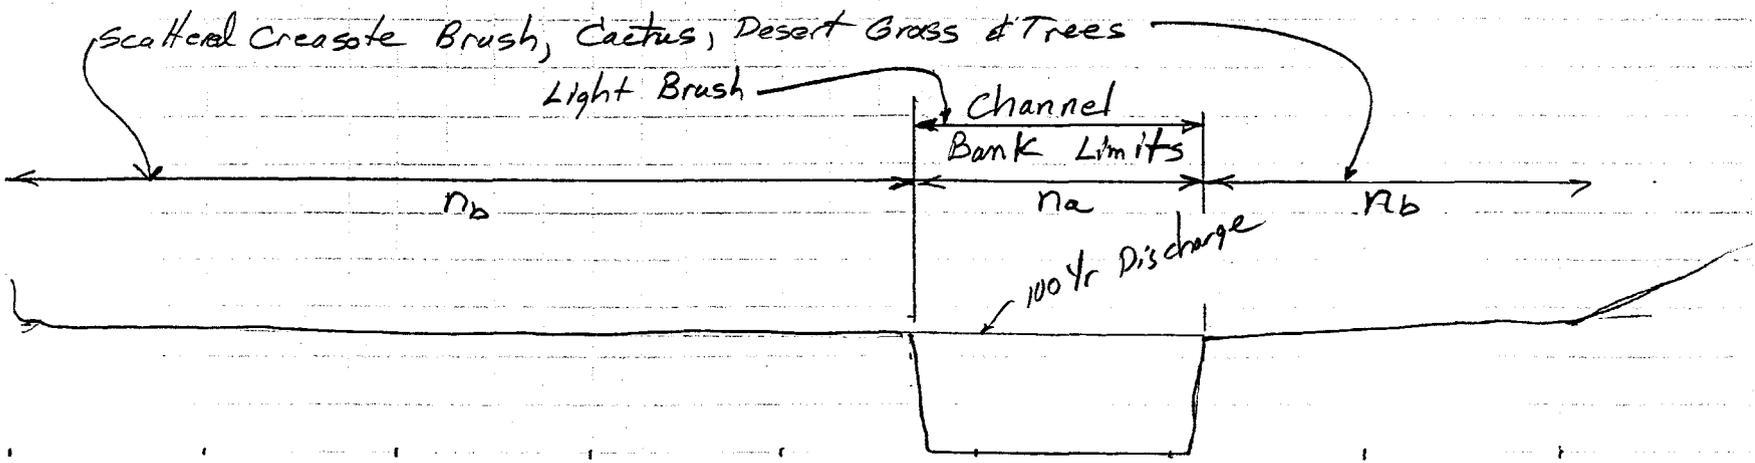
RM 2.8 +  
Looking Downstream

Scale H: 1" = 100'  
V: 1" = 5'

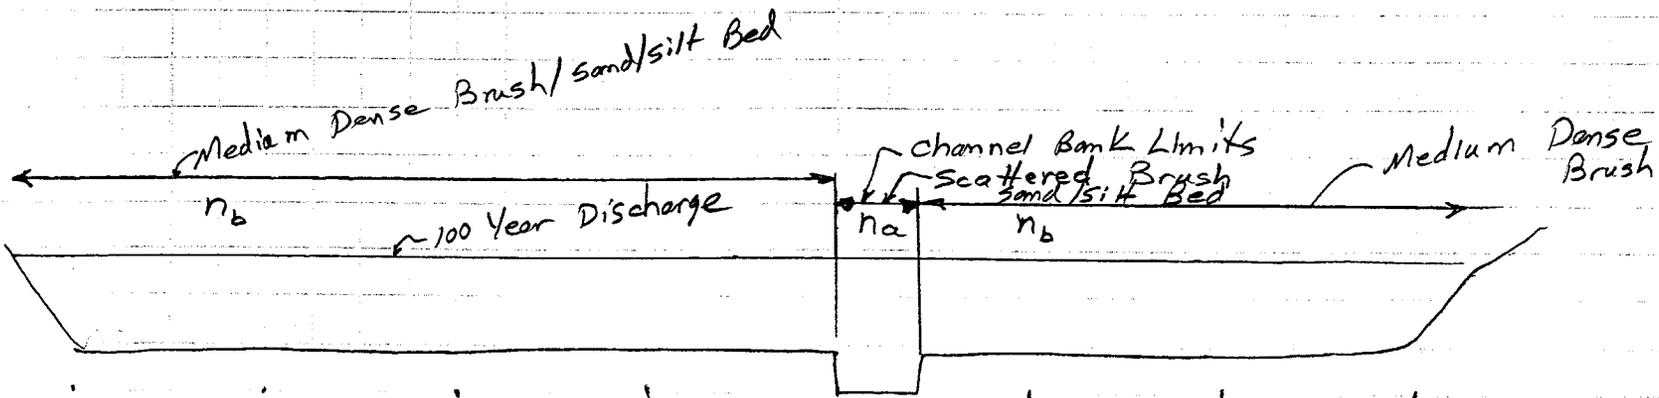
RM 3.2  
Looking Downstream

Scale H: 1" = 100'  
V: 1" = 5'
