**TECHNICAL DATA NOTEBOOK  
FOR DAGGS WASH  
SECTION 4.2 FIELD RECONNAISSANCE  
AND HYDRAULIC PARAMETER ESTIMATION**

**DECEMBER, 1992**

**PREPARED FOR:  
FLOOD CONTROL DISTRICT OF MARICOPA COUNTY  
2801 WEST DURANGO STREET  
PHOENIX ARIZONA 85009**

**FCD NO. 92-08  
A-N WEST NO. 7158-02**

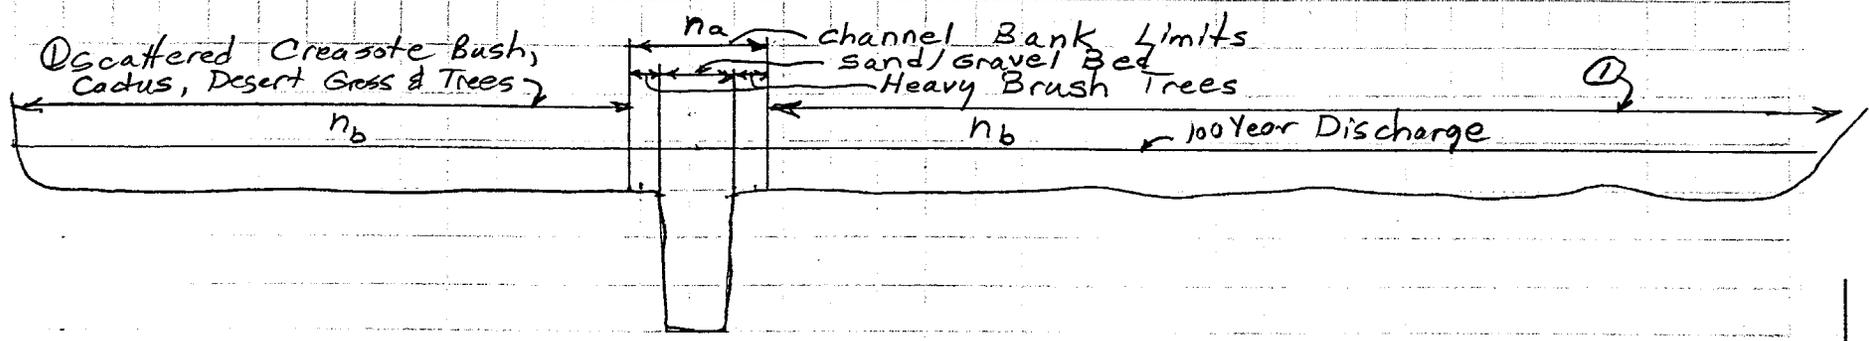
RM 4.0 Looking Upstream  
Scale:  $H: 1'' = 100'$   
 $V: 1'' = 5'$

Note: Cross-sections at RM 6.0, 7.6, 9.75, 10.4, 11.3 and 12.2 are representative of RM 4.0 and 5.3 above

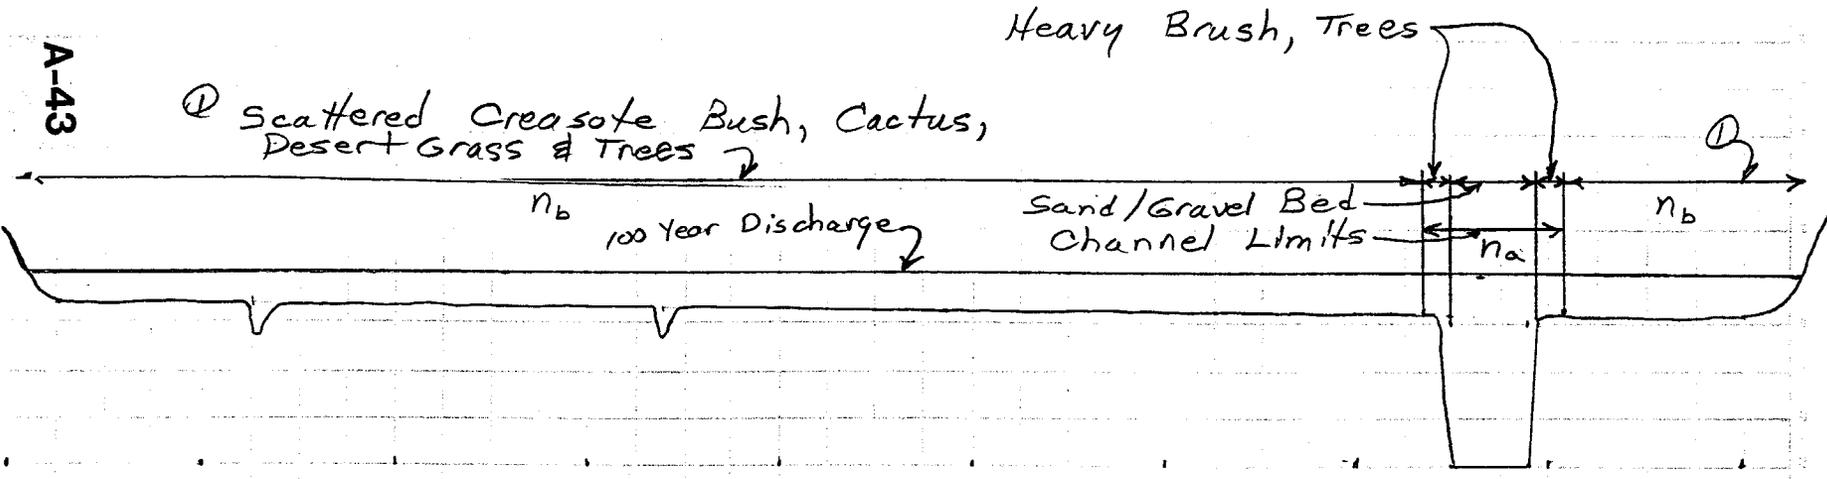
RM 5.3 Looking Downstream Scale:  $H: 1'' = 100'$   
 $V: 1'' = 5'$

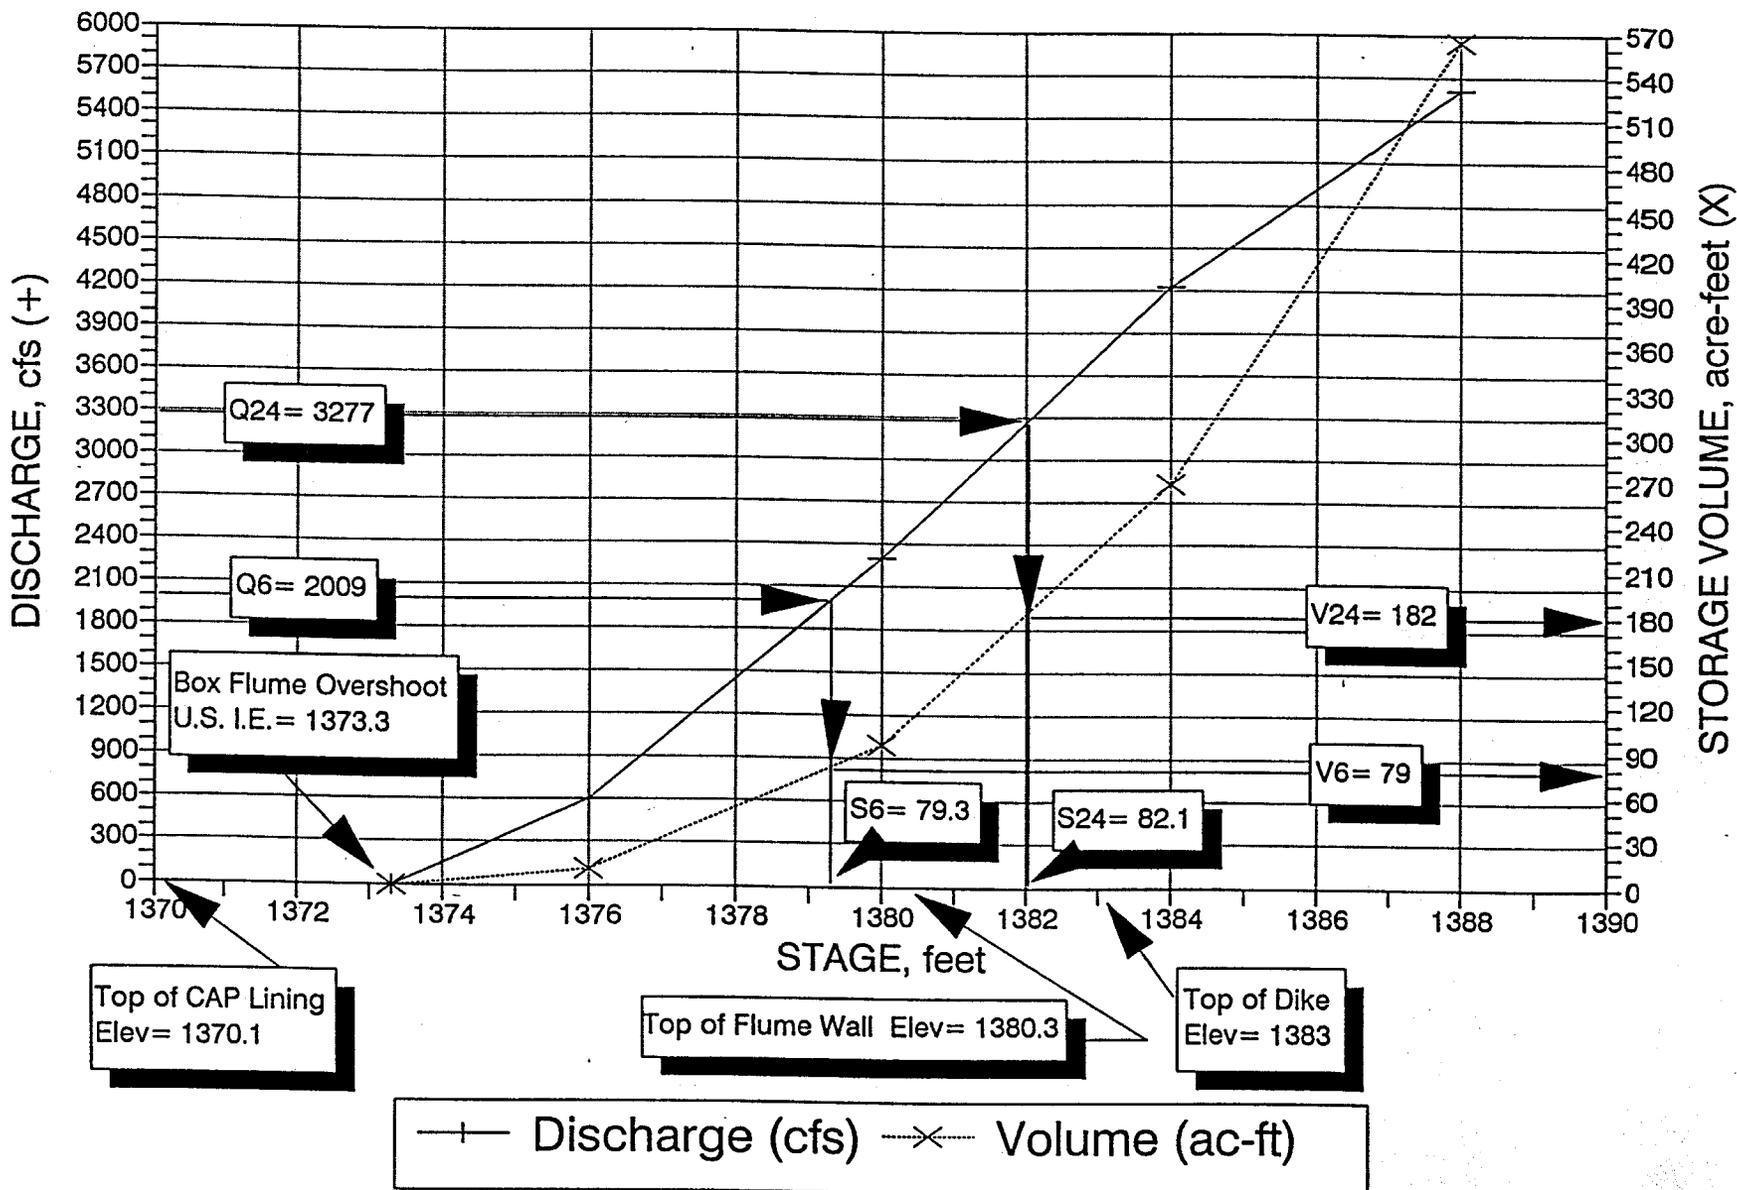
**FIGURE 8: CAP-8  
DISCHARGE AND STORAGE VOLUME vs STAGE**

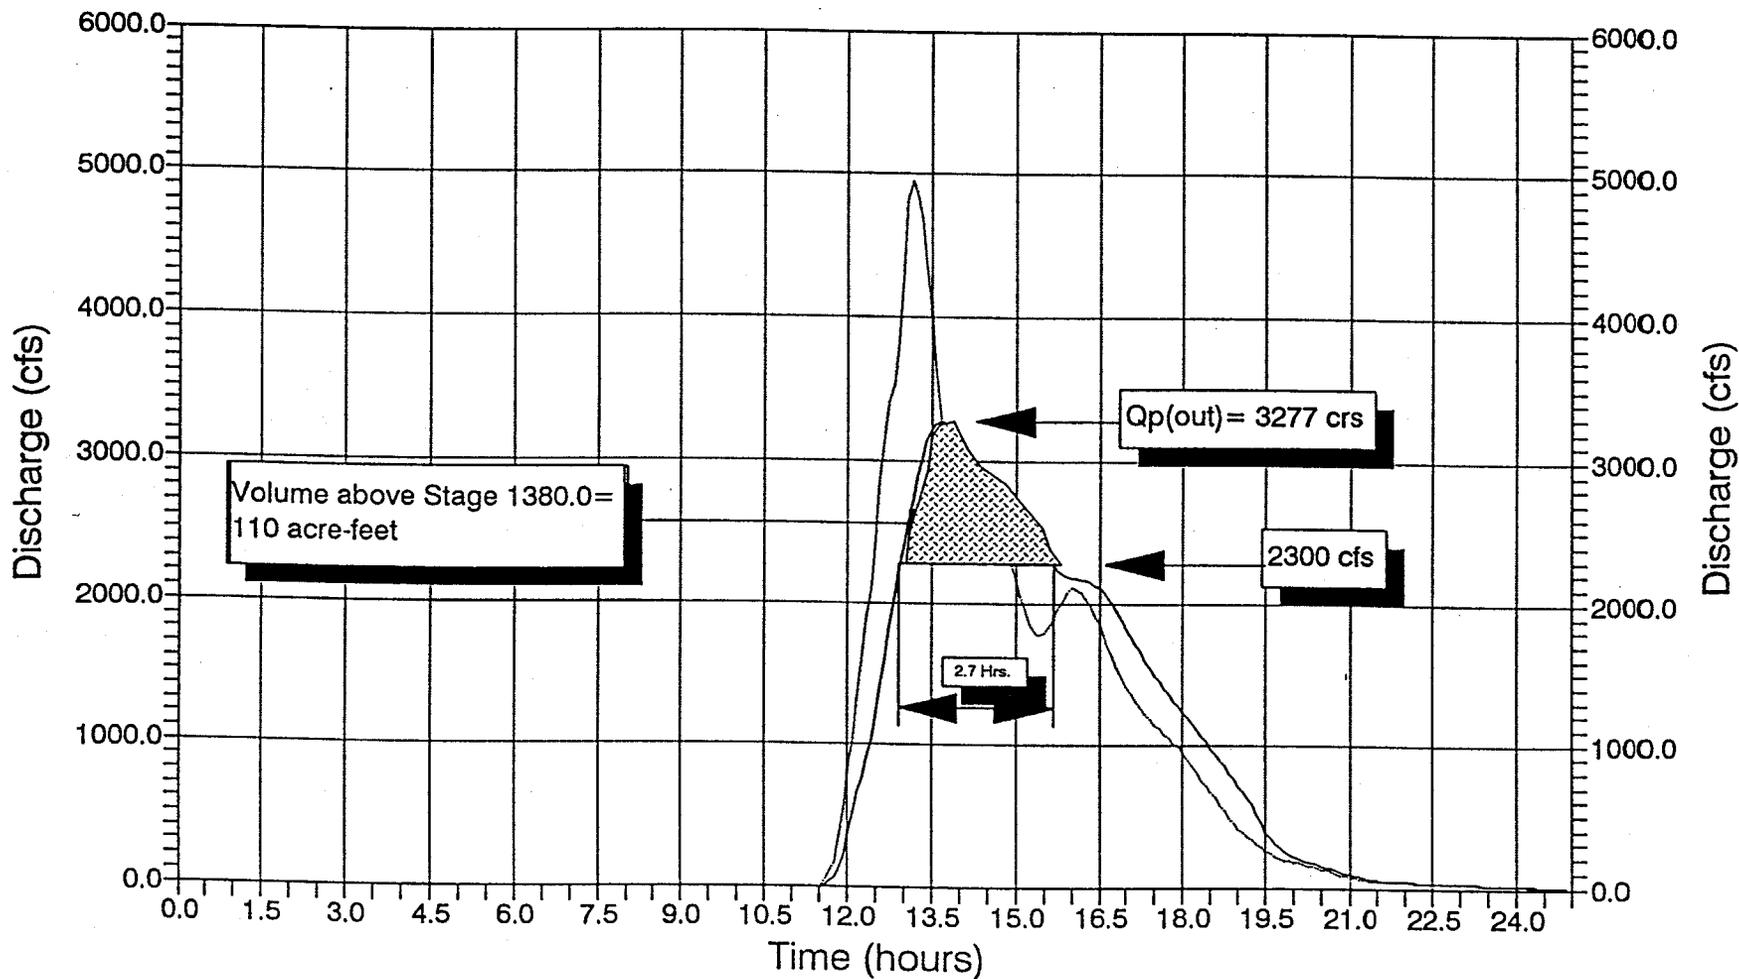
### FIGURE 15: CAP-8

100-Yr 24-Hr Inflow and Outflow Hyds.

— Inflow Hydrograph    - - - Outflow Hydrograph

The outflow hydrograph for CAP-8 was examined to estimate the duration that ponding would exceed elevation 1380.0, the top of the compacted portion of the collective dikes. Refer to Figure 15. Assuming the uncompacted embankment does not fail, the duration is estimated to be less than 3 hours.
