WITTMANN PHASE III FLOODPLAIN DELINEATION STUDY

Technical Data Notebook
Volume II of II

The Flood Control District of
Maricopa County

**MANNING’S *n* VALUE DETERMINATIONS
FOR THE WITTMANN PHASE III FLOODPLAIN DELINEATION STUDY**

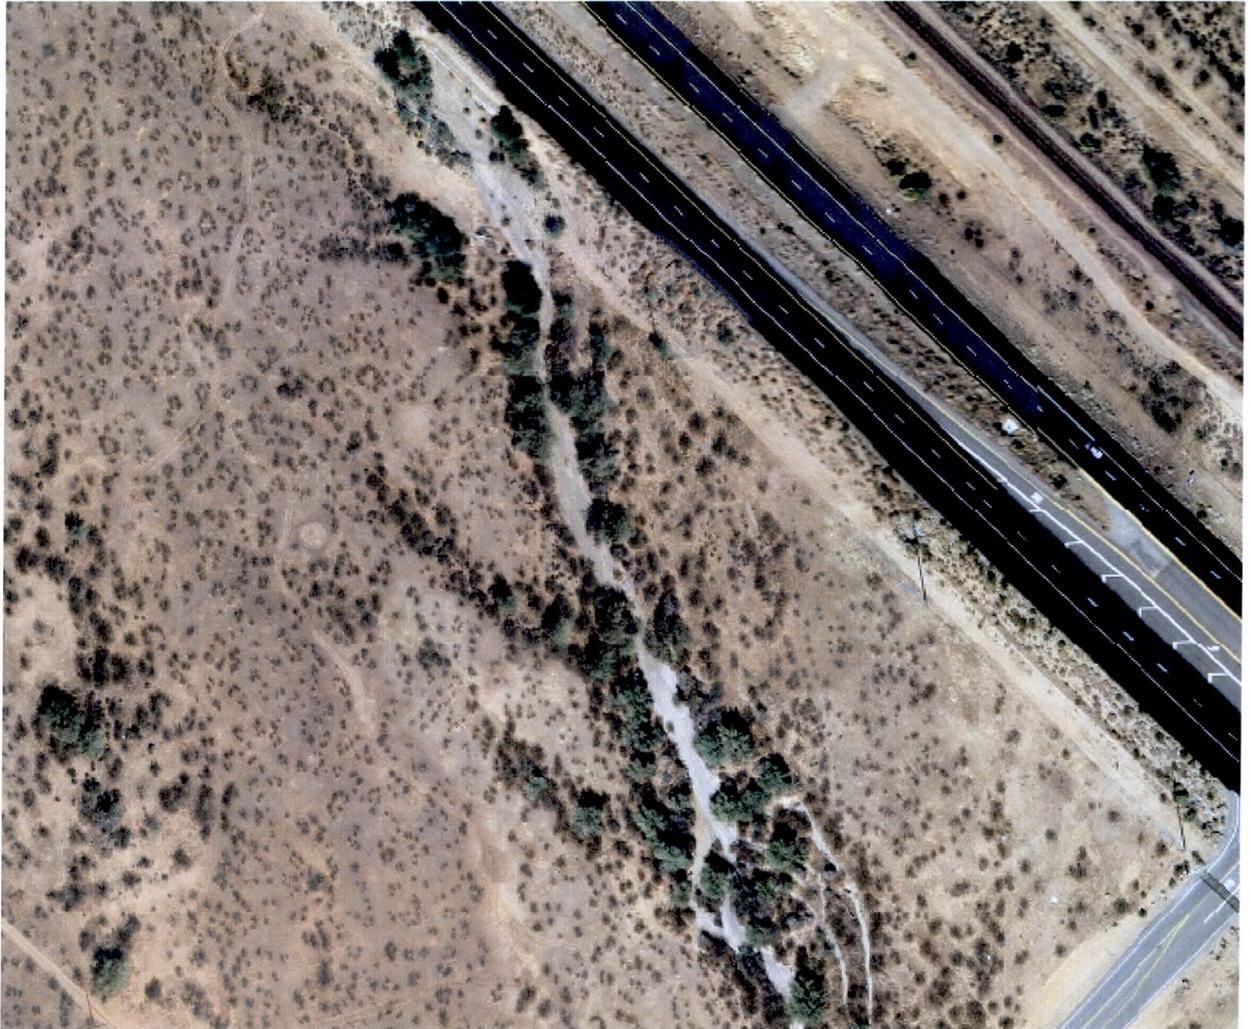
Figure 2: Aerial photograph of Area 1. Scale is 1:24,000.

Portion of Cross Section	Components	Composite n Value
Channel	$n_b=0.030$	0.033
	$n_1=0.001$	
	$n_2=0.002$	
	$n_3=0.000$	
Overbanks	$n_b=0.029$	0.064
	$n_1=0.005$	
	$n_2=0.000$	
	$n_3=0.030$

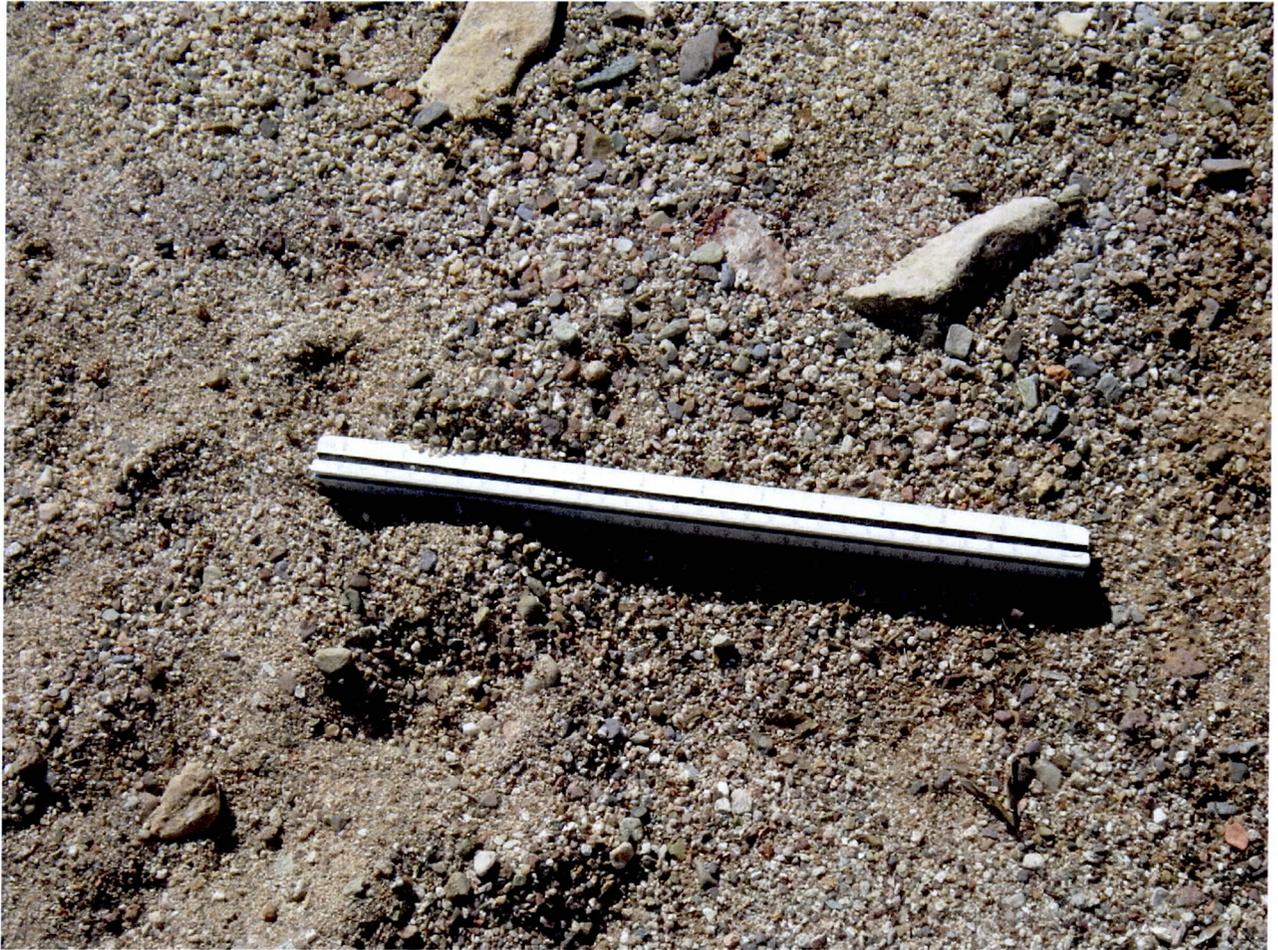
Figure 3: Area 1 channel bed (IMG0701.JPG).

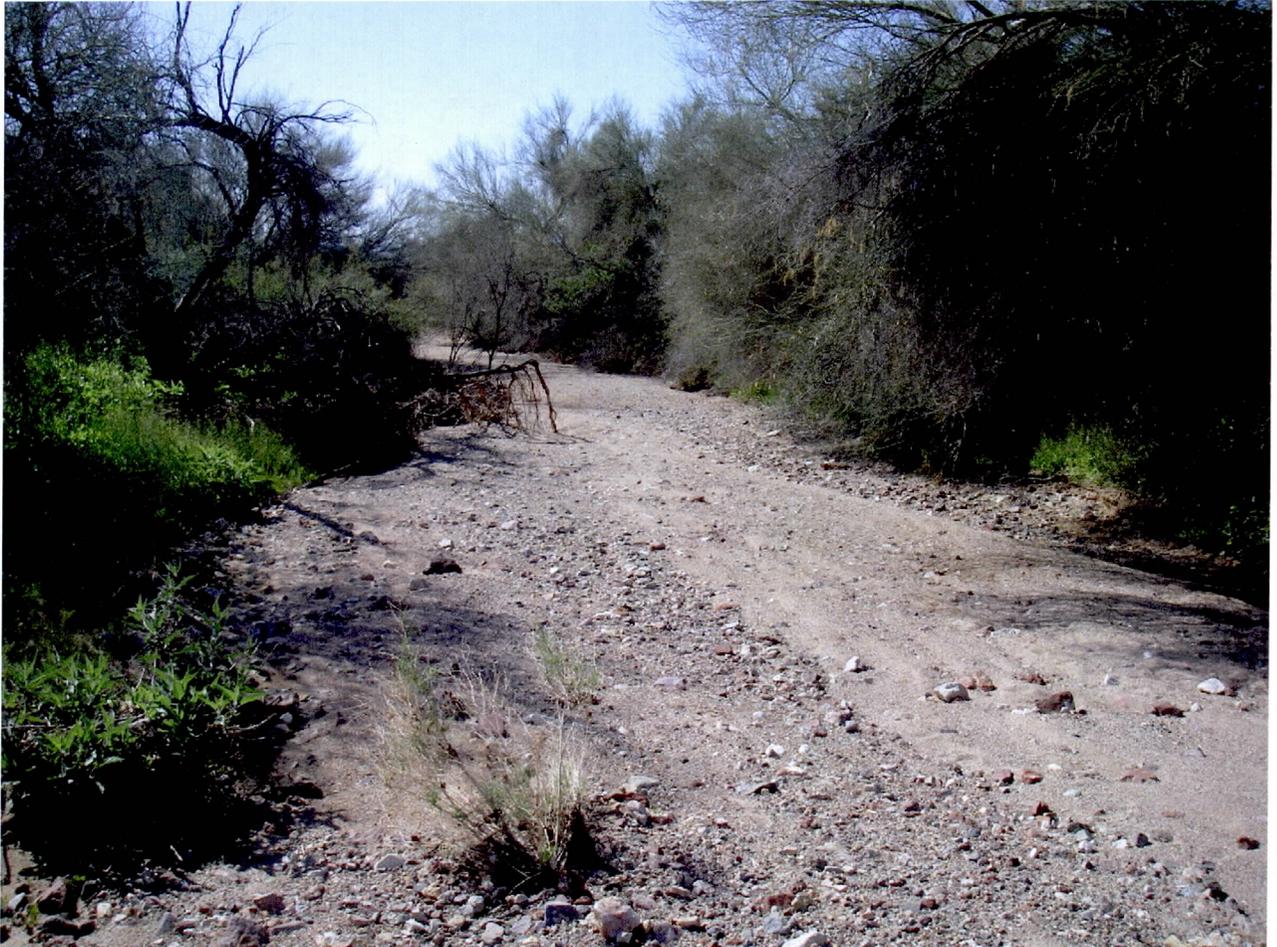
Figure 4: About 200 feet downstream from US 60, looking downstream (IMG0709.JPG).

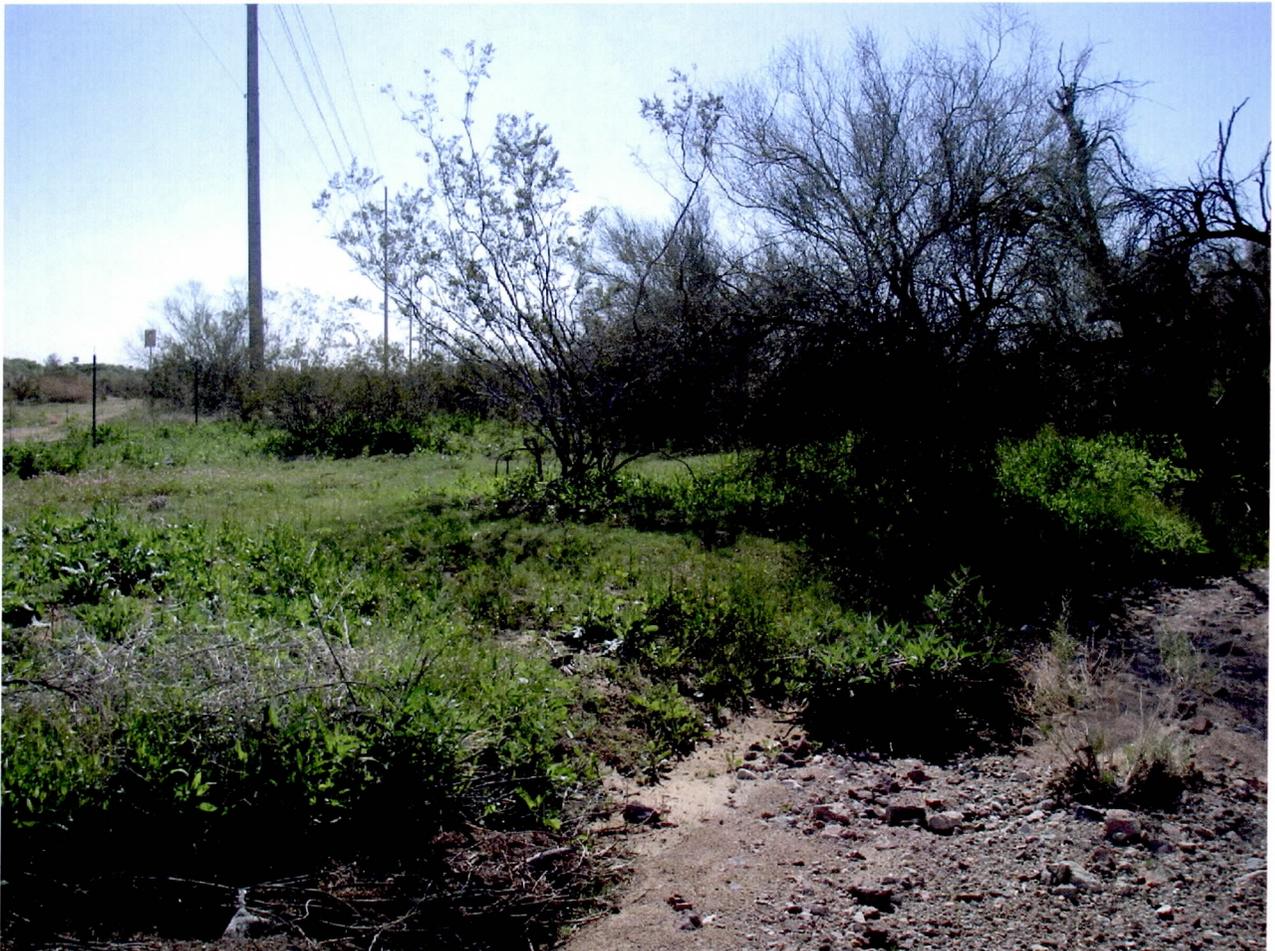
Figure 5: About 200 feet downstream from US 60, looking downstream (IMG0708.JPG). This is the far left overbank. This photograph is representative of the right overbank as well.

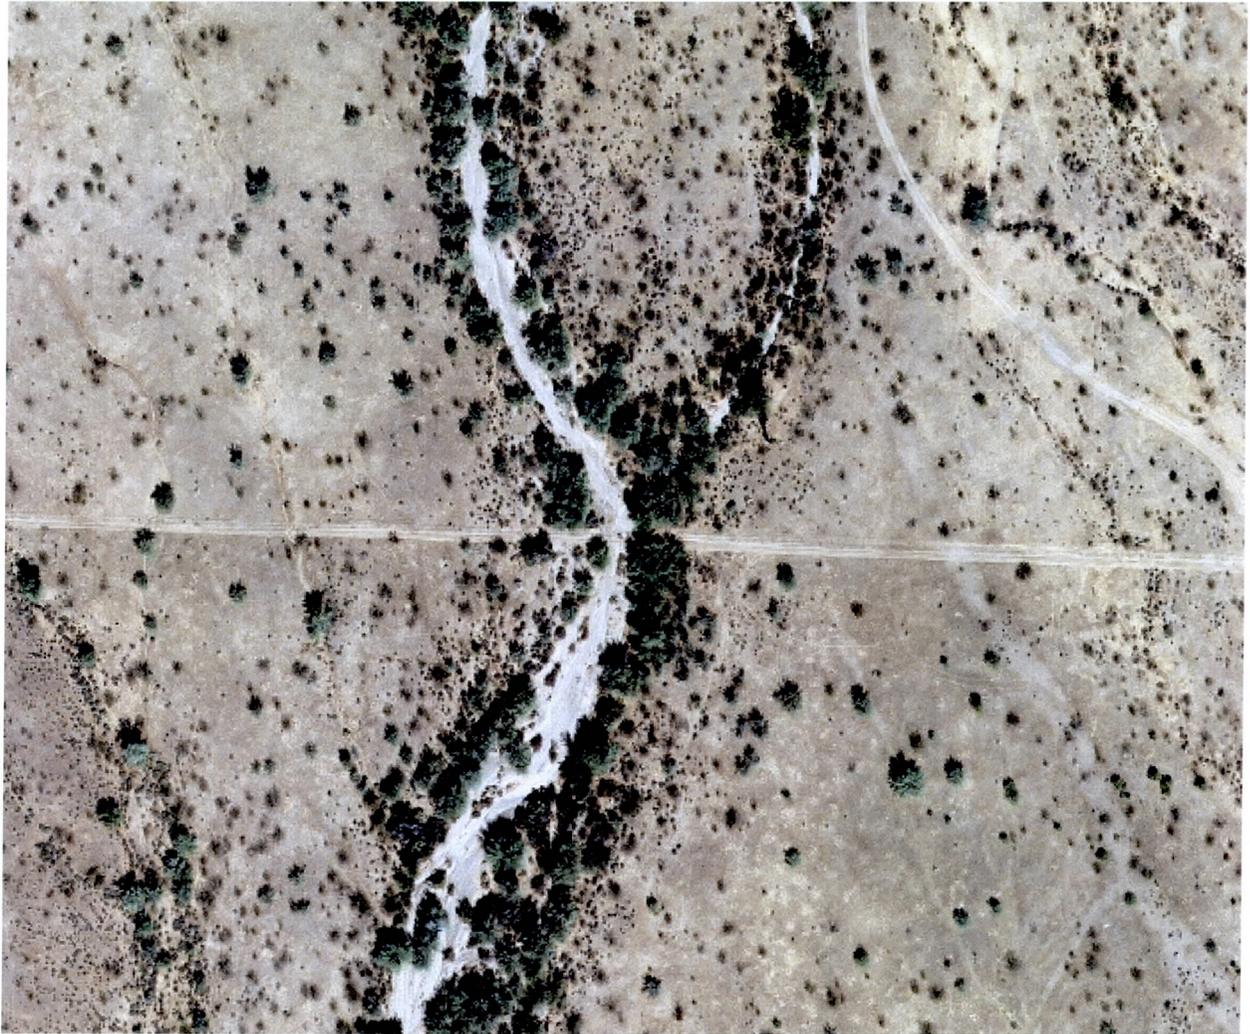
Figure 6: Aerial photograph of Area 2. Scale is 1:24,000.

Area 2: Manning's n values were computed along 2W Tributary 1 at the Florentine Road alignment. The channel in this area is composed of small gravel with an average size in the range of 0.1 to 0.2 inches. There are some larger cobbles, but very few pieces are larger than one inch. There is minimal erosion along the channel banks. The field photography shows a wood debris pile in the middle of the channel, but inspection of the aerial photography indicated that this pile is an aberration, and that it is reasonable to assume that the channel is free of obstructions.

Portion of Cross Section	Components	Composite n Value
Channel	$n_b=0.030$	0.033
	$n_1=0.001$	
	$n_2=0.002$	
	$n_3=0.000$	
Overbanks	$n_b=0.029$	0.059
	$n_1=0.005$	
	$n_2=0.000$	
	$n_3=0.025$

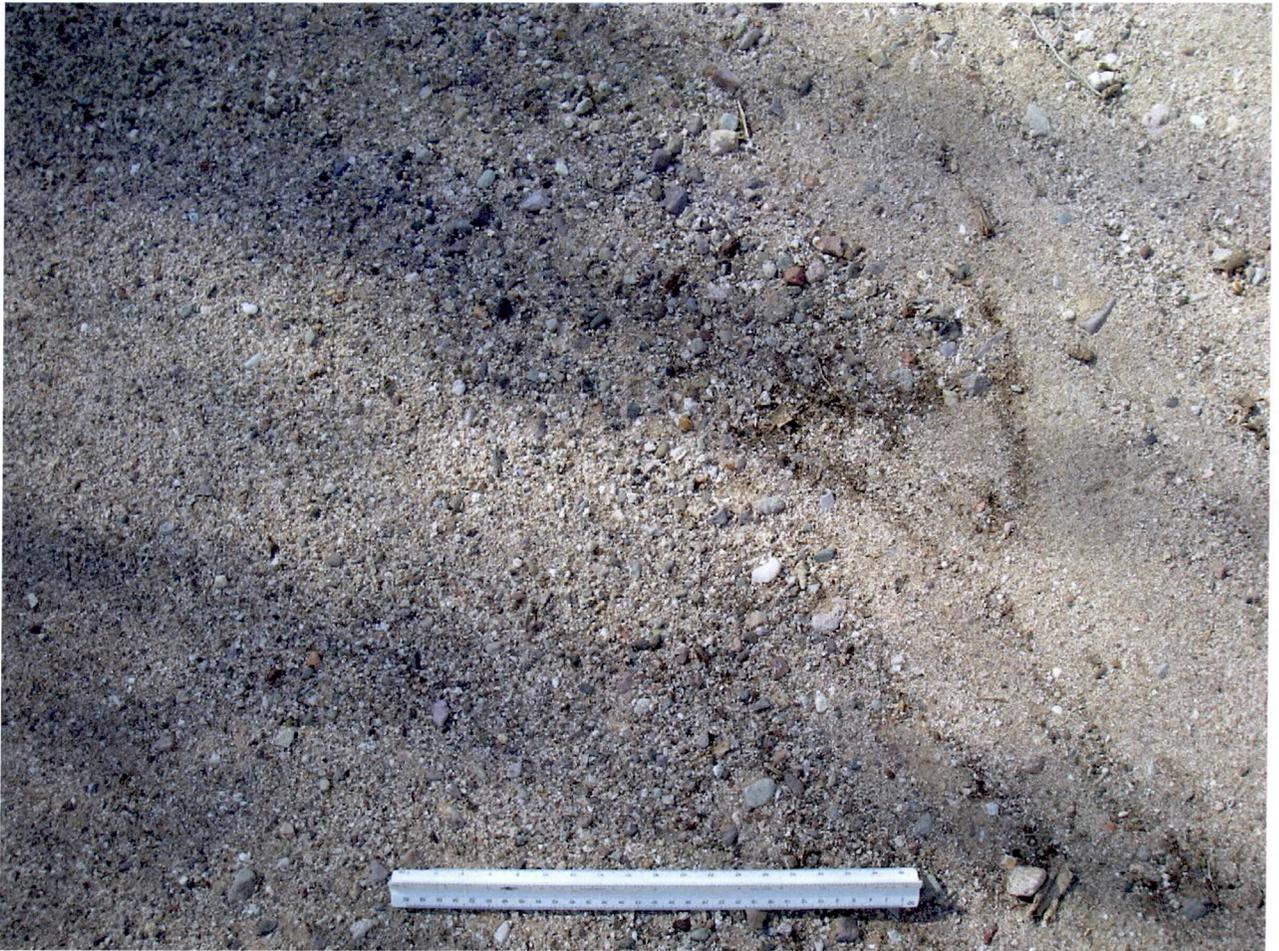
Figure 7: Area 2 channel bed (IMG0872.JPG).

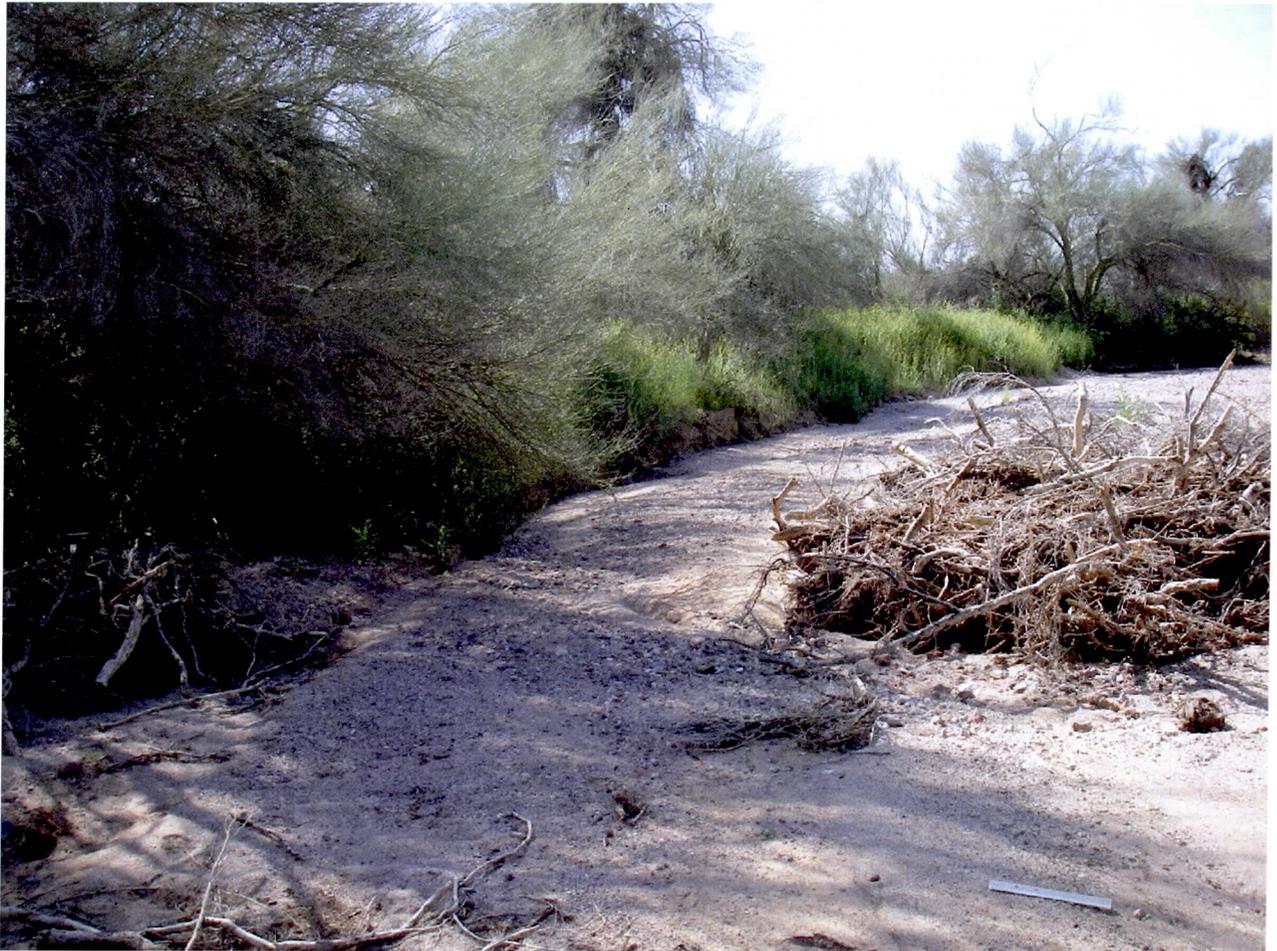
Figure 8: 2W Tributary 1 at the Florentine Road alignment, looking downstream (IMG0871.JPG). Although there is obstruction in the channel (wood debris pile), these obstructions are not common.

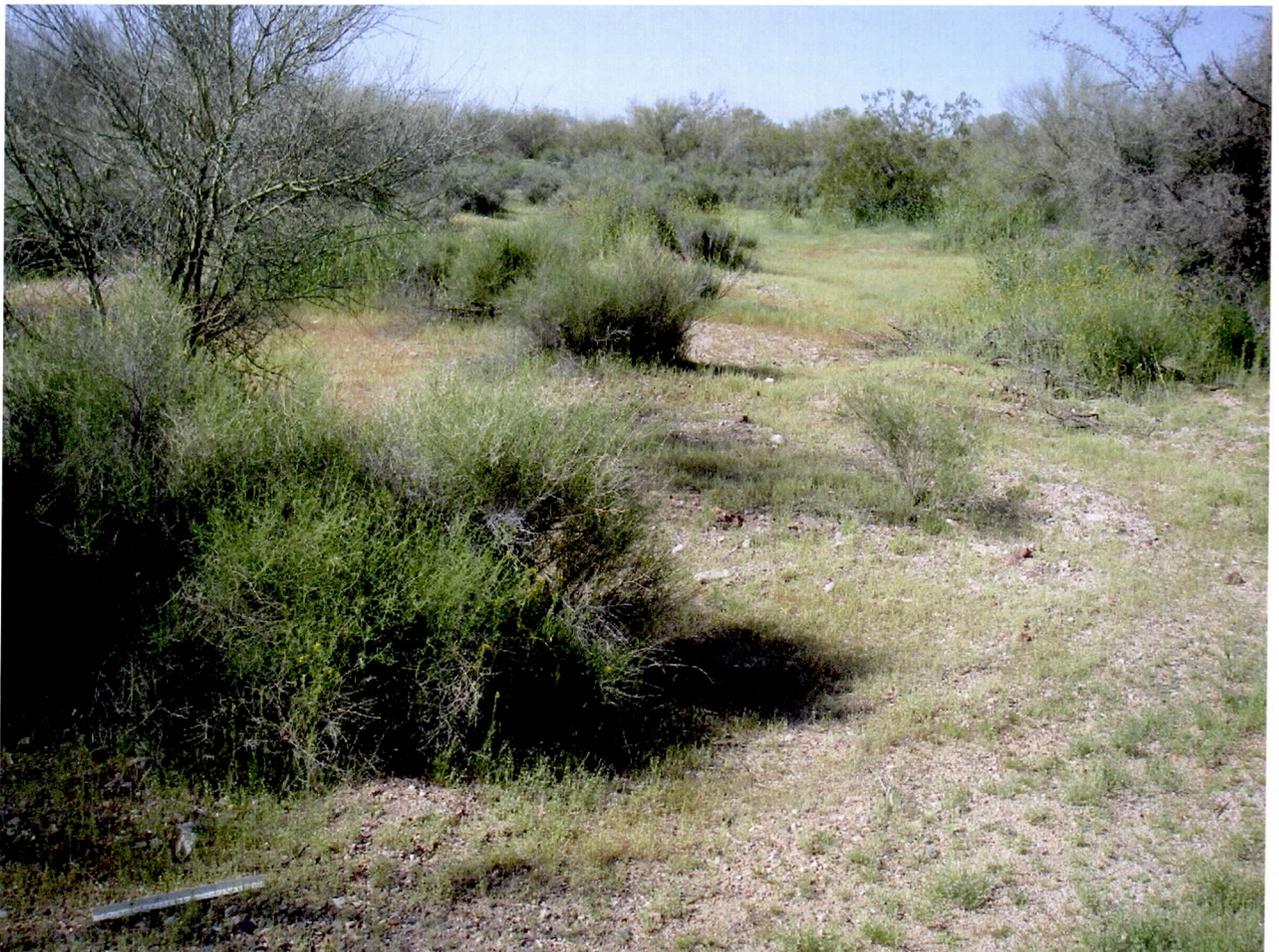
Figure 9: 2W Tributary 1 at the Florentine Road alignment, looking downstream (IMG0868.JPG). This is the far right overbank. This photograph is representative of the left overbank as well.

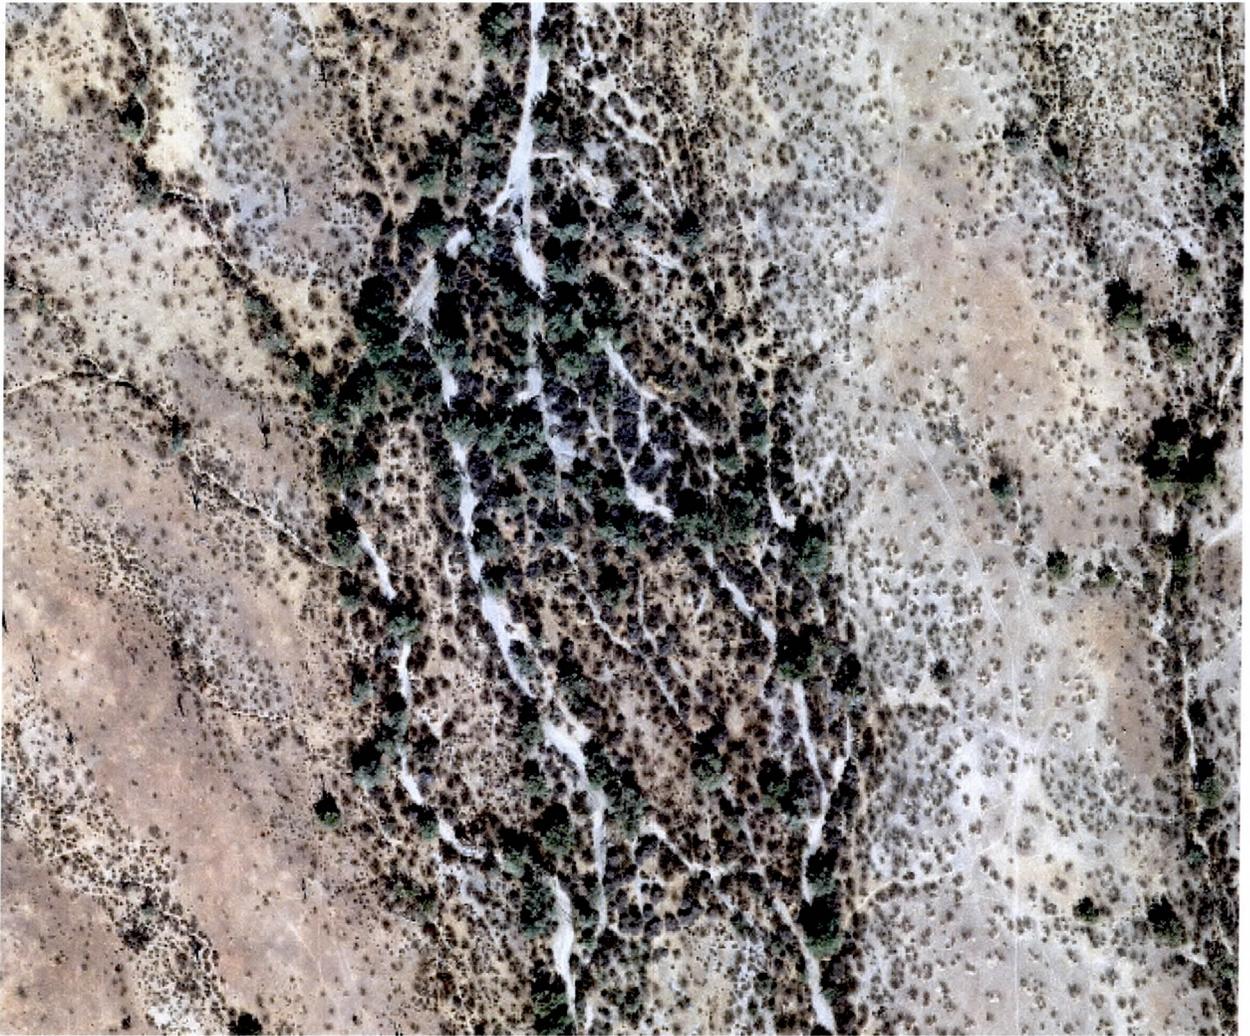
Figure 10: Aerial photograph of Area 3. Scale is 1:24,000.

Area 3: Manning's n values were computed along 2W Tributary 1 about 7,000 feet upstream of US 60. Like Area 6, this area is braided. This is the smallest area in the study, only about 2,000 feet long. A unique n value has been calculated for this area only because the vegetation is thicker here than it is anywhere else in the study. Due to its small size, this area is difficult to reach. Only a few roads cross the study area in this undeveloped watershed, and none crosses this area. Therefore, the n values have been calculated based on the characteristics of the areas nearby (Area 2 and Area 4) and information gleaned from the aerial photography.

Portion of Cross Section	Components	Composite n Value
Channel	$n_b=0.031$	0.034
	$n_1=0.001$	
	$n_2=0.002$	
	$n_3=0.000$	
Overbanks	$n_b=0.031$	0.082
	$n_1=0.001$	
	$n_2=0.000$	
	$n_3=0.050$

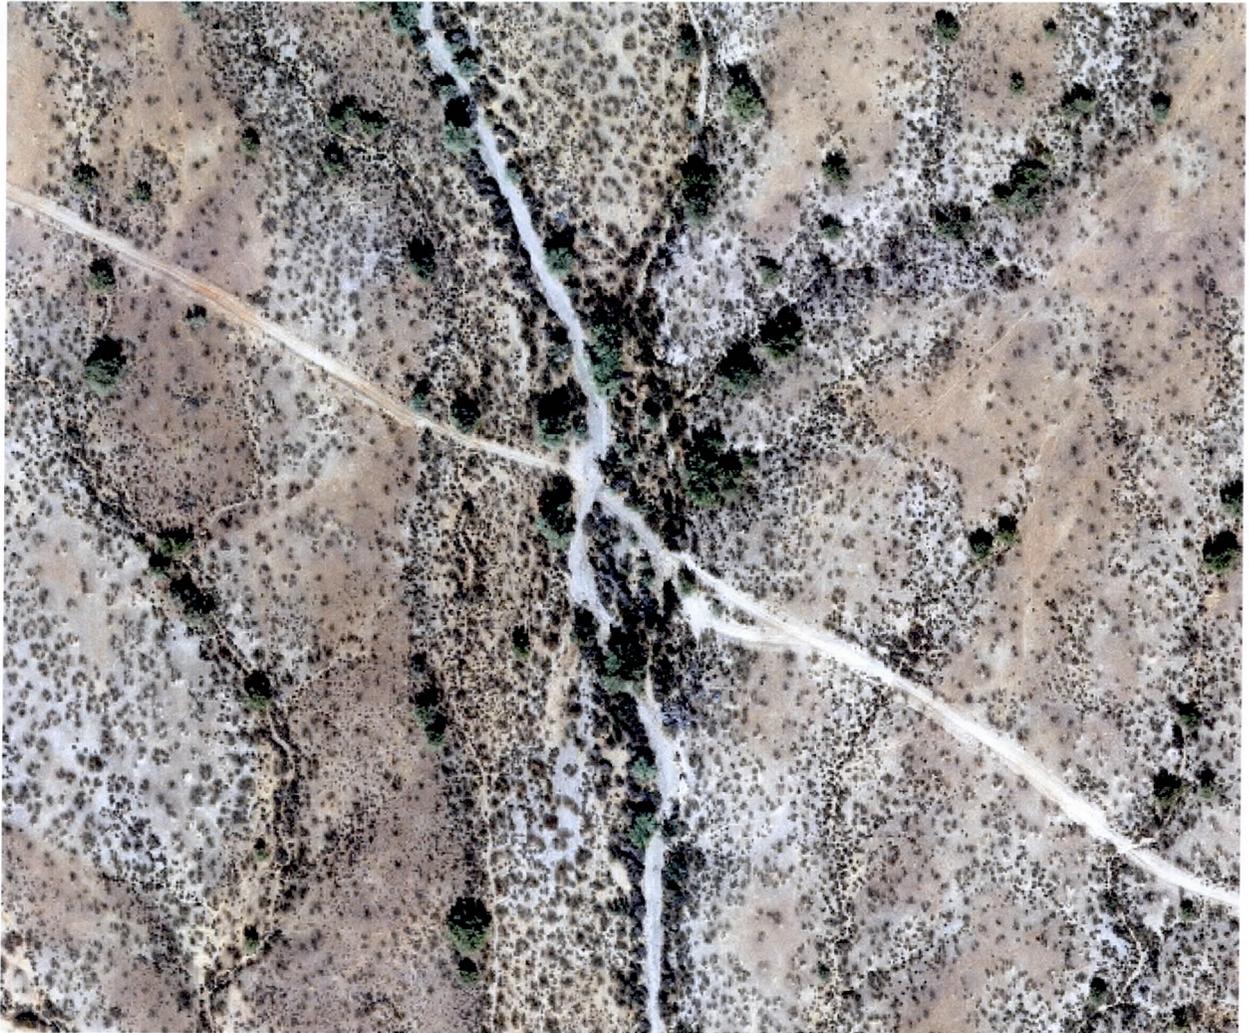
Figure 11: Aerial photograph of Area 4. Scale is 1:24,000.

Area 4: Manning's n values were computed along 2W Tributary 1 at an unnamed road that is oriented in a northwest-southeast fashion. This road is about halfway between SR 74 and US 60. The channel in this area is composed of small gravel with an average size in the range of 0.2 to 0.3 inches. There are many larger cobbles, too. These larger stones are typically about one to two inches across. There is minimal erosion along the channel banks.

Portion of Cross Section	Components	Composite n Value
Channel	$n_b=0.032$	0.035
	$n_1=0.001$	
	$n_2=0.002$	
	$n_3=0.000$	
Overbanks	$n_b=0.029$	0.069
	$n_1=0.005$	
	$n_2=0.000$	
	$n_3=0.035$

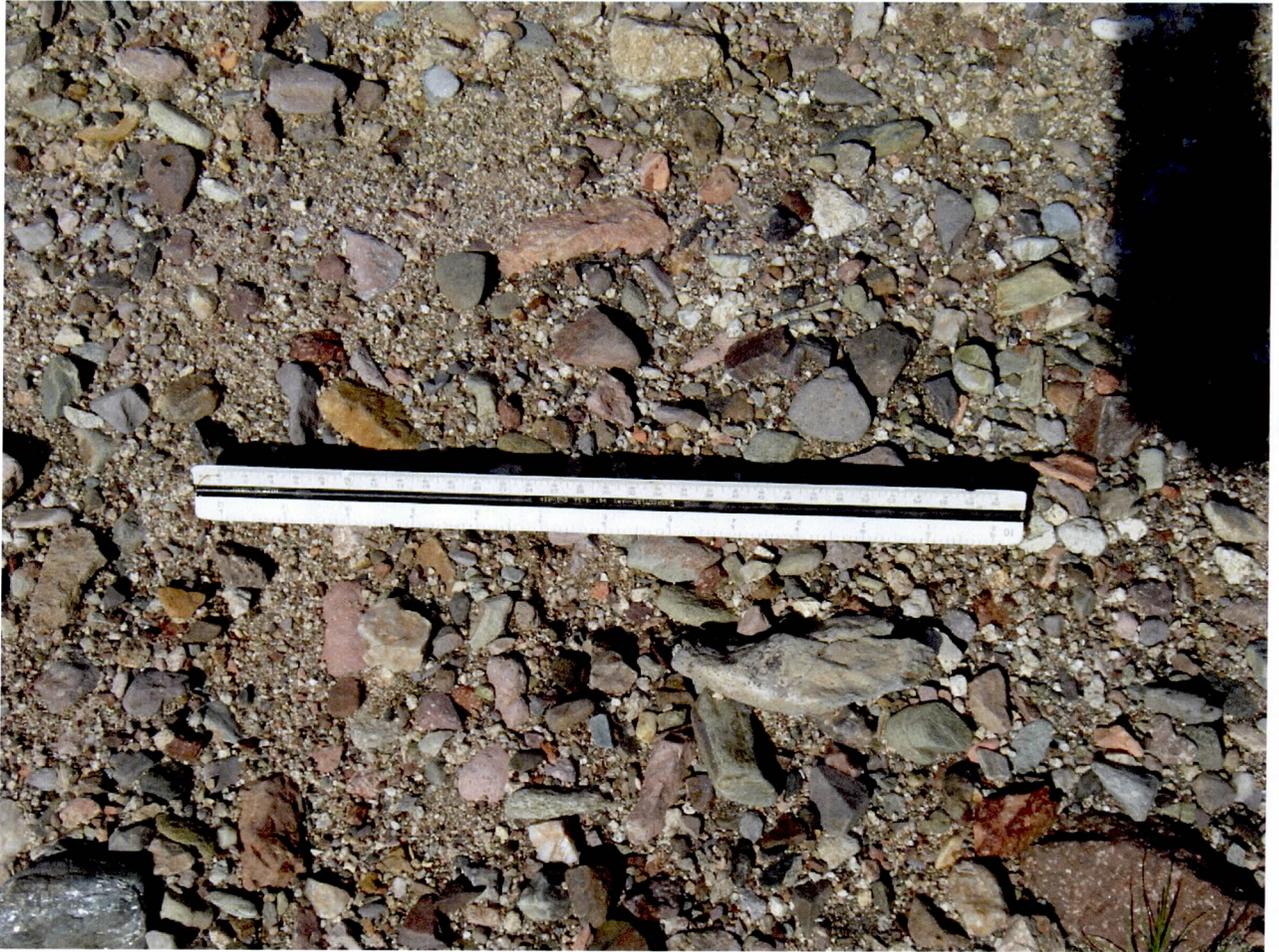
Figure 12: Area 4 channel bed (IMG0752.JPG).

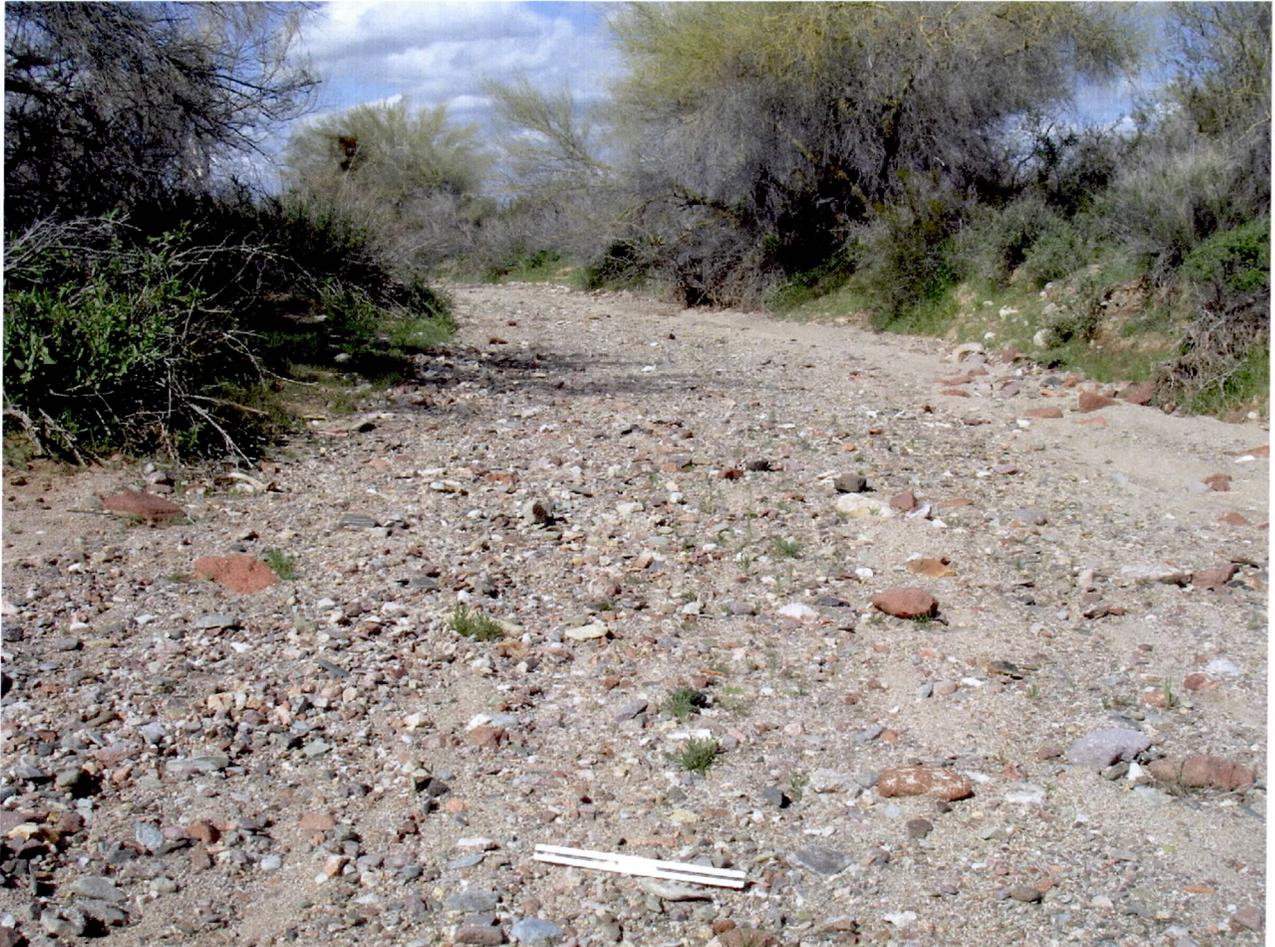
Figure 13: 2W Tributary at the unnamed dirt road that crosses the study area on a northwest-southeast alignment, looking upstream (IMG0751.JPG).

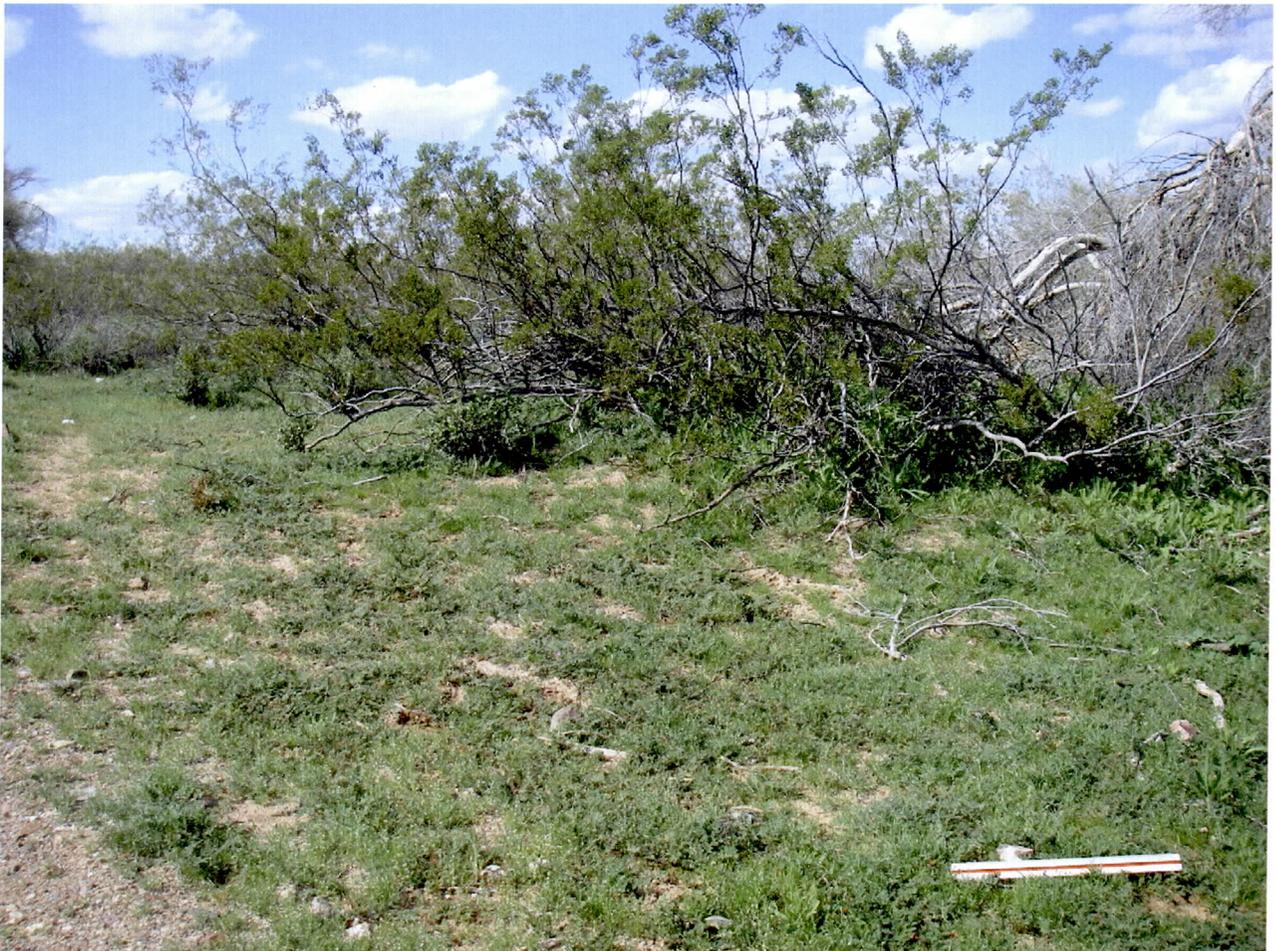
Figure 14: 2W Tributary at the unnamed dirt road that crosses the study area on a northwest-southeast alignment, looking upstream (IMG0754.JPG). This is the far right overbank. This photograph is representative of the left overbank as well.

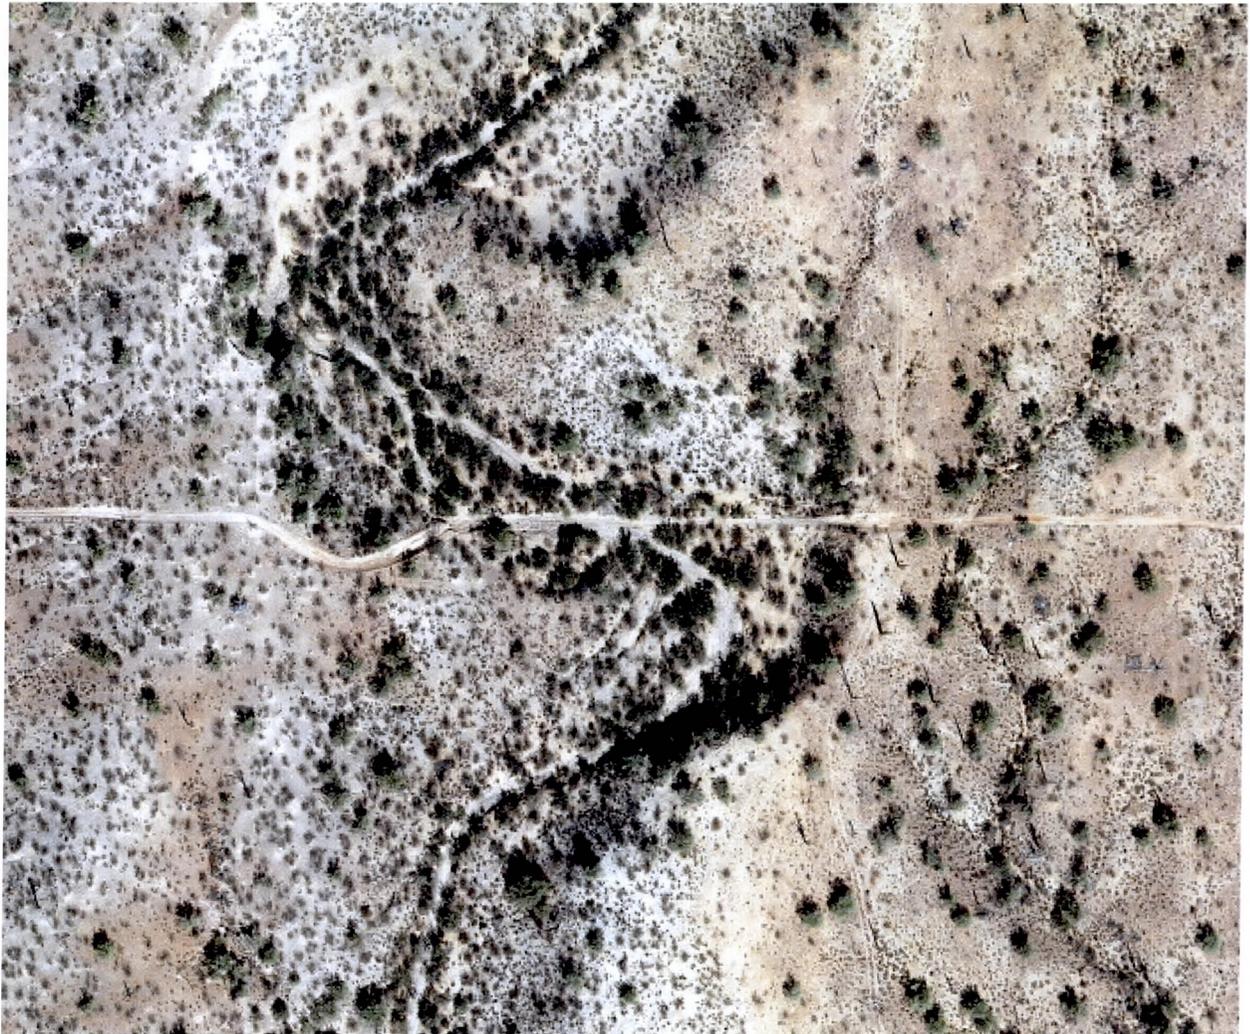
Figure 15: Aerial photograph of Area 5. Scale is 1:24,000.

Area 5: Manning's n values were computed along 2W Tributary 1 about 1,500 feet north of SR 74. About two-thirds of the channel in this area is composed of small gravel with an average size of about 0.1 inches speckled with gravel with a diameter of about 0.5 inches ($n=0.030$), and about one-third of the channel in this area is composed of large gravel with an average size of 2.5 inches ($n=0.035$). Using a weighted average to combine these two, $n_b = 0.032$. There is minimal erosion along the channel banks.

Portion of Cross Section	Components	Composite n Value
Channel	$n_b=0.032$	0.035
	$n_1=0.001$	
	$n_2=0.002$	
	$n_3=0.000$	
Overbanks	$n_b=0.029$	0.074
	$n_1=0.005$	
	$n_2=0.000$	
	$n_3=0.040$

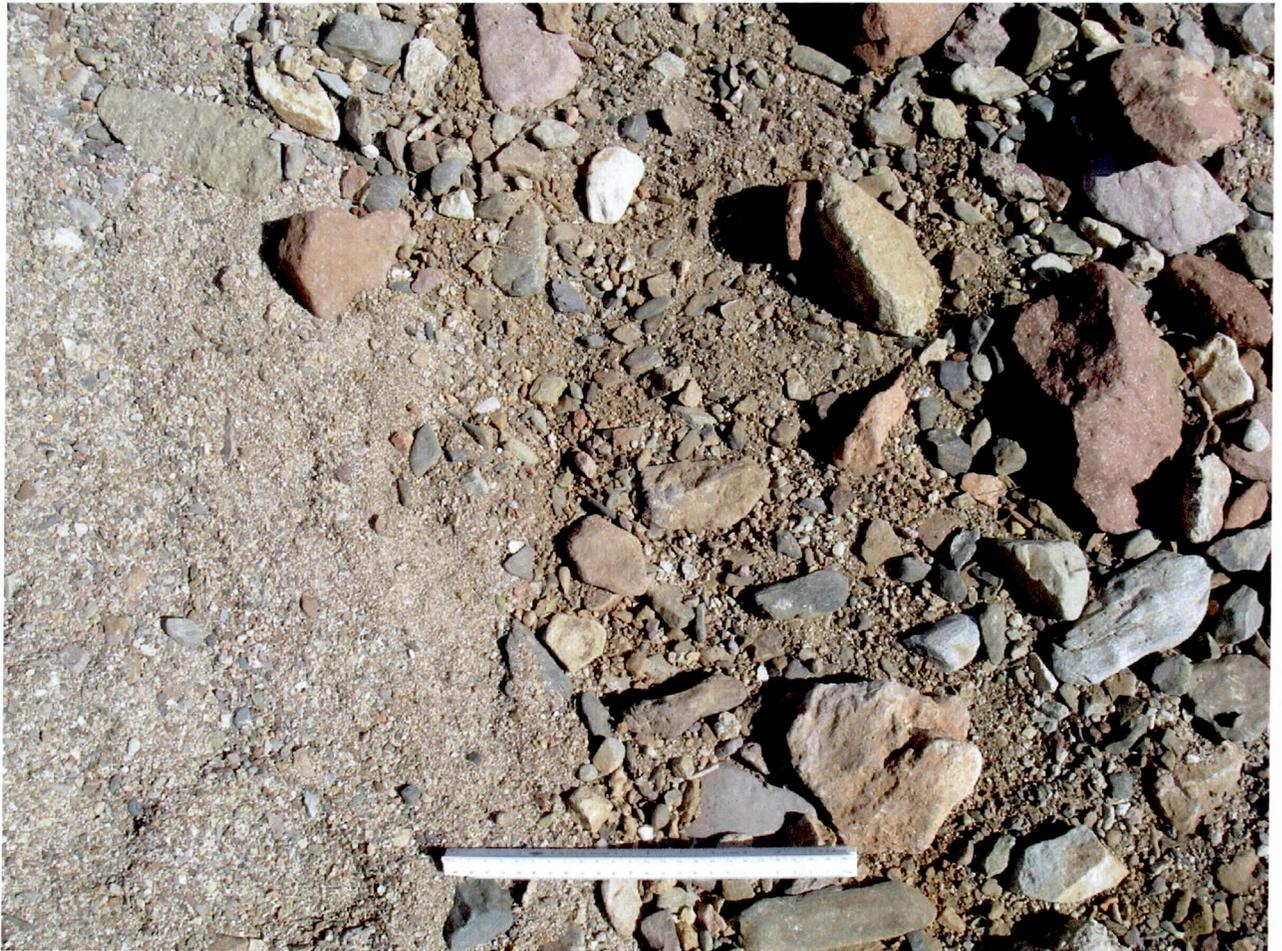
Figure 16: Area 5 channel bed (IMG0929.JPG).

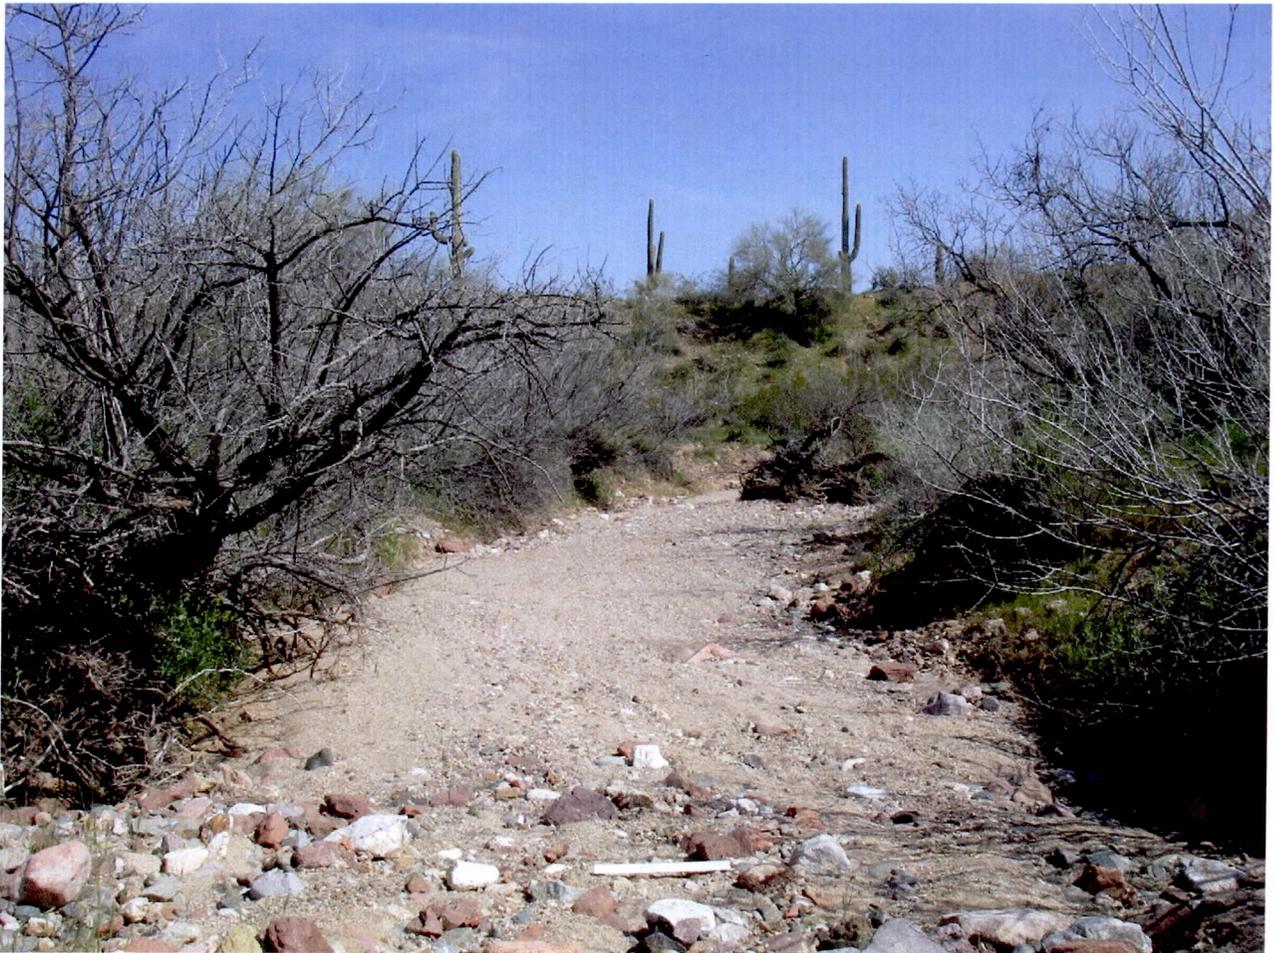
Figure 17: Tributary 2W about 1,500 feet north of SR 74, looking downstream (IMG0933.JPG).
Note the presence of the debris pile in the channel.

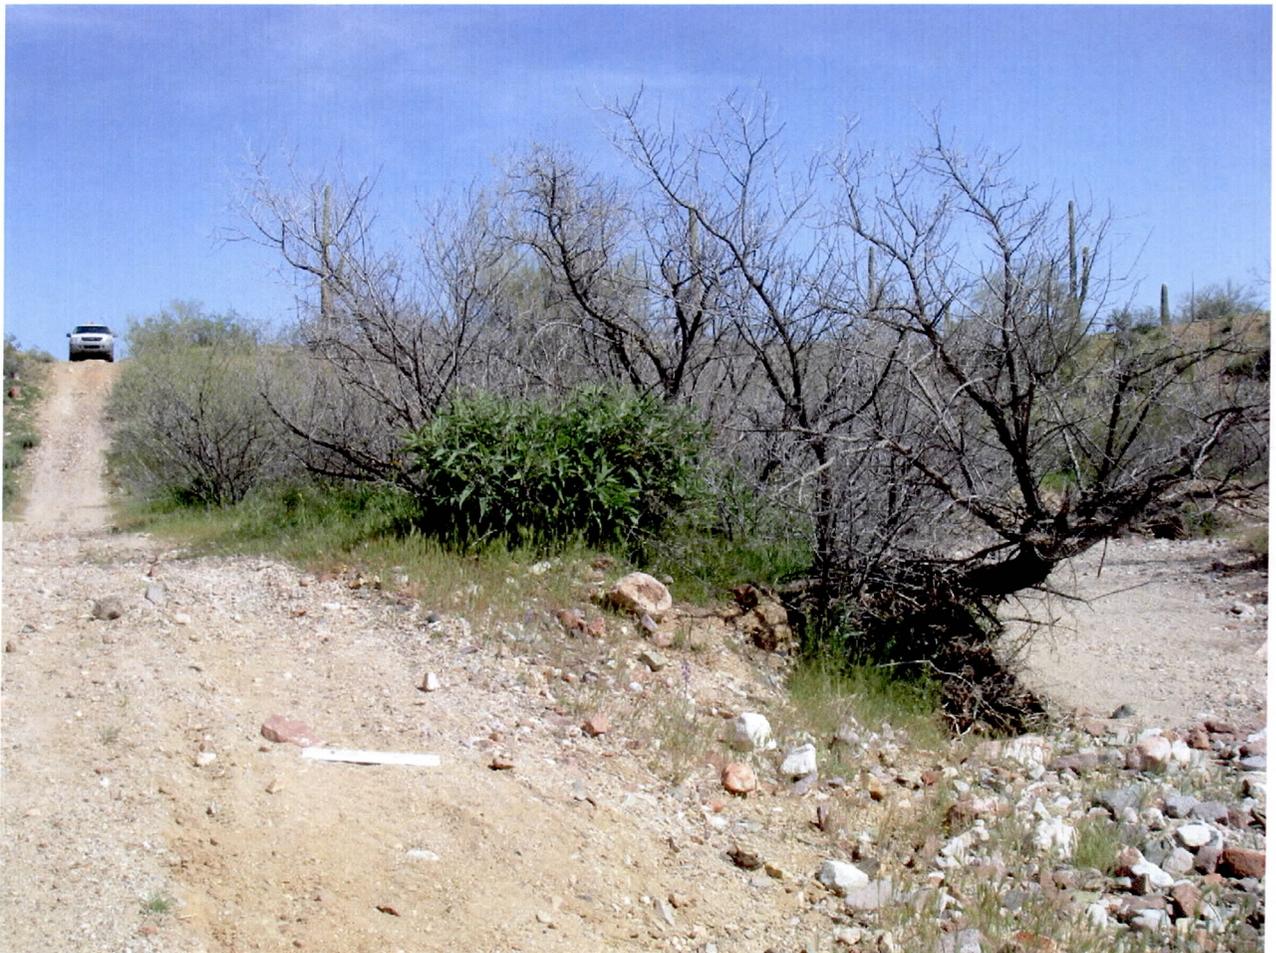
Figure 18: Tributary 2W about 1,500 feet north of SR 74, looking downstream (IMG0932.JPG). This is the left overbank. This photograph is representative of the right overbank as well.
