WITTMANN PHASE III FLOODPLAIN DELINEATION STUDY

Technical Data Notebook
Volume II of II

The Flood Control District of
Maricopa County

**MANNING’S *n* VALUE DETERMINATIONS
FOR THE WITTMANN PHASE III FLOODPLAIN DELINEATION STUDY**

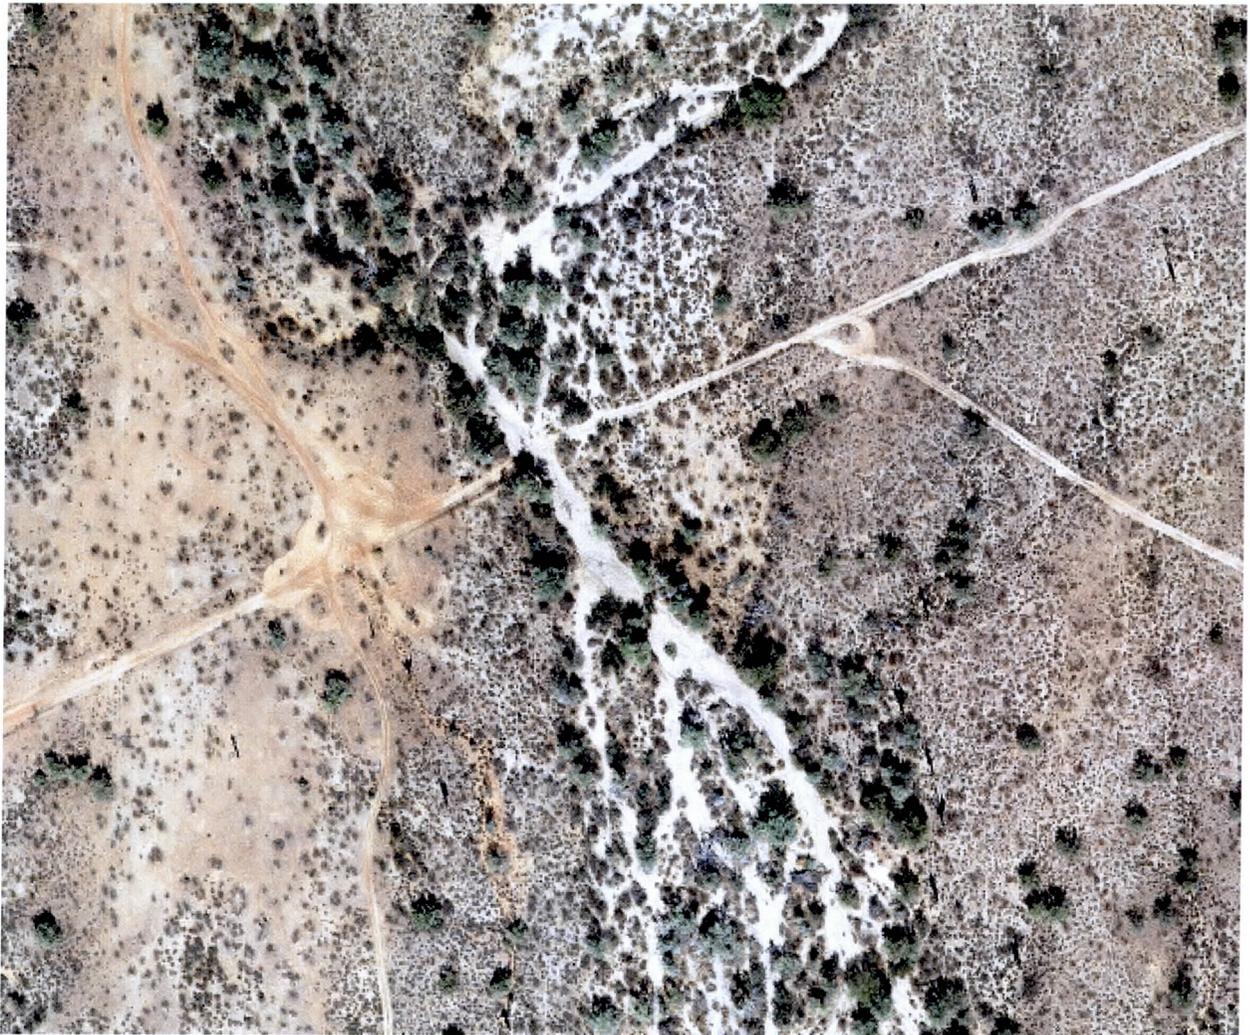
Figure 19: Aerial photograph of Area 6. Scale is 1:24,000.

Area 6: Manning's n values were computed along Wittmann Wash Tributary 1 at Bonita Road. This is one of the few portions in the study area that is braided. The channel in this area is composed of coarse sand, which has an average n_b value of 0.031. There is minimal erosion along the channel banks.

Portion of Cross Section	Components	Composite n Value
Channel	$n_b=0.031$	0.039
	$n_1=0.001$	
	$n_2=0.002$	
	$n_3=0.000$	
	Meandering Factor = 1.15	
Overbanks	$n_b=0.031$	0.077
	$n_1=0.001$	
	$n_2=0.000$	
	$n_3=0.035$	
	Meandering Factor = 1.15

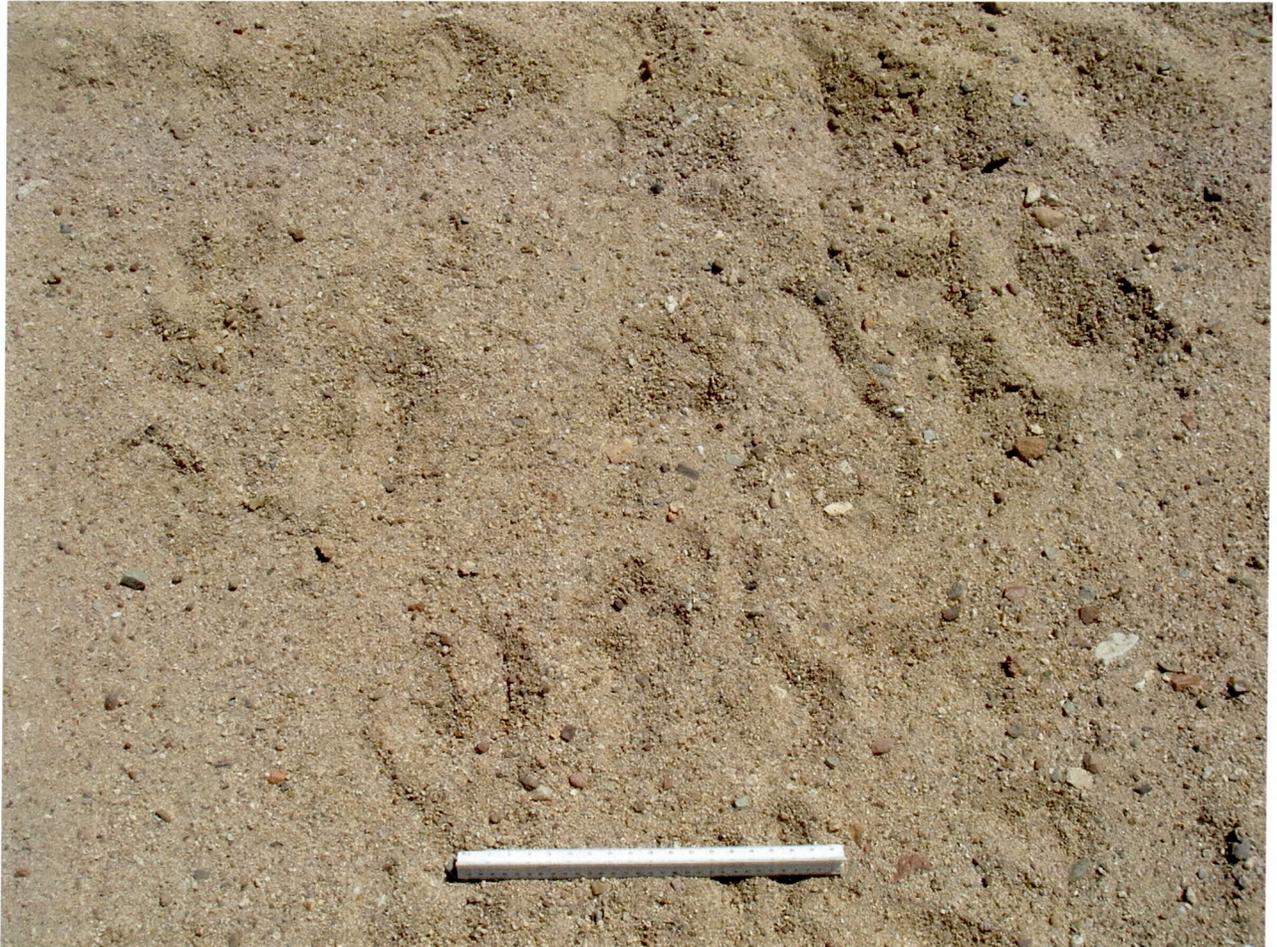
Figure 20: Area 6 channel bed (IMG0891.JPG).

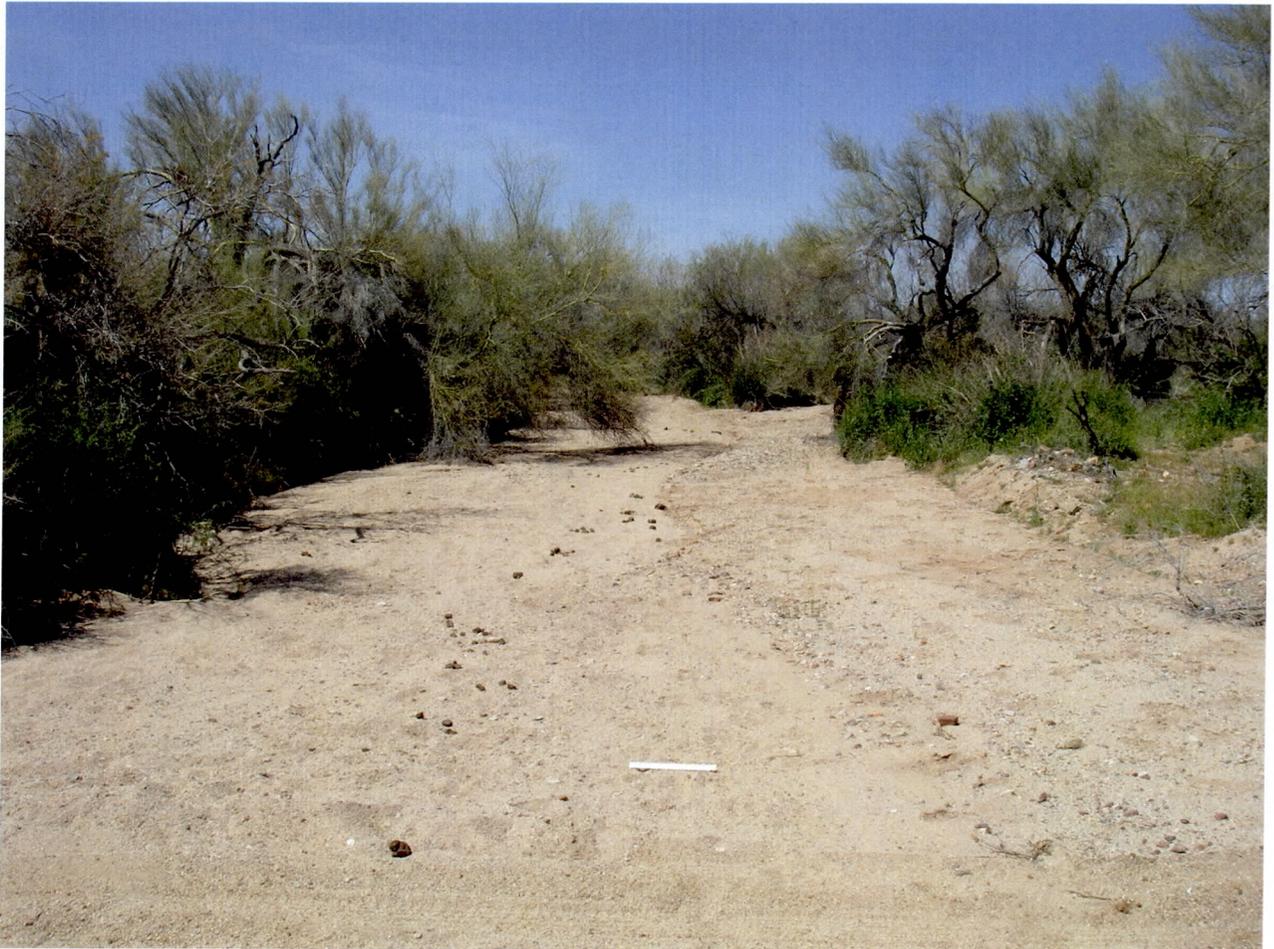
Figure 21: Wittmann Wash Tributary 1 at Bonita Road, looking upstream (IMG0890.JPG).

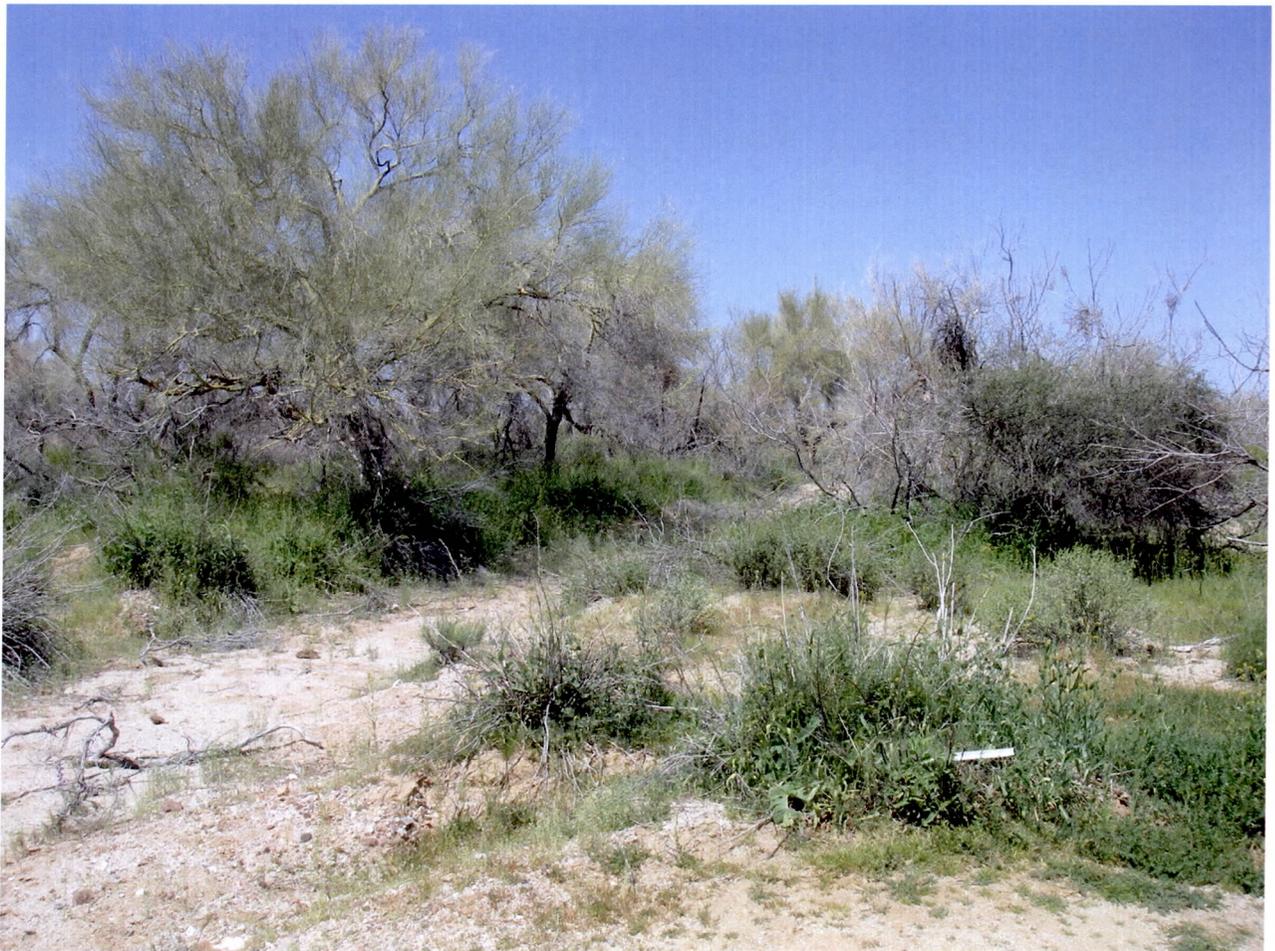
Figure 22: Wittmann Wash Tributary 1 at Bonita Road, looking upstream (IMG0889.JPG). This is the left overbank area. This photograph is representative of the right overbank as well.
