REPORT
PHASE I ENVIRONMENTAL SITE
ASSESSMENT
PROPOSED DETENTION BASIN
SEC QUEEN CREEK AND MCQUEEN
ROADS
CHANDLER, ARIZONA

Prepared For
FLOOD CONTROL DISTRICT OF
MARICOPA COUNTY

URS Job No. E1-15448010.58
June 17, 2002

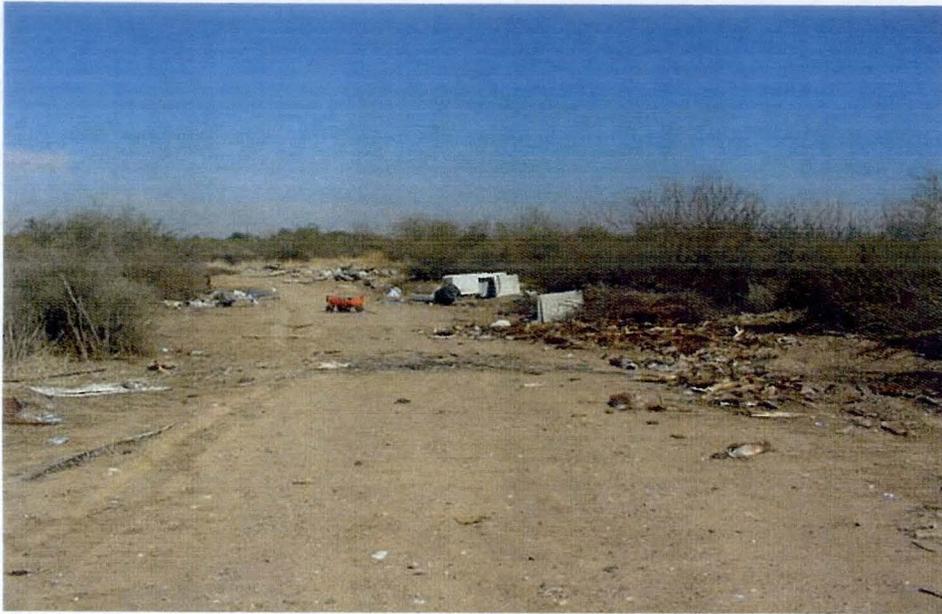
Photograph 1 – Debris along unimproved road (southwest section of site)

An unimproved dirt road was observed leading from the southwest corner of the subject property into the property interior. Large areas of debris (see Section 3.1.3) were observed along the road and mostly within the southern half of the subject property. In addition, URS observed a wooden fence and raised wooden platform-like structure located in the central southern half of the site.

Solid waste does not appear to be currently generated on the subject property. However, URS observed several large areas of dumping primarily within the southern portion of the subject property. The scattered and piled debris included old tires, discarded appliances, general trash (paper and plastic), automobile parts and bodies, furniture, scrap metal, wood, and concrete slab pieces (see Site Photographs 1, 2, and 3). Although some of the concrete slab pieces were large, they appeared

- URS recommends environmental oversight be conducted during the removal of the on-site debris to evaluate the contents of the piled debris, observe the condition (i.e. presence of staining) of the exposed dirt surface, and collect soil samples, if necessary.
- If the FCDMC wishes to evaluate the potential for contaminants in the mounded dirt piles, URS recommends a limited Phase II ESA consisting of soil sampling and laboratory analysis.

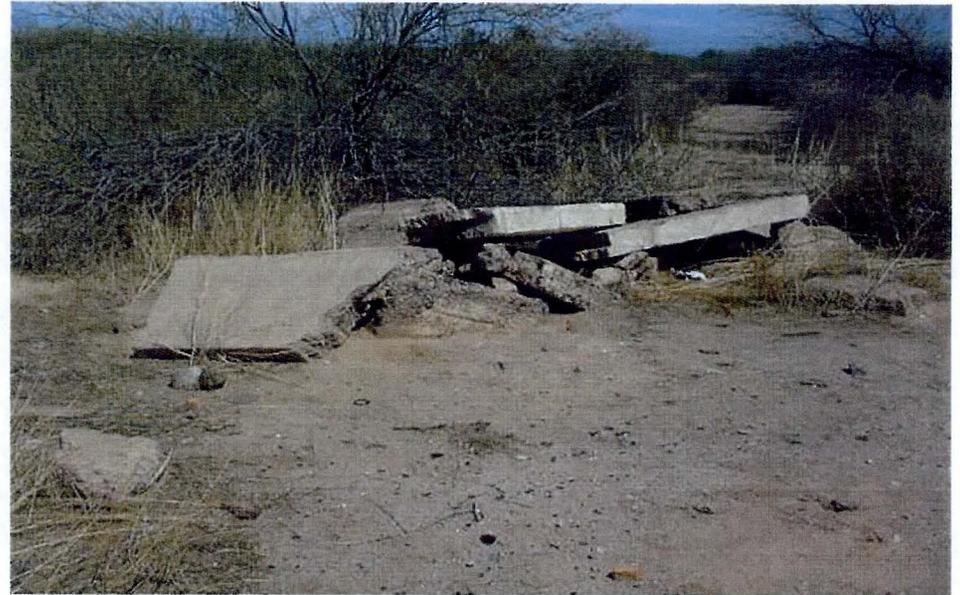
Photograph 4 – Concrete slab pieces

to be discarded and not associated with a former on-site structure or water well (see Site Photograph 4). Many of the mounds of debris were extensive and therefore, neither their exact content nor the condition of the soil beneath could be evaluated. In addition, URS observed a wooden fence and remnants of a platform-like wooden structure. These appear to be associated with a former corral-like pen and platform viewing area (see Site Photograph 5).

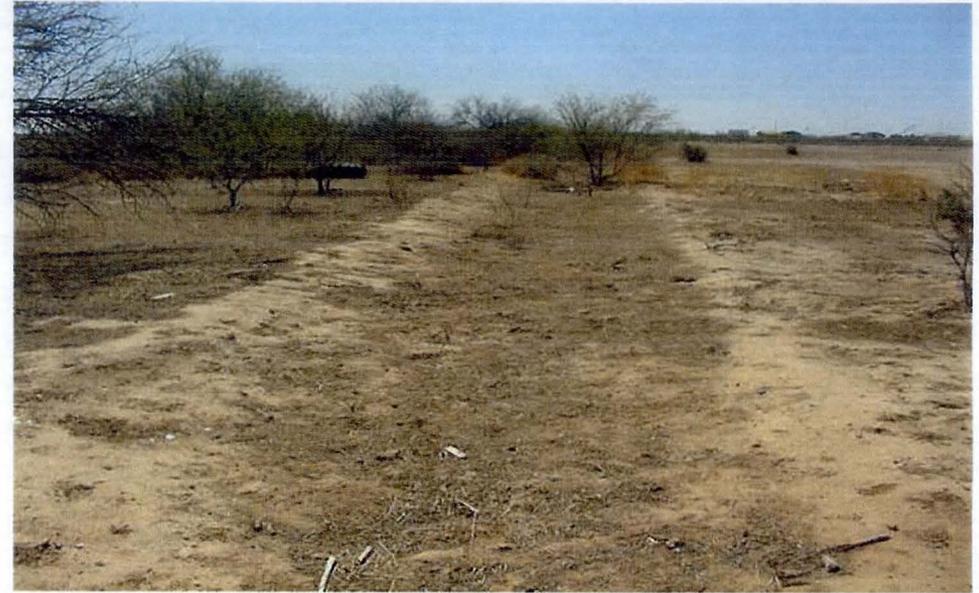
Photograph 6 – Earthen depression along the eastern border of the subject property

Topographic relief in the area of the subject property is relatively flat. Therefore, stormwater would most likely pool in low-lying areas for most of the subject property with the following exceptions. Stormwater accumulated in the northern border of the subject property would most likely collect in the small drainage ditch located along the edge of Queen Creek Road. In addition, URS observed an approximately 4-foot wide earthen depression along the eastern border of the subject property (see Site Photograph 6). Although this depression appeared to be a former earth-lined ditch, it did not appear to be leading to or from any specific area.

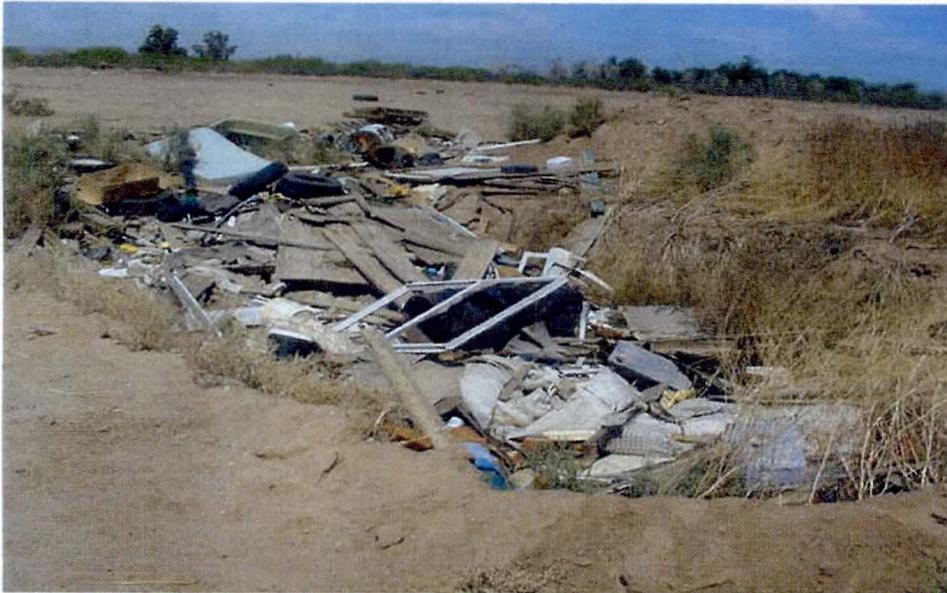
Photograph 7 - Pit filled with debris

No ponds or lagoons were observed on the subject property at the time of our site reconnaissance. However, URS observed one approximately 10-foot by 20-foot pit located in the mid-eastern section of the subject property. Although no pipes leading to or from the pit were observed, the pit was partially filled with debris (see Site Photograph 7).

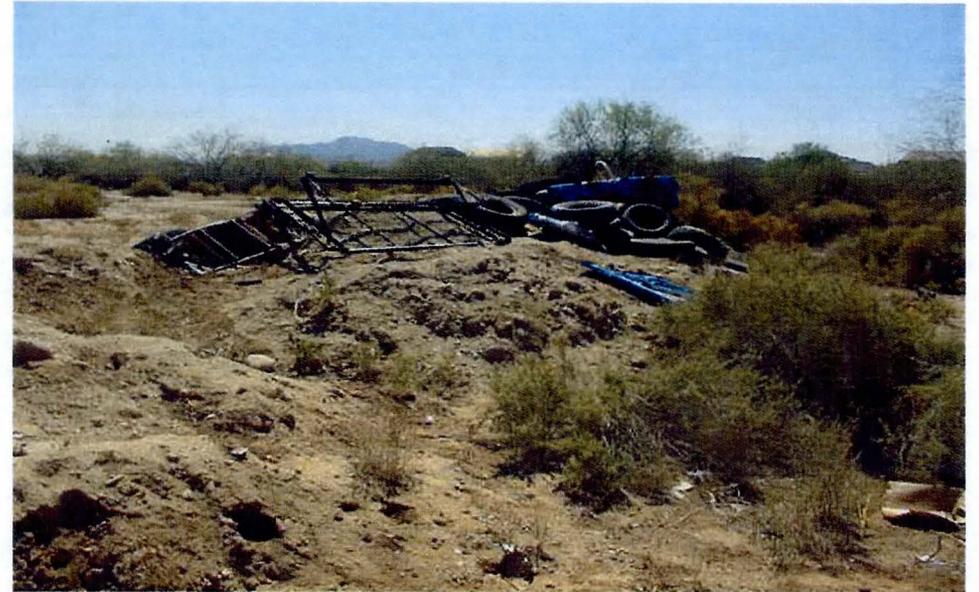
Photograph 8 – Mounded dirt with debris (southern section of subject property)

URS observed several large piles of dirt mounded in the southern portion of the subject property. The mounds were littered with automobile parts and tires. The exact source of the dirt piles could not be determined (see Site Photograph 8).

URS also observed several large piles of dirt mounded in the southern portion of the subject property. The exact source of the dirt piles could not be determined. URS did not observe any chemical containers, stained soil, or petroleum odors within or surrounding the dirt piles.
