GILA BEND AREA FLOODPLAIN DELINEATION STUDY

Project 11358: GILA BEND F.I.S.

FCD 90-67

Photographs: Reach Route Cross Sections, Basins 4-6

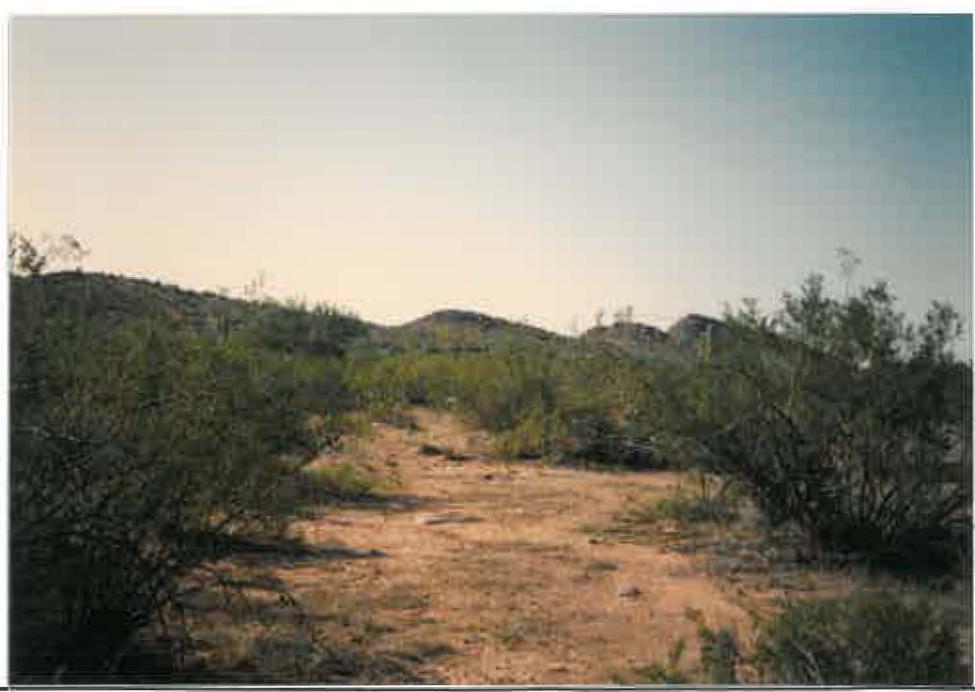
VCD - RC-PT7

High Water Indications: Debris at ✓ feet deep, Left _____ Right 4' (old storm)
Bank Scour _____ feet deep, Left _____ Right _____
None observed _____

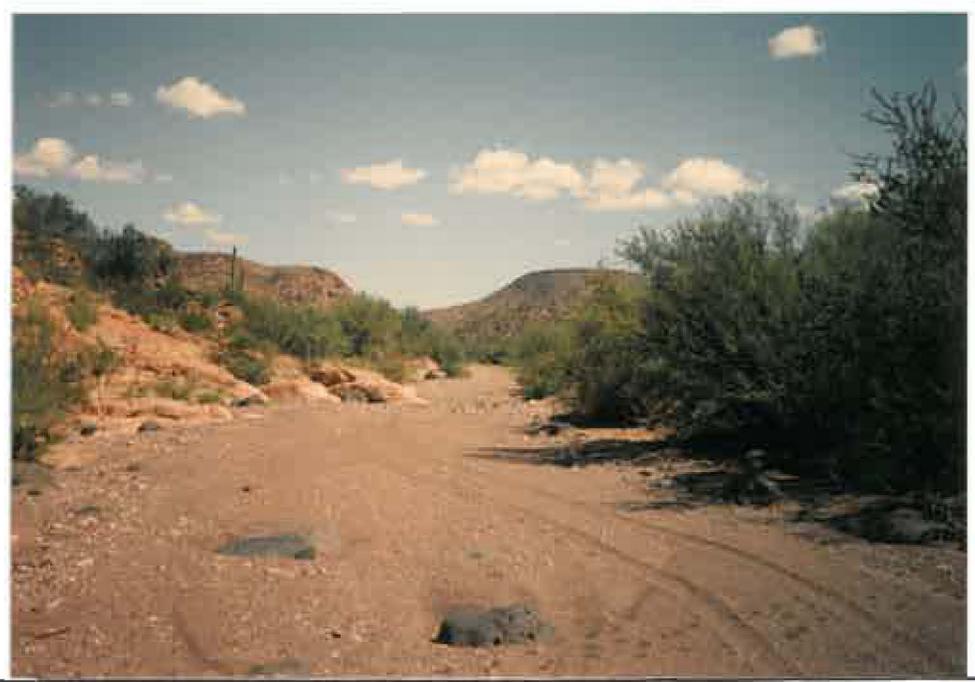
PHOTOGRAPH #2: Downstream from Site RB-P19

Bed Soils are very gravelly sands, brown & black in color with very large cobbles, Typical.

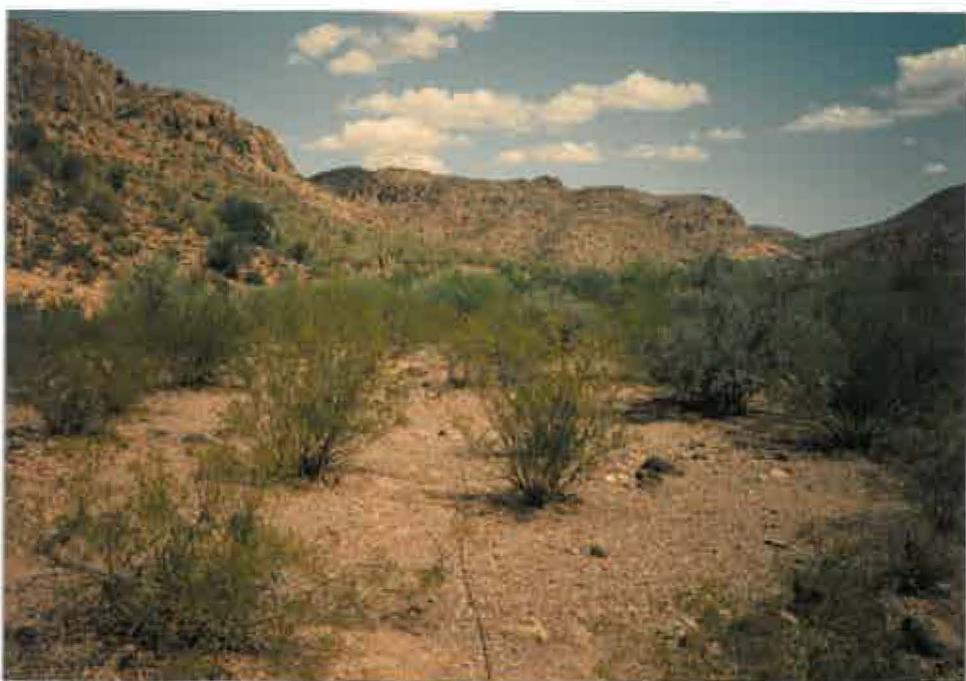
VCD, RB-P23

ADDITIONAL NOTES: Very Recent Storm (9/4/91?)

High Water Indications: Debris at Shot 4.1 Rk feet deep, Left _____ Right 4.9'
Bank Scour _____ feet deep, Left _____ Right _____
None observed _____

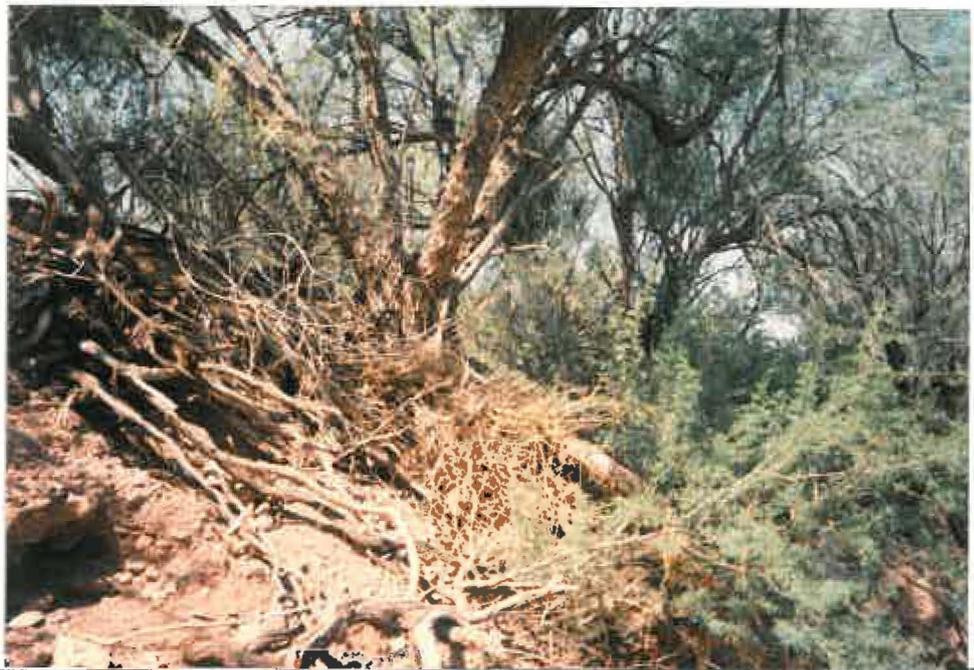
RB-P18 Left Bank Debris

ADDITIONAL NOTES: Very Recent Debris - 9/4/91?

High Water Indications: Debris at Shot 4.8 feet deep, Left 6' Right 7.2'

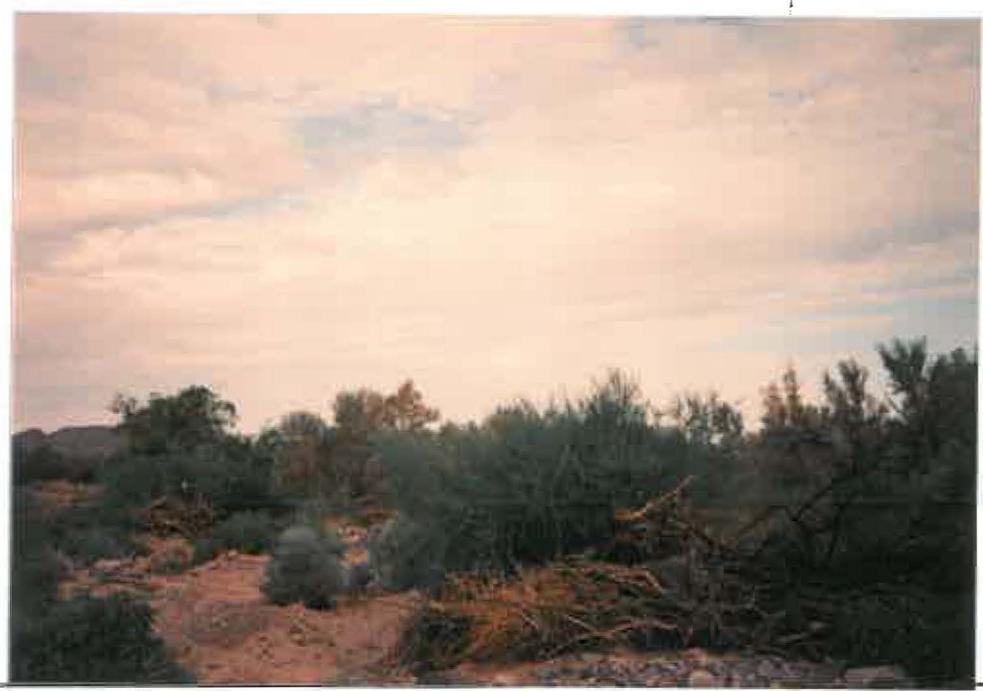
PHOTOGRAPH #3: Left Channel Bank and Left Overbank RH-P5 (Debris)

Channel Bed = Very gravelly sand, 12" cobbles
R o/B = Silt
L o/B = Very gravelly sand to elev. 6.9, Above 6.9 = gravelly silty sand

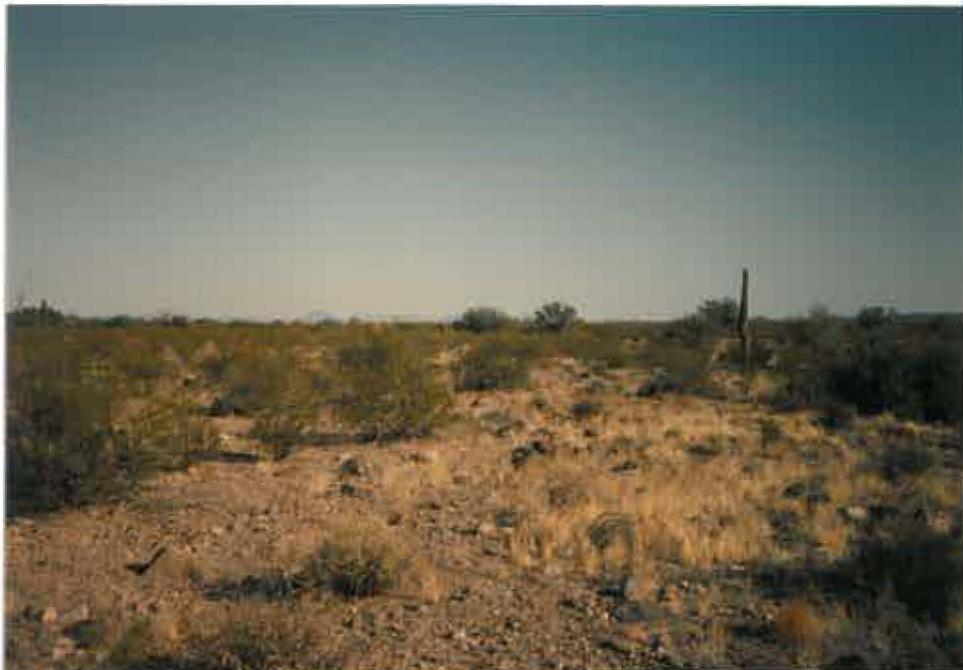
VCD RB-PTZ

High Water Indications: Debris at _____ feet deep, Left _____ Right _____
Bank Scour _____ feet deep, Left _____ Right _____
None observed X No Recent Marks

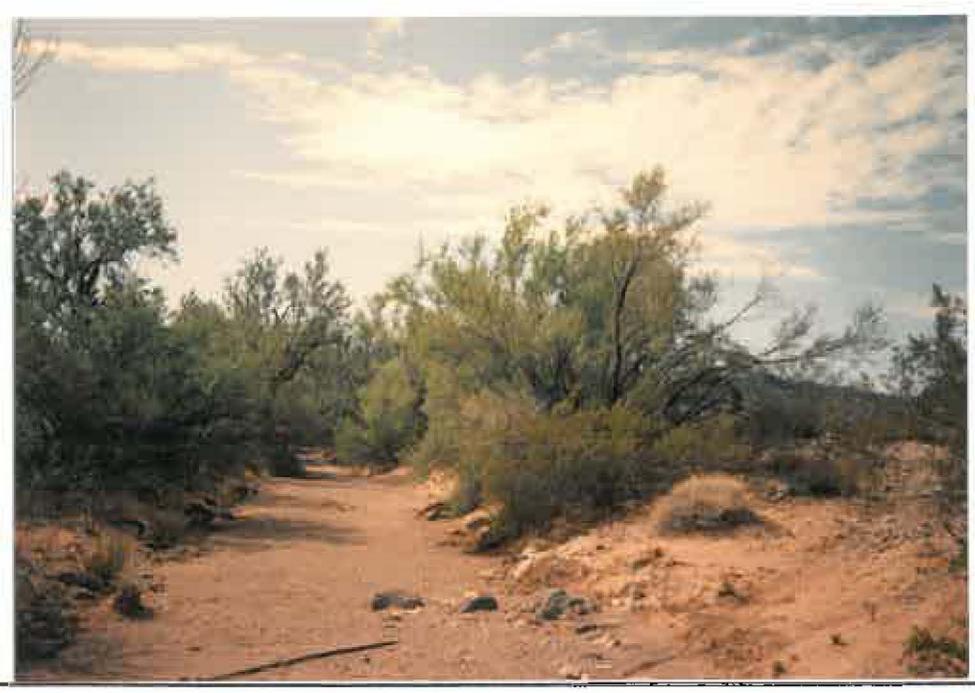
PHOTOGRAPH #1: Upstream from Sample Site RK-P1

SAMPLE TYPE:
 Sediment Modeling (top 3 inches of wash bottom) *Channel Bed = Coarse Gravelly Sand*
 First Level (top 24 inches) *O/B = Sandy Silt*
 Second Level (24-48 inches)
 Third Level (48-72 inches)
 Other - Description:
 Armoring : Yes No Sizes _____ Depth _____ Thickness _____

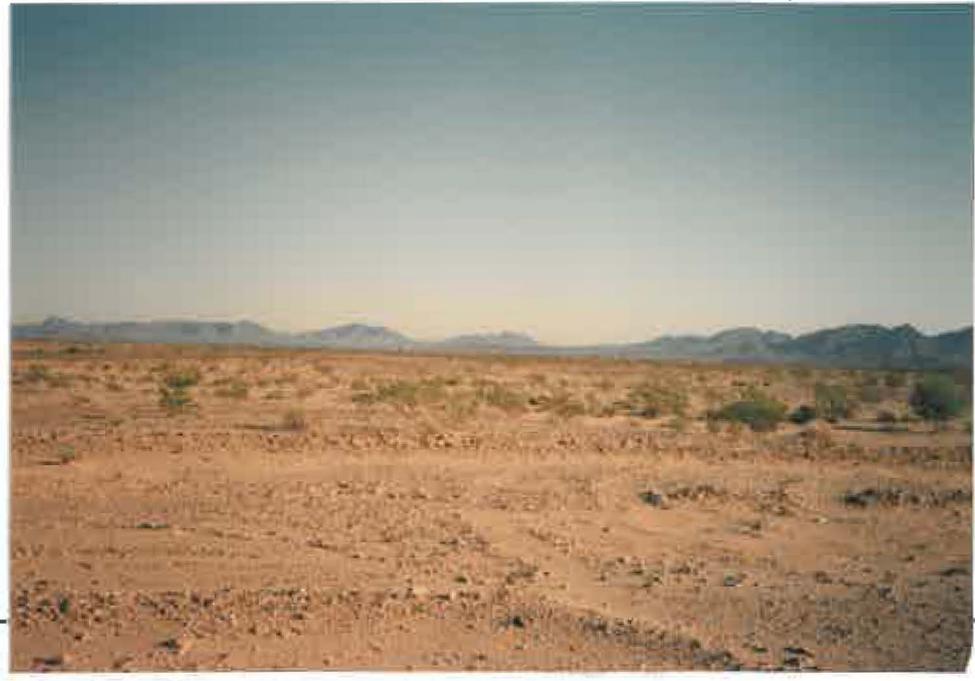
PHOTOGRAPH #3: ~~Left Channel Bank and Left Overbank~~ RL-P15
VCD 0.25 miles west of Saucedo Wash looking north
from north line of section 33 Assume VCD=10%

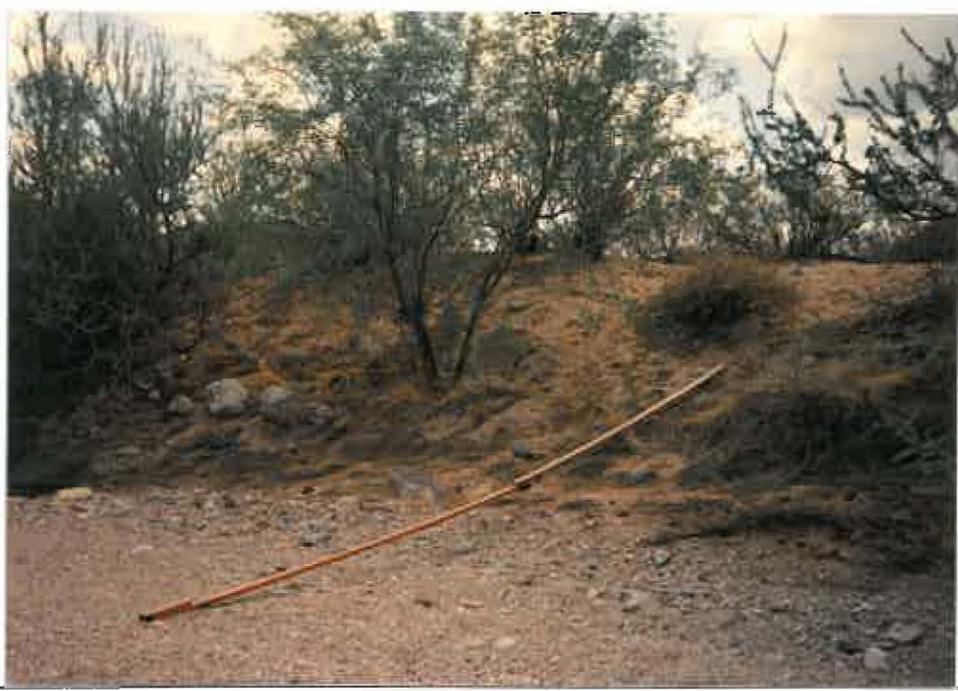
PHOTOGRAPH #5: ~~Wash showing Sample Area~~ Debris along edge of channel RA-P20

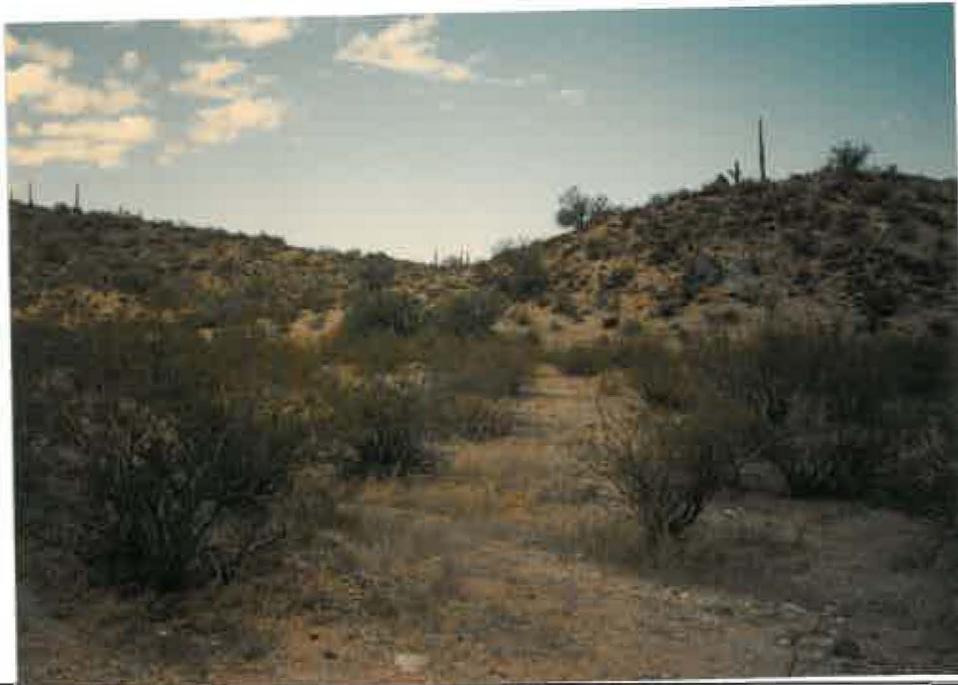
RA-P21 = VCD

High Water Indications: Debris at 2.8' feet deep, Left _____ Right _____
Bank Scour _____ feet deep, Left _____ Right _____
None observed _____ Recent

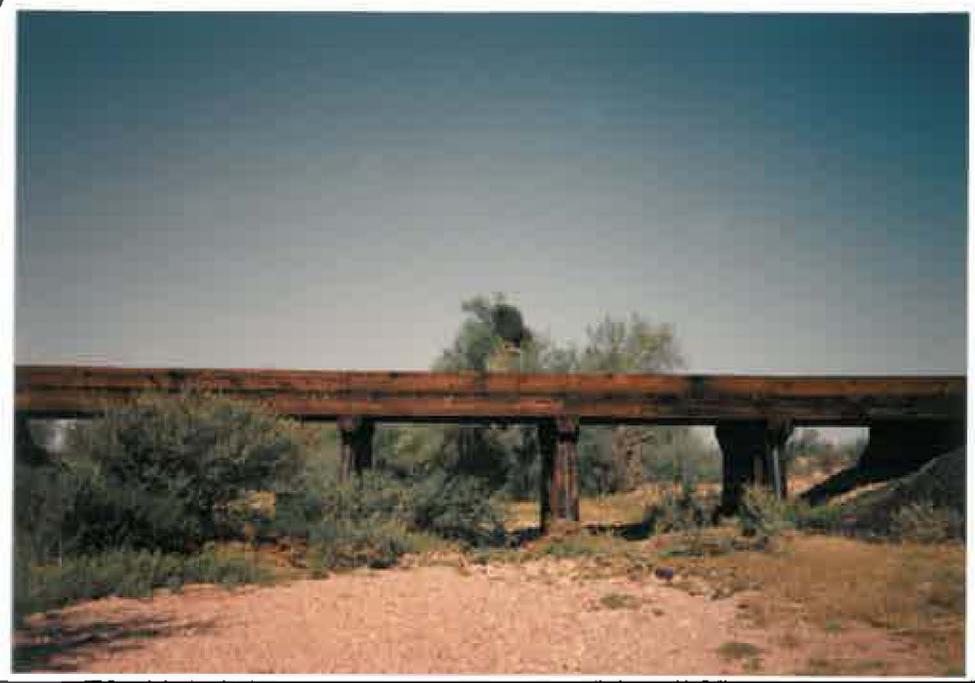
PHOTOGRAPH # 9: ~~Upstream from Sample Site~~ RCC-P22, D/S at RR Bridge Inlet Middle

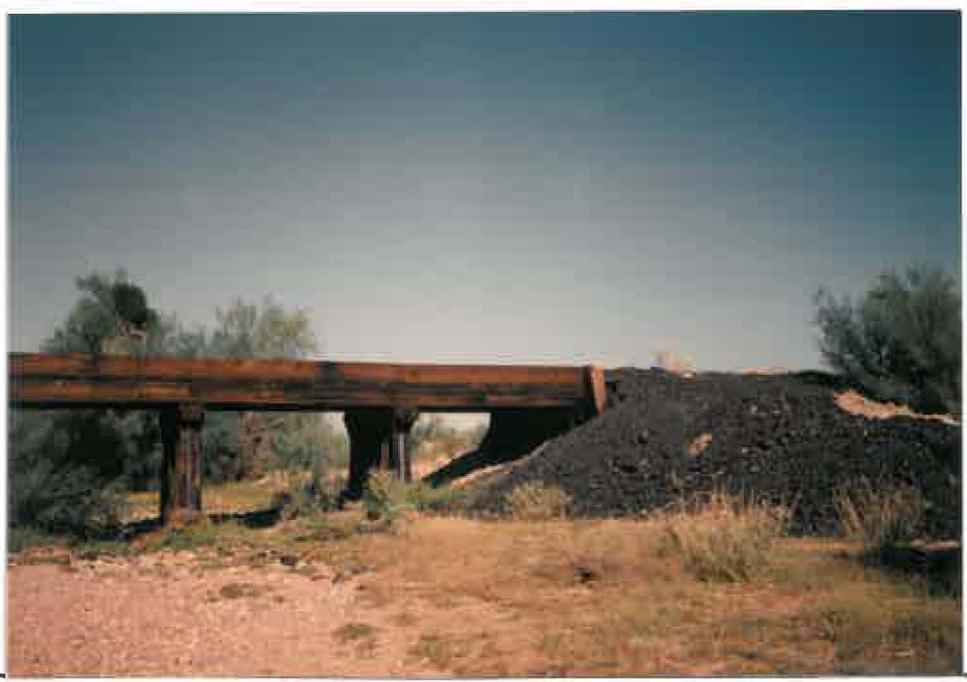
PHOTOGRAPH # 10: ~~Downstream from Site~~ RCC-P23, D/S at RR Bridge Inlet, Right

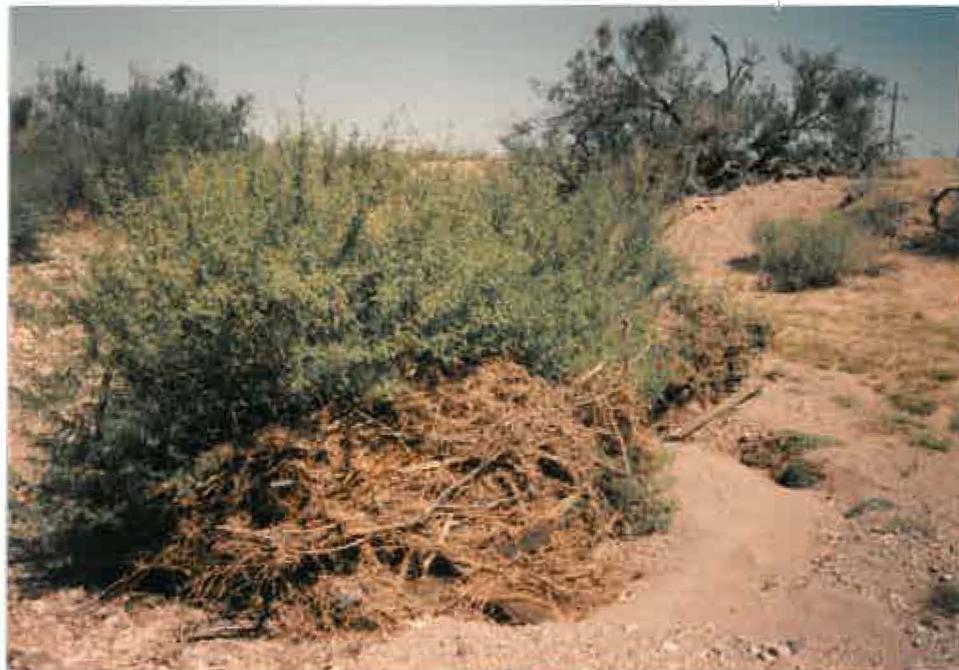
None observed _____ *RDD-P232 Debris in Channel*

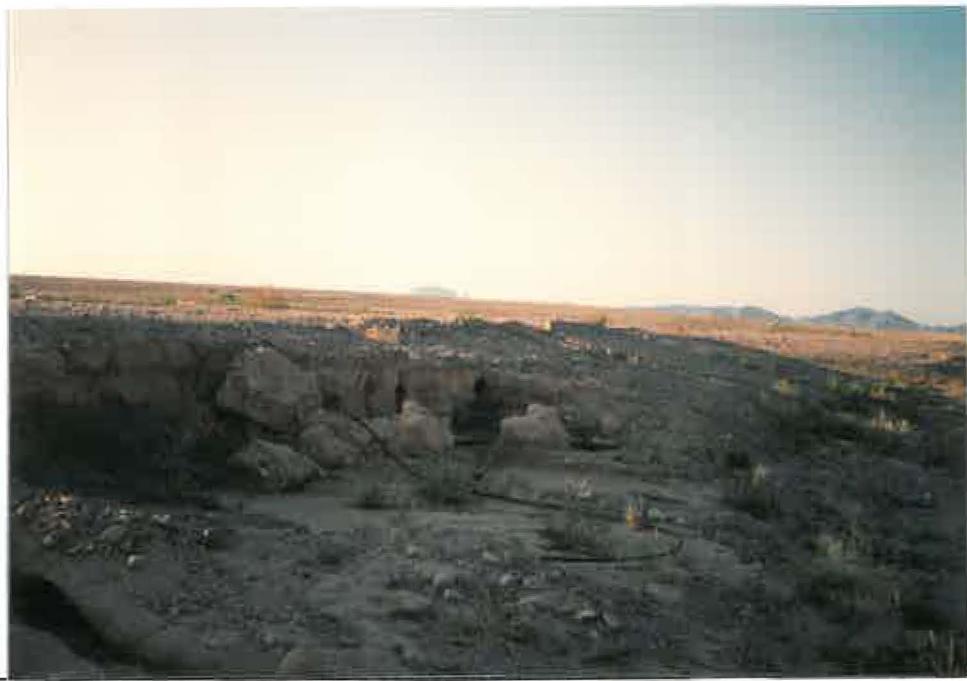
ADDITIONAL NOTES:
High Water Indications: Debris at _____ feet deep, Left _____ Right _____
Bank Scour X feet deep, Left _____ Right _____
None observed _____
Left Bank Scour, RD-P17
