**Final
BRIDGE SCOUR ASSESSMENT
REPORTS
for 16 Maricopa County Bridges**

**VOLUME I
Structure Numbers
9691, 8981, 9301, 9859
9145, 7819, 8028, 8639**

**MARICOPA COUNTY
DEPARTMENT OF
TRANSPORTATION (MCDOT)
Work Order No. 80407**

**Cannon & Associates, Inc.
Consulting Engineers**

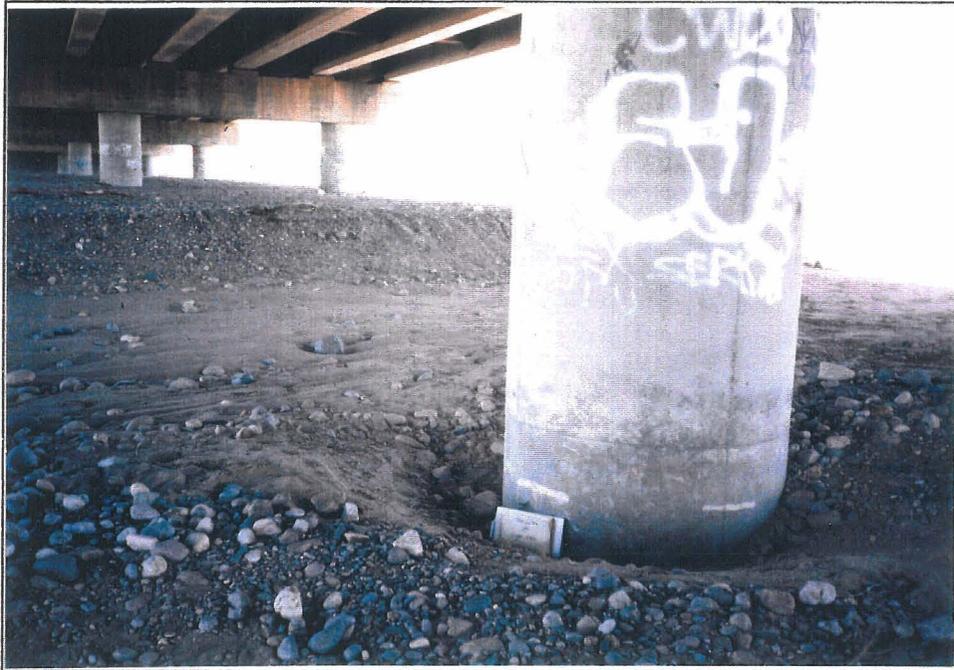
Photo 5: View looking east at upstream side of typical pile. Note variation in relief between bents of 2-3 feet was typical due primarily to variations in channel configuration. Also note that maximum depth of local scour at piers was 2-3 feet. Sediment type typically ranged from med. sand to cobbly gravel in vicinity of piers. Waterway was generally clear without significant variations in cross-section.

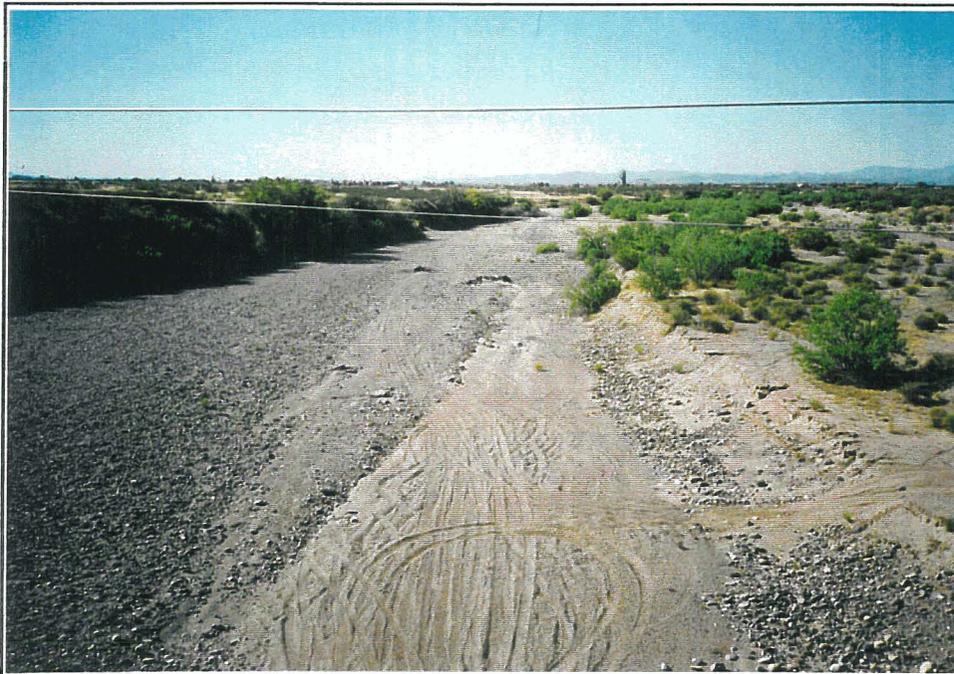
Photo 1: View looking upstream from west side of bridge deck. Note primary low flow channel composed of coarser material near bank with finer material toward bar. Also note west bank of main channel being undercut by flow and transition in bank relief from relatively shallow upstream to well defined near structure. Further note contrast in vegetation density between low flow channel and adjacent bar. Bar relief is approximately 5 feet above low flow channel.

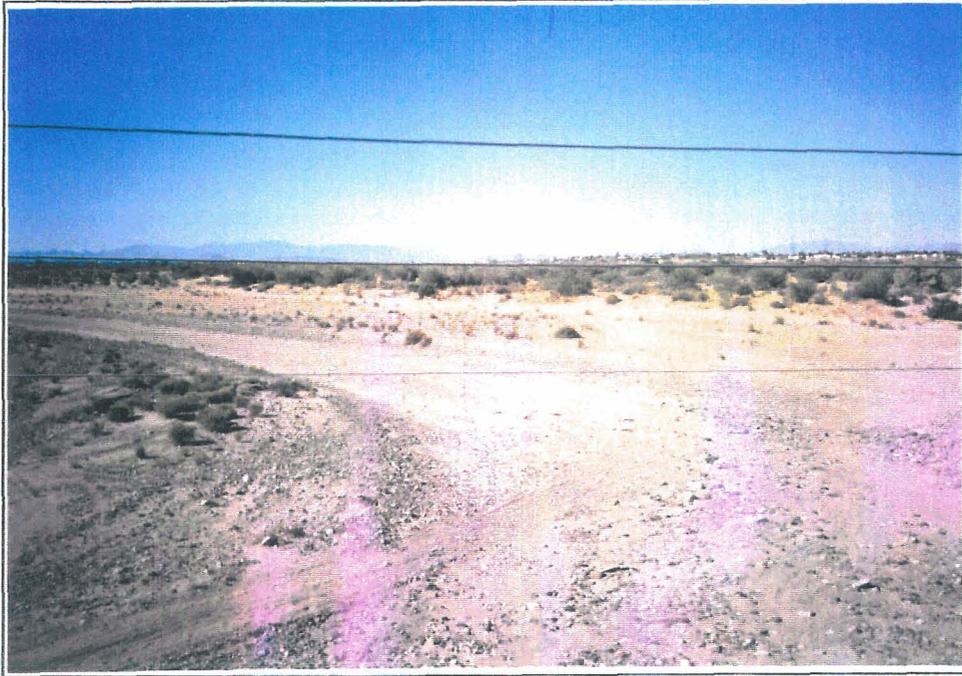
Photo 3: View looking upstream from east side of bridge deck. Note secondary low flow channel impinging on east side of structure. Also note upstream left overbank is poorly defined with mild slope toward bench in background. Typical vegetation is sparse grasses, occasional low brush and moderately dense mesquite and palo verde trees.

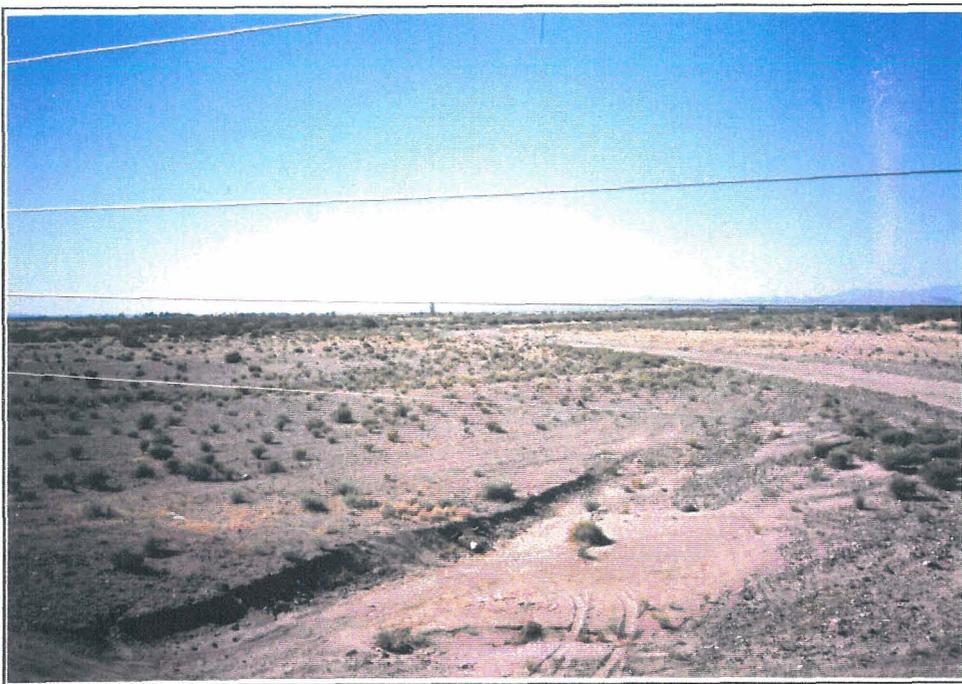
Photo 4: View looking toward upstream mid-channel from east side of bridge deck. Note secondary low flow channel in upper right. Also note relatively coarse nature of surface sediments and absence of vegetation typical of east side of main channel upstream of bridge.

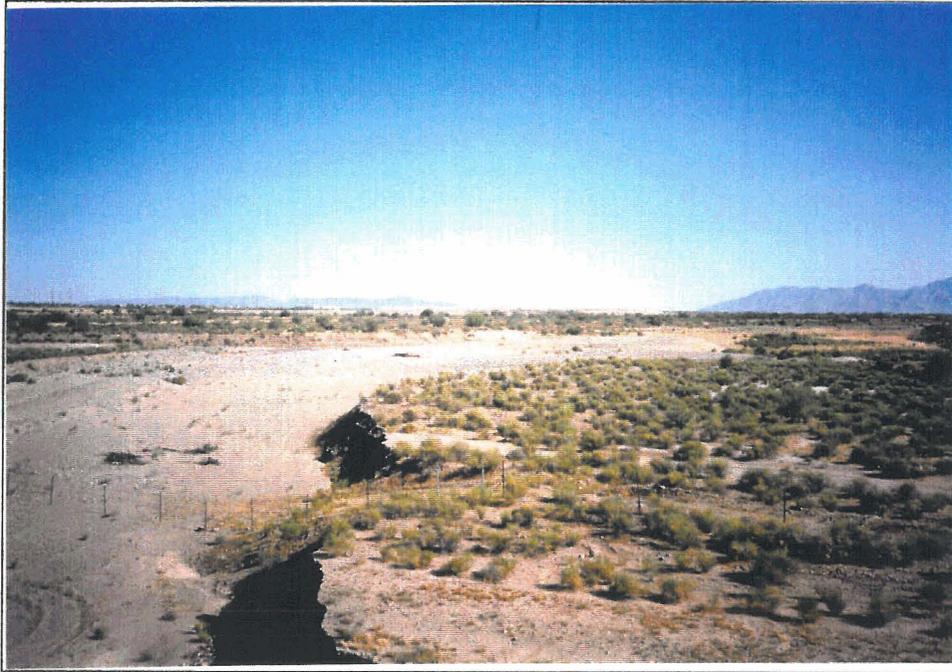
Photo 5: View looking downstream from west side of bridge deck. Note sharply cut banks of primary low flow channel as it trends toward middle of main channel downstream of structure. Also note effect of dip in channel (possible gravel pit) further downstream. Delta deposits forming from loss of stream energy and rapid deposition of sediment load.

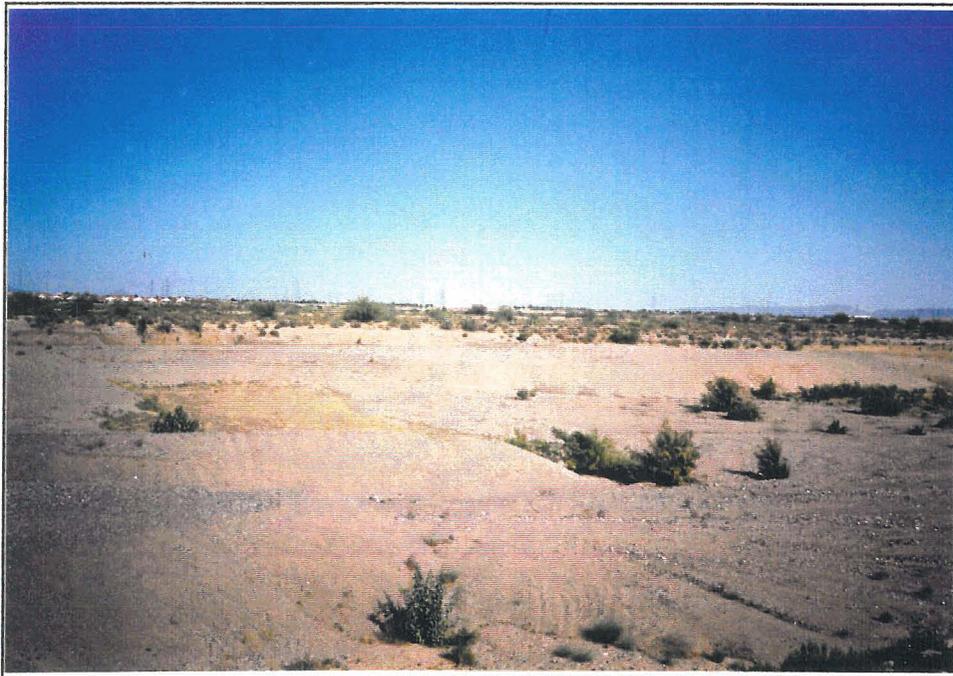
Photo 6: View looking approximately southeast from west bank across channel downstream of structure. Note typical relief from upper delta surface to channel bottom is approximately 8 feet.

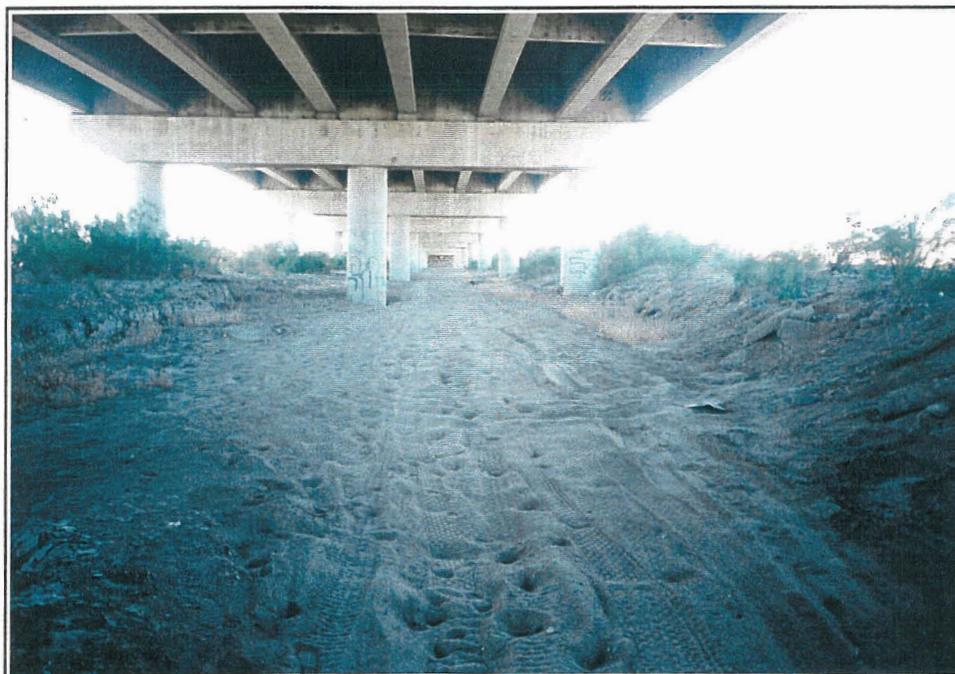
Photo 8: View looking west beneath bridge. Note sandy depression near mid-span of structure may increase flow turbulence locally.

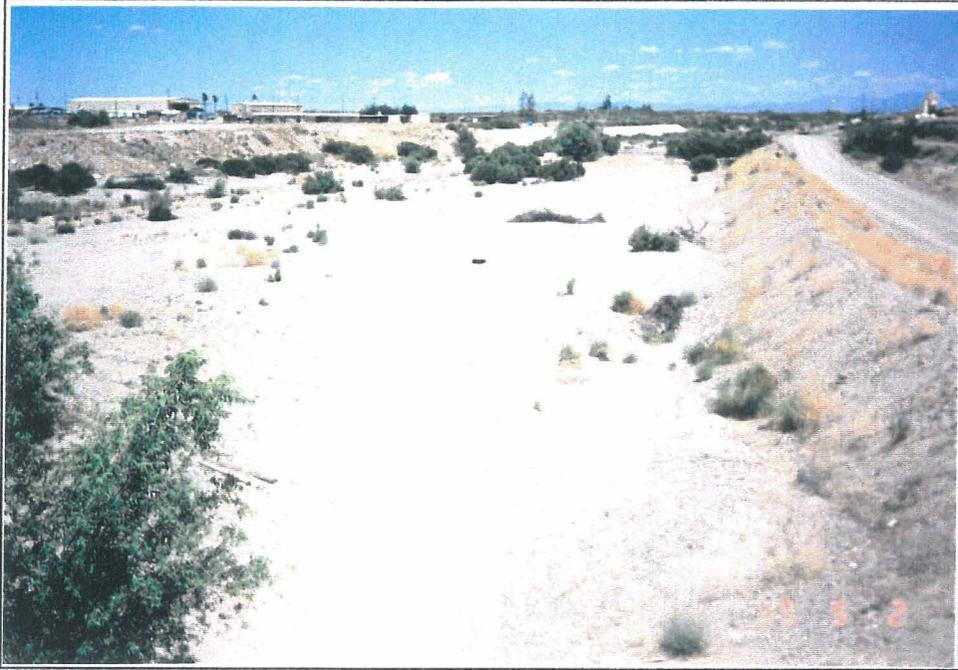
Photo 1: View looking upstream from approximately mid-span of structure. Note low dumped gravel levee forming east bank of a primary channel with haul road to east of levee. Large flows might potentially collapse poorly constructed levee and allow flow to expand east. Note short reach of white concrete grouted rip-rap along west bank in background. Upstream vegetation gives sparse to moderate coverage of channel and includes low brush and small trees. Channel surface sediments consist primarily of sandy gravel with occasional coarse sand bars.

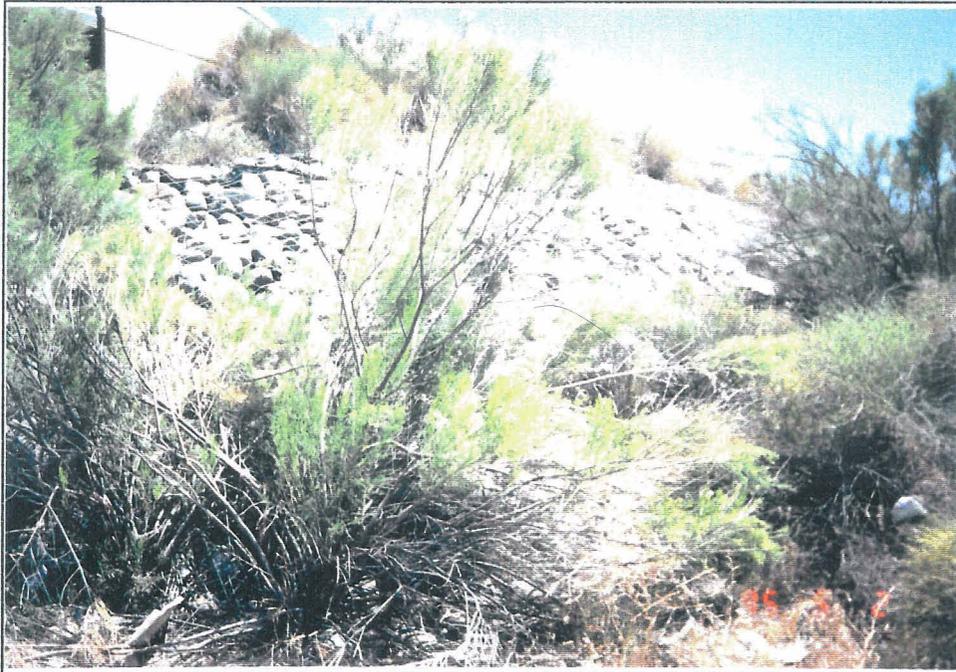
Photo 2: View of wire-tied rip-rap placed along upstream side of west abutment. Note overgrowth and potential for debris capture.

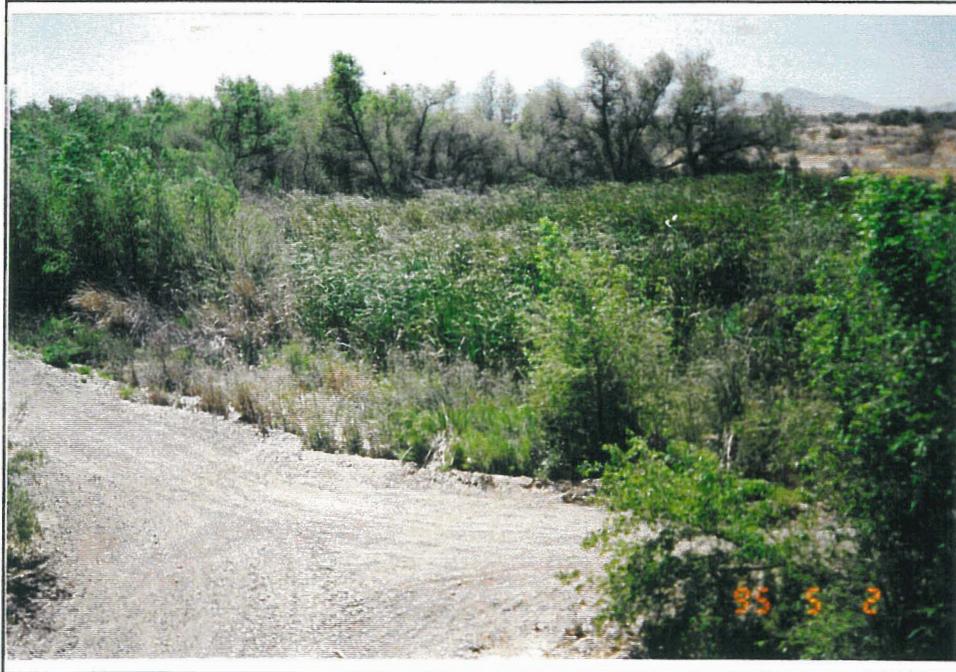
Photo 3: View looking downstream from approximately mid-span of bridge deck. Note extremely dense marshy vegetation immediately downstream of structure near west abutment.

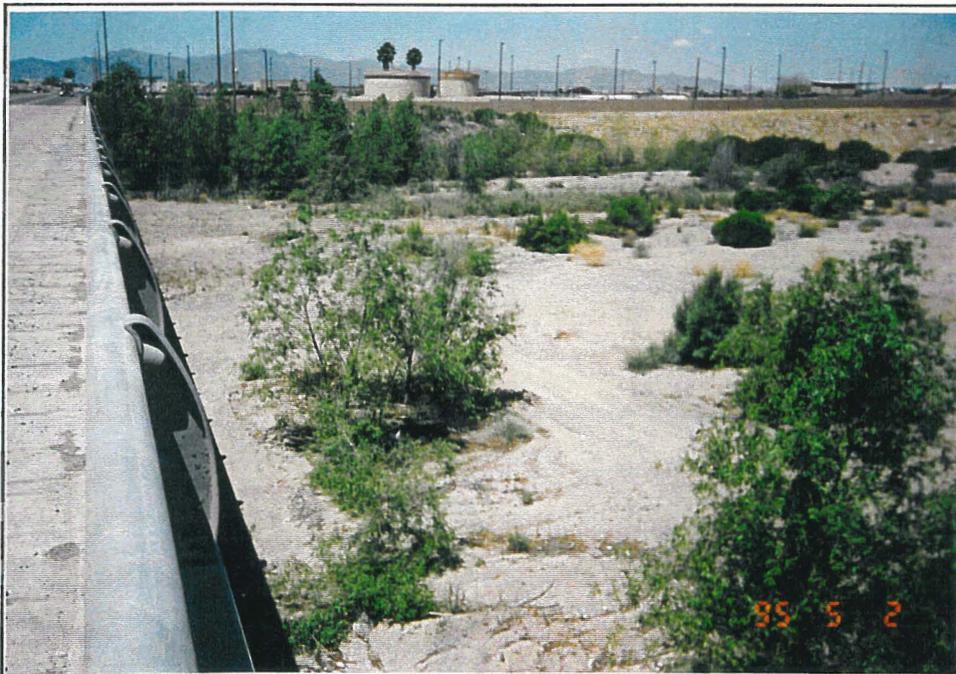
Photo 4: View along upstream face of structure from approximately mid-span of deck. Note the presence of significant mature vegetation adjacent to west abutment along low flow channel. Note increasingly sandy nature of surficial sediments near structure.

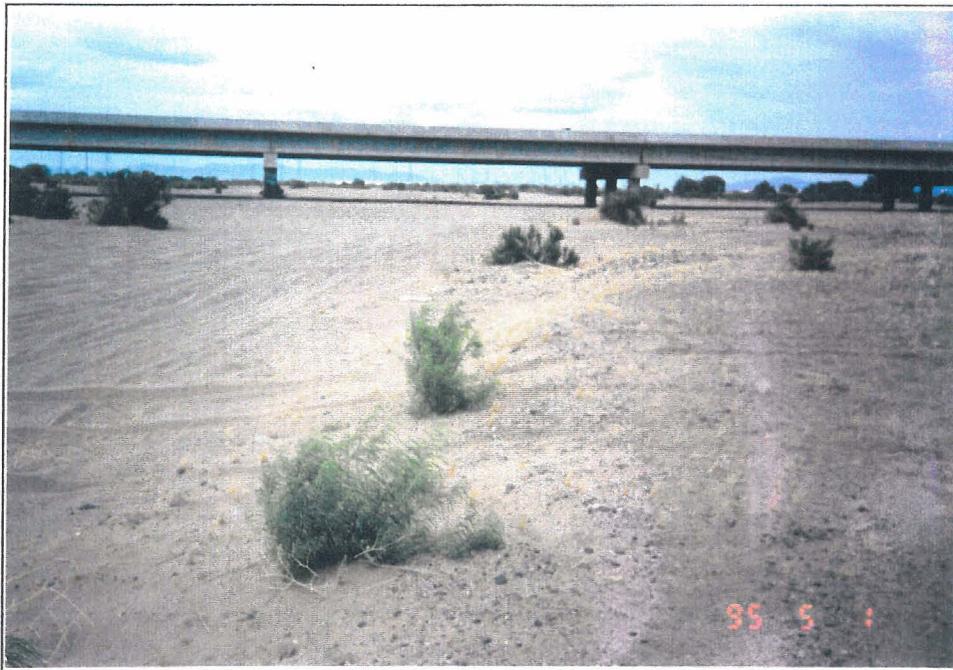
Photo 1: View looking toward downstream face of structure from approximately mid-channel. Note that channel surface sediments consist primarily of gravelly sand with cobbles locally. Channel is not well vegetated near structure with occasional sparse grasses, low brush, and mesquite established on the low bars.

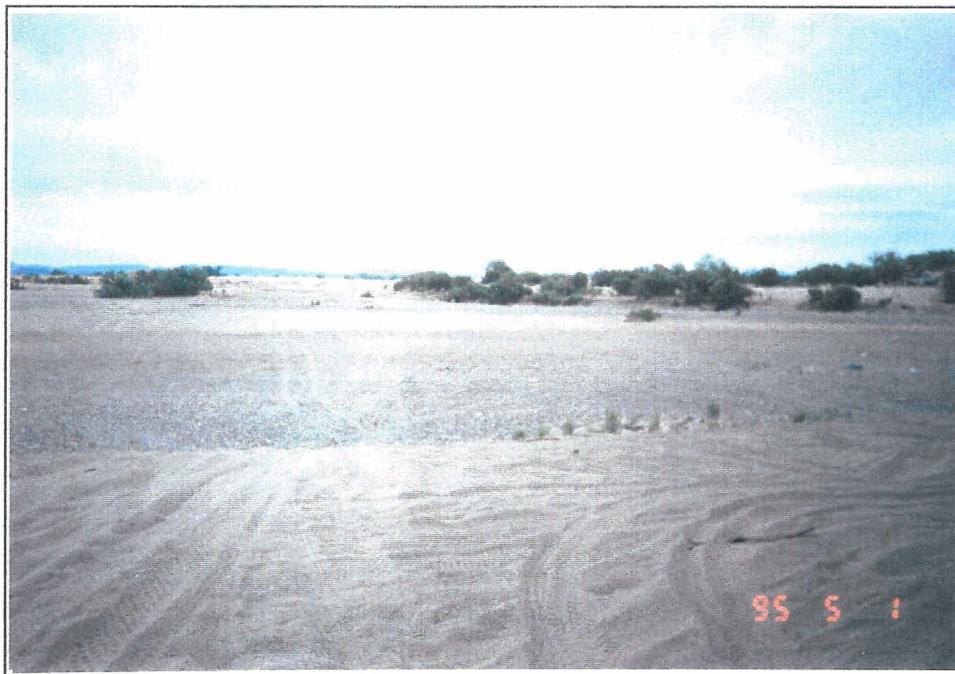
Photo 2: View looking northeast across thalweg of upstream low flow channel near east abutment. Note that channel banks are generally not sharply defined with overall vertical relief ranging from 3 to 8 feet.

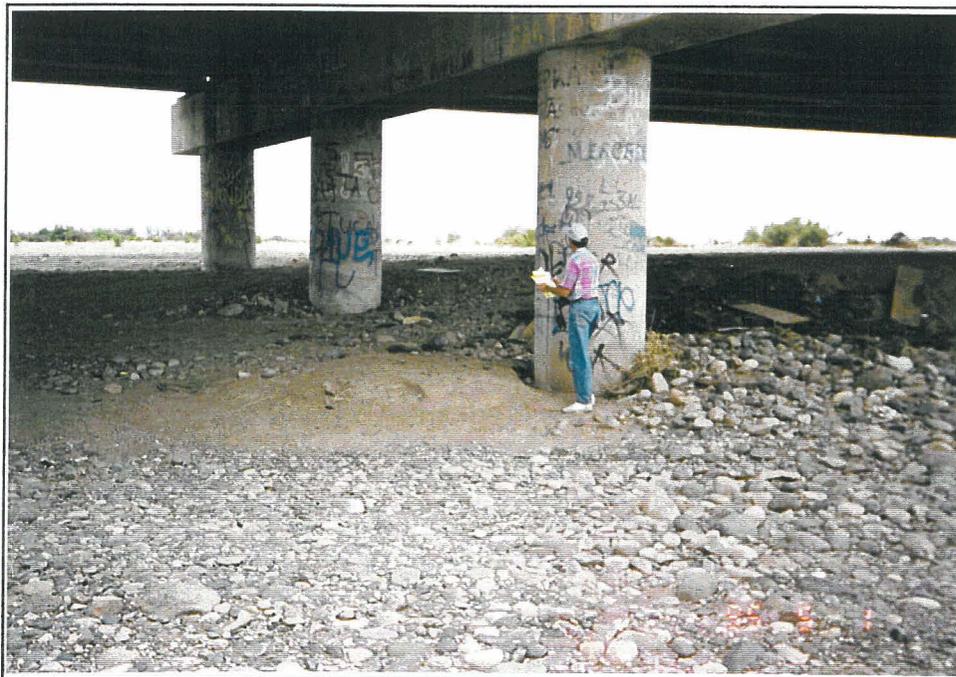
Photo 4: View looking toward upstream end of third pile bent from east abutment. Note position of relatively coarse material armoring channel locally. Also note variation in pile exposure along bent is approximately 4 feet.

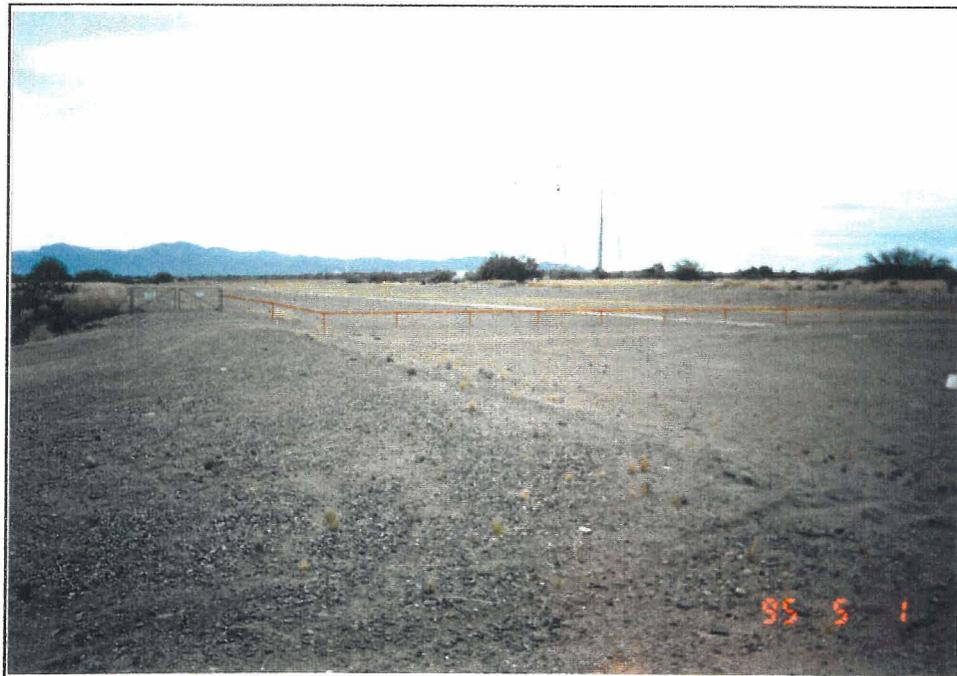
Photo 6: View looking approximately northwest near right bank of main channel upstream of structure. Note trapezoidal channel joining main channel at right angle upstream of west abutment.

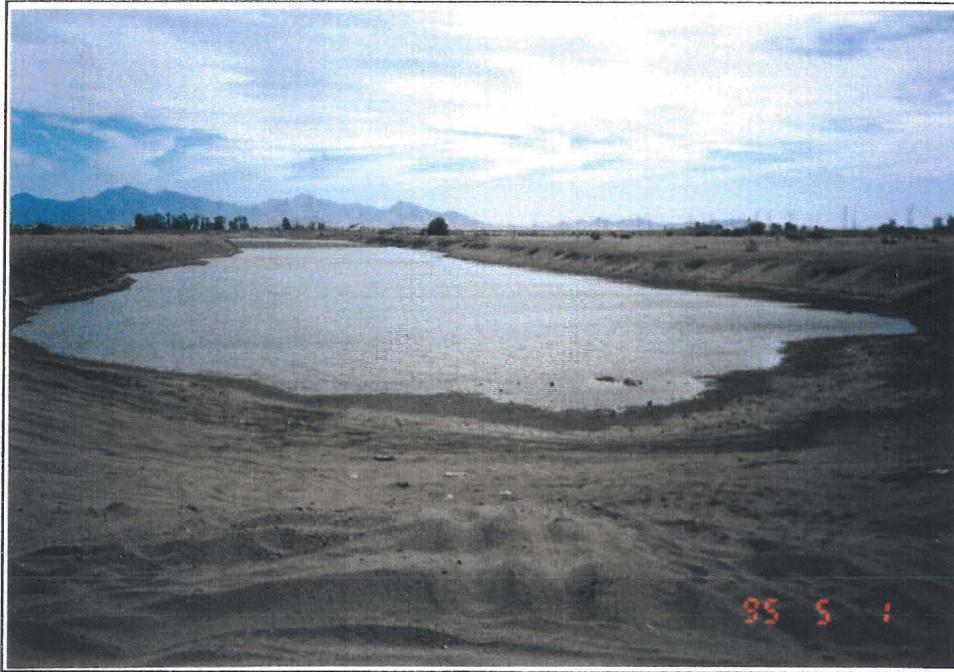
Photo 7: View looking downstream from a position approximately 1500 feet downstream of west abutment. Note formation of elongate pond possibly in location of former materials pit. Water surface is approximately 6 feet below main channel surface.

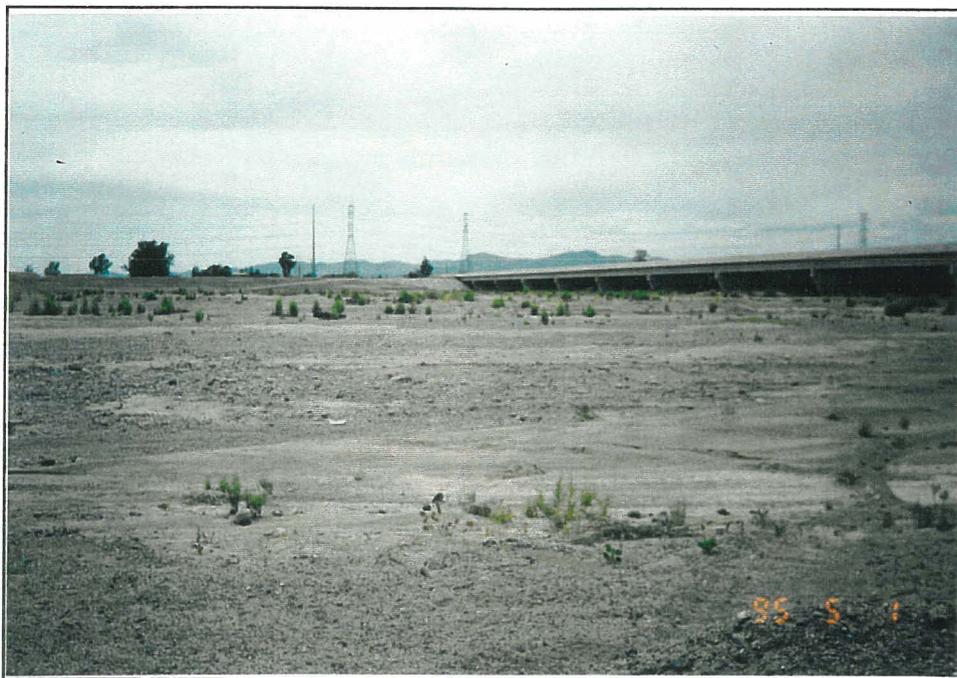
Photo 3: View looking toward west abutment from east side of main channel downstream of structure. Note relatively coarse surficial sediments of low flow channel with finer sands forming low bars in background. Note relatively sparse distribution of small brush on bars. Also note channelized banks typical of upstream and downstream channel along this reach in background.

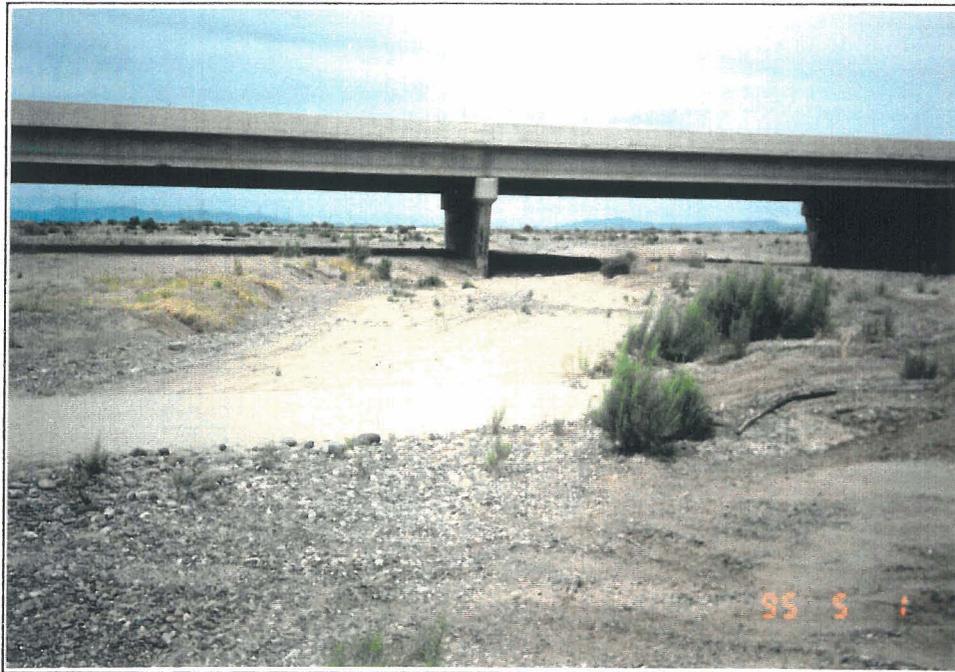
Photo 5: View looking at downstream face of structure. Note primary low flow channel crossing concrete slab.

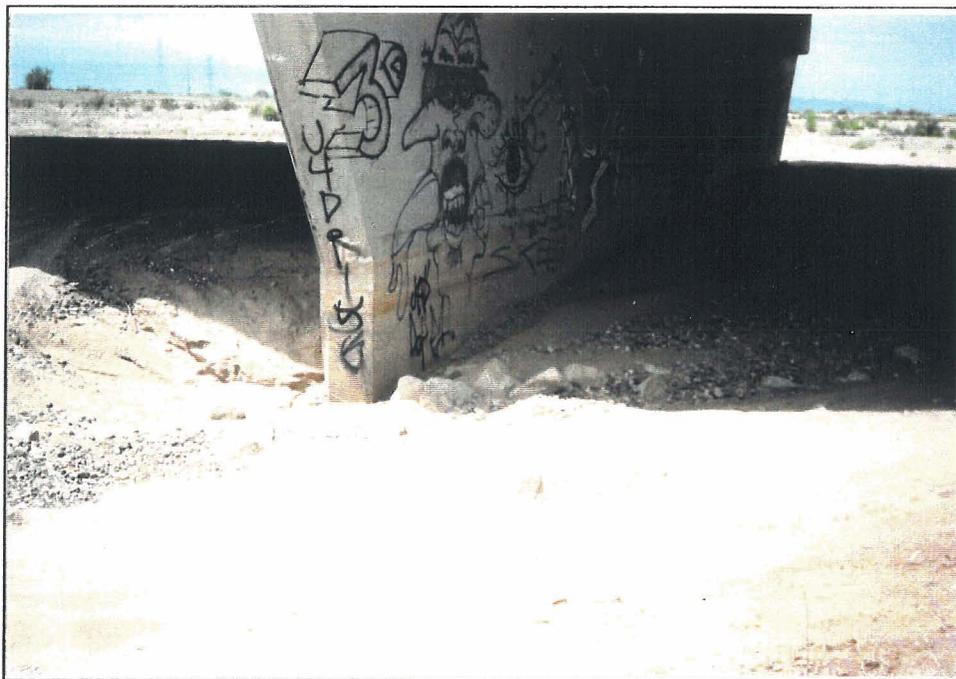
Photo 6: View looking at upstream face of typical solid pier. Note residual scour of 3-4 feet was most severe case observed. Also note staining of concrete and exposure of rip-rap.

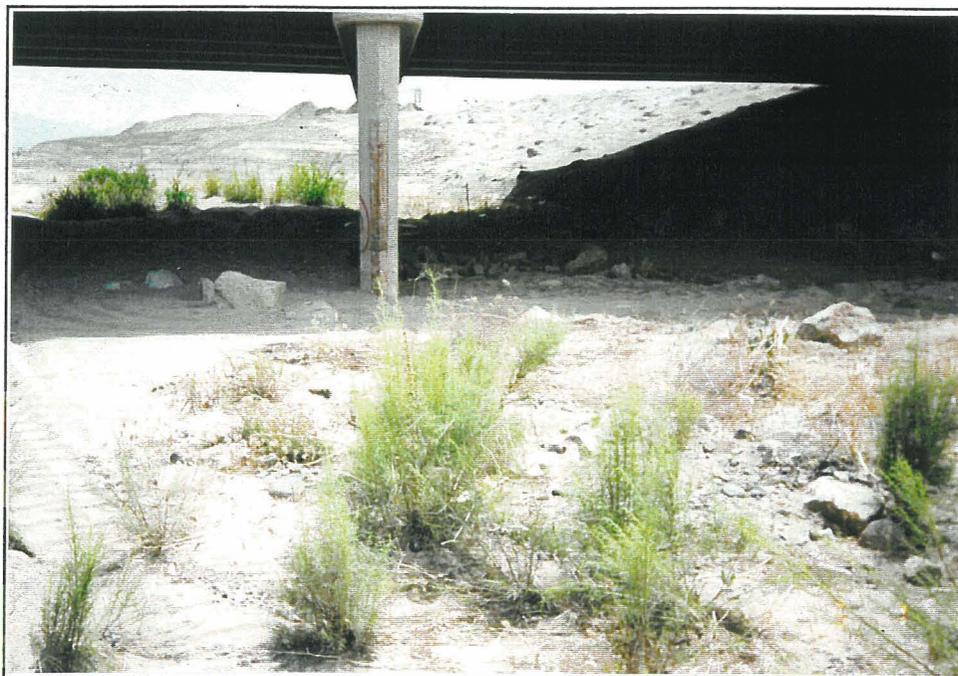
Photo 7: View looking at upstream edge of first pier from west. Note the differential deposition on east side of pier and scour of west side was typical of several solid piers possibly indicating recent flow angle of attack may be slightly west of north.

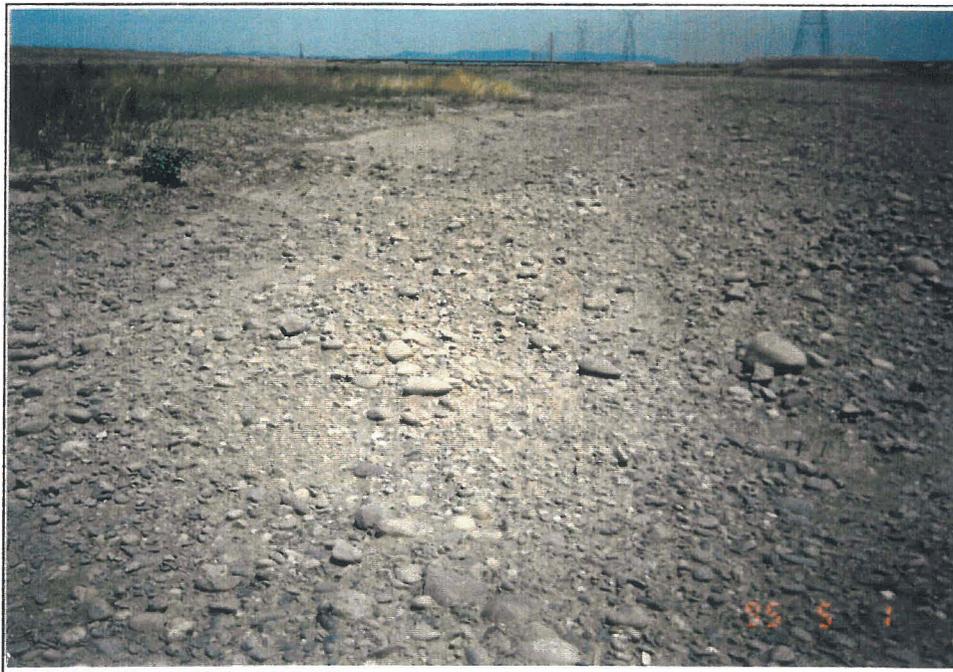
Photo 1: View looking upstream from approximately mid-channel near SPRR bridge. Note slightly meandering, relatively clear, shallow low flow channel comprised of somewhat armored coarse surficial sediments. Also note low grasses typical of main channel on either side of shallow low flow channel. Further note power line islands positioned in east central portion of channel. Both upstream banks are formed of soil cement into relatively high trapezoidal levees.

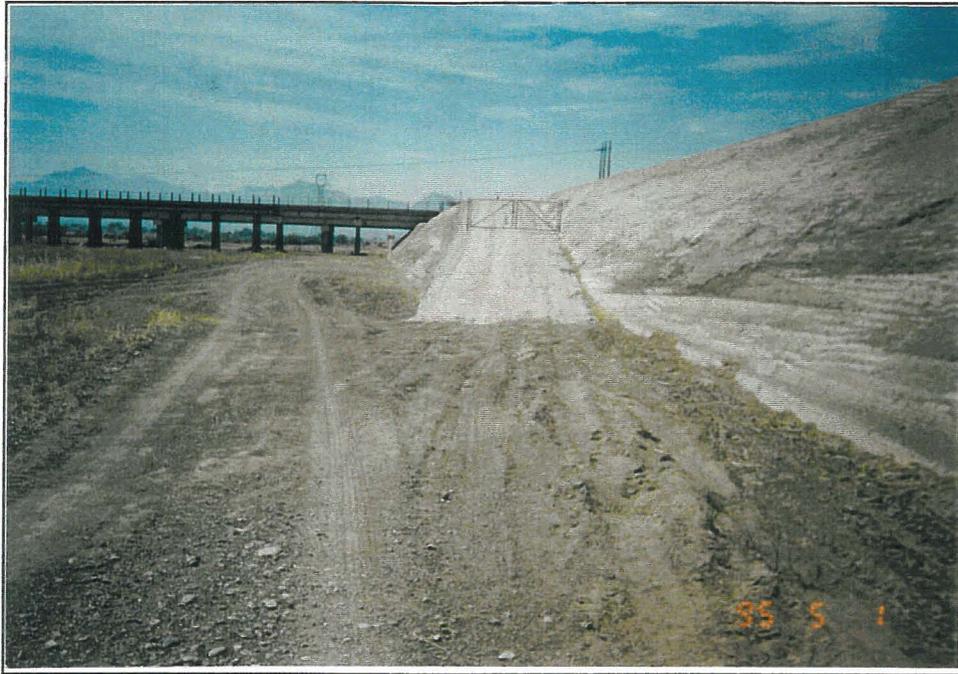
Photo 3: View looking downstream toward structure along west levee embankment. Note typical embankment configuration with channel access road.

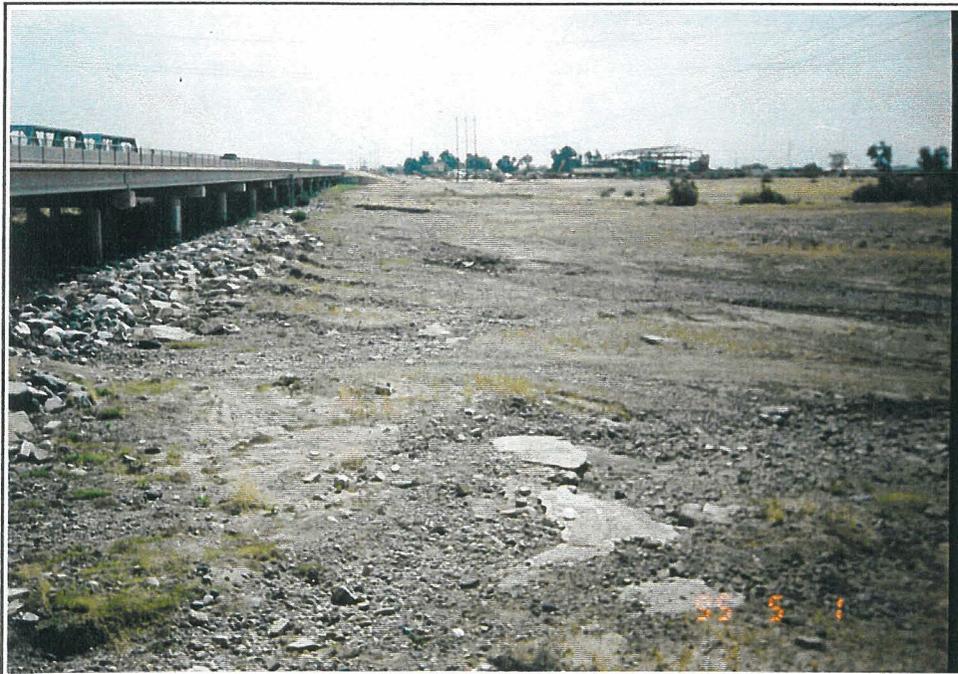
Photo 4: View of downstream face of bridge from top of west levee embankment. Note placement of angular rip-rap around piers. Also note pattern of downcutting immediately downstream of rip-rap with several smaller channels forming into a larger low flow channel immediately downstream of structure. Note east bank is natural downstream of structure. Also note relatively coarse nature of downstream sediments exposed near structure. Some mining of channel sediments may have occurred immediately downstream of structure serving to direct low flow.

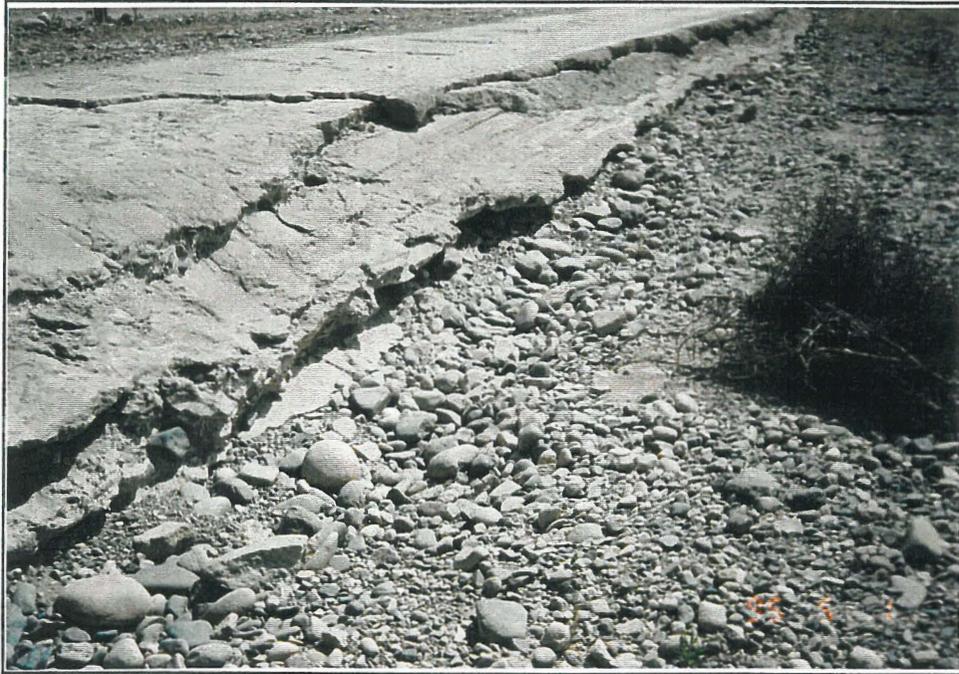
Photo 7: View of downstream side of narrow grade control structure located approximately 2000 feet upstream of structure. Note that channel grasses occur at significantly greater density upstream of this grade control (not shown).

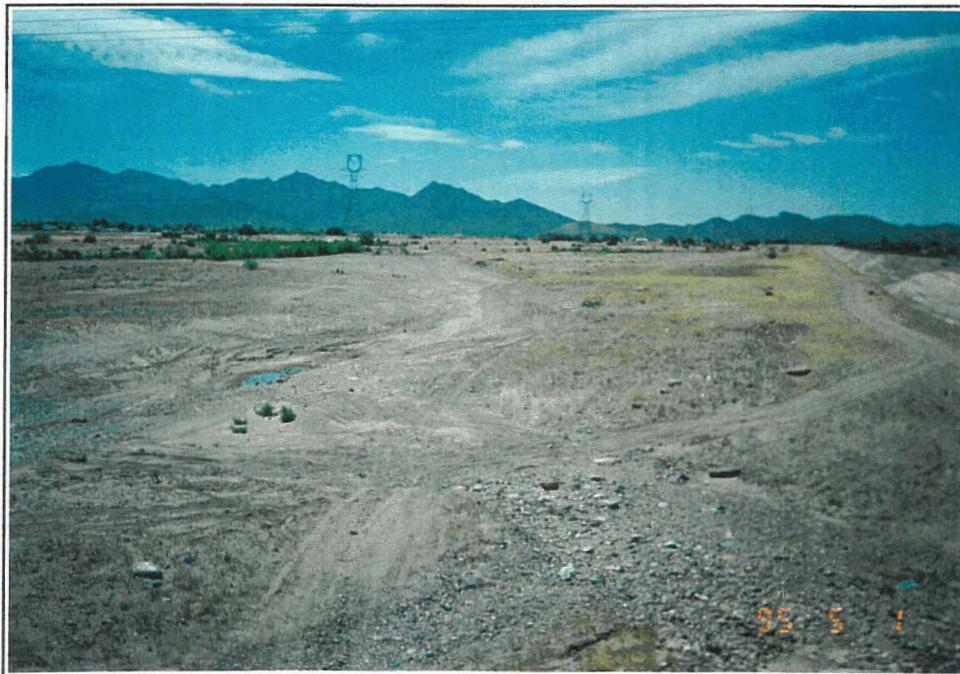
Photo 8: View of downstream channel from bridge deck. Low flow channel drains toward ponding area for irrigation runoff. Confluence is identified by locally well developed vegetation visible in background.

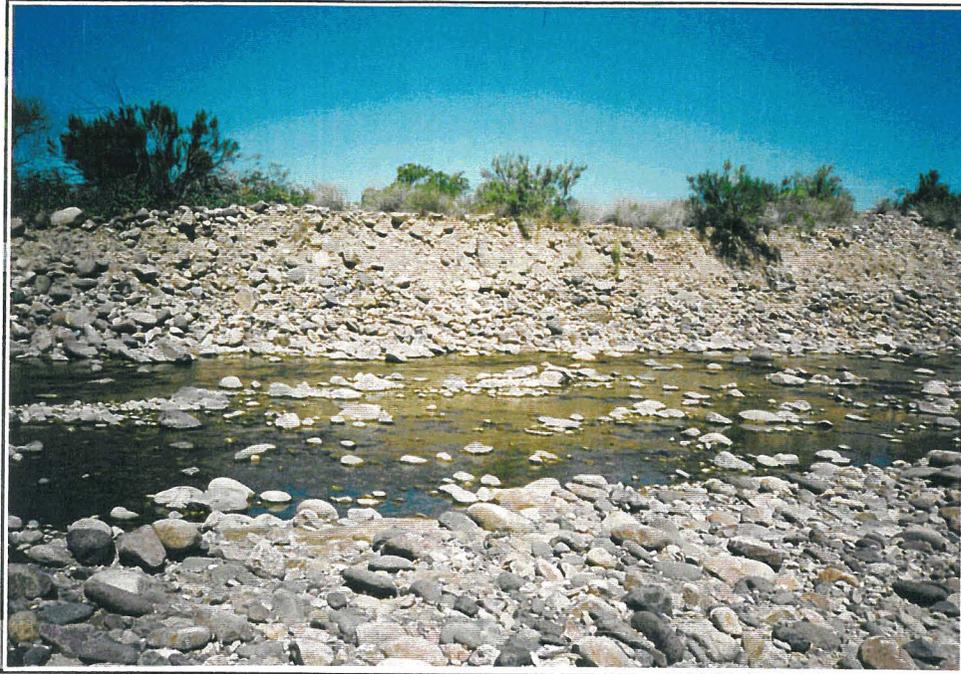
Photo 3: View of upstream channel looking west across low flow channel. Note unstable rocky slope in main channel being undercut by low flow channel. Vertical relief is approximately 8 feet.

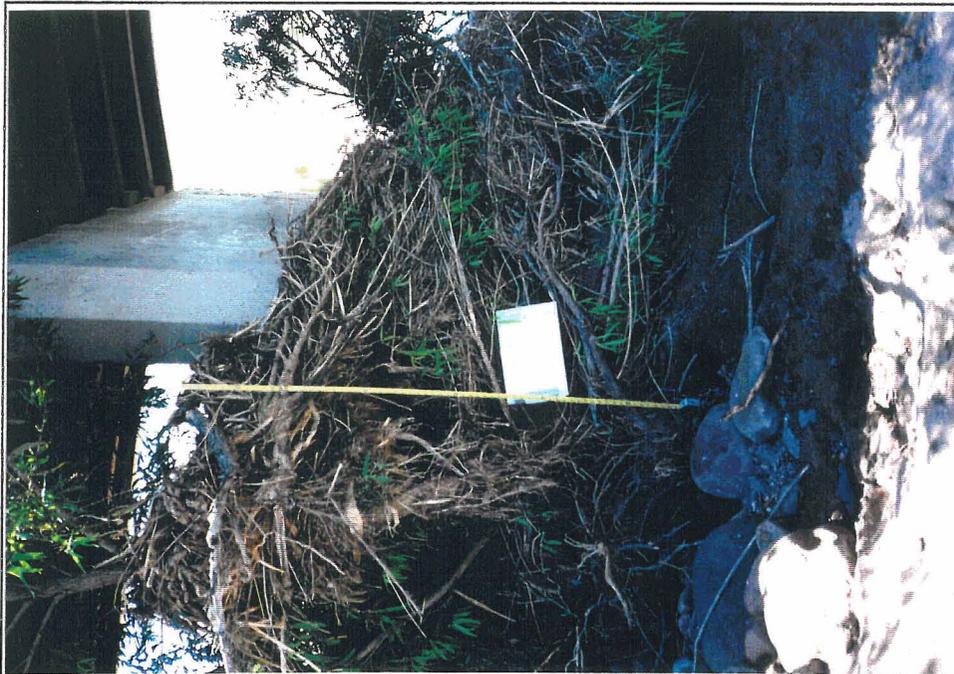
Photo 6: View of upstream edge of pier 3. Note significant debris accumulation. Accretion pattern on piers suggests recent flow angle of attack is slightly east of north.

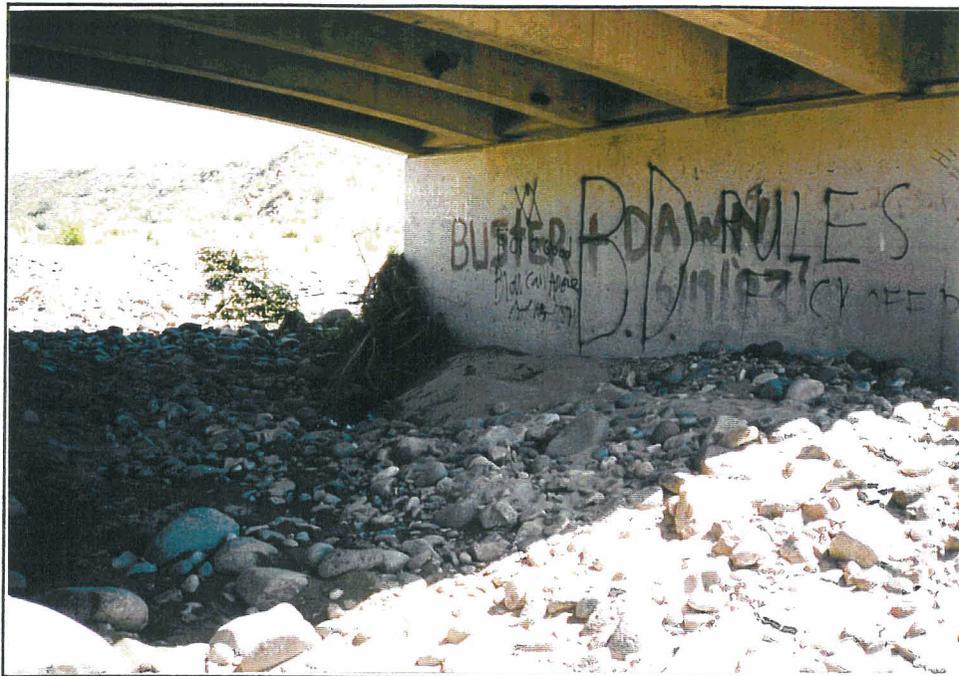
Photo 7: View of west side of pier 2. Note residual pattern of local scour at upstream face reflects debris accumulation on leading edge.

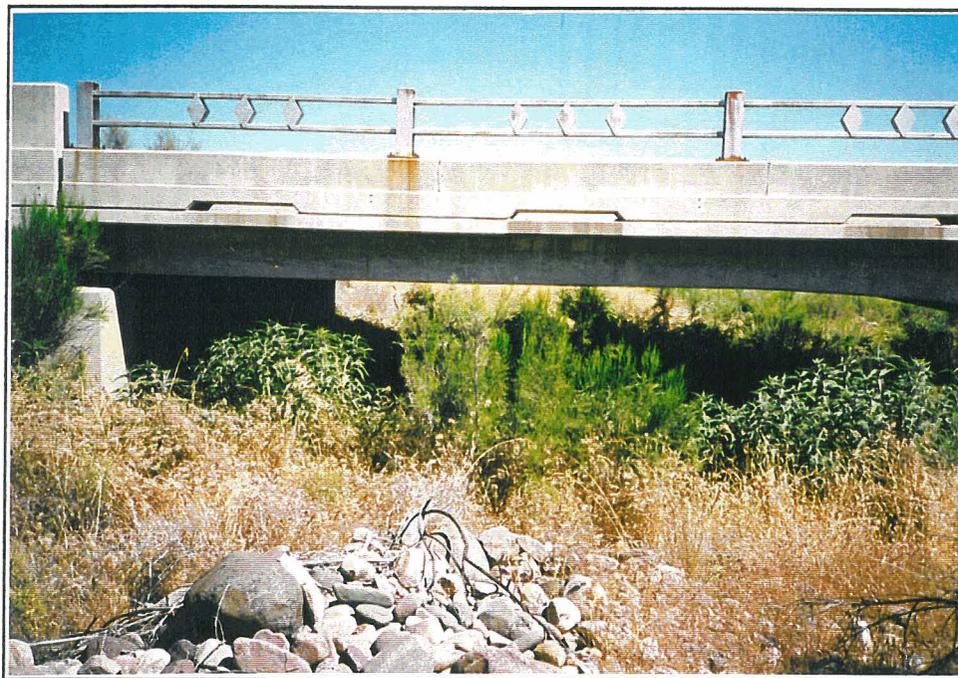
Photo 8: View of west abutment from downstream. Note this reduced clearance was also observed in waterway below adjacent span.

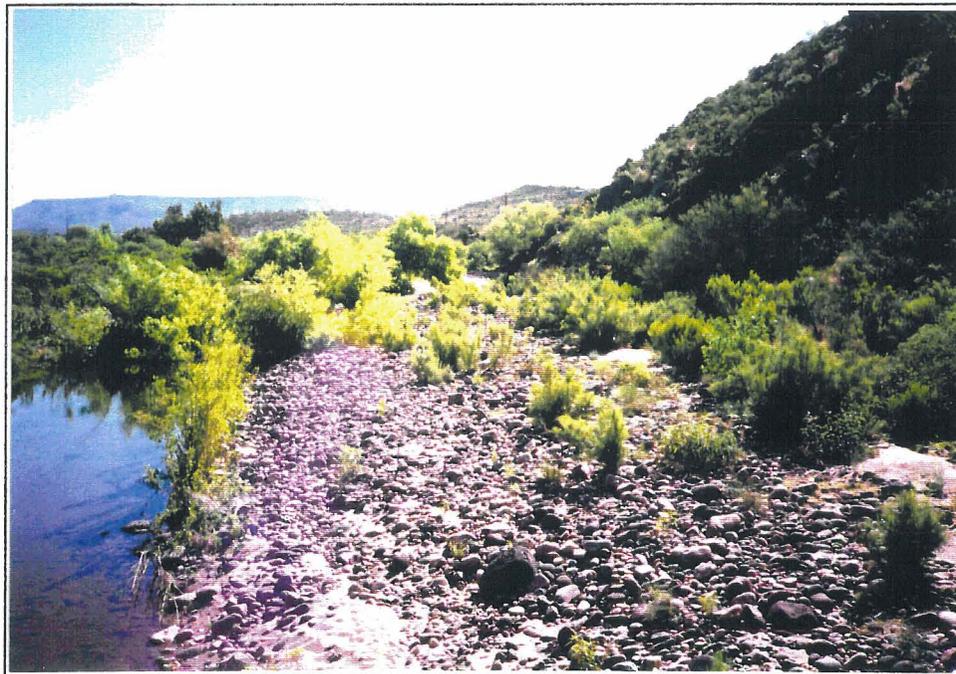
Photo 2: View looking east along upstream left bank from bridge deck. Note boulders up to 2 feet on axis were commonly observed. Also note proximity of cliffs to right providing coarse material and lateral control of stream.

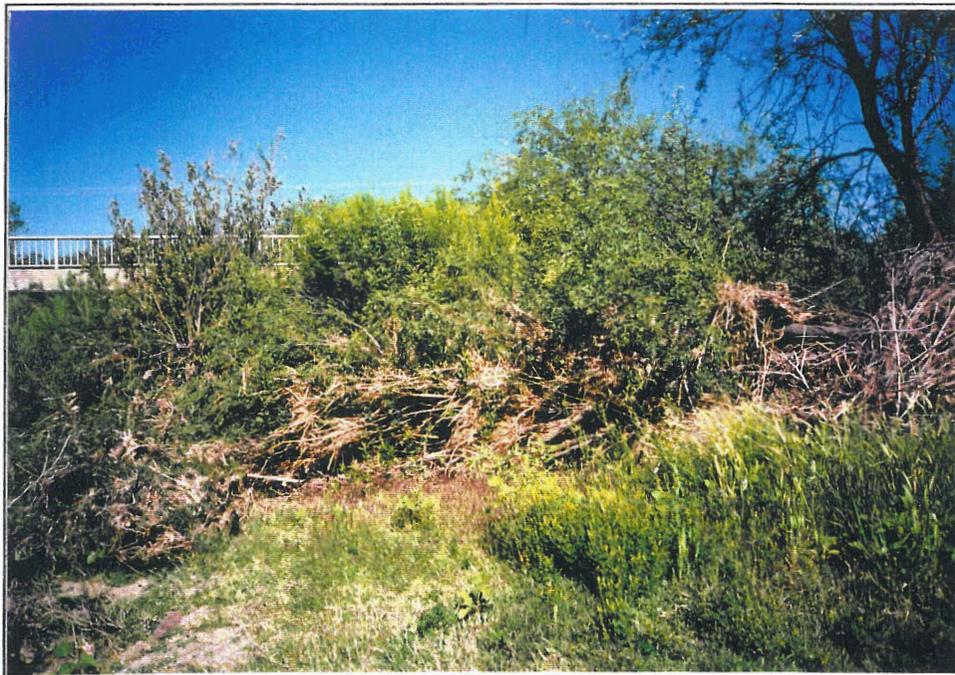
Photo 4: View looking west toward upstream face of structure from right bank. Note mature vegetation on typical of right overbank. Also note large amount of debris captured.

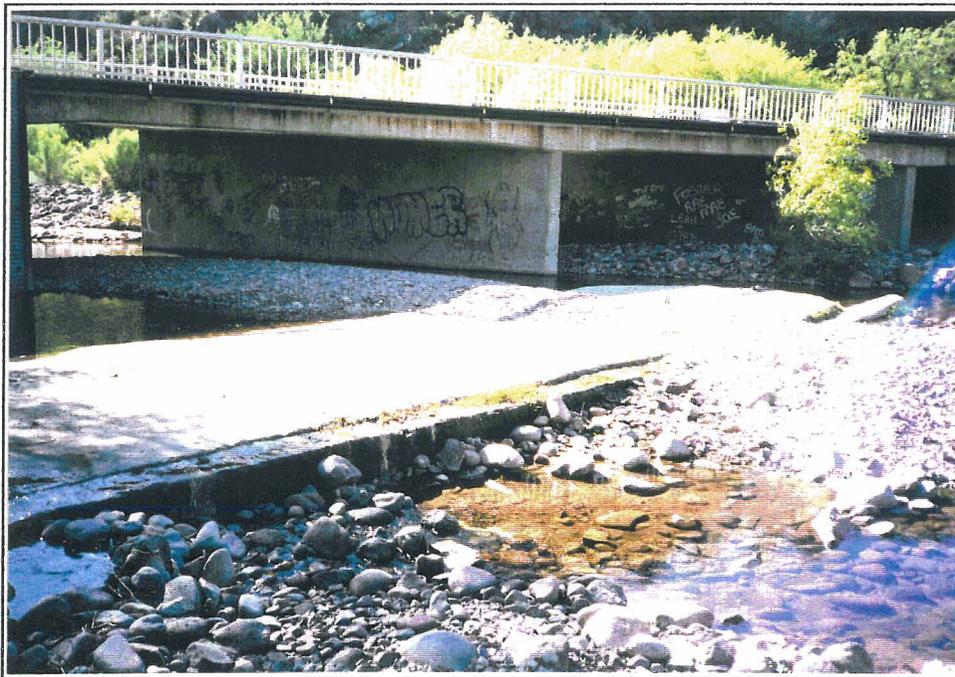
Photo 6: View of downstream face of bridge at piers 1 and 2. Note presence of concrete slab functioning as limited grade control and as flow diversion.
