**Final
BRIDGE SCOUR ASSESSMENT
REPORTS
for 16 Maricopa County Bridges**

**VOLUME I
Structure Numbers
9691, 8981, 9301, 9859
9145, 7819, 8028, 8639**

**MARICOPA COUNTY
DEPARTMENT OF
TRANSPORTATION (MCDOT)
Work Order No. 80407**

**Cannon & Associates, Inc.
Consulting Engineers**

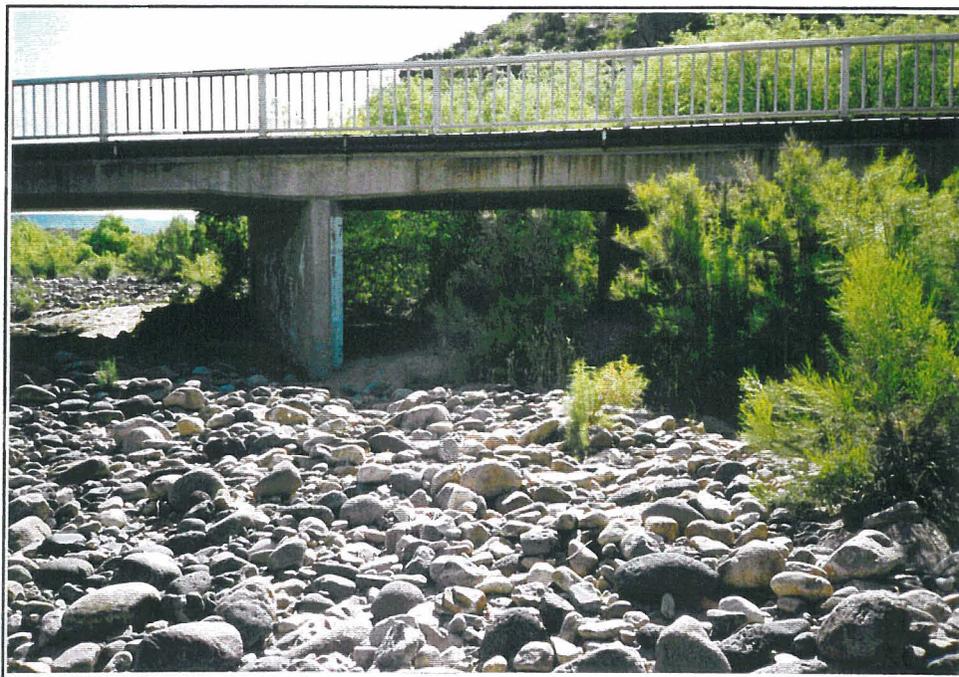
Photo 7: View of downstream face of bridge near pier 1. Note boulder-sized material up to 2 feet on axis may form armor surface in portions of channel and may possibly accelerate scour in less protected portions of channel.

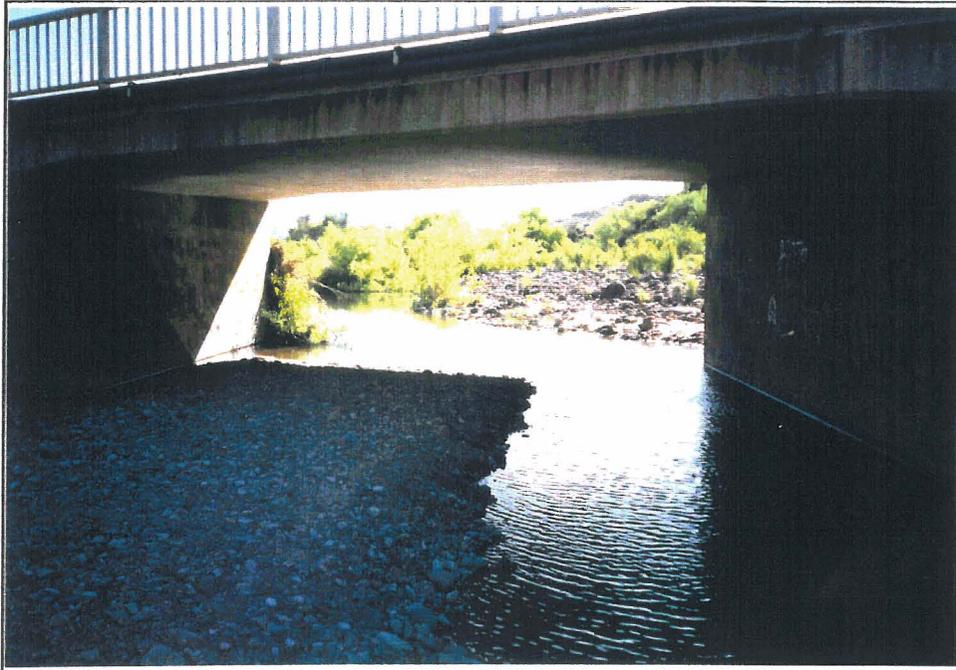
Photo 9: View of span 3 from downstream face. Note pattern of sediment deposition indicates that the angle of attack of recent flows may be north of pier skew.

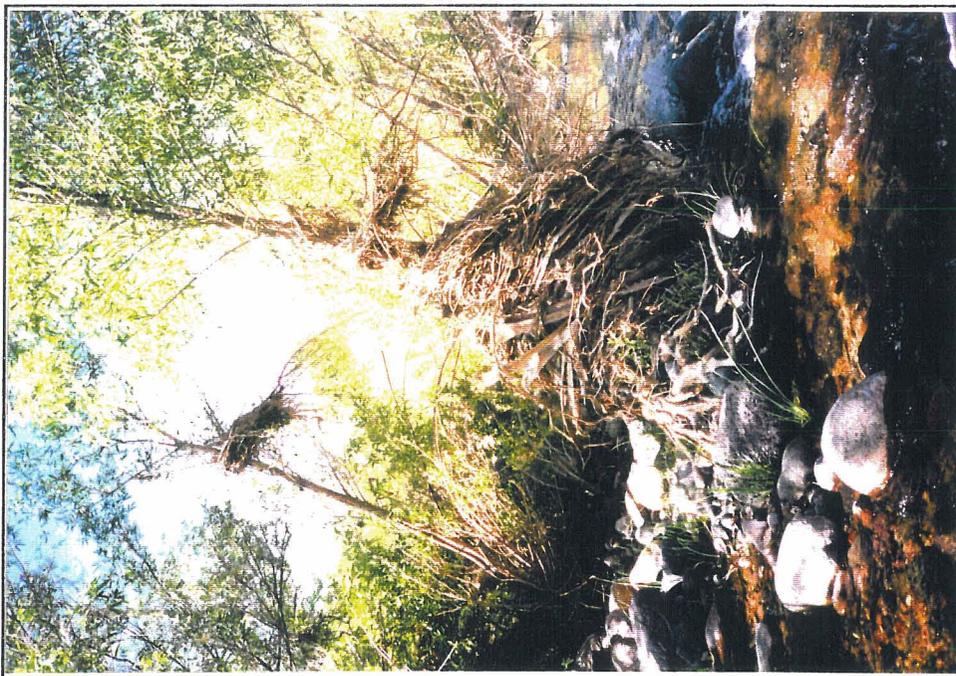
Photo 10: View alongside low flow channel approximately 125 feet downstream. Note that captured debris was measured to heights up to 10 feet above channel in this vicinity.
