**Maricopa County
Department of
Transportation**

**Bridge Scour Investigation
and
Design of Corrective Measures**

Final Report

Deer Valley Road Bridge at Wash (189th Avenue)

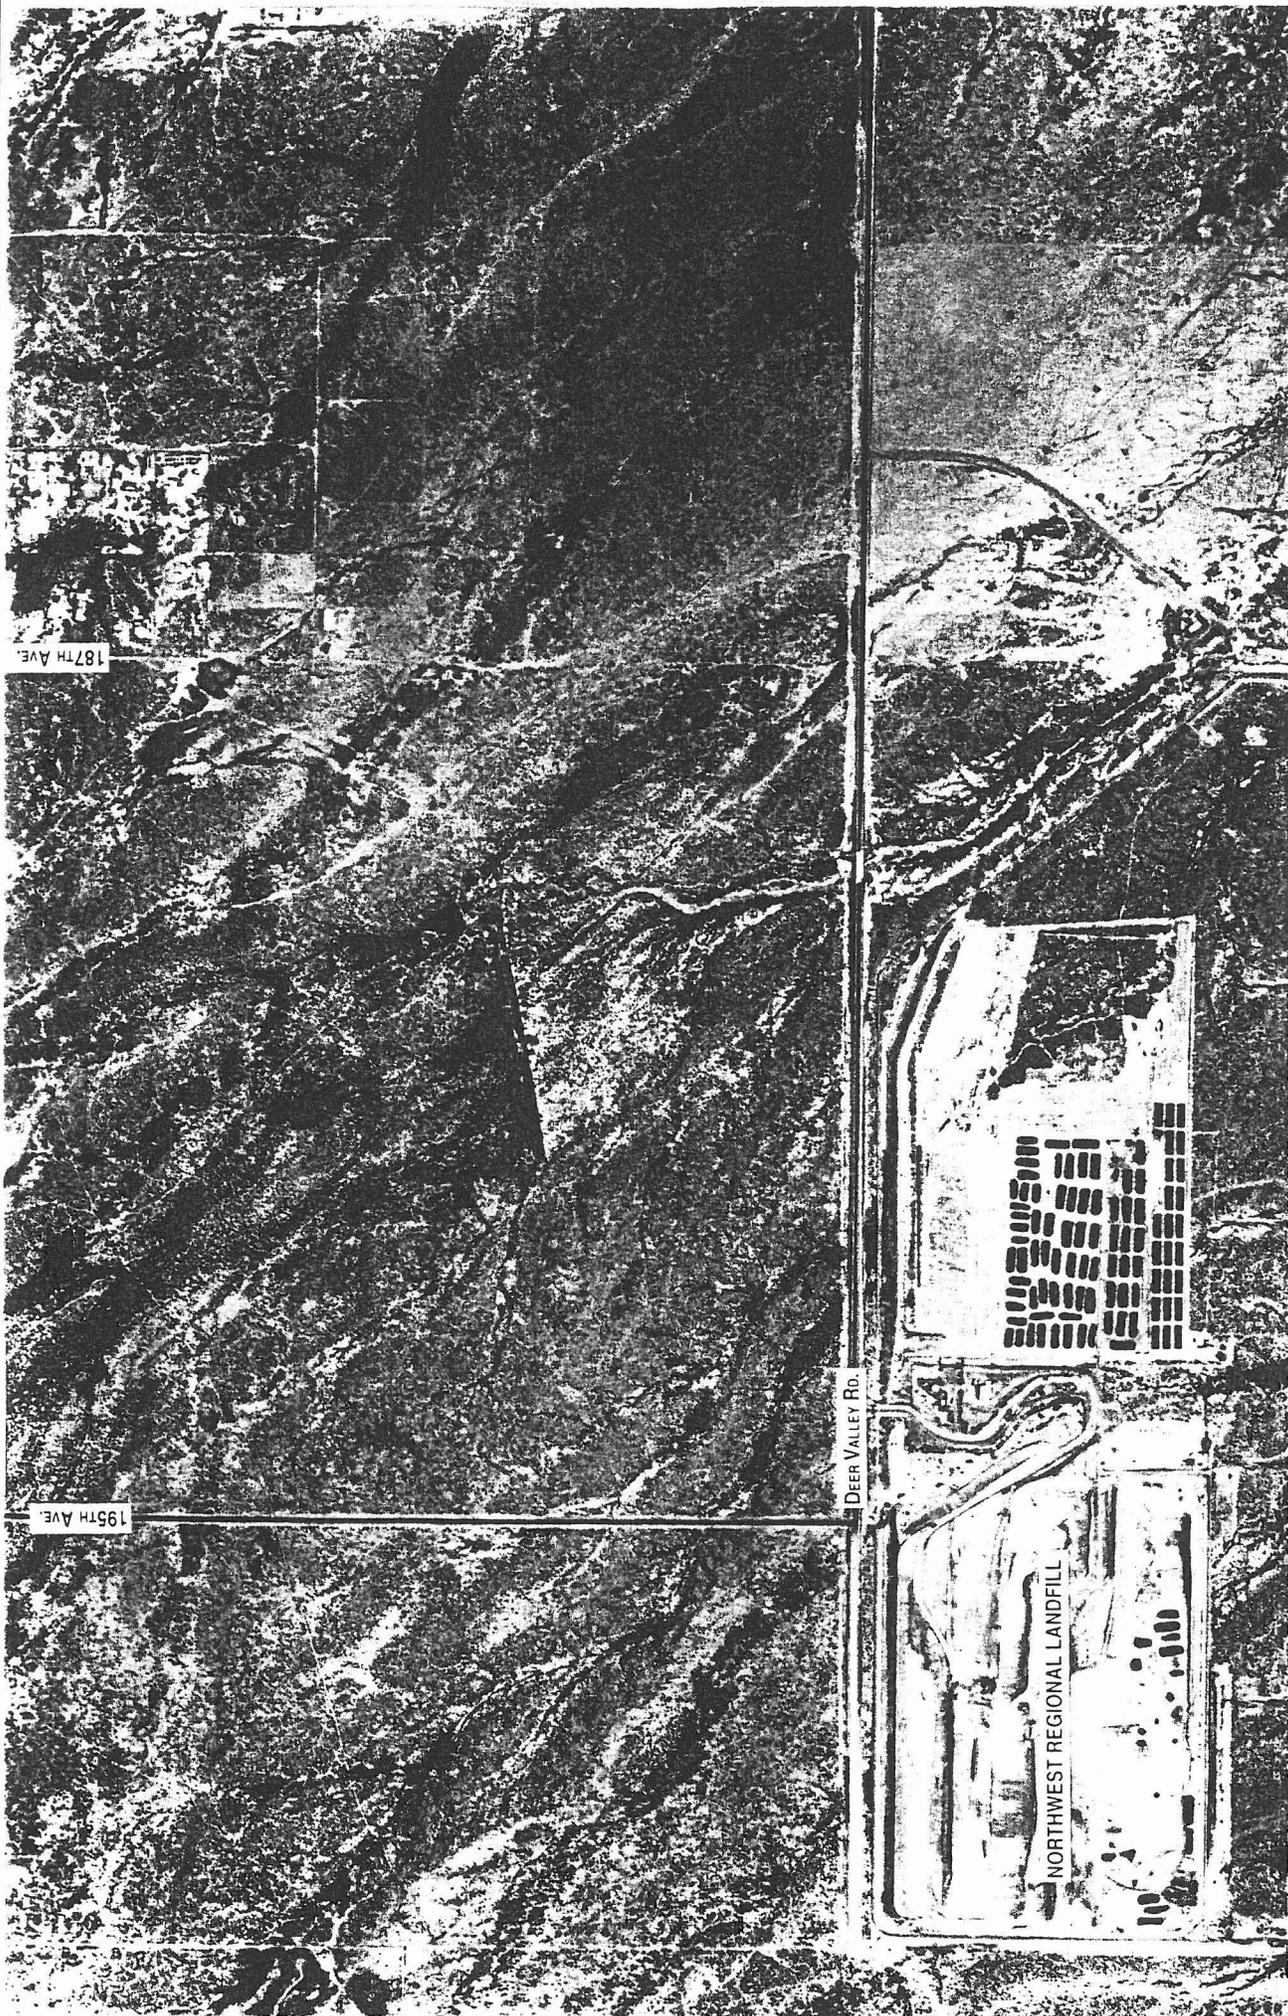
DEER VALLEY ROAD BRIDGE @ 189TH AVENUE

4. There appears to be a dike or berm (about 200 feet in length) located approximately 2100 feet upstream of the bridge crossing. This dike is perpendicular to and centered on the main wash leading to the bridge crossing. From the aerial photographs and USGS Quad maps, it appears that this dike may allow the wash runoff to pond behind it, thus attenuating the peak runoff slightly (the amount of potential attenuation was not determined) but this may only be effective during smaller magnitude events (i.e. 2-5 year frequency). When full, it appears that the spillway is at the east end of the dike. Once over the spillway the runoff will continue to the bridge. Refer to the included copies of the Aerial Photograph and Quad map for additional information.

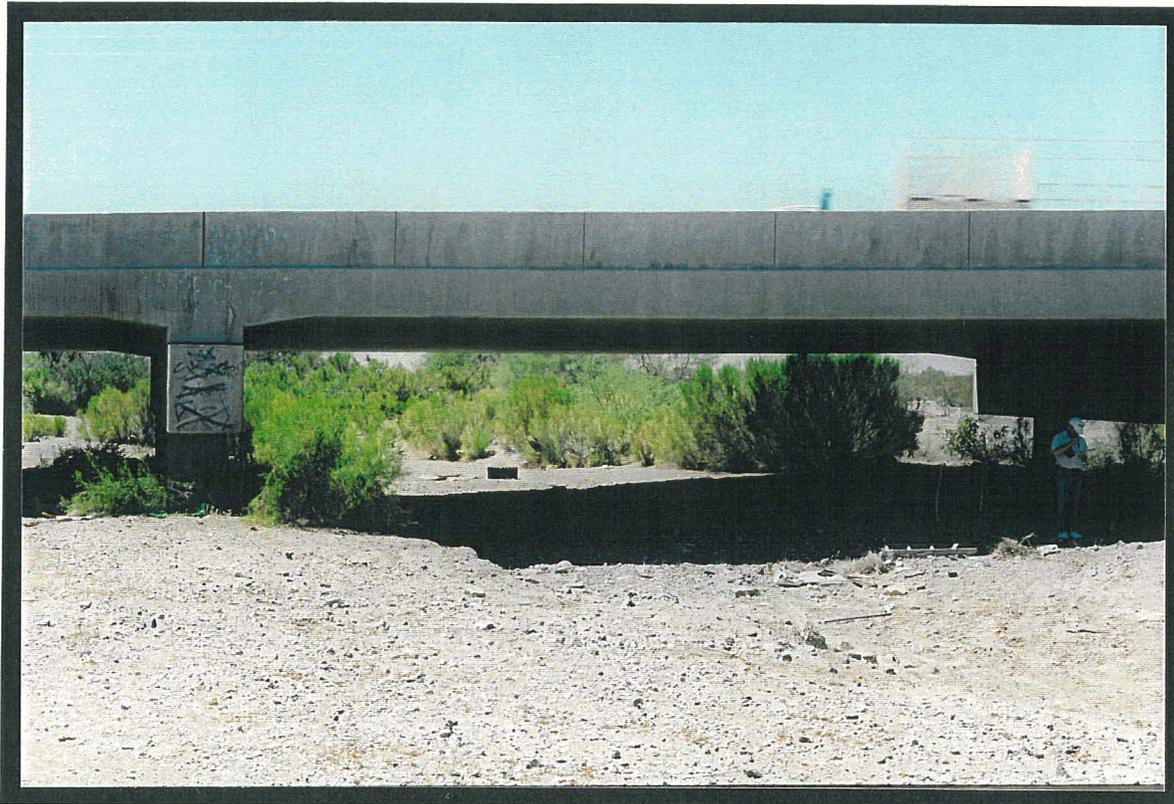
1. The upstream and downstream wash is very shallow. Additional survey work is needed to help determine the water surface elevation overtopping the Wash. It may not be possible to pass large flows through the bridge.

Looking Downstream (Note: Shallow Wash)

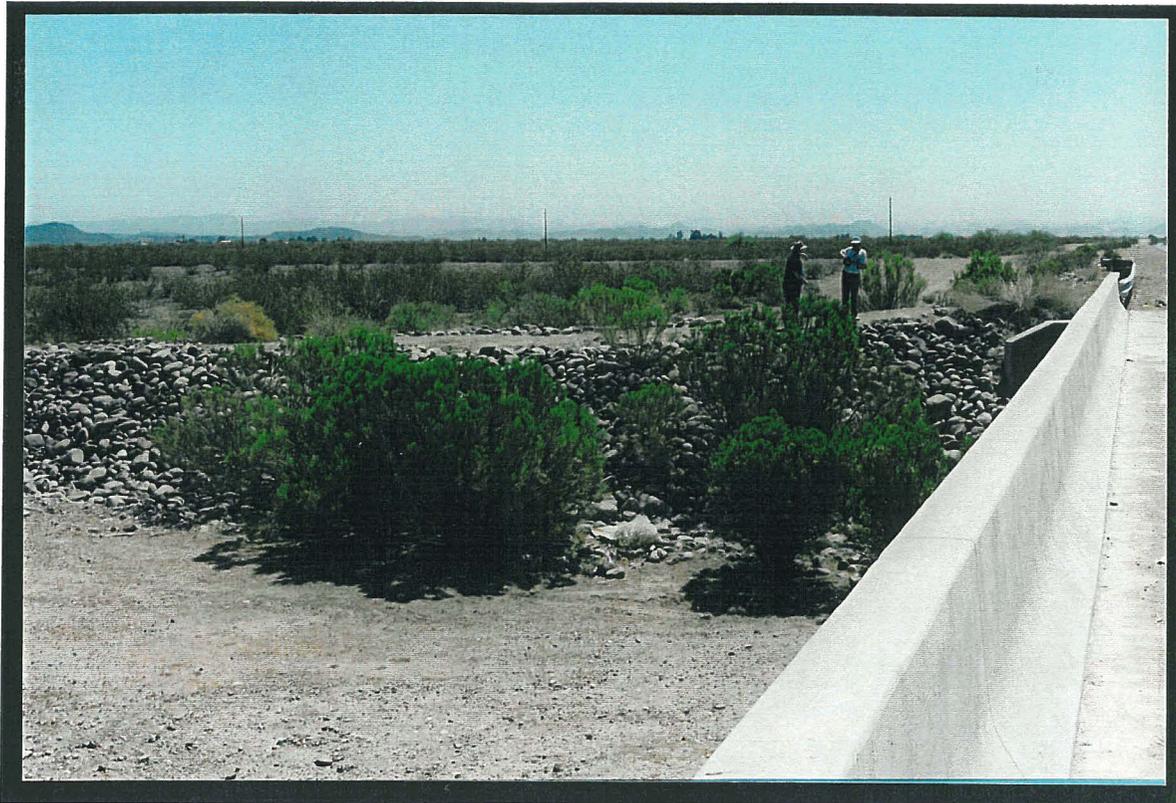
East Spur Dike Upstream

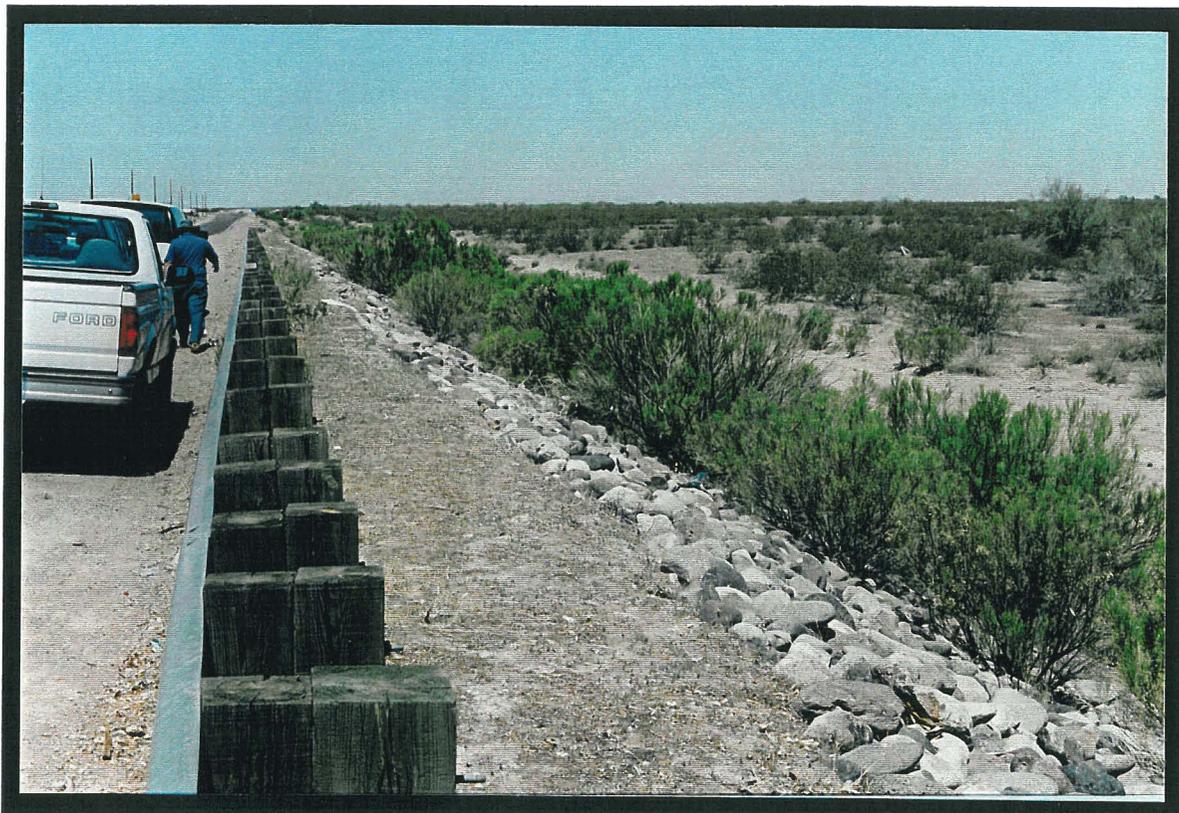
2. The channel paralleling Deer Valley Road appears to be subjected to significant discharge and it was decided that additional hydrologic investigation would be necessary to quantify this flow. For the purposes of this study, the contributing area was quantified and USGS regression equations were used to determine the flows and frequencies.

Drainage Channel North of Roadway and West of Bridge

5. This site is not suitable for soil cement due to the low clearance under the bridge.
6. The selected countermeasure will have to incorporate the side channel at the northwest corner of the bridge.

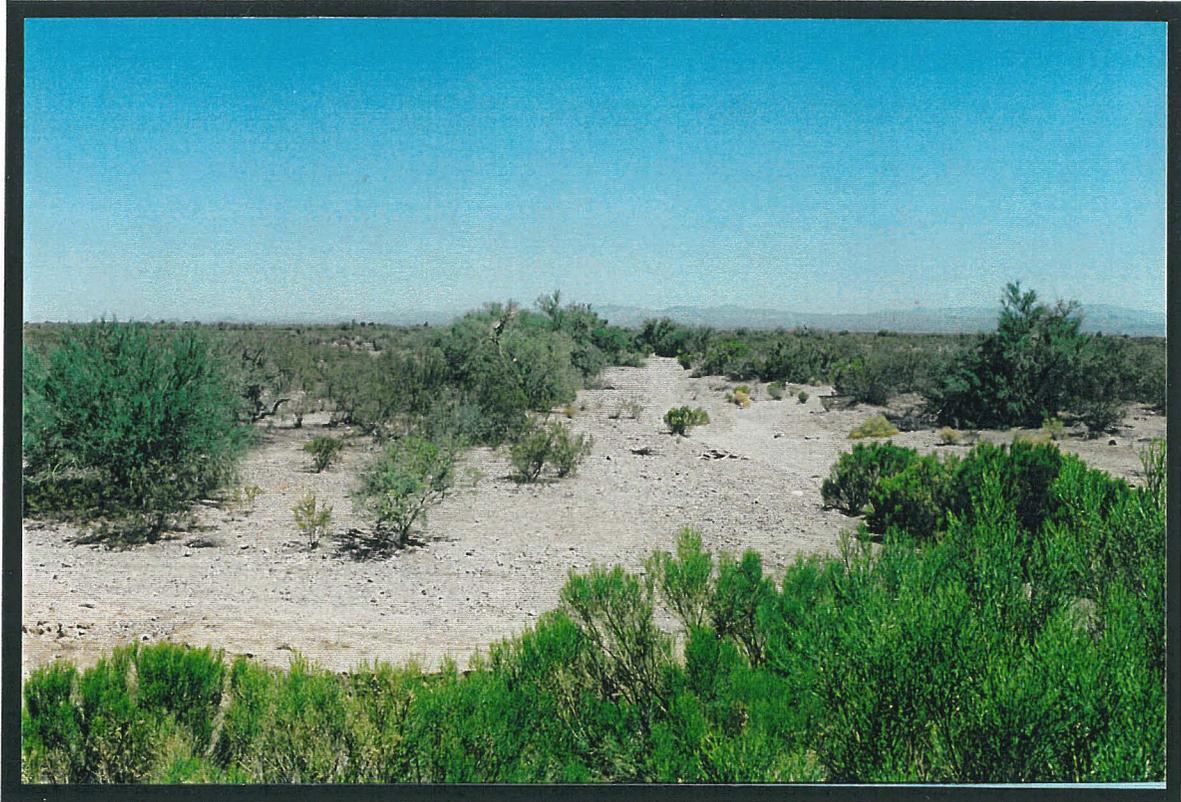
Looking Upstream of Bridge
