Determination of Channel Change for Selected Streams, Maricopa County, Arizona

Water-Resources Investigations Report 01–4209

Prepared in cooperation with the
FLOOD CONTROL DISTRICT OF
MARICOPA COUNTY

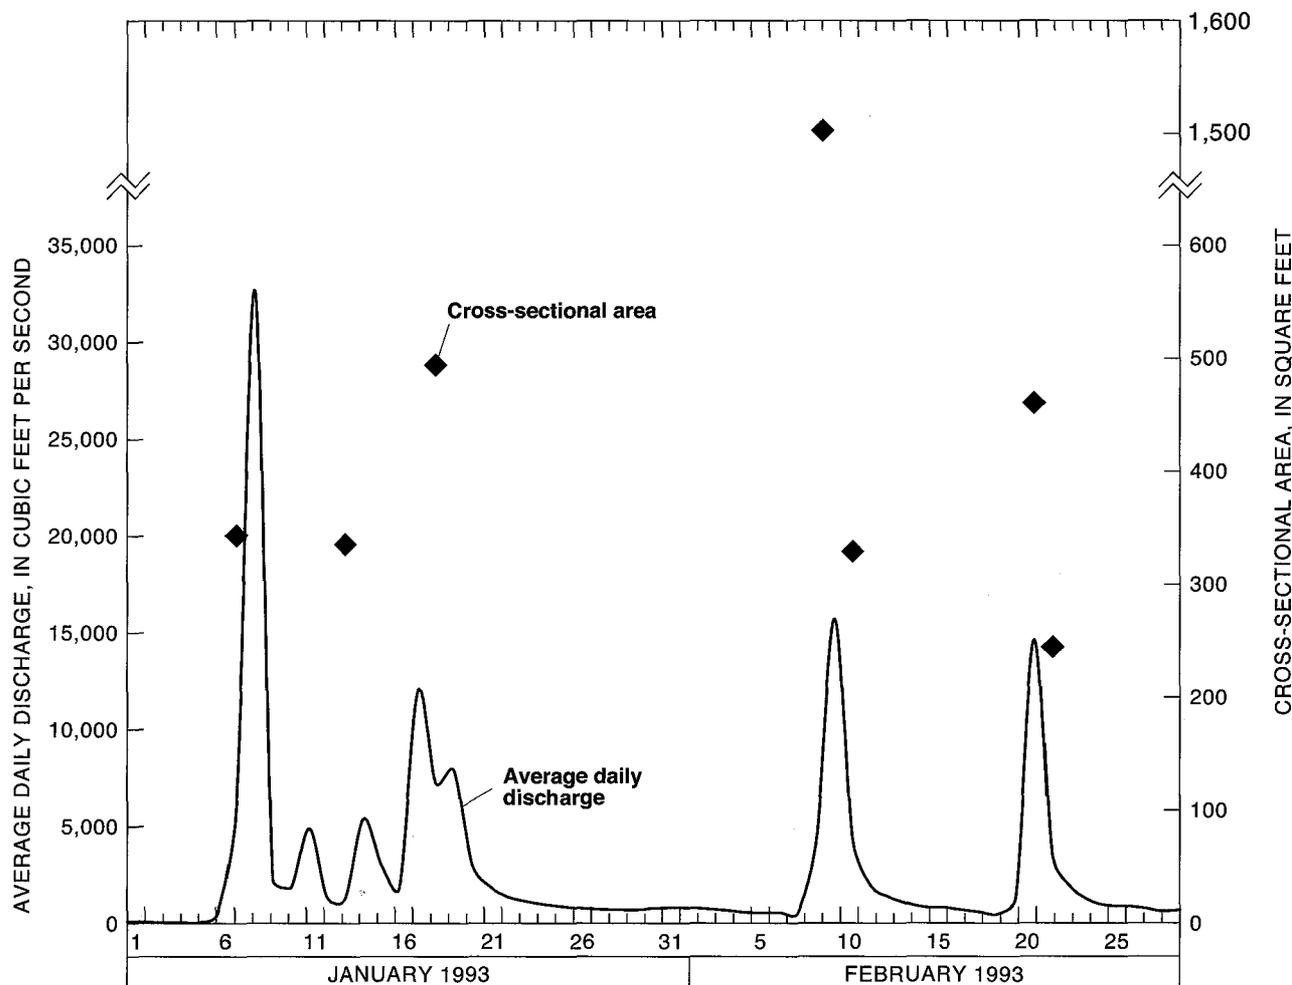
Figure 2. Average daily discharge and cross-sectional area, determined from current-meter measurements, at cableway, Agua Fria River near Rock Springs, Arizona, 1993.

Data for cross sections were reconstructed from cross-section surveys and current-meter measurements (figs. 2-5; table 1). The current-meter measurements were made from the cableway. The surveyed cross sections are 315 and 800 ft downstream from the gaging station, at the

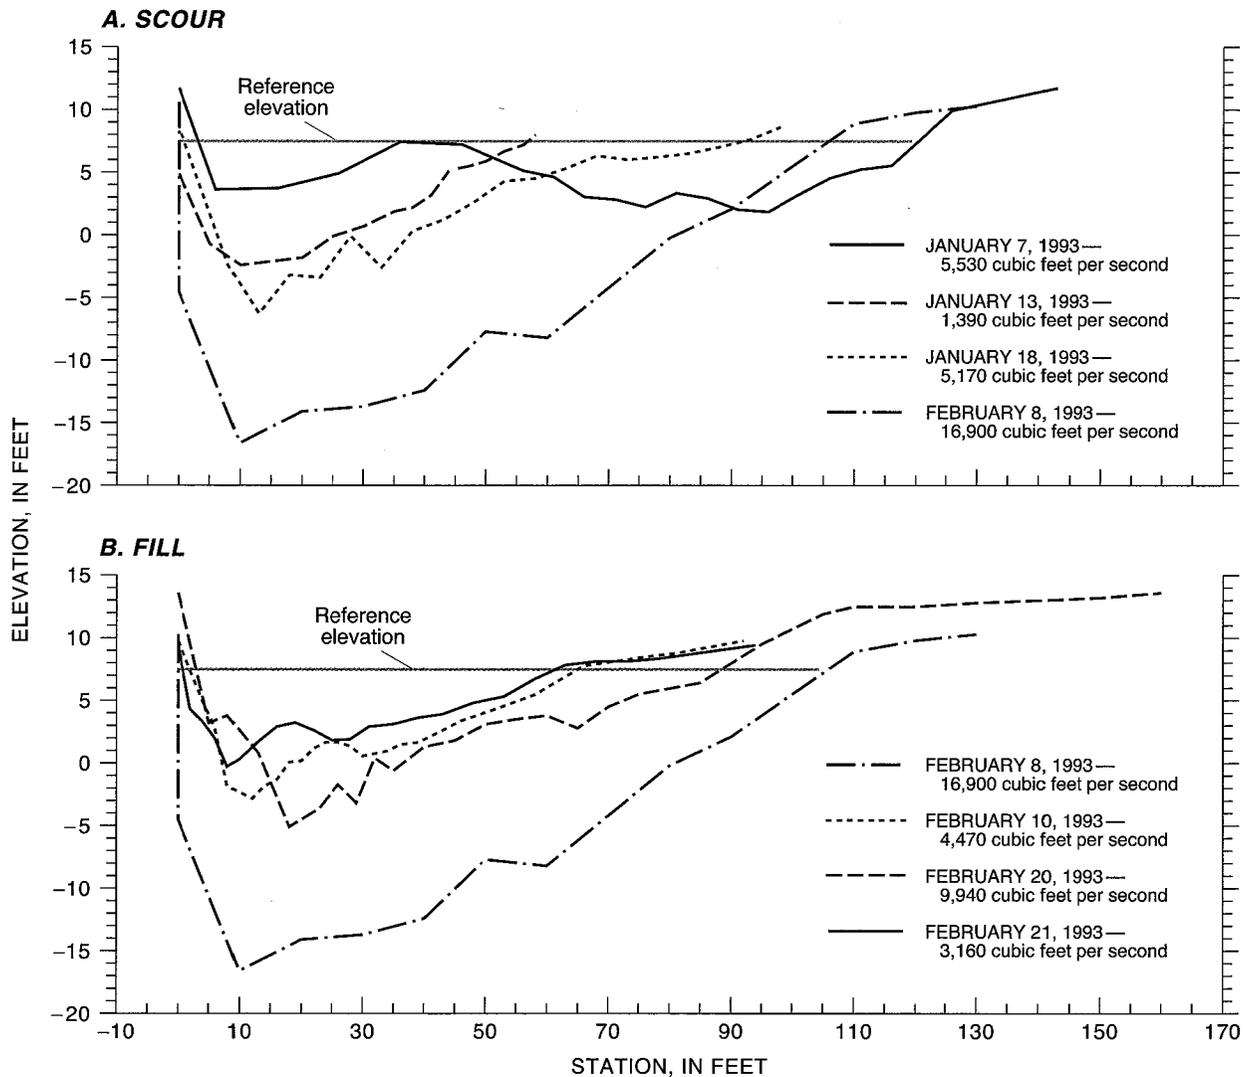
Figure 3. Cross section from discharge measurements at cableway, Agua Fria River near Rock Springs, Arizona, 1993. A, Scour, January 7 through February 8, 1993. B, Fill, February 8–24, 1993.

After February 8, increases in discharge caused an increase in channel scour, and decreases in discharge caused the channel to fill (fig. 3). Data from the discharge measurement made on February 10 at 4,470 ft³/s show the cableway cross section filled with as much as 15 ft of sediment after February 8. The final 1993 flood peak of 30,400 ft³/s occurred on February 20. A discharge

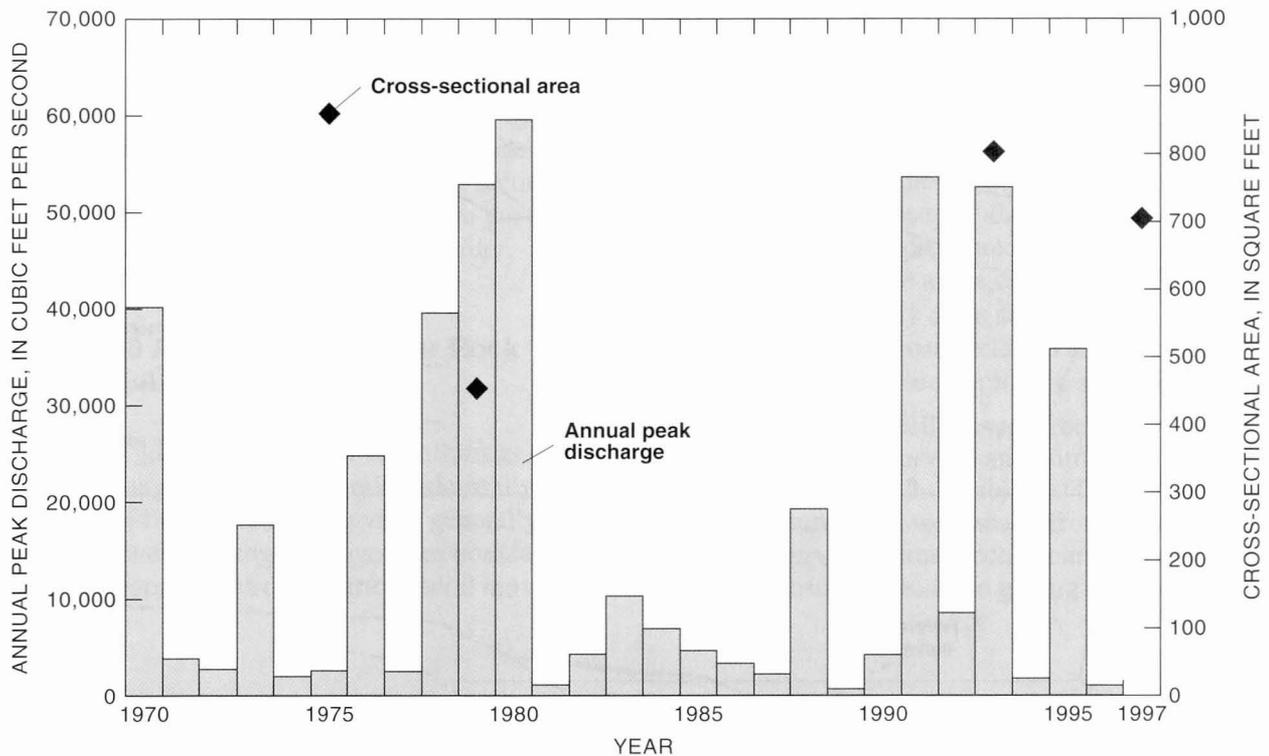
Figure 4. Annual peak discharge and cross-sectional area from surveys during indirect measurements of discharge at cross-section 2, Agua Fria River near Rock Springs, Arizona, 1970–97.

and by varying amounts in the overbank area at all four cross sections. In 1997, cross-section 2 was resurveyed. Since 1993, the only substantial change to cross-section 2 occurred along the low-flow channel where some fill occurred. Channel change is common along the reach near the gaging station. Figure 4 shows the annual peak discharge and the cross-sectional area relative to the reference elevation at cross-section 2.

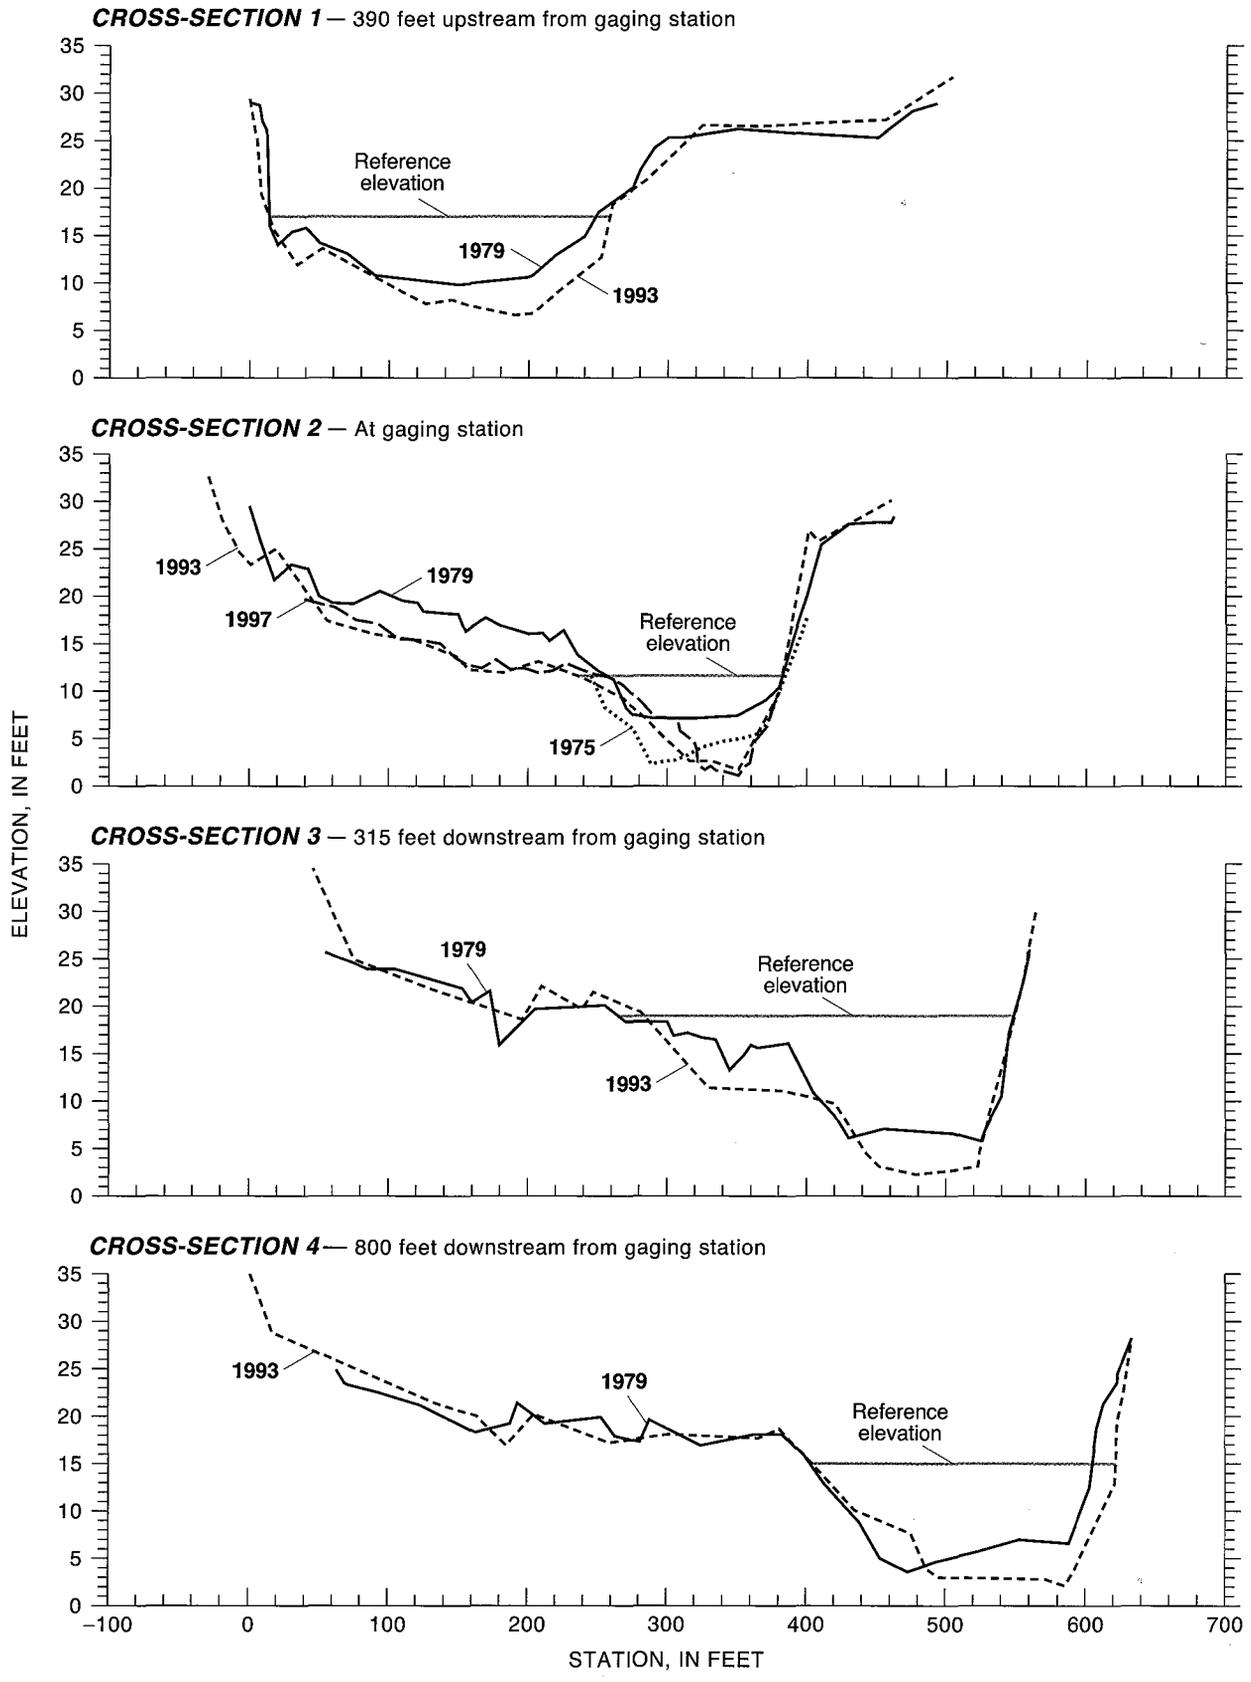
Figure 5. Cross sections from surveys during indirect measurements of discharge, Agua Fria River near Rock Springs, Arizona, 1975–96.

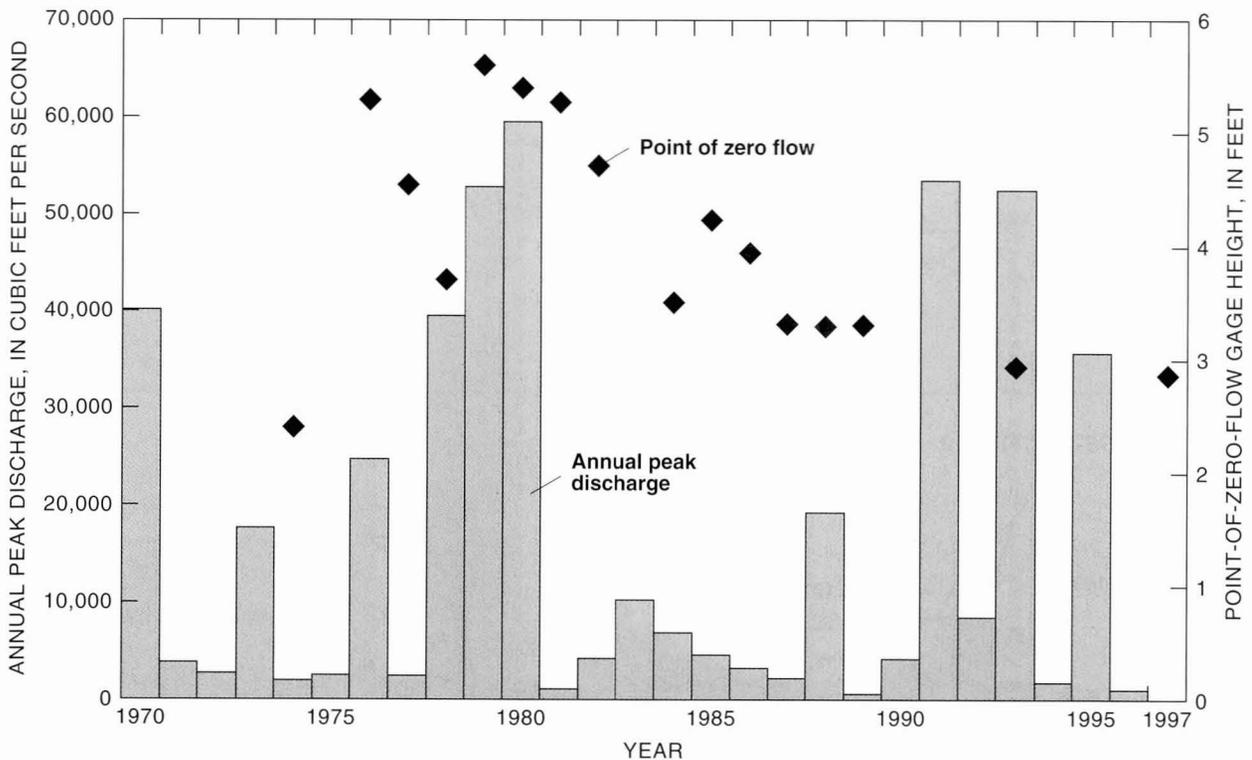
Figure 6. Point-of-zero-flow gage height and annual peak discharge, Agua Fria River near Rock Springs, Arizona, 1970–97.

gaging station, and 390 ft upstream from the gaging station. Historical changes to the PZF were compiled and are presented (fig. 6).

PZF analysis.—The PZF at the Agua Fria gaging station changed by several feet over a period of a few decades. A correlation, however, could not be determined between PZF and annual peak discharge at this site (fig. 6). The highest PZF of 5.6 ft was measured in July 1979 when the channel filled with sediment after a large flood on December 18, 1978. The large floods that occurred in 1978–80 were followed by 10 years of low flow in which no flood exceeded the 10-year recurrence interval, and only two floods exceeded the 2-year recurrence interval. By 1988, the PZF had decreased in elevation to 3.29 ft. Since 1989, only a slight additional decrease in the PZF has occurred despite three floods with peak instantaneous dis-

charges greater than the 10-year recurrence interval. The PZF was 2.93 ft in 1993 and 2.86 ft in 1996. This small decrease appears inconsistent with the large amount of scour measured at the cableway cross section (fig. 3); however, the channel filled following the high flows of January and February 1993, and the PZF was measured at the control of the gaging station upstream from the cableway primarily during low-flow conditions and may not reflect channel conditions at the cableway.

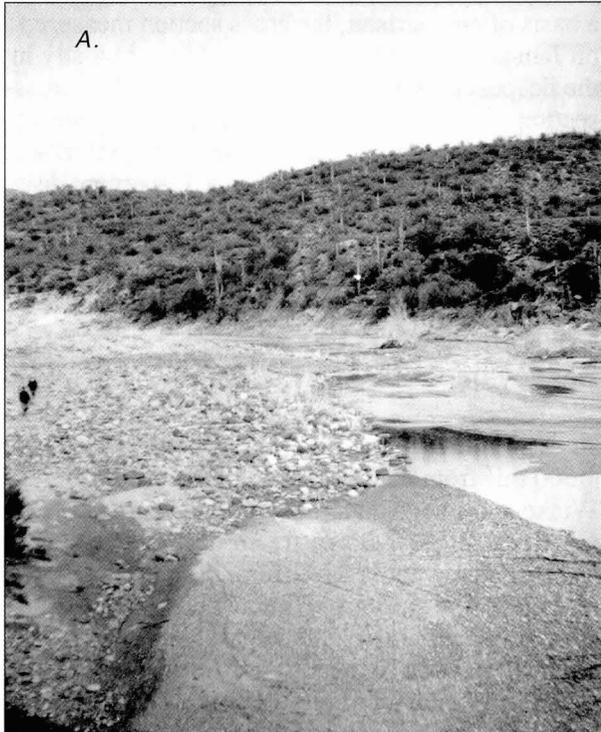
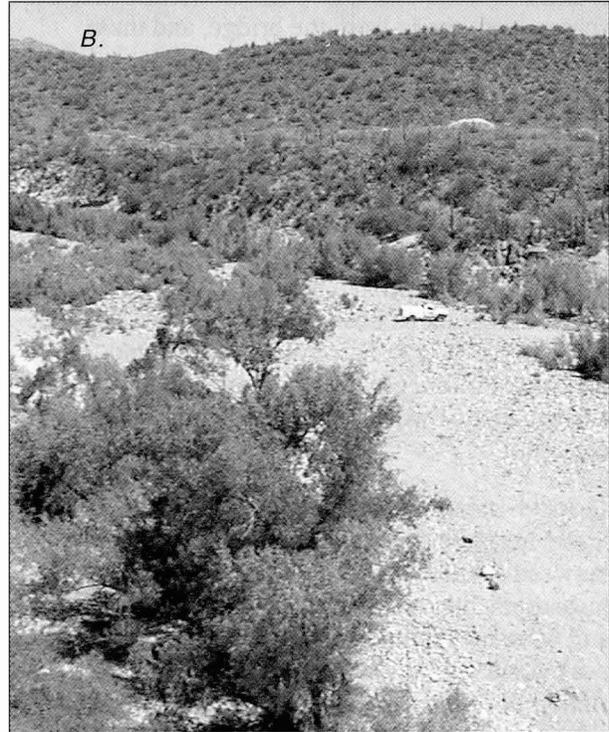
Figure 7. View downstream from cableway, Agua Fria River near Rock Springs, Arizona. A, January, 1979 after the flood of December 18, 1978. B, June 18, 1998.

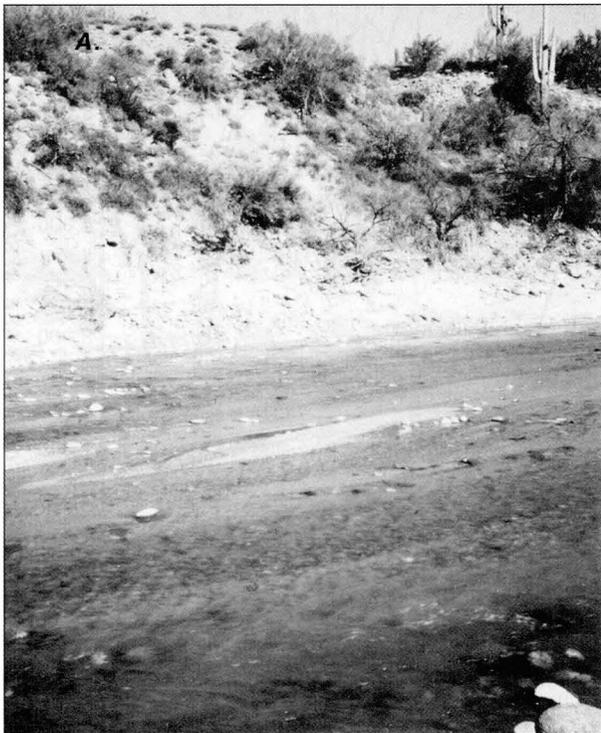
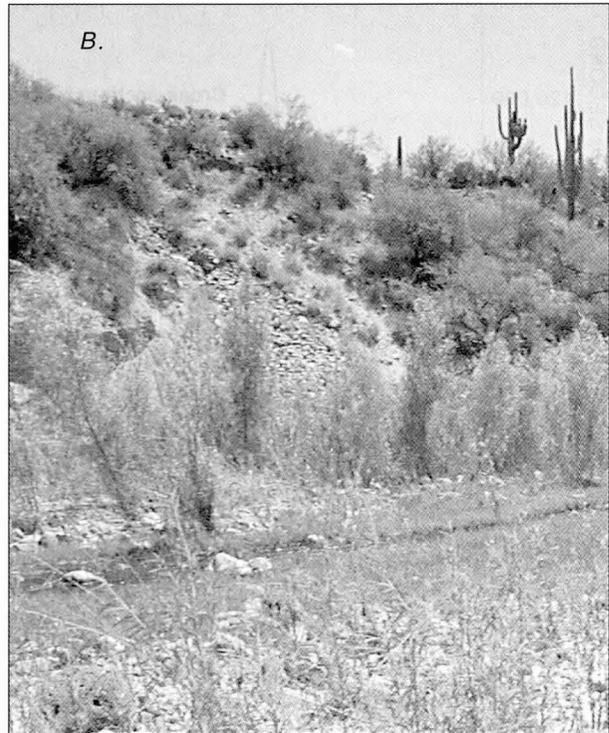
Figure 8. View of right bank near cross-section 3, Agua Fria River near Rock Springs, Arizona. A, January, 1979 after the flood of December 18, 1978. B, June 18, 1998. Flow is from right to left in photographs.

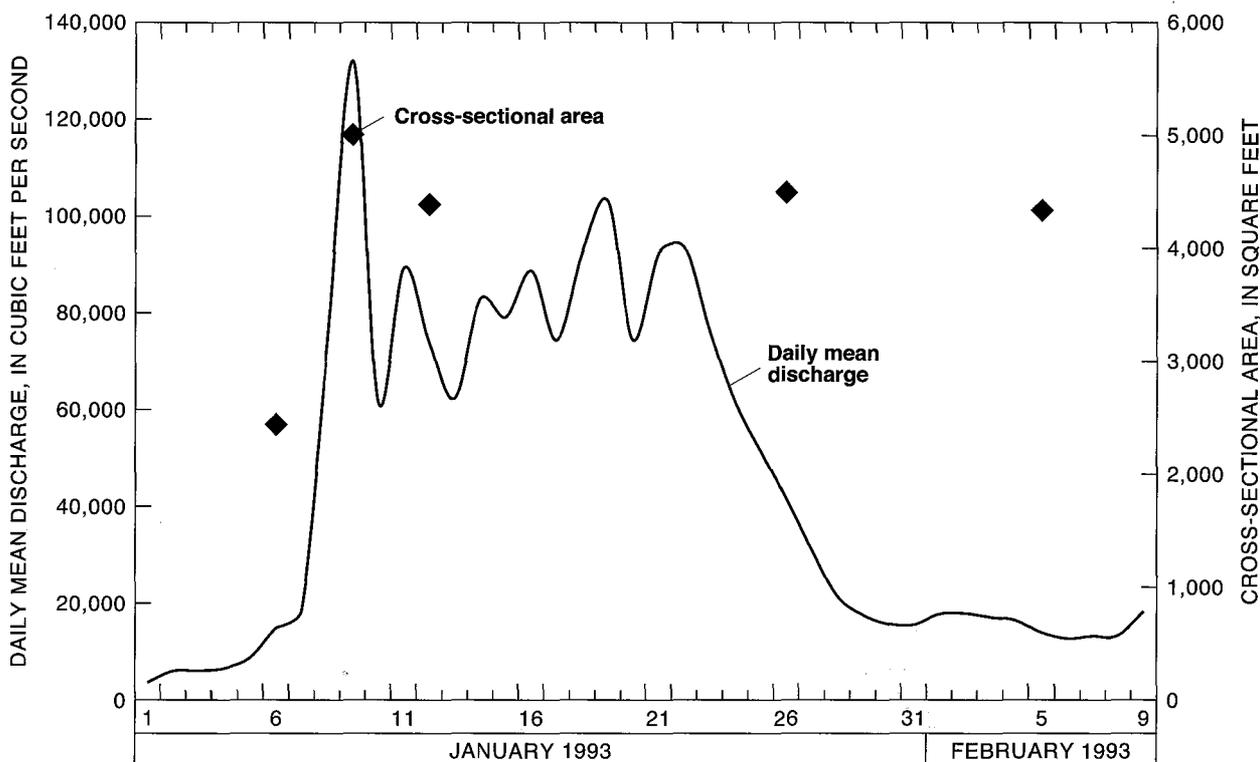
Figure 9. Daily mean discharge and cross-sectional area, Gila River at Estrella Parkway, near Goodyear, Arizona, 1993.

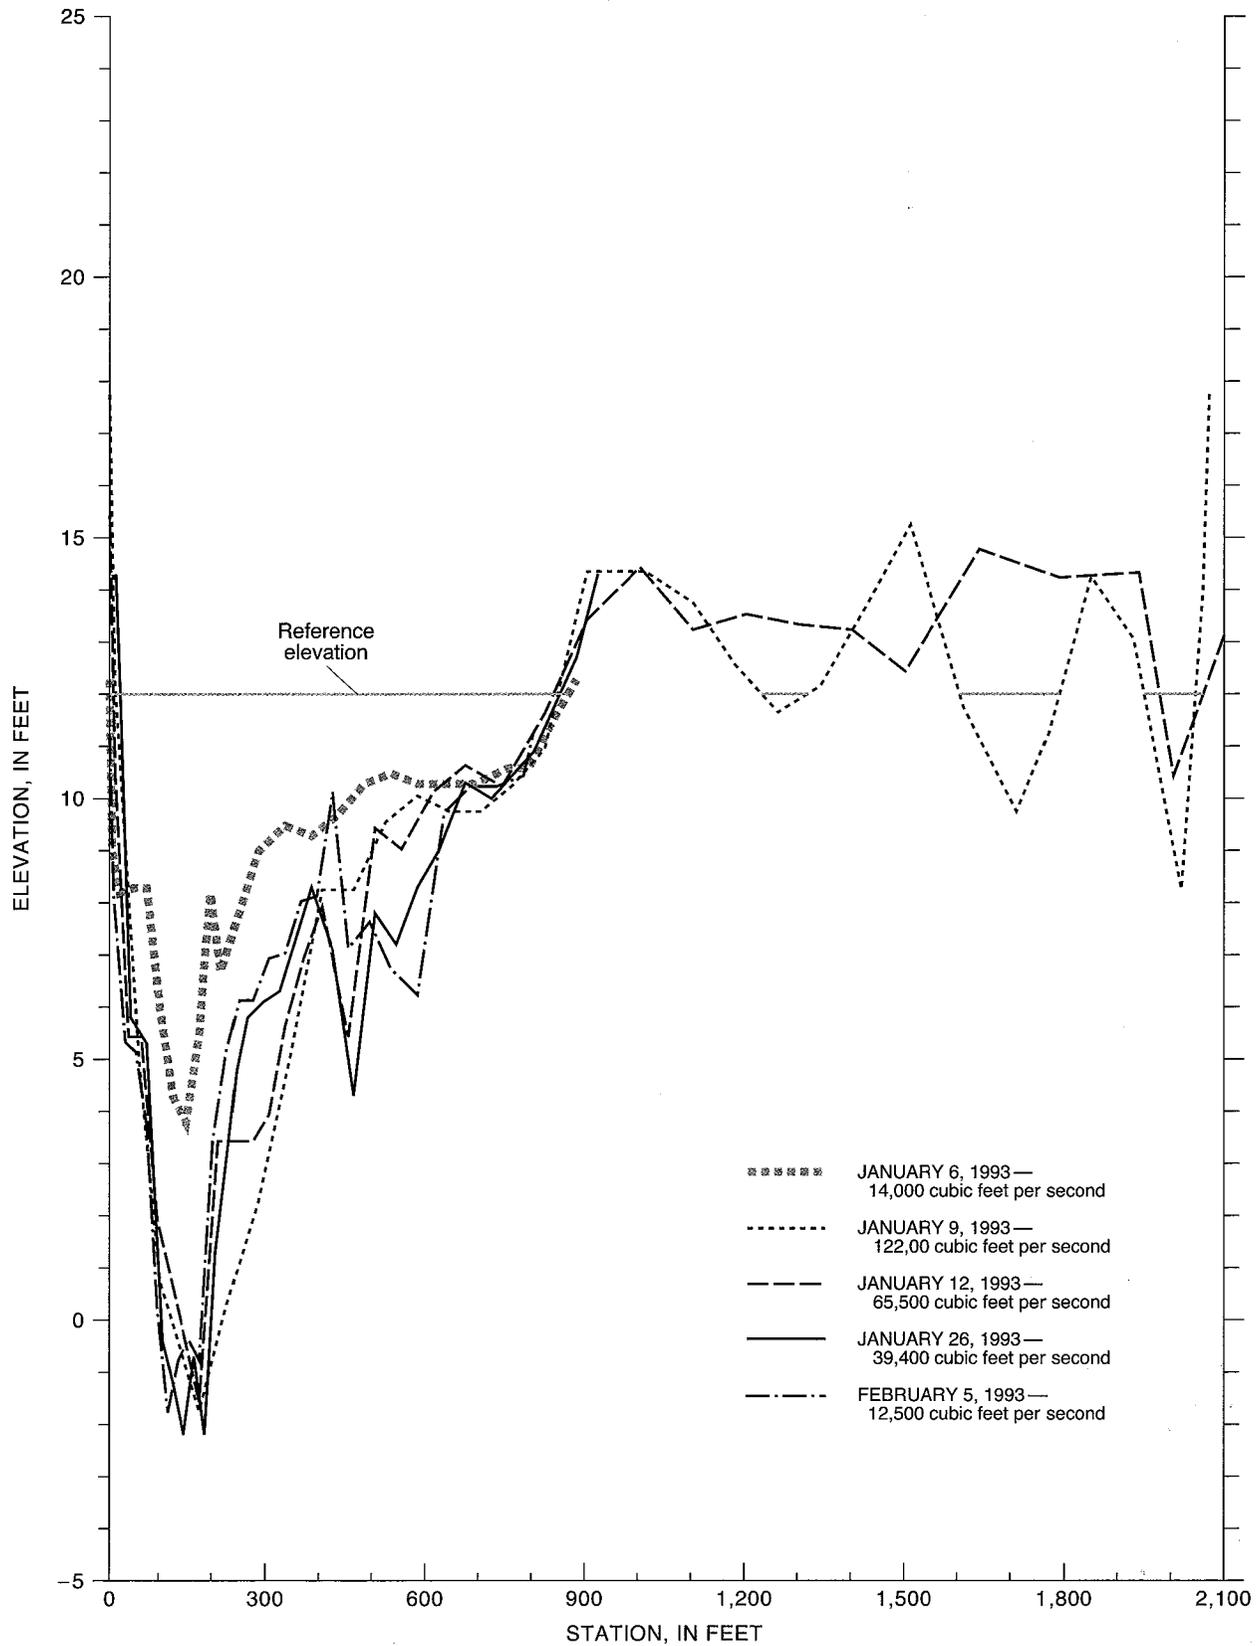
Figure 10. Cross section from discharge measurements and cross-section survey, Gila River at Estrella Parkway, near Goodyear, Arizona, 1993.

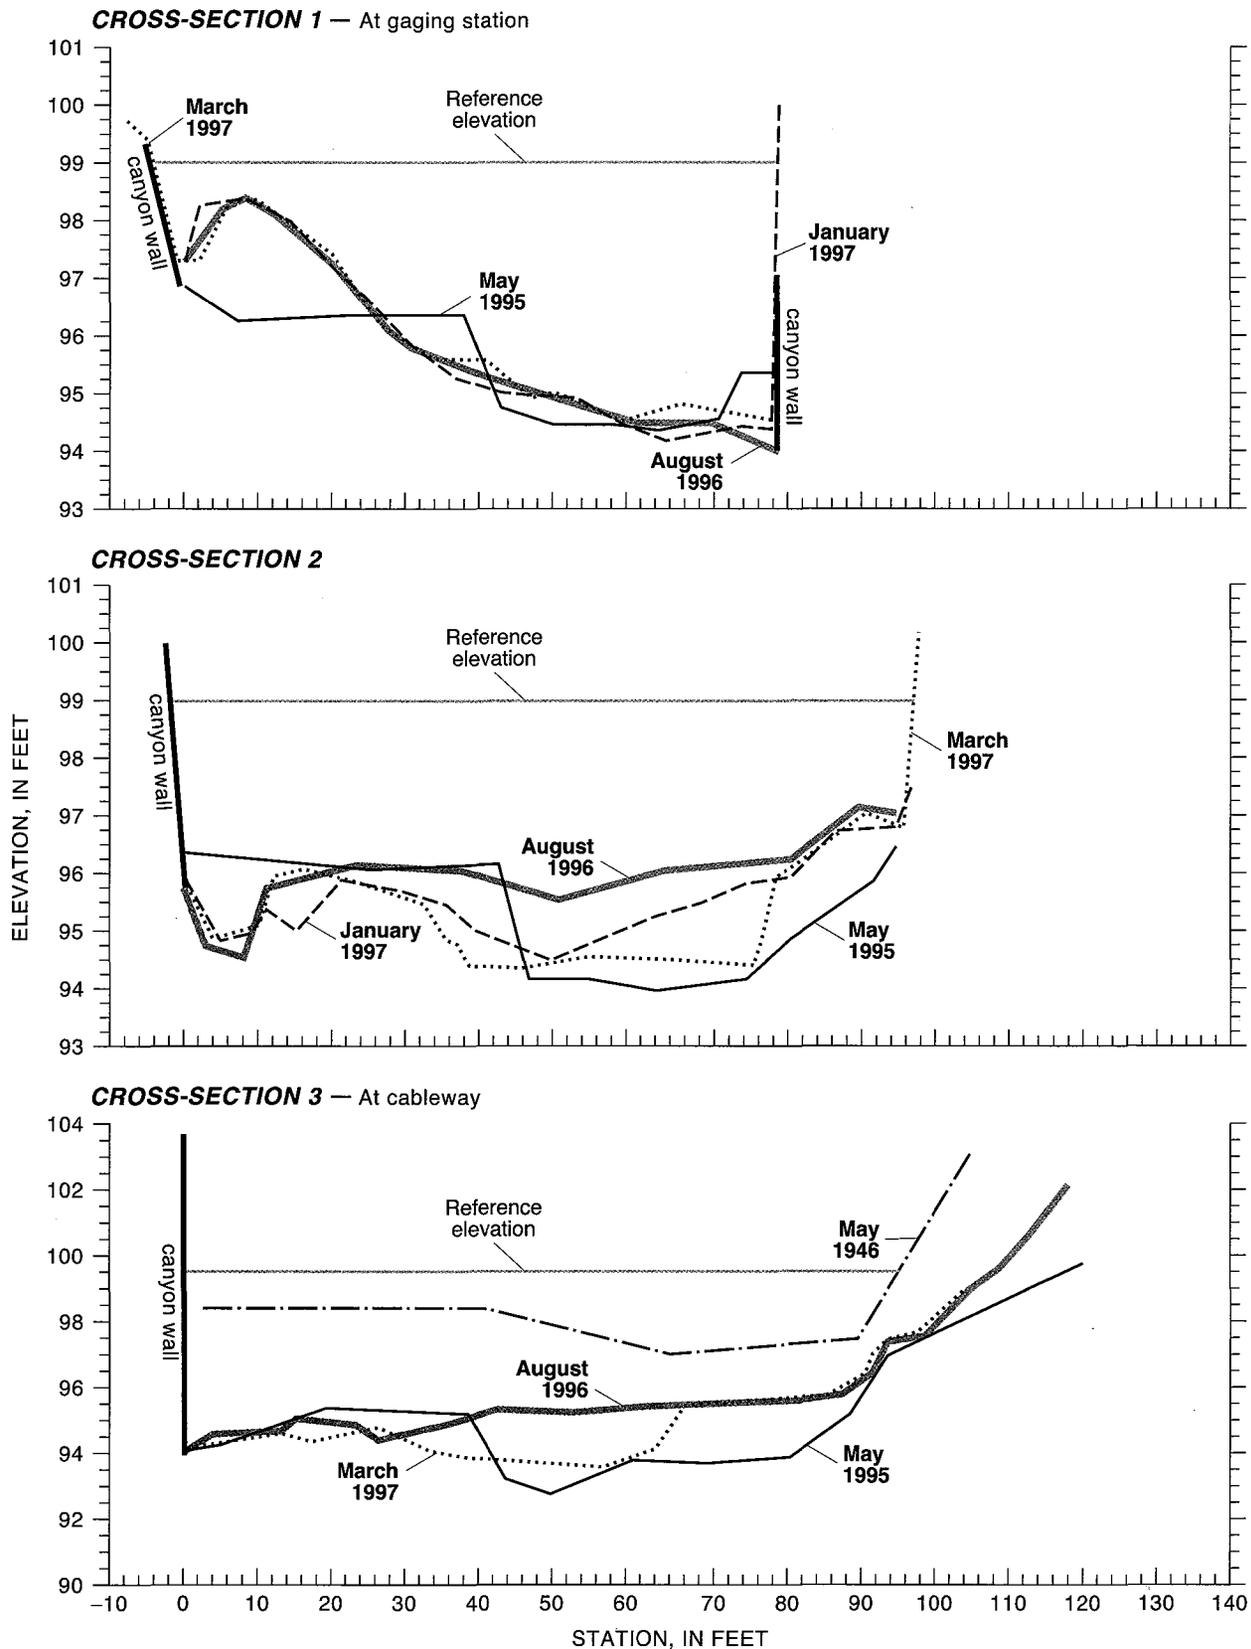
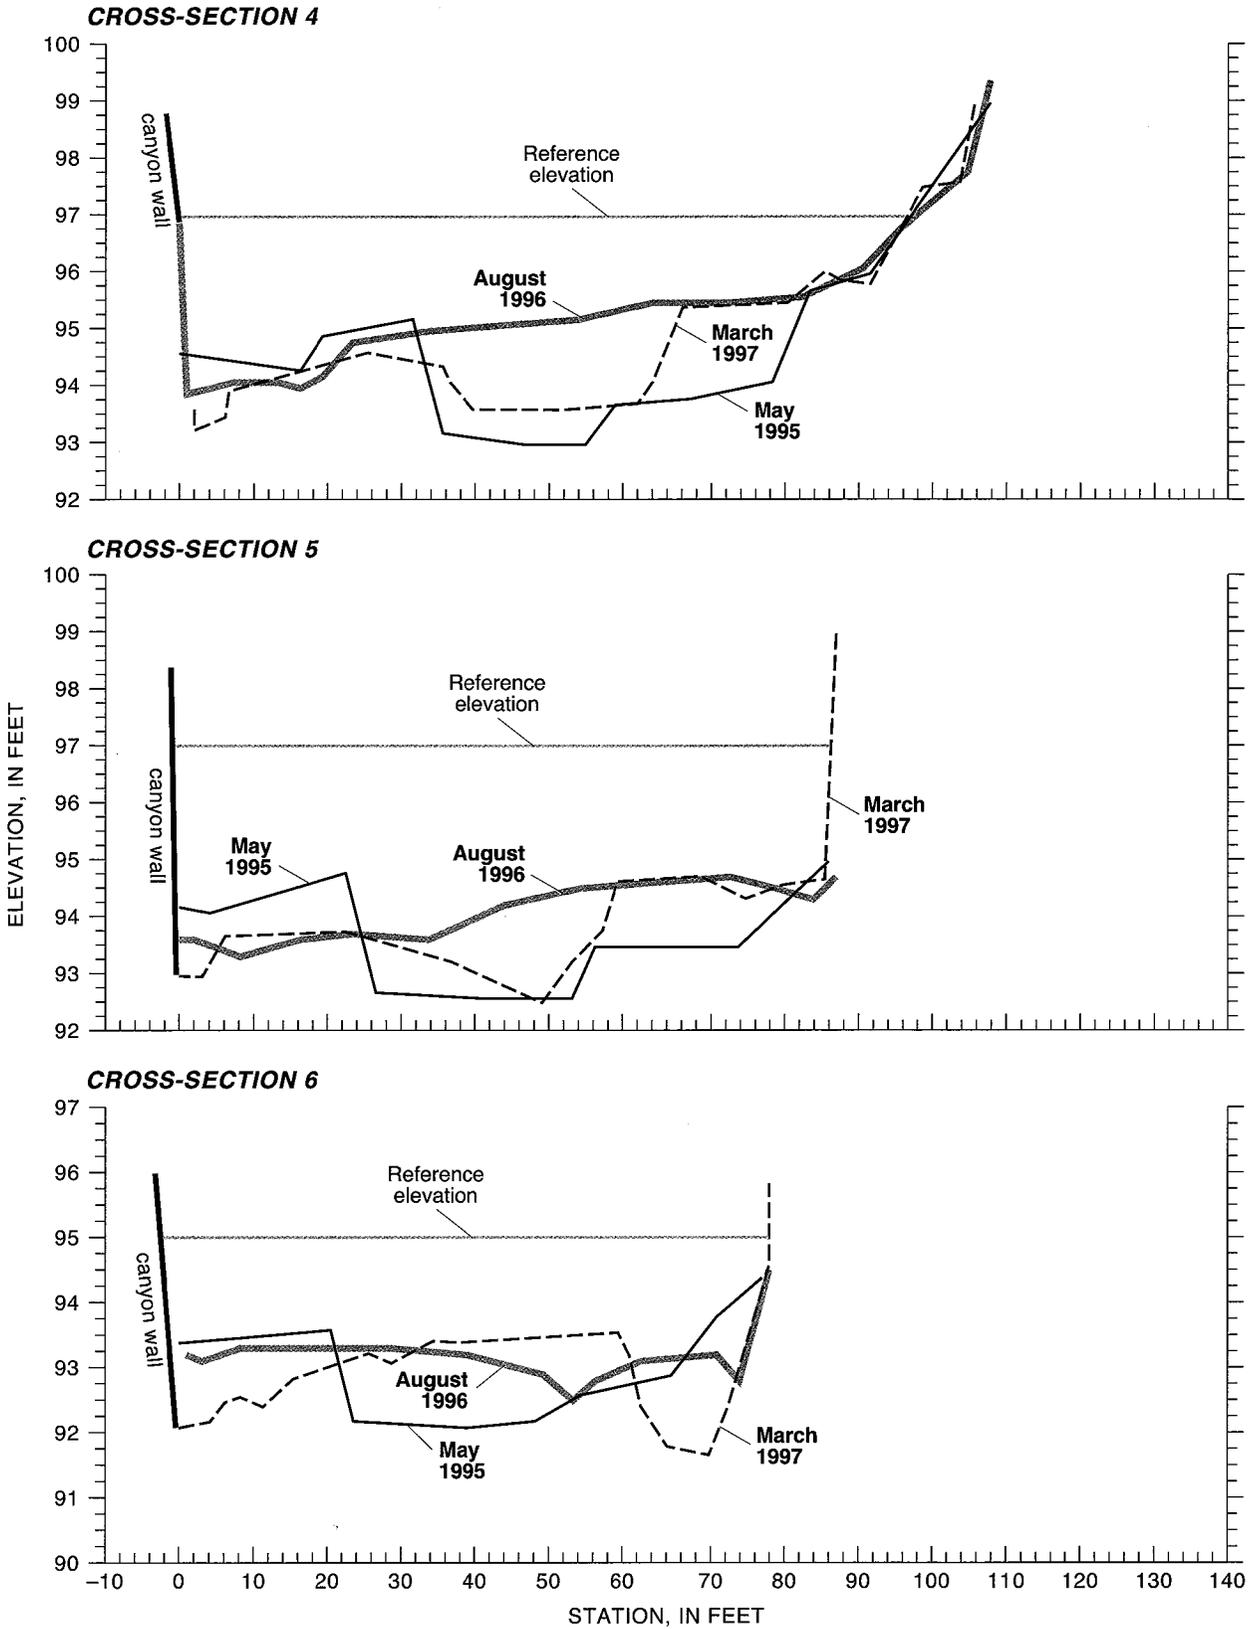
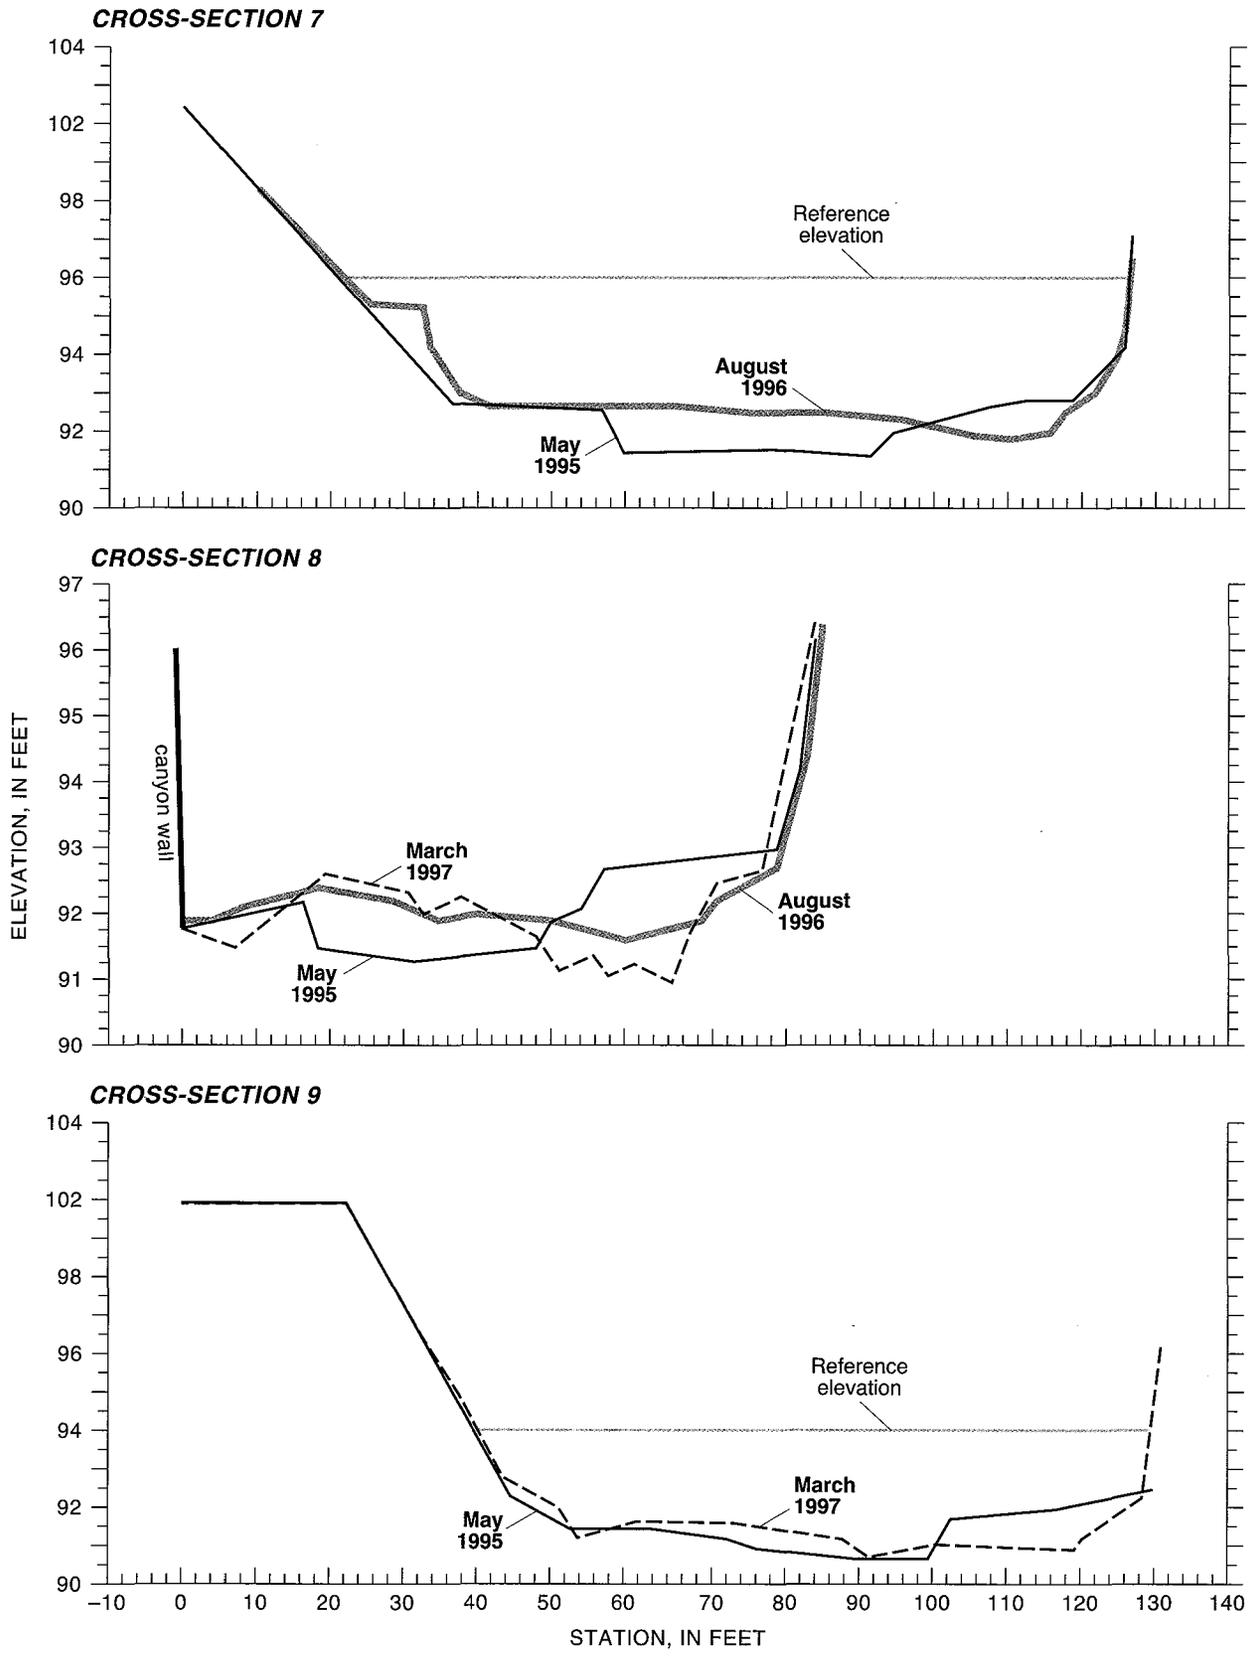
Figure 11. Cross sections from surveys, Hassayampa River at Box Canyon, near Wickenburg, Arizona, 1946–97.

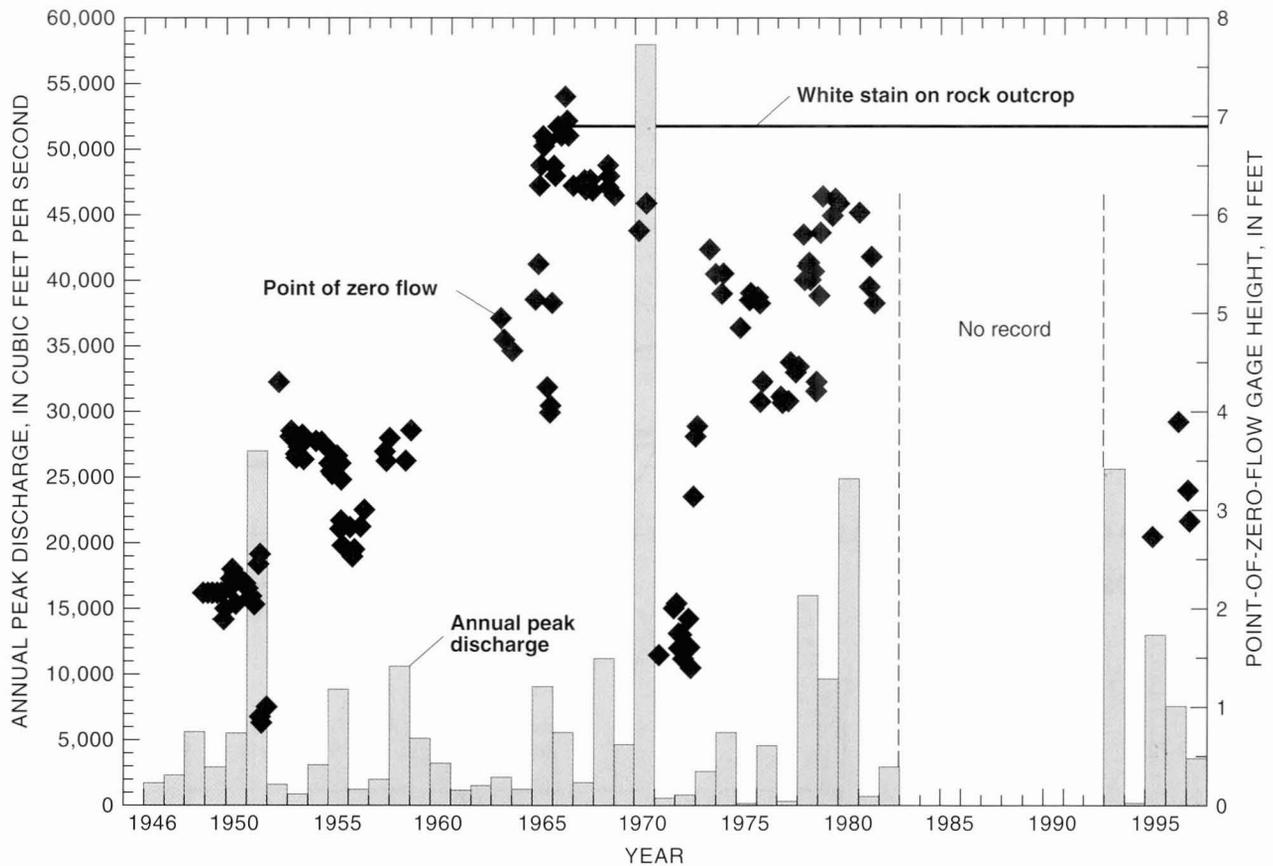
Figure 12. Point-of-zero-flow gage height and annual peak discharge, Hassayampa River at Box Canyon, near Wickenburg, Arizona, 1946–97. Data for 1993–97 from Flood Control District of Maricopa County.

In addition to the large, single-event changes in the PZF, there seem to be longer-term patterns of change at this site. For example, the PZF generally decreased from the highest PZF measured in 1966 until the peak flood of record in 1970 (fig. 12). Following several years of low PZF measurements immediately following the large flood, the channel filled, and by 1974 the PZF increased to within 0.5 ft of the PZF before the flood of 1970. After 1975, the PZF again decreased at about the same rate as before the flood of 1970.

Longitudinal profile.—Four longitudinal profiles were made of the reach near the gaging station (fig. 13). The three profiles measured between May 1995 and March 1997 generally show parallel slopes and vertical shift of about 0.5 ft. An examination of historic photographs and field observations revealed a distinct white line along the canyon walls in Box Canyon, especially upstream from the gaging station. The fourth plotted profile, therefore, is that of a white stain line that generally parallels the surveyed channel profiles (as plotted in relation to the reference elevation on fig. 13). This white line appears in the same position on the canyon walls in 1998 as it did in photographs of the gaging station taken in 1970. The white line is found at a gage height of 6.9 ft at the gaging station (fig. 12). The PZF elevation of

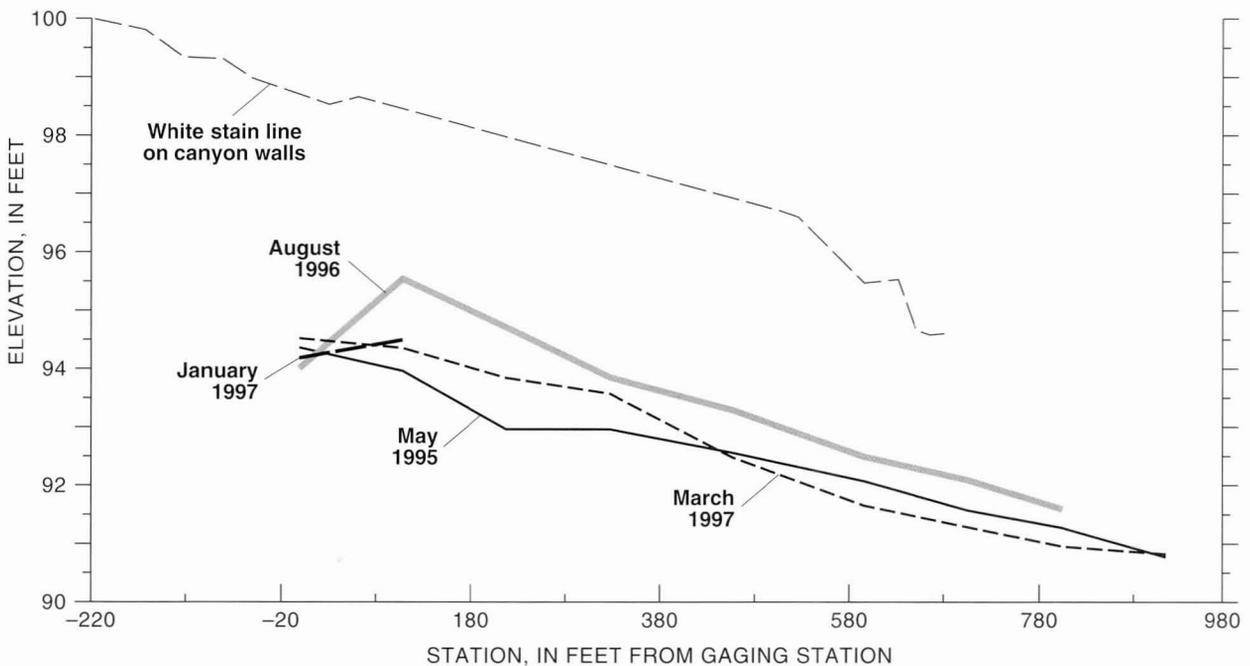
Figure 13. Longitudinal-profile changes, Hassayampa River at Box Canyon, near Wickenburg, Arizona, 1995–97.
