Determination of Channel Change for Selected Streams, Maricopa County, Arizona

Water-Resources Investigations Report 01–4209

Prepared in cooperation with the
FLOOD CONTROL DISTRICT OF
MARICOPA COUNTY

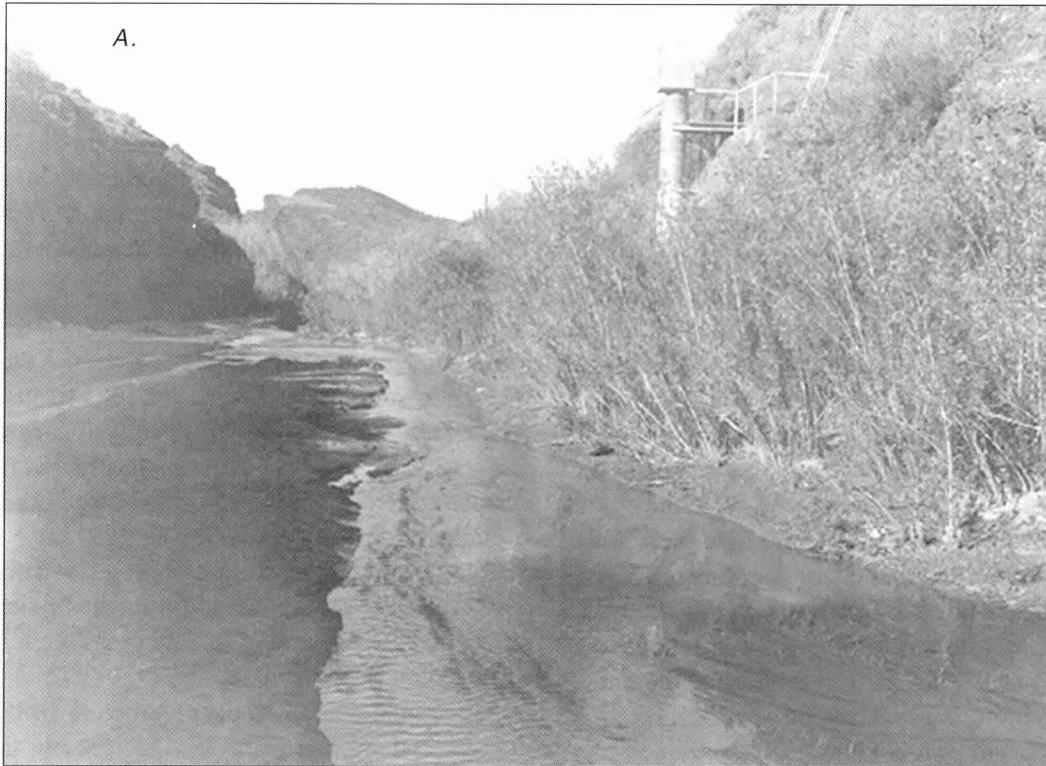
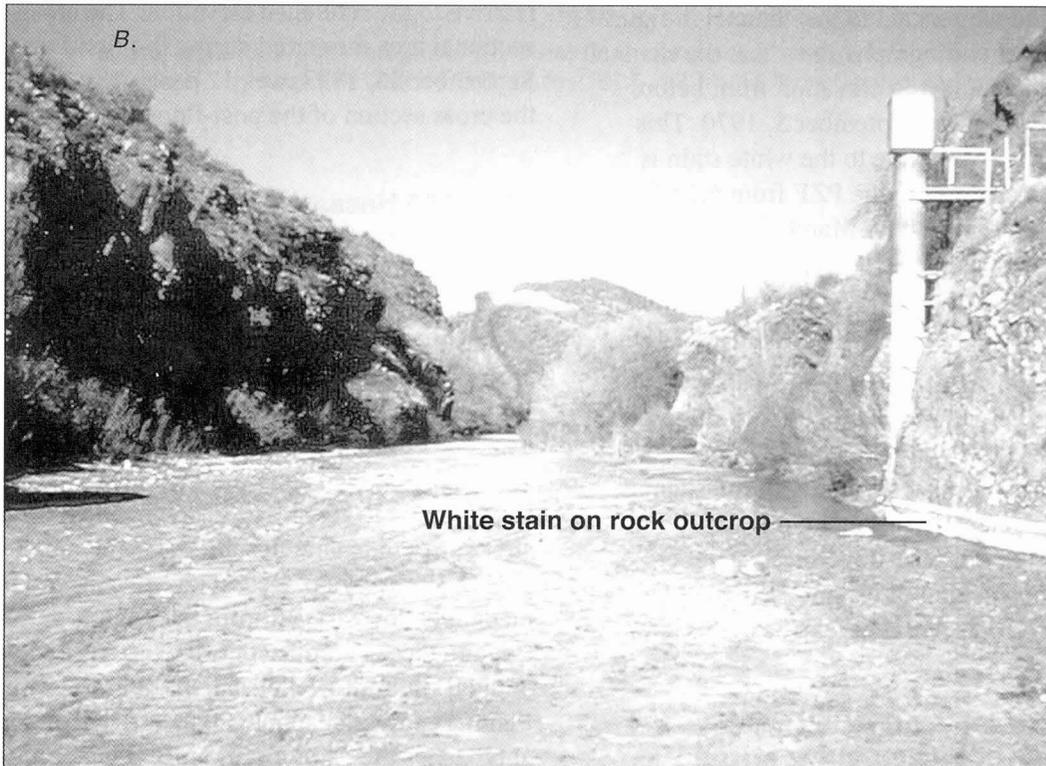
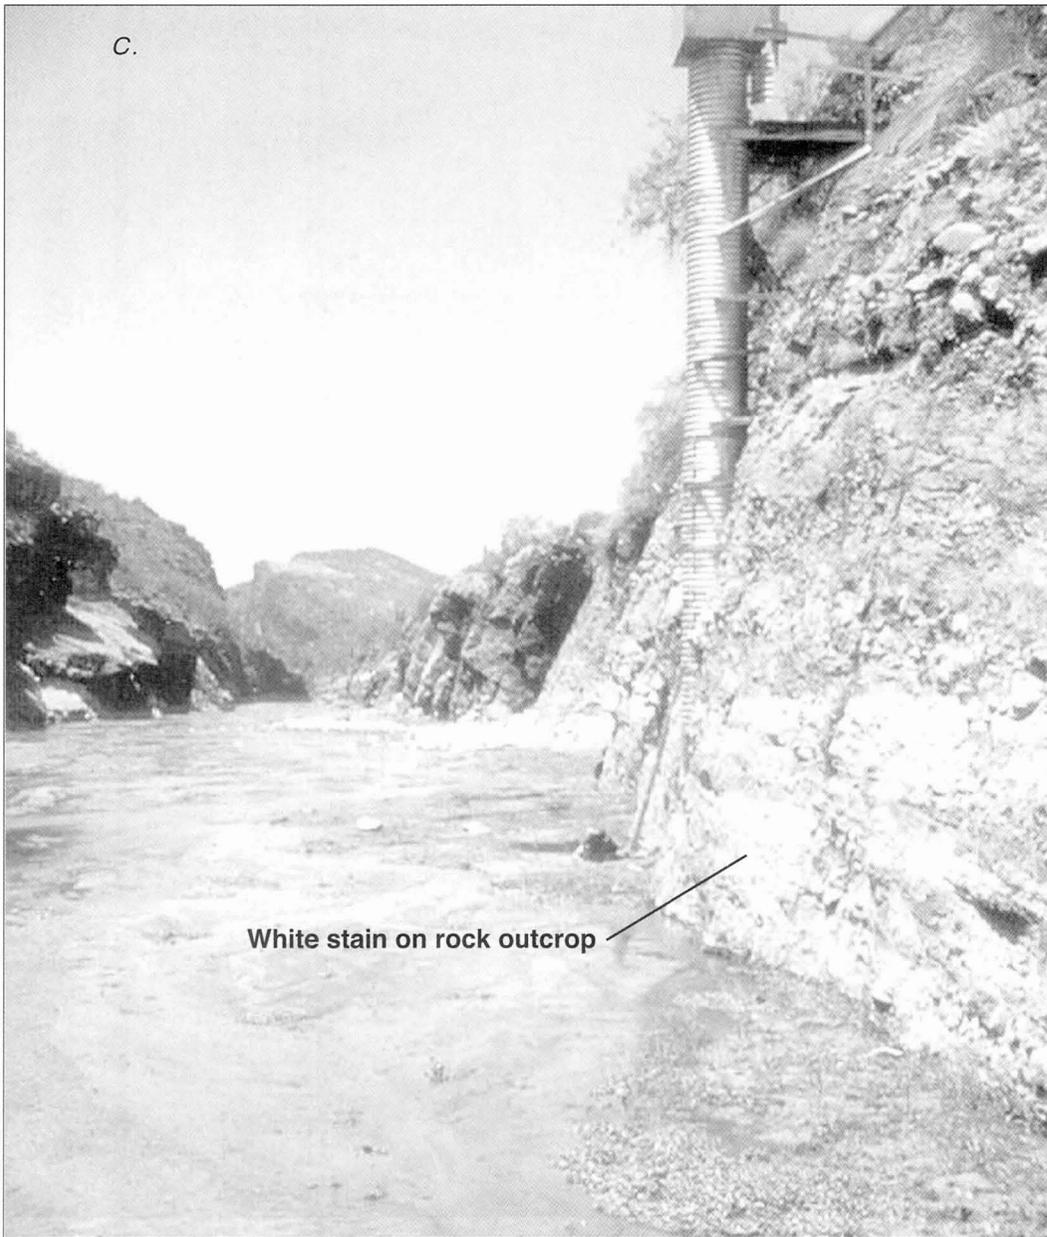
Figure 14. View downstream past stilling well, Hassayampa River at Box Canyon, near Wickenburg, Arizona. *A*, January 9, 1964. *B*, 1970, exact date unknown. *C*, After flood of September 5, 1970.

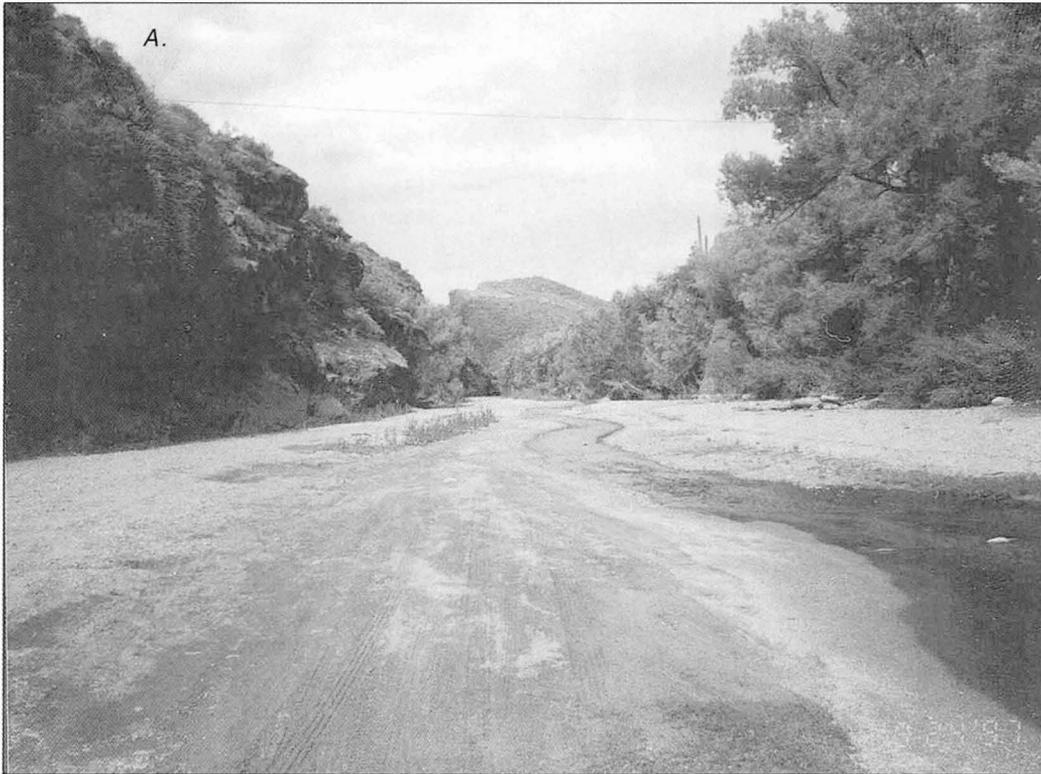
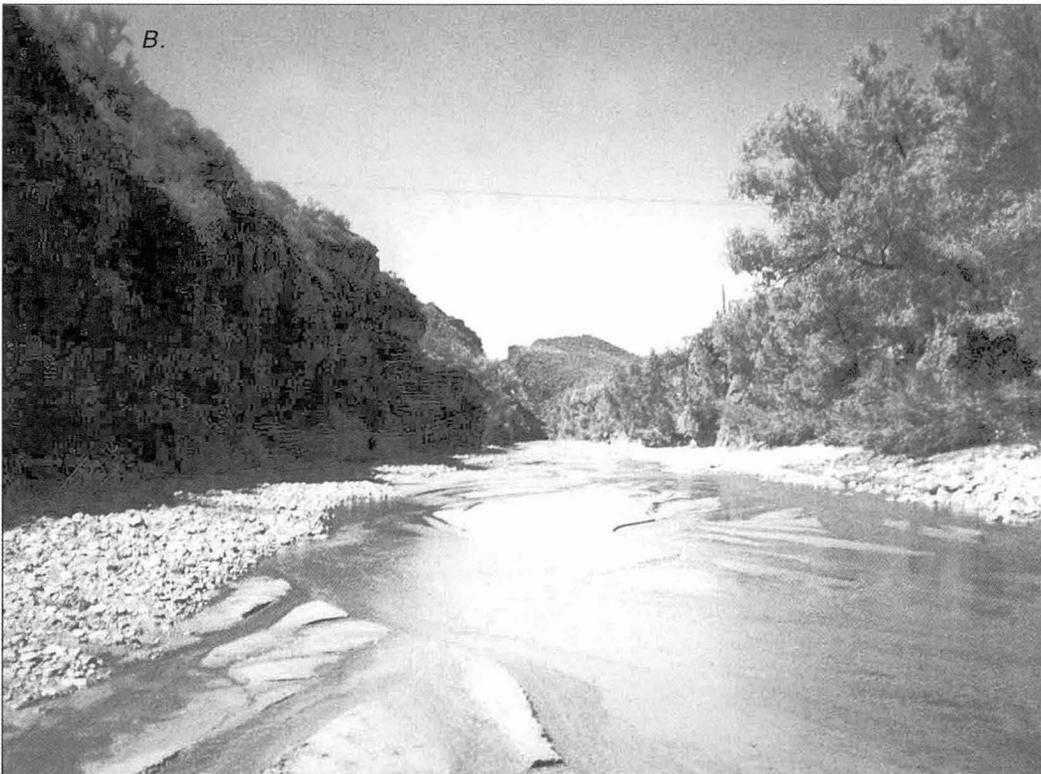
Figure 15. View downstream from gaging station, Hassayampa River at Box Canyon, near Wickenburg, Arizona. A, September 24, 1997. B, September 30, 1997.

The second set of repeat photographs were taken 2 days before and 4 days after the flood on September 26, 1997 (figs. 15A–15B). The photographs show the coarsening of the channel sediment immediately following prolonged flows, which occurred after the flood on September 26, 1997. This coarsening of channel sediment has been observed on several occasions at this site.

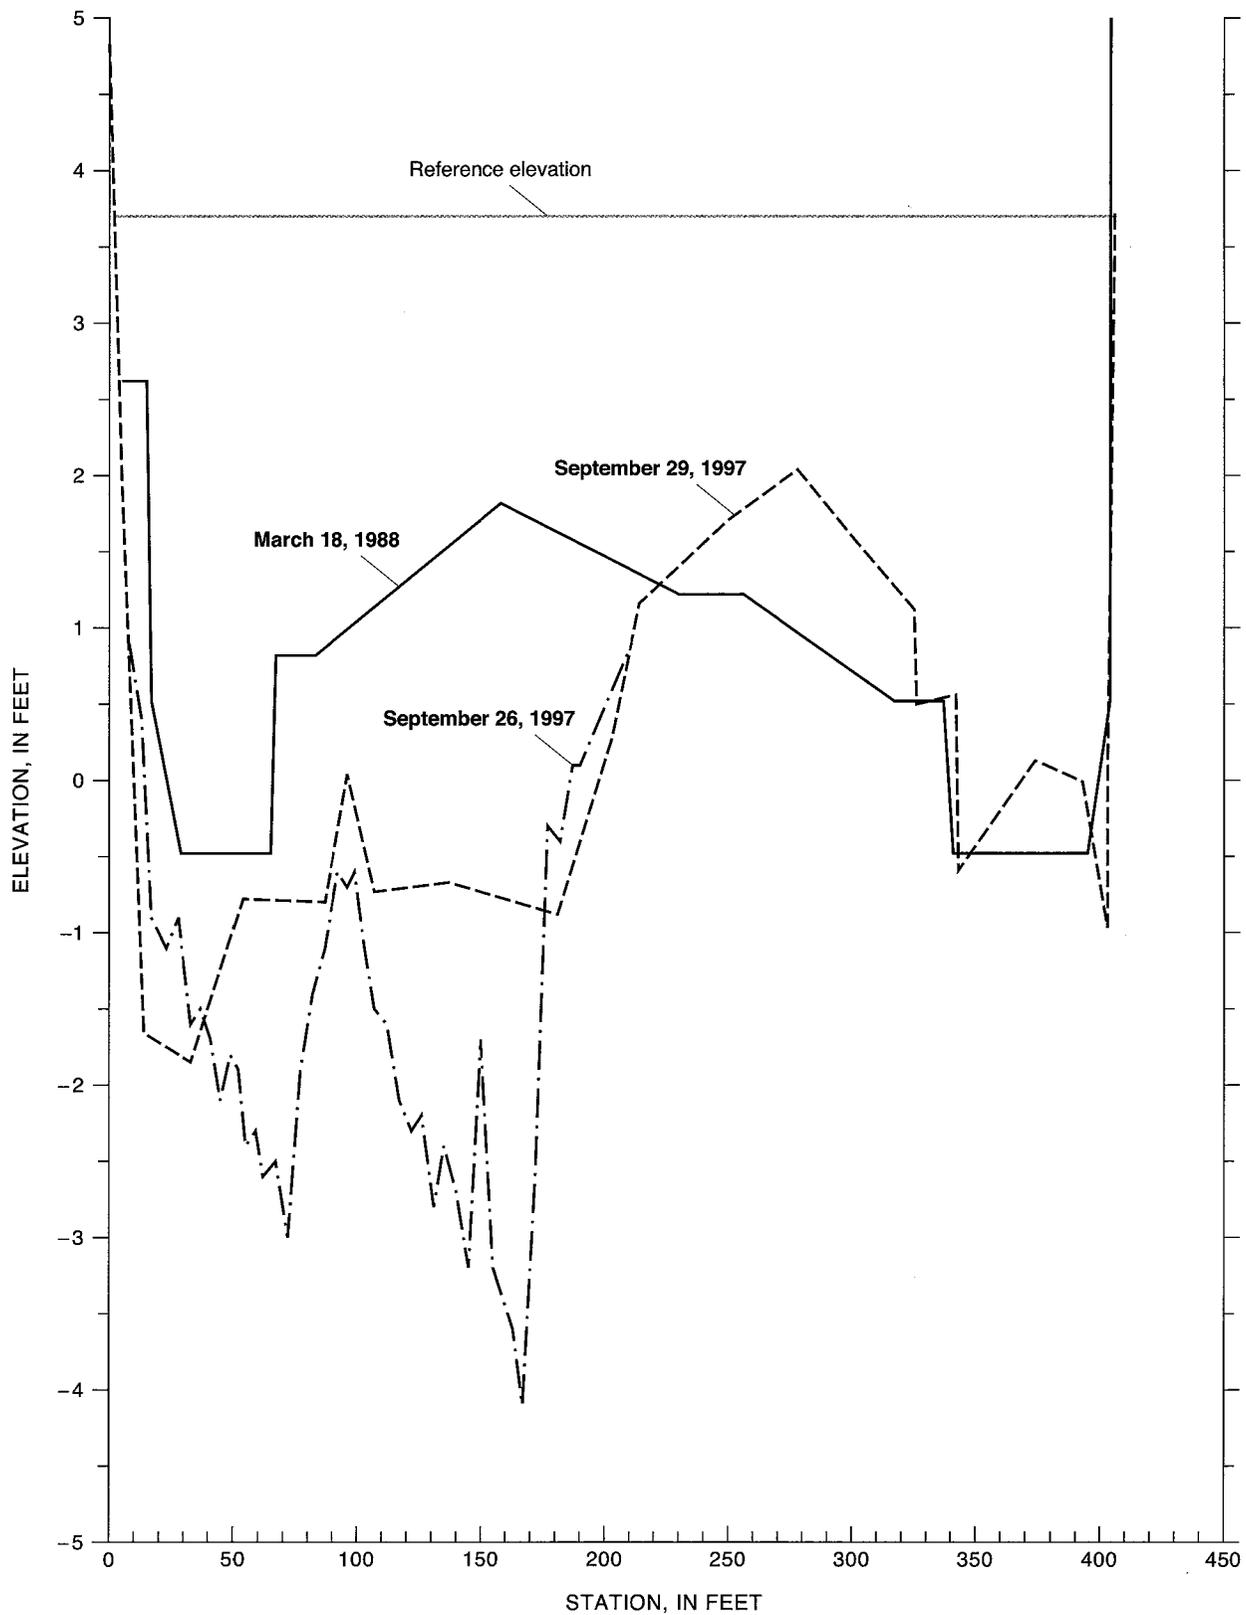
Figure 16. Cross section from current-meter measurement of discharge and from cross-section surveys on downstream side of the bridge, Hassayampa River at U.S. Highway 60, at Wickenburg, Arizona, 1988–97. Data for cross section of March 18, 1988, from Cella Barr Associates, (written commun., 1989).

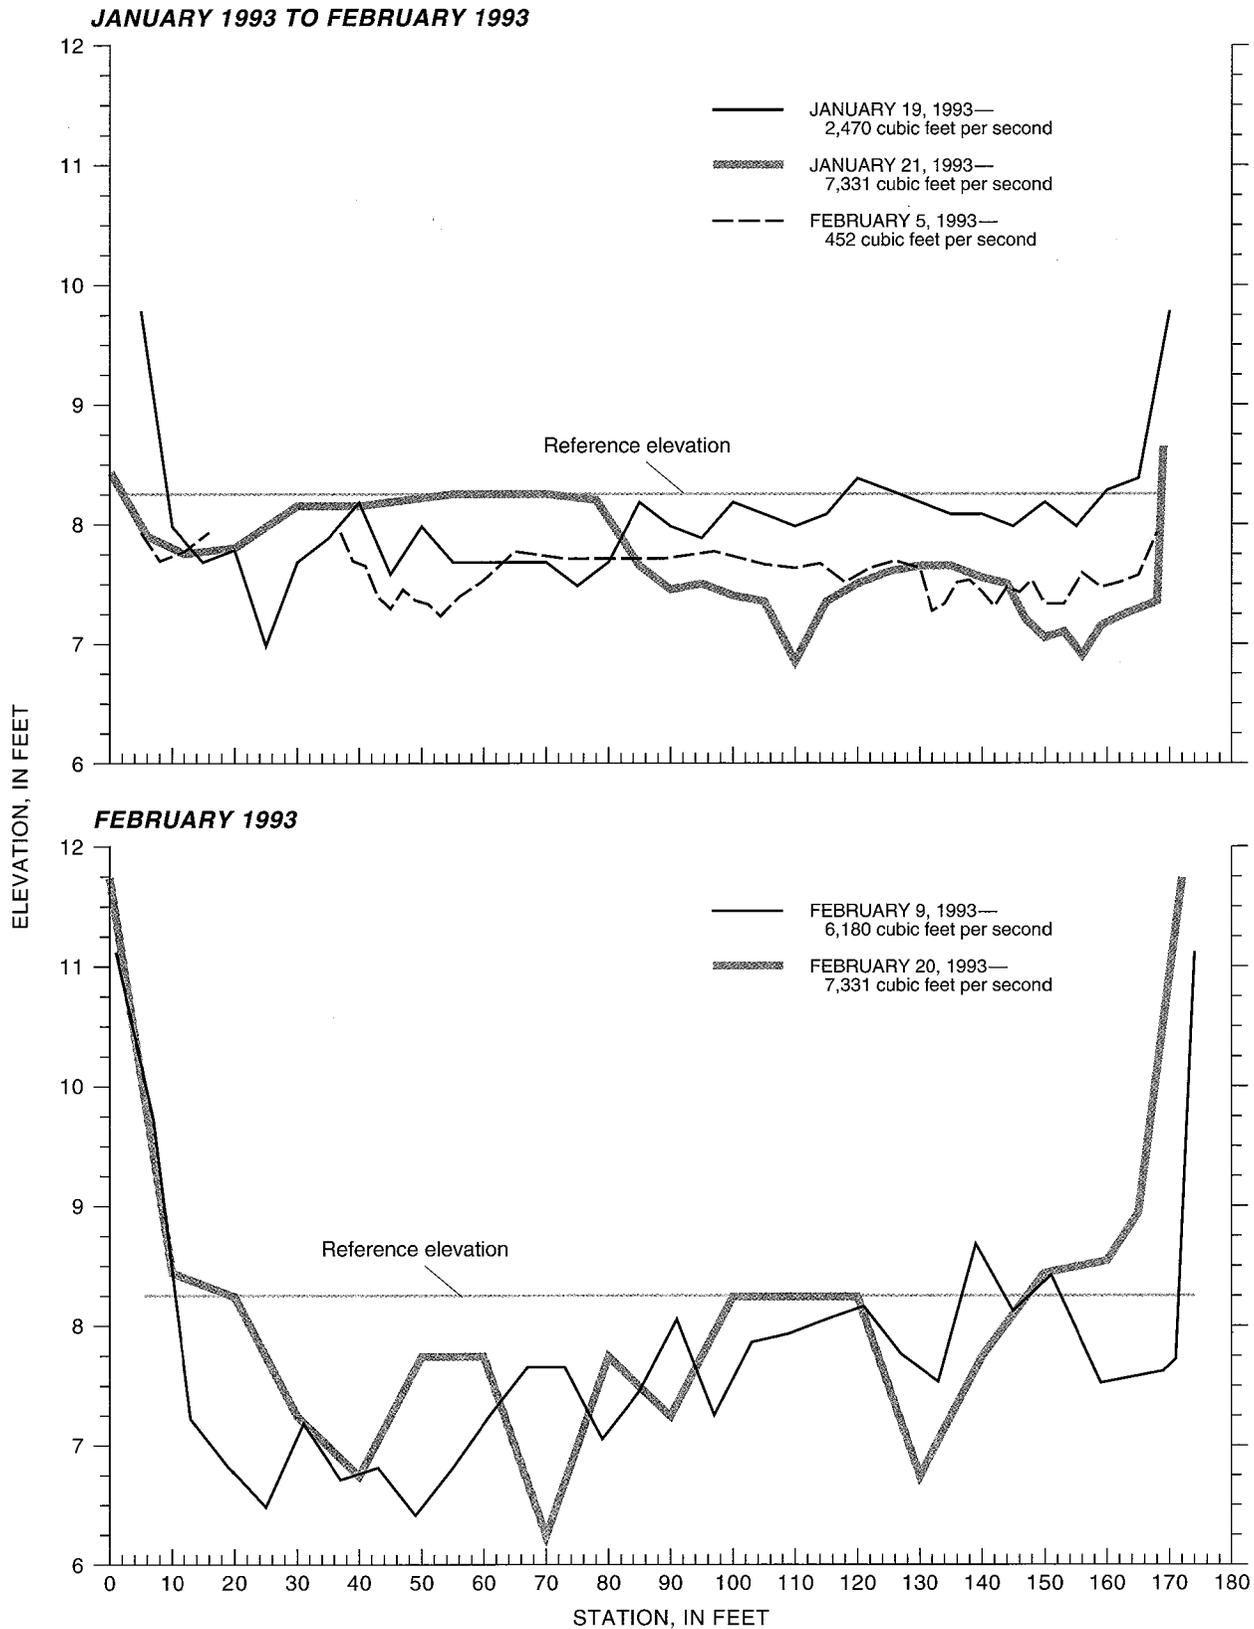
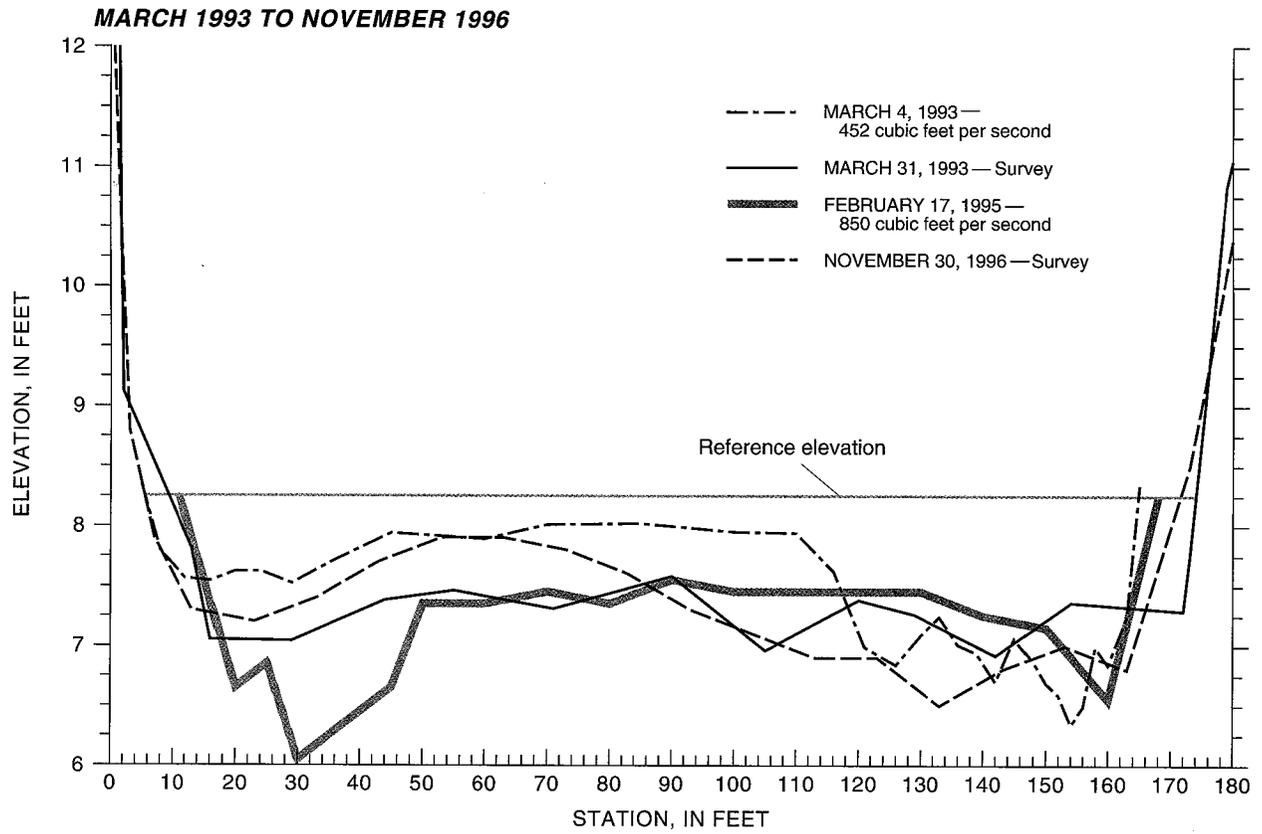
Figure 17. Cross section at cableway from discharge measurements and cross-section surveys, Hassayampa River near Morristown, Arizona, 1993-96.

after the flood of 1993—seven measurements were made from cableway-discharge measurements and two measurements were made from cross-section surveys at the cableway, which is at the gaging station (fig. 17).

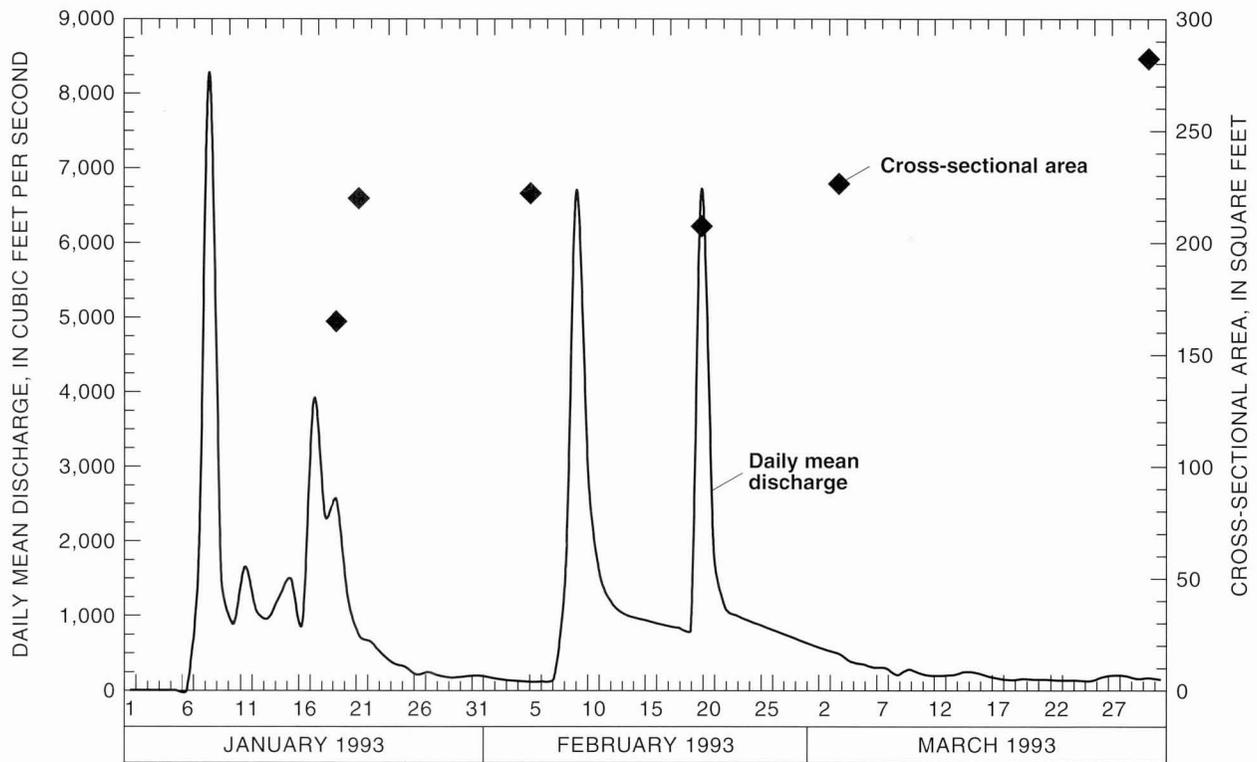
Figure 18. Daily mean discharge and cross-sectional area, Hassayampa River near Morrystown, Arizona, 1993.

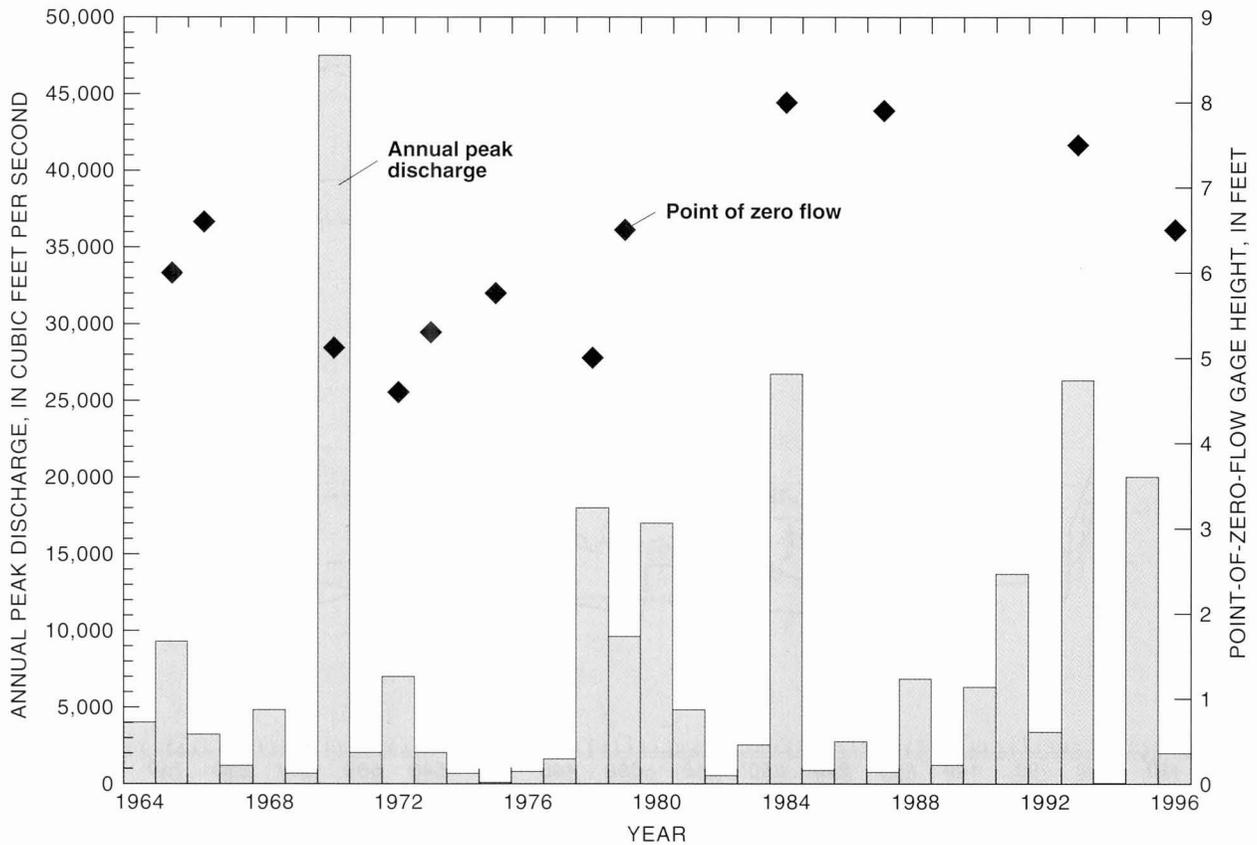
Figure 19. Point-of-zero-flow gage height and annual peak discharge, Hassayampa River near Morrystown, Arizona, 1964-96.

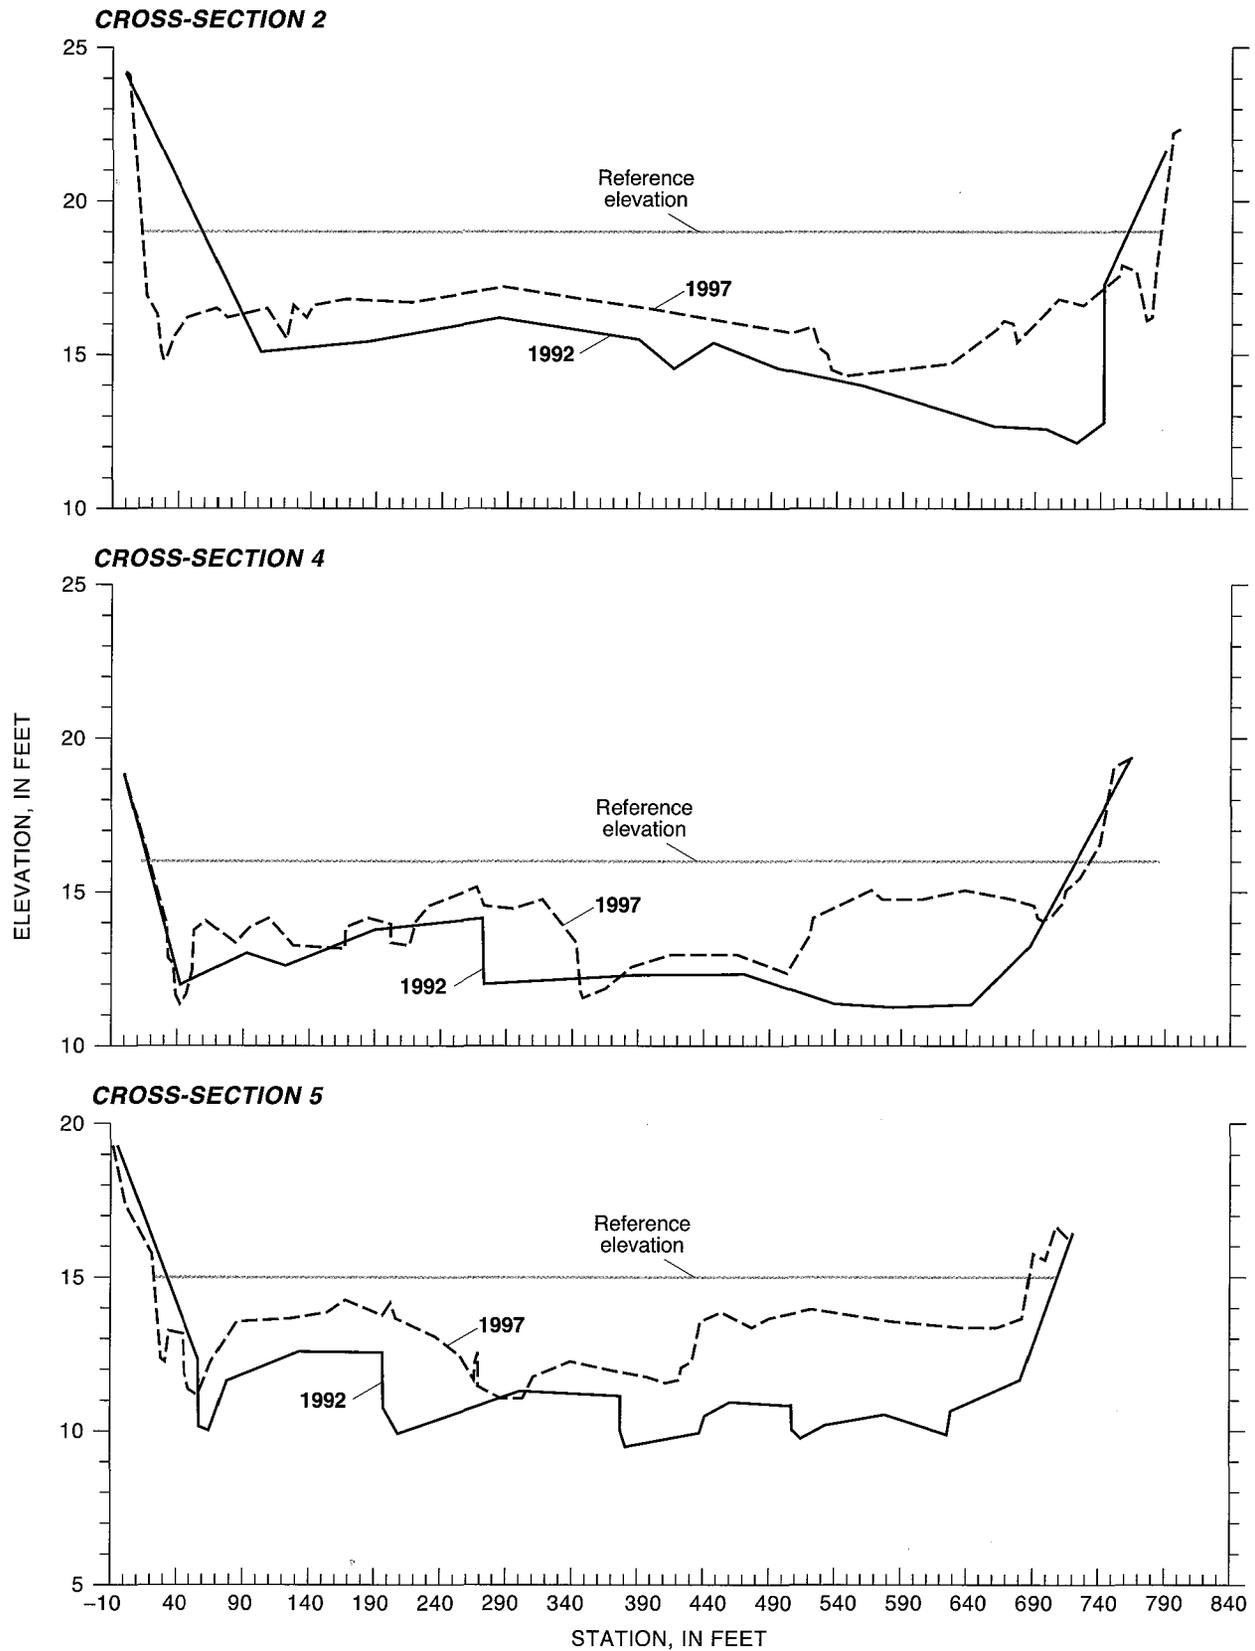
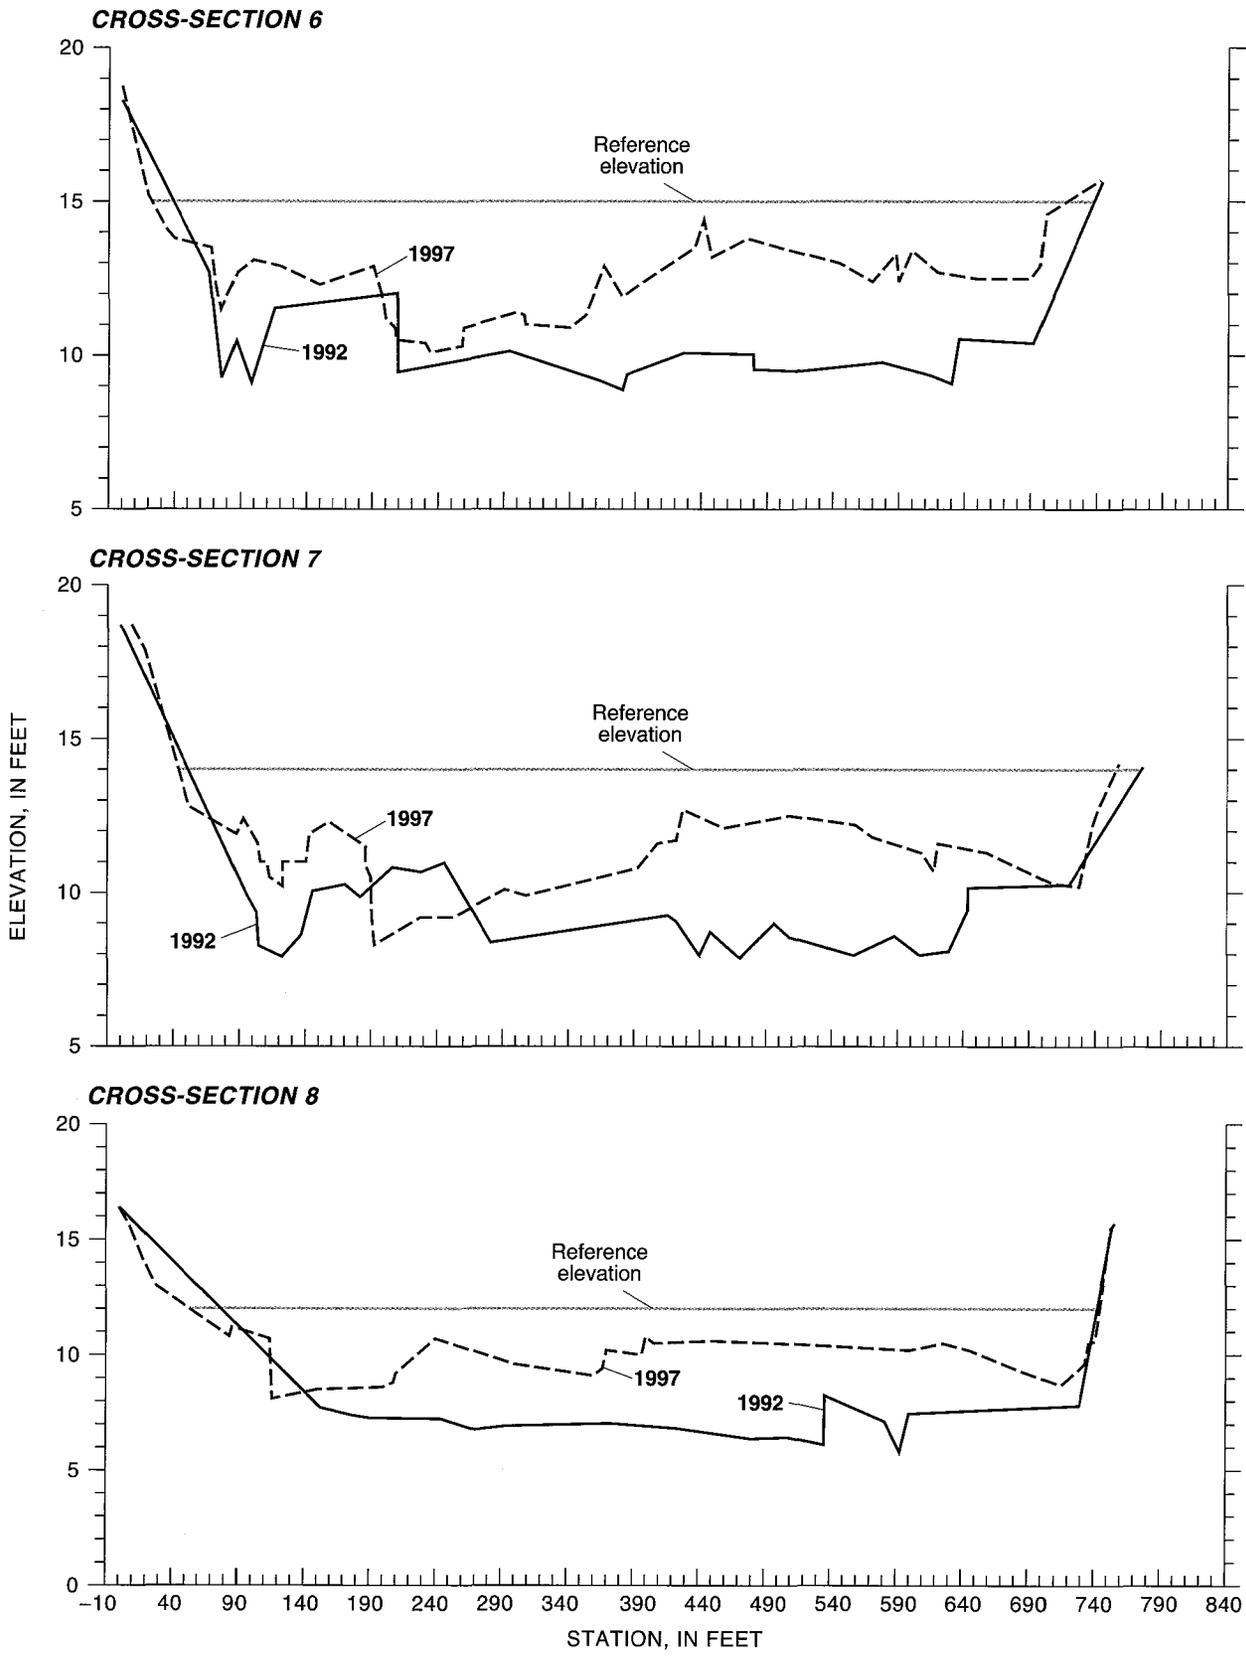
Figure 20. Cross sections from surveys, Hassayampa River near Arlington, Arizona, 1992 and 1997. Cross sections for 1992 and cross-section numbers are from Parker (1995).

Surveyed cross sections.—Although Parker (1995) originally surveyed 11 cross sections, only 6 of these cross sections were found and resurveyed. The resurveyed cross sections are cross-sections 2 and 4–8 as numbered in Parker (1995; fig. 20, this report). Since 1992, the cross sections generally filled with sediment (fig. 20). Cross sections surveyed in 1991 (Parker, 1995) have been omitted from the graphs because the changes from 1991 to 1992 were minor compared with the large changes between the surveys of 1992 and 1997. Relative to the reference elevation, the cross sections lost between 737 and 1,586 ft² of cross-sectional area to deposition of sediment. The greatest depths of fill occurred in the deepest sections of the cross sections of 1992. The channel probably filled during the floods in 1993 or 1995 (fig. 21).

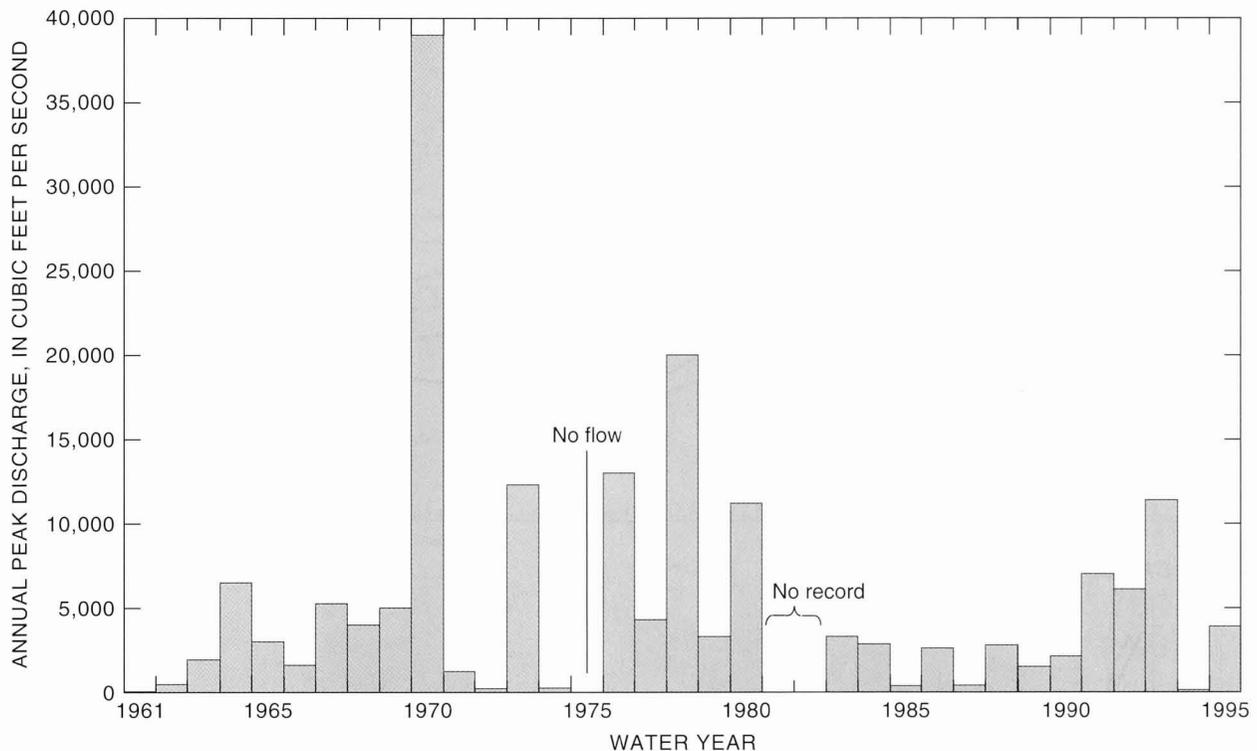
Figure 21. Annual peak discharge, Hassayampa River near Arlington, Arizona, 1961–95.

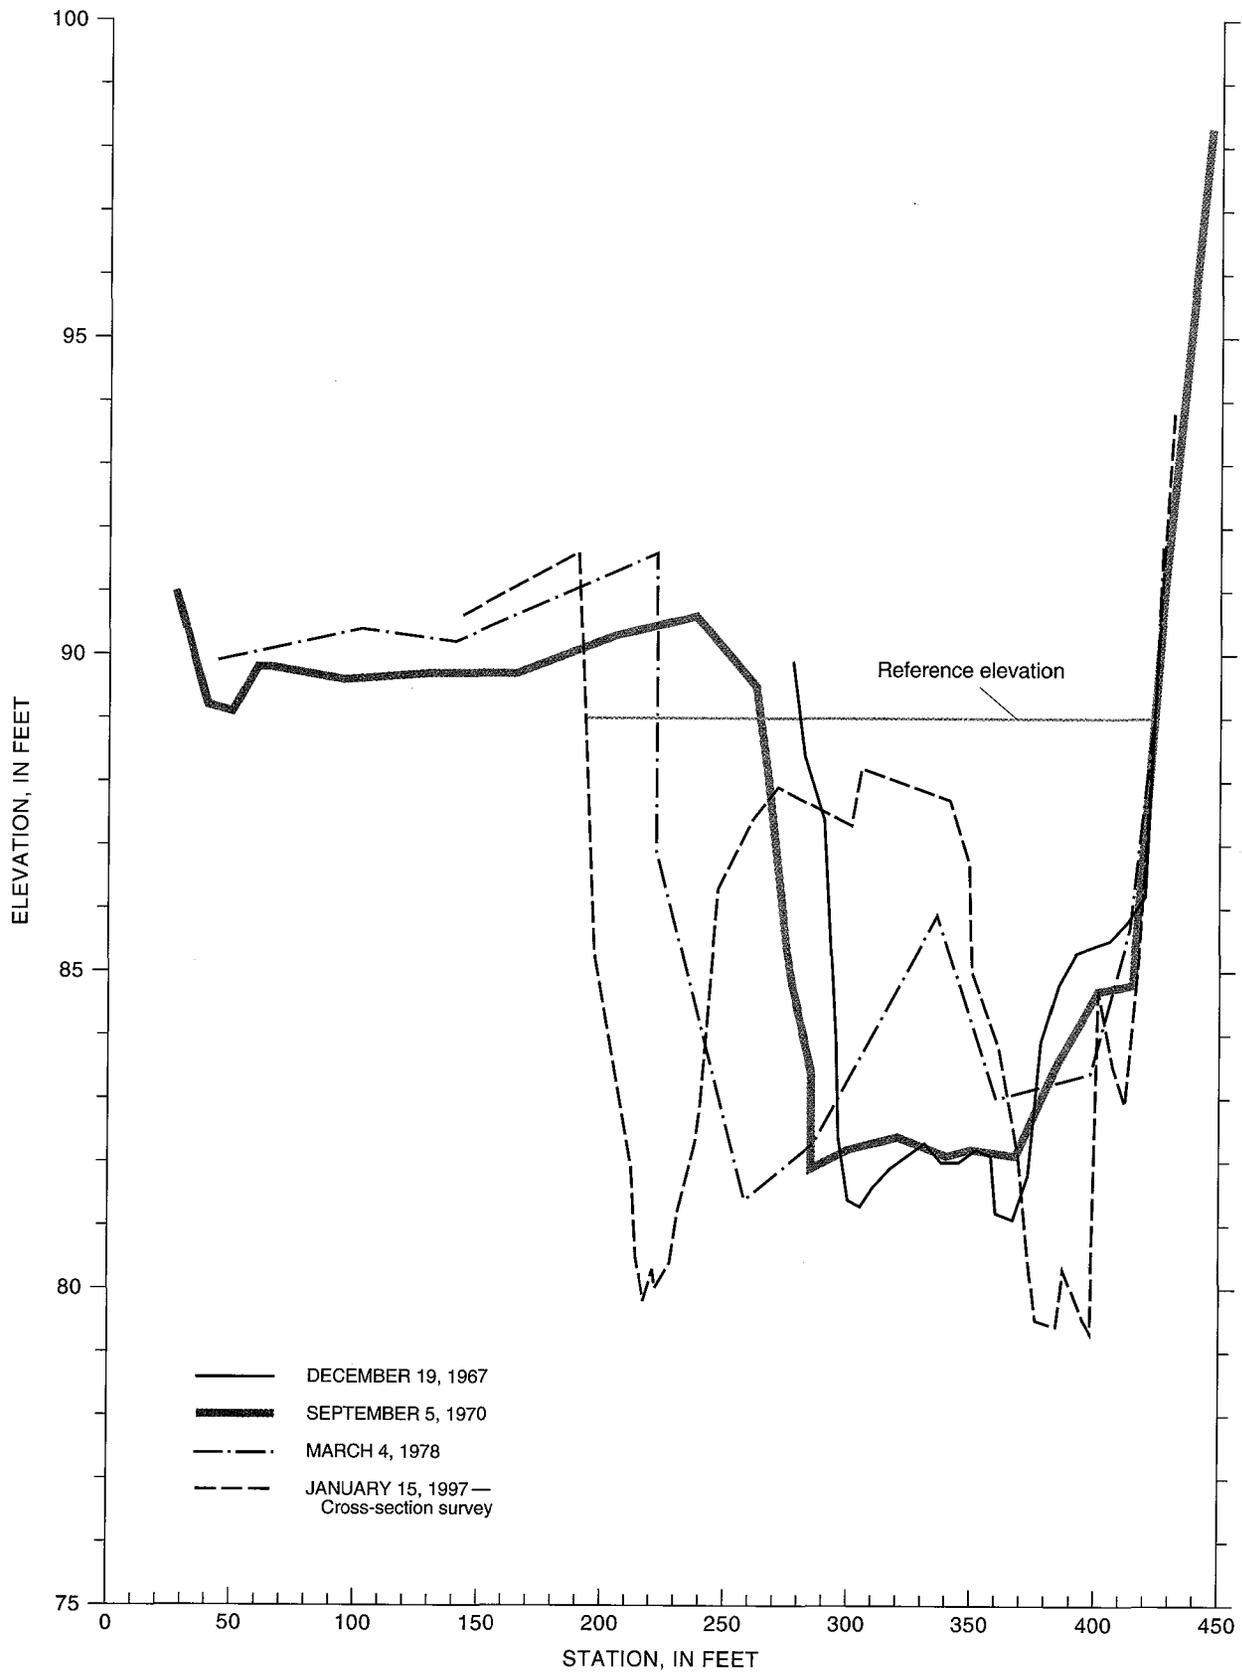
Figure 22. Cross section from surveys during indirect measurements of discharge and from cross-section survey, New River at New River, Arizona, 1967-97.

Surveyed cross sections.—Three cross-section measurements used for this site were from indirect measurements of discharge in 1967, 1970, and 1978 (fig. 22). The cross section also was

surveyed in 1997 as part of this study (fig. 22). From 1967 to 1997, the channel increased in width by more than 40 percent, the bed was scoured along both banks, and a large midchannel bar developed (fig. 22; table 1). Along the right bank, the alluvial channel was scoured to bedrock. In 30 years, the left bank of the channel appears to have eroded during each large flood. A midchannel bar first appeared in the cross section in 1978, and by 1997, the bar had grown 2 ft in height and 60 ft in width.

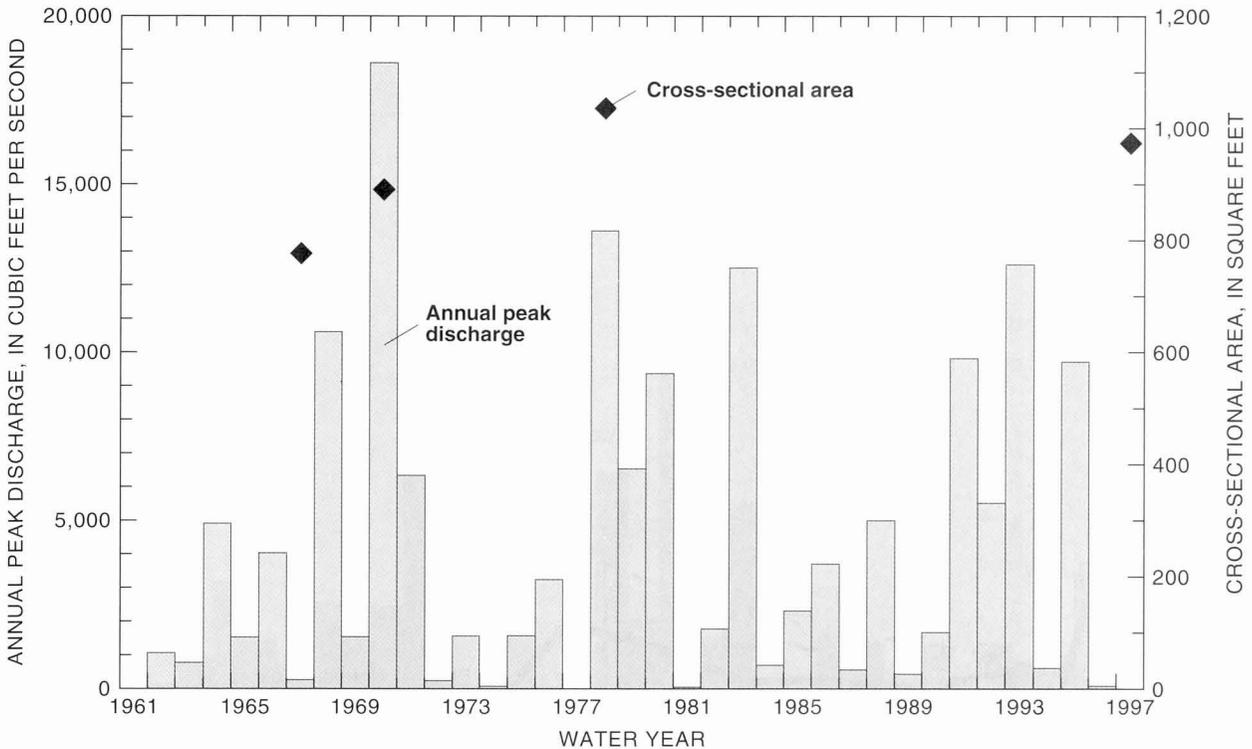
Figure 23. Annual peak discharge and cross-sectional area relative to reference elevation, New River at New River, Arizona, 1961–97.

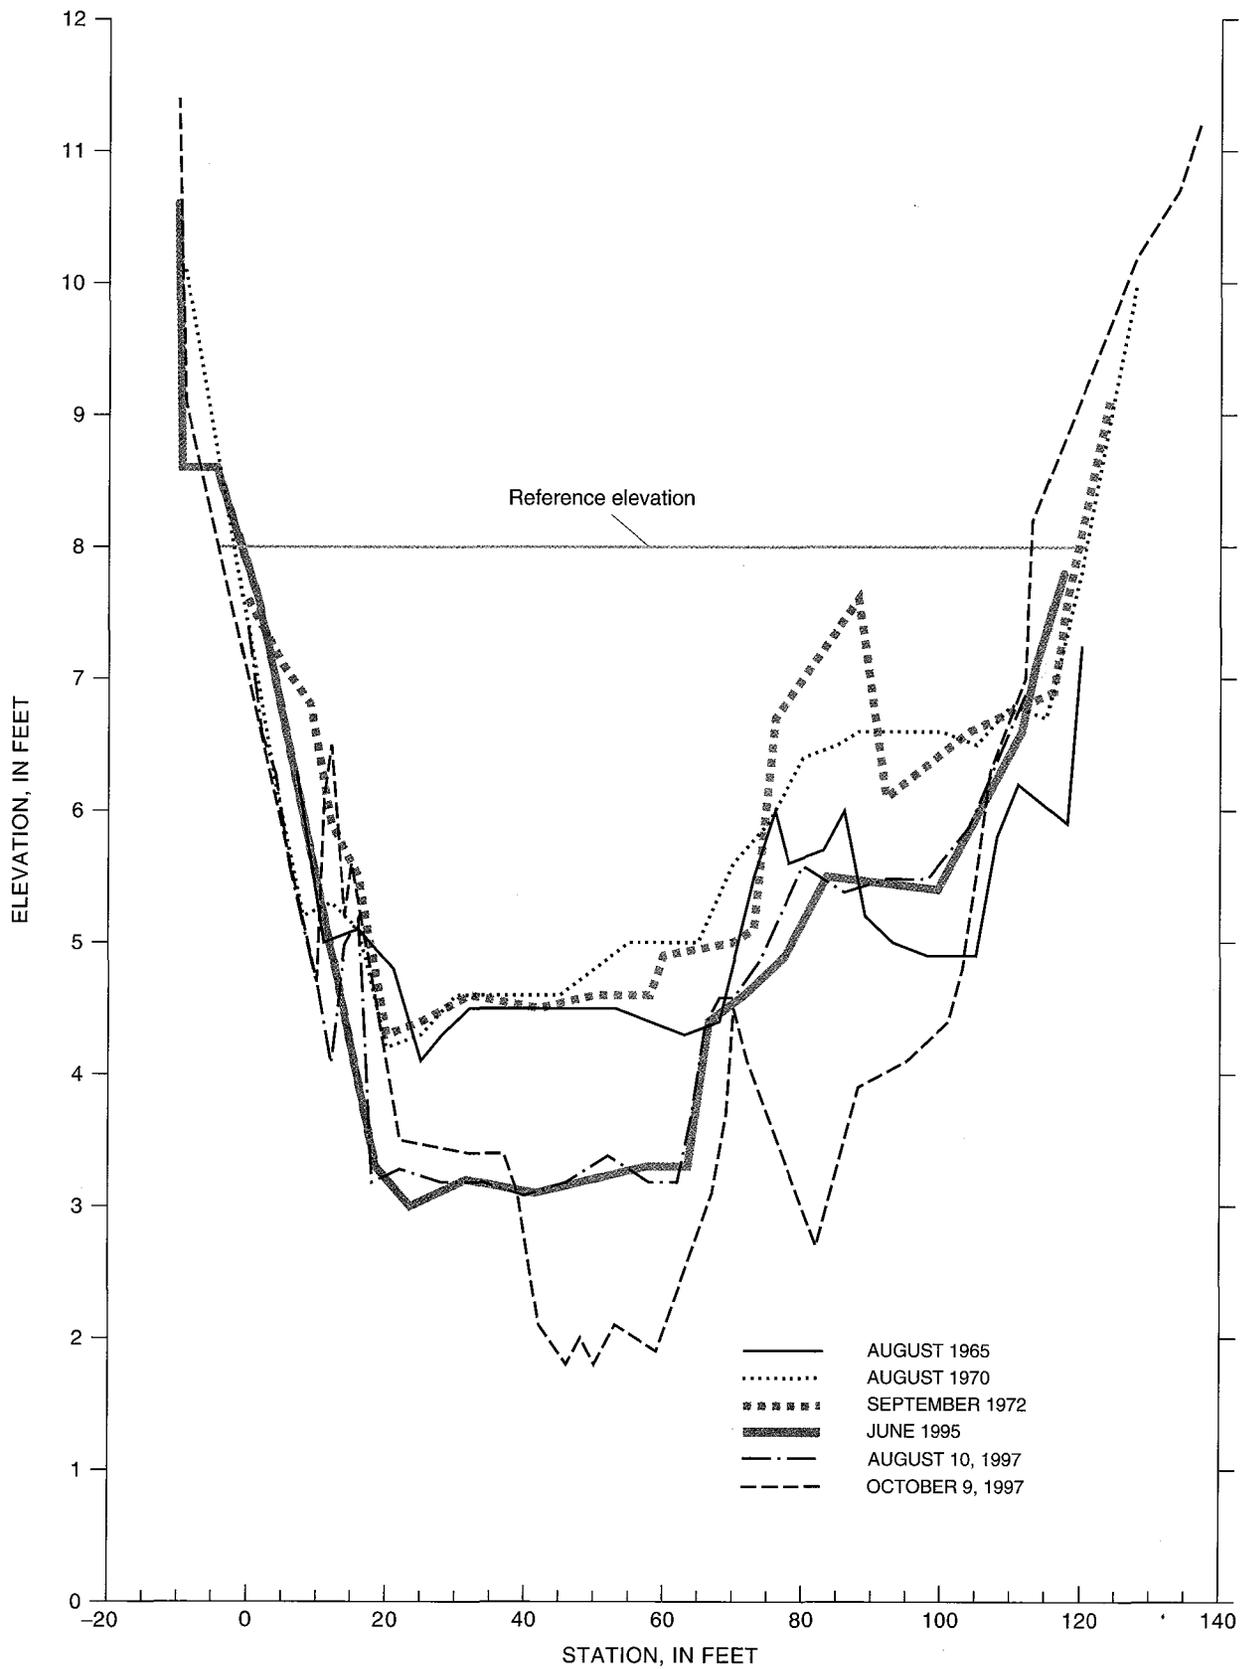
Figure 24. Cross section from surveys during indirect measurement of discharge and from cross-section surveys, Tiger Wash near Aguila, Arizona, 1965–97.

Surveyed cross sections.—The surveys used to document channel change at this site were all at the crest-stage gaging station. The channel was measured in 1965, 1970, and 1972 (fig. 24). Little channel change was measured for these three surveys. The crest-stage gaging station was not operated from 1979 to 1991 except for a miscellaneous discharge measurement of 3,170 ft³/s in 1983. Streamflow-data collection was resumed in 1991. In 1995, a slope-area measurement showed that the main channel had incised about 1.5 ft since 1972 (fig. 24). The gravel bar on the right bank appeared to have eroded as well. In 1997, surveys of the channel showed that the cross section changed little after moderate flows on August 3 and August 8, but considerable erosion occurred following the flood of record at the site on September 26, 1997. During this flood, the
