Determination of Channel Change for Selected Streams, Maricopa County, Arizona

Water-Resources Investigations Report 01–4209

Prepared in cooperation with the
FLOOD CONTROL DISTRICT OF
MARICOPA COUNTY

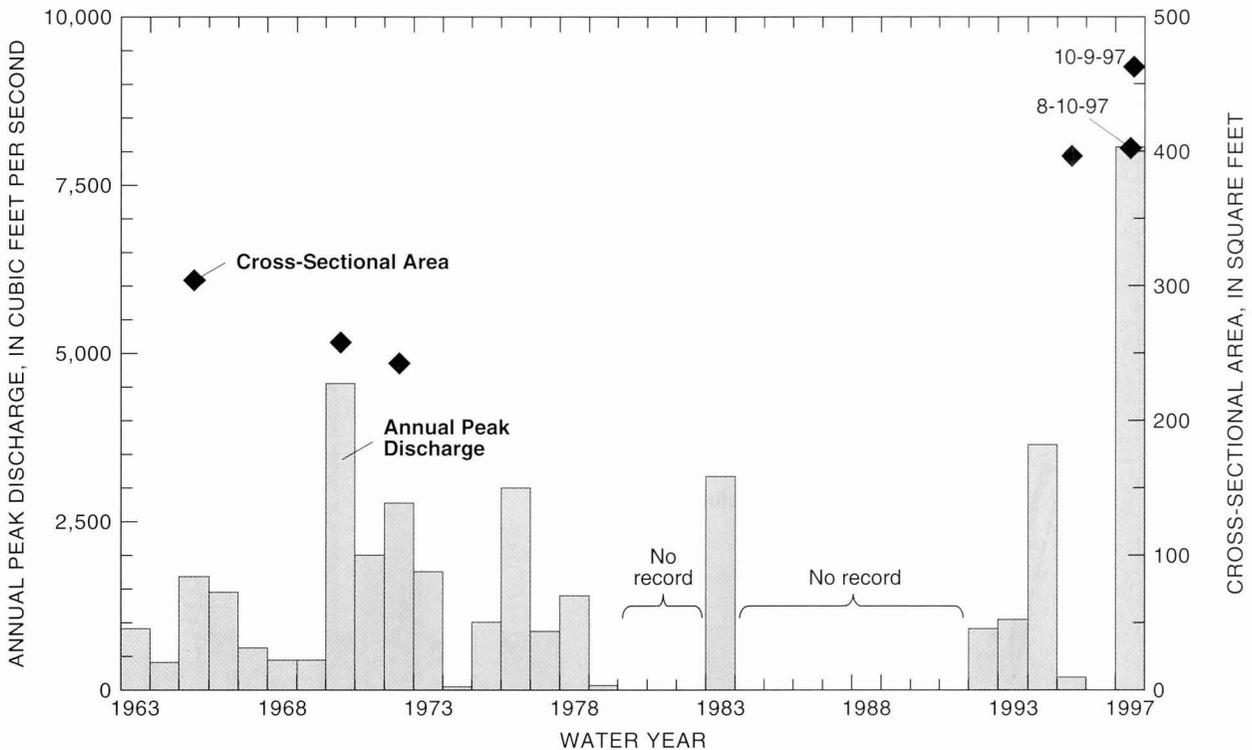
Figure 25. Annual peak discharge and cross-sectional area, Tiger Wash near Aguila, Arizona, 1963–97.

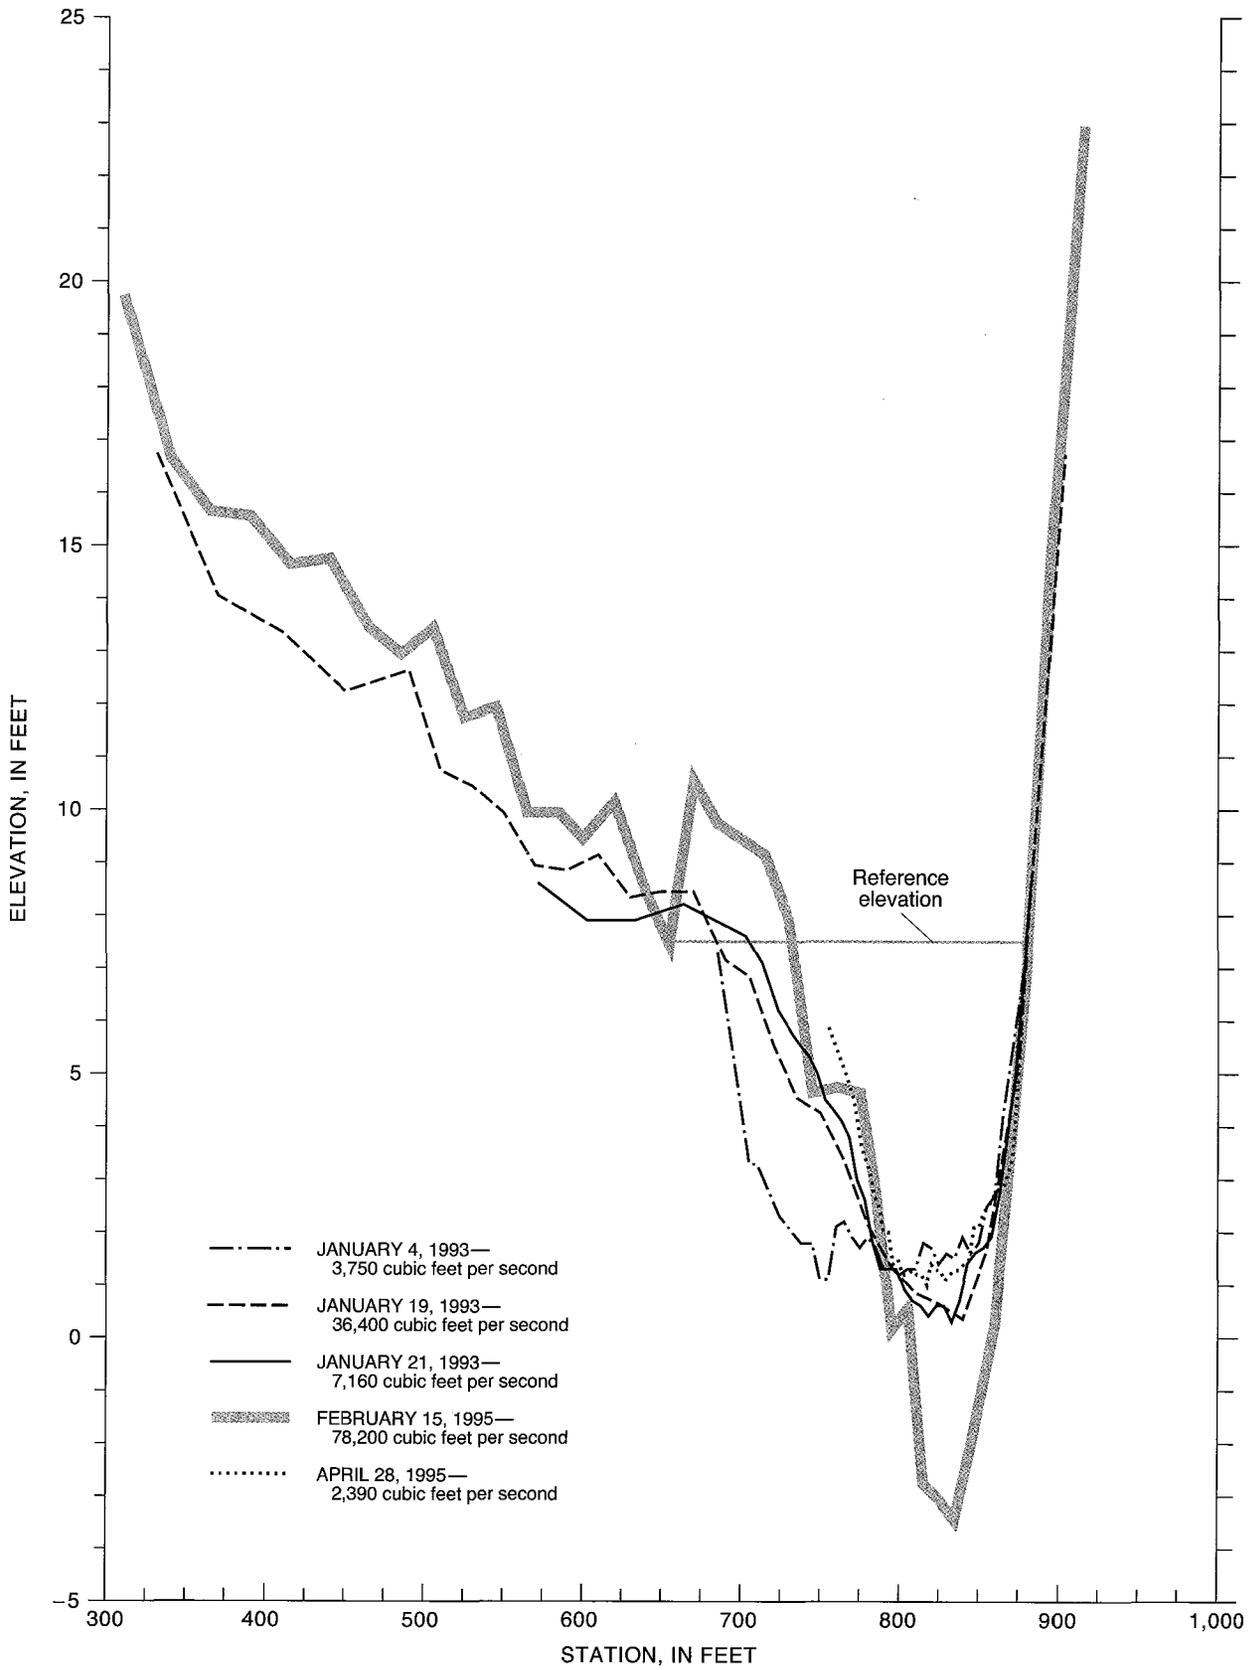
Figure 26. Cross section from cableway discharge measurements, Verde River below Bartlett Dam, Arizona, 1993–95.

Cableway cross sections.—The cross section is at the cableway, which is about 200 ft upstream from the gaging station. The first cross section was measured on January 4, 1993, during a discharge of 3,750 ft³/s (fig. 26). This measurement was made before the peak of record of 110,000 ft³/s that occurred on January 8, 1993 (fig. 27). The second discharge measurement of 36,400 ft³/s was made on January 19, 1993, at 36,400 ft³/s. Between these two measurements, the cross section filled with sediment. The third discharge measurement was made on January 21, 1993, at 7,160 ft³/s. The cross section narrowed

and deepened as compared to the previous measurement. Sediment was scoured from the channel bottom and deposited on the left bank (fig. 26).

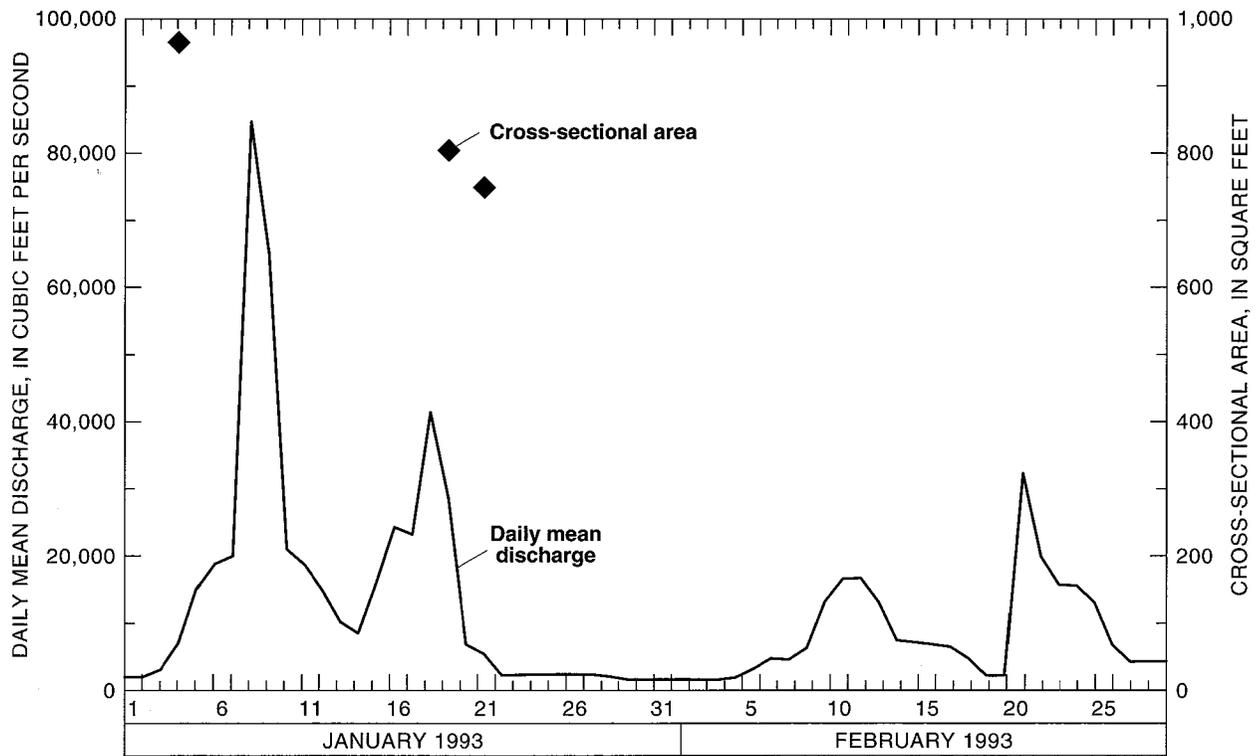
Figure 27. Daily mean discharge and cross-sectional area, Verde River below Bartlett Dam, Arizona, January and February 1993.

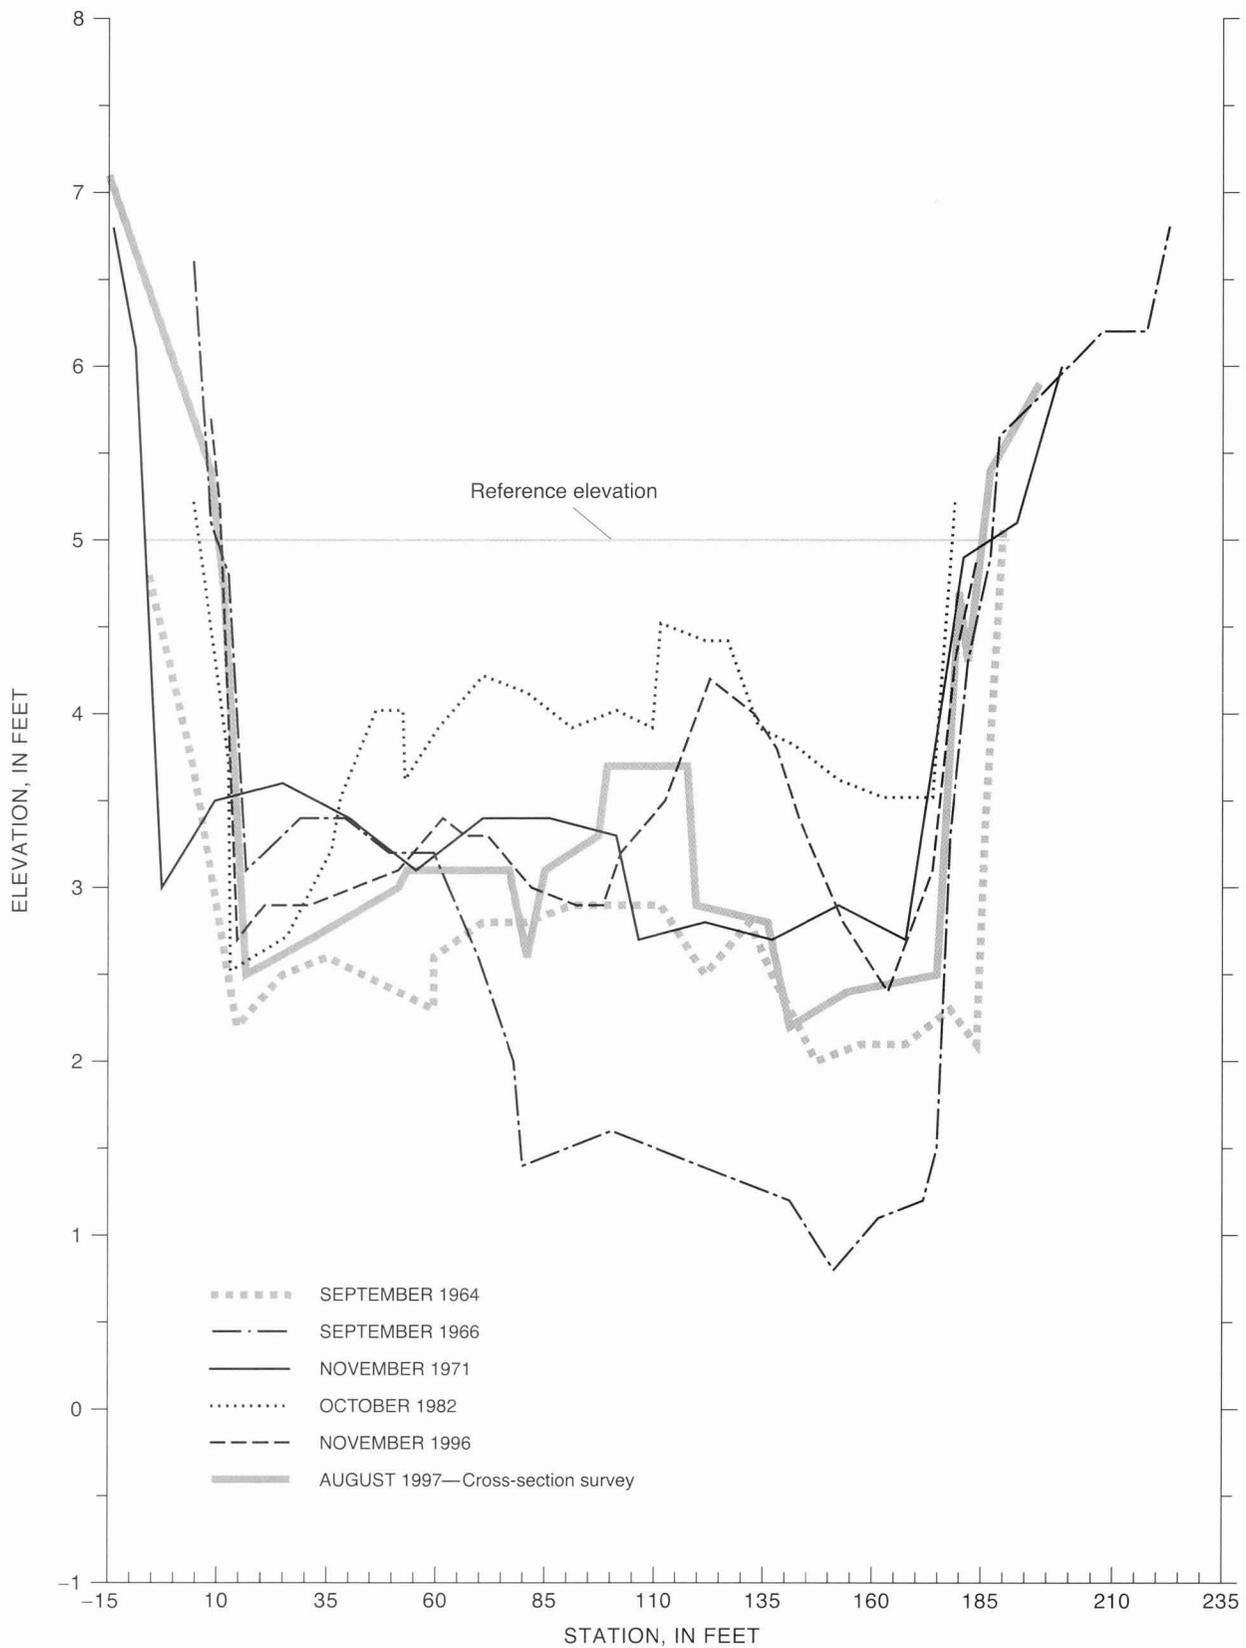
Figure 28. Cross section from surveys during indirect measurements of discharge and from cross-section survey, Waterman Wash near Buckeye, Arizona, 1964–97.

Surveyed cross sections.—The cross section was measured near the gaging station. Resurveys were reconstructed from five indirect measurements of discharge and one cross-section survey (fig. 28). The first measurement was made in 1964. Subsequent cross sections were surveyed in 1966, 1971, 1982, 1996, and 1997. Nearly all channel change was vertical (fig. 28). Vertical change in the streambed elevations has been as much as 2 ft between surveys and as much as 3.5 ft overall between 1966 and 1982. The channel filled almost 60 percent of the cross-sectional area relative to the reference elevation between 1964 and 1982. A survey following the flood of August 8, 1997, showed a 13-percent increase in cross-sectional area. The flow of August 8, 1997, of 9,400 ft³/s was the peak discharge of record at this site (fig. 29).

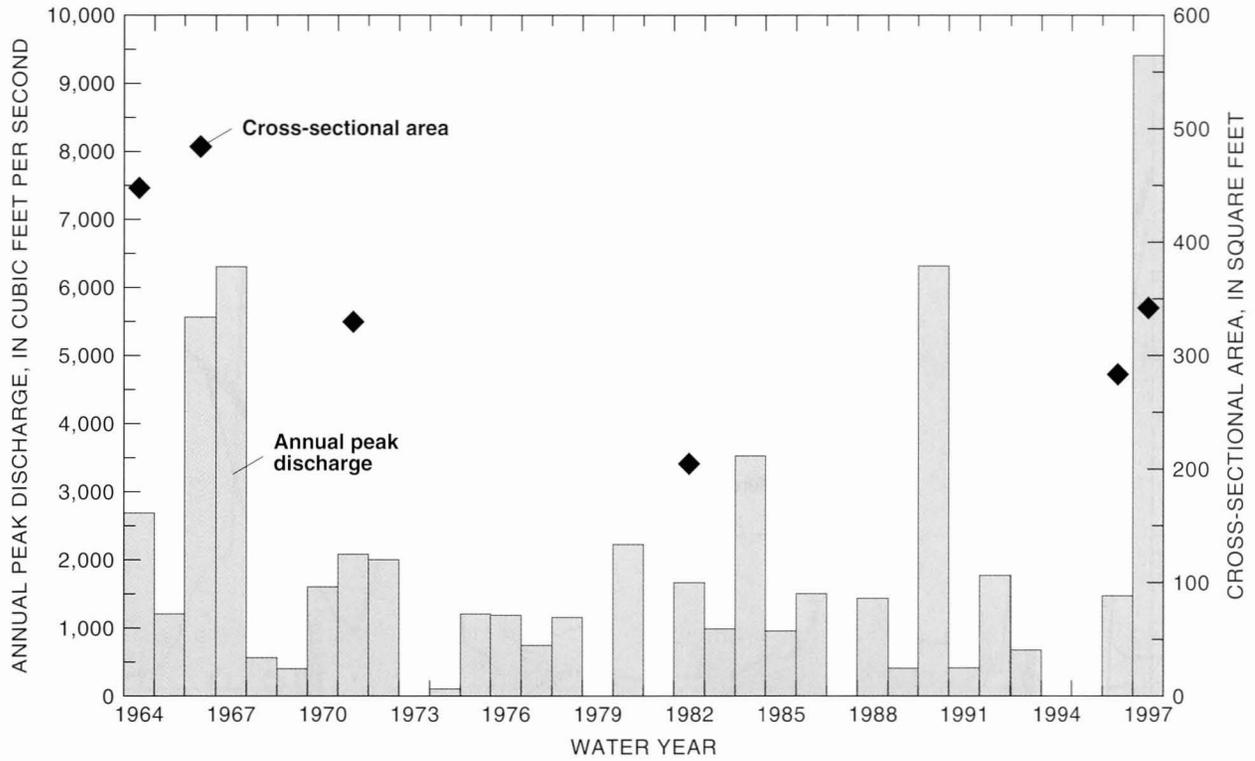
Figure 29. Annual peak discharge and cross-sectional area, Waterman Wash near Buckeye, Arizona, 1964–97.
