# DESERT FLOODS

A REPORT ON SOUTHERN ARIZONA FLOODS  
OF SEPTEMBER, 1962

PREPARED BY THE GEOLOGICAL SURVEY  
UNITED STATES DEPARTMENT OF THE INTERIOR

DOUGLAS D. LEWIS

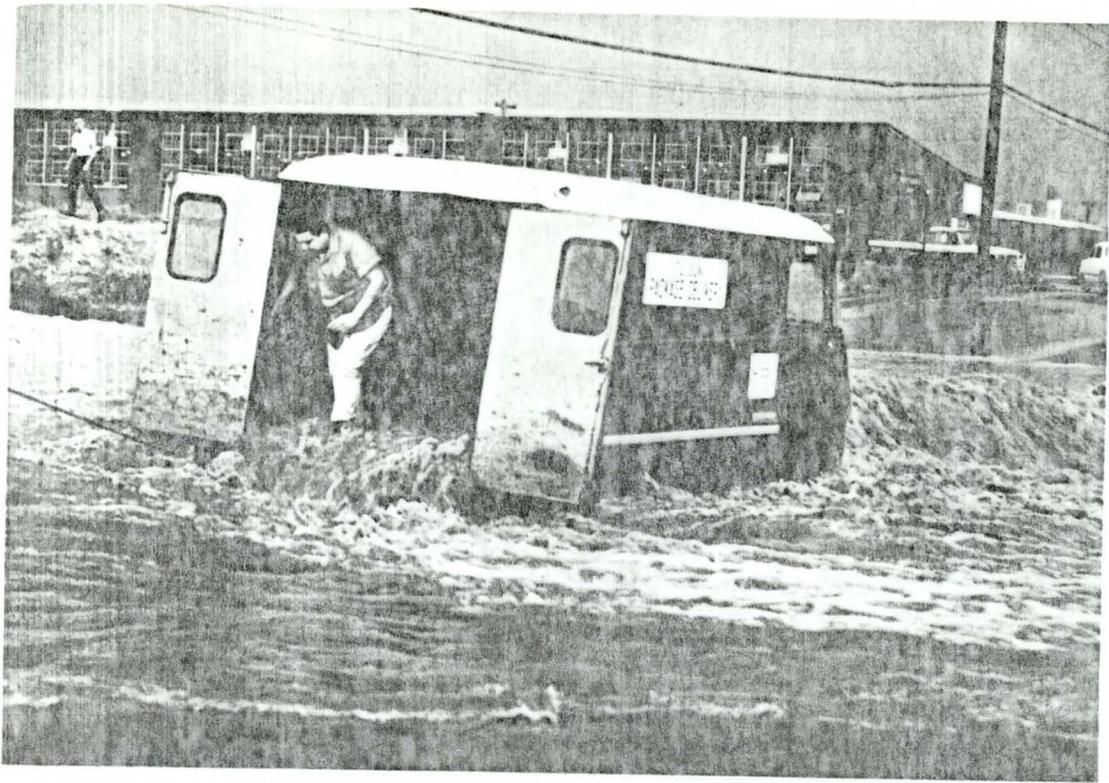
Flood at Campbell Ave. and 15th St.

Highway damage on Pantano Road  
Photographs from Tucson Daily Citizen  
Figure 4.--Results of flood at Tucson

High intensity runoff was first noticed in Tucson because the large areas of impermeable street and roof surfaces allowed a high percentage of the rainfall to become surface runoff which quickly flooded streets and disrupted traffic. As the flood developed, roads, culverts, and bridges were damaged (fig. 4). A few vehicles trapped by the waters were swept downstream and destroyed. However, the flooding in the Tucson area was largely of a local nature and the effects were not particularly significant.

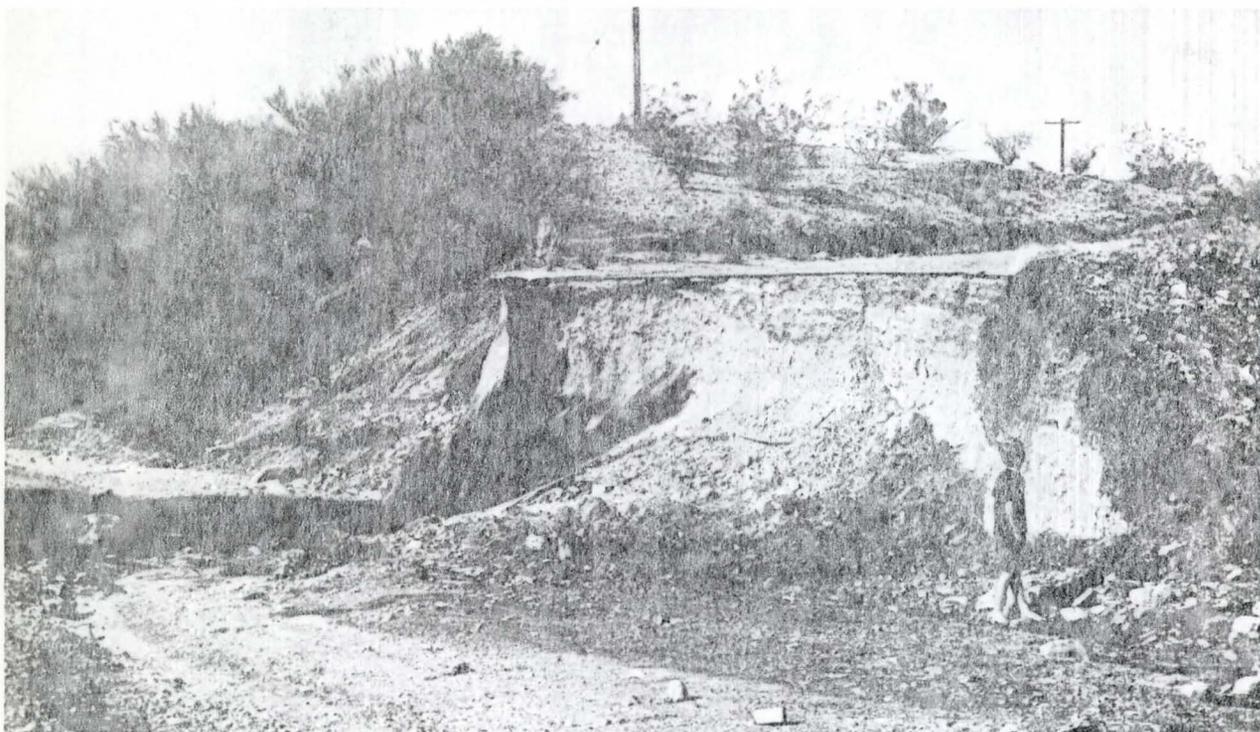
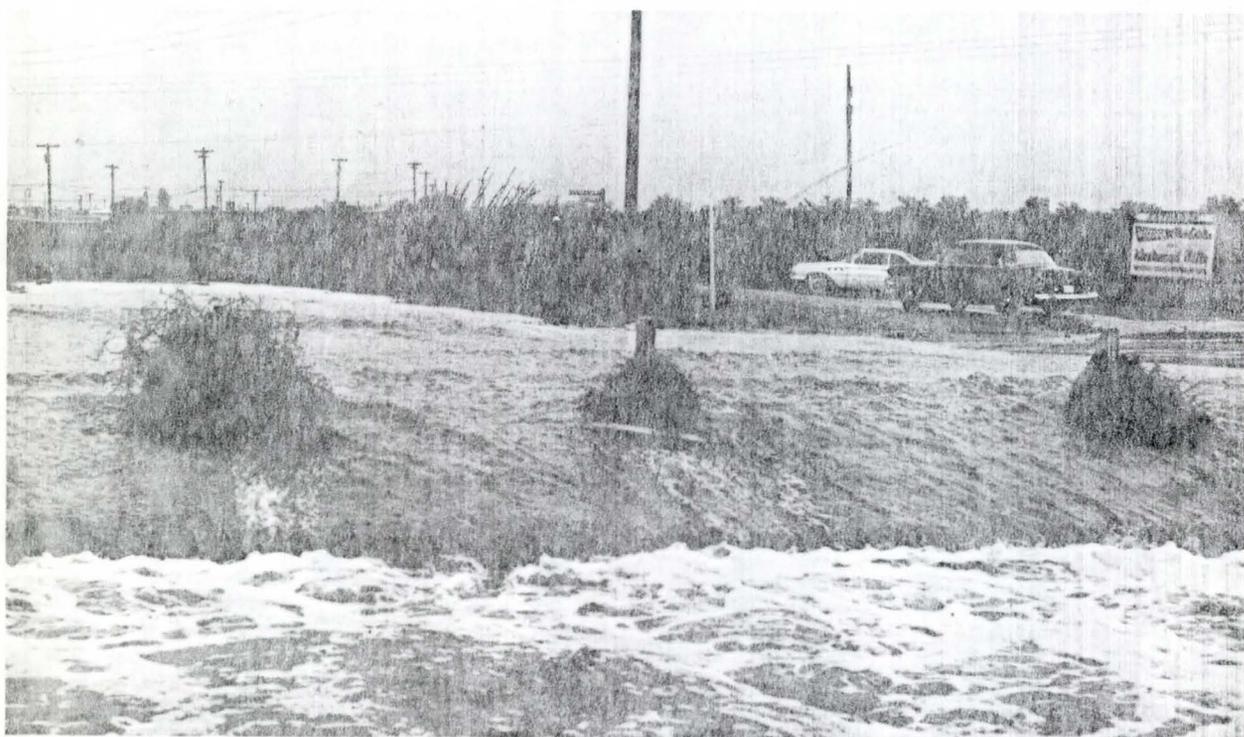
County Road near Tucson Mountains cut by floodwaters.

Figure 5.--Floodflows at Silver Bell Road near Tucson.  
Photographs from Tucson Daily Citizen

There is evidence of very intense runoff from all slopes of the Tucson Mountains except the southern ones. Observations after the flood indicated that runoff from the eastern slopes may have been greater than that from the western slopes. Silverbell Road was cut in several places where the intense runoff crossed, and severe gullying occurred in some arroyos (fig. 5). The rain gage at the Arizona-Sonora Desert Museum recorded 5.95 inches of precipitation, but this amount may not have been representative of the rainfall over the entire area.

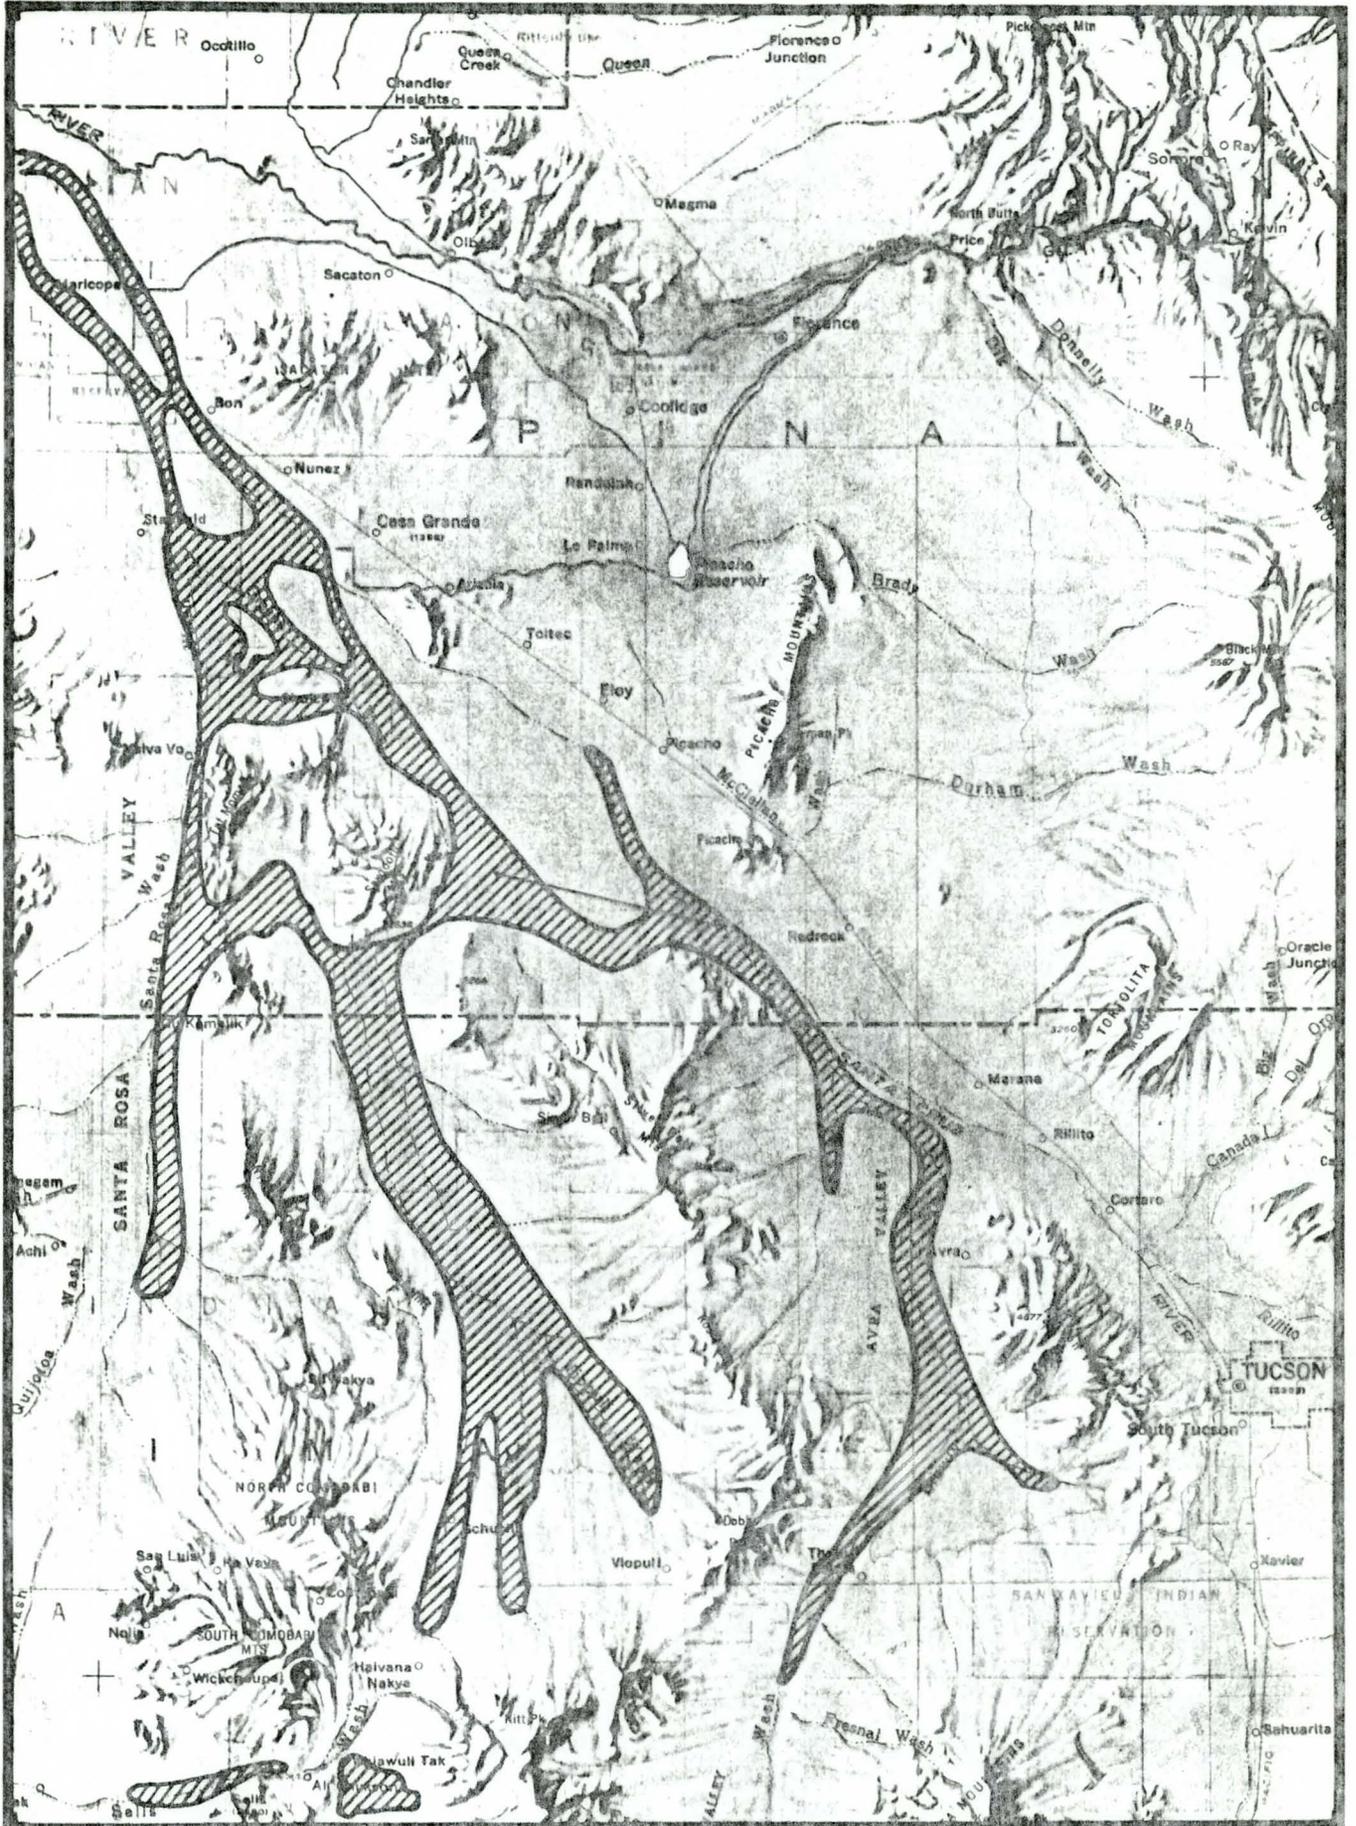
Figure 10.--Approximate areas inundated

The large areas inundated by the flood of September 26-28, 1962 have been mentioned previously. An attempt has been made to map these areas on the basis of aerial photographs obtained during the flood, newspaper reports, and observations by field parties. Figure 10 shows the approximate limits of this inundation. The flooded areas could have been more accurately delineated by a transit survey of the floodmarks, but adequate funds and personnel were not available for such a survey.

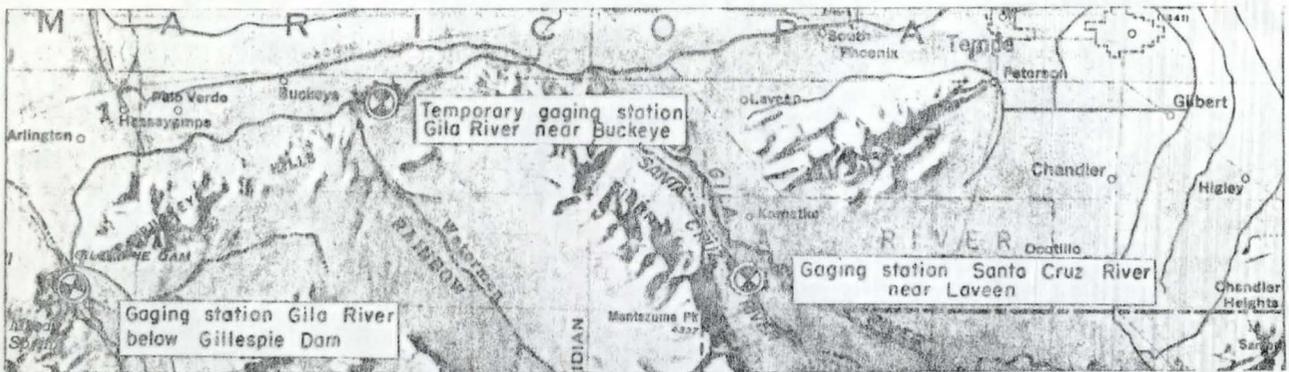
Figure 12.- Where did the water go? Attenuation of flow from Santa Cruz River near Laveen to Gila River at Gillespie Dam.

The hydrographs on figure 12 show further progress of the flood along the Gila River. A temporary gage had been installed on the Gila River at Jackrabbit Road, near Buckeye, and the combined runoff of the Gila River and Buckeye Canal was less than 7,500 acre-feet. Although 6,700 acre-feet of water passed Gillespie Dam, most of this appeared to be return flow from upstream irrigation, and all but a small portion of it was diverted at the dam. None of the floodwater reached Painted Rock Dam farther downstream.
