Salt River Project Report of
North Mountain Flood of
August, 1943

DESERT FLOOD OF AUGUST 3, 1943

To facilitate explanations of conditions this report has been divided into eight areas as indicated on the accompanying map. Locations of pictures are indicated on area maps with the direction of flow of flood waters shown in green and breaks in canal banks shown in red.

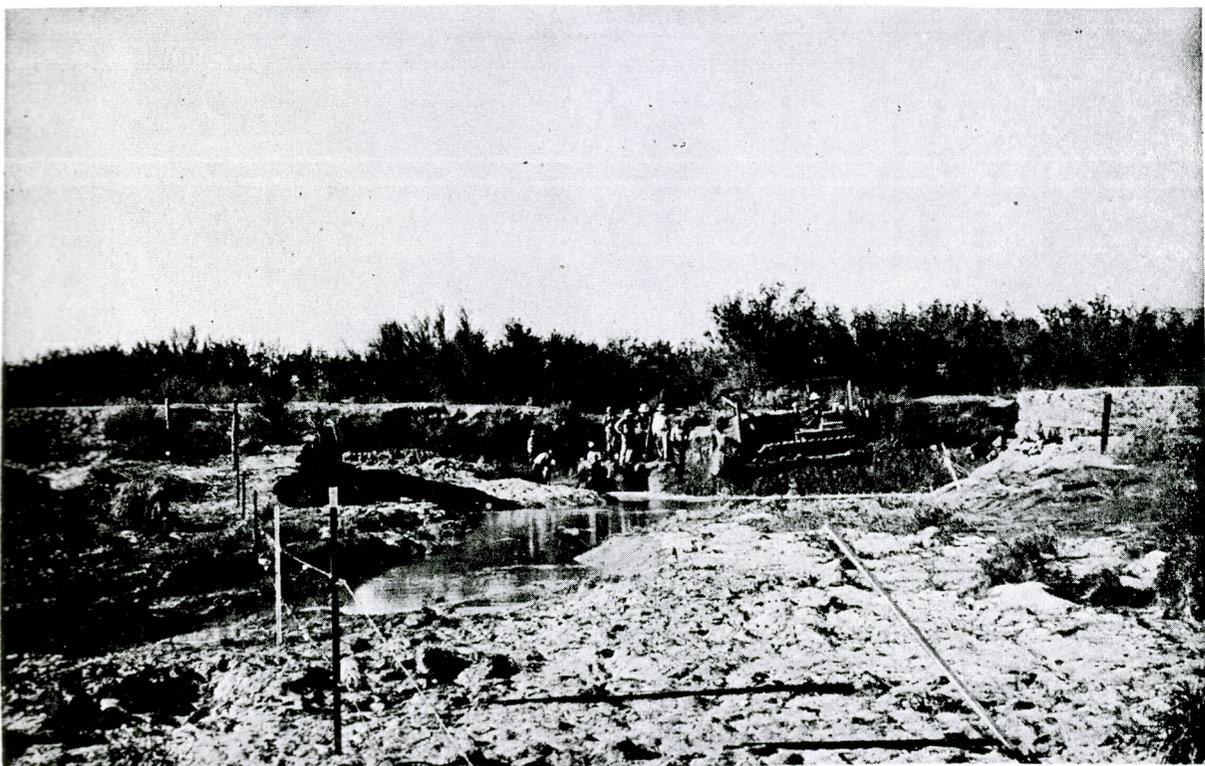
(2) Sand bagging and bulldozer repairing canal bank east of Indian Bend (8/5/43)

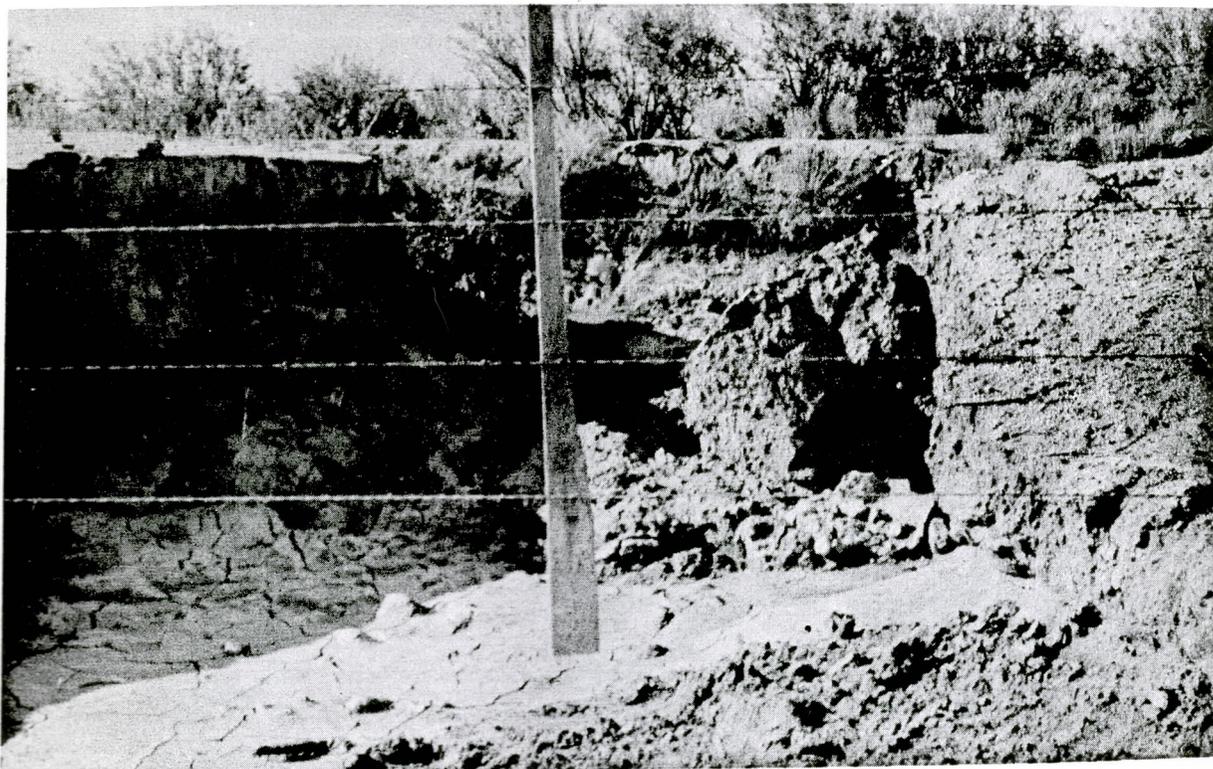
(3) Result of a gopher hole - West of Indian Bend 8/5/43

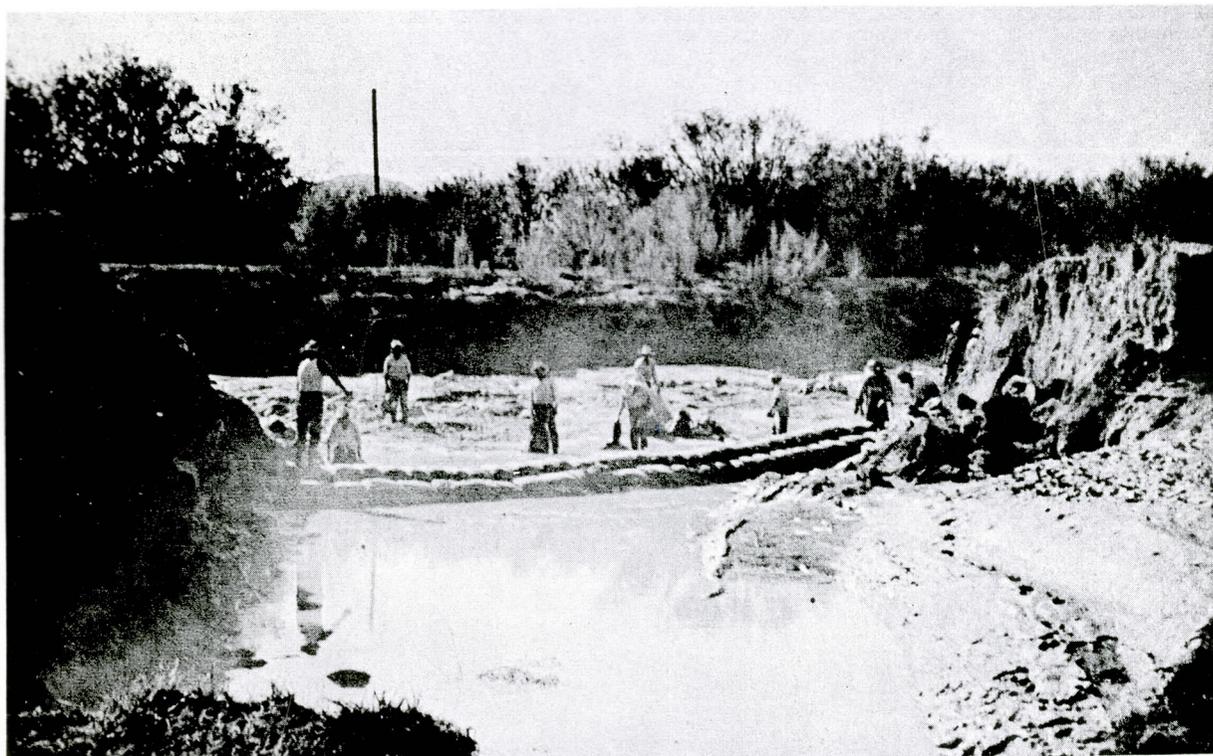
(4) Sand bagging break East of Indian Bend 8/5/43

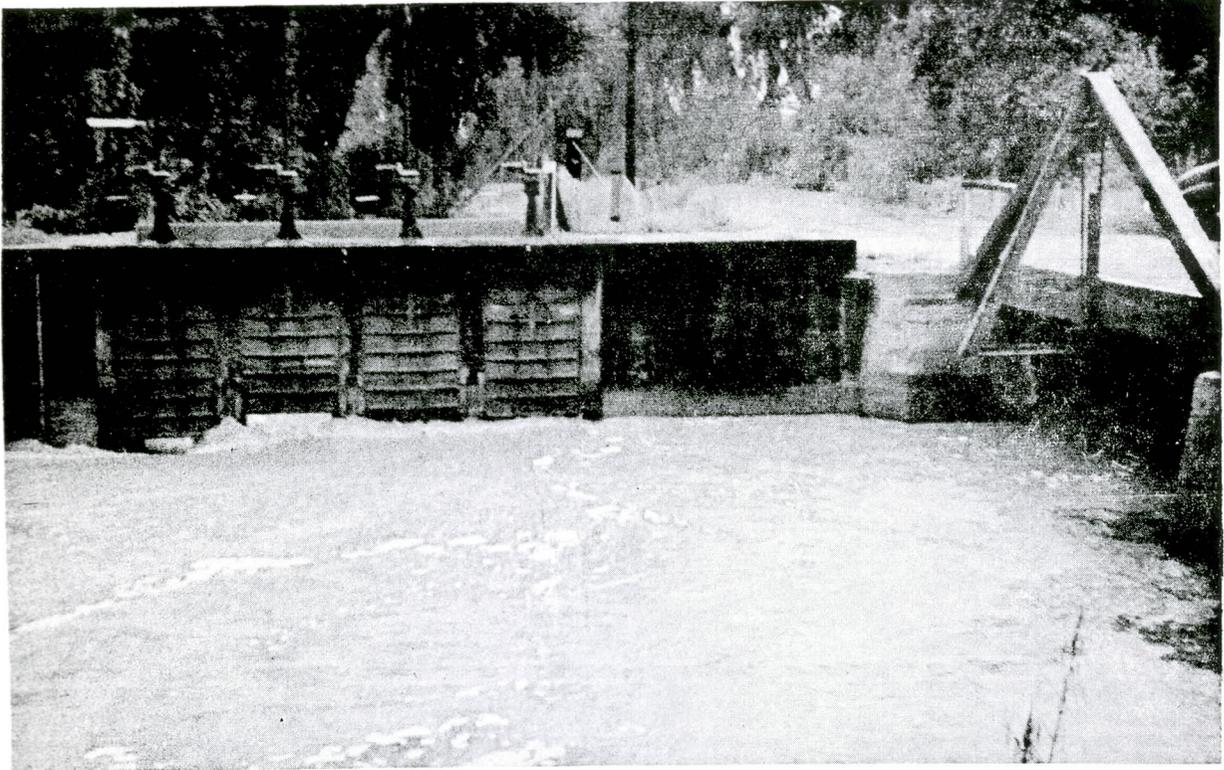
(5) Head Gates old Cross Cut 10:00 A.M. 8/3/43

The flow in the channel of the Old Cross-Cut Canal is retarded by vegetation and bank sloughing to a great extent, and the gate capacity was inadequate to furnish sufficient relief to the canal at this point. Although no breaks in the canal bank happened in this section, undoubtedly the large amount of water going down the canal below Lateral 6 was a contributing factor to the breaks in the vicinity of Lateral 10.

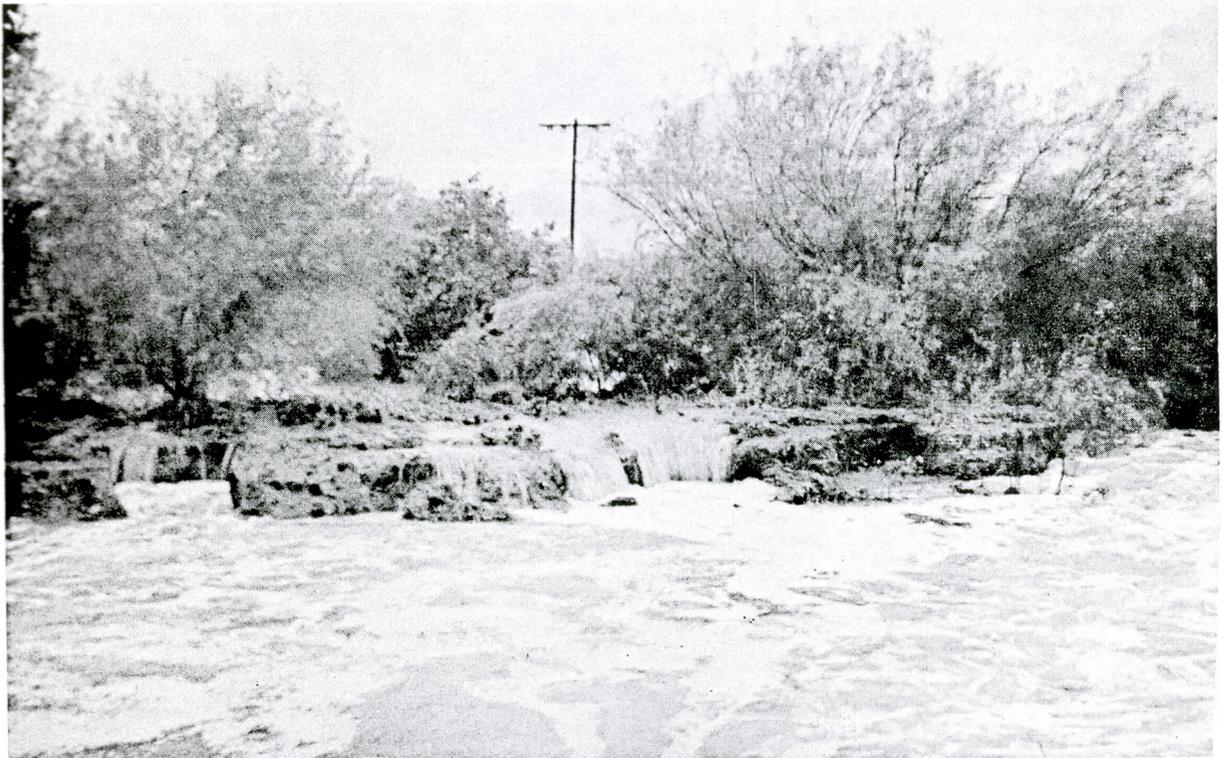
(6) Inflow 100' East of Camelback Road

Both north and south banks in this section were intact with exception of a heavy inflow approximately 100 ft. east of Lateral 7, which was the accumulation of the runoff from the south side of Camelback Mountains which followed the course of the canal in a northwesterly direction until intercepted by Camelback Road. The inflow to the Arizona Canal was at a point where the north bank was very low and appeared to be a natural waterway. Inflow at this point was very heavy.

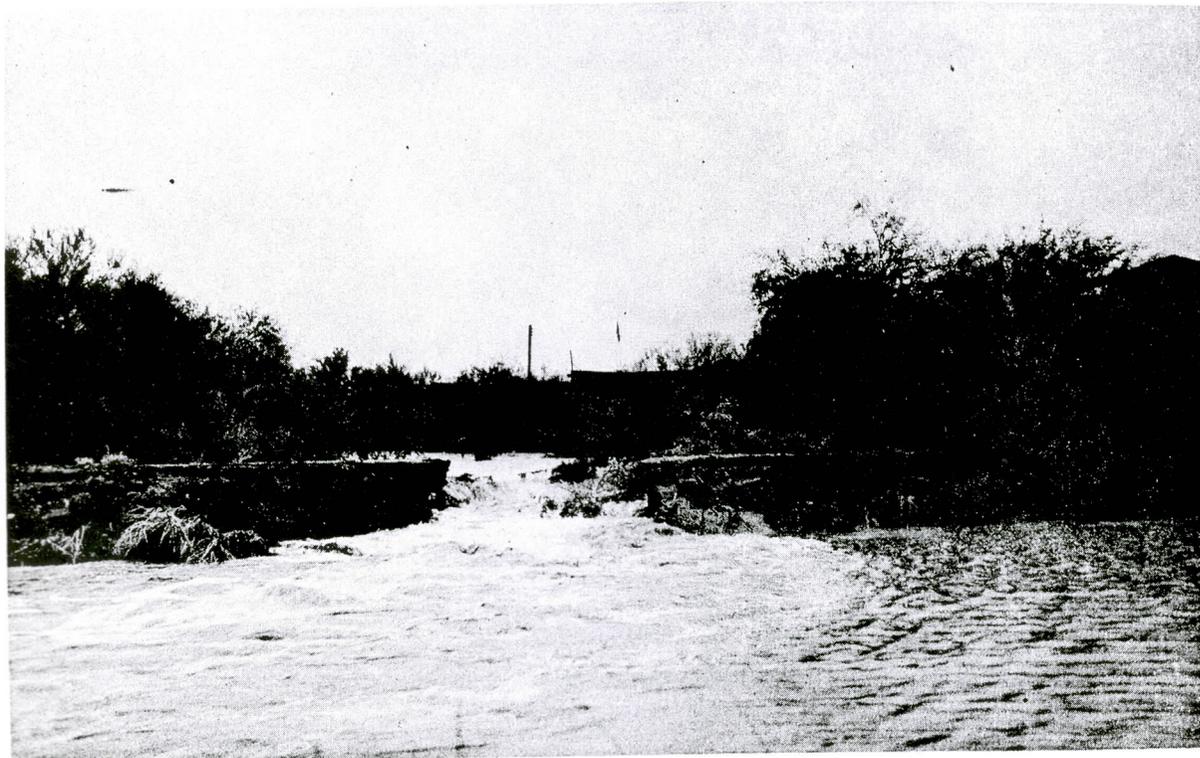
(7) Inflow west of Lateral 7 10:15 AM (8/3/43)

A heavy inflow of flood water from the Squaw Peak-Camelback area occurred approximately 1/10 of a mile west of Lateral 7. The north bank overflowed for approximately 1500 ft. in this vicinity. The spillway in south bank at Lateral 7 1/4 was not flowing at 10:15 A.M., and showed no indications of having been in operation previous to that time. A very heavy inflow occurred opposite the spillway at Lateral 7 3/4. This spillway was not flowing at 10:17 A.M., and showed no indication of having operated prior to that time.

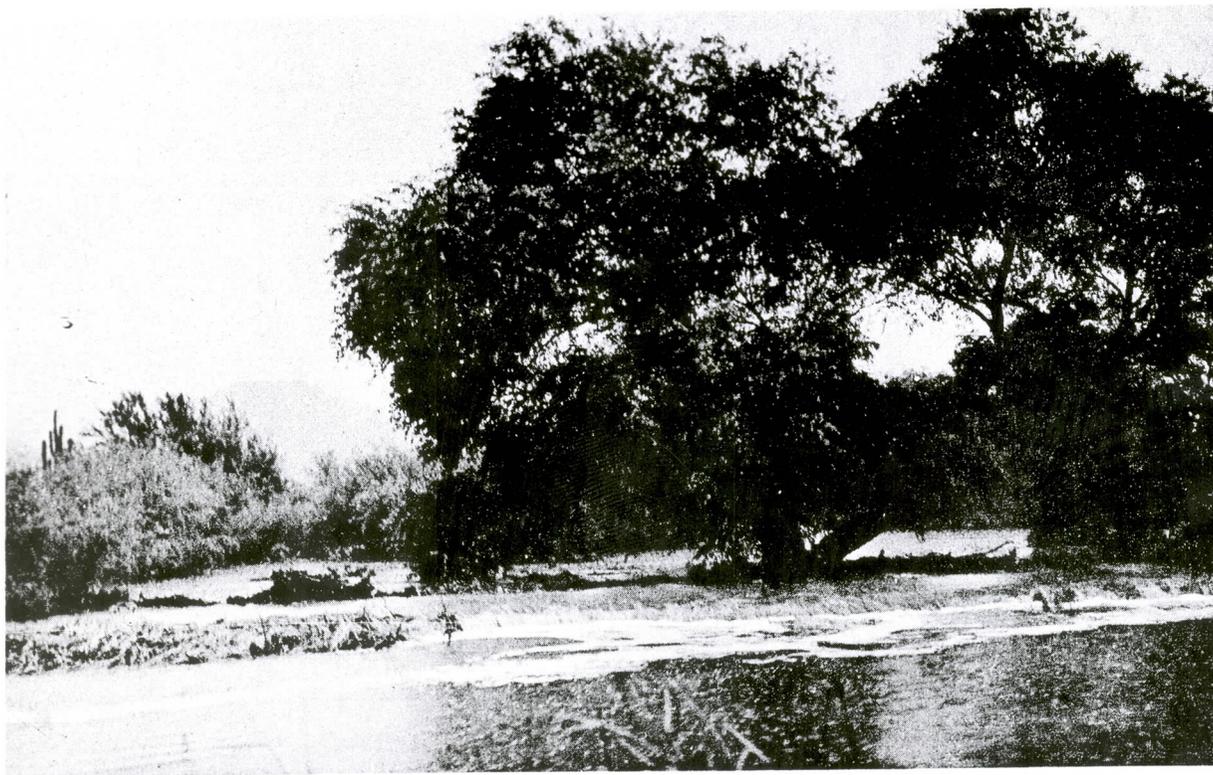
(8) Inflow opposite spillway at 17 1/4E - 9 1/2N 10:17 AM
(8/3/43)

The flow from the desert was reported to have reached Lateral 9 at 6:00 A.M. and Lateral 7 at 7:00 A.M. A heavy inflow occurred opposite the spillway at the Biltmore Hotel Golf Course, and water was flowing over this spillway at 10:19. This spillway was operating perfectly and when inspected after flow had ceased, there were no indications of wash or erosion below the spillway. The Arizona Canal was banked full at the Biltmore Hotel, and water standing on the lawn approximately 2/3 of the way from the canal to the hotel. There were two points of definite inflow in the vicinity of the hotel, one approximately 300 ft. east and the other 300 ft. west.

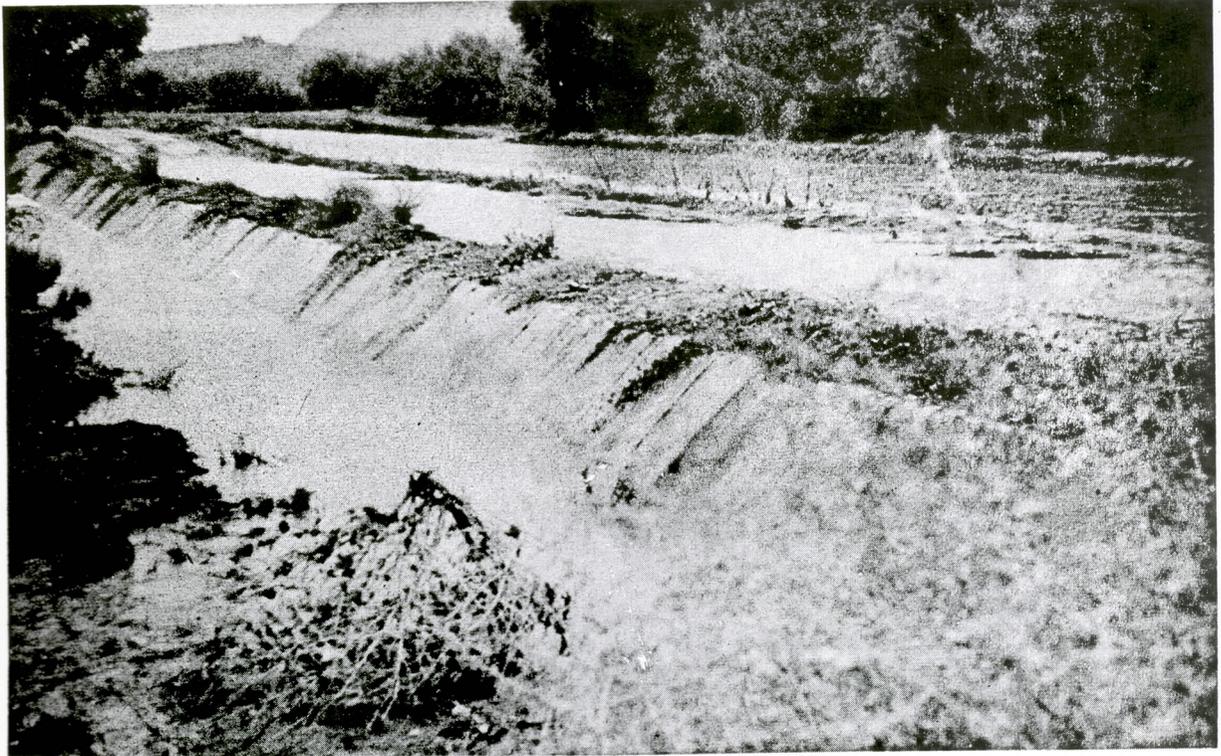
(9) Spillway at Biltmore Golf Course Lateral 8 1/2 10:20 AM
(8/3/43)

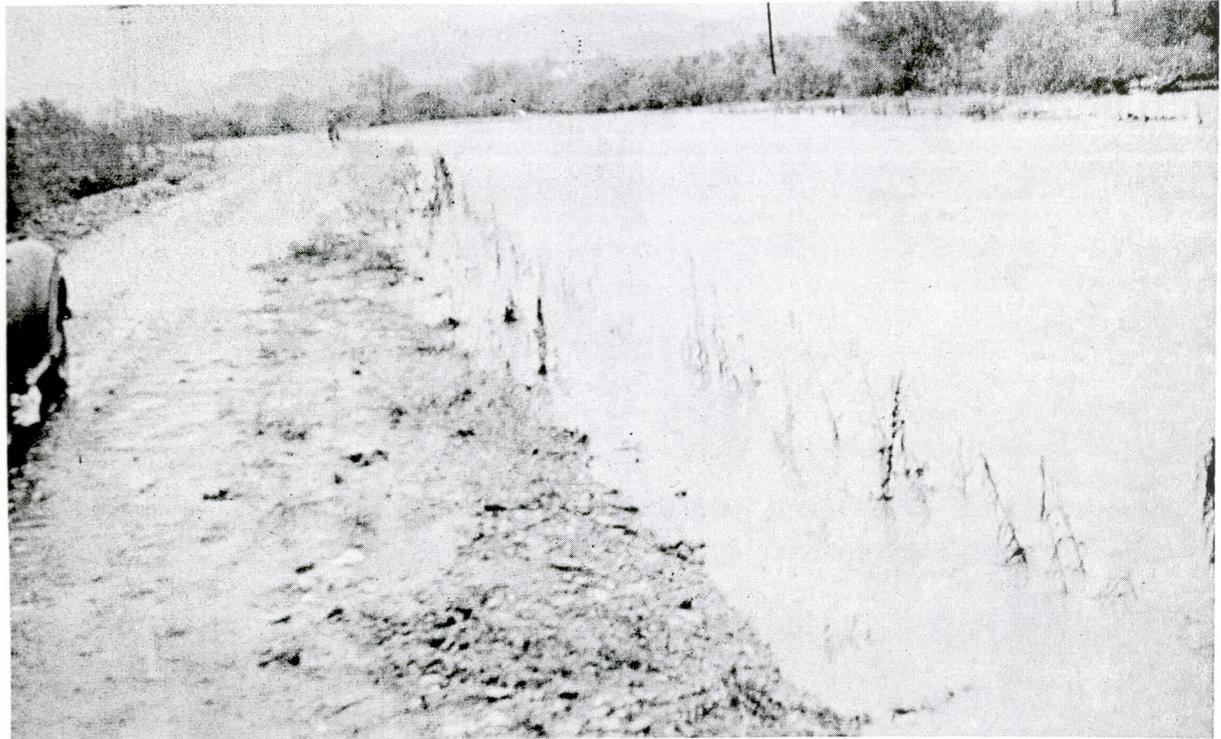
(10) Looking west from Lateral 9 3/4 10:28 AM (8/3/43)

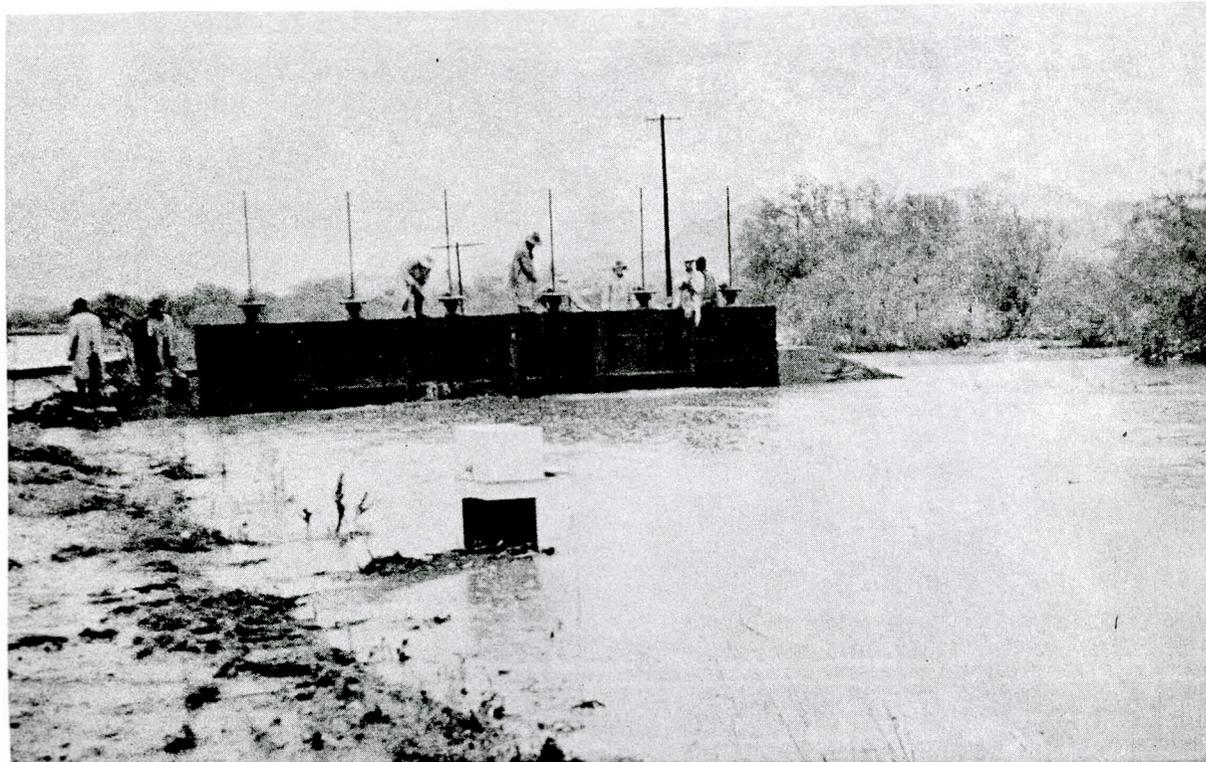
(11) Trash crew working on check at Lateral 10 10:32 AM
(8/3/43)

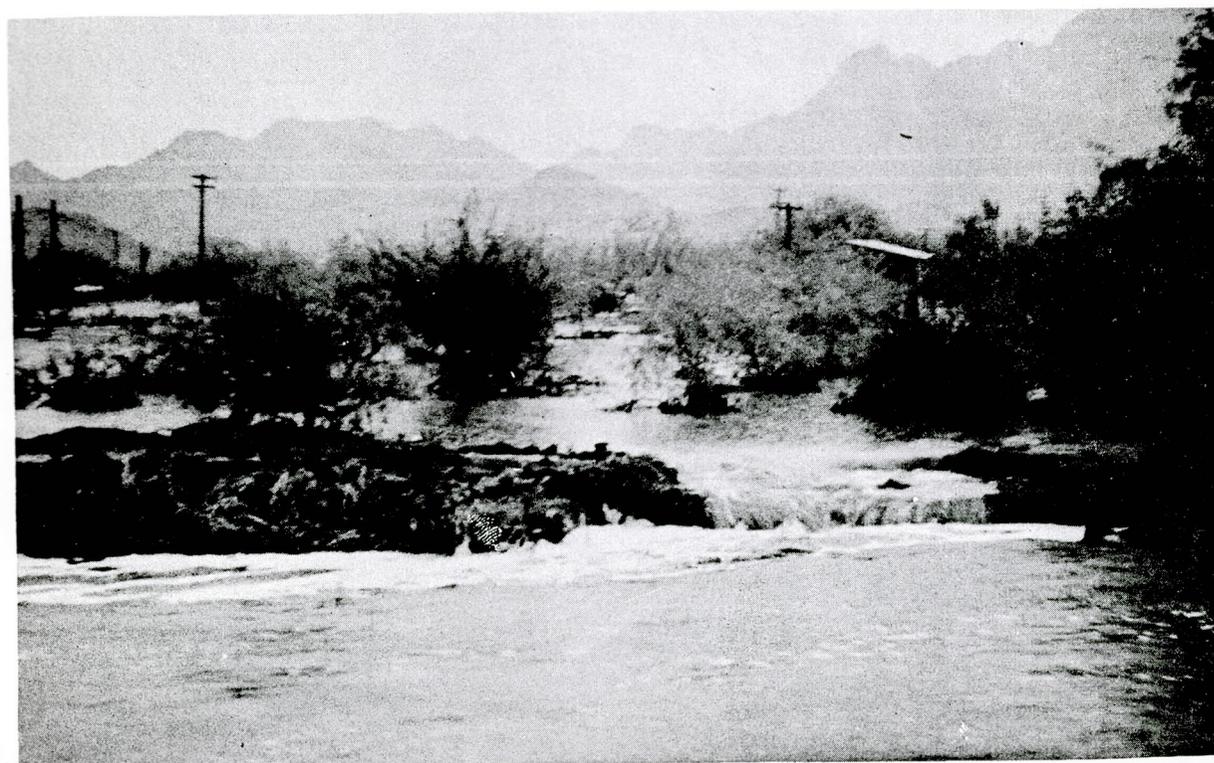
(12) Inflow 1/8 mile west of Lateral 10 10:35 AM (8/3/43)

A very heavy inflow to the canal occurred immediately west of Lateral 10 from flood waters intersected by 16th Street, north of the Arizona Canal. The second inflow channel was opposite the Clausen Spillway east of Lateral 10 1/8. This spillway was spilling prior to 11:10 A.M., and an inspection below the spillway after the water had subsided indicated that no damage had occurred to the orchard and no indications of wash were found.

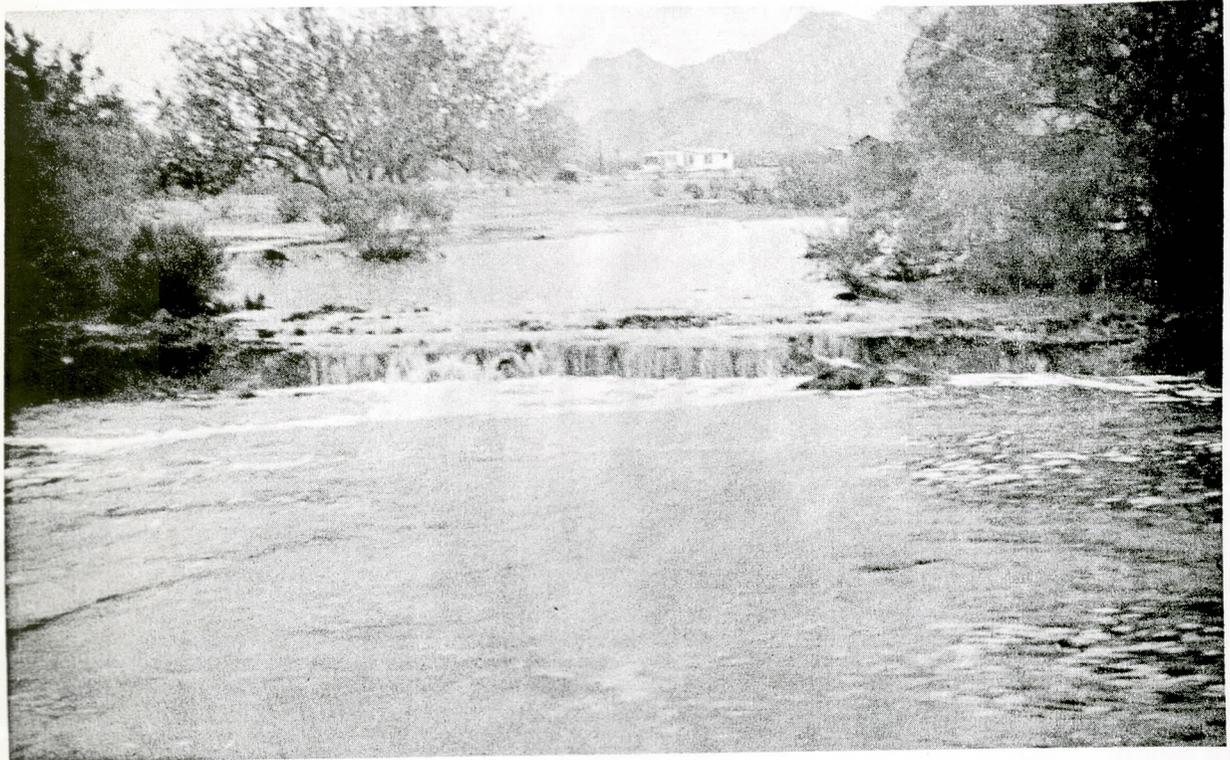
(13) Inflow opposite Clausen Spillway 10:30 AM (8/3/43)

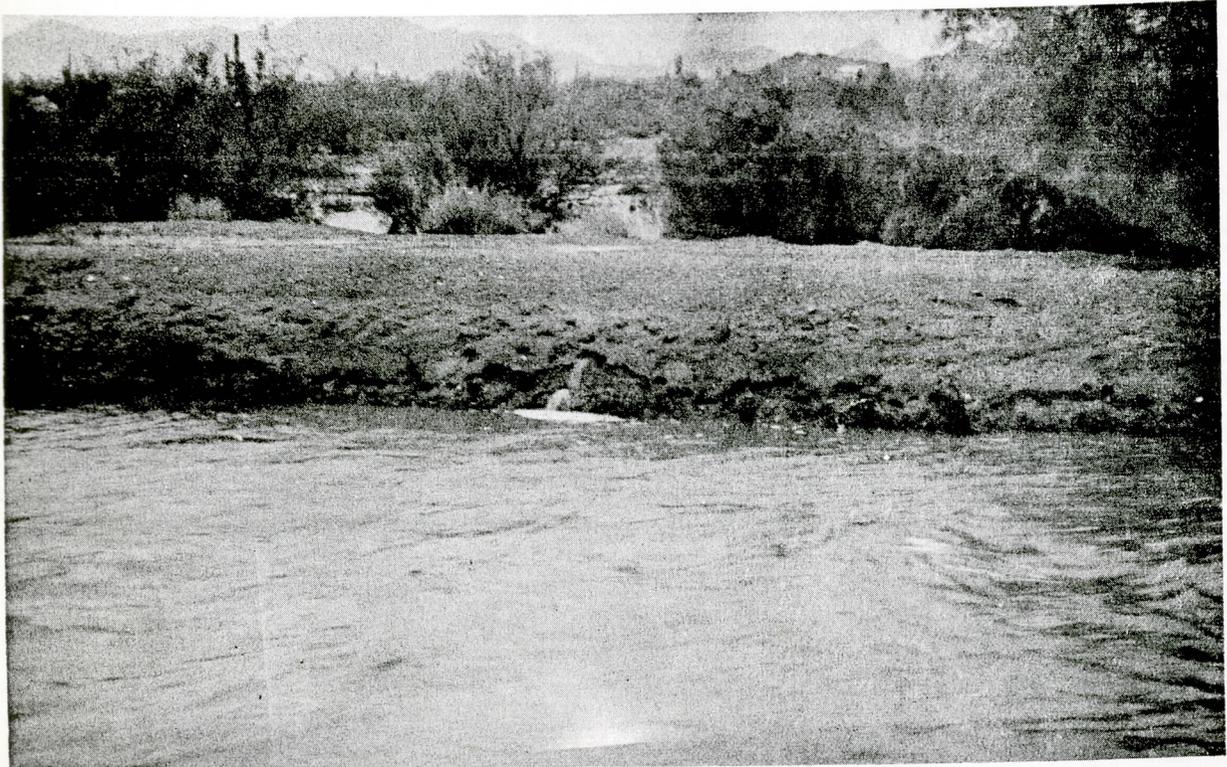
(14) Gopher hole in north bank northwest of Clausen Spillway

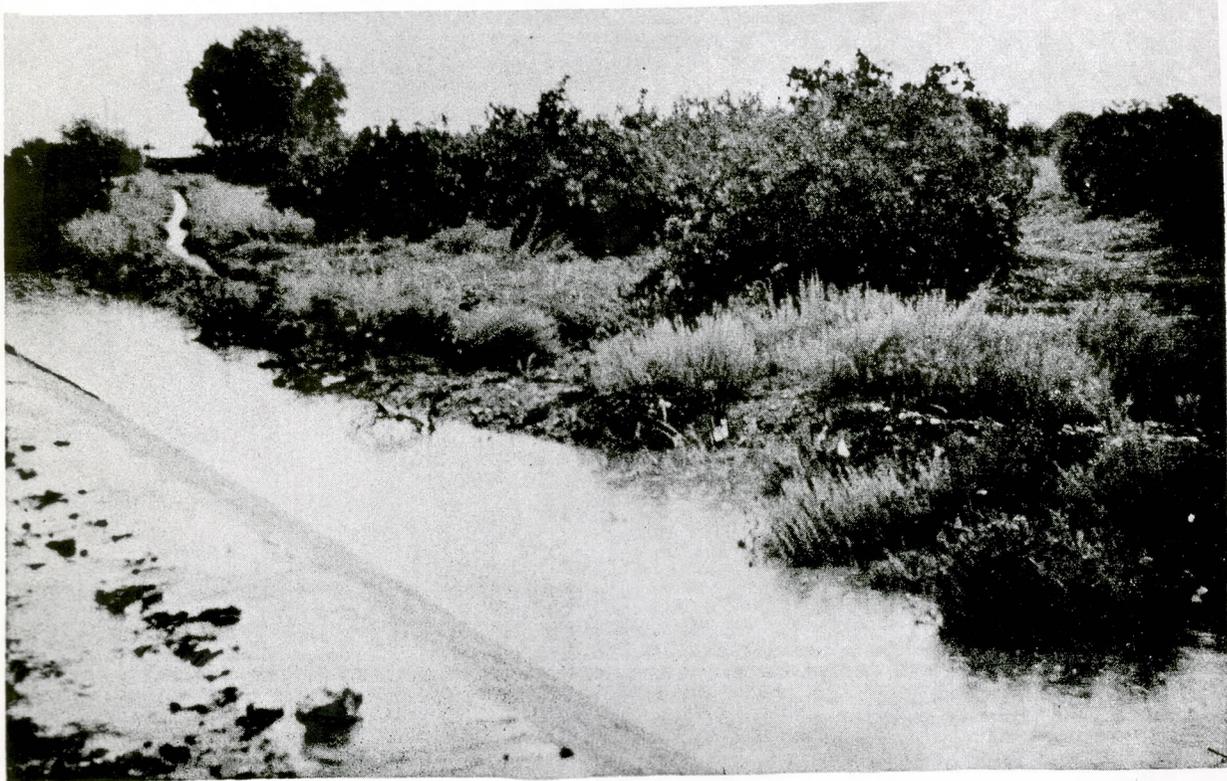
(15) Clausen Spillway 10:50 AM (8/3/43)

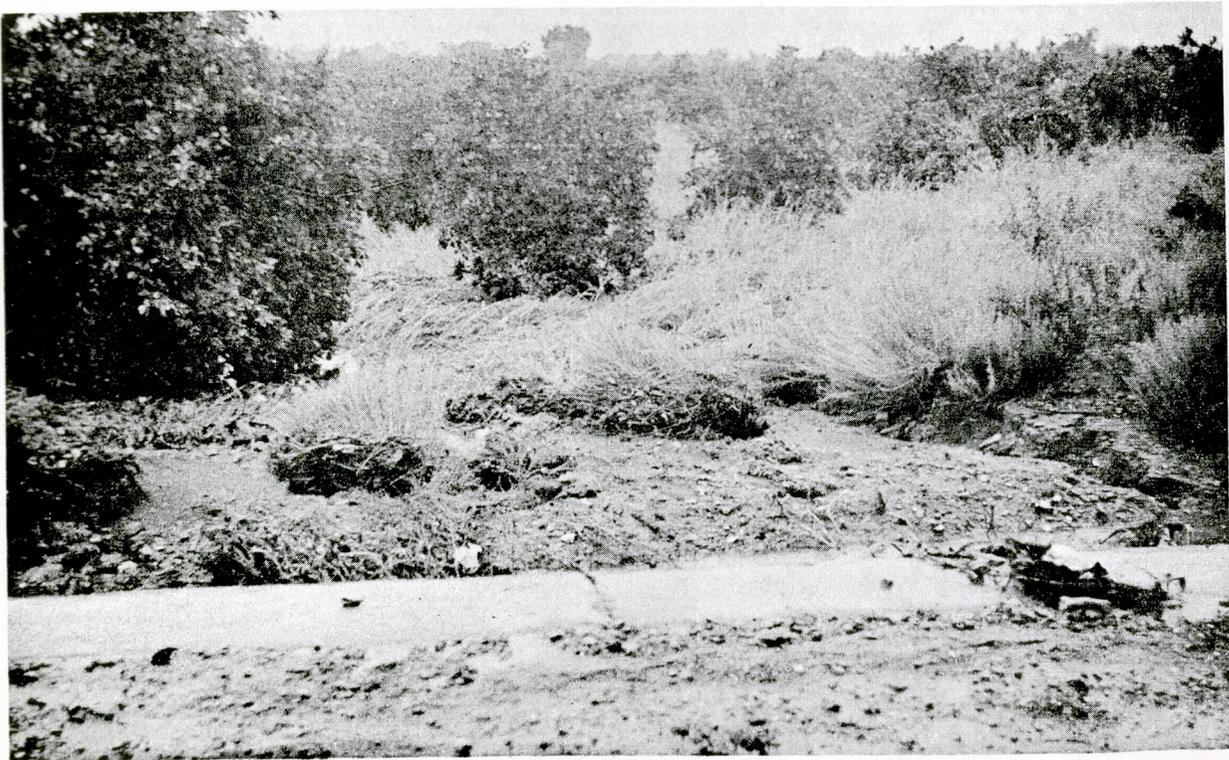
(16) Looking southwest from Clausen Spillway

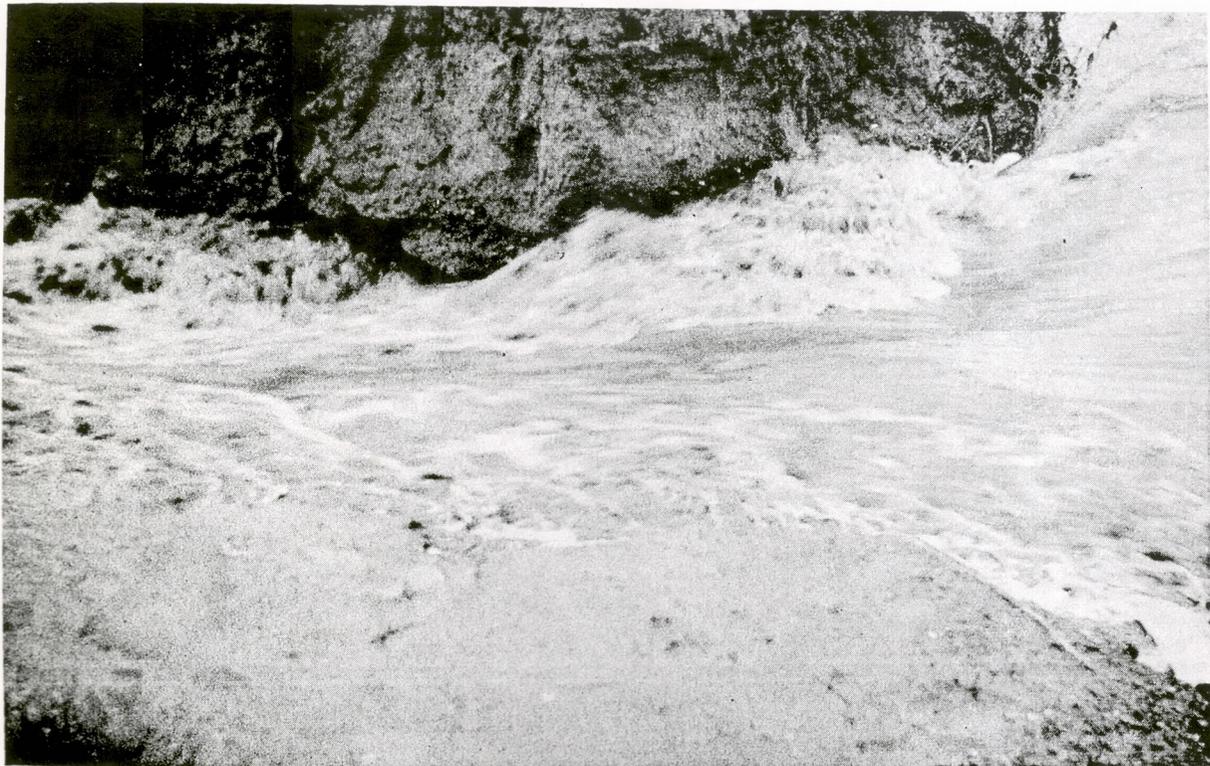
(17) Break at Lateral 10 1/8 10:37 (8/3/43)

The water from the break at Lateral 10 1/8 flowed in a south-westerly direction and combined with the water from the break at Lateral 10 5/8 in the vicinity of the Grand Canal and Central Avenue. The break at Lateral 10 5/8 inundated 7th Street but not sufficiently to entirely stop traffic. Central Avenue and 7th Avenue were inundated from the combined flow of the breaks at 10 5/8, and the one just east of Lateral 12. At 1:00 P.M. it was impossible to travel south of Northern Avenue on either 7th Avenue or Central Avenue.

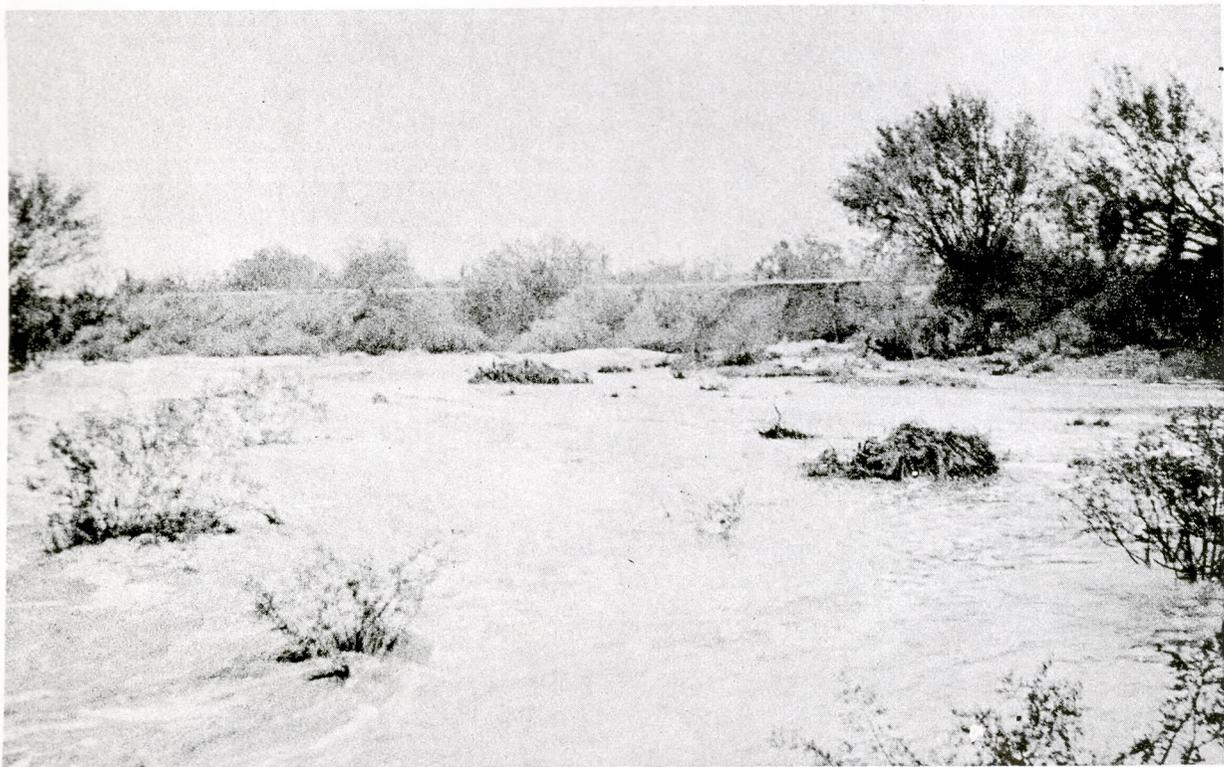
(18) Looking towards break at Lateral 10 1/8 10:45 AM (8/3/43)

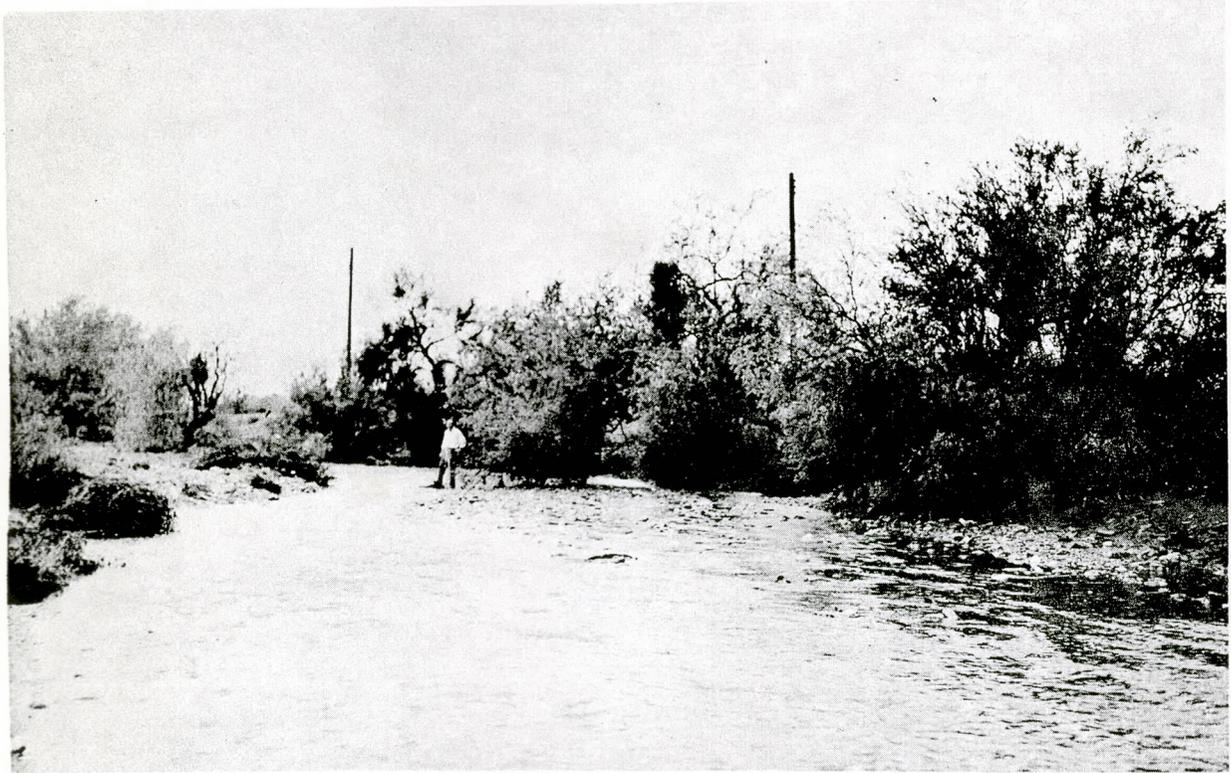
(19) Dreamy Draw opposite Fransen House-one mile north
of Arizona Canal 11:30 AM (8/3/43)

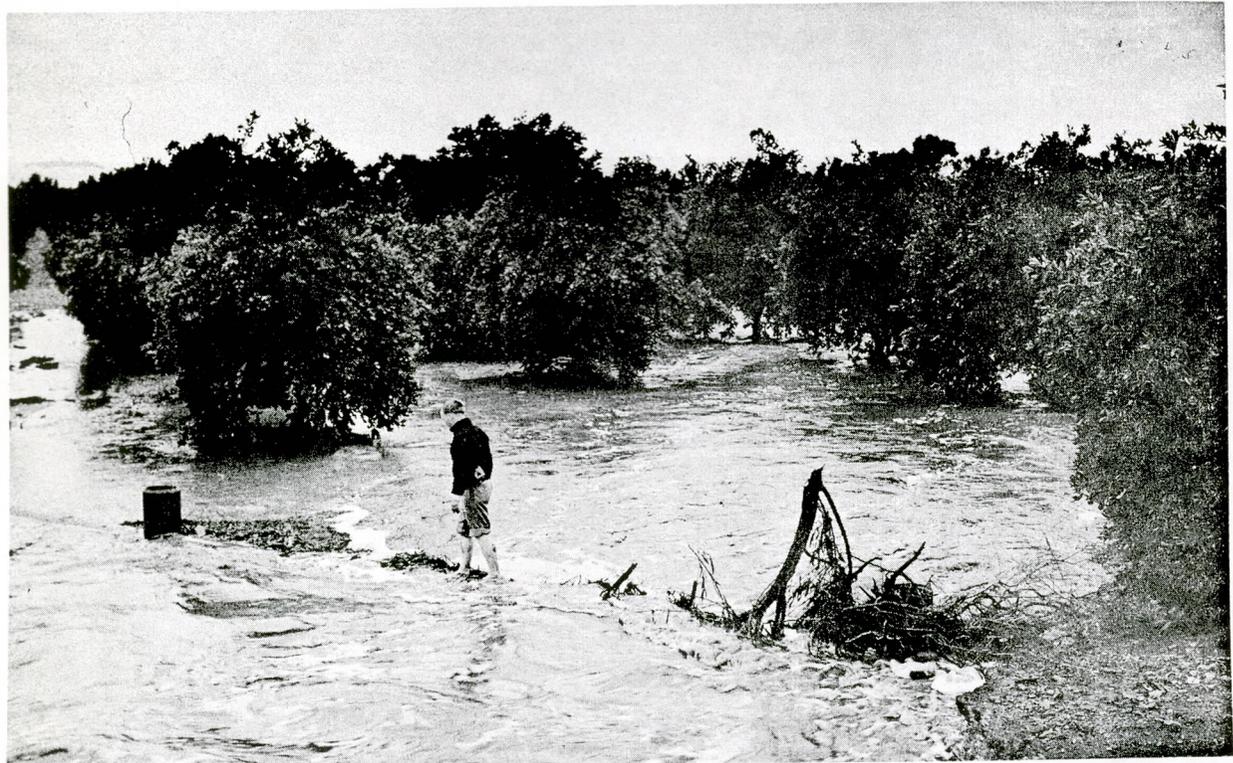
(20) Break in canal 350 ft. south of Northern Ave. 11:35 AM
(8/3/43)

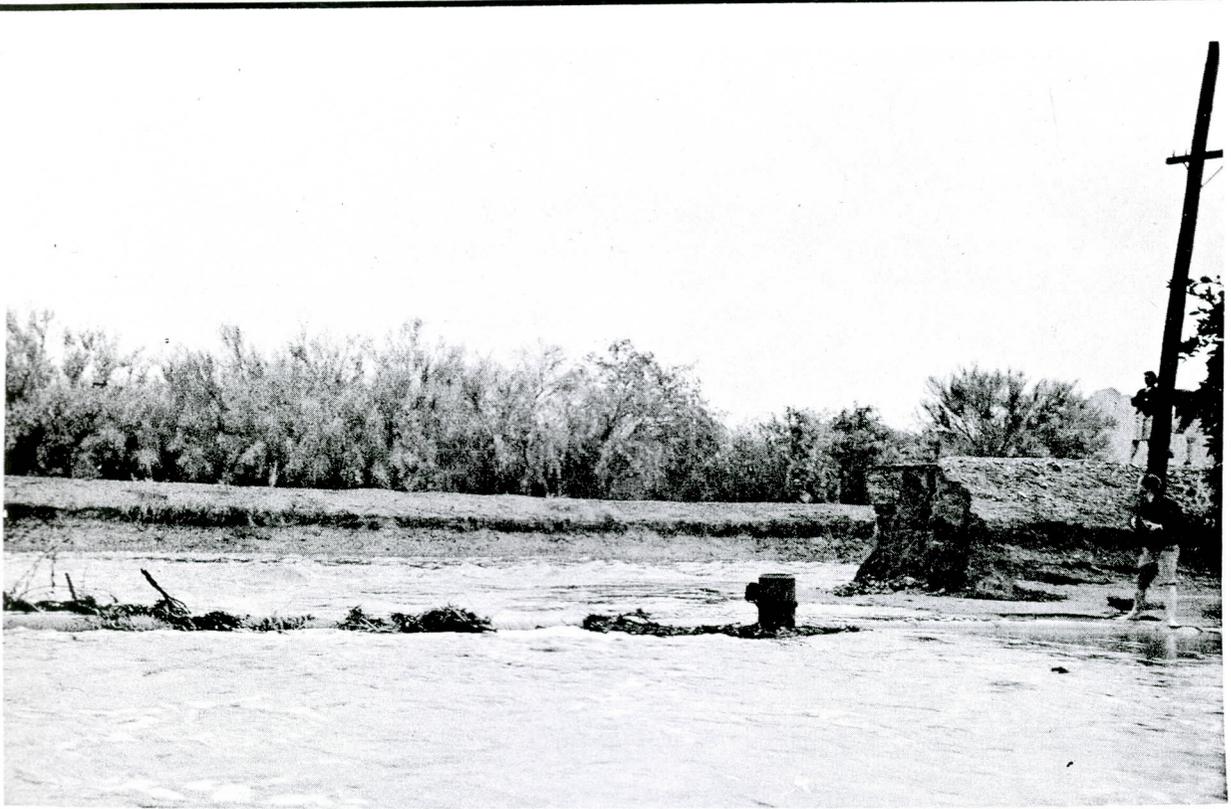
(20a) Break in canal 350 ft. south of Northern Avenue

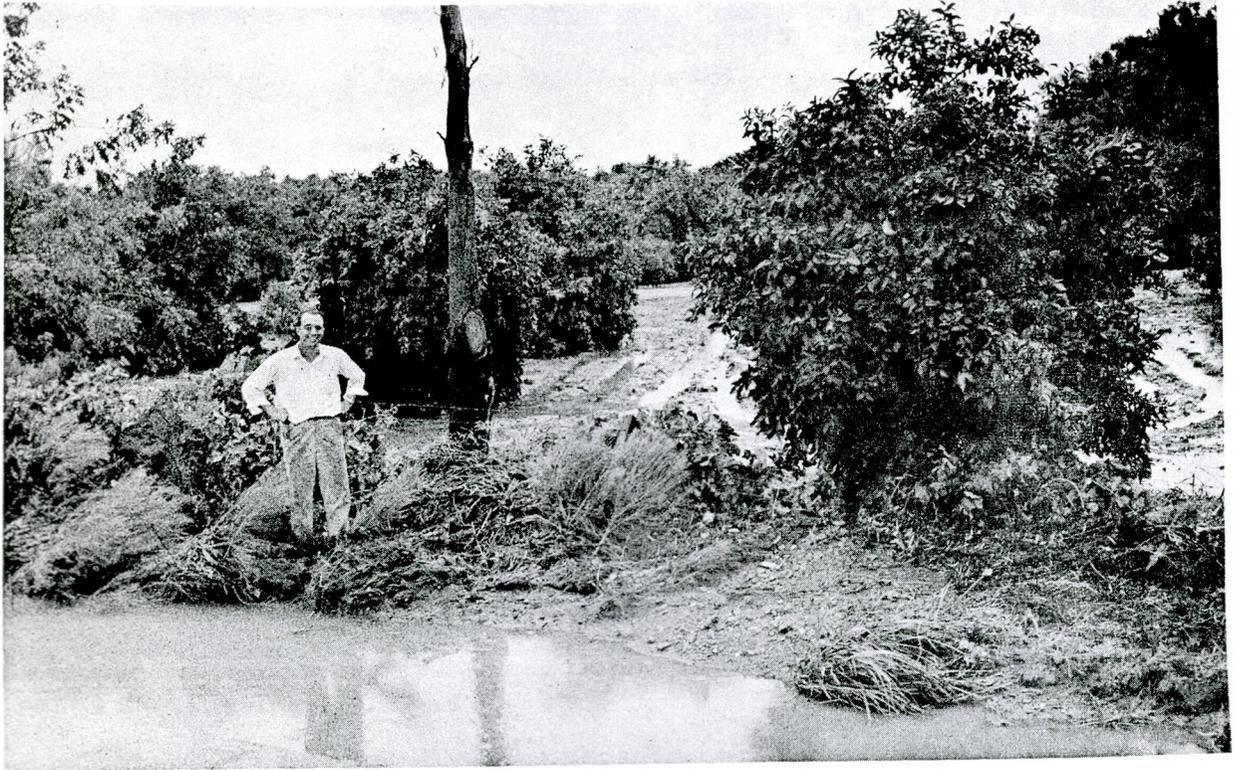
(21) Looking south from Spillway east of 7th Street

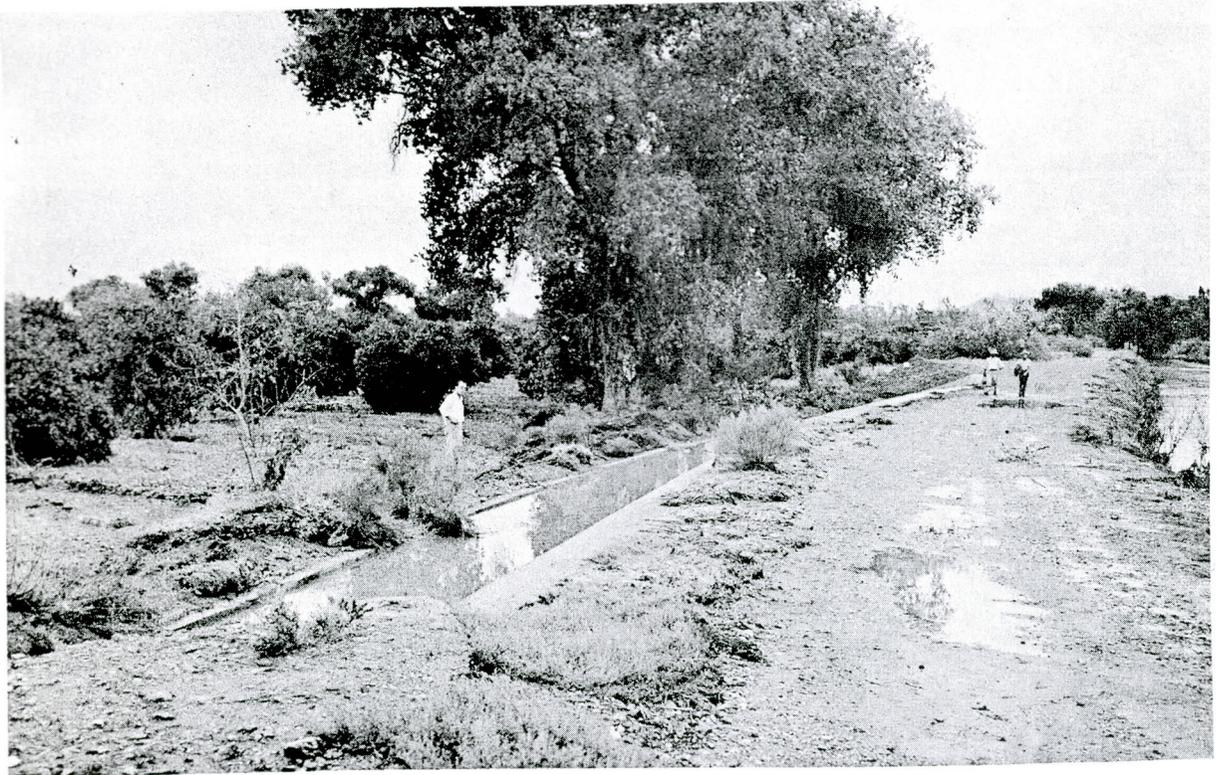
(22) Looking north along Conway Spillway 12:04 PM (8/3/43)

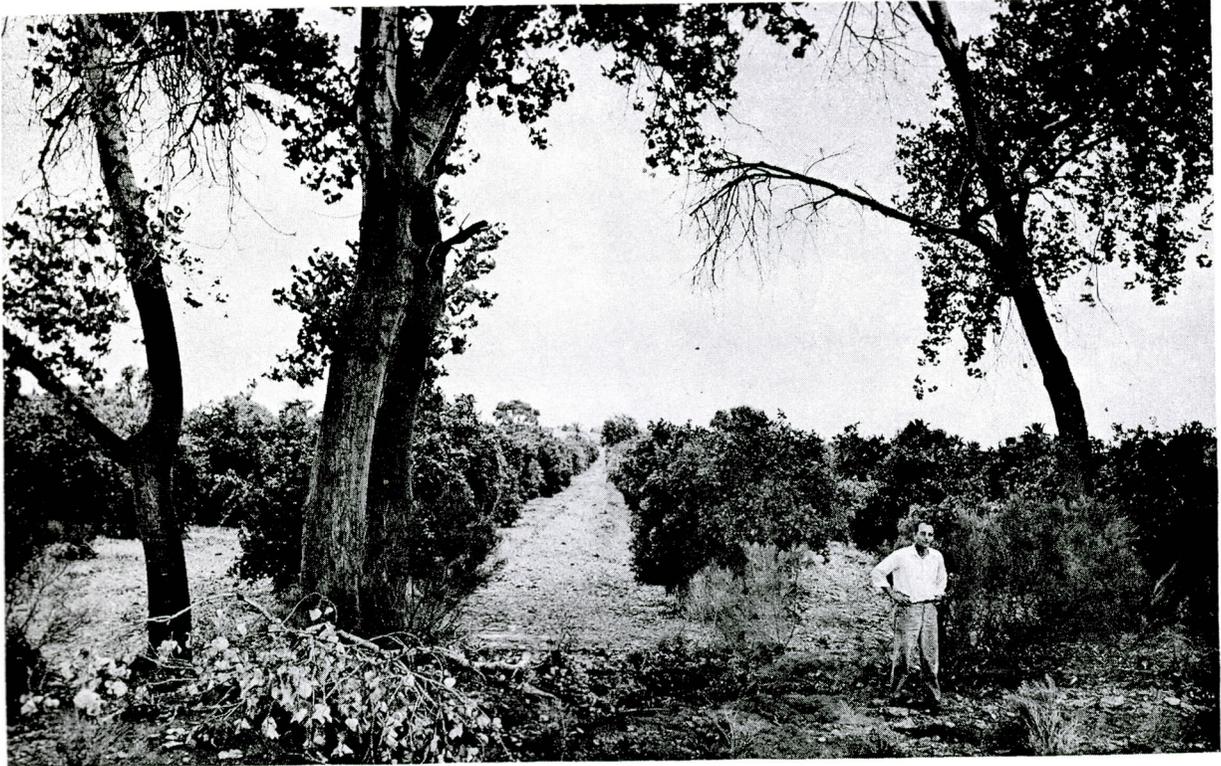
(23) Looking west at Conway Orchard below Spillway 12:08 PM
(8/3/43)
