Salt River Project Report of
North Mountain Flood of
August, 1943

DESERT FLOOD OF AUGUST 3, 1943

To facilitate explanations of conditions this report has been divided into eight areas as indicated on the accompanying map. Locations of pictures are indicated on area maps with the direction of flow of flood waters shown in green and breaks in canal banks shown in red.

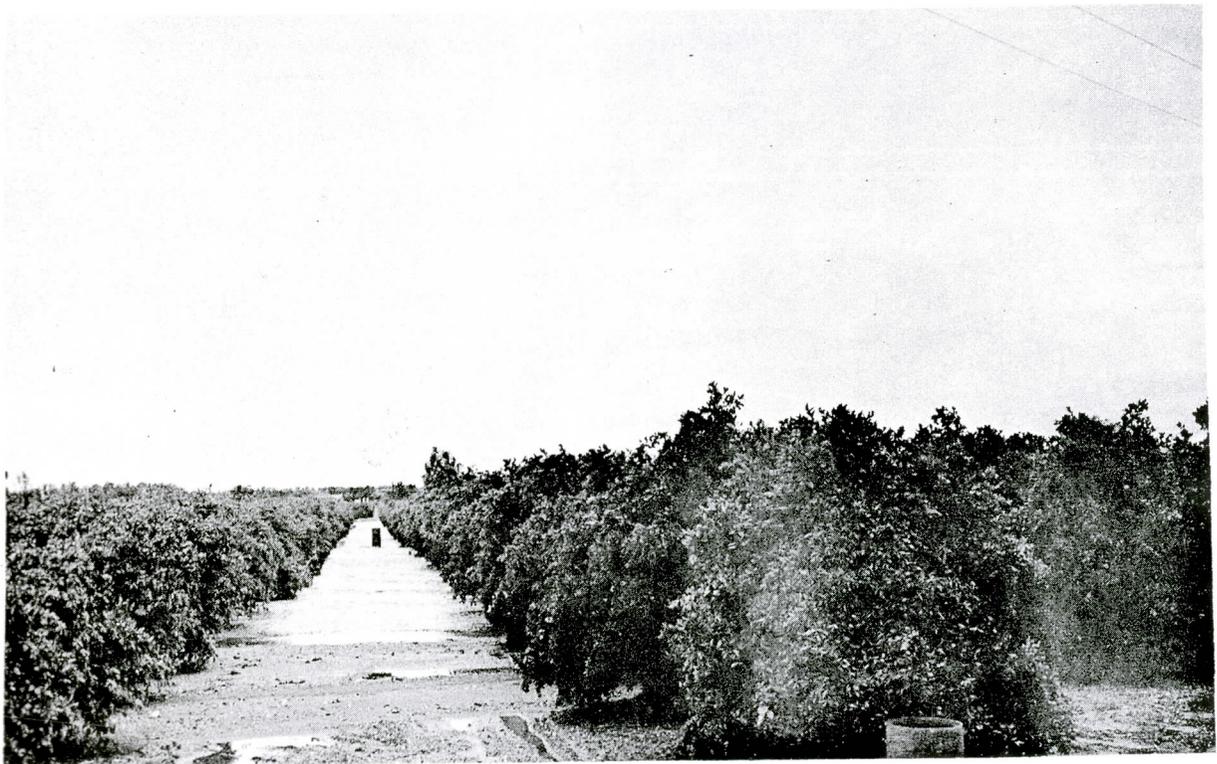
(24) Orchard north of Conway. Water from break near Northern Ave.
12:20 PM (8/3/43)

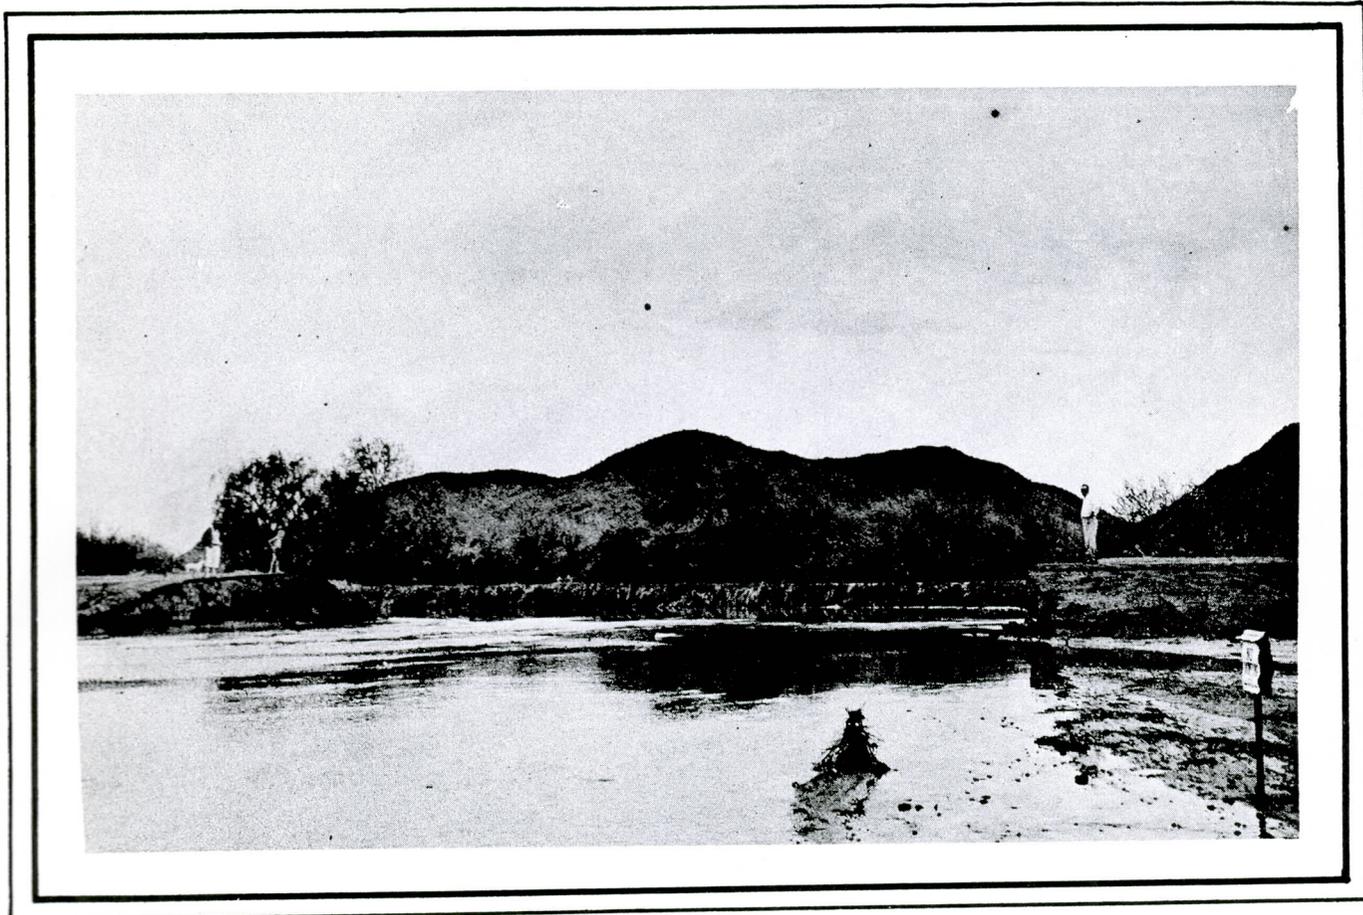
(24a) Break east of Lateral 12.

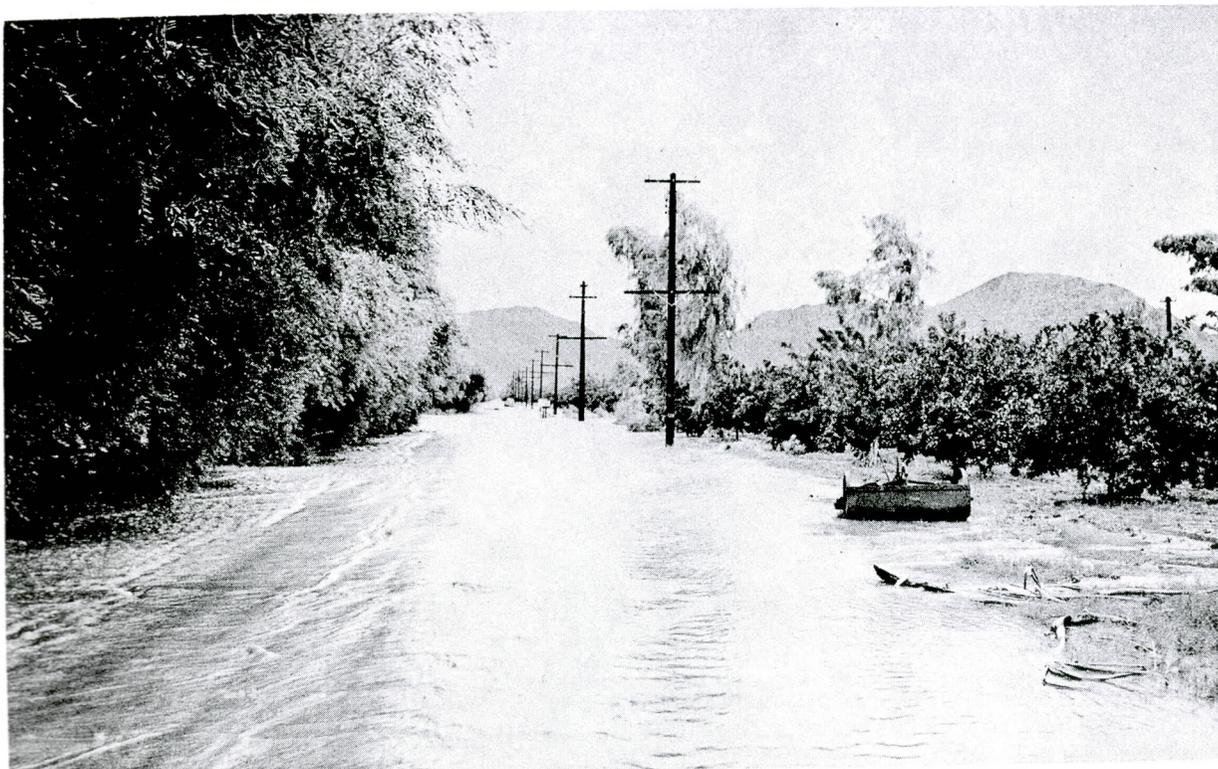
(25) Looking north on 7th Avenue north of Northern 12:54 PM
(8/3/43)

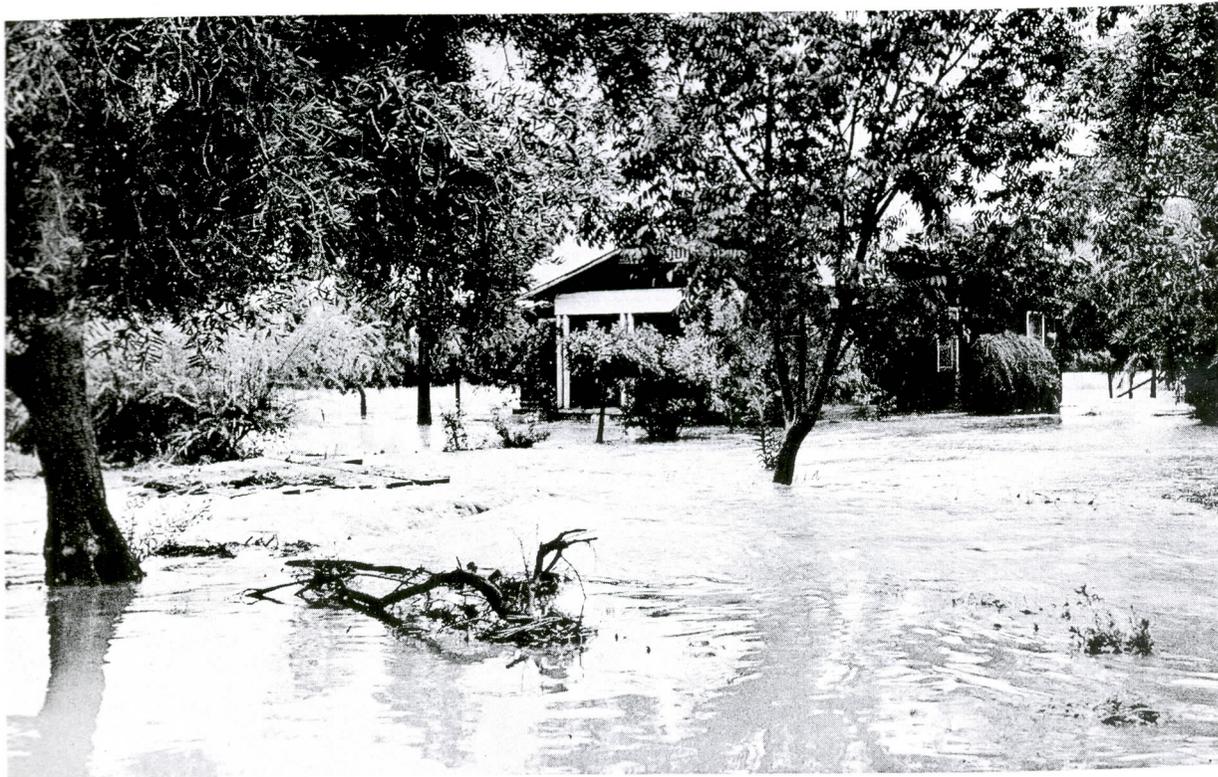
(26) Looking southwest from 7th Avenue south of Northern - Lateral 12 Spillway -
flood waters from break east of Lat. 12 - 1:00 PM (8/3/43)

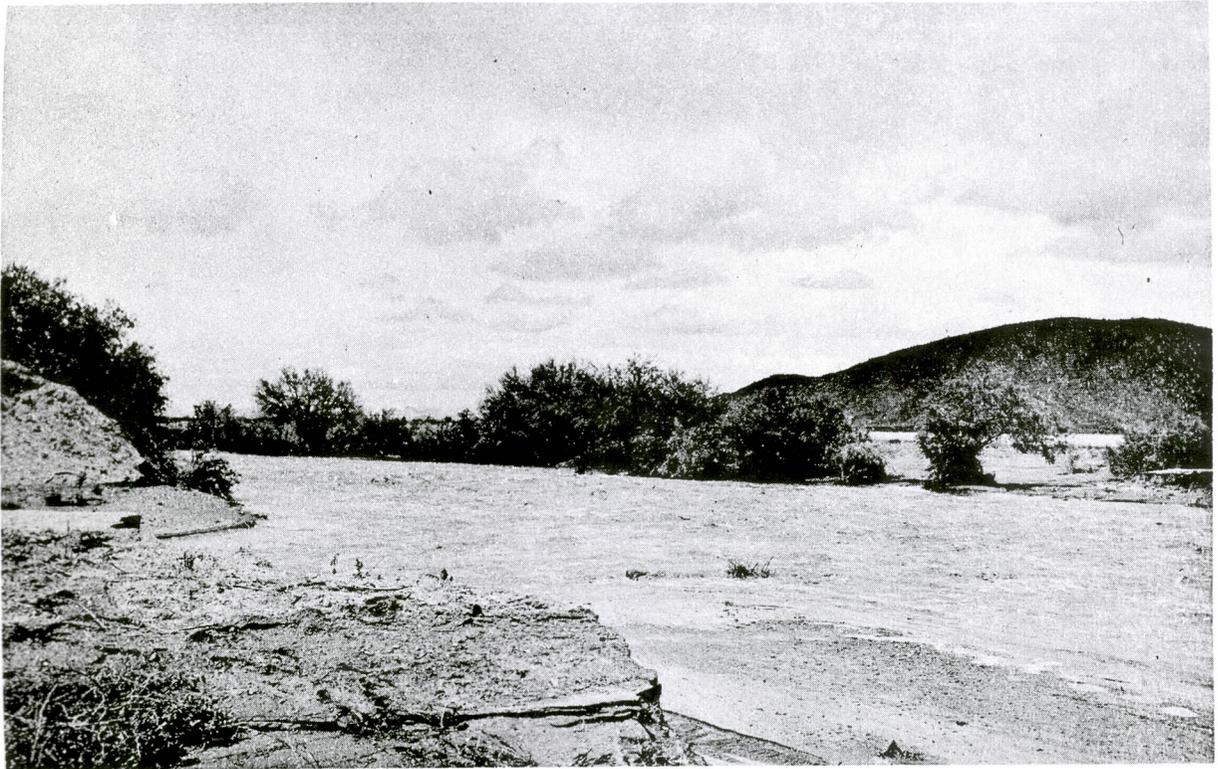
(27) Looking up Main Channel of Cave Creek from west bank of break 3:20 PM (8/3/43)

Water from the Cave Creek break continued southwardly causing considerable damage and averaged 2 1/2 ft. deep from 19th to 23rd. Avenue on Glendale Avenue. Highwater marks showed a maximum depth of 4 ft. at the N.G. Hill equipment yard. At the Bethany Home Road, (10N) the water was split by a slight ridge at 11 1/2E. The major portion of the Cave Creek flood crossed 19th Avenue and continued southwestwardly between 12 and 13 east. The heaviest flow apparently being between 12 1/4 and 12 1/2 east at Bethany Home Road, continuing southwestwardly and striking the Grand Canal immediately east of 19th Avenue. The west branch of the flood waters crossed the Bethany Home Road between 11 1/2 and 11 3/4E, continuing almost directly southwardly and entering the Grand Canal immediately east of the Indian School crossing at 23rd Avenue.

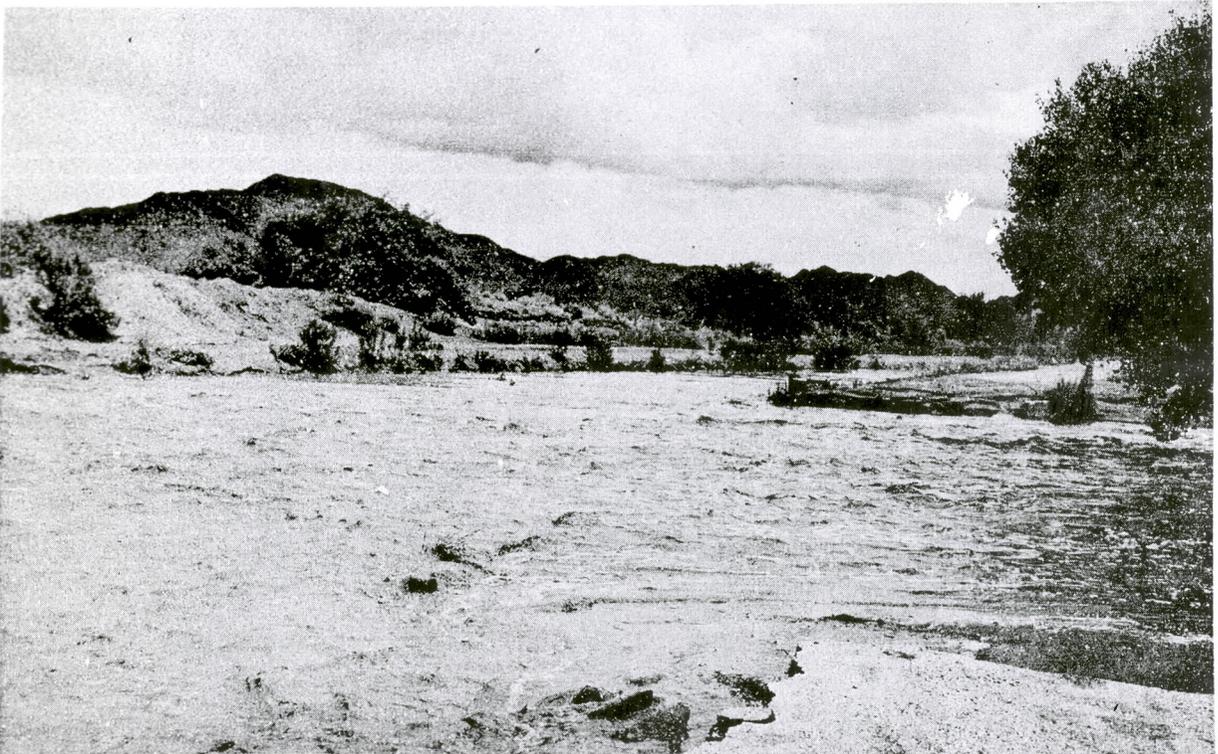
(28) Looking east across Cave Creek break (8/3/43)

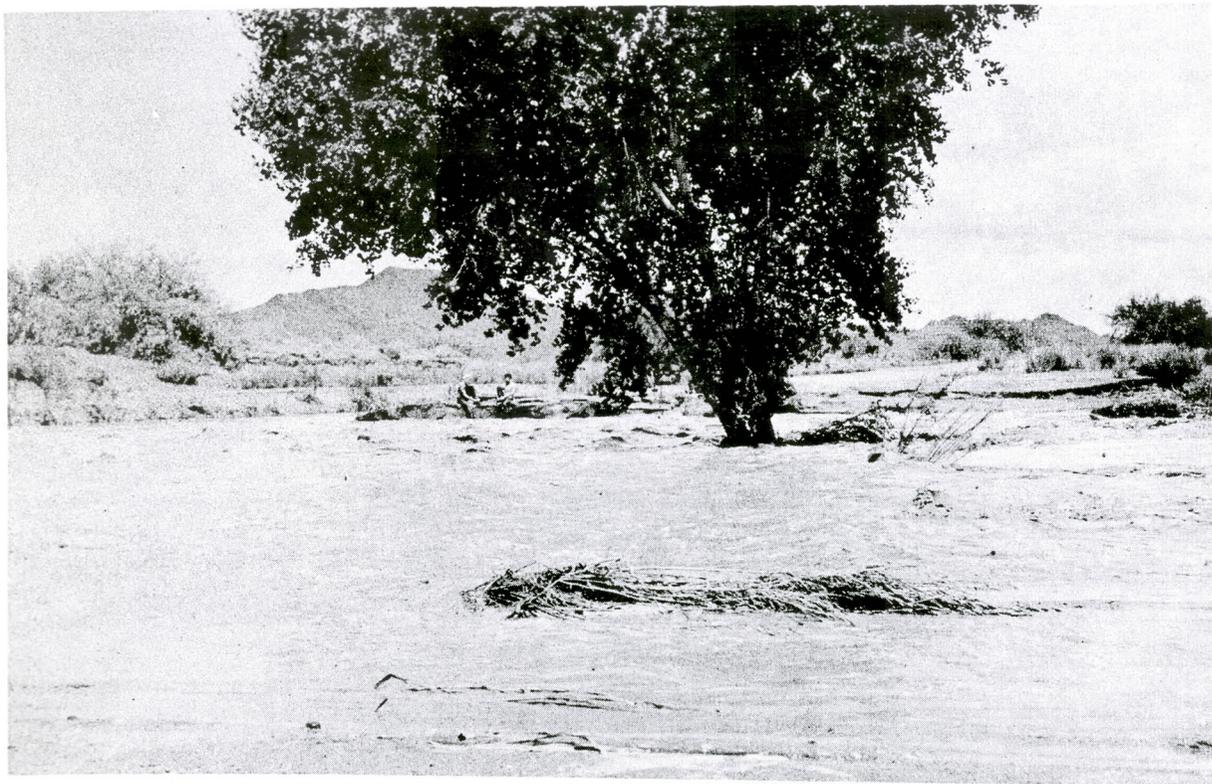
(29) Looking across Cave Creek break 3:25 PM (8/3/43)

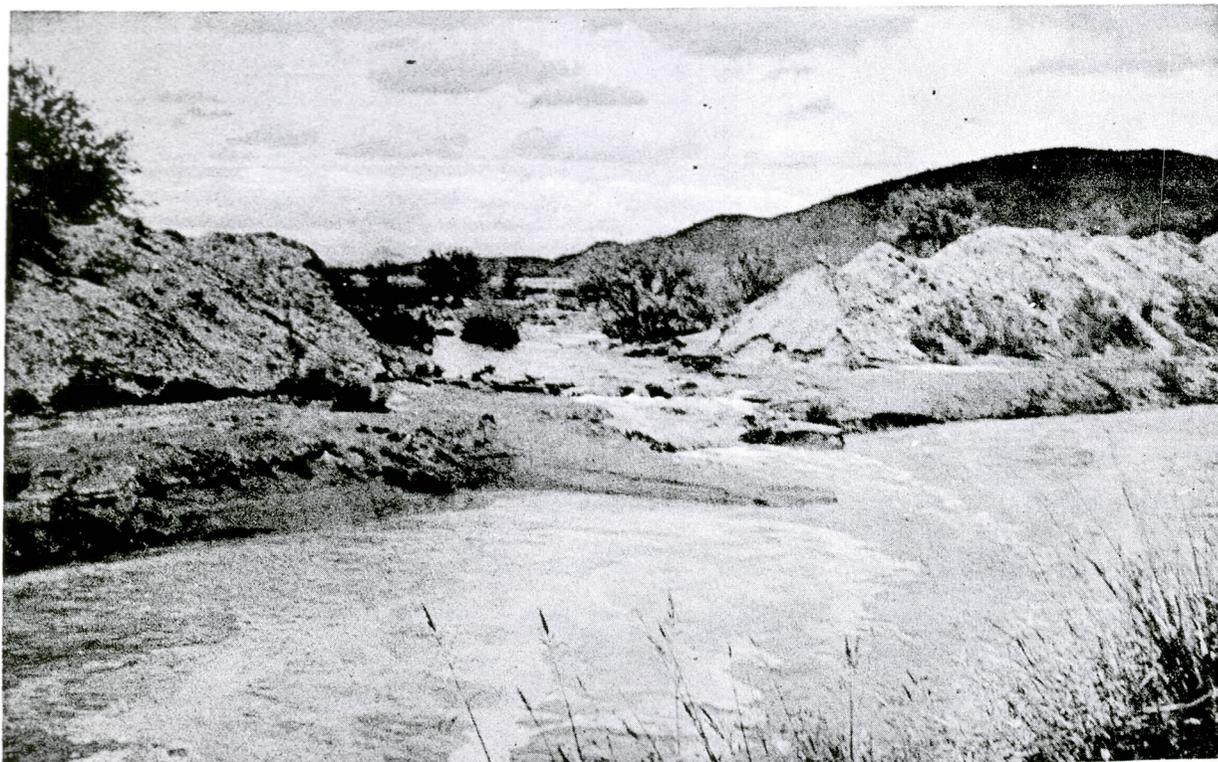
(30) Inflow from west branch of Cave Creek 3:40 PM (8/3/43)

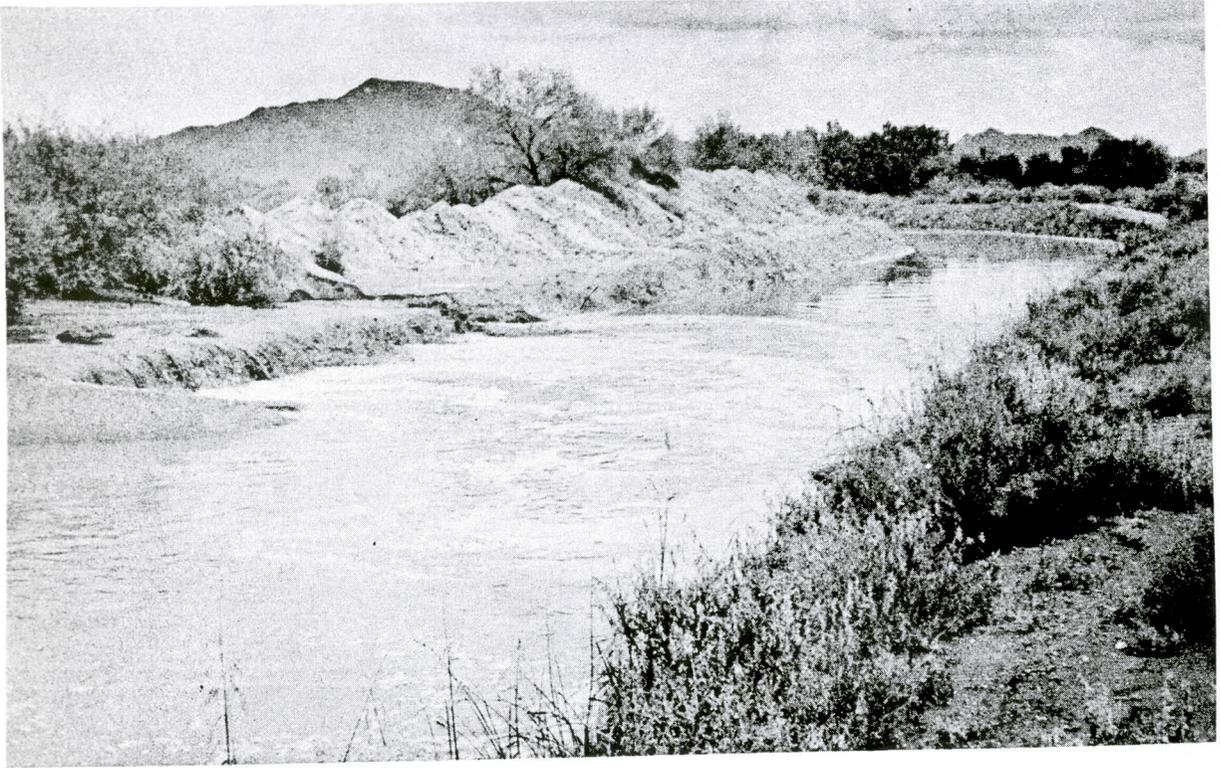
(31) Inflow from Cave Creek east of Lateral 14 3:45 PM (8/3/43)

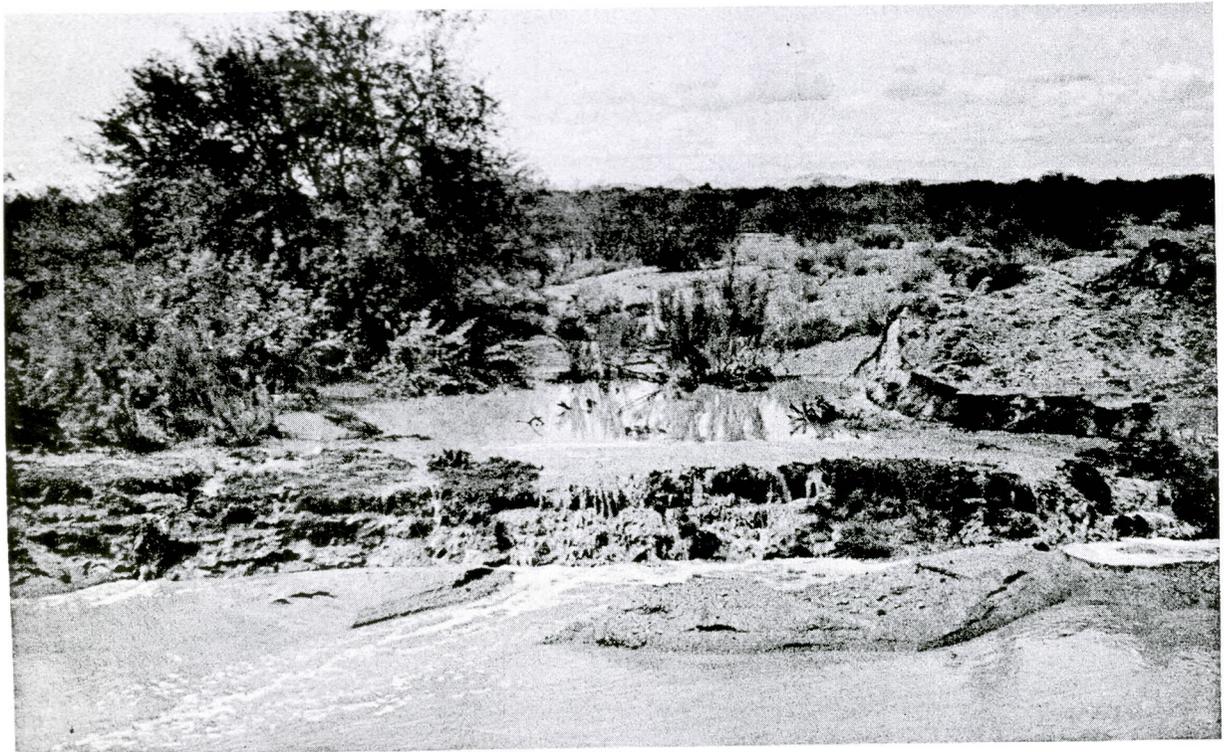
(32) Inflow east of Lateral 14 3:47 PM (8/3/43)

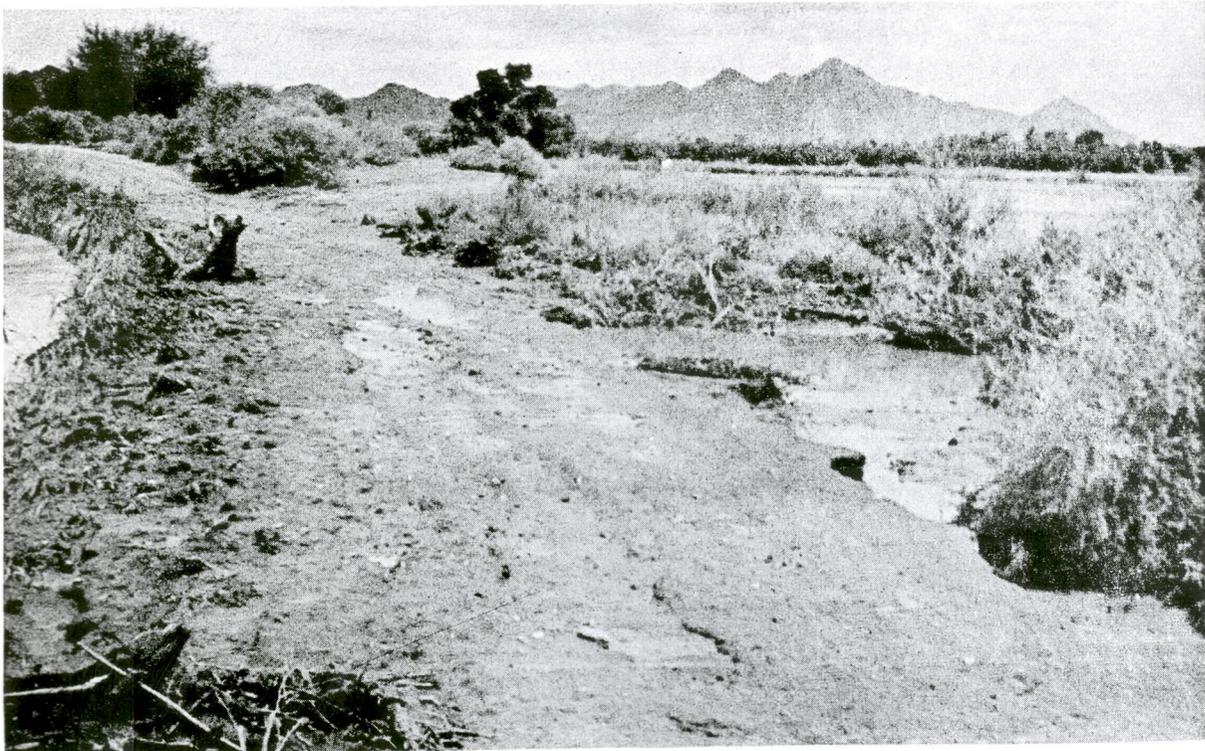
(33) East of Lateral 14. Looking east at damage to canal banks by overflow 3:47 PM (8/3/43)

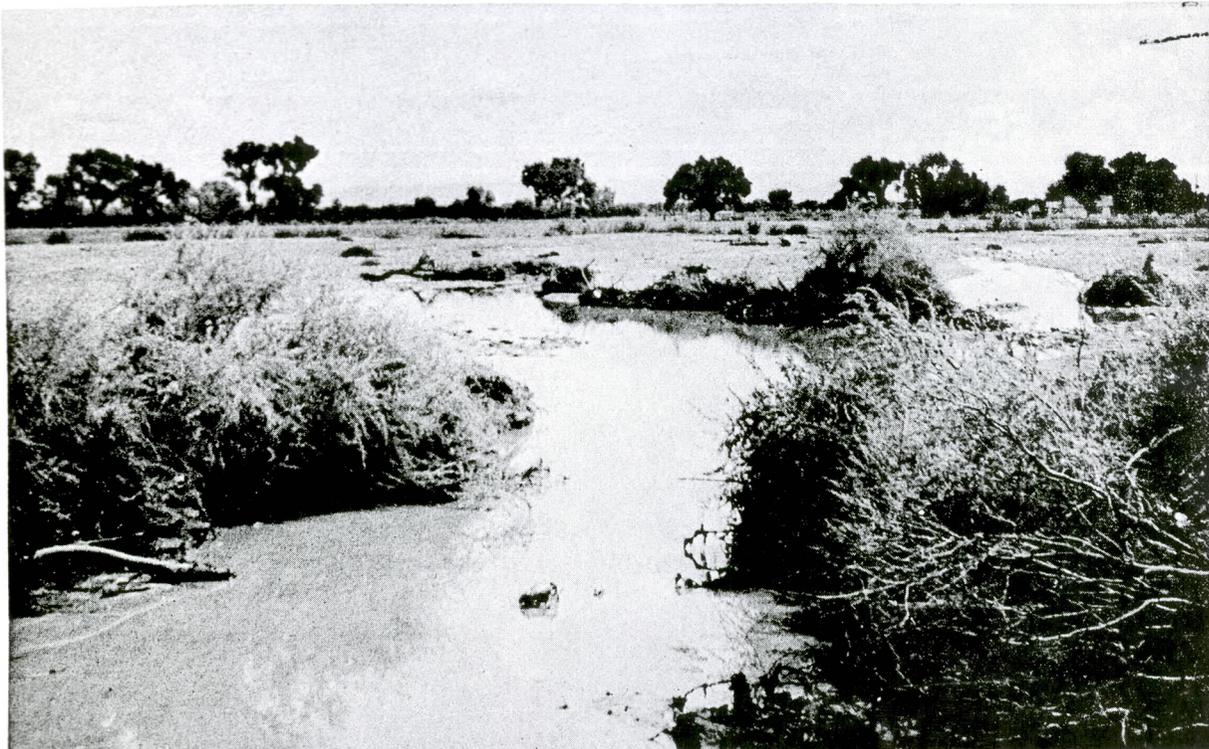
(34) Looking south from Arizona Canal east of Lateral 14. Frank Kinnley land below breaks (8/3/43)

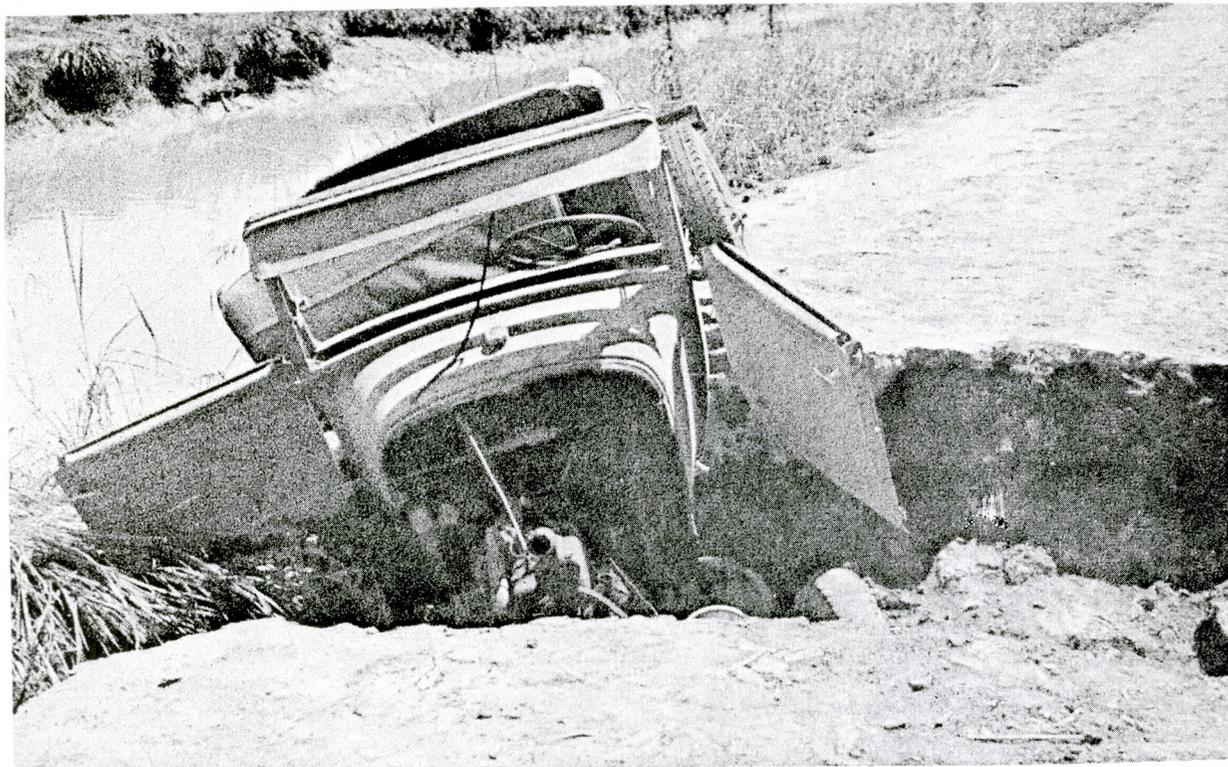
(35) Fourth break east of Lateral 19 1:30 PM (8/5/43)

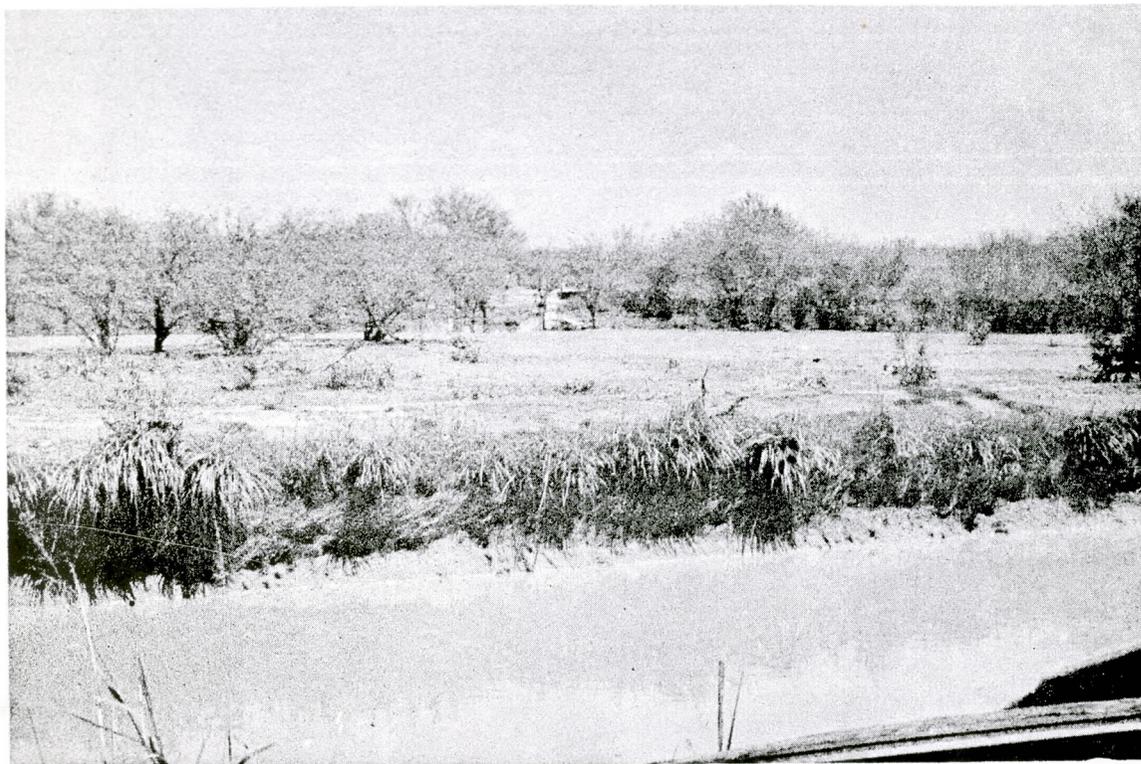
(36) Looking north from fourth break east of Lateral 19 (8/5/43)

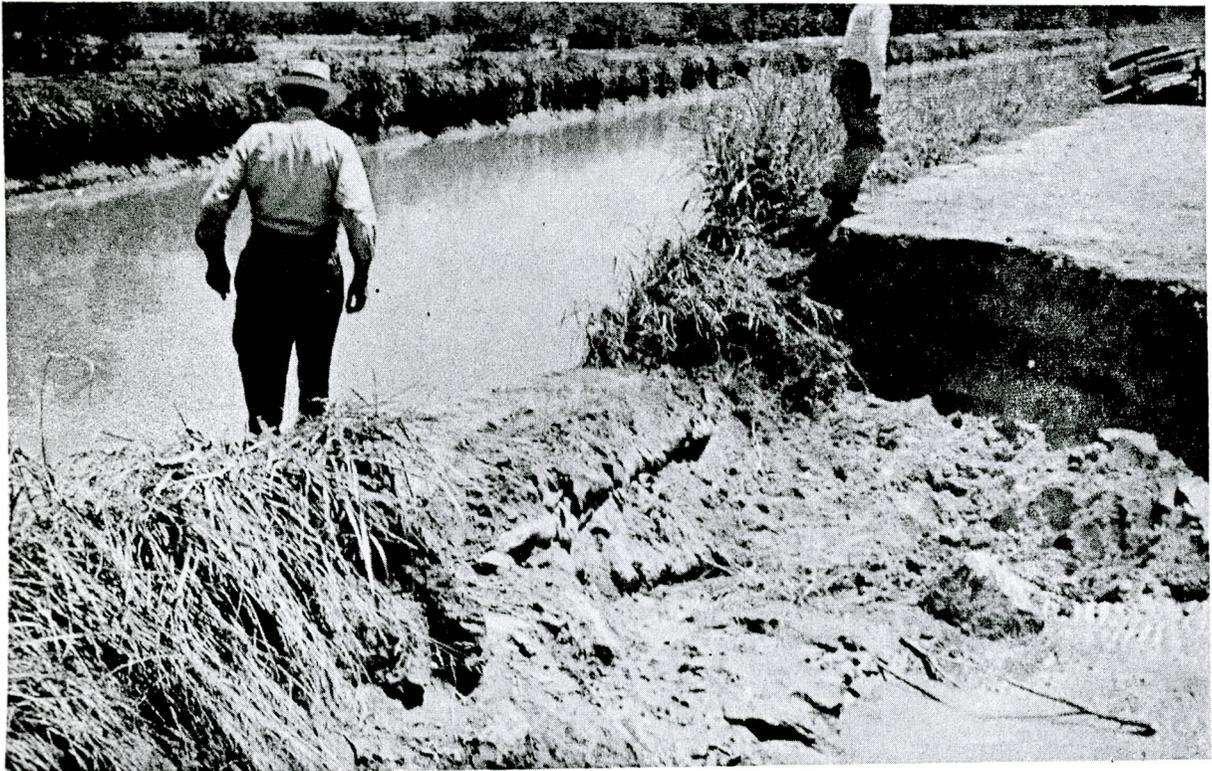
(37) Third break east of Lateral 19 (8/5/43)

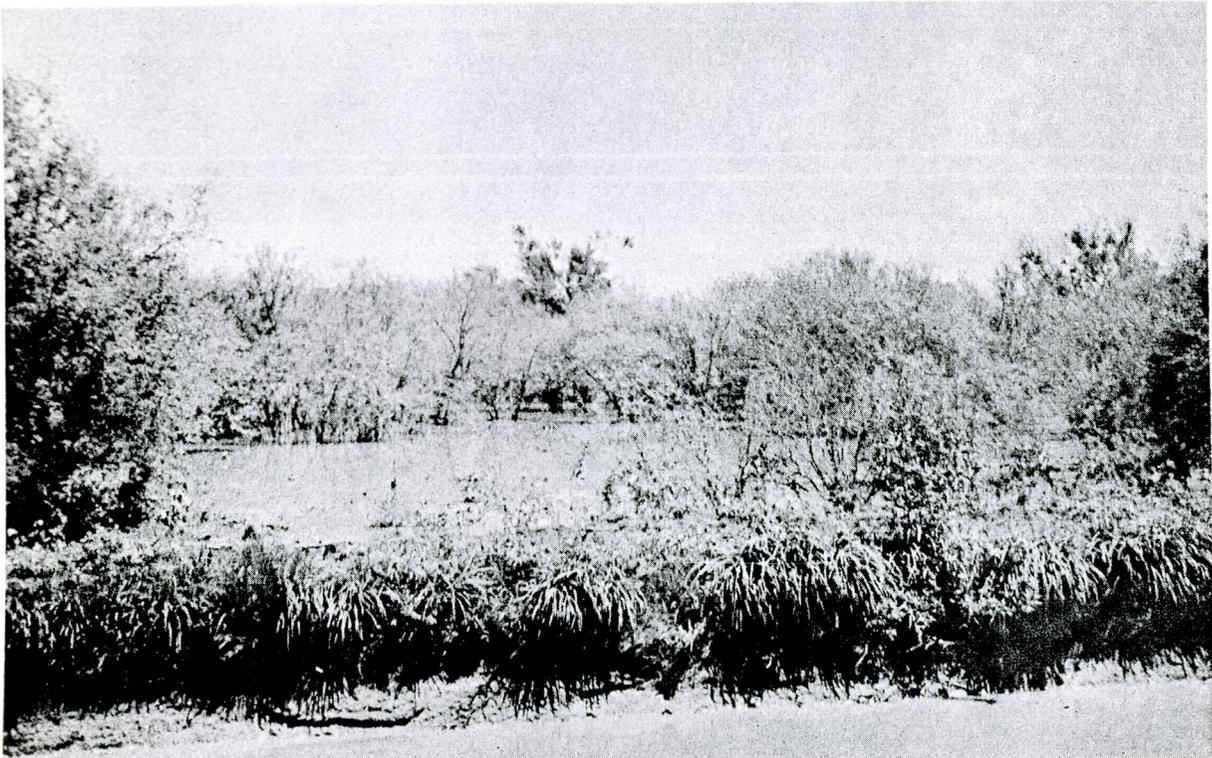
(38) Looking north from Lateral 18 3/4 (8/5/43)

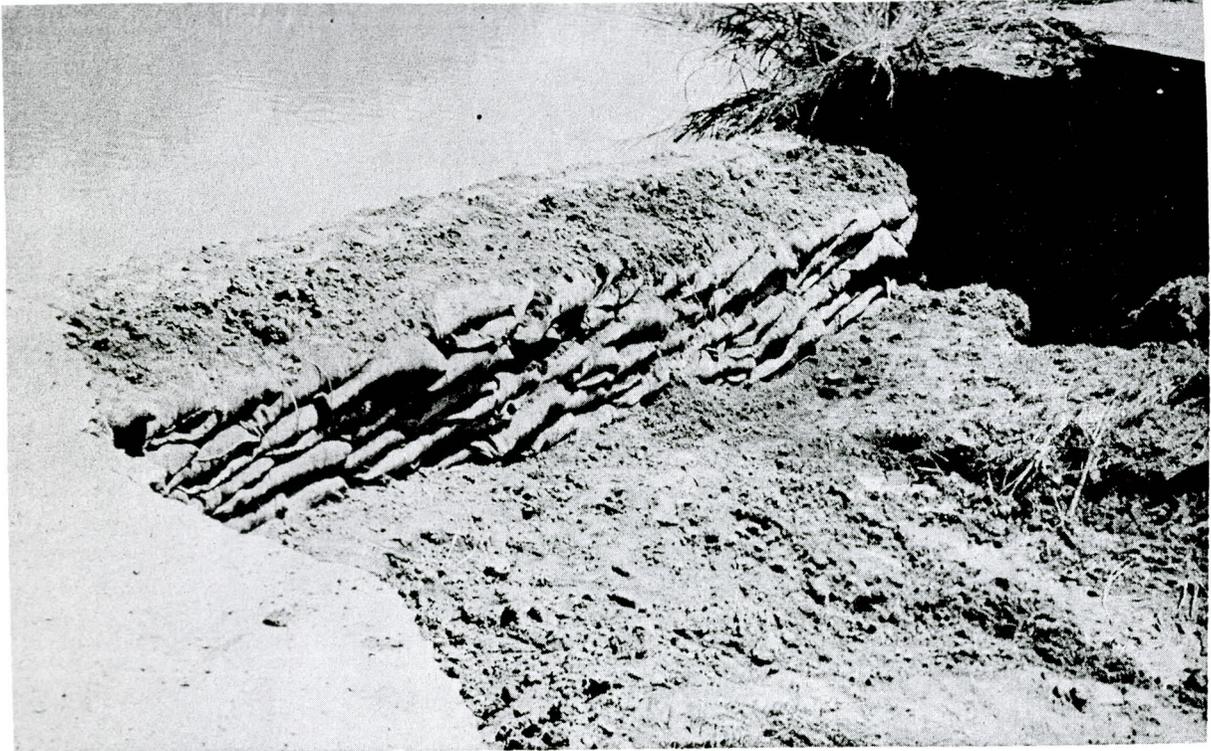
(39) First break east of Lateral 19 (8/5/43)

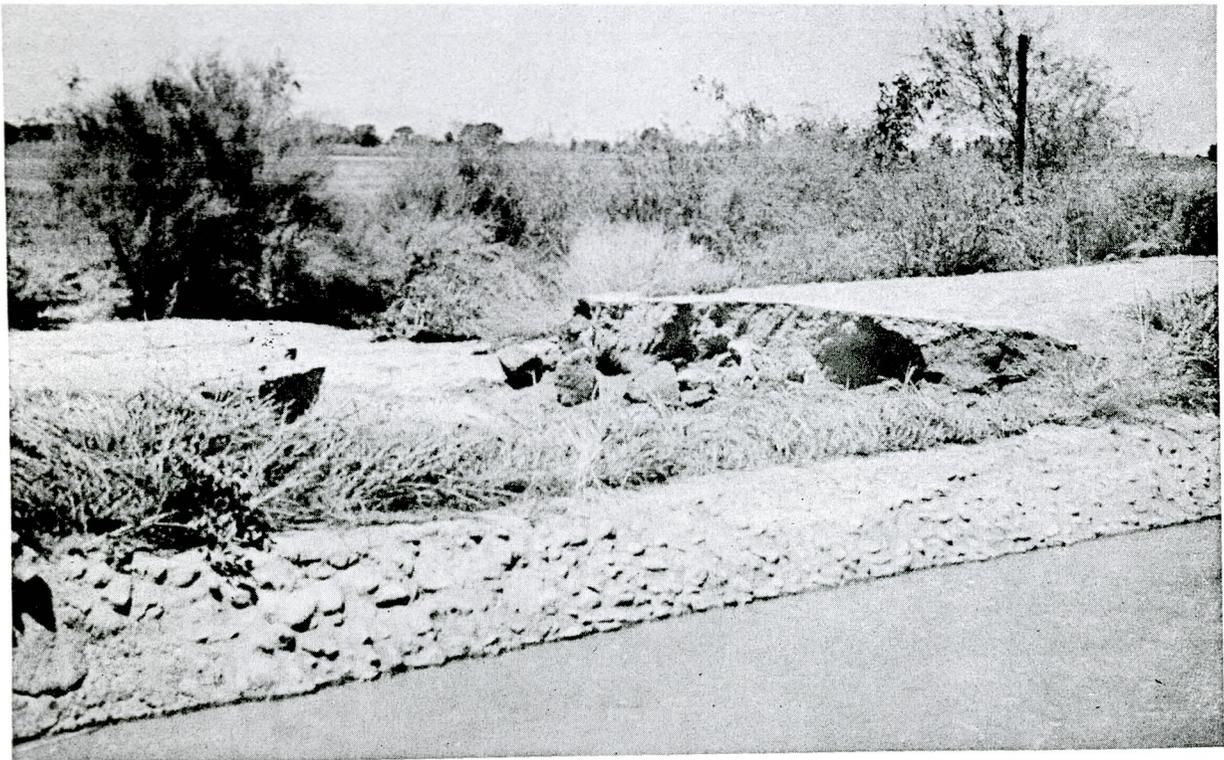
(40) One of two breaks west of Lateral 19 (8/5/43)

2 breaks occurred in the south bank between Lateral 19 and Lateral 20. The first being approximately 50 ft. west of Lateral 19, and the other 600 ft. west. Indications of overflow of the south bank were found at Lateral 19 1/8 and Lateral 19 1/4. The inflow between Lateral 18 and Lateral 20 appeared to contain some overflow from the Skunk Creek drainage areas.

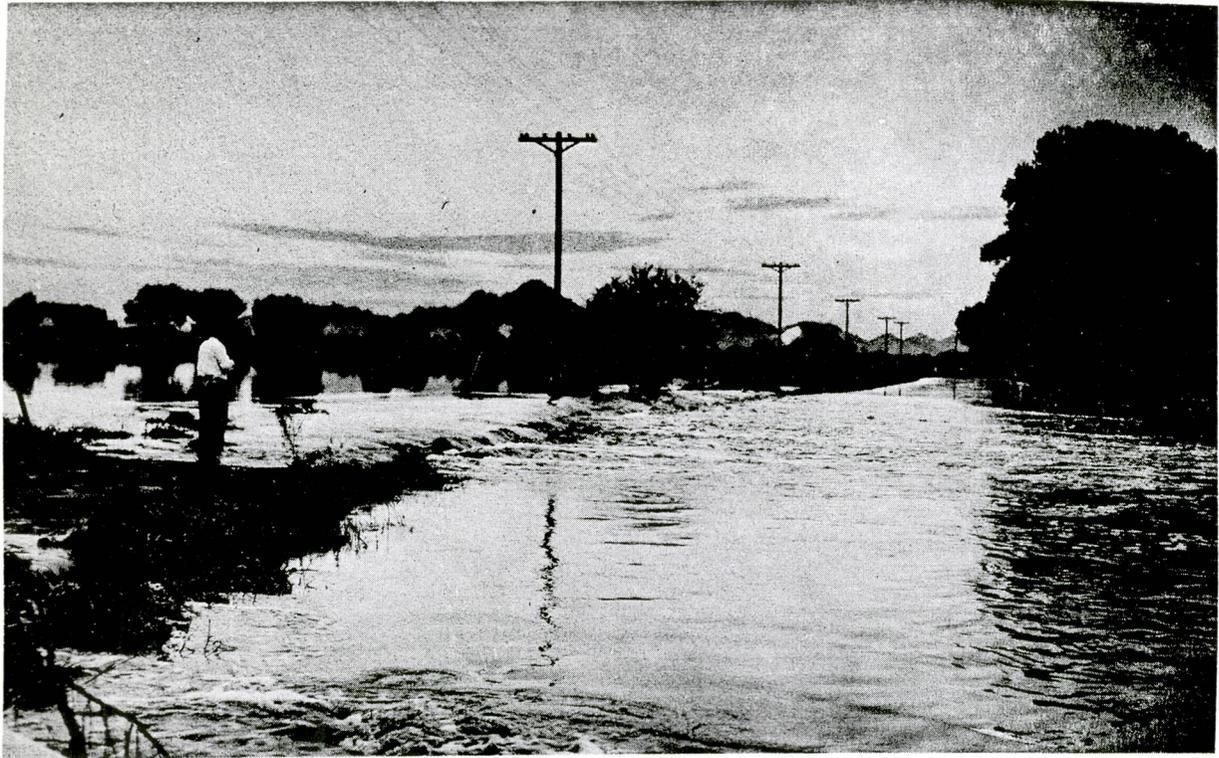
(41) Inflow east of Lateral 13 on Grand Canal 6:00PM (8/3/43)

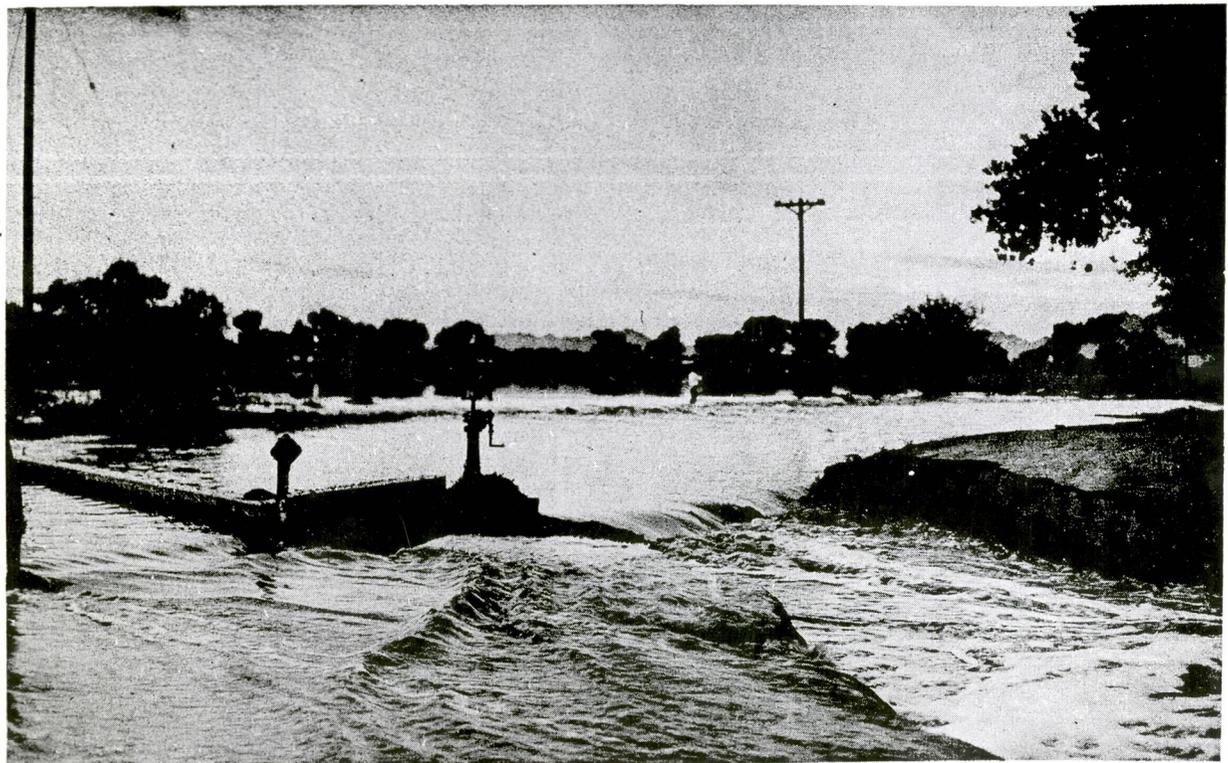
(42) Lateral 13 on Grand Canal 6:05 PM (8/3/43)

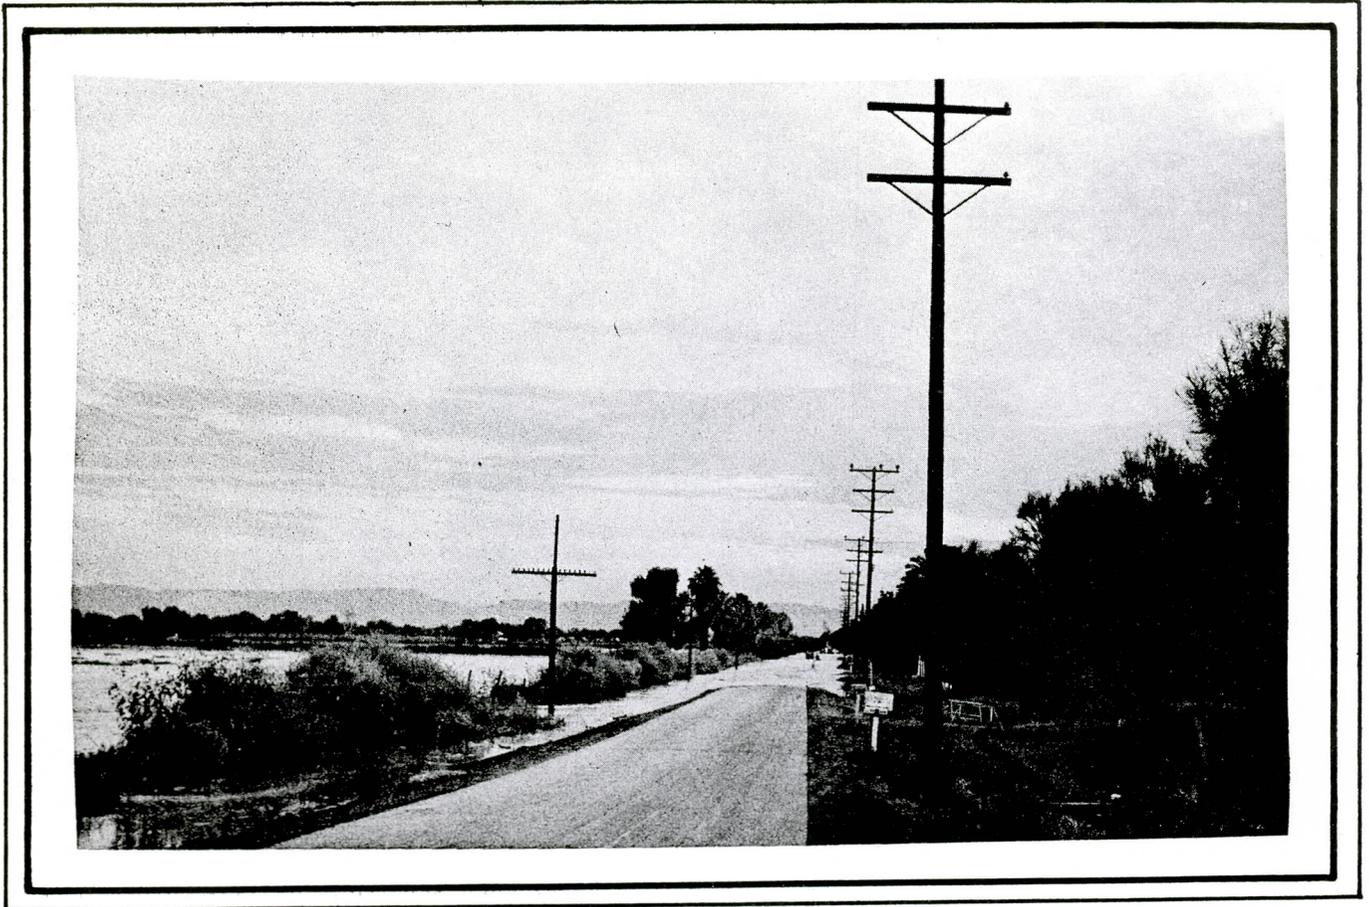
(44) Looking south on 19th? 6:25 PM (8/3/43)
27th Ave.

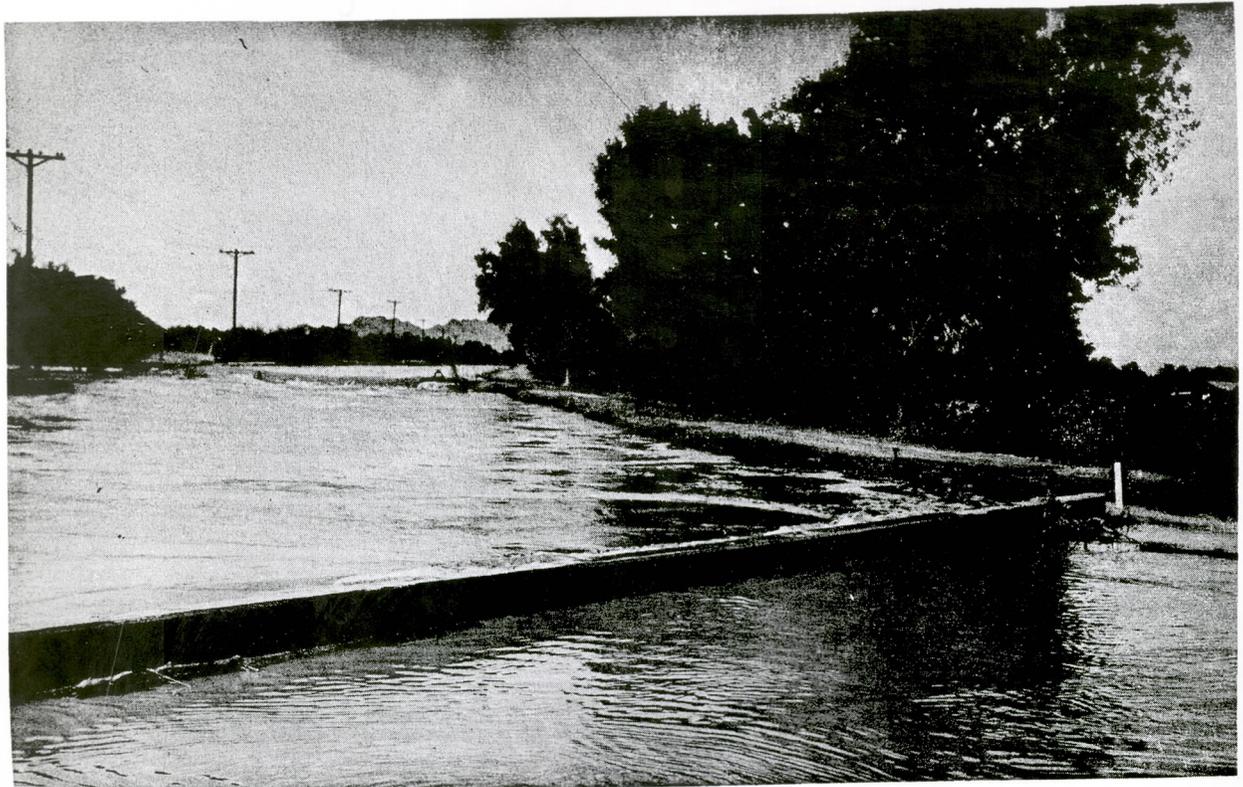
(45) Looking east from Indian School Road east
of 23rd Avenue 5:15 PM (8/3/43)

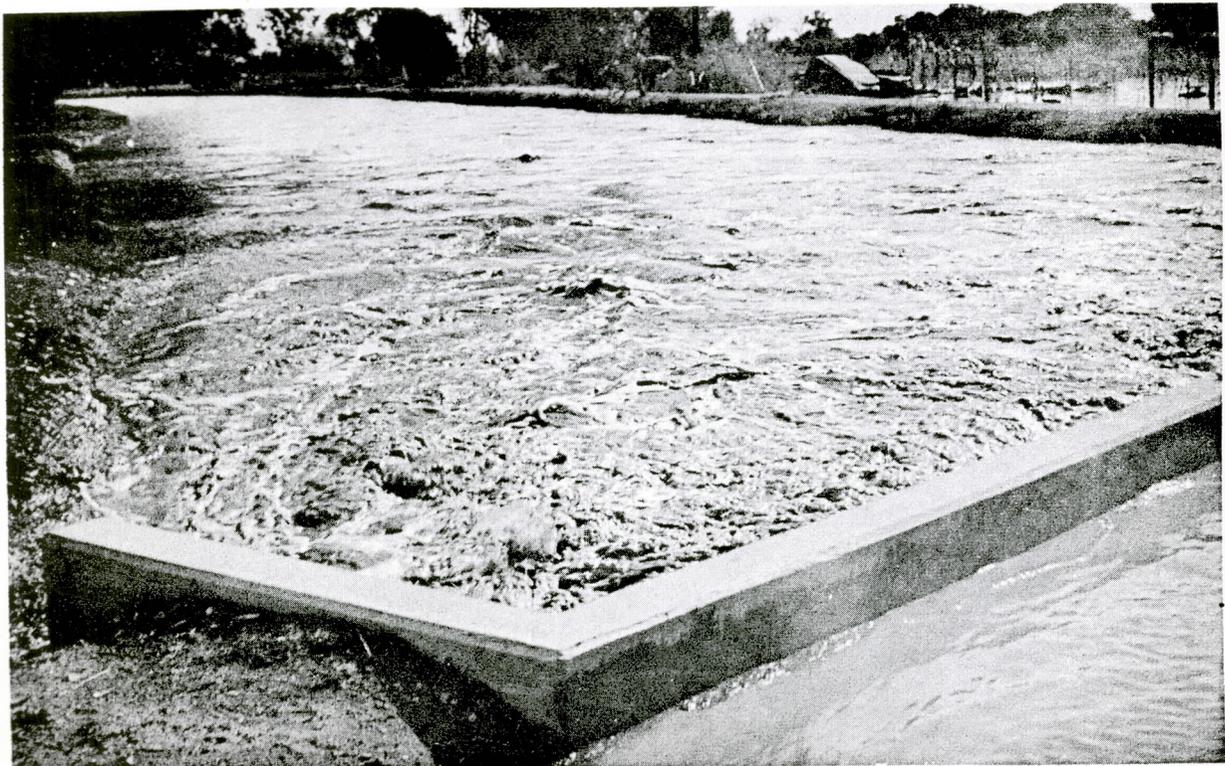
(46) Looking west from same point
