Salt River Project Report of
North Mountain Flood of
August, 1943

DESERT FLOOD OF AUGUST 3, 1943

To facilitate explanations of conditions this report has been divided into eight areas as indicated on the accompanying map. Locations of pictures are indicated on area maps with the direction of flow of flood waters shown in green and breaks in canal banks shown in red.

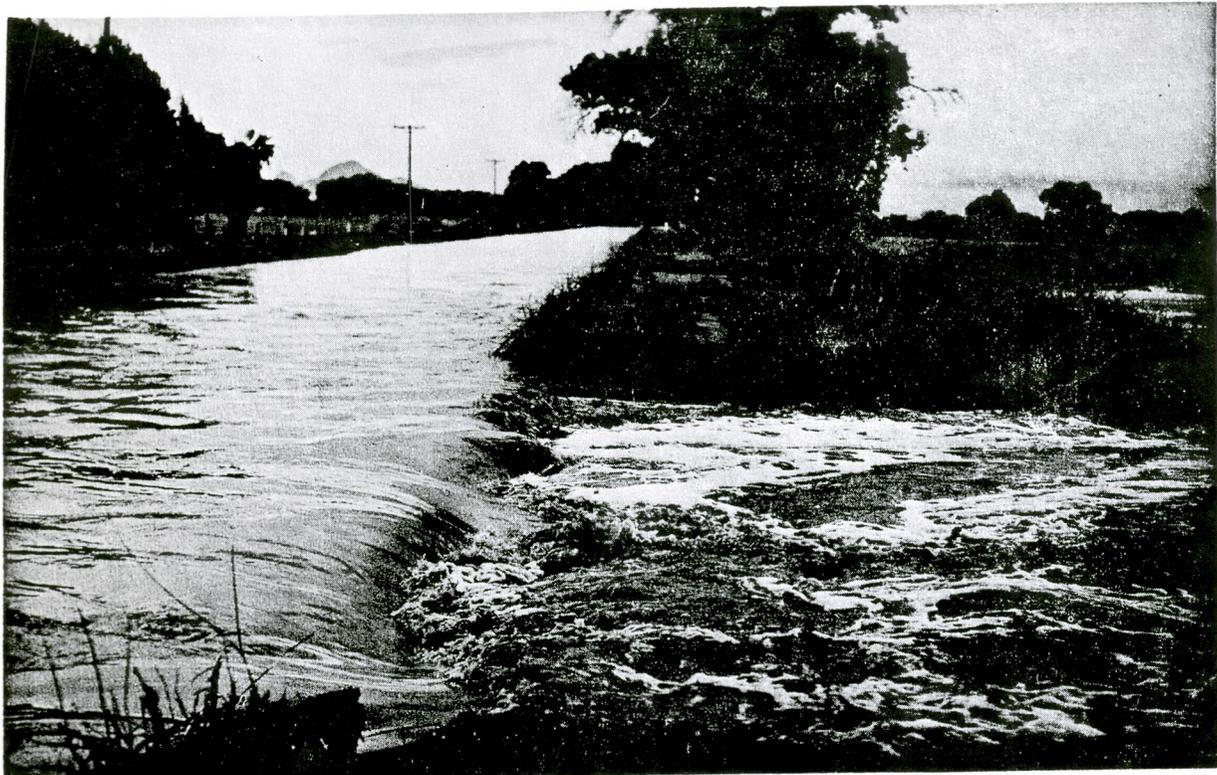
(47) Break east of Lateral 14 on Grand 5:30 PM (8/3/43)

Water from the breaks at Lateral 14 flowed southeastwardly along Grand Avenue to Six Points, then south along the Santa Fe Railway.

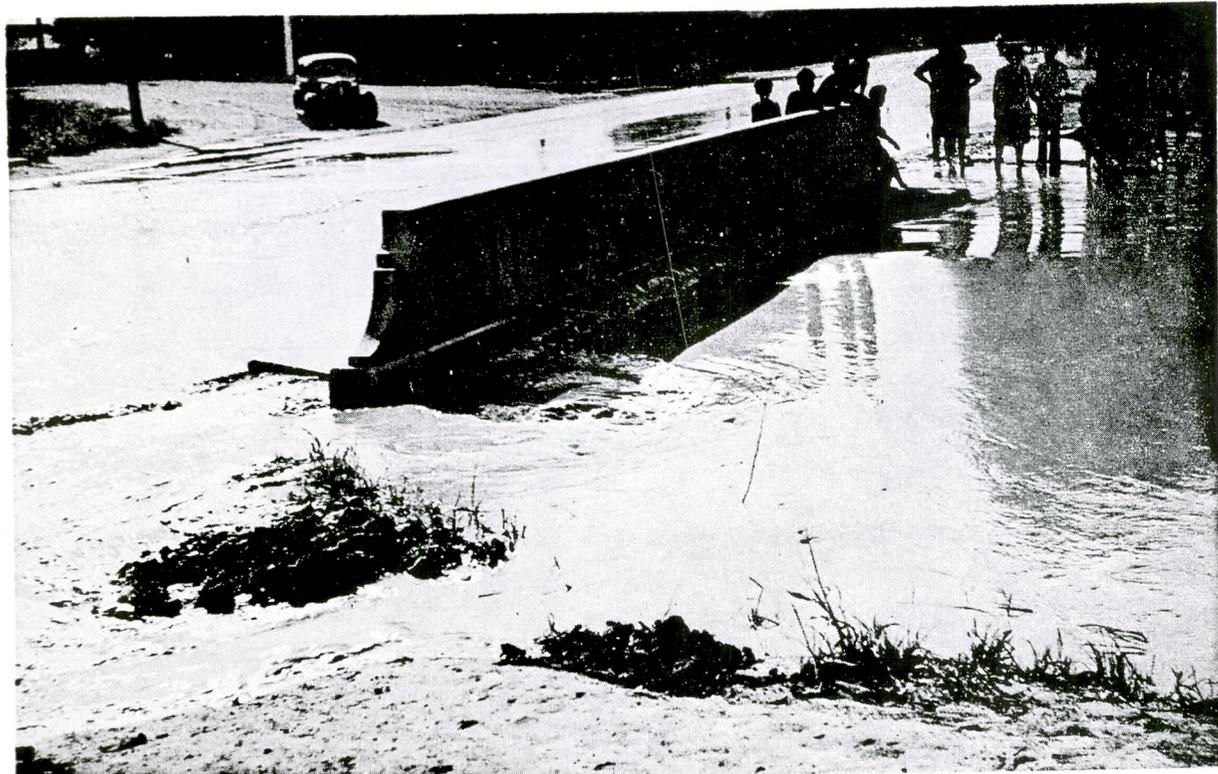
(48) Grand Canal at Grand Ave. 5:35 PM (8/3/43)
