CAREFREE DRAINAGE MASTER PLAN EXECUTIVE SUMMARY REPORT

Carefree, Arizona

Carefree Drainage Master Plan Executive Summary

May 2004

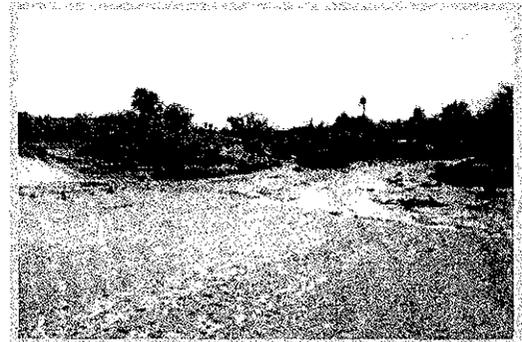
FIGURE 16. WATER OVER ROADWAY – PIMA ROAD NEAR SHORT PUTT PL.

Many of the problems within the Town can be considered nuisance problems, without immediate danger to loss of life or property damage. Additionally, some of the problems are considered localized and affect only the immediate area surrounding the drainage feature. (Figures 16 and 17.)

Galloway Wash flows over Pima Road near Short Putt Place, with a 100-year future flow of 1,260 cfs. An existing floodplain and floodway map shows the overtopping flow to split to the north and south and surround an existing house with floodwaters. The proposed improvements, five-11 feet x 3 feet 6 inches corrugated metal pipe arches, are designed to eliminate the flow around one side of the house, thus improving the flooding situation on that property. Revising the floodplain map with FEMA and Maricopa County showing this change in condition would be advantageous.

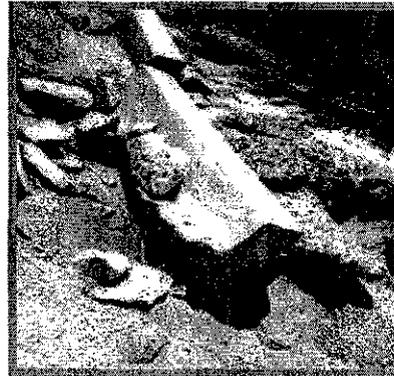
FIGURE 18. DAMAGE TO
DOWNSTREAM CUT-OFF WALL

Localized erosion also contributes to damage (Figure 18), particularly on the downstream side of culverts and at-grade crossings. Failure of many erosion protection measures is evident in the Town. Continued erosion could cause damage to roadways and private properties. Table ES-1 in Appendix E contains a list of the locations of damaged facilities.

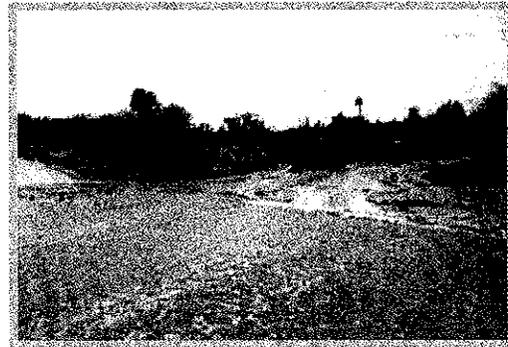
FIGURE 34. FLOW OVER ROADWAY DIP CROSSING GALLOWAY WASH AT PIMA ROAD

- Accessibility shall be performed for the 100-year runoff event.
- Road overflows (Figure 34), or longitudinal flows at the roadway crown, of more than 1-foot deep are considered impassable.
- Improvements are desired in the Town such that no more than 30 single-family residential lots, or equivalent multifamily or commercial/industrial areas, are inaccessible due to design flood flows in any given wash; and, no lot is inaccessible for more than 10 hours.

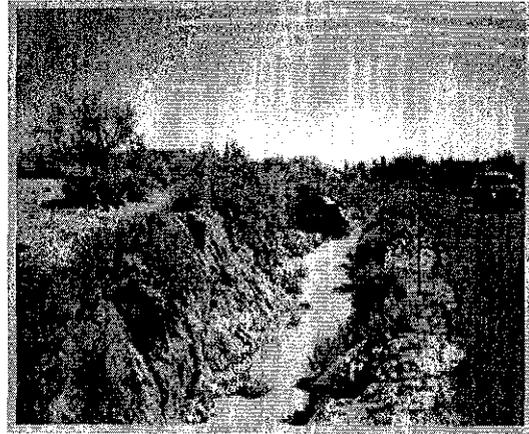
FIGURE 38. EXAMPLE OF EROSION CAUSED BY CHANNELIZATION REQUIRING MITIGATION

Channelization is not recommended as a development alternative. Additionally, in washes that have floodplain delineations, the floodplain must be reanalyzed to determine the effects of the channelization on the floodplain elevations.

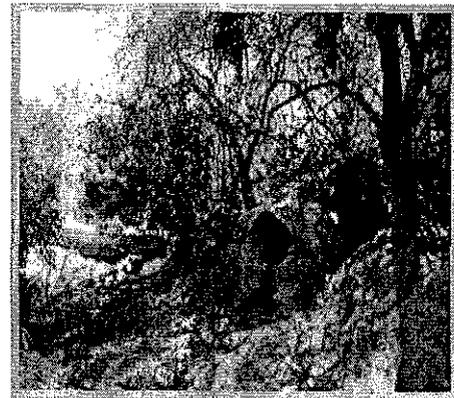
FIGURE 39. EXAMPLE OF SCOUR AT CULVERT OUTLET DUE TO LACK OF OUTLET PROTECTION

Outlet protection should be designed to reduce impacts of high-exit velocities and scour potential downstream of culverts. The design of outlet protection, including adequate size and bedding material, is required in compliance with *Drainage Design Manual for Maricopa County, Arizona, Volume II-Hydraulics*.
