**HYDRAULICS AND FLOODING ANALYSIS
OF
THE 1993 FLOOD ON THE GILA RIVER
IN REGARD TO
THE
BREACH OF GILLESPIE DAM**

Prepared for:
**Helm & Kyle, Ltd.
Attorneys At Law**

by:
**Thomas R. Loomis, P.E., R.L.S.
ASL Sierra Consulting Engineers, Inc.**

January 1997

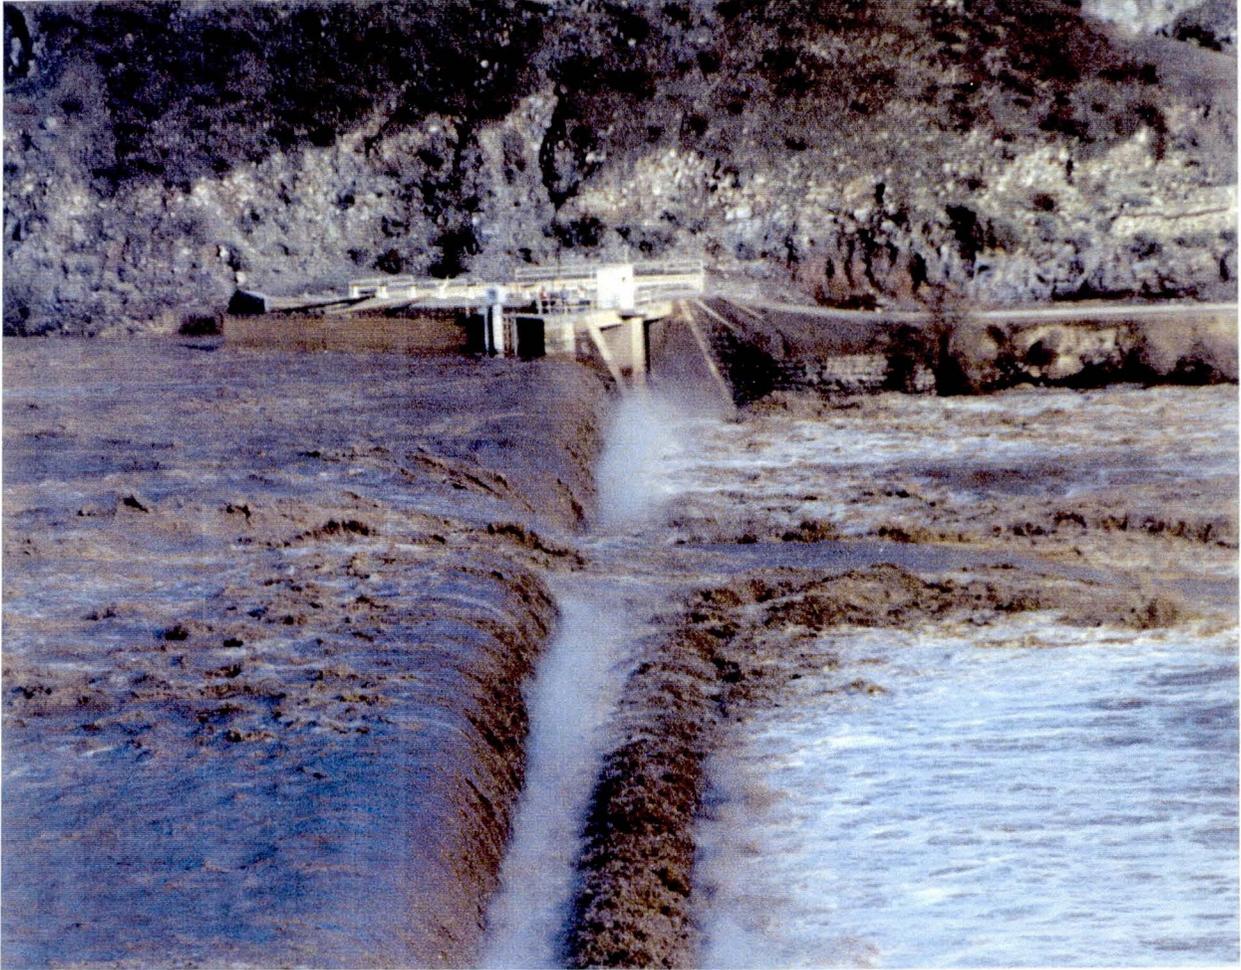
Figure 2.1
Photograph of Gillespie Dam after the initial breach occurred, on the afternoon of
9 January 1993
(Bates Number 0002051)

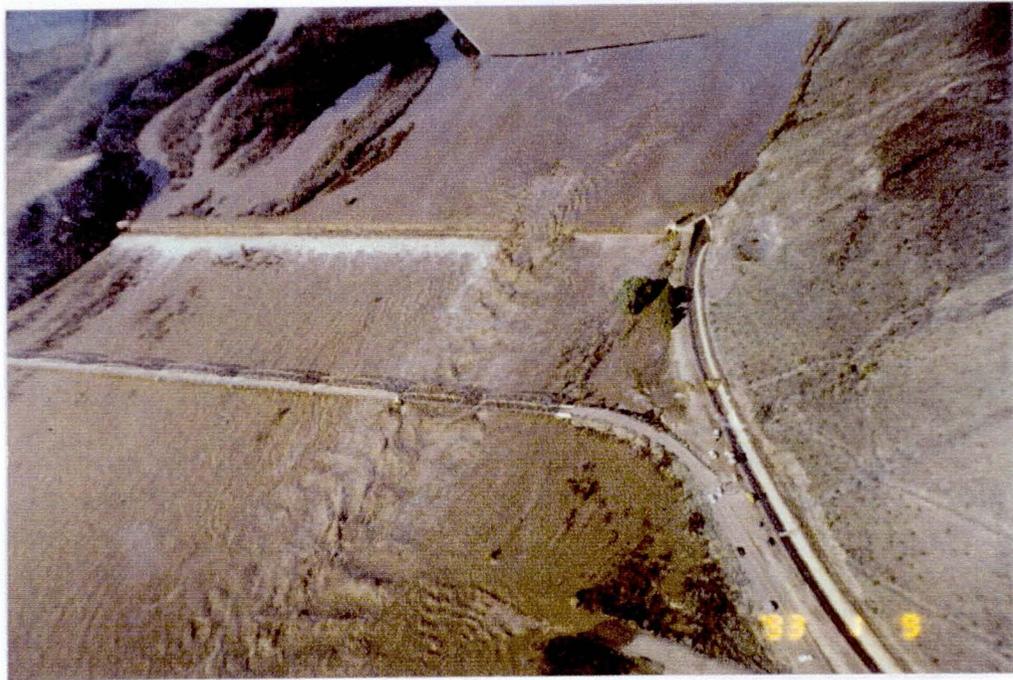
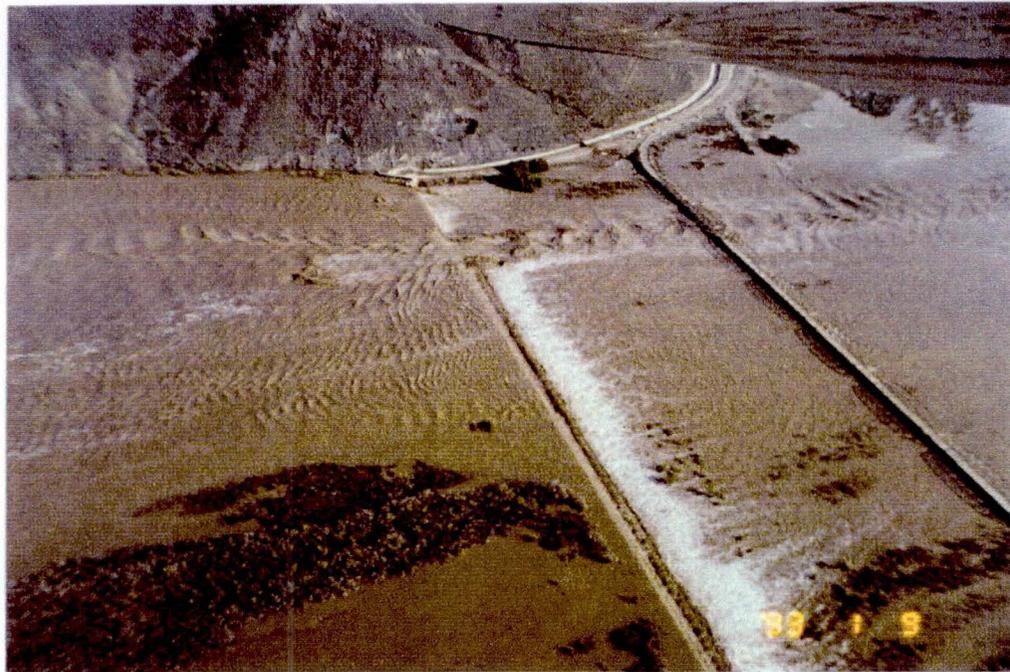
Figure 2.2

Gila River at Gillespie Dam looking
upstream at about 1530, By H.H. Schumann
1-9-93

Over Gila River at Gillespie Dam looking
toward left-bank (east) side. By
H.H. Schumann 1-9-93.

Photographs of Gillespie Dam and SR 80 bridge on the afternoon of
9 January 1993

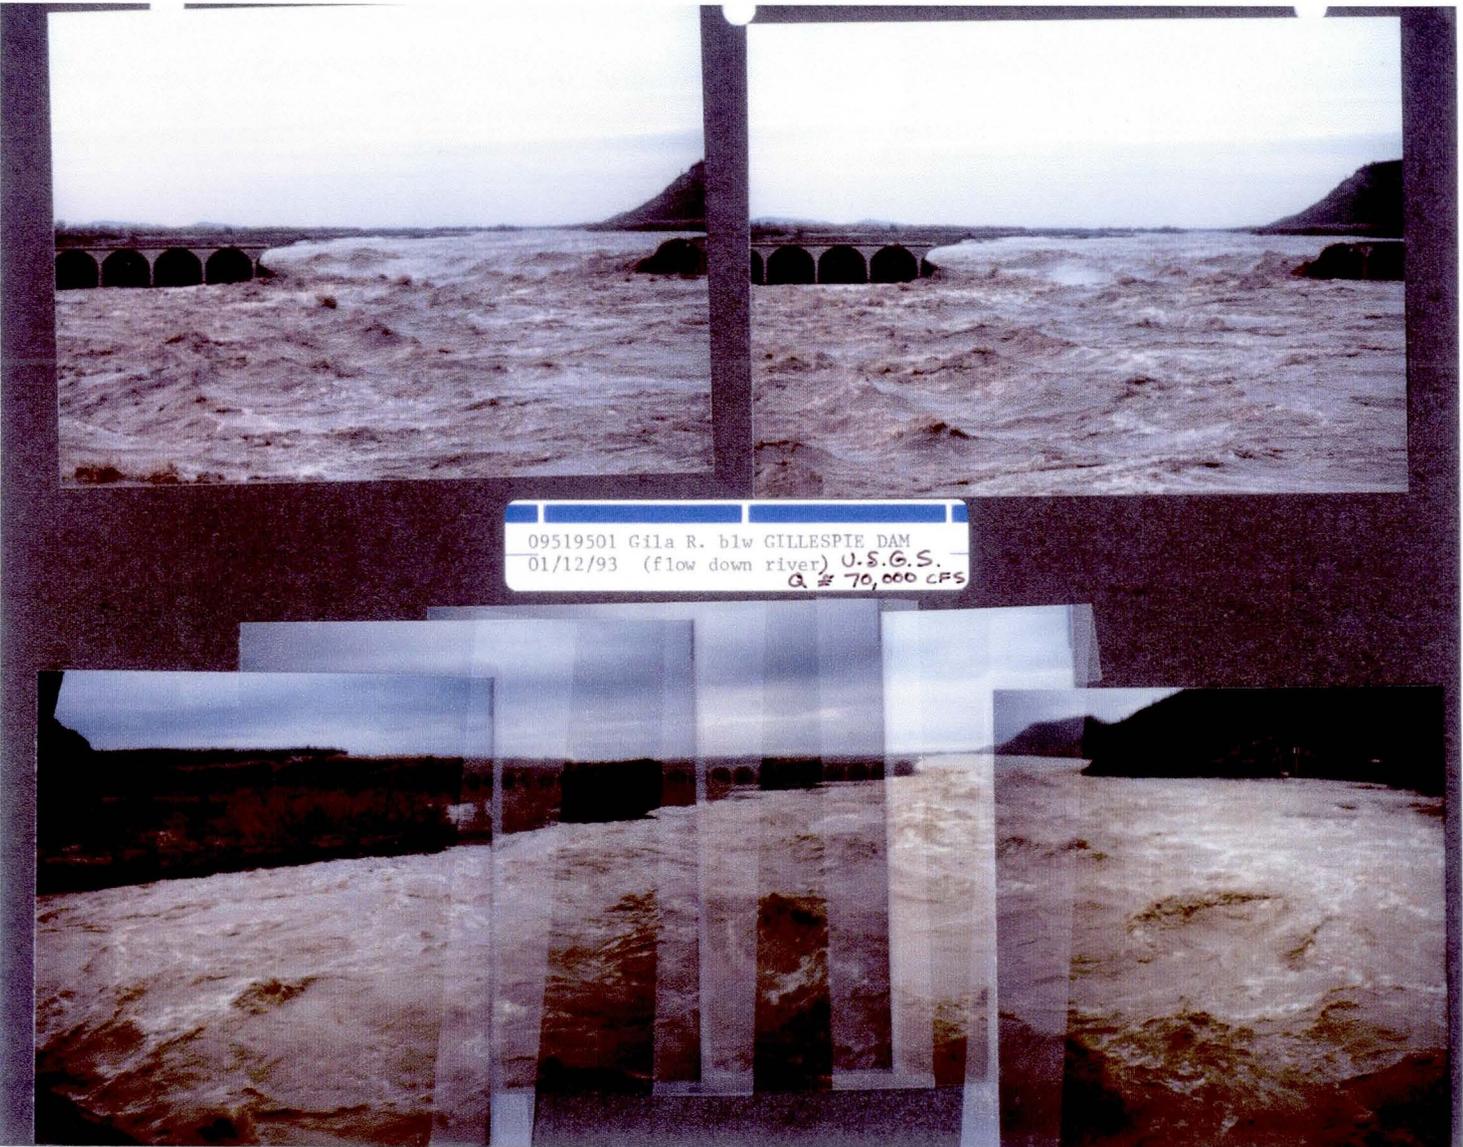
Figure 2.3
Photographs of Gillespie Dam on 12 January 1993
(Bates Number 0015834)

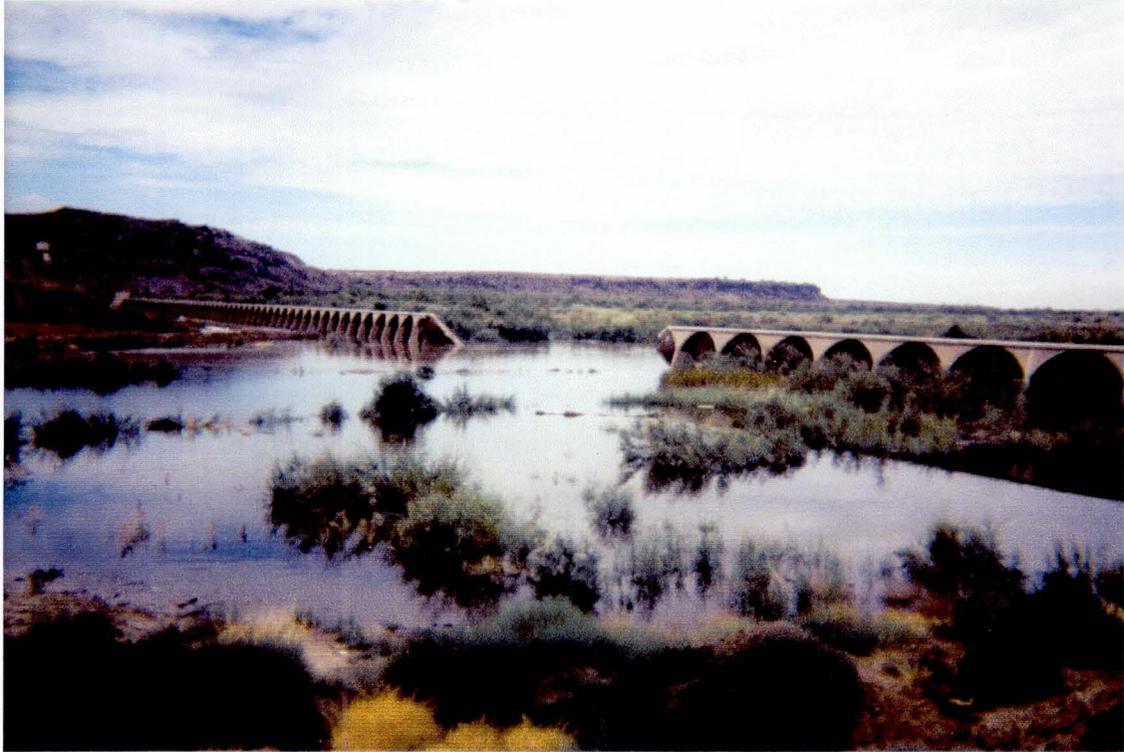
Figure 2.4

Photograph of full 206 feet wide breach in Gillespie Dam, looking upstream on 15 July 1996

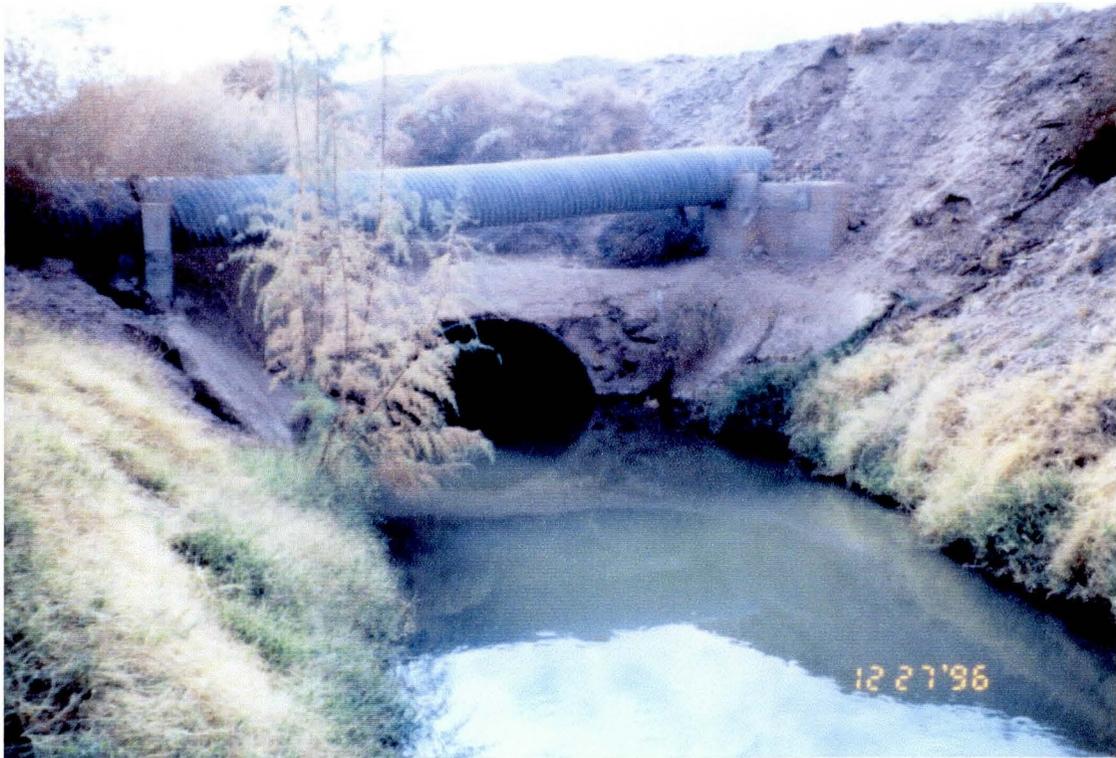
Figure 3.13

Photograph of Enterprise Canal looking downstream at inlet of culvert constriction just downstream of SR 80 (December 1996)

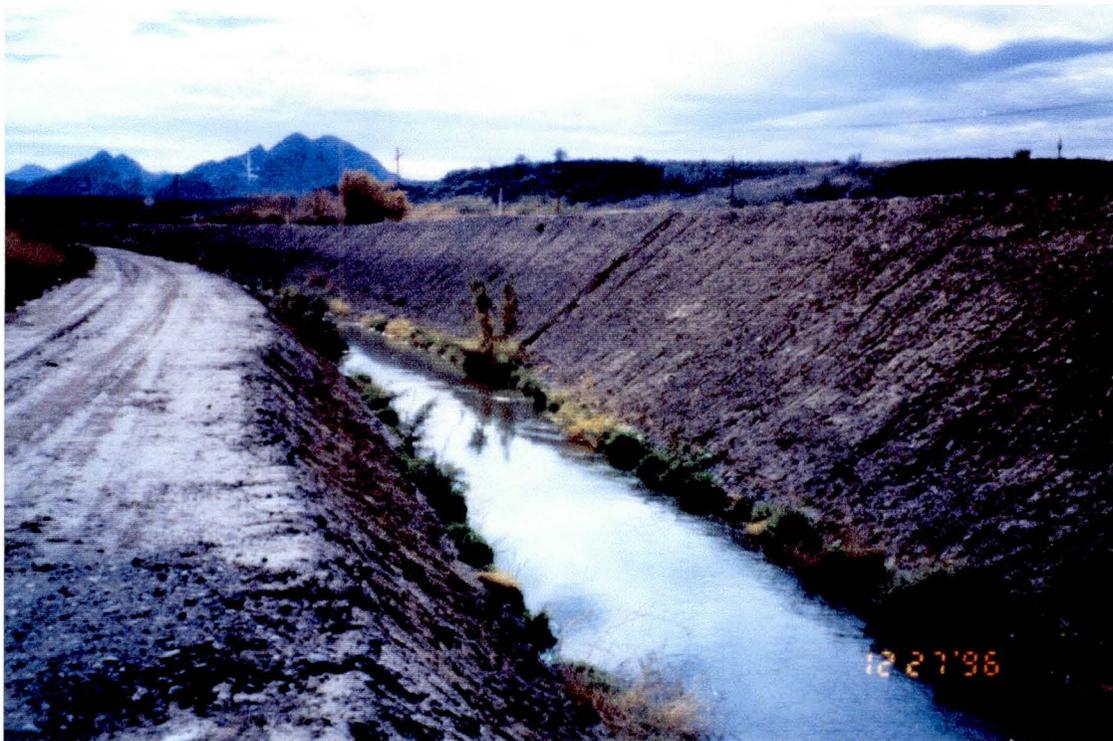
Figure 3.14

Photograph of Enterprise Canal looking downstream from outlet of culvert constriction just downstream of SR 80 (December 1996)

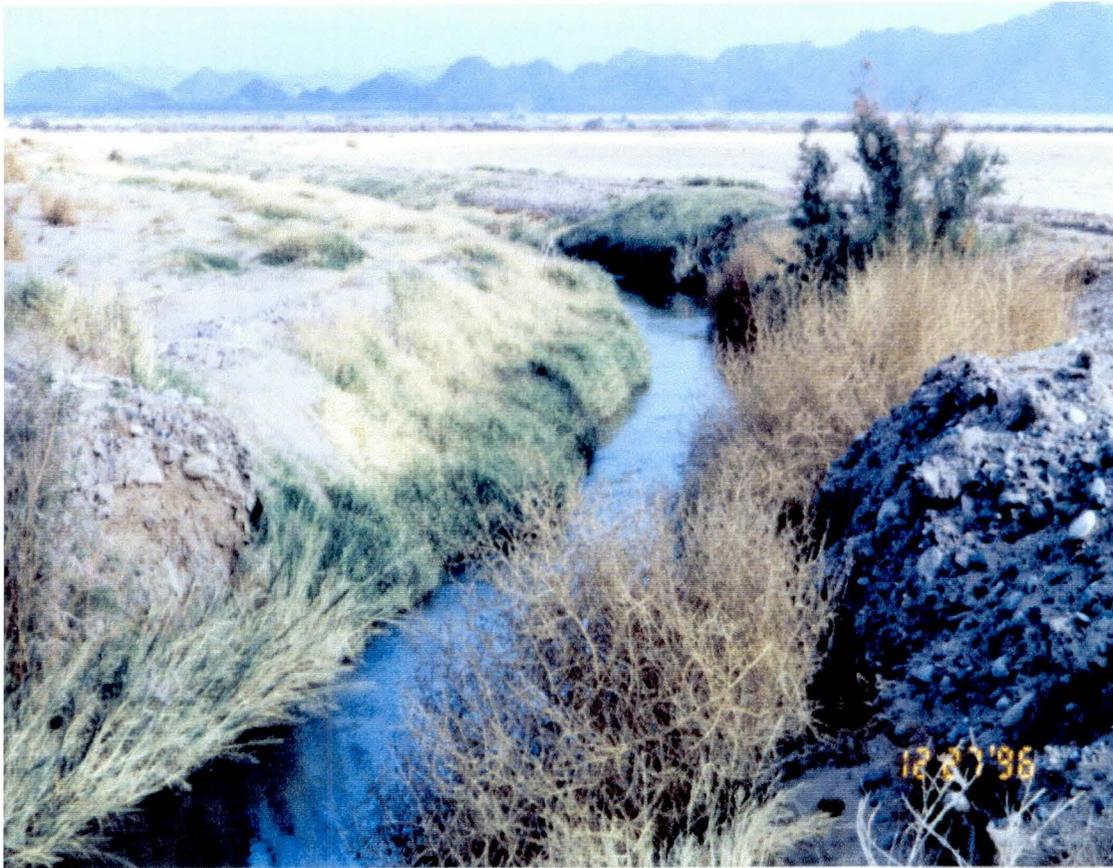
Figure 3.15

Photograph of Enterprise Canal about 3 miles downstream of the SR 80 bridge looking downstream at area of canal failure (December 1996)

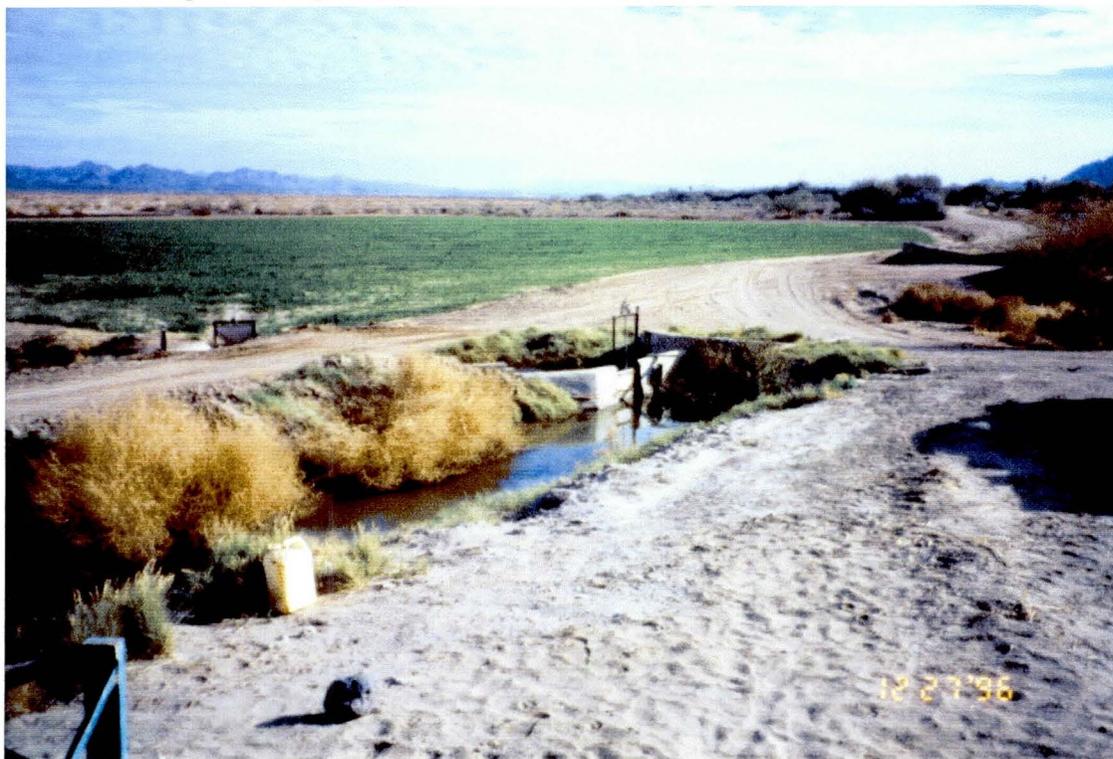
Figure 3.16

Photograph of Enterprise Canal about 3.6 miles downstream of the SR 80 bridge looking downstream at canal head gate structure (December 1996)

A canal head gate structure just downstream of failure point two is shown in Figure 3.16. The hydraulic constriction caused by that structure would be sufficient to cause a backwater effect in the vicinity of the failure point,

particularly if the gate was not fully open, as was the case on the date this photograph was taken. The bank failure at location two was likely the result of overtopping and scour resultant from backwater from the head gate.

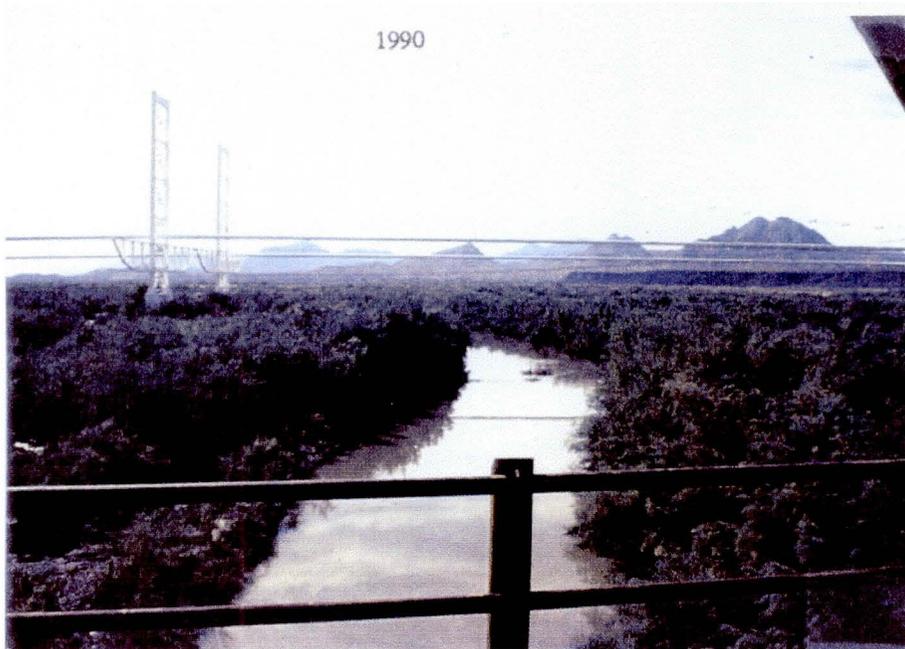
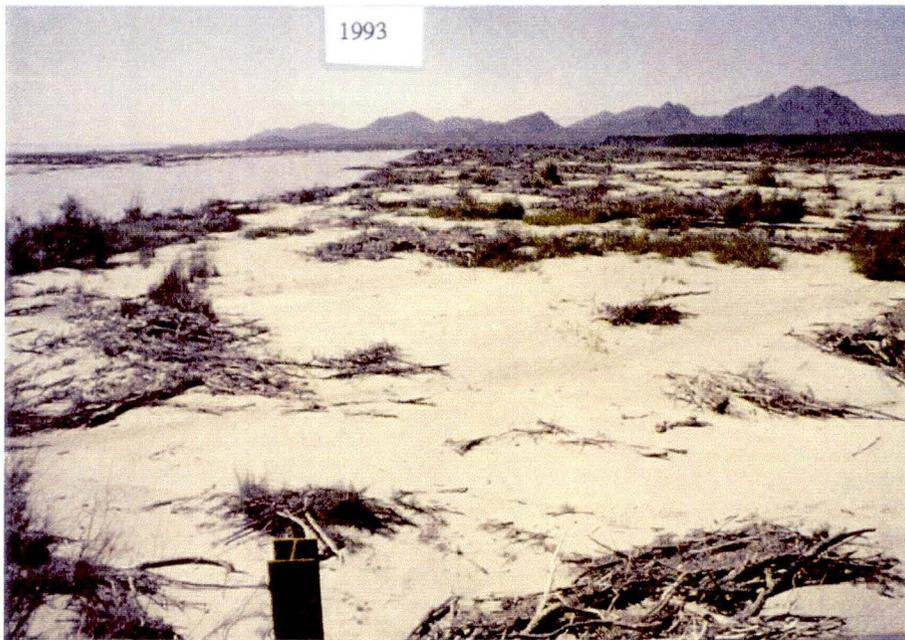
Figure A.2
Photographs of the Gila River looking downstream from the
SR 80 Bridge, pre- and post-flood

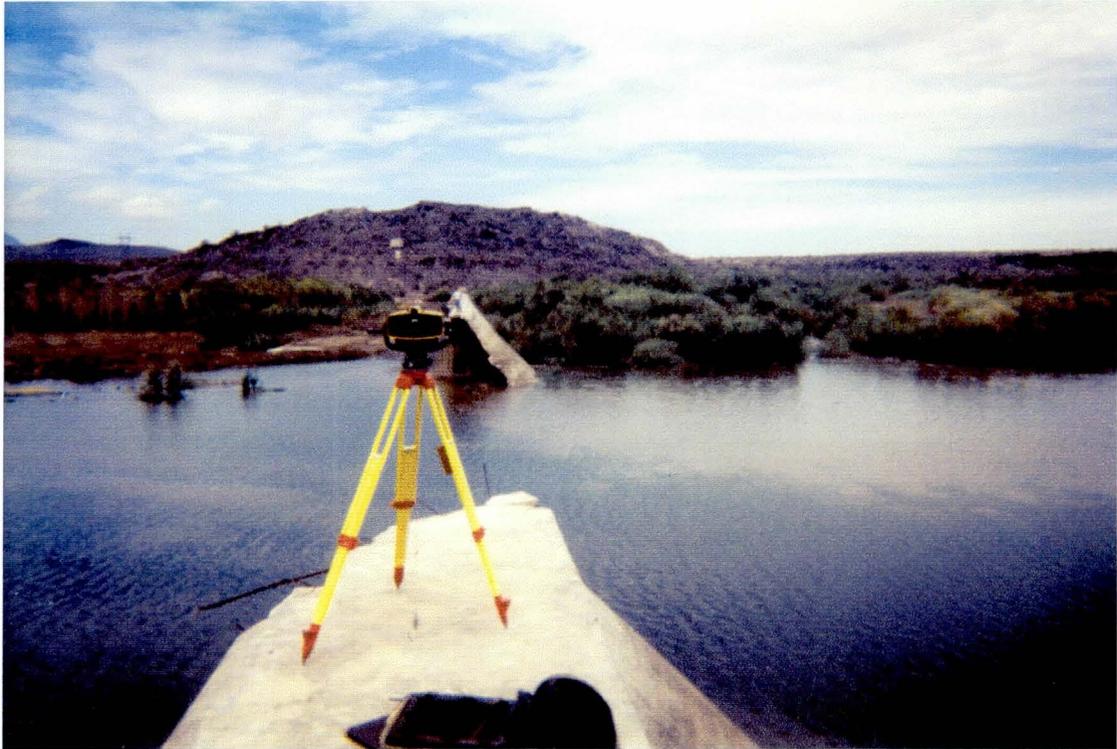
Figure A.4

Photograph of Gillespie Dam looking west from the east side of the breach
(15 July 1996)

occurred as a result of the 1993 flood, immediately downstream of Gillespie Dam. A similar condition is assumed for the reach upstream of Gillespie Dam and n-values were selected accordingly. The tamarisk vegetation quickly reestablishes itself, as demonstrated by Figure A.4, taken in 1996.
