AGUA FRIA

WATERCOURSE MASTER PLAN

Ecological Evaluation of the Lower Agua Fria River Corridor New Waddell Dam to Confluence with Gila River

Kimley-Horn & Associates, Inc.

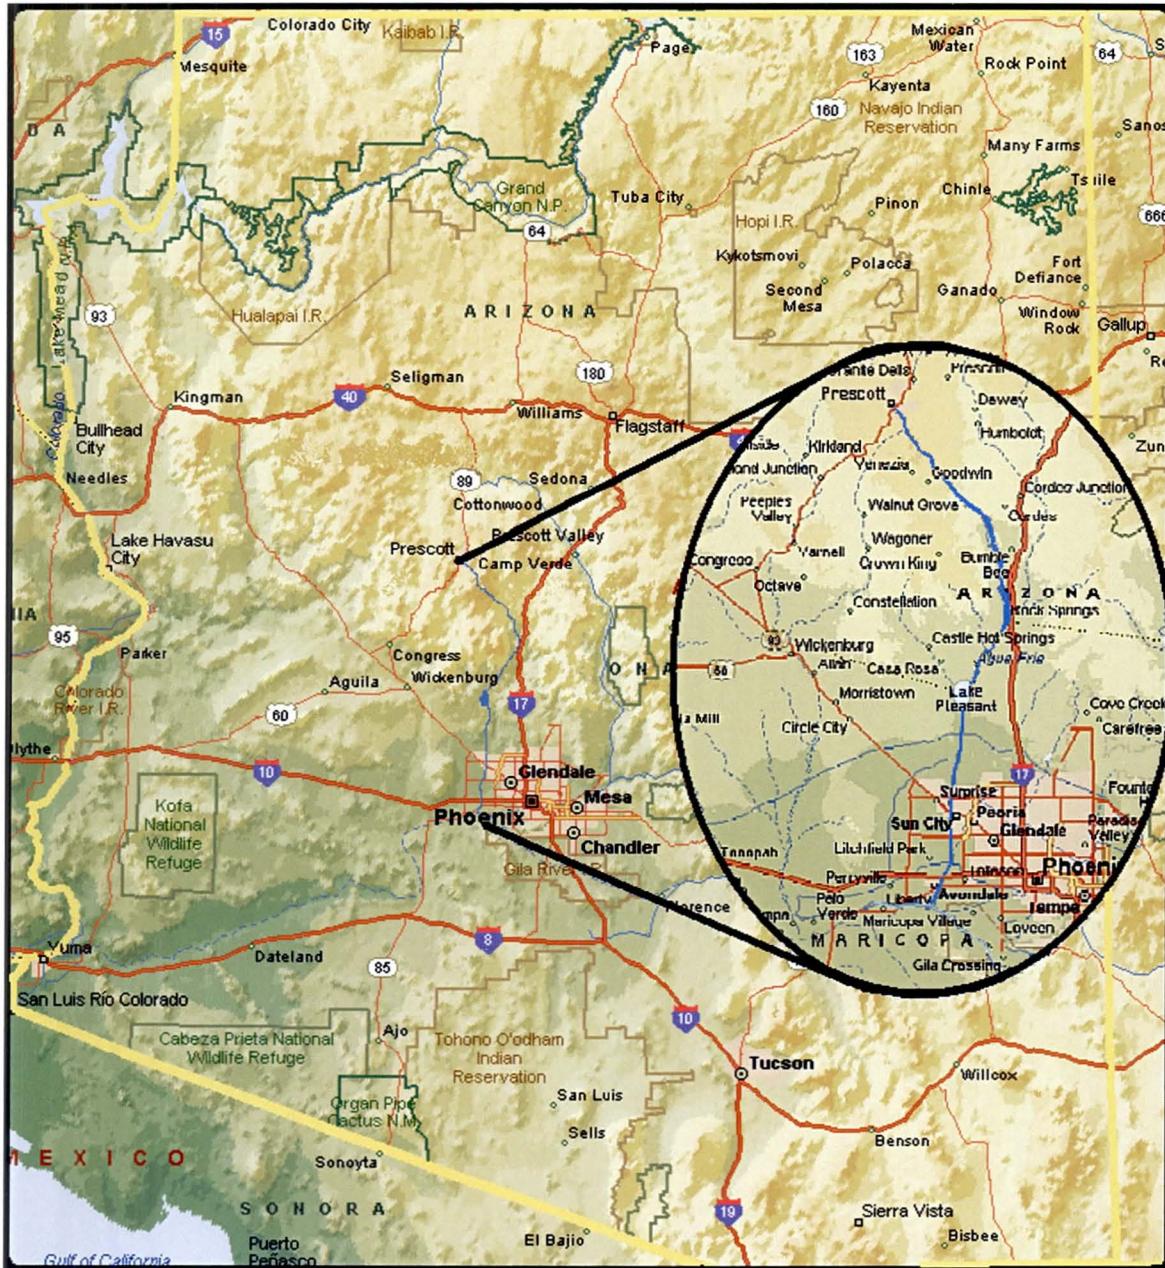
FIGURE 1
Agua Fria River Watershed

The Agua Fria River watershed extends from near Prescott, Arizona to the confluence of the Gila River south of the Metro-Phoenix area. The approximately 2250-square mile watershed has varied topography, soils and vegetation characteristics and has been altered by land management activities. The upper 65-mile portion of the watershed includes a portion of the Bradshaw Mountains and Granite Dells area, where elevations are approximately 5000 feet above mean sea level (MSL). Vegetation and land use varies but is typically high to mid elevation arid vegetation with agricultural and residential/commercial uses. Portions of this reach of the channel are perennial and others are intermittent. This portion of the watershed discharges into Lake Pleasant, the reservoir formed behind New Waddell Dam

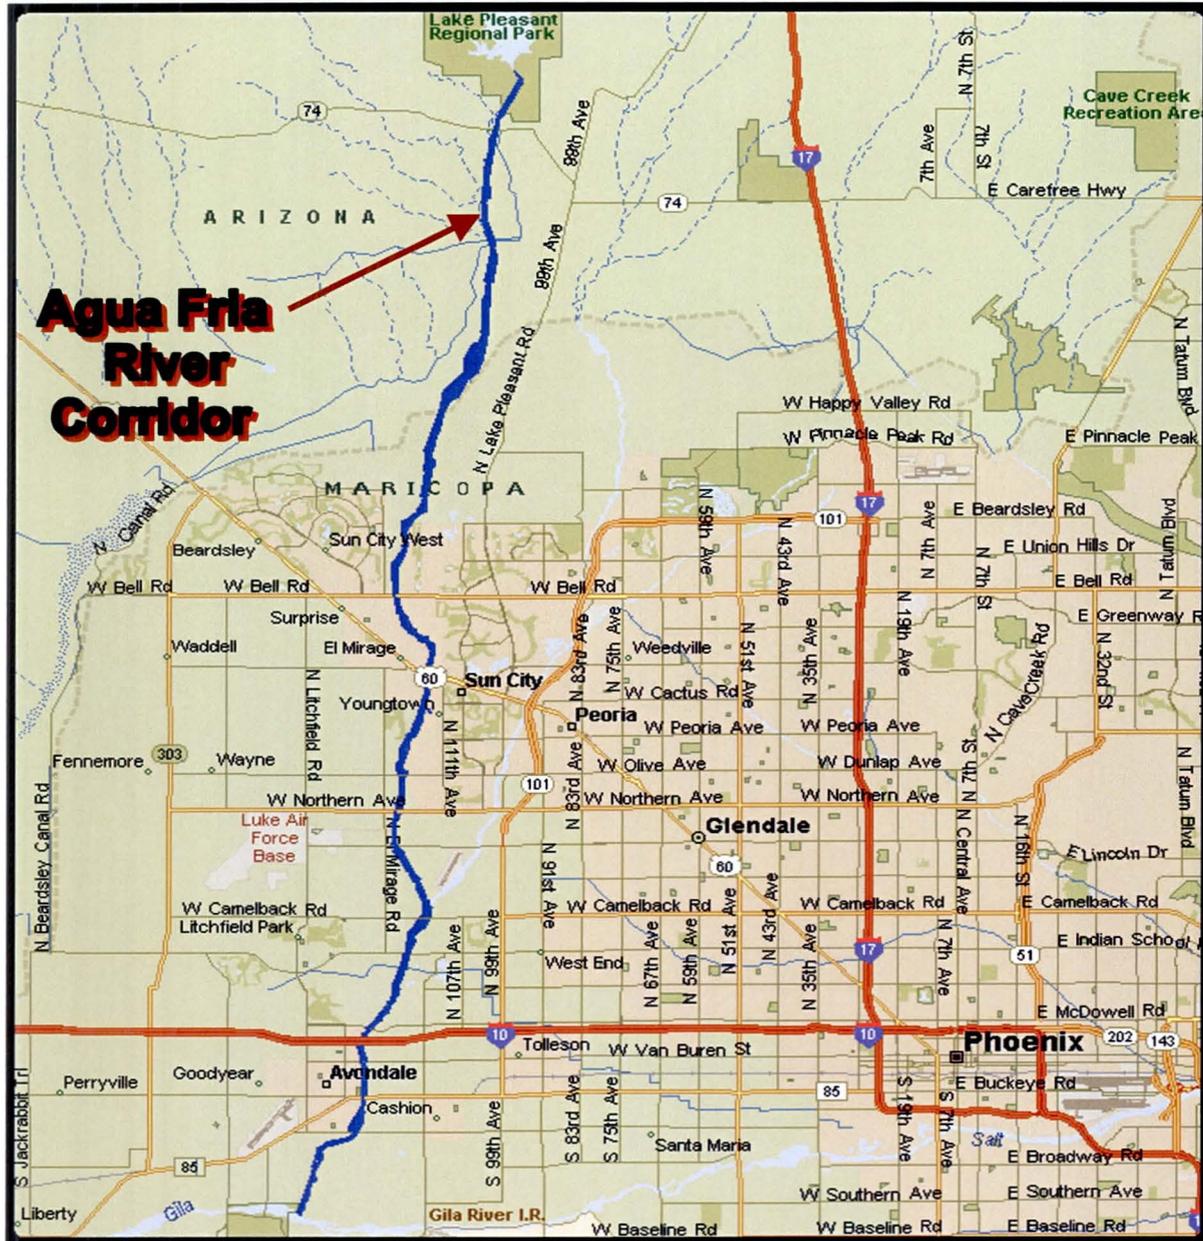
FIGURE 2
Agua Fria River Study Corridor

Below New Waddell Dam the Agua Fria River channel is primarily ephemeral (the reach immediately below the dam is intermittent based on discharge from Morgan City Wash.). Under all but the extreme flood condition, there is no discharge from Lake Pleasant to the lower reach of the channel. This reach of the Agua Fria traverses an area that has undergone more extensive development than the upper reach. This report details the results of the evaluation of the lower portion of the Agua Fria River channel from New Waddell Dam to the confluence with the Gila River (**Figure 2**).

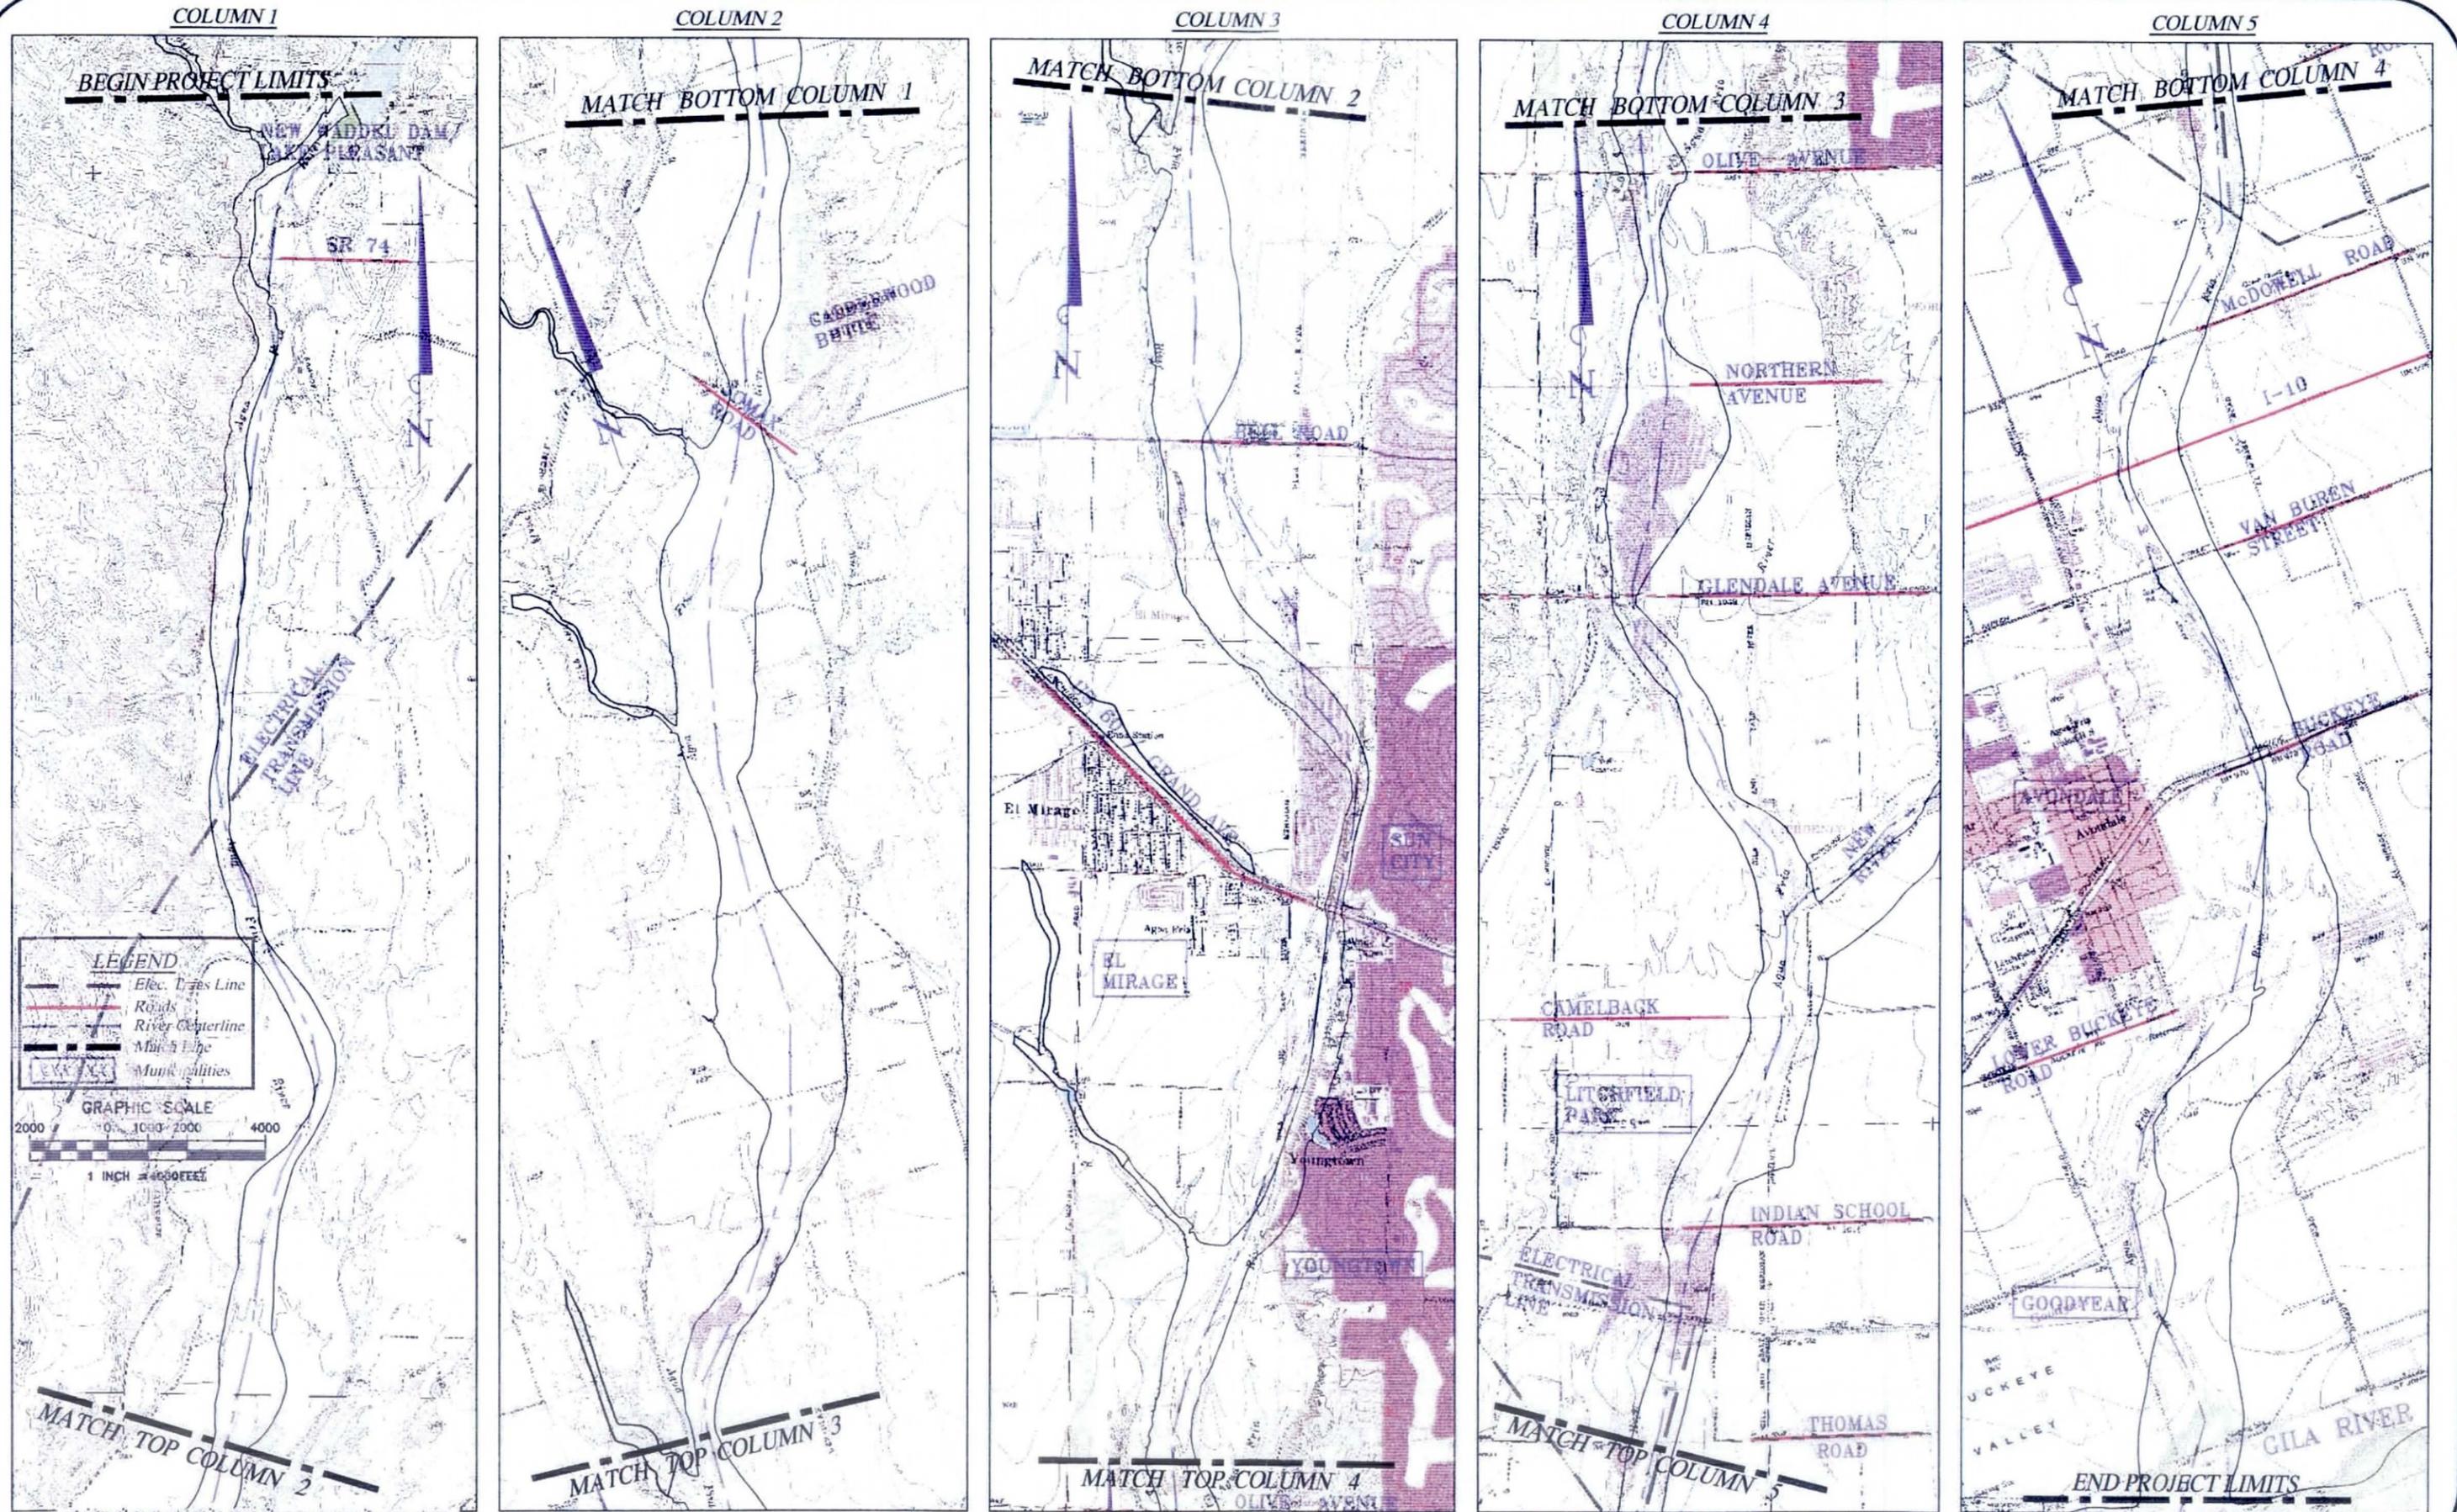
For purpose of this report, the Agua Fria Watercourse Master Plan study area was divided into three reaches. The three reaches are:

- 1) **Upper Reach:** New Waddell Dam south to approximately Bell Road
- 2) **Middle Reach:** Bell Road to New River confluence
- 3) **Lower Reach:** New River confluence to Gila River confluence

See **Figure 3** for an illustration of the reach areas.

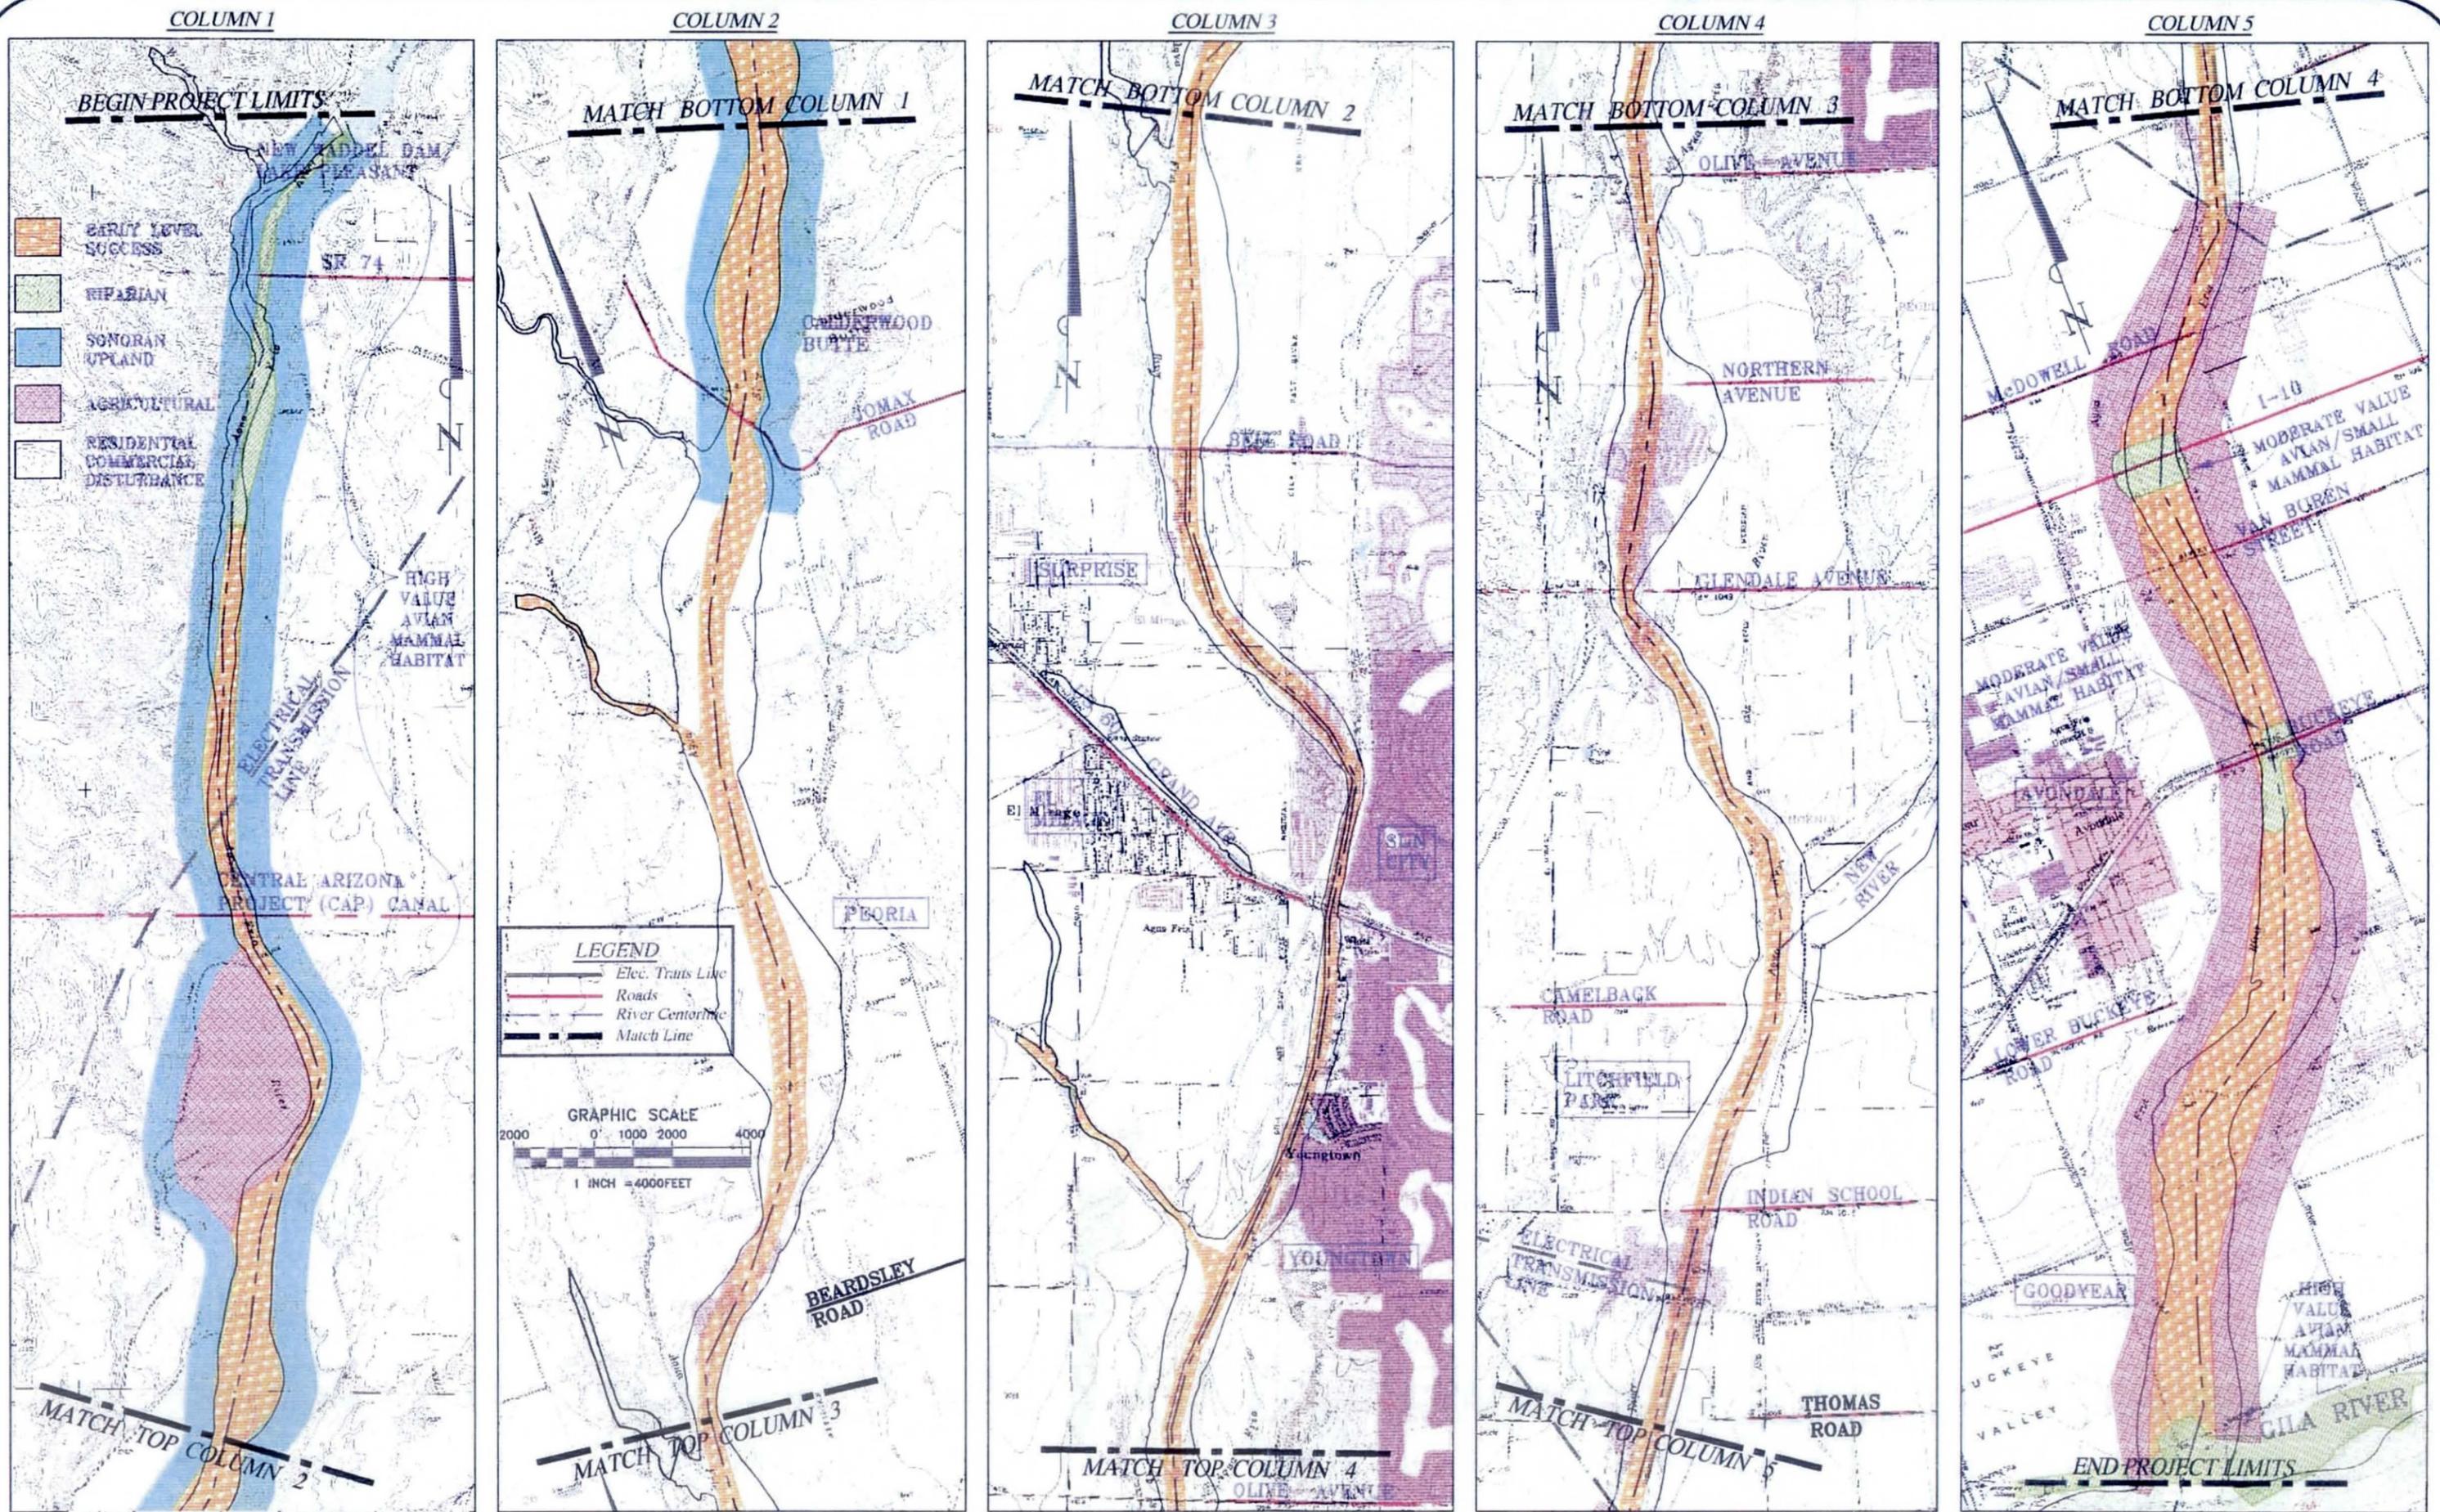
A brief discussion of some of the major forces affecting the community is also included. Figure 4 illustrates the general locations of the various communities. Small inclusions of each of the different communities are interspersed along the corridor and within areas mapped as a different community.

The evaluation of the Agua Fria River corridor identified five general categories of vegetation communities:

- Early Level Successional
- Sonoran Upland
- Agricultural
- Commercial/Residential
- Mesic/Hydric Riparian
