FINAL "n" VALUE REPORT
CAVE CREEK
FLOOD INSURANCE STUDY

FLOOD CONTROL DISTRICT OF MARICOPA COUNTY

WILLDAN ASSOCIATES
1717 W. Northern Avenue, Suite 112
Phoenix, Arizona 85021

February, 1997

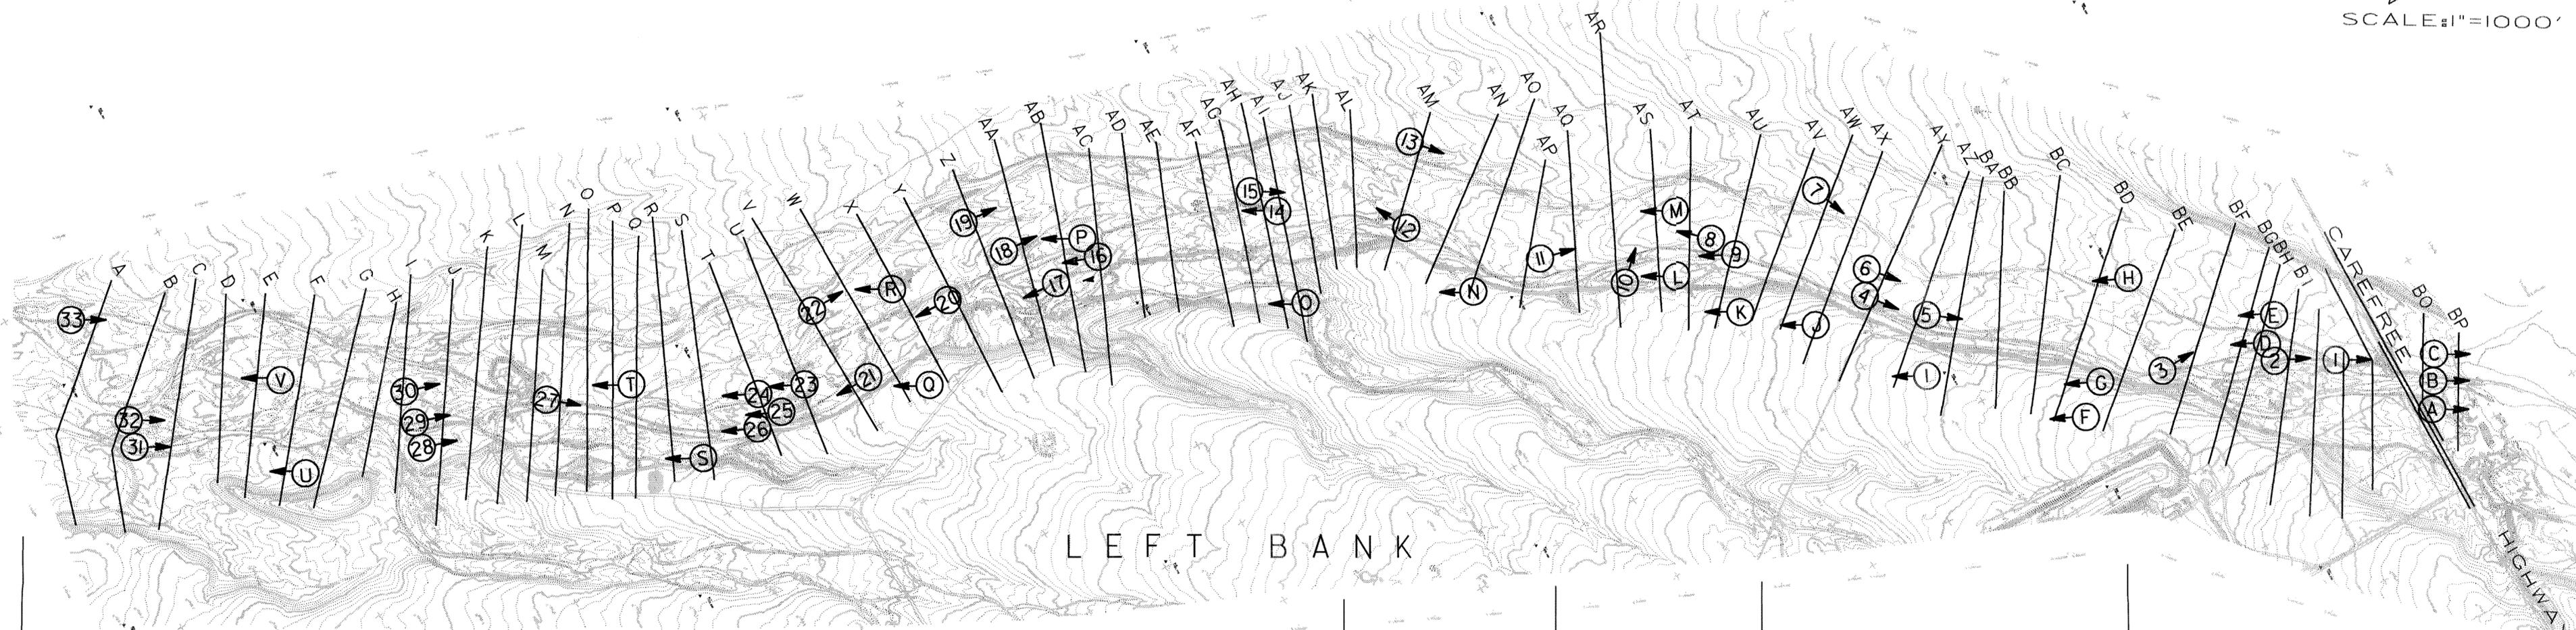
PHOTO LOCATION MAP

This report is being prepared by Willdan Associates as part of the Flood Insurance study of Cave Creek for the Flood Control District of Maricopa County. The limits of the study are the Cave Buttes Dam to 600 feet upstream of Carefree Highway a distance of approximately five miles. The Photo Location/Cross Section map in Appendix 1 shows the study limits.

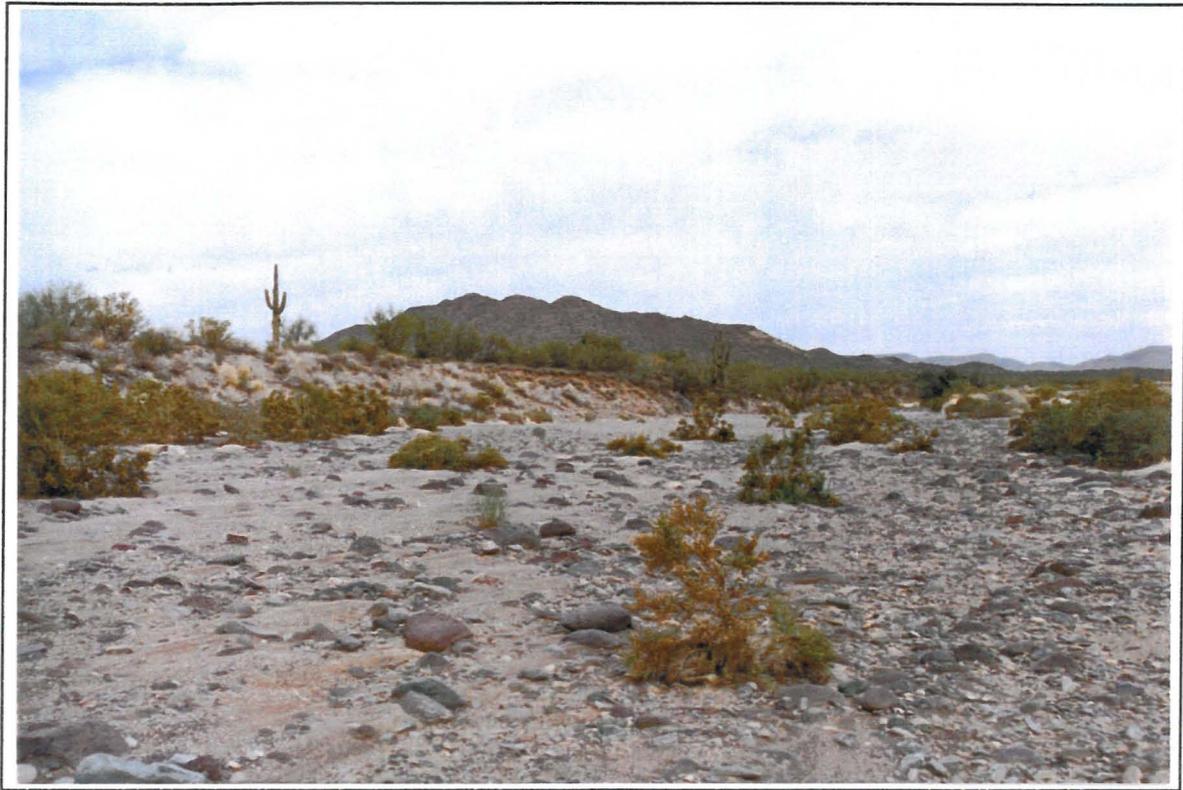
A. Reach 8 - Looking Upstream From Bridge at Left Bank Rip Rap

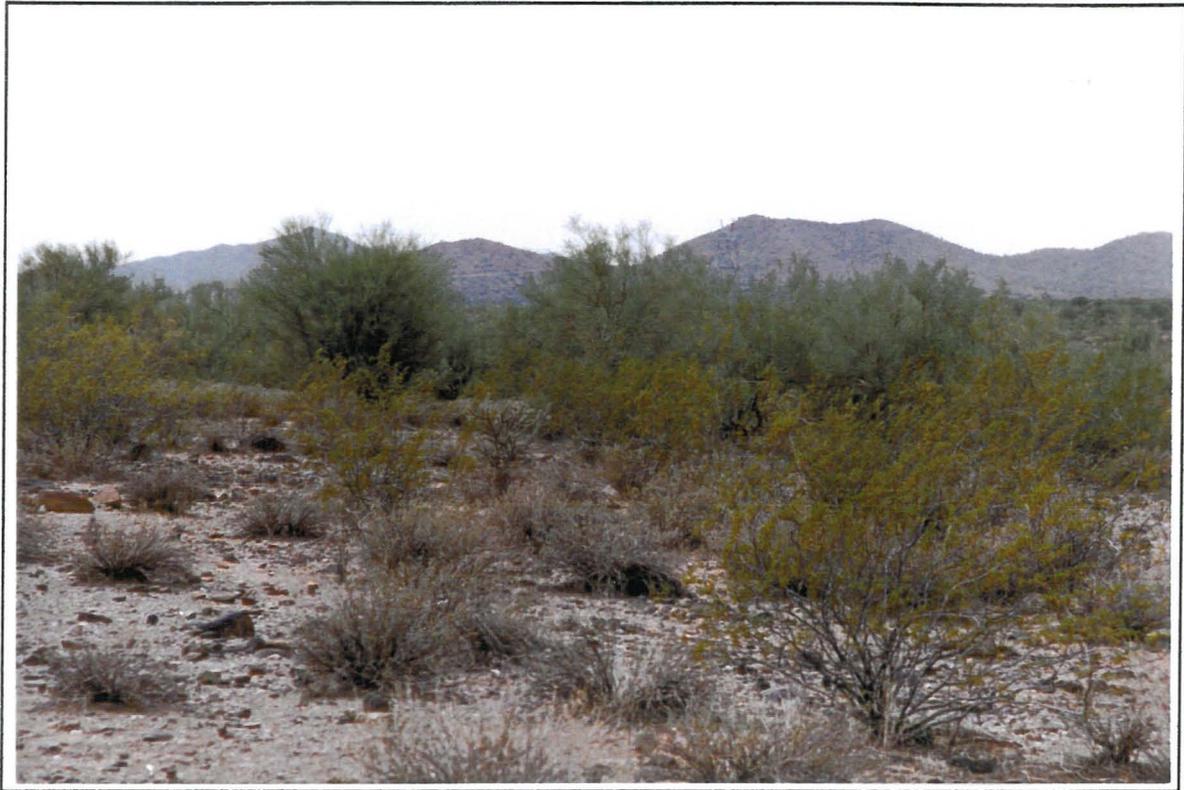
E. Reach 8 - Looking Downstream at Right Over Bank

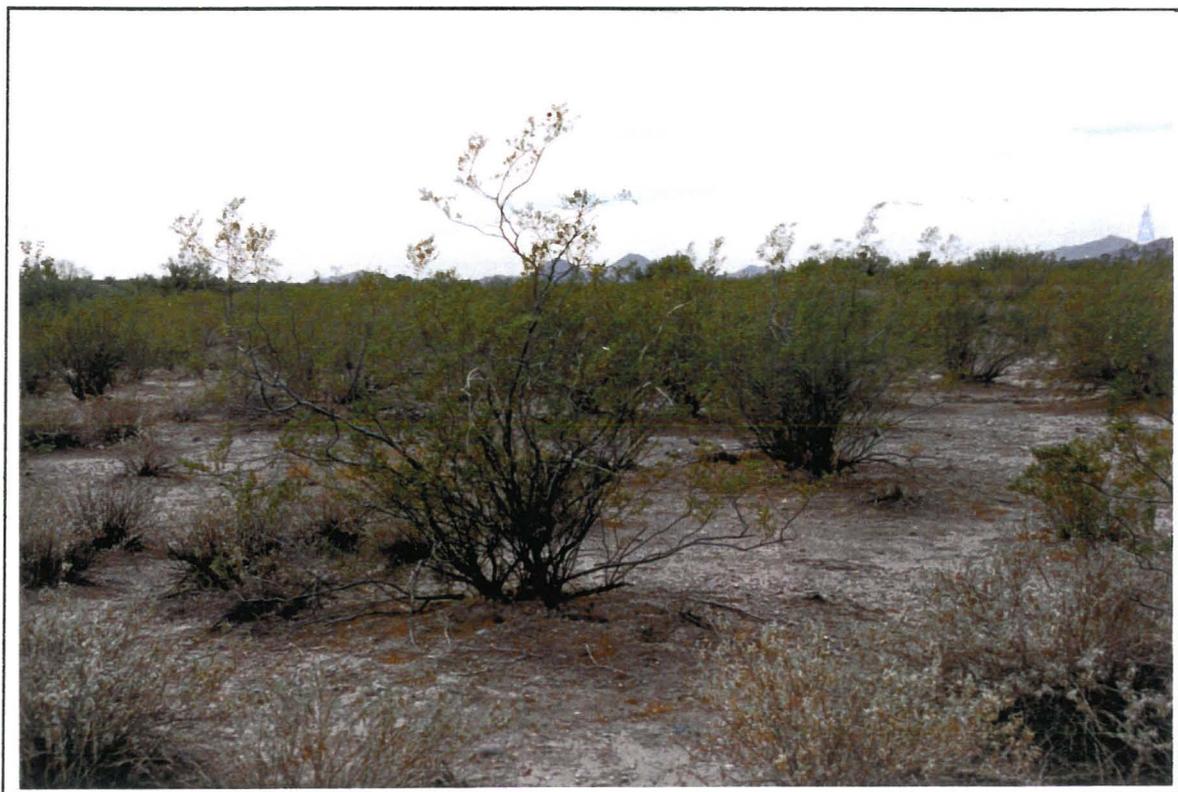
M. Reach 6 - Looking Downstream at Right Over Bank
