Bridge Scour Investigation  
and Design of Corrective Measures

Work Order No. 80407  
Maricopa County Department of Transportation

**FINAL REPORT (REVISED)**

Structure Number 9825  
Carefree Highway Bridge over Cave Creek

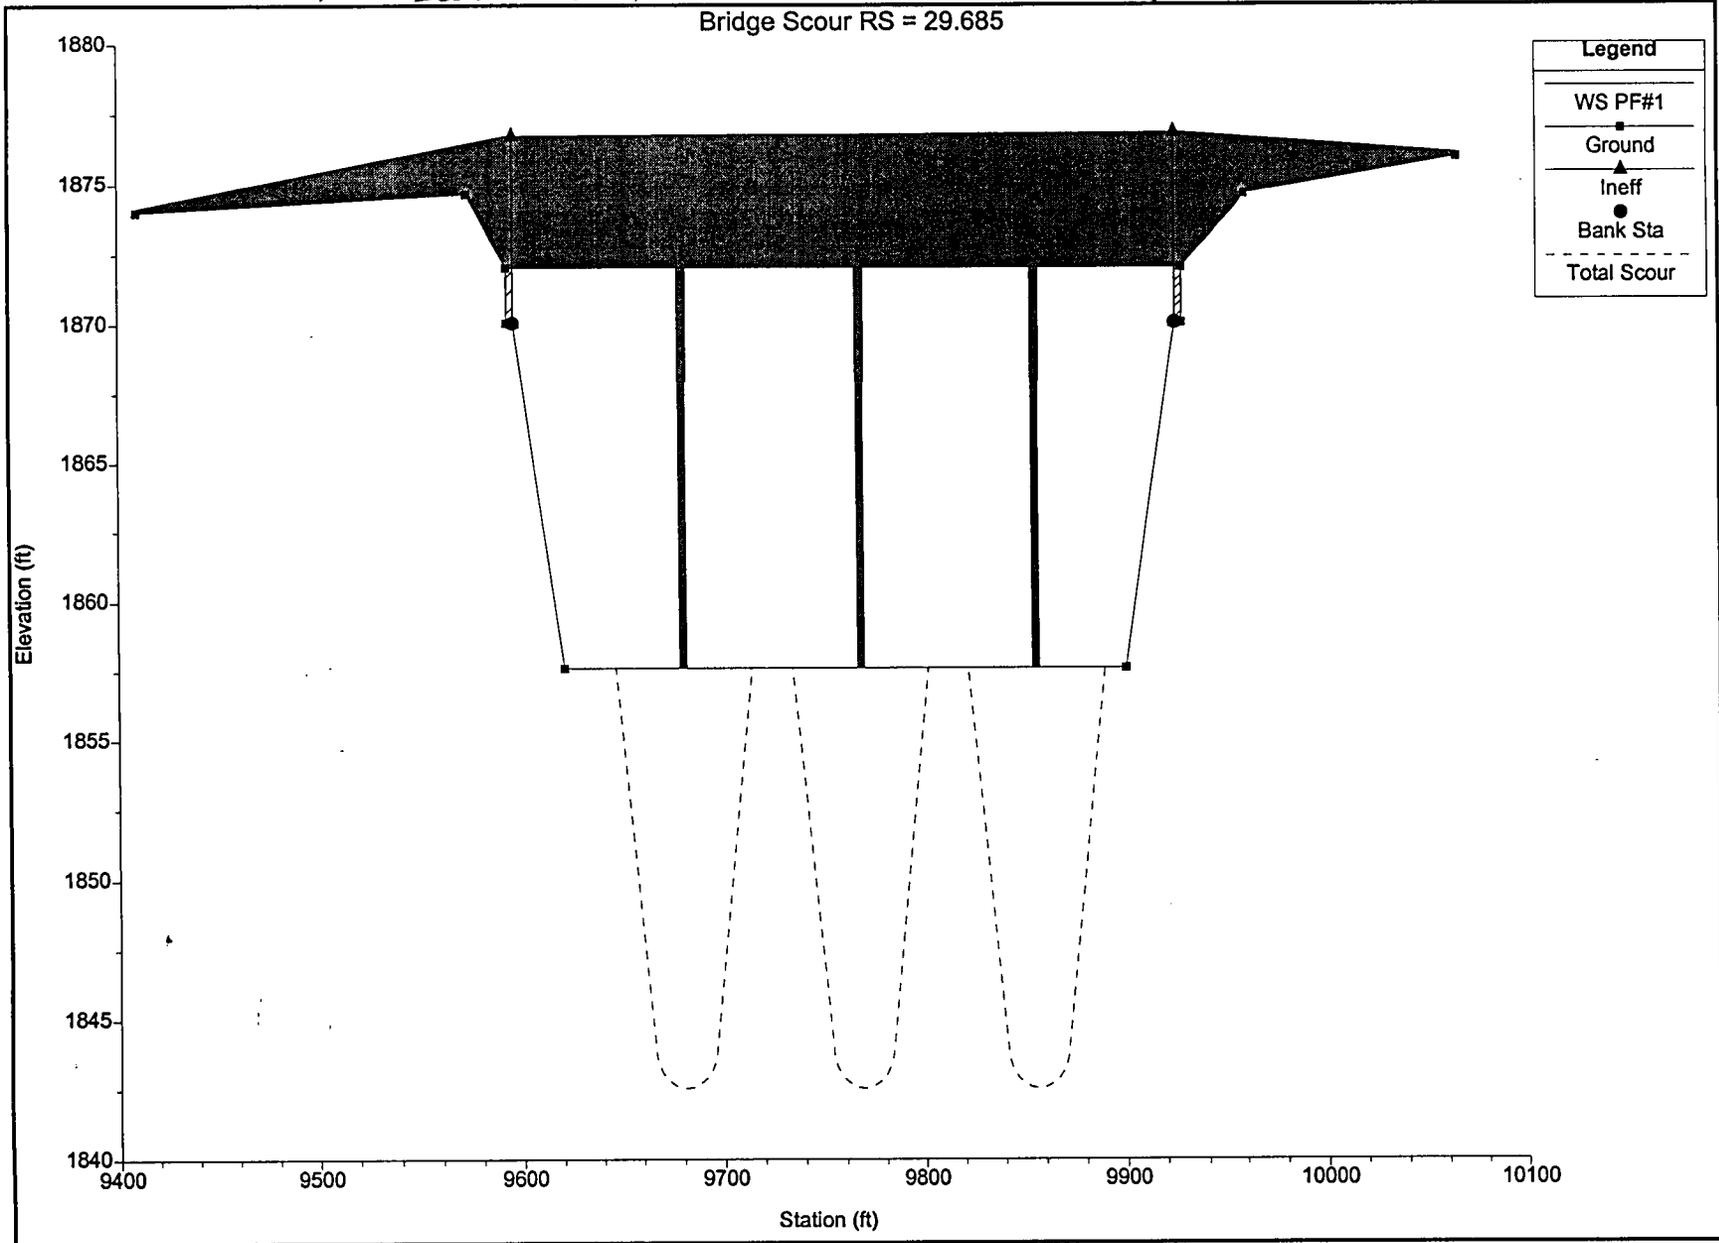
Scour Depth Ys (ft):	15.07
Froude #:	0.70
Equation:	CSU equation

PIER SCOUR PLOT - 100 YR NEW BRIDGE (CONTRACTION + LTERM WOULD BE ADDED)  
 Bridge Scour RS = 29.685

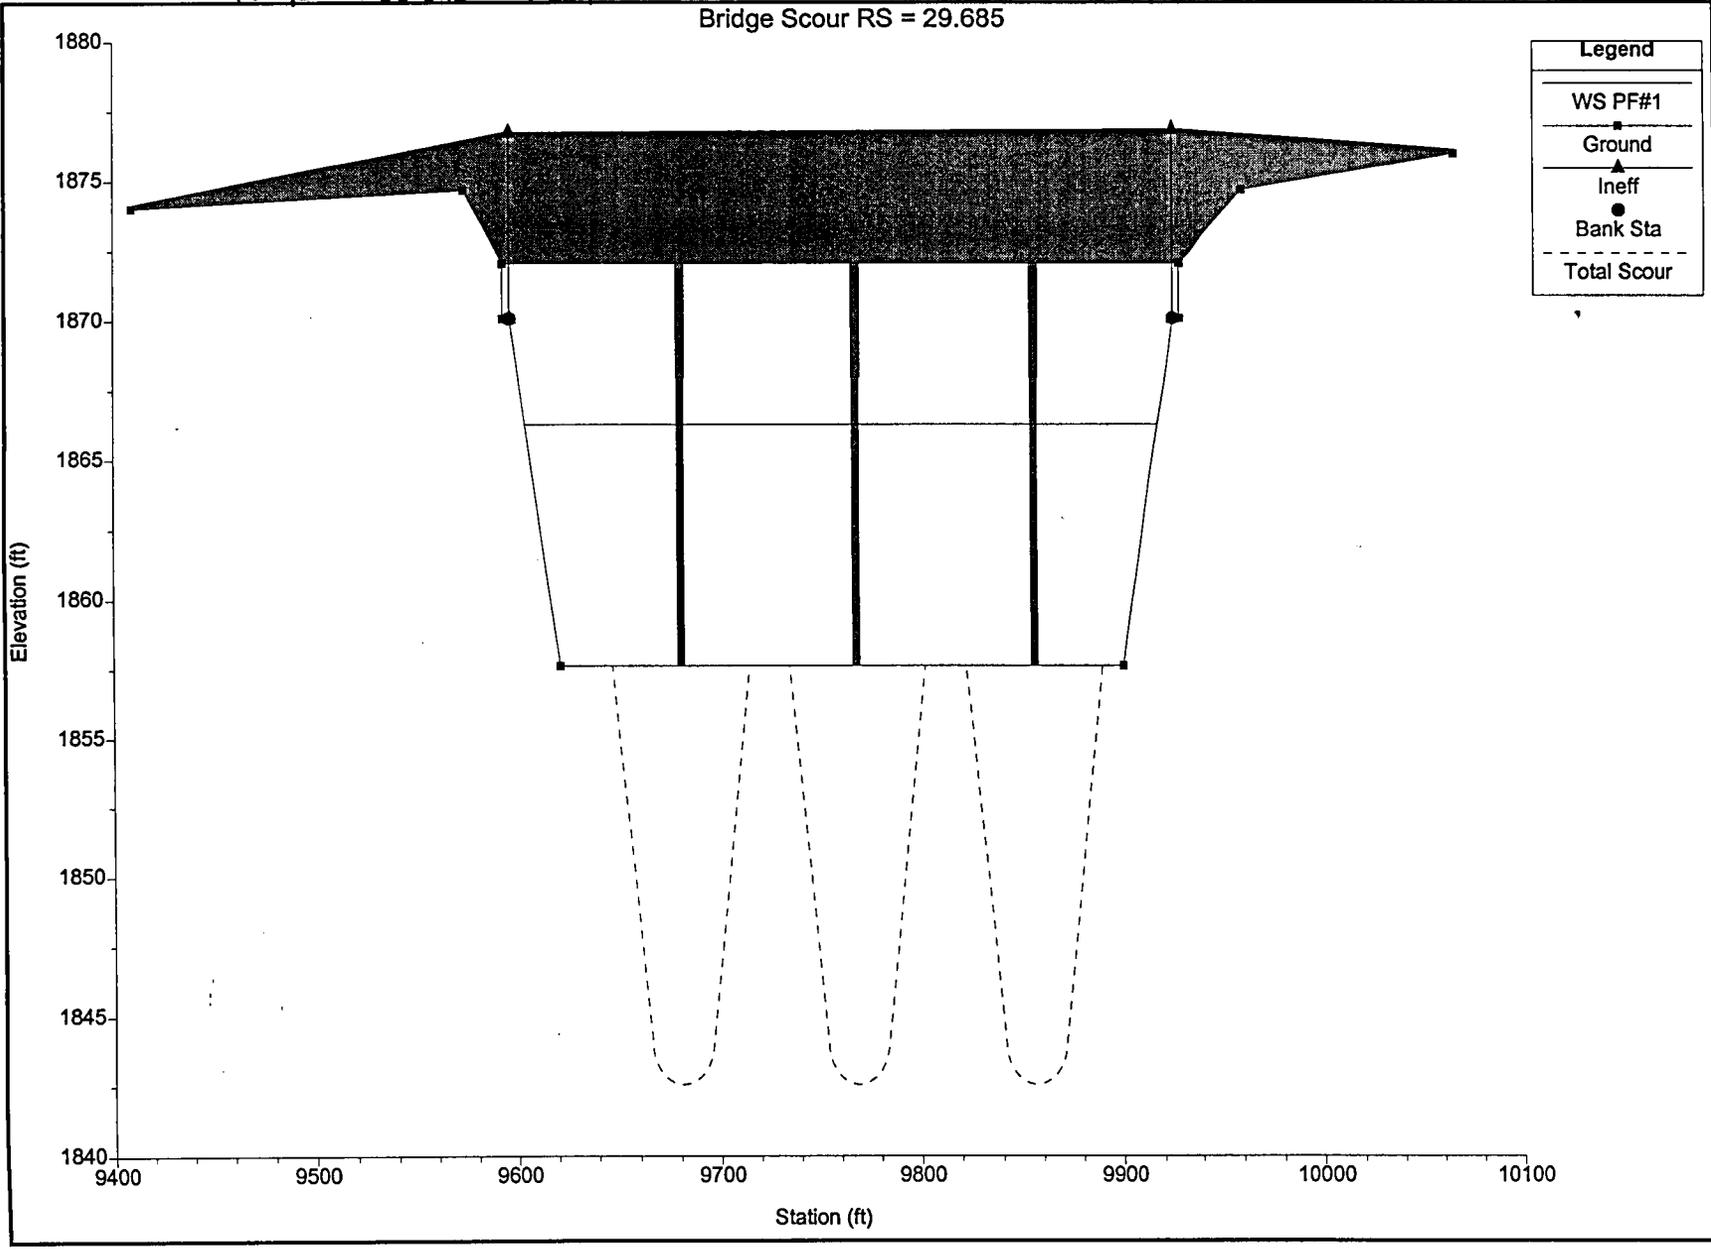
# New Bridge (500 - 1/2 Flow)

Bridge Scour RS = 29.685

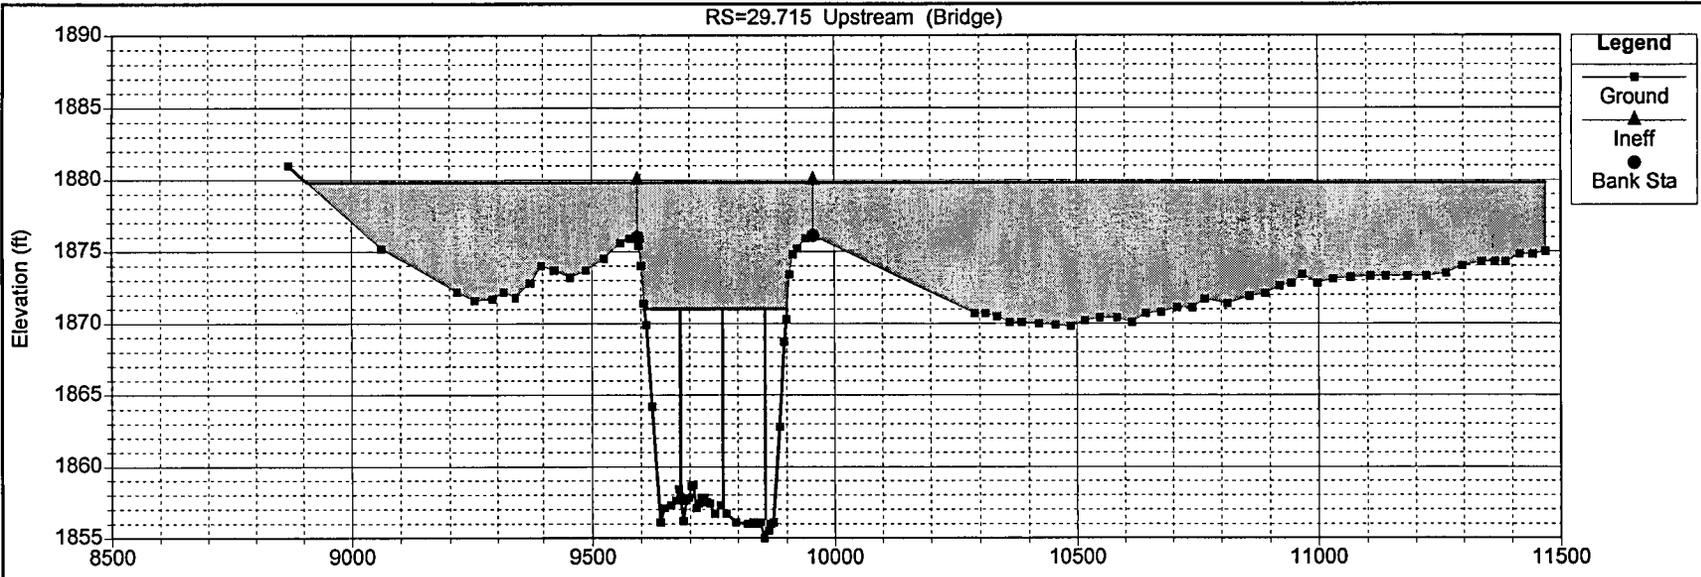
RS=29.715 Upstream (Bridge)

EXIST.

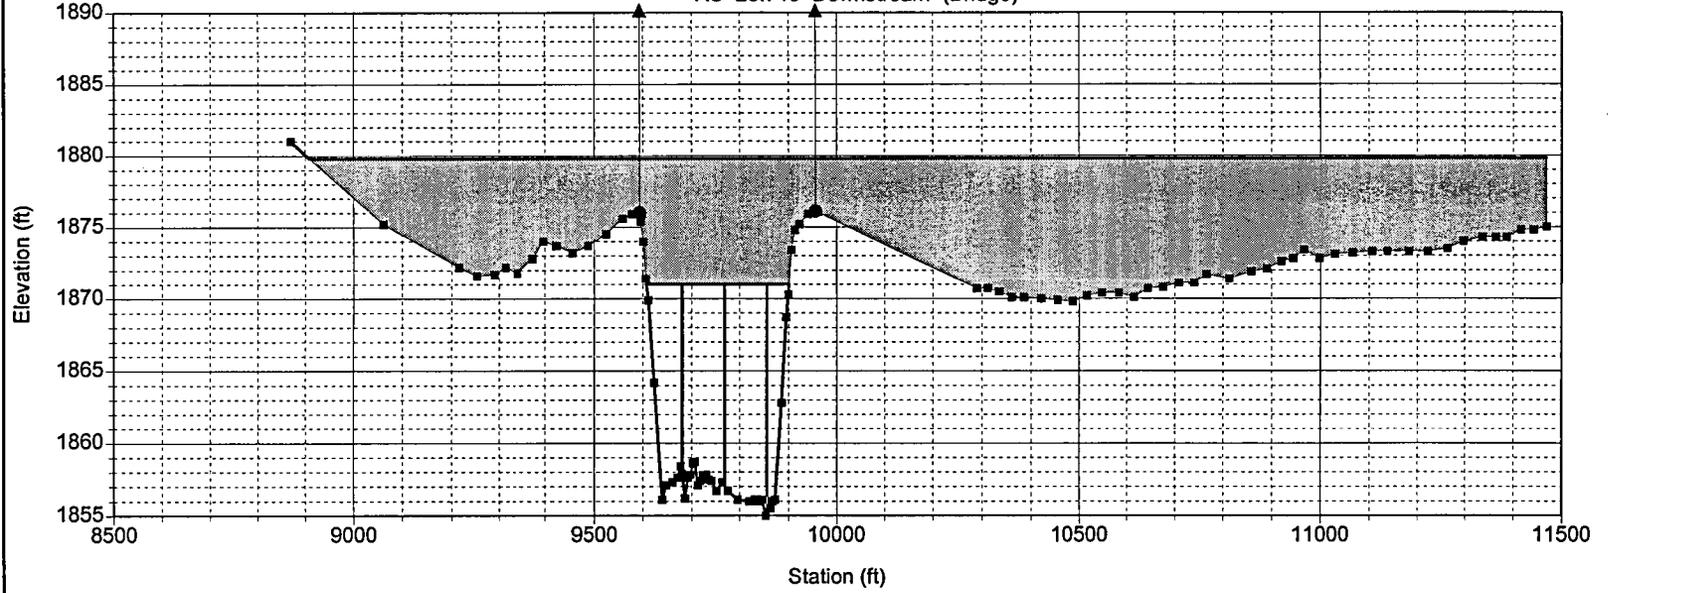
RS=29.715 Downstream (Bridge)

EXIST.

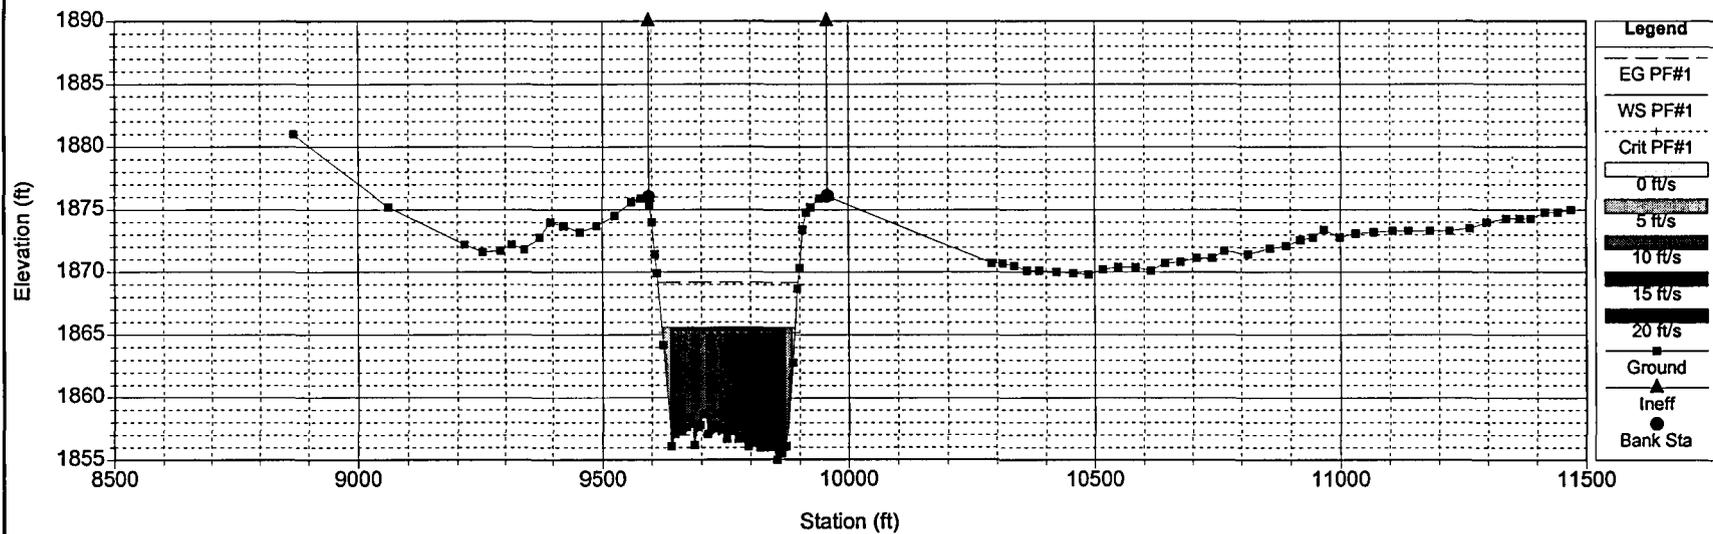
RS = 29.71

1ST SECTION D/S OF BRIDGE mcdot  
SECTION NO. BM (SECTION BN MOVED 50' DOWNSTREAM TO FRONT OF BRIDGE)

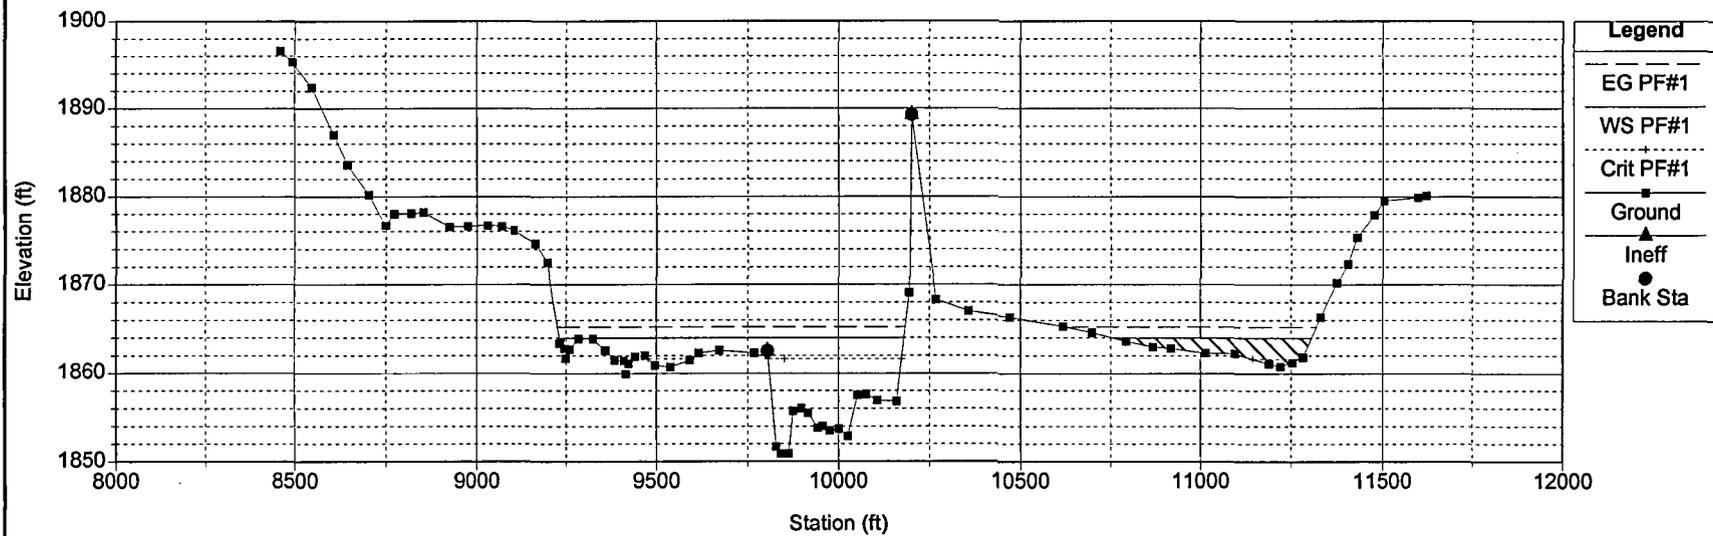
RS = 29.663

2nd Section D/S OF BRIDGE mcdot  
SECTION NO. BL

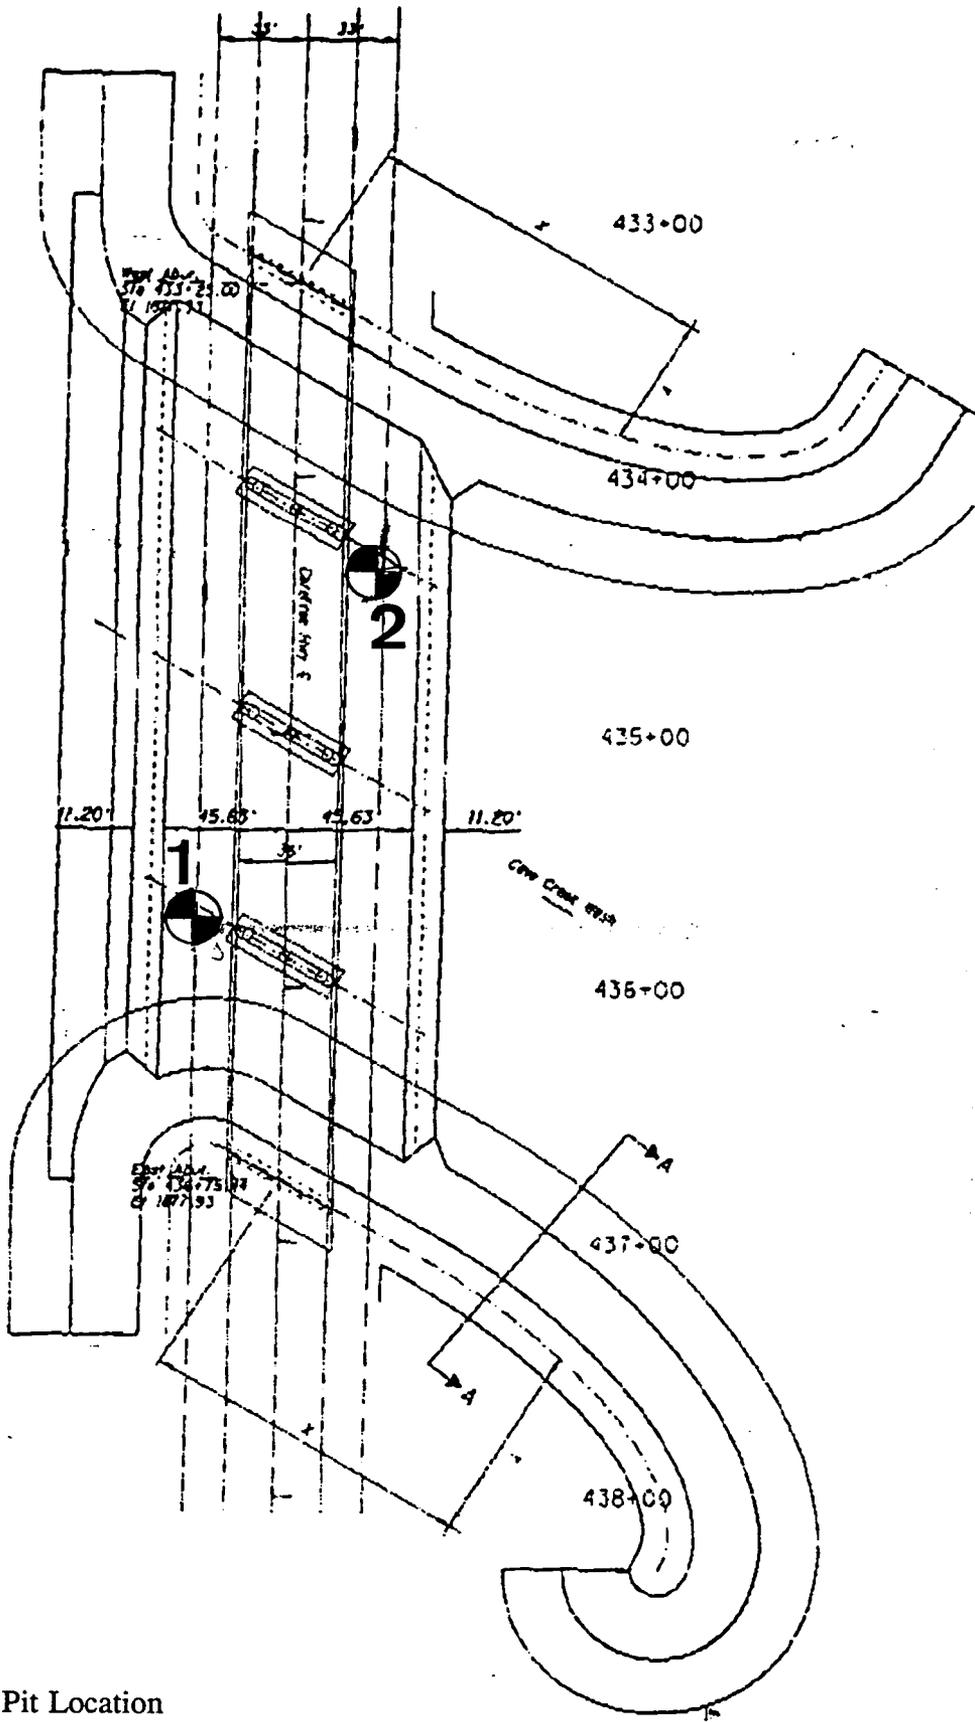
SITE PLAN

Test Pit Location

The existing site surface conditions and available subsurface data have been reviewed and a limited subsurface exploration program consisting of two test pits has been performed. The test pits were excavated with a John Deere 310 rubber-tired backhoe. A site plan, logs of the test pits and results of some laboratory testing are attached. The subsurface soils consisted of sand, gravel and cobbles with various amounts of boulders and some clay. Generally, the percentage of boulders increased with depth and several reached over 24 inches in least dimension. No groundwater was encountered during the field exploration.

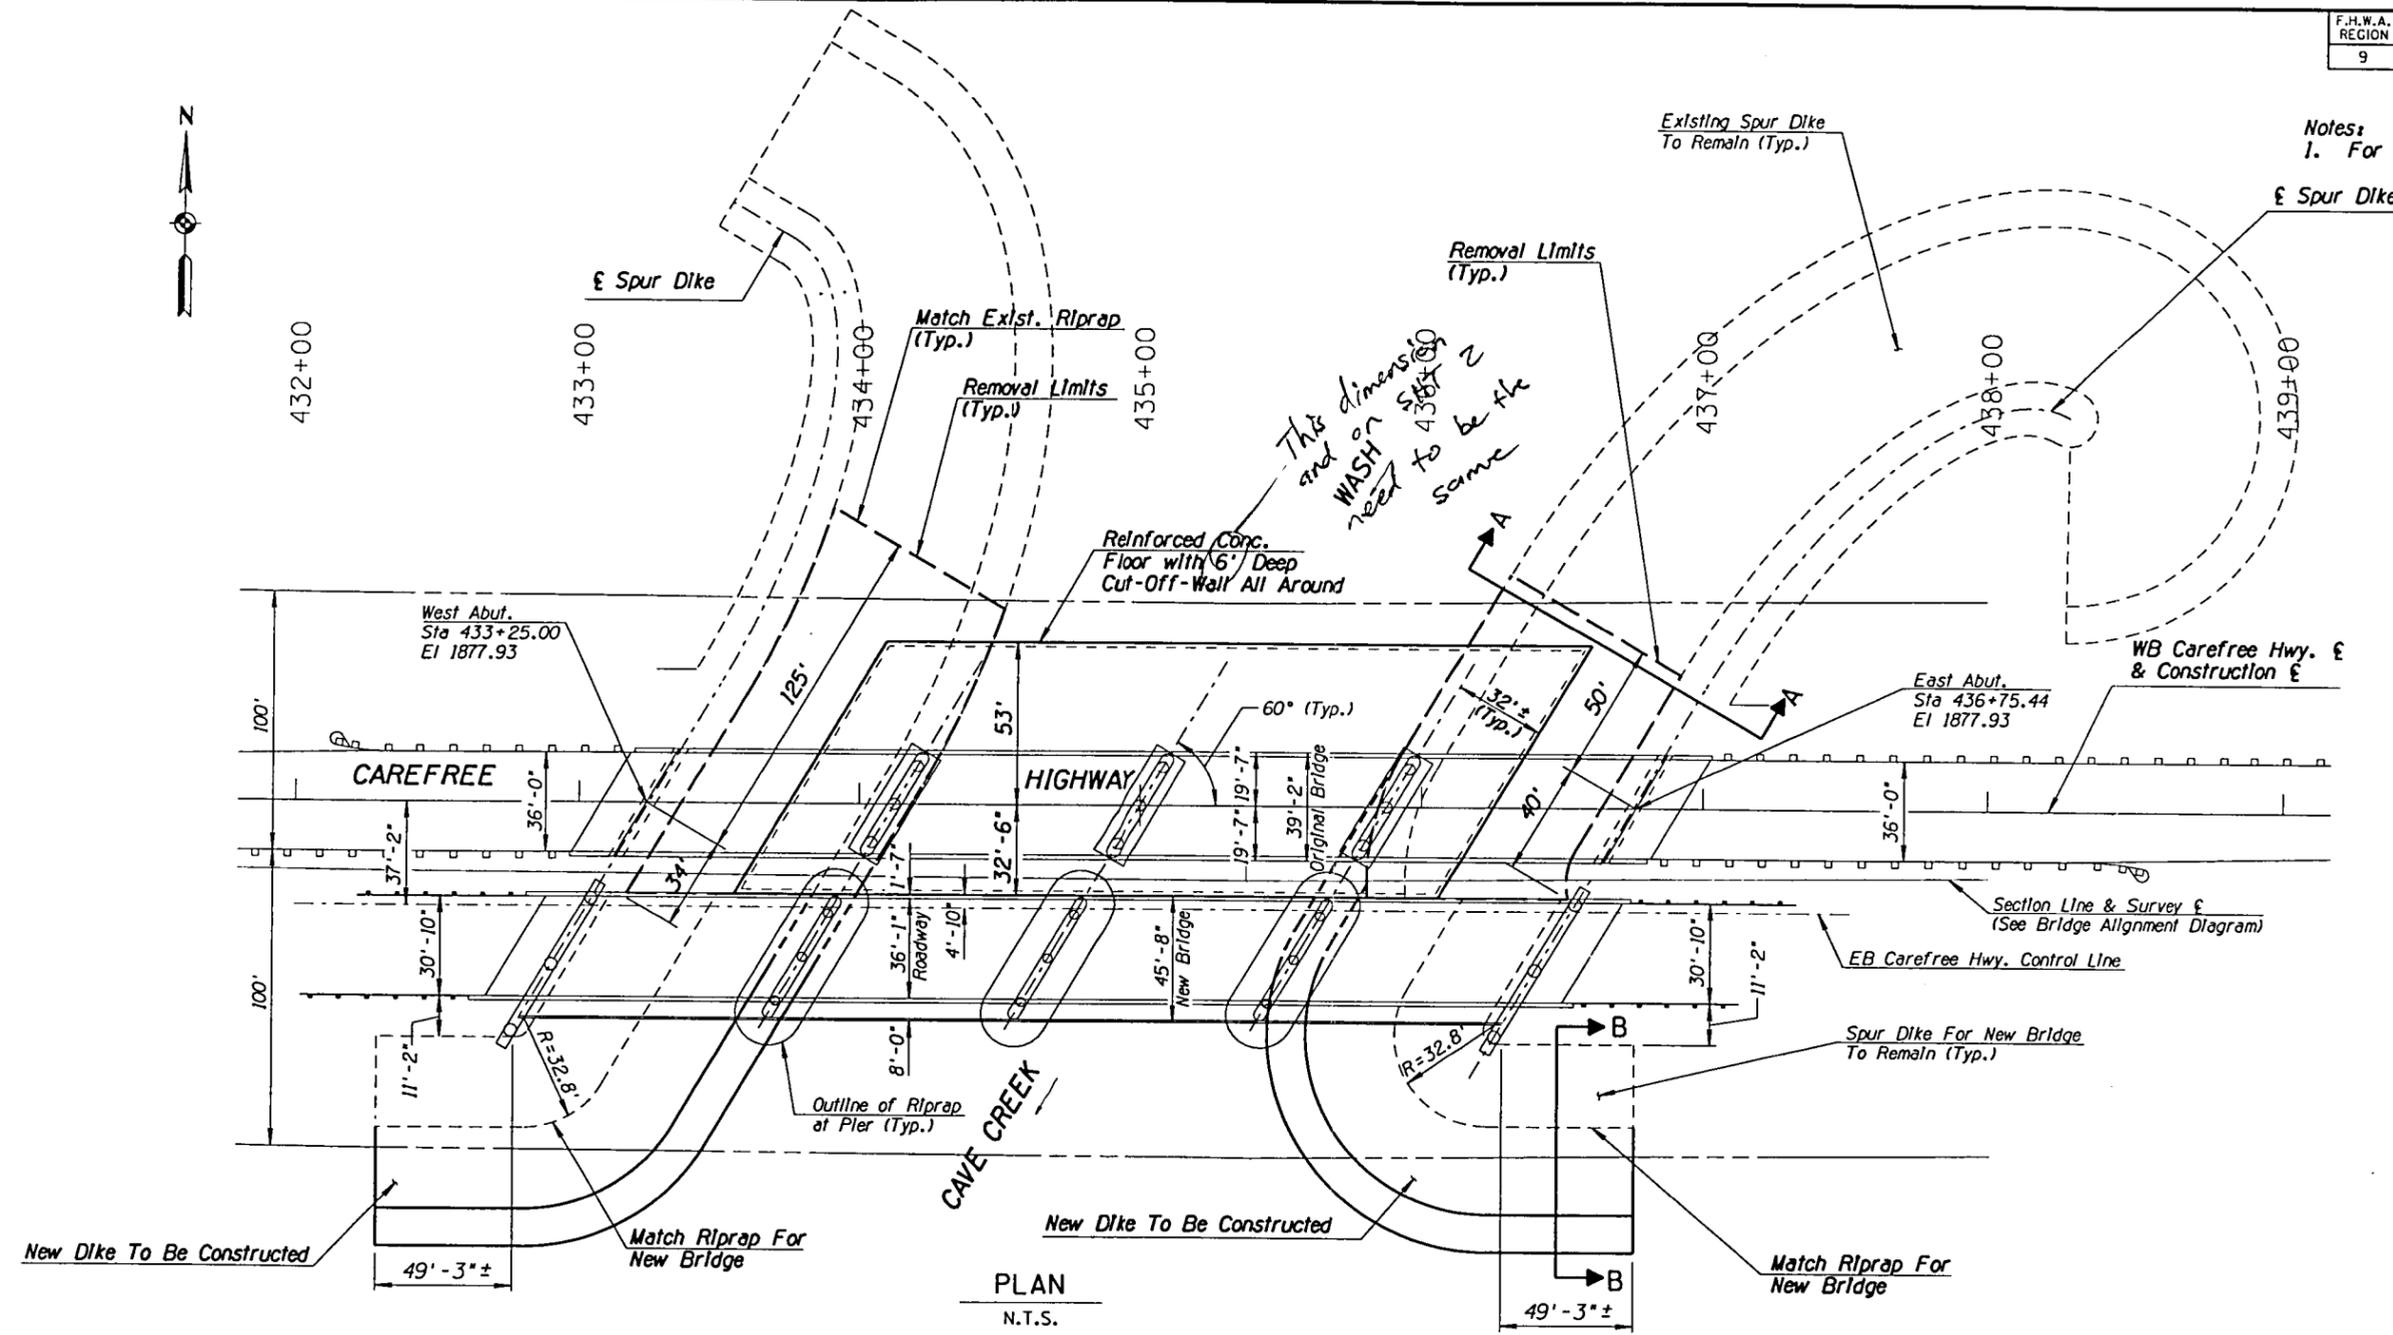
PLAN  
N.T.S.

Notes:  
1. For Section A-A & B-B See Sht. 2 of 2.

ALTERNATIVE 1

Alternative No. 1, a reinforced concrete floor with strengthened bank protection is recommended. This alternative is the least cost, and utilizes existing dumped riprap protection that is in place.

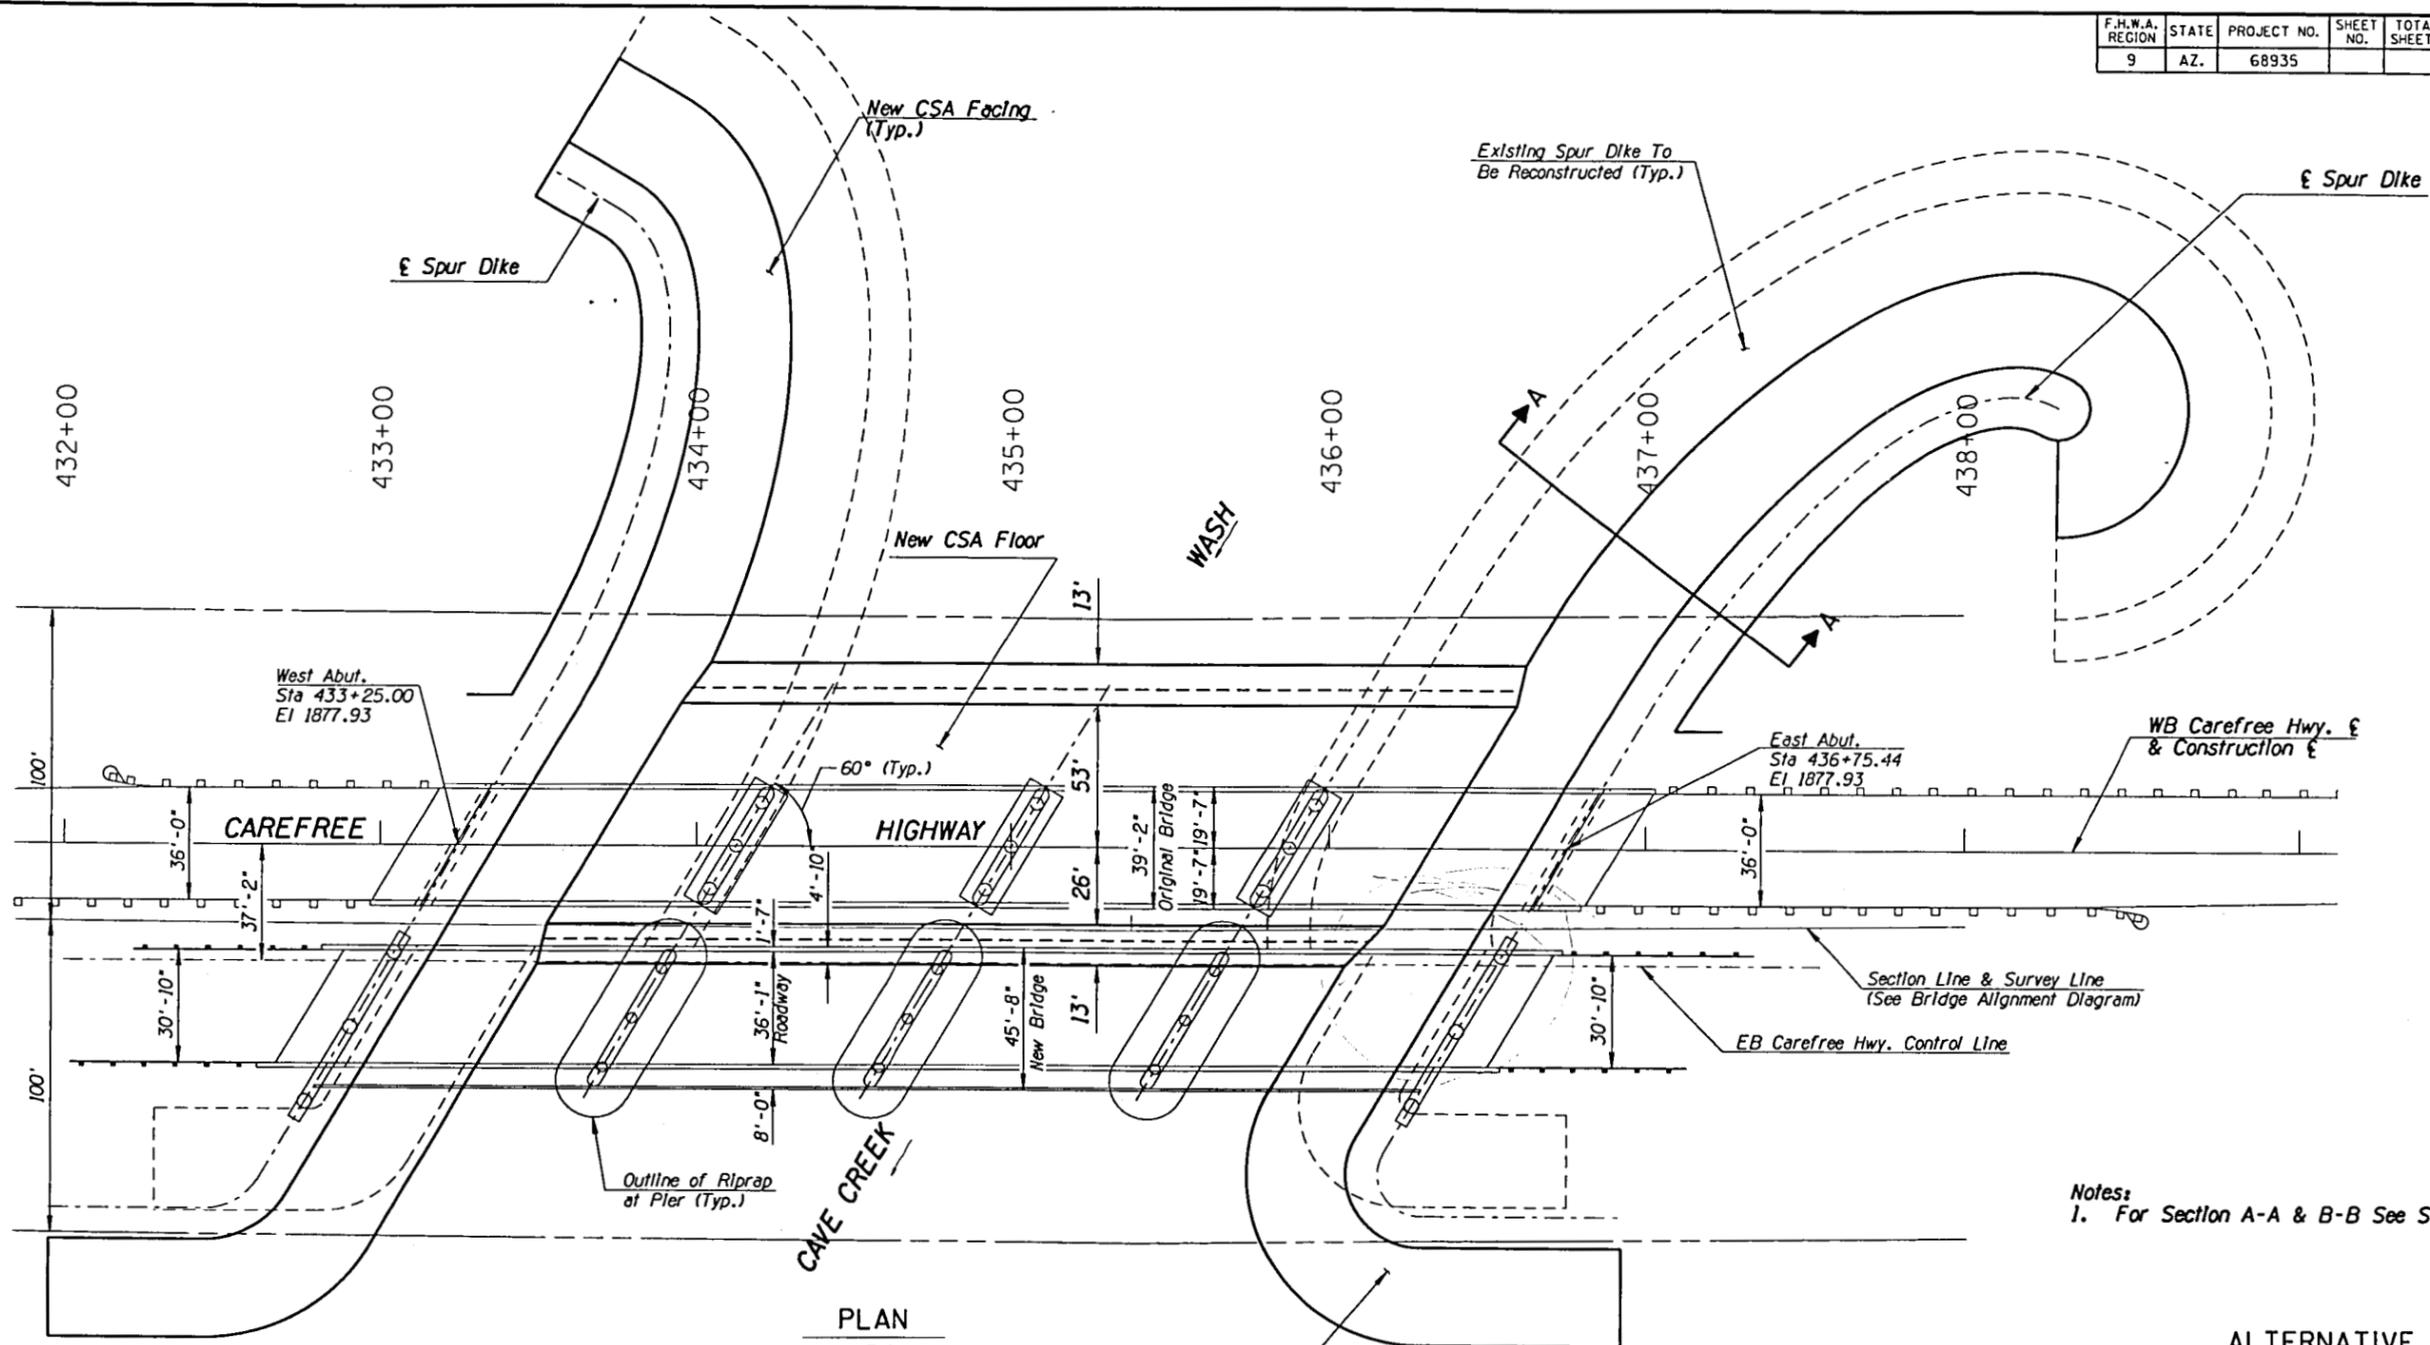
PLAN  
N.T.S.

Notes:  
1. For Section A-A & B-B See Sht. 2 of 2

ALTERNATIVE 2

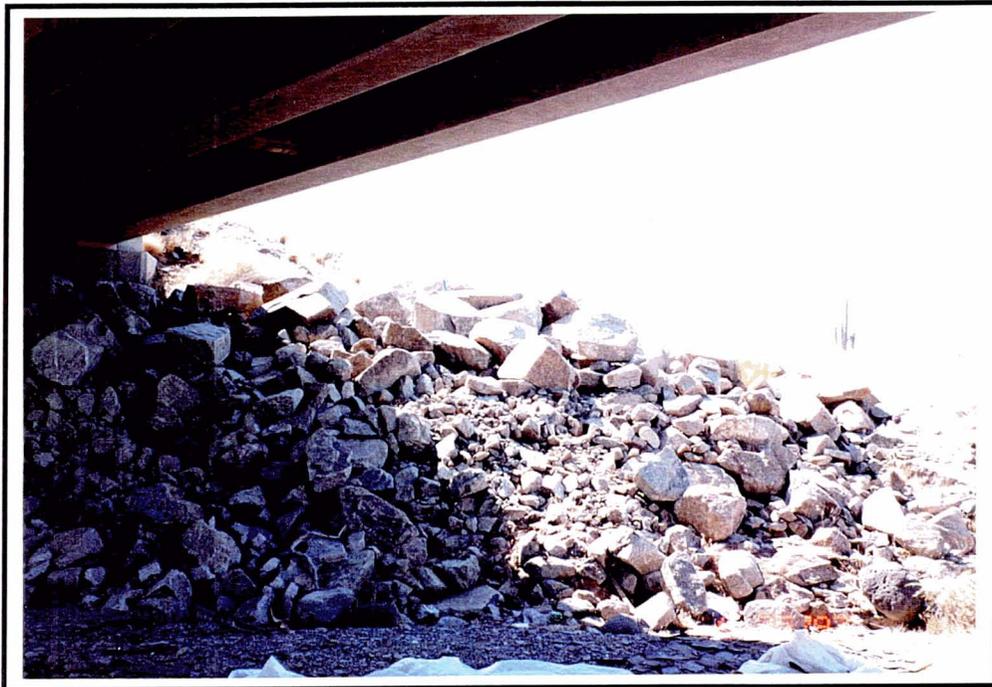
5. The gradation of the riprap in place appears to be of a larger size than that specified on the plans, but is somewhat gap-graded with areas of large material without smaller stones and areas with none of the larger stones. Maximum size is up to 48 inches.

During the field reconnaissance we observed that the existing riprap at the abutments was highly segregated, i.e., there were areas with predominantly large stone and other areas with small stone. Also, the smaller stones in the revetment appeared roughly the same size as the larger bed material in the channel. These two factors raised doubts regarding the adequacy of the existing protection. Using preliminary results from the HEC-RAS model with the 100-year event, rock size and thickness were calculated. Results are presented in Table 4.

Gap-graded riprap on abutment.

If riprap is selected as a countermeasure for the abutments, we recommend using a FHWA 2-ton gradation (Table 5) with a layer thickness of 5 feet. Existing rock could be used as part of the new revetment in one of two ways. If the existing rock is completely removed first to remedy the segregation problem, the rock could be mixed with new (larger) stones to make up the required gradation. Bedding and filter fabric should be used as per the original bridge plans (as-builts dated 6/25/86). A second option would be to leave the existing rock in place and install the rock with the new gradation over the existing revetment. The layer thickness of the new rock over the existing rock would be equal to 4.5 feet, the largest rock size of the 2-ton gradation. Construction quality control should be provided to prevent placement of segregated rock.

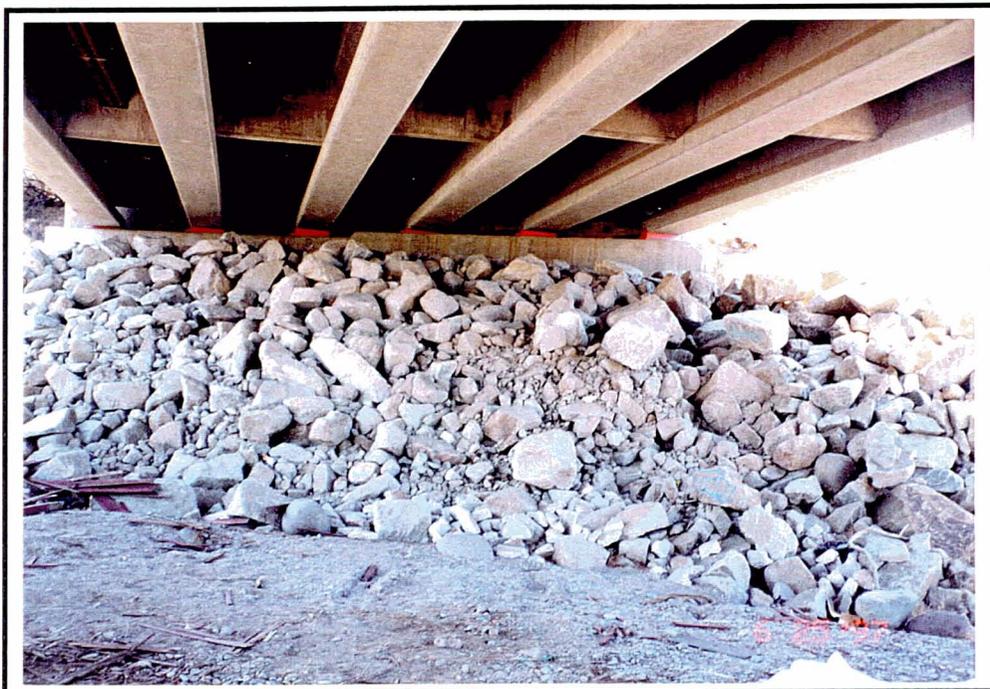
Riprap on abutment.

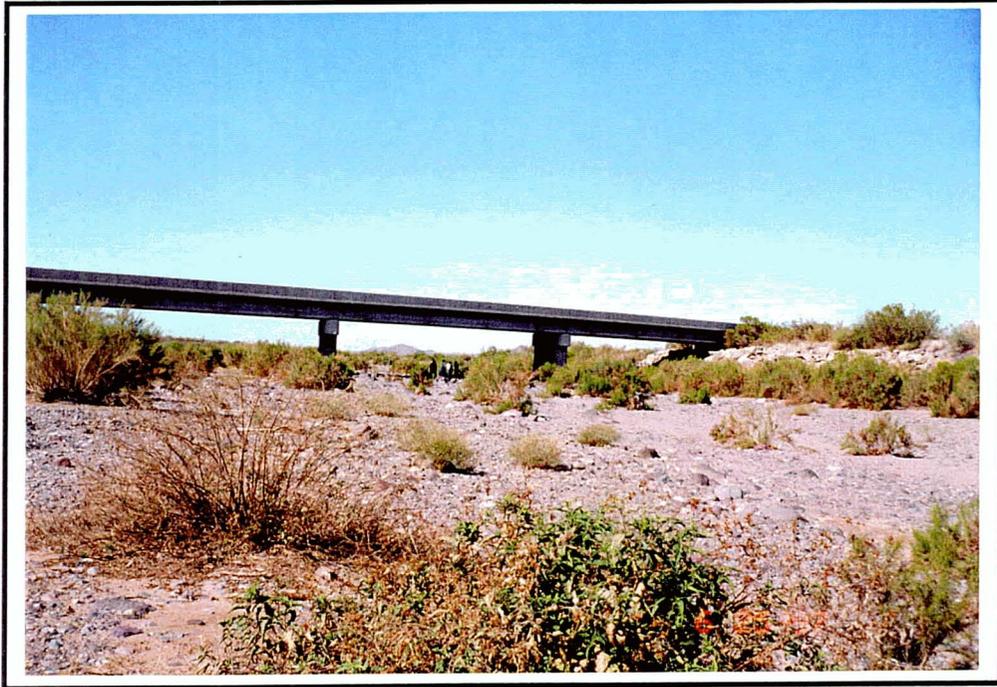
Looking downstream. Western spur dike to right.

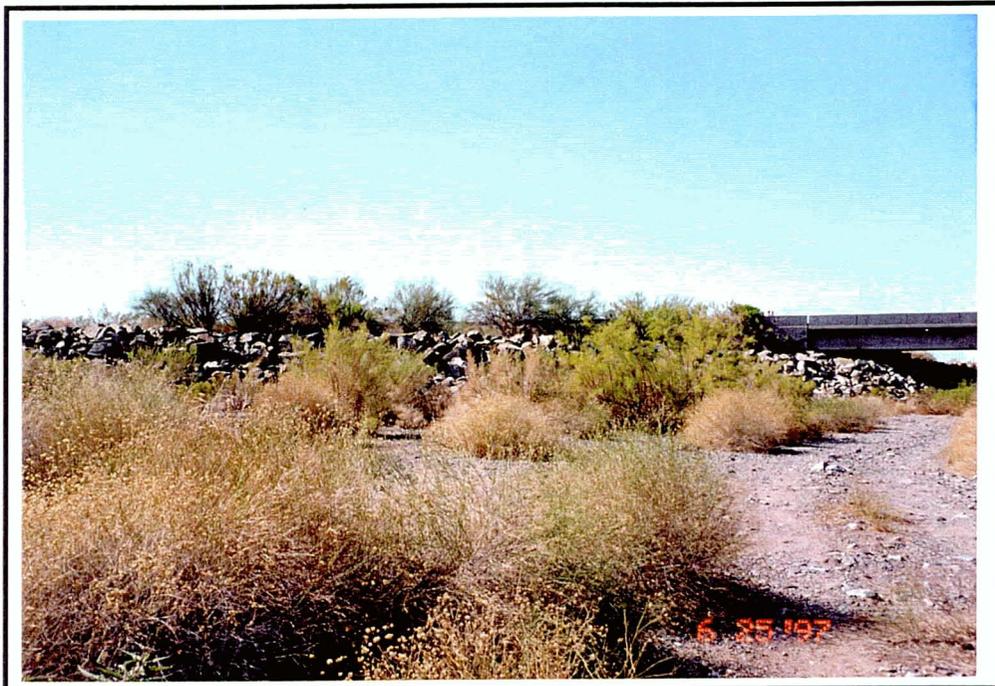
Looking downstream. Eastern spur dike.

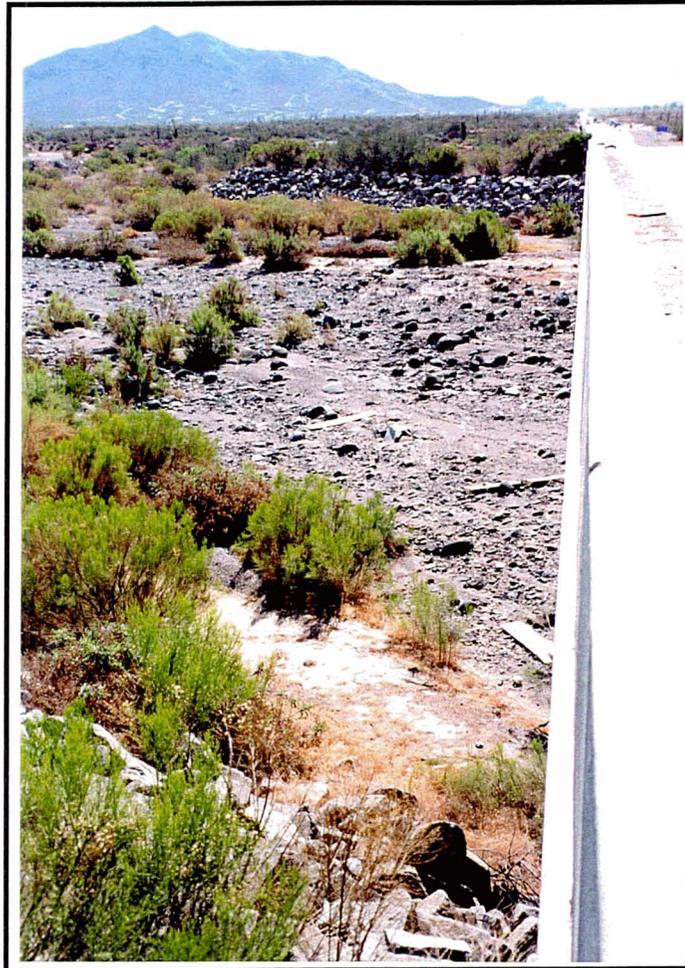
Upstream drip-line of bridge looking east.
