**PHASE I ENVIRONMENTAL SITE ASSESSMENT
UPPER NEW RIVER FLOODPLAIN MITIGATION PROJECT
PARCELS R-7222-100 THROUGH R-7222-111 AND
R-7222-112 AND R-7222-123
NEW RIVER,
MARICOPA COUNTY, ARIZONA**

FLOOD CONTROL DISTRICT OF MARICOPA COUNTY
2801 West Durango Street
Phoenix, Arizona 85009

GROWTH ENVIRONMENTAL SERVICES, INC.
4041 North Central Avenue, Suite 1050
Phoenix, Arizona 85012
(602) 248-8808

May 19, 1995
Growth File AZ009523

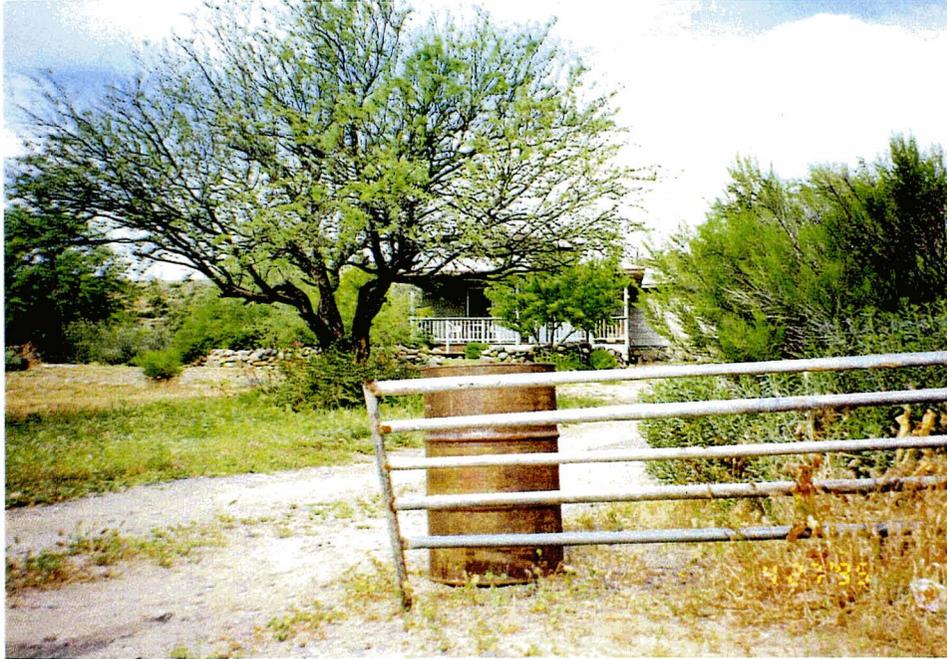
Photograph #1

Parcel 100 - 49801 North 37th Avenue. This parcel consists of a single residential property. An empty 55-gallon drum labelled uninhibited 1,1,1-trichloroethane was observed on the west side of the entrance gate to the property. No evidence of leakage or staining was observed around the empty drum. A water well and water storage tank were observed on the north side of the property. A grave marker was observed northwest of the residence. The headstone was labelled "Fern W. Hartley, Beloved Wife and Mother, 1906-1970."

View of Parcel 100 looking west from eastern property boundary. Note empty drum.
Drum is labeled 1,1-trichloroethane.

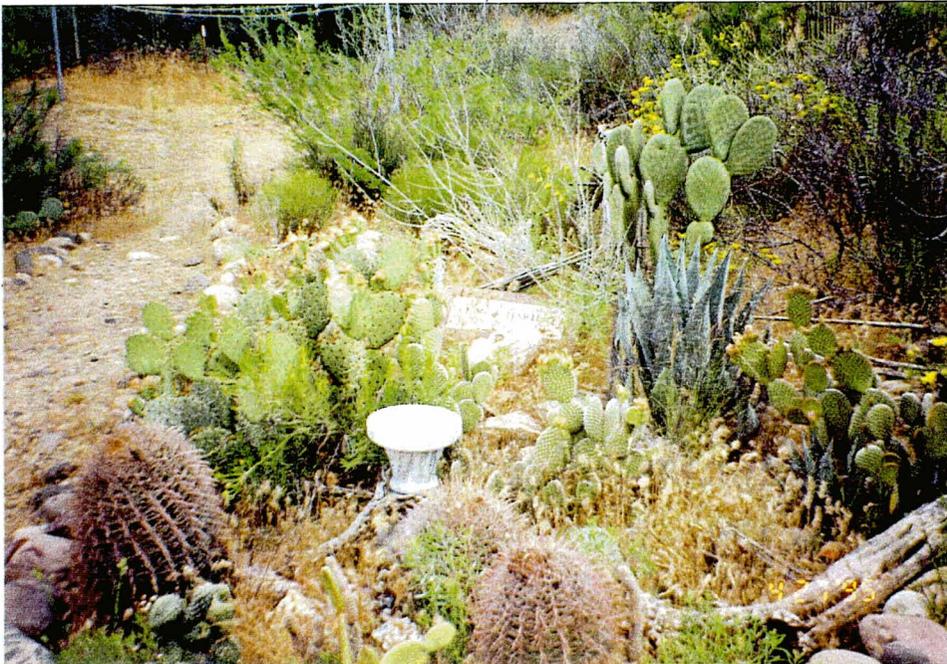
Photograph #2

View of headstone on Parcel 100.

Grave Marker. A headstone was observed on Parcel 100. Further investigation into whether this marker is a memorial or a grave should be determined. If the Site has a potential for flooding, FCDMC may wish to explore having the grave marker moved to a higher location.

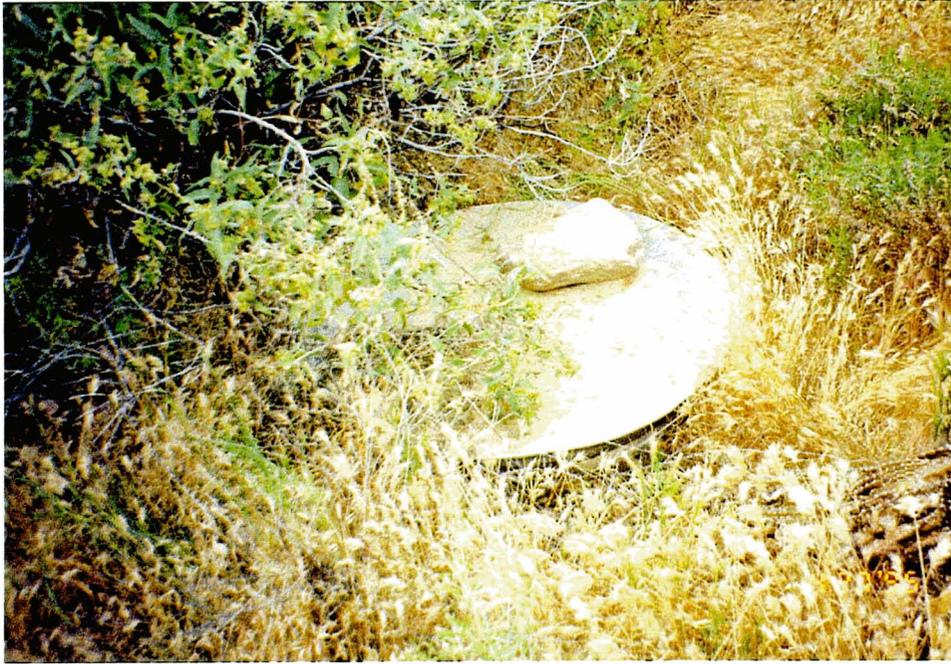
Photograph #3

A steel lid covering a corrugated metal pipe (CMS) was observed along the western edge of the property. The pipe was approximately 24 inches in diameter and extended below the ground surface. Growth attempted to remove the steel lid to determine the depth and function of the CMS, however they were unsuccessful. A small concrete pad was observed directly south of the CMS. A horse corral was observed along the southern edge of the parcel. East of the corral was the remains of a wooden foundation. A discarded air compressor and a pile of scrap wood, pipe, and discarded household material was observed by Growth.

View of steel manhole cover lid near western boundary of Parcel 100.

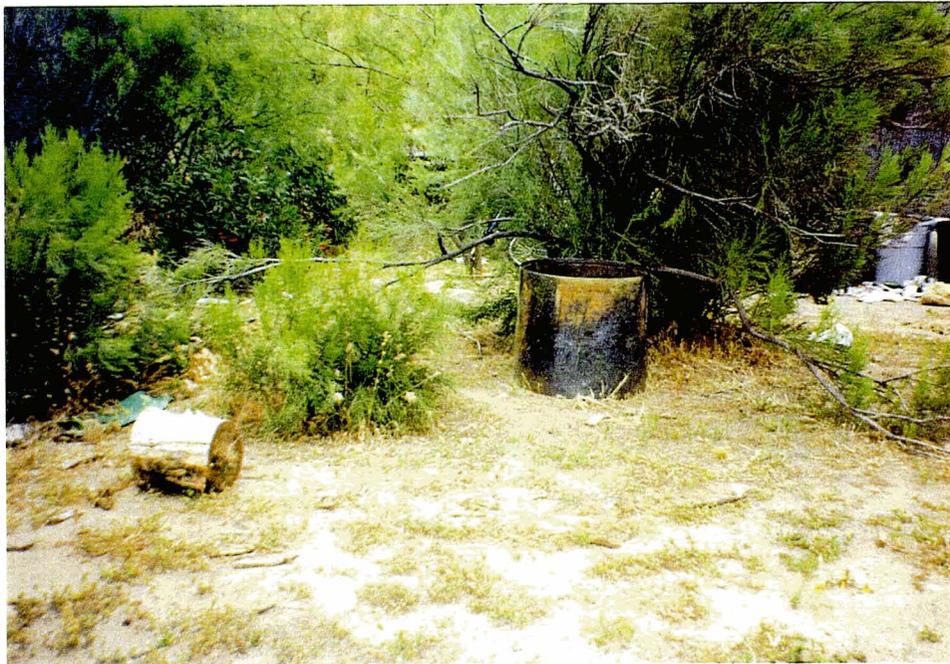
Photograph #4

View of burn barrel on Parcel 101.

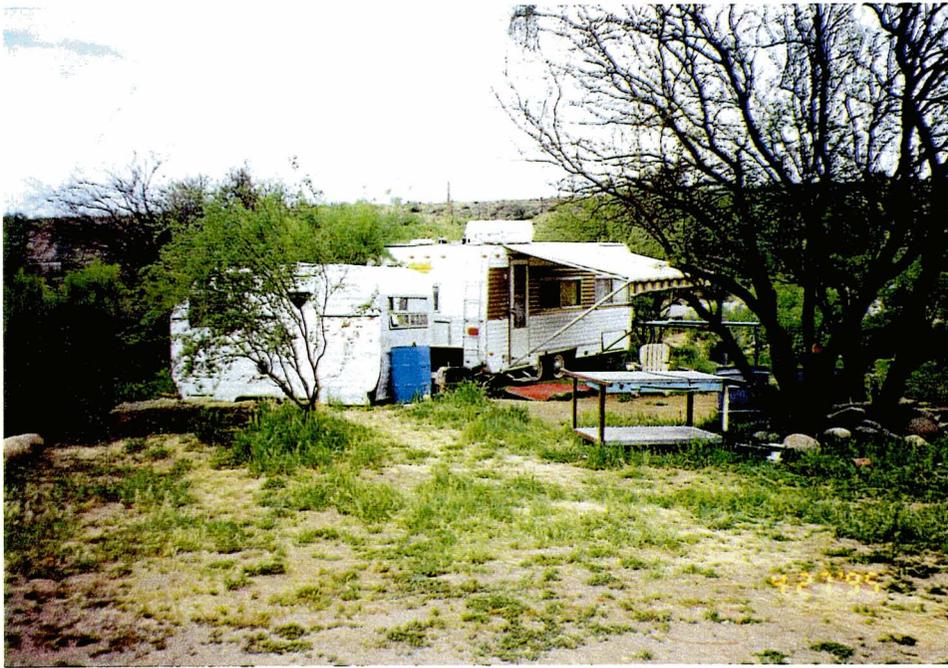
Photograph #5

View of mobile homes and 55-gallon drums on Parcel 101. View is looking south.

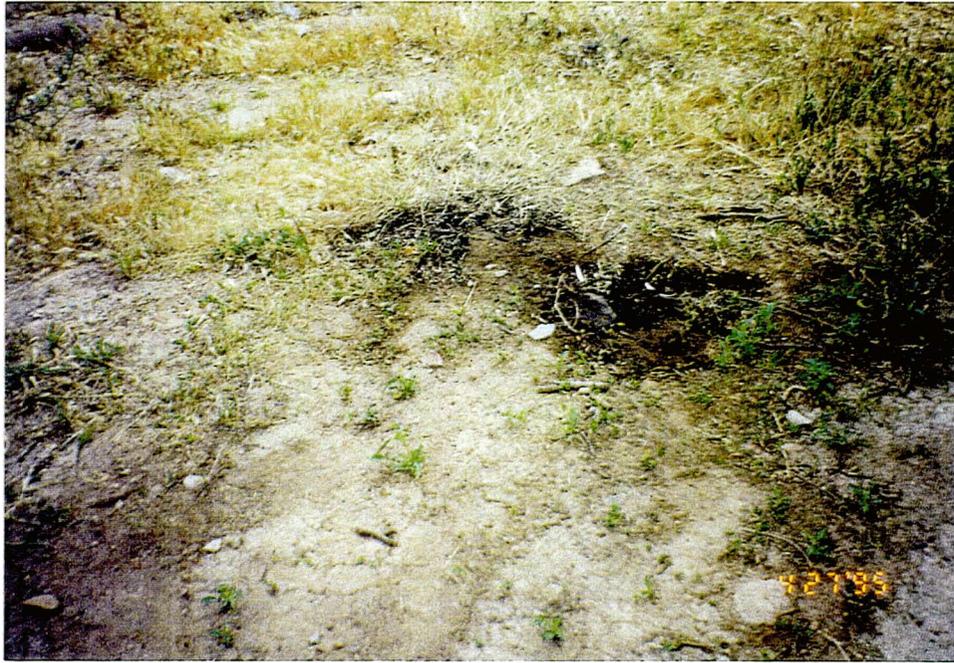
Soil Staining. Three parcels contained areas of oily stained soil within the Site boundaries. An area of soil staining was observed on Parcel 103, south of a trailer that contained empty 55-gallon drums formerly containing diesel fuel. A 35-gallon metal trash-can was observed on Parcel 109 in the entrance drive. The can was approximately one-half full of oily stained soil. An area of oily stained soil was observed adjacent to the trash-can where it appeared that the staining extended several inches into the soil.

Photograph #7
View of oily stained soil on Parcel 103.

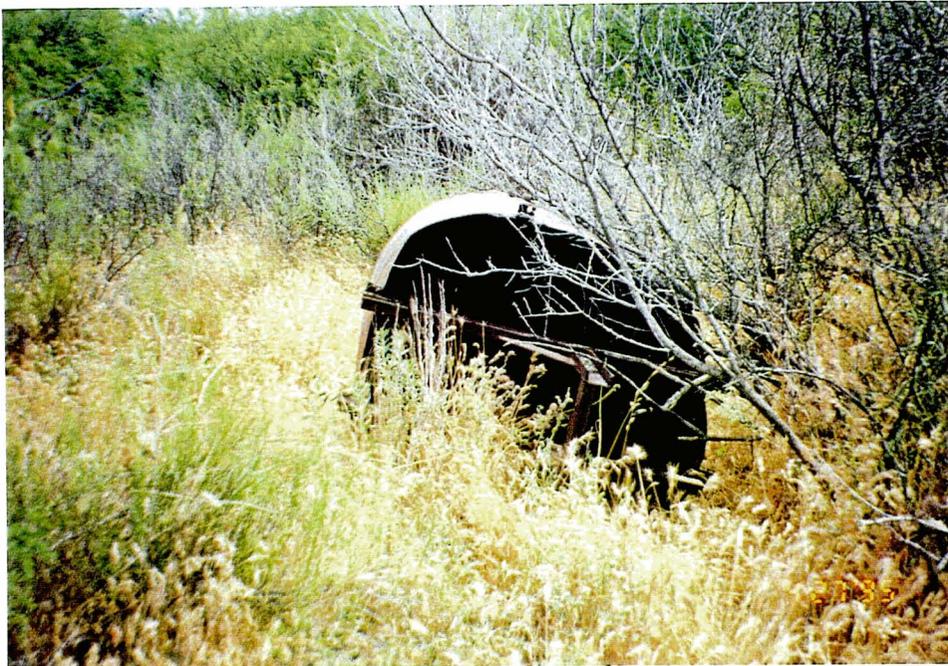
Photograph #10
View of steel tank on Parcel 105.

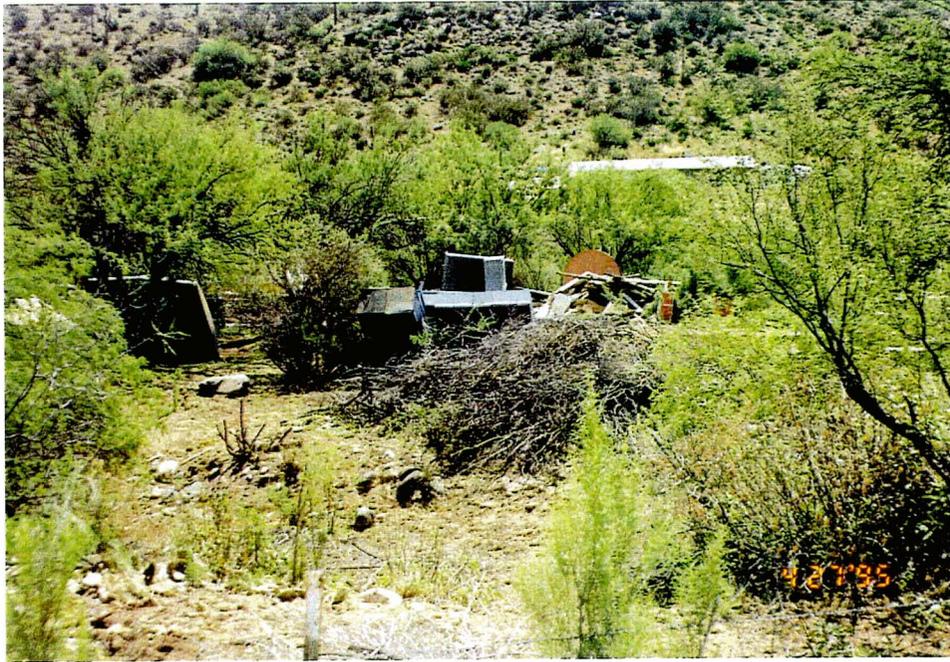
Photograph #11

View of discarded material in corral on Parcel 106. View is looking east .

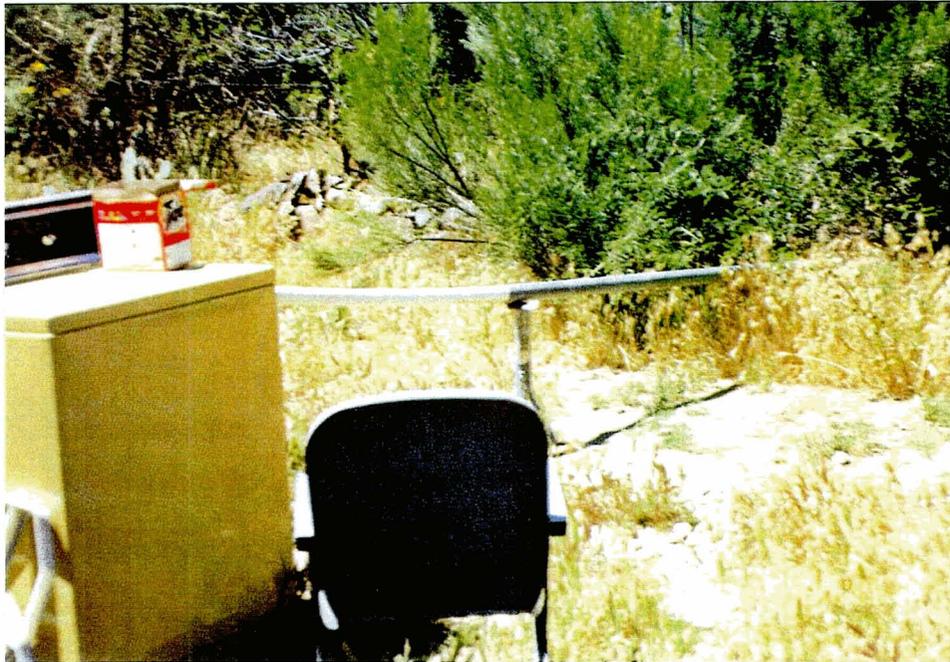
Photograph #12

View of discharge pipe from washing machine on Parcel 106.

Septic Systems. The area of the Site is serviced by individual septic systems. It is Growth's understanding that the residential properties will be demolished as the properties are located within the floodplain of the New River. Septic tanks provide a continuous access to the sub-surface, and therefore represent an element of risk to environmental conditions of the property through the potential introduction of petroleum or hazardous substances through sinks, toilets, drains and other openings to the sub-surface. Growth recommends that the septic systems be closed and a program of soil sampling and analysis be conducted if it appears that petroleum or hazardous substances have been introduced into the systems.

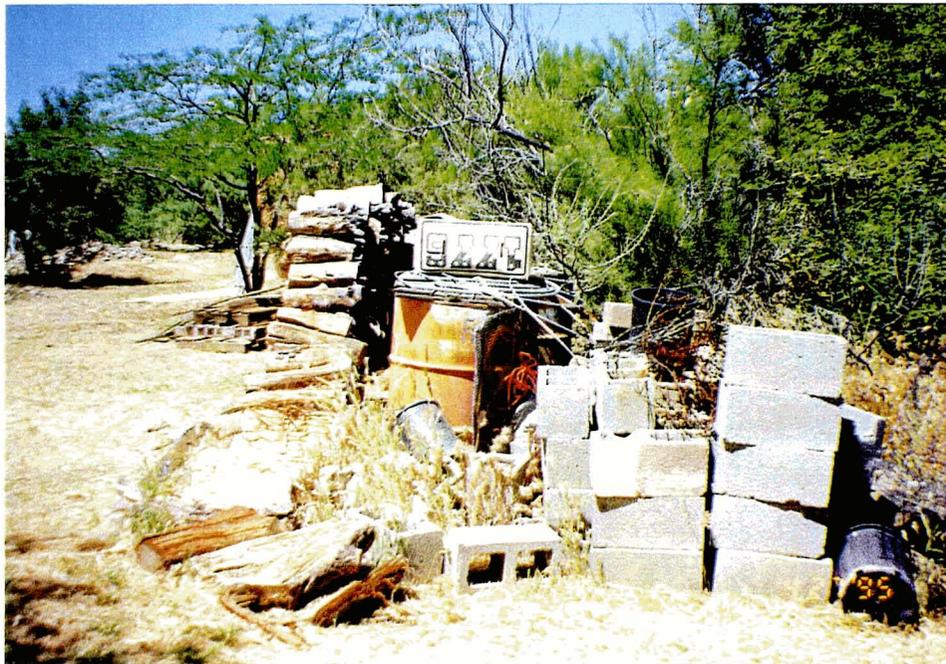
Photograph #14

View of wood storage area, empty drums and landscaping material on Parcel 107.
View is looking north.

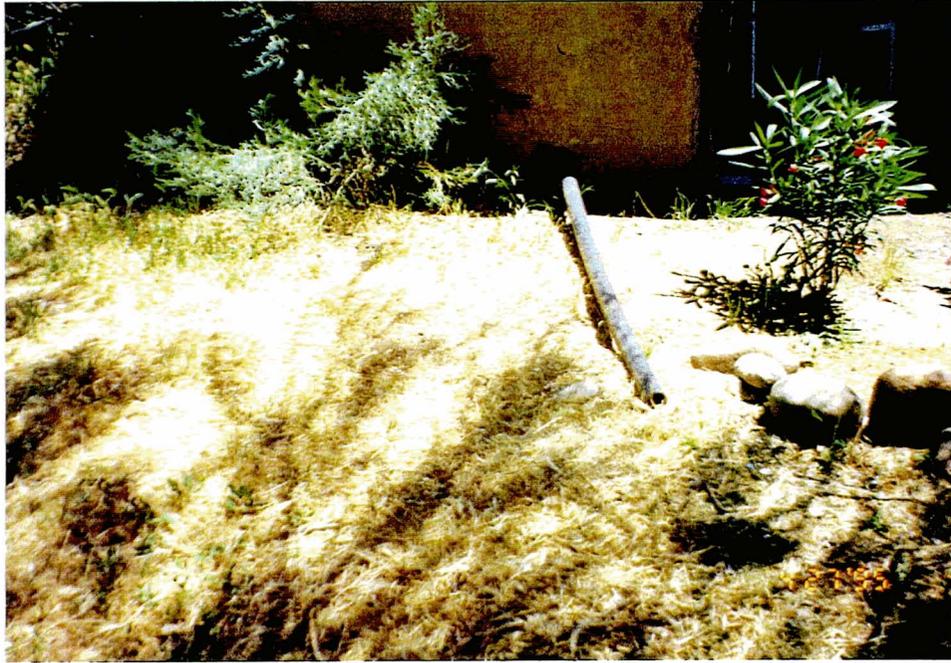
Photograph #15

Parcel 108 - 52018 North 36th Avenue. This parcel was developed with a single family residence and an unfinished pagoda-shaped building intended as living quarters for the owner's son. A discarded battery and anti-freeze container were observed near a parking area to the east of the pagoda building. No staining was observed around the automotive parts. Gray water appeared to be discharged to the property from black ABS pipes observed on the west of the residence and the south side of the pagoda building. No discolored sediment or stressed vegetation was observed in the vicinity of the pipes.

View of discharge pipe form residence on Parcel 108. View is looking east.

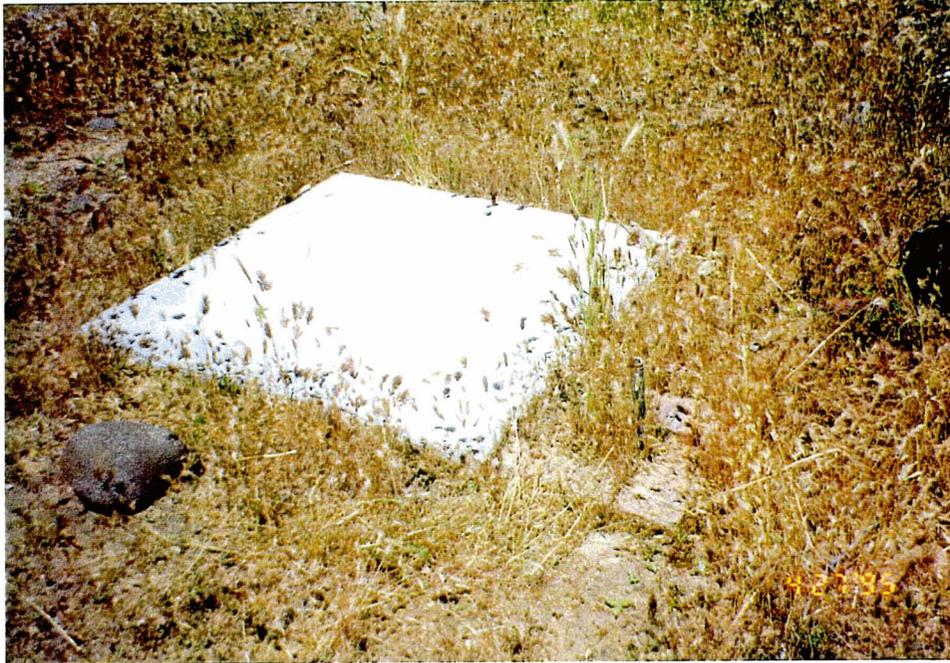
Photograph #17

View of small concrete pad and cut-off pipe on Parcel 109.

Water Well Abandonment. Growth recommends that the Flood Control District of Maricopa County (FCDMC) abandon all water wells on the Site. At least ten wells are currently registered as being located on the Site. A small concrete pad and one-inch diameter pipe was observed on Parcel 109. The function of the pipe was unknown, although it may have been an unused domestic well. In addition, a corrugated metal pipe (CMP) approximately 24 inches in diameter was observed near the western edge of the parcel. This pipe was covered with a steel lid. Its function was unknown. Due to the anticipated use of the Site and its location in a floodplain, Growth recommends that the wells be permanently abandoned and the CMP removed.

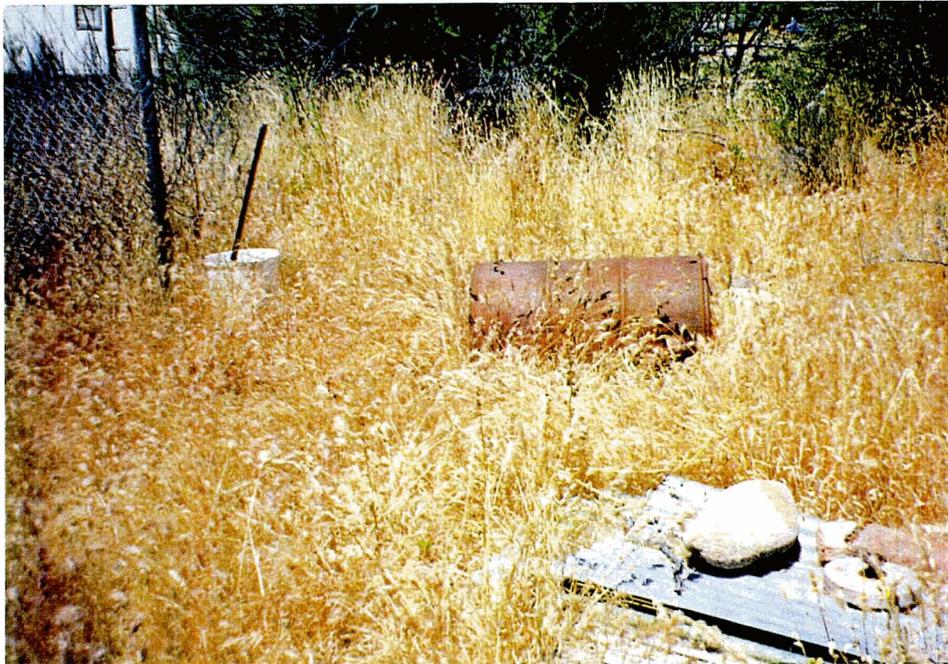
Photograph #8

View of 55-gallon drum containing dirt on Parcel 109.

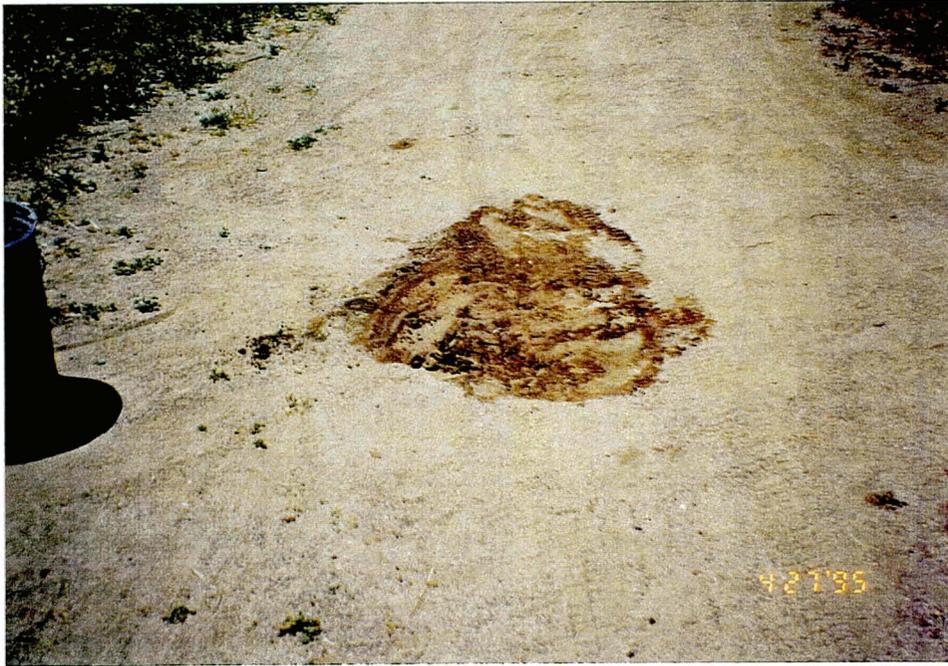
Photograph # 19

Parcel 109 - 50422 North 36th Avenue. A single family residence and detached garage structure was on located near the western portion of this parcel. Two smaller fenced areas with storage sheds were observed near the northeast corner of the parcel. Seven empty drums that appeared to be used for burning trash were observed on the west side of the garage and north of a small concrete slab near the southwest corner of the parcel. A 55-gallon drum was observed lying on its side near the northern boundary. No labeling was observed on the drum and it appeared to have approximately two inches of dirt in the bottom of the drum. Several areas of metal scrap were observed near the northeast corner of the property as well as an area of landscaping debris. Growth observed an area of oily soil staining on the dirt drive into the property. A 35-gallon trash-can appeared to be approximately half full of oily stained soil and the soil stain appeared to extend into the soil for several inches.

View of oily stained soil on Parcel 109. Edge of trash can is visible.

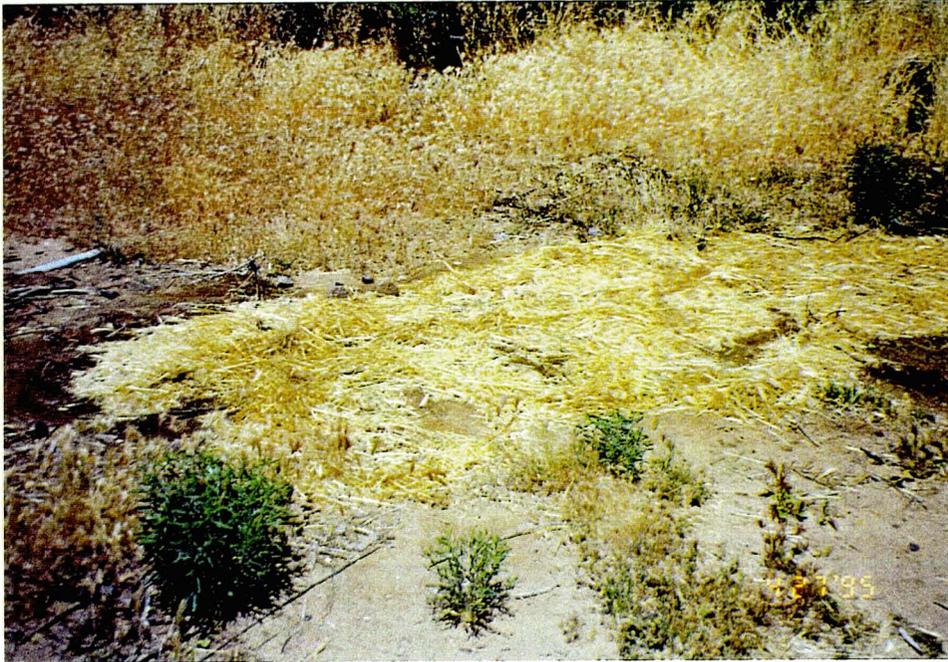
Photograph #21

On Parcel 110, two areas of oily stained soil were observed. The first area is located on the west side of the entrance drive, where the dirt had been covered with a layer of straw. A second area was observed on the dirt floor of a storage shed adjacent to an automotive repair facility at the northeast corner of the parcel. The dirt floor was heavily stained.

A small auto-repair facility appeared to have been located on Parcel 110 located at 50440 North 36th Avenue. A engine hoist and other automotive equipment and parts were observed in several small sheds and structures near the northeast corner of the parcel. An area of heavy oily staining was observed on a dirt floor in a storage shed adjacent to the repair facility. In addition, an area of oily stained soil was observed on the west side of the entrance drive. This area had been covered with a layer of straw.

View of oily stained soil covered with straw on Parcel 110.

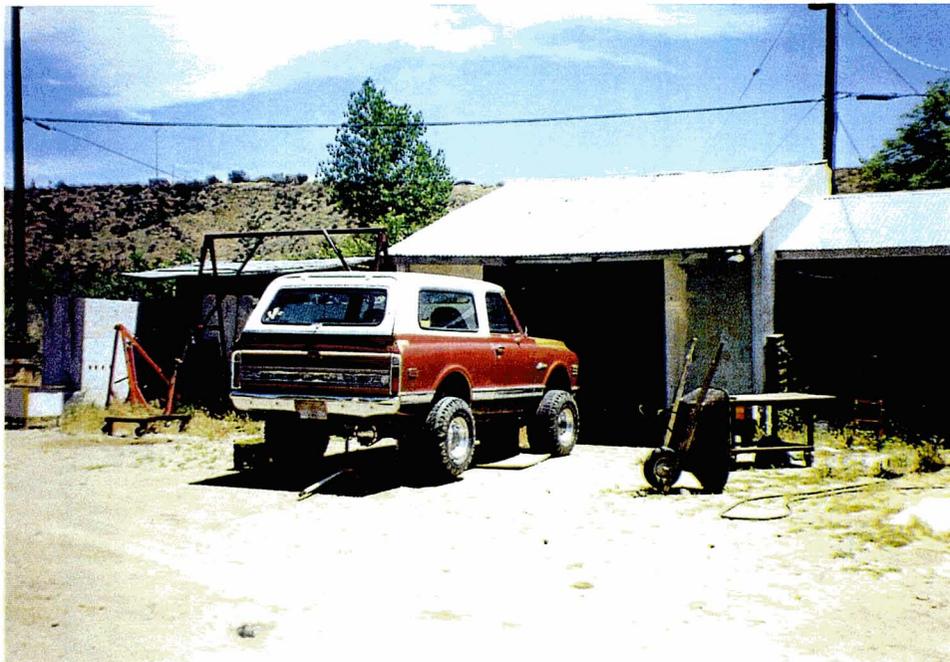
Photograph #22

View of auto repair facility on Parcel 110. View is looking towards the northeast.

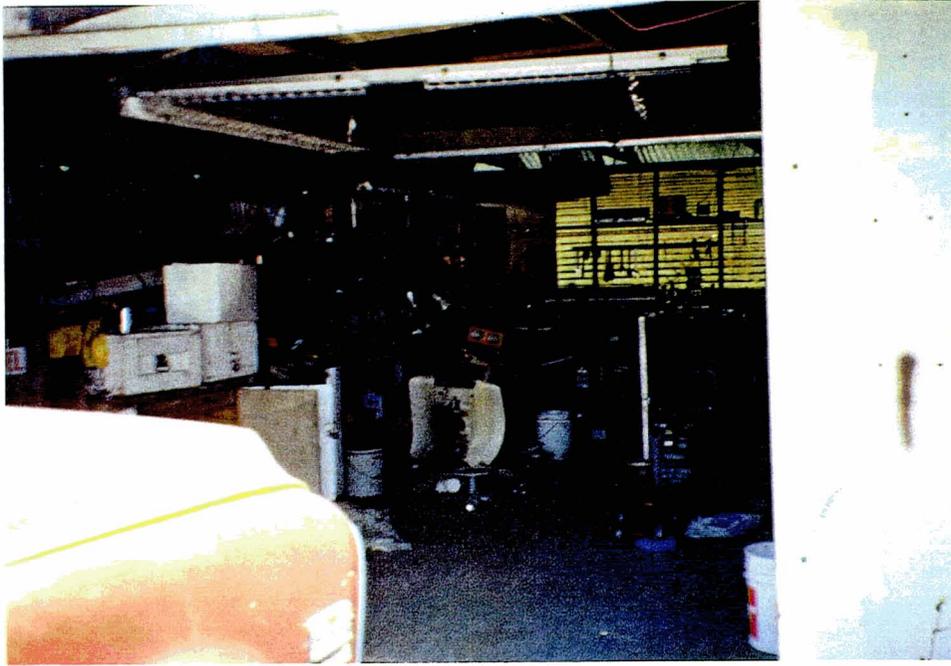
Photograph #23
View of interior of auto repair facility on Parcel 110.

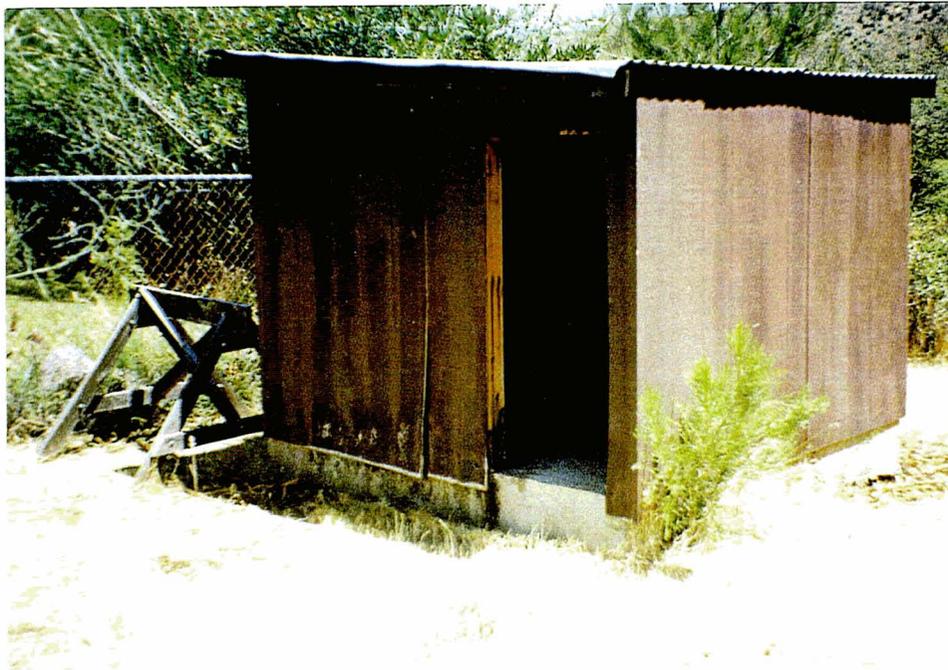
Photograph #26

View of pump house on Parcel 111. View is looking northeast.

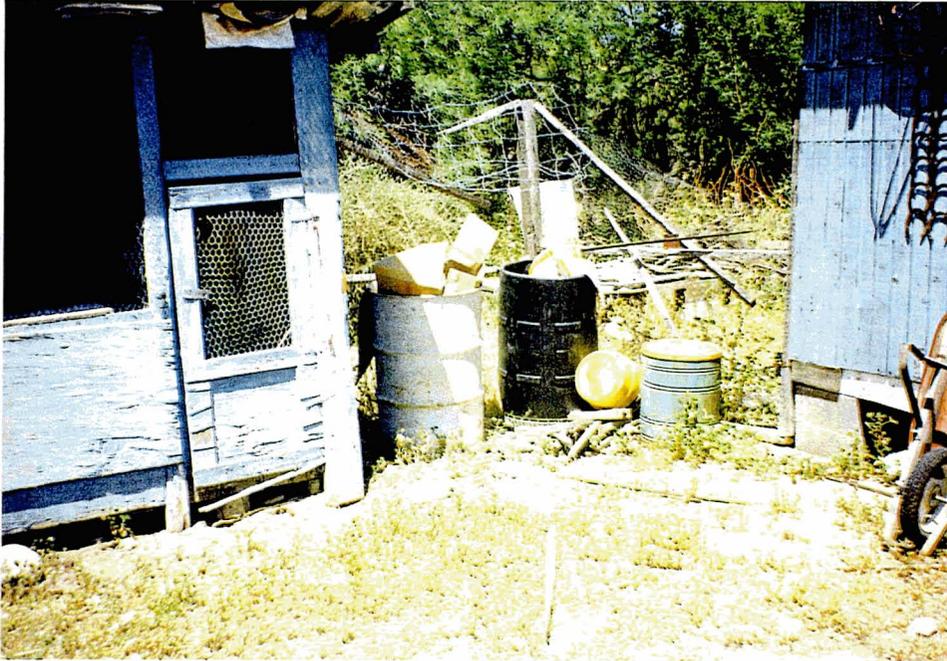
Photograph #27

Parcel 113 - 3525 Photo View Road. Access to Parcel 113 was from North 36th Avenue. Photo View Road effectively formed the northern property boundary. A single family residence was observed near the southern portion of the parcel. South of the residence was a fenced corral. Five pigeon coops were located along the western fence line and a sixth coop was located along the eastern boundary. A dirt drive crossed the property and provided access to the neighboring parcel to the east. A car battery and an area of household debris was observed north of the drive along the western fence line. Two 55-gallon drums were observed directly north of the debris. An area of metal scrap, household trash and two 55-gallon drums also were observed along the northern edge of the property. All four 55-gallon drums appeared to have been used to burn household trash.

View of pigeon coops and trash-filled 55-gallon drums on Parcel 113.
