Summary of Field Inspection

Cline Creek Rodger Creek FCD 89-15

Flood Control District
of
Maricopa County

Michael Baker, Jr., Inc
Phoenix, Arizona

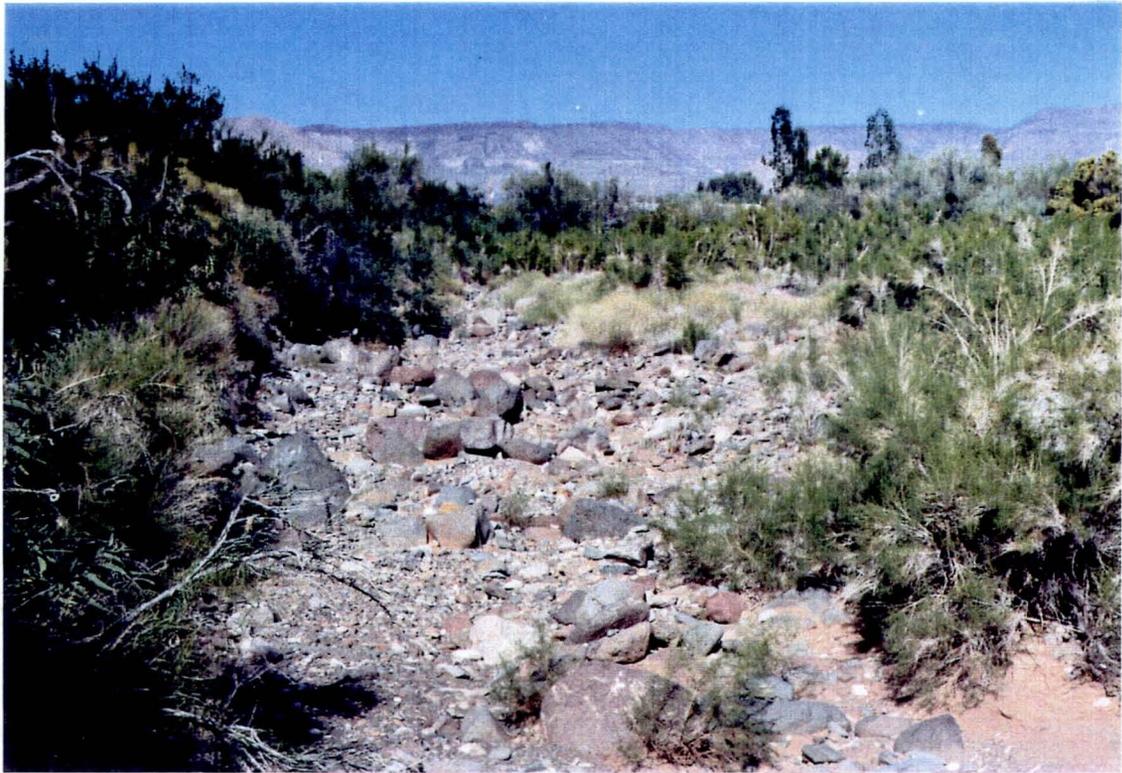
PHOTO 1: CLINE CREEK - MAIN STEM UPSTREAM OF CIRCLE MOUNTAIN ROAD DIP CROSSING, LOOKING UPSTREAM. BED WIDTH 15' TO 25', CHANNEL INCISED 6' TO 10' DEEP. MAIN CHANNEL DEFINED AS UNVEGETATED GRAVEL/BOULDER BED. OVERBANKS BEGIN AT VEGETATION LIMITS.

CHANNEL N = 0.045 OVERBANK N = 0.065

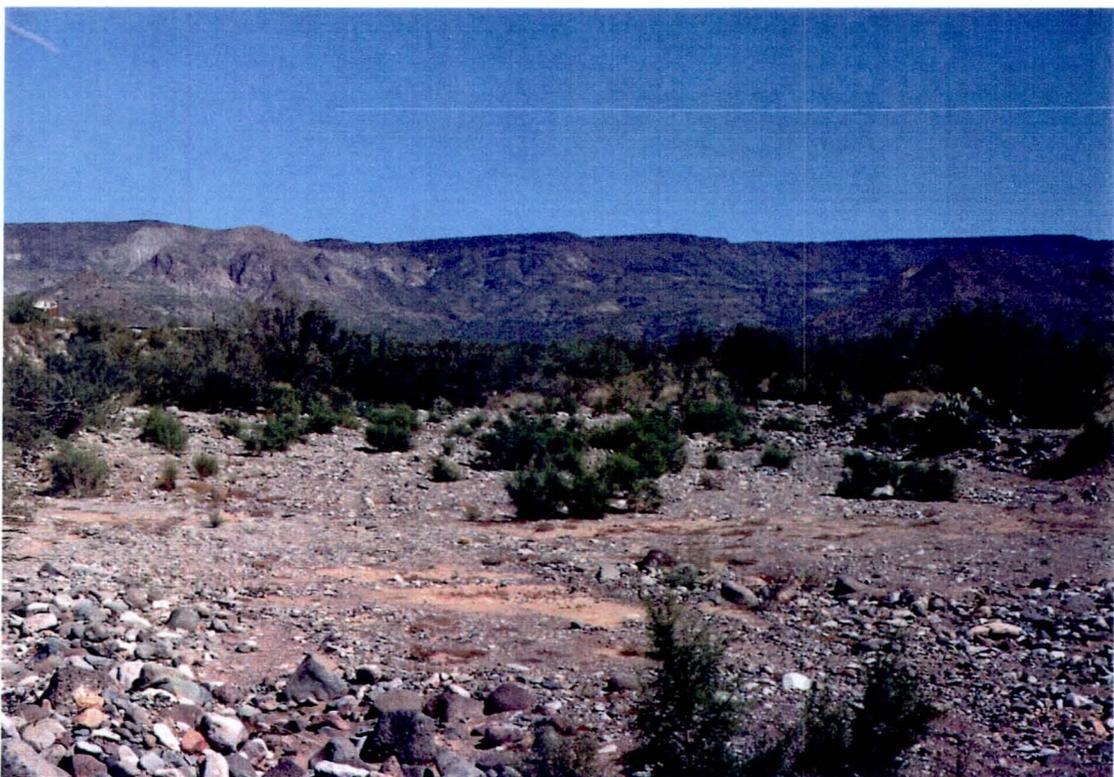
PHOTO 2: CLINE CREEK - MAIN STEM WEST OF 10TH STREET, LOOKING UPSTREAM. APPROXIMATE FLOODPLAIN WIDTH IS 200' TO 300', 50' TO 150' WIDE MAIN CHANNEL IS NOT SHARPLY DEFINED, LIMITS OF MAIN CHANNEL DEFINED AS 2' TO 3' HIGH BENCH. OVERBANKS ARE ATOP THE BENCH ON EITHER SIDE AND SUPPORT ESTABLISHED RIPARIAN VEGETATION.

CHANNEL N = 0.055 OVERBANK N = 0.070

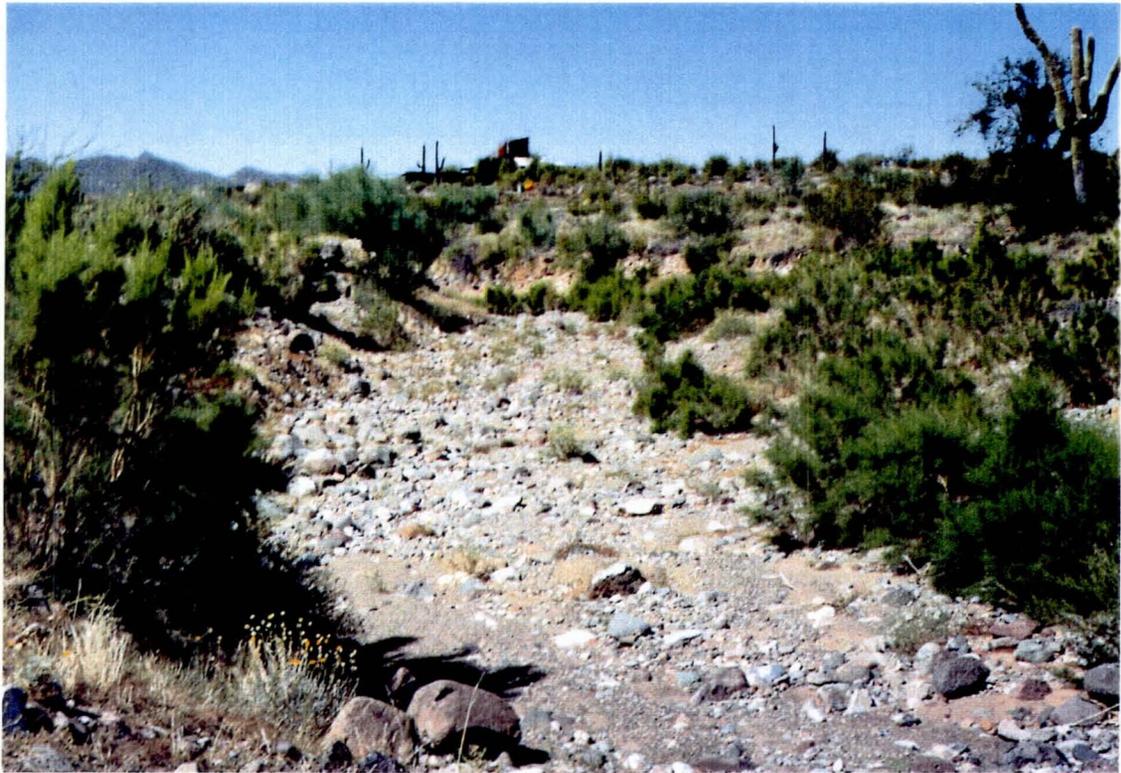
PHOTO 3: CLINE CREEK - MAIN STEM AT 12TH STREET, LOOKING DOWNSTREAM. BED INCISED 3' TO 6', WIDTH 100' TO 150', MAIN CHANNEL DEFINED AS 20' TO 30' WIDE SAND/GRAVEL/COBBLE BED AREA SOUTH SIDE. RIGHT OVERBANK - BRUSHY GRAVEL BAR, SECONDARY CHANNEL, VEGETATED BANK 3' TO 6' HIGH. LEFT OVERBANK - LIGHT TO MODERATE VEGETATION ON SLOPED BANK 5' HIGH.

CHANNEL N = 0.055
BRUSHY BAR N = 0.075

OVERBANK N, VARIABLE:
SECONDARY CHANNEL N = 0.055 VEGETATED BANKS N = 0.065

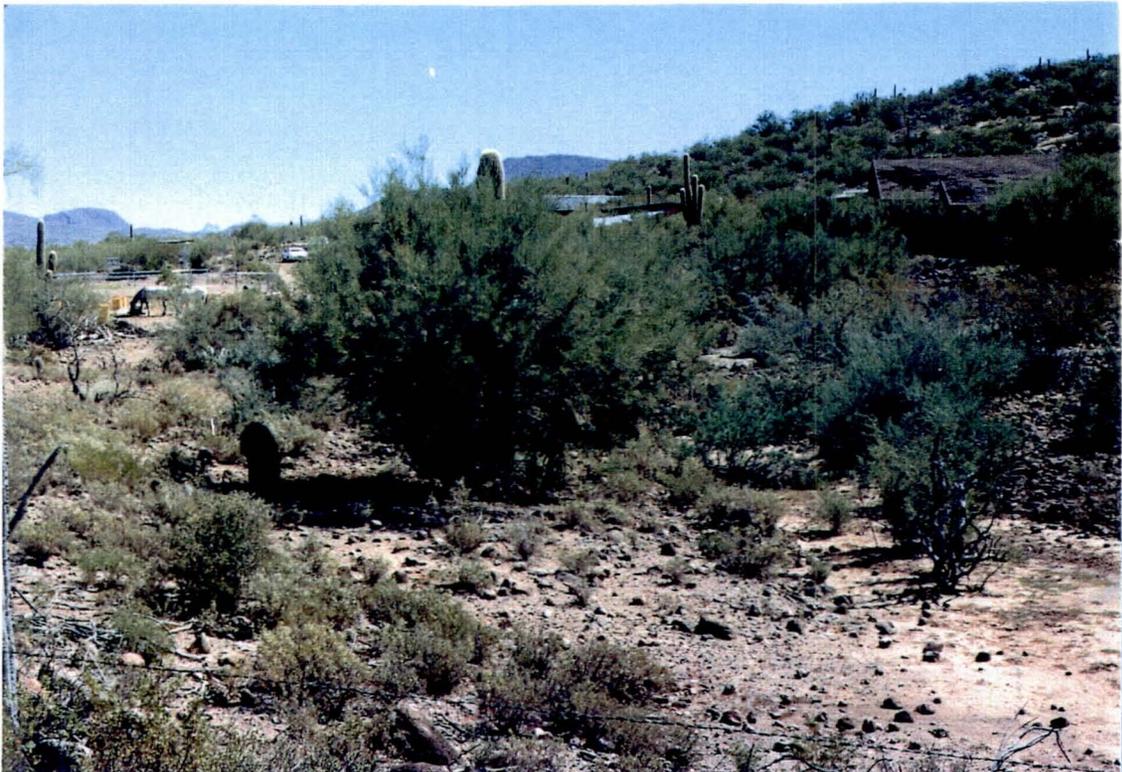
PHOTO 4: C-9 TRIBUTARY-OBlique TO WASH, LOOKING UPSTREAM. TYPICAL SMALL TRIBUTARY WASH. CHANNEL DEFINED AS 4' TO 8' COBBLES AREA. OVERBANKS - DEVEGETATED BY GRAZING.

CHANNEL N = 0.055 OVERBANK N = 0.055

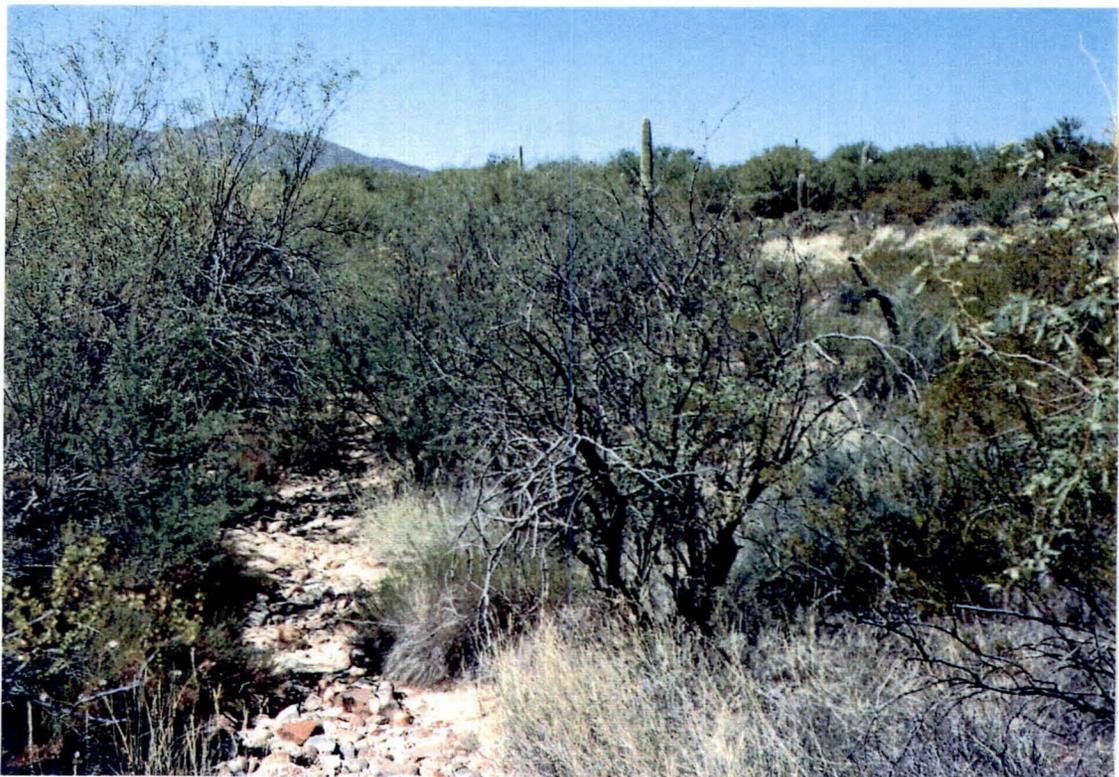
PHOTO 6: TRIBUTARY C-6A AT 16TH STREET, LOOKING DOWNSTREAM. BED WIDTH 4' TO 8' ADJACENT TO 50' WIDE FLAT OVERBANK AREA NEAR BED ELEVATION. CHANNEL DEFINED AS CLEAR GRAVEL/COBBLE AREA. OVERBANKS WITH MODERATELY DENSE VEGETATION.

CHANNEL N = 0.055 OVERBANK N = 0.070

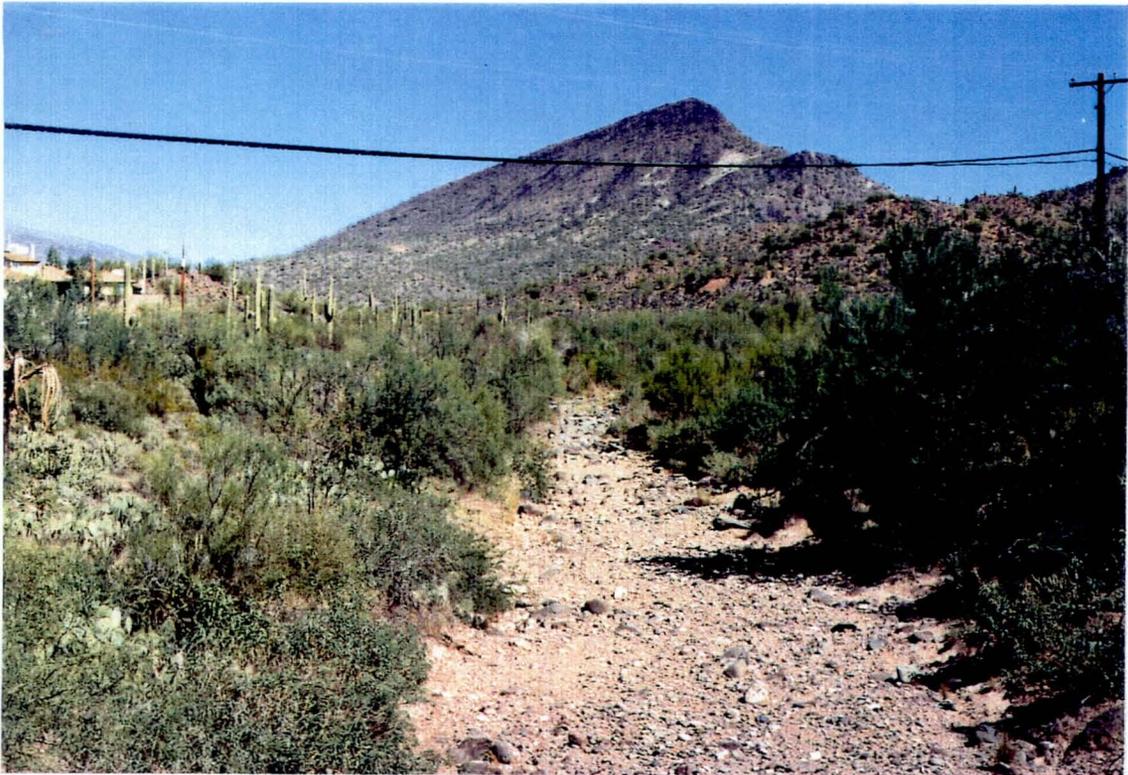
PHOTO 7: RODGER CREEK AT NEW RIVER ROAD, LOOKING UPSTREAM. FLOODPLAIN INCISED 6' TO 10'. CHANNEL FAIRLY WELL DEFINED, WIDTH 15' TO 30', SAND/GRAVEL/COBBLES. OVERBANKS - DENSE BRUSH ON LOW BANK 2' ABOVE BED.

CHANNEL N = 0.045 OVERBANK N = 0.060

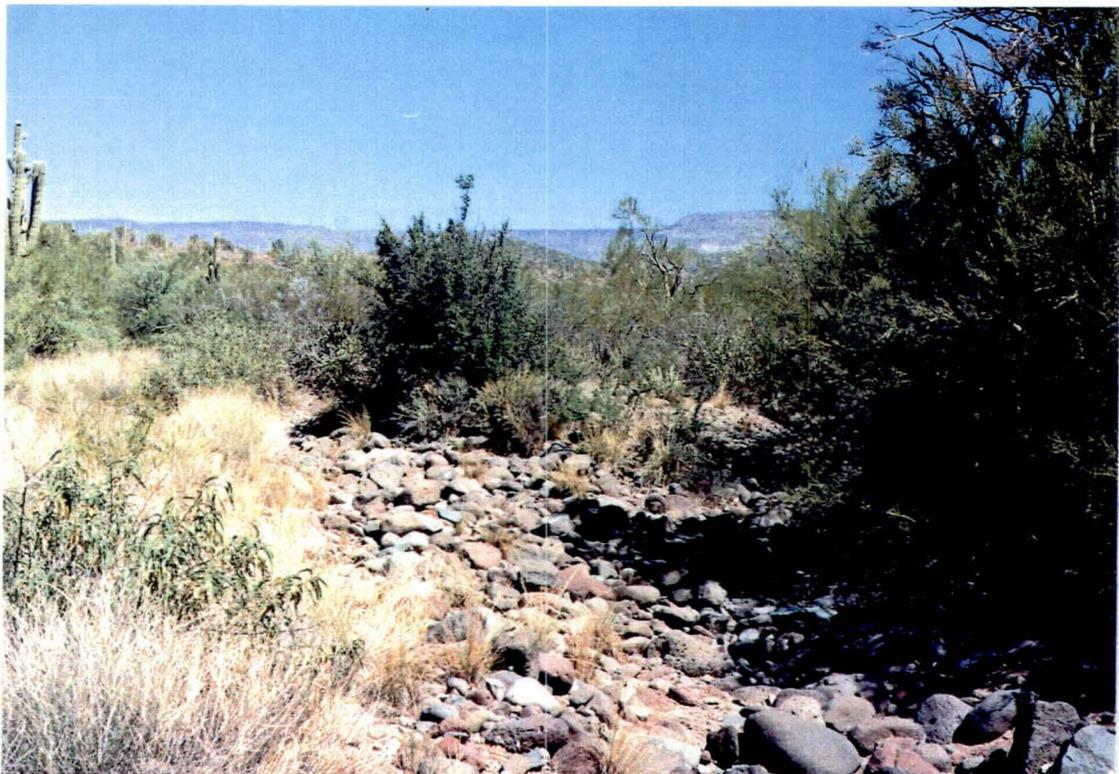
PHOTO 8: RODGER CREEK WEST OF 18TH STREET, LOOKING UPSTREAM. CHANNEL WIDTHS 5' TO 20', COBBLES AND BOULDERS. OVERBANKS - DENSE VEGETATION WITH OCCASIONAL SECONDARY CHANNELS 3' TO 10' WIDTH.

CHANNEL N = 0.060 OVERBANK N = 0.075
