**GEOTECHNICAL EVALUATION  
HERMOSA VISTA DRIVE/HAWES ROAD  
STORM DRAIN AND BASIN  
MESA, ARIZONA**

July 31, 2007  
Project No. 601527001

Subject: Geotechnical Evaluation  
Hermosa Vista Drive/Hawes Road, Storm Drain and Basin  
Mesa, Arizona  
Contract No. FCD 2005C009  
PCN 420.02.31

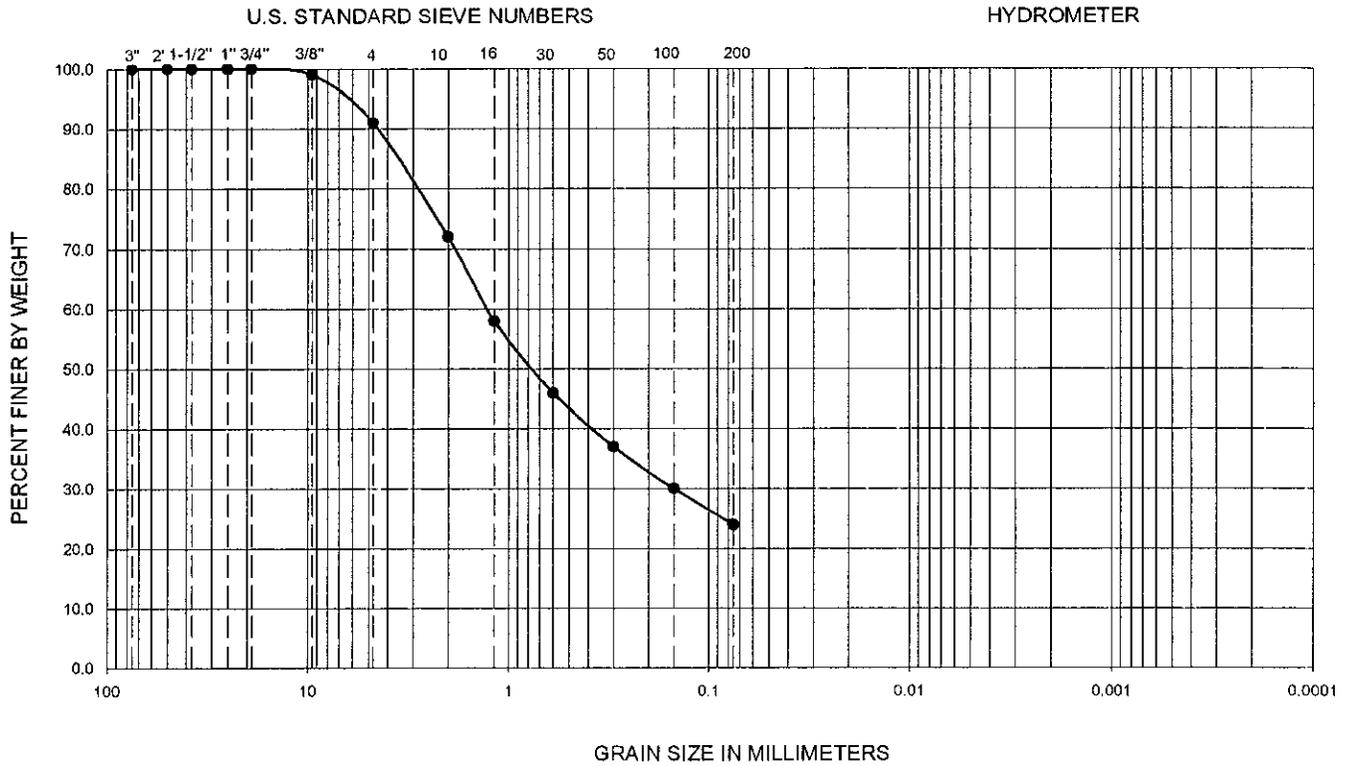
Symbol	Sample Location	Depth (ft)	Liquid Limit	Plastic Limit	Plasticity Index	D <sub>10</sub>	D <sub>30</sub>	D <sub>60</sub>	C <sub>u</sub>	C <sub>c</sub>	Passing No. 200 (%)	U.S.C.S
●	B-19	6-6.9	--	--	--	--	--	--	--	--	24	SM

PERFORMED IN GENERAL ACCORDANCE WITH ASTM D 422-63 (02)
