# Siphon Draw Drainage Improvements

2010 Engineering Excellence Awards Competition  
American Council of Engineering Companies of Arizona

Project Name Siphon Draw Drainage Improvements

## Executive Summary

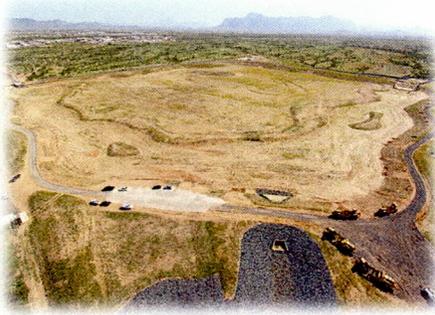
**Photo 1:**

"Hawk Rock" earth fissure. A fissure in a flood control detention basin could undermine the basin's ability to detain water. This fissure zippered (extended) 200 feet from one rainfall event during the design stage. The design team studied multiple basin configurations before concluding that avoiding fissures altogether within the existing site constraints was impossible.

Land subsidence induced earth fissures are highly undesirable within a flood control basin. Earth fissures can appear unexpectedly and can rapidly increase in size. A fissure in a flood

control basin could undermine the basin's ability to retain water. The team studied multiple basin configurations and components before finally concluding that avoiding potential fissures within the existing site constraints was impossible. Once this conclusion was reached, the challenge became how to design a flood control basin in an area with an encroaching fissure and that was also likely to develop more fissures. The solution was to apply fissure mitigation techniques designed to maintain basin impoundment integrity with proper long-term monitoring and maintenance. To our knowledge the mitigation utilized has never before been applied to a flood control basin project.

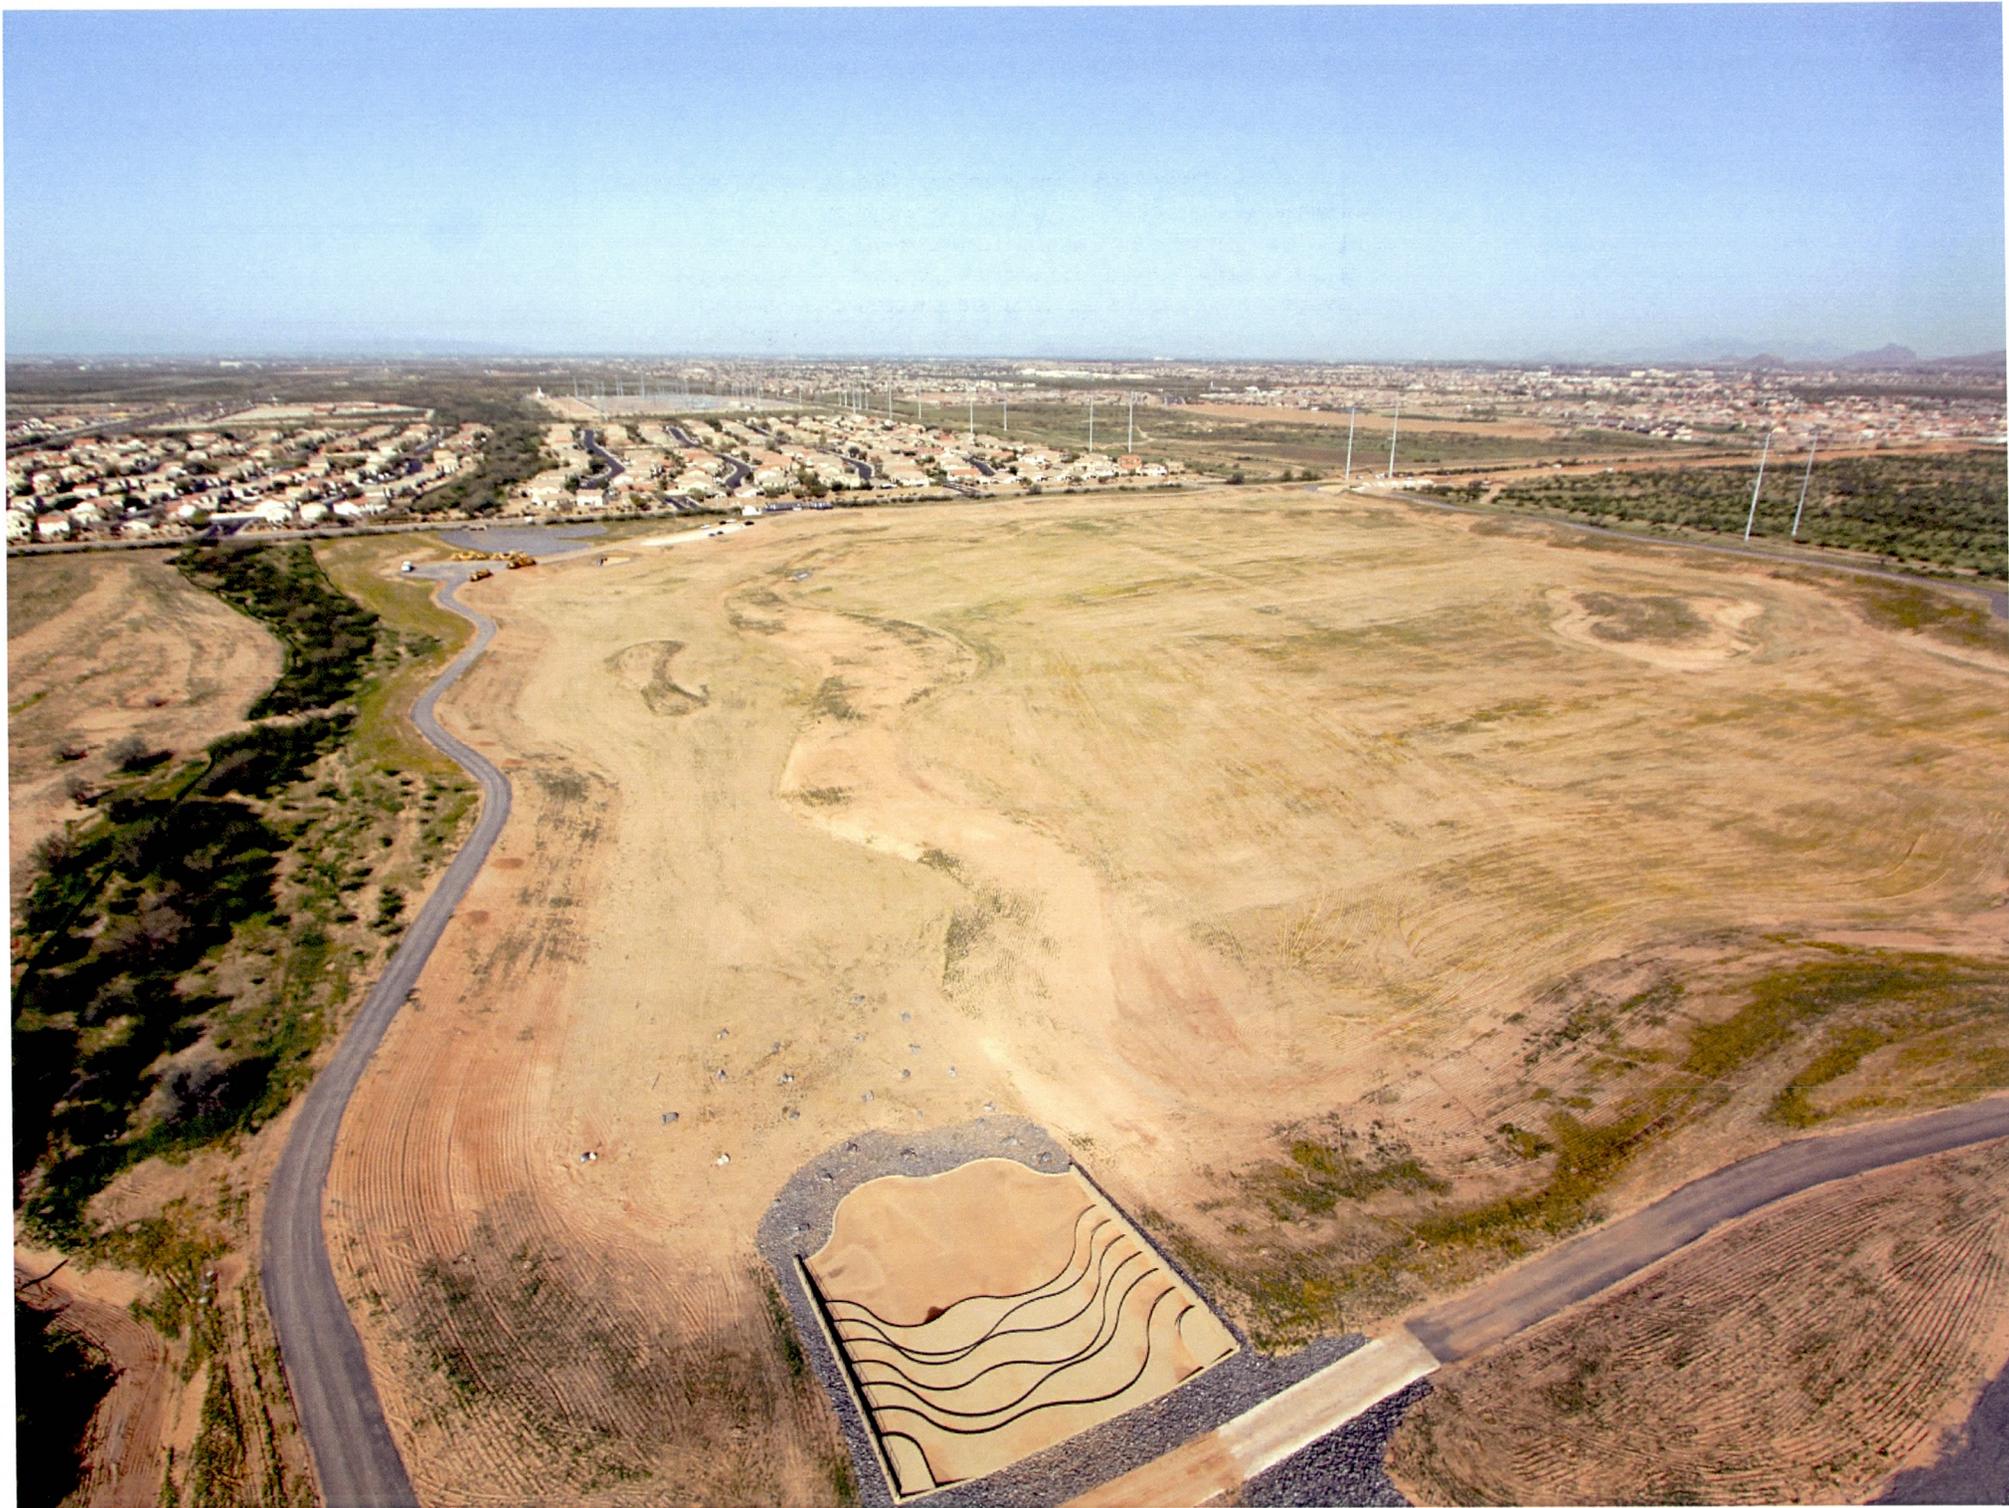
**Photo 3:**

The basin is equipped with a stepped inlet structure to capture flows from Siphon Draw (foreground) and another inlet structure (foreground) to capture flows from the Meridian Channel. The outlet is an un-gated box-culvert that discharges flows back into the Siphon Draw Wash that travels through the Meridian Point Subdivision. (facing west)

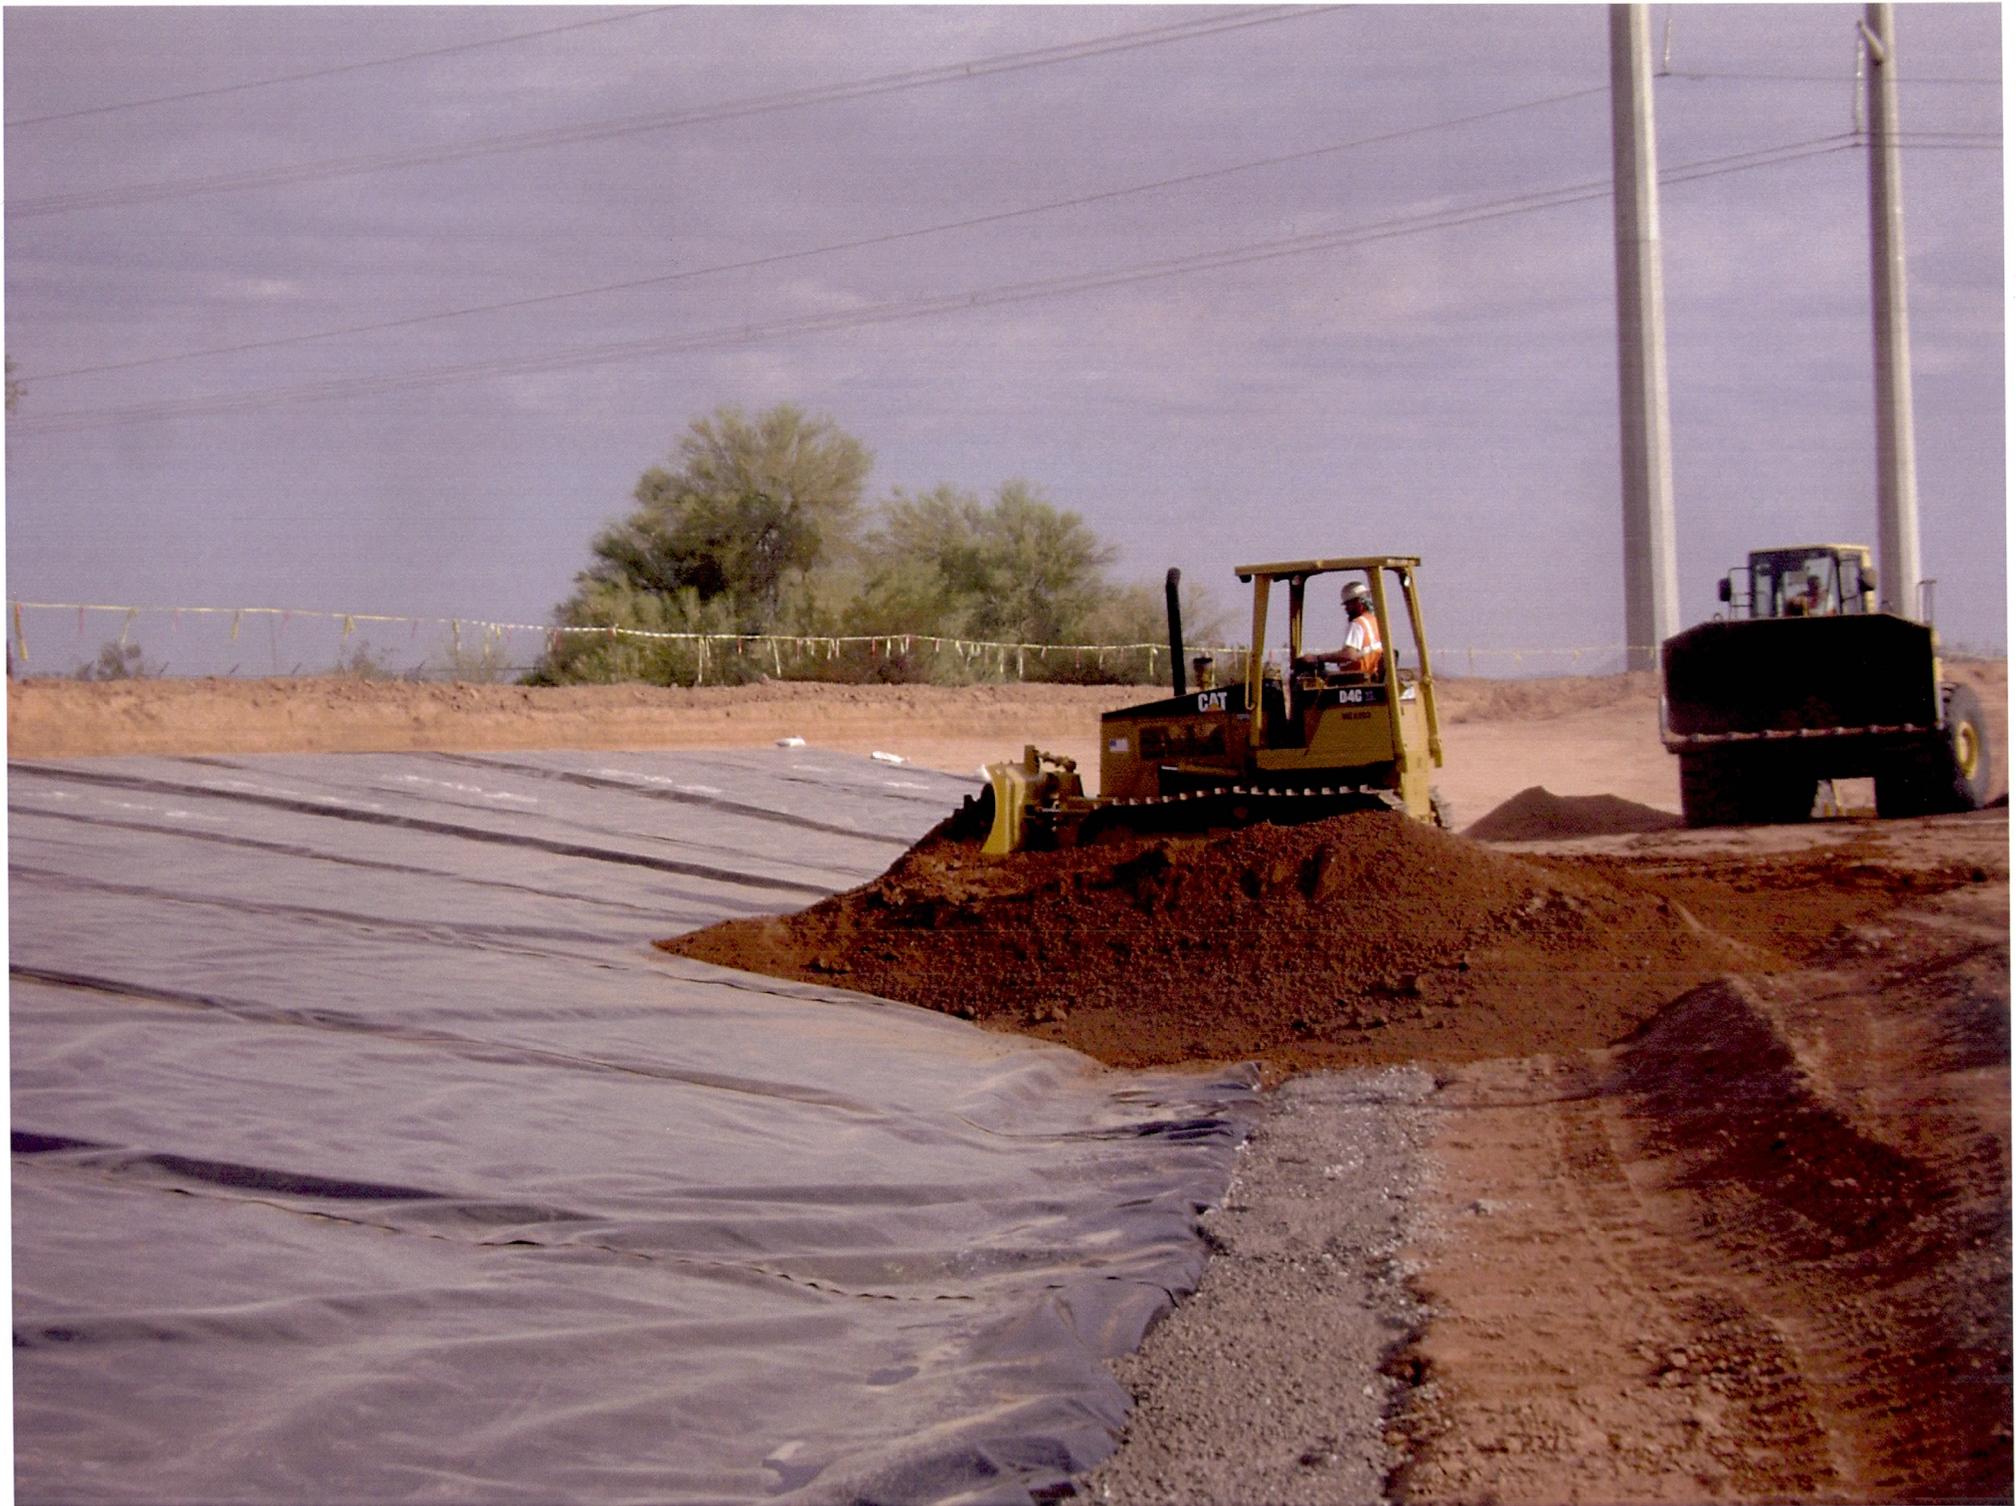
**Photo 6:**

Geomembrane was installed three feet below the finished surface along the south and west slopes of the basin with concrete cutoff walls along its toe. The team developed fissure mitigation consisting of low strength concrete and a geomembrane.

The final design included a series of cut-off walls between the basin and downstream of the encroaching fissure, and used excavation spoils to redirect surface runoff away from the fissure. On the down-stream side of the project, a vertical low strength concrete cut-off wall was constructed. Along the slope of the flood control basin a geomembrane material was buried three feet deep to act as a barrier between the water and potential earth fissures.

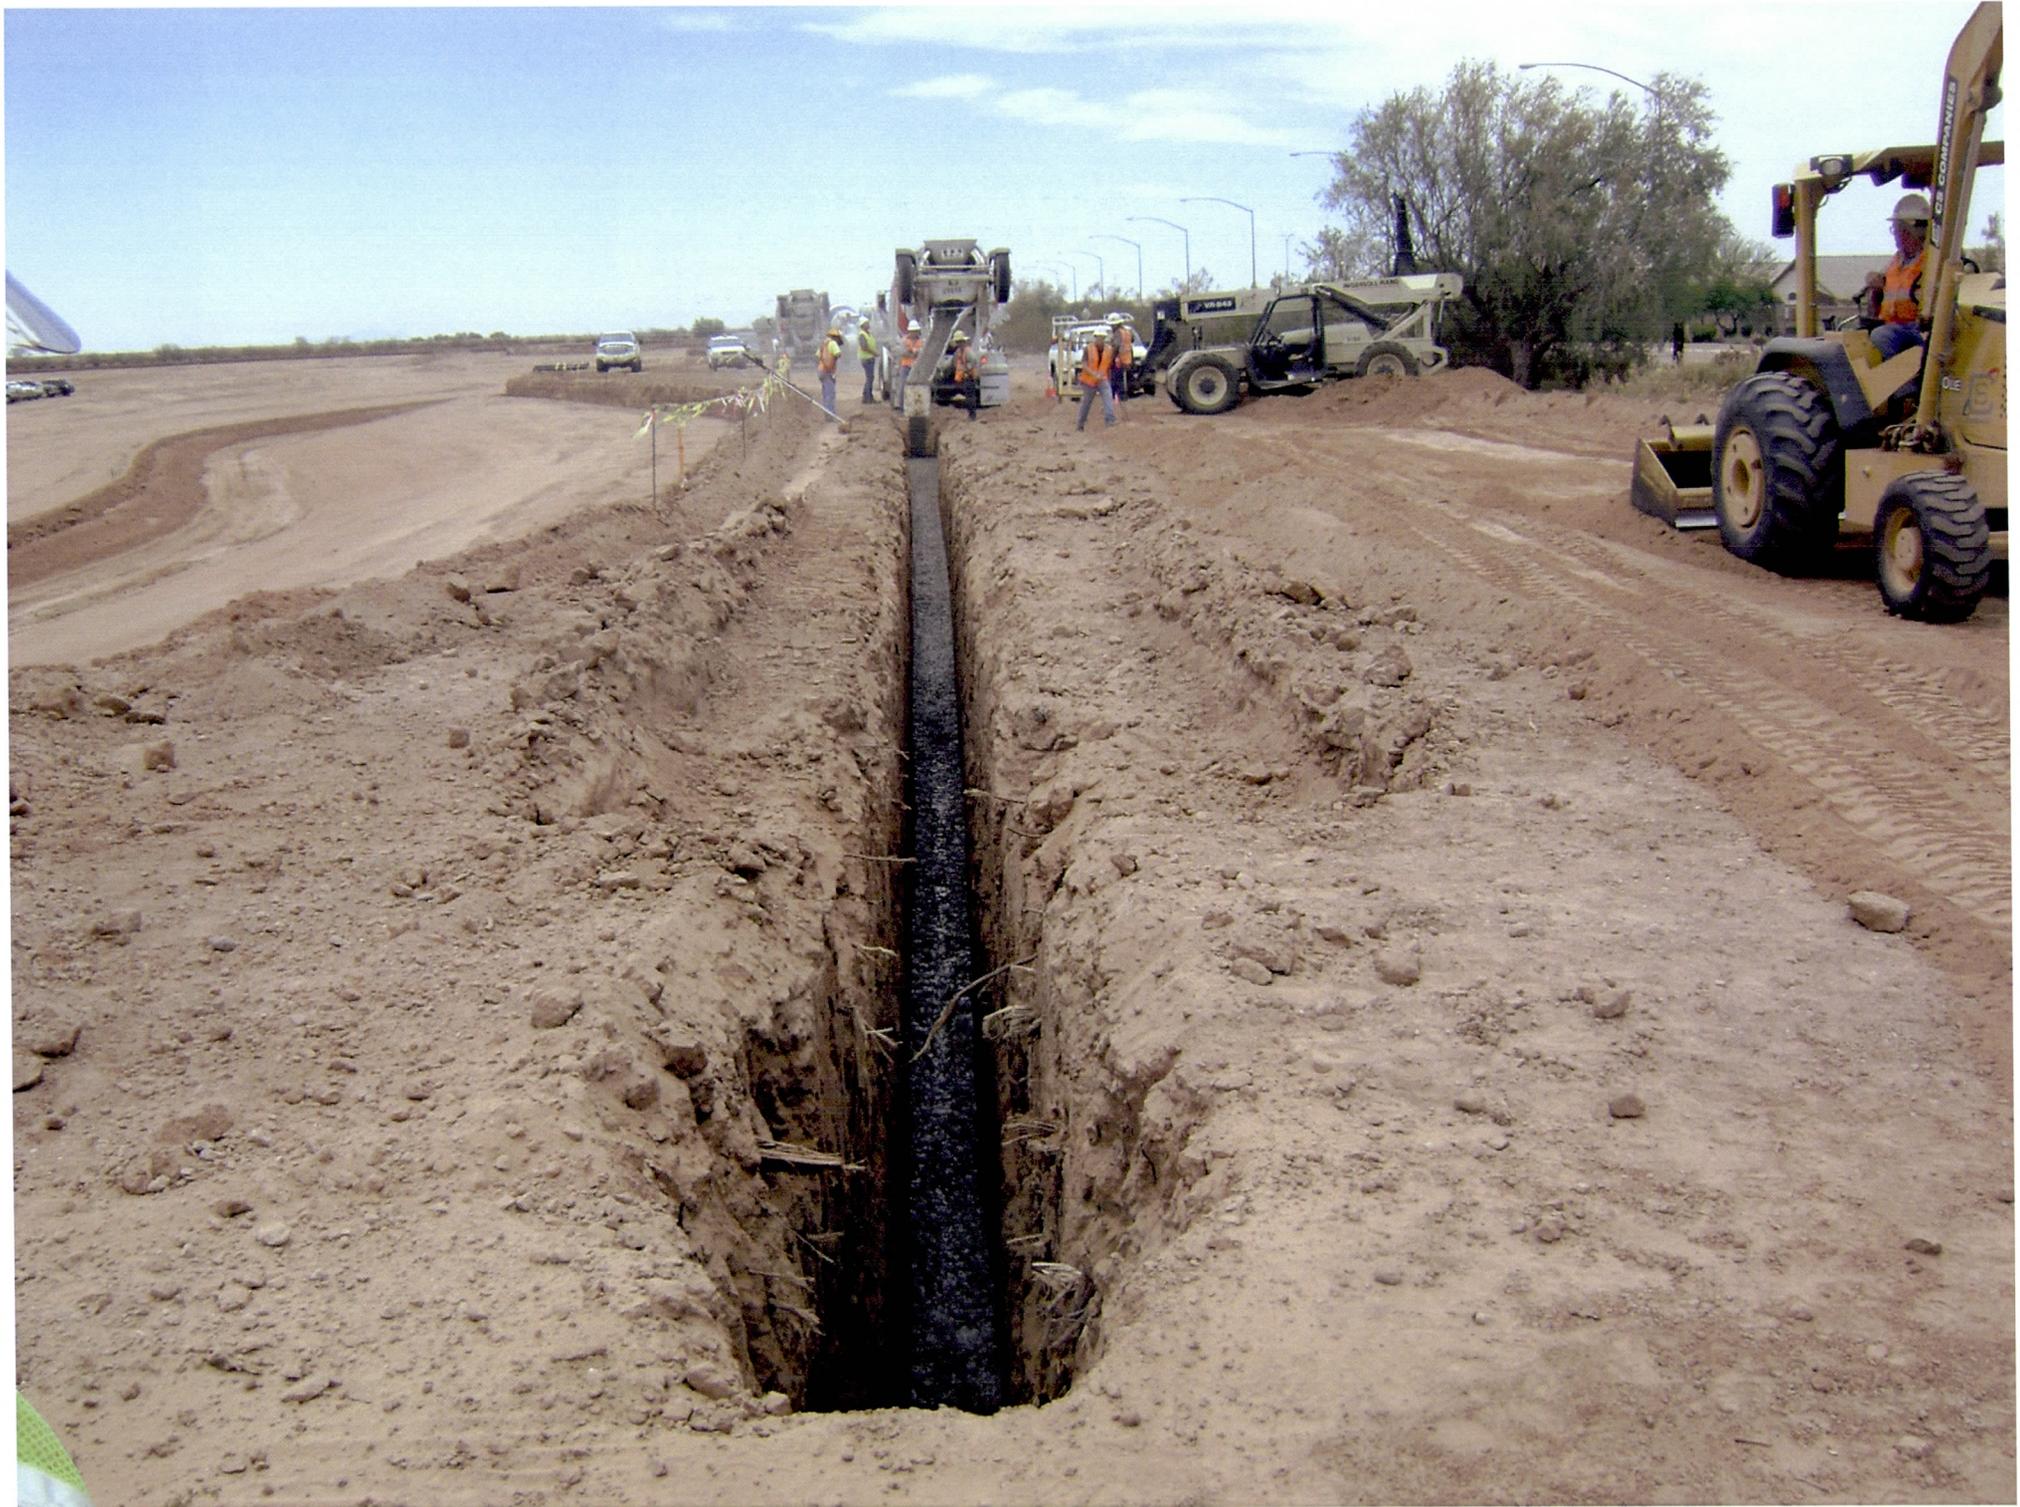
**Photo 7:**

A cutoff wall was constructed downstream of the basin's south and west slope. The cutoff wall will force any flows that penetrate the geomembrane down 20 to 25 feet before it can travel toward any developments.

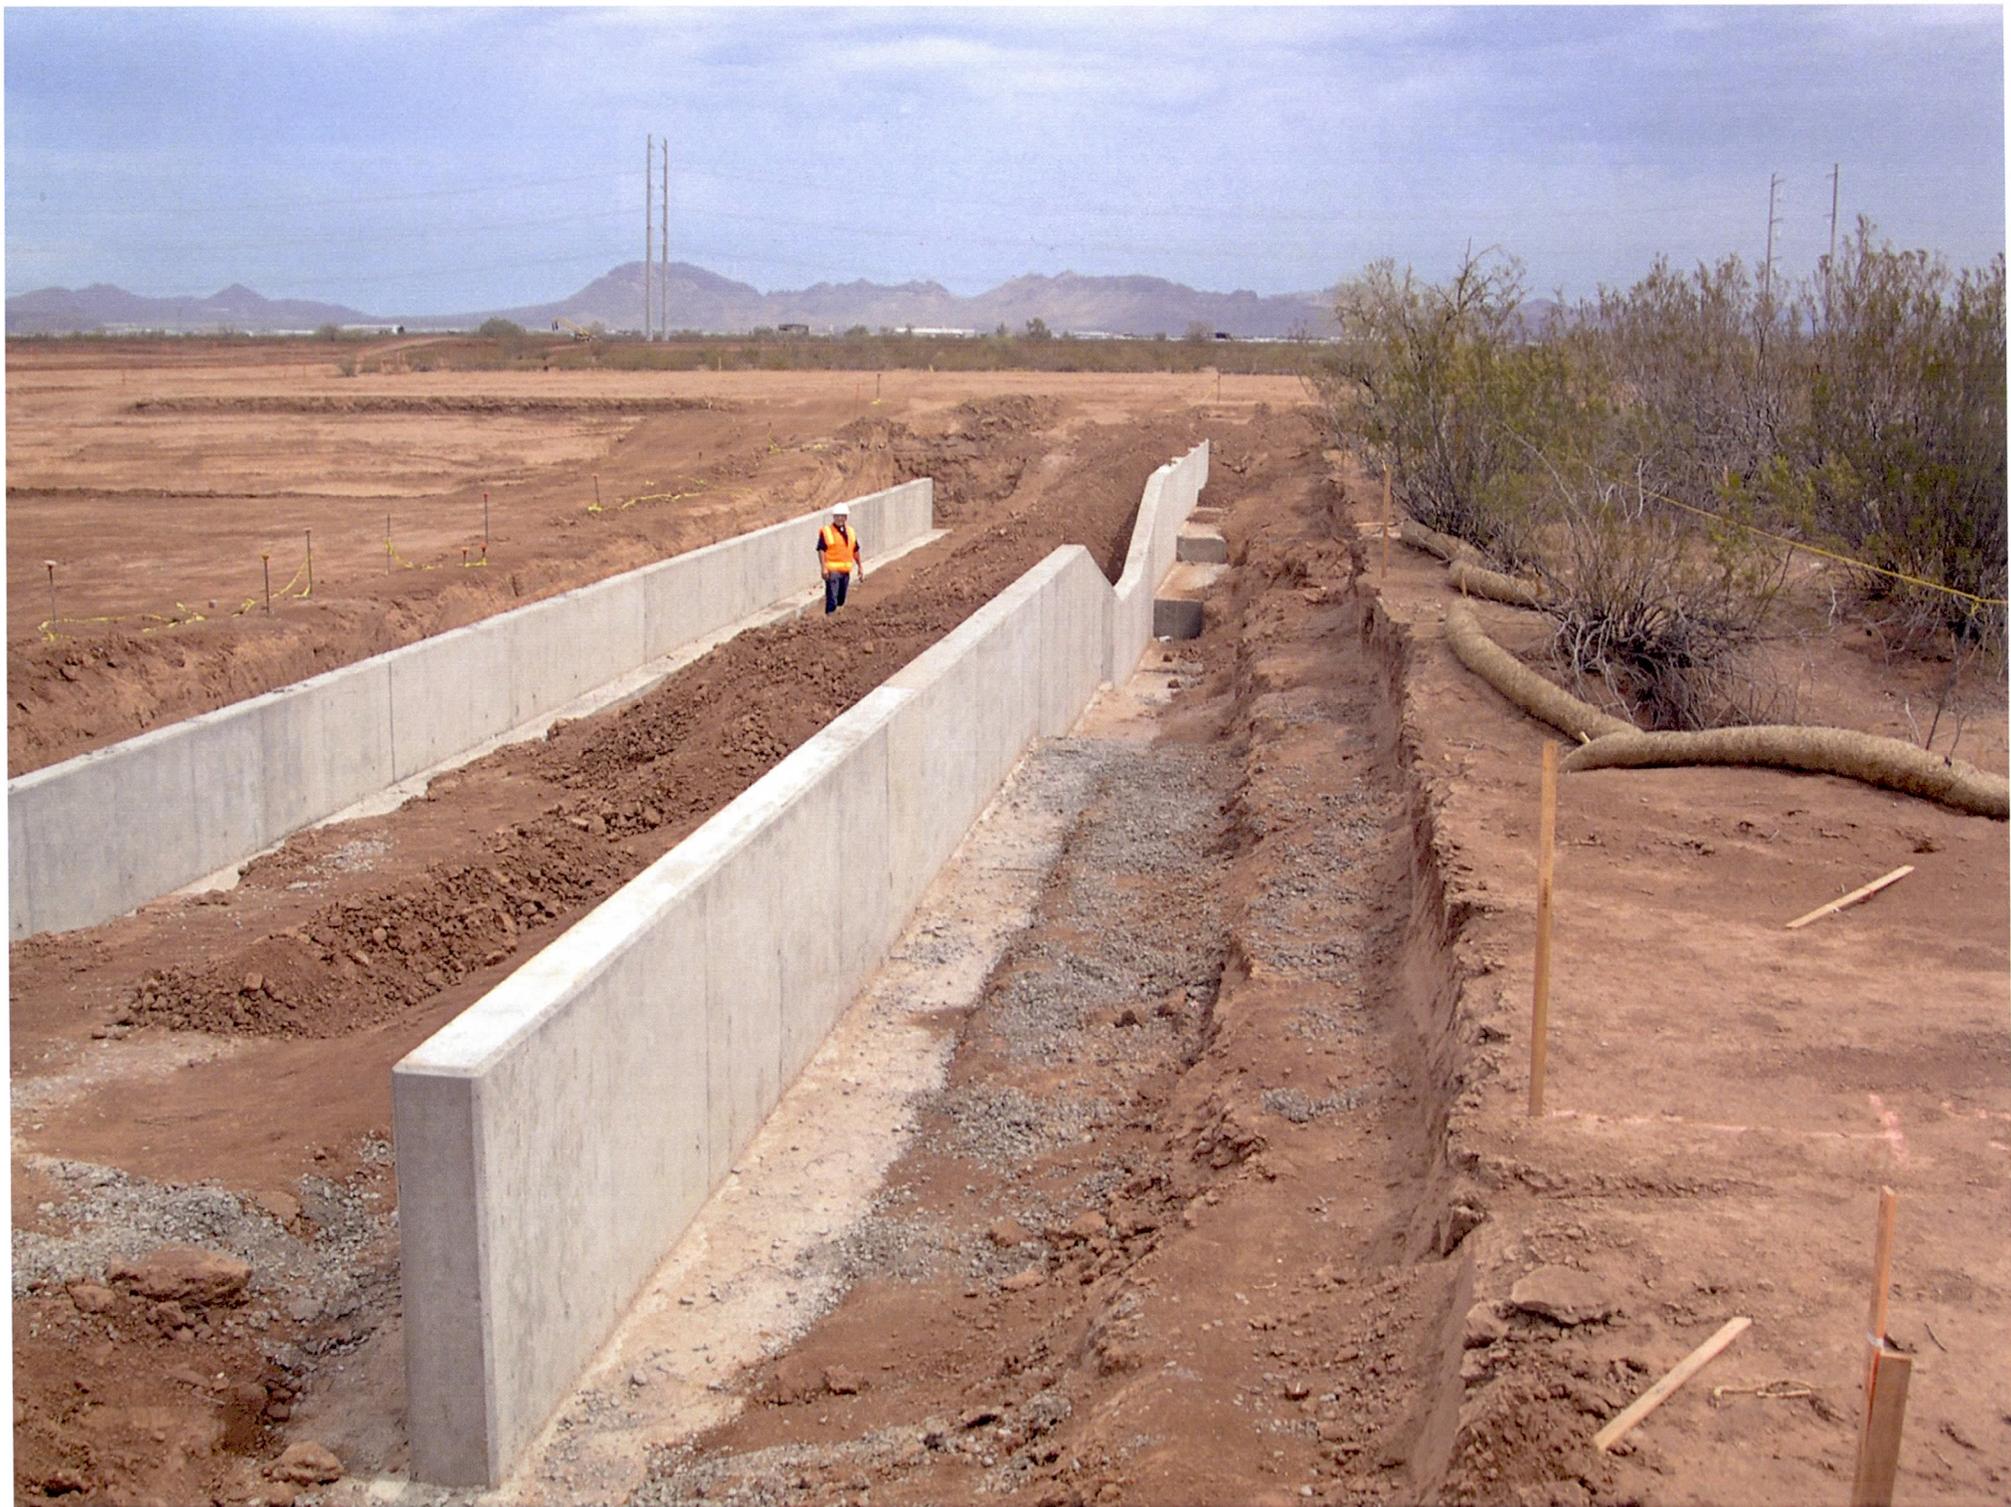
**Photo 8:**

Concrete drop structure and cutoff walls upstream of the stepped spillway. The drop structure directs sheet flows into a channel that connects to the stepped drop structure.

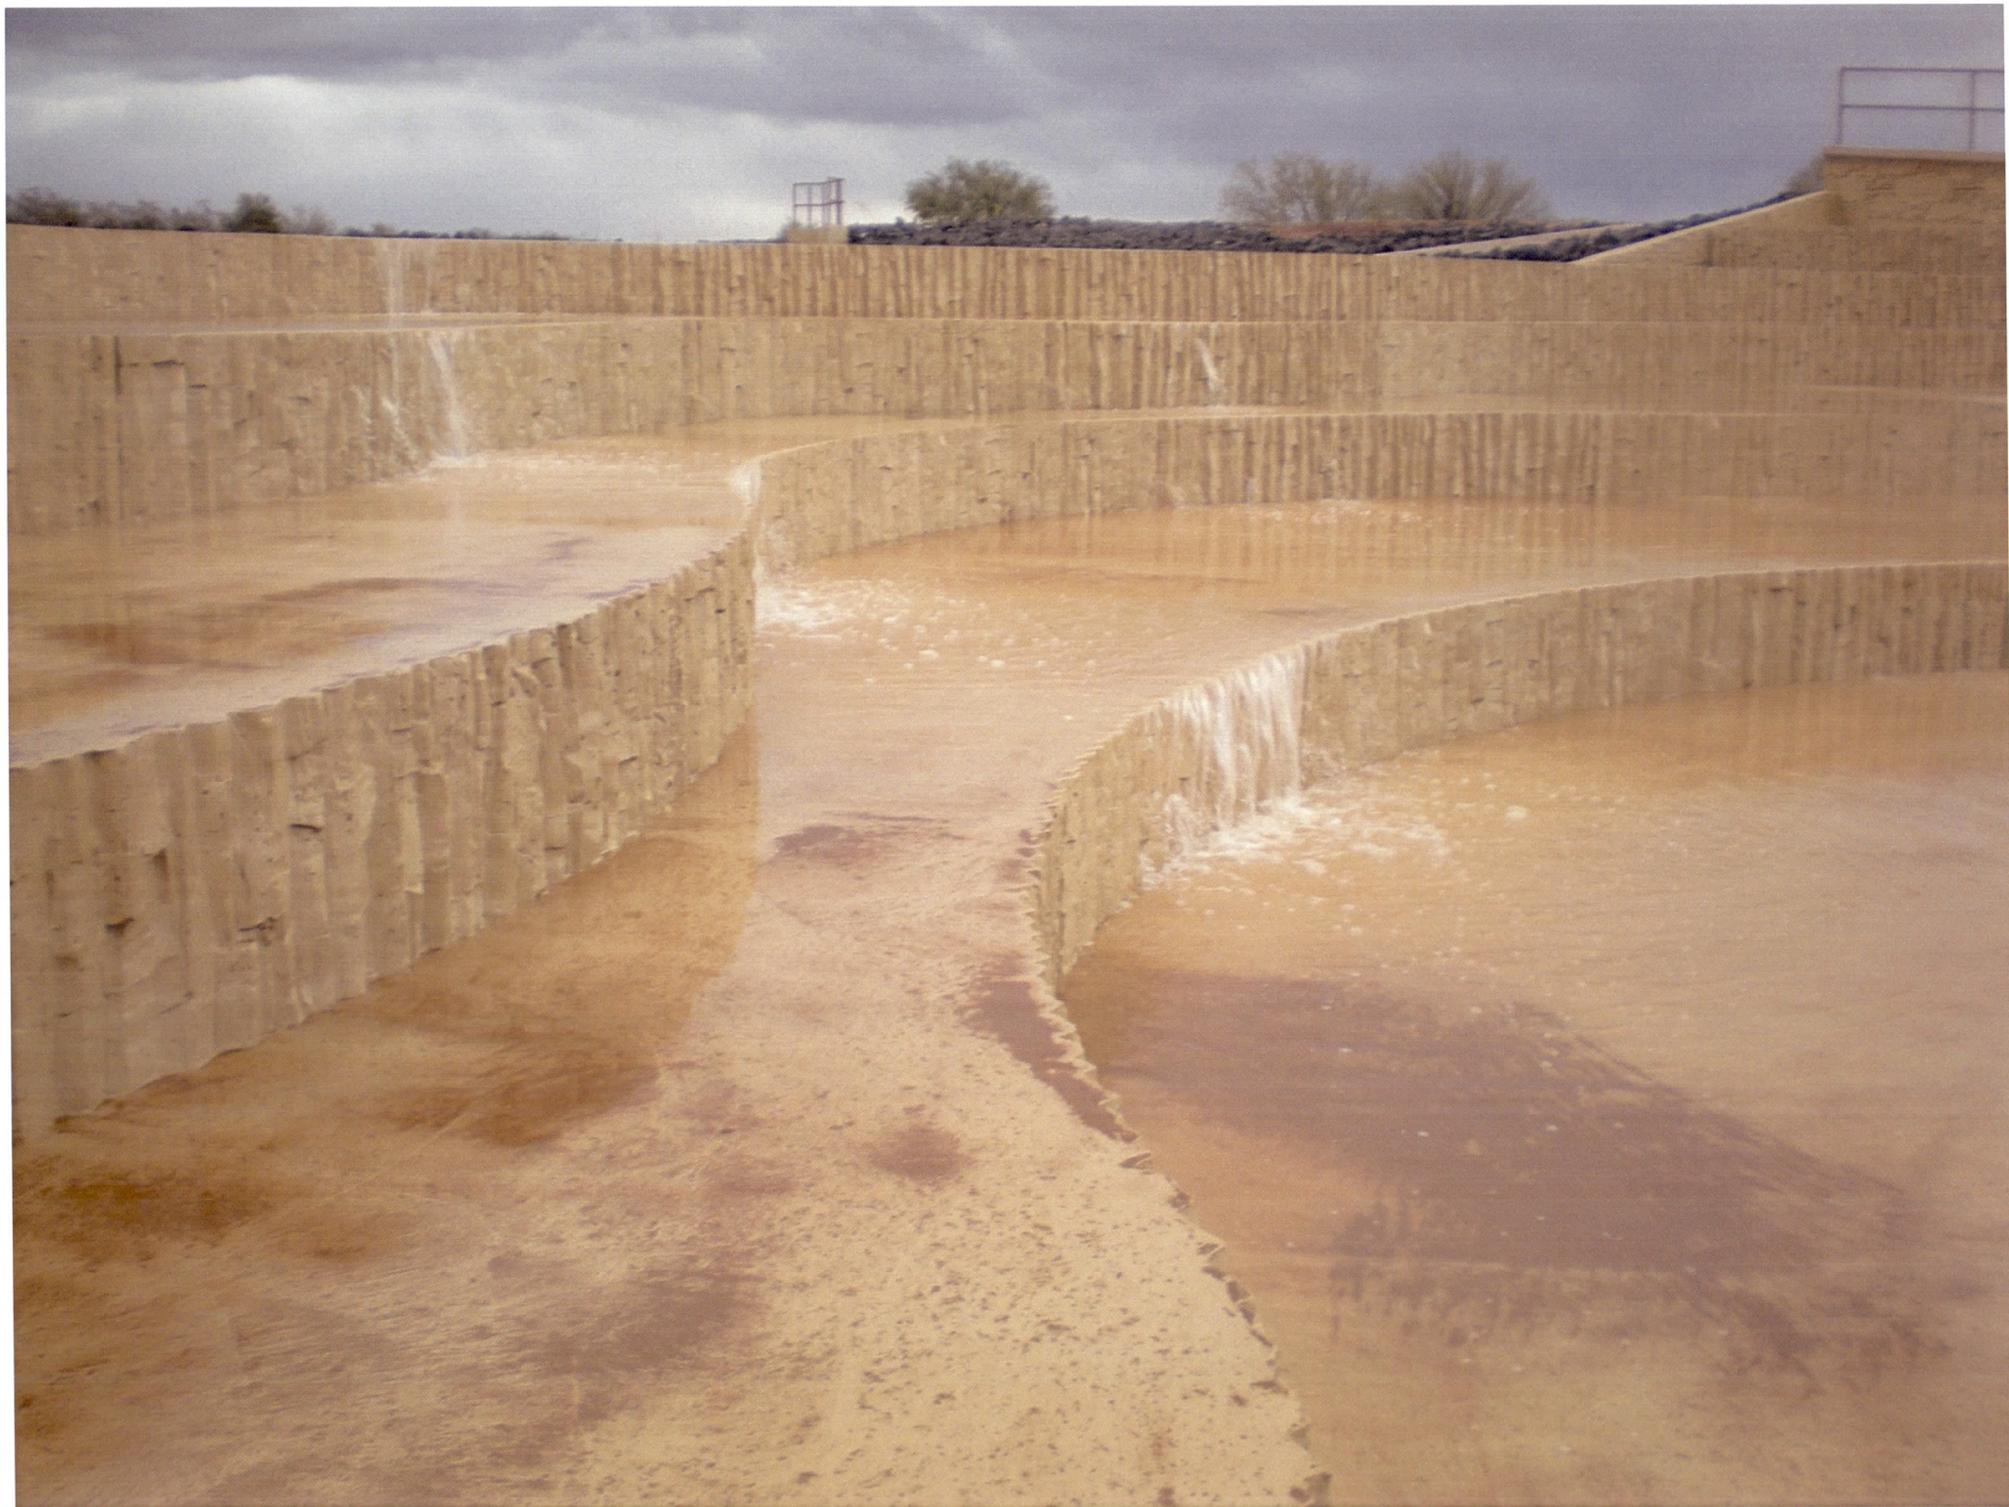
**Photo 9:**

This stepped drop structure will dissipate the energy from flows from the Siphon Draw Wash. When not functioning as a drop structure, the steps can become the seats of an amphitheater, with the bottom of the drop structure serving as a stage. Though the impetus for the project was flood protection, all structures were designed for regional multi-use.

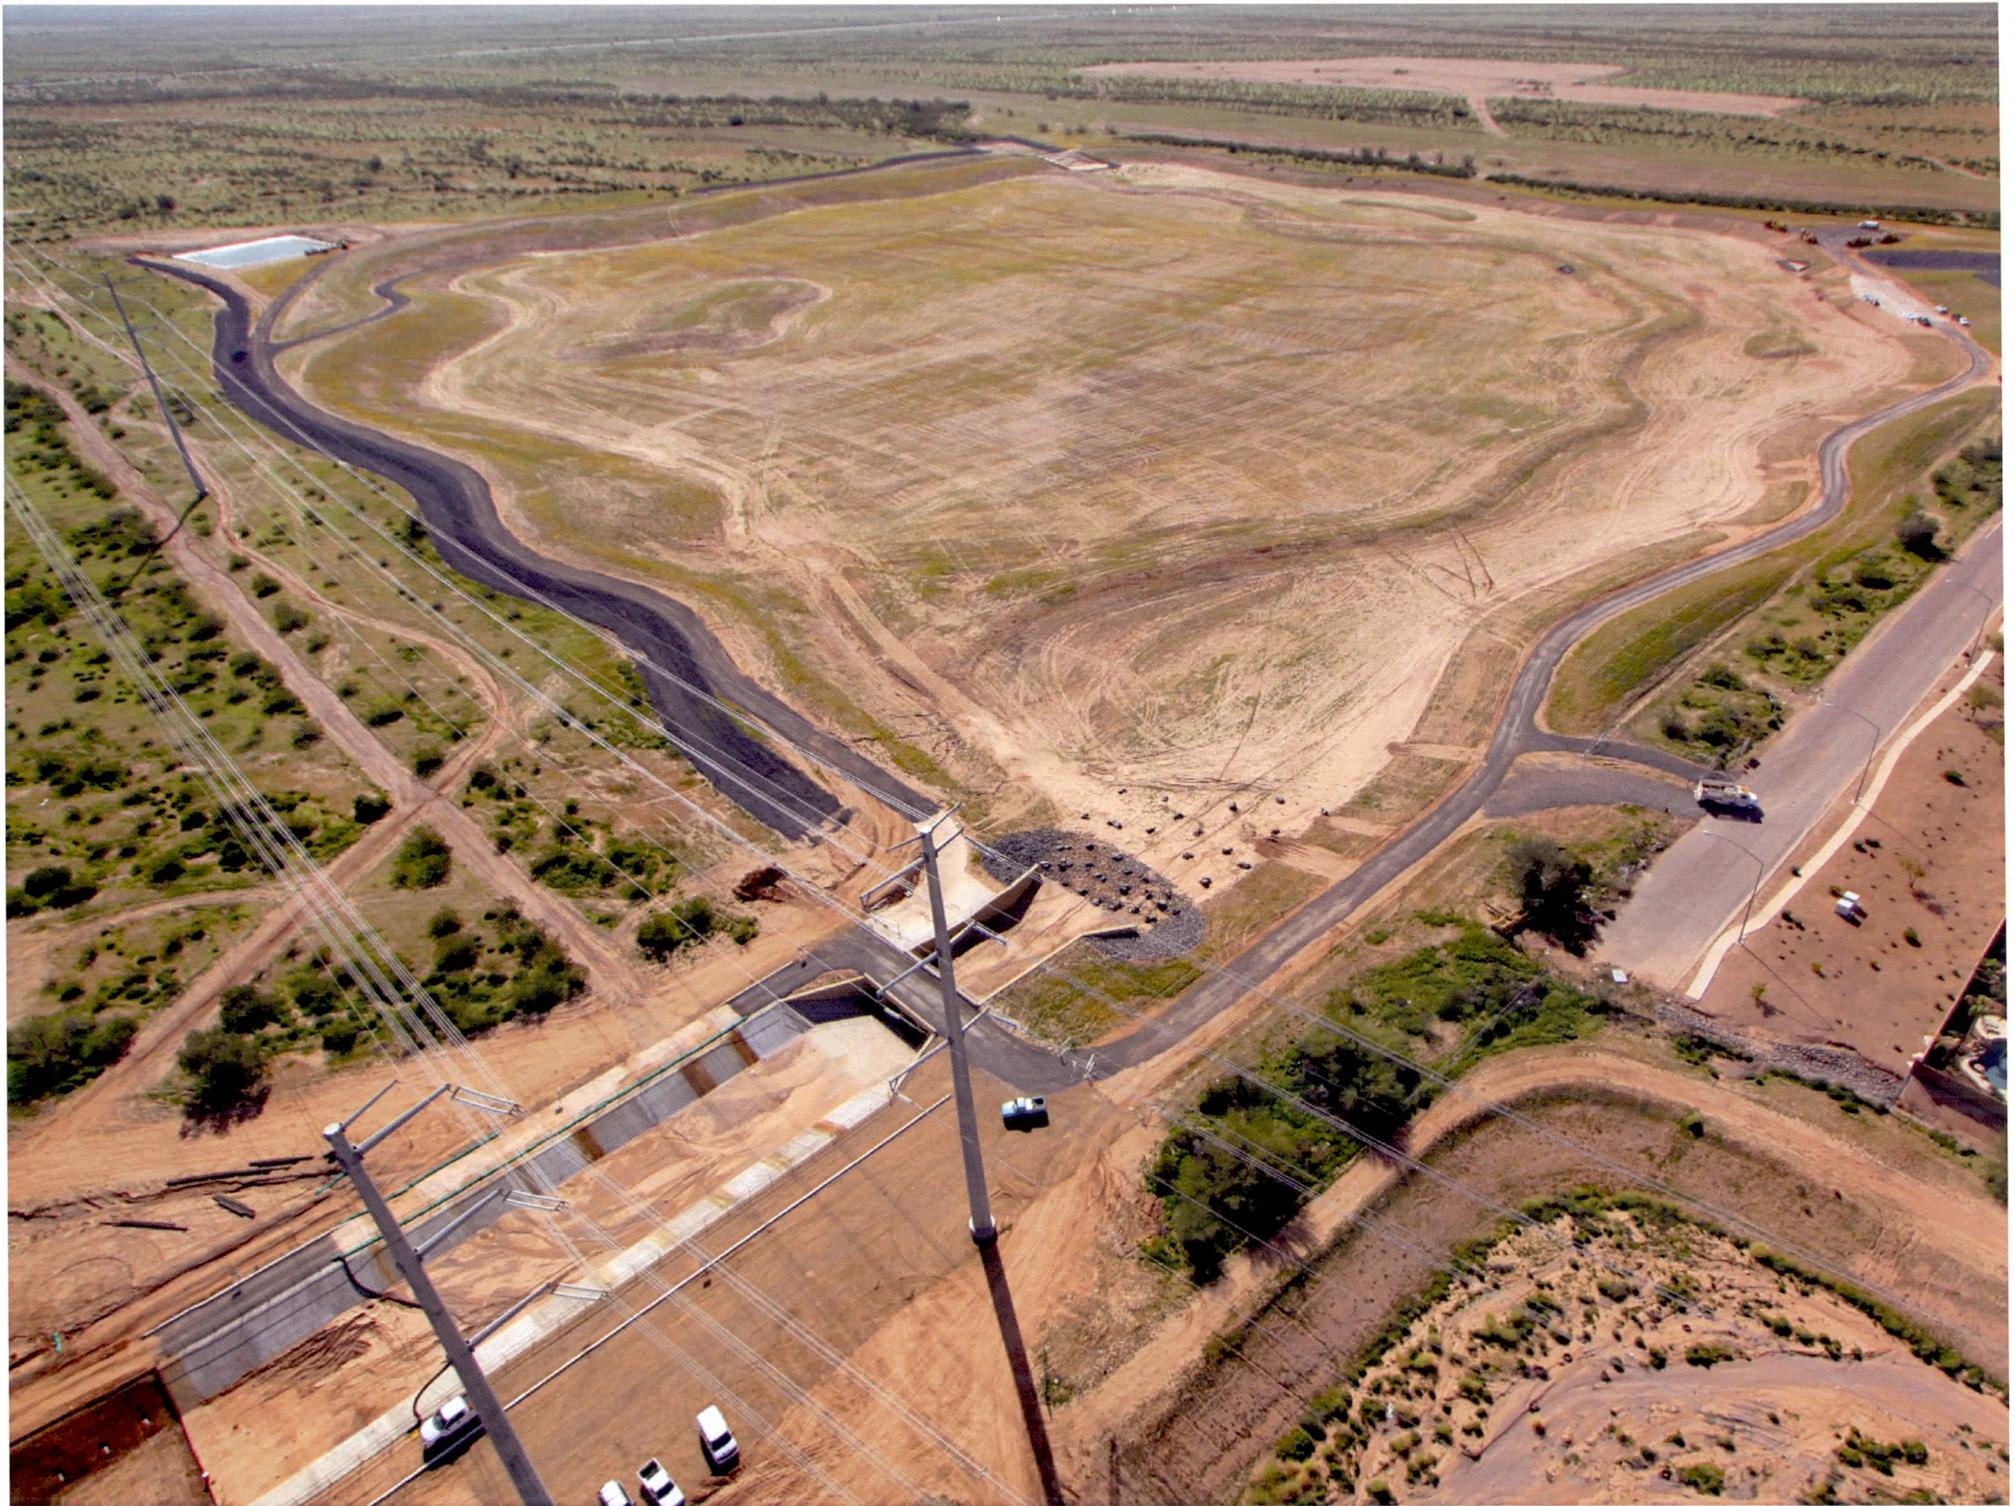
**Photo 10:**

The Meridian Channel and inlet structure are in the bottom left foreground. Along the left side of the basin is an inlet channel that intercepts flows and delivers them to the channel to discharge into the basin. The box culvert crossing the Meridian channel serves the District maintenance staff and SRP for its powerline access.
