REPORT OF INVESTIGATING COMMITTEE  
FOR  
WILLIAMS - CHANDLER WATERSHED  
RWCD FLOODWAY, REACH I  
PINAL COUNTY, ARIZONA

Subject: ENG - Engineering Report, RWCD Floodway,  
Reach I, Williams-Chandler WPP, Arizona

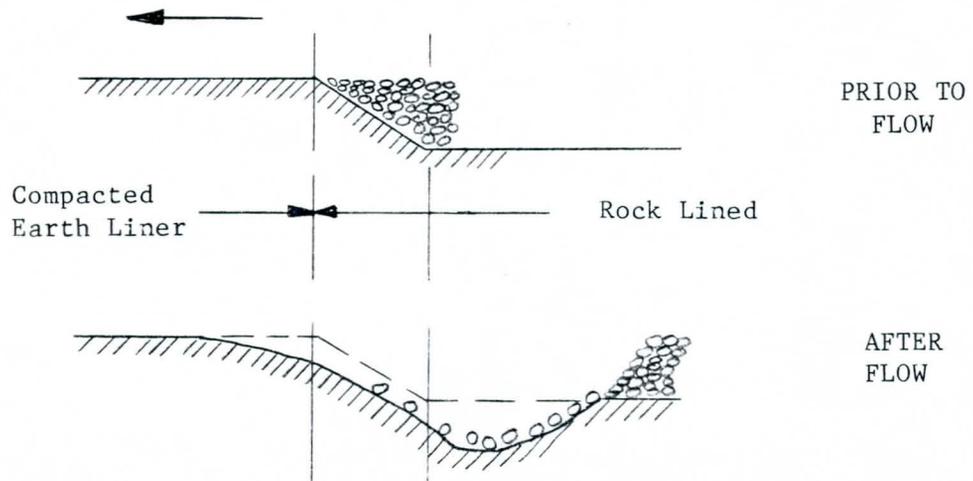
There is no filter under the riprap lining. The flow has washed bed material from under the rock, and the rock has settled into the cavities. As shown in the sketch below, the drop in the rock surface creates a chute-like situation which heightens the erosive capacity of the water.

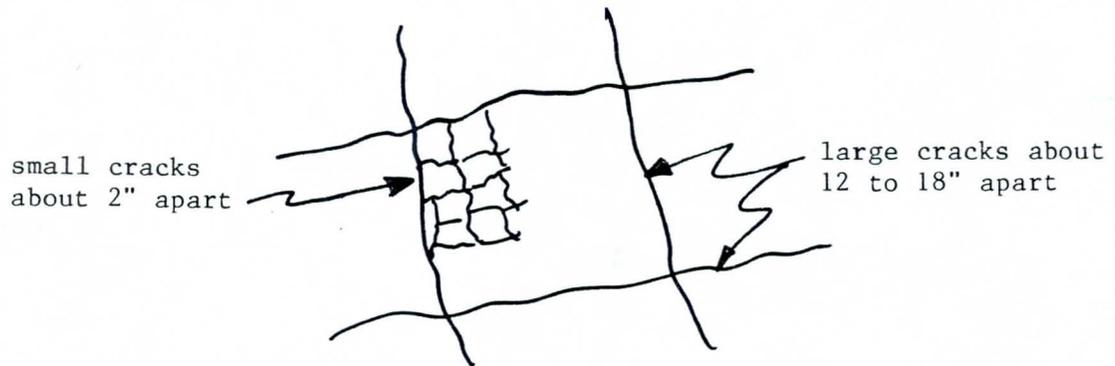
4. Cracks in bed liner - Cracking of the bed liner was evident throughout the reach. These shrinkage cracks should be expected due to the moderately to highly plastic clay used as liner material and the very hot, dry climate. The sketch below shows a typical cracking pattern.

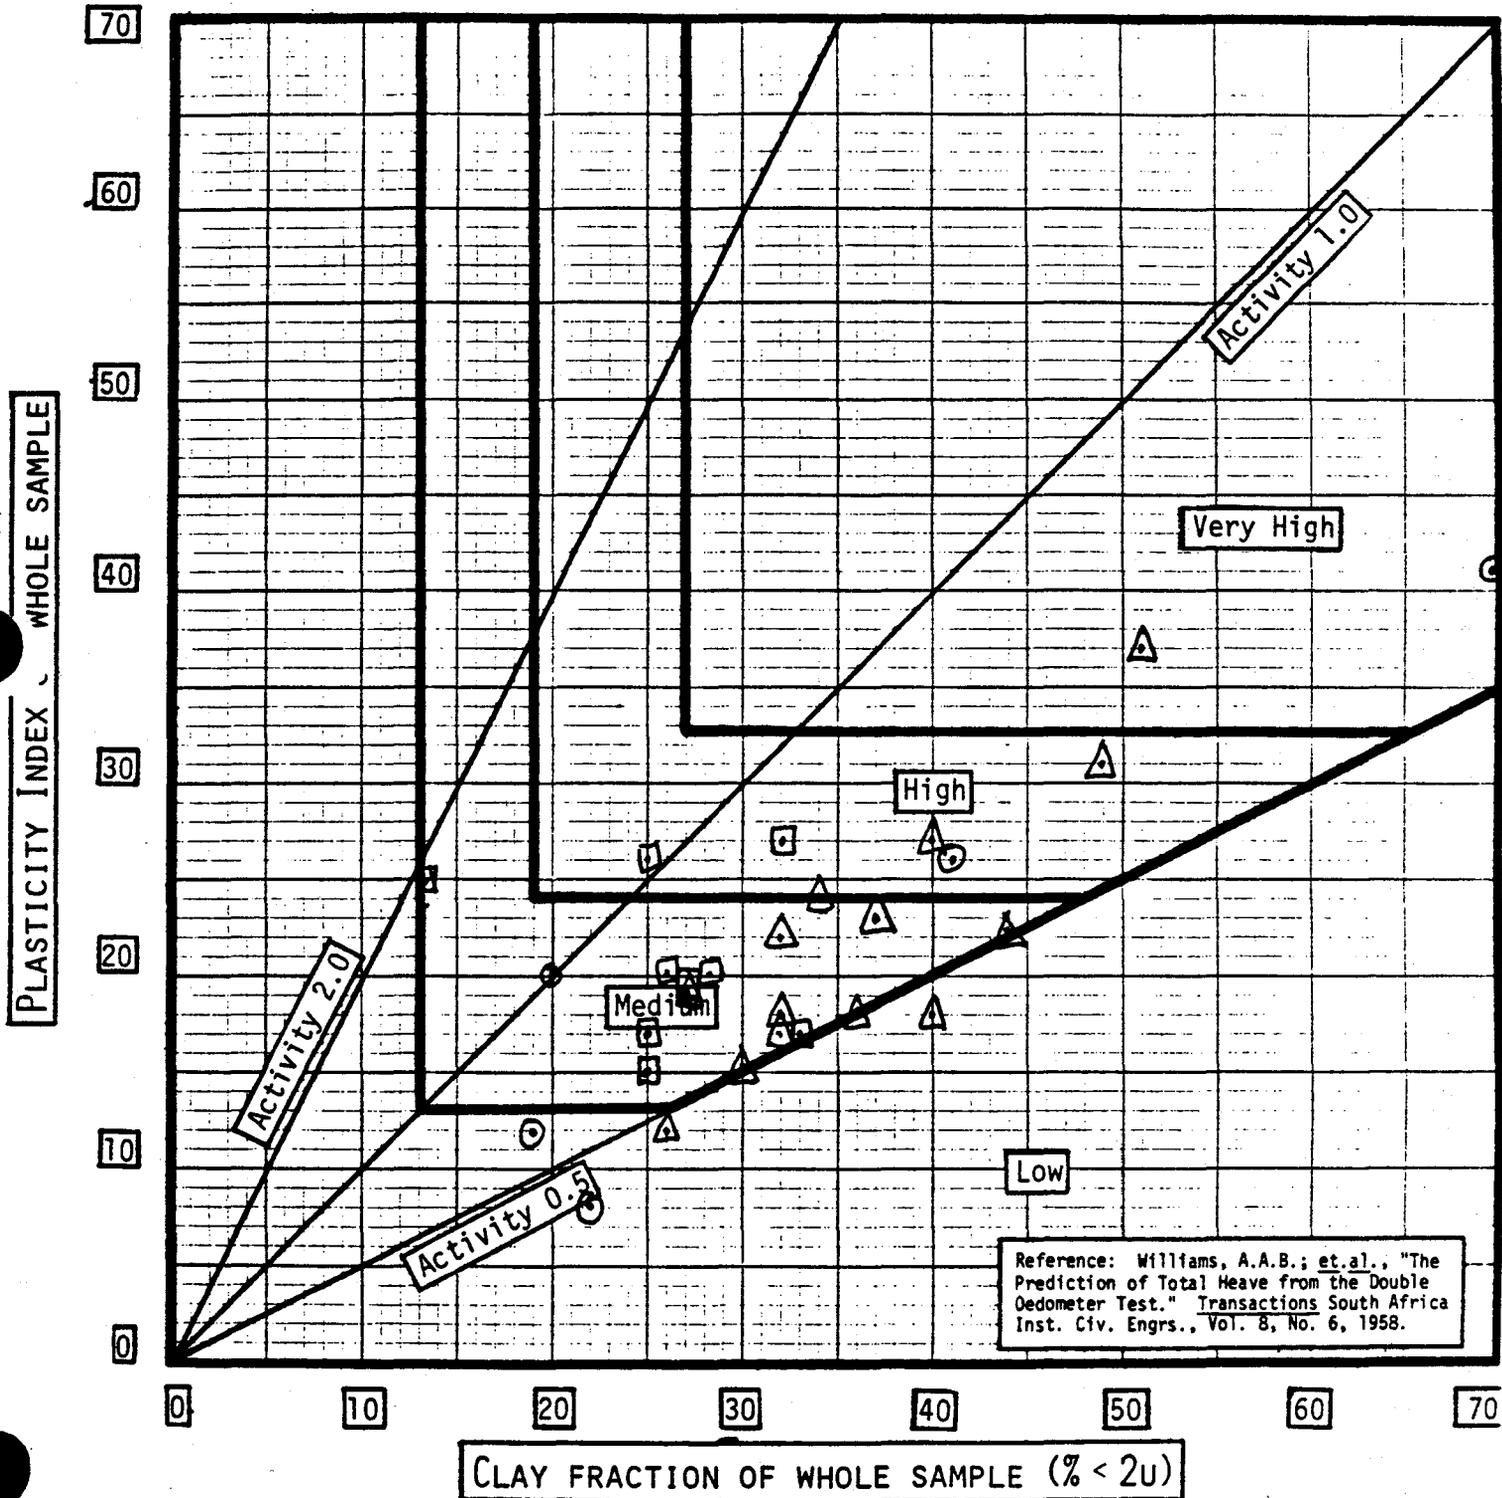
PREDICTION OF SHRINK-SWELL CLASS  
BASED ON PI AND % < 2 MICRON

WILLIAMS - CHANDLER Ws, RWCD REACH I  
ARIZ.

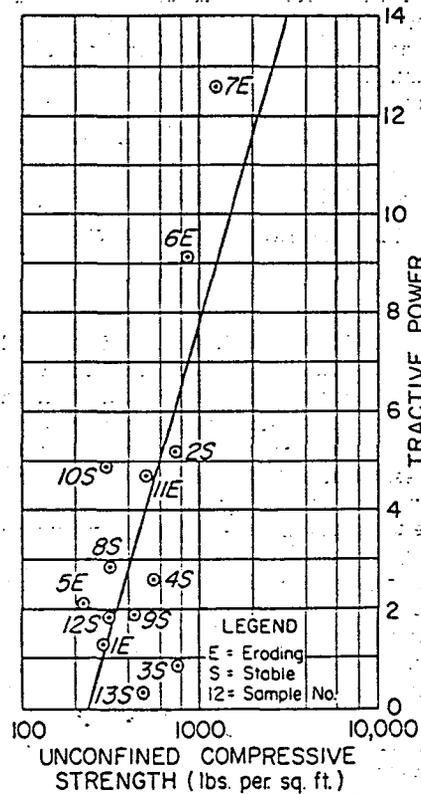
FIG. 2.—RELATIONSHIP BETWEEN UNCONFINED COMPRESSIVE STRENGTH AND TRACTIVE POWER

indicated to be stable although the point plotted far above the line. In this instance, the estimated n-value was considerably in excess of the average, due to heavy vegetation in the vicinity of the sampled surface. Additional data are needed in order to establish the validity of tractive power as defined, or some similar indicator of the relative stress and the opposing shear strengths related to stability.

estimate of rates of erosion have been obtained are shown by the lines connecting sample numbers 5, 6, and 7. The stream measurements for the plotted points on Figs. 2 and 3 are given in Table 1. Data as shown on Fig. 3 can be graphically useful in evaluating the degree of channel deterioration that will occur if flows exceed the calculated stable limits.

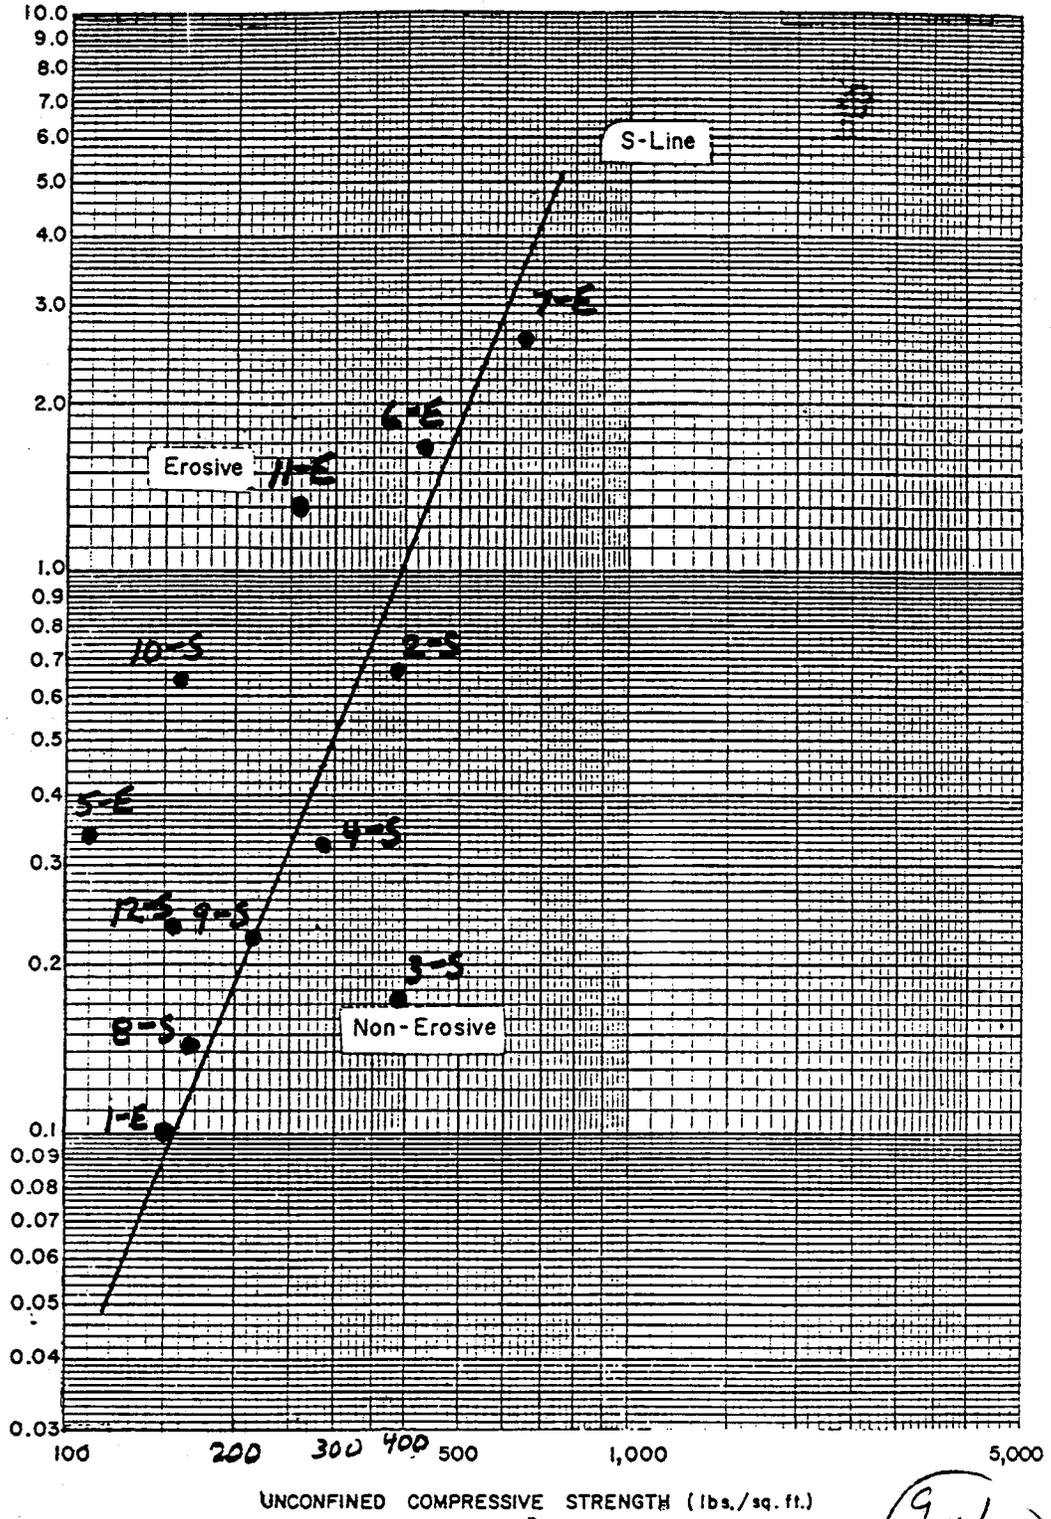
Figure 6-15

Unconfined Compressive Strength And Tractive Power As Related To Channel Stability

4. The Engineering Division, NHQ should conduct a survey to determine the performance of existing channels designed using the tractive power procedure. If possible, data should be collected for channels in both natural soils and compacted soils and for both ephemeral and perennial flow conditions. The collected data should be used to substantiate or revise figure 6-15 of TR-25.

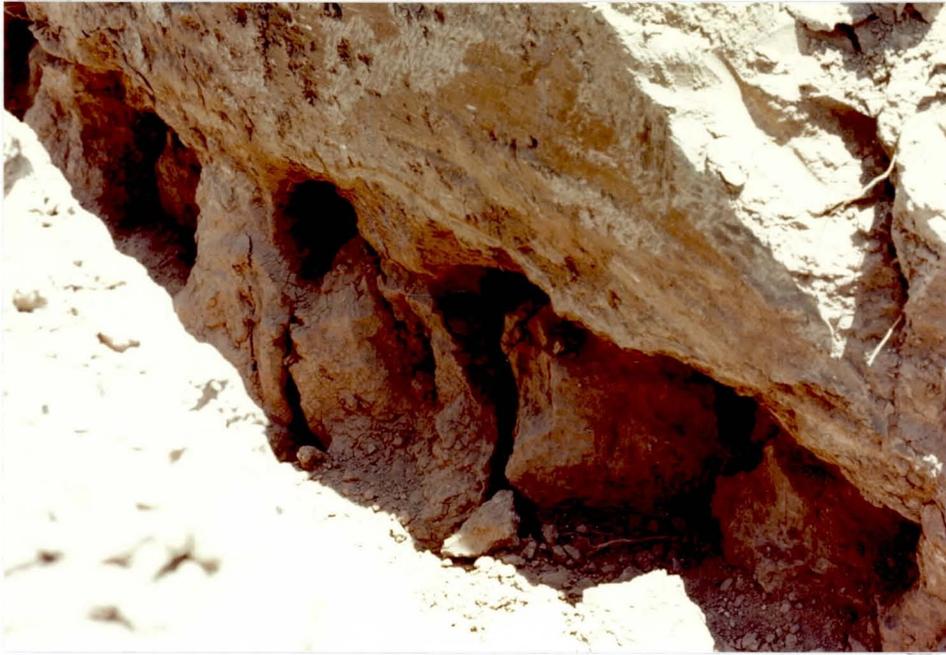
Photo #1 - Shows holes exposed by excavation for repair of jug holes in dike area - Sta 1241 + 50

4. Rainfall penetrating drying cracks in the dispersed clays probably caused the numerous jug holes in the crests of the dikes and on the banks.
5. The rills and gullies present on the channel banks do not appear to be excessive for this climatic condition. However, any such surface disturbances in dispersed clays will continue to enlarge.

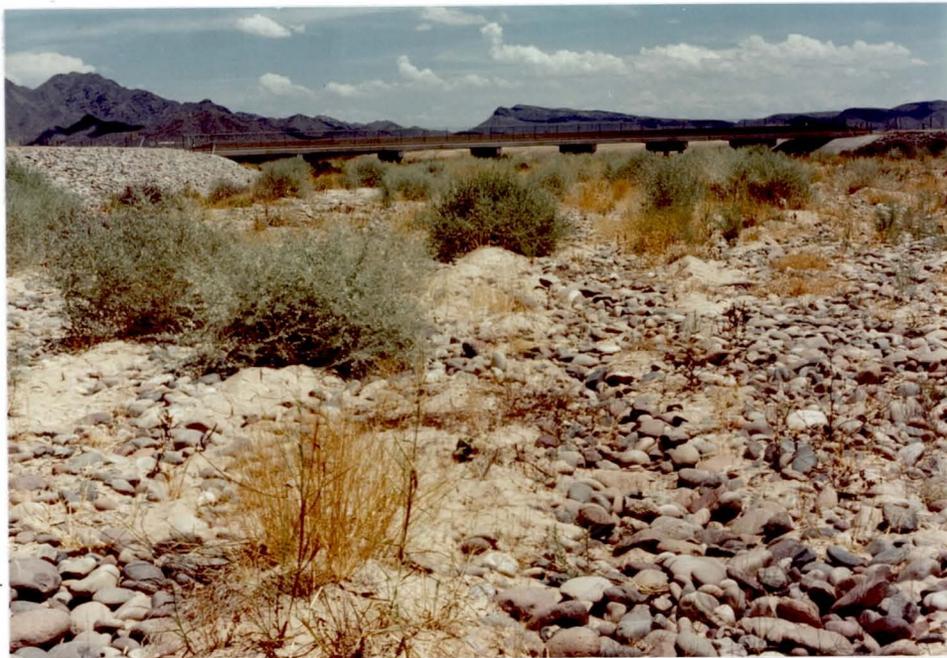
Photo #2 - Looking upstream in riprap-lined section showing sand bars - Sta 1241 + 50

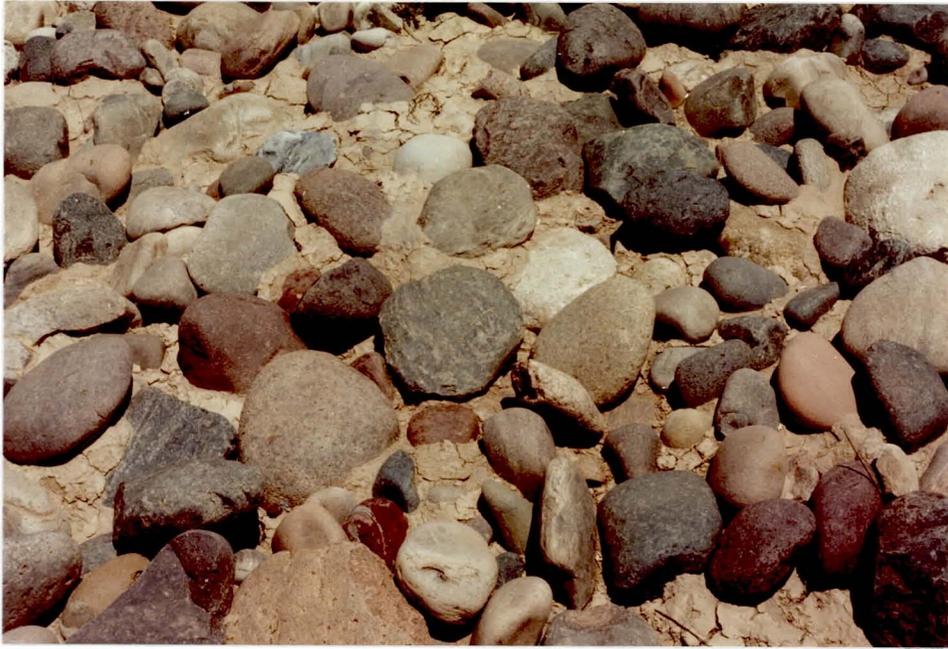
Photo #3 - Shows close-up of riprap and deposition - Sta 1241 + 50

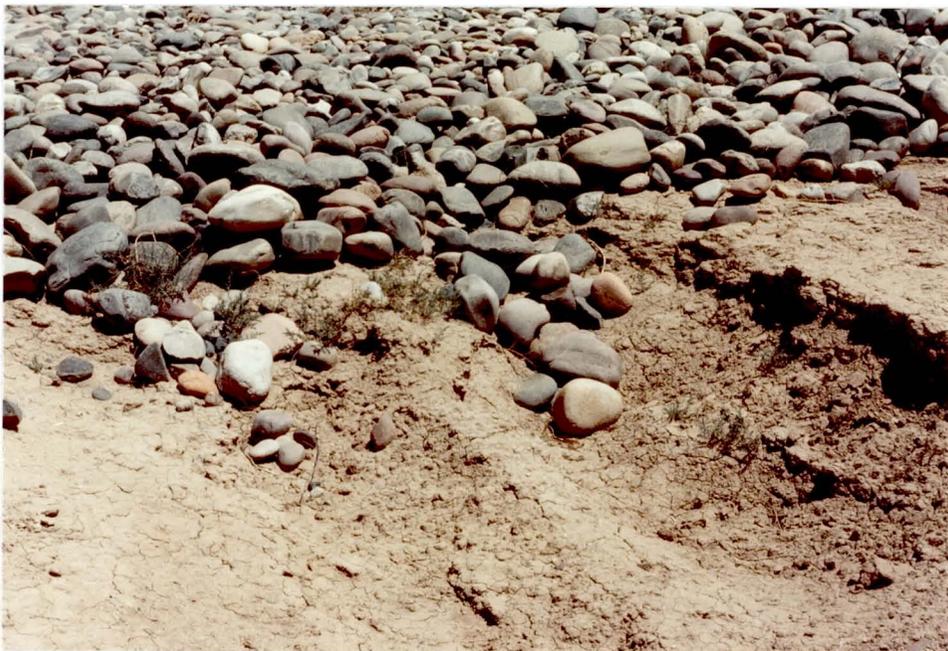
Photo #4 - Looking upstream at localized scour (2.5 to 3 foot deep) at downstream end of riprap section - Sta 1250 + 00

Transitions from riprap to earth.--The localized scour immediately downstream of the riprap sections of the channel may be caused by the turbulence created when the flow passes from the riprap to the earth lining. In some instances, large vegetation in the riprap and vehicle tracks in the riprap may have caused flow concentrations and turbulence which caused the observed scour patterns. Another possibility is the lowering of the riprap surface due to movement of the bedding material through the rock with the resulting settlement.

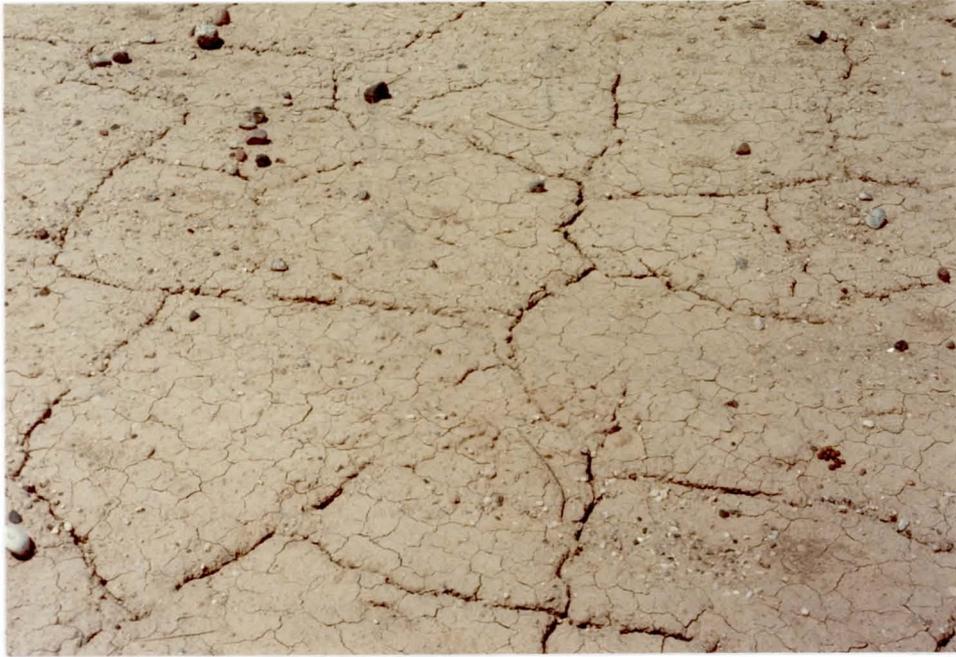
Photo #5 - Shows typical cracking pattern in earth liner - just downstream of Sta 1250 + 00

Shrinkage cracks.--Shrinkage cracking occurred in the moderately to highly plastic clays used in portions of the liner due to dessication in an extremely hot and arid climate. The cracking of the compacted earth liner greatly reduced the erosion resistance of the material; in fact, the flow could very easily remove the surface of the liner.

This cracking extends at least two feet deep in places and results in a very blocky structure. Flow in the channel easily penetrates these cracks and creates uplift pressures with a resulting "plucking" of the soil blocks.

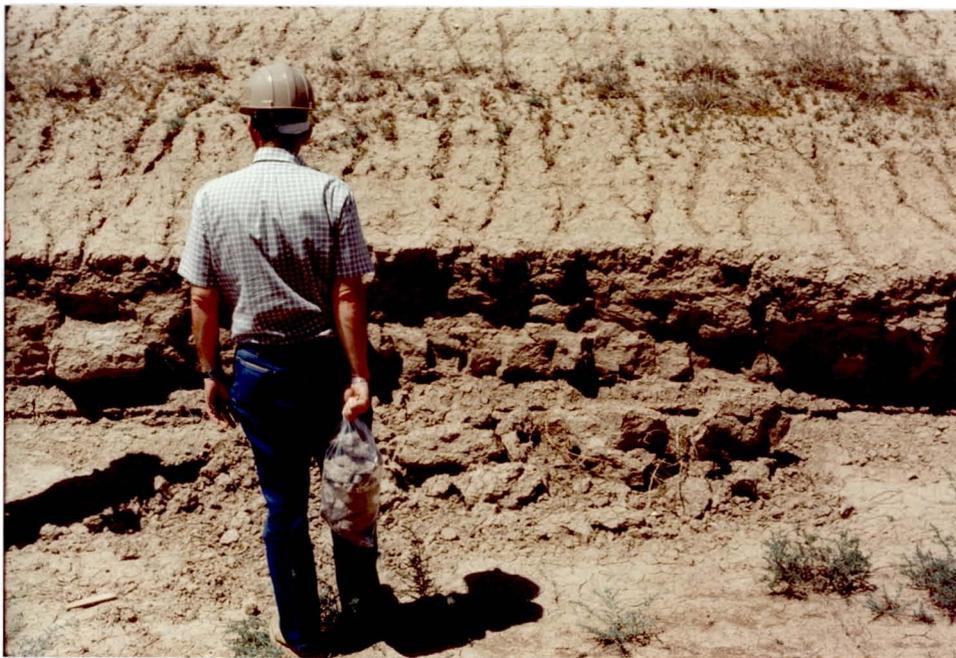
Photo #6 - Shows bank toe erosion - about 3 foot cut

2. Bank toe erosion - Long stretches of the bank toe exhibited bank failure by erosion. In uniform reaches of the earth channel, the general bed erosion appears to have caused the toe erosion, and, with but one observed exception, bank and toe erosion in Reach I occurred on one bank or the other but never on both banks at the same section. The exception was immediately downstream of the road crossing at Station 1315 + 00, where other factors may have contributed to the most severe toe erosion in the channel (a vertical cut of 4 to 4.5 feet). As shown in the sketch above, the crossing appears to have caused a contraction of the flow. General bed scour occurred in the central portion of the channel as if it were subjected to a concentrated jet of water, with sediment disposition in the zones of stagnation on either side of the jet, and subsequent bank erosion further downstream as the jet fanned out.

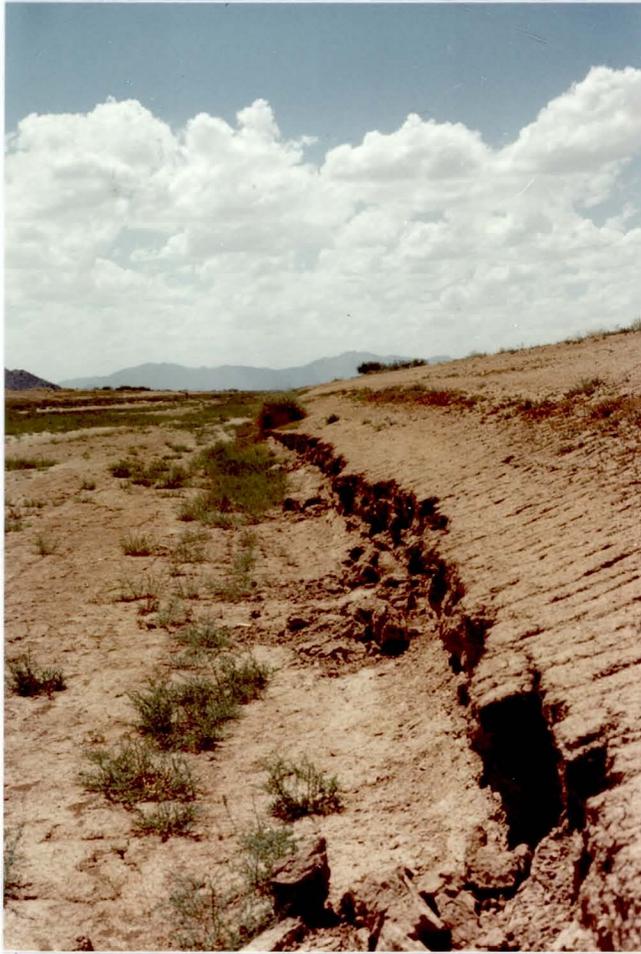
Photo #7 - Looking downstream at right bank - same location as photo #6

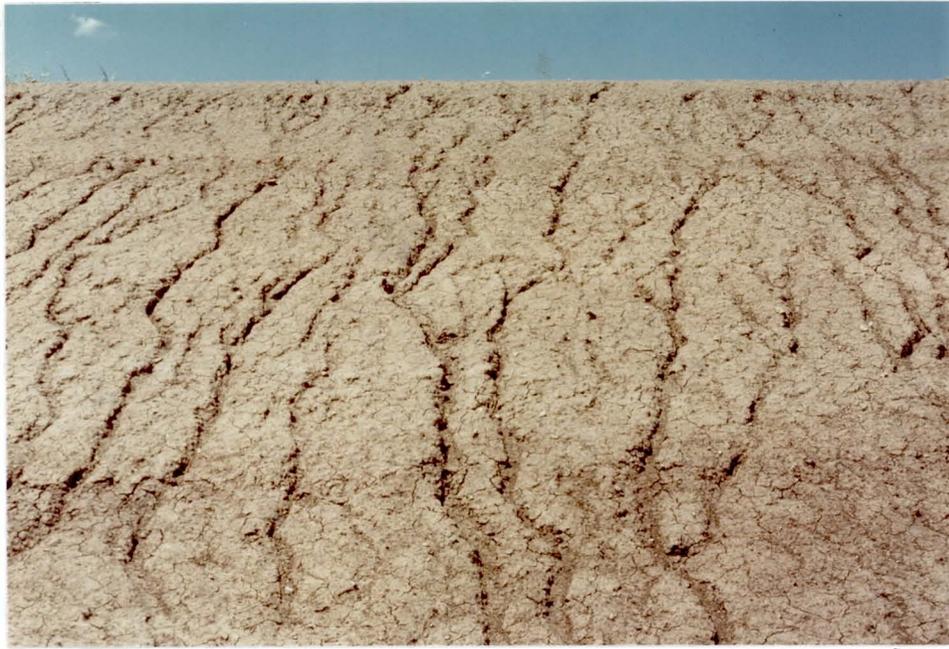
Photo #8 - Shows rills on channel bank - 2 to 3 inches deep

6. Bank rilling - The channel banks are rilled and, in at least one section of the channel, the rills are 2 to 3 inches deep. However, most of the rilling is not that deep. The bank rilling at some locations has resulted in deposition on the bed at the toe of the bank.
7. Jug holes - Jug holes are evident on the crests and banks of the dikes, with the worst section being the lower 1000 feet of the reach. In the vicinity of Station 1241 + 50, numerous jug holes and a large piping failure, extending from the crest of the right dike into the channel, were noted. The jug holes were especially numerous in the diking above riprap sections.

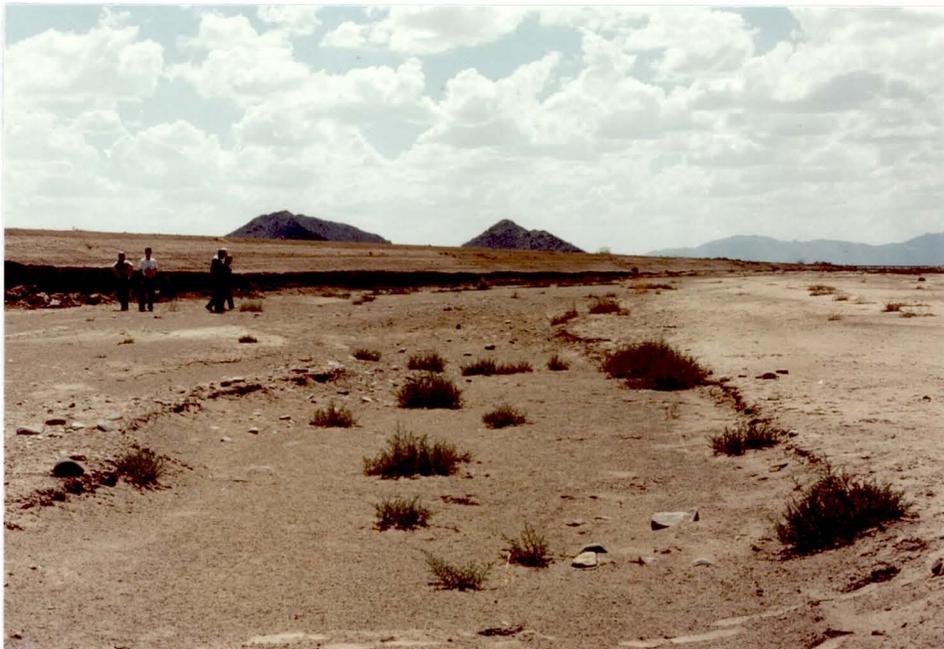
Photo #9 - Looking downstream showing sub-channel in main channel -  
Sta 1317 + 00

In sections of the channel, a great deal of sub-channelization is present. Three, four, or even more sub-channels were observed within the main channel width. Each probably caused localized high velocity currents that scoured the compacted earth lining, with sediment deposited bars acting as levees separating the sub-channels. The sub-channels showed signs of meandering. When located near the main channel bank, this meandering tendency increased the bank and toe erosion and created the cyclic erosion pattern on the main channel bank as the meandering sub-channel proceeded downstream.

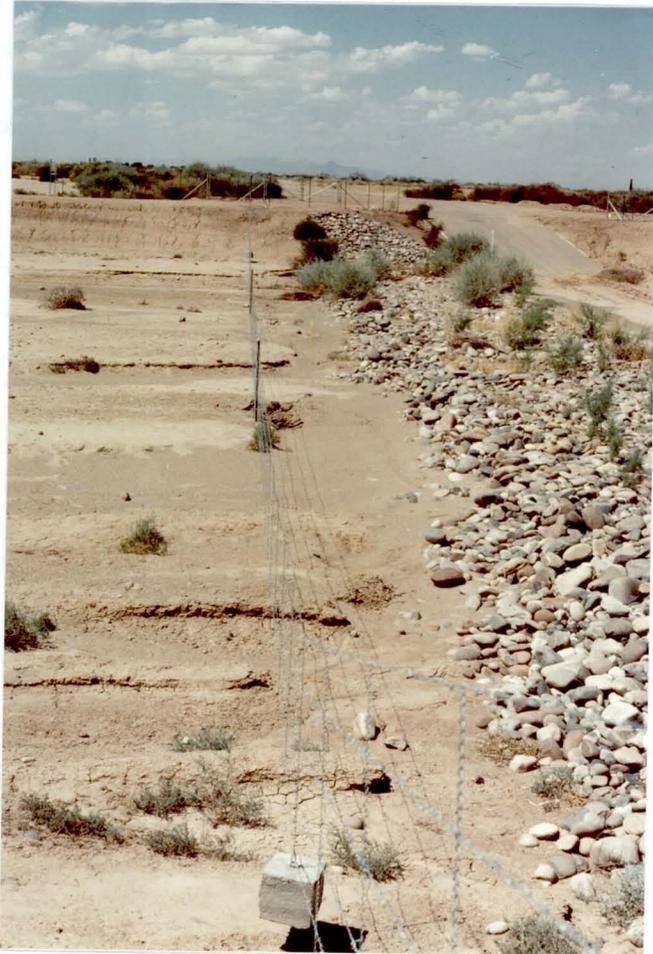
Photo #10 - Shows local scour of soil liner immediately downstream of riprap road crossing - Sta 1317 + 00

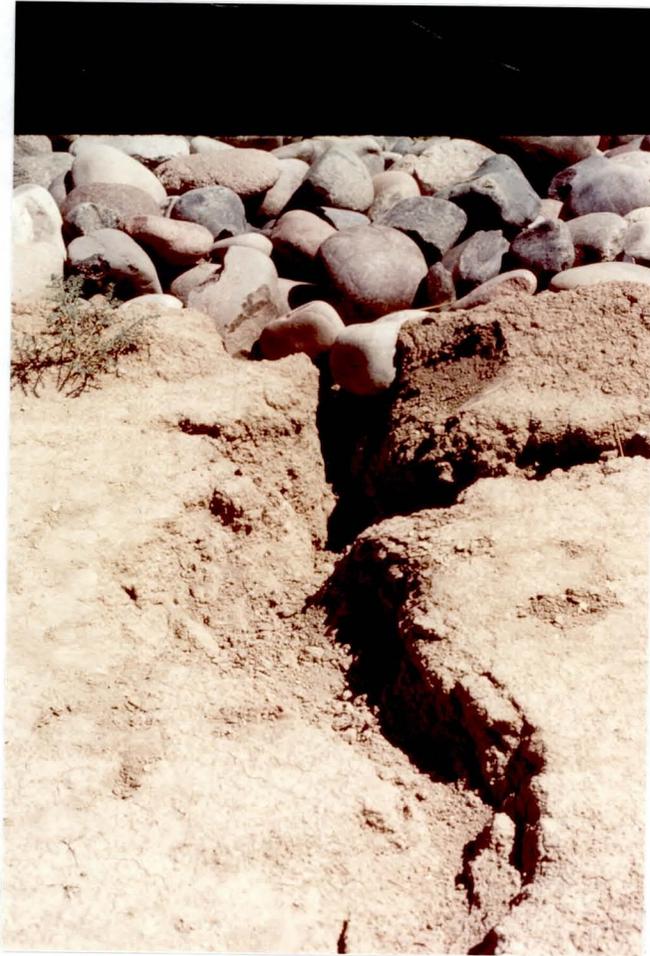
Photo #11 - Shows jug hole in crest of dike at downstream end of Reach I
