REVIEW OF FLOOD HAZARDS OF RAWHIDE WASH

By H. W. Hjalmarson, PE

FLOOD CONTROL DISTRICT OF MARICOPA COUNTY

FCD 99-01

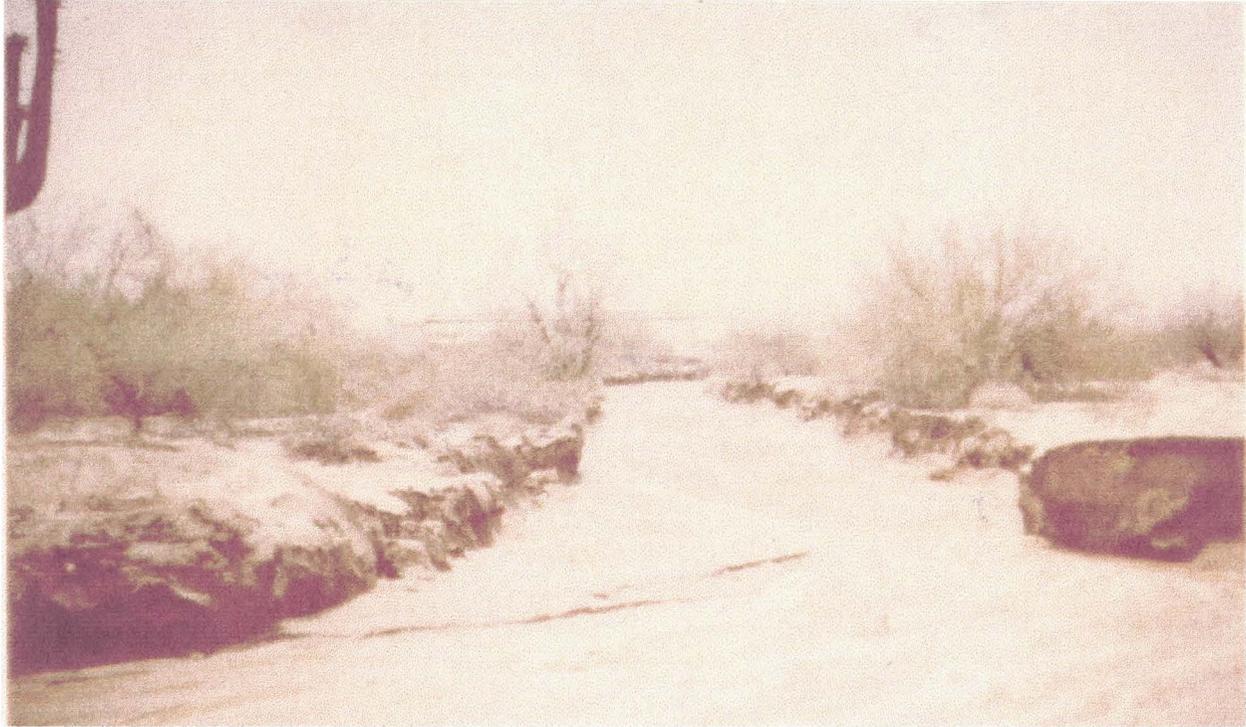
Photo 3. Looking downstream and southwest from Pinnacle Peak Road at one of Rawhide Wash channels. Channel is 0.1 mile east of Scottsdale Road. Soil along banks has eroded. Photo taken on June 22, 1972 shortly after the flood peak.

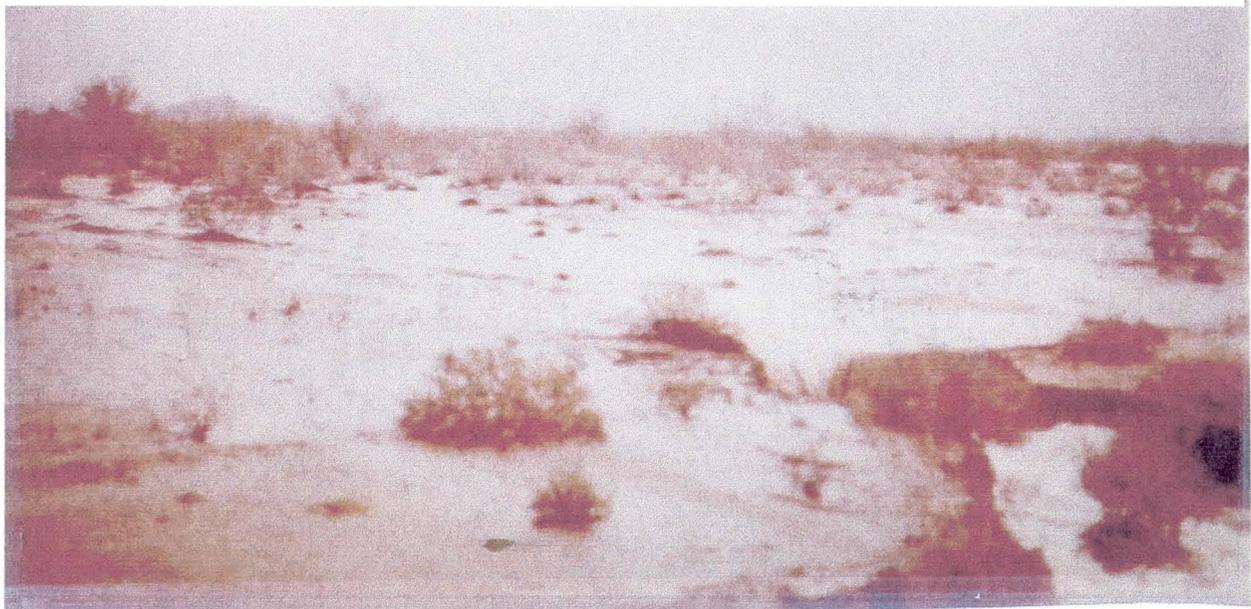
Photo 4. Floodwater of flood of June 22, 1972 at Pinnacle Peak Road about 0.5 mile west of Scottsdale Road. Site is about 1/2 mile west of Scottsdale Road next to APS Pinnacle Peak Substation. Looking northeast at sheetflow with small headcut. Landslope is about 2.0 percent. Some of this flow may be from Rawhide Wash but most of flow probably is from area to the west of Rawhide Wash.

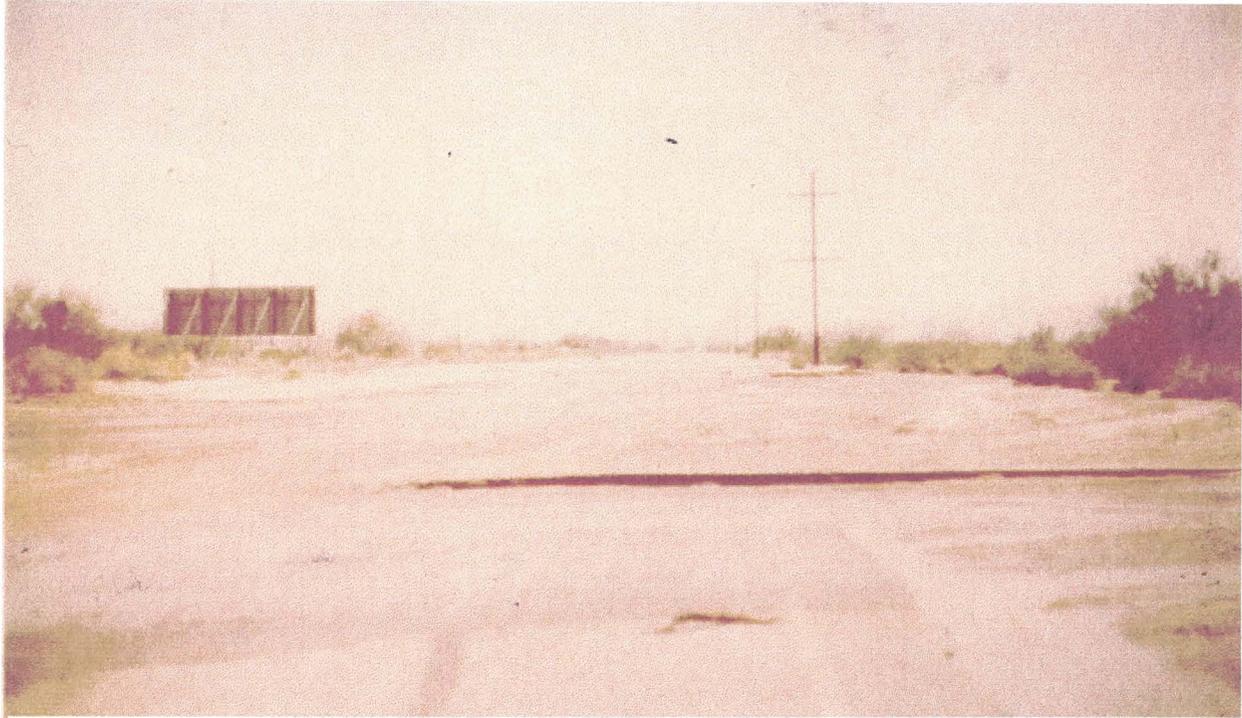
Photo 1. View looking south across Rawhide Wash channel at deposited sediment and floodwater in dip crossing at Scottsdale Road. Site is about 0.6 mile south of Pinnacle Peak Road. Photo is of recession of large flood on June 22, 1972.

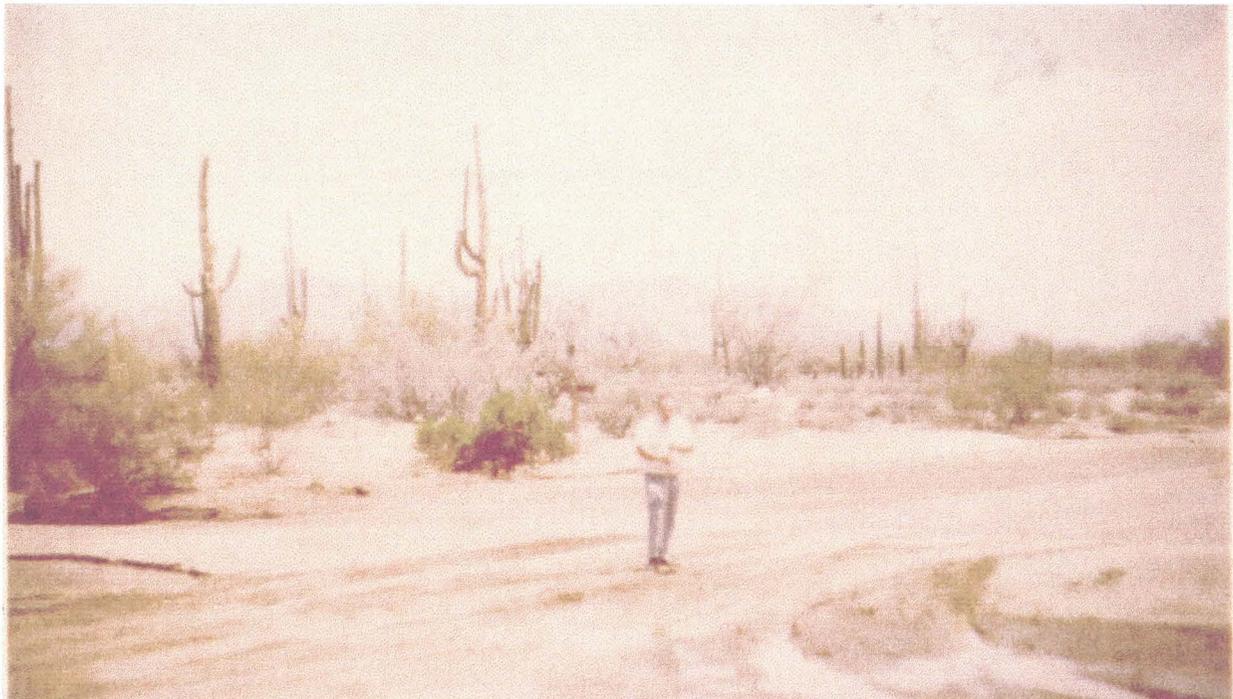
Photo 2. View looking southeast and across channel at dip crossing on Scottsdale Road about 0.1 mile north of Jomax Road. Deposited sediment is about 6 inches deep and several tens of feet wide. Photo taken on June 22, 1972 shortly after the flood peak.
