**Final
BRIDGE SCOUR ASSESSMENT
REPORTS
for 16 Maricopa County Bridges**

**VOLUME II
Structure Numbers
9427, 9588, 9999, 8038
7818, 9154, 9142, 7553**

**MARICOPA COUNTY
DEPARTMENT OF
TRANSPORTATION (MCDOT)
Work Order No. 80407**

**Cannon & Associates, Inc.
Consulting Engineers**

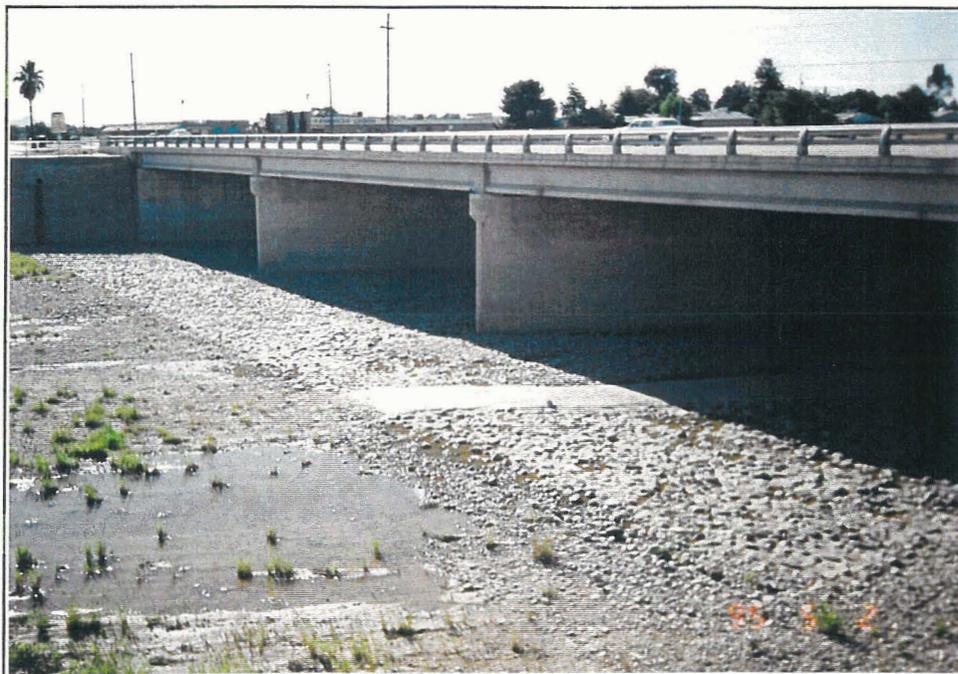
Photo 3: View looking across upstream face from right embankment. Note grouted rip-rap channel bottom extending approximately 30 feet upstream and downstream of structure. Also note absence of significant debris in bridge waterway.

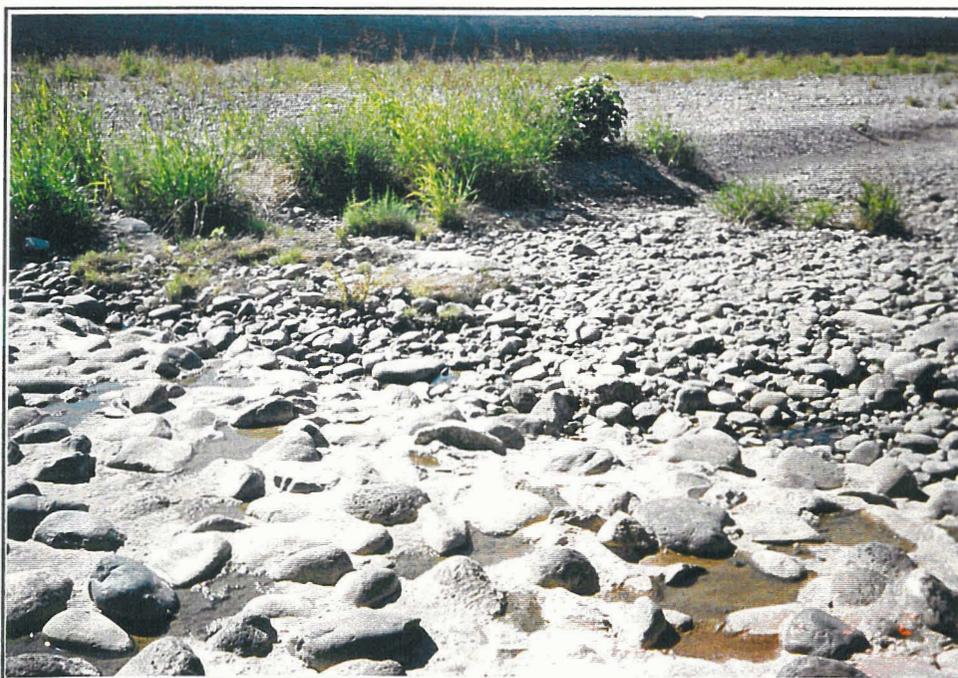
Photo 4: View of grouted rip-rap and typical channel material downstream of structure. Concrete is somewhat eroded and slight scour has occurred at interface.

DEFICIENCIES AND COUNTERMEASURES: The condition of the sill and banks should be monitored frequently and any erosion be promptly repaired.

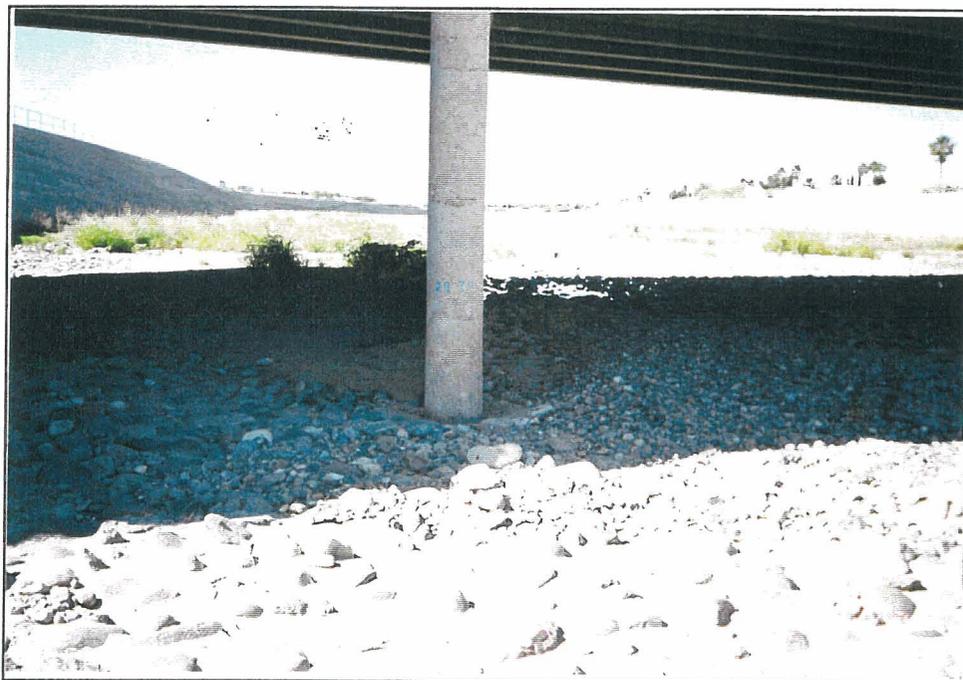
Photo 6: View looking at upstream edge of east side pier. Note sediment deposition along east side of solid pier.

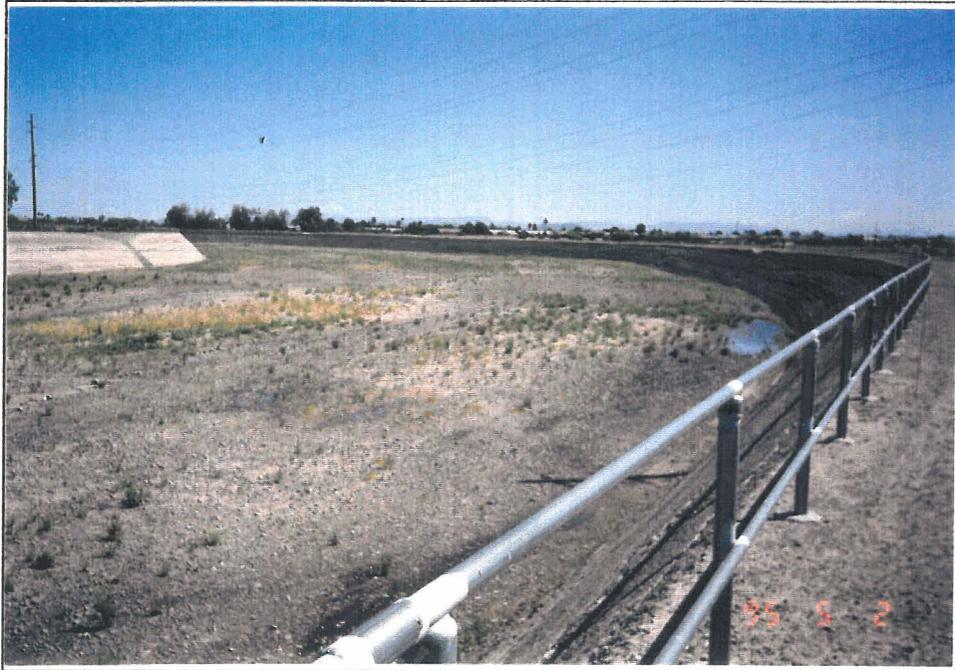
Photo 1: View looking upstream from alongside east abutment. Note wide, sparsely vegetated main channel constrained by levee embankments. Also note that main channel surface sediments are relatively coarse with a substantial percentage of cobble-sized material.

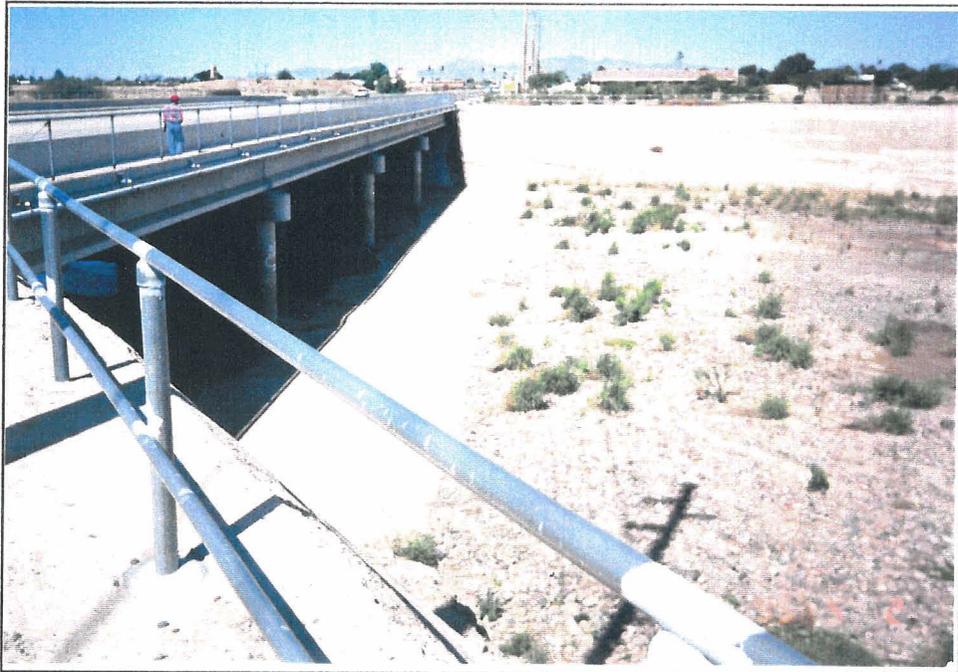
Photo 3: View looking across upstream face of bridge from alongside east abutment. Note sloping upstream section of concrete apron which extends approximately 30 feet upstream and downstream of bridge faces. Also note low flow notch toward center of channel.

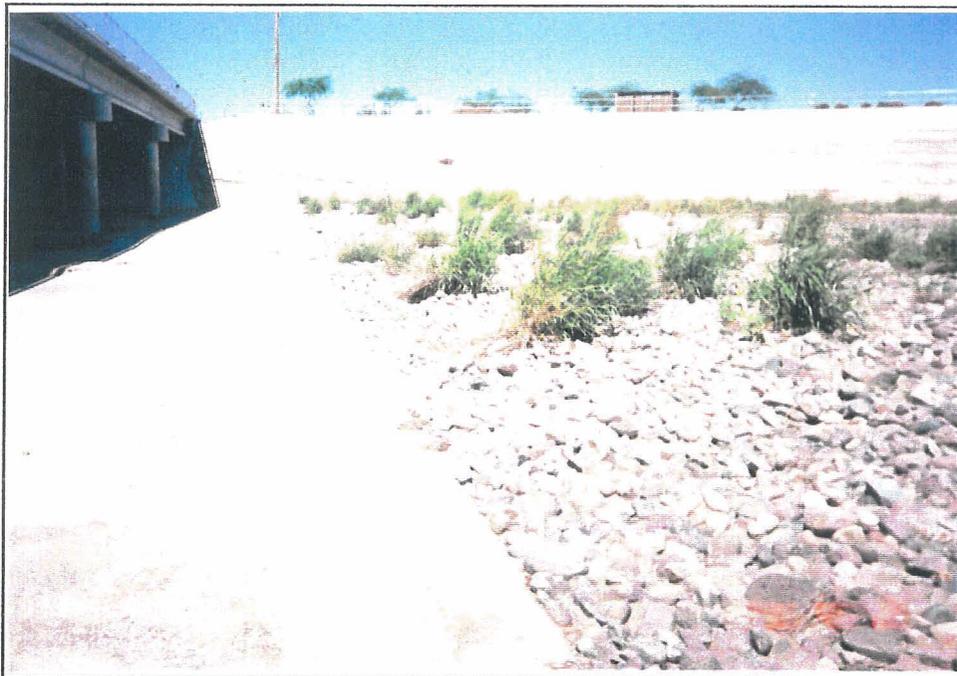
Photo 4: View looking west across upstream face of structure. Note local accumulation of very coarse channel material along upstream edge of concrete apron.

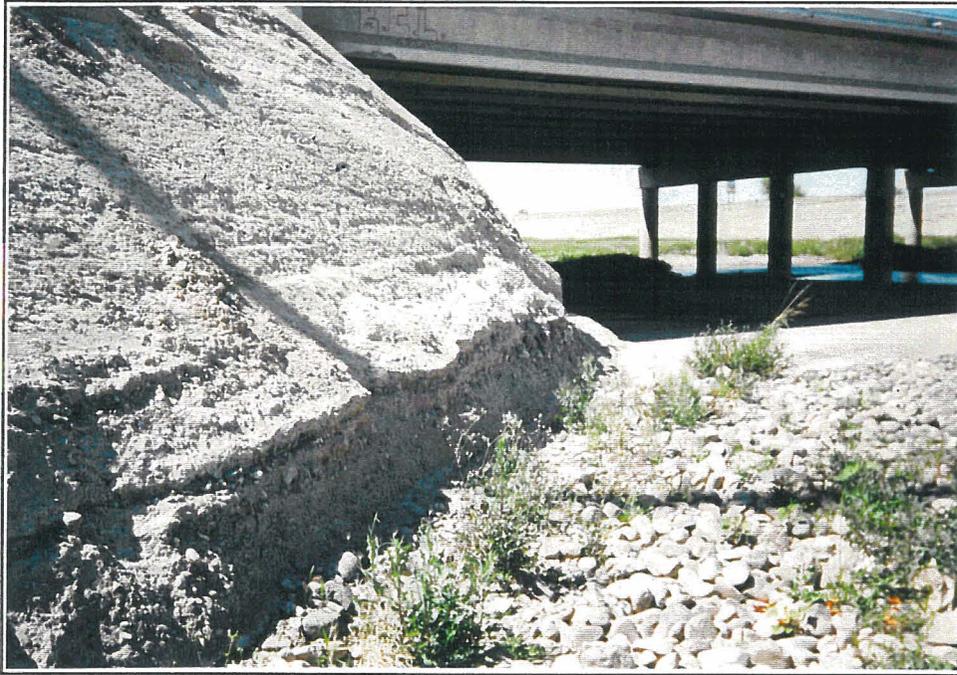
The only scour observed during the site inspection was minor erosion of the soil-cement bank at the upstream side of the east abutment.

Photo 5: View of upstream side of east abutment. Note erosion of embankment toe occurring near change in channel direction at upstream face of bridge.

DEFICIENCIES AND COUNTERMEASURES: The condition of the sill and banks should be monitored frequently and any erosion be promptly repaired.

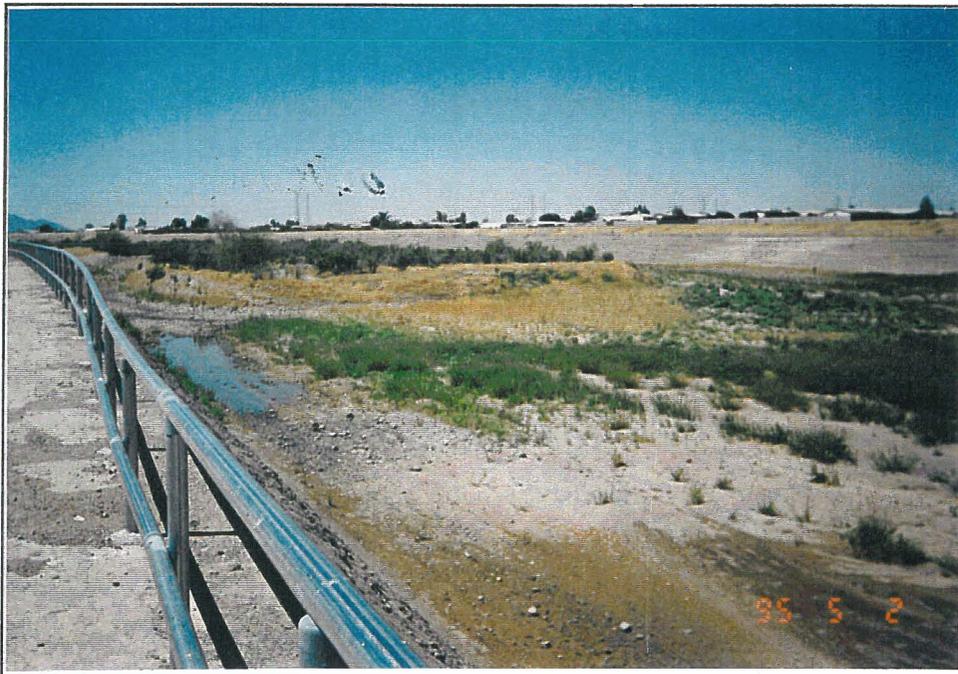
Photo 6: View of downstream channel from embankment. Note island in center of main channel. Vertical relief is approximately 8 feet above main channel. Flow forced to east and west around island.

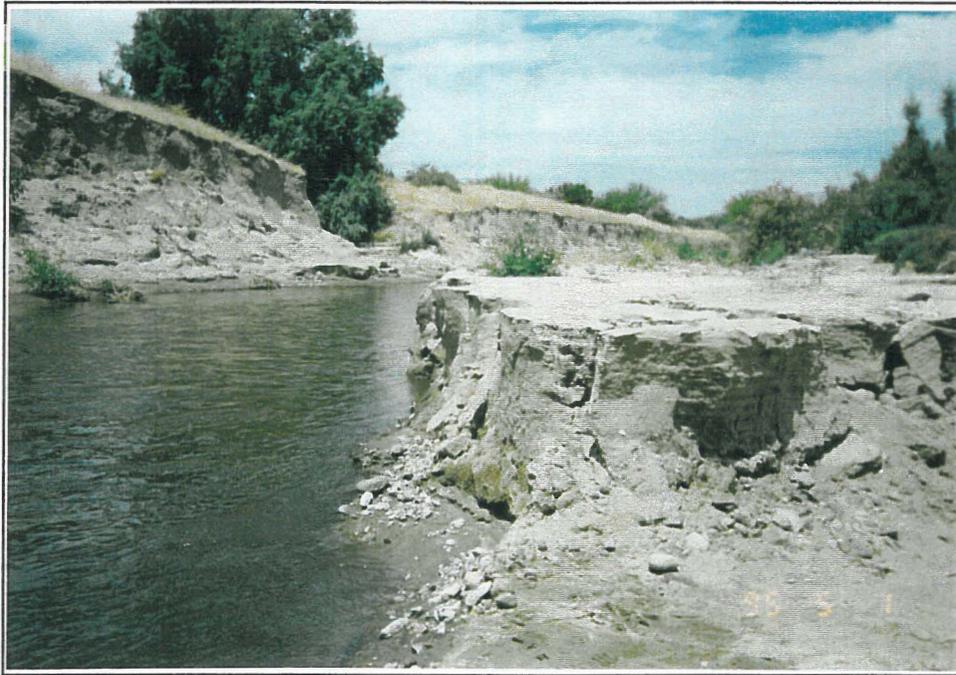
Photo 5: View looking upstream of structure alongside low flow channel. Note significant proportion of medium to coarse sand comprising channel surface sediments and its potential erodability under high flow conditions.

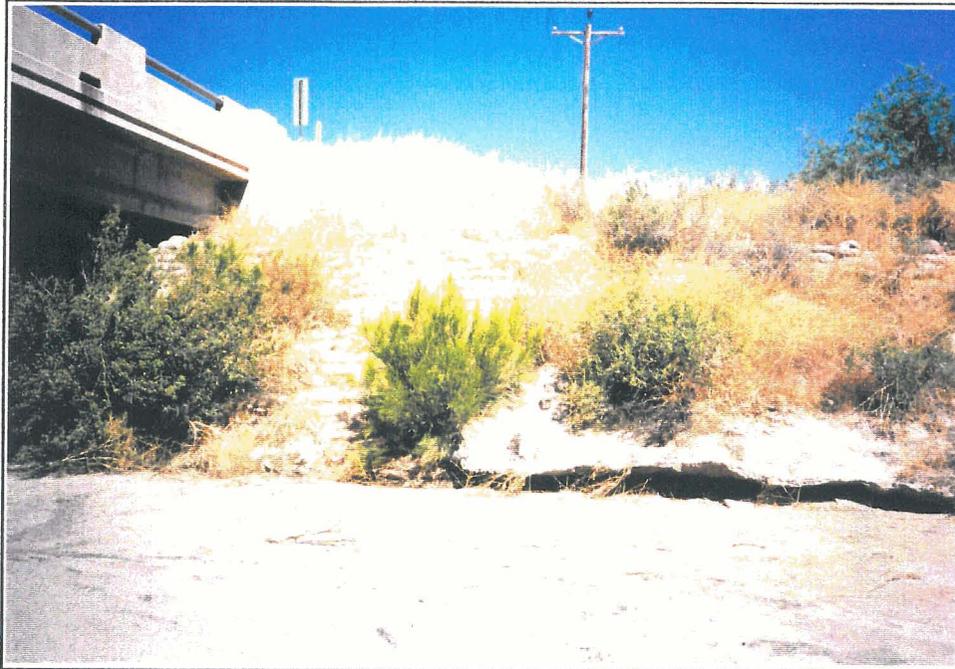
Photo 1: View of upstream side of north abutment. Note sacked concrete rip-rap protecting north abutment outslope and trowelled concrete added later. Also note undercutting at base by impinging flow.

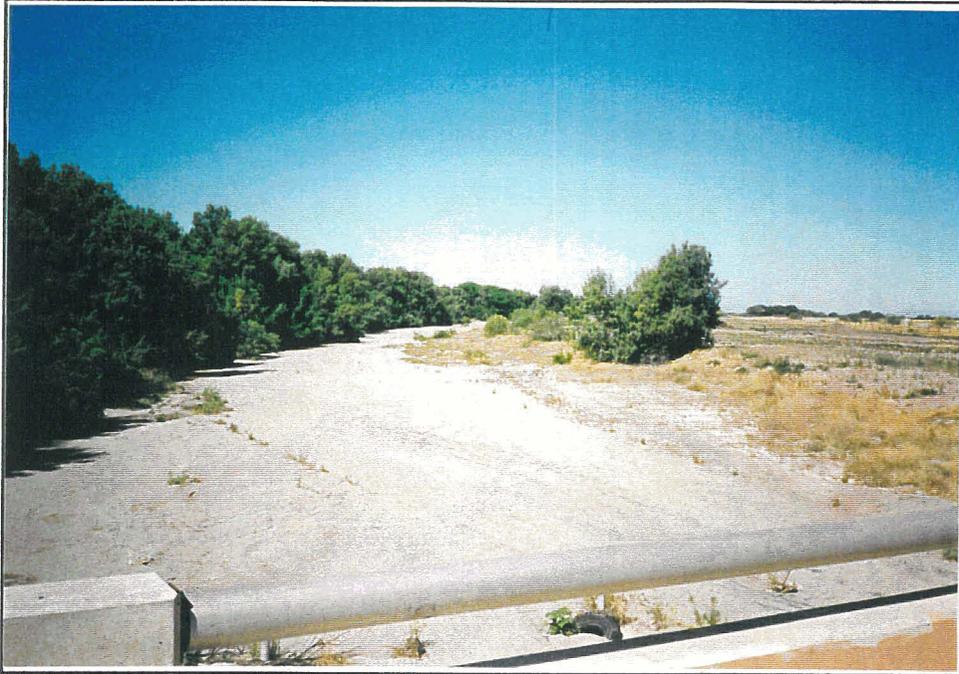
Photo 3: View looking downstream from approximately mid-span of bridge deck. Note thalweg curving from lower right to upper left. Note low point bar to right and low alternate bar to left. Also note sandy, sparsely grassed downstream right overbank and mature trees providing stabilization to left bank downstream.

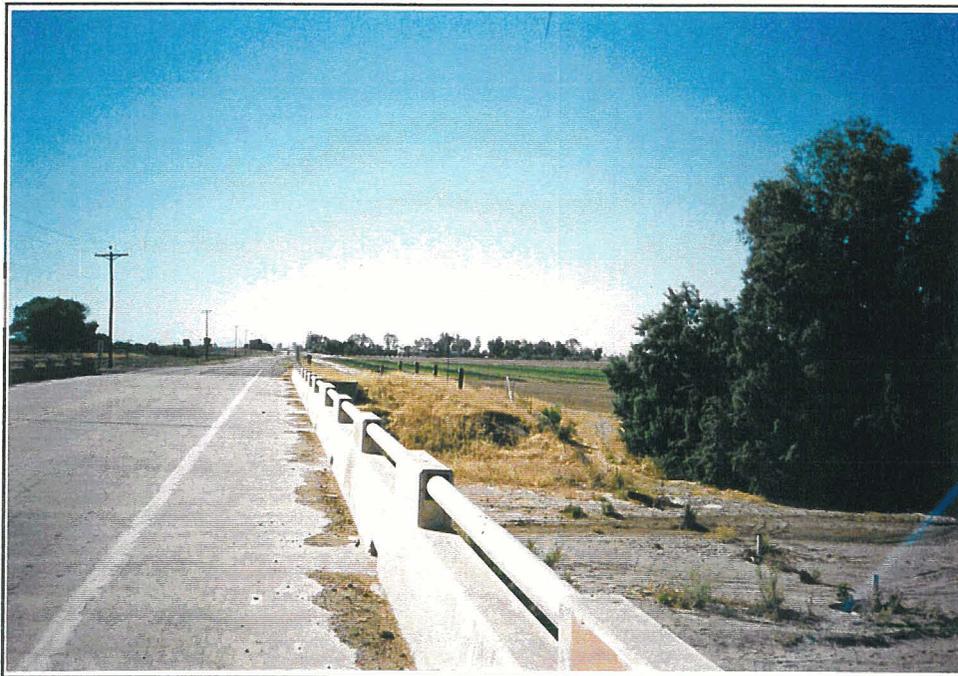
Photo 4: View looking along downstream rail toward south abutment. Note tree-lined banks and cultivated fields in background comprising downstream left overbank. Also note left overbank is not substantially elevated above channel.

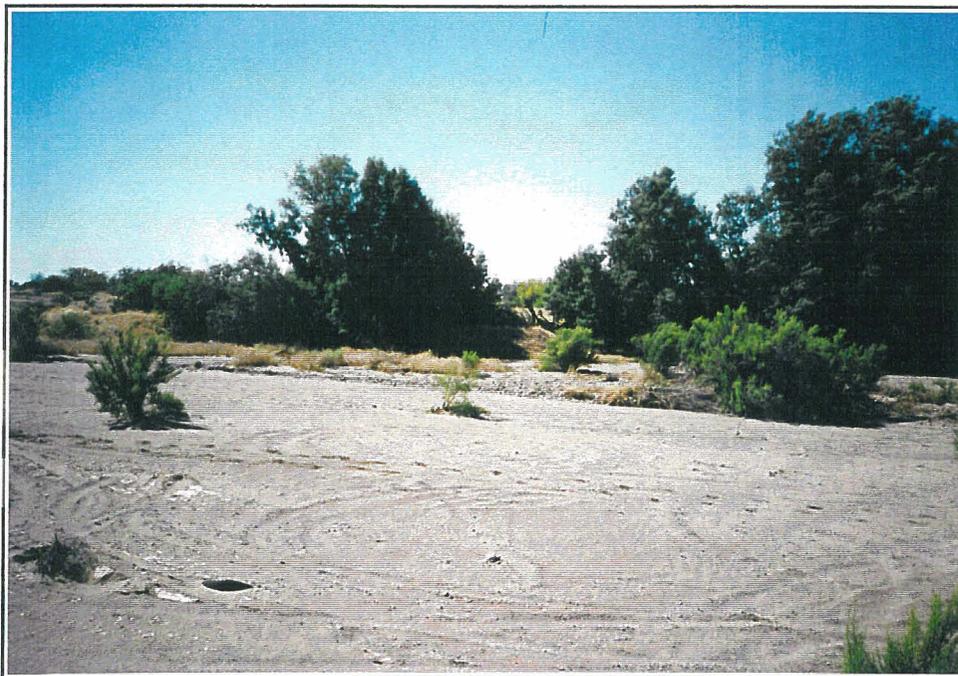
Photo 6: View looking approximately south across channel upstream of both bridges. Note tree-lined banks and grassy, vegetated upstream left overbank. Also note low vegetated bar being undercut adjacent to a primary channel consisting mainly of coarse sand.

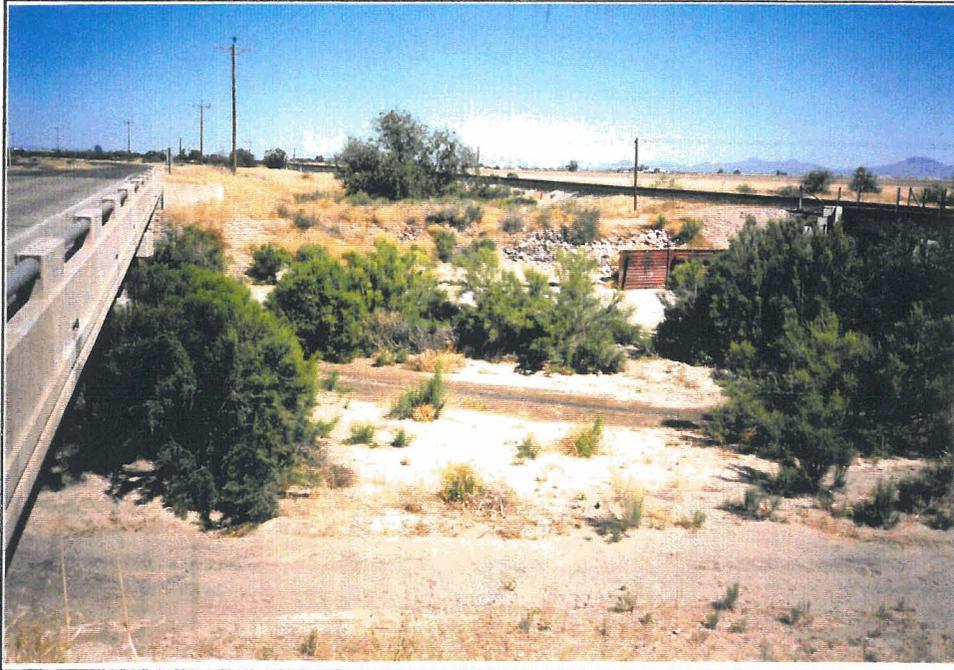
Photo 7: View looking along upstream face of bridge toward north abutment. Note low area between embankments. Also note railroad box car used as bank protection just downstream of SPRR bridge. Further note low bars and established vegetation in channel between structures. Bar relief is typically 1-2 feet above low flow channels. Note locally braided condition of stream near structures.

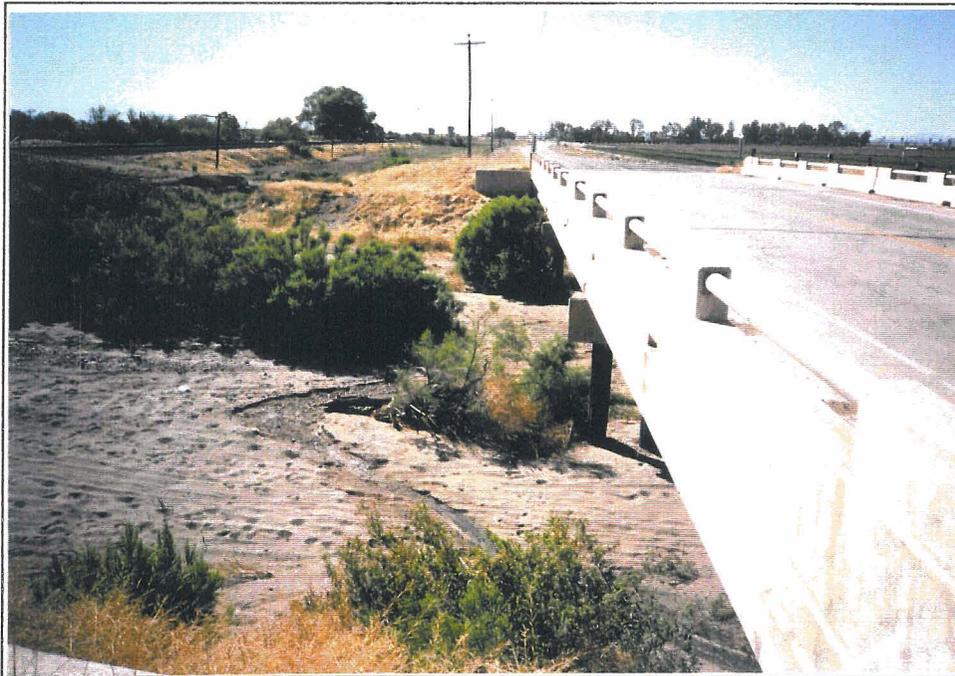
Photo 8: View along upstream face of structure looking toward south abutment. Note low area between embankments capturing runoff. Also note minor scour developed upstream of pier due to debris blocking flow.

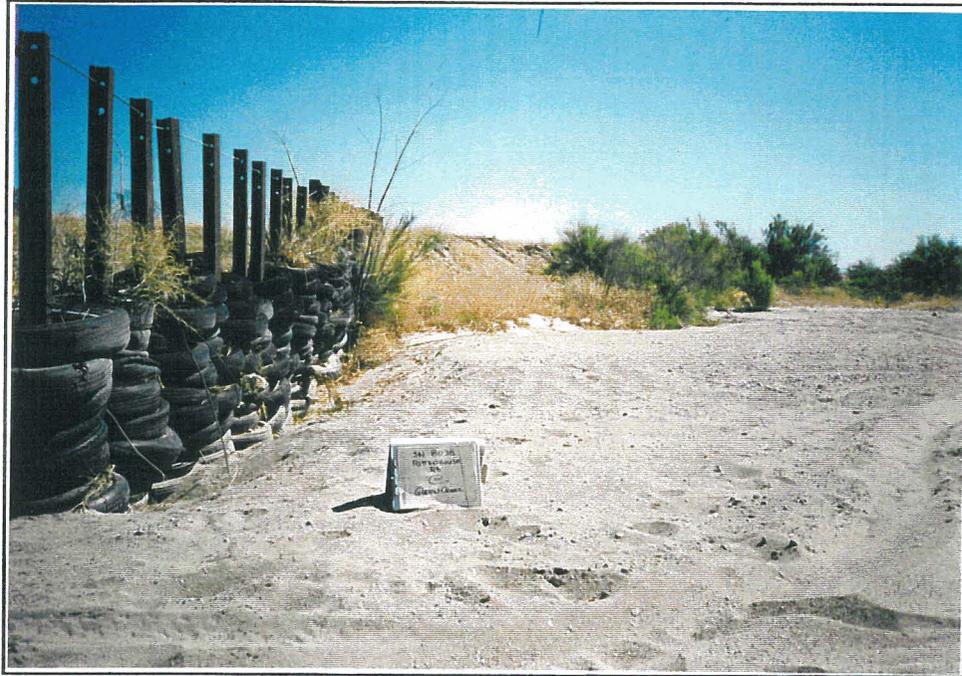
Photo 9: View of I-beam and rubber tire dike used to deflect flow from north bank upstream of SPRR bridge. Note residual scour along base and deposition of sediment immediately upstream.

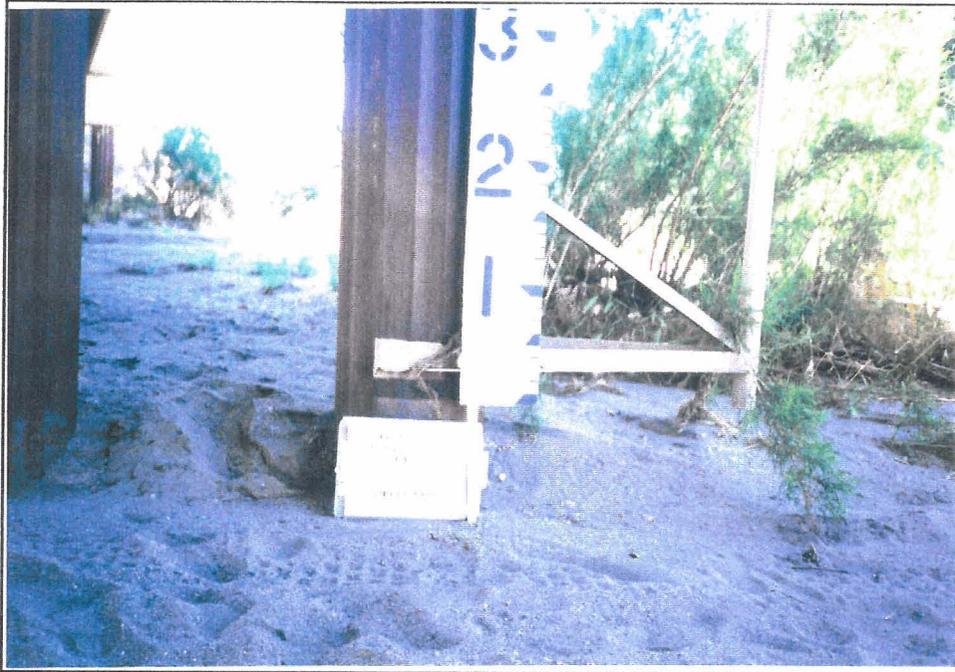
Photo 11: View of stream gage showing typical fluctuations of channel depth in vicinity of piles. Overall relief through piles is approximately 2 feet. Note staining of column at assumed original grade, however, substantial residual local scour at piers was not observed. Under high flows, close spacing of piles may assist debris capture and enhance local scour.

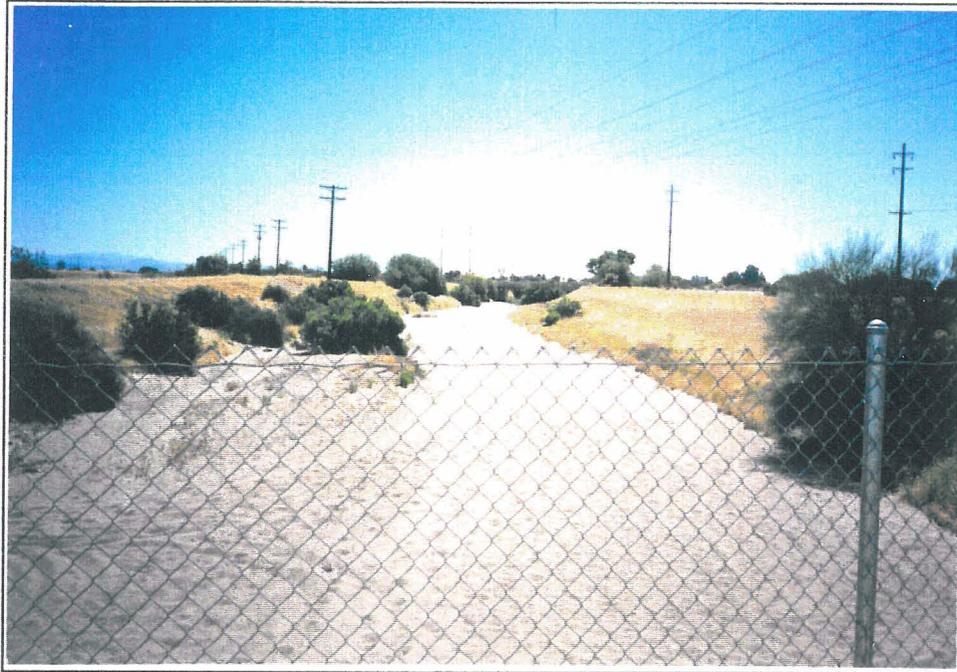
Photo 1: Looking upstream from approximately mid-span of structure. Note generally uniform trapezoidal section formed by levee embankments. Note channel developing meandering form with thalweg shifting to impinge on south abutment while a low bar forms upstream of north abutment. Some mature vegetation is established along north embankment.

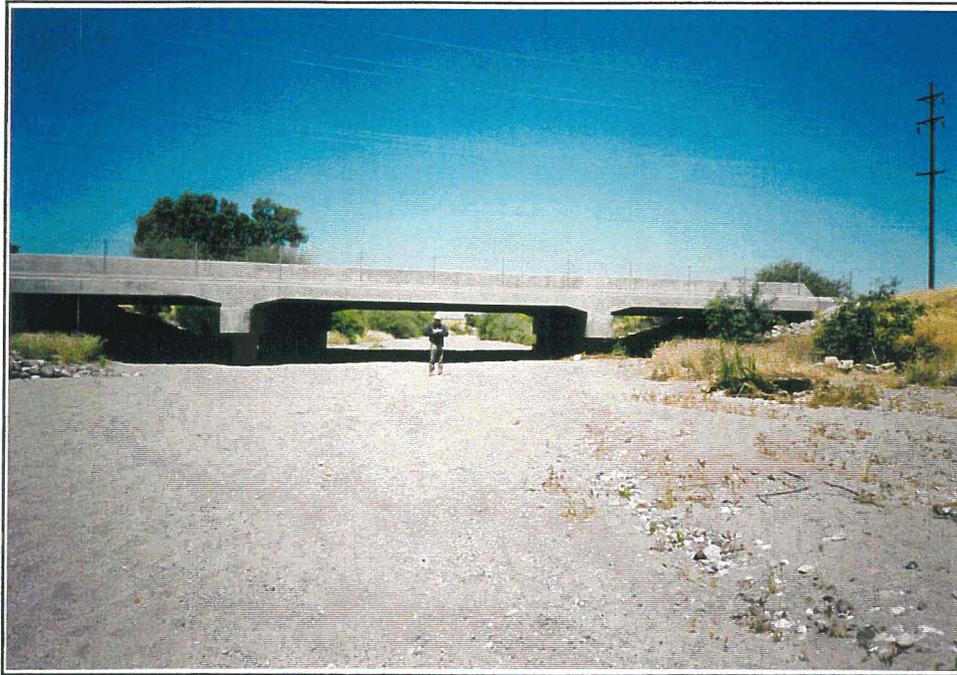
Photo 3: Looking toward upstream face of structure. Note reduced clearance toward north abutment. Also note bar development upstream from north pile bent.

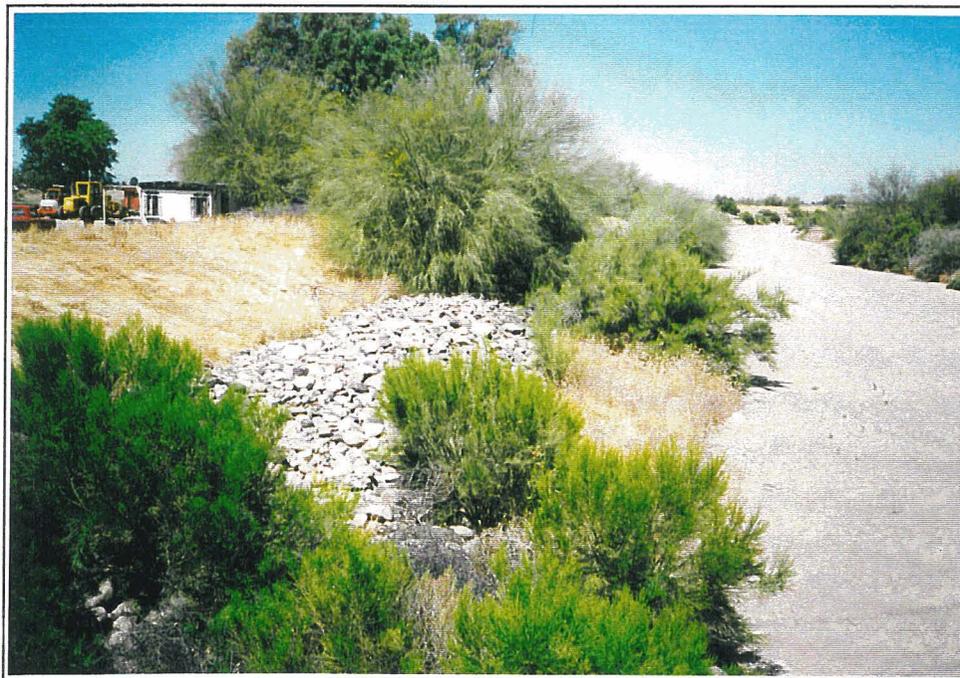
Photo 4: Looking toward south bank just downstream of south abutment. Note placement of rip-rap.

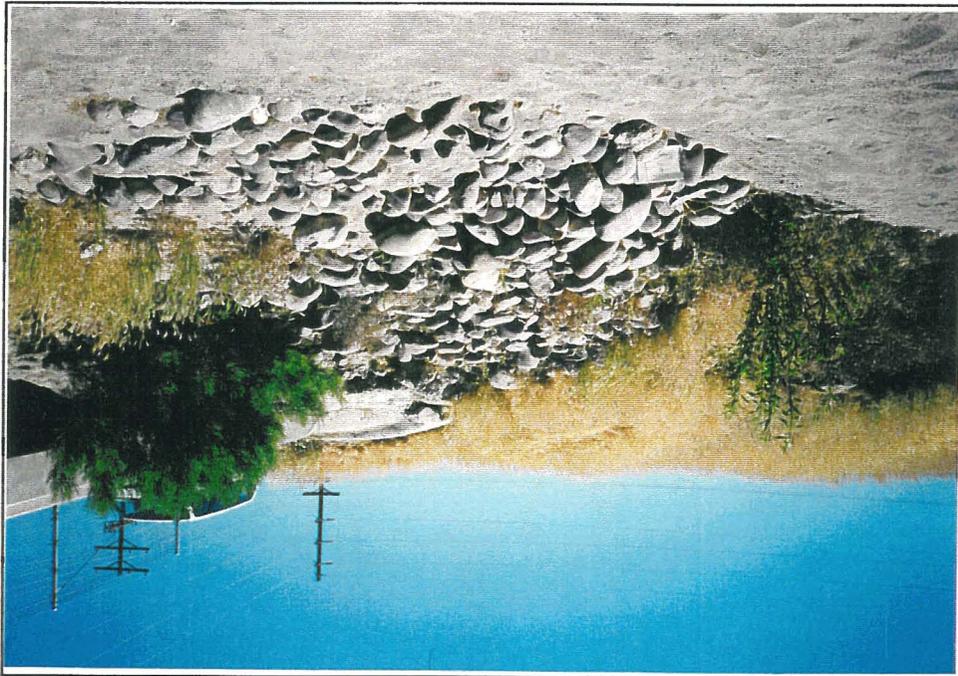
Photo 5: View of rip-rap placed along upstream side of south abutment. Note how scour by impinging flow has destabilized rip-rap at scupper outfall. Similar condition exists at downstream side of south abutment.

DEFICIENCIES AND COUNTERMEASURES: There is some sloughing of riprap at the upstream side of the south abutment that should be repaired.

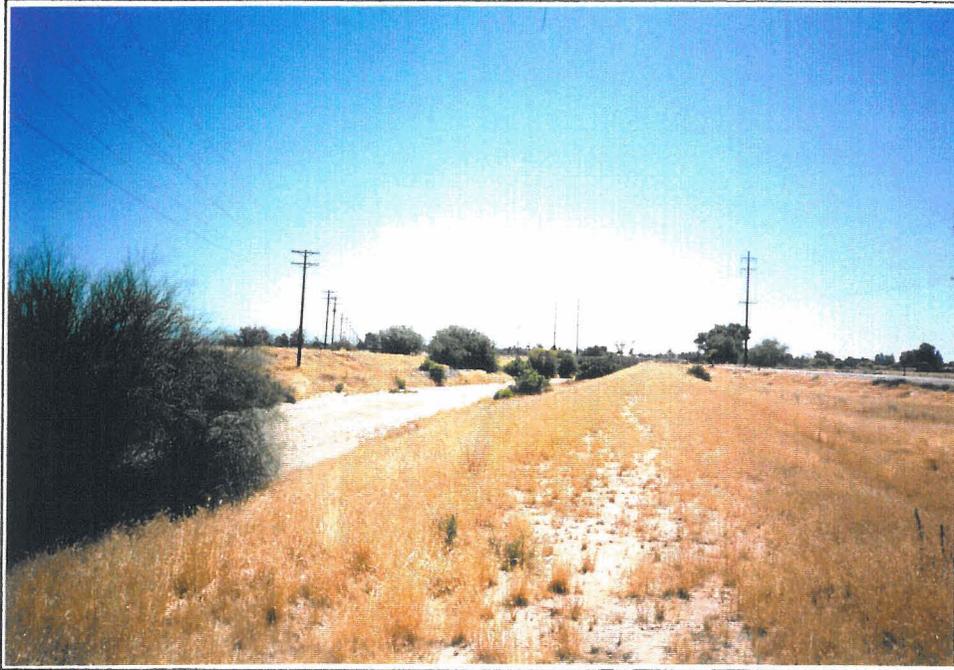
Photo 7: View of south side levee upstream of structure. Note dry grass growing in sandy soil is typical of near stream overbanks. Levee crest is typically 3-5 feet minimum above surrounding overbanks. Cultivated fields generally surround stream beyond levees with roadway embankments and structures in overbanks locally.

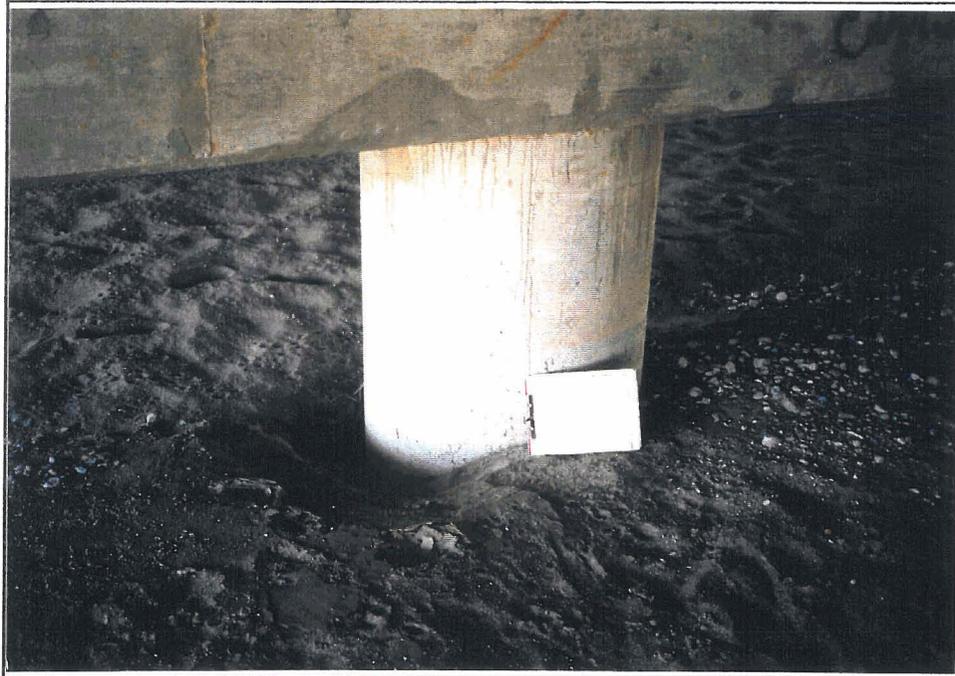
Photo 8: View of typical north side pile. Note residual local scour of 1-2 feet.

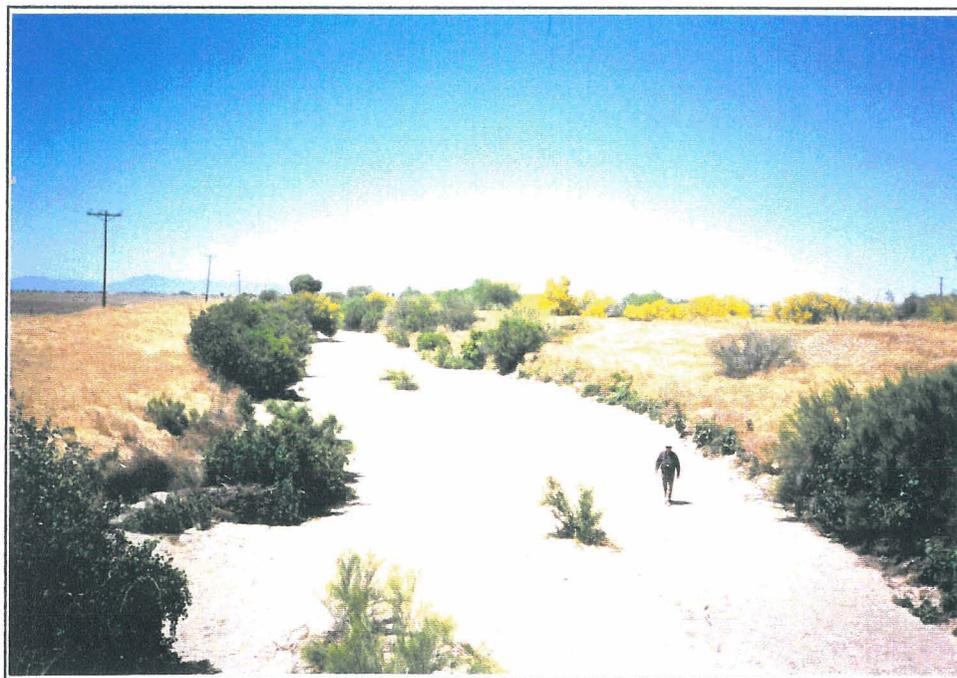
Photo 2: View looking downstream from approximately mid-span. Note substantial expansion of clear trapezoidal channel immediately downstream of bridge. Also note downstream overbanks are generally cultivated fields with occasional structure on north side.

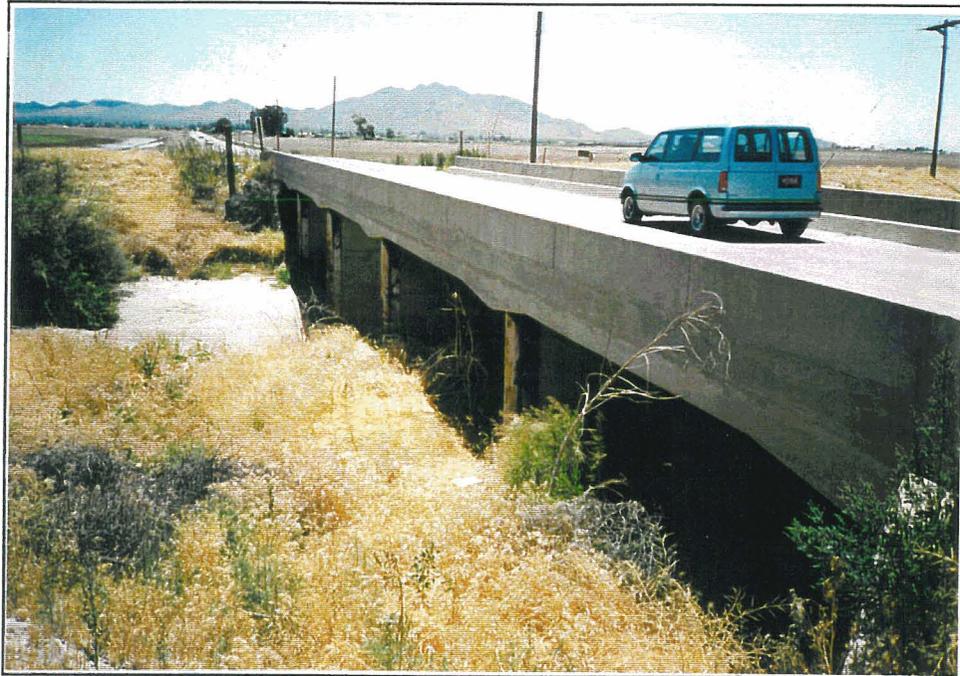
Photo 3: View from top of levee embankment looking south along upstream face of structure. Note substantially decreased cross-section through spans 1, 2, (nearest) and 5 resulting in constrained flow through spans 3 and 4.

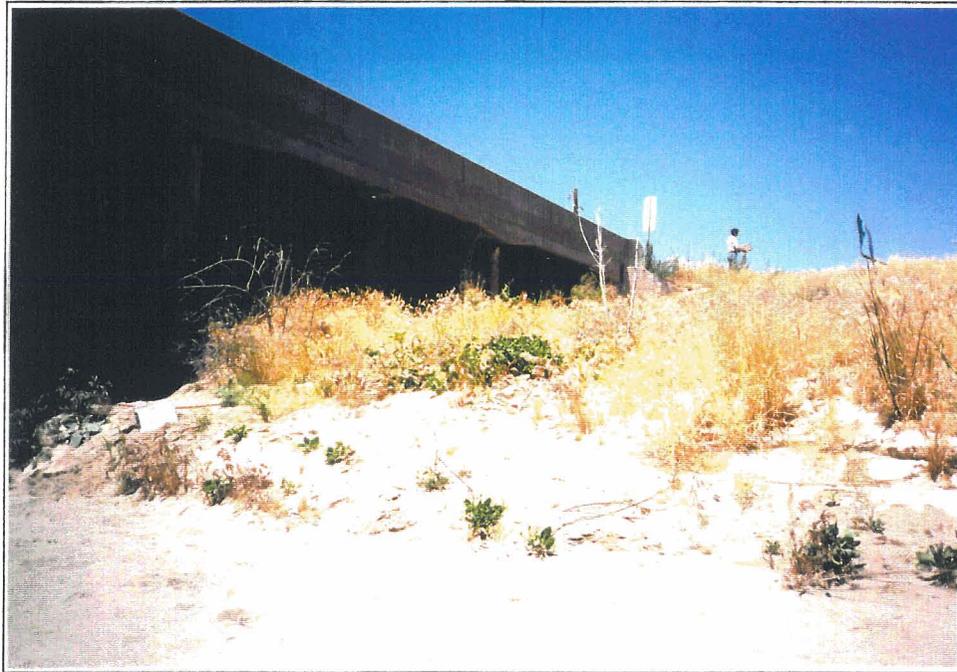
Photo 5: View of spans 1 and 2 from upstream low flow channel. Note clean coarse sand typical of low flow channel. Also note low grasses established on bank.

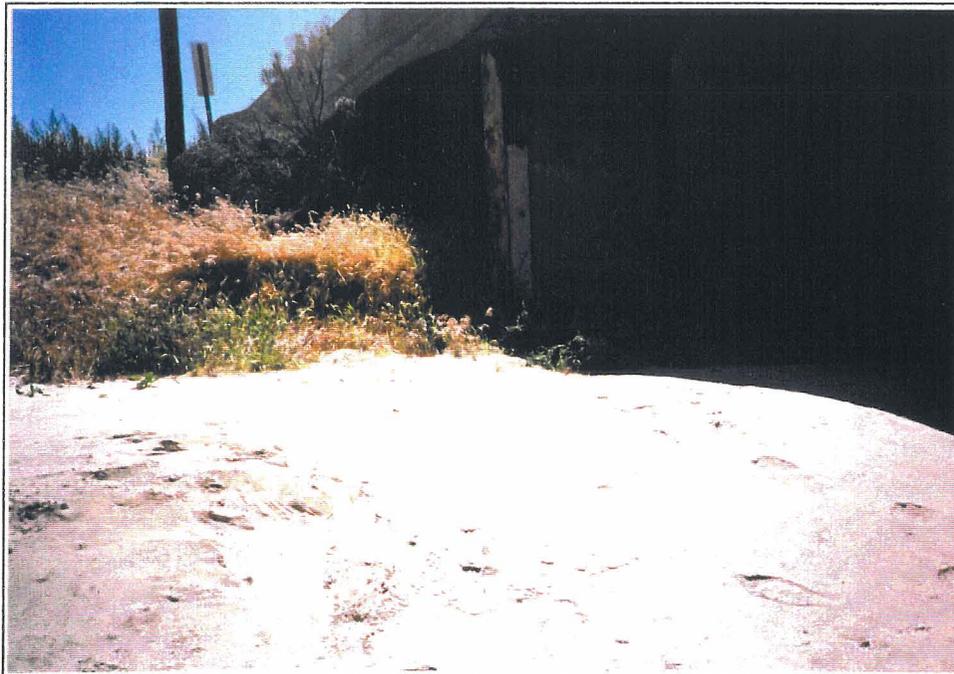
Photo 6: View of upstream face of span 5. Note reduced cross-section and vegetation.

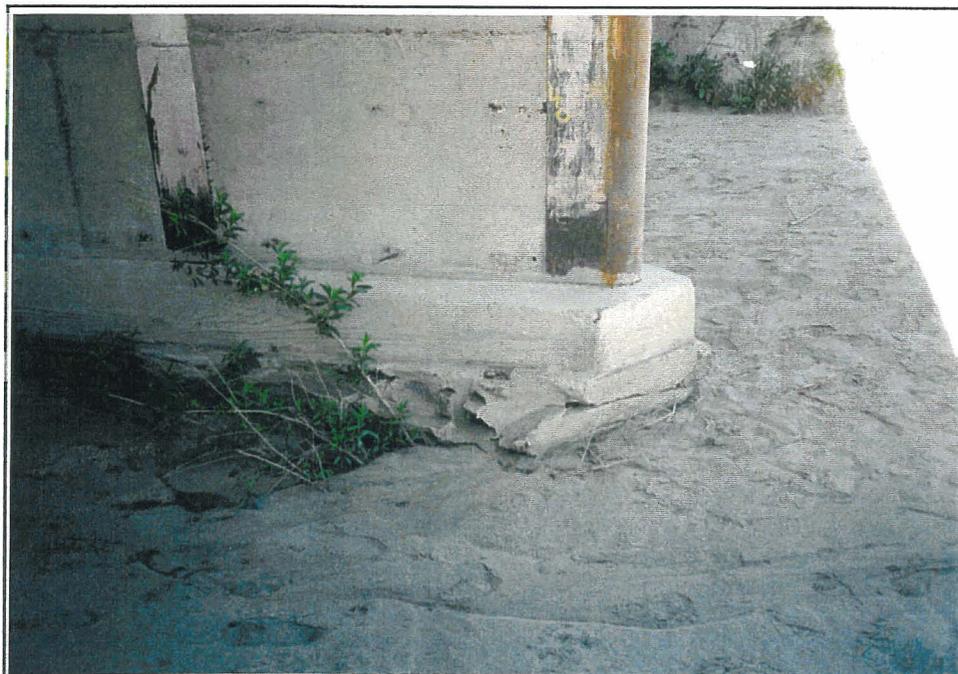
Photo 7: View of upstream end of pier 3. Note scour below base of pier cap.

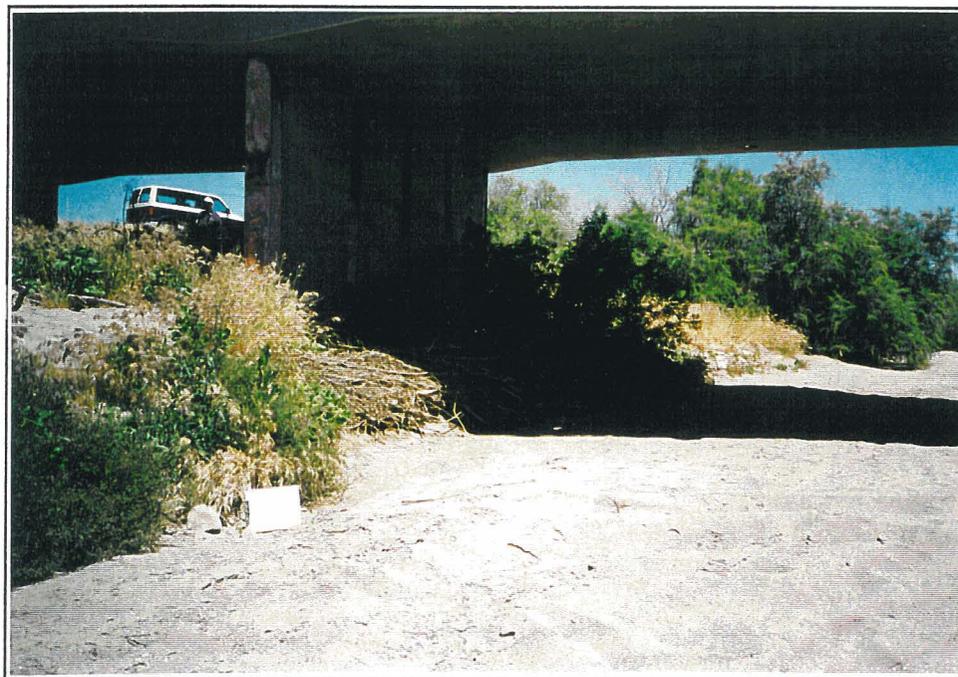
Photo 8: View of downstream end of pier 2. Note debris buildup typical of several locations during inspection. Note variability in channel cross-section.

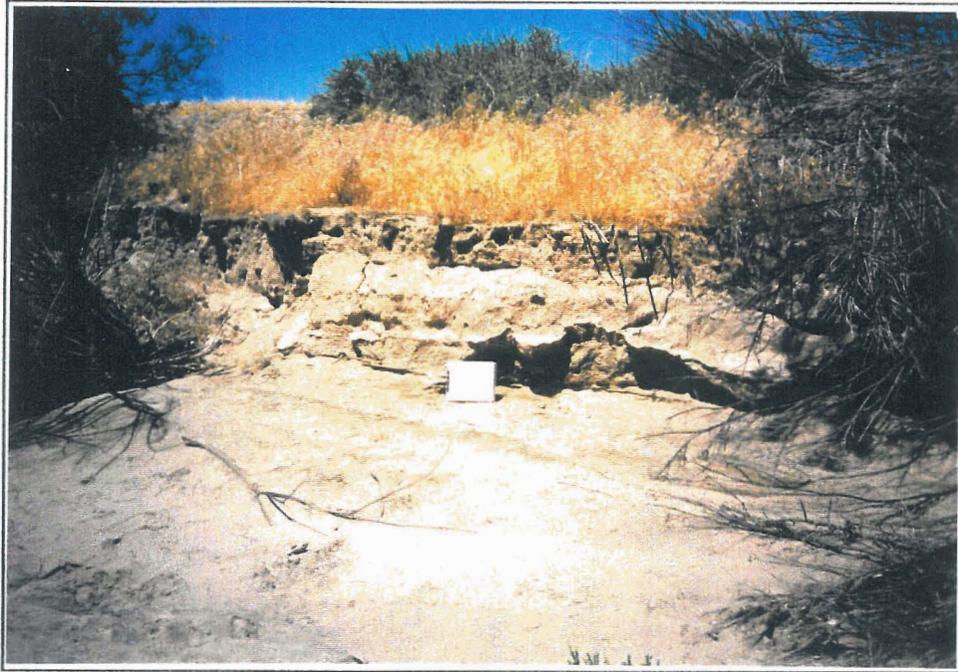
Photo 9: View of north side bank approximately 800 feet upstream of structure. Note cut bank and destabilized vegetation.

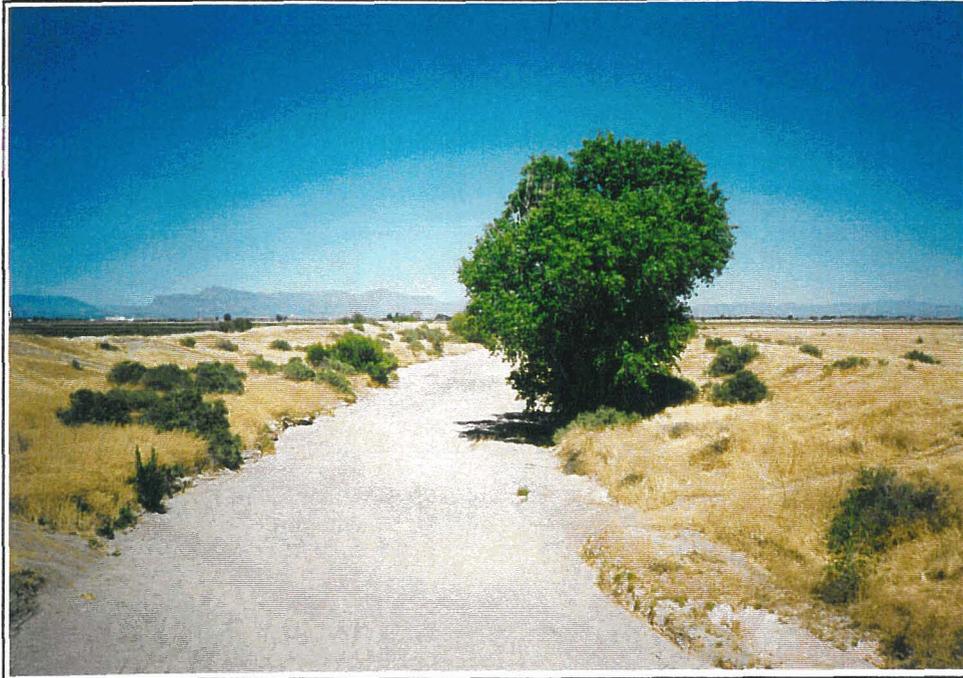
Photo 1: View looking upstream from approximately mid-span of structure. Note relatively stable trapezoidal section formed by levees upstream of bridge. Levees generally border cultivated fields with crests 3 - 8 feet above overbanks. Note relatively well established vegetation along levee banks. Channel bottom consists of coarse sand.

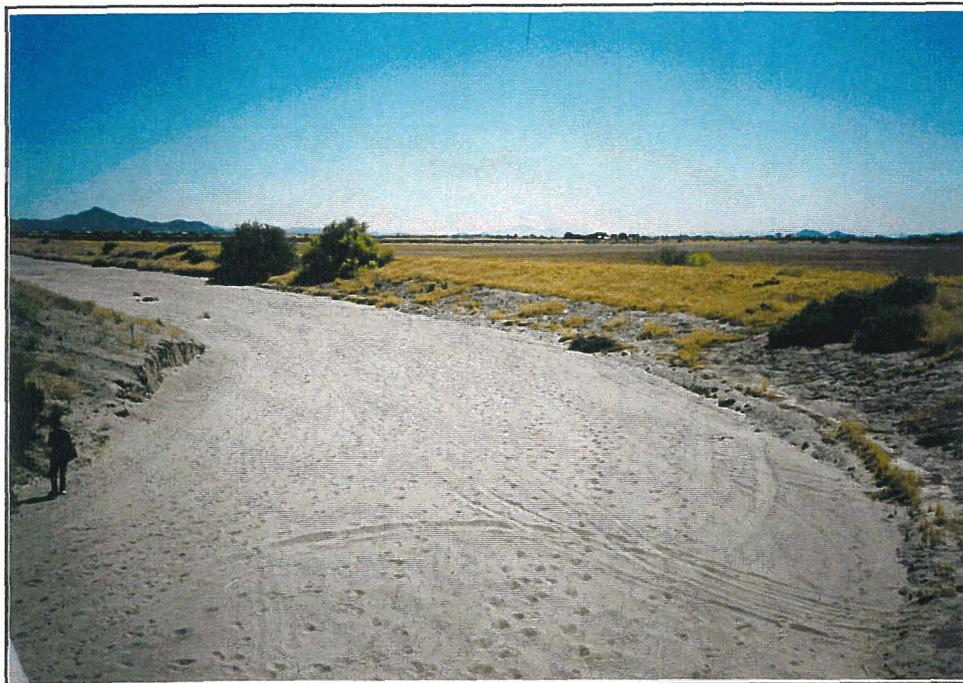
Photo 2: View looking downstream from approximately mid-span of structure. Note coarse sand channel and relatively wide trapezoidal section formed by levees. Also note wire mesh reinforced concrete bank protection extending from structure to completion of turn. Downstream right overbank is cultivated field while left bank is alongside roadway.
