**Final
BRIDGE SCOUR ASSESSMENT
REPORTS
for 16 Maricopa County Bridges**

**VOLUME II
Structure Numbers
9427, 9588, 9999, 8038
7818, 9154, 9142, 7553**

**MARICOPA COUNTY
DEPARTMENT OF
TRANSPORTATION (MCDOT)
Work Order No. 80407**

**Cannon & Associates, Inc.
Consulting Engineers**

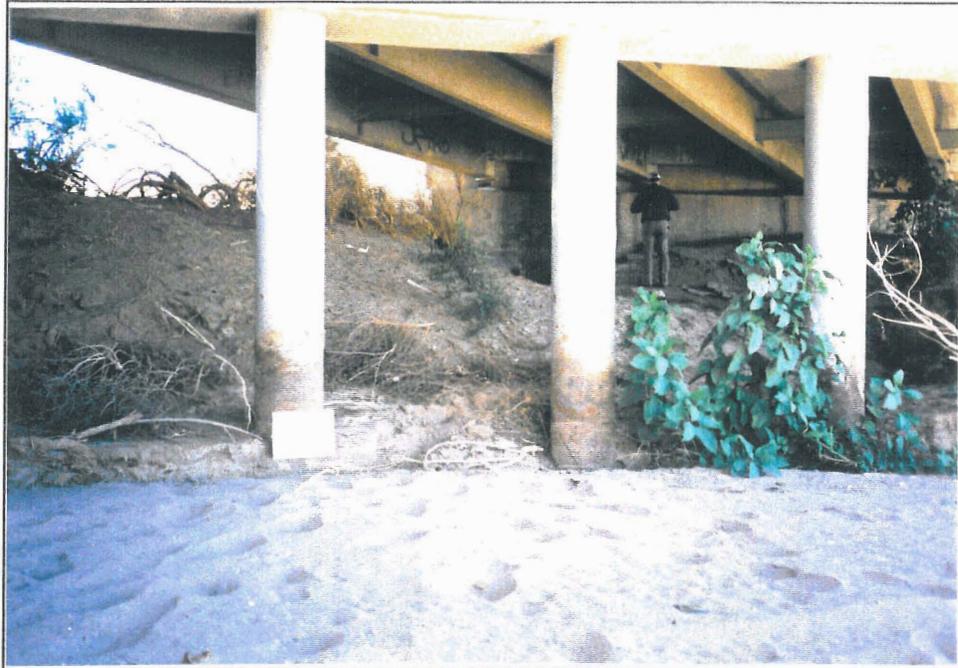
Photo 3: View of south abutment and pile bent. Note variability in sediment deposition on either side of bent. Also note rust on piles.

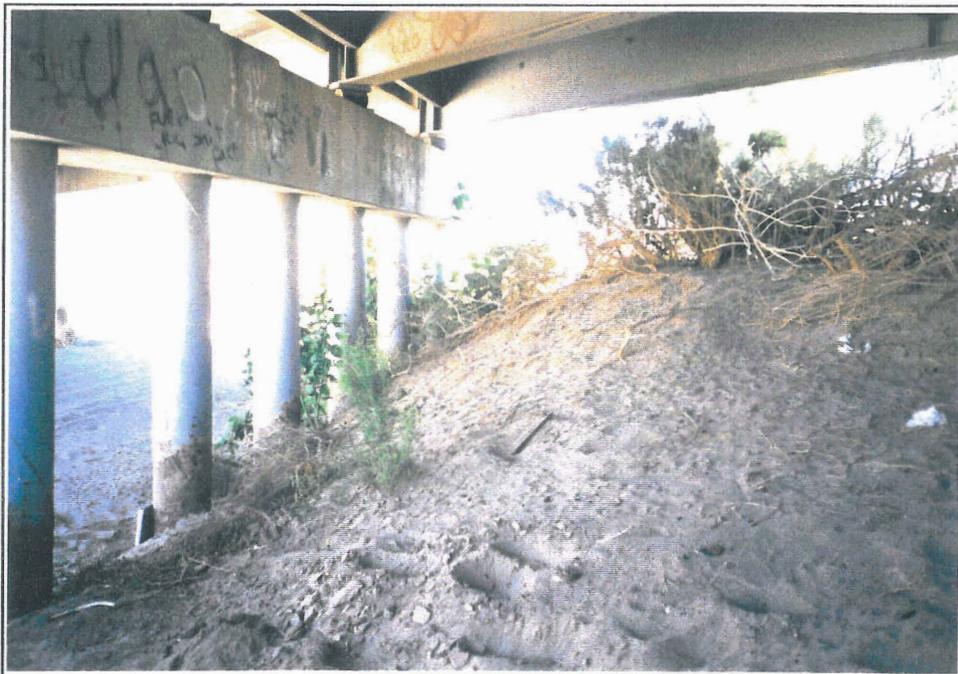
Photo 4: View looking upstream along south pile bent. Note depositional variation along bent. Maximum relief is approximately 6 feet. Note reduced cross-section.

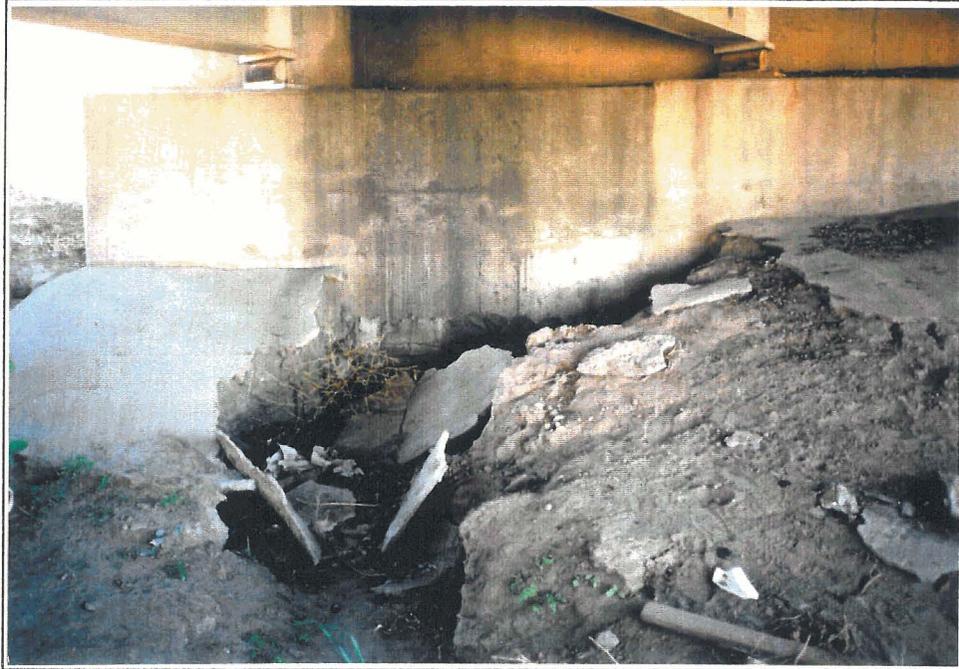
Photo 5: View of south abutment. Note washout of concrete paving and staining pattern on abutment surface.

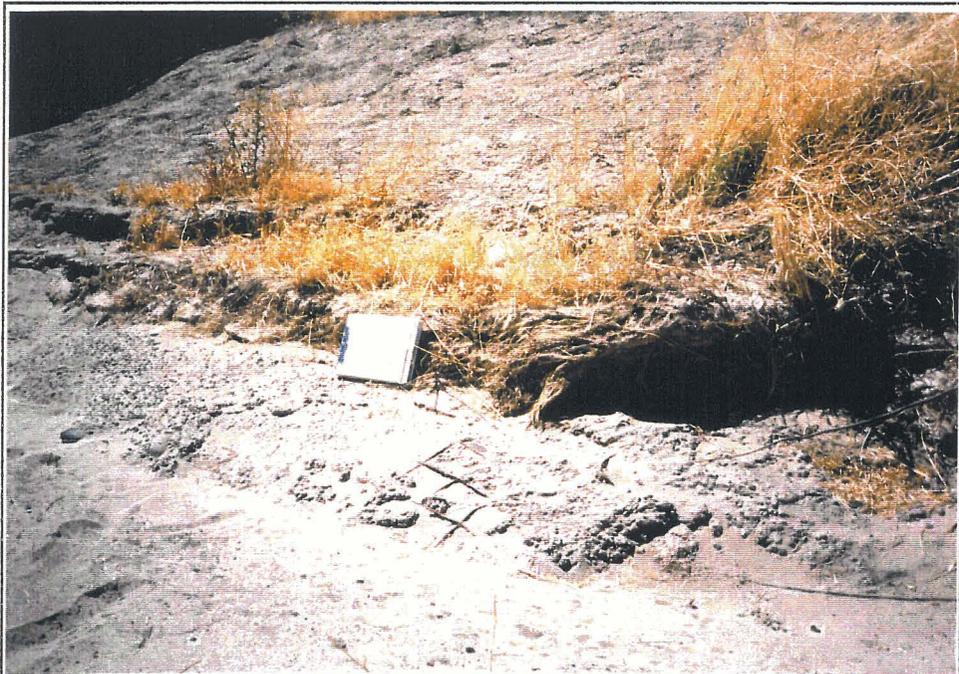
Photo 6: View of slope immediately upstream of north abutment. Note scour of concrete slope protection by impinging flow and exposure of wire mesh.

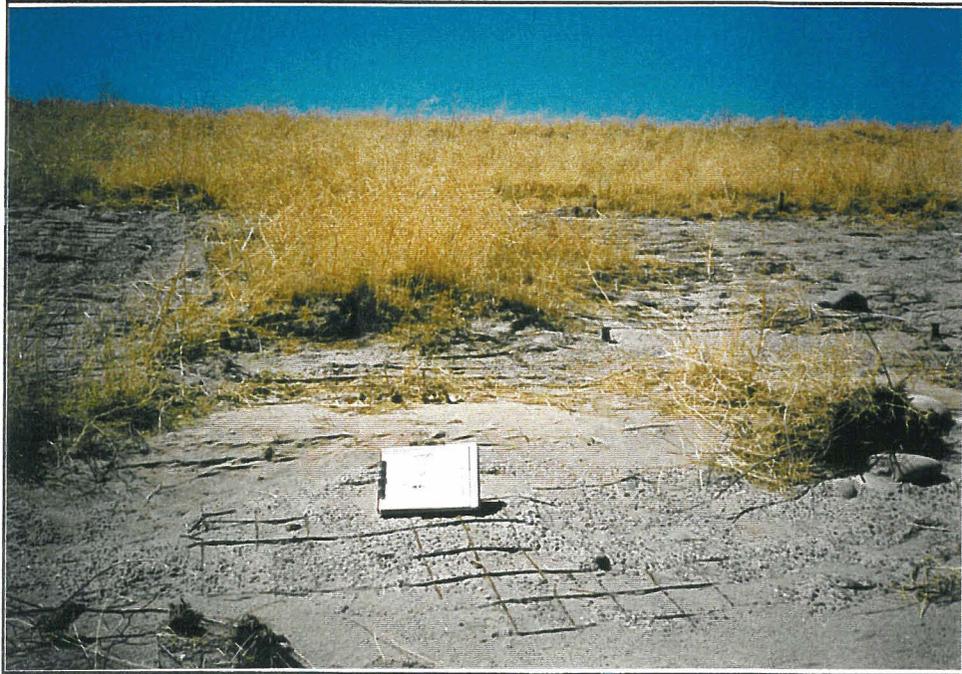
Photo 7: View of concrete pavement slope protection along west bank downstream of structure. Note scour of surface exposing wire mesh.

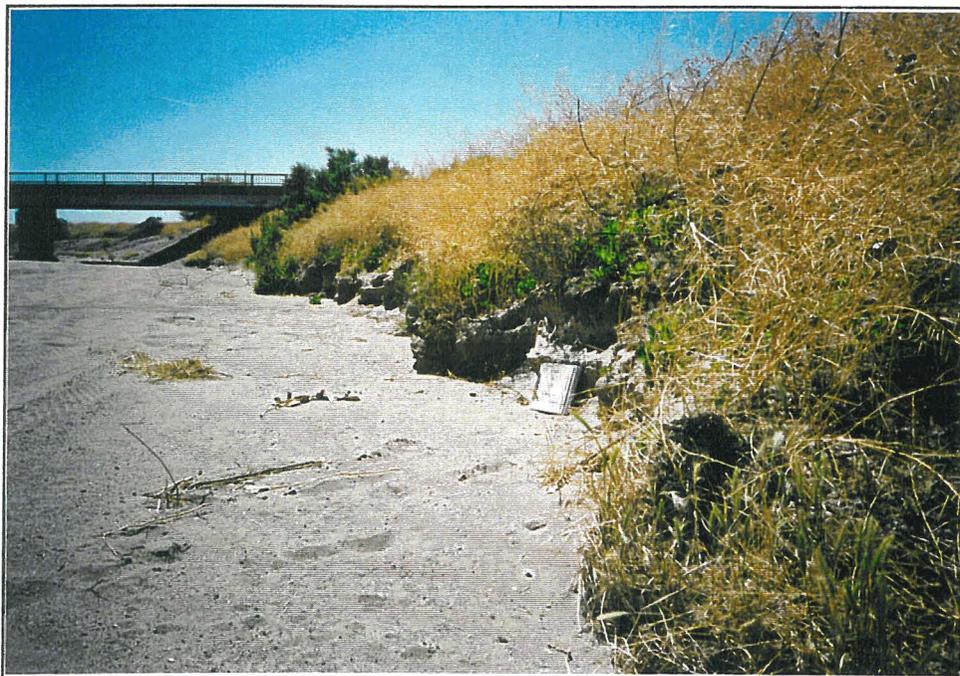
Photo 8: View of north bank upstream of structure. Note minor slumping of bank and destabilization of vegetation by impinging flow.

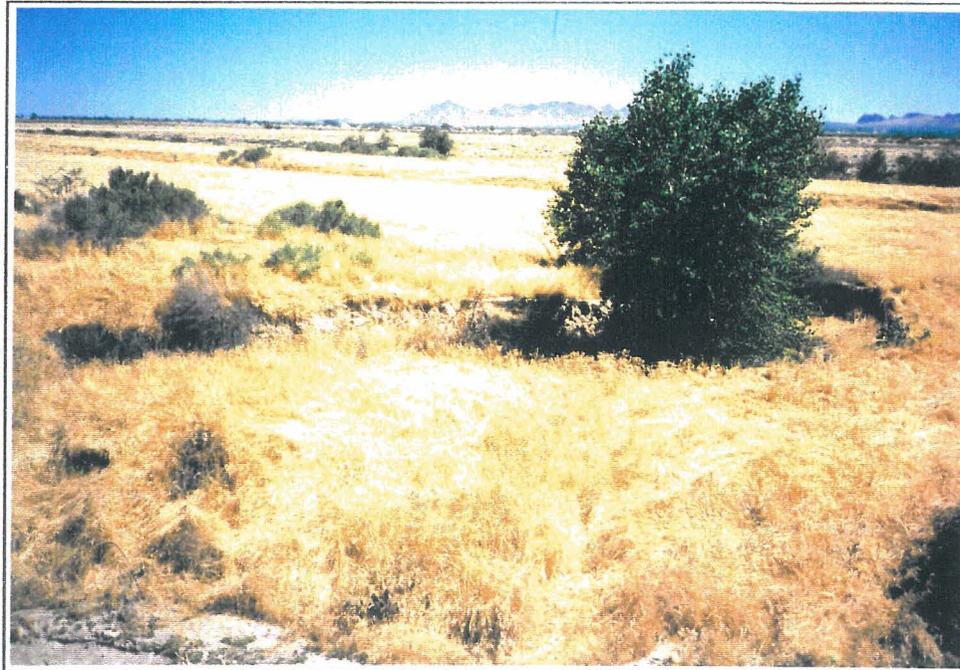
Photo 9: View of south bank immediately upstream of structure. Note erosion of levee embankment with vertical cut walls. Further instability may occur during severe flow conditions.

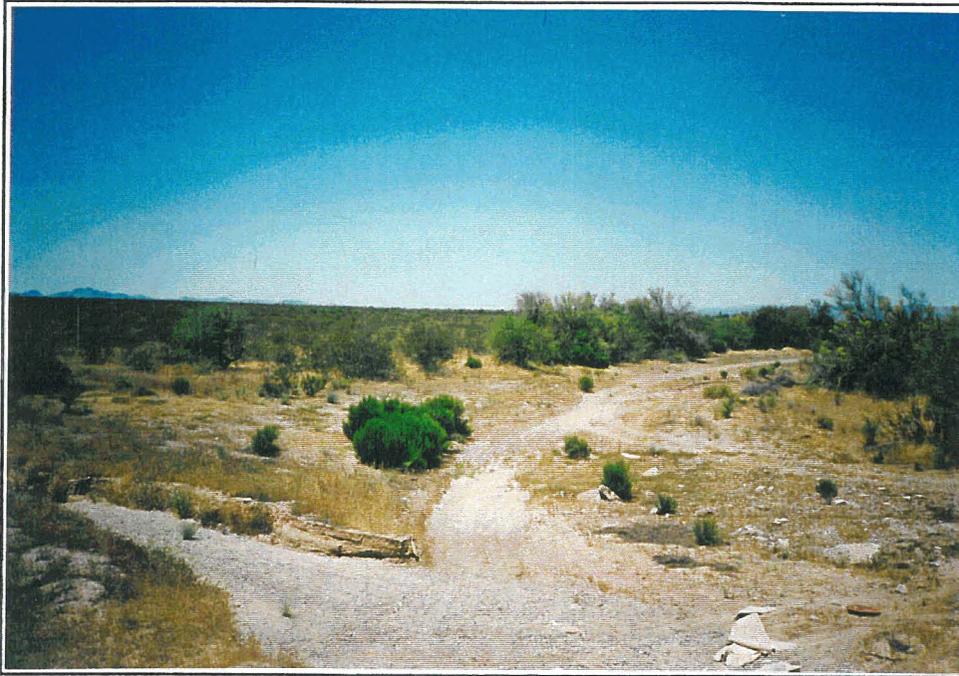
Photo 1: View looking approximately northwest in upstream direction from bridge deck. Note that wash is not well defined immediately upstream of bridge. Also note incision made by flow intercepted by west side roadway embankment. In background note upstream right overbank characterized by low grasses, creosote and salt bush, and occasional mesquite in a sandy soil.

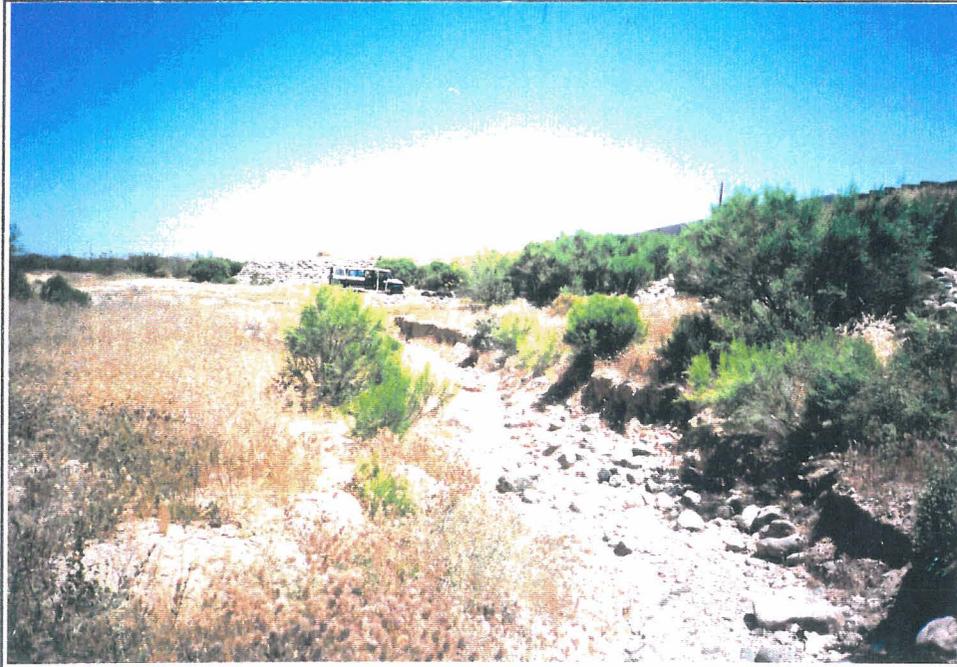
Photo 3: View looking east along upstream roadway embankment west of structure. Note 2-3 foot incision made by concentrated flow and potential for destabilization of embankment under severe flow conditions.

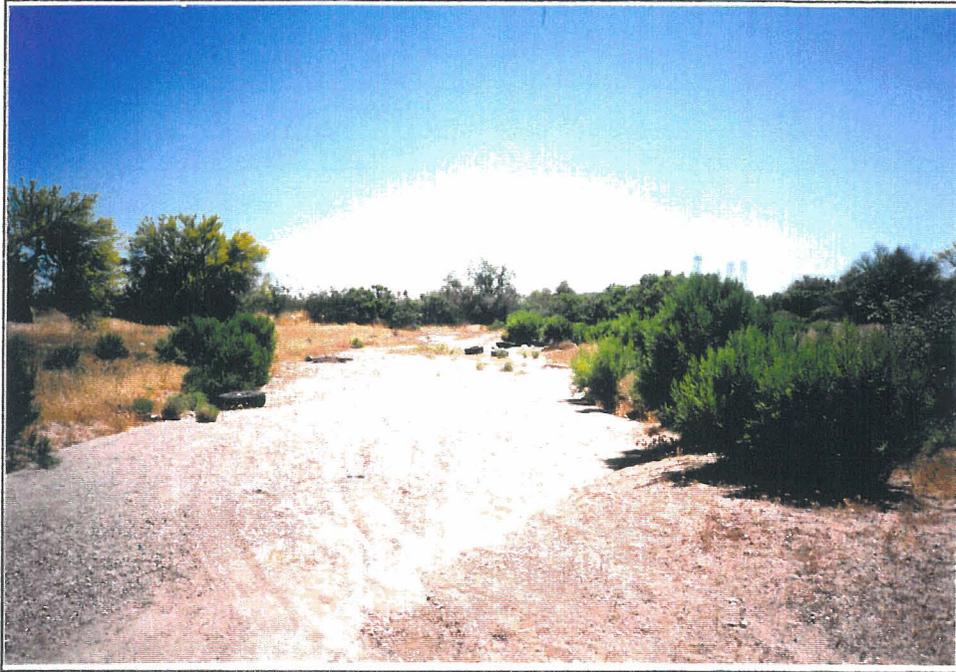
Photo 5: View looking south downstream of bridge. Note shallow cross-section with channel bottom composed of gravelly sand. Note low grasses, creosote and salt bush, palo verde and mesquite adjacent to channel.
