**WATERS OF THE UNITED STATES
AND
WETLAND DELINEATIONS FOR STATE ROUTE 87**

**Job No. 11344-061-050
February 18, 1993**

DAMES & MOORE

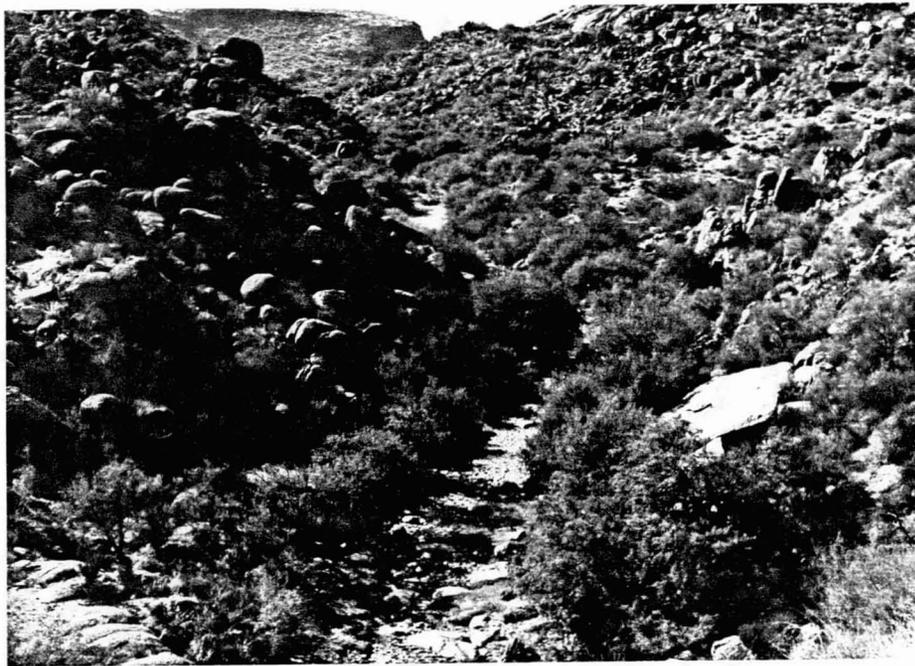
Wetland No. 1: This drainageway has been classified R4SBJ by the USFWS, indicating an intermittent riverine system whose streambed is intermittently flooded. On September 12, 1992, sandy soils were wet to the surface and some water was standing on the west side of existing SR 87. On February 8, 1993, the stream was flowing in a braided channel that ranged from about 2 to 8 feet in width. Vegetation along and in the stream channel is dominated by mesquite (FACU), catclaw, desert hackberry, and canyon ragweed (*Ambrosia ambrosioides*). In addition, hopbush (*Dodonea viscosa*) occurs on nearby hillsides and extends down to the edge of the wetland channel. Seepwillow (*Baccharis glutinosa* - FACW) is fairly common in the stream channel west of existing SR 87 as is horsebush (*Hymenoclea monogyra*) (see Photo 1). Vegetation on the upstream (east) side of existing SR 87 is similar except that the stream channel is very sandy and generally lacking horsebush, canyon ragweed, and seepwillow. However, in this drainageway on the east side of SR 87 are several cottonwoods (*Populus fremontii* - FACW) and at least one, fairly large Goodding willow (*Salix gooddingii* - OBL) (see Photo 2).

Photo 1. Downstream view of USFWS-designated wetland near the Sugarloaf turnoff on existing SR 87.

Wetland No. 1 is likely to be affected by construction at two locations; at the existing SR 87 crossing and approximately 500 feet downstream at a proposed, new crossing.

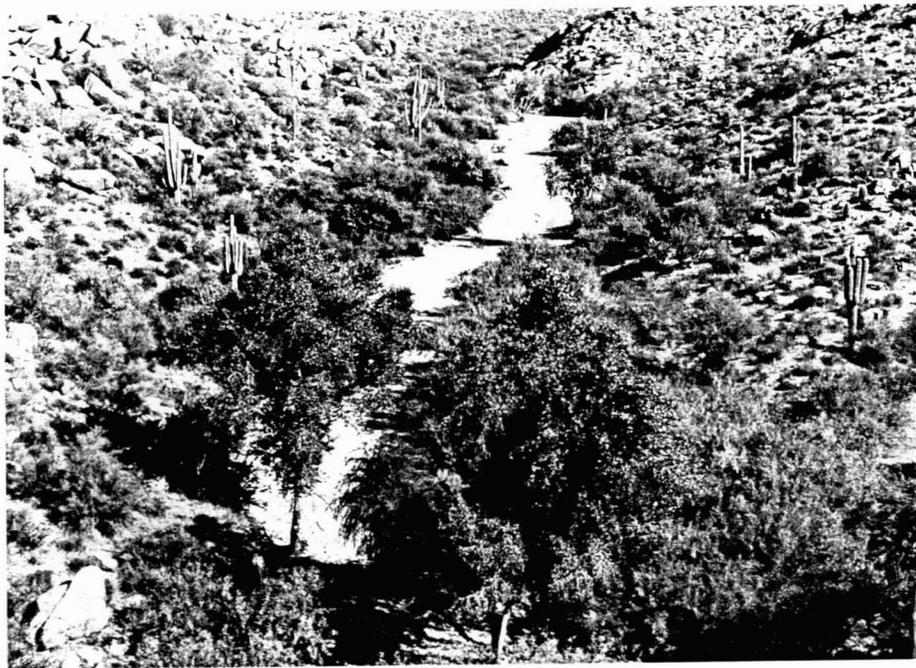
Photo 2. Upstream view of the same wetland in Photo 1. Large trees in the photo are cottonwood and willow.

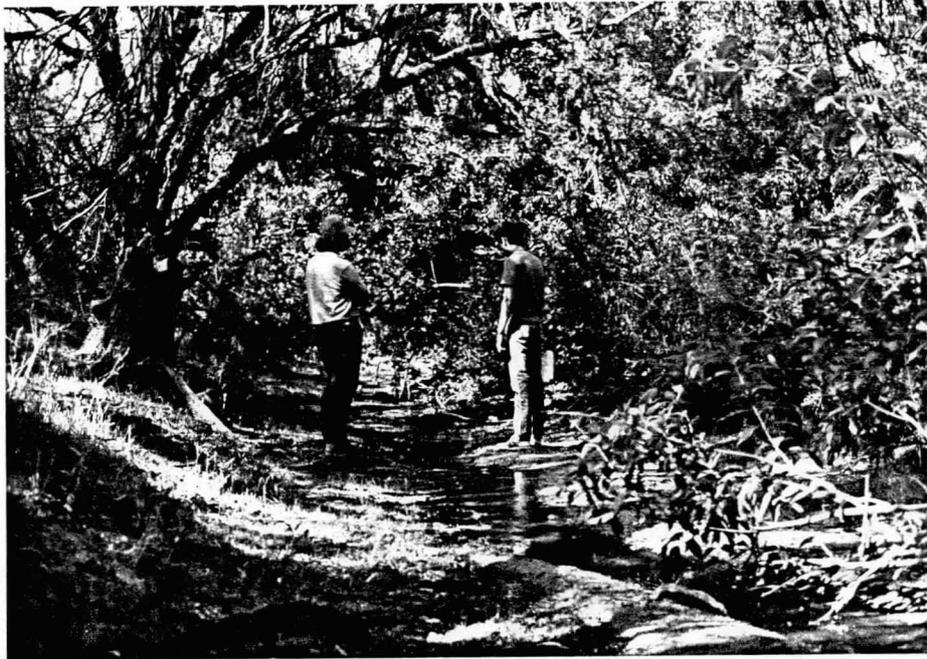
Photo 3. Characteristic vegetation at Rock Creek. Much of the shrubby vegetation in the photo is buttonbush. Several, lowland leopard frogs were present at this site.

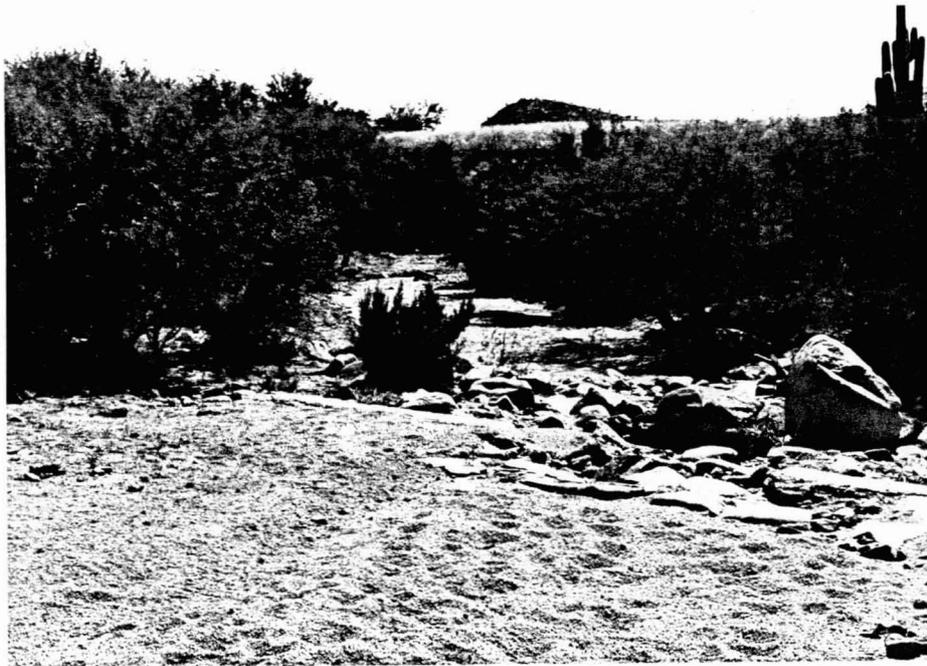
We question the USFWS wetland designation for this site based on soils and vegetation (see Photo 4) and have mapped it as a non-wetland Water of the United States for this project. Construction of a box culvert at this crossing of Camp Creek would result in an impact to approximately 0.11 acres. There is a small spring immediately on the downstream side of the existing box culvert that carries SR 87 over this drainageway. On September 12, 1992, this spring fed a small pool (about 3x3 feet and 1 inch deep) that contained 15, live and 1, dead fish (cf. *Agosia chrysogaster*). In addition to the fish, at least 10 individuals of *Rana yavapaiensis* were noted within about 45 feet of the pool and up under the culvert.

Photo 4. A characteristic aspect of Camp Creek. Note the lack of wetland indicator plants; vegetation shown here consists mostly of mesquite and catclaw.

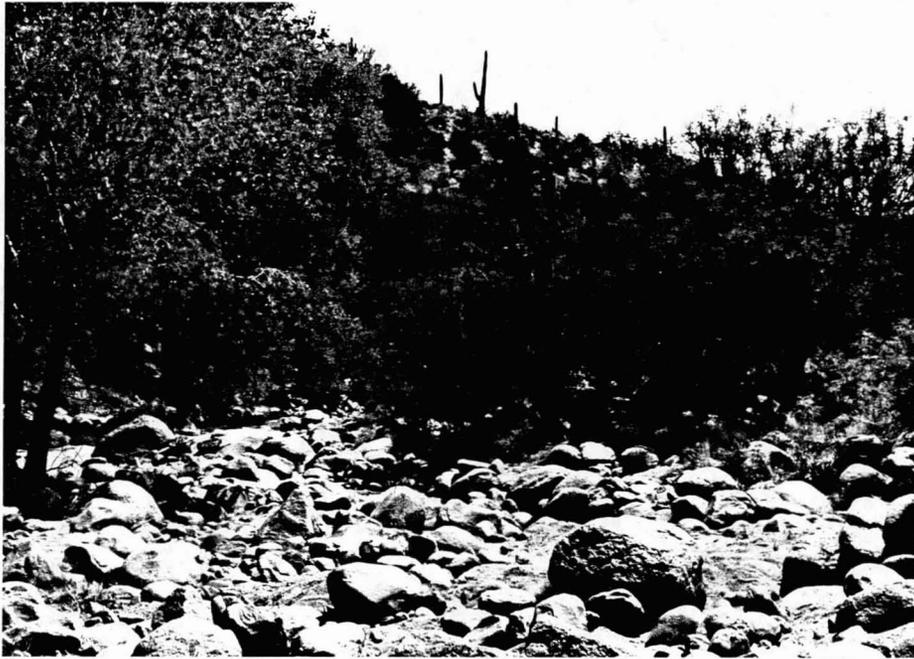
Floodplain vegetation consists of mesquite (FACU), catclaw, foothill paloverde, jojoba, and canyon ragweed. Within the stream channel, we noted the presence of cottonwood (FACW), seep willow (FACW), netleaf hackberry (FACU), deergrass (*Muhlenbergia rigens* - FACU), clammy-weed (*Polanisia dodecandra* - FACU-), and buttonbrush (OBL) (see Photos 5 and 6).

Photo 5. Pine Creek at the approximate location of a proposed, new crossing. Note the young cottonwood trees at the left.

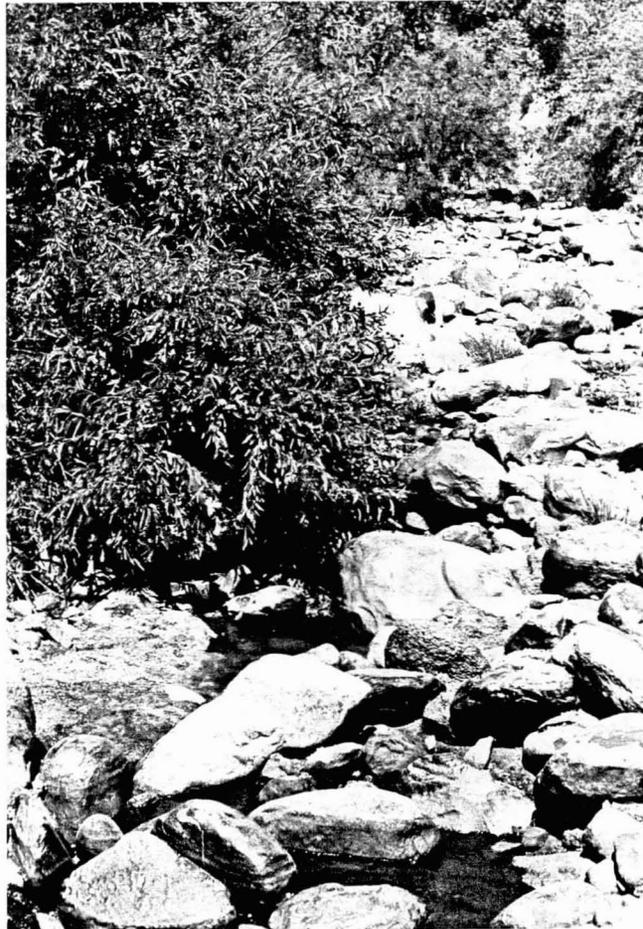
Photo 6. Pine Creek at the approximate location of a proposed, new crossing. Note the standing water, water marks on boulders, and buttonbush.

Construction of a new bridge at Pine Creek would result in a potential impact to 0.04 acres of wetland.

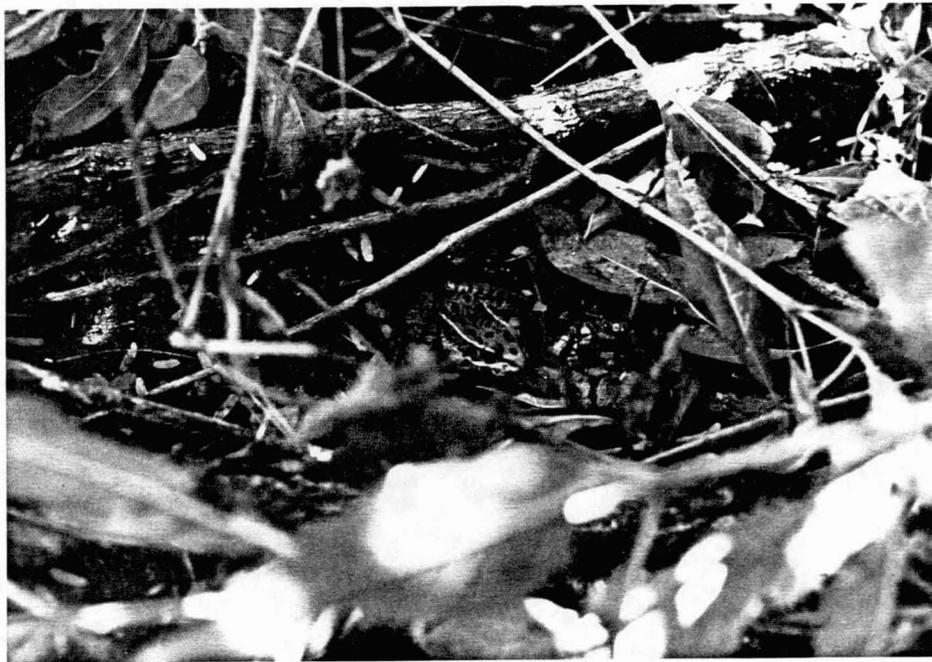
Photo 7. An individual *Rana yavapaiensis*. This frog was one of several that were occupying the pool shown in Photo 6.

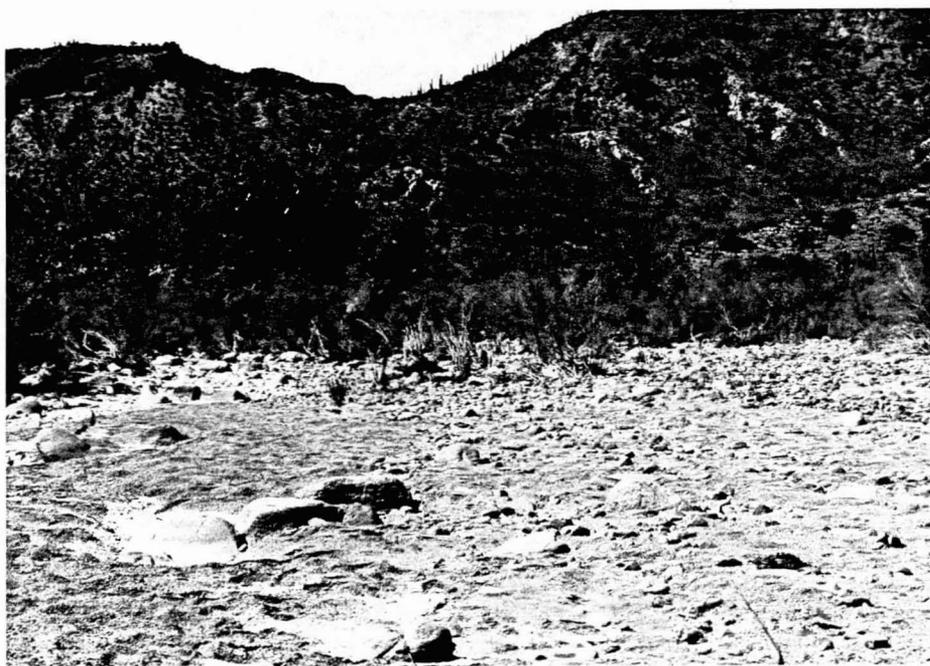
Vegetation within the channel consists of seepwillow (FACW), horsebush, and scattered sycamores (FACW-). Heavy flows along this stretch of Sycamore Creek appear to limit perennial plant establishment in the stream channel (see Photo 8). We noted drift debris on a barbed-wire fence under the existing Sycamore Creek bridge more than 4.5 feet above the surface of the stream channel. Water marks were also obvious on bridge support structures in the stream channel at the south end of the existing bridge. Vegetation on terraces immediately above the stream channel is dominated by mesquite (FACU), with bermuda grass forming a common ground cover.

Photo 8. Sycamore Creek at Round Valley looking downstream from the existing bridge. The large tree to the left of center is a sycamore. Shrubby plants in the stream channel are primarily horsebrush.

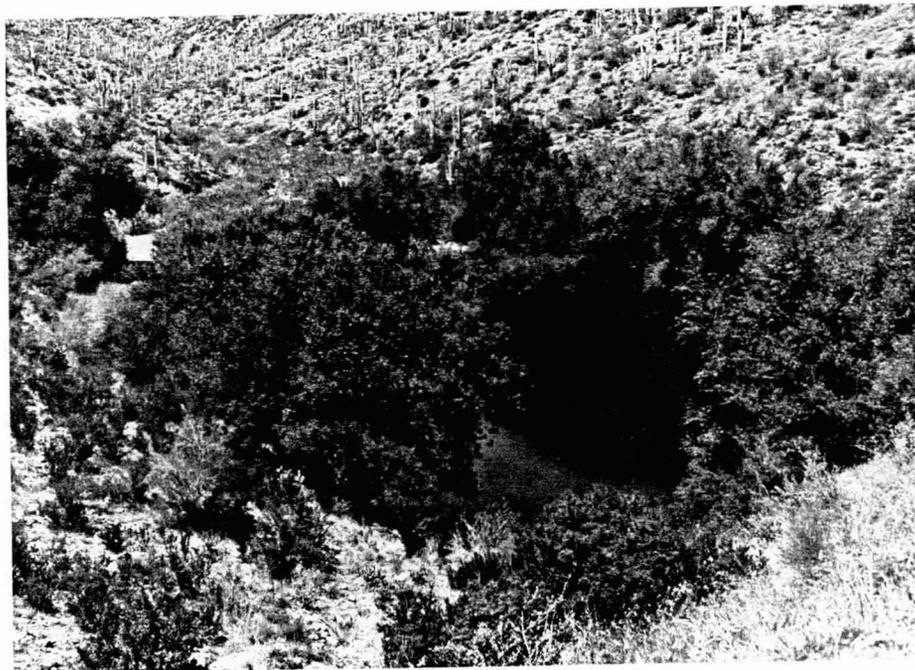
On September 12, 1992 both wetlands contained standing water (see Photos 9 and 10). The impoundment on the west side of the highway supports a number of large, mature Goodding willows (OBL-) and the upstream wash that drains into it supports strand vegetation of horsebrush and seep willow (FACW). The riparian community on the east side of the highway is strongly dominated by large cottonwood (FACW) and Goodding willows (OBL) immediately east of the existing highway. Downstream, the presence of

Photo 9. Tank on the west side of existing SR 87. Large trees surrounding the tank are willows, probably Goodding willow.

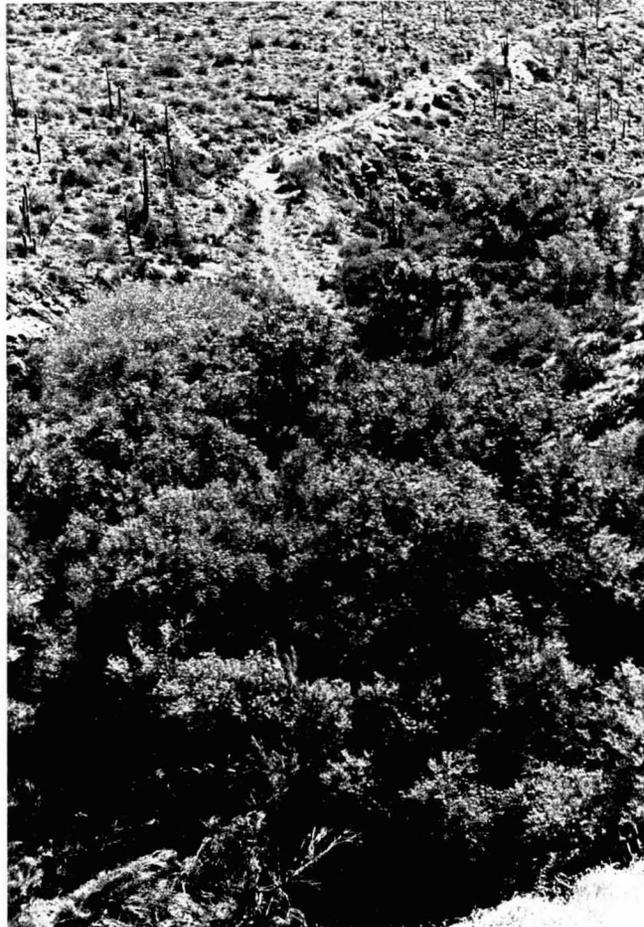
Photo 10. Wetland area extending downstream from SR 87 at the proposed site of the new, Lower Screwtail Bridge. This wetland is on the east side of the existing highway opposite the tank shown in Photo 9.

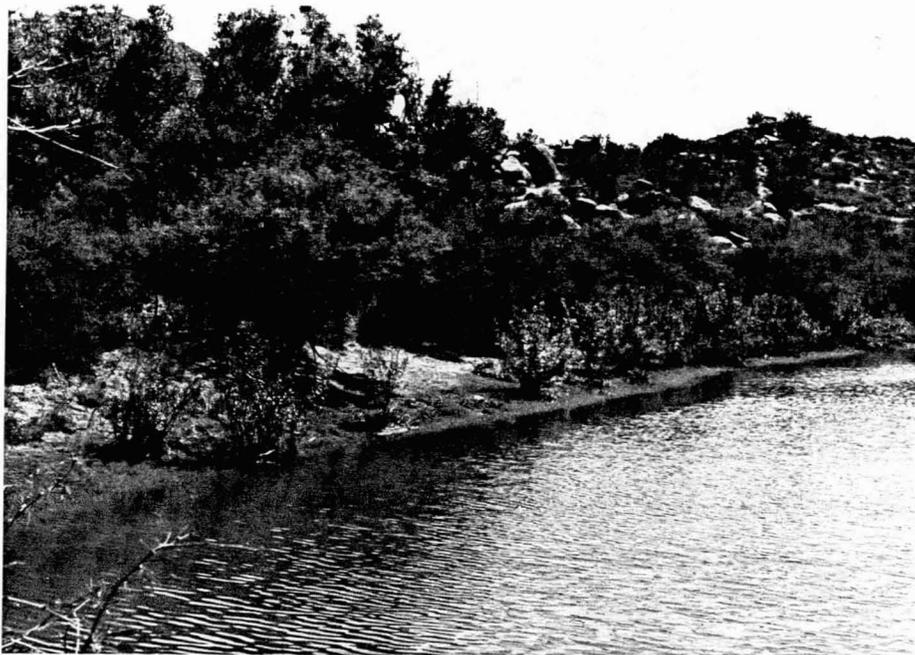
Photo 11. Earthen dam at O'Neil Tank with seepwillow growing along the shoreline and mesquites on the dam itself.

Construction of a new highway at this location would probably result in the destruction of at least 1.13 acres of wetlands associated with O'Neil Tank.

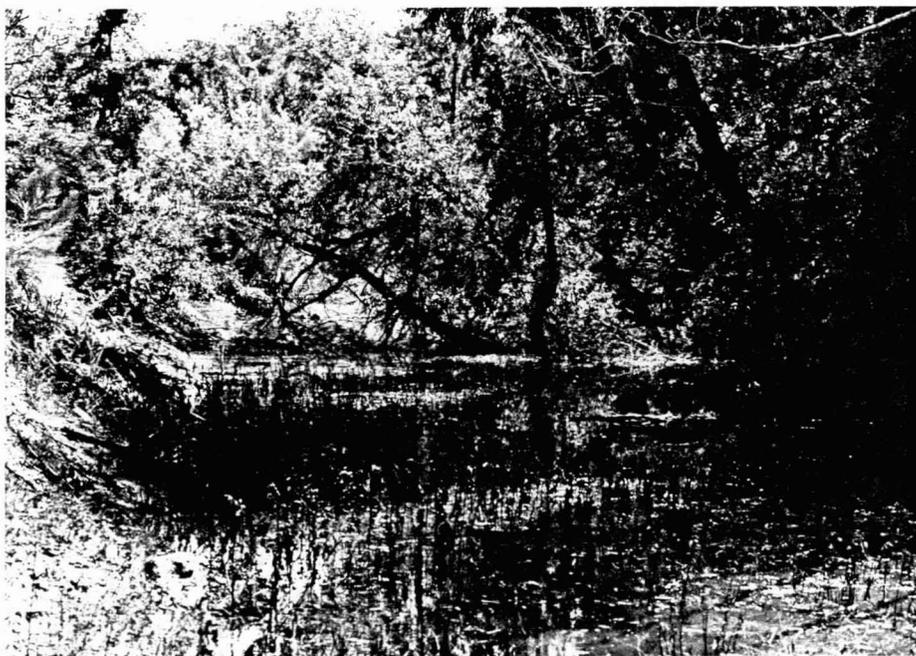
Photo 12. Seepage area below the dam (to the right) at O'Neil Tank. The fill from existing SR 87 extends into the photo on the left.

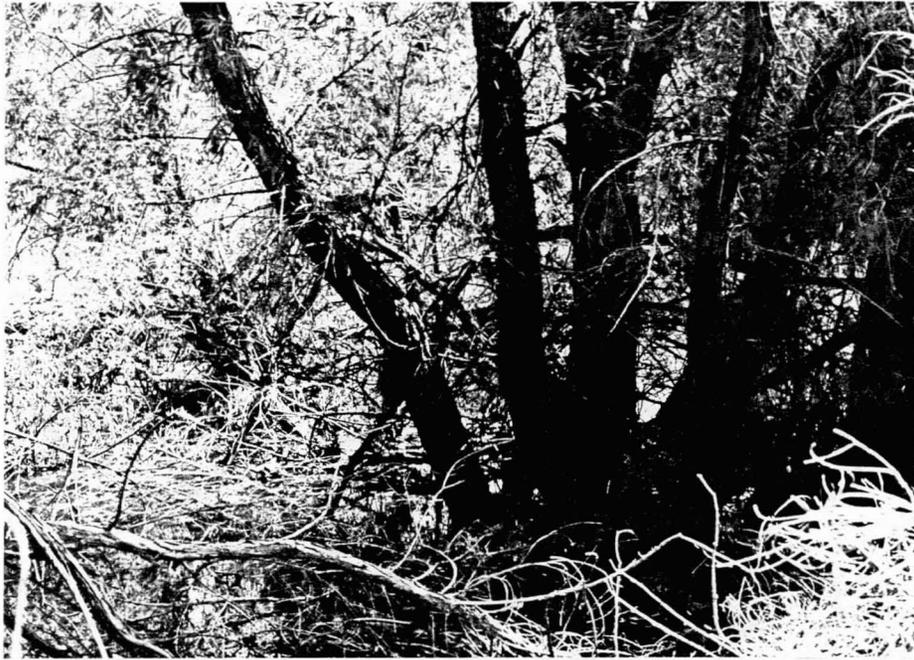
Photo 13. Willows growing in the seepage area below O'Neil Tank.

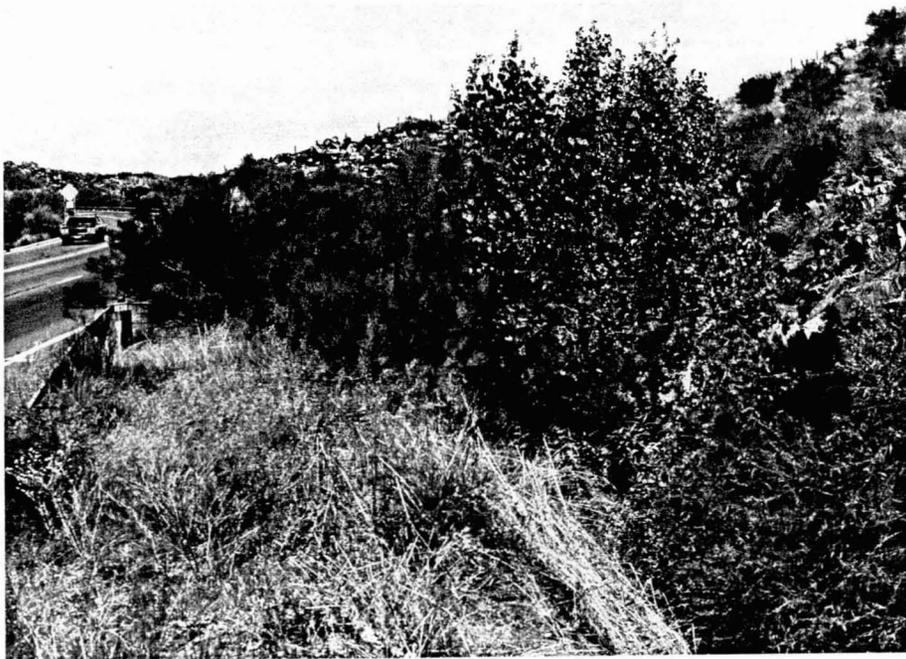
Photo 14. A wetland designation problem area along existing SR 87. Prominent wetland indicator plants shown are cottonwood (center) and willow (lower right).

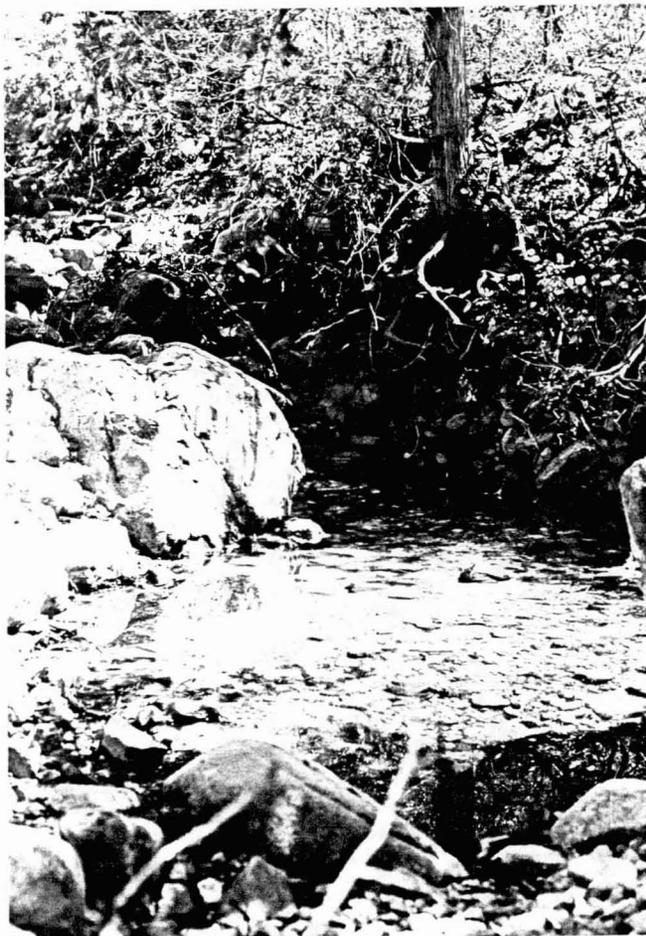
Vegetation along the stream channel is dominated by sycamore (FACW-). One, large cottonwood tree (FACW) is present at the spring and overshadows a pool (see Photo 15) in which we observed six *Rana yavapaiensis*. Occasional velvet ash (FAC+) and net-leaf hackberry (FACU) are also present. *Muhlenbergia rigens* (FACU) is a common to abundant perennial grass species growing among the boulders in the stream channel. The terrace above the stream channel is dominated by juniper, wait-a-minute bush, mesquite (FACU), scrub oak (*Quercus turbinella*), barberry, holly-leaf buckthorn (*Rhamnus crocea*), and squawbush (*Rhus trilobata*). Occasional, small walnut (*Juglans major*-FACW-) trees are also present on the terrace. As one travels downstream toward Kitty Joe Canyon, the wetland influence declines until about 600 to 900 feet upstream from the confluence with Kitty Joe Canyon, the vegetation becomes more xeric in nature and dominated by mesquite, juniper, and wait-a-minute bush.

Photo 15. Spring and pool in an unnamed tributary of Kitty Joe Canyon. *Rana yavapaiensis* was noted at this site. Similar pools occur along most of this drainage nearly to its confluence with Kitty Joe Canyon.

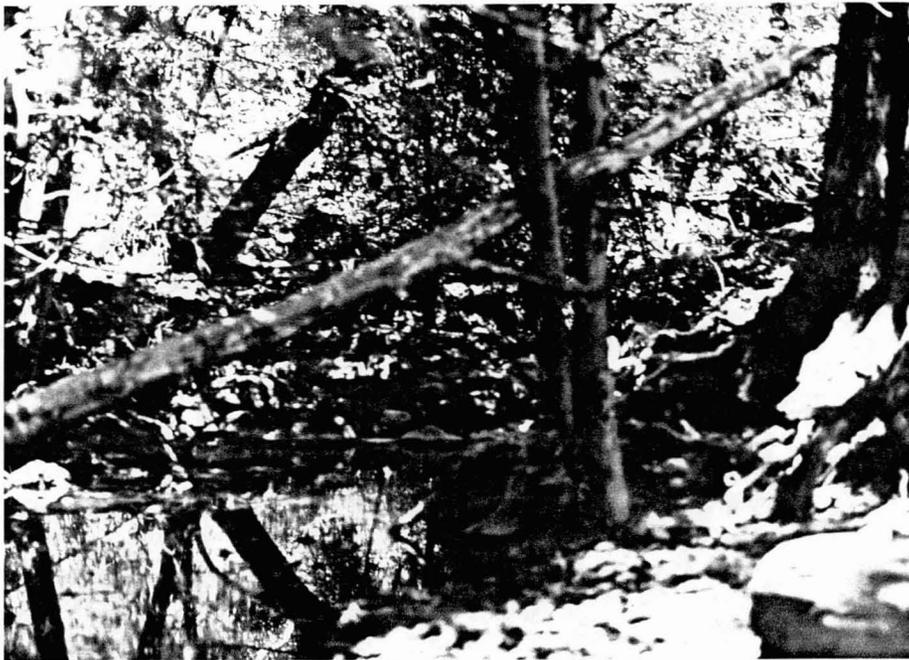
Photo 16. A typical pool and associated riparian vegetation in Kitty Joe Canyon to the west of the proposed Kitty Joe Canyon Alternative for the SR 87 upgrade project.
