**Verde River Visual Assessment:**

**Verde River Corridor Study,**

**Tapco to Beasley Flat**

Verde River Corridor Project  
Arizona State Parks  
800 West Washington, Suite 415  
Phoenix, Arizona 85007

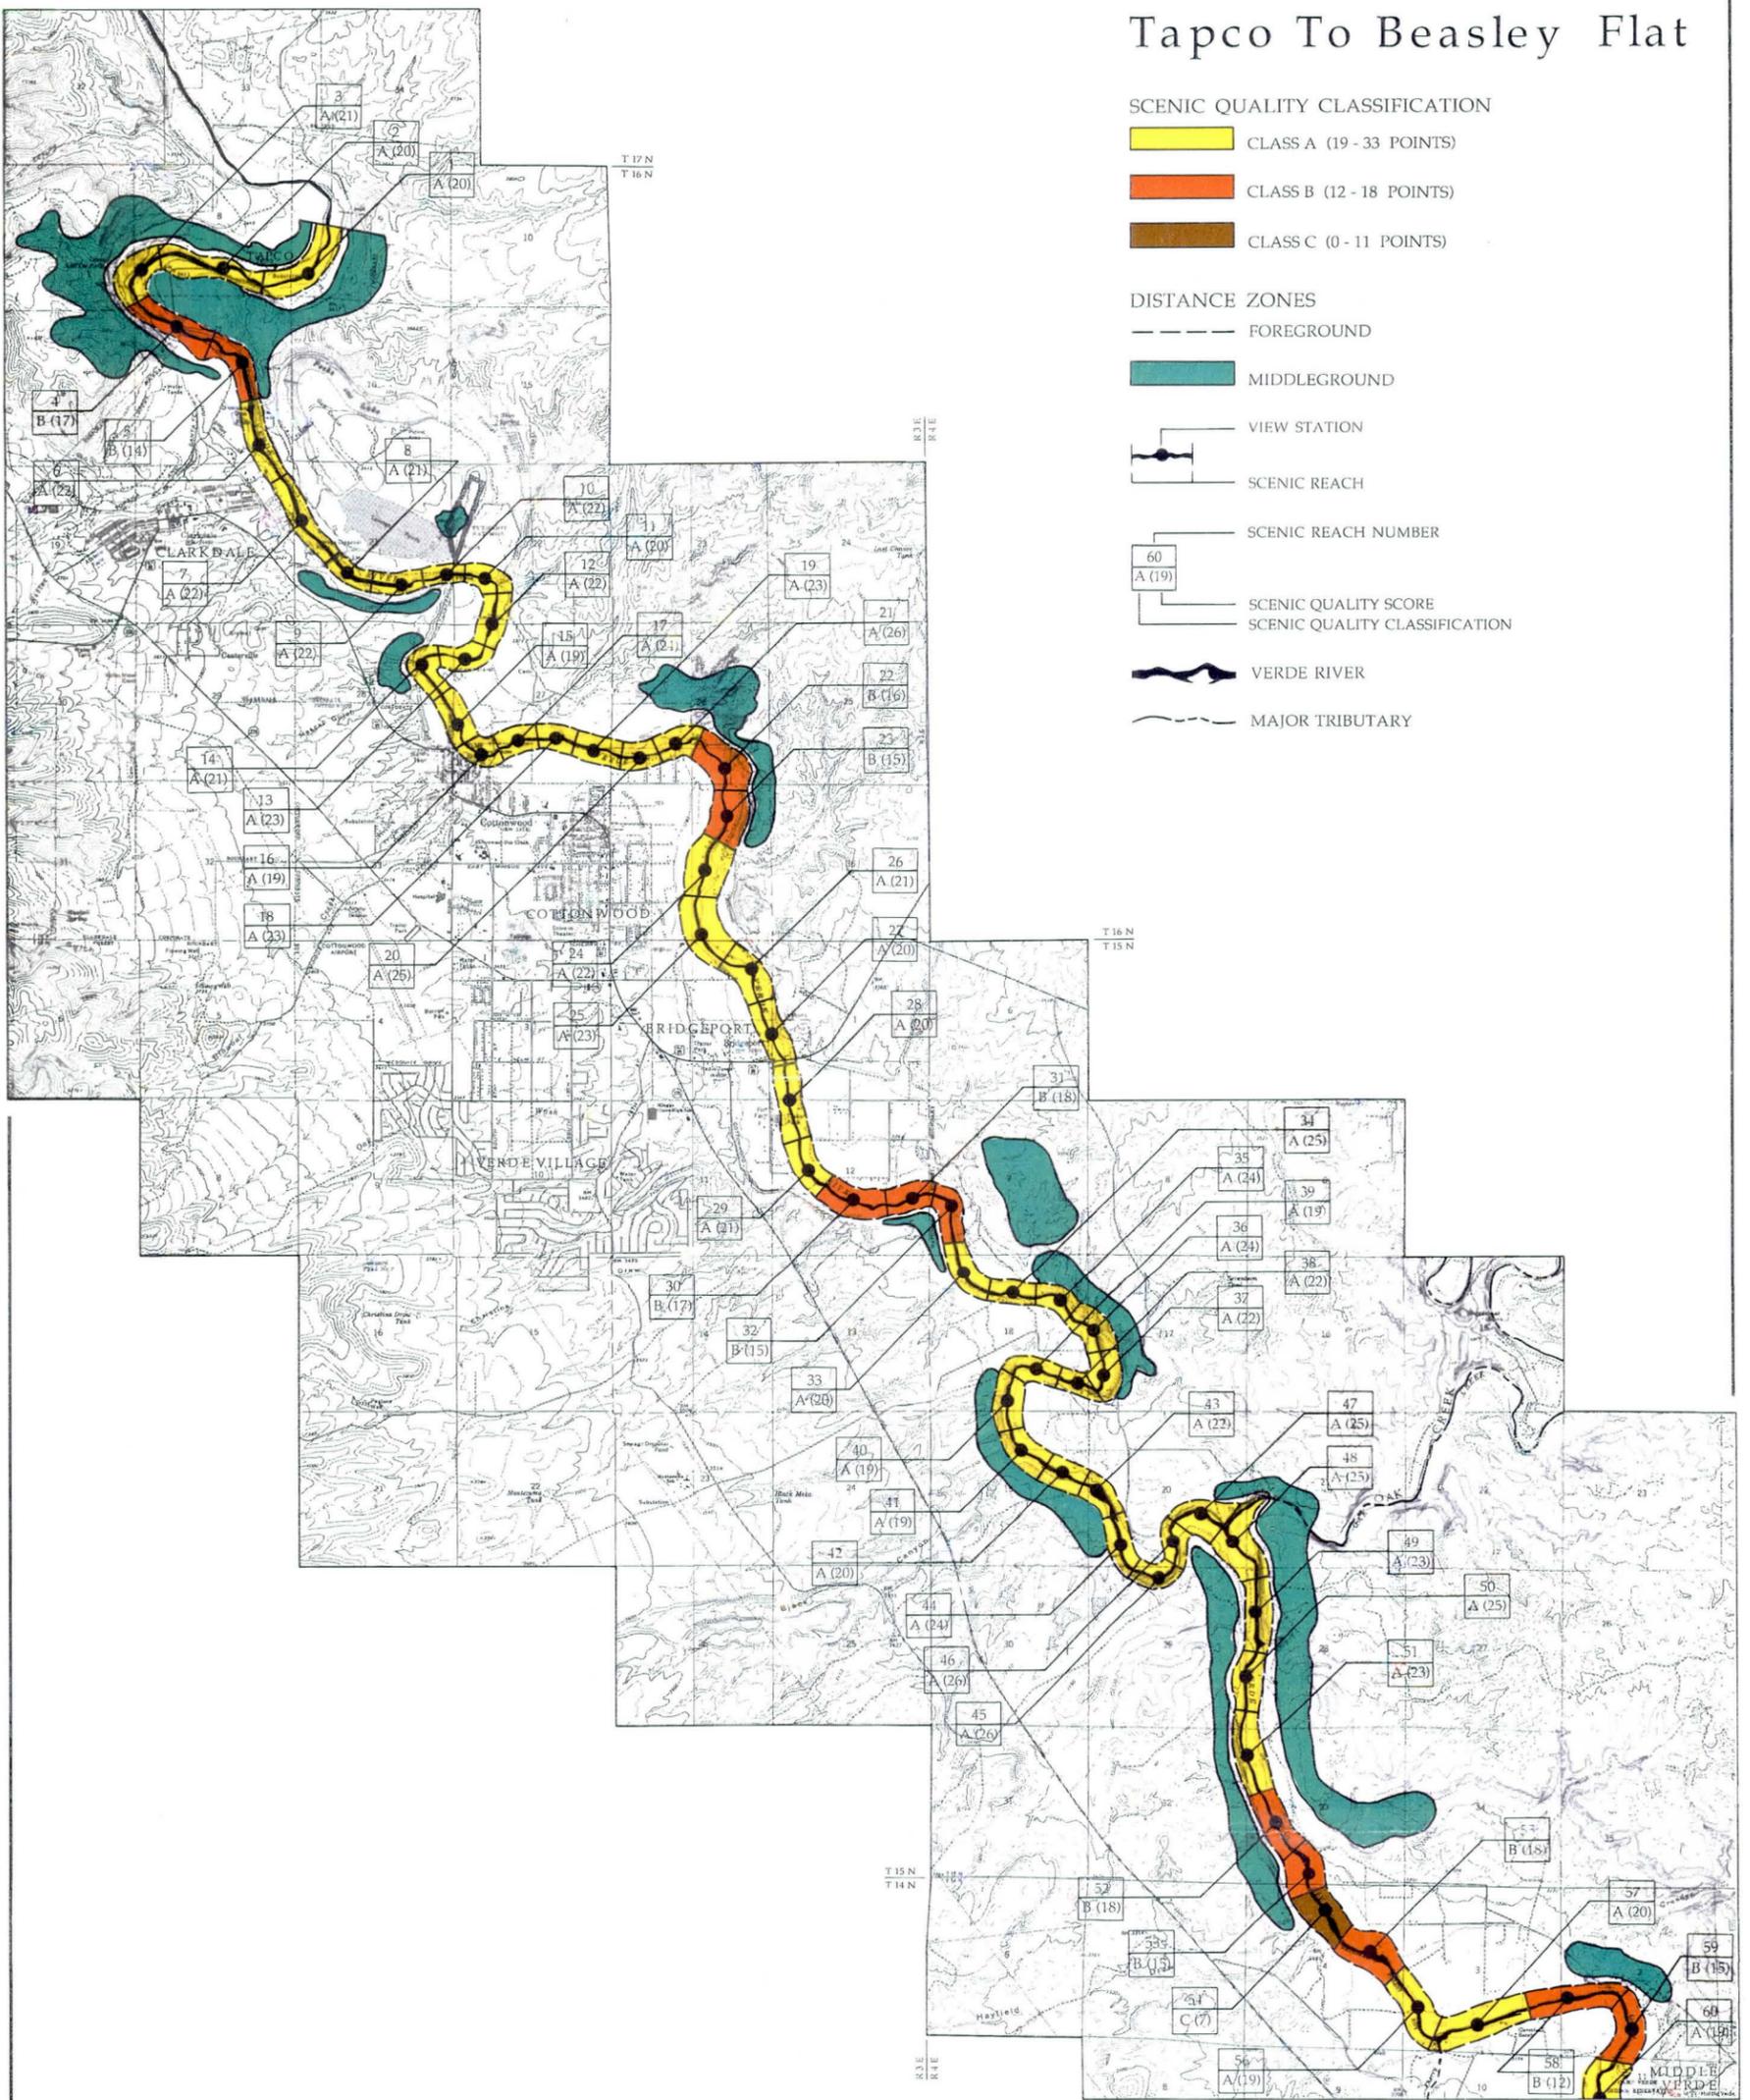
### SCENIC QUALITY CLASSIFICATION

- CLASS A (19 - 33 POINTS)
- CLASS B (12 - 18 POINTS)
- CLASS C (0 - 11 POINTS)

The scenic quality scores were mapped, showing the results of BLM's rating system as it was applied to the scenic reach divisions of the Verde River corridor. Maps SQ 1 and SQ 2 show that there are 83 scenic reaches with a score of A, 14 with a score of B, and 2 with a score of C. These scores reflect respectively a high, middle, and low visual rating. The preponderance of A ratings is explained by the fact that the Verde River corridor is an unusual type of landscape in the area. The river represents the presence of water in an arid environment, with a variety of vegetation not found in adjacent areas. Its physiography is also visually unique, with the adjacent midground distance zone often consisting of striated colors of the limestone of the Verde Formation.

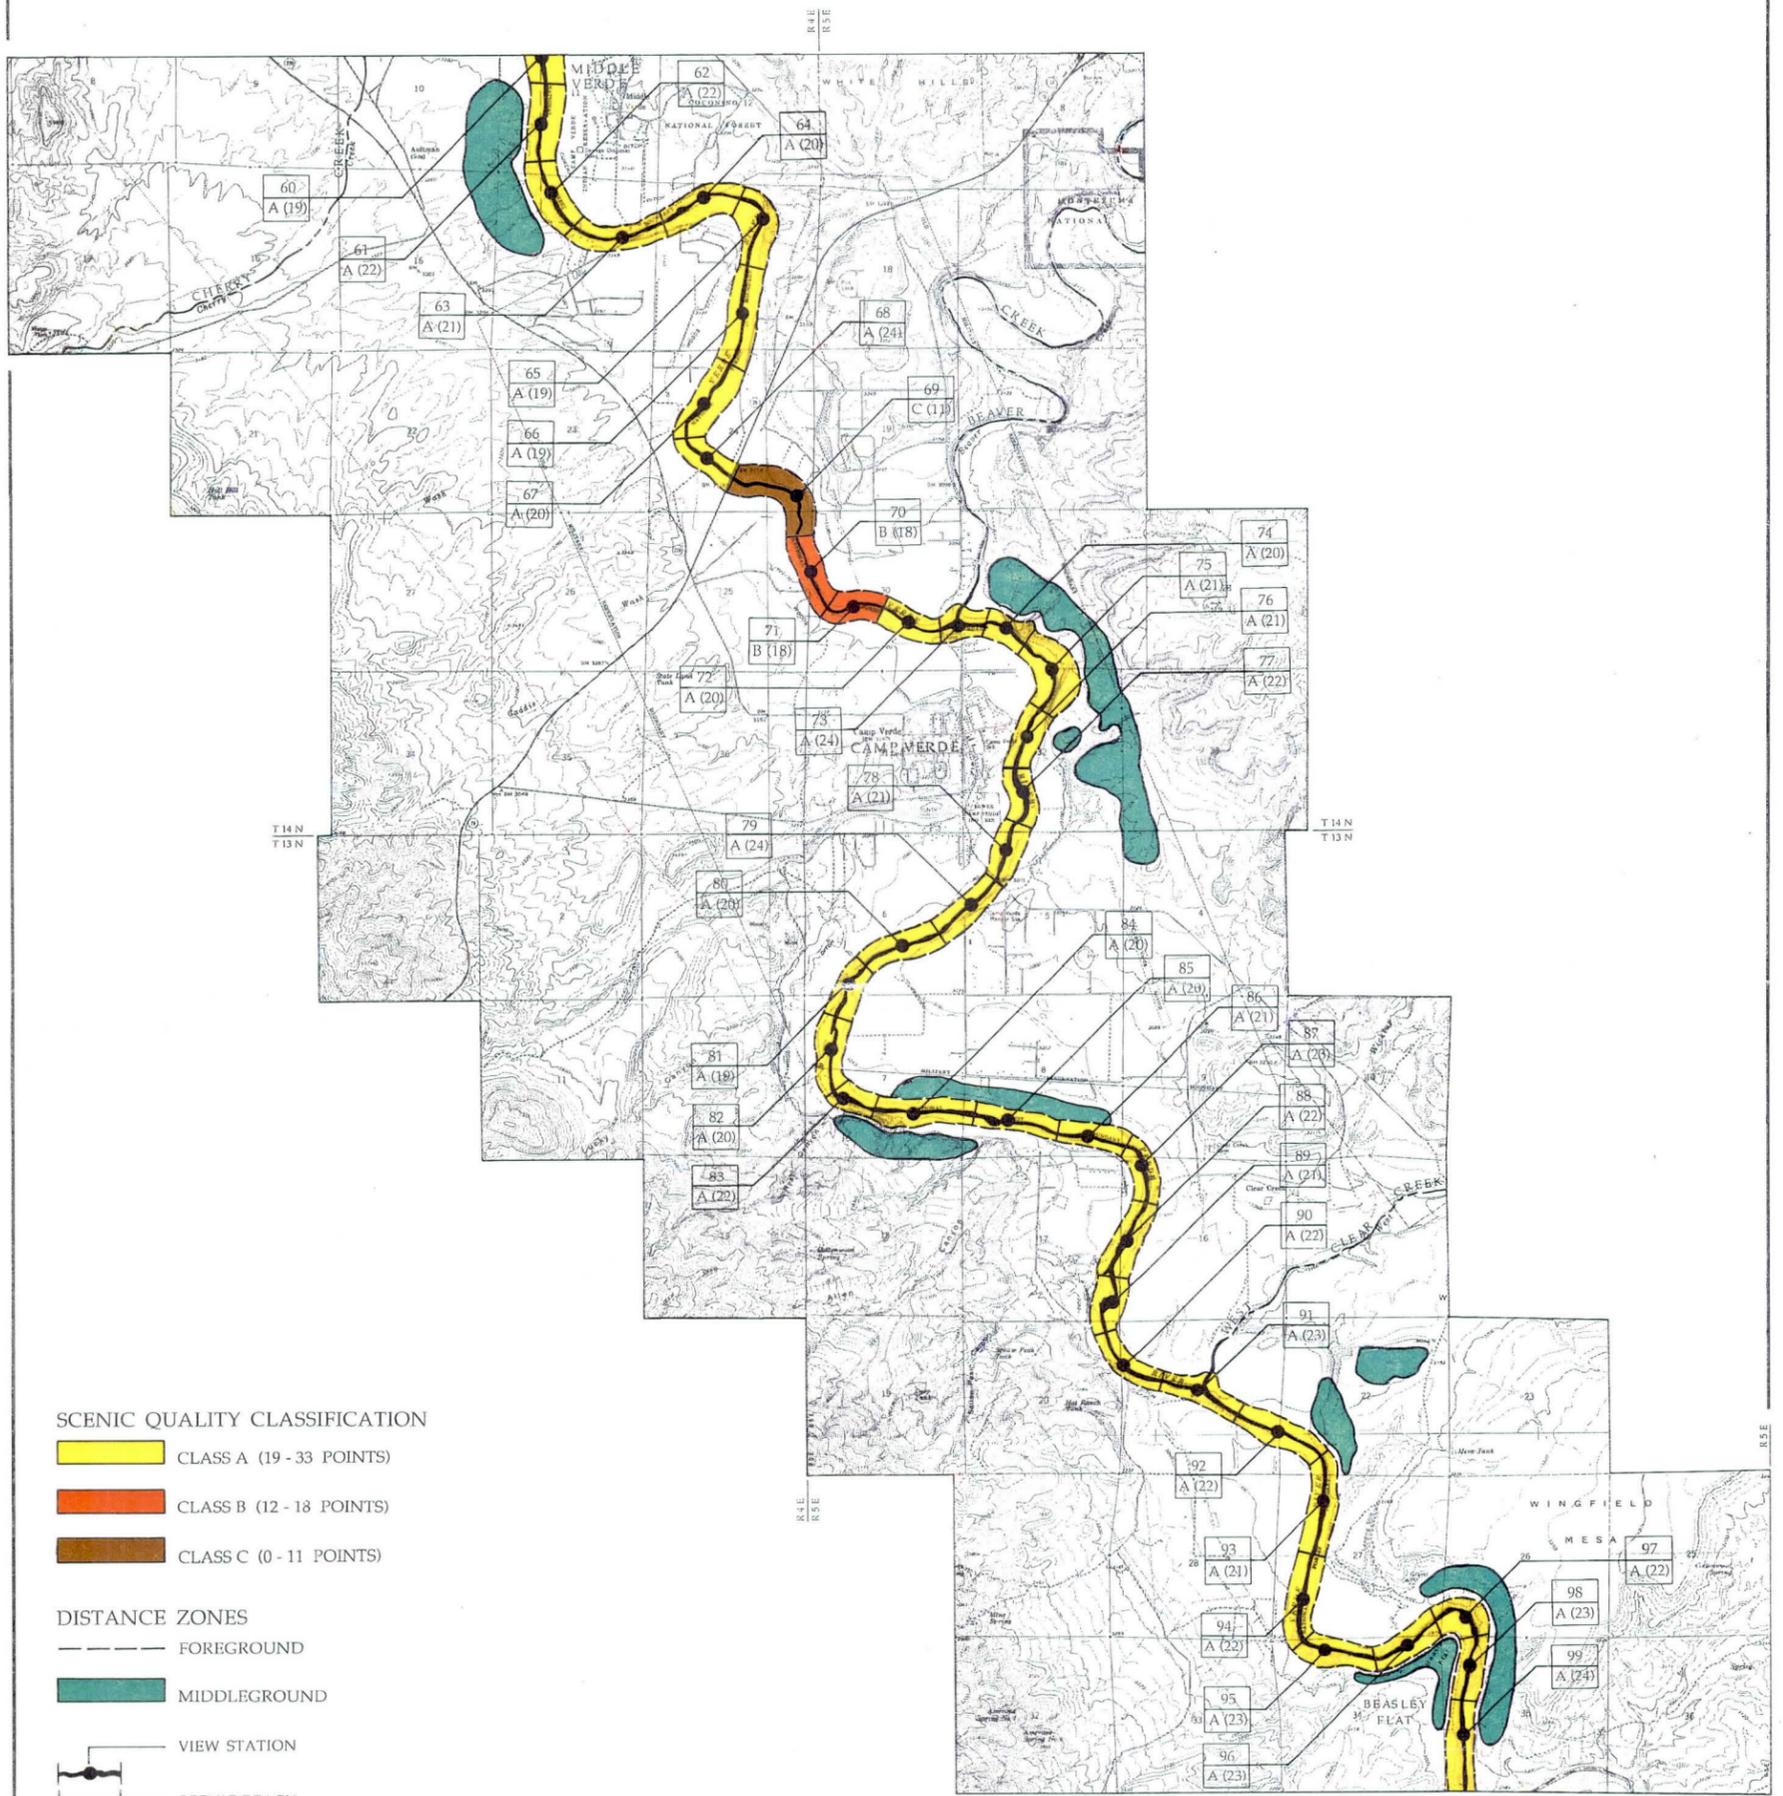
### SCENIC QUALITY CLASSIFICATION

- CLASS A (19 - 33 POINTS)
- CLASS B (12 - 18 POINTS)
- CLASS C (0 - 11 POINTS)

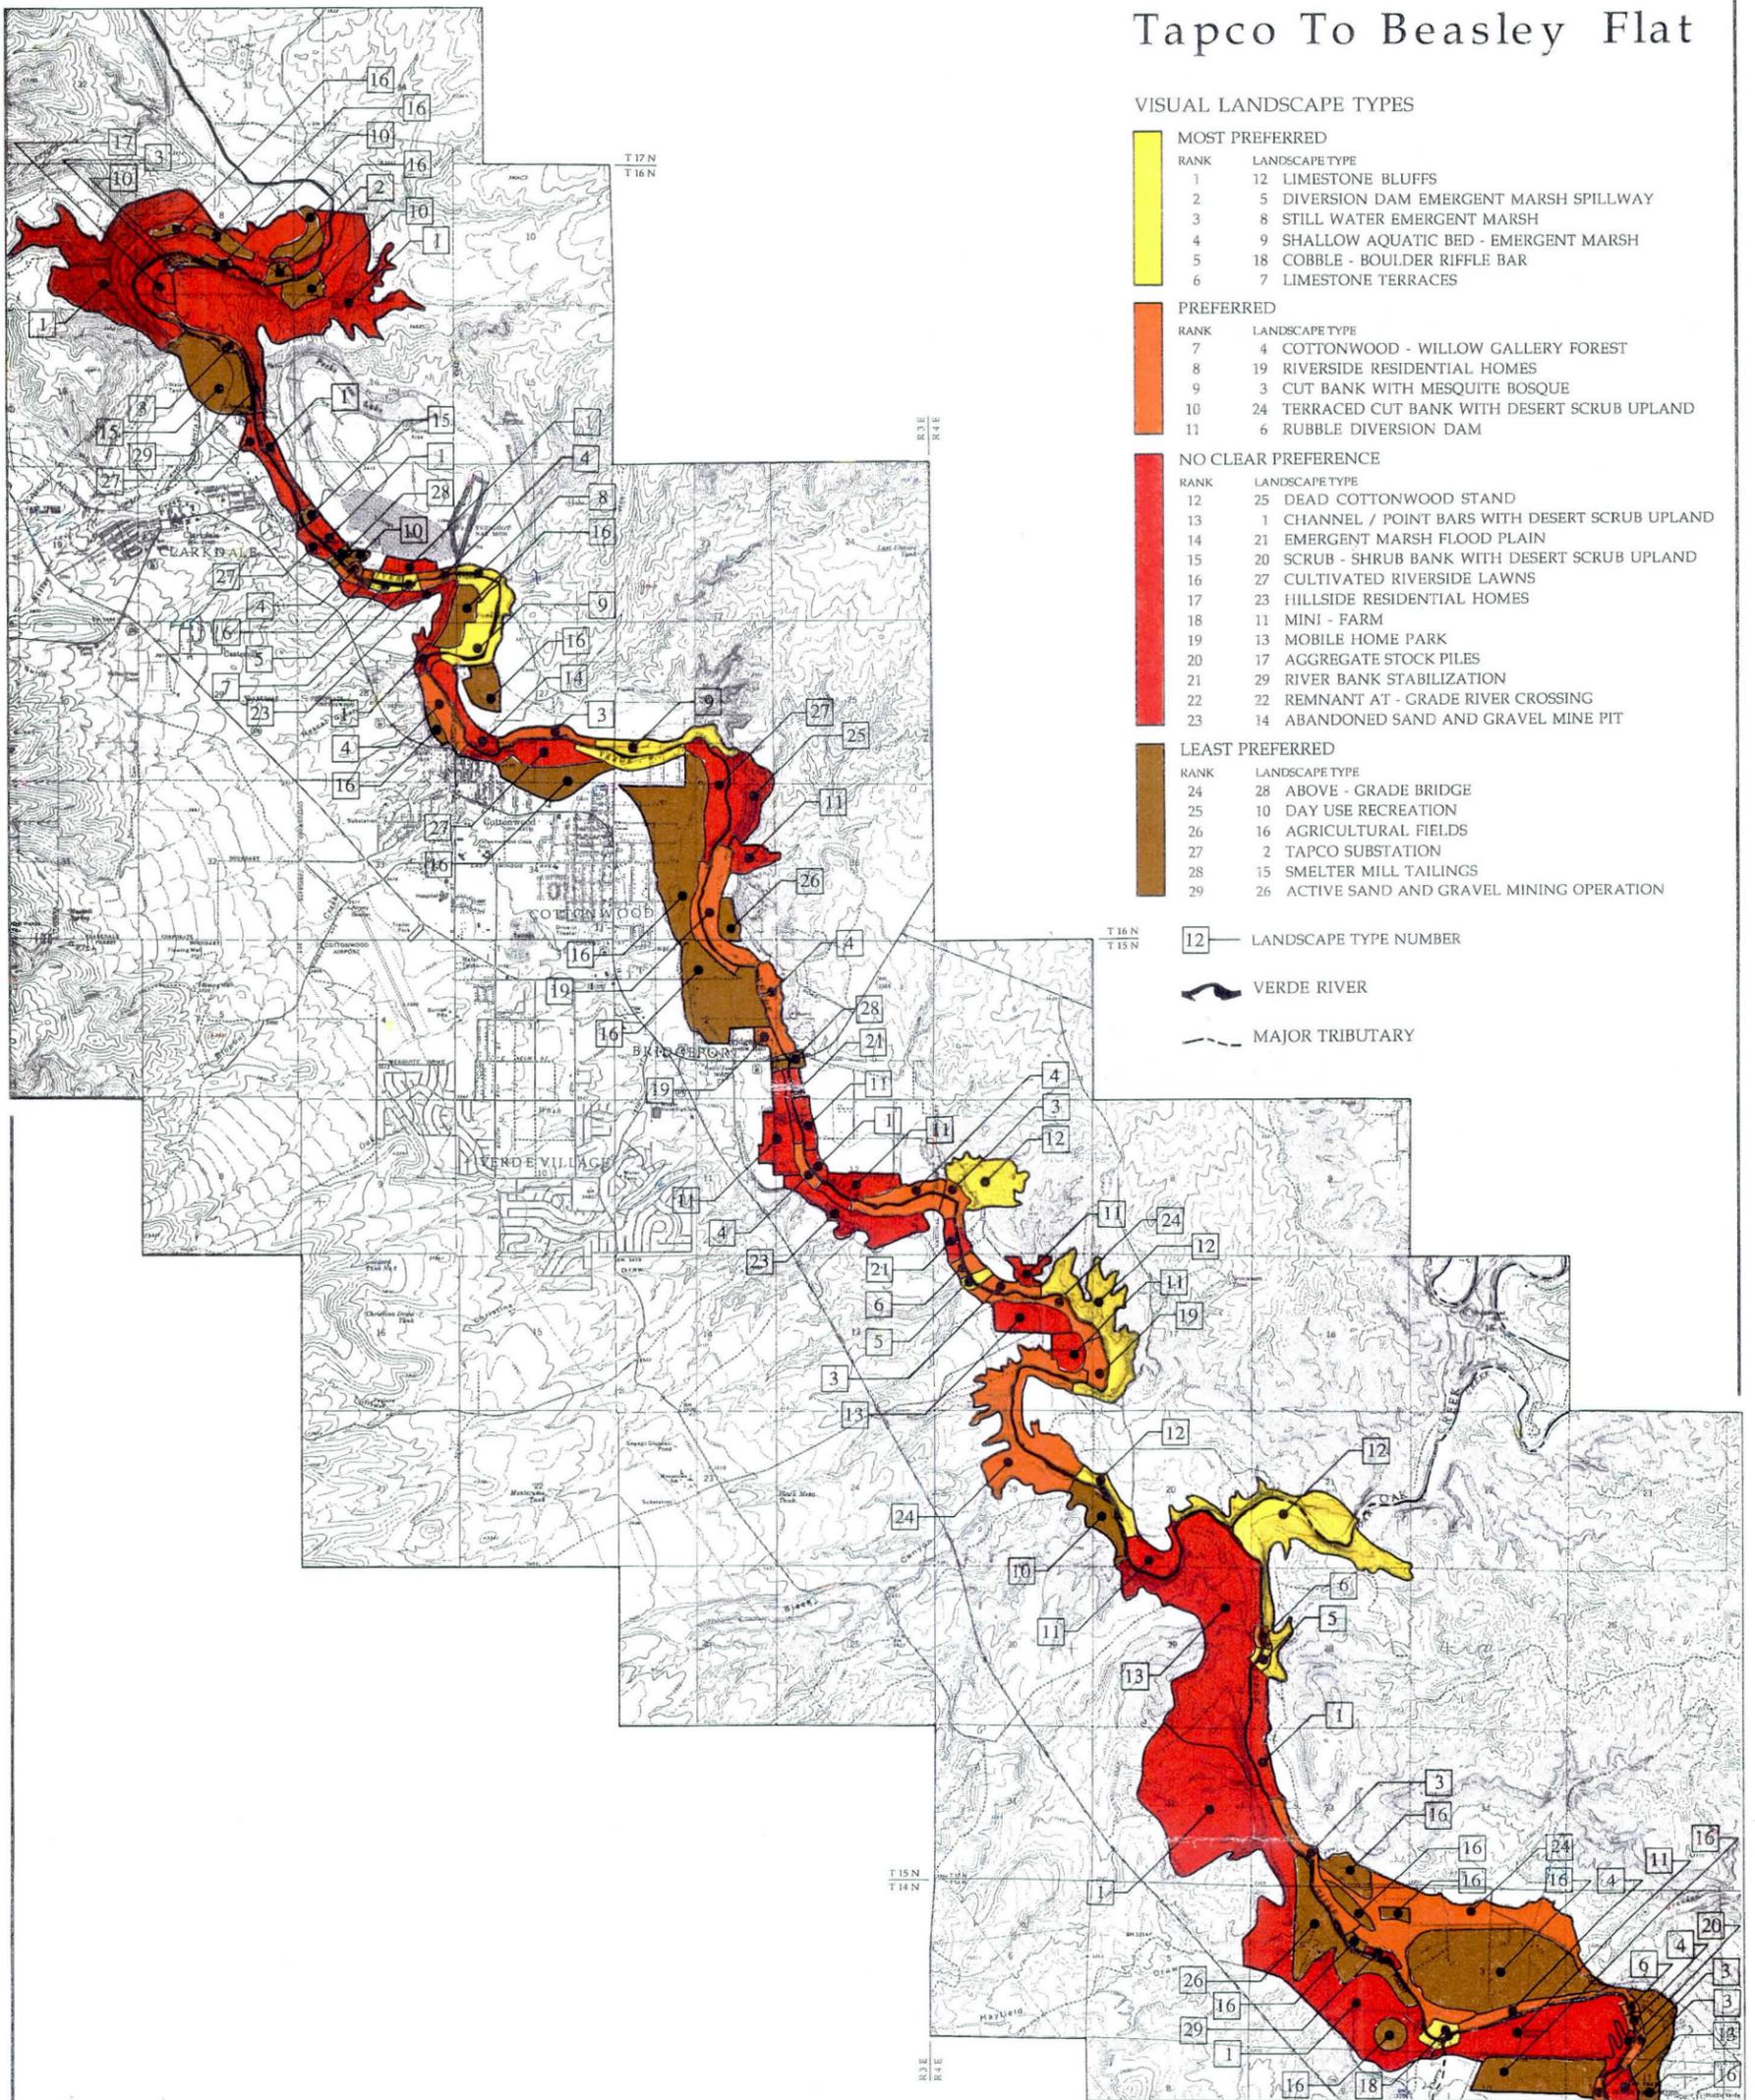
### VISUAL LANDSCAPE TYPES

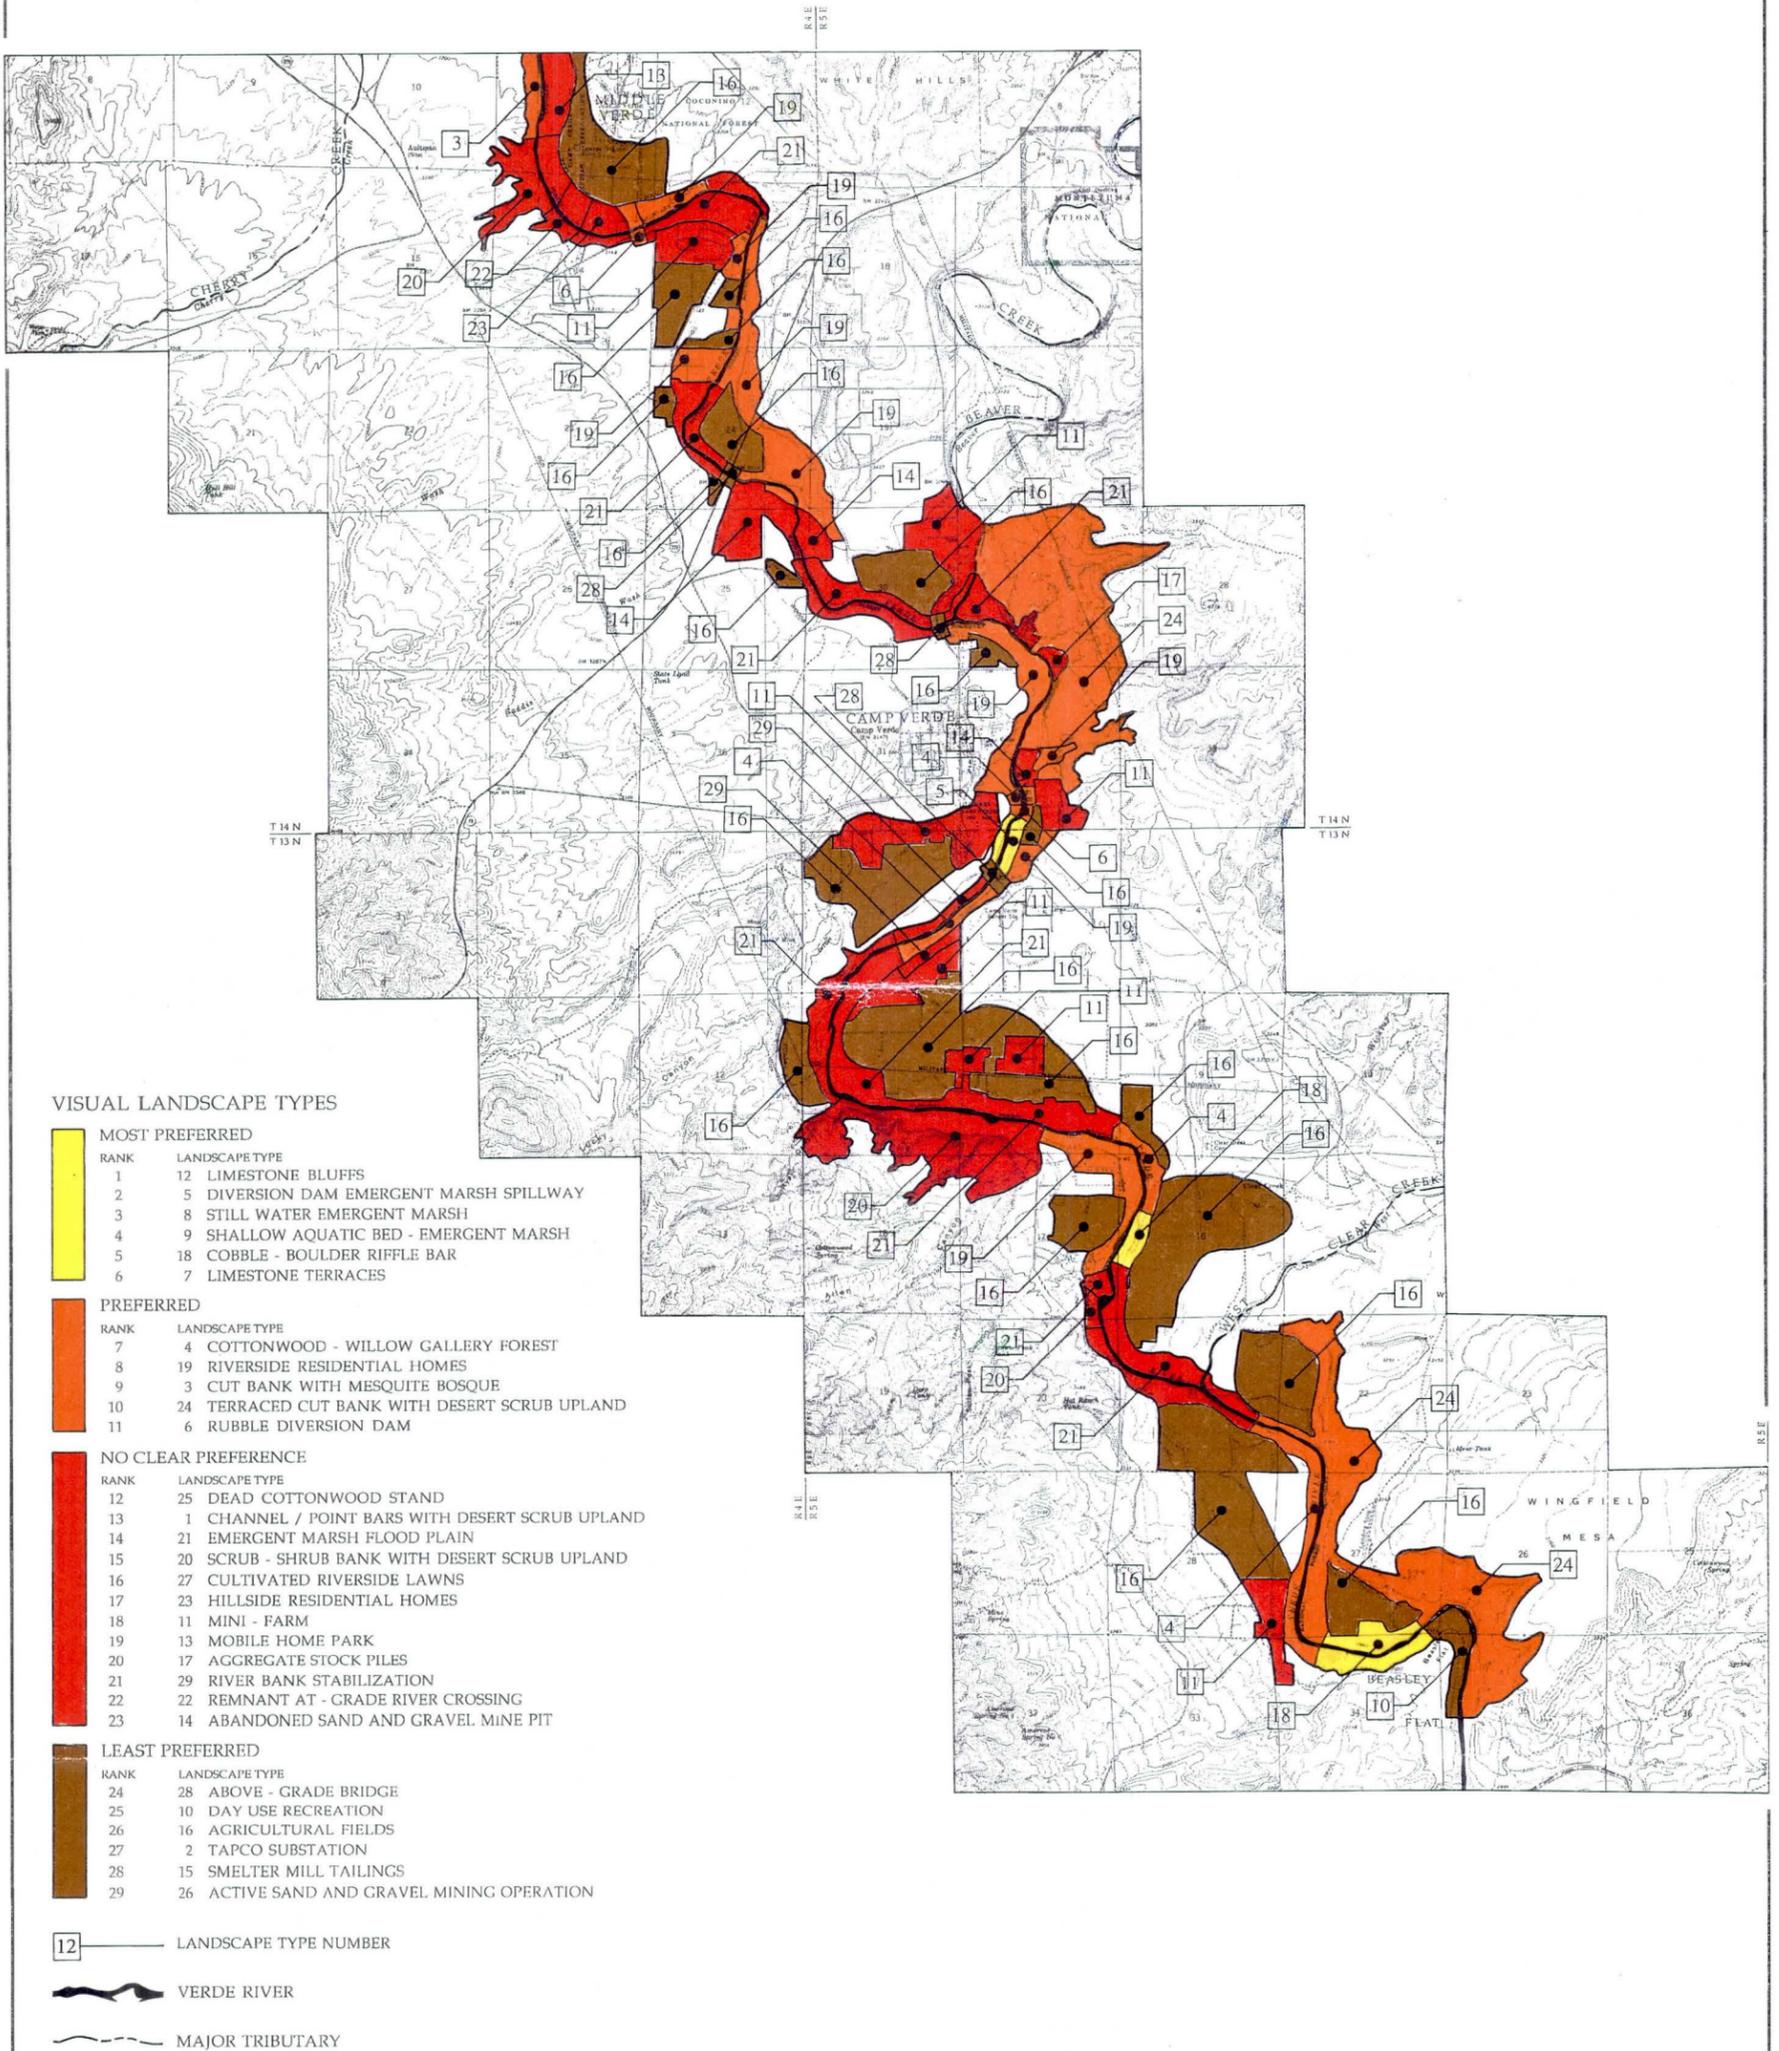
## VLP 2

# VISUAL LANDSCAPE PREFERENCE

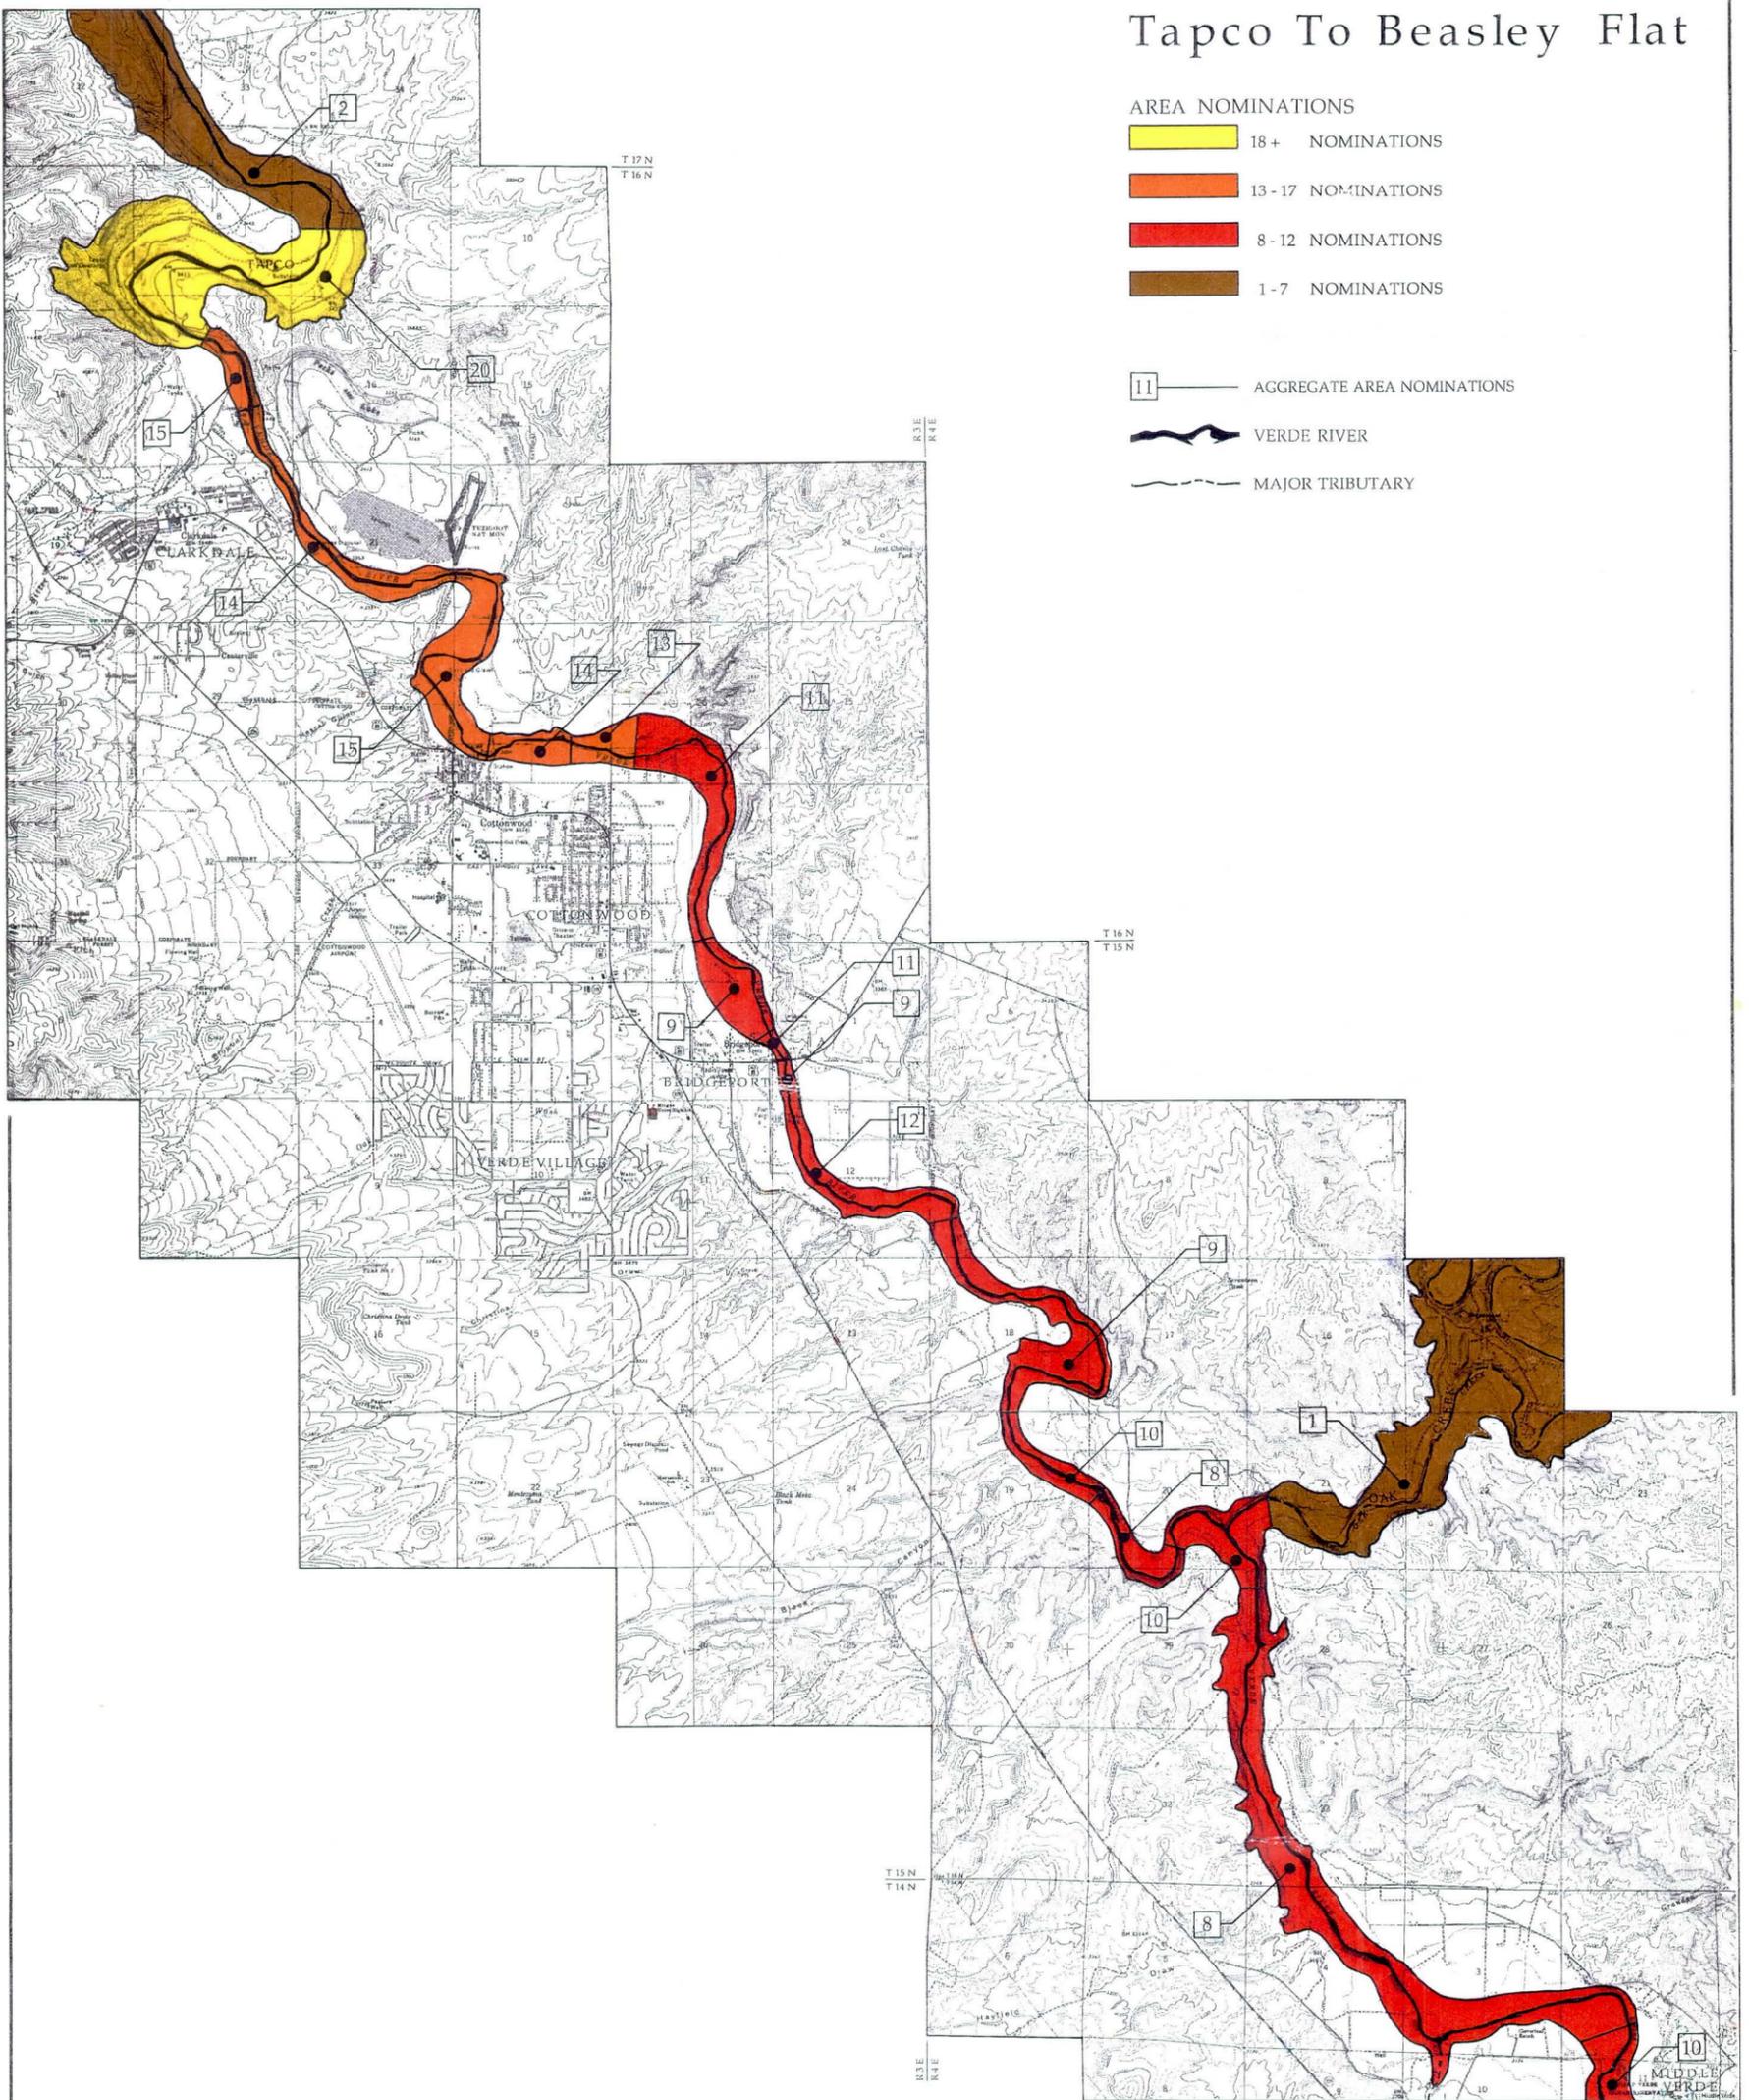
### AREA NOMINATIONS

- 18+ NOMINATIONS
- 13-17 NOMINATIONS
- 8-12 NOMINATIONS
- 1-7 NOMINATIONS

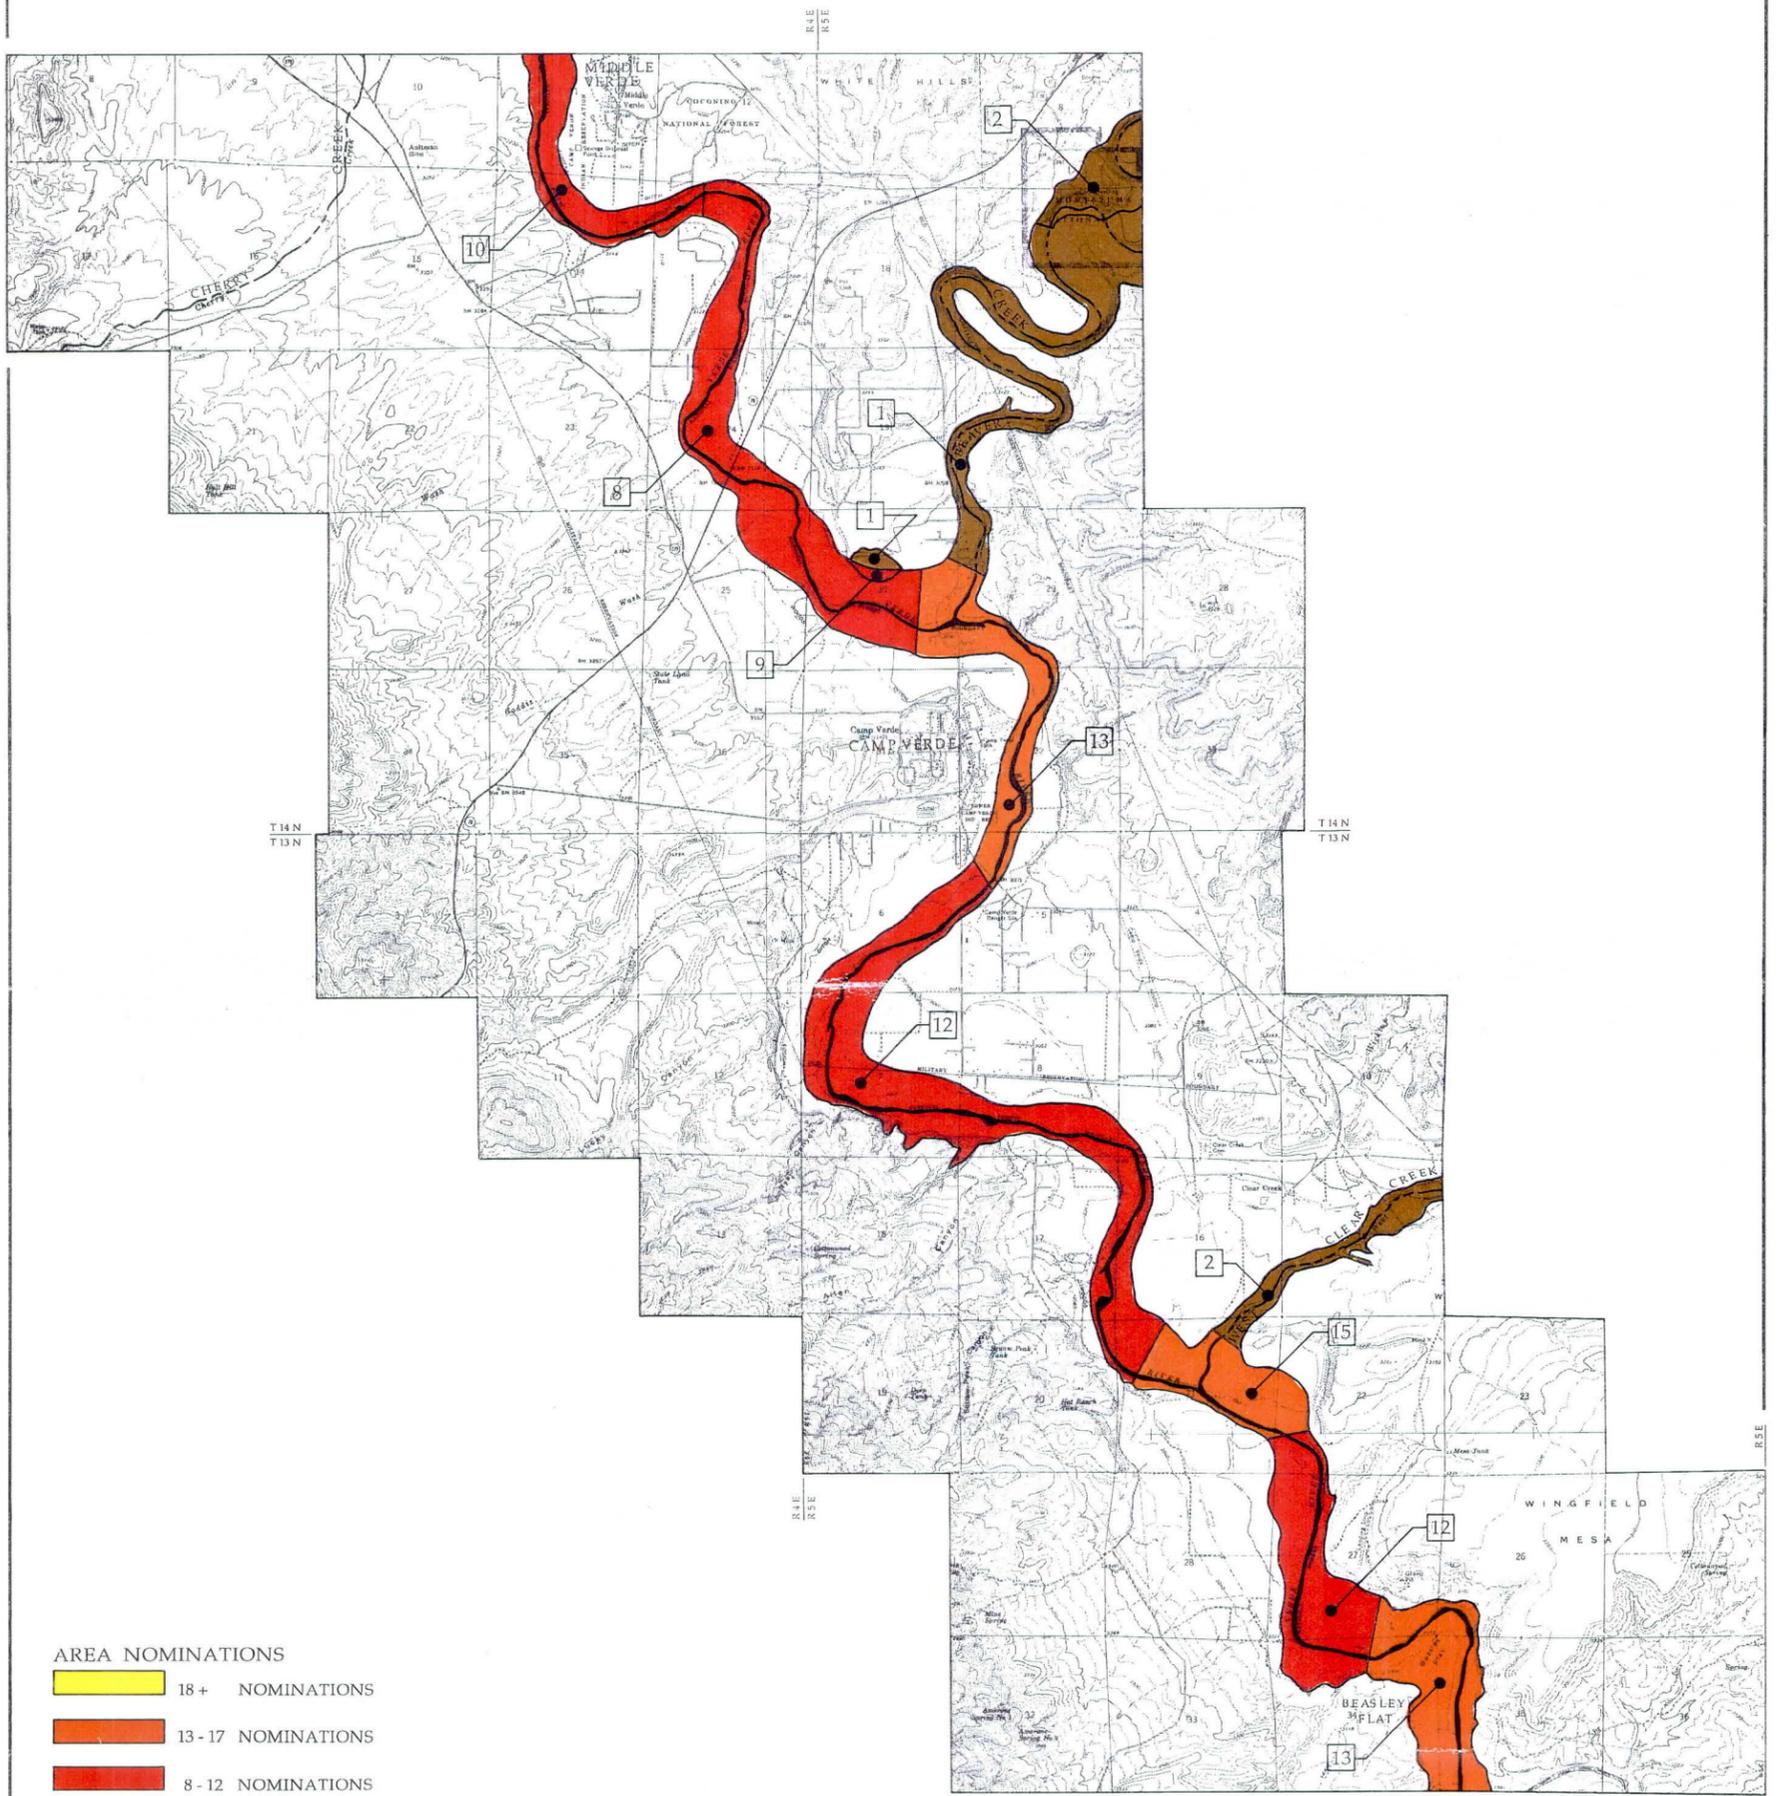
SAN 2

### SCENIC AREA NOMINATION
