ARIZONA DEPARTMENT OF TRANSPORTATION

REPORT NUMBER: FHWA-AZ89-260

SIZING RIPRAP FOR THE PROTECTION OF APPROACH EMBANKMENTS & SPUR DIKES AND LIMITING THE DEPTH OF SCOUR AT BRIDGE PIERS & ABUTMENTS

Volume I: Literature Review & Arizona Case Histories

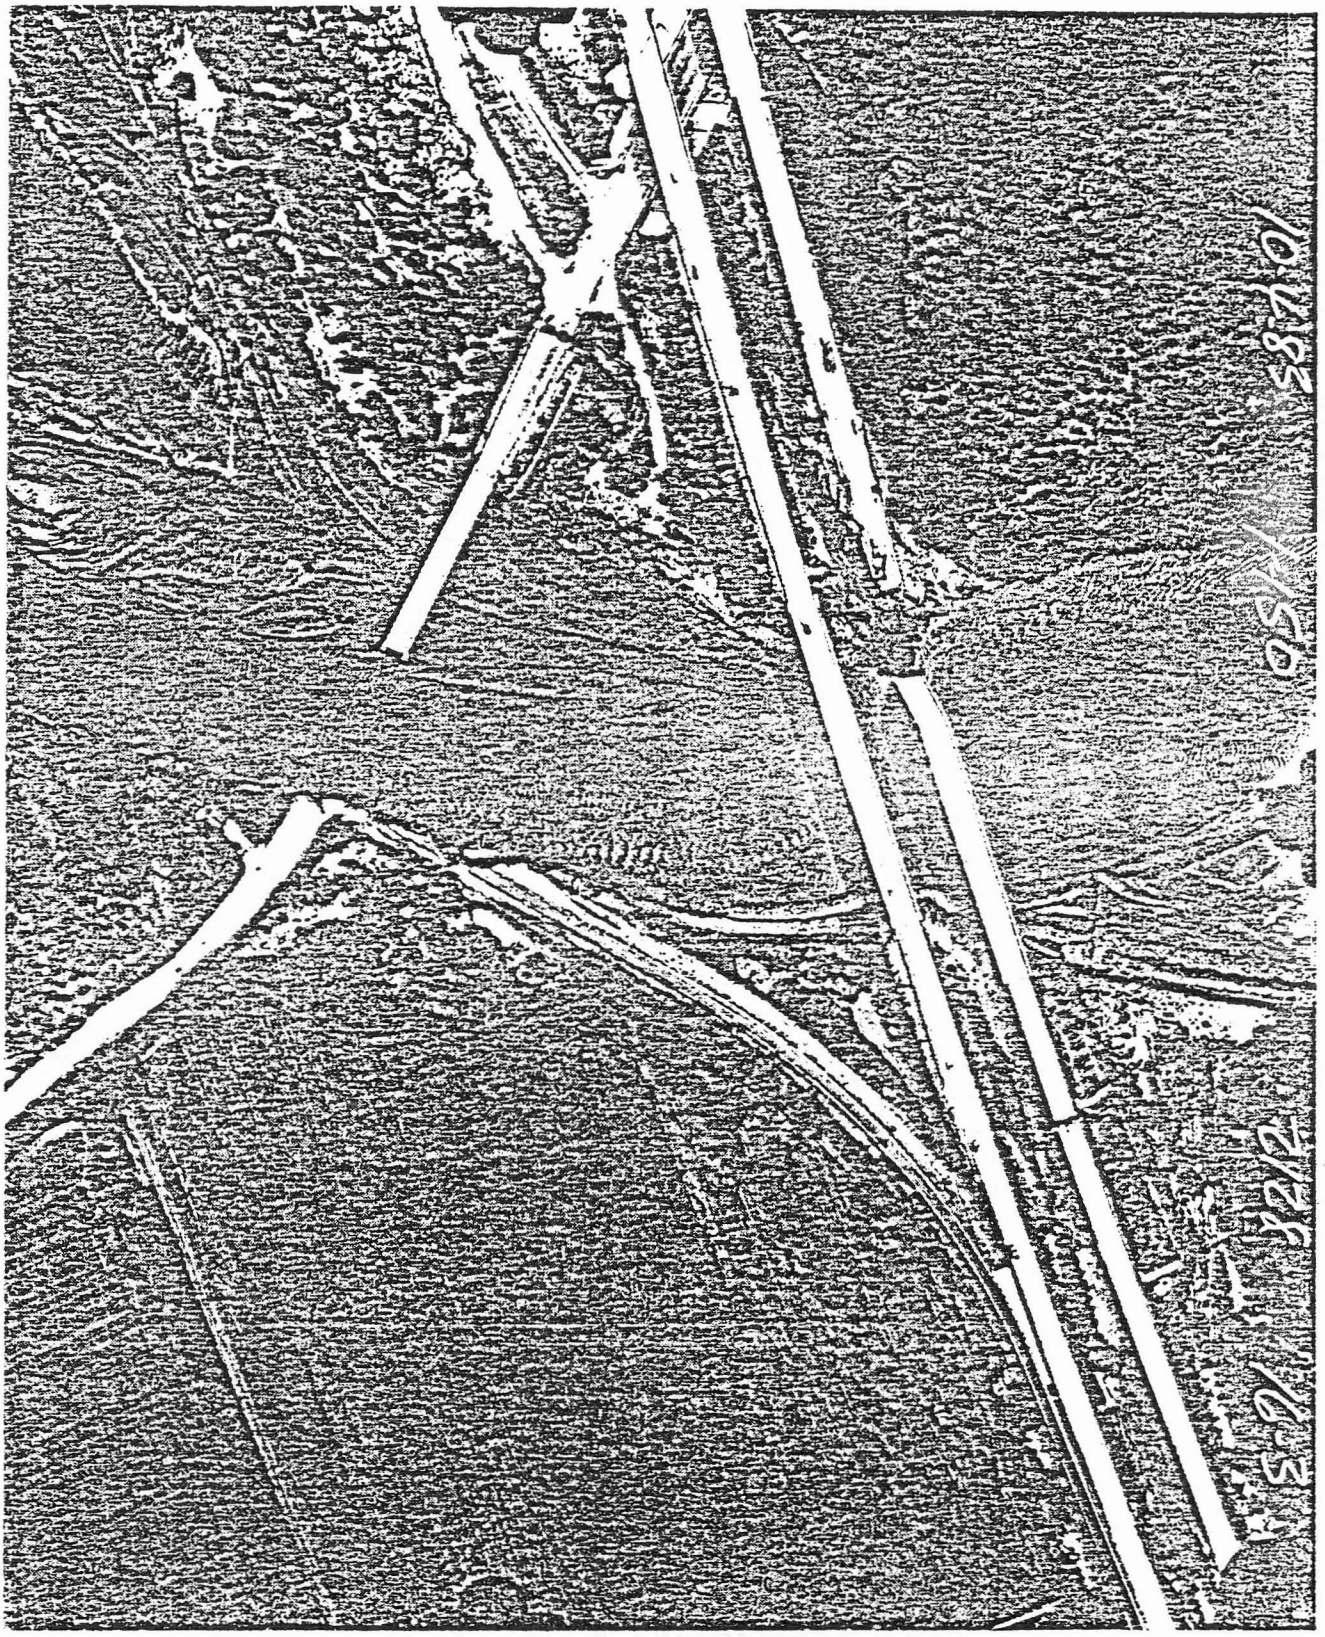
Figure 7. Aerial photograph of Santa Cruz River at I-19 bridge after October 1983 flood. (ADOT Photogrametry Section)

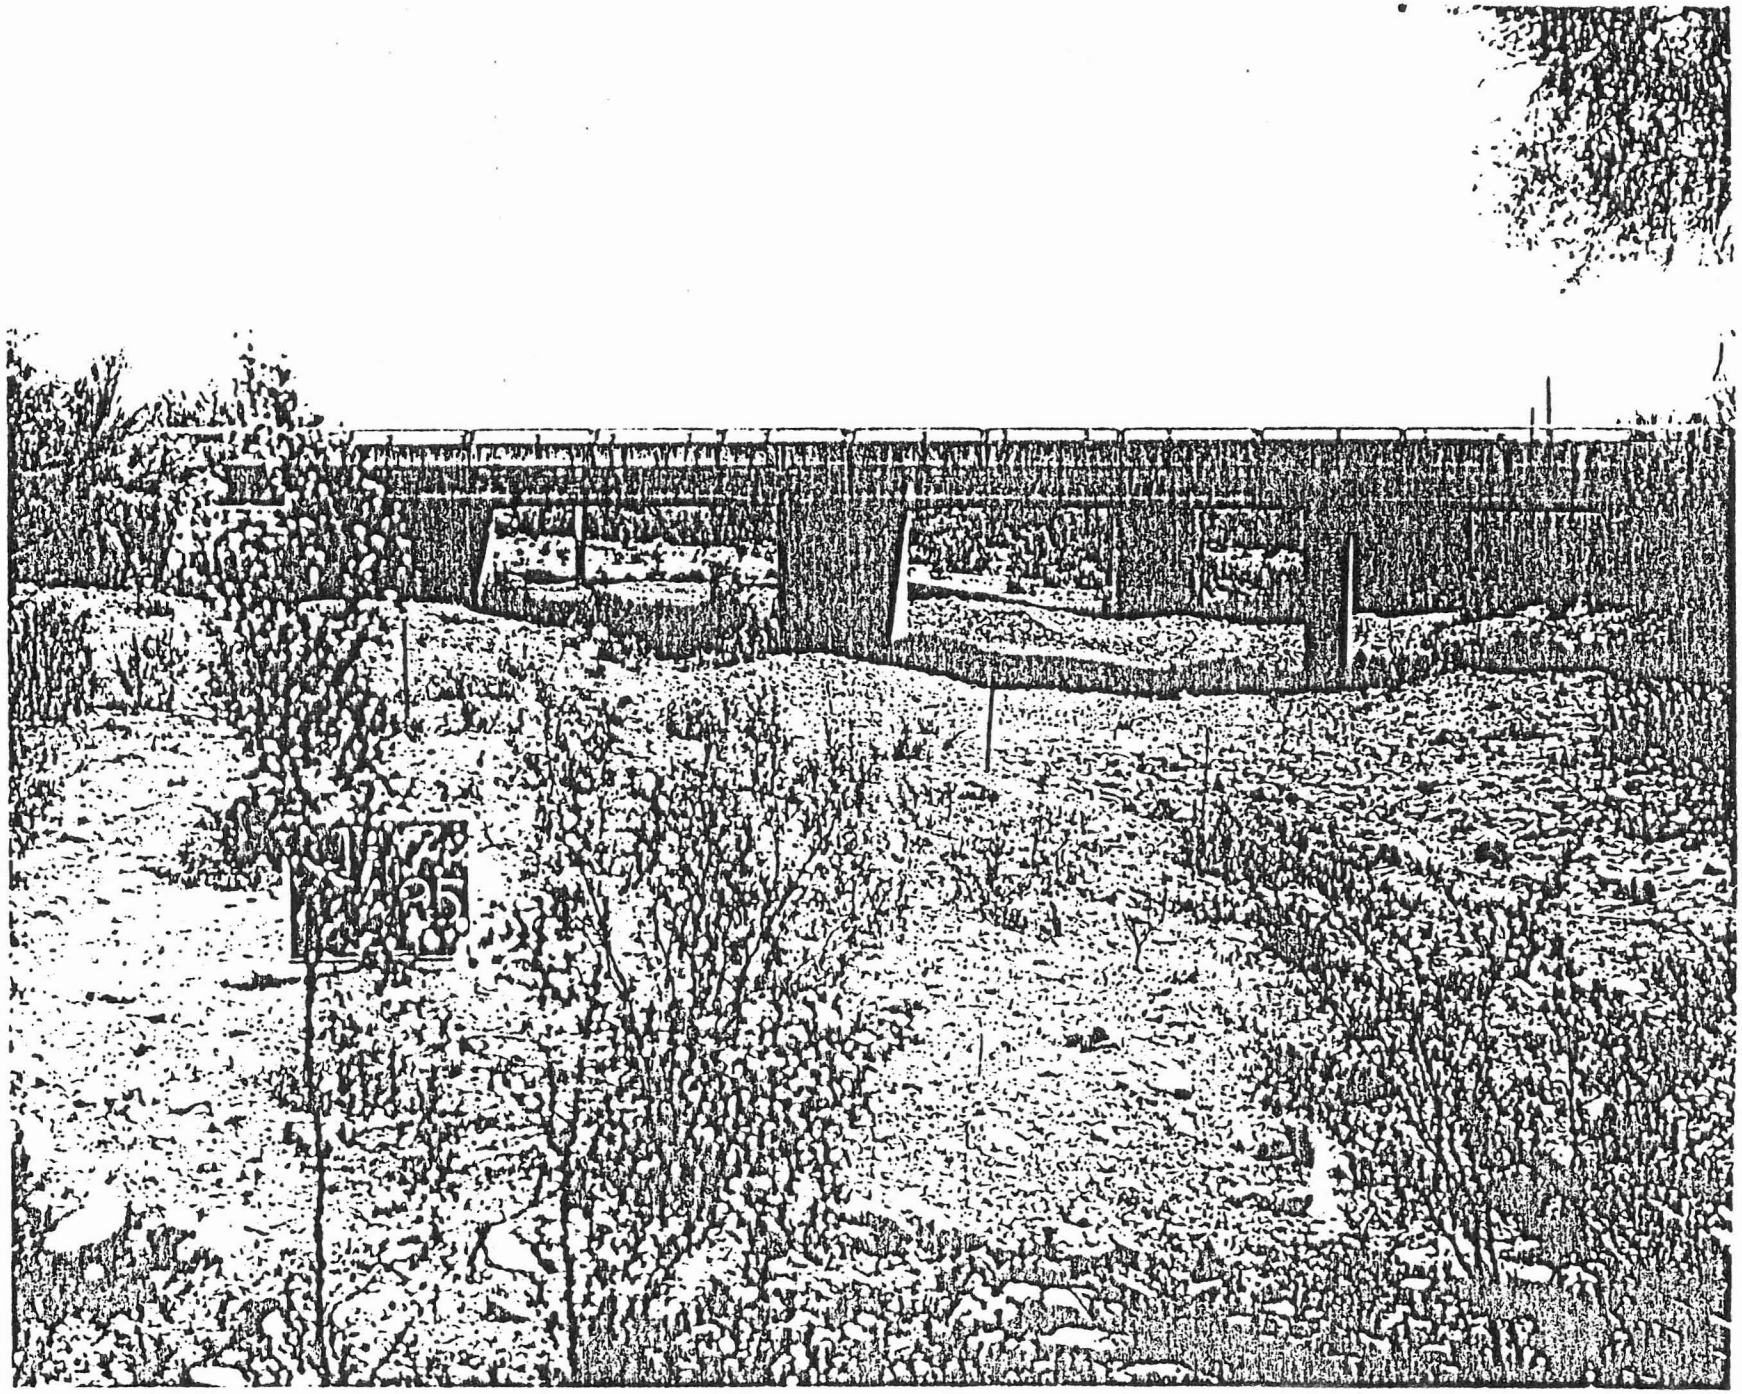
SITE NO 2
JOINT FHWA/ADOT
BRIDGE INSPECTION
JUNE 1979

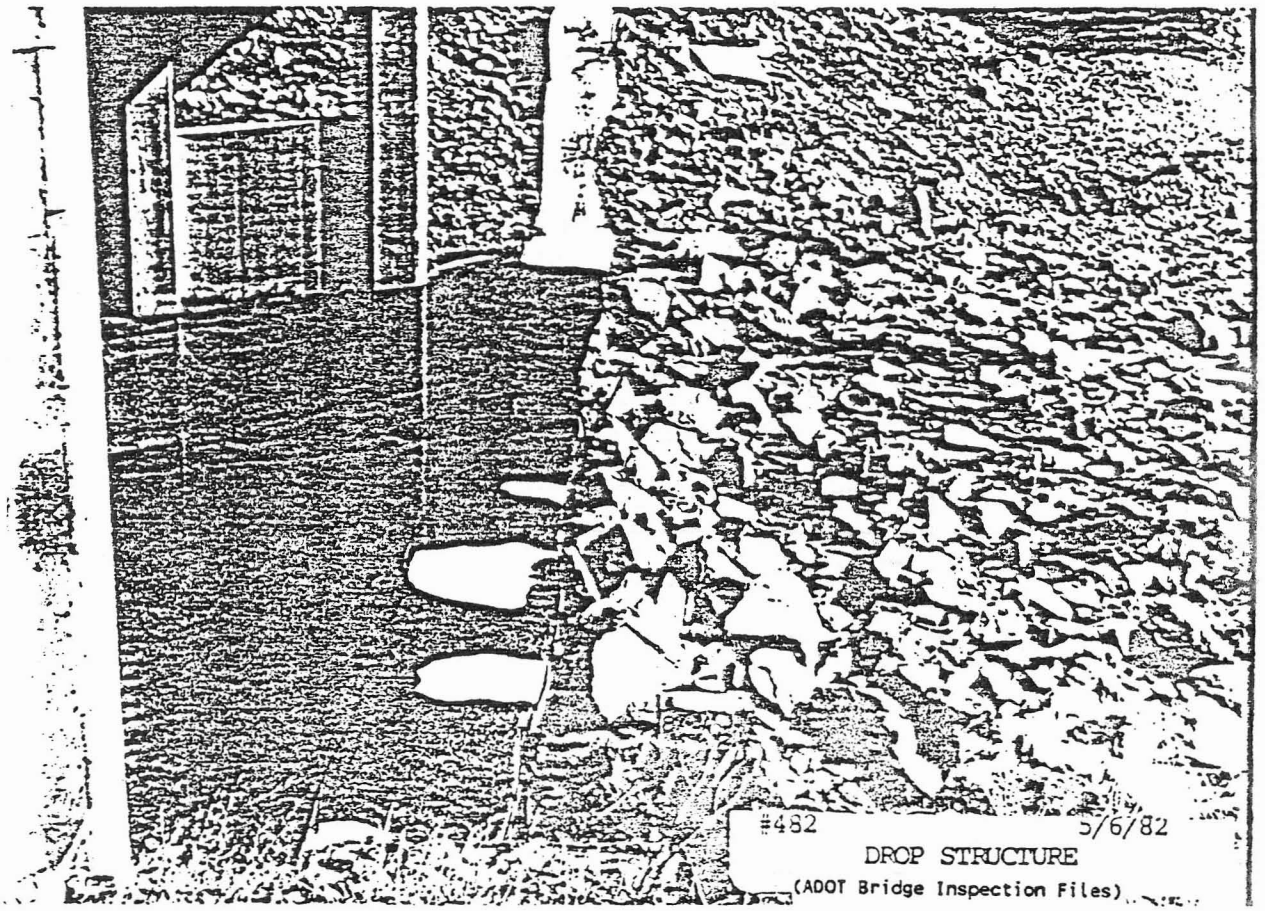
#482 5/6/82
DROP STRUCTURE
(ADOT Bridge Inspection Files)

Bridge inspection report: The downstream drop structure and stilling basins are working well. The channel has remained stable.

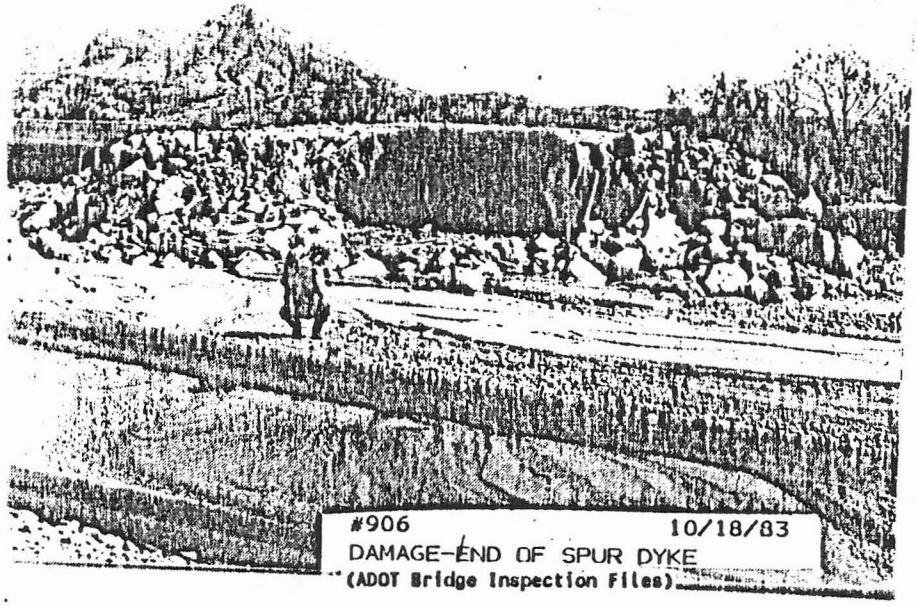
#906 10/18/83
DAMAGE-END OF SPUR DYKE
(ADOT Bridge Inspection Files)

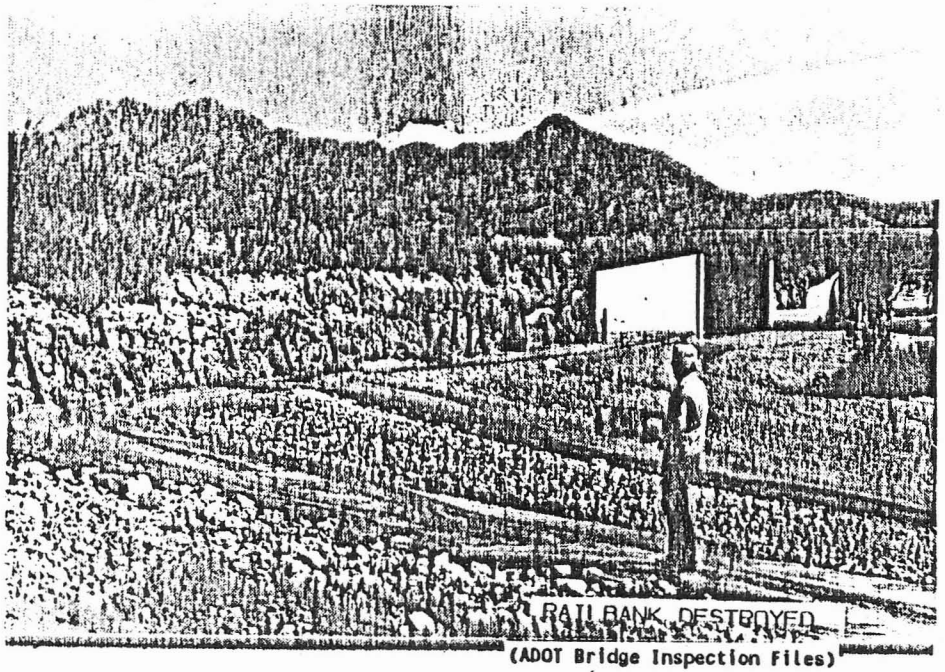
RAIL BANK DESTROYED
(ADOT Bridge Inspection Files)

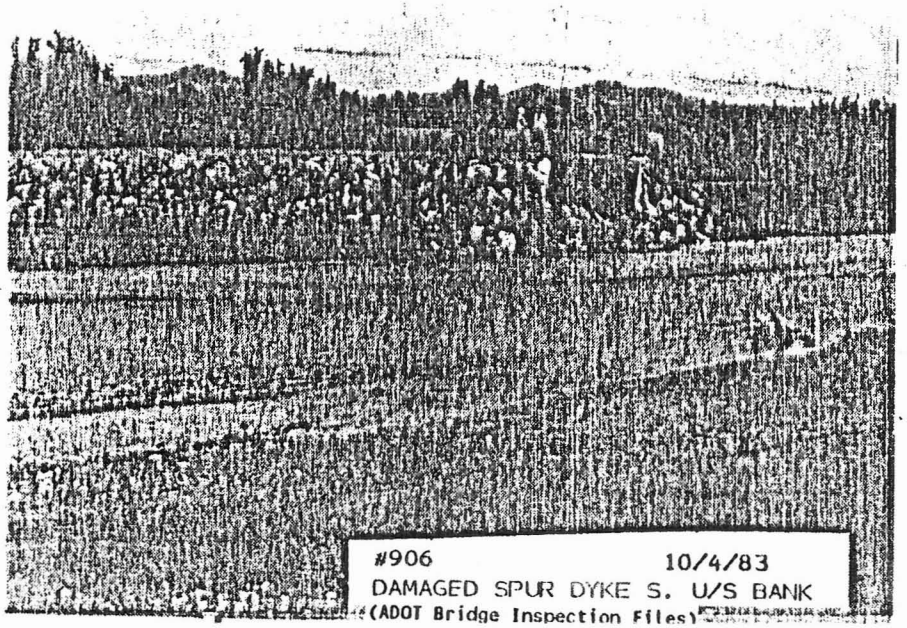
#906 10/4/83
DAMAGED SPUR DYKE S. U/S BANK
(ADOT Bridge Inspection Files)

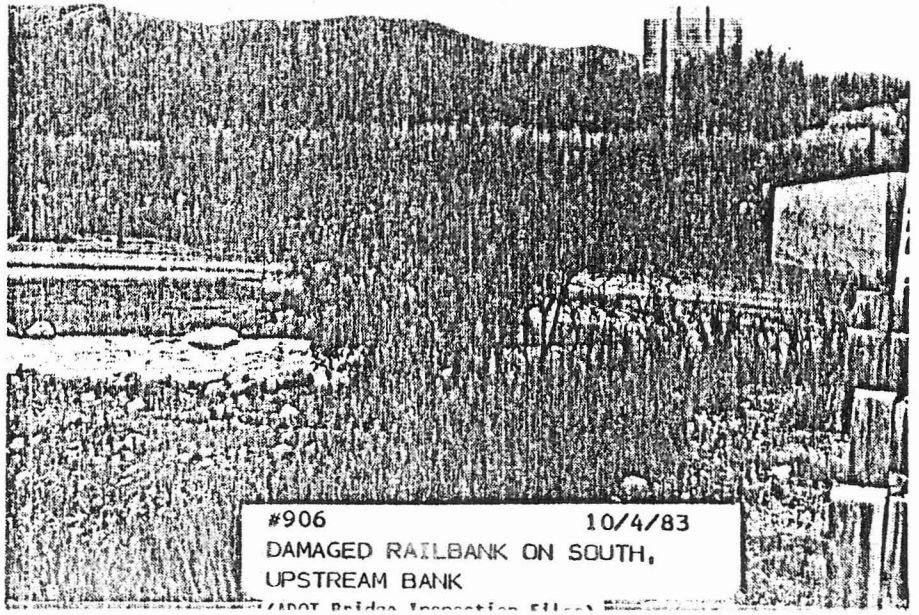
#906 10/4/83
DAMAGED RAILBANK ON SOUTH,
UPSTREAM BANK

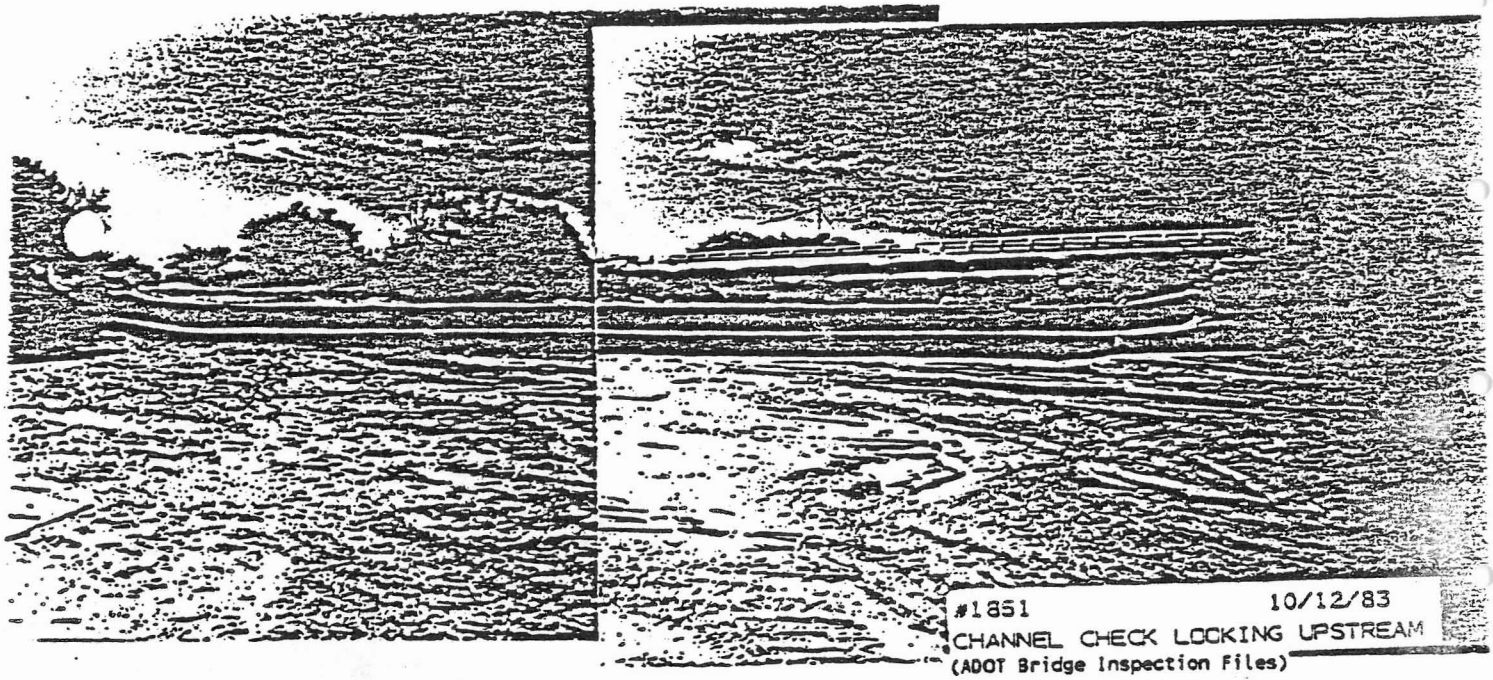
#1851 10/12/83
CHANNEL CHECK LOOKING UPSTREAM
(ADOT Bridge Inspection Files)

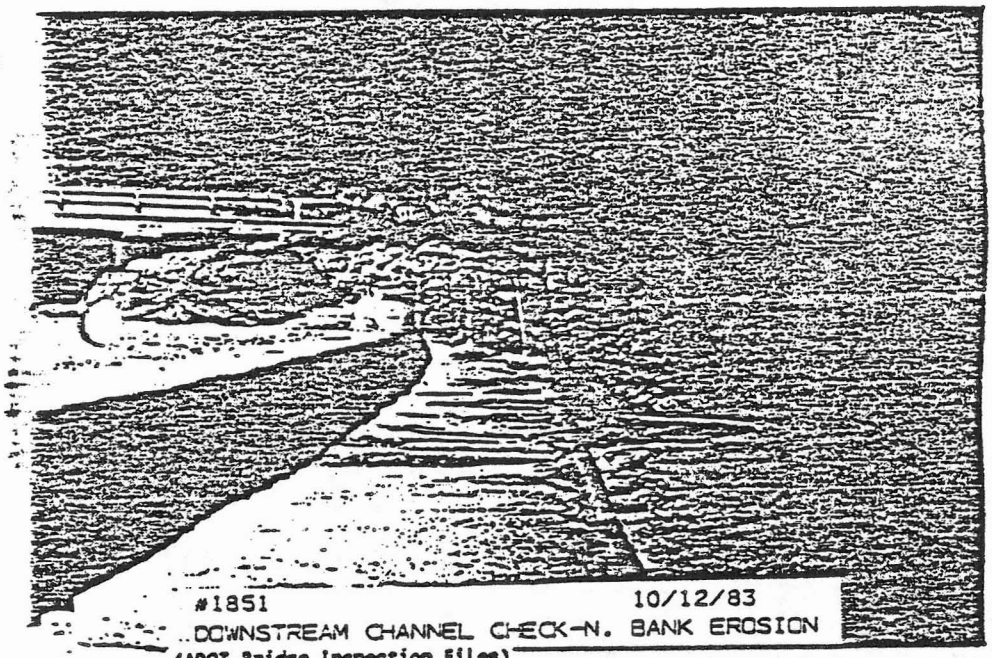
#1851 10/12/83
DOWNSTREAM CHANNEL CHECK-N. BANK EROSION
(ADOT Bridge Inspection Files)

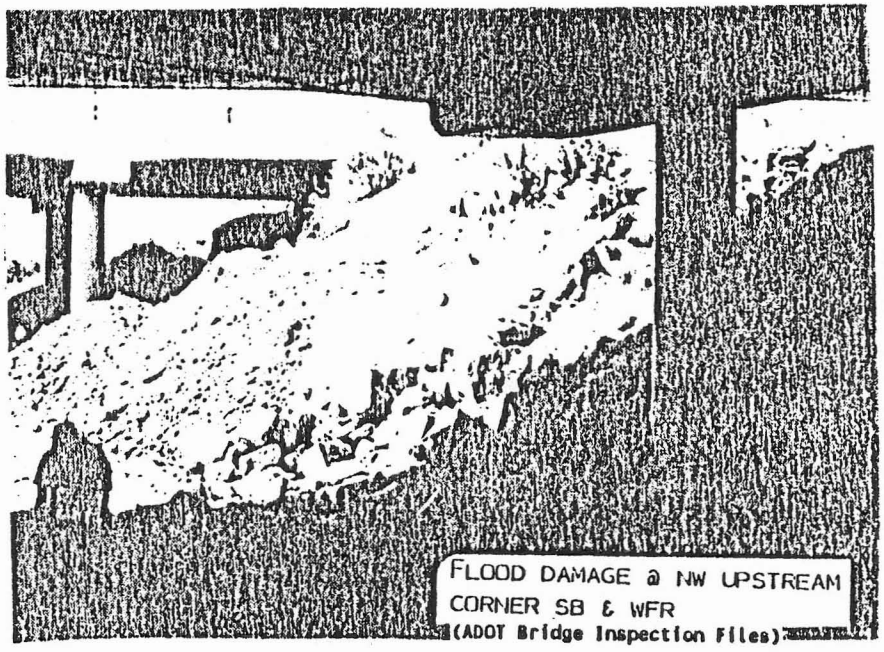
FLOOD DAMAGE @ NW UPSTREAM CORNER SB & WFR
(ADOT Bridge Inspection Files)

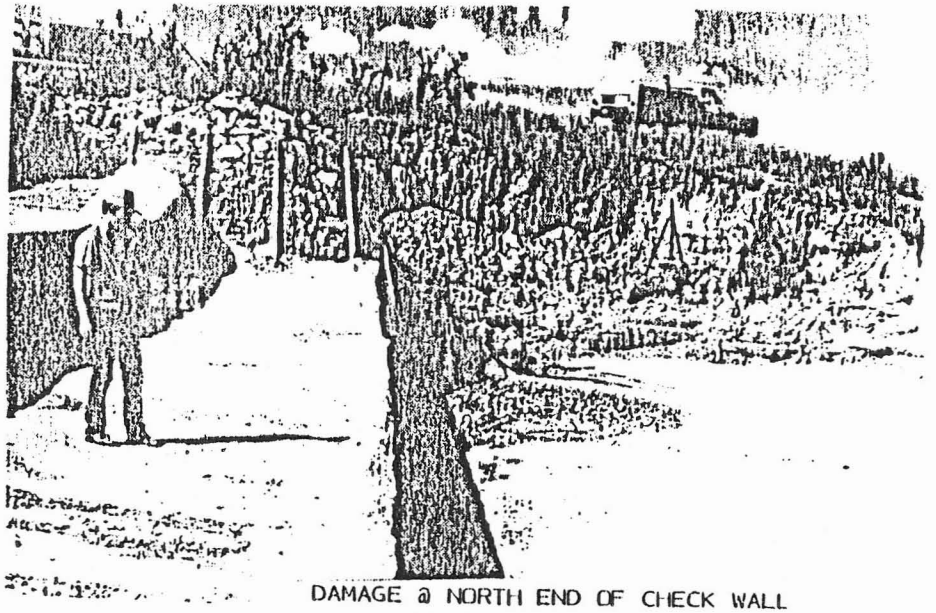
DAMAGE @ NORTH END OF CHECK WALL
(ADOT Bridge Inspection Files)

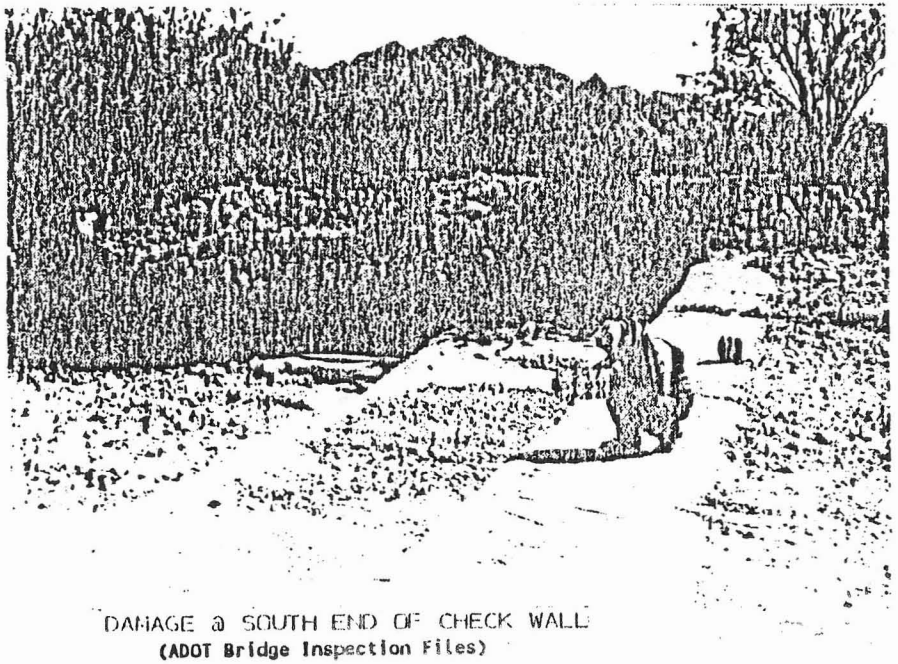
DAMAGE @ SOUTH END OF CHECK WALL
(ADOT Bridge Inspection Files)
