FINAL REPORT TO CONGRESS

THE STREAMBANK EROSION CONTROL EVALUATION AND DEMONSTRATION ACT OF 1974 SECTION 32, PUBLIC LAW 93-251

Appendix E - Missouri River Demonstration Projects

MISSOURI RIVER BETWEEN GAVINS POINT DAM AND PONCA; NEBRASKA AND SOUTH DAKOTA

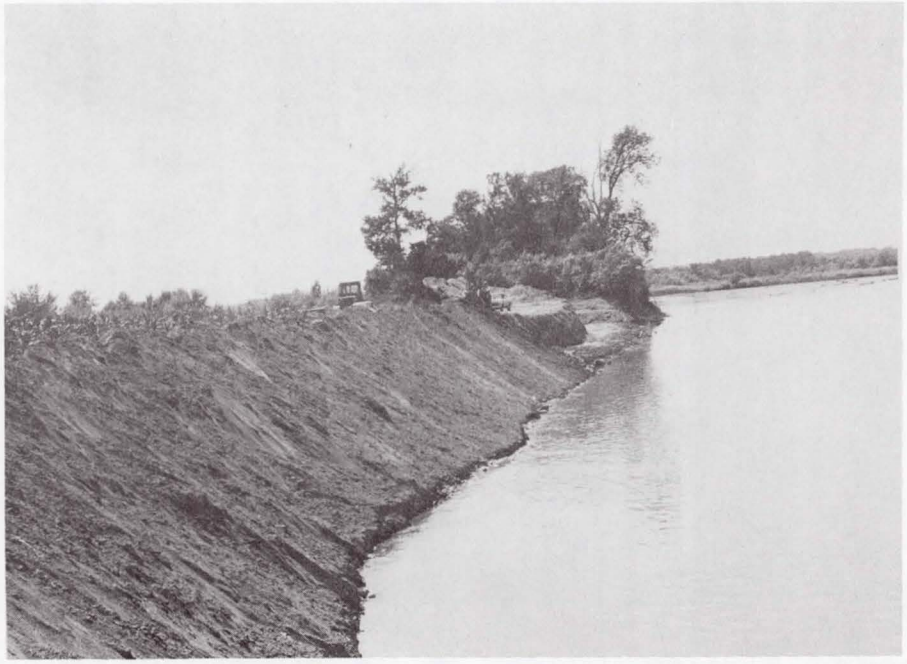
PHOTO 5. WINDROW REVETMENT 799.43*, TYPE A, LOOKING U/S AFTER EXCAVATION
(Photo Taken 23 July 1979)

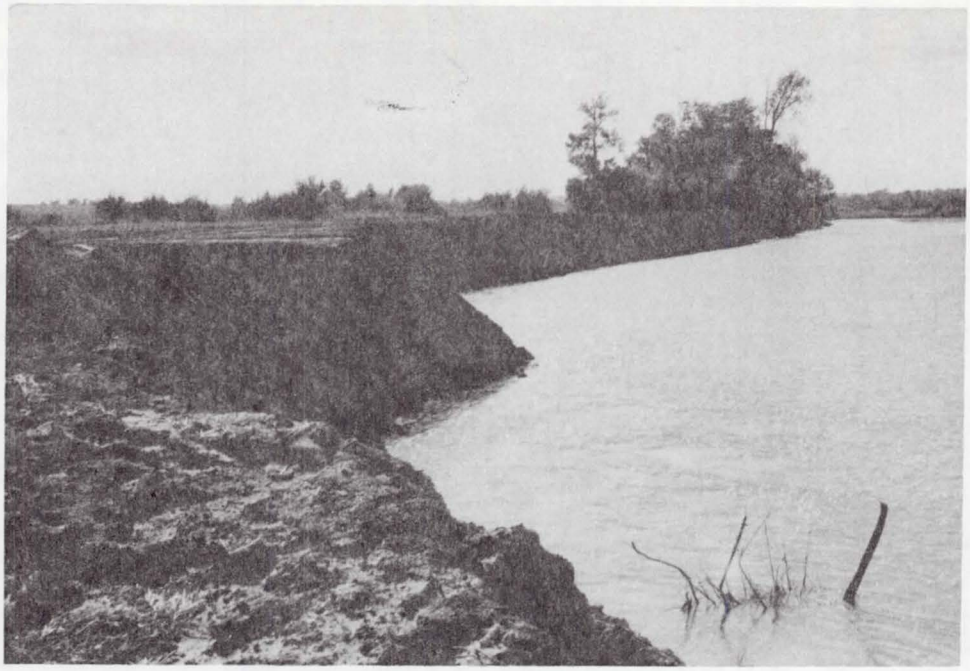
PHOTO 6. WINDROW REVETMENT 799.43*, TYPE A, PHOTO SHOWS STAGE OF CONSTRUCTION 6 DAYS PRIOR TO COMPLETION OF THE ENTIRE SEGMENT
(Photo Taken 25 July 1979)

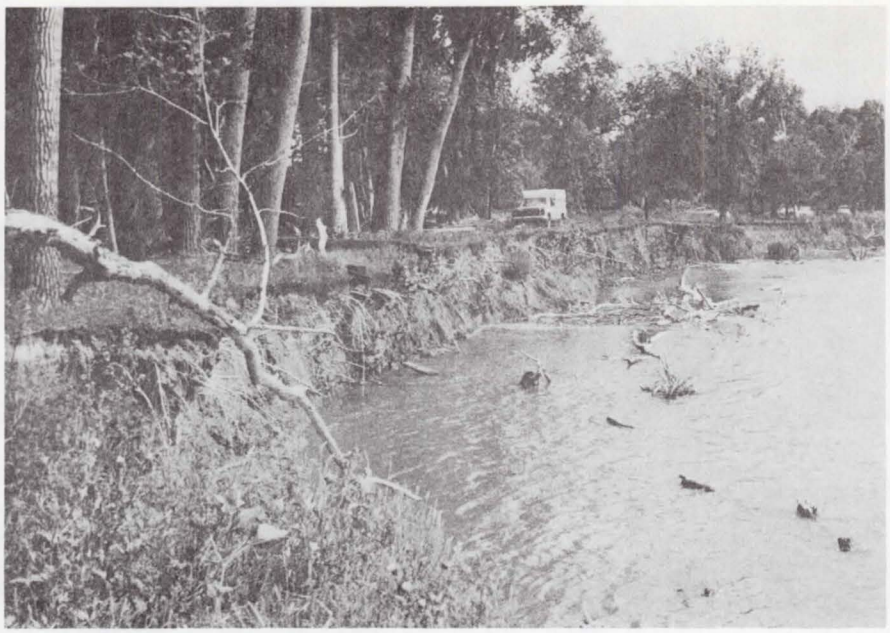
PHOTO 18. REINFORCED REVETEMNT 796.45* APPROXIMATELY ONE YEAR AFTER COMPLETION. THIS PHOTO, LOOKING U/S, PROVIDES A VISUAL COMPARISON OF THE ORIGINAL SEVERELY ERODING UNPROTECTED BANK CONDITION AND ITS PRESENTLY STABILIZED CONDITION
(Photo Taken 5 October 1979)

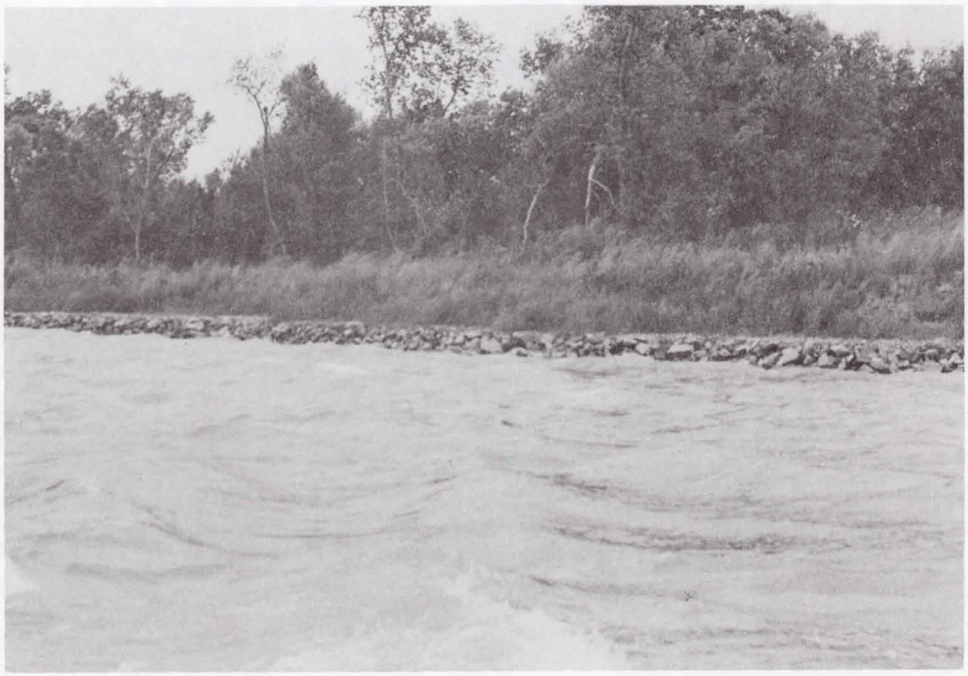
PHOTO 21. REINFORCED REVETMENT 796.9* NINE MONTHS AFTER COMPLETION. STRUCTURE SHOWS SUBSTANTIAL VEGETATIVE COVER WHICH GREATLY ENHANCES THE AESTHETIC QUALITIES OF THE SITE (Photo Taken 28 June 1979)

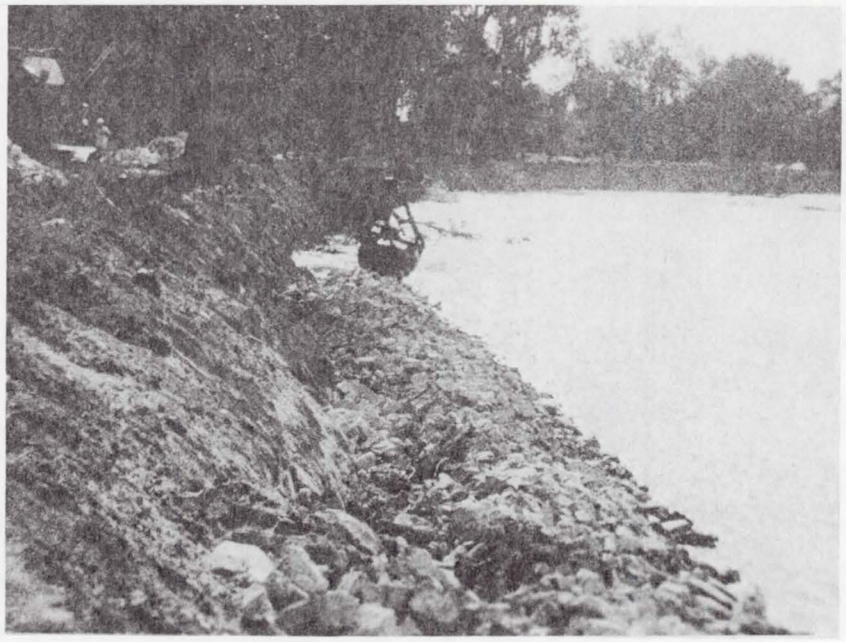
PHOTO 22. COMPOSITE REVETMENT 795.6*, LOOKING W/S, ONE YEAR AFTER COMPLETION. NOTE THE MINIMAL AMOUNT OF UPPER BANK DISTURBANCE AND THE DENSE VEGETATION GROWTH (Photo Taken 5 October 1979)

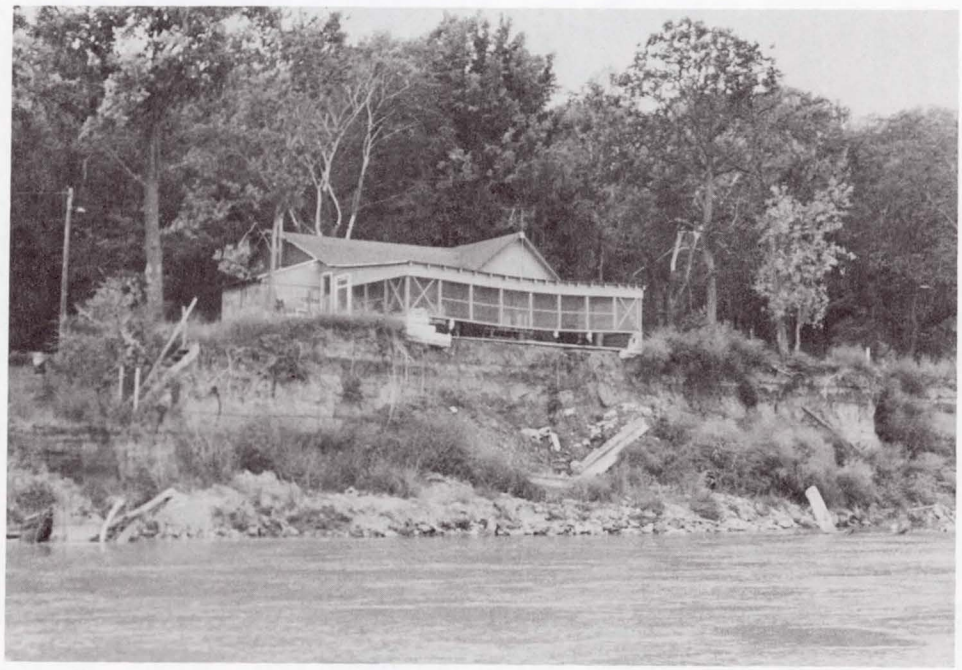
PHOTO 33. TYPICAL SEVERE EROSION CONDITIONS AT RIVER MILE 783.2*
(Photo Taken 12 April 1977)

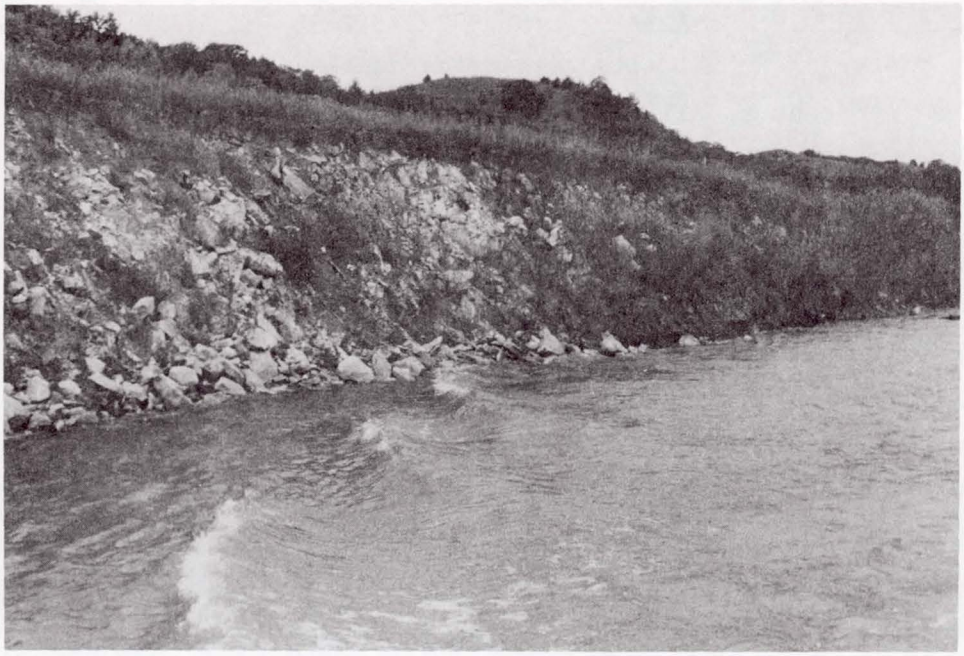
PHOTO 41. WINDROW REVETMENT 785.5* APPROXIMATELY TWO YEARS AND NINE MONTHS AFTER COMPLETION, LOOKING U/S (Photo Taken 5 October 1979)

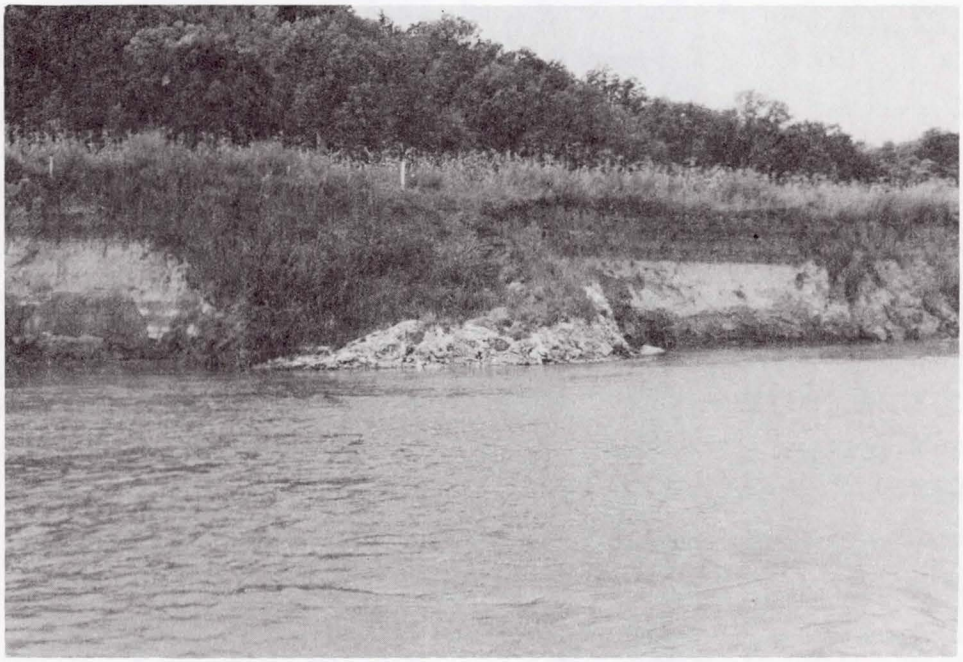
PHOTO 42. L-SHAPED HARDPOINT 785.82* TWO YEARS AND SEVEN MONTHS AFTER COMPLETION, LOOKING U/S (Photo Taken 5 October 1979)

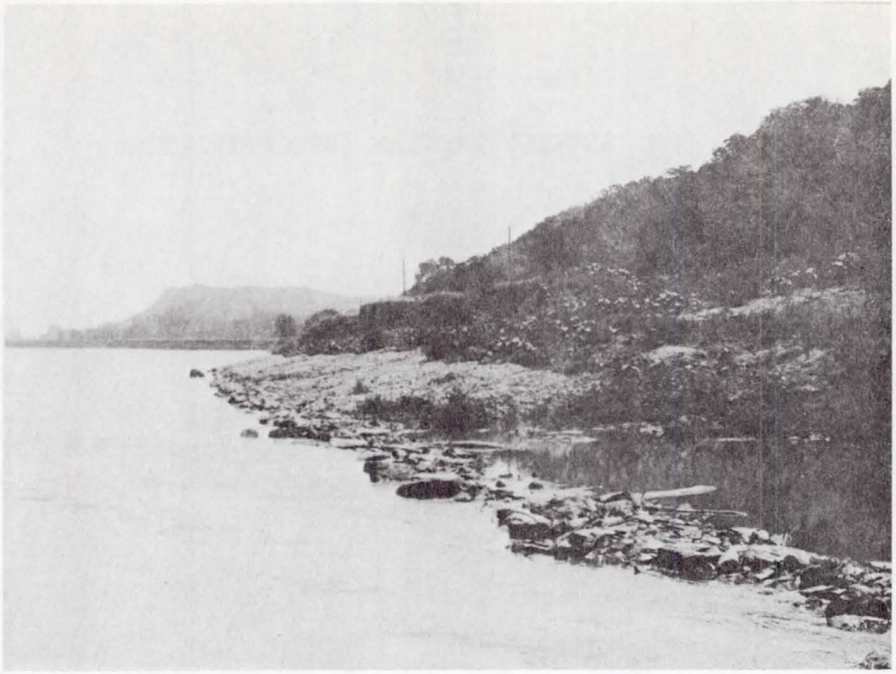
PHOTO 43. COMPOSITE REVETMENT 775.9* STATION 6+00, LOOKING D/S. LOW GRADE MATERIAL TOE FILL PLACED RIVERWARD AND PARALLEL TO THE BANKLINE (Photo Taken 6 August 1978)

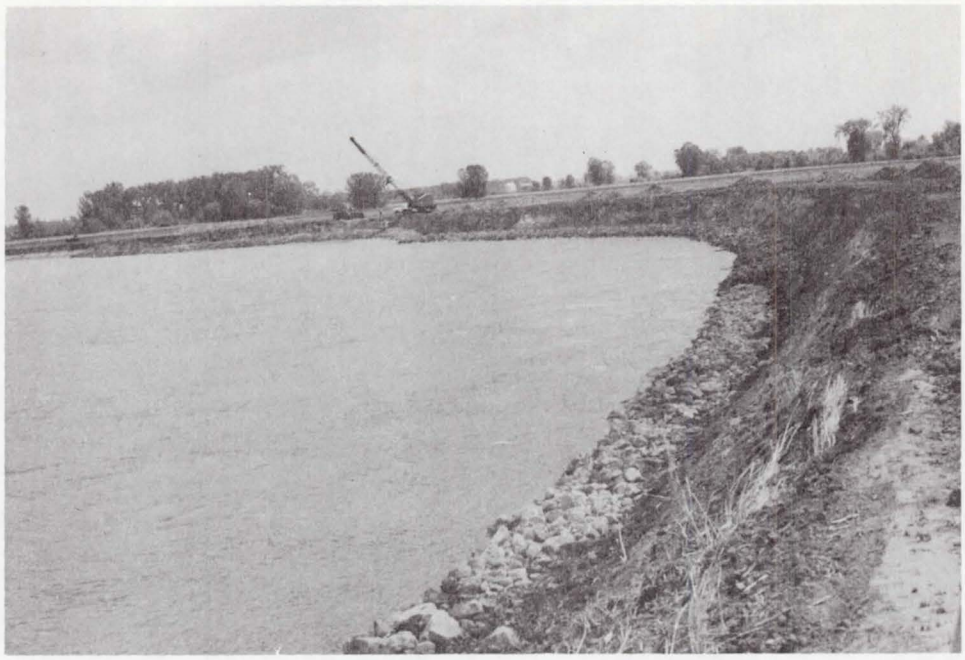
PHOTO 47. COMPOSITE REVETMENT 774.9* DURING CONSTRUCTION. TOE CONSTRUCTED ENTIRELY OF LOW GRADE MATERIAL AND COVERED WITH A THIN LAYER OF GRAVEL (Photo Taken 14 May 1980)

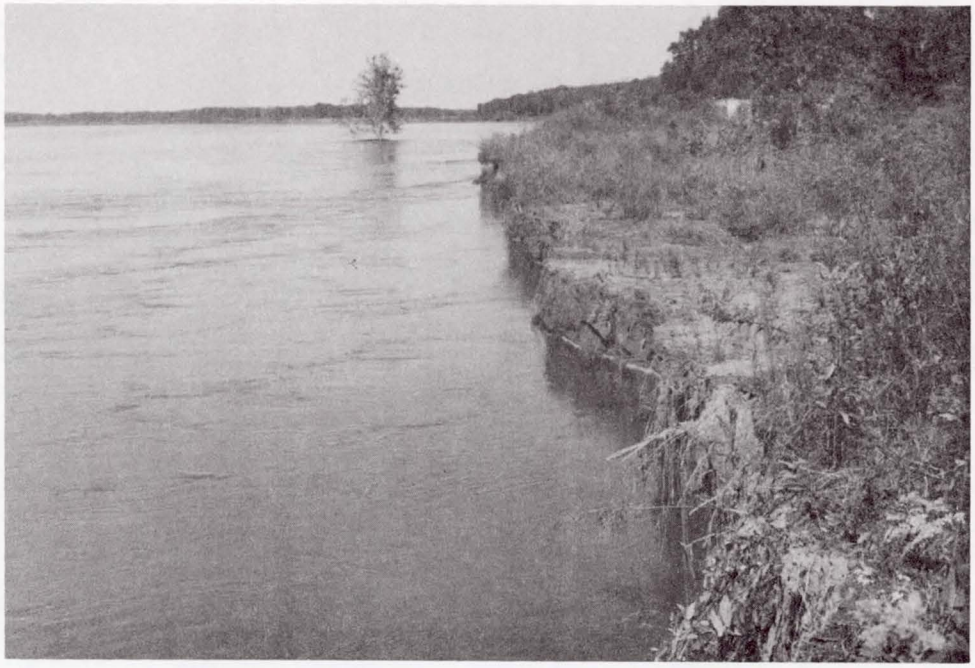
PHOTO 49. TYPICAL EROSION ALONG THE VERMILLION RIVER CHUTE AREA THIS PHOTO IS IMMEDIATELY D/S OF THE VERMILLION RIVER (Photo Taken 13 September 1979)

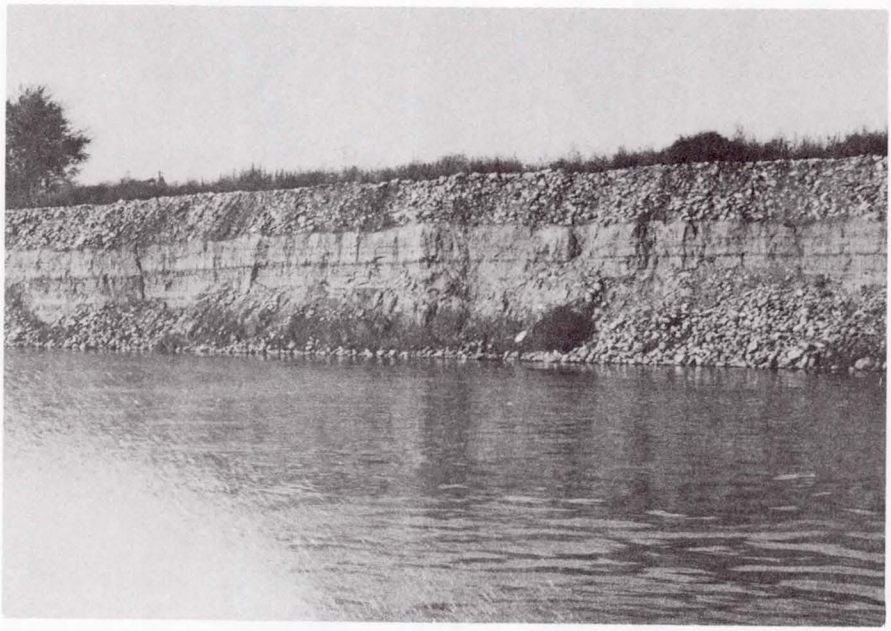
PHOTO 53. WINDROW REVETMENT 771.9*, APPROXIMATELY 5 MONTHS AFTER COMPLETION. THE UNPROTECTED AREA ON THE PHOTO IS JUST UPSTREAM OF REFUSAL 771.91
(Photo Taken 26 October 1977)

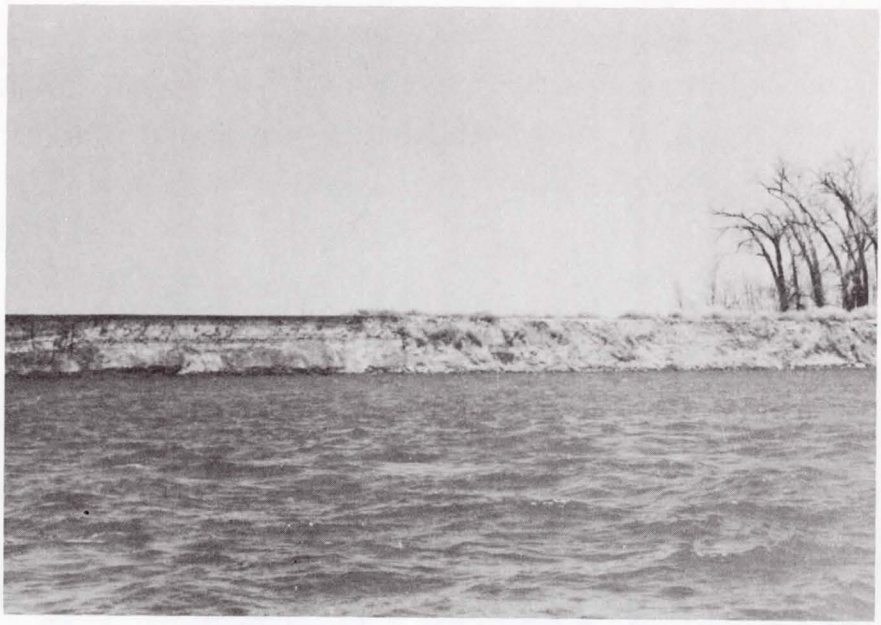
PHOTO 56. WINDROW REVETMENT 771.9*, APPROXIMATELY 1 YEAR AND 11 MONTHS AFTER COMPLETION (Photo Taken 17 April 1979)

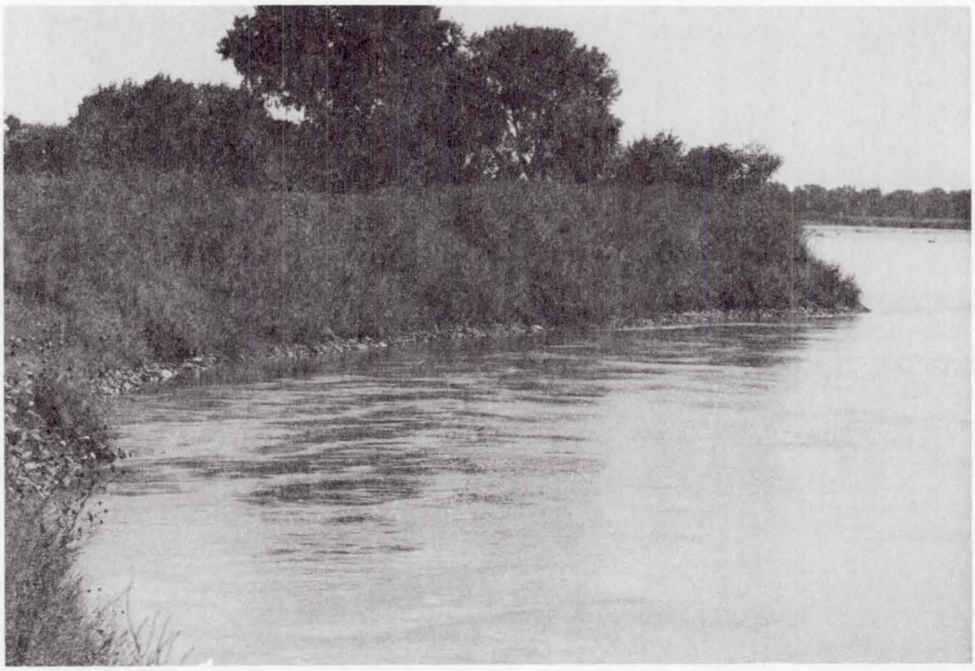
VERMILLION RIVER CHUTE AREA
Photos 57 and 58

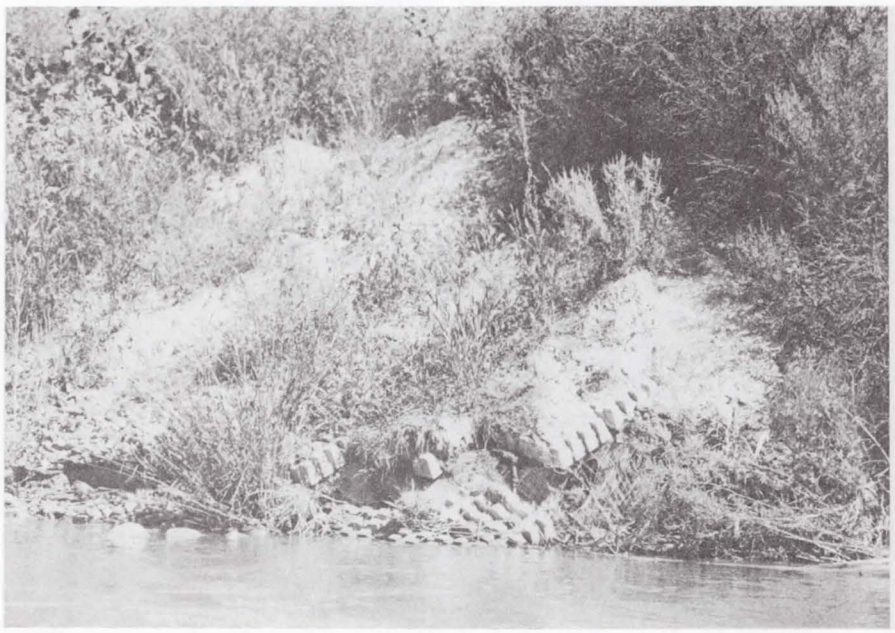
PHOTO 79. COMPOSITE REVETMENT 754.05* SHOWS MINOR DAMAGE TO UPPER BANK PROTECTIONS CAUSED BY NATURAL RUNOFF, WAVE WASH, AND LEACHING (Photo Taken 5 September 1980)
