Assessment of Structural Flood-Control Measures on Alluvial Fans

October 1993

Hydrologic Engineering Center
US Army Corps of Engineers
609 Second Street
Davis, CA 95616-4687
(916) 756-1104

Federal Insurance Administration
Federal Emergency Management Agency
500 C Street, SW
Washington, D.C. 20472

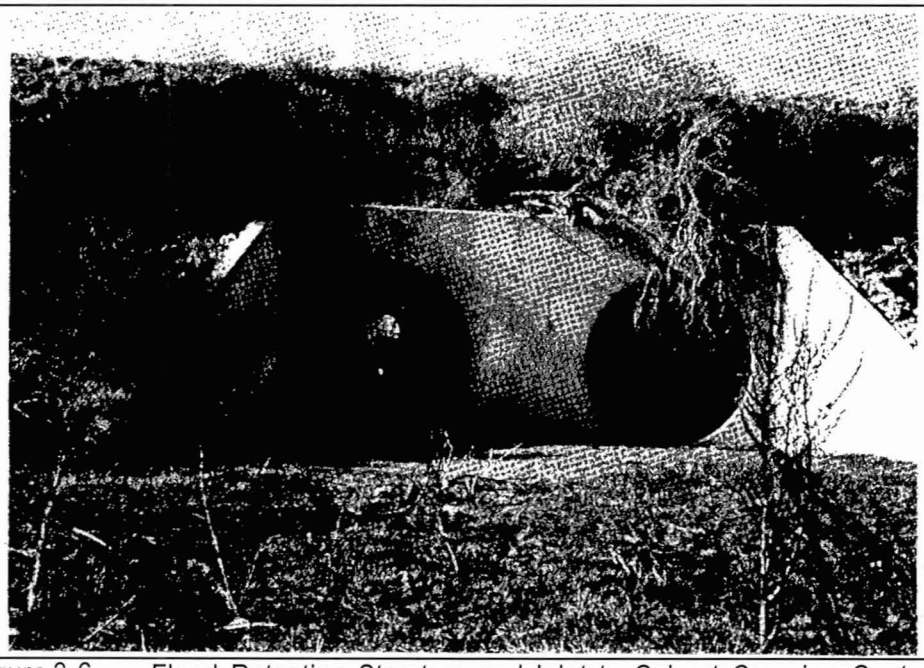
The Central Arizona Project (CAP) canals are protected, in some locations, by a flood-retention structure across fan outwash areas, just above and parallel to the canal. The outlet works are simple culverts (referred to as "overshoots") that carry the flood flow across the canal, preventing contamination of the canal water. Figure 3-6 shows the flood-retention structure and the inlet to a culvert crossing the CAP. The flow is then released into controlled or natural drainage systems below the canal. While the rural locations support using the natural drainage systems, more developed locations typically use a concrete-lined flood channel. The local experience indicated that flood-control performance has been favorable; however, there have been some problems with settlement. The settlement is probably the result of consolidation of fan

Figure 3-6 Flood Retention Structure and Inlet to Culvert Crossing Central Arizona Project, near Scottsdale, Arizona

material caused by flood inundation. Similar problems have occurred along the California Aqueduct in the Central Valley of California. Portions of the aqueduct right-of-way were flooded to consolidate the material prior to project construction.
