FINAL REPORT TO CONGRESS

**THE STREAMBANK EROSION CONTROL
EVALUATION AND DEMONSTRATION ACT OF 1974
SECTION 32, PUBLIC LAW 93-251**

Appendix E - Missouri River Demonstration Projects

A COMPREHENSIVE SUMMARY REPORT ON TWENTY-EIGHT
STREAMBANK EROSION CONTROL DEMONSTRATION PROJECTS ON
THE MISSOURI RIVER IN THE THREE REACHES: GARRISON DAM
TO LAKE OAHE, FT. RANDALL DAM TO NIOBRARA, AND GAVINS
POINT DAM TO PONCA

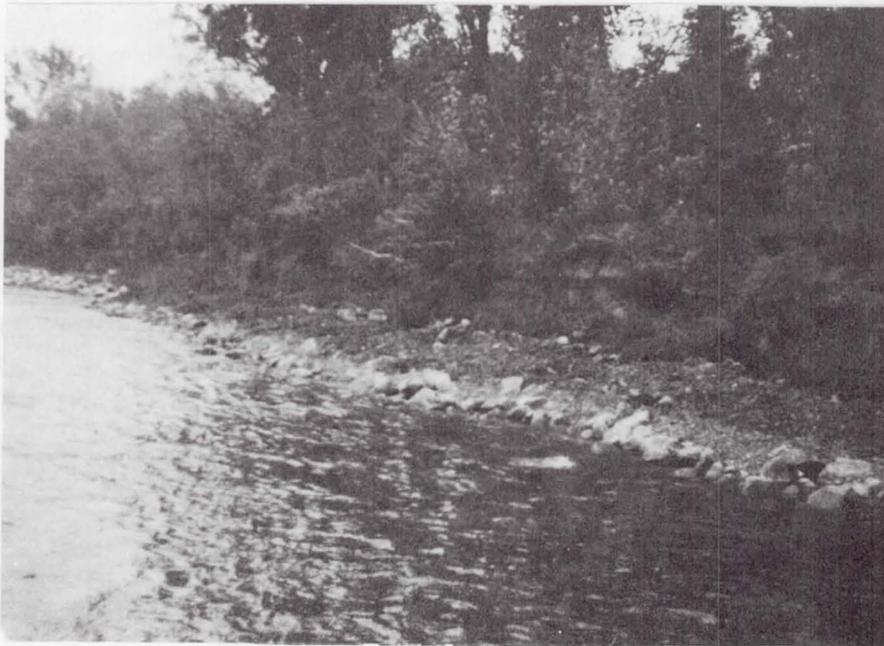
Photo 36. Composite Revetment 1317.78 approximately 3 months after completion. (Photo taken 2 September 1980)

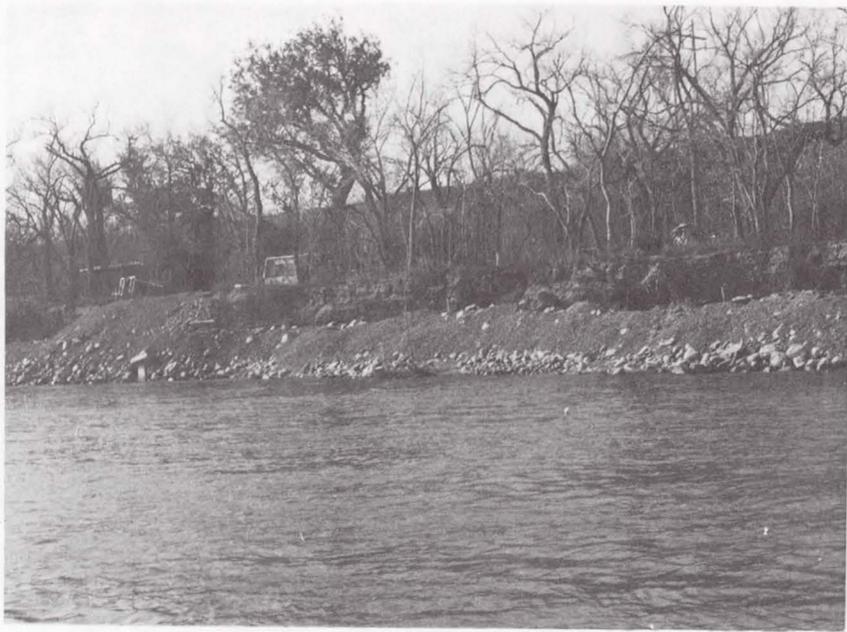
Photo 37. Composite Revetment 1318.2 approximately 4 months after completion. (Photo taken 9 October 1980)

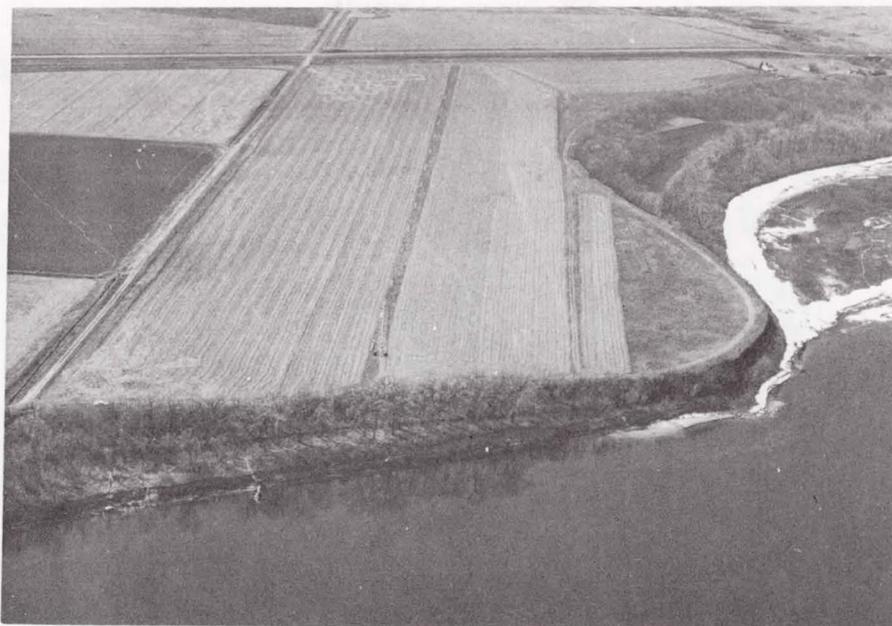
Photo 42. Aerial view of upstream portion of Pretty Point-Phase I Area prior to construction. (Photo taken 15 April 1980)

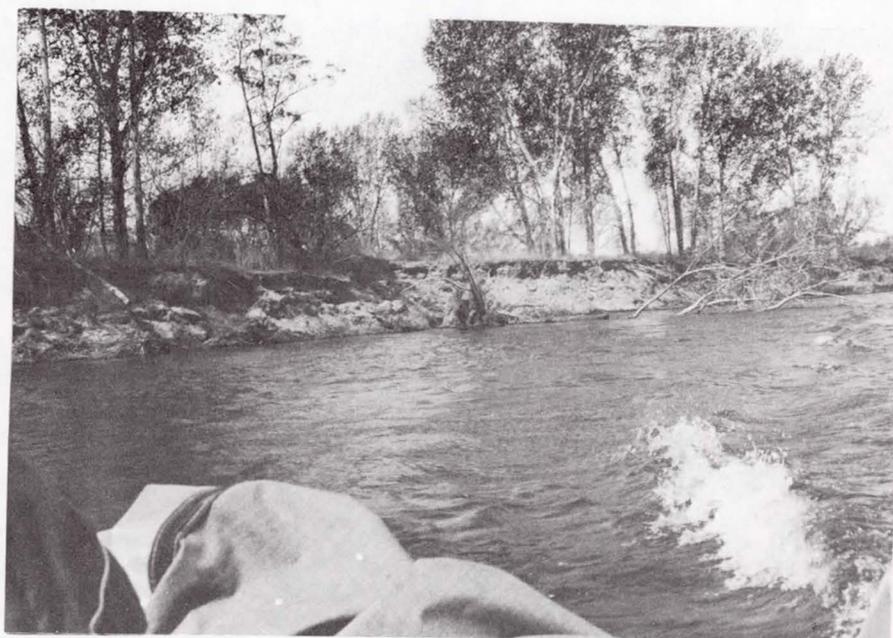
Photo 43. Typical downstream bankline along Pretty Point-Phase I Area prior to construction. (Photo taken 22 May 1980)

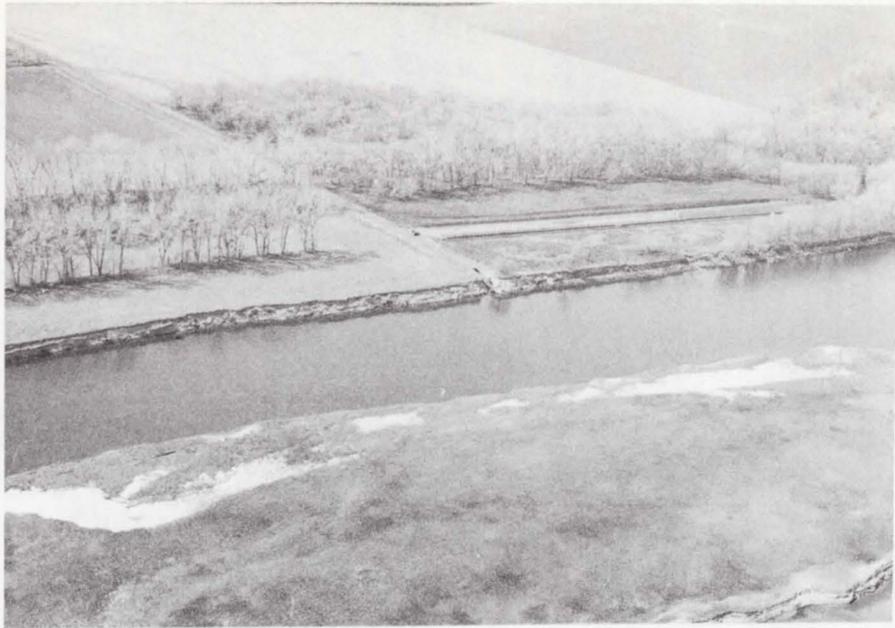
Photo 44. Aerial view of Price-Part I Phase I area, prior to construction. (Photo taken 15 April 1980)

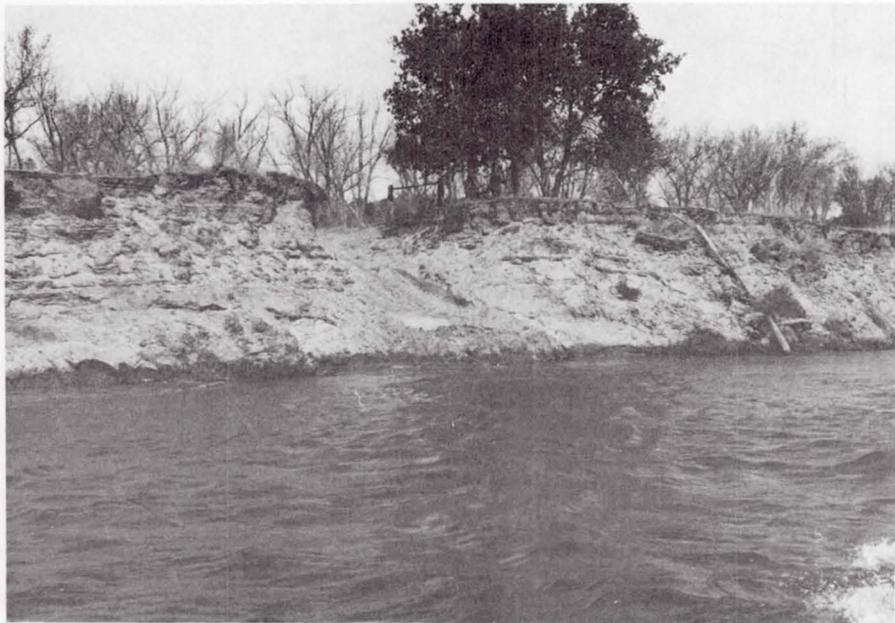
Photos 44 and 45 show typical eroding banklines along the Price-Part I (Phase I) project area.

Photo 45. Typical eroding bankline. (Photo taken 22 May 1980)

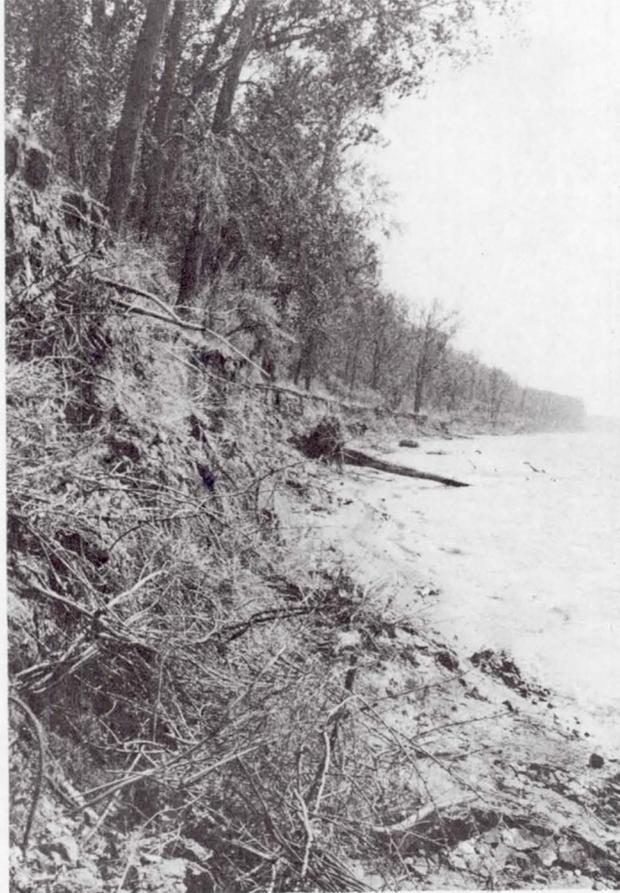
Photo 46 shows the typical eroding bankline along the Coal Lake Coulee (Phase I) project area.

Photo 46. Typical severely eroding bankline along the Coal Lake Coulee - Phase I project area. (Photo taken 23 May 1980)

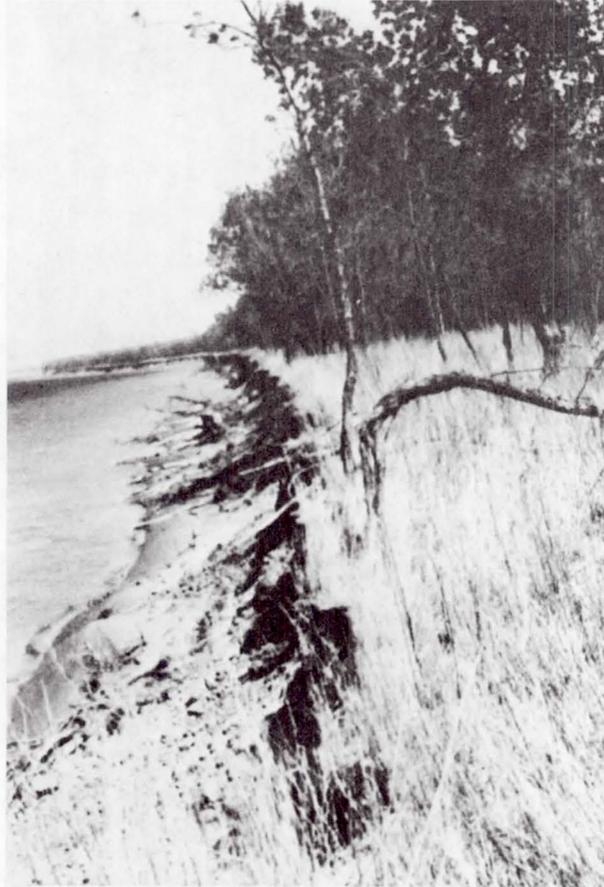
A photograph of the typical eroding bankline at the Knife Point - Part I (Phase I) project area is shown on Photo 47.

Photo 47. Typical eroding bankline along the Knife Point - Part I - project area. (Photo taken 23 May 1980)

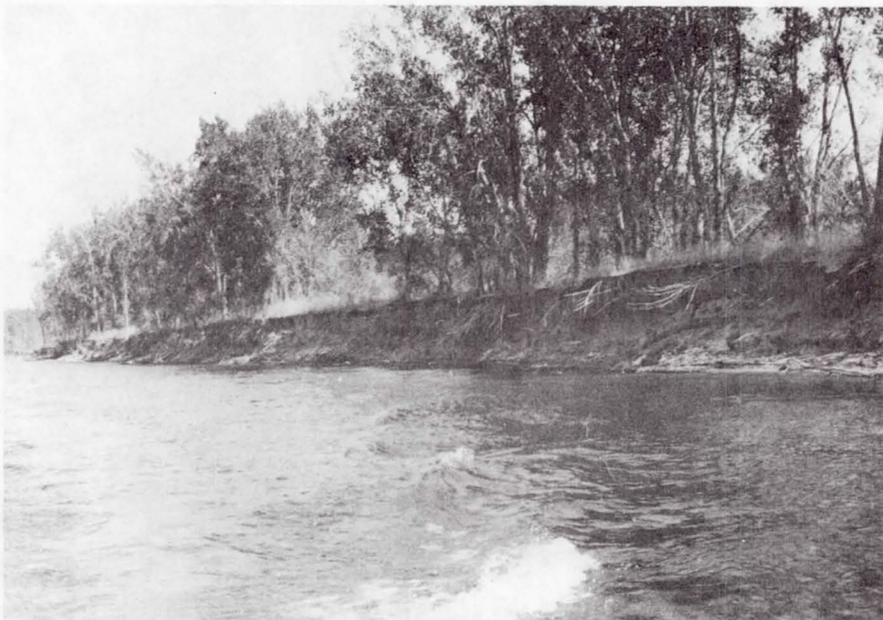
A photograph of the typical eroding bankline along the Wildwood (Phase I) Project area is shown on Photo 48.

Photo 48. Typical eroding bankline along Wildwood - Phase I project area. (Photos taken 22 May 1980)

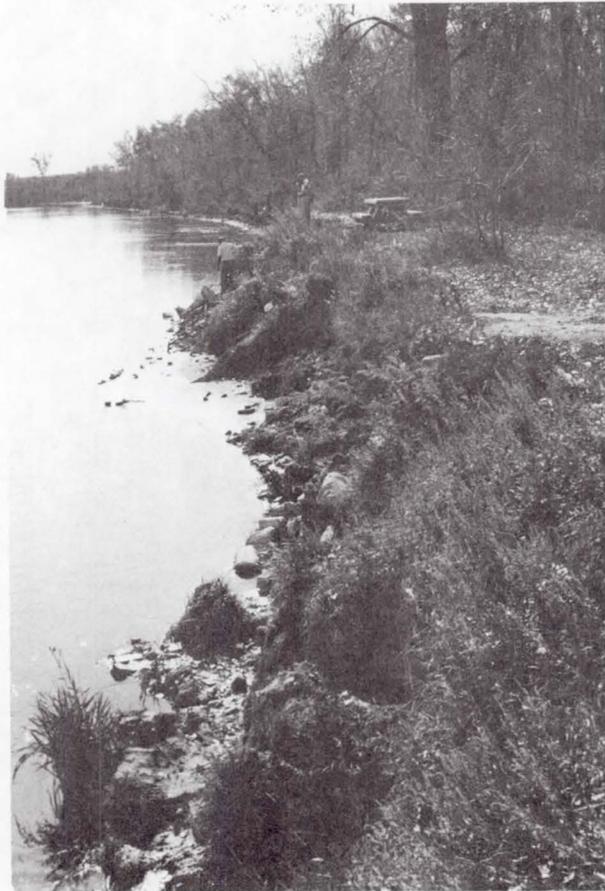
A photograph of the typical eroding bankline along the Fort Lincoln (Phase I) project area is shown on Photo 49.

Photo 49. Typical eroding bankline along the Fort Lincoln - Phase I project area. (Photo taken 9 October 1980)

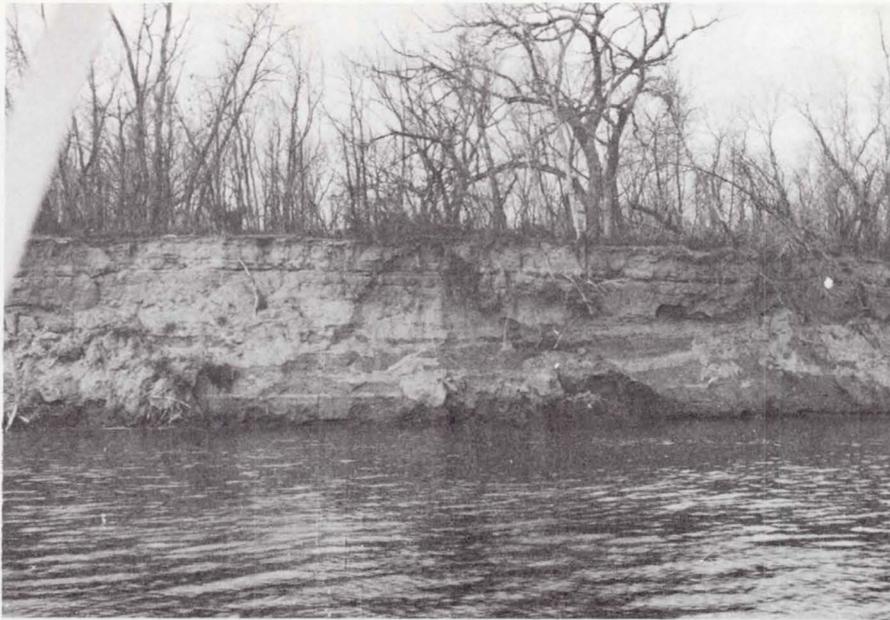
Photo 50. Typical eroded bankline along upstream portion of the Horseshoe Butte-Phase project area. (Photo taken 9 October 1980)

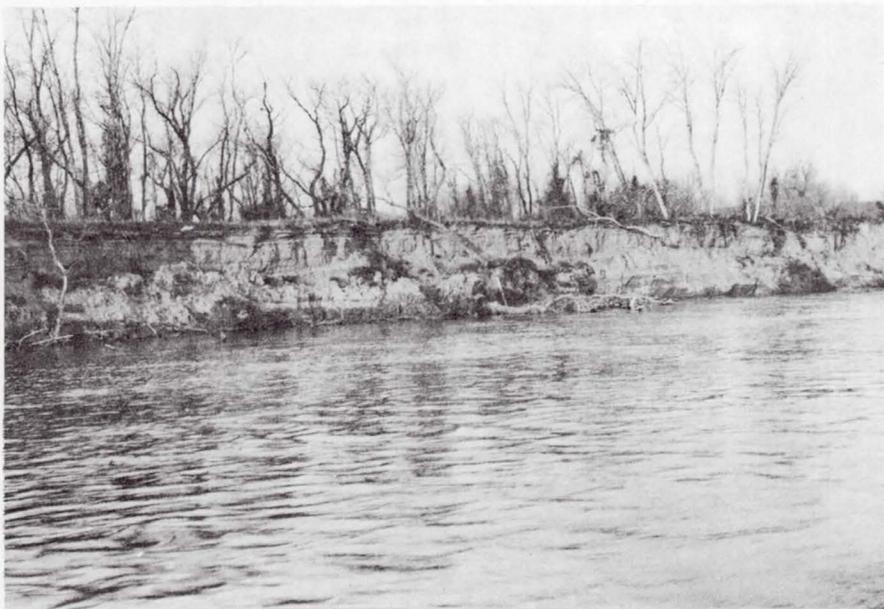
Photo 51. Typical eroding bankline along Horseshoe Butte-Phase I project area. (Photo taken 9 October 1980)

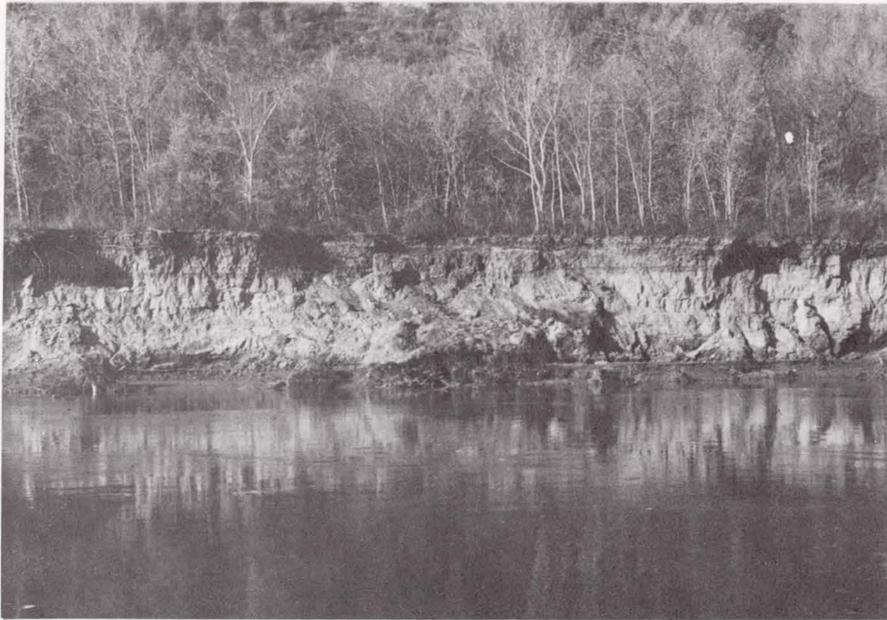
Photo 52. Typical eroding bankline along upstream portion of the project area. (Photo taken 8 October 1980)

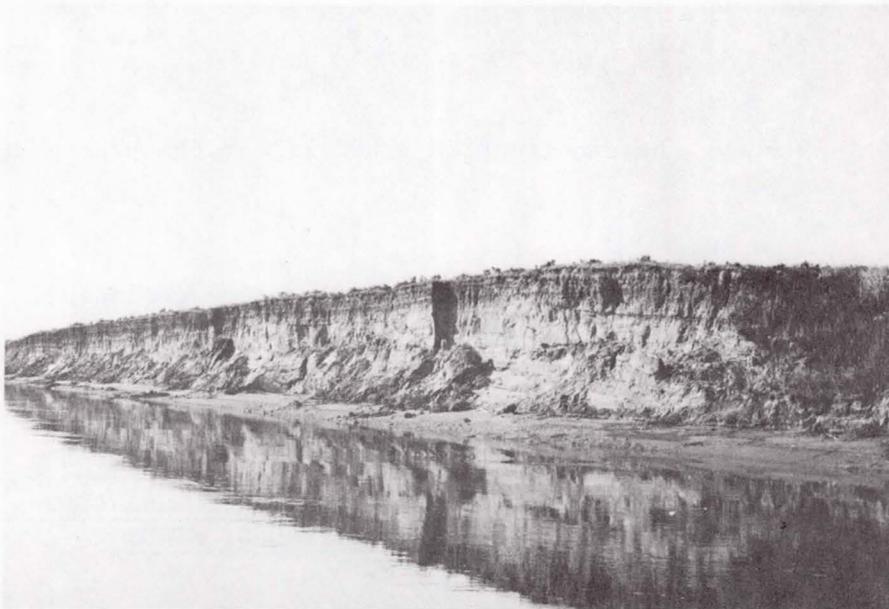
Photo 53. Typical eroding bankline along downstream portion of the project area. (Photo taken 18 July 1980)

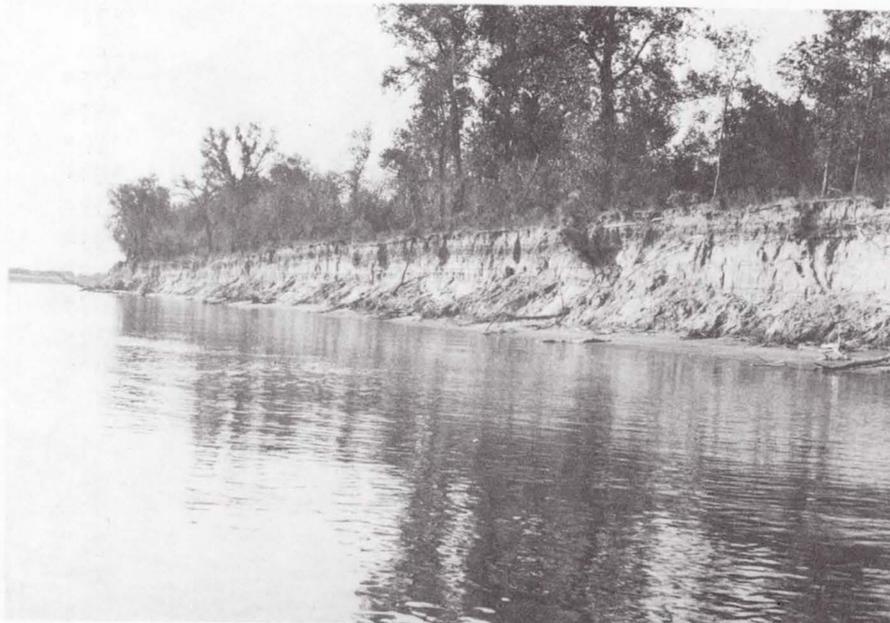
A photograph of a typical eroding bankline along the Hancock (Phase I) project area is shown on Photo 54.

Photo 54. Typical severely eroding bankline along Hancock-Phase I project. (Photo taken 18 July 1980)

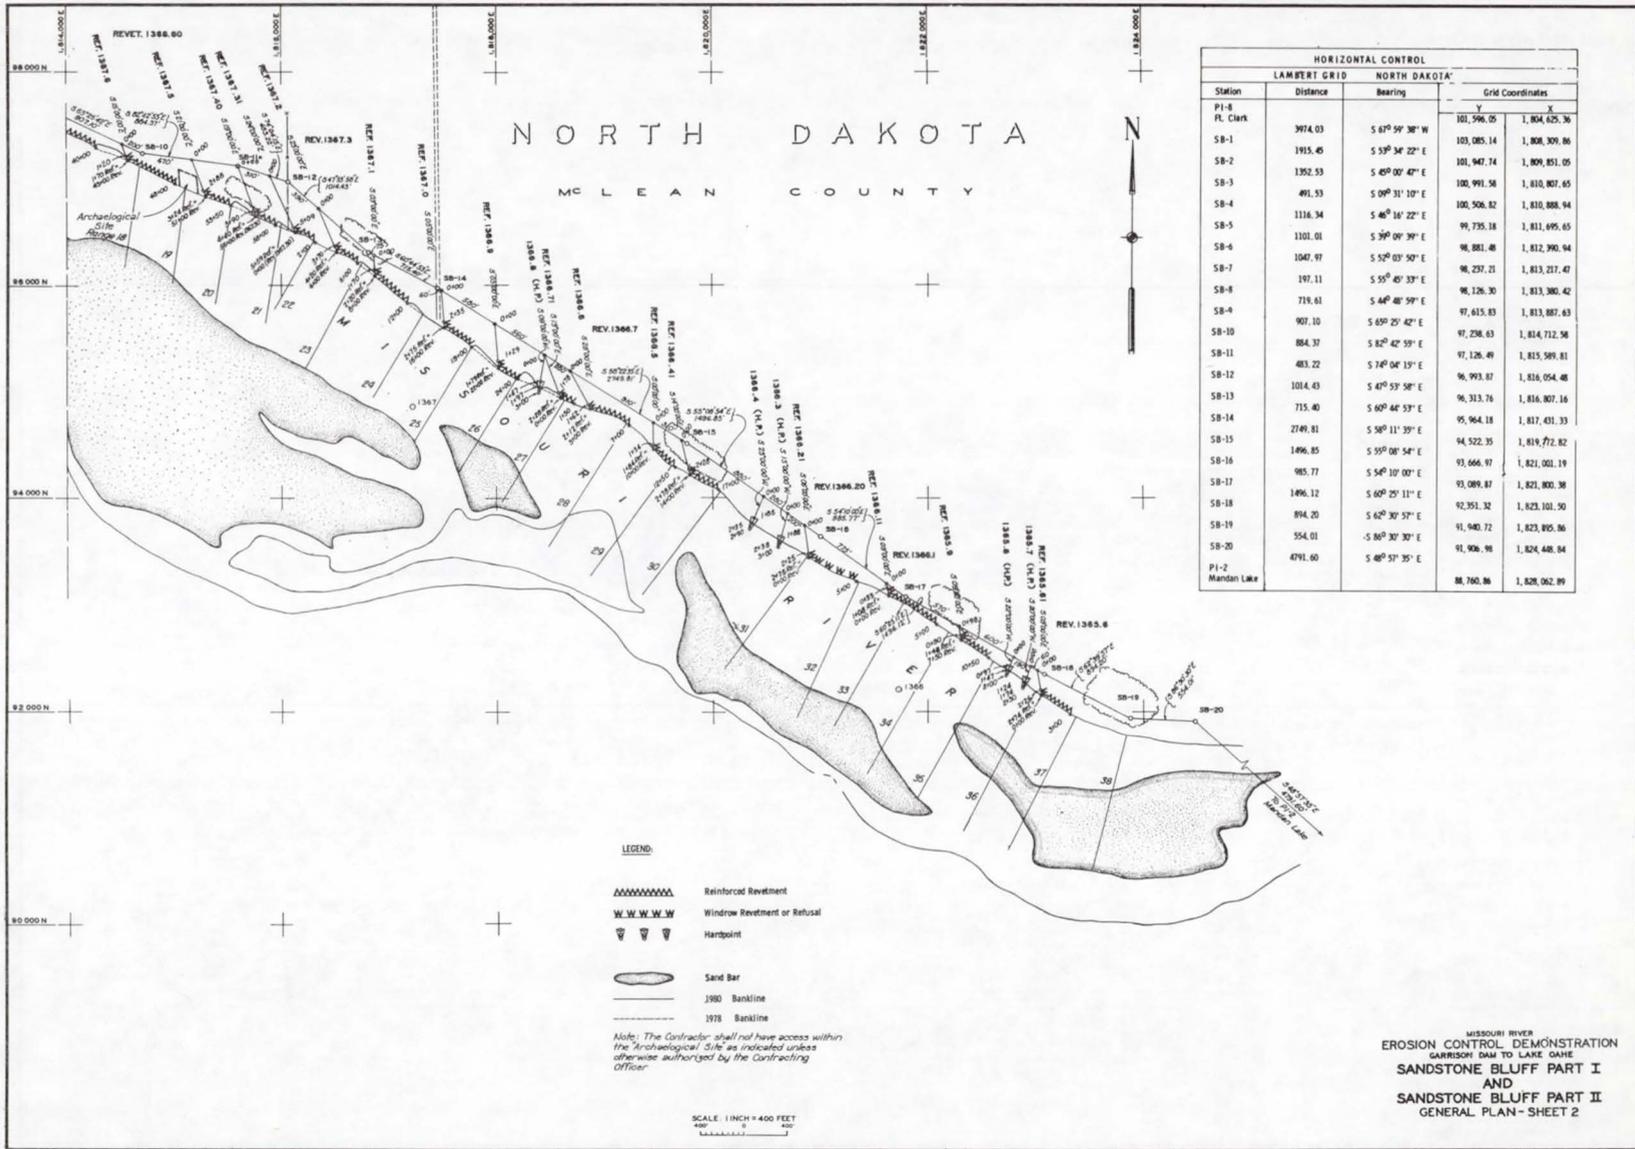
PLATE 4-1

concentrated along the bankline in the downstream portion of the project area as shown on Plates 4-1 and 4-2. The channel bed character within 25 feet of water's edge along the left bank is very irregular with depths ranging from 3 feet to 11 feet. The underwater bank slope in May 1978 varied considerably from 1V on 2H up to 1V on 14H.

(1) The concentration of flows along the project area has resulted in erosion of the unprotected bankline between revetment segments as shown on Plates 4-1 and 4-2. The interstructure erosion has developed to such an extent that several windrow refusal structures are in danger of being flanked. Rehabilitation to extend the length of these refusals will be completed in the summer of 1981.

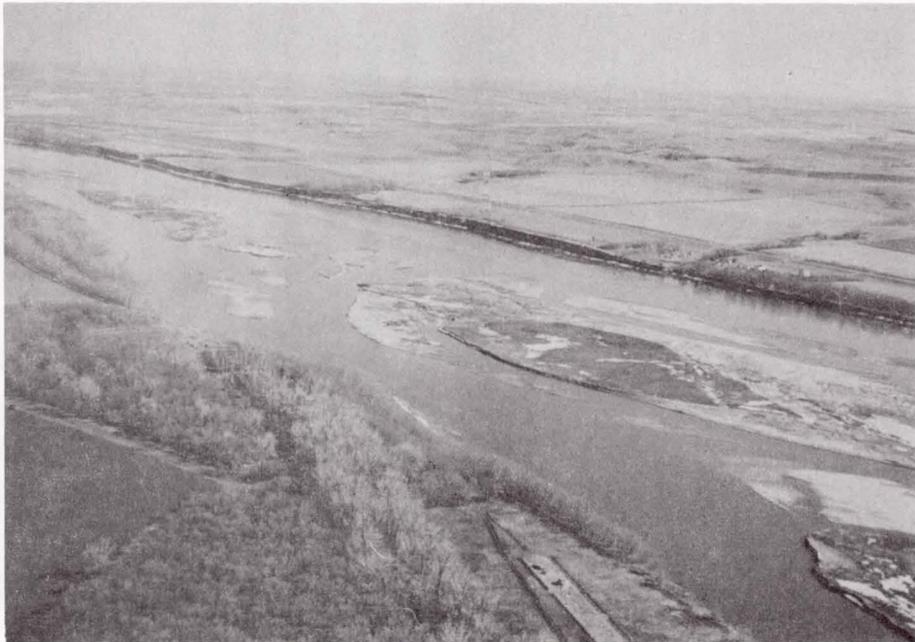
Photo No. 1. Wilton Area
(Note the woodland pattern)

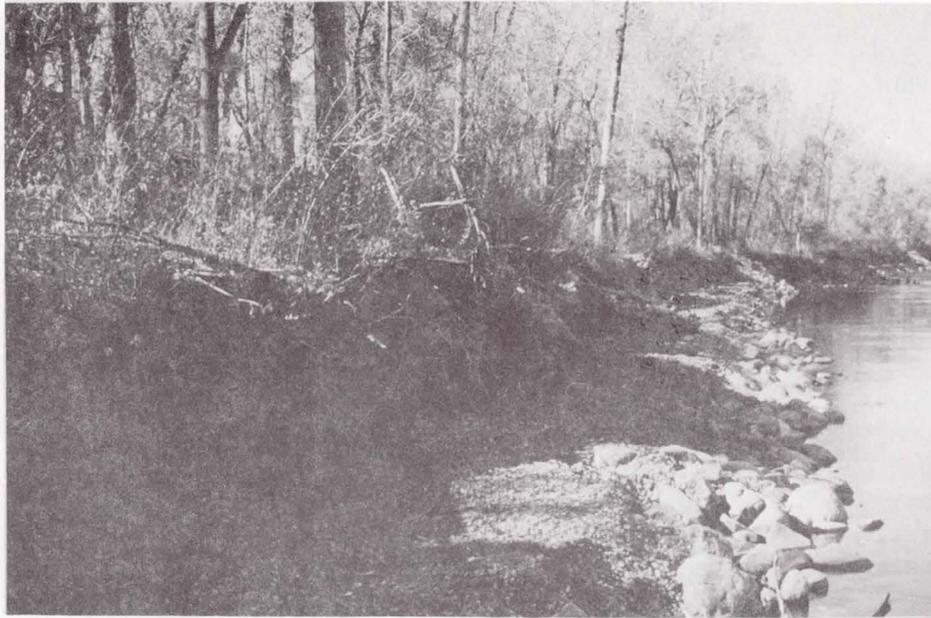
Construction methods consist of two types; from land or floating plant (barge). A land based operation is used when access to the stabilization site can be accomplished with minimal clearing or using existing roads and trails in the area. A barge is used at sites where extensive tree and shrub clearing would be necessary to complete the work (Photo No. 2).

Photo No. 2. I-94 Area

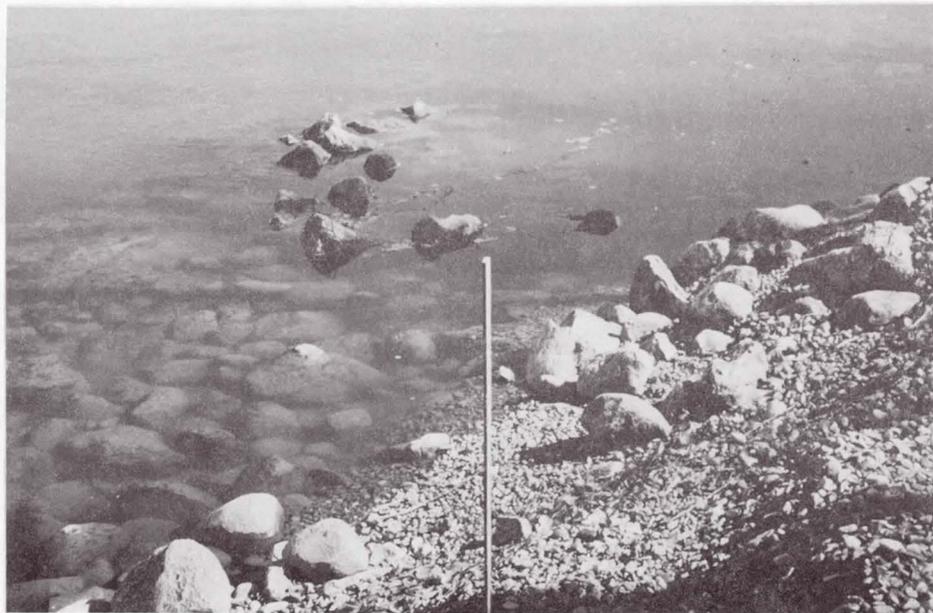
Effects on Fish and Wildlife Resources - Fish. Adverse impacts to the aquatic ecosystem have been minimal. In fact, there could be some minor positive effects. The rock used in many of the revetments provides a suitable substrate for invertebrates (Photo. 3). At the I-94 site, colonization by mayflies (Ephemeroptera) and caddis flies (Trichoptera), as well as other invertebrates, were noted. These invertebrates help to increase the food base for many river fishes. It should be recognized, however, that the overall contribution to the food base is very small. With 160 miles of shoreline of the free flowing Missouri River in North Dakota, a few hundred or few thousand feet of submerged rock will not significantly increase the food base of the river.

Photo No. 3. Rock Substrate, I-94 Area

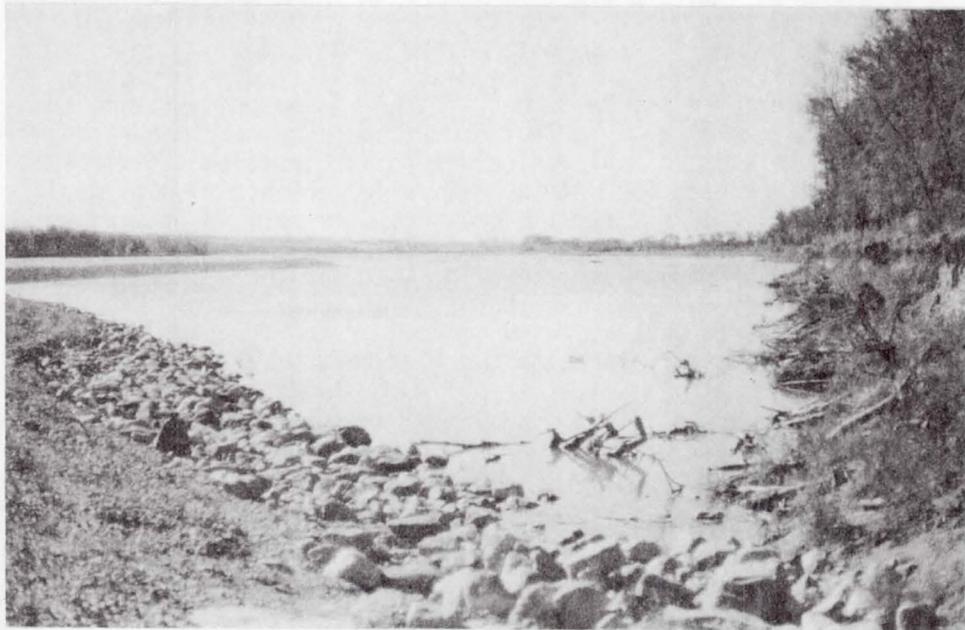
No. 4. - Sanger

At the Sanger site, a large backwater area was created behind the earth-core dike (Photo No. 4). In these backwater areas the water warms up faster and submerged aquatics have a chance to become established. This type of habitat provides a nursery area for many fishes including walleye, northern pike, crappie, white bass, white sucker and carp. Previous sampling efforts in areas similar to this one has confirmed this conclusion.

One problem with the earth-core dikes is that the area behind them has a tendency to become silted in or the lower end closes off completely. If this is combined with a decrease in the water releases from the dam, many small pools remain and the fish become stranded. The environmental notches and culverts through the dike were supposed to keep the areas behind the dikes from becoming silted in. While this is good in theory, it does not appear to have worked well in practice. At one site, instead of a large backwater area below a culvert, a narrow, shallow channel had been formed. As river levels receded, an isolated chute developed, deepest by the dike and dry at the lower end. This type of situation does little to benefit the fishery and can actually be a detriment to it. Young-of-the-year fish that might have stayed in the main river are now trapped in these isolated pools.

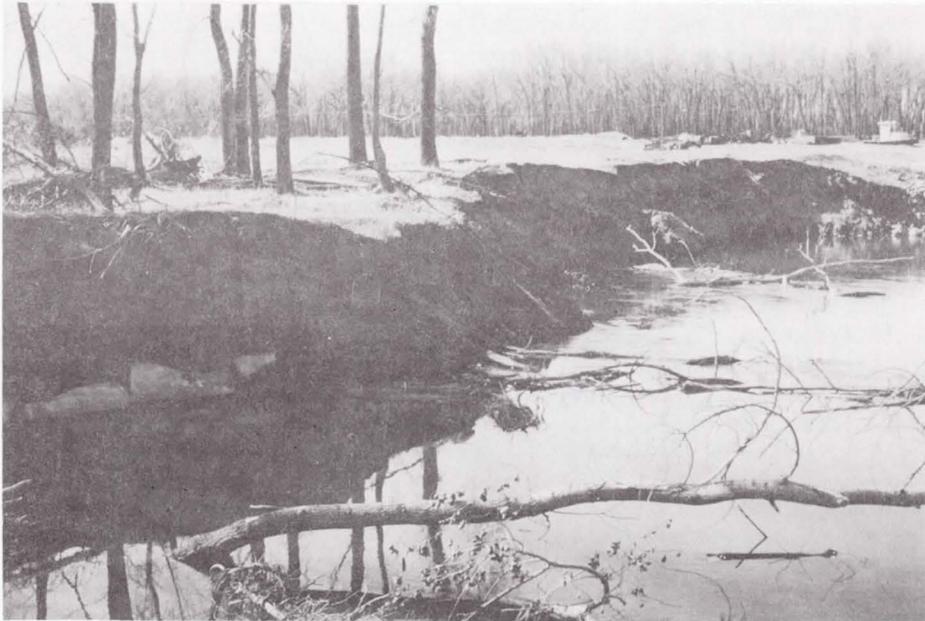
No. 5 - Eagle Park

Project construction has resulted in minimal habitat destruction. To date, we have documented approximately 3 acres of habitat lost. This all occurred at the Sanger site where a brushy hillside was cleared and the area was used as a borrow site (other previously cleared areas were already available). At other sites, individual trees have also been lost either due to direct removal for a project feature or because of structure placement (Photo 5). Generally, the amount of land involved is too small to quantify or would have been lost to erosion.

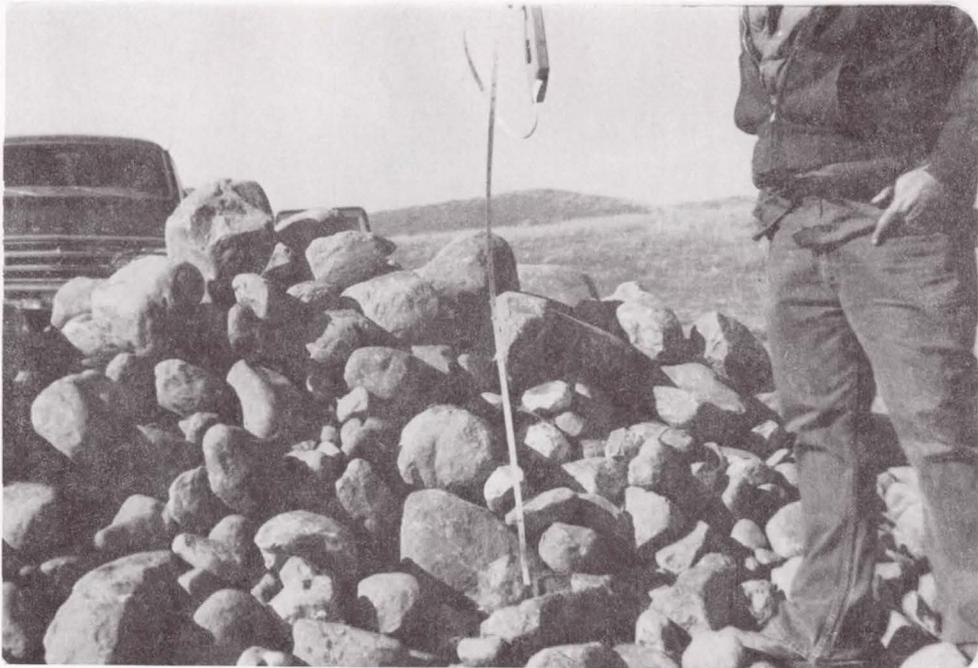
PHOTO 1. 200 LB. GRADATION STONE
(Photo Taken September 1980)

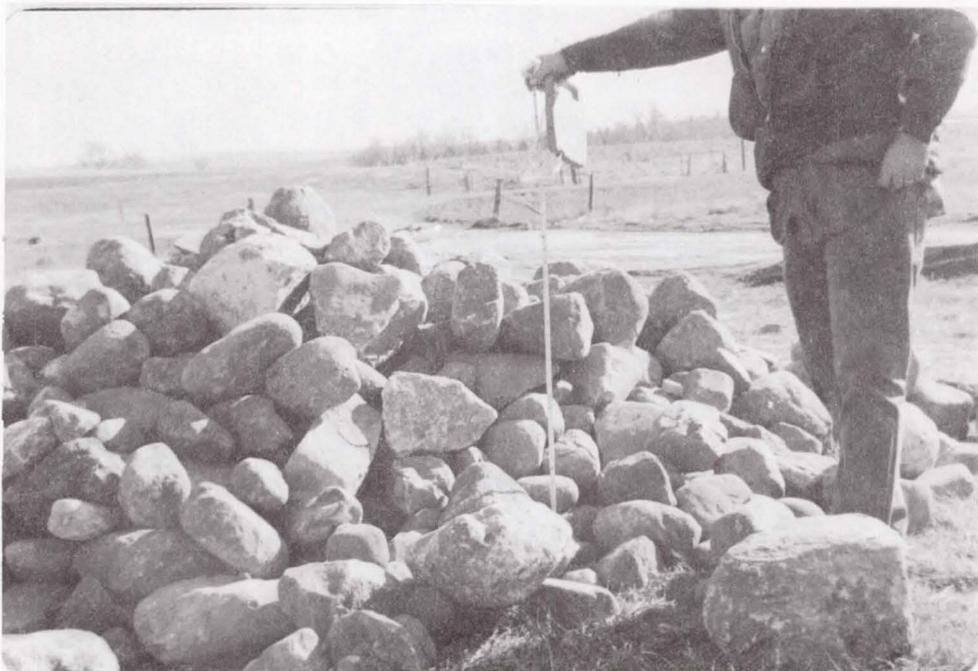
PHOTO 2. 500 LB. GRADATION STONE
(Photo Taken September 1980)

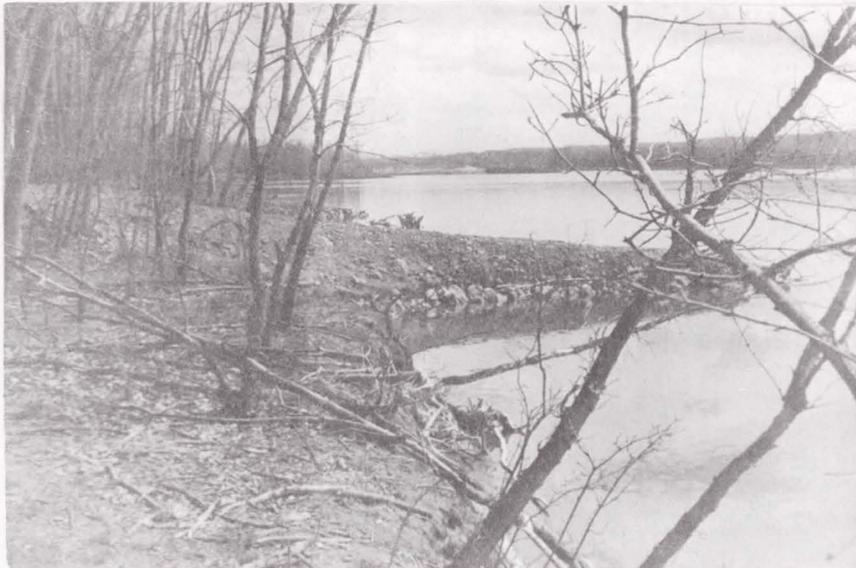
PHOTO 5. HARDPOINT 869.24, LOOKING UPSTREAM ALONG THE MIDDLE AND DOWNSTREAM PORTION OF THE PROJECT AREA. (Photo Taken 6 April 1981)

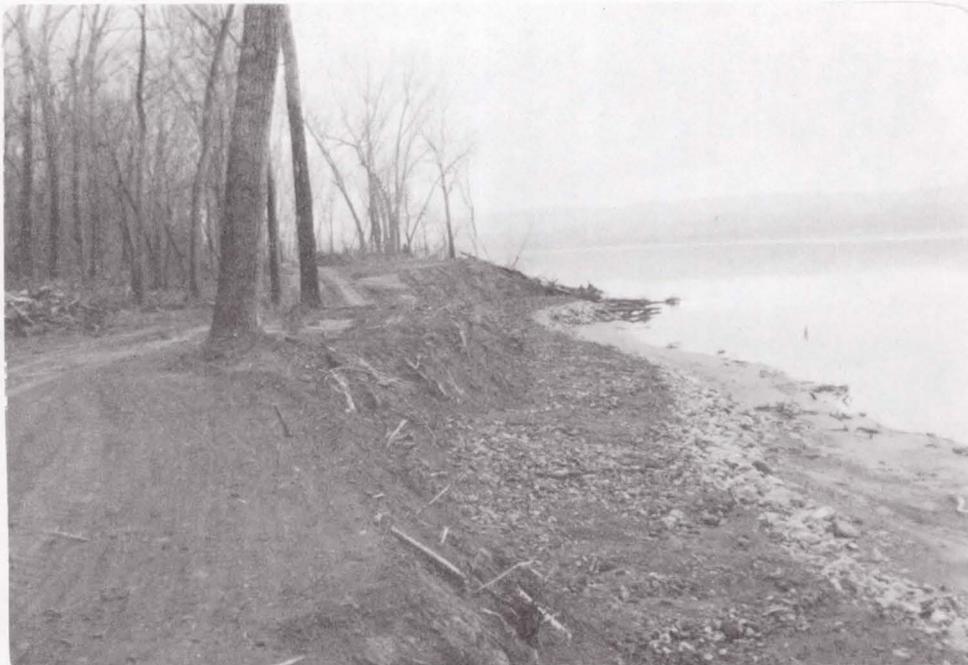
PHOTO 6. COMPOSITE REVETMENT 869.57, IMMEDIATELY AFTER COMPLETION. (Photo Taken December 1980)

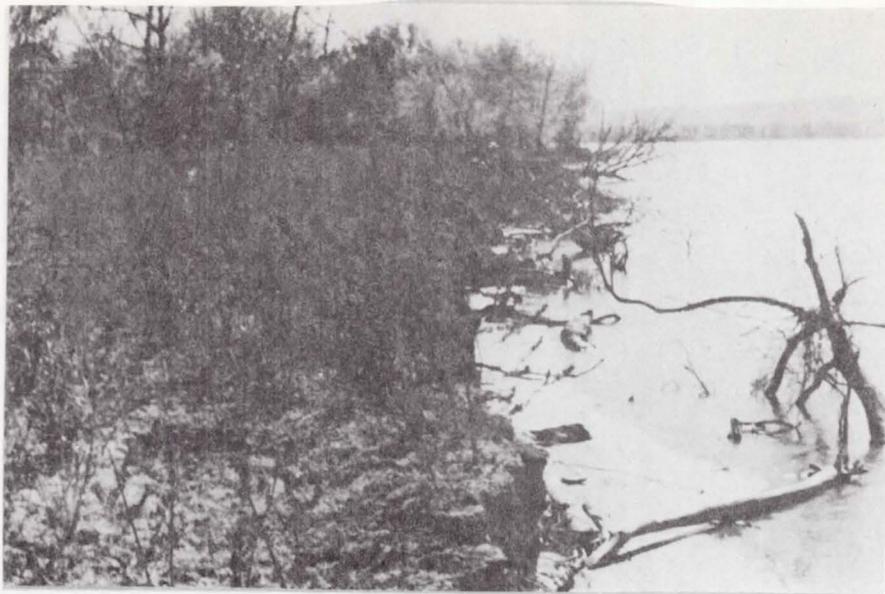
PHOTO 7. SITE OF WINDROW REVETMENT 870.0, STATION 15+50 PRIOR TO CONSTRUCTION. (Photo Taken 19 September 1980)

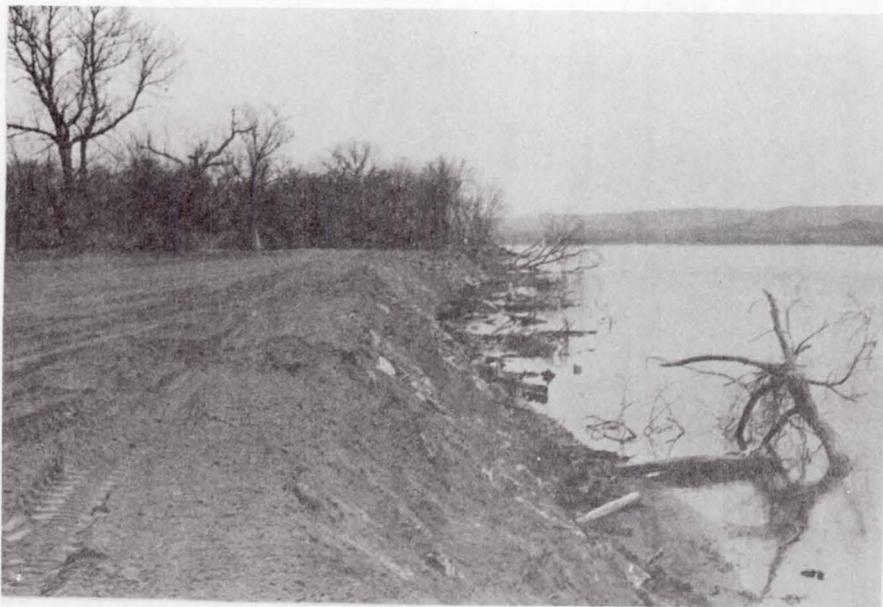
PHOTO 8. WINDROW REVETMENT 870.0, STATION 15+50, IMMEDIATELY AFTER COMPLETION. (Photo Taken December 1980)

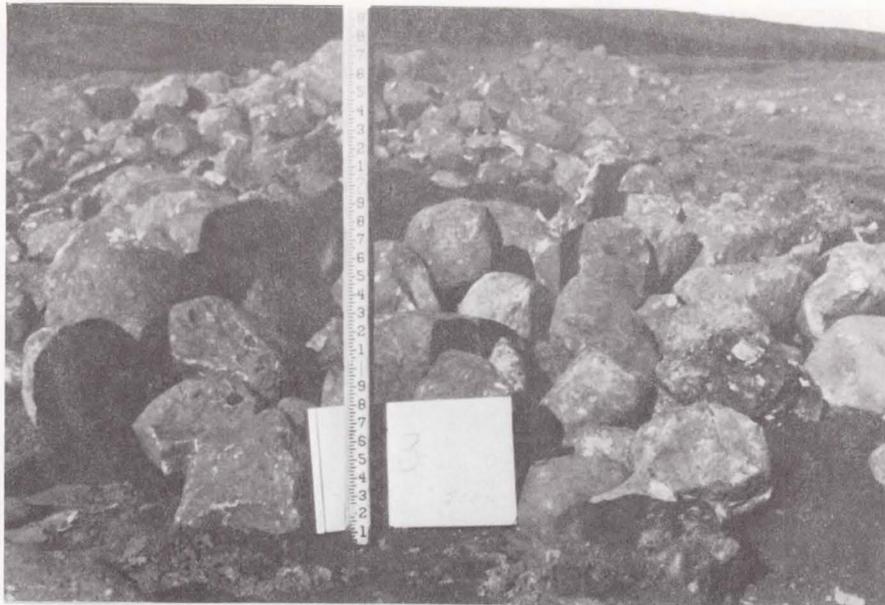
**PHOTO 9. 200 LB. GRADATION TEST
(Photo Taken 19 April 1979)**

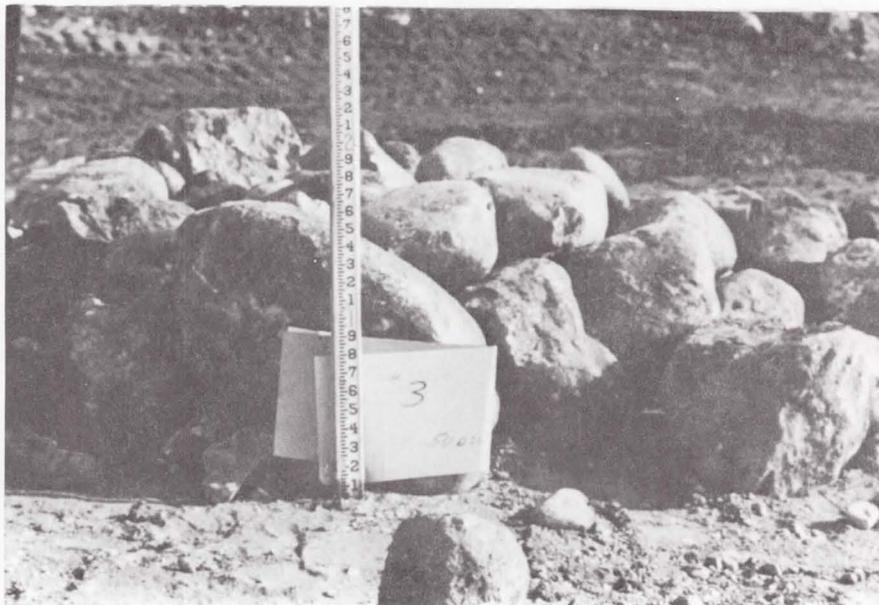
**PHOTO 10. 500 LB. GRADATION TEST
(Photo Taken 10 March 1979)**

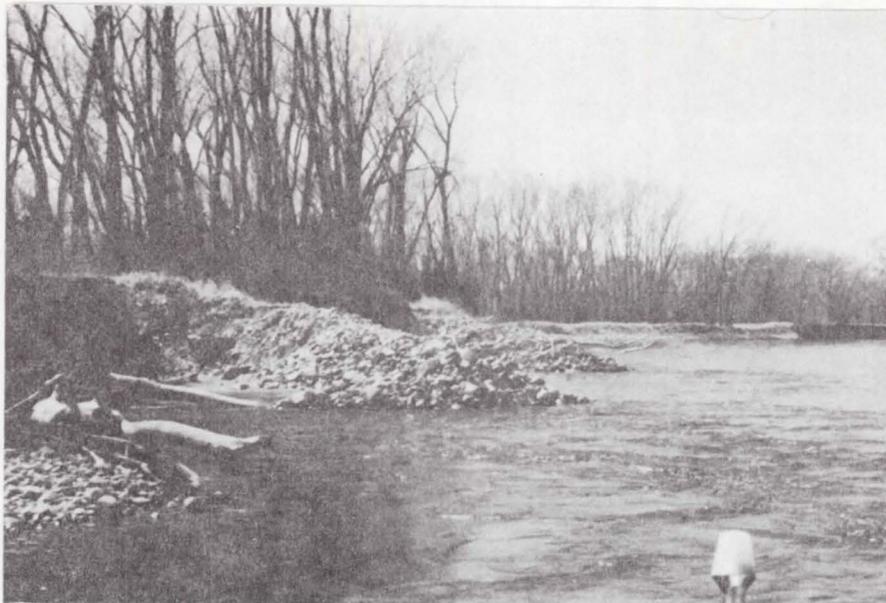
**PHOTO 11. HARDPOINTS 866.9 AND 866.8, APPROXIMATELY
1 YEAR AFTER COMPLETION. (Photo Taken
15 April 1980)**

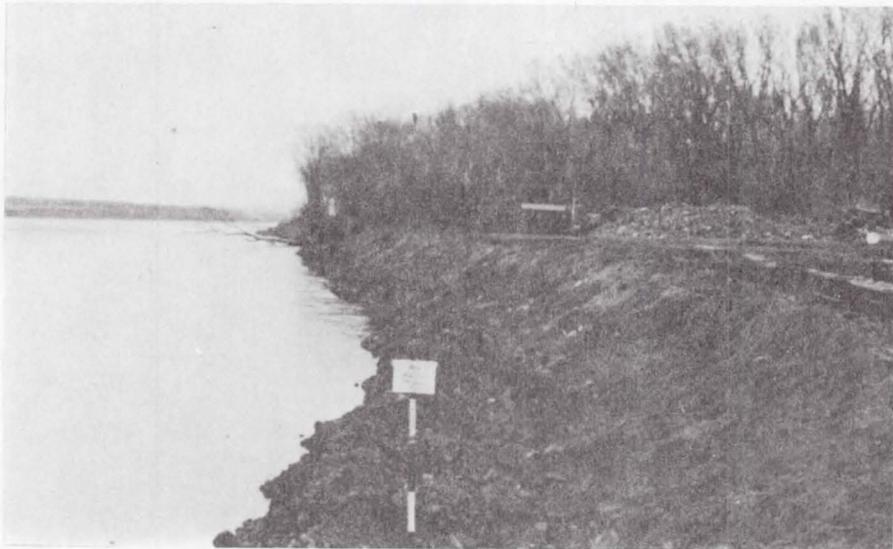
**PHOTO 12. REINFORCED REVETMENT 867.0, STA. 10+00, AFTER
STONE TOE PLACEMENT AND PRIOR TO TIEBACK
CONSTRUCTION. (Photo Taken 23 April 1979)**

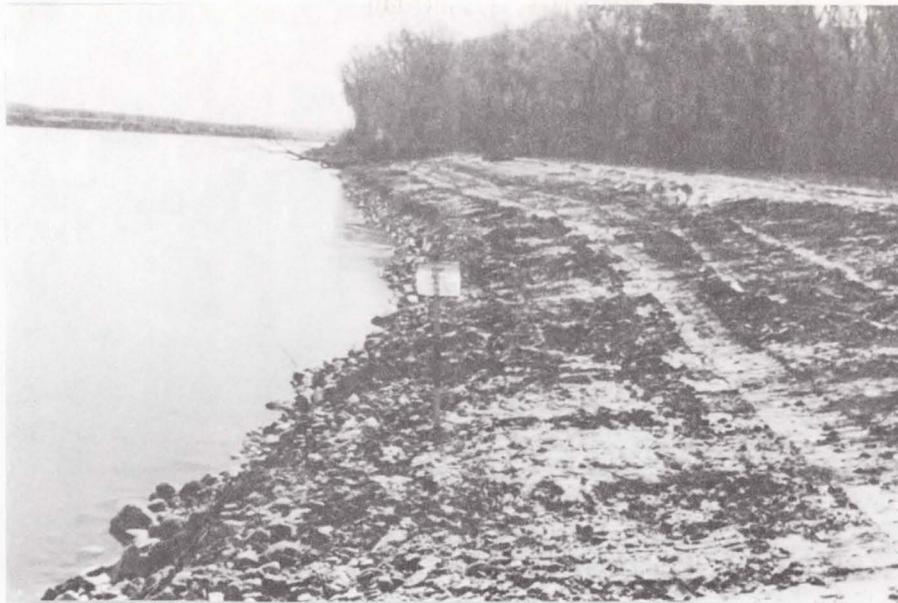
**PHOTO 13. REINFORCED REVETMENT 867.0, STATION 10+00,
IMMEDIATELY AFTER COMPLETION. (Photo Taken
12 April 1979)**

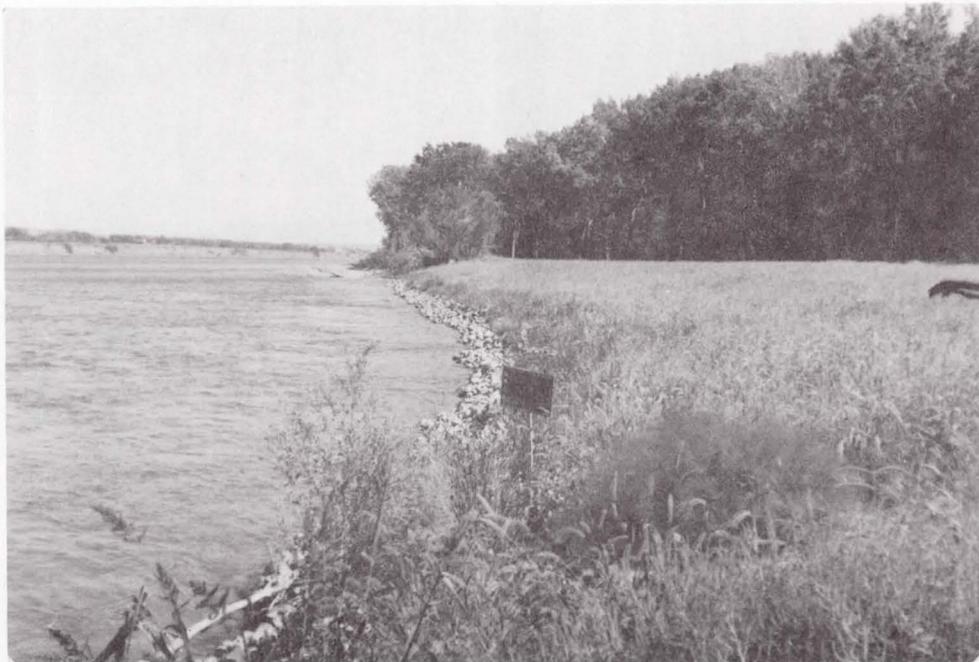
**PHOTO 14. REINFORCED REVETMENT 867.0, STA. 10+00,
APPROXIMATELY 15 MONTHS AFTER COMPLETION.
(Photo Taken August 1980)**

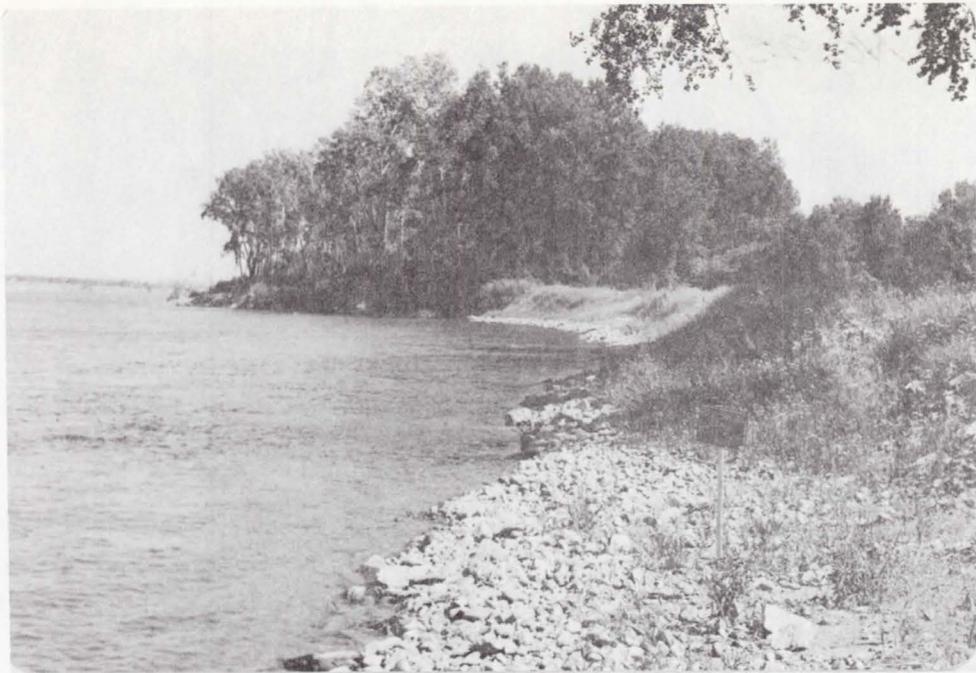
**PHOTO 15. REINFORCED REVETMENT 867.0, STATION 0+00,
APPROXIMATELY 15 MONTHS AFTER COMPLETION.
(Photo Taken August 1980)**
