FINAL REPORT TO CONGRESS

**THE STREAMBANK EROSION CONTROL
EVALUATION AND DEMONSTRATION ACT OF 1974
SECTION 32, PUBLIC LAW 93-251**

Appendix E - Missouri River Demonstration Projects

A COMPREHENSIVE SUMMARY REPORT ON TWENTY-EIGHT
STREAMBANK EROSION CONTROL DEMONSTRATION PROJECTS ON
THE MISSOURI RIVER IN THE THREE REACHES: GARRISON DAM
TO LAKE OAHE, FT. RANDALL DAM TO NIOBRARA, AND GAVINS
POINT DAM TO PONCA

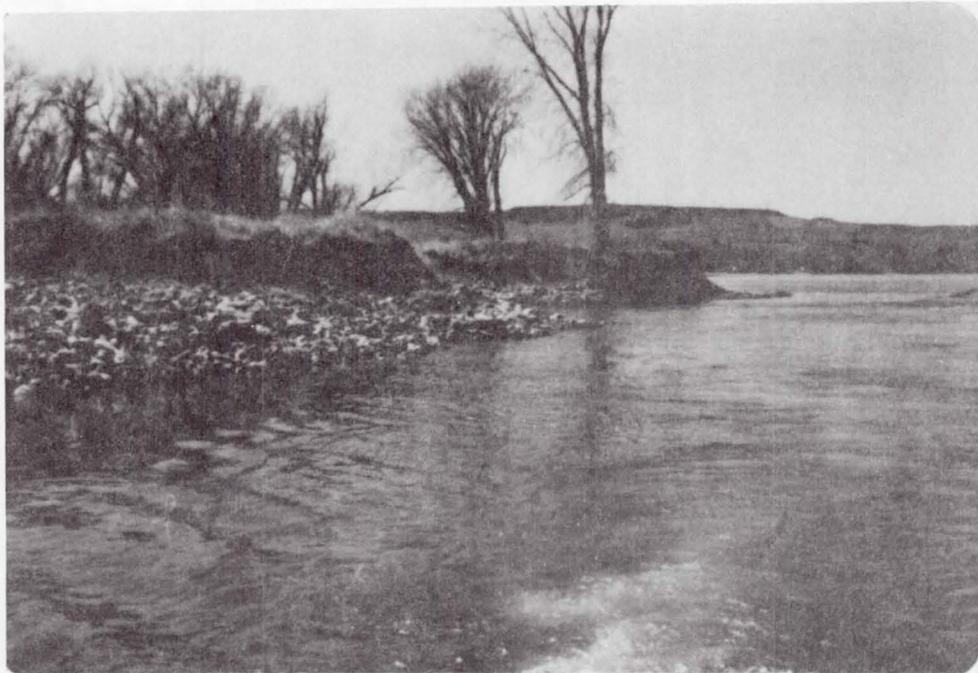
**PHOTO 16. COMPOSITE REVETMENT 868.0, STA. 17+00,
APPROXIMATELY 11 MONTHS AFTER COMPLETION.
(Photo Taken 15 April 1980)**

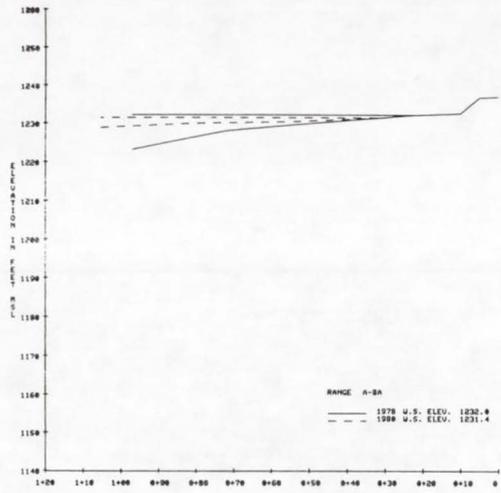
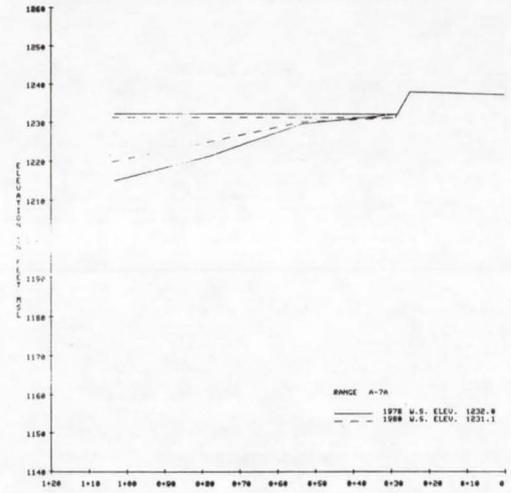
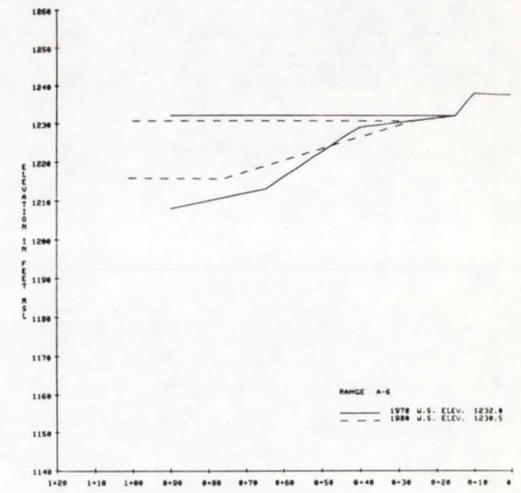
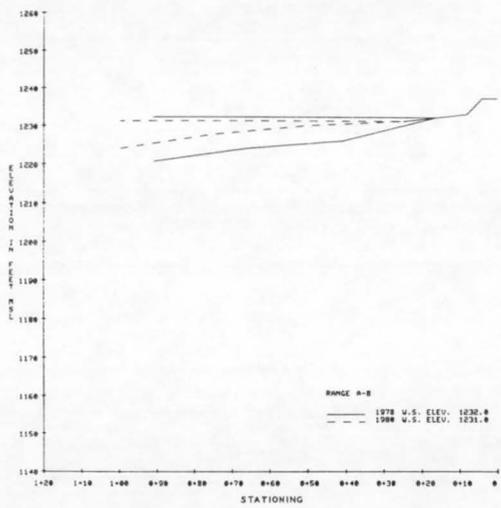
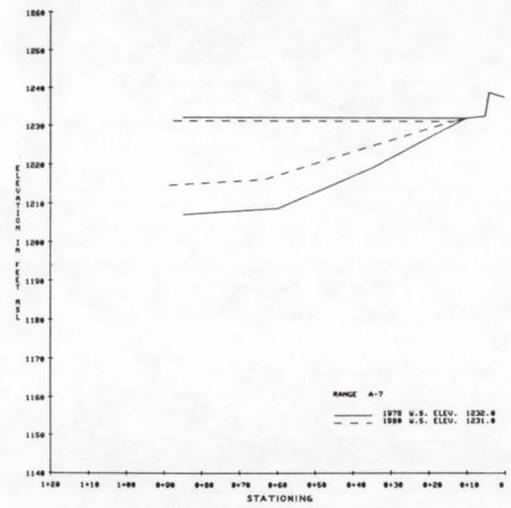
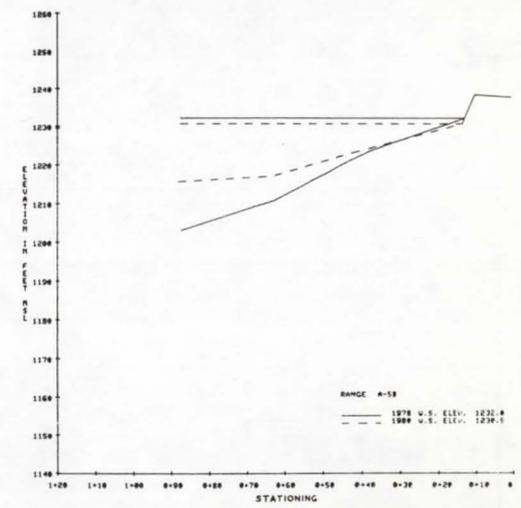
PLATE 2-5

MISSOURI RIVER
 EROSION CONTROL DEMONSTRATION
 FT RANDALL DAM TO HIOBRARA, NEBRASKA
 SUNSHINE BOTTOM AREA
 CROSS SECTIONS
 SHEET 1
