**US Army Corps  
of Engineers**

# FINAL REPORT TO CONGRESS

**THE STREAMBANK EROSION CONTROL  
EVALUATION AND DEMONSTRATION ACT OF 1974  
SECTION 32, PUBLIC LAW 93-251**

## APPENDIX H EVALUATION OF EXISTING PROJECTS

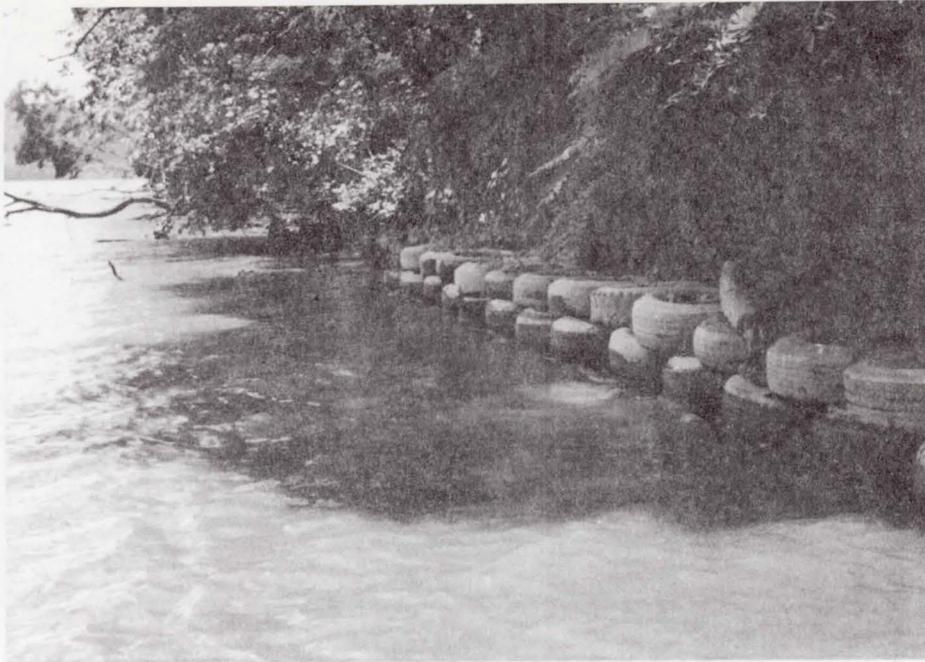
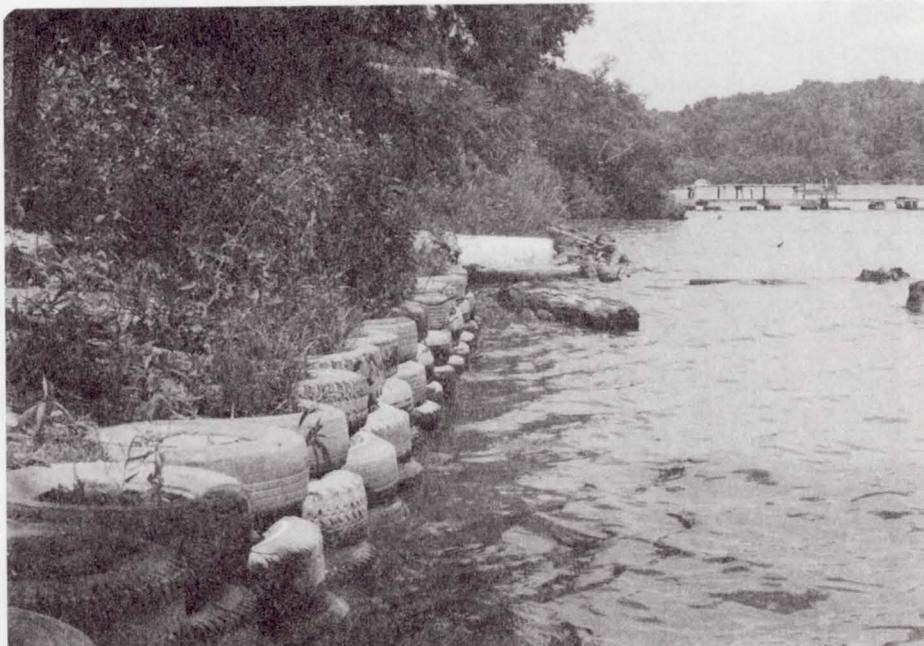
Exhibit 2. Stone-filled tire revetment constructed  
by property owners (successful)

Connecticut River at Thetford, Vermont

Monogahela River (left bank) near California, Pennsylvania

- The most cost-effective means observed for protecting streambanks against erosion was where landowners on smaller rivers used locally available materials (used tires filled with stone) and did the work themselves.
- Thirty-two of the fifty existing projects incorporate some type of stone ranging from total riprap revetment (e.g., quarry-run or graded-stone blankets; see Exhibit 4) to trench-fill longitudinal toe protection, grade-control structures, stone-filled fences, stone-covered lumber mats, timber cribs filled with stone, used tires filled with stone, pile dikes with stone fill, gabion mats,

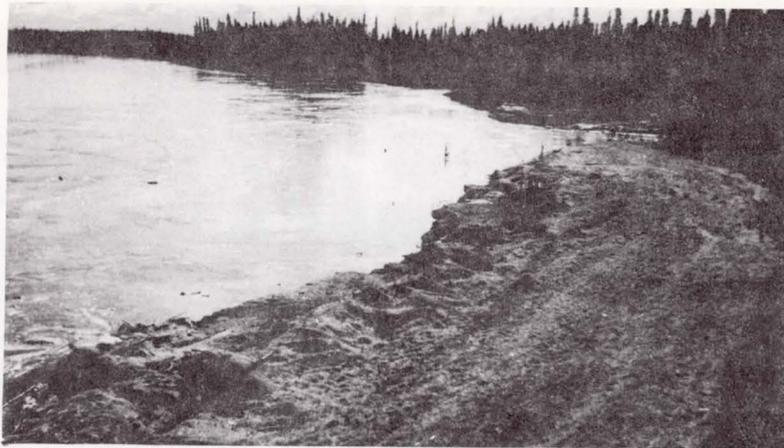
5 May 1979, discharge is 55,000 cfs, slumping and erosion of riverbank on downstream end, ice revetment still in place on upstream end

Exhibit 3. Ice revetment, Tanana River, Alaska (failure)

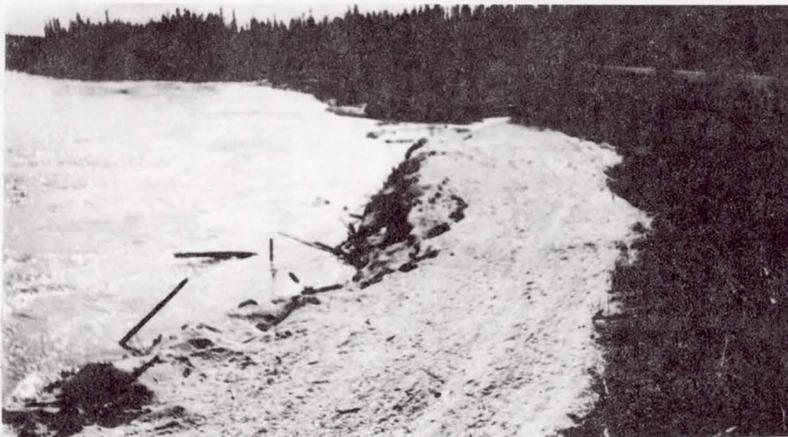
12 May 1979, river discharge is 27,400 cfs, ice revetment completely melted, riverbank erosion underway on upstream end

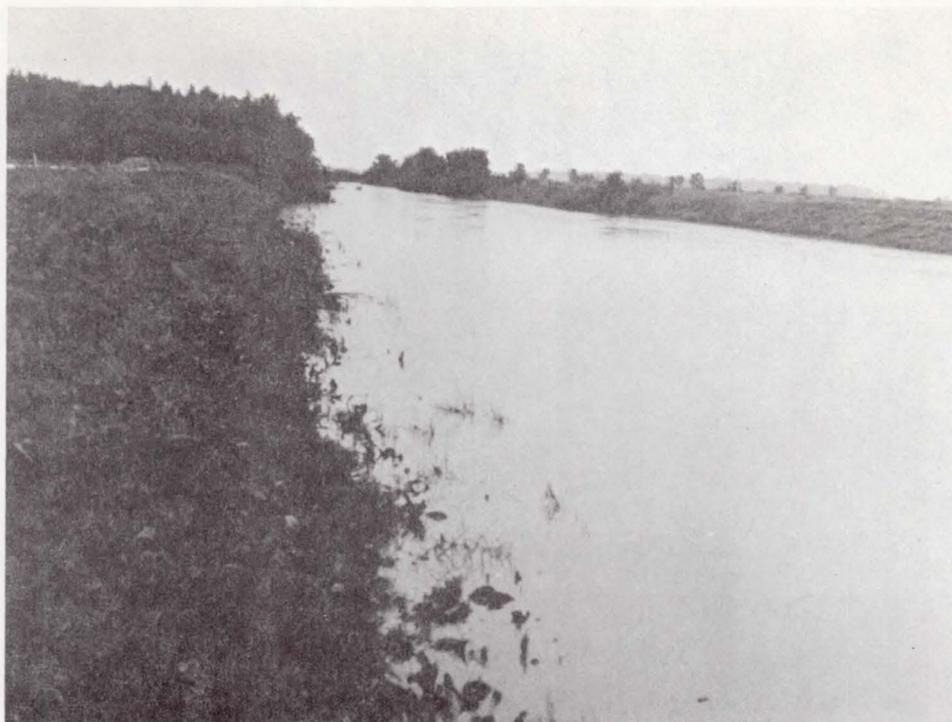
LOOKING DOWNSTREAM AT LOWER END DURING HIGH FLOW

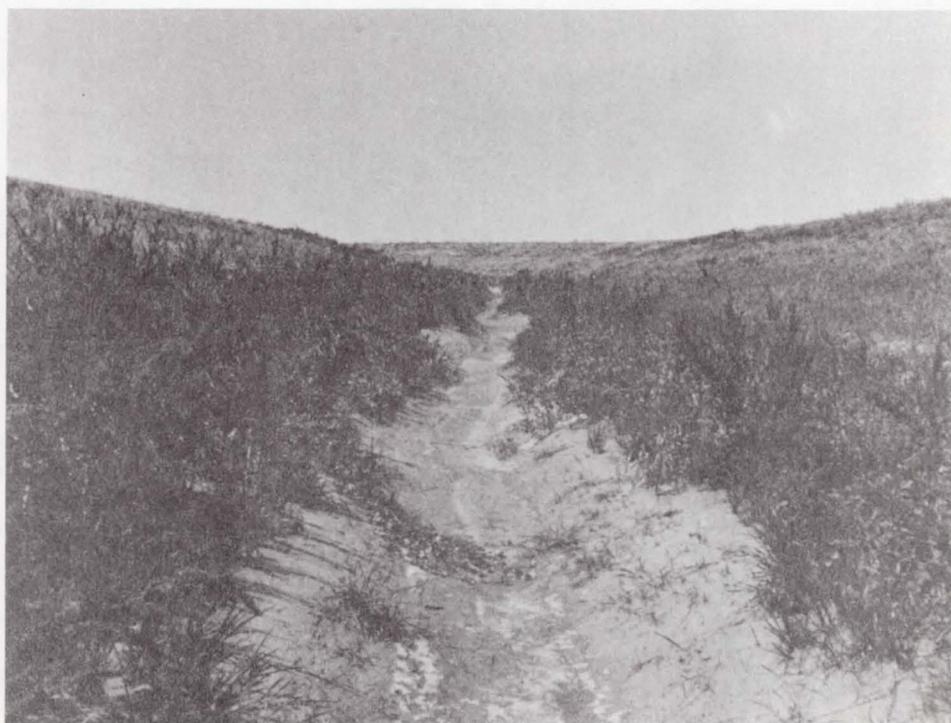
LOOKING DOWNSTREAM FROM UPPER END AFTER DESIGN FLOW

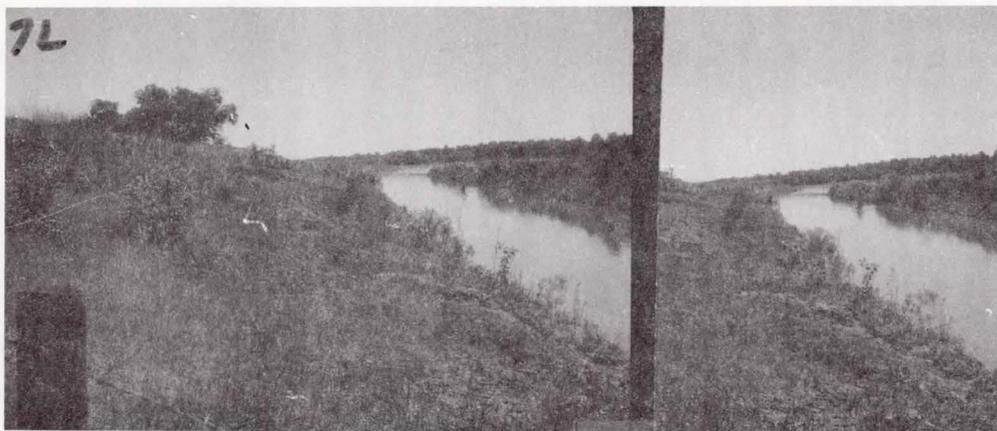
Section 1. Standard Trenchfill Riprap - Looking Downstream

RED RIVER AT MORAMEAL, LA.  
PHOTOGRAPHS 2-1/2 YEARS AFTER CONSTRUCTION

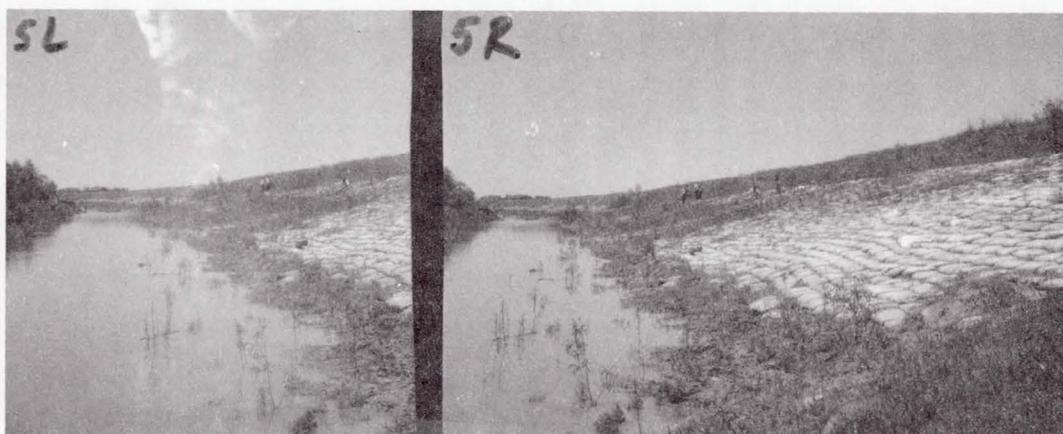
Section 3. Sand-filled Acrylic Bags - Looking Downstream

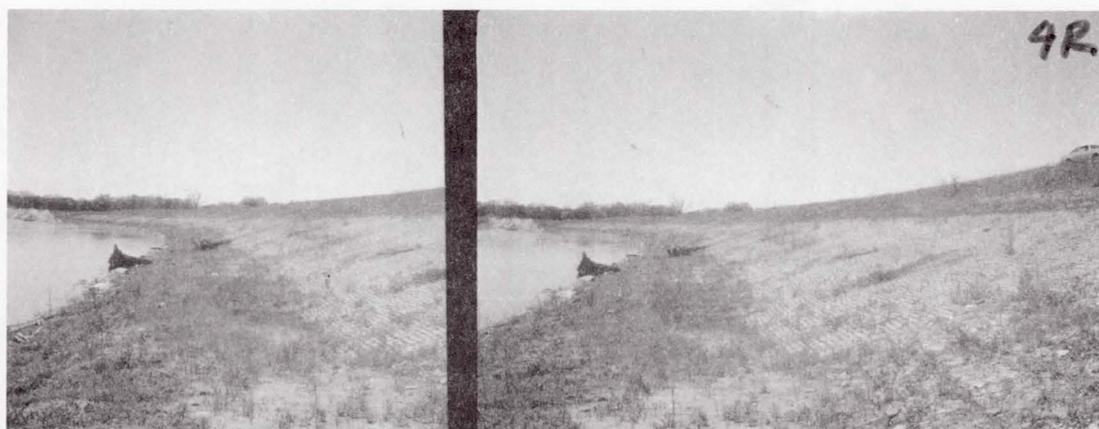
Section 5. Gabion Mattress with Filter Fabric - Looking Upstream

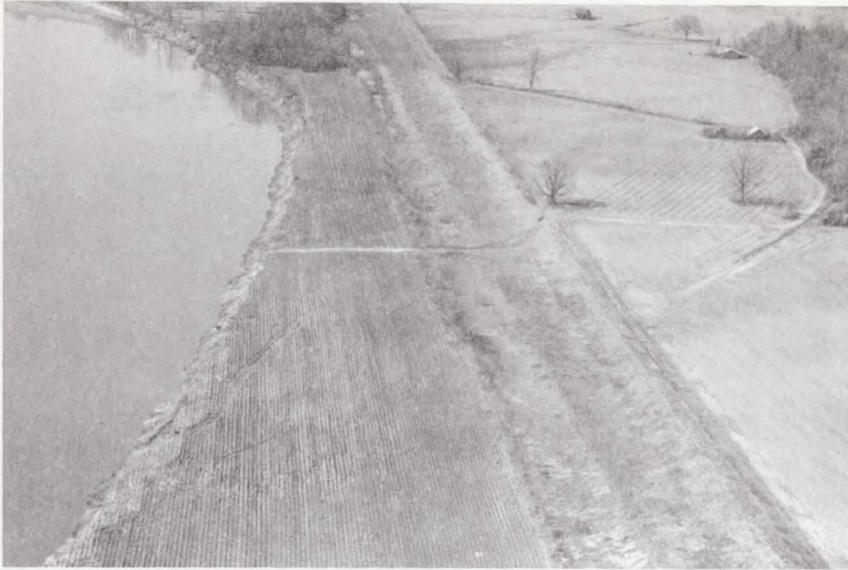
Aerial view of site before serious bank erosion  
occurred which threatened the levee

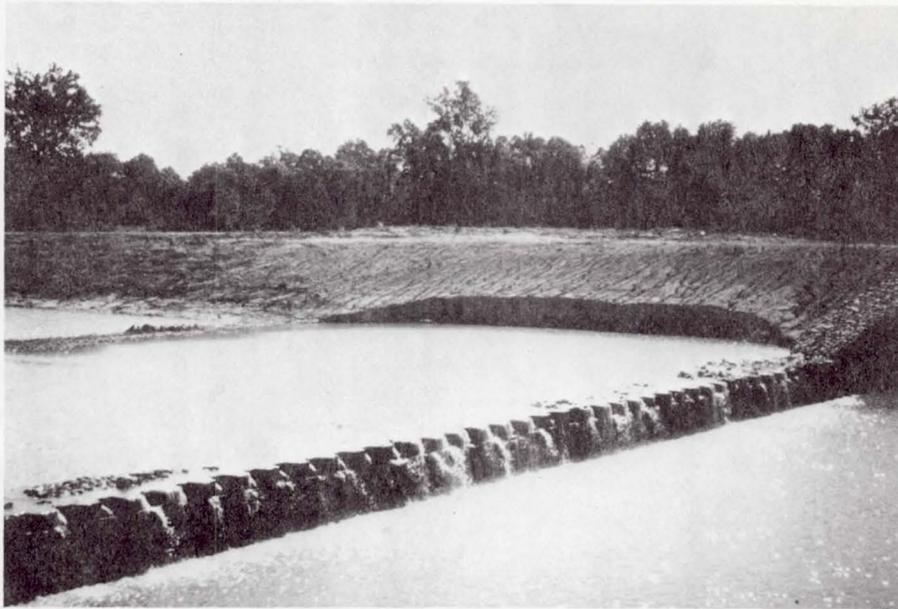
AFTER CONSTRUCTION MAY 1977  
Weir 4 Upstream Bank Sloughing

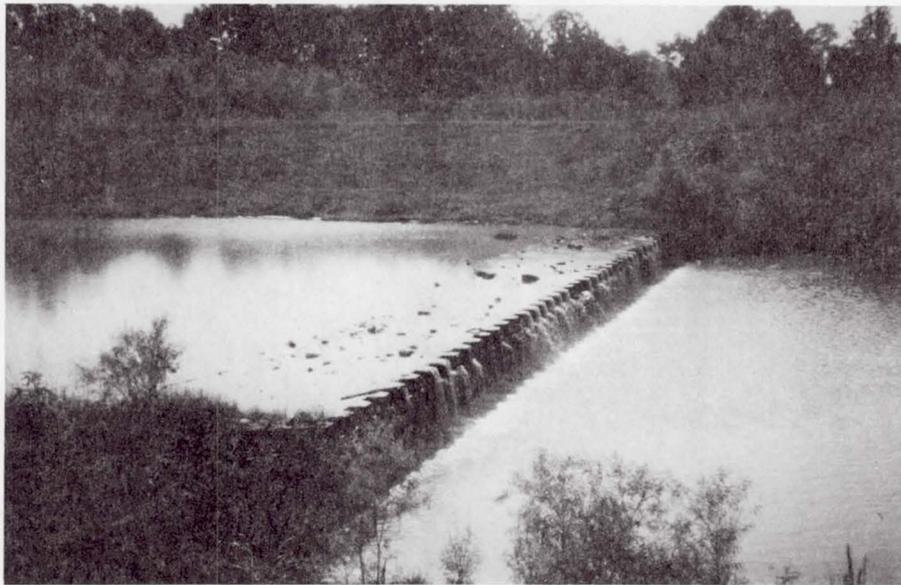
3 YEARS AFTER CONSTRUCTION JULY 1980  
Weir 4 Downstream

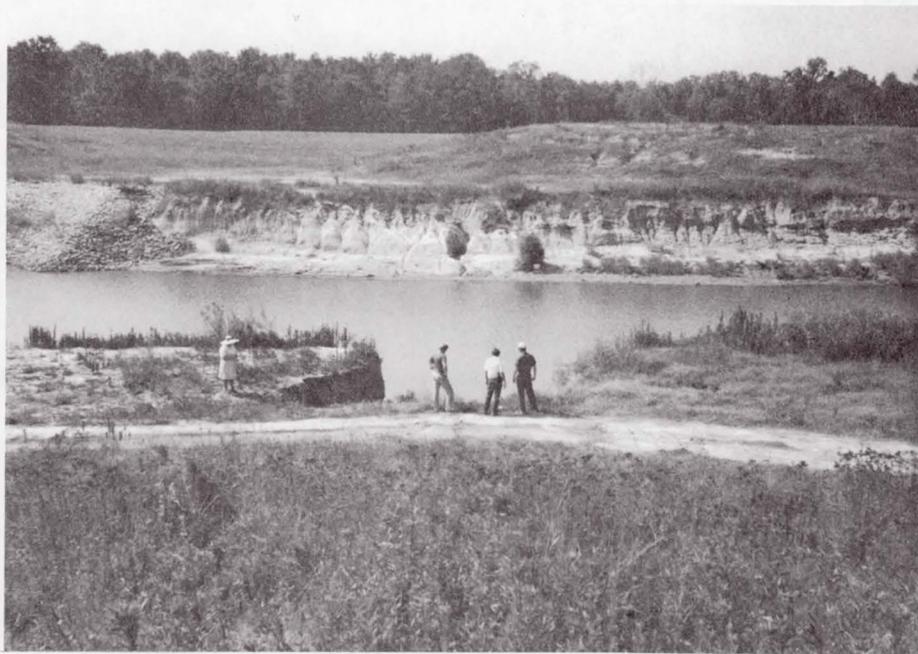
ERODED BANK DOWNSTREAM OF WEIR DUE TO OVBANK RUNOFFS

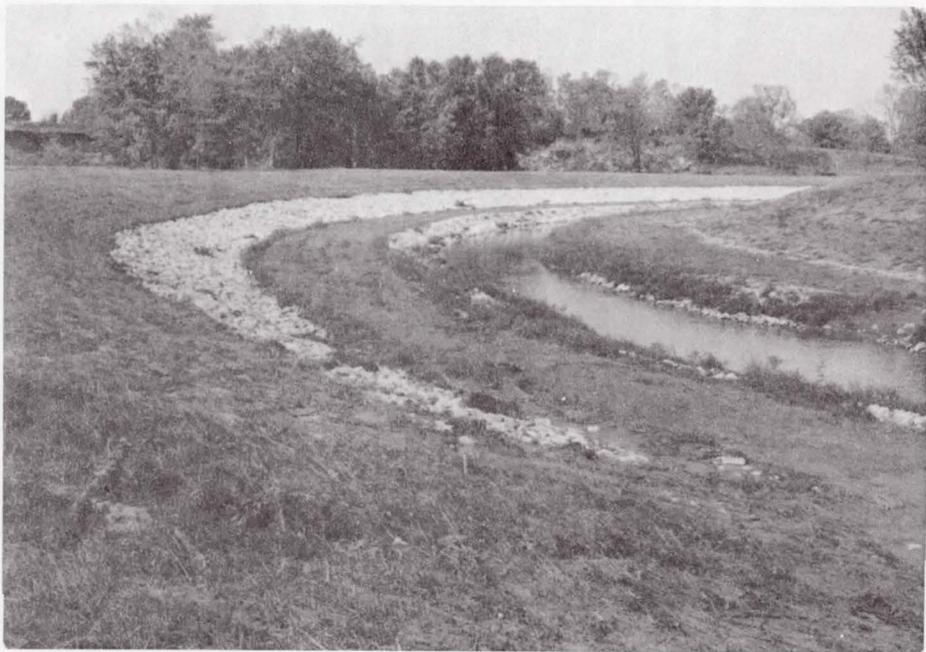
The flood of record in September 1977 (17,000 c.f.s.) caused no damage to any of the structures in the Stage I reach. Visual inspections of the Stage I reach through January 1981 indicate that the bank protection measures are performing well.

Figure 3. Little Blue River at Independence, Mo. Side slopes of low-flow channel protected by stone riprap

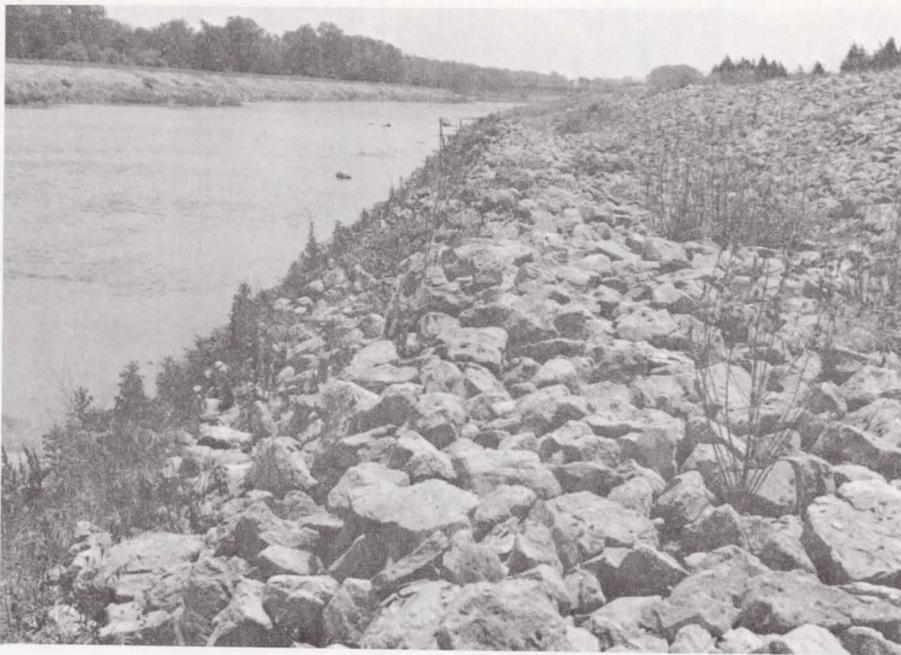
A team consisting of personnel from MRD and MRK conducted the 6th Periodic General Inspection of Milford Dam in May 1981. As part of this inspection, the outlet channel riprap was examined. The team found the rock protection on the channel side slopes was performing satisfactorily, Figure 6, even though the streambed had degraded nearly 6 ft. Progressive armoring was developing over the entire length of the channel bed, and the upstream one-half to two-thirds of the channel bed was armored to the point where no additional degradation was expected. No areas of weakness in the toe protection were noted during this inspection, Figure 7.

Figure 6. Republican River at Milford Dam Outlet Channel, Kans. General appearance of the middle reach of the outlet channel at the time of the July 1981 inspection.

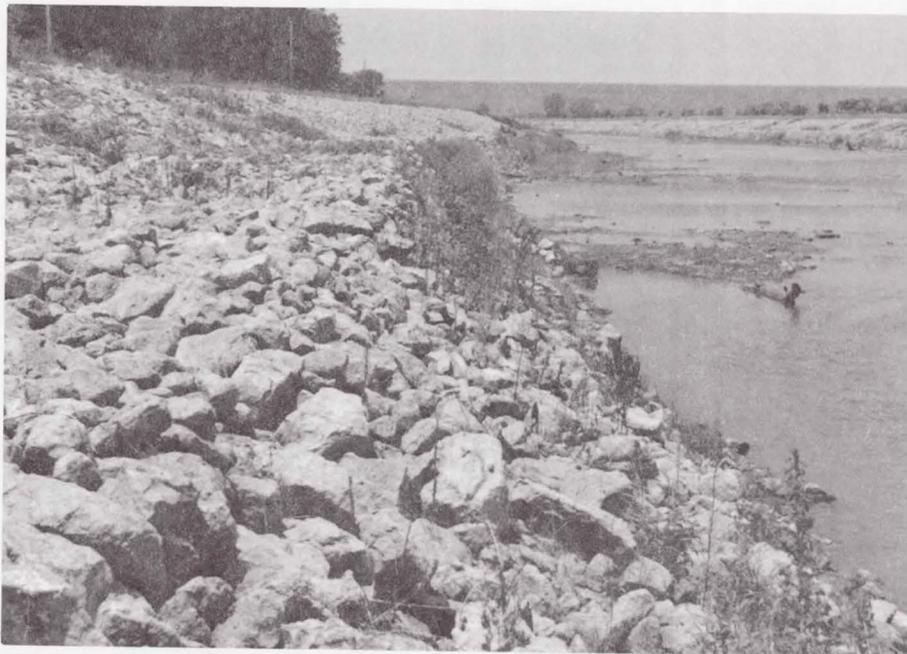
Figure 7. Republican River at Milford Dam Outlet Channel, Kans. Typical view of the revetment toes as of July 1981, Note break in slope between the blanket and the slope to the water.

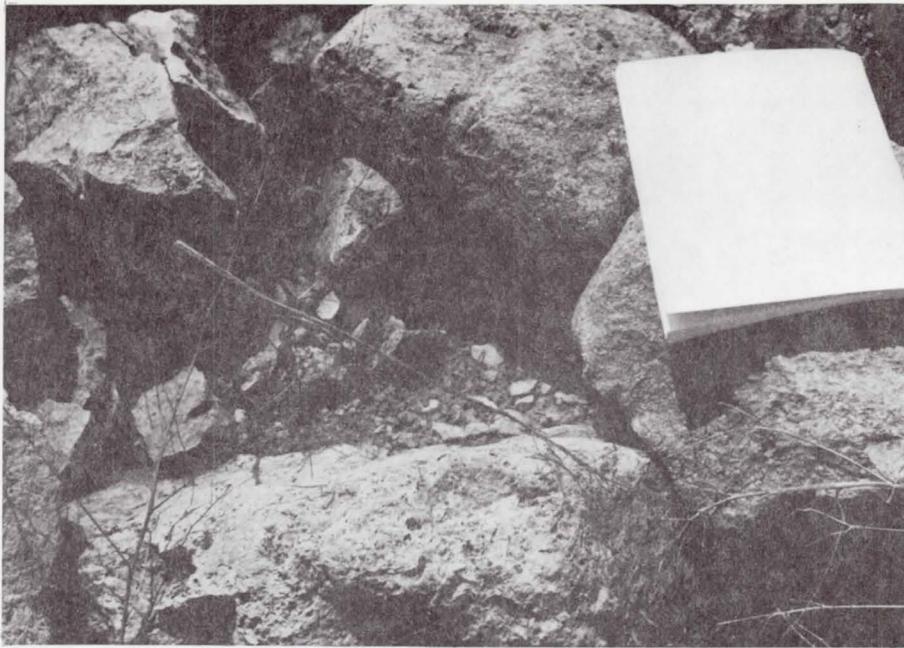
An inspection of the four toe test sections revealed some exposed areas between individual rocks. This was typical of the slope below the 12-in.-thick horizontal blanket in Test Section 3, Figure 8, and isolated areas over Test Sections 1 and 2, Figure 9. Good coverage of riprap on the slope below the 30-in.-thick horizontal blanket was noted in Test Section 4, Figure 10. No areas of exposed sand could be found in this test section. A substantial growth of willows, cottonwoods, and other woody vegetation had developed over Test Section 3, Figure 11. The team concluded that this growth could retard the downward movement of rock from this test section and that in order to retain a valid test, the vegetation should be removed. Breakdown of stone on the left bank near the waterline was noted. This was due to exposure to the sun during the winter and the resulting range of temperature variation that the riprap experiences; however, the extent of deterioration was not considered sufficient to affect the integrity of the revetment.

Figure 12 shows upstream and downstream views of the revetment in the outlet channel. The project is performing as designed, Figures 4 and 5. No apparent failures have occurred with the exception of minor areas where stone has been displaced and exposed the bedding material, Figures 8 and 9.

Figure 8. Republican River at Milford Dam Outlet Channel, Kans. Areas of exposed sand visible between individual rocks below the 12-inch thick horizontal blanket in Test Section 3 (July 1981)

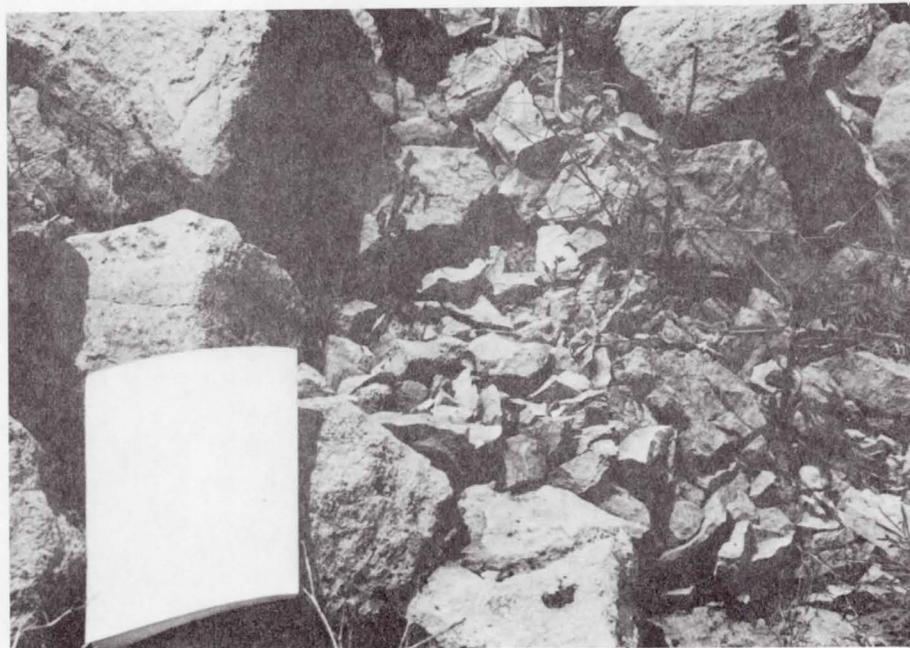
Figure 9. Republican River at Milford Dam Outlet Channel, Kans. The area is typical of the isolated areas of exposed bedding material in Test Sections 1 and 2 (July 1981).

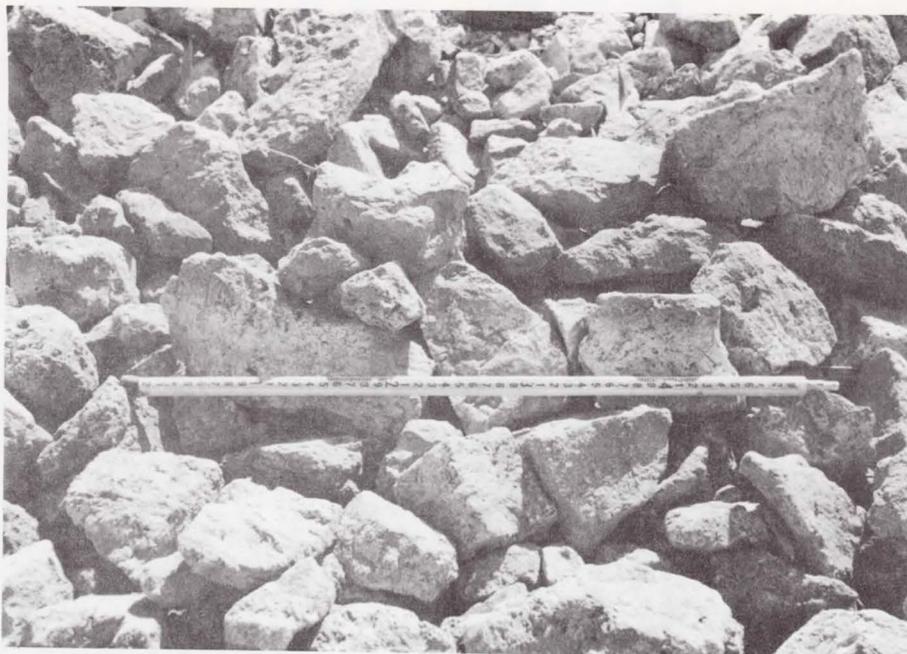
Figure 10. Republican River at Milford Dam Outlet Channel, Kans. There was good coverage of rock on the slope below the 30-in.-thick horizontal blanket at the time of the July 1981 inspection (Test Section 4).

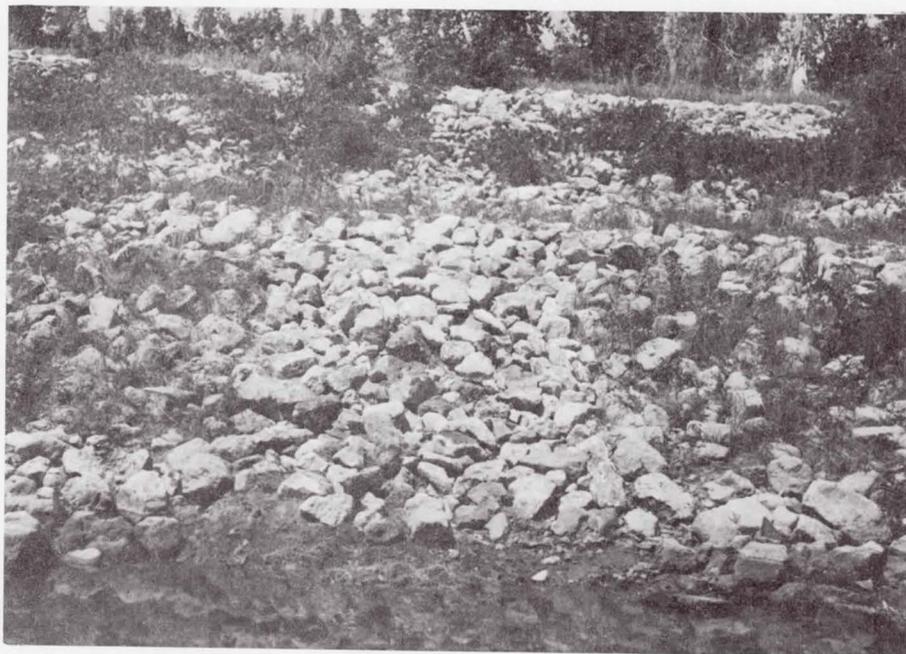
Figure 11. Republican River at Milford Dam Outlet Channel, Kans. There was a substantial growth of woody vegetation over Test Section 3 at the time of the May 1977 inspection.

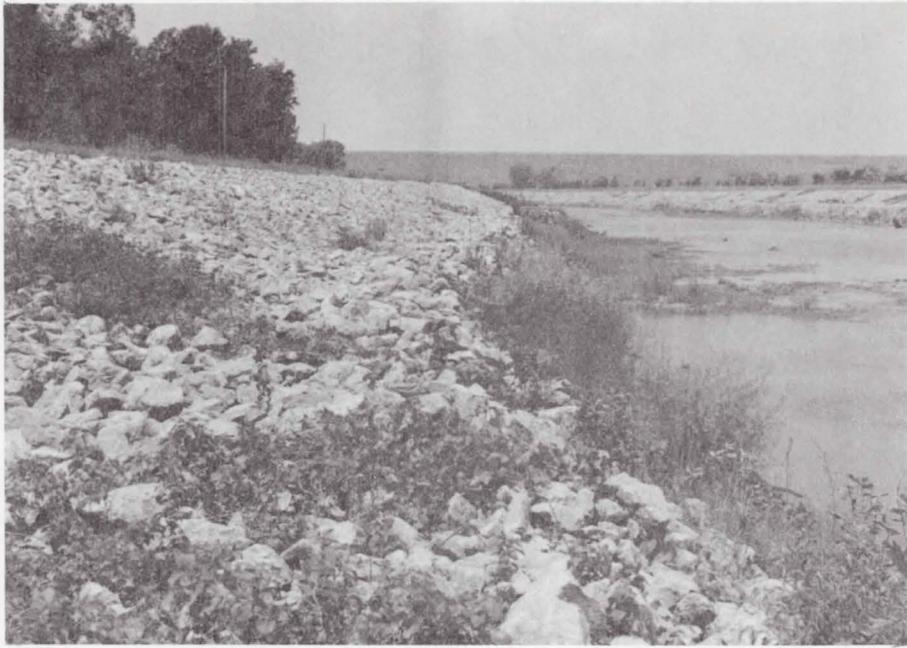
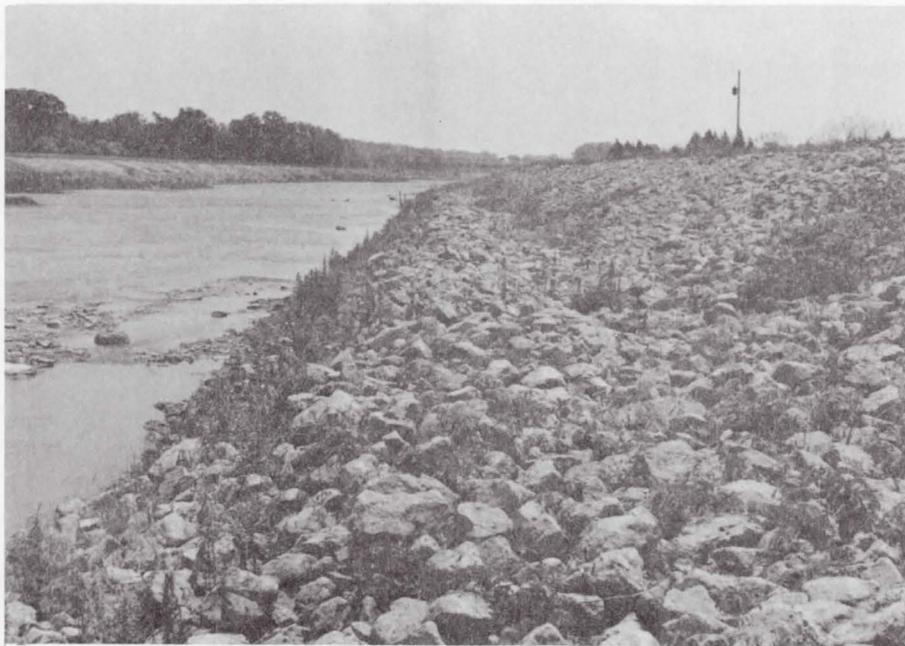
Figure 12. Republican River at Milford Dam Outlet, Kans.  
Upstream and downstream views of the outlet channel revetment.  
(July 1981)

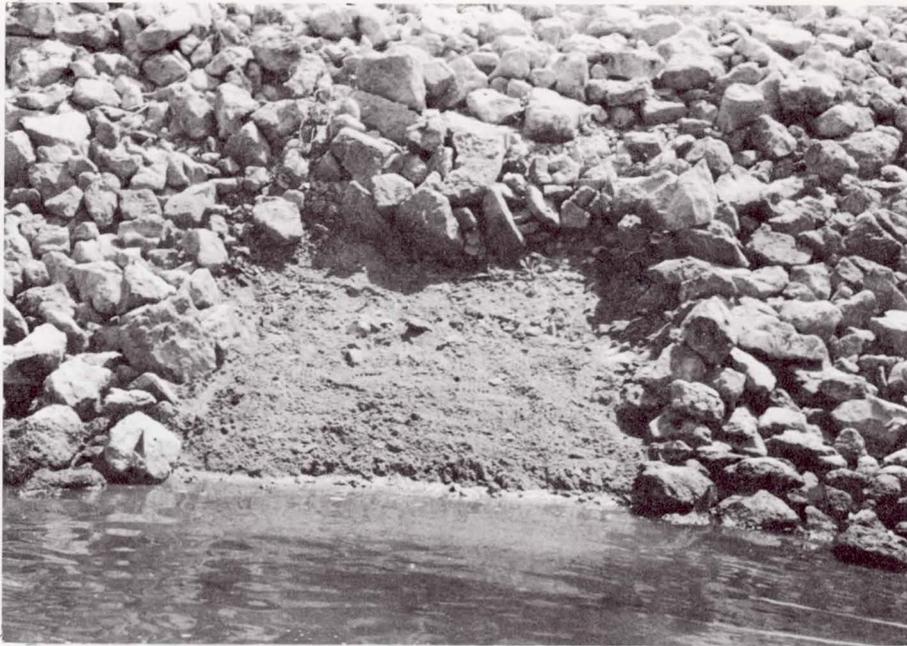
In August 1980, five test areas of stone were excavated and graded, Figures 13 and 14. The results showed the median size of the stone to be 22 pounds against the 25 pound median specified during construction and maximum size of 160 pounds against 150 pound maximum specified. This could indicate some breaking down of stone in the mid-range of the original gradation. The stone coverage in the test sections varied from an average of 1.5 to 2.25 rock diameters. Overall the revetment is performing as designed.

Figure 13. Republican River at Milford Dam Outlet, Kans.  
Test area sampled in August 1980 in Test Section 3.

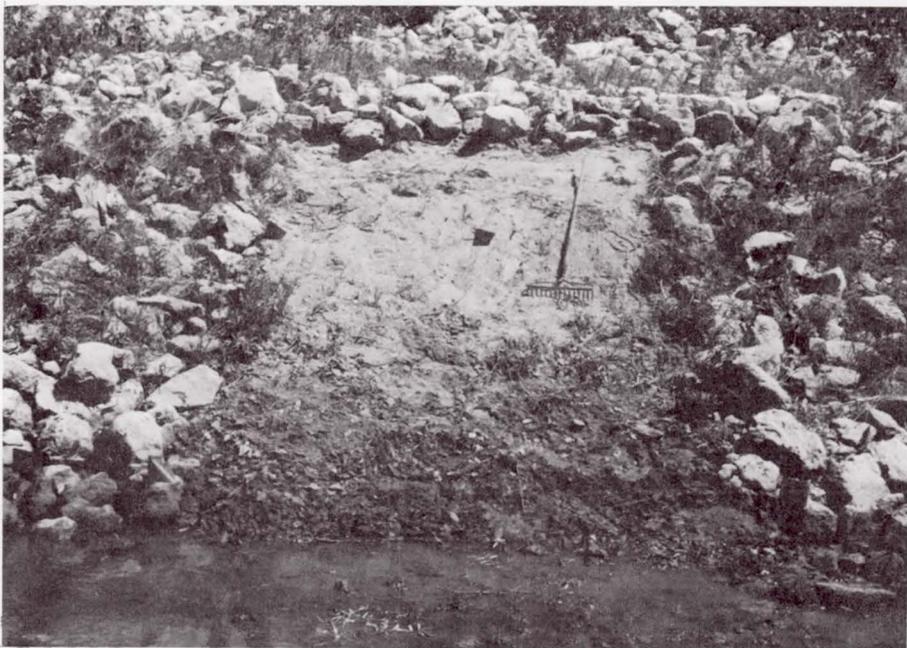
Figure 14. Republican River at Milford Dam Outlet, Kans.  
Test area sampled in August 1980 in Test Section 4.

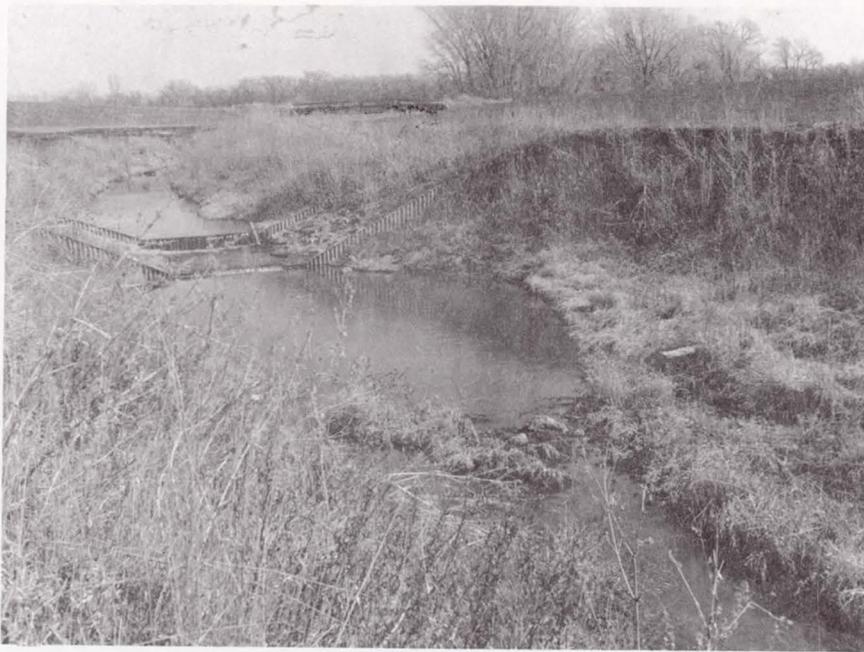
In October 1977, an inspection was made of the condition of the improvements on Little Timber Creek and found that the structures had been performing their intended function; however, a scour hole had developed downstream from ditch check 1, Figure 4, and the grouted rock revetment had been undermined and was breaking off at ditch check 2, Figure 5. The damage to the grouted rock has been repaired by the city of Frankfort. The Section 32 inspection team from the Waterways Experiment Station inspected the Frankfort site on 19 September 1978 and found the grade-control structures to be performing as designed. Inspections through 10 March 1981 indicate that the ditch checks continue to prevent channel degradation (Figure 6).

Figure 4. Little Timber Creek at Frankfort, Kansas.  
View of scour hole downstream from ditch check 1.

Repairs and Costs (Item, Cost, Date) Damage to revetment below Check #1 has  
been repaired by sponsor.

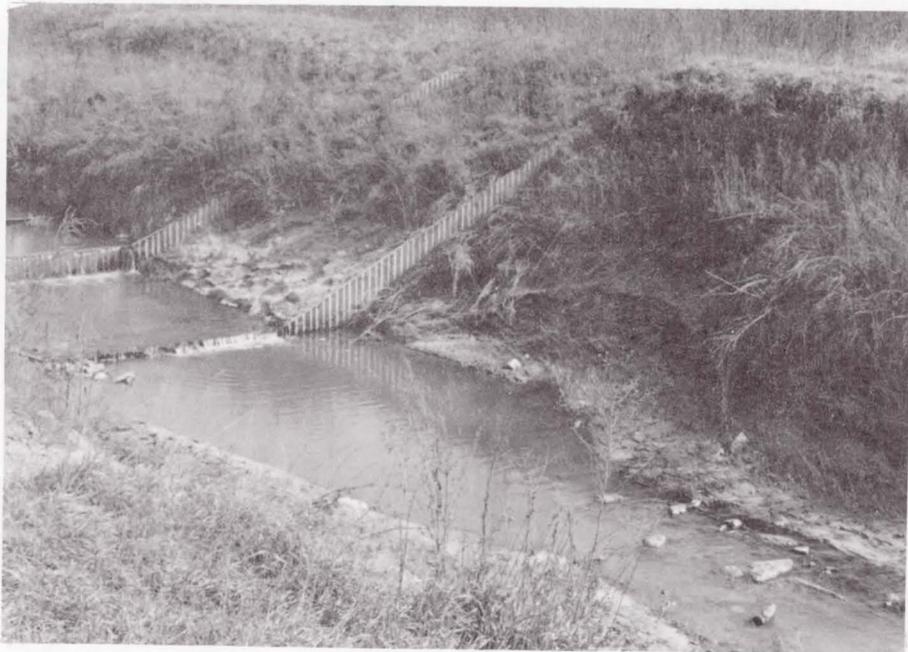
Figure 5. Little Timber Creek at Frankfort, Kansas.  
Downstream view showing loss of grouted rock from  
ditch check 2.

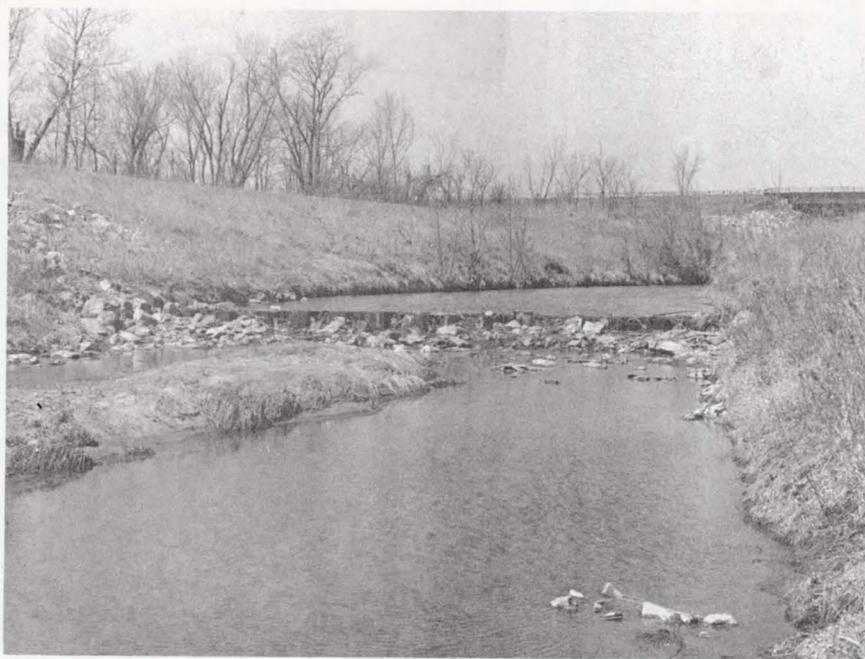
At the time of the 1978 inspection by the Waterways Experiment Station team, the project was performing as designed. Additional inspections through March 1981 (Figures 6 and 7) indicate that the structures are intact and no headcutting is evident through the project reach. Riprapped banks of the preformed scour holes have prevented the formation of lateral erosion.

Figure 6. Mud Creek at Lawrence, Kans. Sheet piling and rock sill at mile 1.55 (11 March 1981)

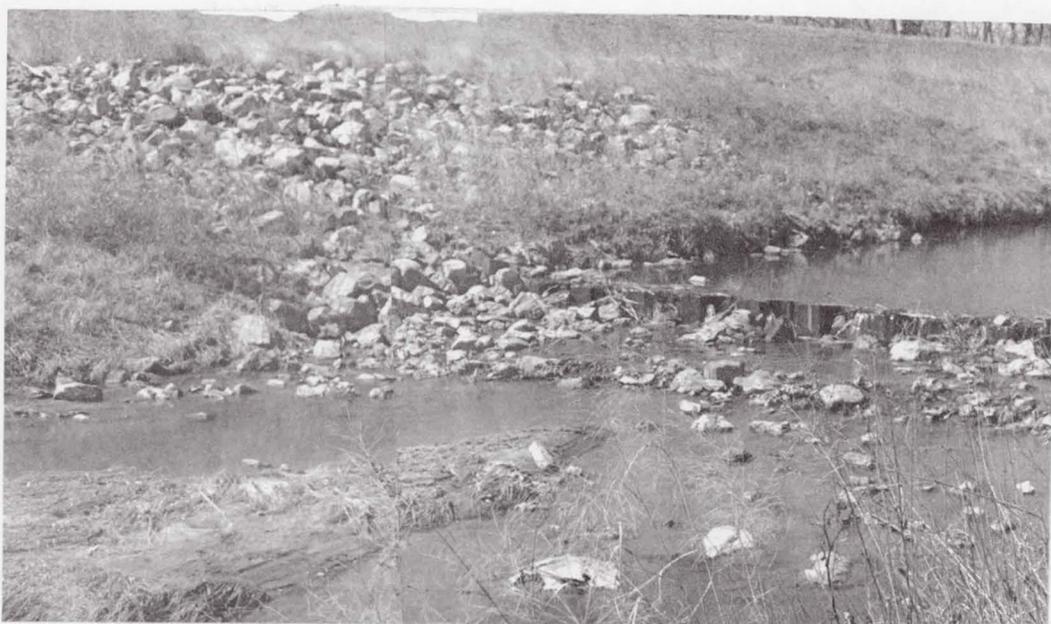
Figure 7. Mud Creek at Lawrence, Kans. Sheet piling and rock sill at mile 0.80 (11 March 1981)

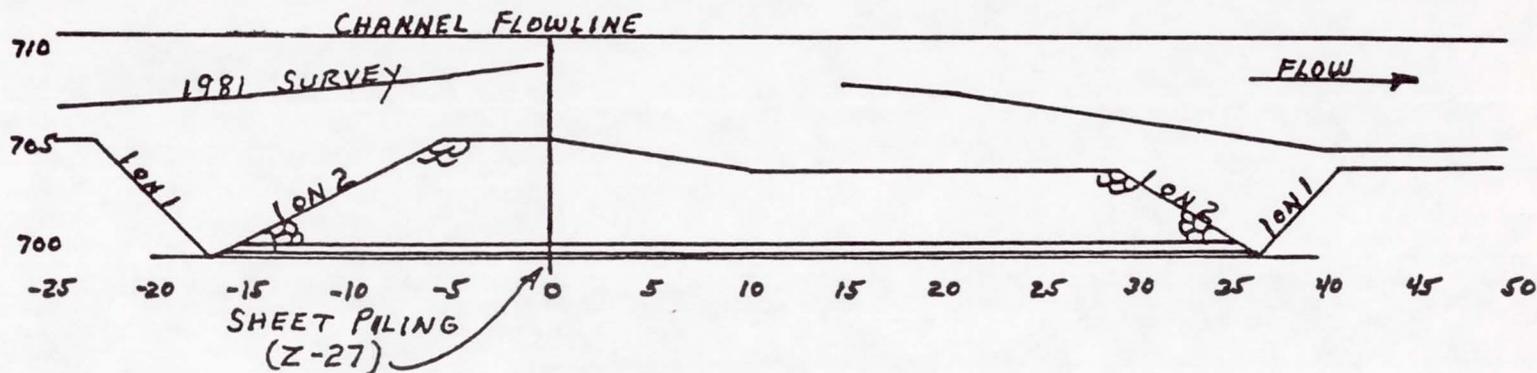
The flood of record in September 1977 (17,000 c.f.s.) caused no damage to any of the structures in the Stage I reach. Longitudinal surveys were made in January 1981 of the sheet piling and rock sills at stations 764+00 and 773+00. The 1981 channel bottom is superimposed on the as-built drawings in Figures 5 and 6. The surveys indicate that the channel is reaching equilibrium.

Figure 5. Sheet pile and rock sill at station 764+00.

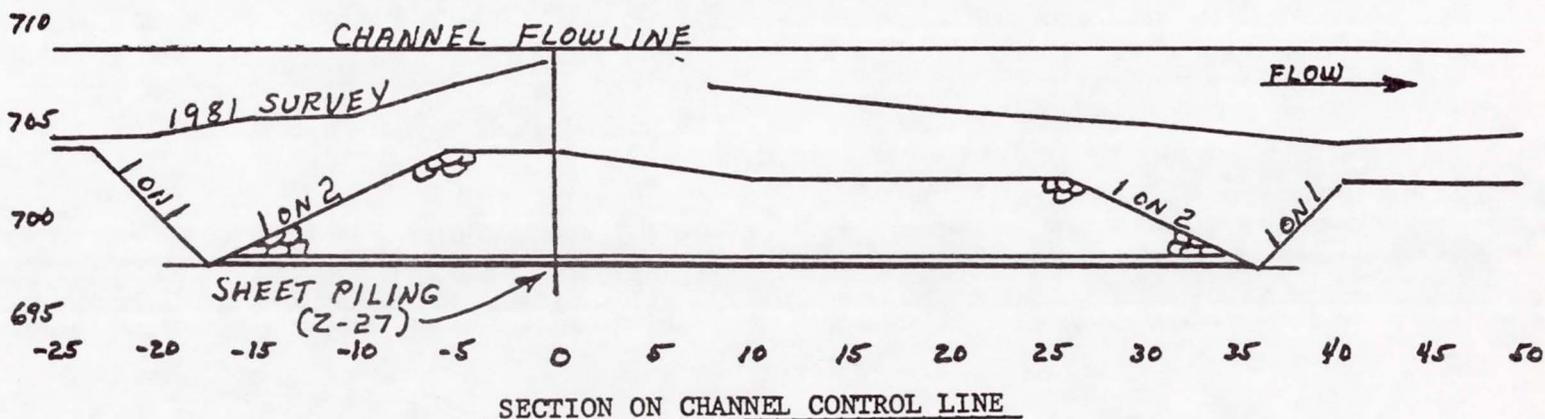
Figure 6. Sheet pile and rock sill at station 773+00.

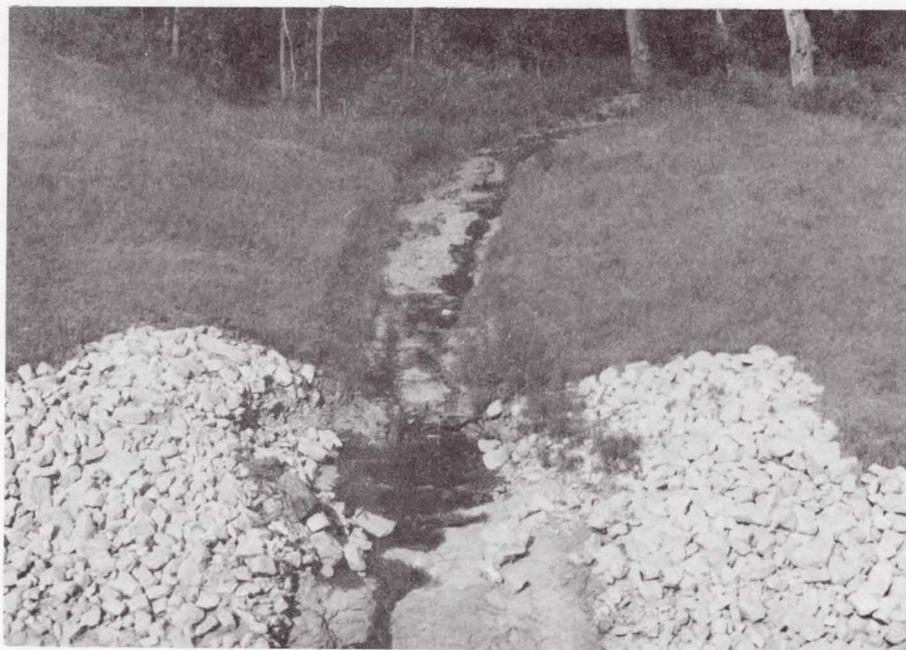
However, as a result of uncontrolled overbank drainage, clay blanket erosion occurred at some locations, Figure 3. These areas have been repaired by the construction of two gabion drop structures, Figure 4, and a number of grouted gutters, Figure 5. Several areas of erosion of the clay blanket on the high flow berm will be repaired by a series of low rock dikes across the berm.

Figure 3. Little Blue River at Independence, Mo. As a result of uncontrolled overbank drainage, clay blanket erosion has occurred at some locations (May 1977)

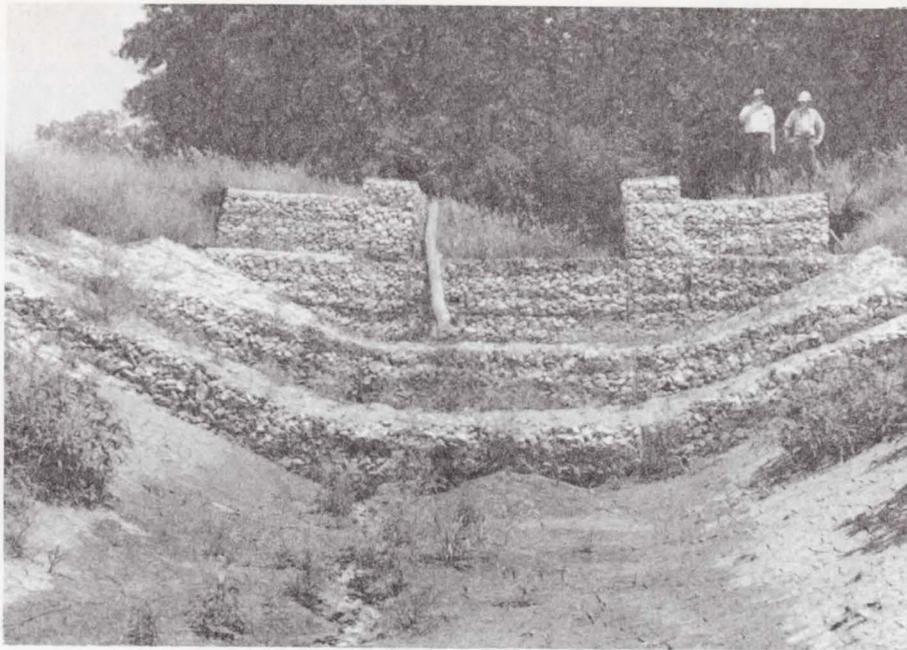
Figure 4. Little Blue River at Independence, Mo. Gabion drop structure to control overbank drainage.

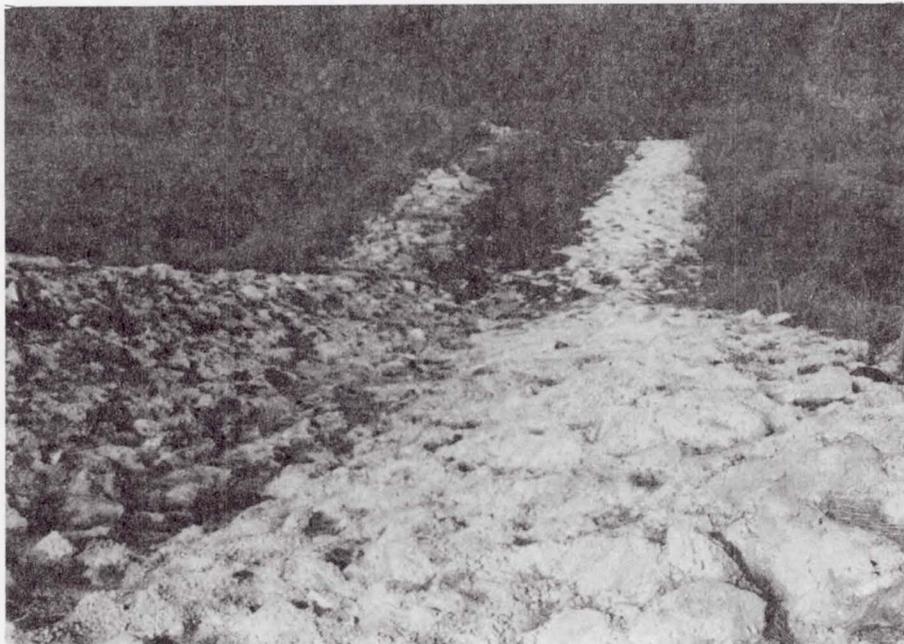
Figure 5. Little Blue River at Independence, Mo. Grouted gutter to control overbank drainage.

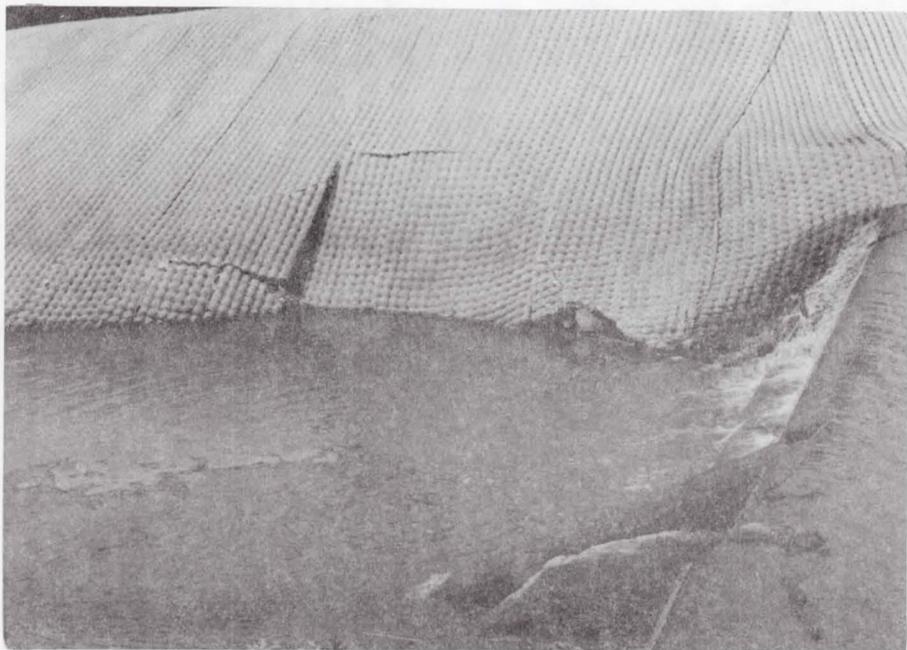
The Waterways Experiment Station (WES) inspection team visited this site on 21 September 1978. Although high flows had undercut the Fabriform at several locations, resulting in pieces breaking off at the toe, Figure 10, or subsidence of sections, Figure 11, most of the revetments were generally in good condition, Figure 12. During the March 1979 flood (2,000 c.f.s. maximum daily flow), the drop structure, Figures 1 and 5, was undercut and failed, Figure 13. In an attempt to protect the upstream reach, a temporary dam was constructed at the site of the structure; the construction proceeded from the right bank across to the left bank. This caused a concentration of flow on the left bank and against the Fabriform mattress before closure was made. As a result, nearly all of the fines were washed out of the rock fill under the Fabriform in this vicinity, creating a "pipe" under the Fabriform that was parallel to the streamflow. This resulted in a relatively large erosion hole on the left bank under the Fabriform. As a result, the undercut Fabriform had to be broken out and rock fill placed in the void.

Figure 11. 102 River (East Fork) at Bedford, Iowa. High flows undercut the Fabriform mattress at the Bedford Water Treatment Plant resulting in subsidence of a section of the revetment.

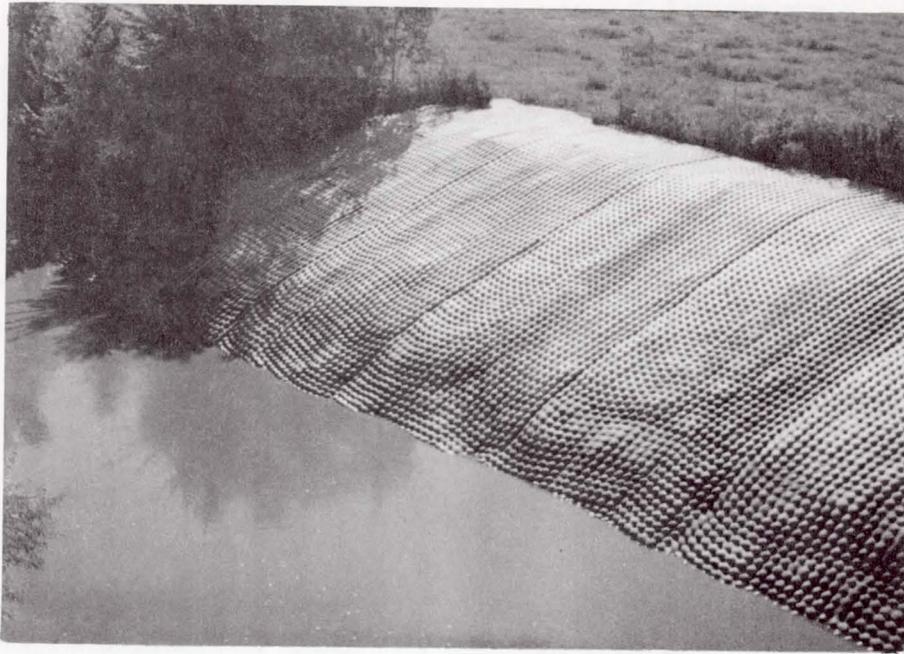
Figure 12. 102 River (East Fork) at Bedford, Iowa. At the time of the 1978 inspection visit, most of the Fabriform revetment was intact. This view shows the mattress downstream from the State Street Bridge.
