**US Army Corps  
of Engineers**

# FINAL REPORT TO CONGRESS

**THE STREAMBANK EROSION CONTROL  
EVALUATION AND DEMONSTRATION ACT OF 1974  
SECTION 32, PUBLIC LAW 93-251**

## APPENDIX H EVALUATION OF EXISTING PROJECTS

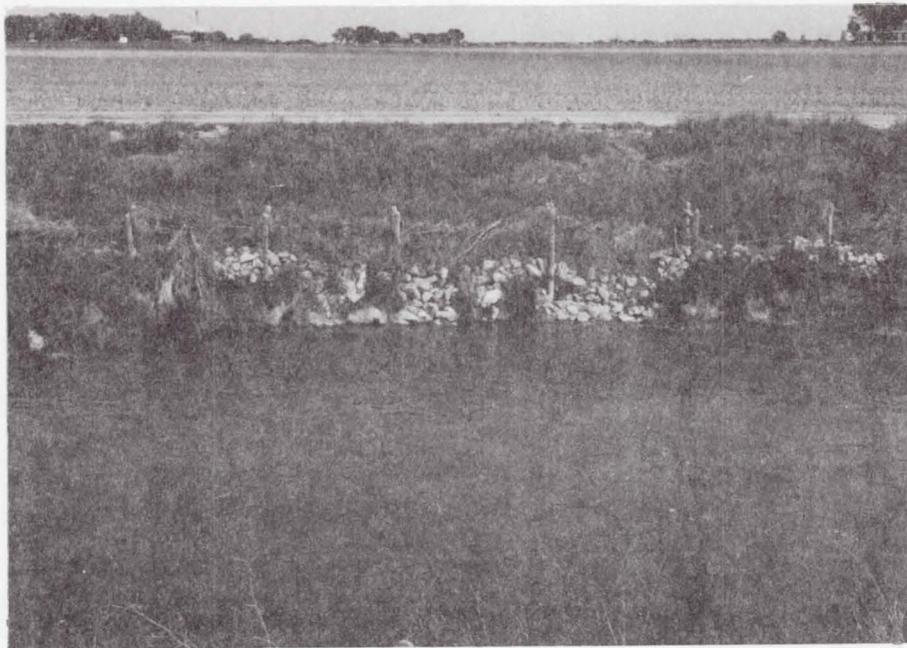
It appears that where the channel degradation has been controlled, the fencing has performed very well in trapping sediments and contributed to the establishment of stabilized flow lines and revegetation of the berm areas, Figure 6.

Figure 6. Gering Drain near Gering, Nebraska.  
View of stone-filled fence with stone moving  
down the bank

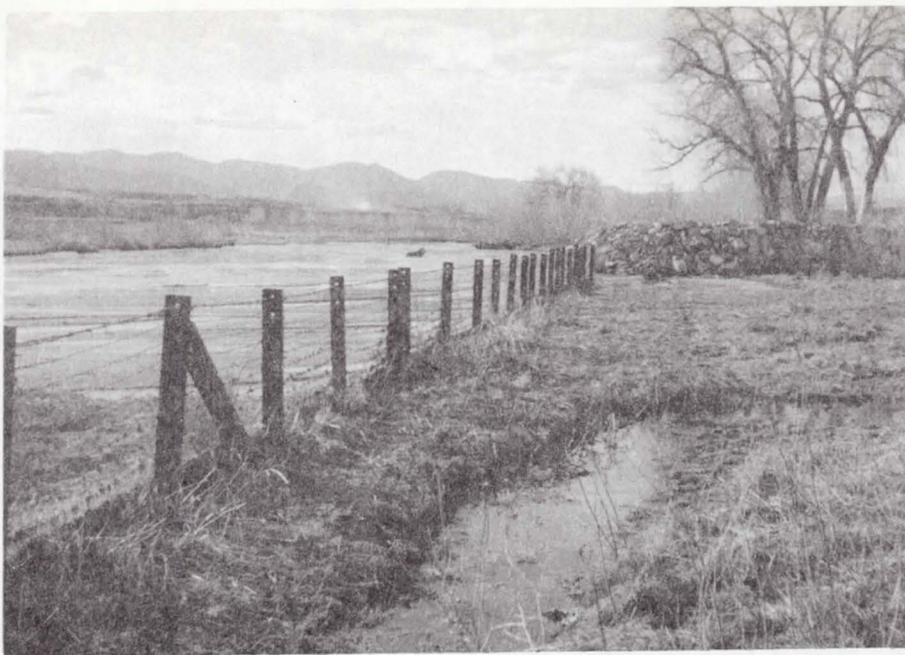
Figure 5. Plum Creek, Douglas County, Colorado.  
Landward side of fence revetment with tieback.

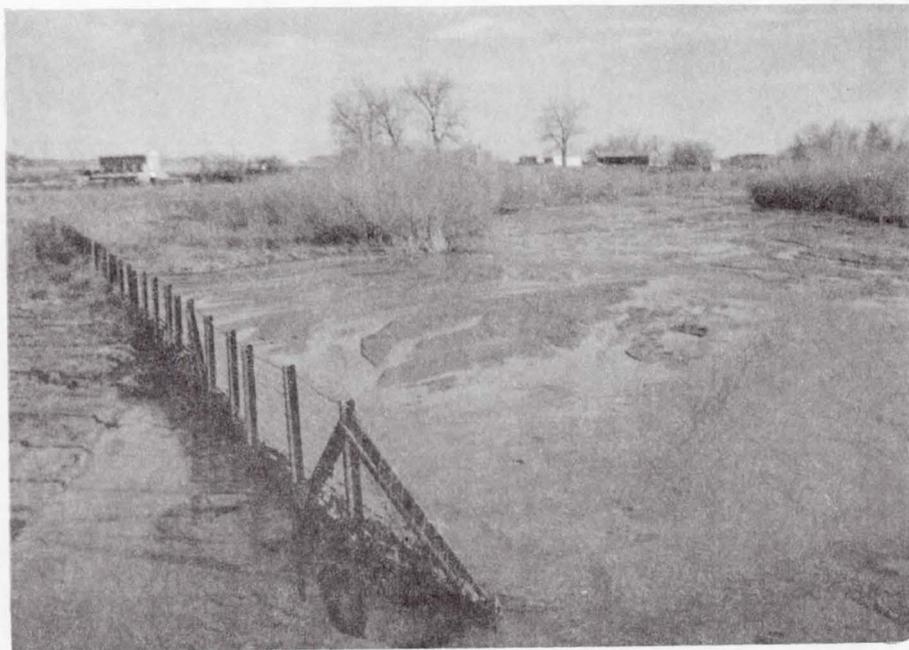
Figure 6. Plum Creek, Douglas County, Colorado.  
Willow growth becoming reestablished.

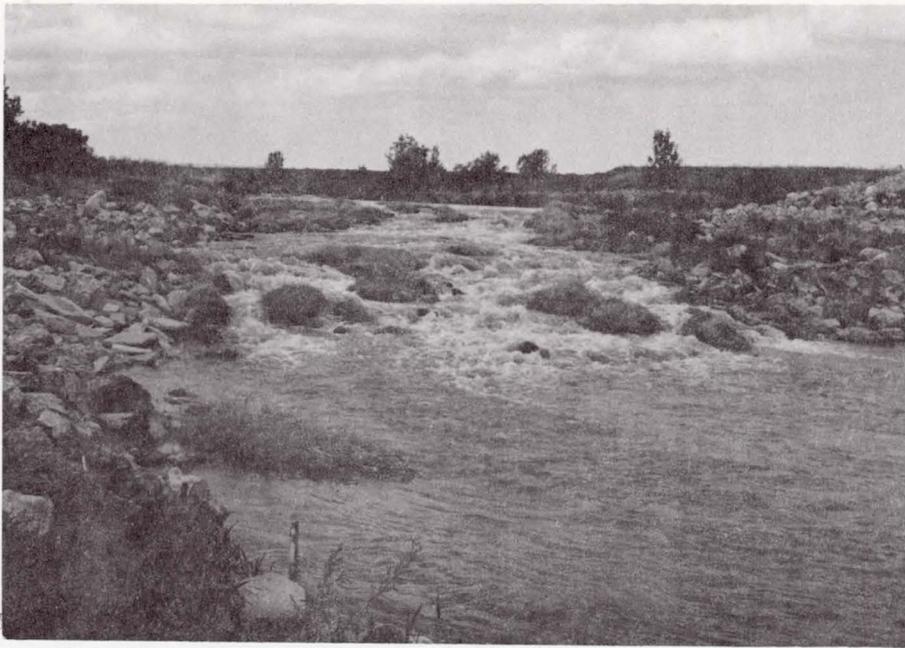
Figure 3. Gering Drain near Gering, Nebraska.  
View upstream of a low rock sill.

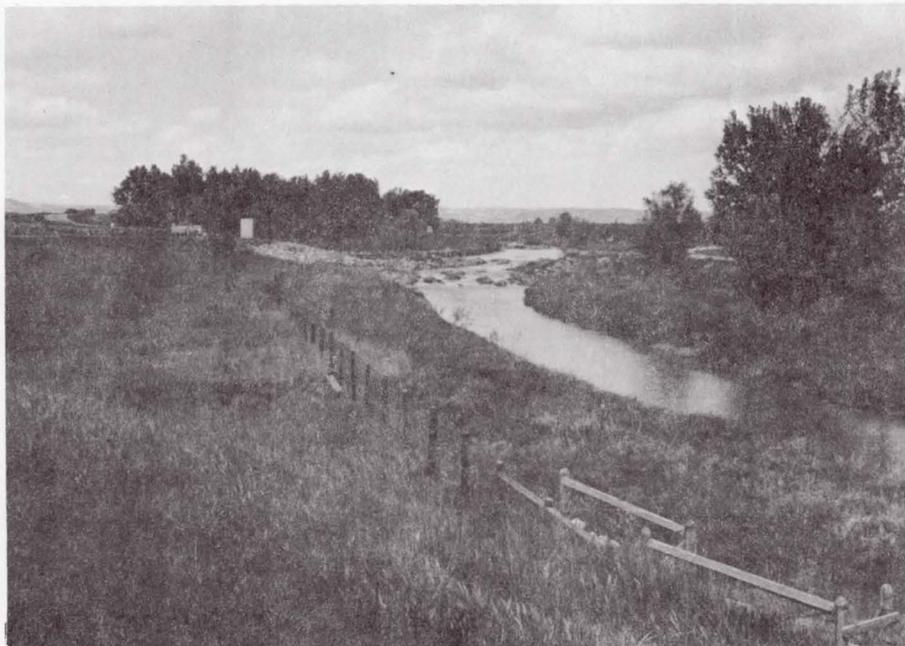
The rock sills, fencing, and earthen groins were constructed as planned and willows were also planted in the berm areas to induce siltation. All structures placed during initial construction phases have functioned as planned. Following the initial construction, which was completed in 1969, downstream degradation required the construction of four additional rock sills and fencing in 1973 at the lower end of the project. The channel below these structures has continued to degrade slowly. Degradation below rock sill 1D is between 4 and 5 feet and has undercut the fencing. This may eventually cause failure of the fencing and erosion of the channel banks.

Figure 4. Gering Drain near Gering, Nebraska.  
View of low rock sill and fence line with  
stabilized channel.

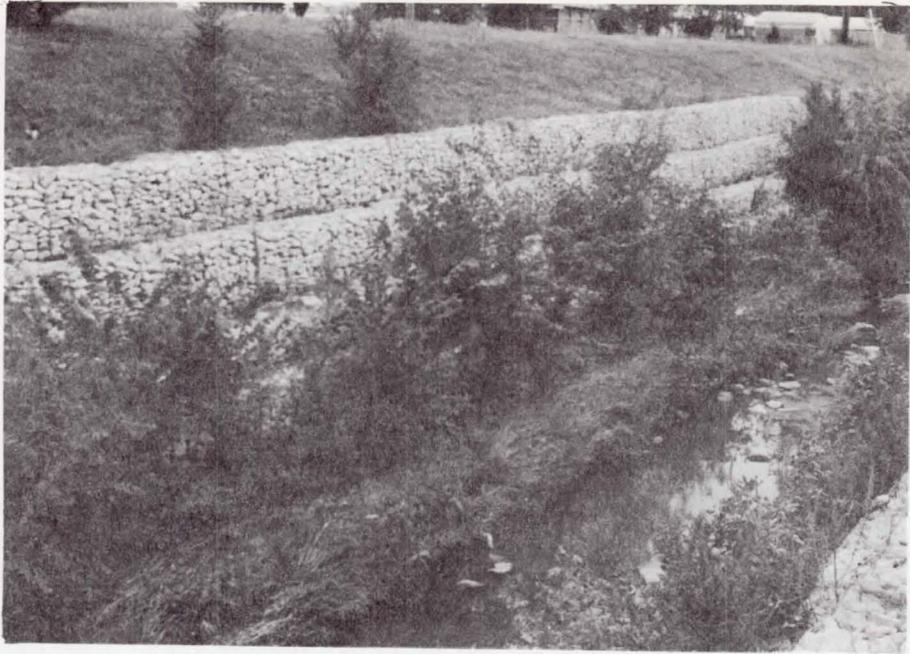
Figure 6. Deadman's Run and Antelope Creek, Lincoln, Nebraska.  
Removal of vegetation is sometimes required to maintain  
channel efficiency

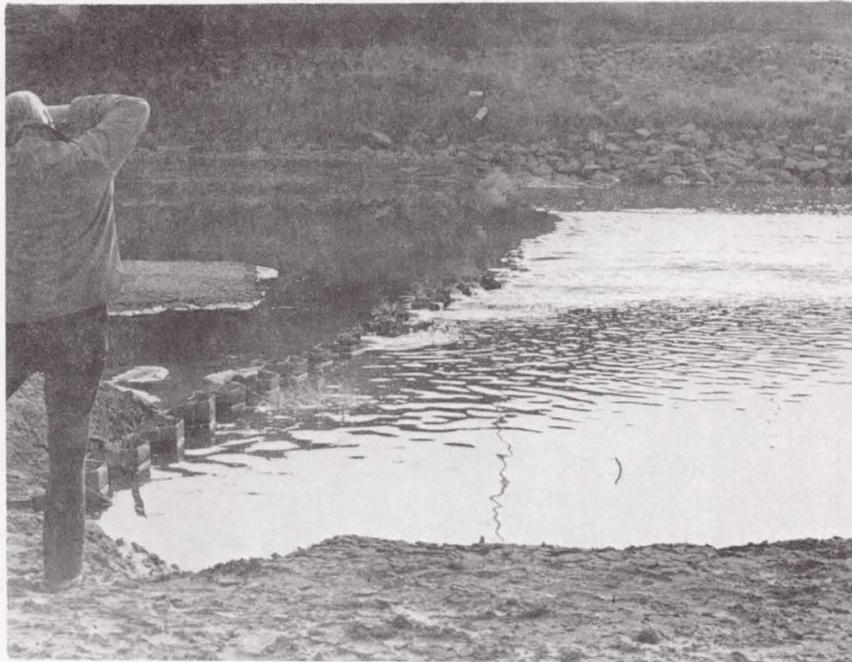
Figure 4. Floyd River at Sioux City, Iowa. Sill at Station 2+90. Sheet pile alignment has deformed in a downstream direction. Note flow of water concentrated in center. 20 March 1981.

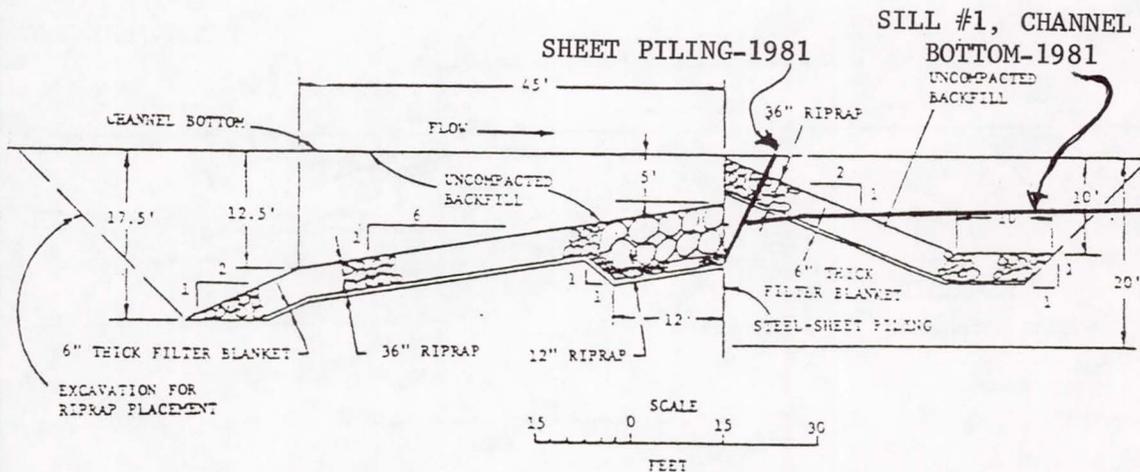
Figure 5. Floyd River at Sioux City, Iowa. Center-line view of sheet piling and rock sill at Sta. 2+90. Results of April 1981 survey superimposed.

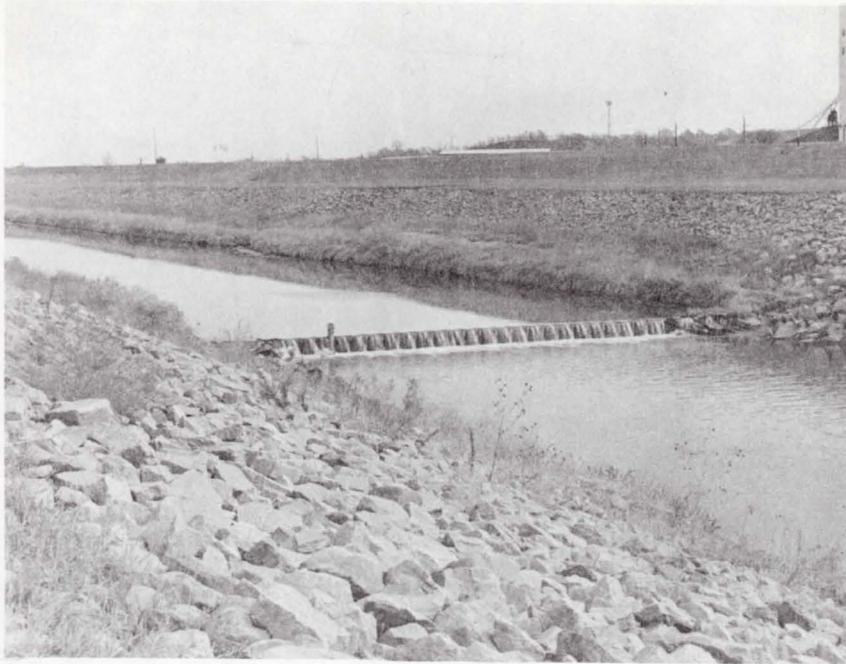
The riprap downstream of sill No. 5 at station 83+00 has been displaced to a depth of 7 feet below the crest of the sheet-piling, Figures 6 and 7. There has been no deformation of the sheet-piling. The other three sills were in excellent condition and overall the project is functioning as designed.

Figure 6. Floyd River at Sioux City, Iowa. Upstream view of sheet piling and rock sill #5, Sta. 83+00

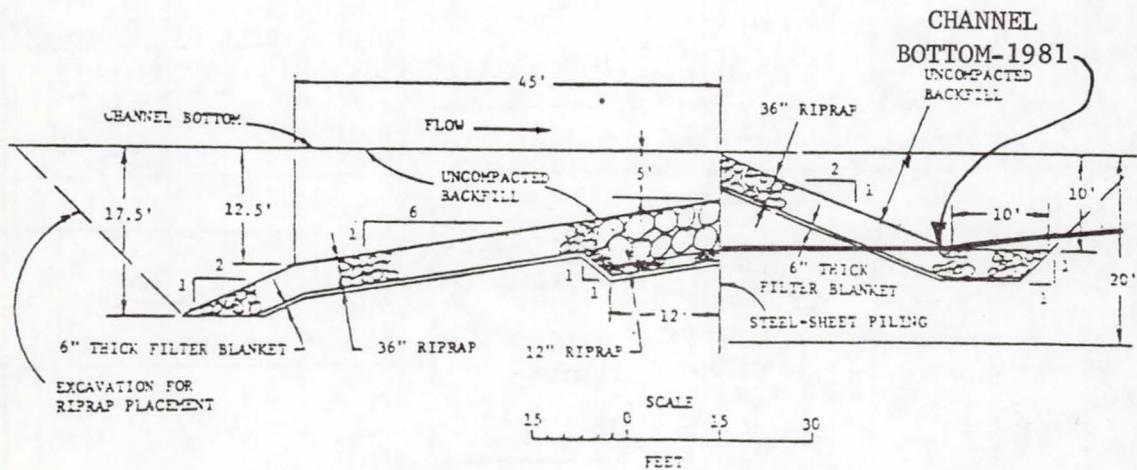
Figure 7. Floyd River at Sioux City, Iowa. Center-line view of sheet piling and rock sill #5, Sta. 83+00 Results of April 1981 survey superimposed.

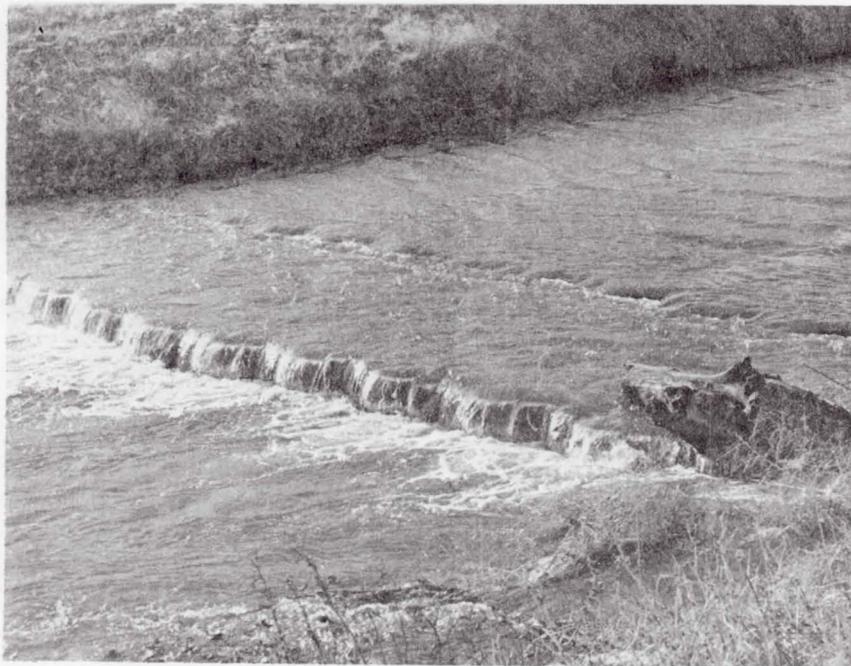
Figure 4. West Fork Ditch at Onawa, Iowa. Sheet-pile crest at sill 3 (March 1981)

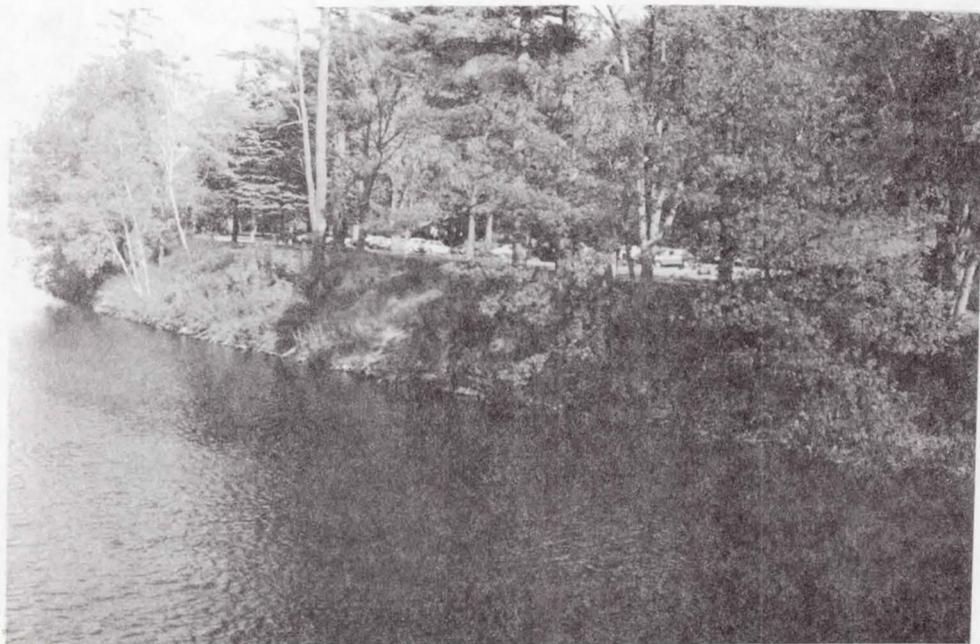
View of riprap 26 years after construction on Connecticut River at Hanover, N. H.

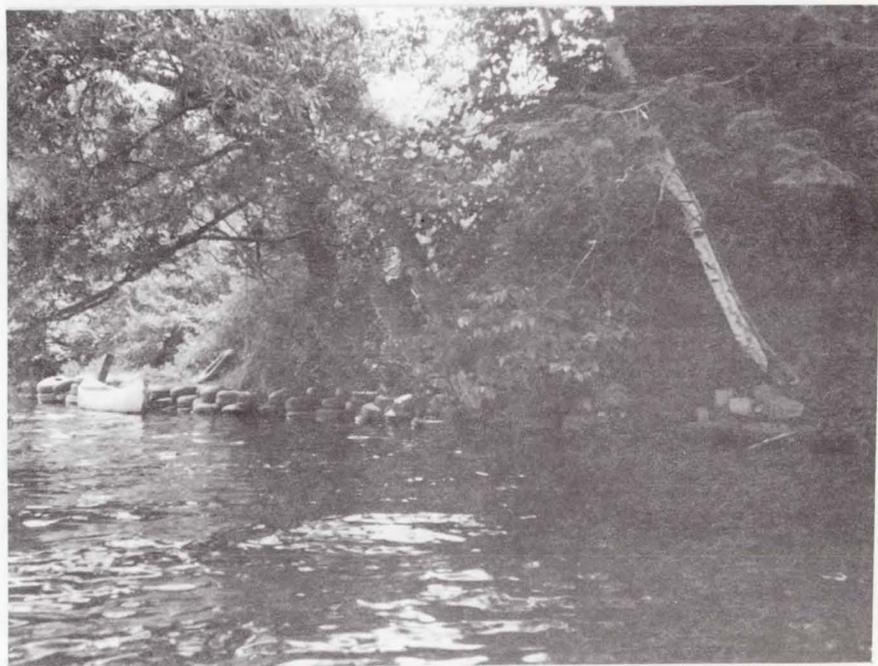
In summer 1972, private landowners constructed a 150-ft-long used-tire revetment on the right bank of the Connecticut River. Height of the protection ranged from three to fourteen layers of tires. Each tire was filled with small stones and tamped. At the time of the 1978 inspection, the revetment was intact, and a good stand of vegetation had become established on the upper bank. Minor structural damage was noted in a few places, including undercutting of tires at the upstream end of the revetment, which has resulted in the sagging of some tires and the spilling of fill material. There has also been some displacement of tires due to impact of ice cakes and heavy overbank drainage. Additional tires have been added to maintain the same top elevation. The New England Division, CE, has recommended that holes be drilled in the sidewalls to prevent flotation, that tires be tied together and anchored to the bank, that tires be stepped back 6 to 12 inches with each row, and that the space between the tires and bank be filled with earth or stone to prevent water or ice flow behind the structure.

At the time of the inspection visit, vegetation had become well established above the revetment, Connecticut River at Thetford, Vt. View is downstream  
(26 July 1978)

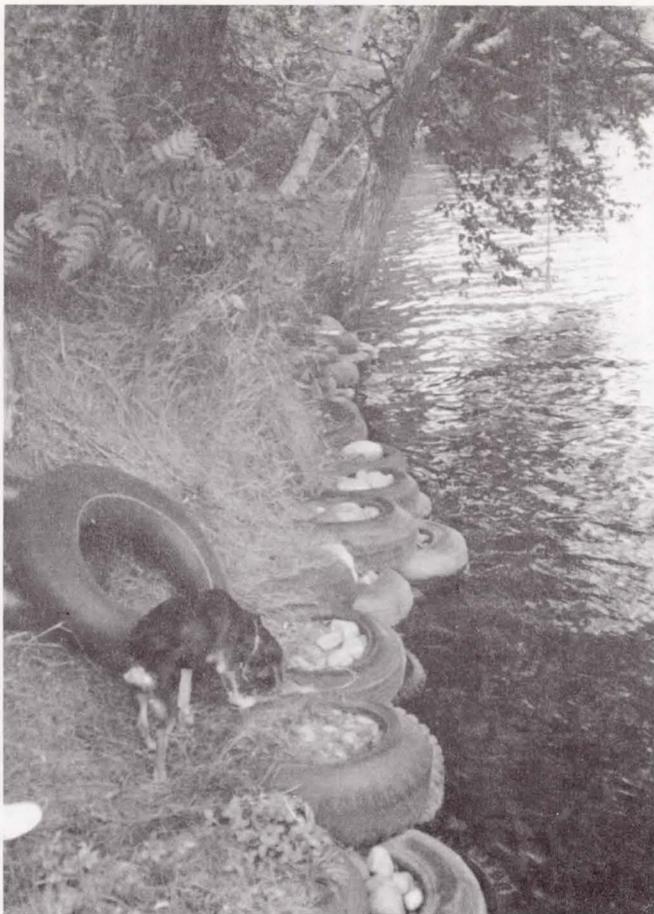
The majority of the used automobile tires have remained in place, although minor realignment has been required, Connecticut River at Thetford, Vt. View is upstream (26 July 1978)

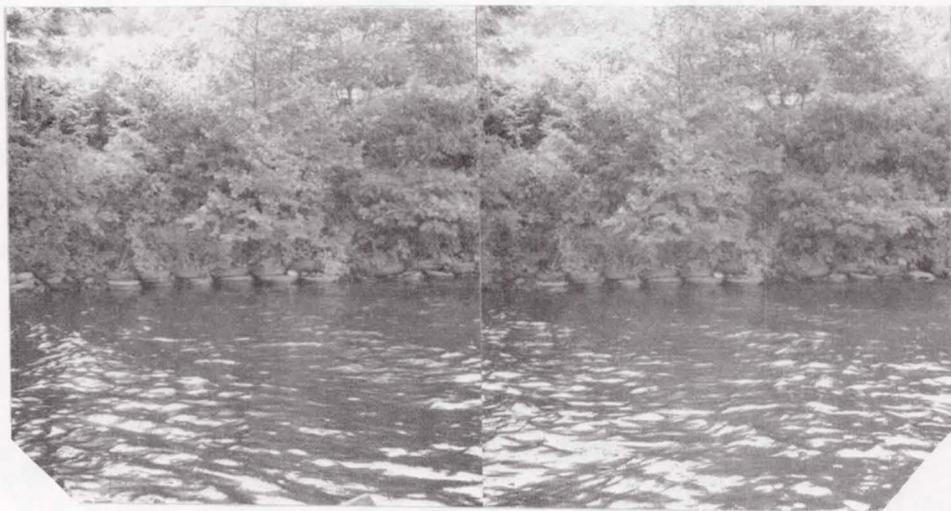
Stereoscopic view of used automobile tire revetment taken during inspection visit, Connecticut River at Thetford, Vt. (26 July 1978)

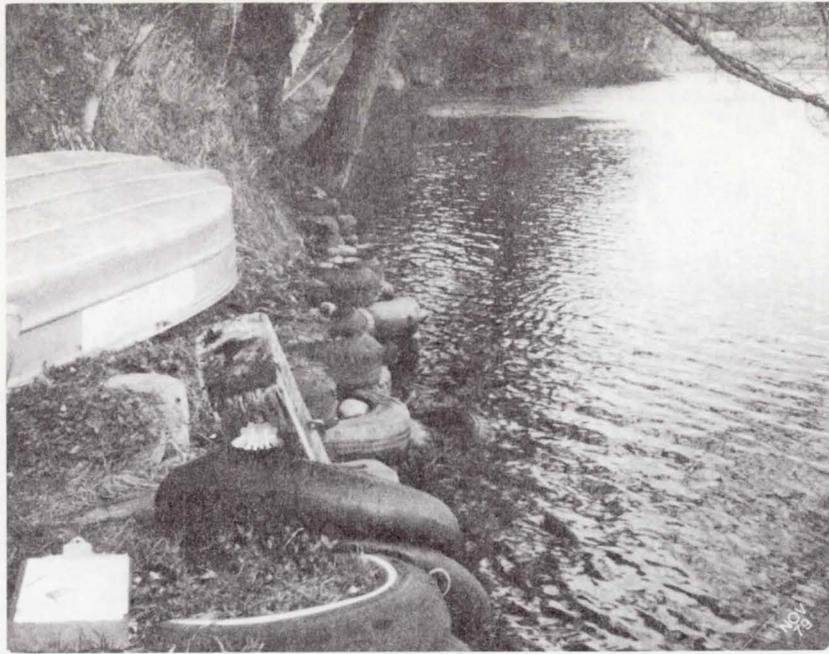
Upstream view of used automobile tire revetment of right bank of the Connecticut River at Thetford, VT. 1980

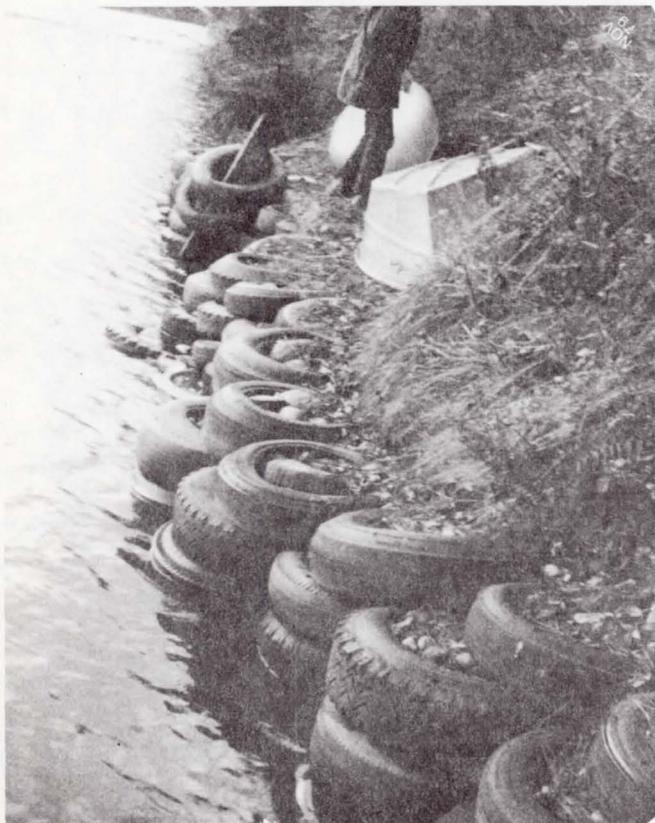
Downstream view of used automobile tire revetment on right bank of the Connecticut River at Thetford, VT. 1980

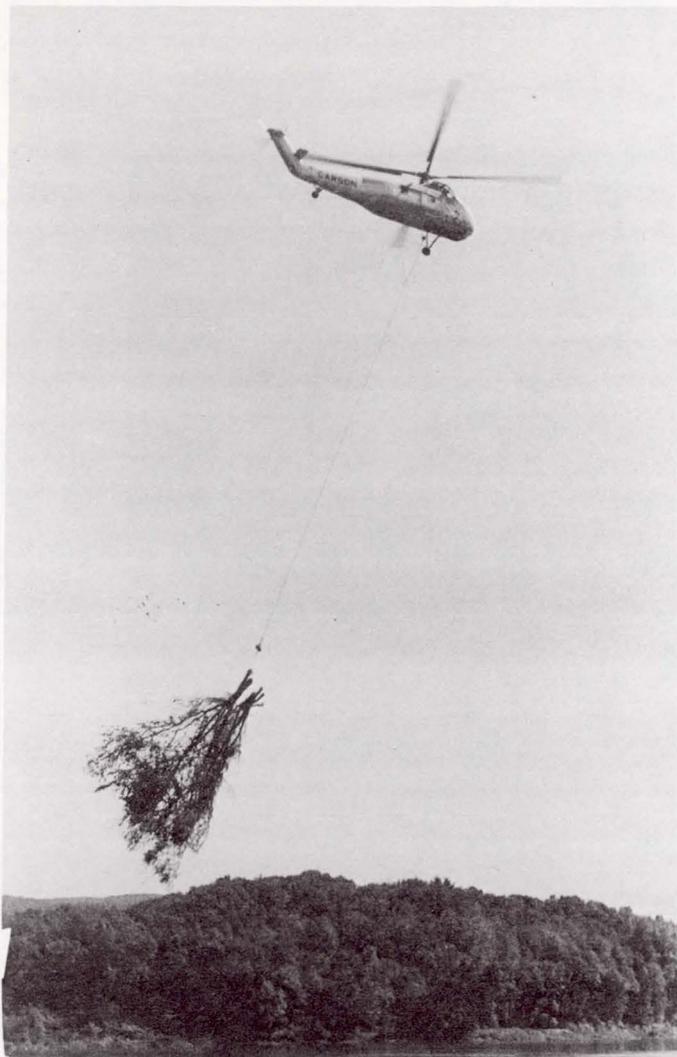
Removal of trees by helicopter (photograph courtesy of Northeast Utilities)

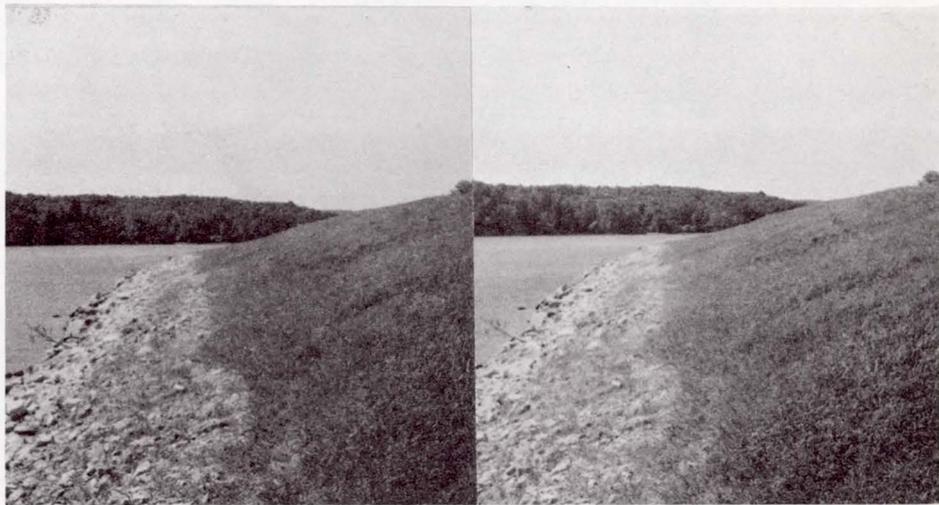
Stereoscopic view of hydroseeded bank with riprap toe protection at Stacy's Ferry, Connecticut River at Turner's Falls Pool. The height from the water surface to the top of the revetment is approximately 4 ft, and to top bank, 12 ft. View is downstream (26 July 1978)

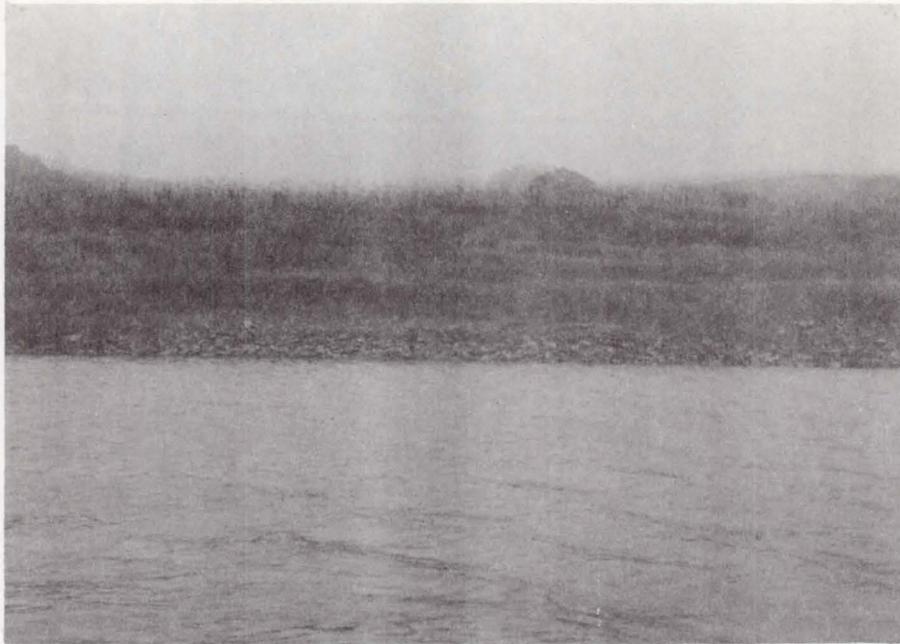
Vegetation had become well established at the Stacy's Ferry site by winter of 1977-78, Connecticut River at Turner's Falls Pool. The height from the water surface to the top of the revetment is approximately 4 ft, and to top bank, 12 ft (photograph courtesy of Northeast Utilities)

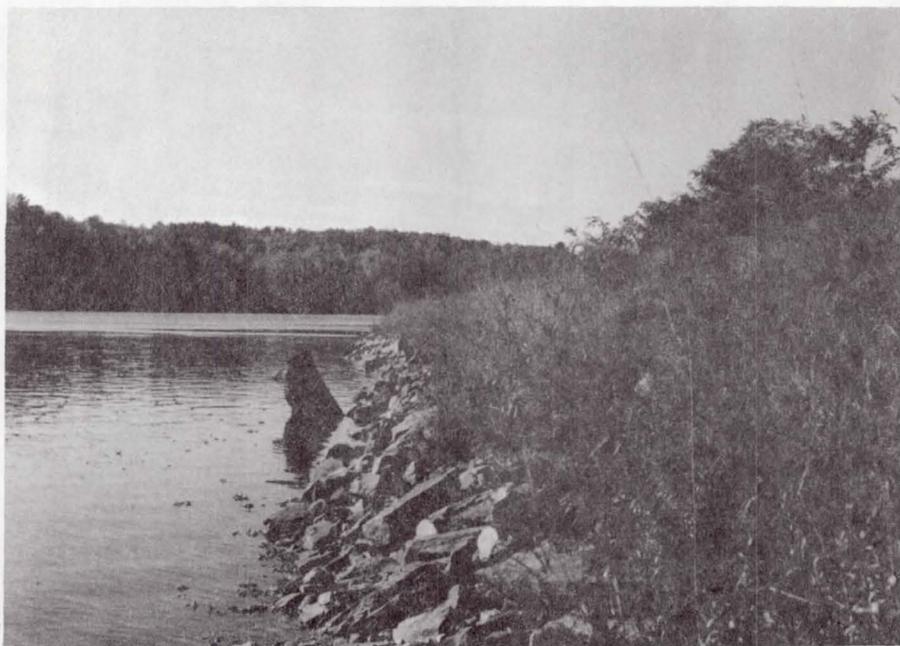
Three years after placing riprap and hydroseeding at Stacy's Ferry, Connecticut River at Turner's Falls Pool (Oct 1980)
