**FLOODING IN  
EAST MARICOPA COUNTY**

**AUGUST 1988**

## A REPORT ON THE AUGUST 1988 RAIN

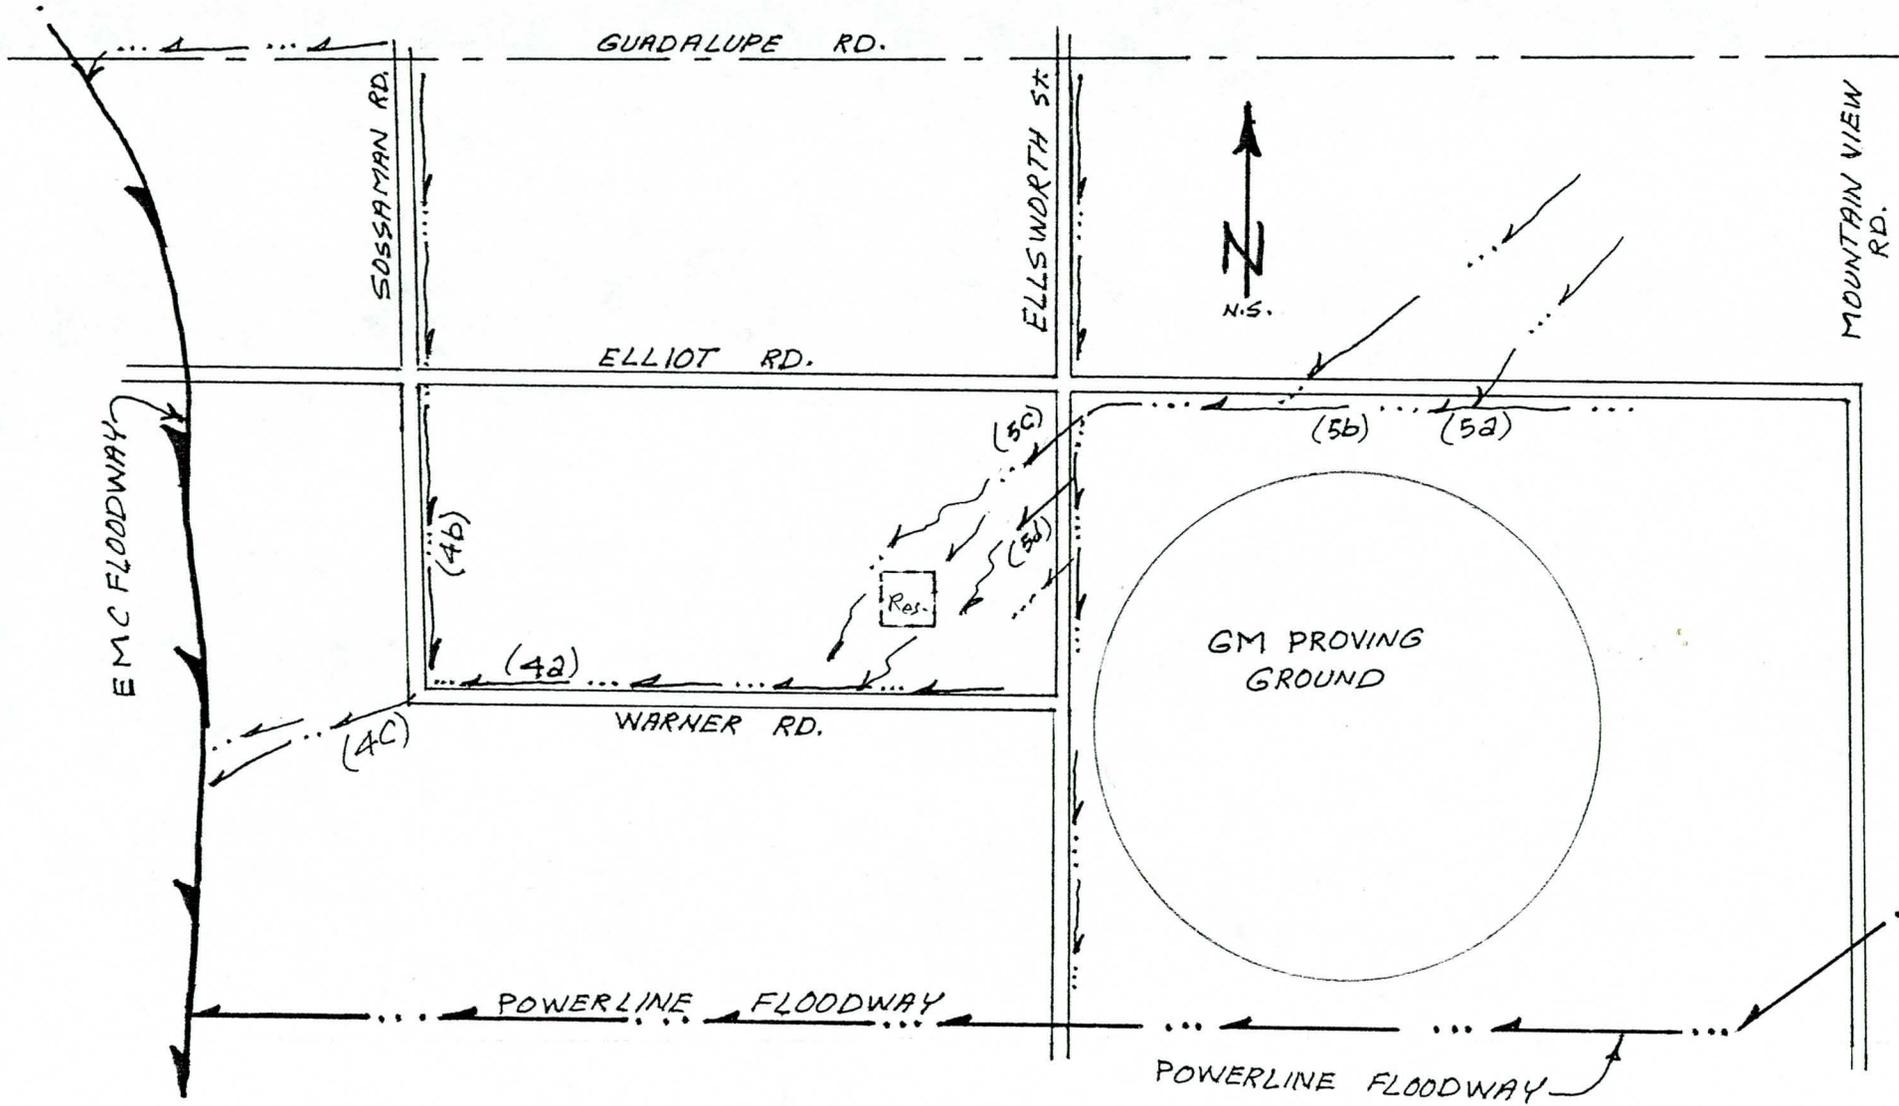
5d. Looking north, Scours and debris along east side of Ellsworth St., and south of Elliot Rd. & Ellsworth St. intersection (south of 5c).
