# Attachment 5 LATERAL MIGRATION ANALYSIS REPORT

## El Rio Watercourse Master Plan and Area Drainage Master Plan

# EL RIO WATERCOURSE MASTER PLAN

## Lateral Migration Analysis Report

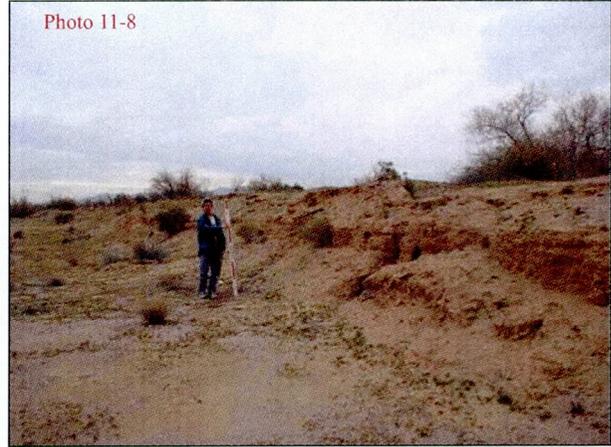
**Figure 40. Cutbank located within active channel corridor and composed of overbank, floodplain sediment**

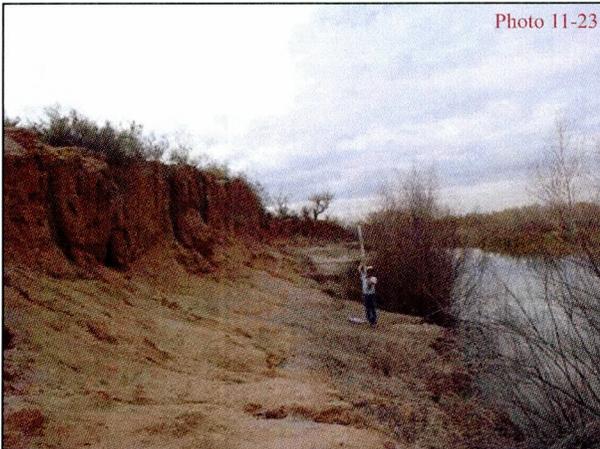
**Figure 41. High relief cutbank near thalweg**

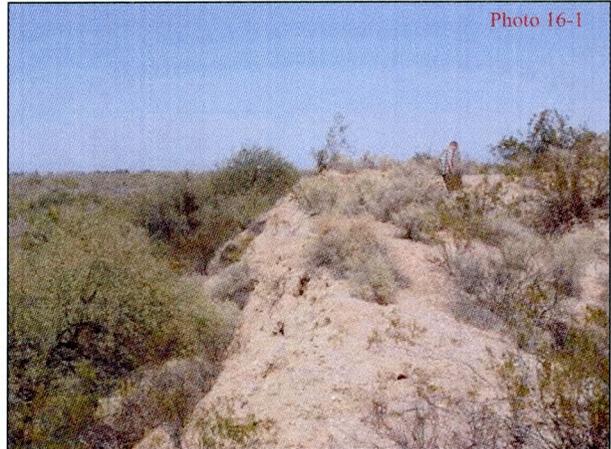
**Figure 42. Soft sediment cutbank upstream of Tuthill Road Bridge**

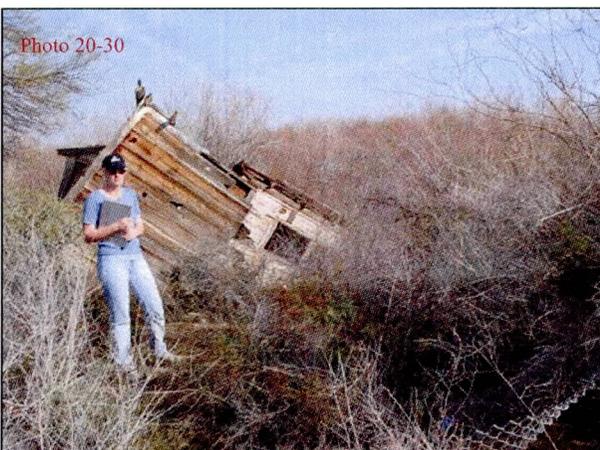
A cutbank is a stream bank that has been eroded (cut) to a steep, vertical or overhanging slope and generally is evidence of active lateral erosive processes. Field observations in the study reach and elsewhere in central Arizona indicate that vertical banks are inherently unstable, although the time scale over which instability is expressed varies with the degree of erosivity and resistance of the local bank characteristics. The location and dimensions of cutbanks observed in the field were recorded in the field at key locations. Cutbanks observed in the study reach were generally composed of unconsolidated fine-grained (floodplain) sediment, unconsolidated (channel) cobbles and gravel, weakly cemented (with  $\text{CaCO}_3$ ) sediment and/or cobbles, or some combination of each. Bank and overbank vegetation appeared to increase the stability of the bank soils, but did not prevent lateral erosion or the formation of cutbanks. The presence of cutbanks indicates that active lateral erosion occurs within the stream system in the study area, regardless of bank vegetation, soil lithology, and soil composition. Figure 39 through Figure 44 show cutbanks observed in the field. Figure 43 and Figure 44 show evidence of structure damage due to active lateral erosion of cutbanks.

**Figure 43. Structure succumbs to lateral erosion. Photo is looking upstream along the right bank of the compound channel. Building is collapsed over the cutbank**

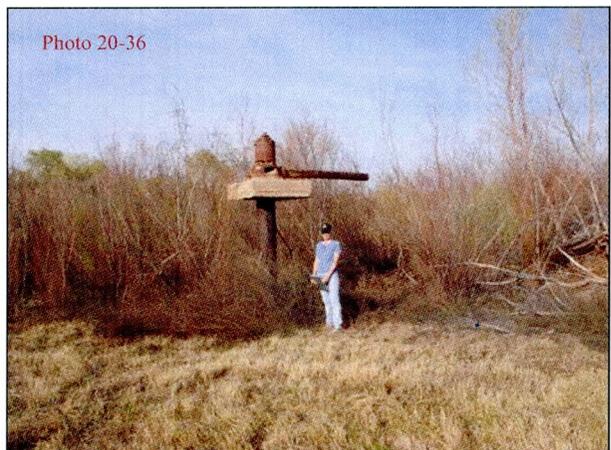
**Figure 44. Well head and casing exposed by lateral erosion along the right bank of the compound channel. Cutbank is located approximately 60 feet behind wellhead**

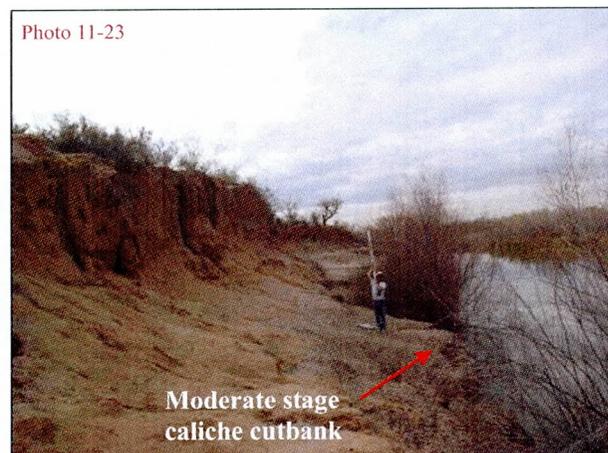
Calcium carbonate rich soil (caliche) is common in the semi-arid climate of southern Arizona. The degree of caliche development increases with time, making it a valuable indicator of soil age and thus, landform stability. Early stage development may include imperceptible, disseminated calcium carbonate ( $\text{CaCO}_3$ ) within the sediment matrix. A more advanced state will include visible  $\text{CaCO}_3$  coatings on gravels and cobbles. Advanced state development includes conglomeritic sediments well cemented by  $\text{CaCO}_3$ , often forming thick, resistant layers resembling bedrock. The advanced stage development may provide significant resistance to lateral erosion. Field investigations of the El Rio study reach did not yield locations of advanced stages of caliche development. Early to moderate caliche development was observed in a few cutbanks. The most notable caliche development was found just downstream of the Tuthill Bridge along the left bank. Narrowing of the river corridor in this area has resulted in degradation of the active channel, exposing moderate stage caliche (Figure 49).

Figure 49. Moderate stage caliche cutbank exposed downstream of Tuthill Bridge

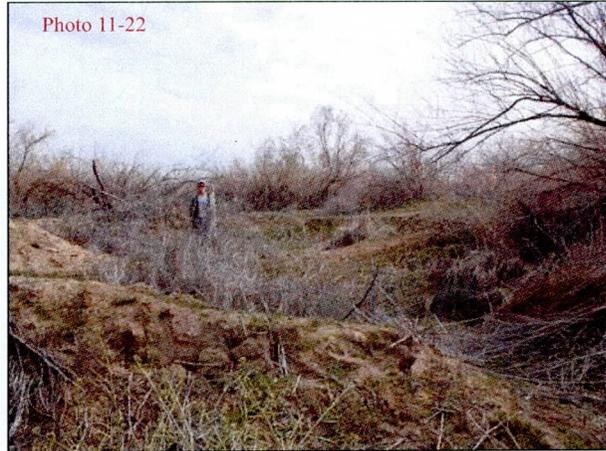
An avulsion is the formation of a channel in a portion of the floodplain not previously occupied by a channel. Avulsions are responsible for some of the most significant lateral channel movement on the large stream systems in central Arizona. Generally formed during flood events, avulsions can be responsible for dramatic changes in river course orientation, causing flooding and erosion hazards in parts of the floodplain that were previously free from such hazards. Incipient and current channels were observed at multiple locations within the study reach. These locations represent high potential for future lateral erosion hazards (Figure 64 through Figure 67).

Figure 65. Right-bank avulsive channels downstream of Estrella Bridge

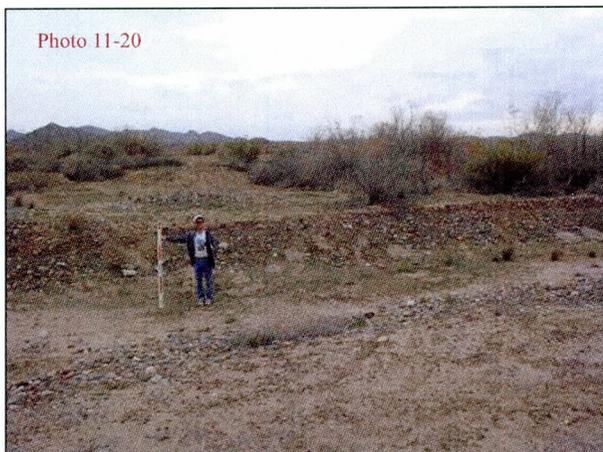
Figure 66. Right-bank avulsive channel downstream of Estrella Bridge (*note cobbles*)

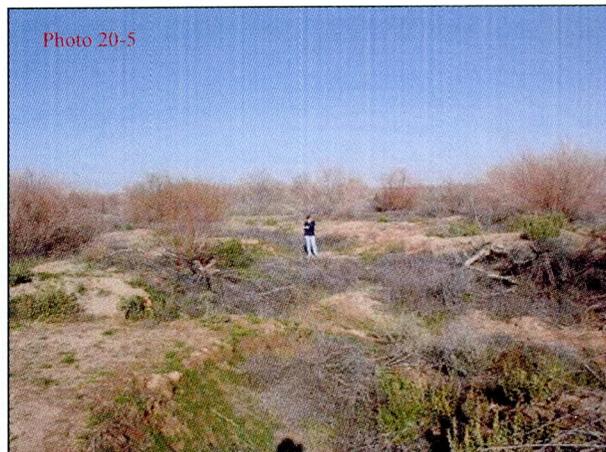
Figure 67. Left-bank avulsive channels near State Highway 85 Bridge

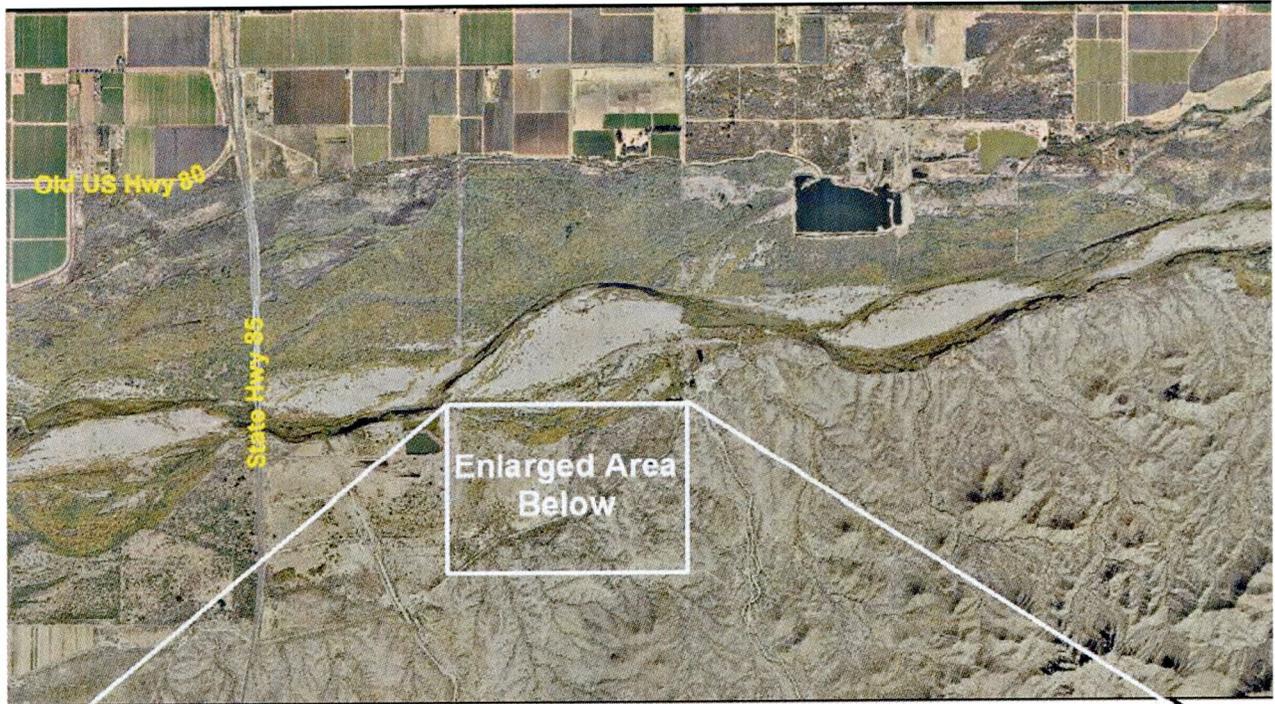
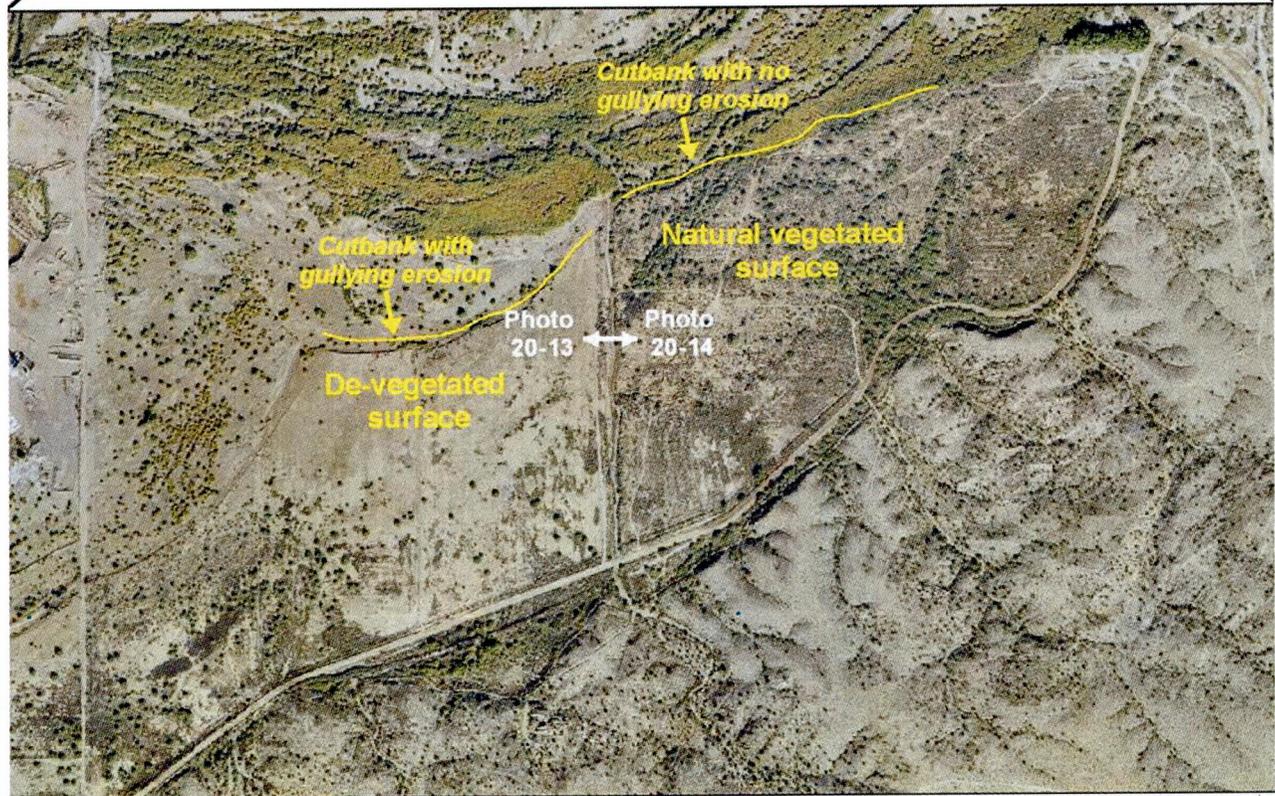
Gully gully of overbank terraces was most severe on cutbank and floodplain surfaces with little to no vegetation. These processes were specifically observed along the left bank just upstream of the State Highway 85 Bridge. The left-overbank floodplain along this reach had historically been used as agricultural land, with the natural vegetation cleared and the soil tilled. An equivalent geomorphic floodplain surface exists adjacent to the cleared surface, and has more undisturbed natural vegetation. Gully gully processes are nearly non-existent on the undisturbed surface, while severe gully gully is present on the developed land. Figure 71 shows an aerial view of these surfaces with Figure 72 and Figure 73 illustrating the vegetation contrast. This evidence suggests that lateral erosion may be accelerated if floodplain areas are cleared or developed without regard to control of increased surface runoff.

**Figure 71. Example of gullying caused by de-vegetation**

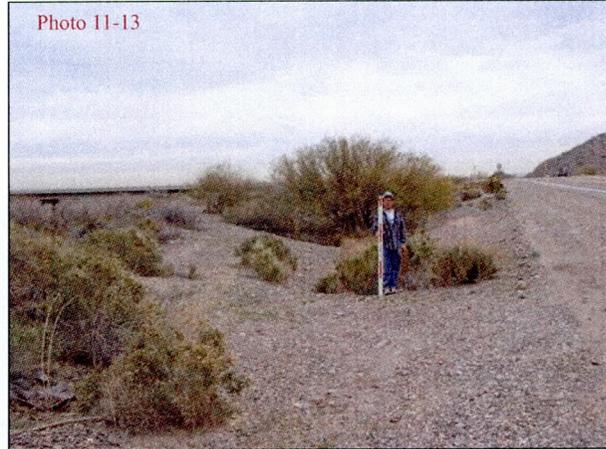
Figure 75. Downstream extent of fill for the left bank bridge approach, looking upstream.

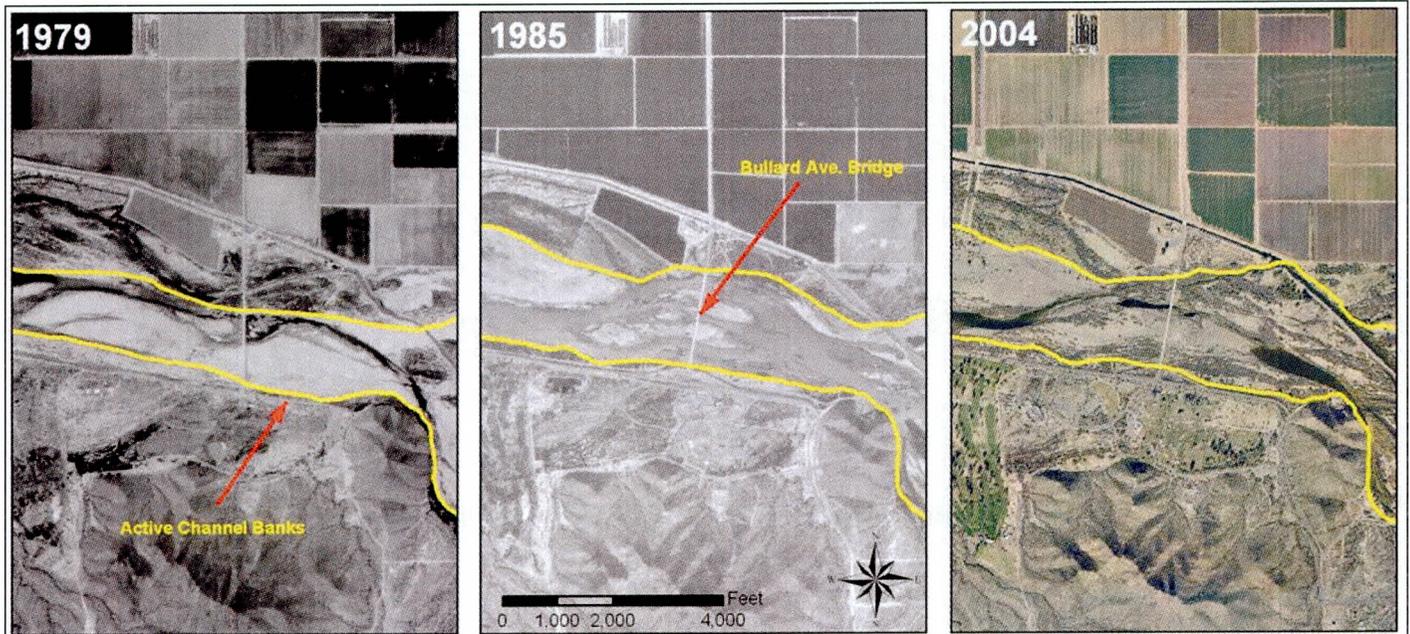
Figure 76. Active channel bank comparison at Bullard Avenue Bridge

The Bullard Avenue Bridge (span approx. 1,850 feet) was completed in 1982 and was nearly immediately subjected to flooding conditions during the January 1983 event. Historic aerial photographic analysis indicates the active channel banks have remained relatively stable both upstream and downstream of the bridge since its completion. The 1983 flood appears to have widened the active channel boundaries to the width of the bridge. Figure 74 and Figure 75 show field photographs of the left bank approach of the bridge. Figure 76 shows the active channel bank comparison for the photographic record both before and after construction of the bridge.

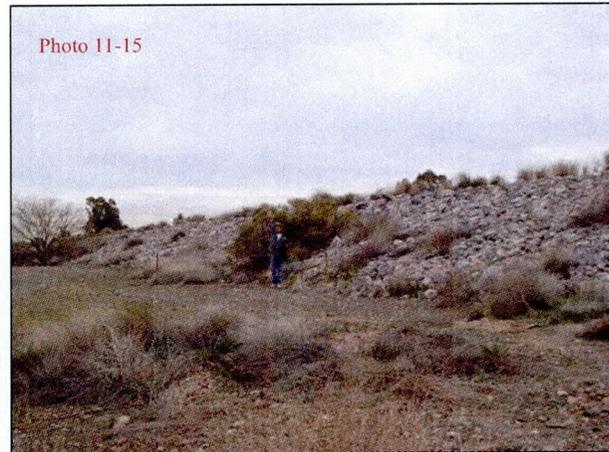
**Figure 78. Left bank levee protecting the King Ranch property directly downstream of Estrella Parkway Bridge, looking upstream**

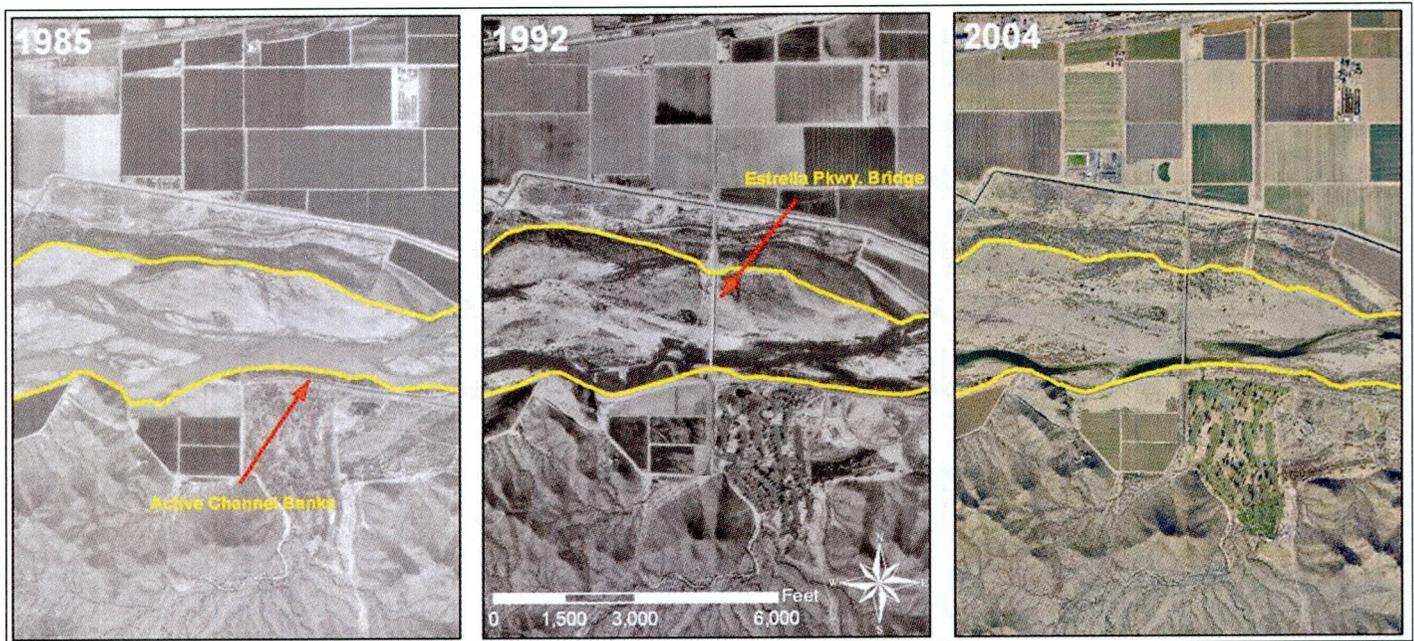
**Figure 79. Active channel bank comparison at Estrella Parkway Bridge**

Completed in 1987, the Estrella Parkway Bridge span measures approximately 2,200 feet. Photographic analysis indicates the channel banks have remained stable near the bridge. The condition of the left bank bridge approach was field inspected to determine the stability and potential for lateral erosion. The approach fill material was armored with boulder-sized rip-rap. The channel banks upstream of the approach appeared stable and showed no signs of lateral erosion. The right bank approach appeared in the same condition with no apparent bank stability problems. Figure 77 and Figure 78 are field photos of the left bank both upstream and downstream of the bridge. Figure 79 is the historic photo comparison of the active channel banks.

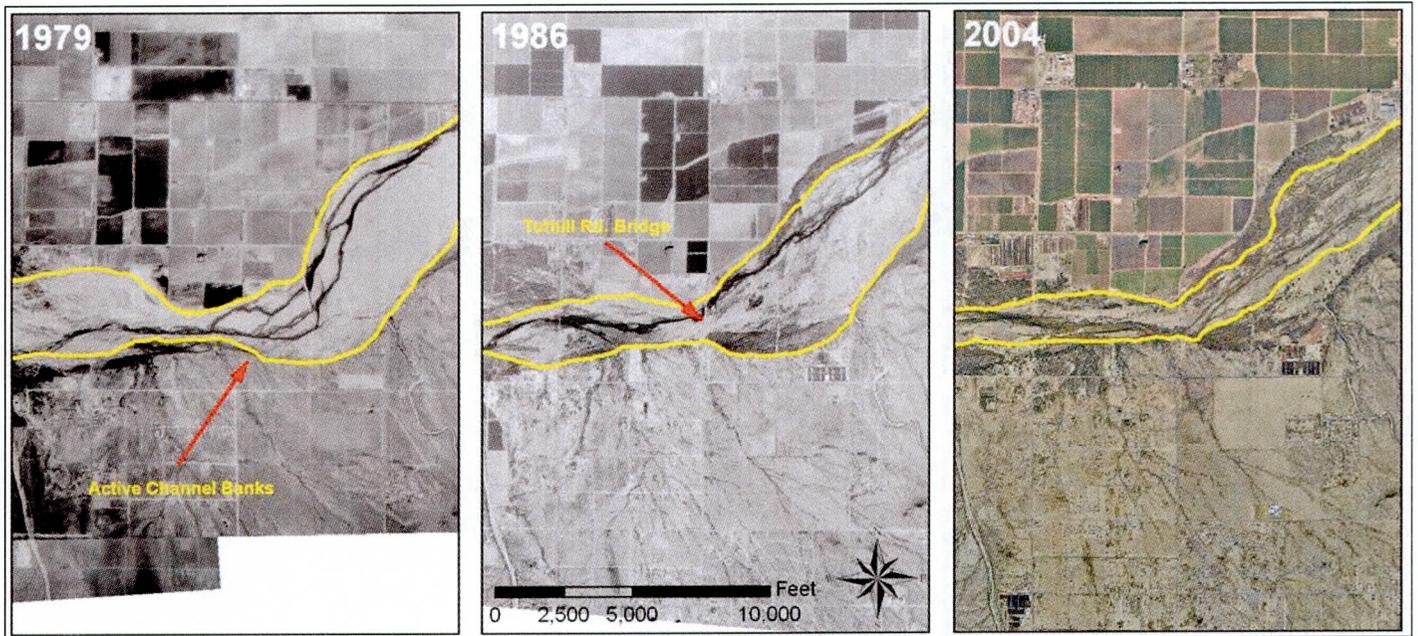
Figure 80. Active channel bank comparison at Tuthill Road Bridge

The Tuthill Road Bridge was completed in 1981 and has the shortest span of all the bridges in the study reach (approx. 1,770 feet). The photographic record indicates this segment of the study reach has historically been the narrowest of the entire reach, but is also one of the more laterally stable reaches. Field investigation revealed a significant cutbank along the left bank both upstream and downstream of the bridge. Pre-bridge photographs do not show the cutbank present, indicating degradation of the thalweg caused by channel narrowing potentially due to the presence of the bridge (see Figure

41). Figure 80 shows the pre- and post-bridge construction aerial photos for this reach. The right bank both upstream and downstream of the bridge has been one of the most stable reaches within all of the El Rio study reach. Both the quantitative lateral migration and channel width analysis indicated very little lateral movement of either the left or right banks within this reach of the Gila.

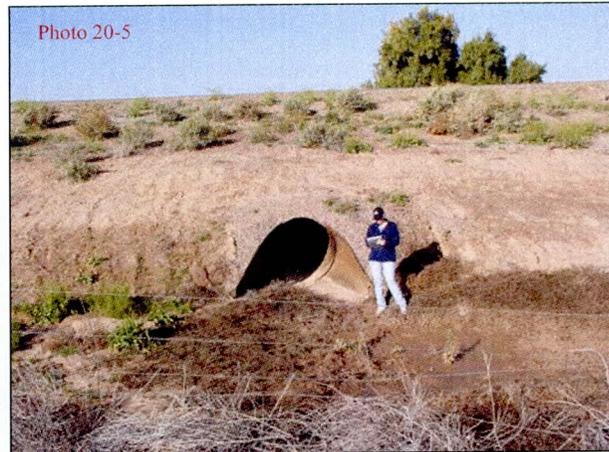
Figure 82. Left bank raised roadway to bridge approach with low-flow culvert, looking downstream direction

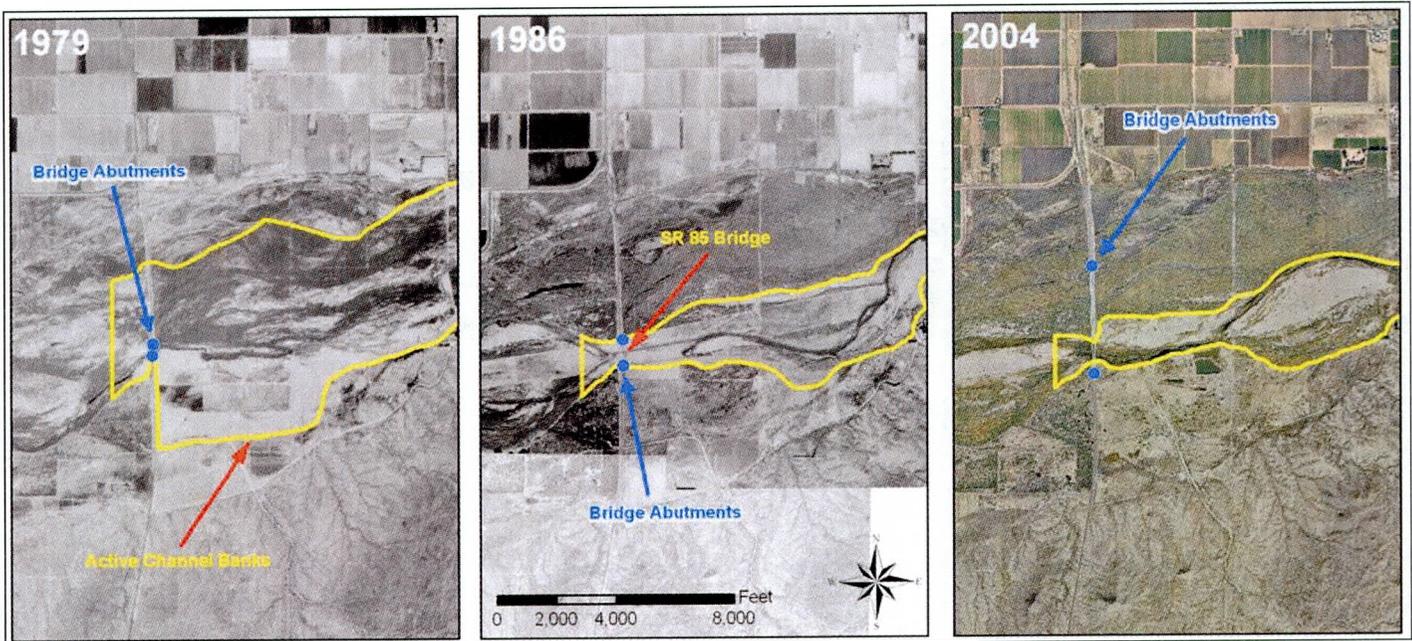
Figure 83. Active channel bank comparison at State Route 85 Bridge

The State Route 85 Bridge was originally completed in 1969 with a span of less than 500 feet. The channel constriction at the bridge caused significant ponding upstream during the December 1978 flood, resulting in considerable lateral erosion of the active channel left bank, as indicated by aerial photographs. Between 1979 and 1983 the bridge was expanded to a width of approximately 800 feet. After the January 1993 flood the bridge was closed. Between 1993 and 1997 a double lane, single-roadway bridge spanning approximately 3,600 feet was constructed. By 2002 a split-roadway, four-lane bridge approximately 3,600 feet in width was in place. Figure 81 and Figure 82 are field photos near the bridge. Since the 3,600 feet expansion of the bridge, the active channel banks have been relatively stable upstream of the bridge as shown by the photo comparison in Figure 83.

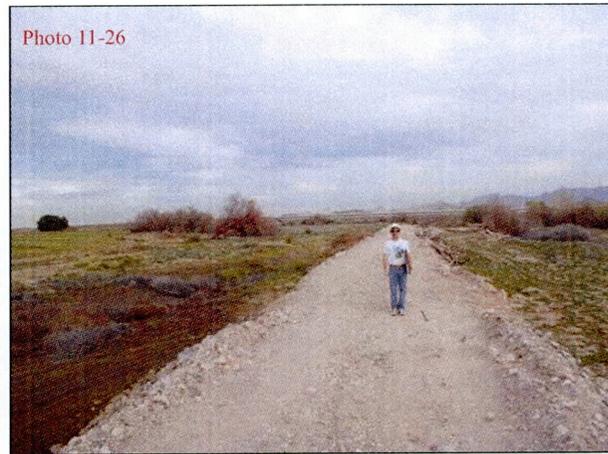
**Figure 85. Right-bank levee under construction, looking upstream direction**

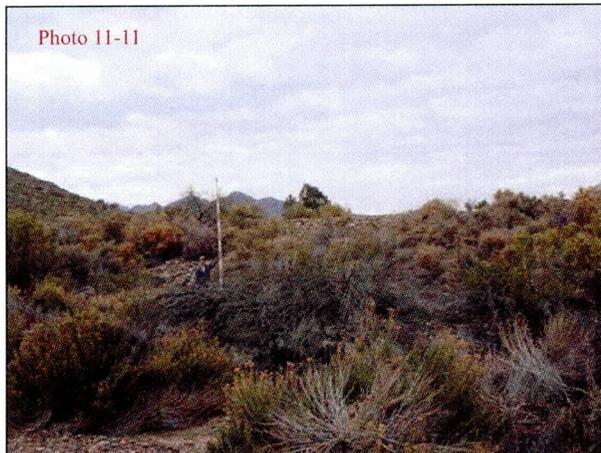
**Figure 86. Left-bank levee along W. Vineyard Avenue (Estrella Mtn. Park), looking upstream**

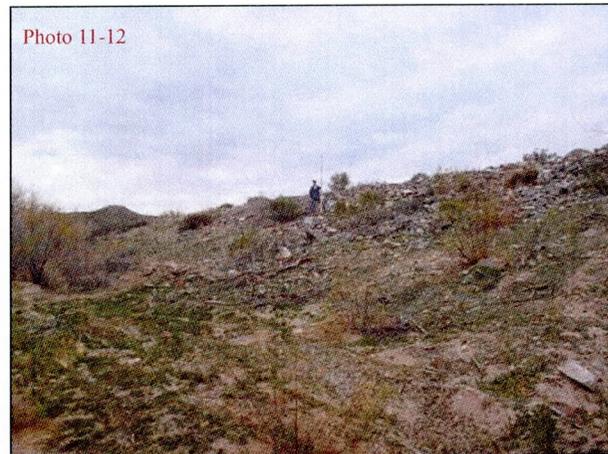
**Figure 87. Left-bank levee just upstream of Estrella Parkway Bridge, looking upstream**

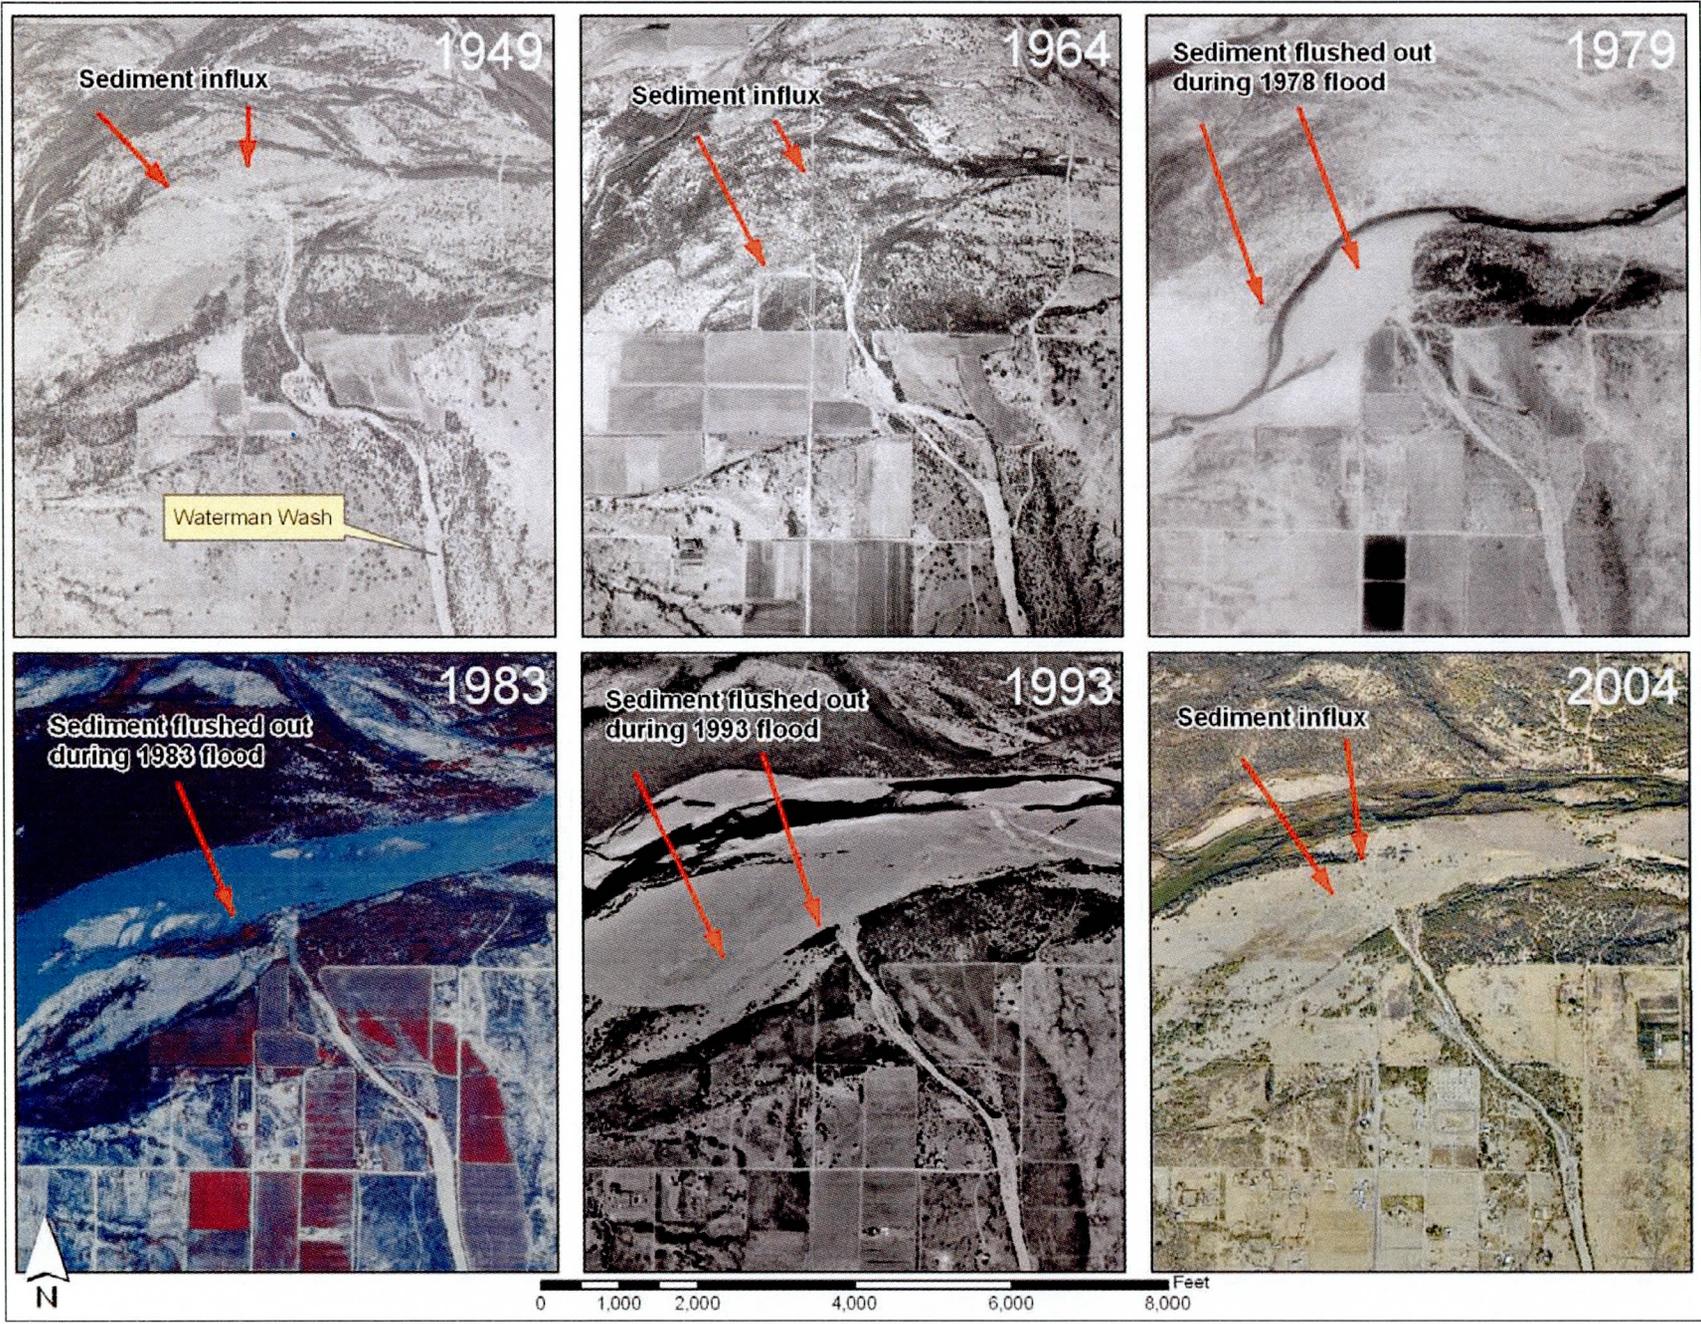
Figure 90. Historic photo comparison of Waterman Wash confluence

The drainage area of Waterman Wash is approximately 420 square miles. Historic aerial photographs show moderate to low sediment volume influxes into the Gila River, which are easily entrained during large magnitude flood events, as illustrated in Figure 90. The drainage area of Waterman Wash is less than 1 percent of the Gila River drainage area upstream of the study reach, suggesting minimal impact on the Gila system outside of the delta area.

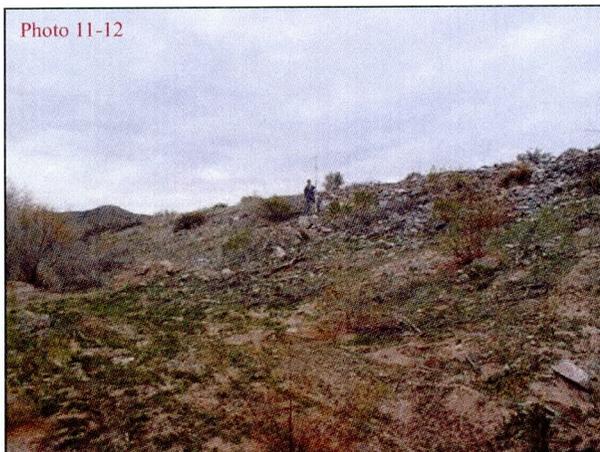
Figure 92. W. Vineyard Avenue roadway embankment, looking upstream direction

The two structures of primary interest were the West Vineyard Avenue roadway embankment and the King Ranch levee downstream of Estrella Parkway Bridge. The West Vineyard Avenue roadway embankment is raised and bank protected with angular rip-rap (Figure 92). Specific engineering for lateral erosion protection was not readily verifiable; therefore the embankment was assumed to be susceptible to lateral erosion. The revised Salt/Gila FDS (Baker, 1999) modeled Vineyard Avenue both to fail during the 100-year design event and to function as a levee. In either situation, the roadway was overtopped. The combination of this information resulted in the roadway being placed inside the EHZ. The King Ranch levee is approximately 10-12 feet in height and bank
