Tres Rio North Levee Final Construction Report

**NATIONAL FLOOD INSURANCE PROGRAM, LEVEE SYSTEM
EVALUATION REPORT (NLSE) FOR TRES RIOS NORTH LEVEE,
MARICOPA COUNTY, ARIZONA**

Date: 25 September 2012
PGT
Project No.: 345-PGT-TO2
Subject: Final Construction Report for the Tres Rios Environmental Restoration Project Phases 1A and 1B, North Levee, Maricopa County, Phoenix, Arizona

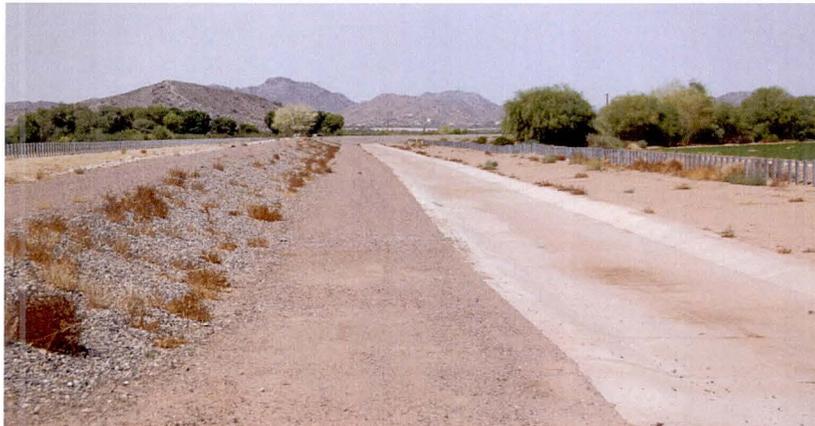
Photo No. F-1. Phase 1A Collector Channel Looking Downstream Near the 105th Avenue.

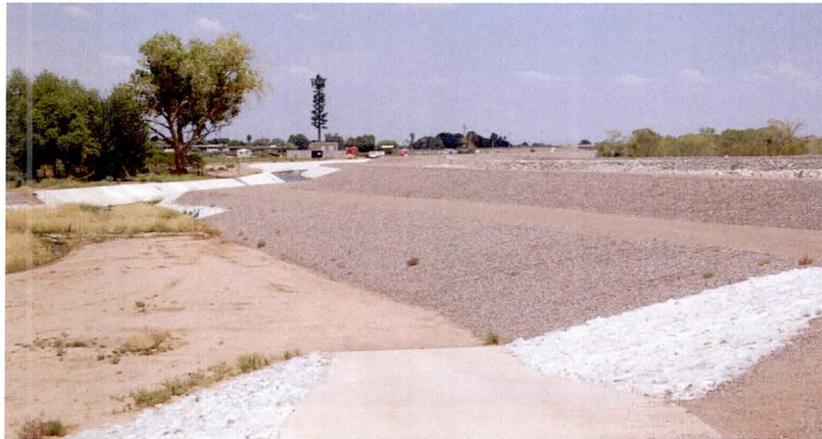
Photo No. F-2. Viewing Upstream from Phase 1B Catch Basin.

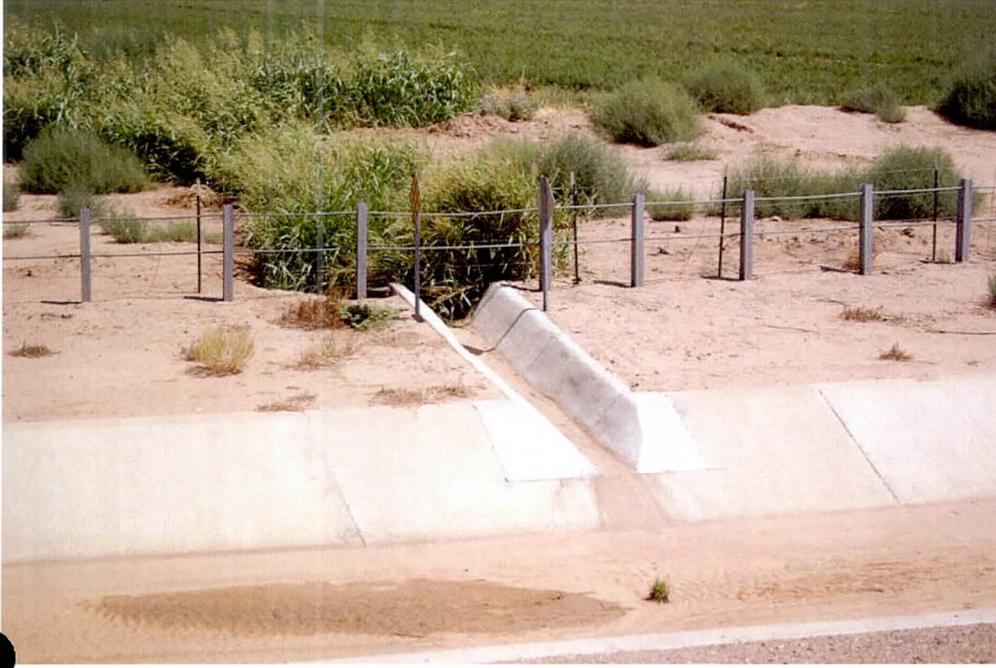
Photo No: 1294

Location: Tres Rios Levee Station 193+00, Phase 1A

Description: Looking northwest at patching of concrete joints in Concrete Irrigation Channel (typical).

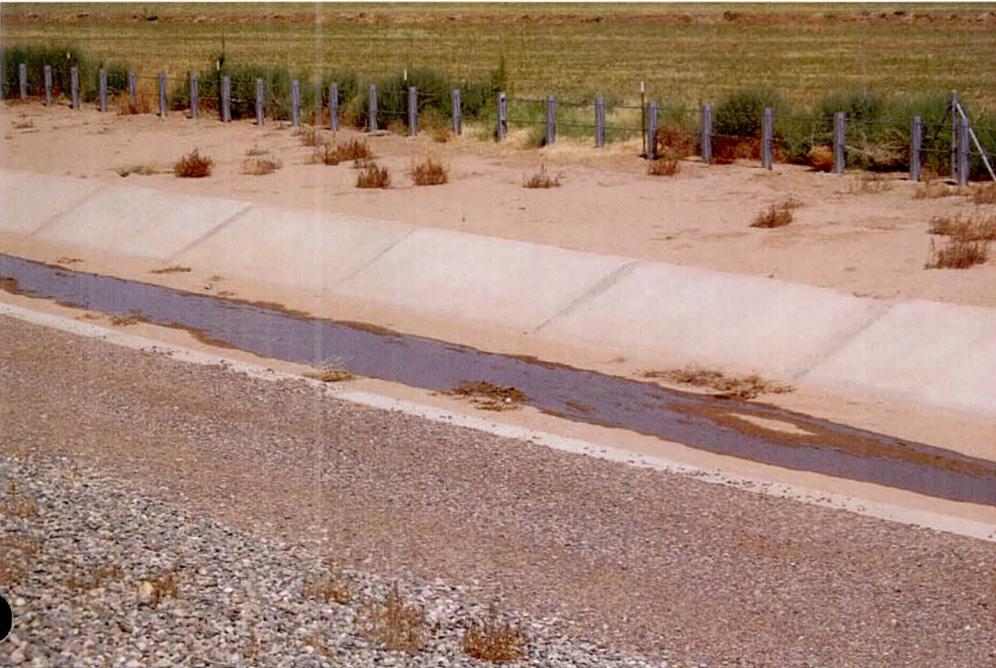
Photo No: 1343
		Location: Tres Rios Levee Station 170+50, Phase 1A
		Description: Looking northwest at 113 th Ave. box culvert obstructed by silt and vegetation.

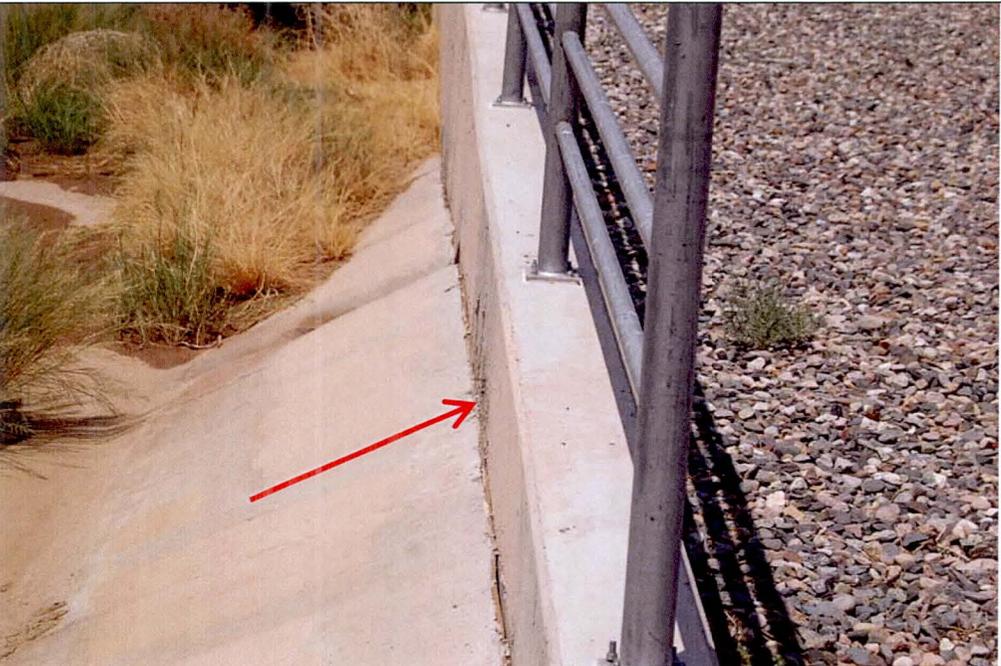
Photo No: 1351
		Location: Tres Rios Levee Station 169+50, Phase 1A
		Description: Looking west at concrete disjuncting in the 113 th Ave. box culvert.

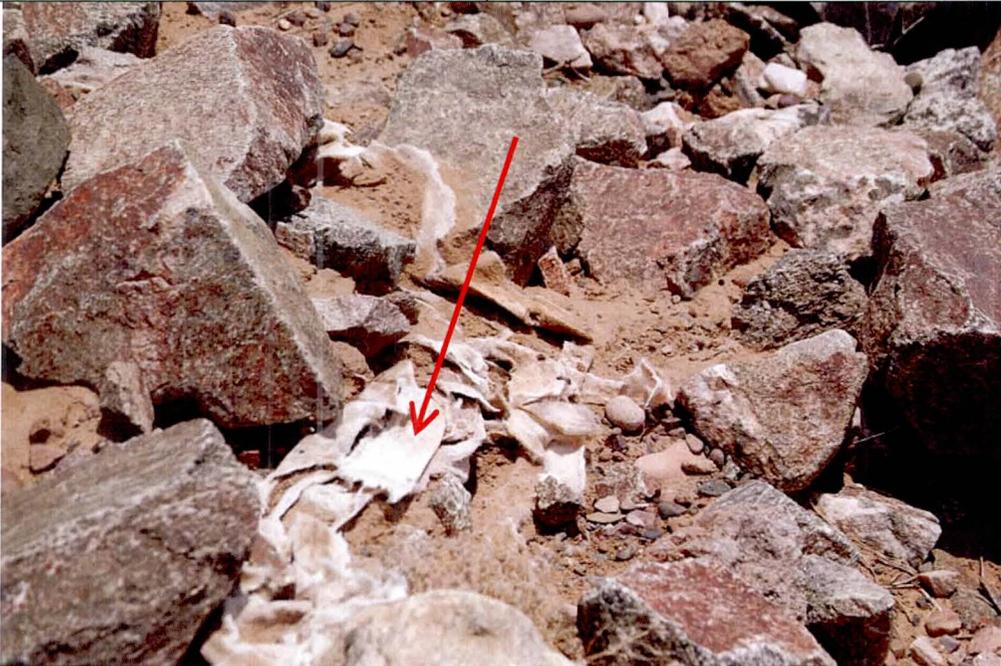
Photo No: 1395
		Location: Tres Rios Levee Station 158+00, Phase 1A
		Description: Looking at exposed woven geotextile filter fabric near East 115 th Ave. Guide Dike.

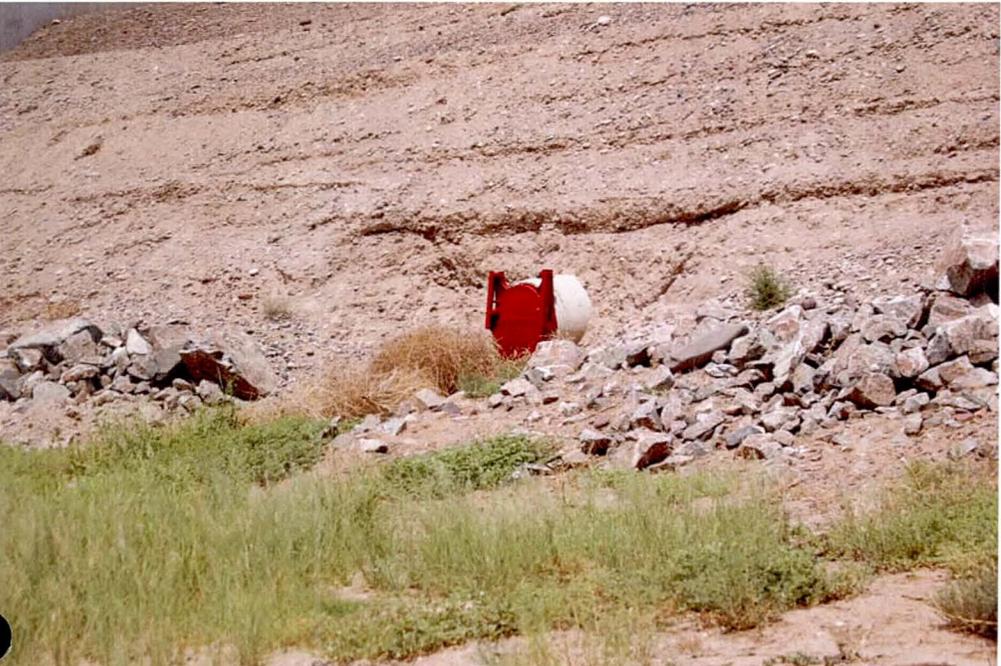
Photo No: 1427
		Location: Tres Rios Levee Station 154+50, Phase 1A
		Description: Looking northwest at 30" CMP through levee upstream of 115 th Ave. bridge. CMP is not shown on the plans.

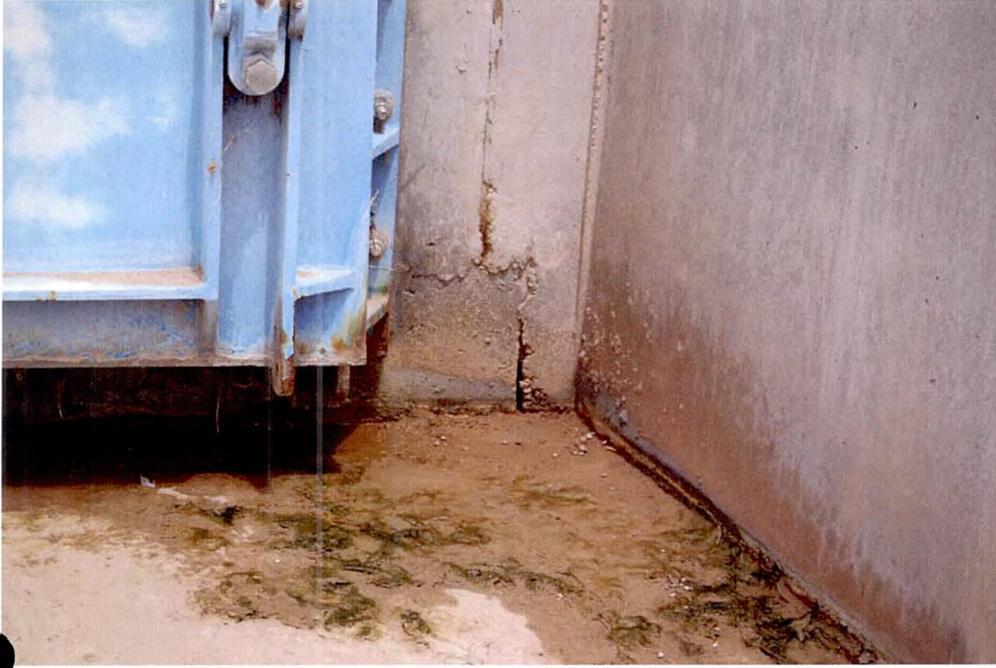
Photo No: 1454

Location: Tres Rios Levee Station 156+00, Phase 1A

Description: Looking northwest at catch basin and RCP inlet upstream of 115th Ave. bridge. They are not shown on the plans.

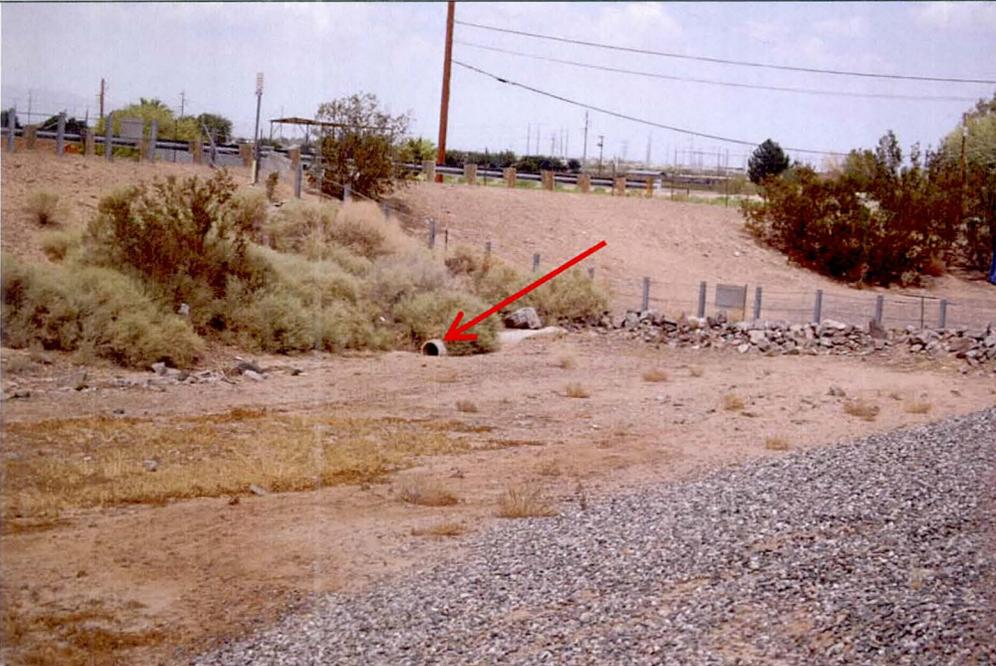
Photo No: 1461
		Location: Tres Rios Levee Station 156+00, Phase 1A
		Description: Looking southwest at catch basin outlet structure upstream of 115 th Ave. bridge which is not shown on the plans. Photo No. 1427 shows the 30" CMP outlet on the waterside of levee.

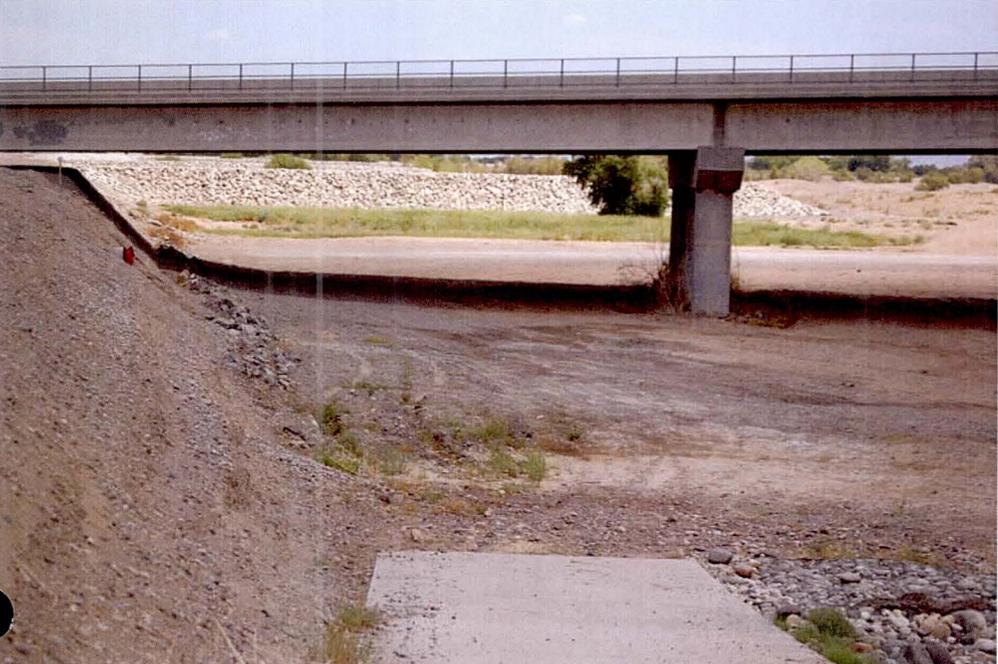
Photo No: 1500
		Location: Tres Rios Levee Station 150+00, Phase 1B
		Description: Looking east at oversteeped slope at 115 th Ave. bridge.

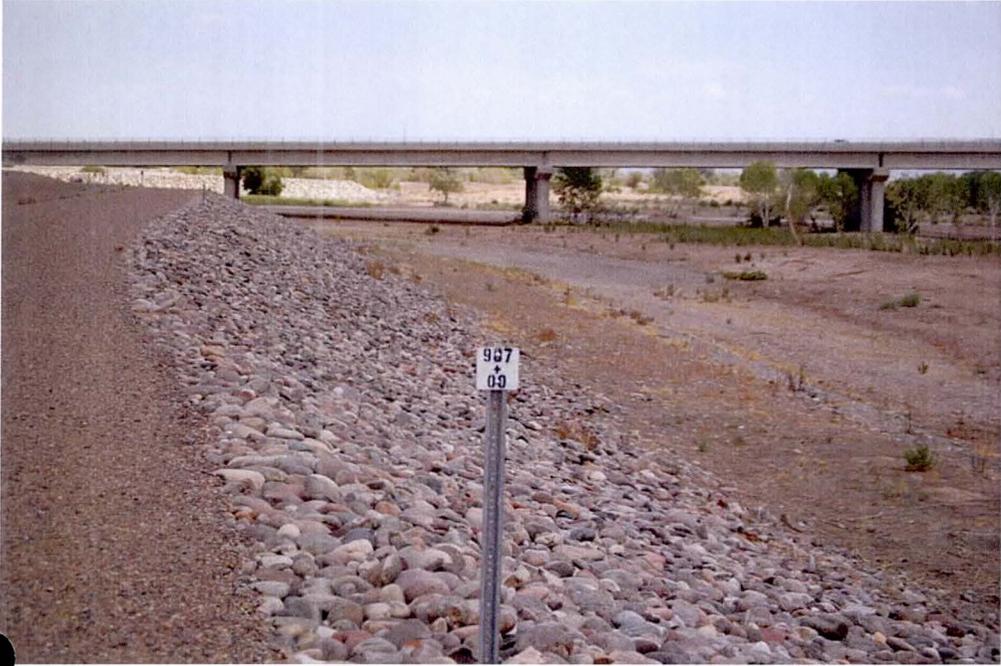
Photo No: 1521
		Location: Tres Rios Levee Station 142+10, Phase 1B
		Description: Looking east (upstream) at rounded river rock riprap on waterside levee slope downstream of 115 th Ave. bridge.

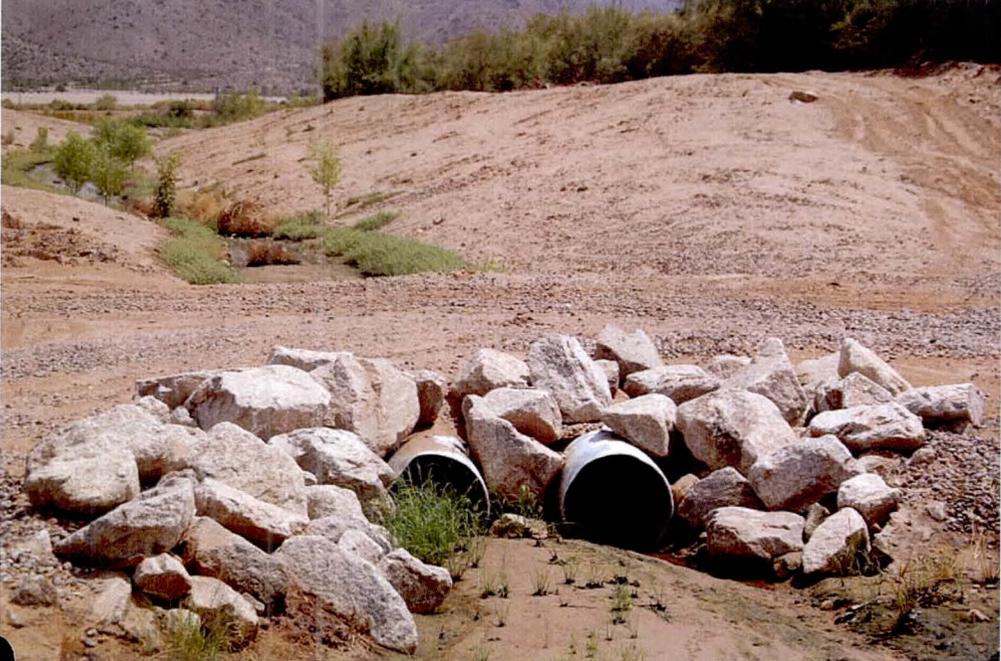
Photo No: 1660
		Location: Tres Rios Levee Station 104+50, Phase 1B
		Description: Looking south at Diversion Channel near El Mirage Rd. Access ramp with 2-CMPs are not as shown on the plans.
