Queen Creek, Arizona

Survey Report
for Run off
and Waterflow
Retardation
and
Soil Erosion
Prevention
in the Interest of
Flood Control

Photographic Supplement

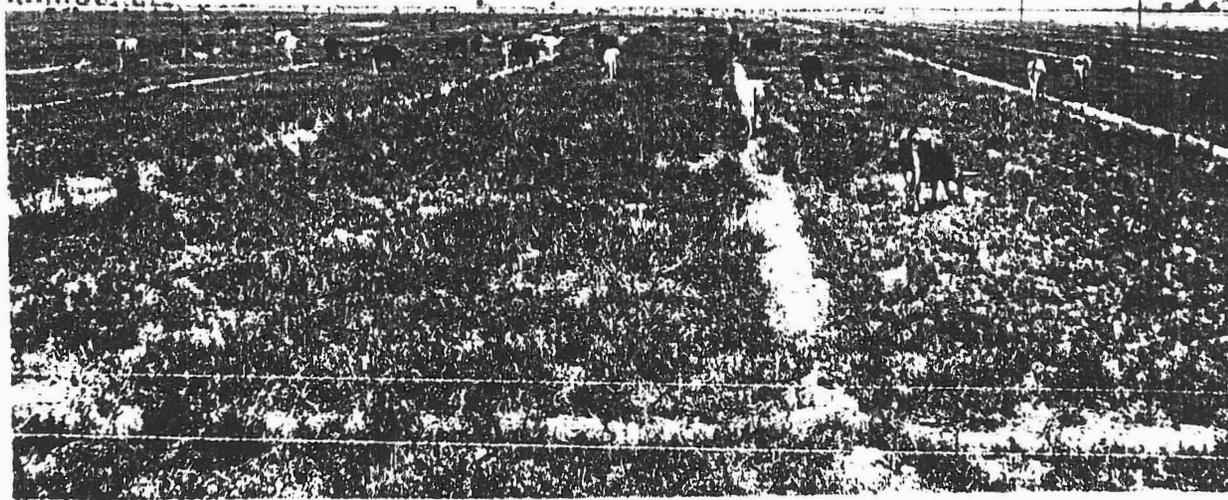
FIGURE 3A ALFALFA PASTURE BEING USED IN WINTER CATTLE-FEEDING OPERATIONS.
IN ADDITION TO PASTURAGE, 5 TONS OF HAY (FROM 5 CUTTINGS) ARE OBTAINED PER
ACRE PER YEAR, AVERAGING 1 TON PER CUTTING.

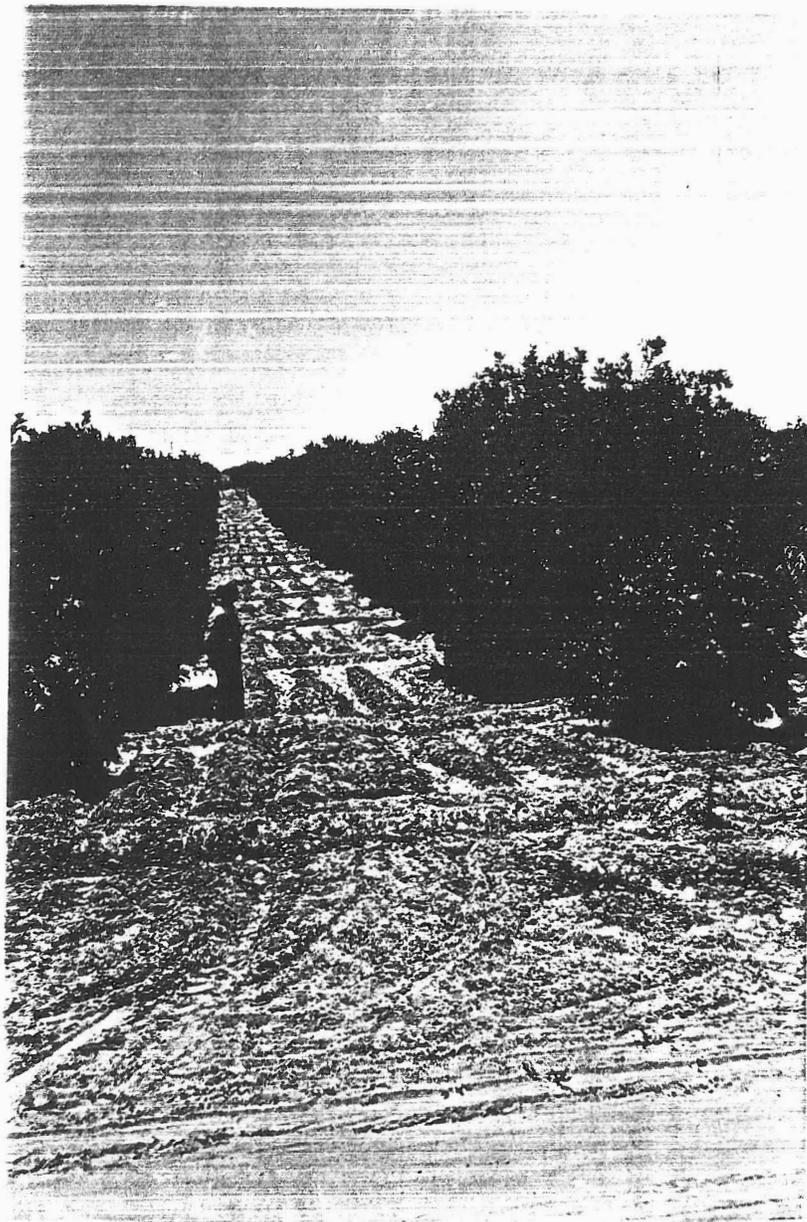
FIGURE 4A CITRUS ORCHARD IN THE CHANDLER HEIGHTS
CITRUS IRRIGATION DISTRICT, QUEEN CREEK WATERSHED.
THE TOTAL ACREAGE OF THIS FRUIT CROP WITHIN THE
WATERSHED IN 1945 WAS 4,000 ACRES. CITRUS LANDS
ARE VALUED AT FROM \$400 TO \$1,500 AN ACRE.
