**FINAL GEOTECHNICAL ENGINEERING REPORT**

**REHABILITATION OF THE OLD US 80 BRIDGE  
AT THE GILA RIVER  
MARICOPA COUNTY, ARIZONA**

**TERRACON PROJECT NO. 65055196  
JANUARY 26, 2007**

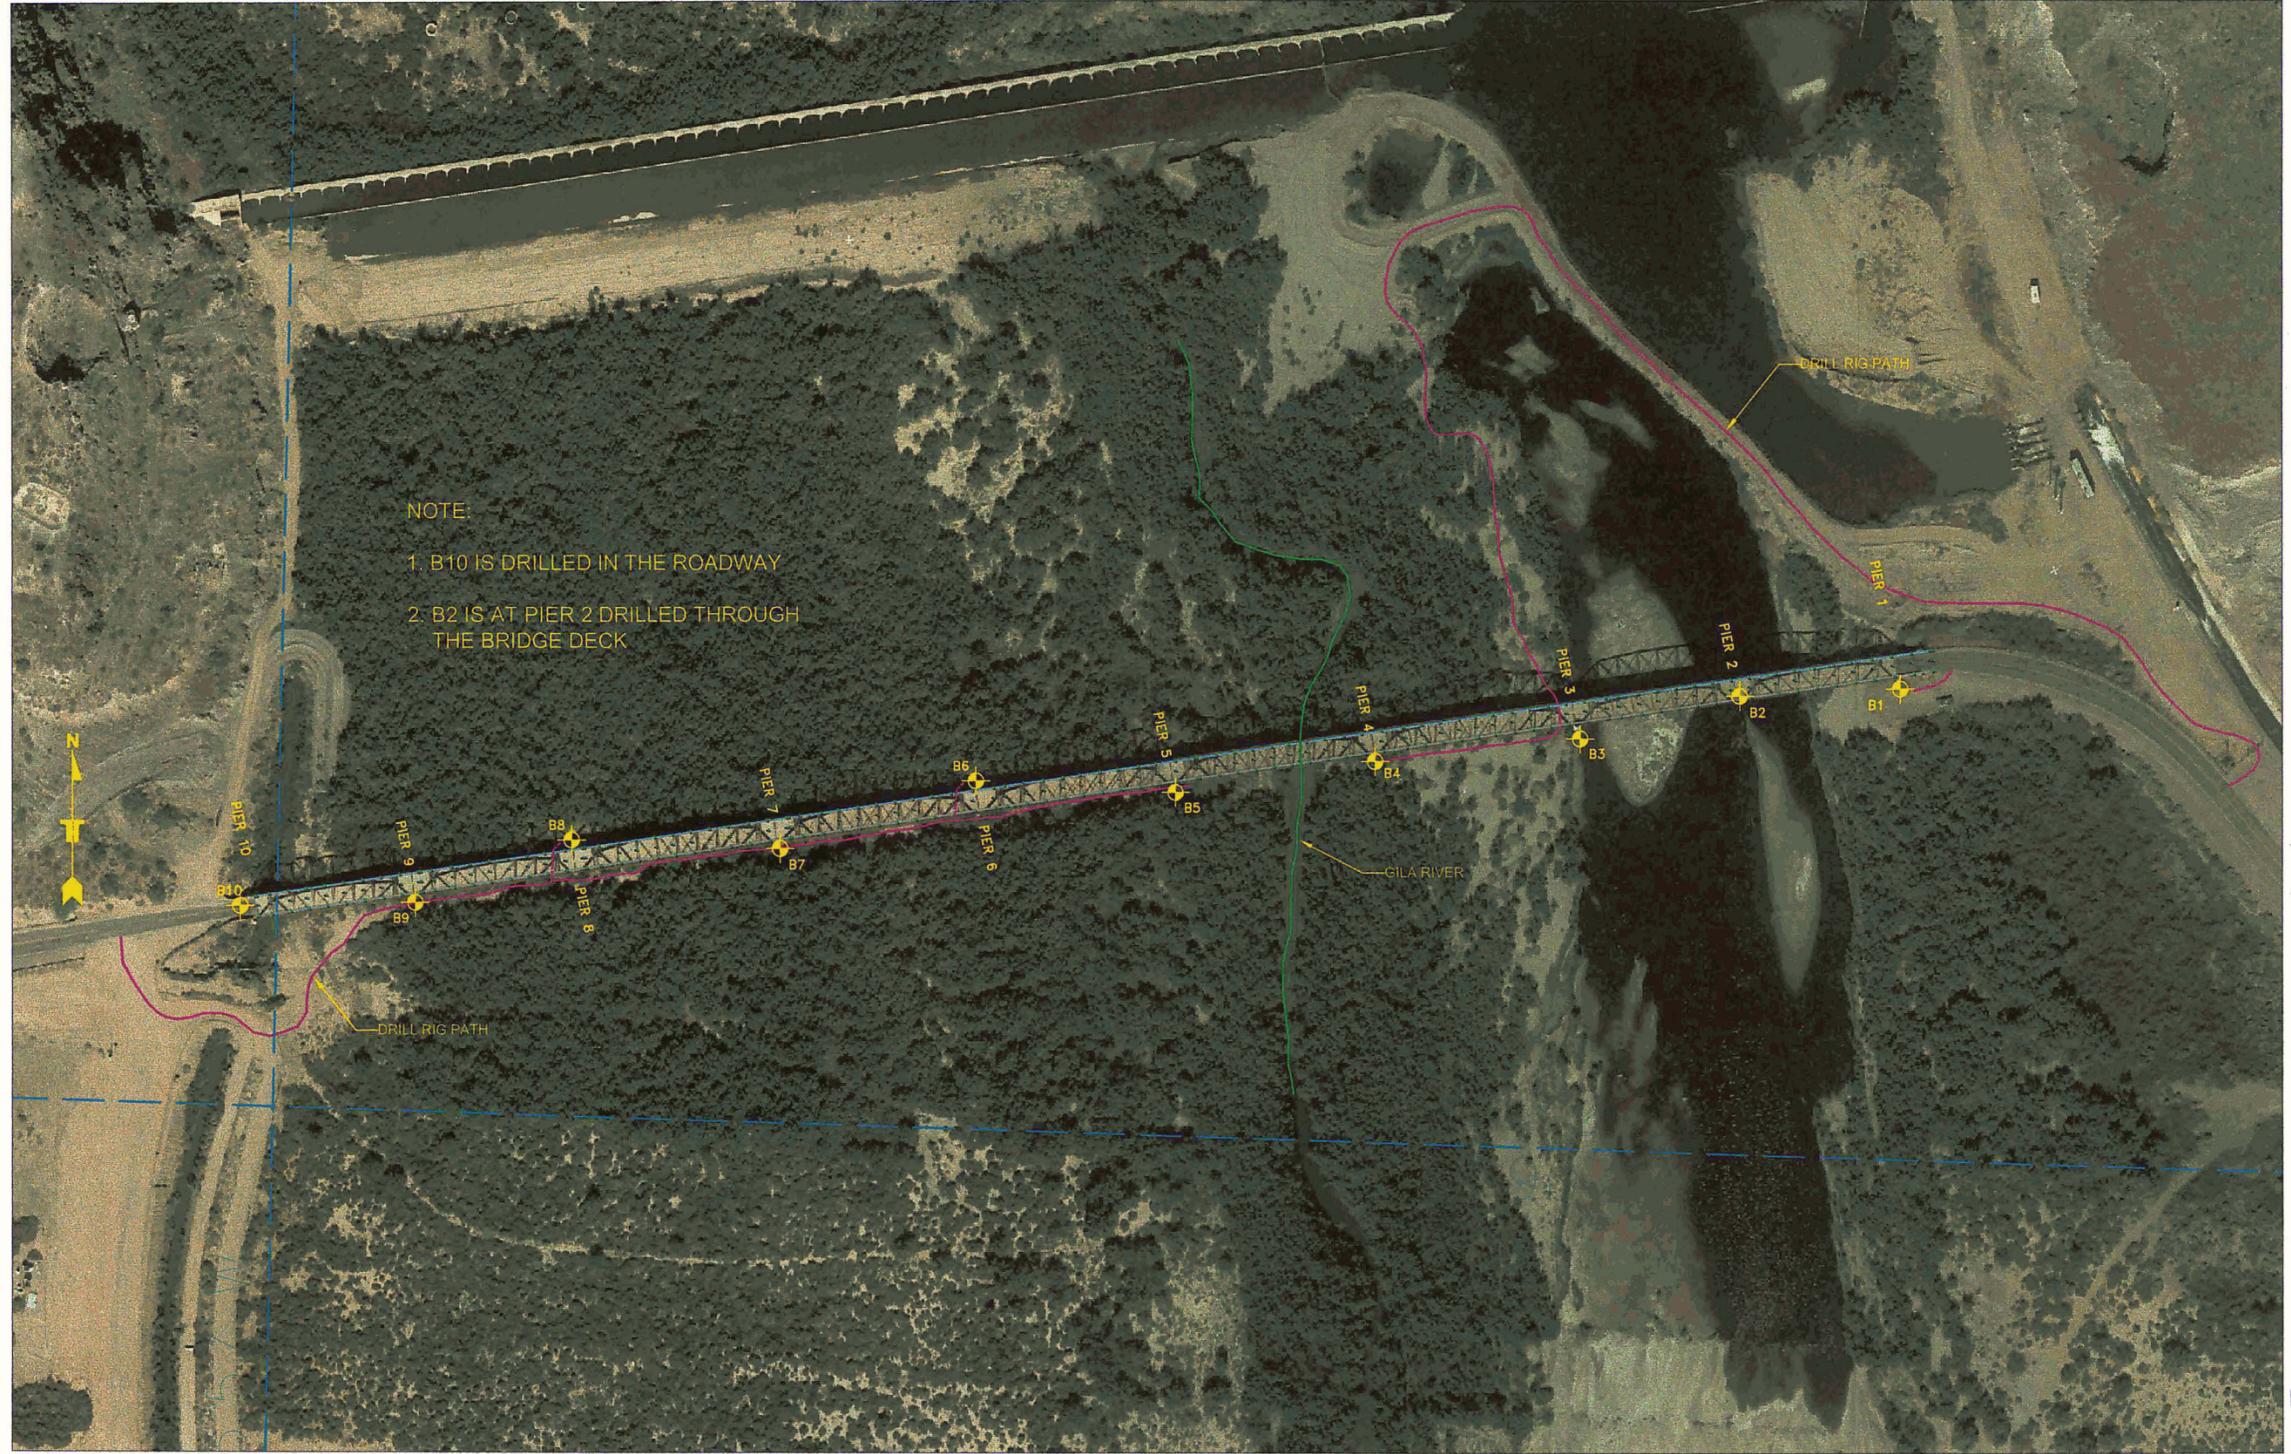
**SUBSURFACE DIAGRAM**

NOTE:  
 1. B10 IS DRILLED IN THE ROADWAY  
 2. B2 IS AT PIER 2 DRILLED THROUGH THE BRIDGE DECK
