**Flood Control
District of
Maricopa County**

**CANDIDATE ASSESSMENT REPORT
Upper Camelback Walk Wash
Flood Control Project
FCD Contract 98-24
Assignment No. 3**

Revised
March 12, 2001

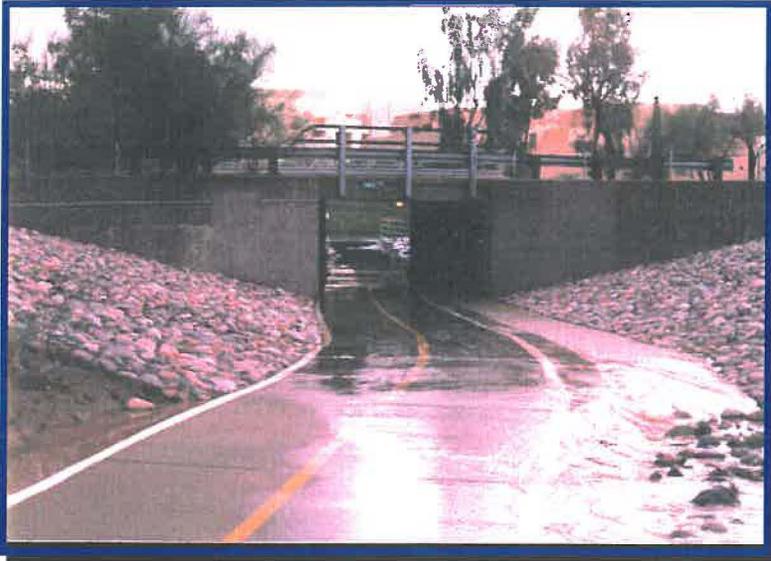
Pic 1.1:

**Box culvert crossing
Shea Boulevard, along
Camelback Walk.**

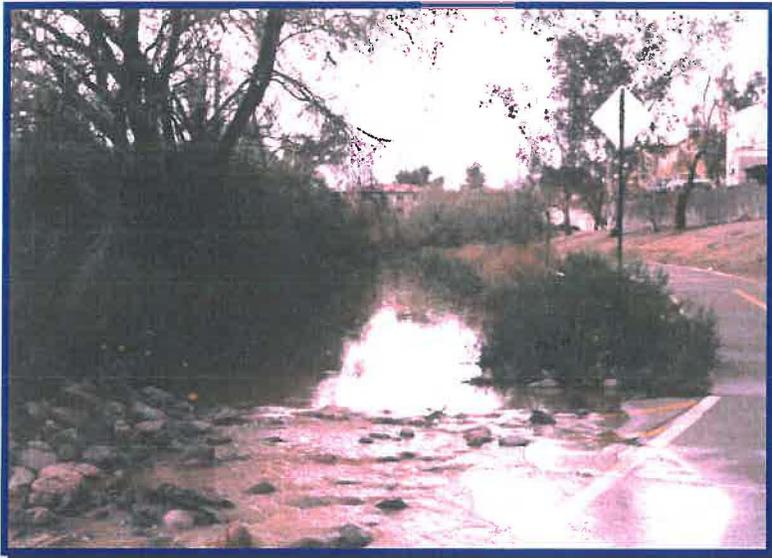
Pic 1.2:

**Camelback Walk
looking Upstream of
Shea Boulevard.**

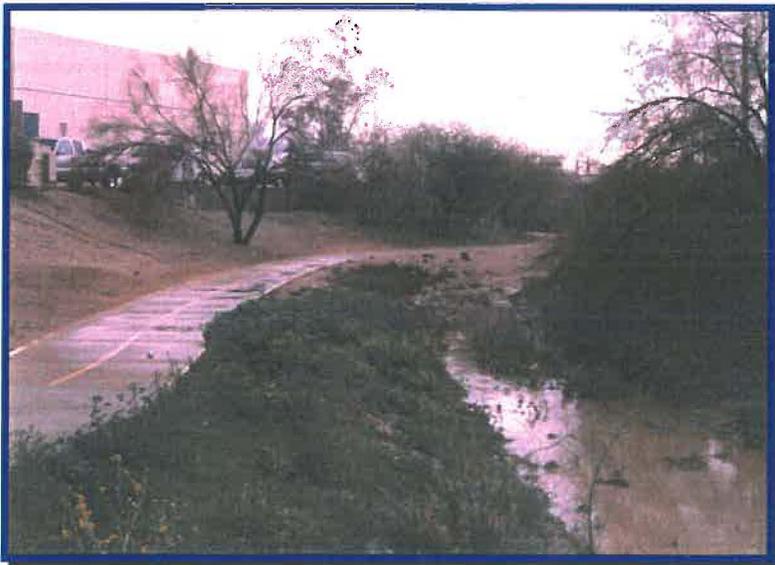
Pic 1.3:

**Camelback Walk looking
downstream of 92nd Street.**

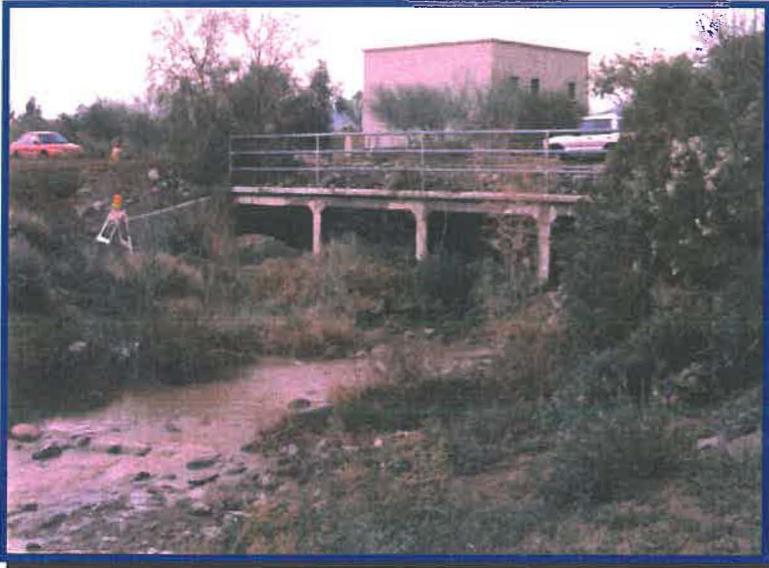
Pic 1.4:

4 Barrel Box Culverts
Crossing 92nd Street at the
downstream end.
The Culvert crossing is
obscured with brush and
construction material.

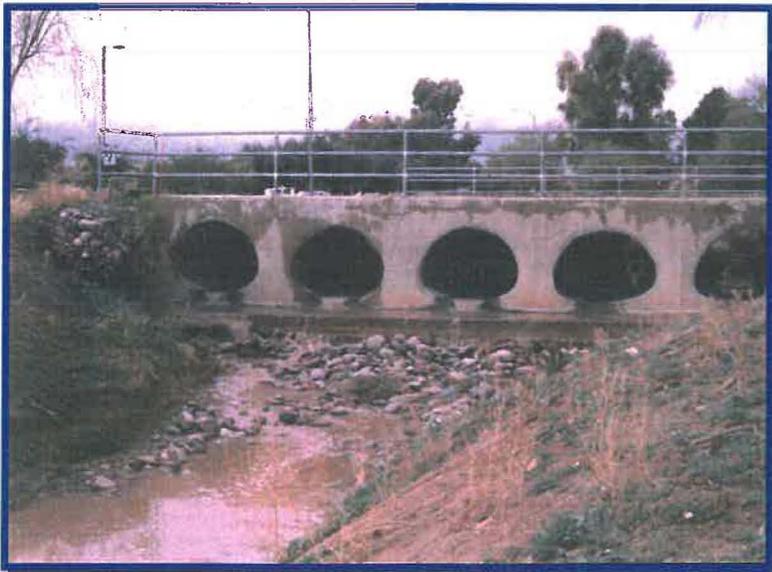
Pic 1.6:

Discharge of 5 Barrel
Elliptical Pipe Crossing at
the entrance-way to the
Cemetery.

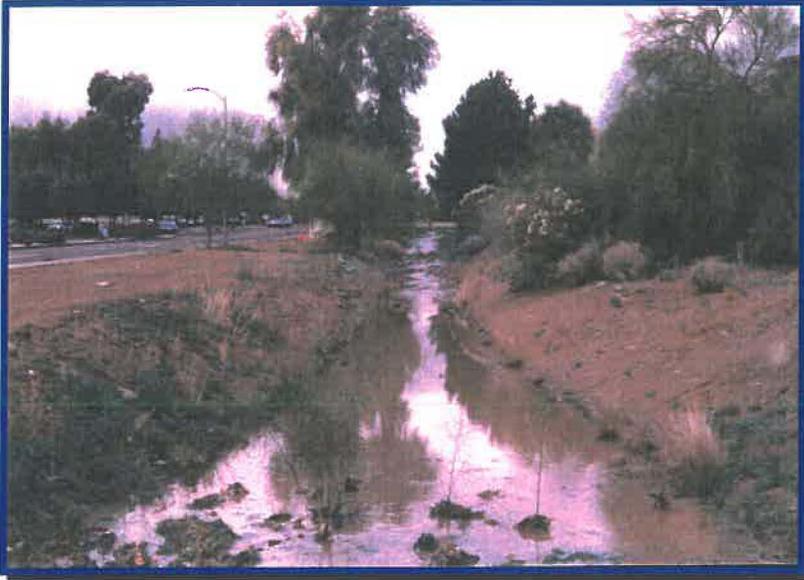
Pic 1.7:

Graded Earth Channel
along the east side of 92nd
Street looking upstream.

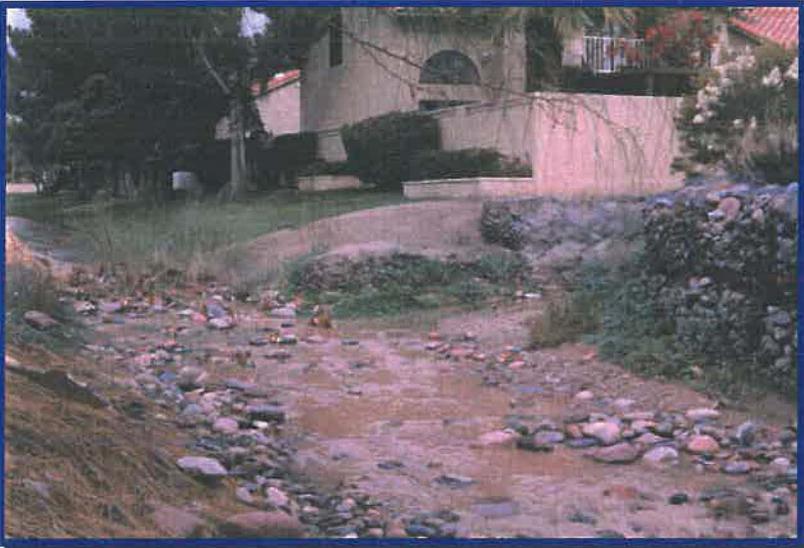
Pic 1.8:

Looking upstream at the
confluence of Wash-1 and
Wash-2.

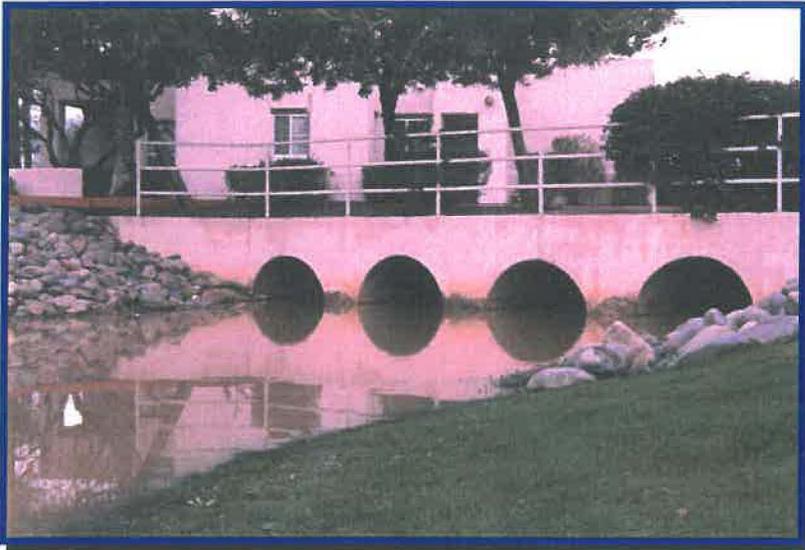
Pic 1.10:

Looking upstream at the grass-lined channel with rip-rap banks and 4-barrel circular CMP pipe crossing the entrance to Mission Del Arroyos.

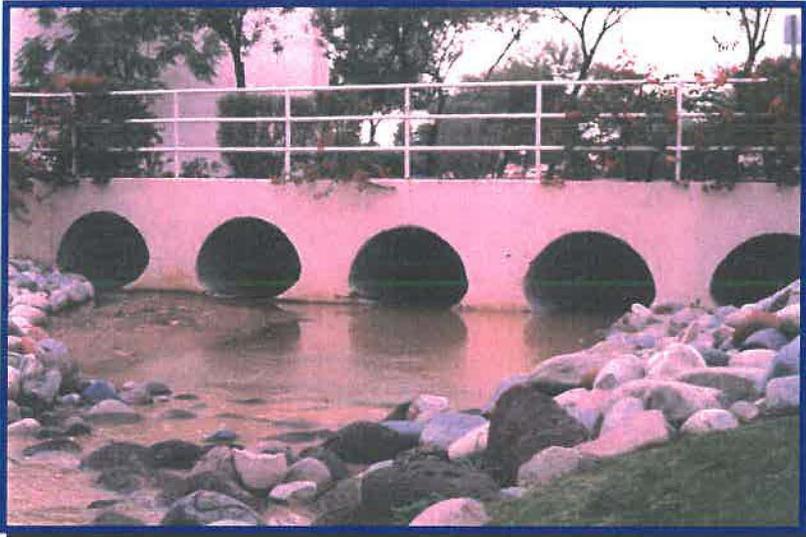
Pic 1.11:

Looking upstream at the channel with rip-rap banks and 5-barrel CMP pipe crossing Mission Del Arroyos Apartment Complex on-site.

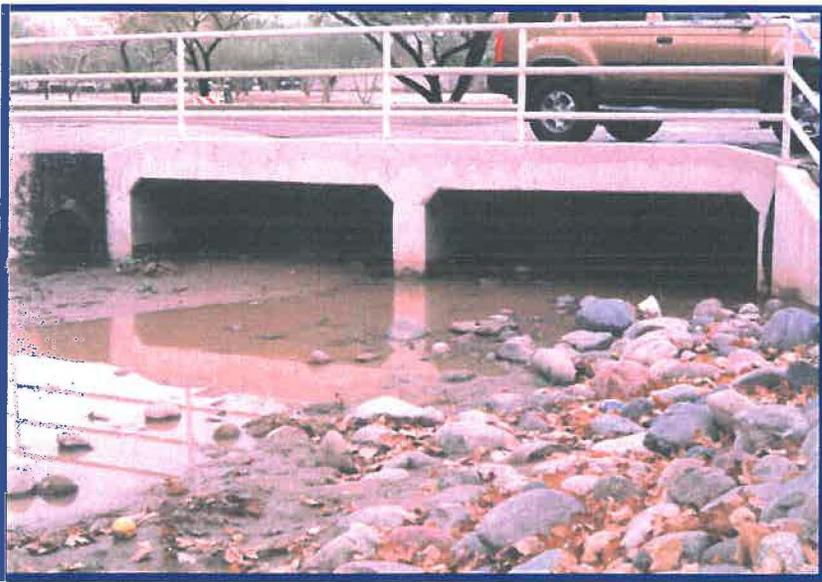
Pic 1.12:

The culverts that impact drainage to site 1 are the 5-barrel 58"x36" CMP (Cul 1) crossing 92nd Street approximately 800-feet north of Cholla, and the 2-barrel 3'x10' concrete box (Cul 2) crossing Cholla approximately 300-feet east of 92nd Street as shown in Pictures 1.12 and 1.13 included in Appendix B Pages 4 and 5. The established Q₁₀₀ flows at Cul1 and Cul2 are 554-cfs and 652-cfs respectively. No return period was provided for the storm event analyzed. The report analyzed capacity at each culvert and its drainage impacts downstream. The major drainage feature that impacts Site 2 is the wash running north and south, west of 92nd Street as shown on Pic 1.30 in Appendix B Page 11. Three separate HEC-2 analyses were performed along the wash for existing conditions, new channel with culvert, and new channel with no culvert.

The 2 Barrel Box culvert crossing Cholla approximately 300-feet east of 92nd Street at Mission Del Arroyos. Picture taken looking upstream.

The report states that the conditions at culvert #1 crossing 92nd Street north of Cholla can be improved to increase capacity to the 100-year Q of 554-cfs by constructing berms around the inlet drainage ditch. Furthermore, the report also recommends installing a 2-foot ± high wall about 12-feet upstream to force flow into the inlet in line with the pipe to eliminate the sediment deposition problem in the most northern pipe. The proposed 2-foot ± high wall is an existing structure per a site investigation conducted on the 26th of February 2001. The existing culvert under Cholla east of 92nd Street will not overflow and add storm water to the southeast corner of 92nd Street/Cholla intersection.

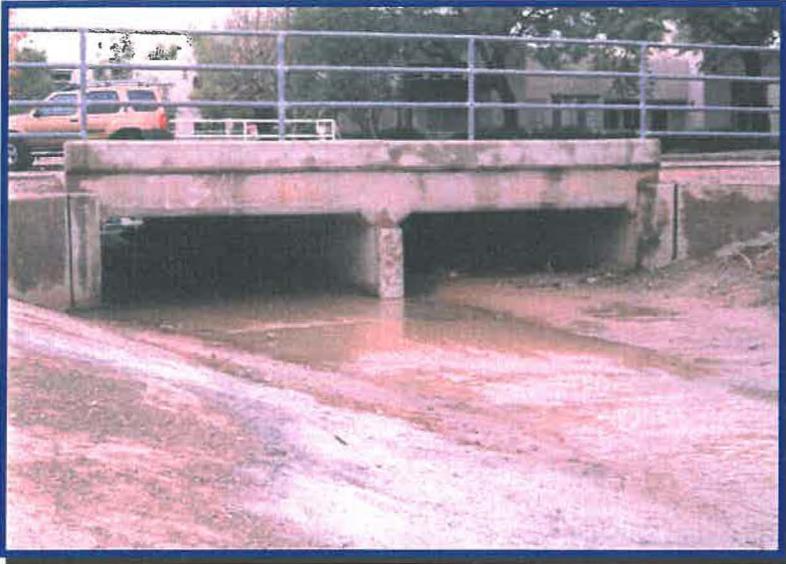
Pic 1.13:

2- Barrel Concrete Box Culvert crossing Cholla, looking downstream with concrete lined banks.

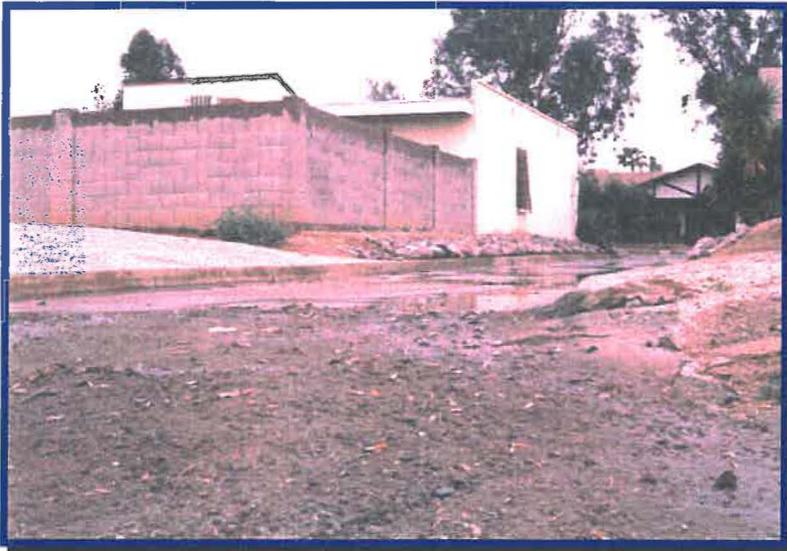
Pic 1.14:

Concrete valley gutter approximately 30-feet wide conveying flows to Wash-1 from the Scottsdale Vista No.2 subdivision.

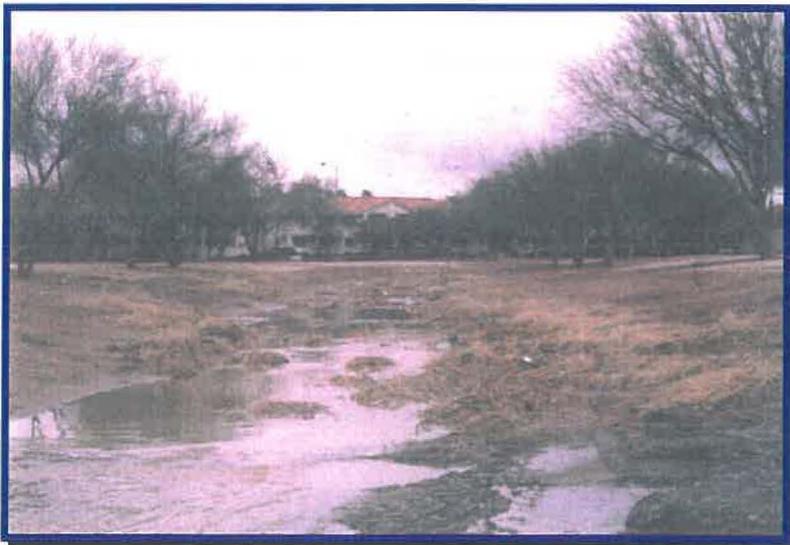
Pic 1.15:

Earth Channel (Wash-1) along the east side of 92nd Street and the west side of Scottsdale Vista No.2 looking upstream.

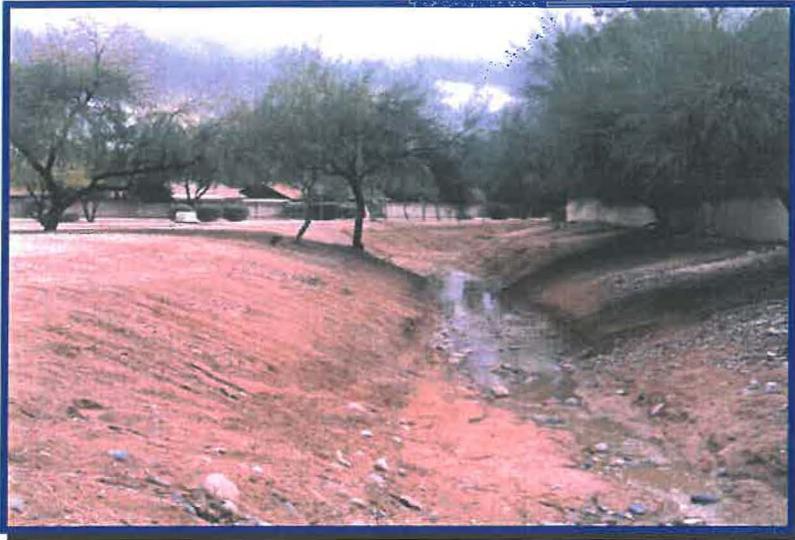
Pic 1.16:

A major discrepancy exists in the Q_{100} flows at the north property line from the Master Drainage Plan. The subject report shows 435-cfs and 549-cfs versus 770-cfs and 1,108-cfs from the Master Drainage Plan at the west and east washes respectively. Furthermore, it does not appear that the subject site has provided any type of on-site retention. The improvements proposed by the subject study for both washes are in-place at the present time as can be seen from Pics 1.16 and 1.17.

Looking downstream at the trapezoidal earth channel (Wash-1) just south of Poinsettia Drive & west of 92nd Street within the Scottsdale Vista No.2 Subdivision. $Q_{100} = 549$ -cfs per drainage study no.14.

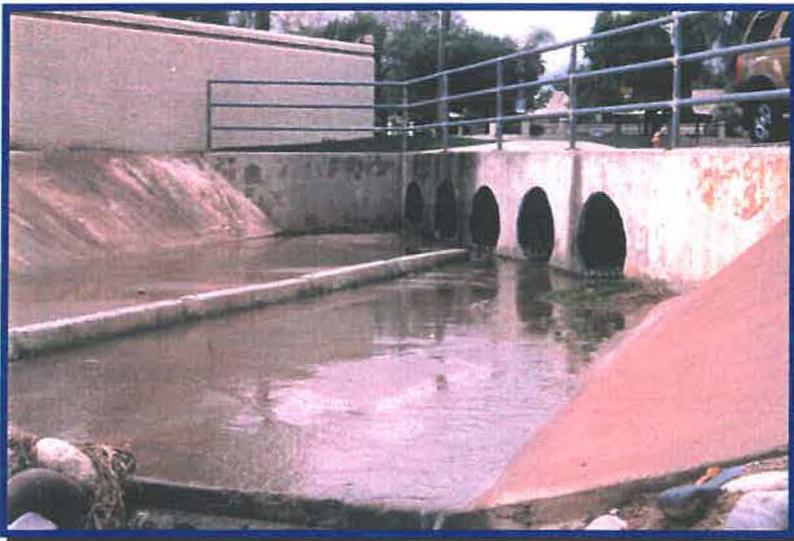
Pic 1.17:

Looking upstream at the 5-barrel CMP pipes crossing Poinsettia Drive approximately 250-feet west of 92nd Street. Discharge channel consist of concrete lined wing walls with energy dissipaters

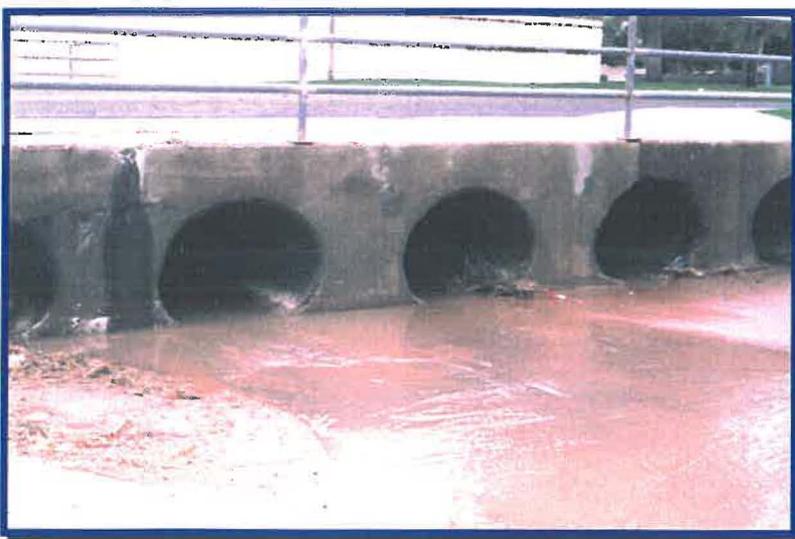
Pic 1.18:

Looking downstream at 5-barrel circular CMP pipe crossing Poinsettia Drive approximately 250-feet west of 92nd Street.

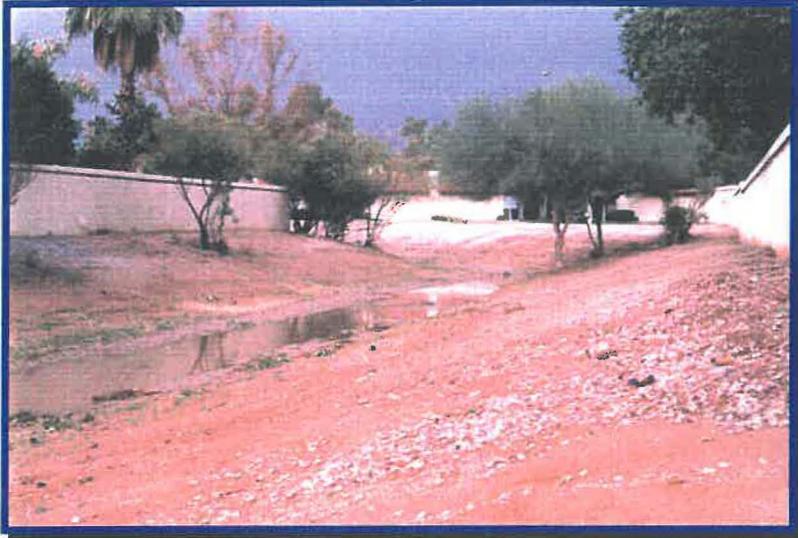
Pic 1.19:

Looking upstream at the graded earthen channel (wash-1) north of Poinsettia Drive approximately 250-feet west of 92nd Street.

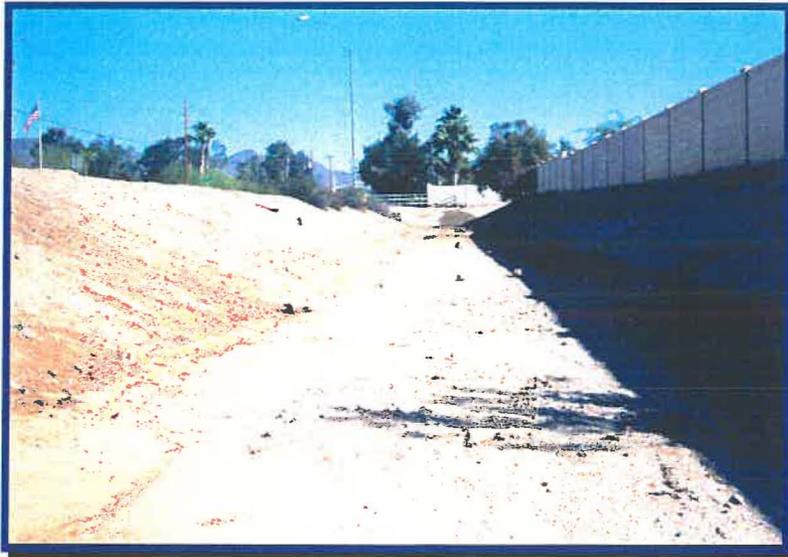
Pic 1.22:

Looking downstream at the trapezoidal earthen channel located along the south side of Cactus Road.

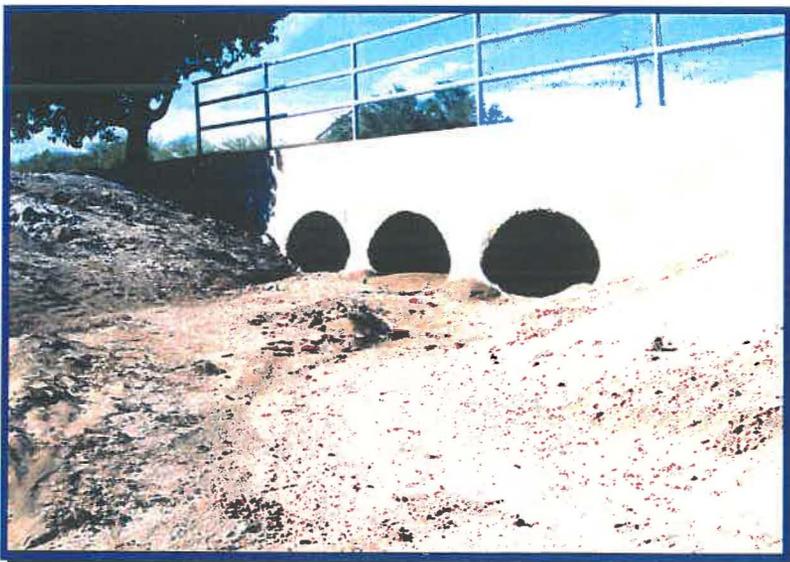
Pic 1.23:

Looking upstream at the 3-CMP pipes crossing Cactus Road approximately 350-feet west of location in Pic 3.5.

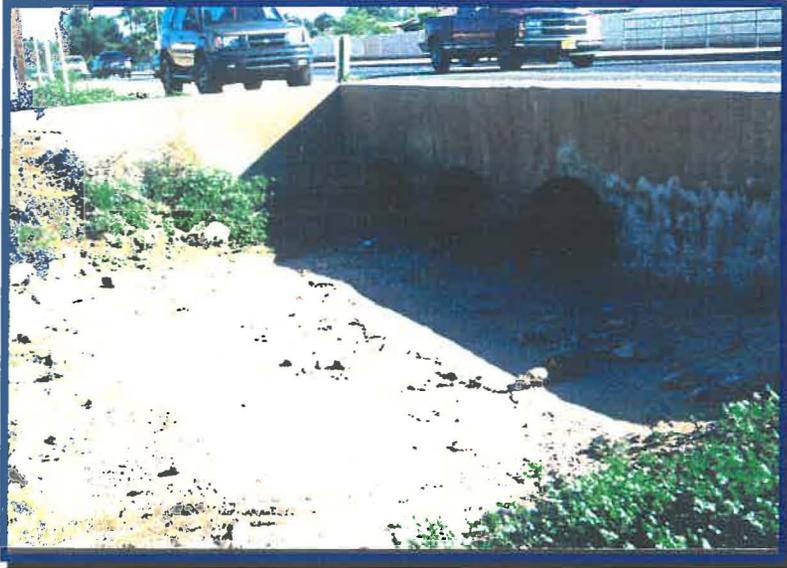
Pic 1.24:

Looking downstream at the 3-CMP pipes crossing Cactus Road located on north side of Cactus approximately 350-feet west of location in Pic 3.6.

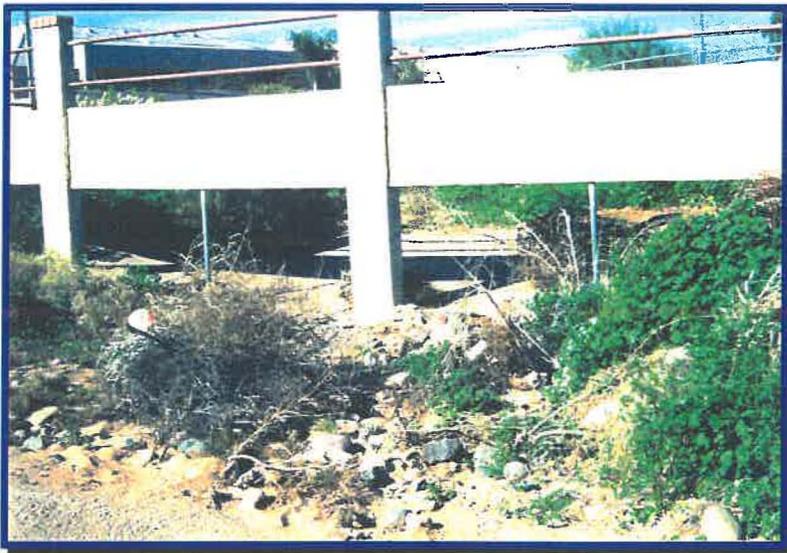
Pic 1.25:

Looking upstream at the wall opening into the horse property located on north side of Cactus Road. It appears that collected debris obstruct storm flows.

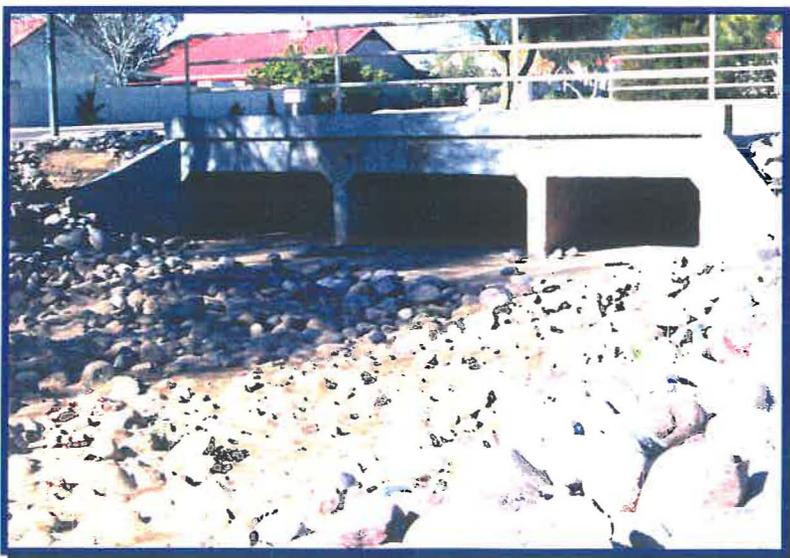
Pic 1.26:

Looking upstream at the 3-barrel box culvert crossing Larkspur Drive approximately 1550-feet west of 94th Street. The structure is discharging flows into a rip-rap lined channel (Wash-1).

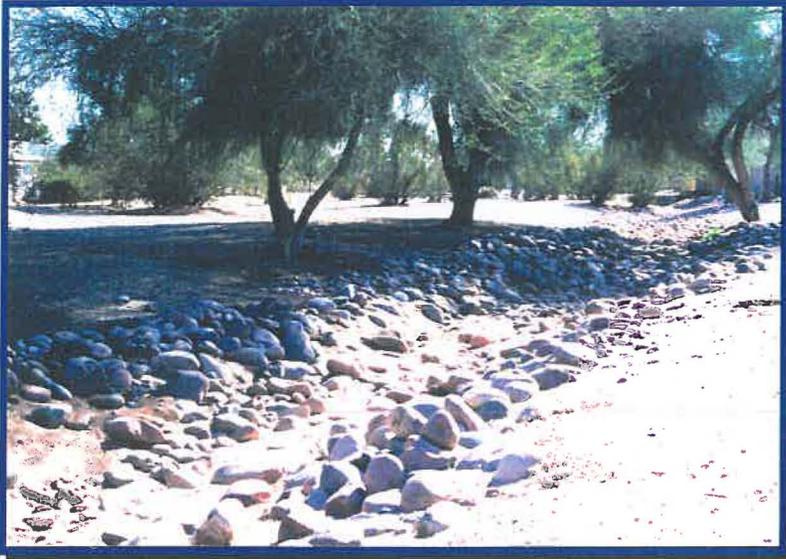
Pic 1.27:

Looking downstream at Wash-1 rip-rap lined.

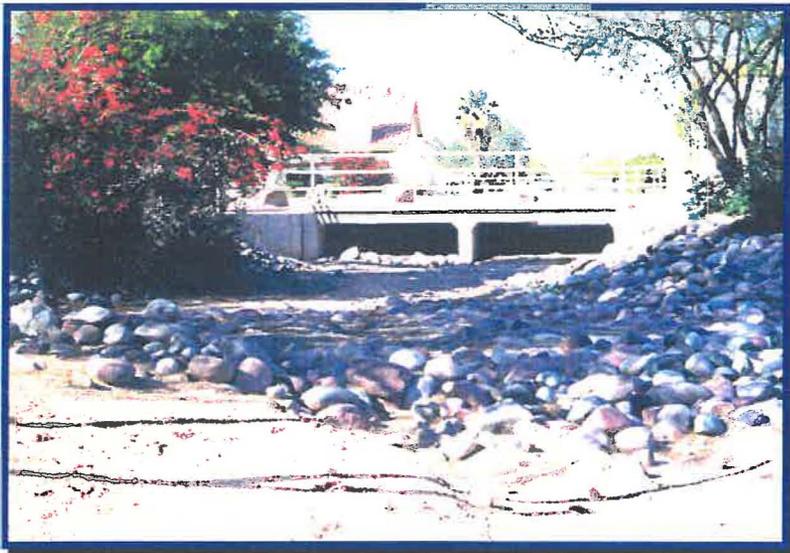
Pic 1.28:

Looking upstream at the 2-barrel box culvert crossing Sweetwater Avenue approximately 1400-feet west of 94th Street. The structure is discharging flows into a rip-rap lined channel (Wash-1).

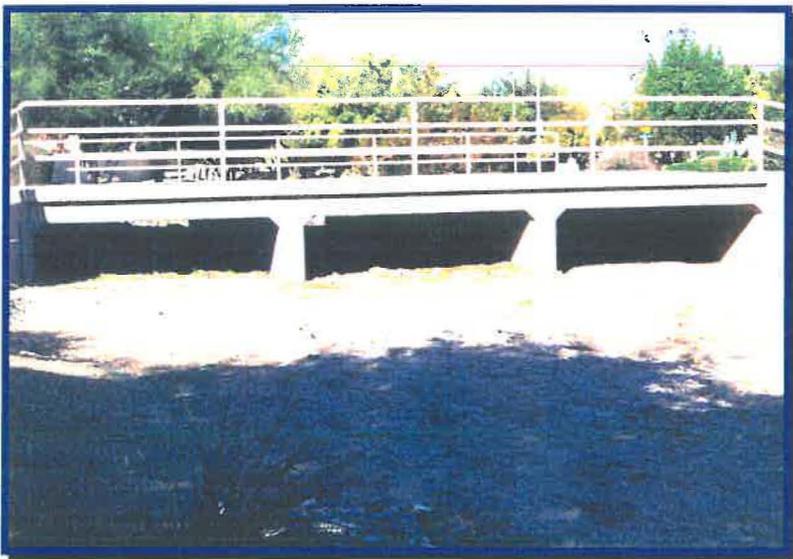
Pic 1.29:

Looking upstream at the 3-barrel box culvert crossing Pershing Avenue approximately 50-feet west of 92nd Street.

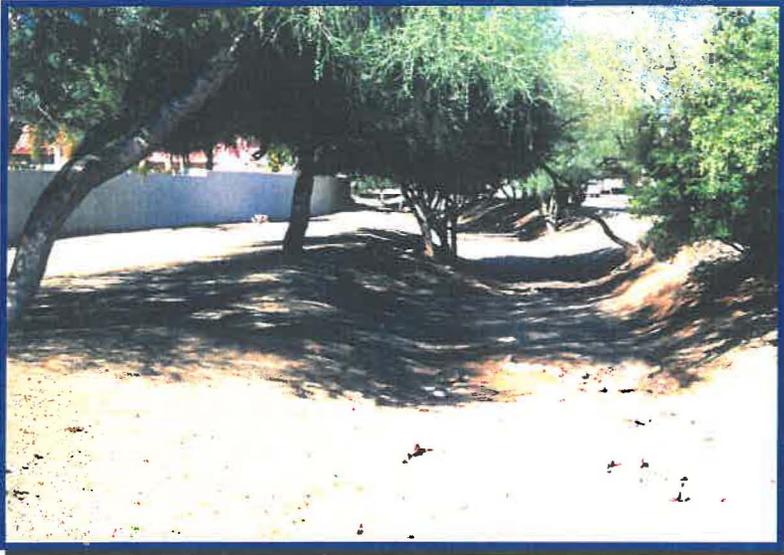
Pic 1.30:

Looking upstream at the graded trapezoidal earthen channel (Wash-1) north of Pershing Avenue.

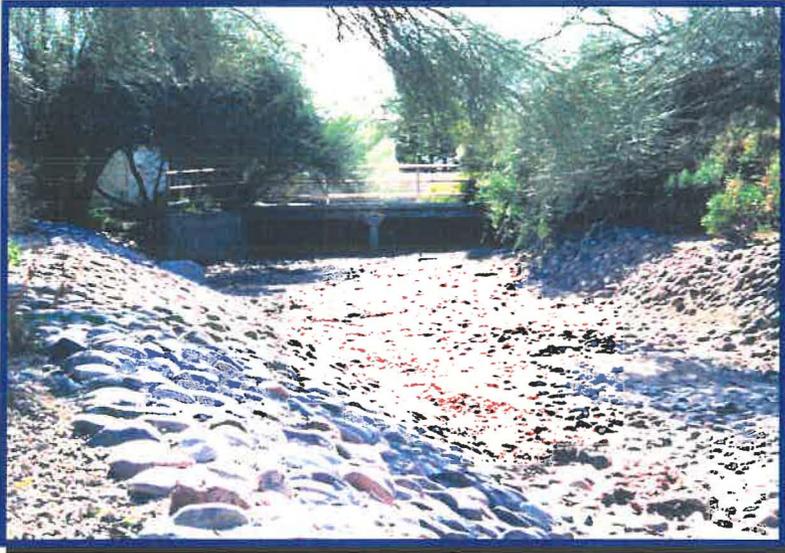
Pic 1.31:

Looking downstream at the 2-barrel box culvert crossing 92nd Street just north of Sutton Drive.

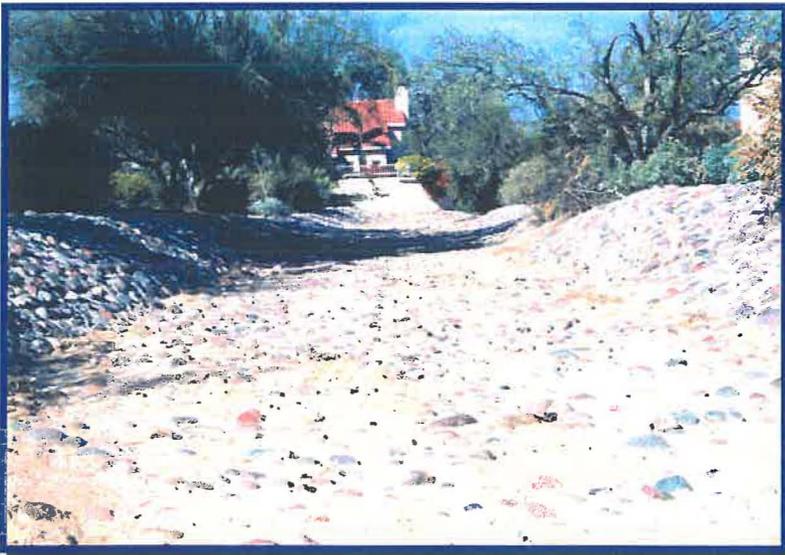
Pic 1.32:

Looking upstream at the rip-rap lined trapezoidal channel along the east side of 92nd Street.

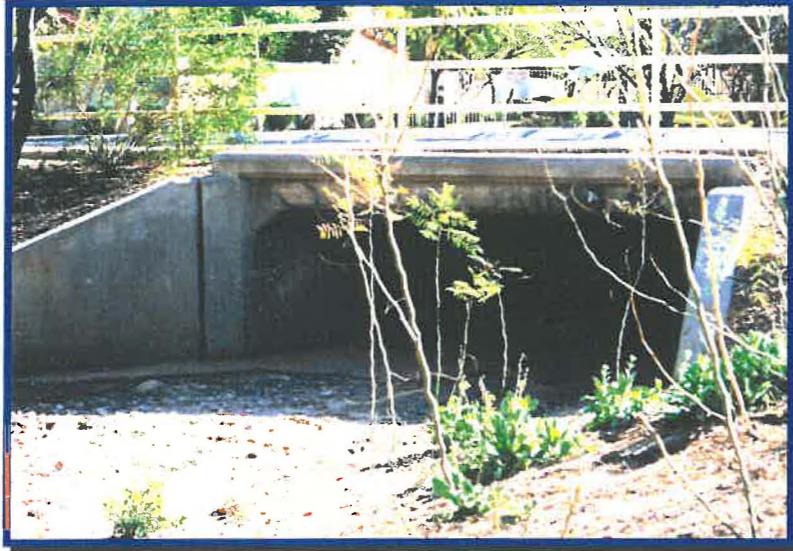
Pic 1.33:

Looking downstream at the box culvert crossing Davenport Drive south of Thunderbird Road.

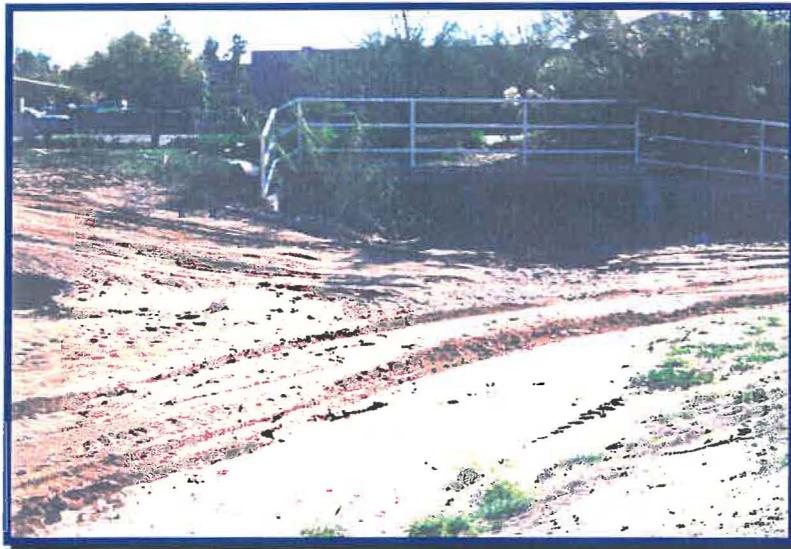
Pic 1.34:

Looking downstream at the 2-barrel box culvert crossing Thunderbird Road approximately 350-feet east of 92nd Street.

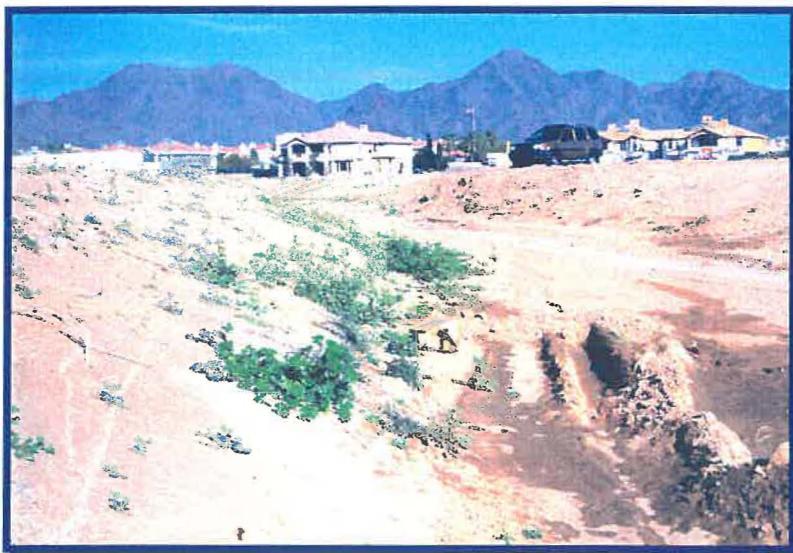
Pic 1.35:

Looking upstream at the unimproved channel (Wash-1) through the existing Bella Vista commercial construction site.

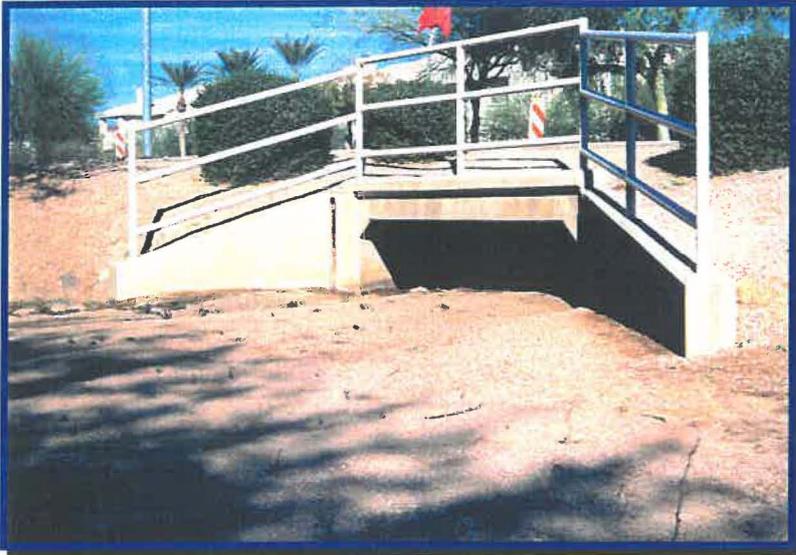
Pic 1.36:

Looking downstream at the box culvert crossing Redfield Road just west of 94th Street within the Sonoran Vista Subdivision.

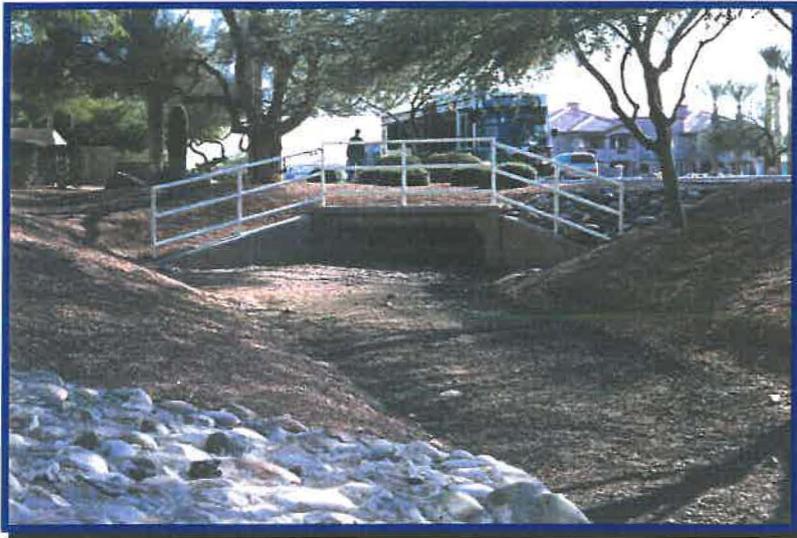
Pic 1.37:

Looking downstream at the box culvert crossing 94th Street just north of Redfield Road. Picture taken from the east side of 94th Street

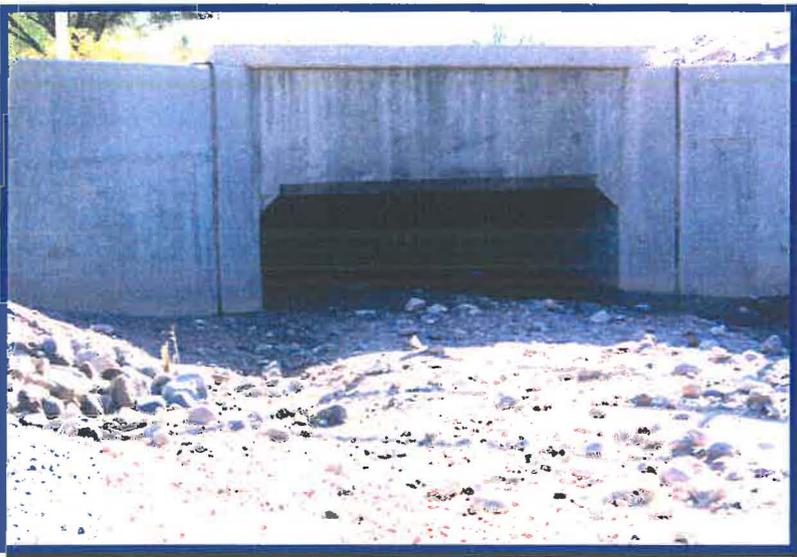
Pic 1.38:

Looking downstream at the box culvert crossing the entrance way to the San Carlos Subdivision along the east side of 94th Street.

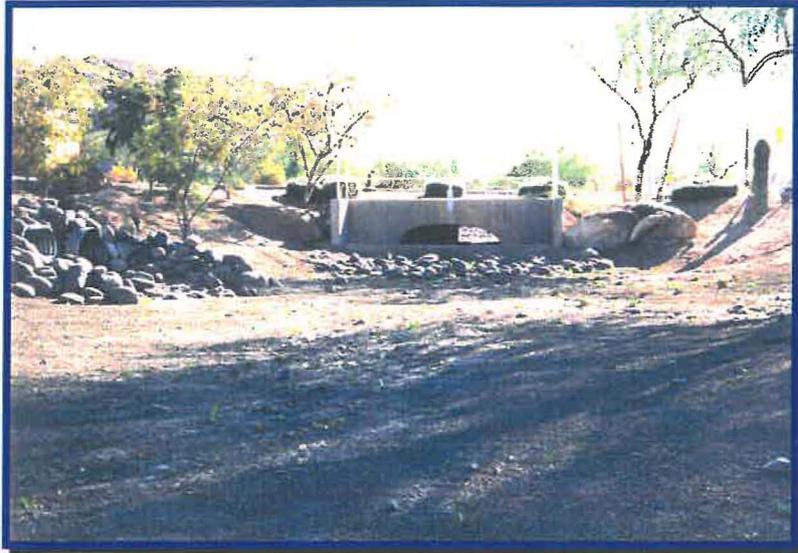
Pic 1.39:

Looking downstream at the box culvert crossing Raintree Drive just east of Thompson Peak Pkwy in the Osco Drug property.

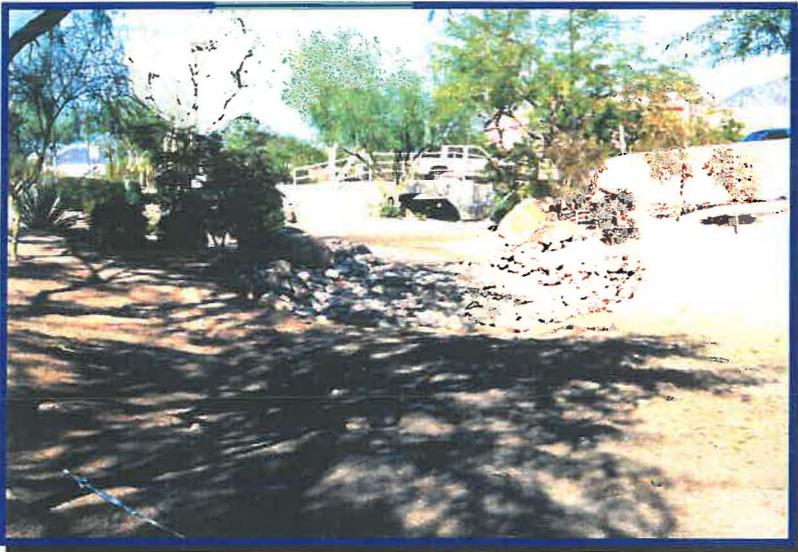
Pic 1.40:

Looking upstream at the box culvert crossing the entrance-way to the Osco Drug property. Culvert located approximately 300-feet north of Raintree Drive & Pic 3.20 and east of Thompson Peak Pkwy.

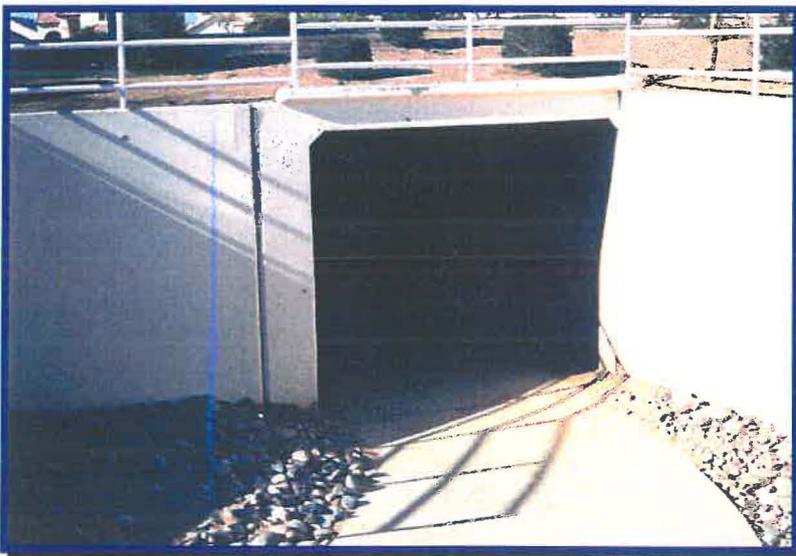
Pic 1.41:

Looking upstream at the box culvert/walk-way bridge crossing Thompson Peak Pkwy approximately 300-feet south of Frank Lloyd Wright.

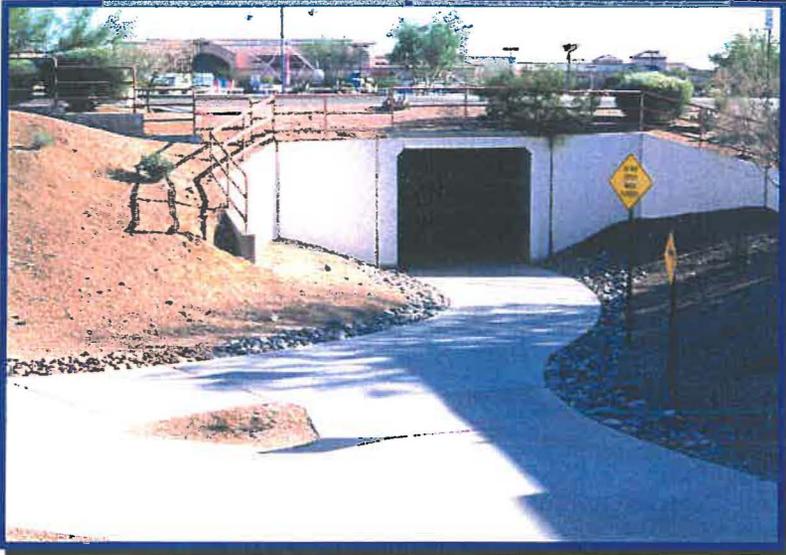
Pic 1.42:

Looking downstream at the box culvert/walk-way bridge crossing Thompson Peak Pkwy approximately 300-feet south of Frank Lloyd Wright.

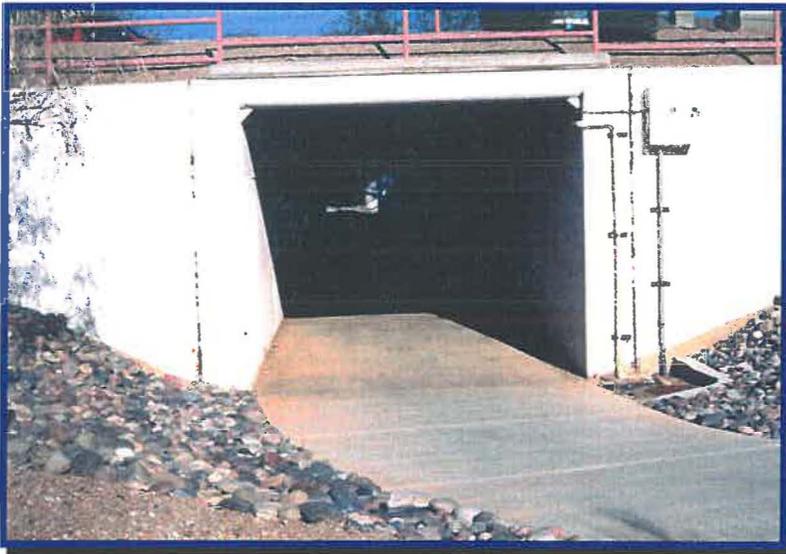
Pic 1.43:

Looking upstream at the box culvert/walk-way bridge crossing Frank Lloyd Wright approximately 300-feet west of Thompson Peak Pkwy.

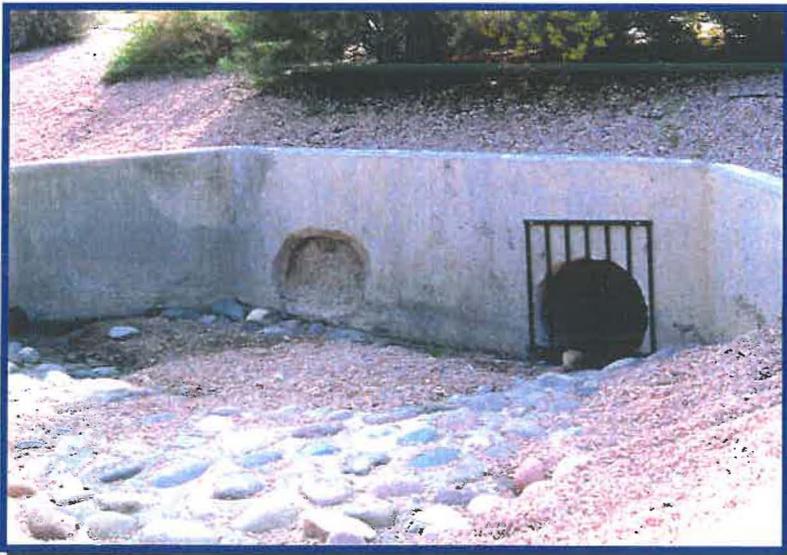
Pic 1.44:

Looking downstream at the RCP pipe crossing 100th Street. One of pipes has been blocked-off. The subject location is the most upstream point of Wash-1.

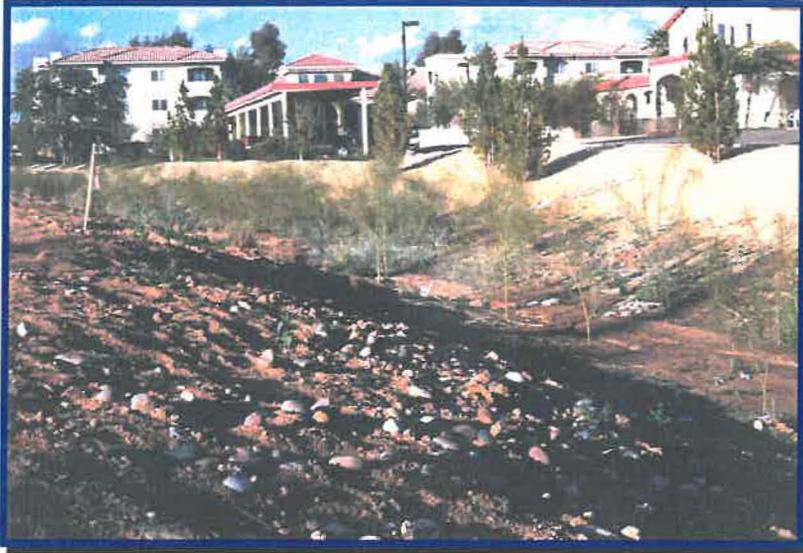
Pic 1A.4:

Looking upstream at the unimproved earthen channel along the west side of the Hospital.

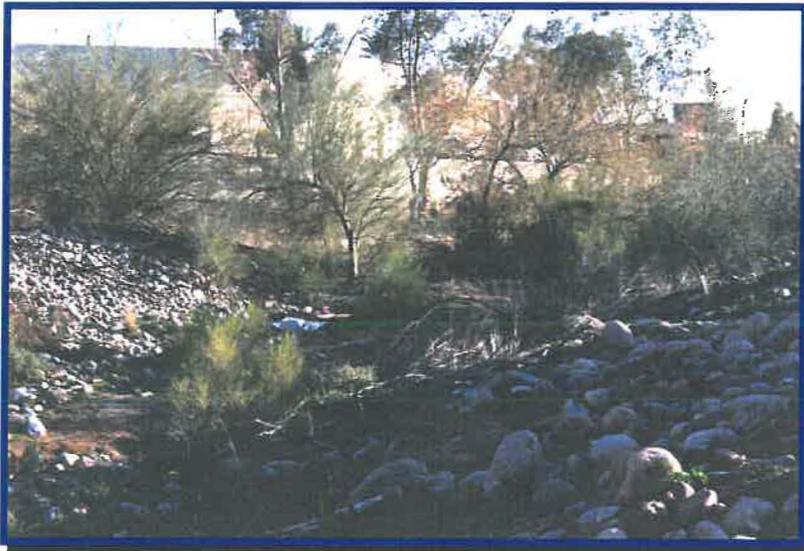
Pic 1A.5:

Looking downstream at the earthen channel converging and conveying flows to Wash-1. The channel banks are rip-rap lined.

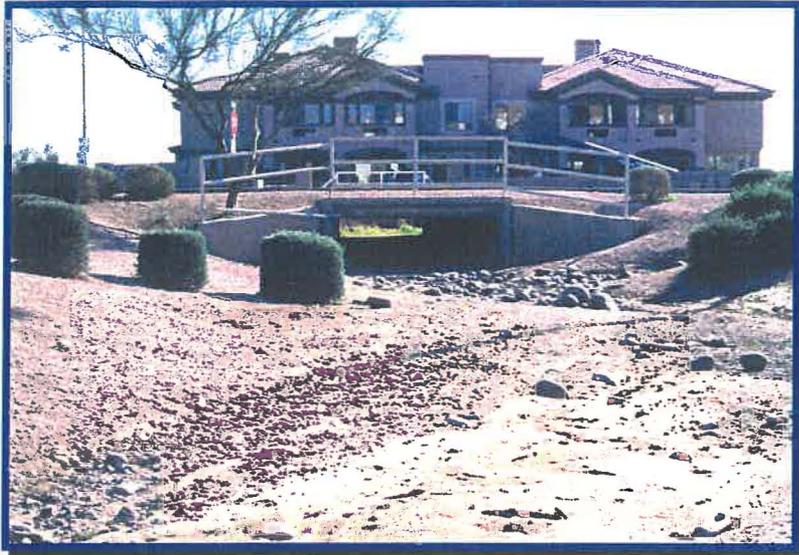
Pic 1B.1:

Looking downstream at Wash-1B and the box culvert crossing Redfield Road.

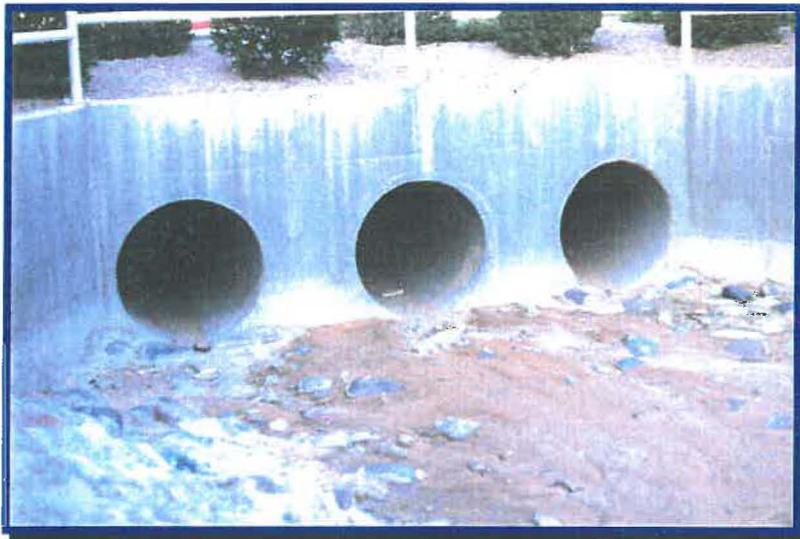
Pic 1B.2:

Looking upstream at Wash-1B and the box culvert crossing the north entrance to Sonoran Vista Subdivision west of 94th Street.

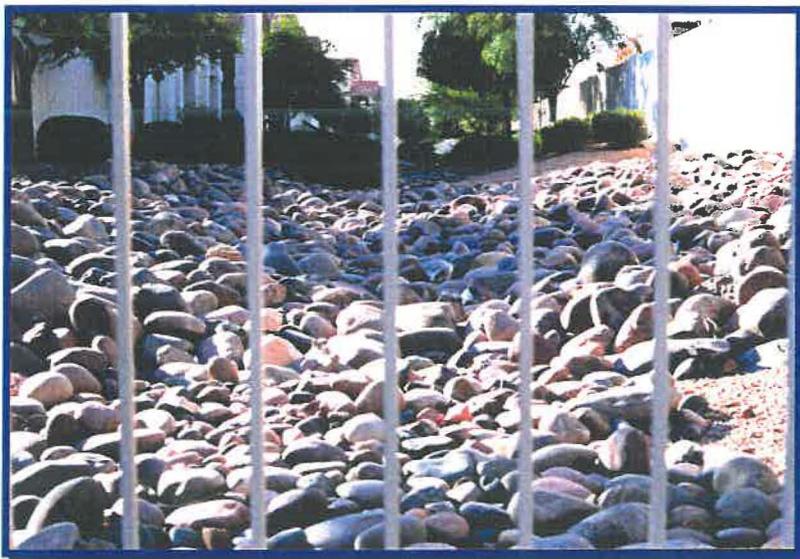
Pic 1B.3:

Looking upstream at the rip-rap lined drainage easement within the Sonoran Vista Subdivision conveying flows to Wash-1B.

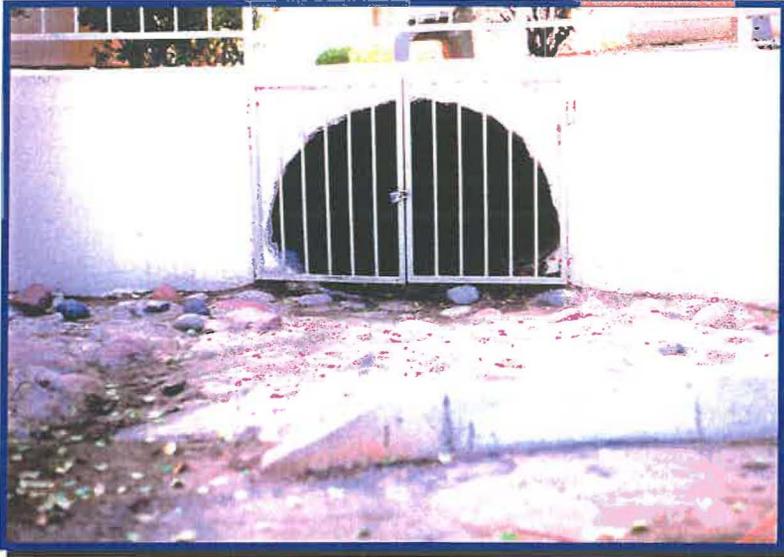
Pic 1B.4:

The storm drain inlet within the Scottsdale Foothills Subdivision discharging flows to Wash-1B.

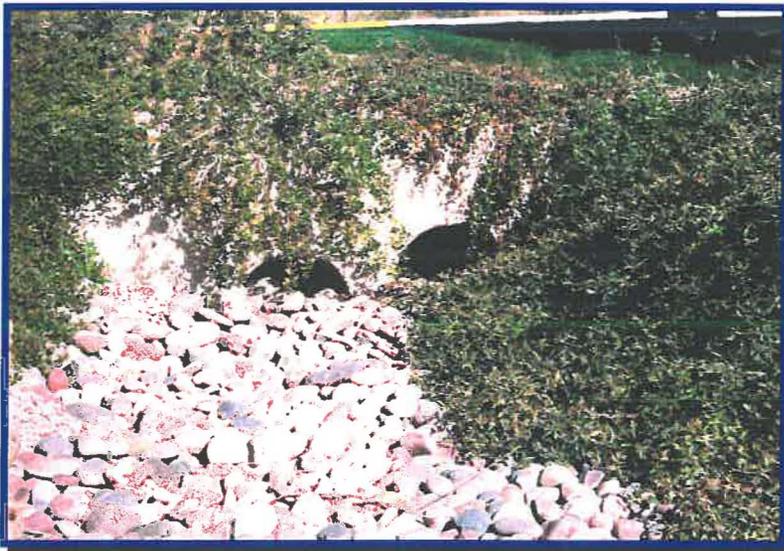
Pic 1B.5:

2-barrel pipe outletting flows to the Scottsdale Foothills Subdivision across Raintree Drive.

It appears that these off-site flow travel within the parking lot and eventually discharges into the storm drain system shown in Pic 1B.4 .
