**Flood Control
District of
Maricopa County**

**CANDIDATE ASSESSMENT REPORT
Upper Camelback Walk Wash
Flood Control Project
FCD Contract 98-24
Assignment No. 3**

Revised
March 12, 2001

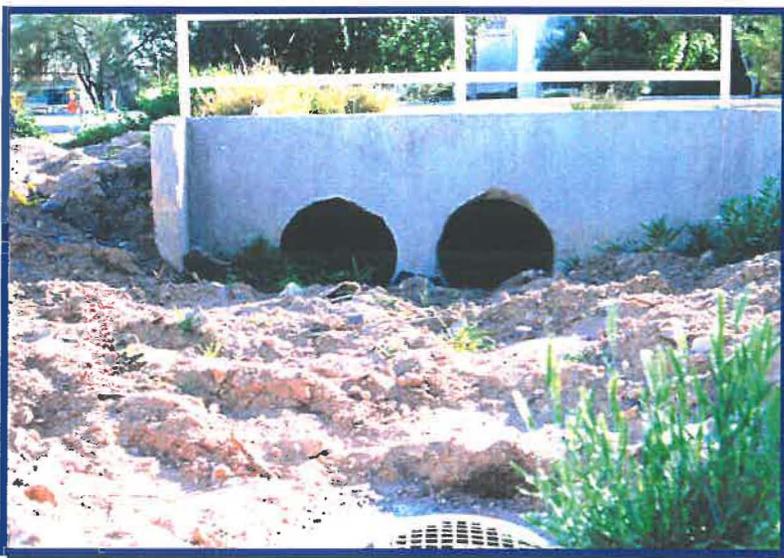
Pic 1B.6:

1.29	2-barrel RCP pipes approximately 24-inch diameter crossing Raintree Drive.	50-cfs @ 0.006'/ft (per Willdan Calcs)			No outlet on the south side of the street could be found.

2-barrel RCP pipes located on the north side of Raintree Drive. It is unclear where these pipes are conveying flows, since there are no outlets on the south side of Raintree Drive. The property to the south of Raintree Drive and west of Scottsdale Foothills is been constructed at the present time.

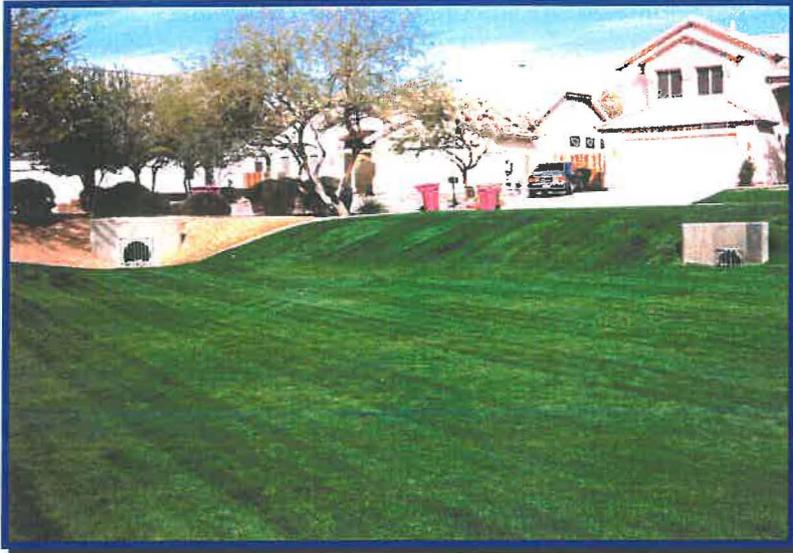
Pic 1C.1:

The retention basin located within the Montage Subdivision.

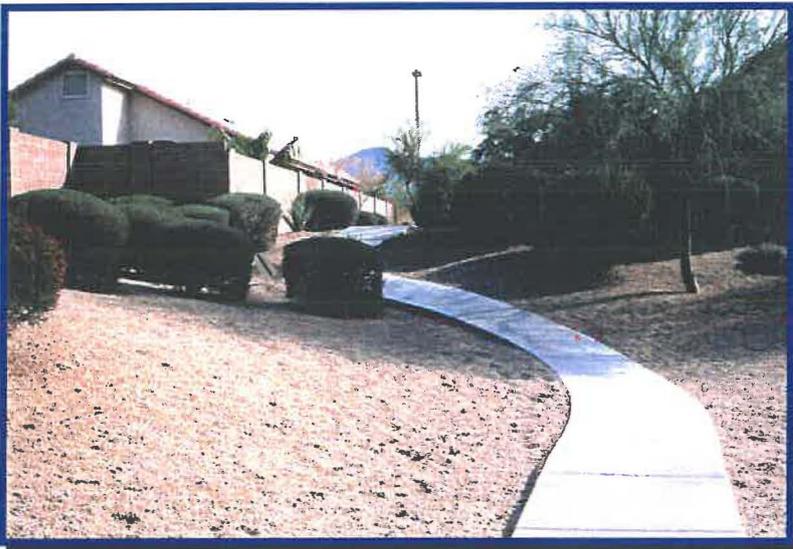
Pic 1C.2:

The emergency out-fall for the retention basin located in the Montage Subdivision shown in Pic 1C.1.

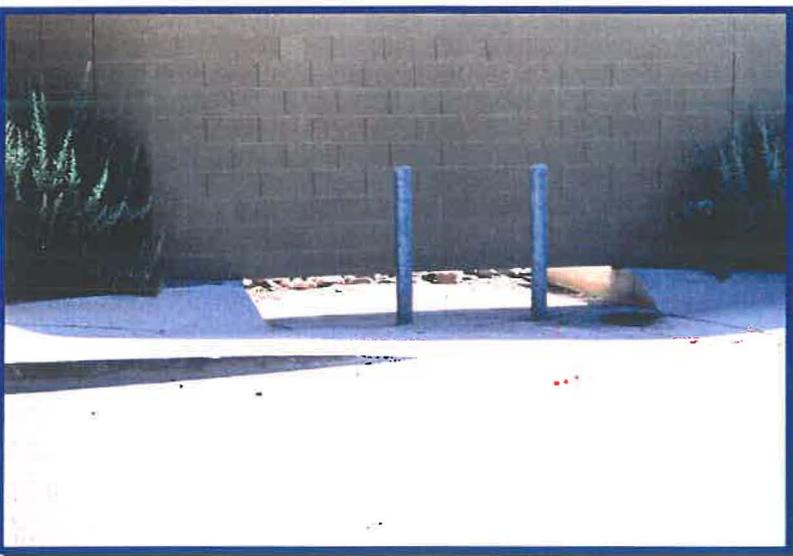
Pic 1C.3:

The block wall opening at the end of the cul-de-sac on 94th Place conveying overflow from the Montage Subdivision and flows from the subdivision east of Montage to a retention basin located along the west side of Thompson Peak Pkwy.

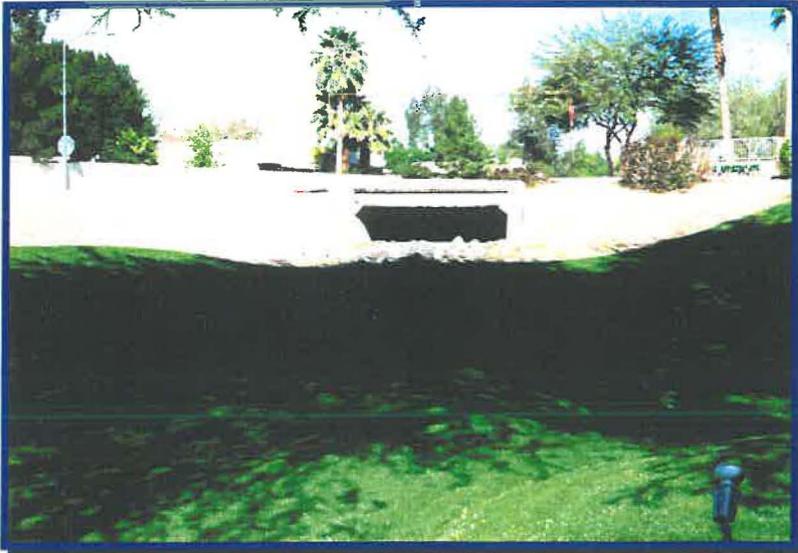
Pic 1D.1:

Looking upstream at the box culvert crossing Redfield Road just east of 92nd Street within the Las Hadas subdivision. Storm flows are been conveyed from Scottsdale Foothills subdivision located at the southeast corner of 92nd Street and Raintree Drive.

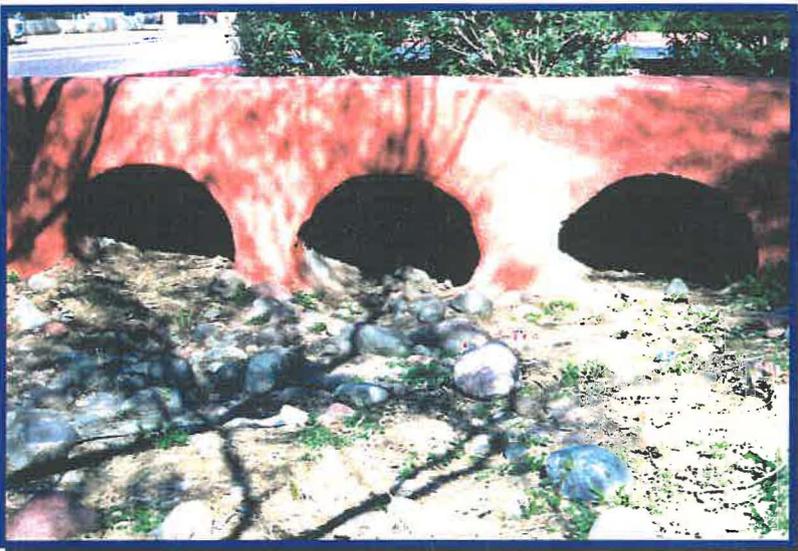
Pic 1D.2:

The 3-barrel RCP pipe crossing the south entrance to Foothill Shadows subdivision along the east side of 92nd Street.

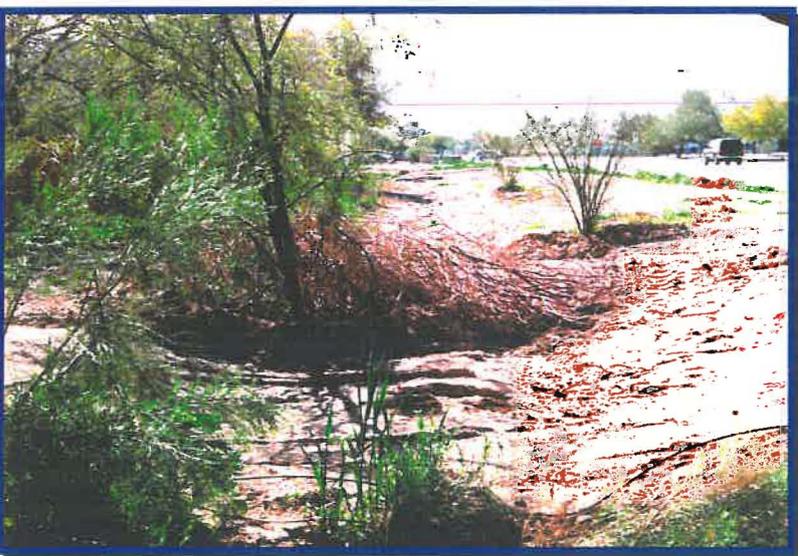
Pic 1D.3:

Looking downstream at the unimproved earthen channel (Wash-1D). The subject channel terminates approximately 400-feet south of Foothill Shadows subdivision.

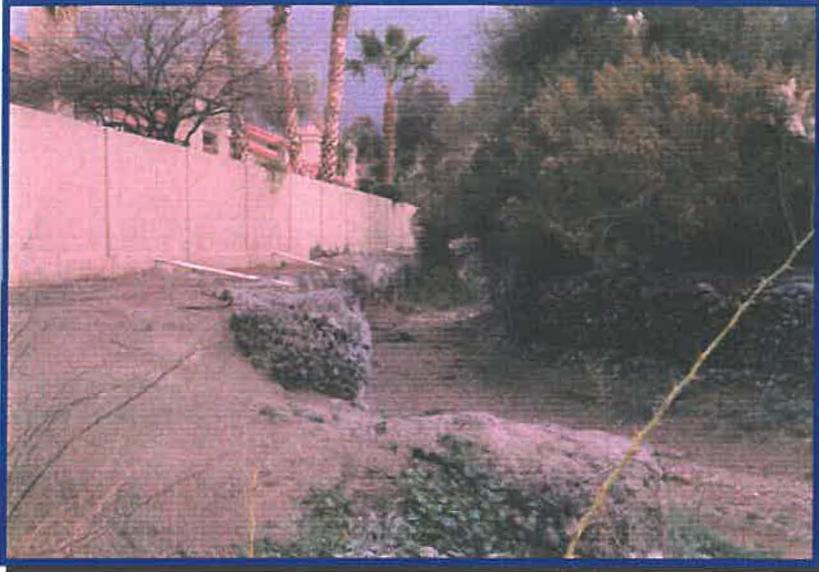
Pic 2.1:

Looking upstream at the Gabion lined channel in Wash-2.

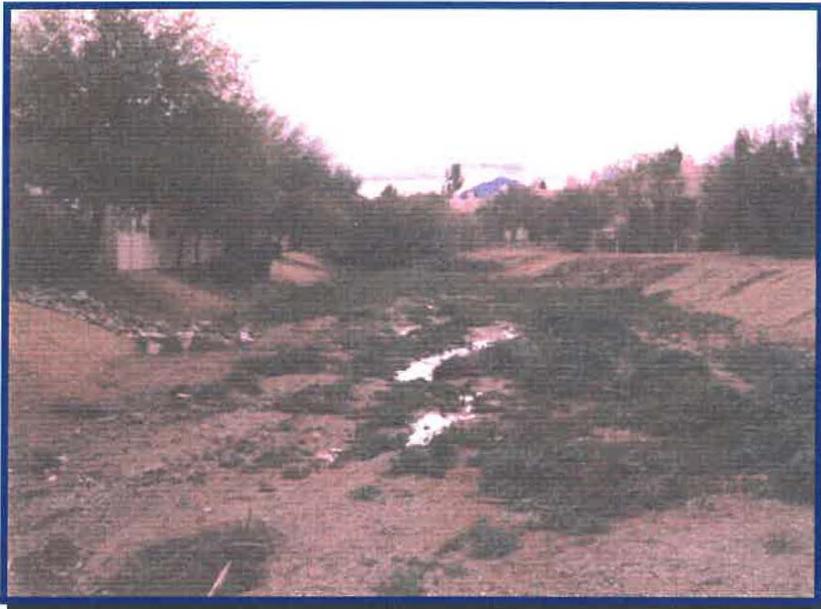
Pic 2.2:

The subject report differs from the Scottsdale Vista II Study on the Q_{100} flows in the two washes. The difference in the flows from these two reports are not that significant compared to the Master Drainage Plan as can be seen from Figures 2 and 4 in Appendix A. All improvements to the subject site were set back approximately 75-feet from the east wash. The east wash remained in its natural condition and no improvements were proposed as can be seen in Pic 2.2 in Appendix B Page 22.

Looking downstream at the earth channel in Wash-2 south of Cholla and approximately 1000-feet west of 96th Street.

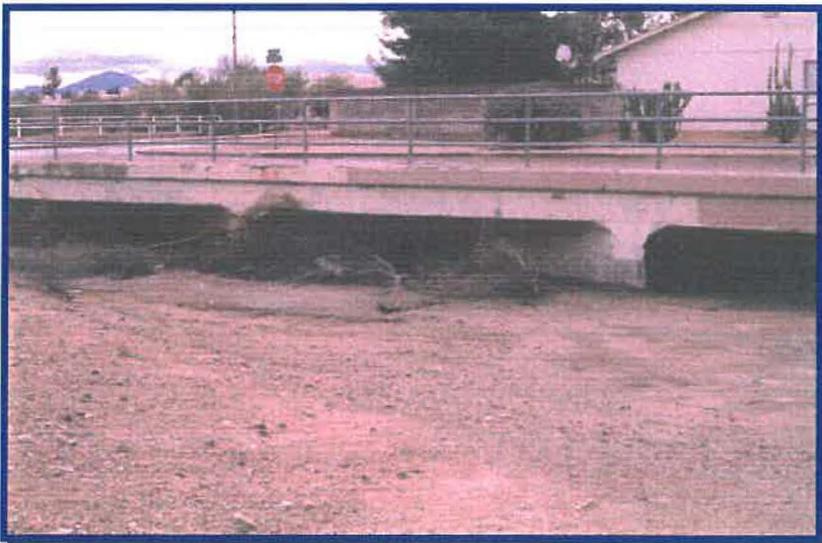
Pic 2.3:

Looking downstream at the 3-barrel box culverts crossing 94th Way & the Cholla intersection.

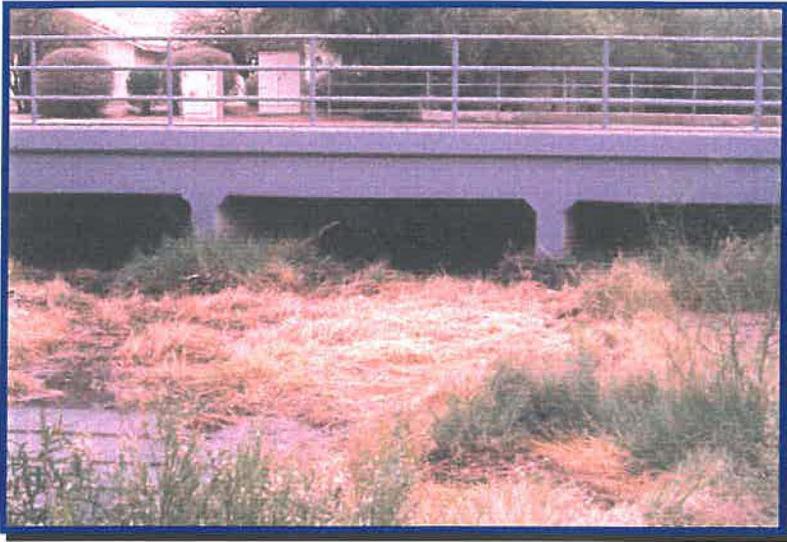
Pic 2.4:

Looking downstream at the 3 Barrel Box Culverts Crossing Poinsettia Drive east of 94th Way. The wash upstream does not appear to be an improved channel.

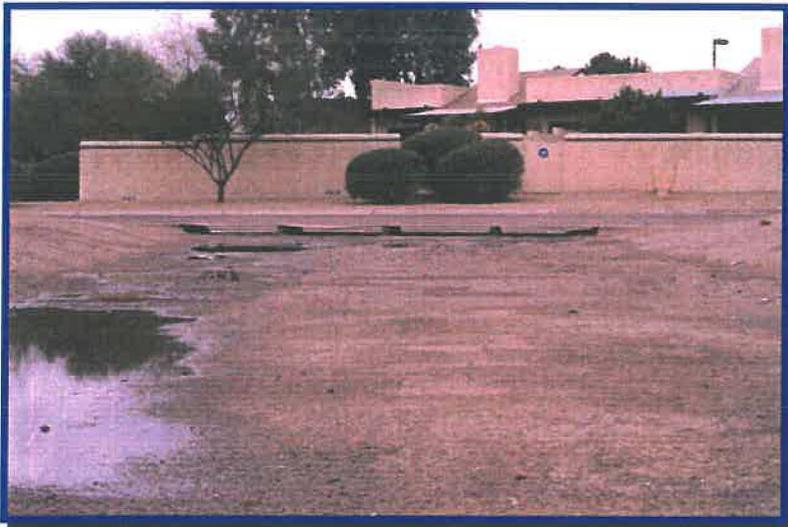
Pic 2.5:

Discharge of street flows from 94th Way into the channel (Wash-2).

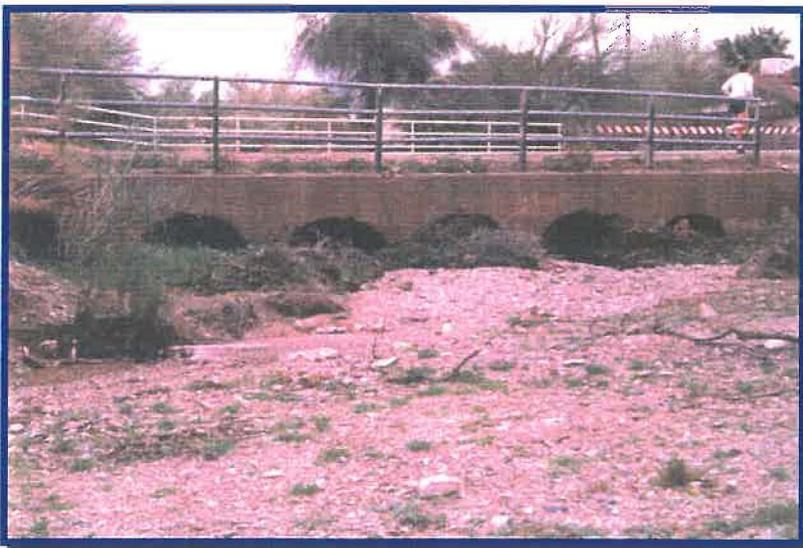
Pic 2.6:

- Channel bottom erosion and sediment and debris deposition in Wash-2 north of Cactus Road, observed during field investigation and as can be seen in Pic 2.6 and 2.7, is caused by the restrictive conveyance of storm flows through an older development area approximately ¼ mile to the north.

Looking downstream at the 6-barrel elliptical CMP pipe crossing Cactus Road approximately 400-feet west of 96th Street.

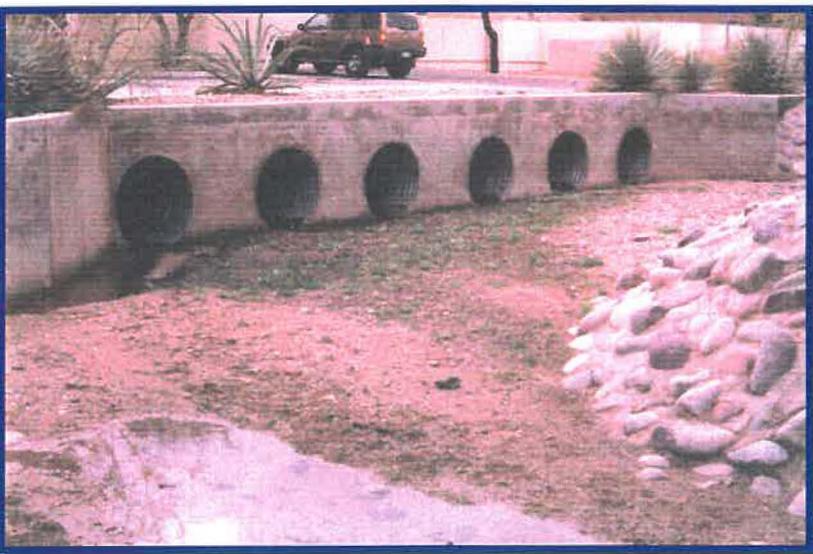
Pic 2.9:

The report provides valuable information about the channel and structure improvements as shown on Pics 2.9, 2B.1, and 2B.2 in Appendix B Pages 24 and 25, and establishes Q₁₀₀ storm flows at both culvert crossings as summarized in Section XII.

Looking downstream at the 6-barrel CMP pipe crossing Oak Drive west of 96th Street. The channel (Wash-2) approaching the pipes are rip-rap lined along the banks and bottom.

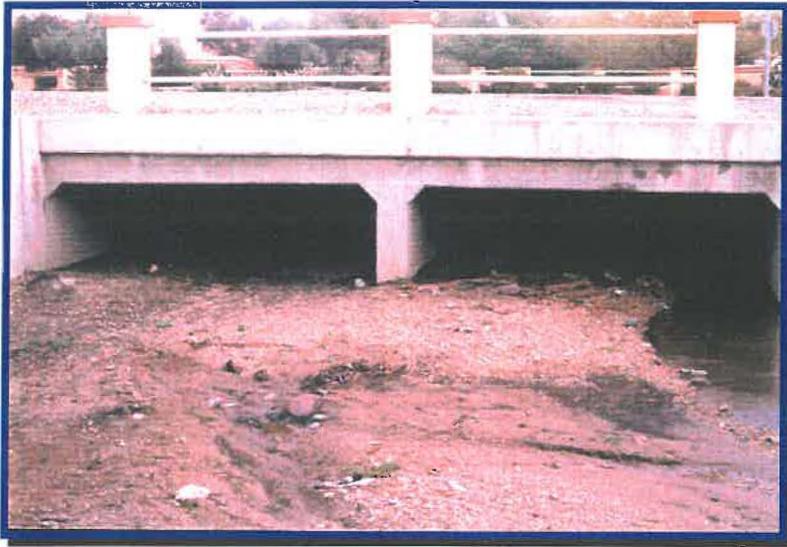
Pic 2B.1:

Looking upstream at the 2-barrel culvert crossing the intersection of 96th Street and Larkspur Drive in Wash-2B.

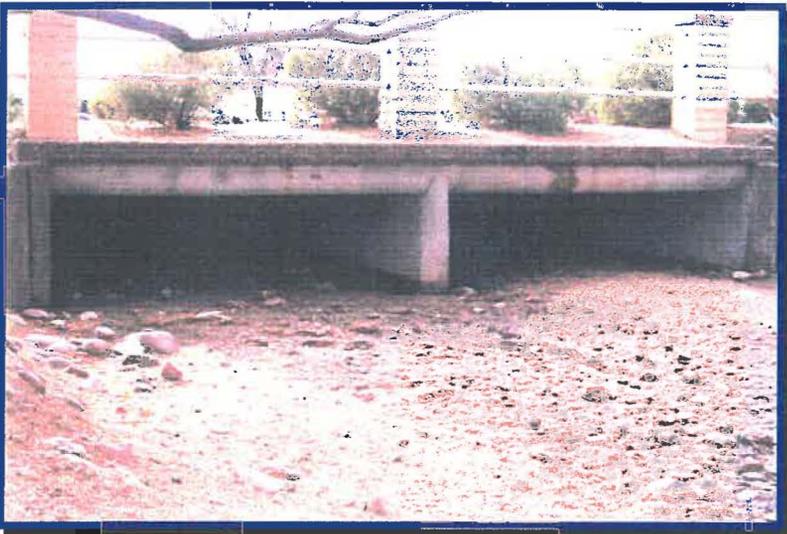
Pic 2B.2:

Looking downstream at the 2-barrel culverts with wing walls crossing the intersection of 96th Street and Larkspur Drive.

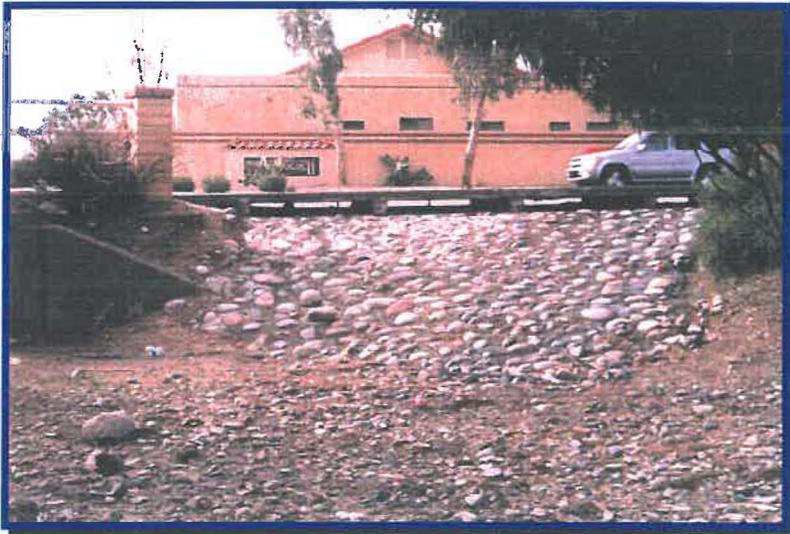
Pic 2B.3:

The sidewalk underdrains conveying street flows from Larkspur Drive into Wash-2B along a rip-rap lined channel at the intersection of 96th Street and Larkspur Drive.

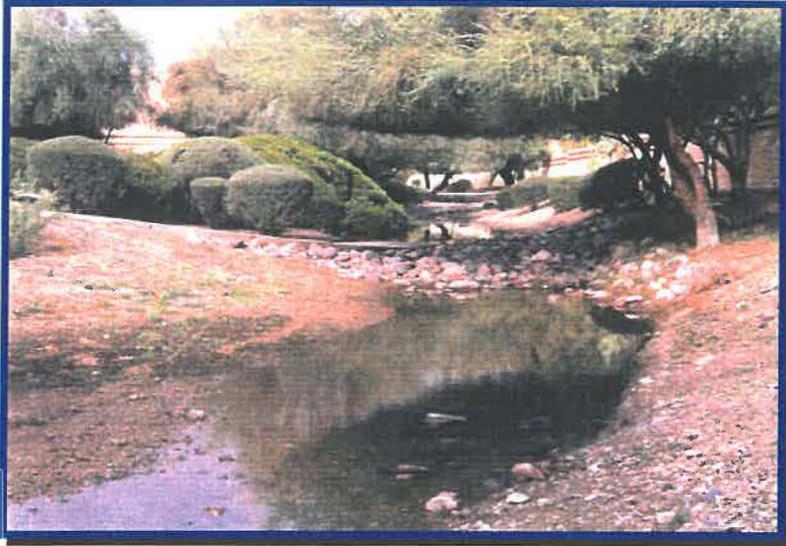
Pic 2B.4:

The Wash-2B looking upstream with equestrian facilities north of Larkspur Drive and east of 96th Street.

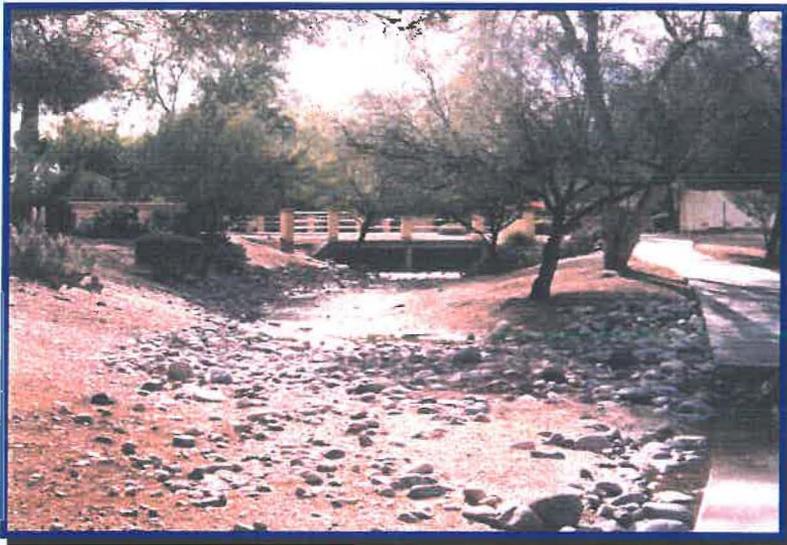
Pic 2B.5:

The Wash-2B looking downstream with the 2-barrel box culverts crossing Sweetwater Avenue. Upstream of this point the wash breaks into two segments.

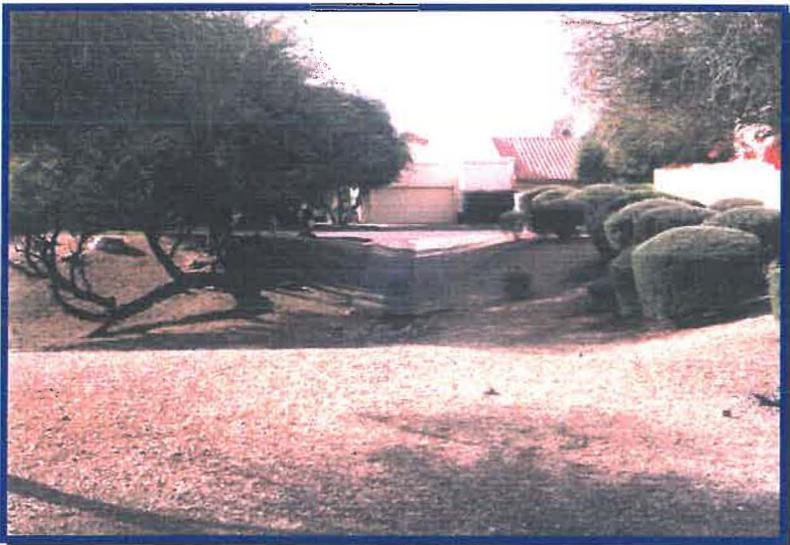
Pic 2B-1.1:

Concrete Valley Gutter discharging flows from Sweetwater Ranch Village into Wash-2B-1.

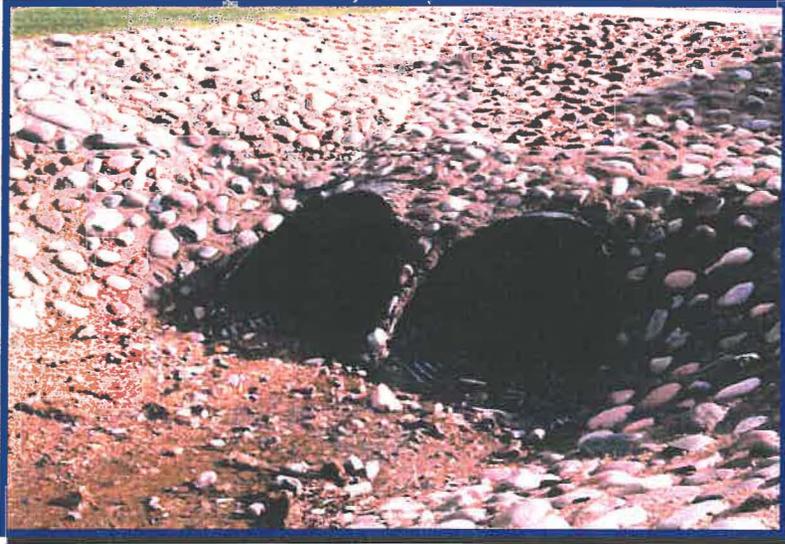
Pic 2B-1.2:

Looking downstream at the two CMP pipes crossing Pershing Avenue approximately 300-feet east of 96th Street.

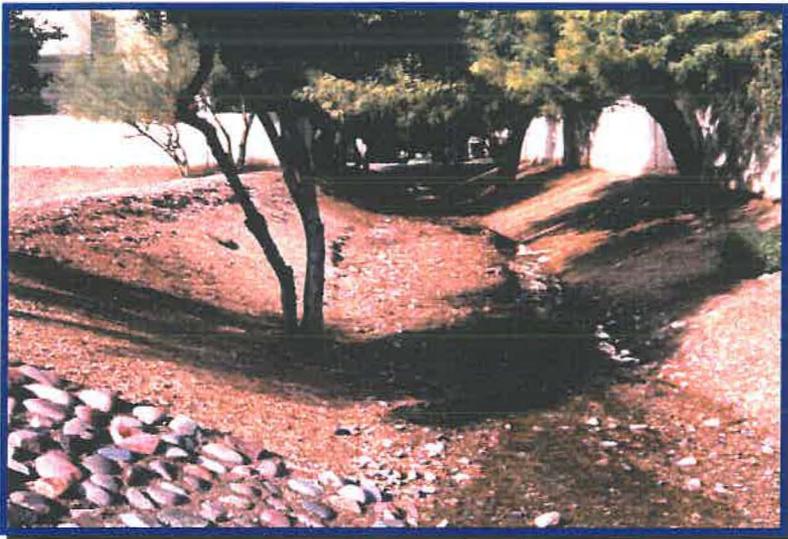
Pic 2B-1.3:

Looking upstream at the improved earthen channel north of Pershing Avenue approximately 300-feet east of 96th Street.

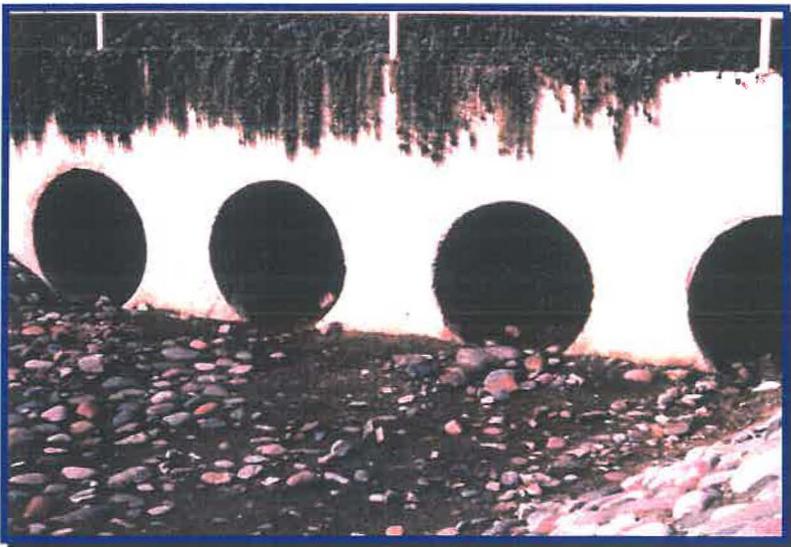
Pic 2B-1.4:

Looking upstream at the improved earthen channel with rip-rap lined banks discharging flows from the 4-barrel CMP pipes crossing Voltaire east of 96th Street.

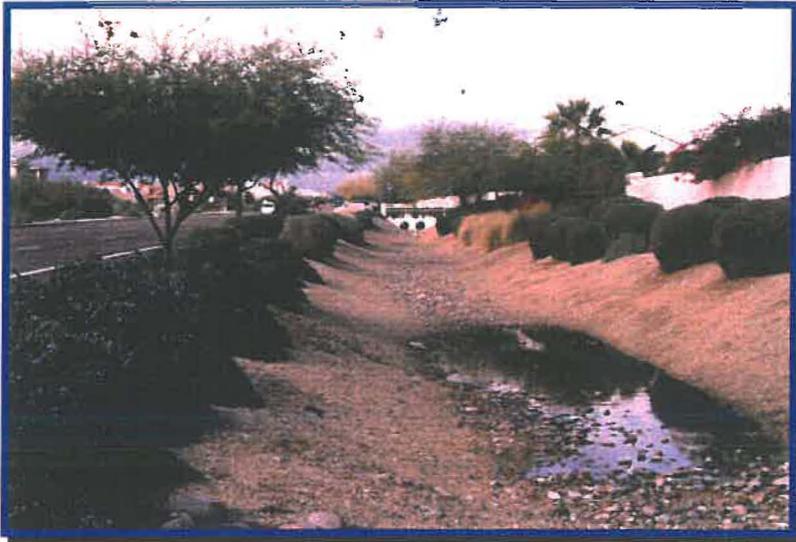
Pic 2B-1.5:

Looking upstream at the improved earthen channel north of Voltaire and along the eastside of 96th Street.

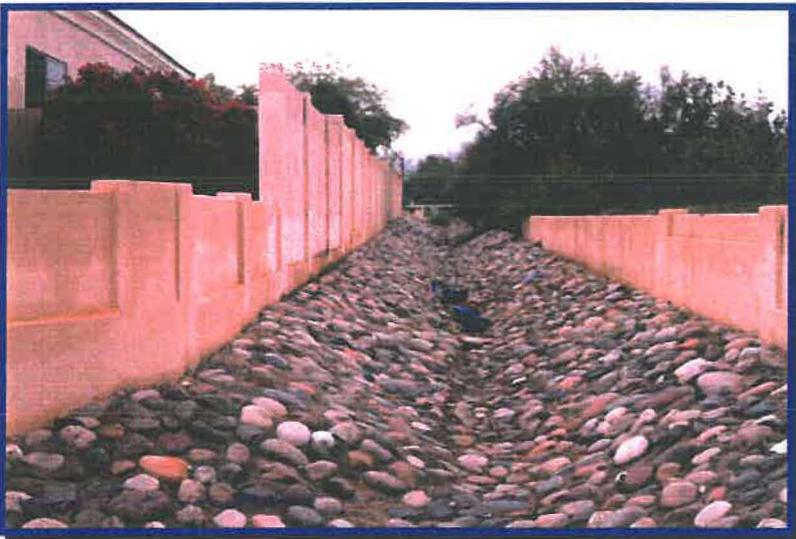
- Pic 2B-1A.1:

The rip-rap lined channel picking up flows from Thunderbird Road and discharging to the storm drain system shown in Pic 2B-1A.2.

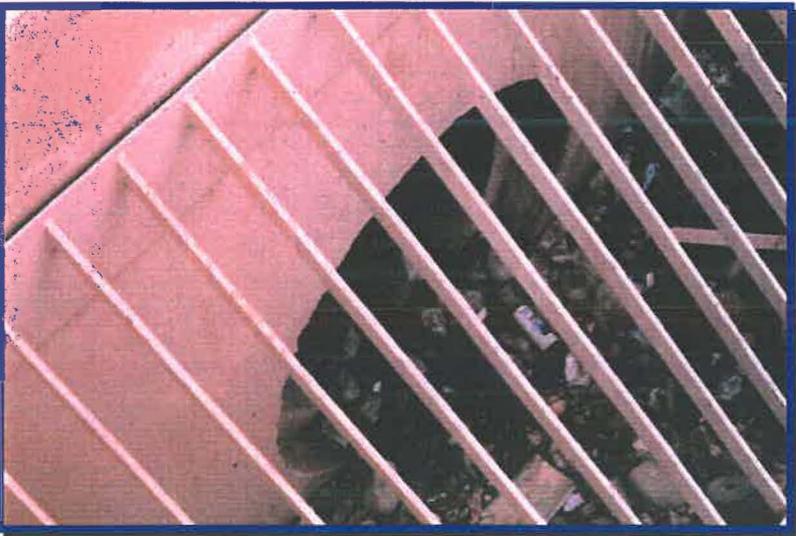
Pic 2B-1A.2:

Looking downstream at the storm drainage inlet with a bar screen at the end of Celtic Drive Cul-de-sac in the Camelot Ranch Subdivision.

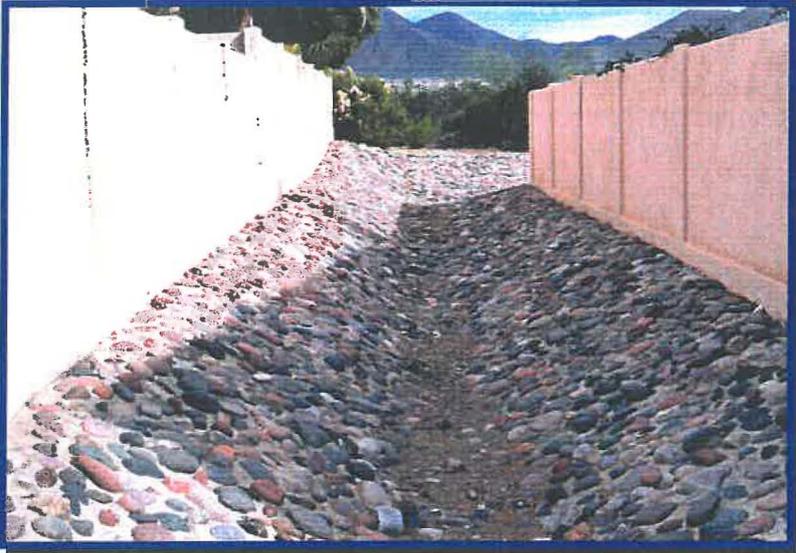
Pic 2B-1A.3:

Looking upstream at the rip-rap lined channel between Celtic Drive and Sharon Drive within the Camelot Ranch Subdivision conveying flows to the storm drain system. Ultimately the storm drain system discharges into Wash-2B-1.

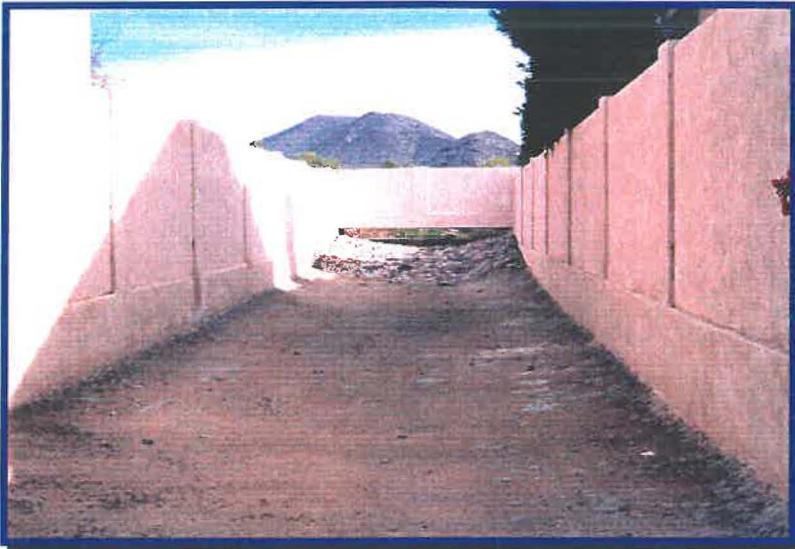
Pic 2B-1A.4:

Looking upstream at the drainage easement within the Camelot Ranch Subdivision conveying off-site flows from the undeveloped property to the east along Voltaire Drive. Ultimately the storm flows been discharge into Wash-2B-1.

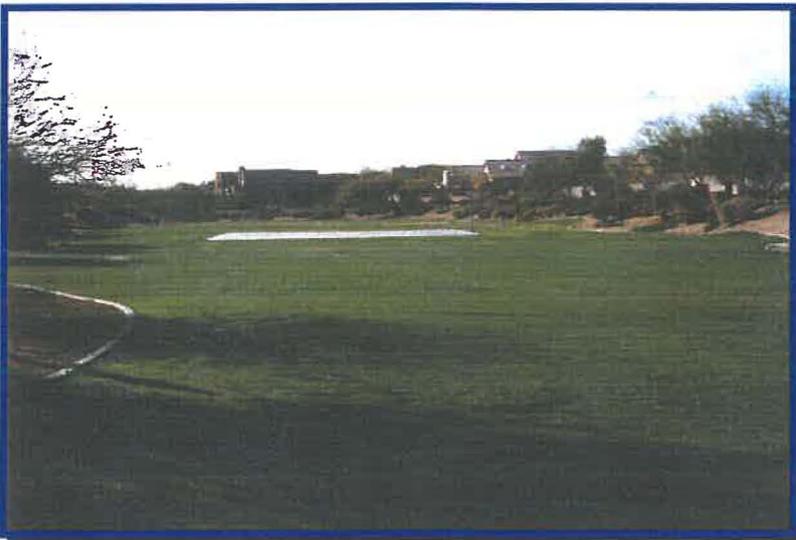
Pic 2B-1.6:

Looking downstream at the retention basin located along the north side of Tunderbird Road within the Vista Del Rincon subdivision conveying the overflow to Wash 2B-1 approximately 350-feet east of 96th Street.

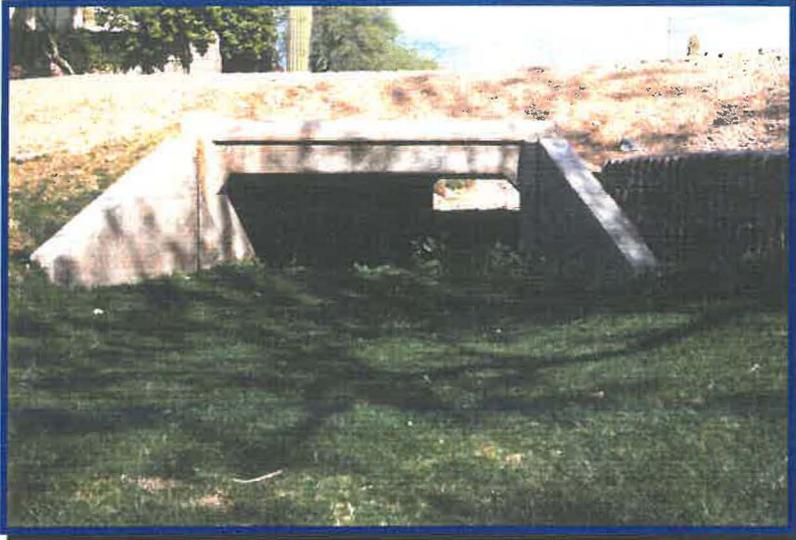
Pic 2B-1.7:

Looking upstream at the box culvert crossing 97th Place with wing walls.

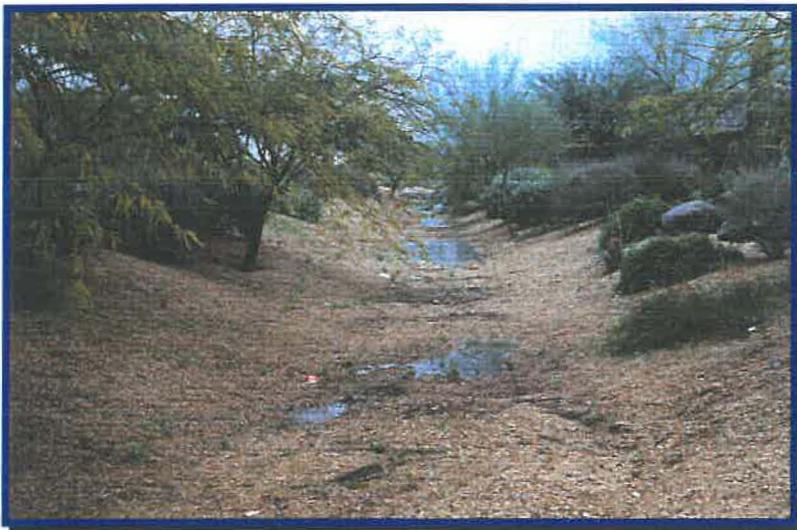
- Pic 2B-1.8:

Looking downstream at the improved graded channel just outside the northeast boundary of Vista Del Rancor along the south side of Frank Lloyd Wright Boulevard.

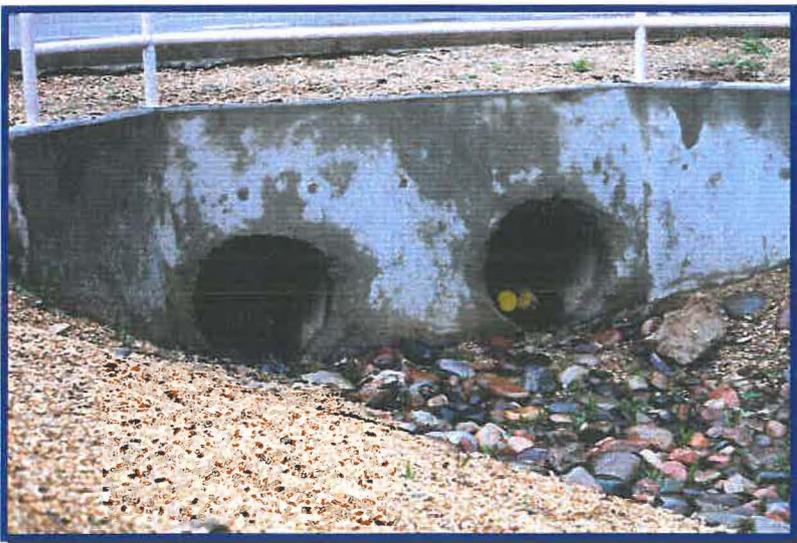
Pic 2B-1.9:

Looking upstream at the 2-barrel RCP pipes crossing Frank Lloyd Wright Boulevard approximately 50-feet east of Redfield Road. The most upstream point of Wash 2B-1.

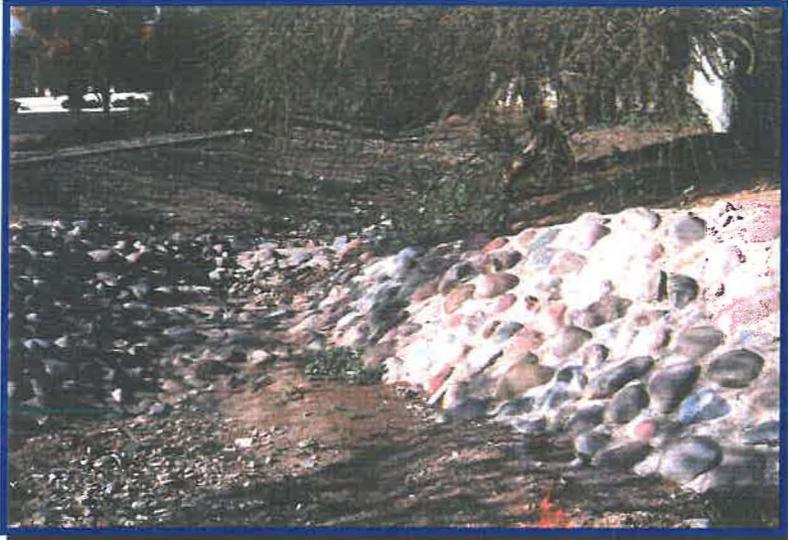
Pic 2A.1:

Looking upstream at the improved earthen channel (Wash-2A) located just north of Oak Drive. The channel at this point breaks-up into two branches, east(Wash-2B) & west(Wash-2A).

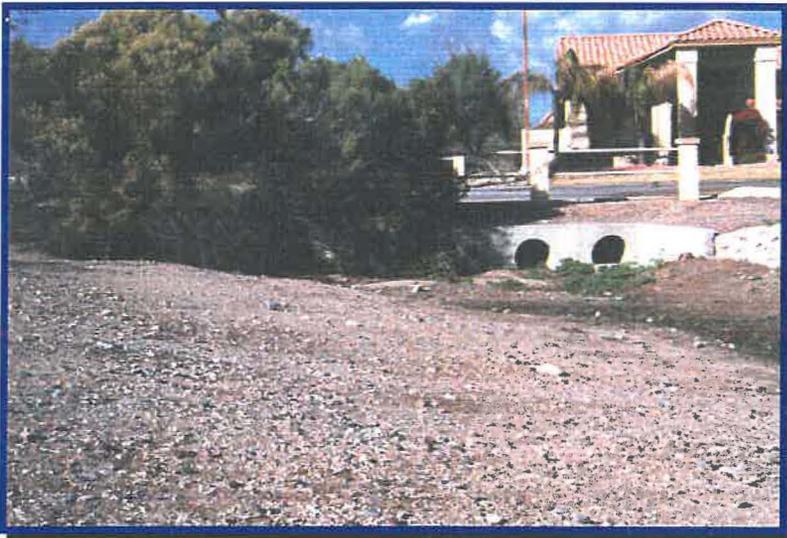
Pic 2A.2:

Looking upstream at the 5-barrel 24"-RCP pipe crossing Larkspur Drive just west of the Eldorado Private School site. The storm flows within Sweetwater Ranch Manor Unit II are part of the off-site flows been discharge at this point.

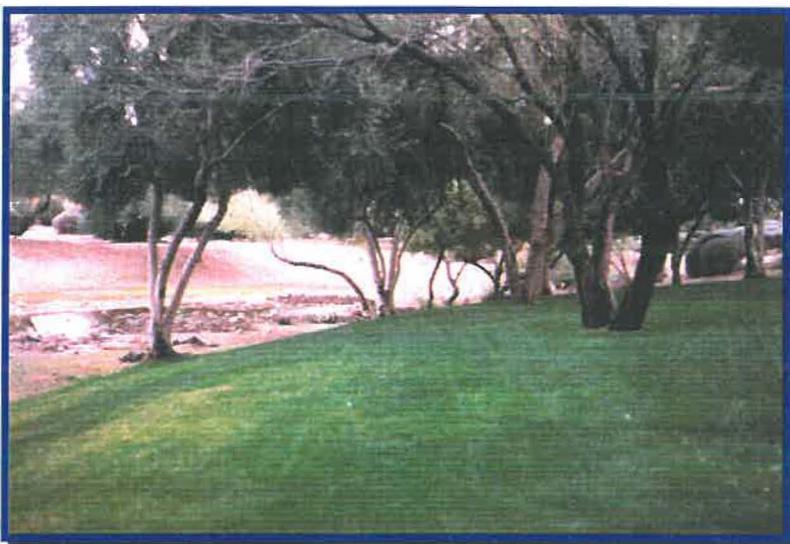
Pic 2A.3:

Looking downstream at the improved earthen channel(Wash-2A), north of Sweetwater Avenue and west of 96th Street.

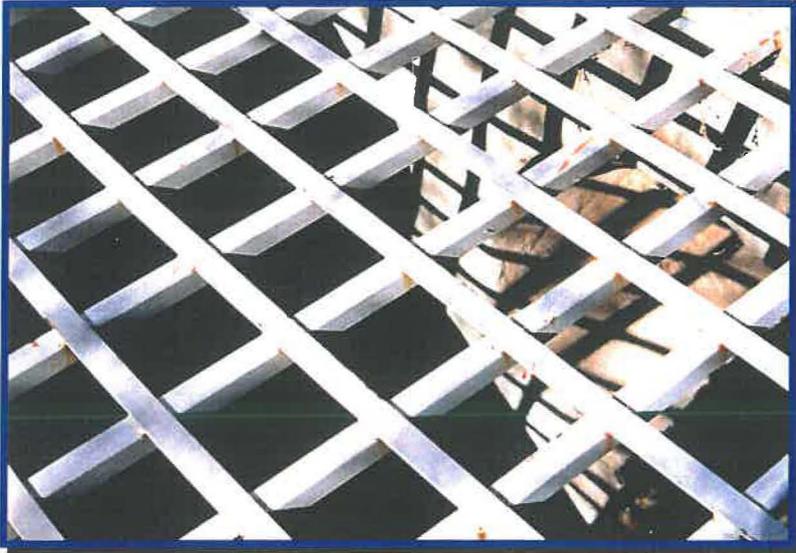
Pic 2A-1.1:

Looking downstream at storm drain inlet located on the south side of Thunderbird Road approximately 450-feet east of 94th Street.

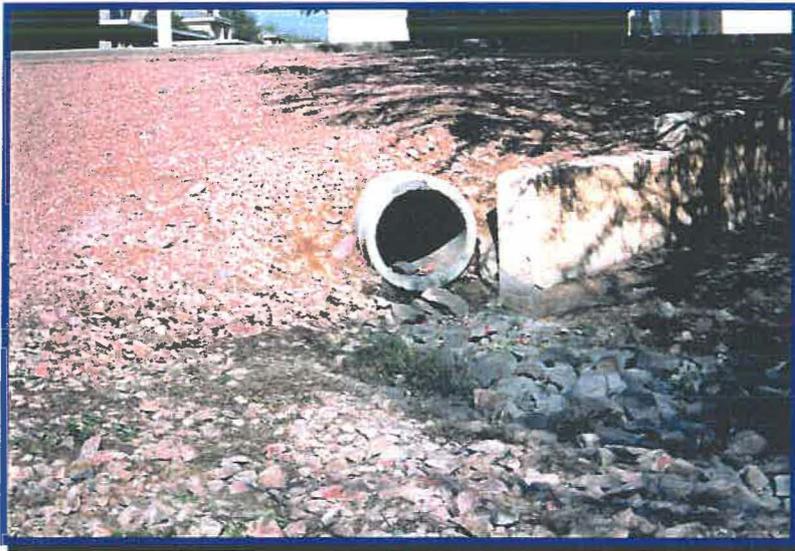
Pic 2A-1.2:

The storm drain pipe outletting flows from the system shown in Pic 2A-1.1 into the retention basin.

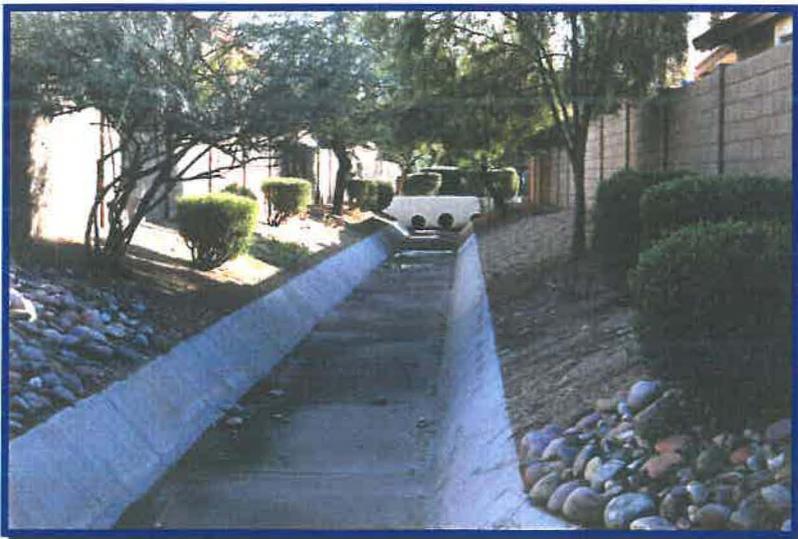
Pic 2A-1.3:

Looking downstream at the concrete lined trapezoidal channel south of Davenport Drive conveying overflow from the property north as shown in Pic 2A-1.2.

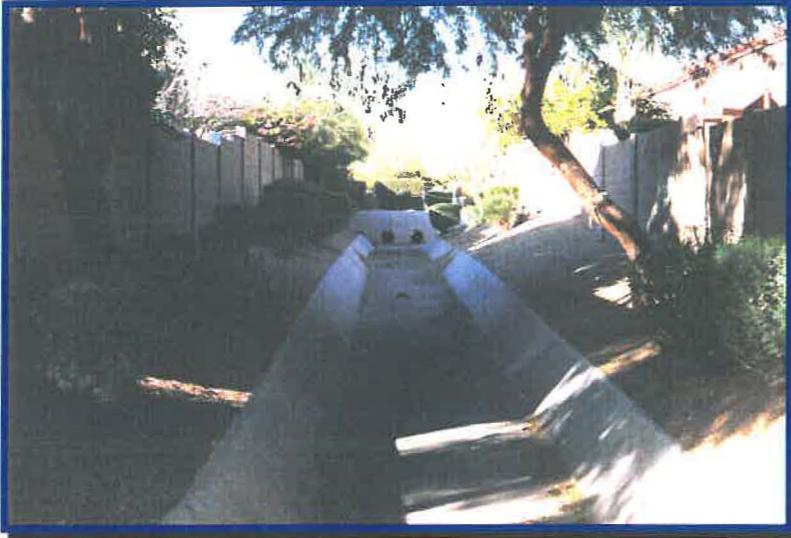
Pic 2A-1.4:

Looking upstream at the concrete lined trapezoidal channel south of Voltaire Drive.

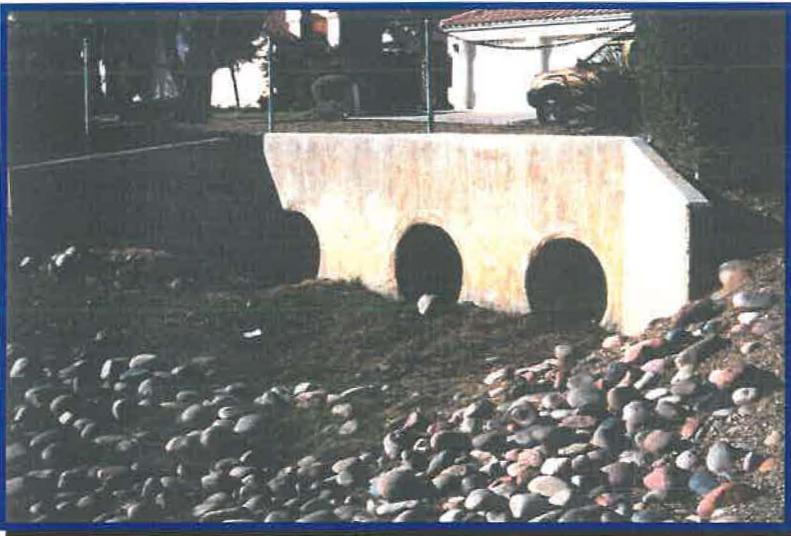
Pic 2A-1.5:

Looking upstream at the 3-barrel RCP pipes crossing Presidio Road.

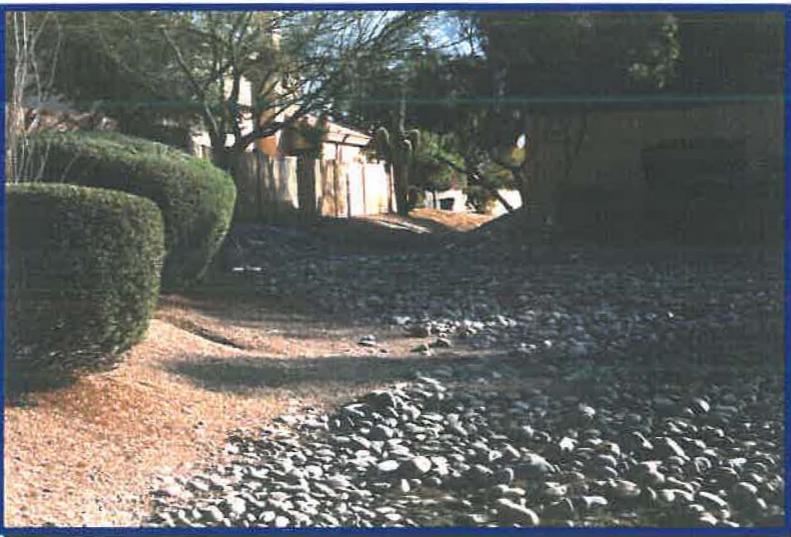
Pic 2A-1.6:

Looking downstream at the rip-rap lined channel conveying overflow from the property north of Sweetwater Ranch Manor.

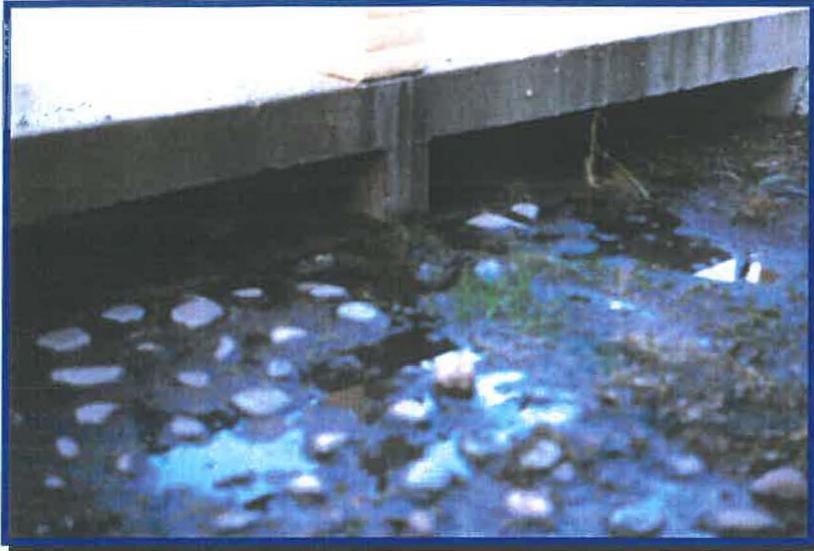
Pic 2A-1.7:

Looking upstream at the 2-barrel box culvert crossing Wood Drive approximately 500-feet east of 94th Street.

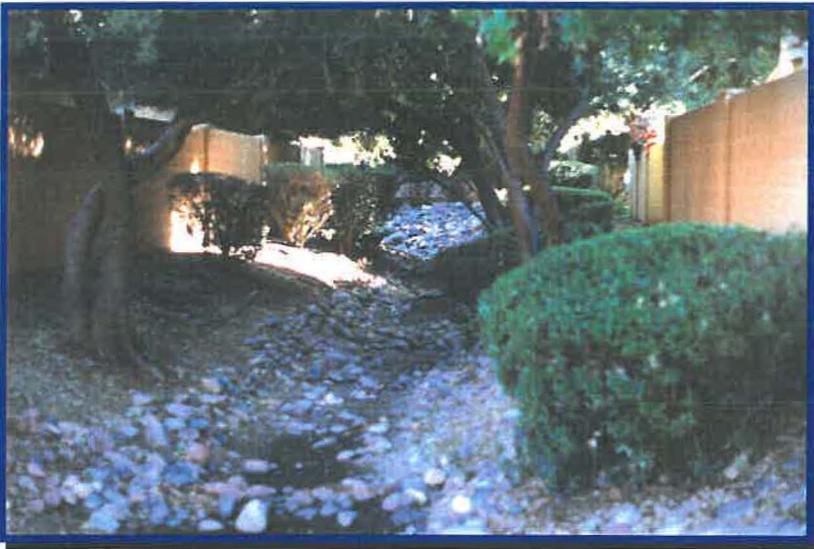
Pic 2A-1.8:

Looking downstream at the rip-rap lined channel turning east and ultimately discharging flows to Wash-2A.

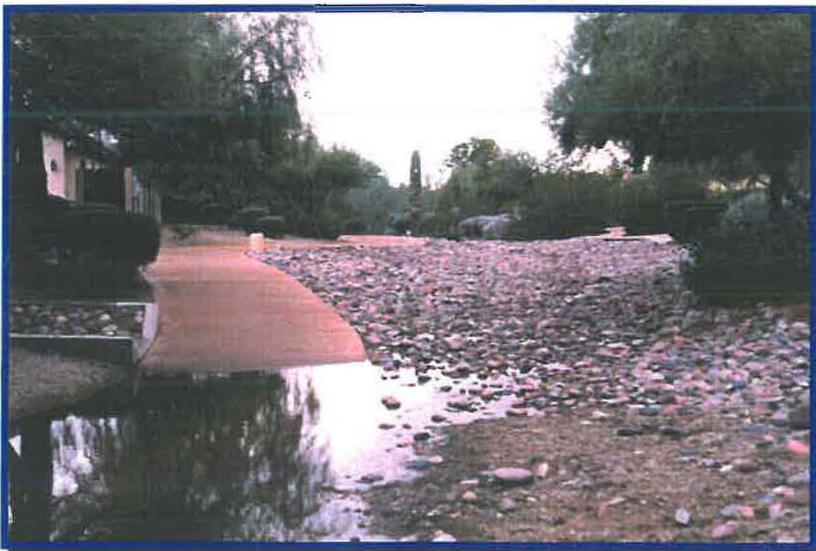
Pic 2A.4:

Looking downstream at Wash-2A from Voltaire Drive cul-de-sac west of 96th Street.

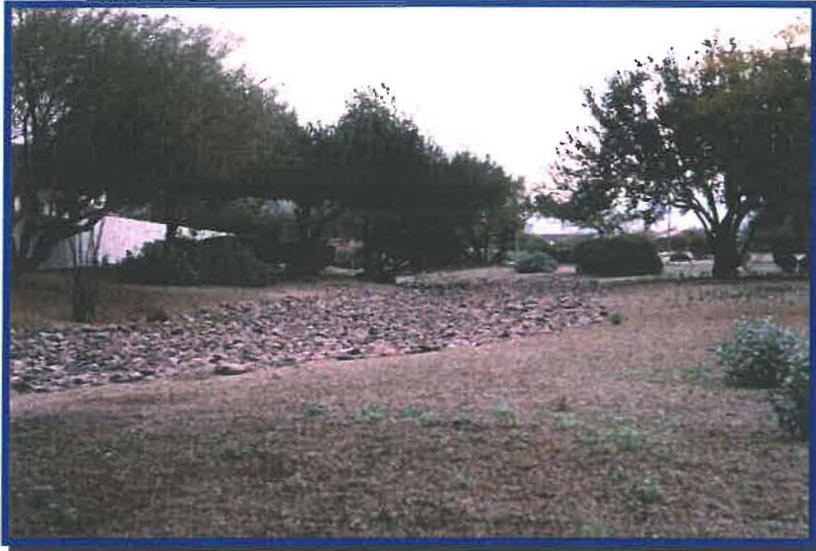
Pic 2A.5:

Looking upstream at the improved channel south of Thunderbird Road and west of 96th Street.

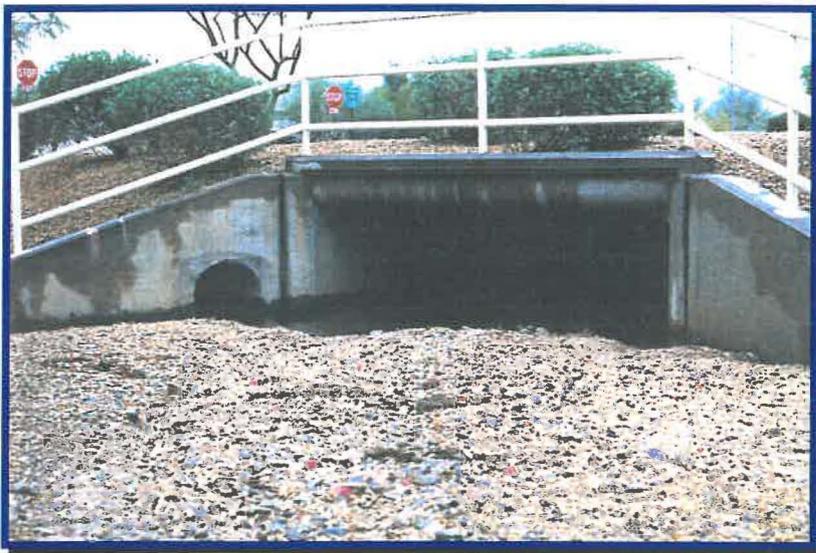
Pic 2A.6:

Looking downstream at the box culvert crossing Thunderbird Road west of 96th Street.

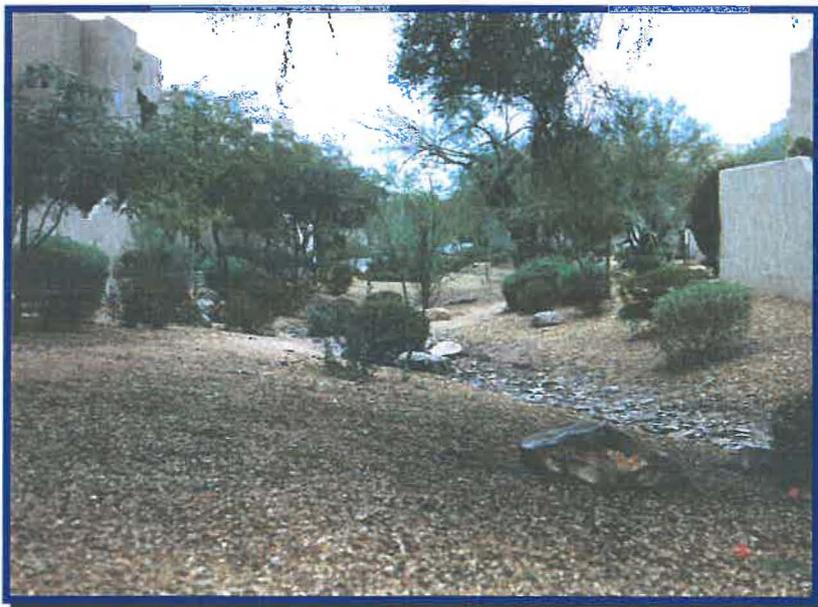
Pic 2A.7:

Looking upstream at the improved channel between the town homes north of Thunderbird Road and approximately 200-feet west of 96th Street.
